NC DEPARTMENT OF TRANSPORTATION  
 DIVISION OF HIGHWAYS  
 STRUCTURE MANAGEMENT UNIT

ATTENTION: **prompt action request, sketches revised**

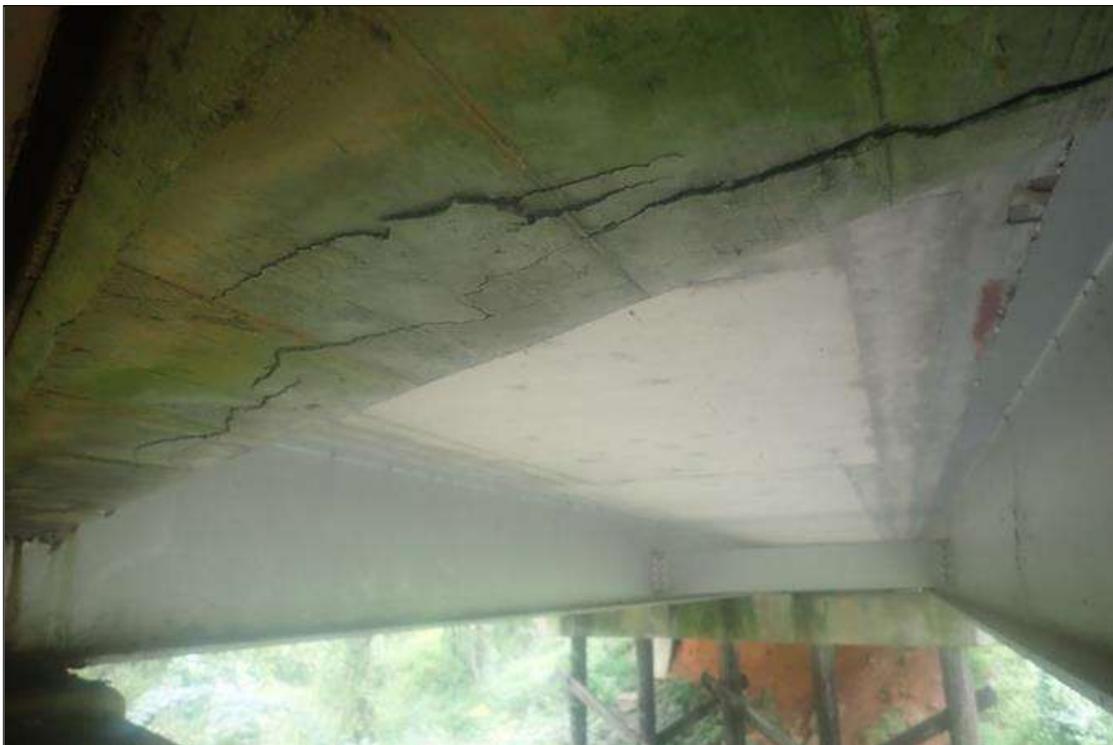
Span 2 Deck: bay 1 end diaphragm at bent 2, delamination (7.5' x 7") with longitudinal cracks (up to 1/8")

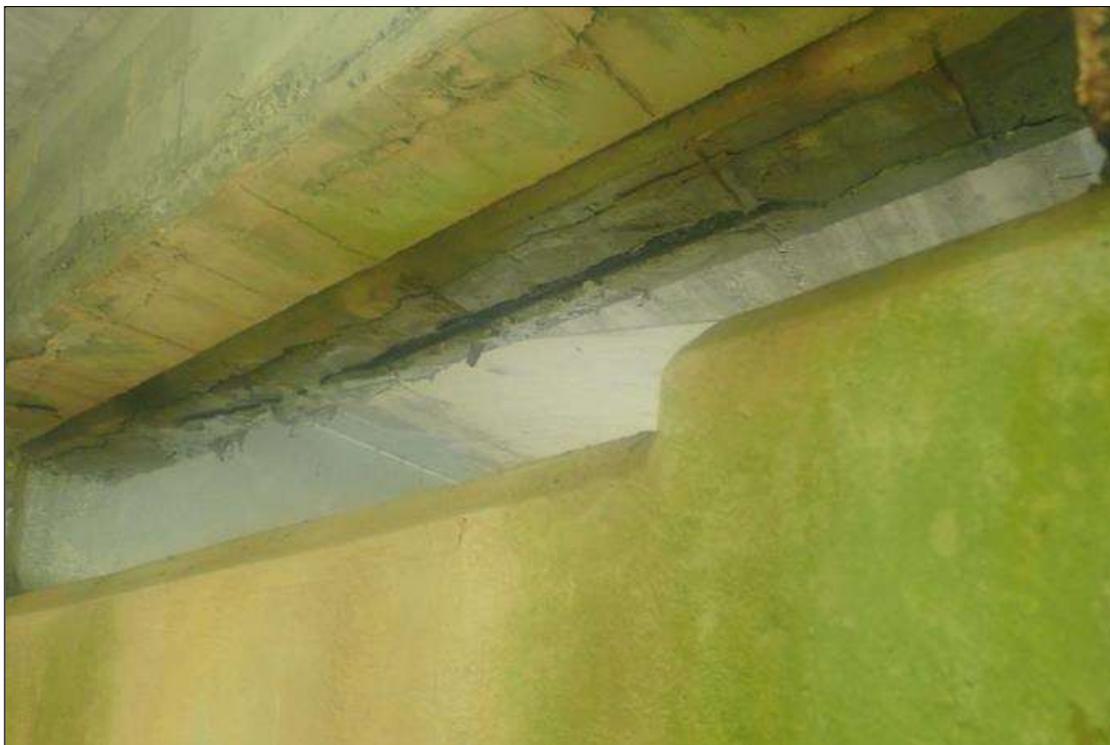
Span 2 Deck: bay 2, end diaphragm at bay 2, spall/delamination (7.5' x 8" x 1.5" deep) with exposed rusted rebar and longitudinal cracks (up to 1/8")

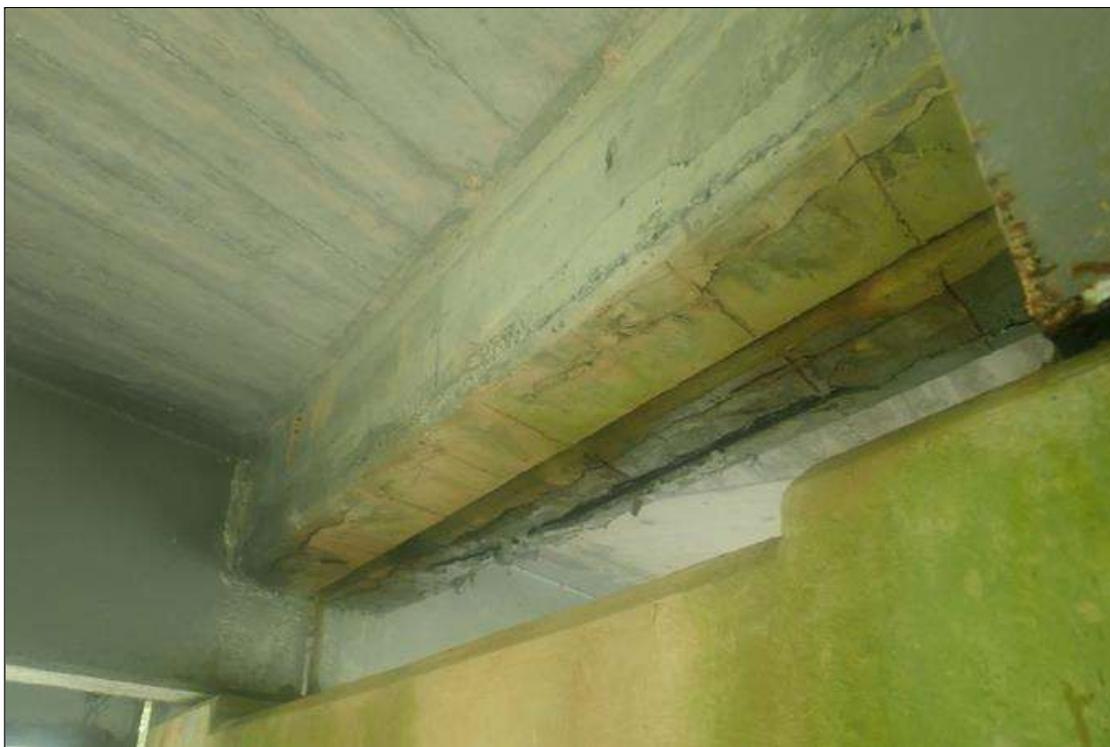
Span 3 Deck: bay 2, end diaphragm at bent 2, spall/delamination (7.5' x 9" x 1/2" deep) with longitudinal cracks (up to 1/8")

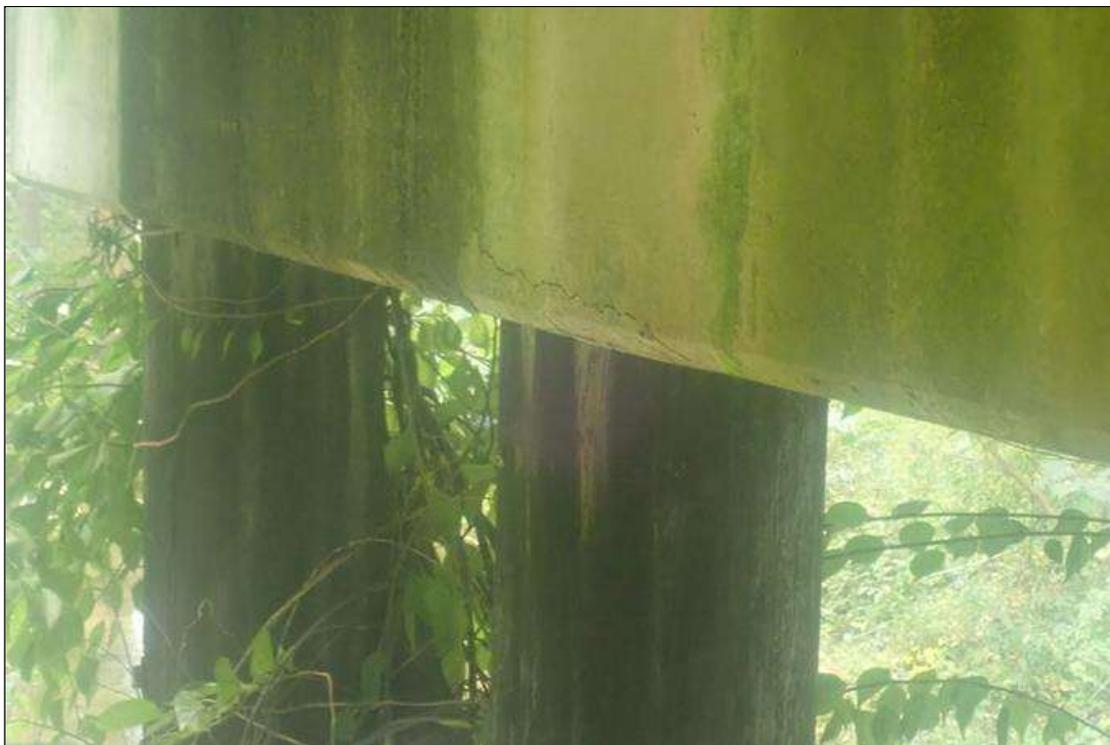
Bent 2 Cap 1: span 3 face, adjacent to piles 2 and 4, delaminations (up to 3.5' x 6") with longitudinal cracks (up to 1/8")

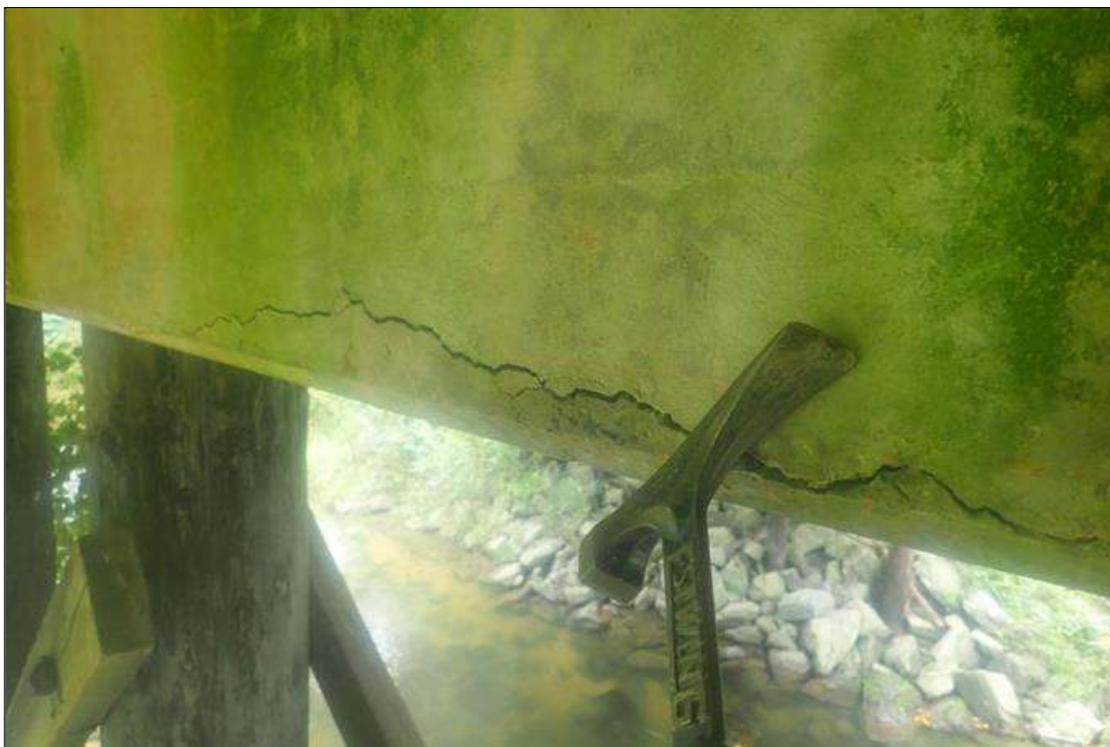
Bent 2 Cap 1: span 3 face, adjacent to piles 2 and 4, delaminations (up to 3.5' x 6") with longitudinal cracks (up to 1/8")

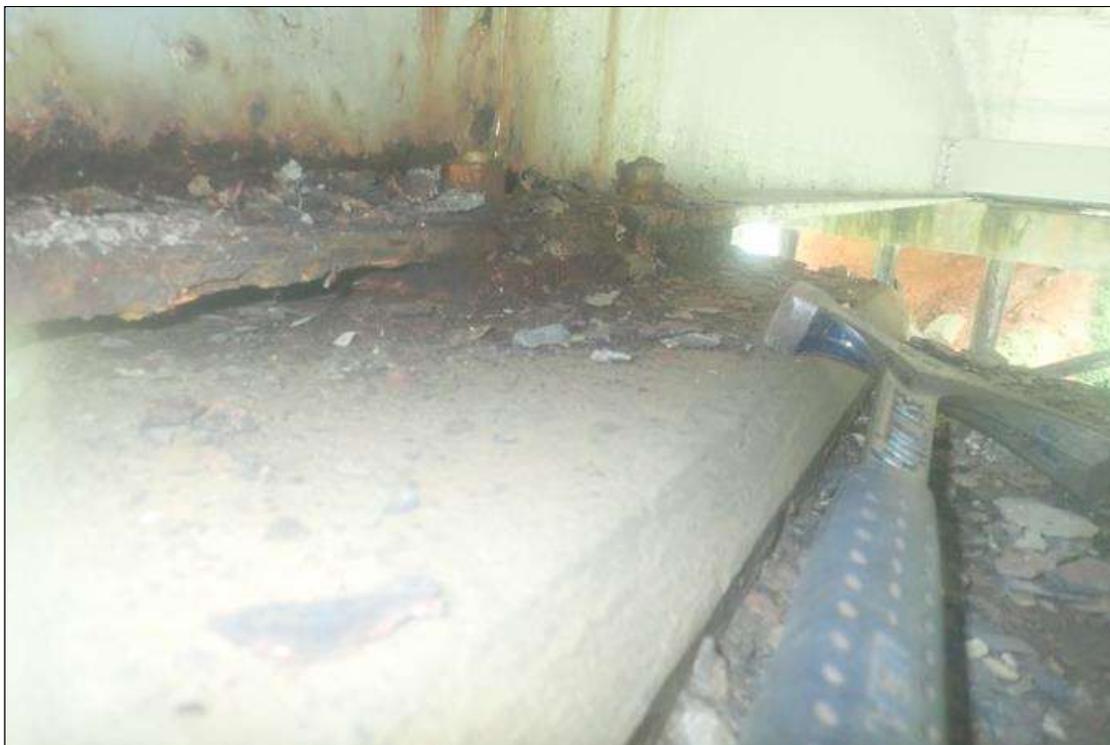
Span 3 Beam 2 - Near Bearing 2: rust scale

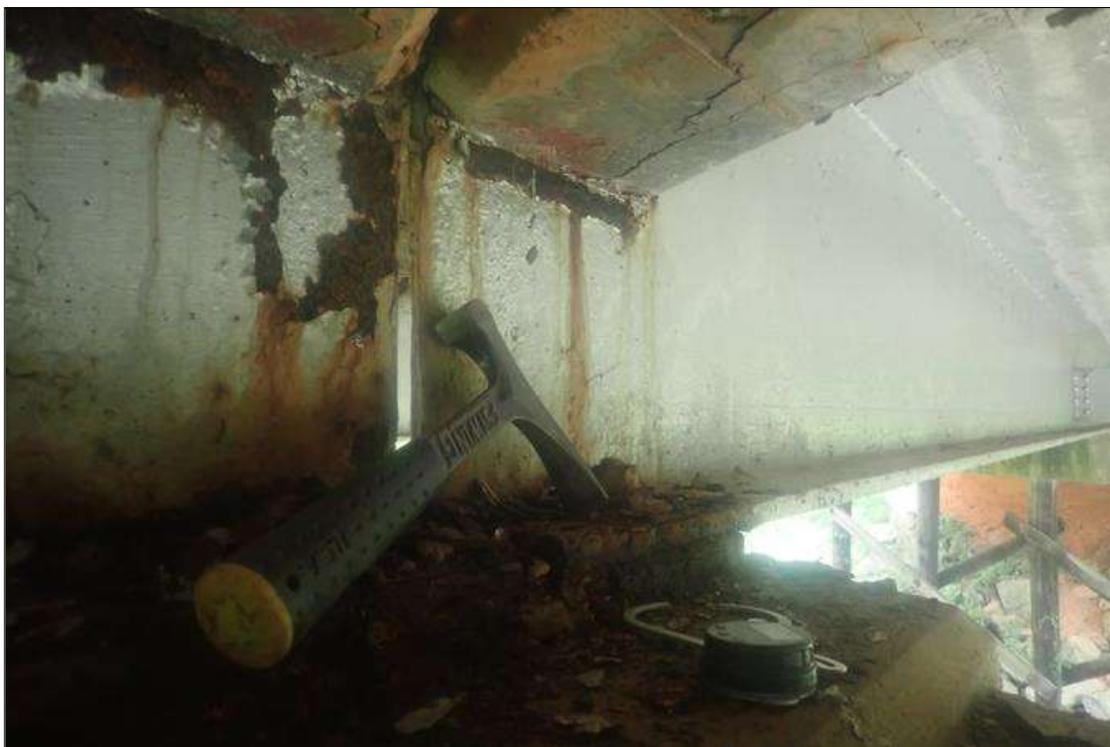
Span 2 Beam 2: (PAR) at bent 2, corrosion with section loss to bottom flange (0.55" average remaining x 1') and web adjacent to end diaphragm (3/8" average remaining x 1' x 1")

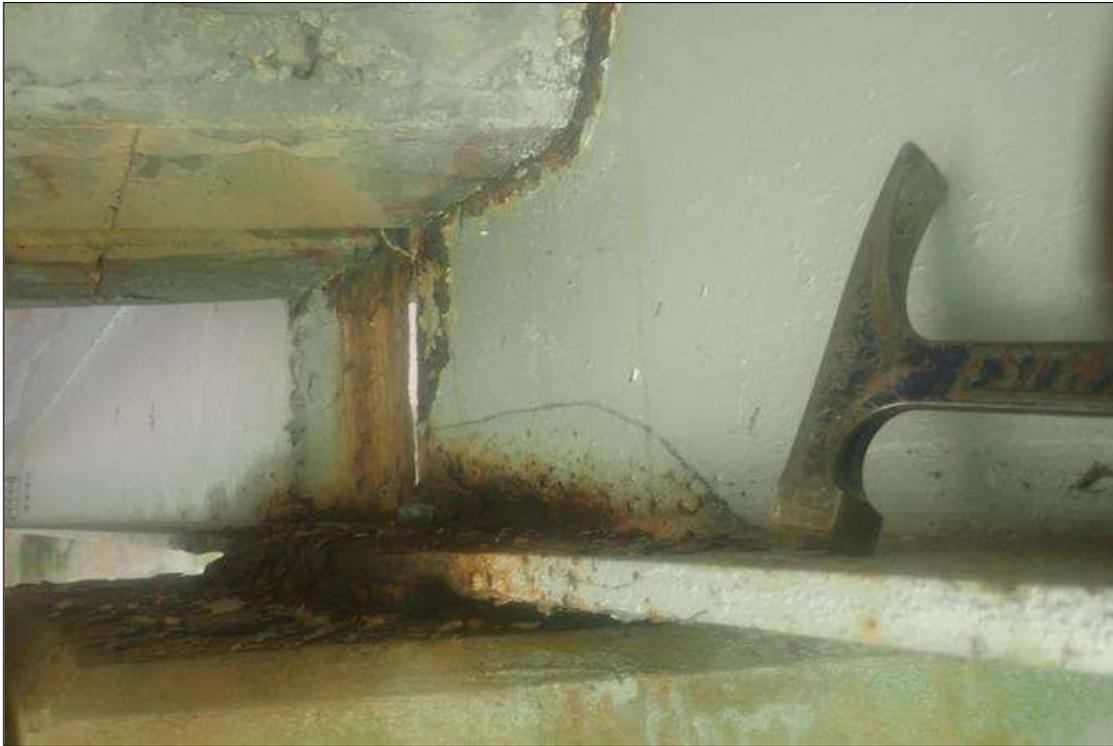
Span 3 Beam 2: (PAR) at bent 2, corrosion with section loss to bottom flange (0.54" average remaining x 1'); lower web (5/16" average remaining x 20" x up to 2" high); web adjacent to end diaphragm (3/8" average remaining x 1' x 1")

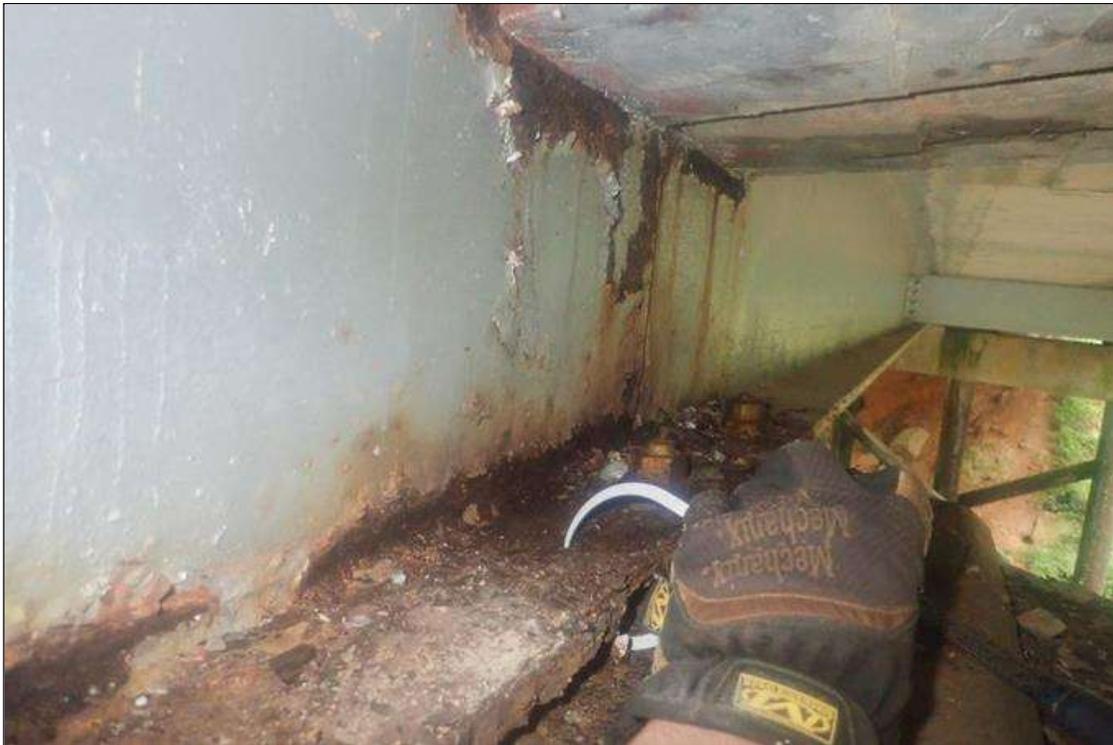
Span 3 Beam 2: (PAR) at bent 2, corrosion with section loss to bottom flange (0.54" average remaining x 1'); lower web (5/16" average remaining x 20" x up to 2" high); web adjacent to end diaphragm (3/8" average remaining x 1' x 1")

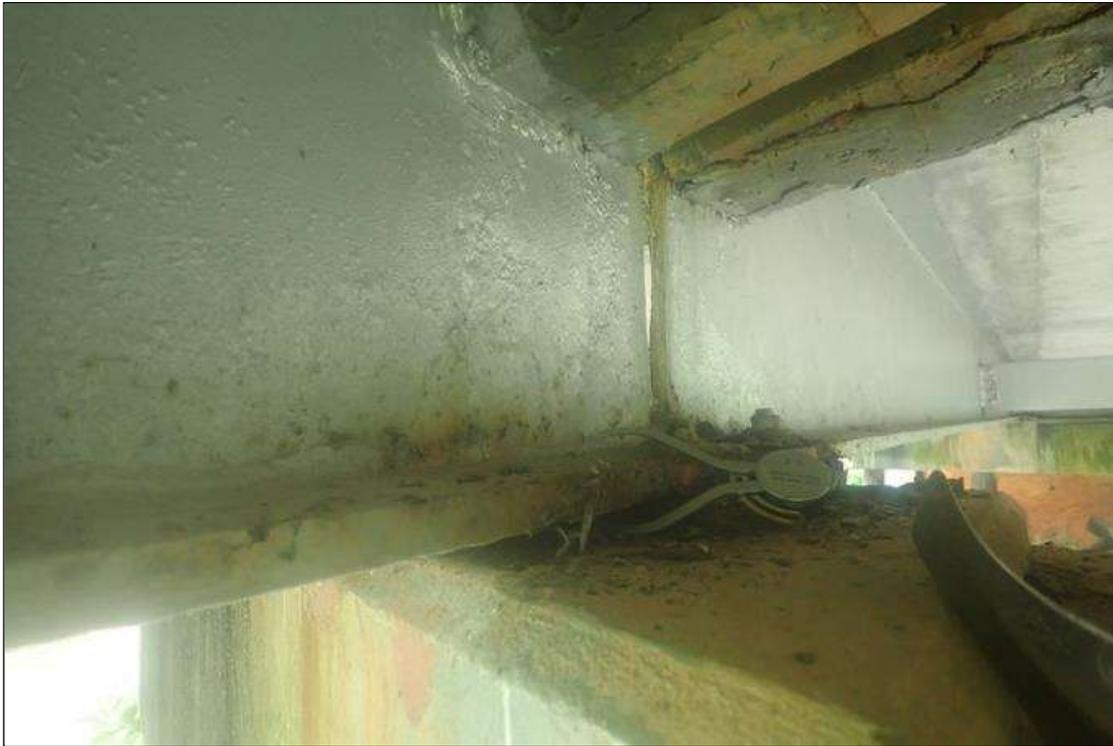
Span 3 Beam 3: (PAR) at bent 2, corrosion with section loss to bottom flange (0.60" average remaining x 1'); pitting in web (up to 1/16" deep x 1' x 10") previously painted over

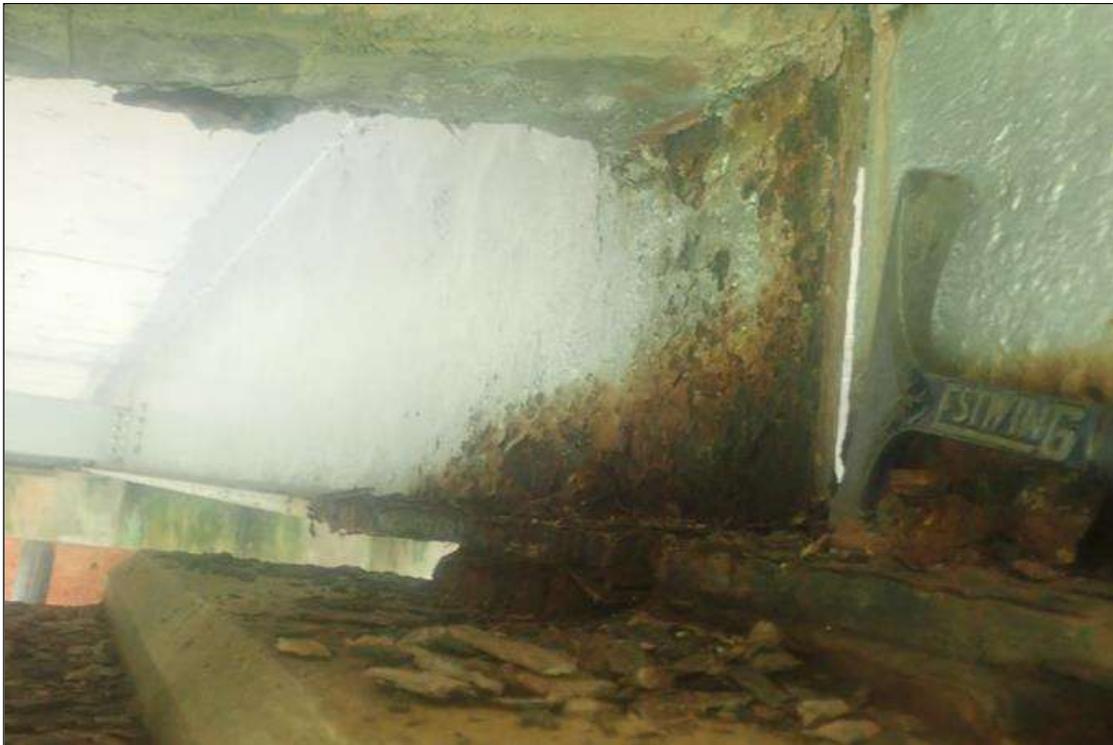
Span 2 Beam 3: (PAR) at bent 2, corrosion with section loss to bottom flange (0.50" average remaining 2') and web (3/8" average remaining x 2' x up to 10")

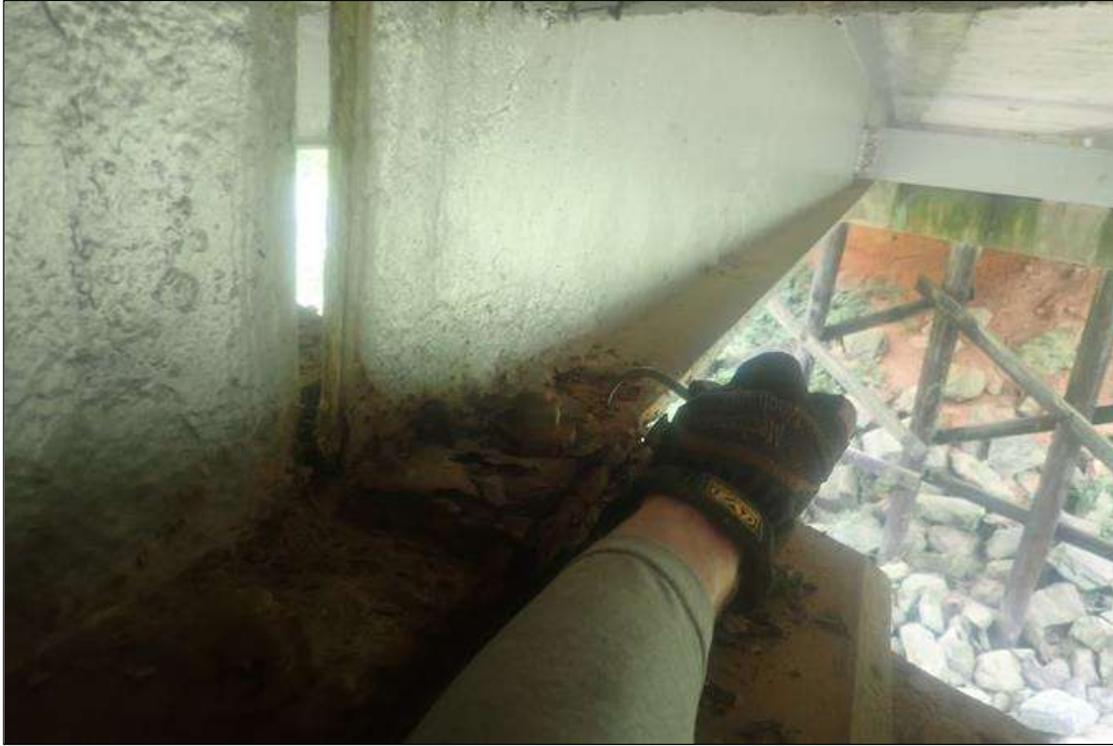
Span 2 Beam 3: (PAR) at bent 2, corrosion with section loss to bottom flange (0.50" average remaining 2') and web (3/8" average remaining x 2' x up to 10")

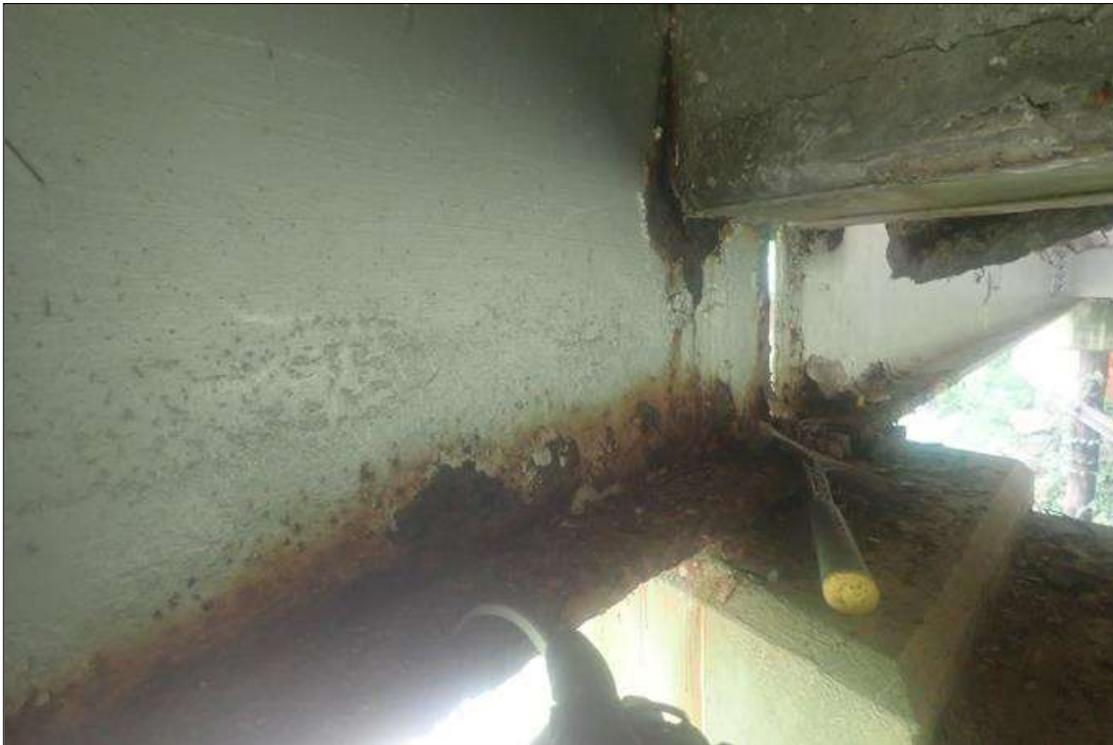
Span 3 Beam 4: (PAR) at bent 2, corrosion with section loss to bottom flange (0.72" average remaining x 5') and lower web (5/16" average remaining x 5' x 3"); web adjacent to end diaphragm (3/8" average remaining x 14" x up to 9")

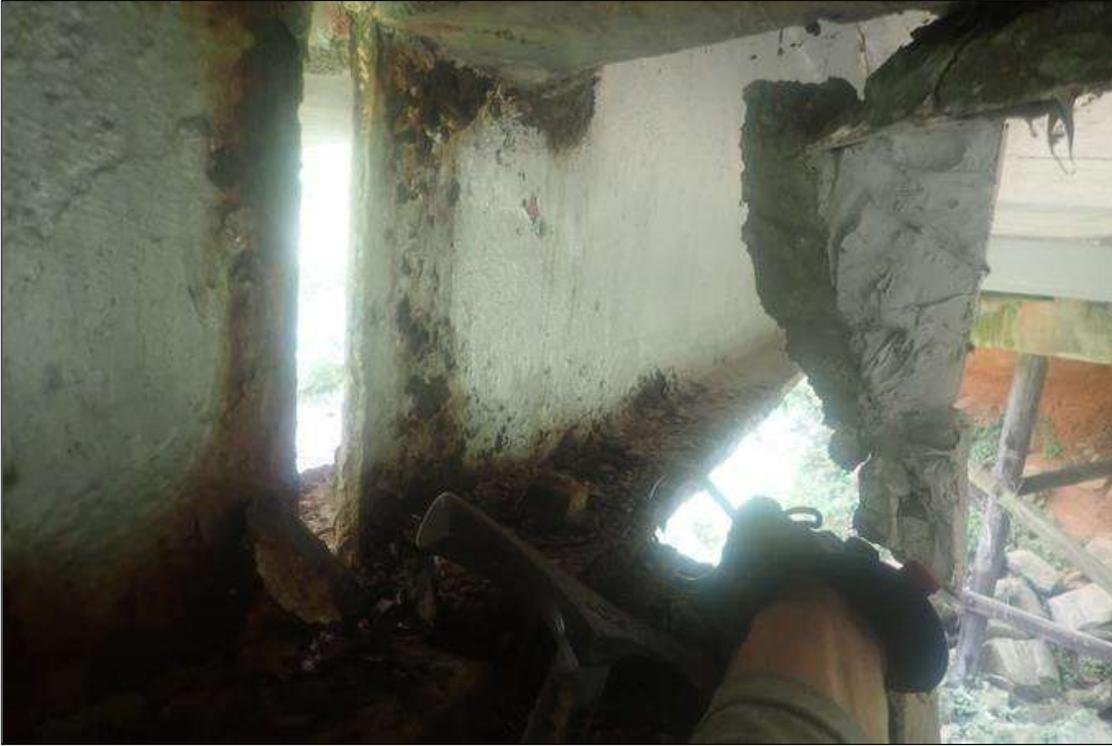
Span 2 Beam 4: at bent 2, corrosion with section loss: bottom flange (0.72" average remaining x 1.5'); lower web (7/16" average remaining x 1.5' x 1"); web adjacent to end diaphragm (7/16" average remaining x 1' x up to 4")

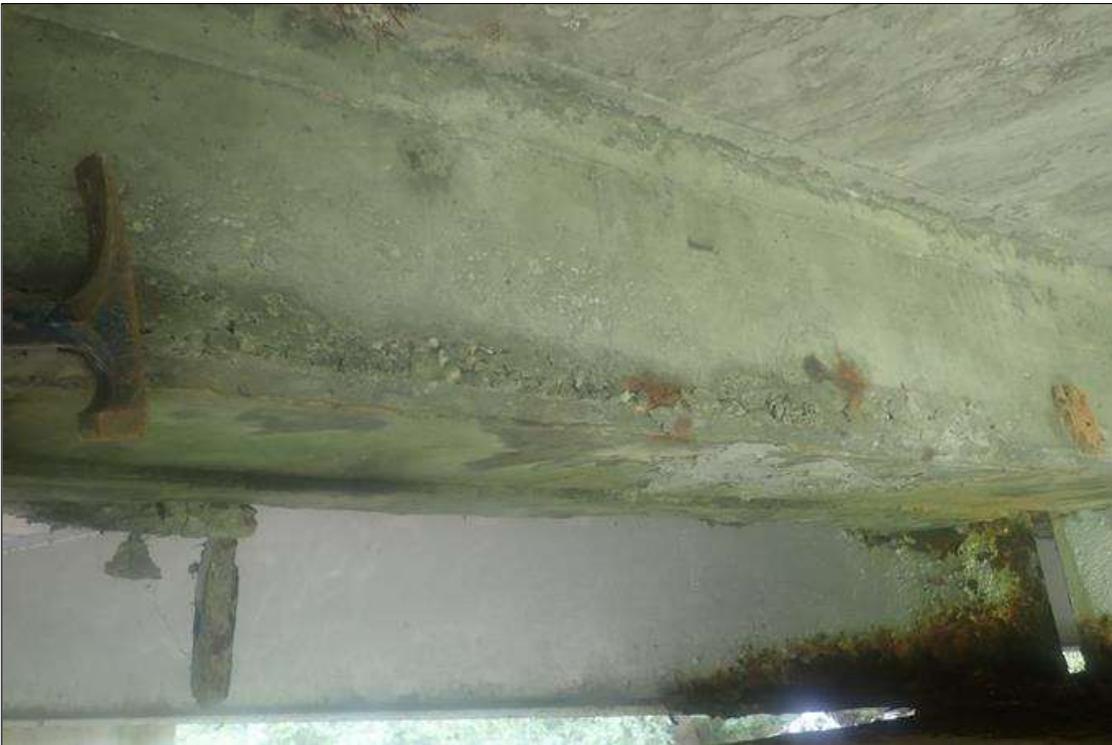
Span 3 Deck: bay 3, end diaphragm at bent 2, delamination (7.5' x 5") with longitudinal cracks (up to 1/16") with rust stains

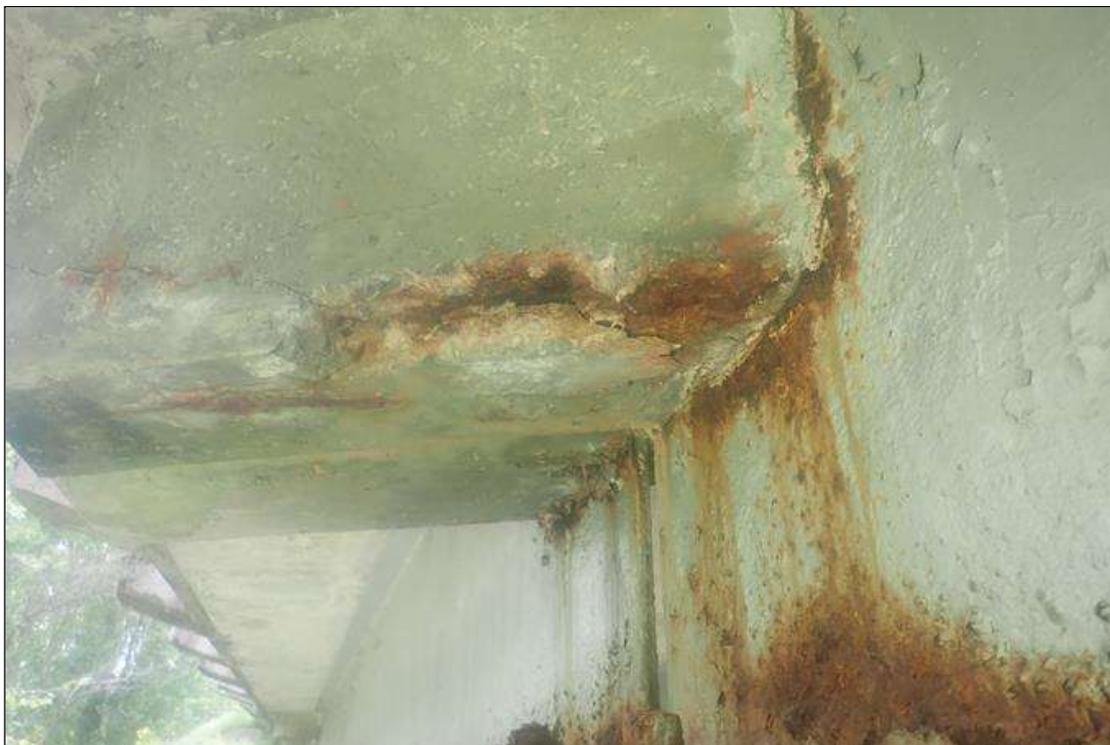
Span 3 Deck: at bent 2 outside of beam 4 end diaphragm, spall (1' x 6" x 1.5") with exposed rusted rebar

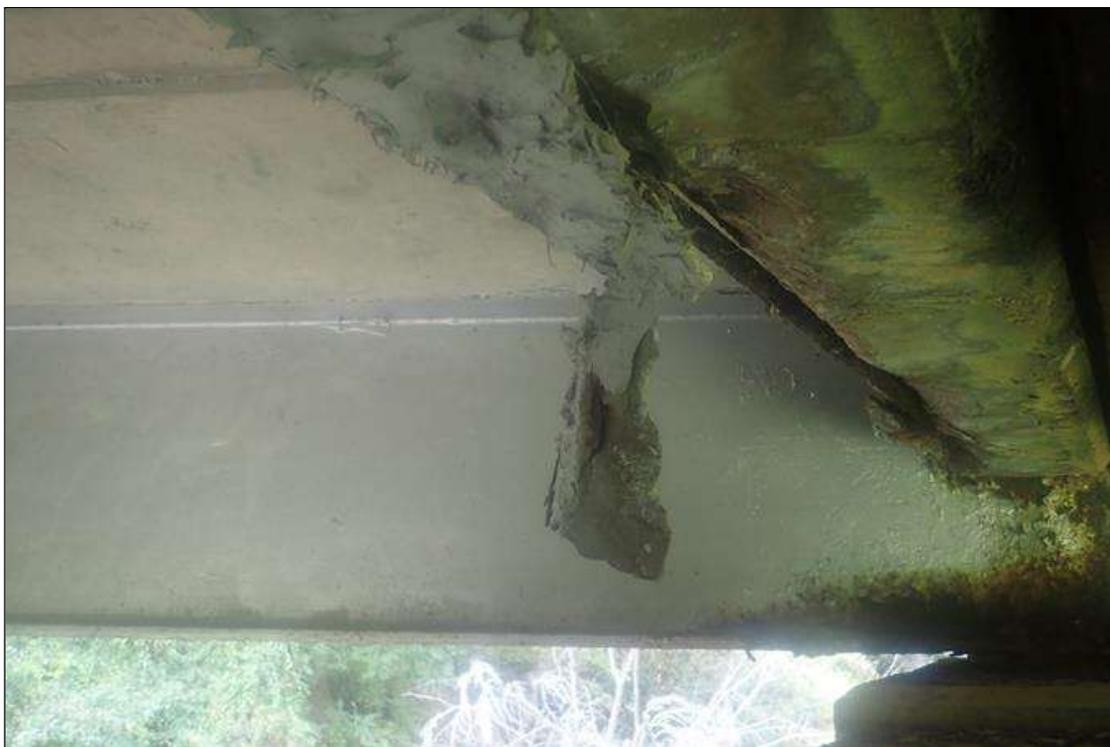
Span 2 Deck: at bent 2 bay 3 end diaphragm, spall/failed patch (7.5' x 8" x 2" deep) with exposed rusted rebar

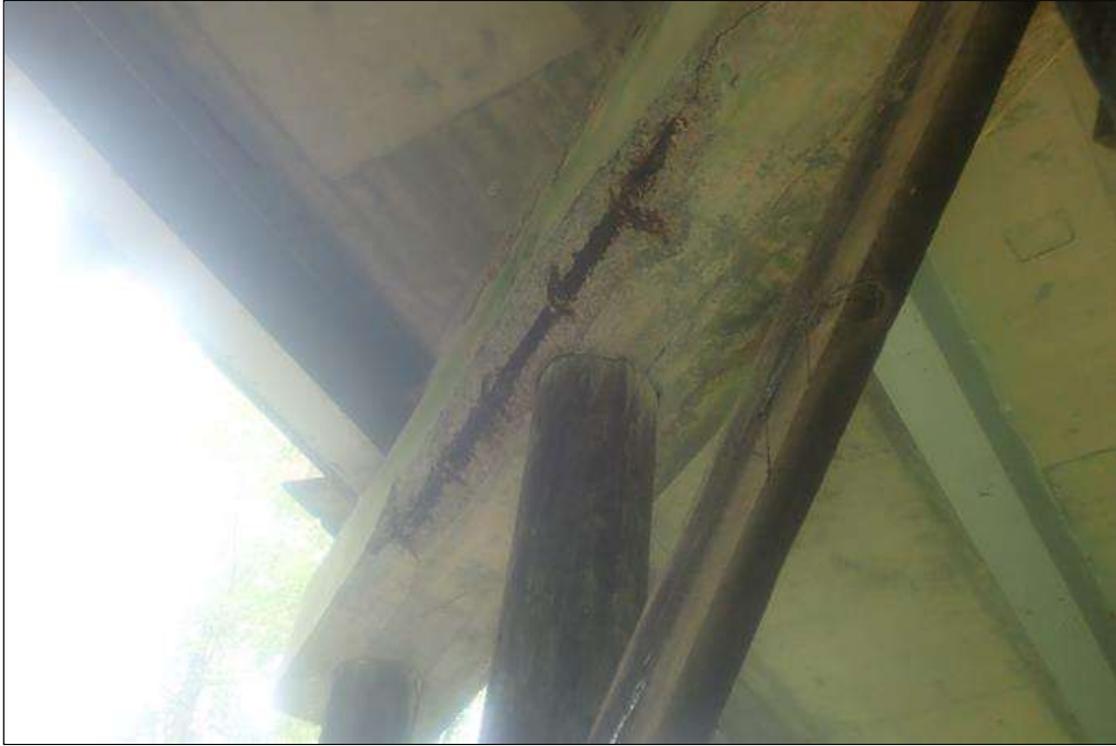
Bent 2 Cap 1: (PAR) between piles 1 and 3, spall/delamination (13' x up to 1' wide x 2.5" deep) with exposed rusted rebar

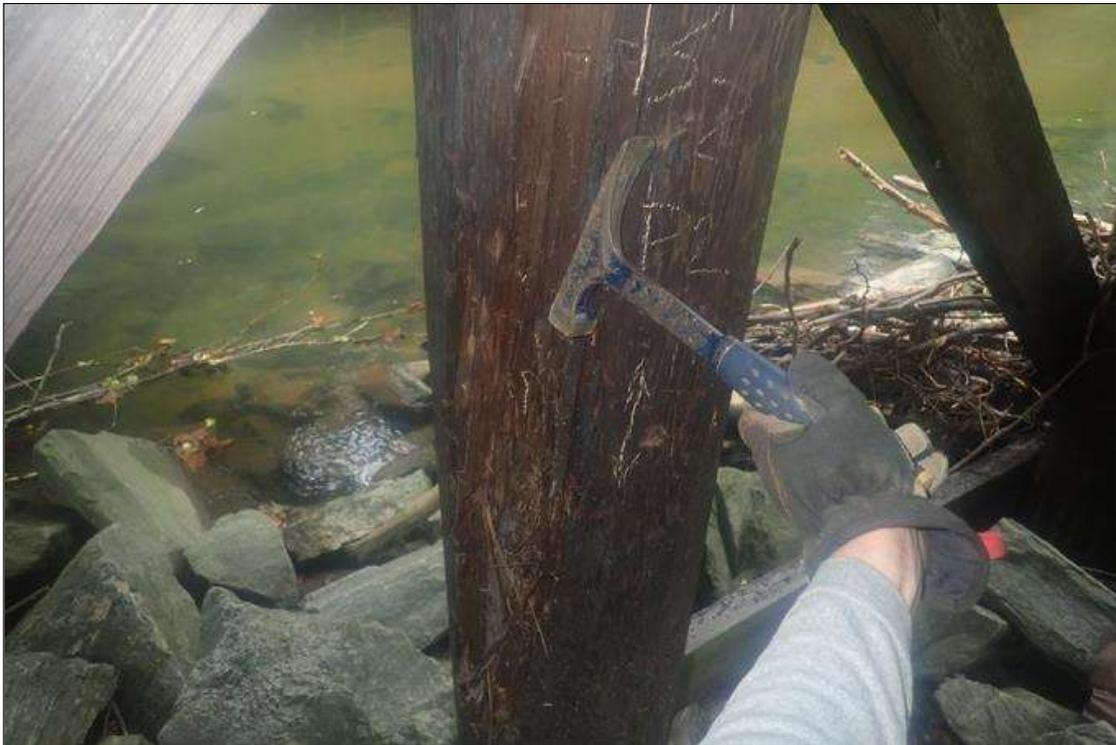
Bent 2 Pile 2: (PAR) 2' from groundline, east face, area of section loss (51" x 5" x 1.75" deep)

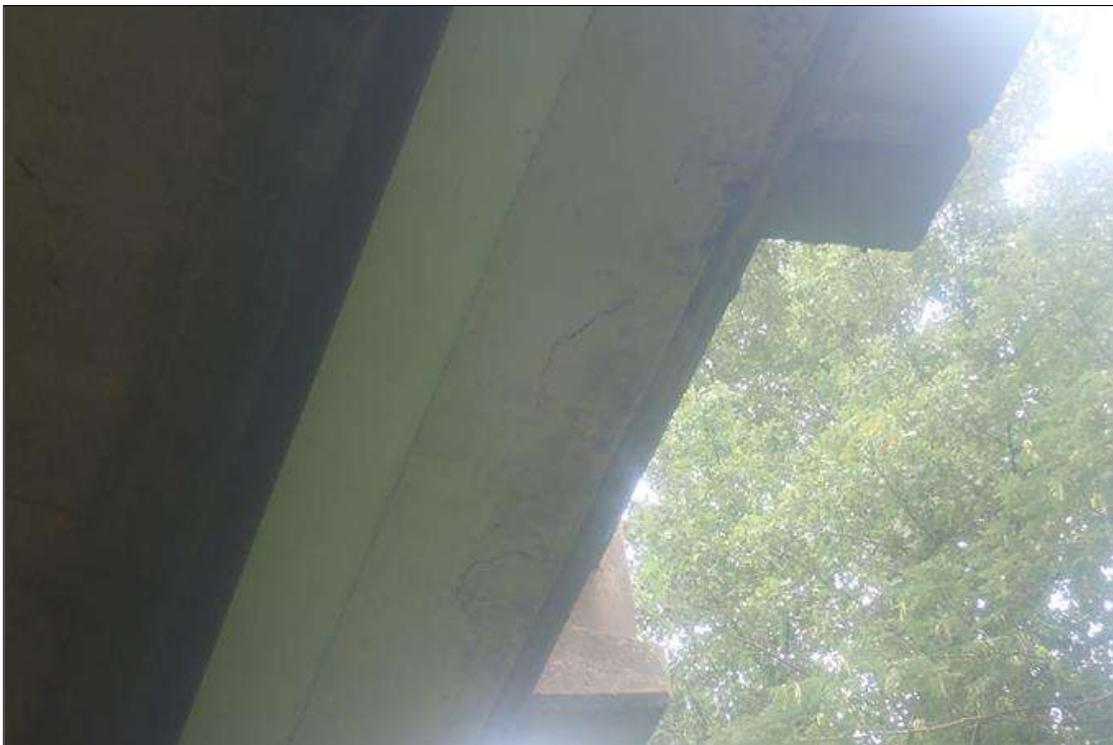
Span 3 Deck: both overhangs, spalls/delaminations (up to 3' x 1' x up to 1" deep), some with exposed rusted rebar

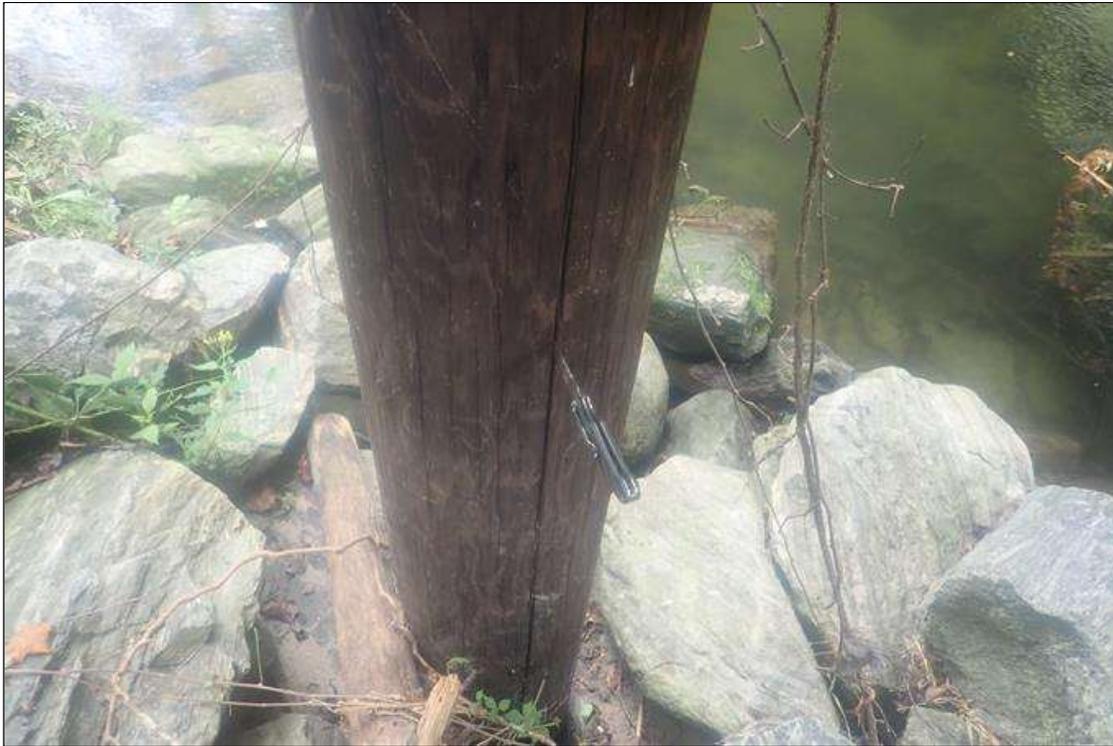
Bent 1 Pile 1: along the pile, checks (up to 1" deep)

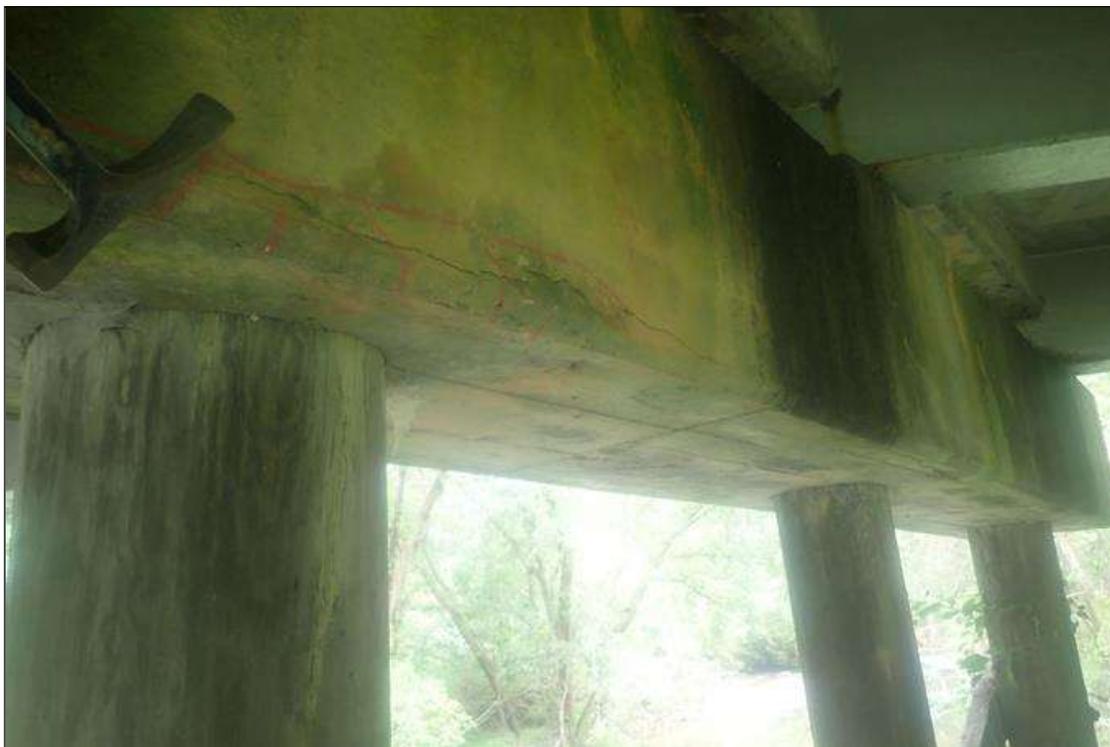
Bent 1 Cap 1: lower edge of cap, span 1 face, delamination (12' x 5") with longitudinal cracks (up to 1/8"), some with rust stains

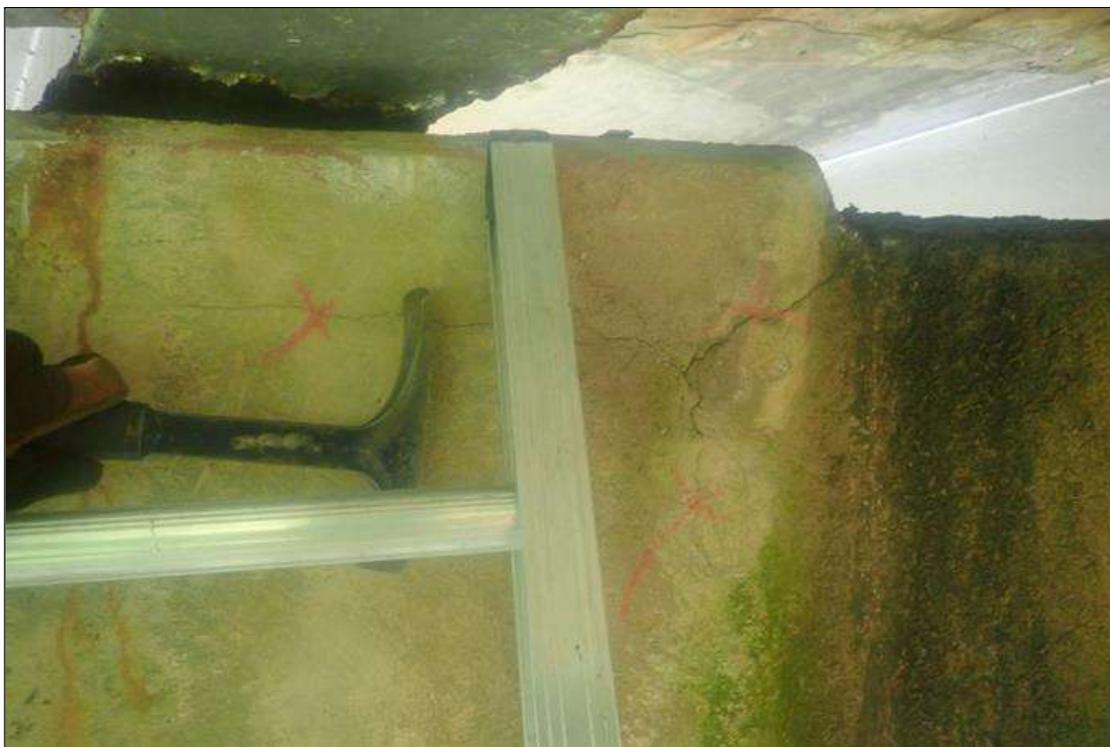
Bent 1 Cap 1: along the length of the cap, vertical and horizontal cracks (up to 1/32" x 1.5') at random

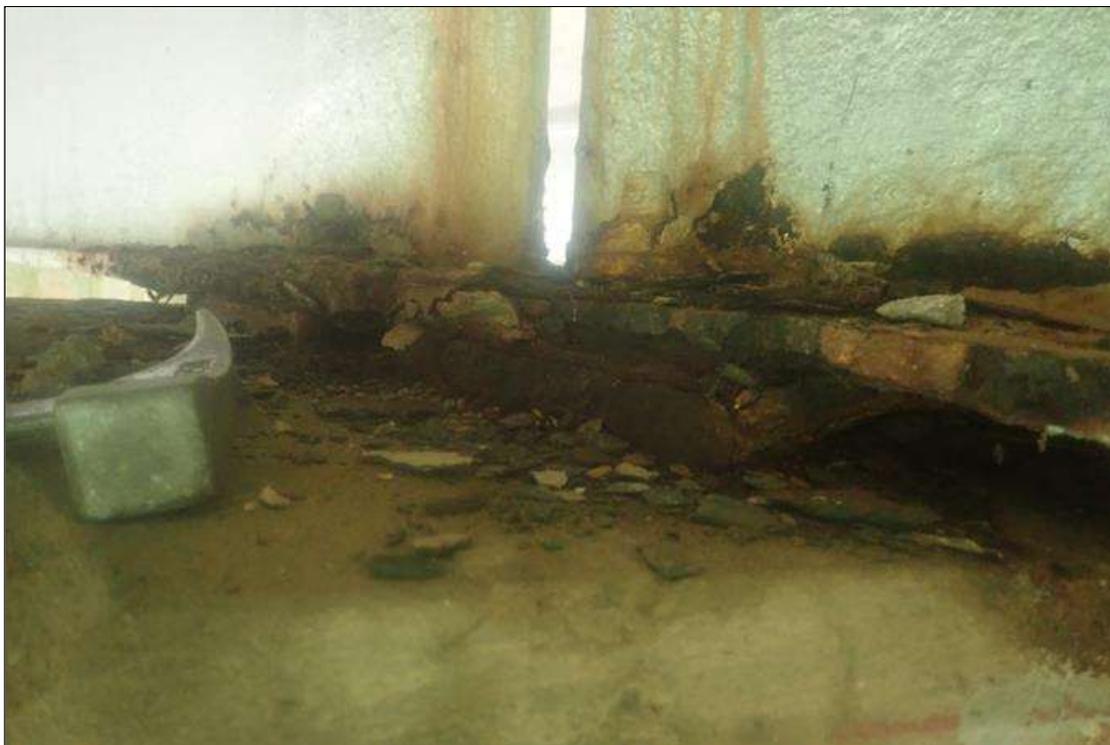
Span 1 Far Bearing 2: rust scale

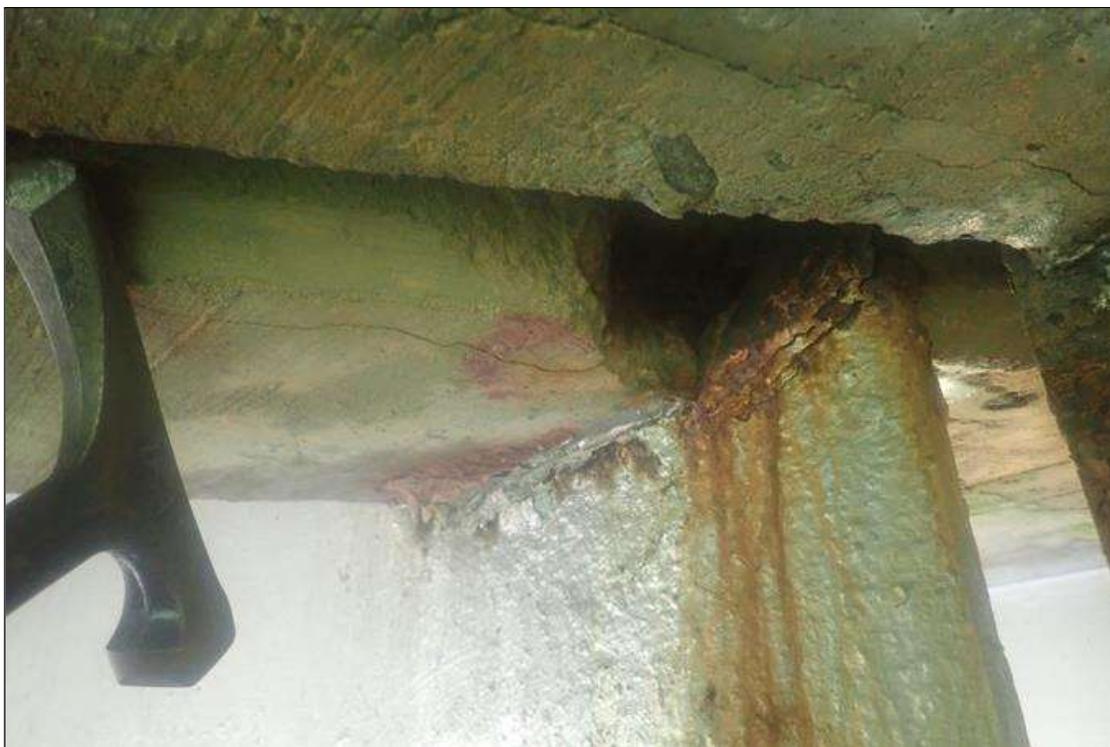
Span 2 Deck: bay 1, end diaphragm at bent 1, adjacent to beam 2, spall/delamination (10" x 4" x 1.5" deep) with exposed rusted rebar

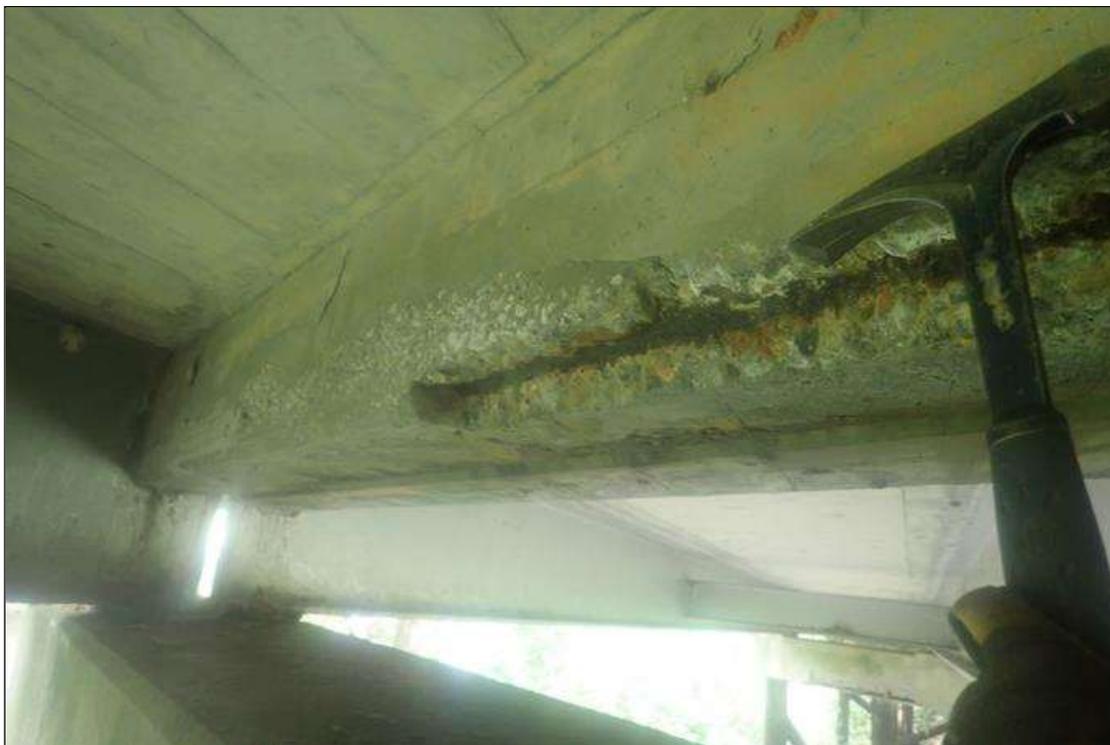
Span 1 Deck: bay 1, end diaphragm at bent 1, spall/delamination (7.5' x 7" x 1.5' deep) with exposed rusted rebar
