NC DEPARTMENT OF TRANSPORTATION  
 DIVISION OF HIGHWAYS  
 STRUCTURE MANAGEMENT UNIT

ATTENTION: **prompt action request, sketches revised**

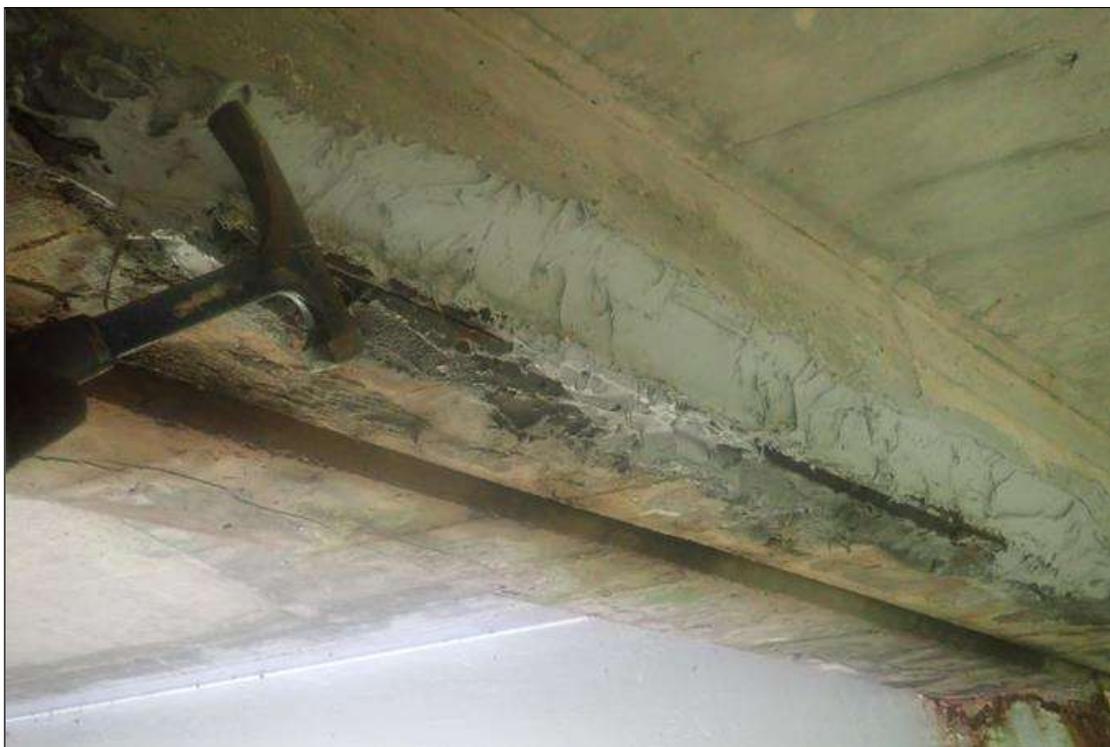
Span 1 Deck: bay 2, end diaphragm at bent 1, failed repair (6' x 8" x 1" deep) with exposed rusted rebar

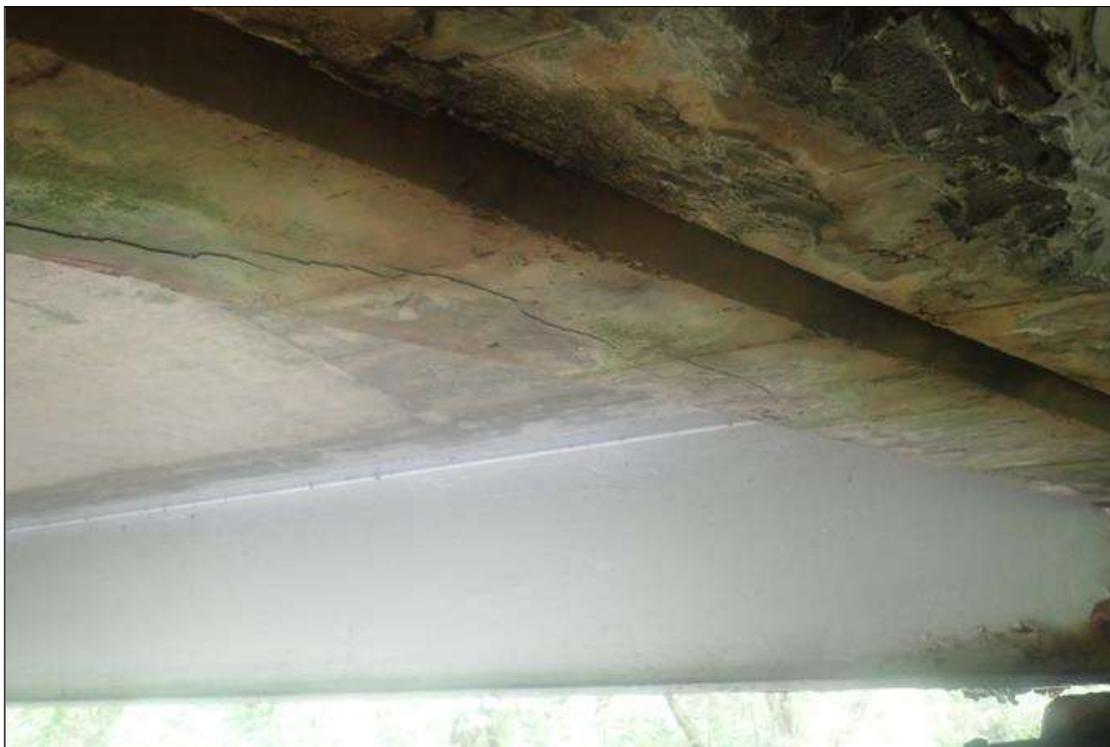
Span 2 Deck: bay 2, end diaphragm at bent 1, (2) delaminations (up to 3.5' x 6") with longitudinal cracks (up to 1/8")

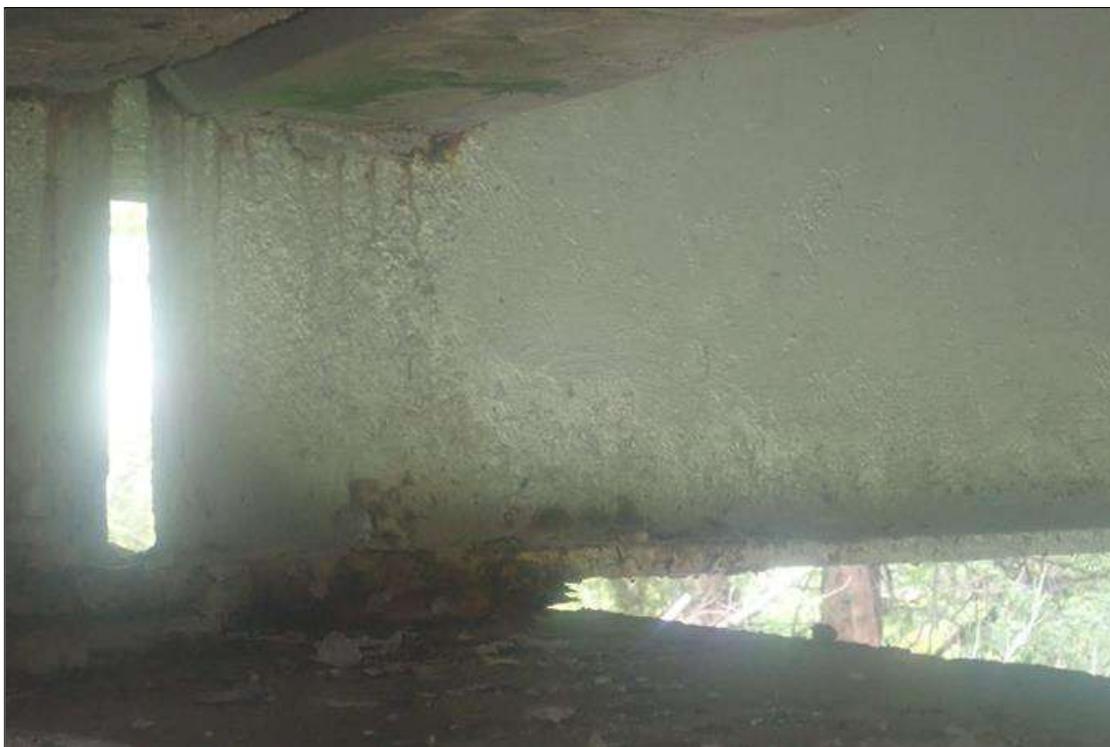
Span 2 Beam 1: at bent 1, painted over pitting: bottom flange (1/16" deep x 4'); web (1/16" deep x 4' x up to 10"); surface rust initiated

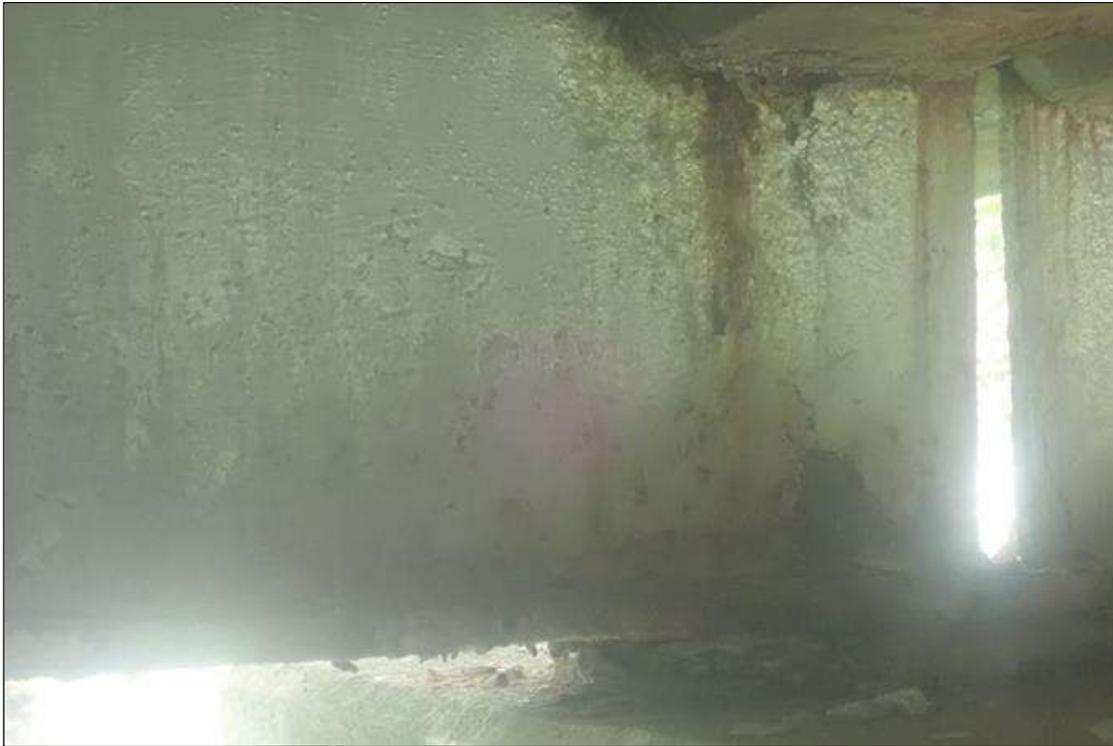
Span 1 Beam 1: at bent 1, corrosion with section loss: bottom flange (0.75" average remaining x 1'); web (7/16" average remaining x 1' up to full height)

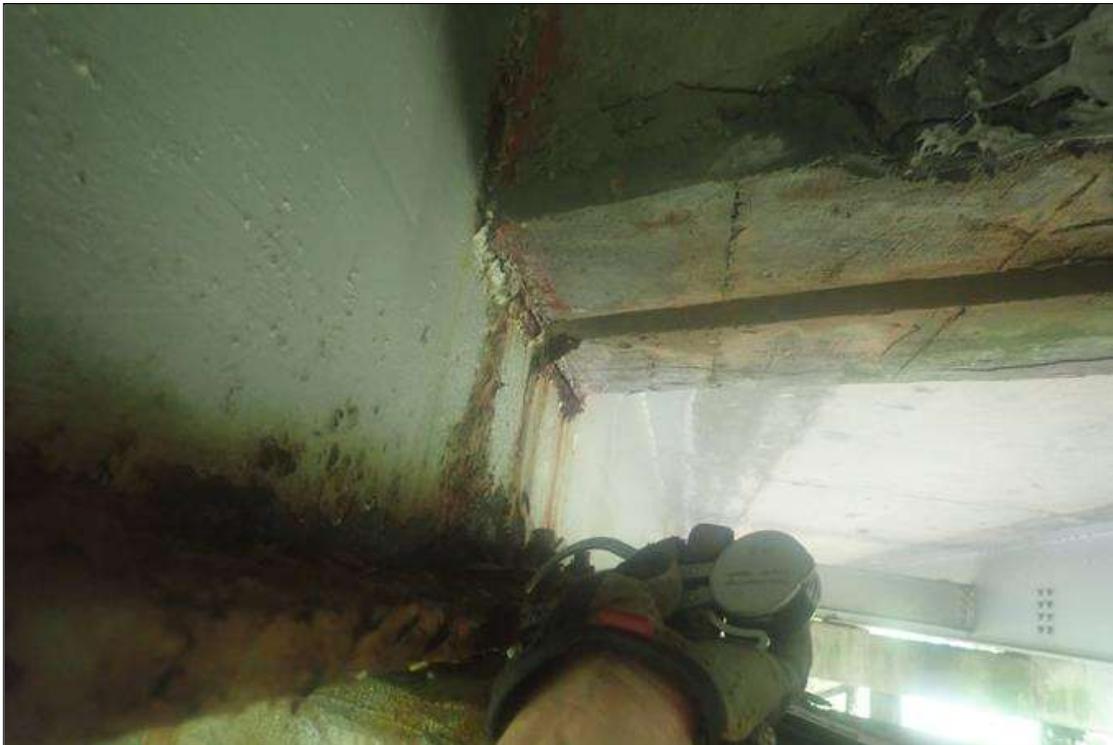
Span 1 Beam 2: (PAR) at bent 1, corrosion with section loss to bottom flange (0.45" average remaining x 1'); lower web (3/8" average remaining x 2.5' x up to 2"); web adjacent to end diaphragm (3/8" average remaining x 1' x 2")

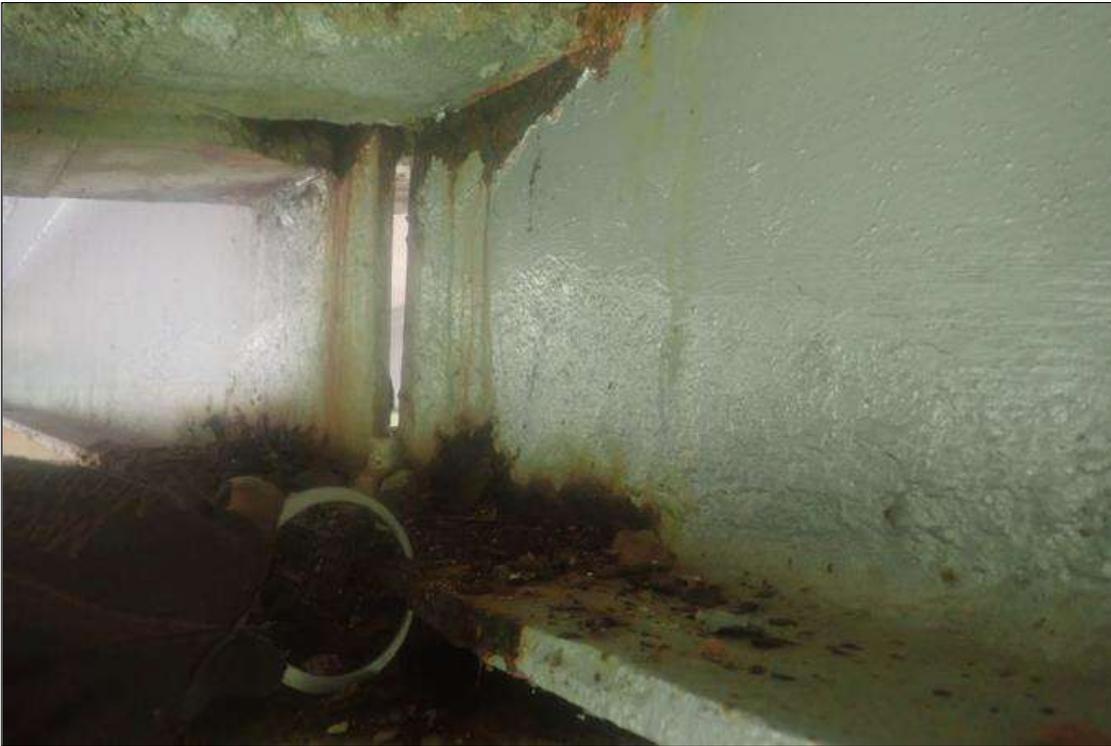
Span 1 Beam 2: (PAR) at bent 1, corrosion with section loss to bottom flange (0.45" average remaining x 1'); lower web (3/8" average remaining x 2.5' x up to 2"); web adjacent to end diaphragm (3/8" average remaining x 1' x 2")

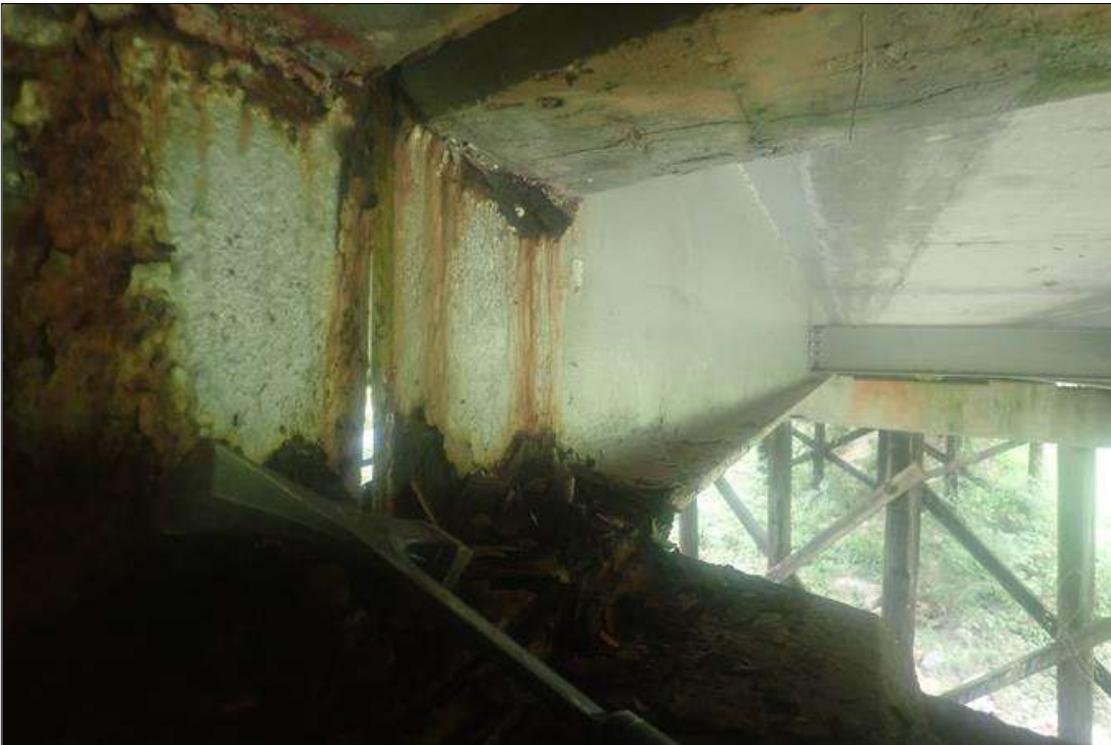
Span 2 Beam 2: (PAR) at bent 1, corrosion with section loss: bottom flange (0.75" average remaining x 15"); lower web (3/8" average remaining x 15" x up to 2"); web adjacent to end diaphragm (1/8" average remaining x 11" x 2") with corrosion hole (3/4" x 1/2")

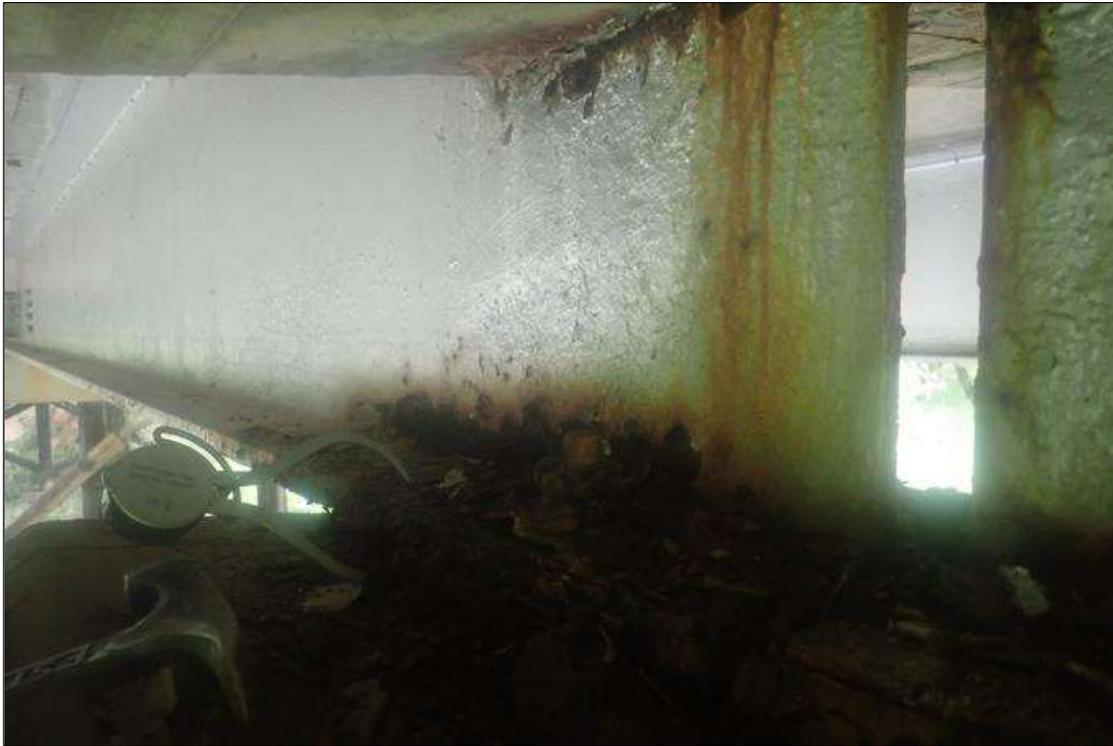
Span 2 Beam 2: (PAR) at bent 1, corrosion with section loss: bottom flange (0.75" average remaining x 15"); lower web (3/8" average remaining x 15" x up to 2"); web adjacent to end diaphragm (1/8" average remaining x 11" x 2") with corrosion hole (3/4" x 1/2")

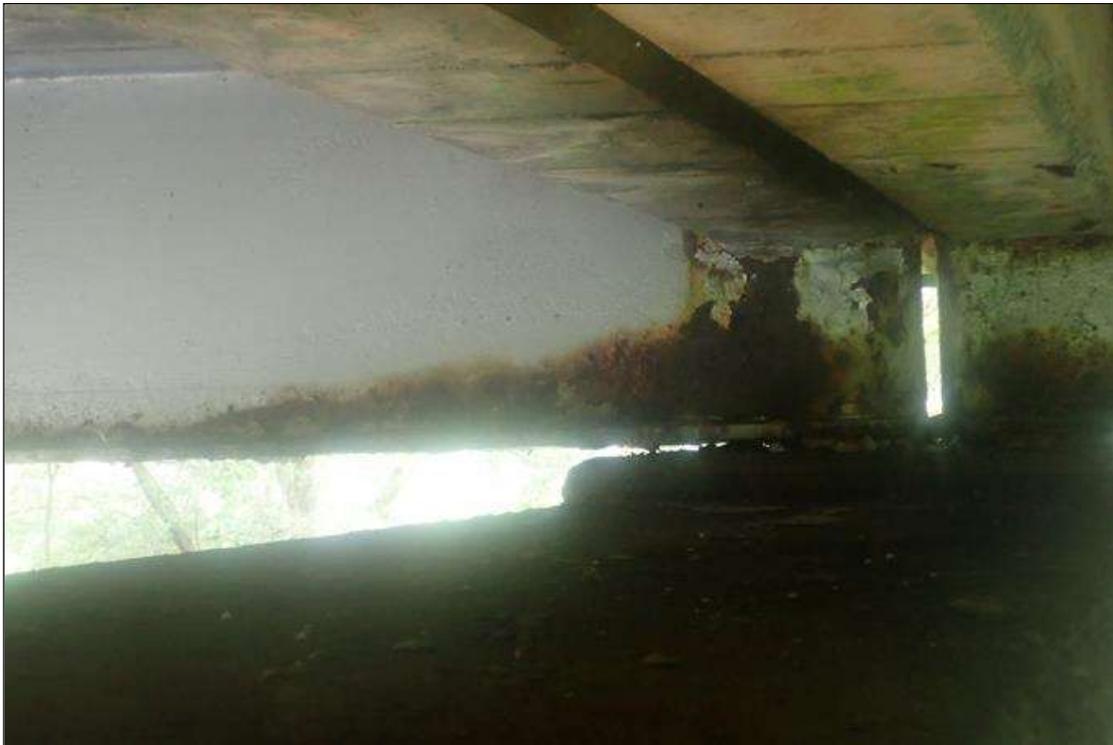
Span 2 Beam 4: at bent 1, rust scale/corrosion with section loss to bottom flange (approximately 3/4" remaining x 4.5'); web, (approximately 7/16" remaining x 4.5' x up to 10"); visually inspected from a distance, no safe ladder access

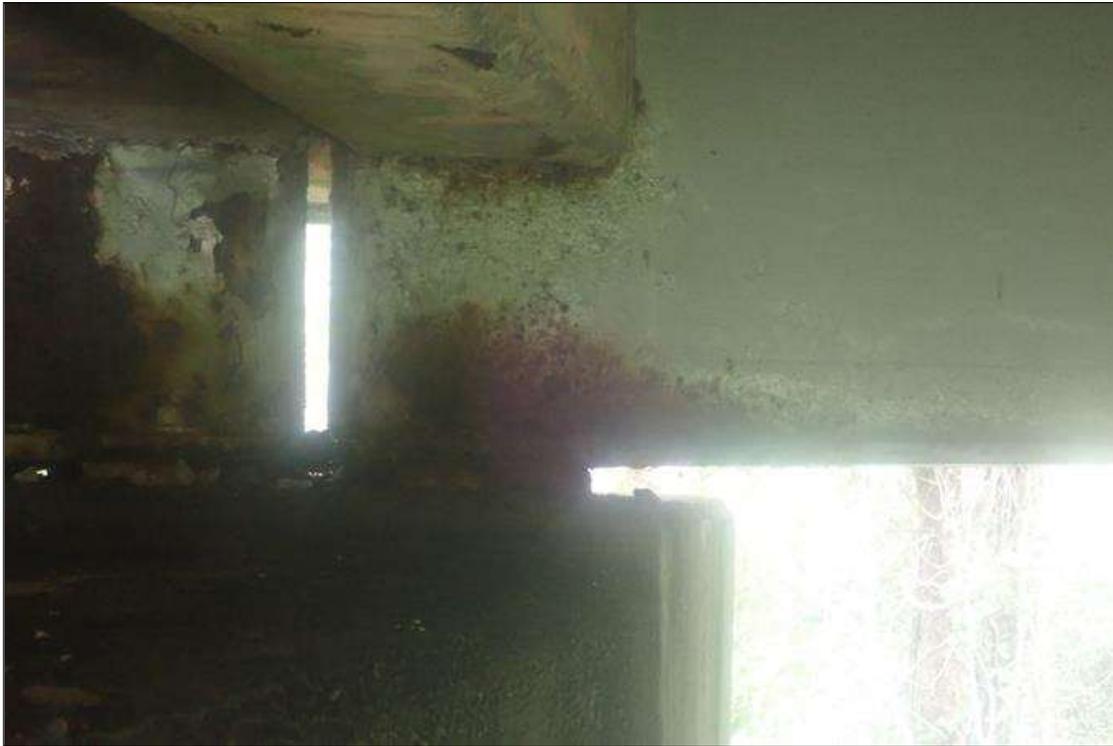
Span 1 Beam 4: at bent 1, rust scale/corrosion with section loss: bottom flange (approximately 3/4" remaining x 1.5'); web (approximately 7/16" remaining x 1.5' x up to 10"); visually inspected from a distance, no safe ladder access

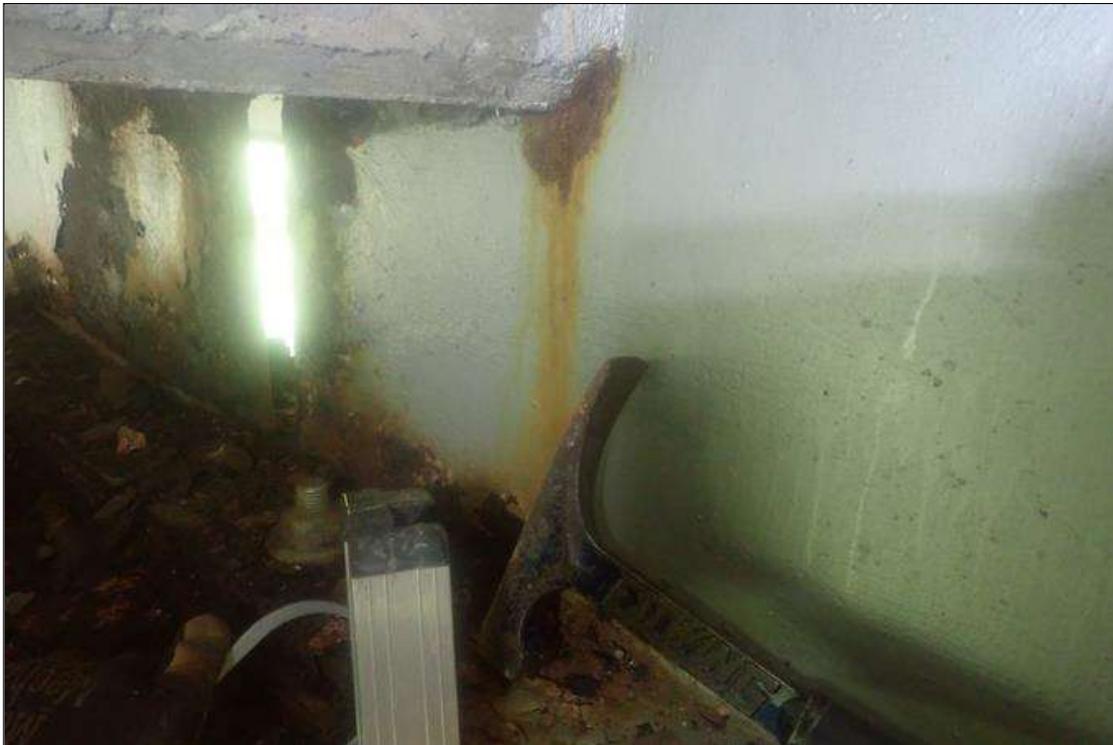
Span 1 Beam 3: (PAR) at bent 1, corrosion with section loss to bottom flange (0.75" average remaining x 1'), lower web (3/8" average remaining x 1' x 1"); web adjacent to end diaphragm (7/16" average remaining x 1' x 1")

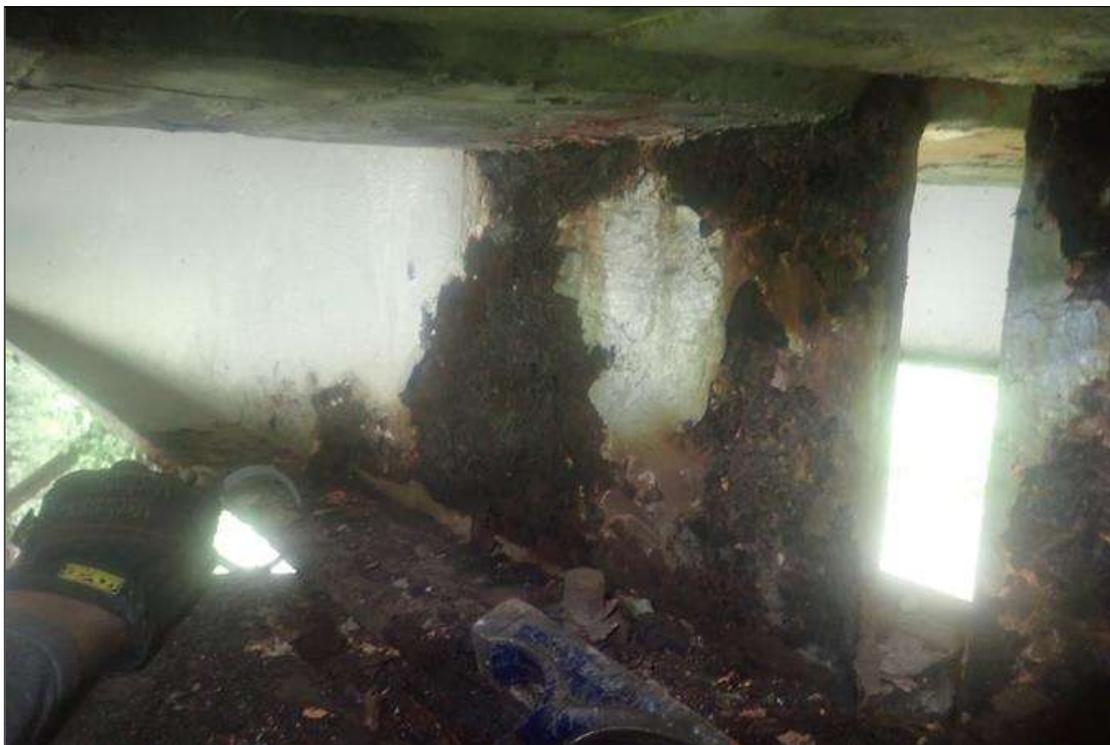
Span 2 Beam 3: (PAR) at bent 1, corrosion with section loss to bottom flange (0.55" average remaining x 2'); web (3/8" average remaining x 2' x up to 10")

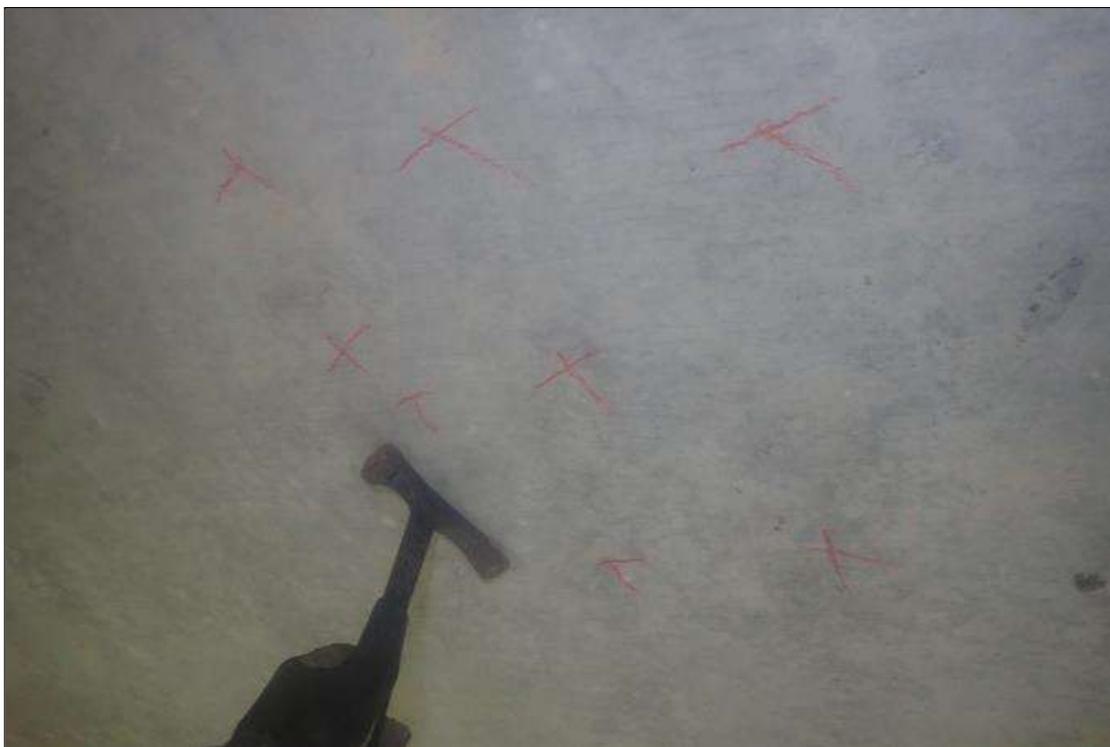
Span 1 Deck: throughout underside of deck, areas of map cracks (up to 1/32") at random; some cracks with dampness

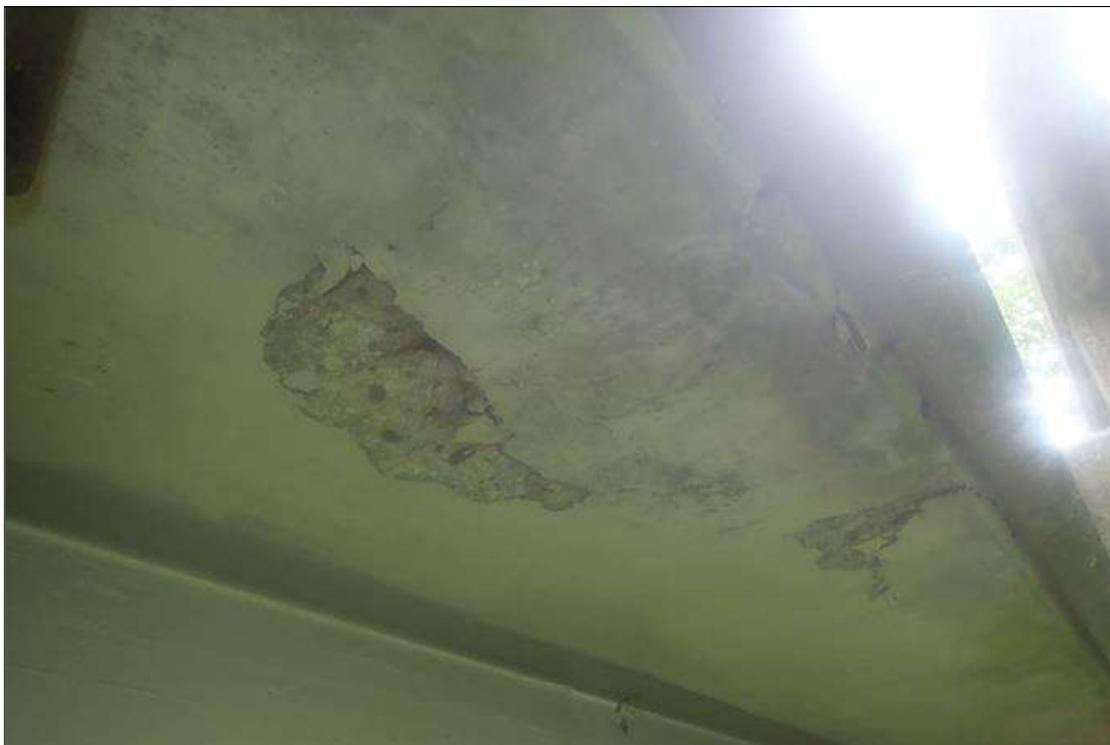
Span 1 Deck: both overhangs, spalls/delaminations (up to 18" x 15" x up to 1" deep), some with exposed rusted rebar

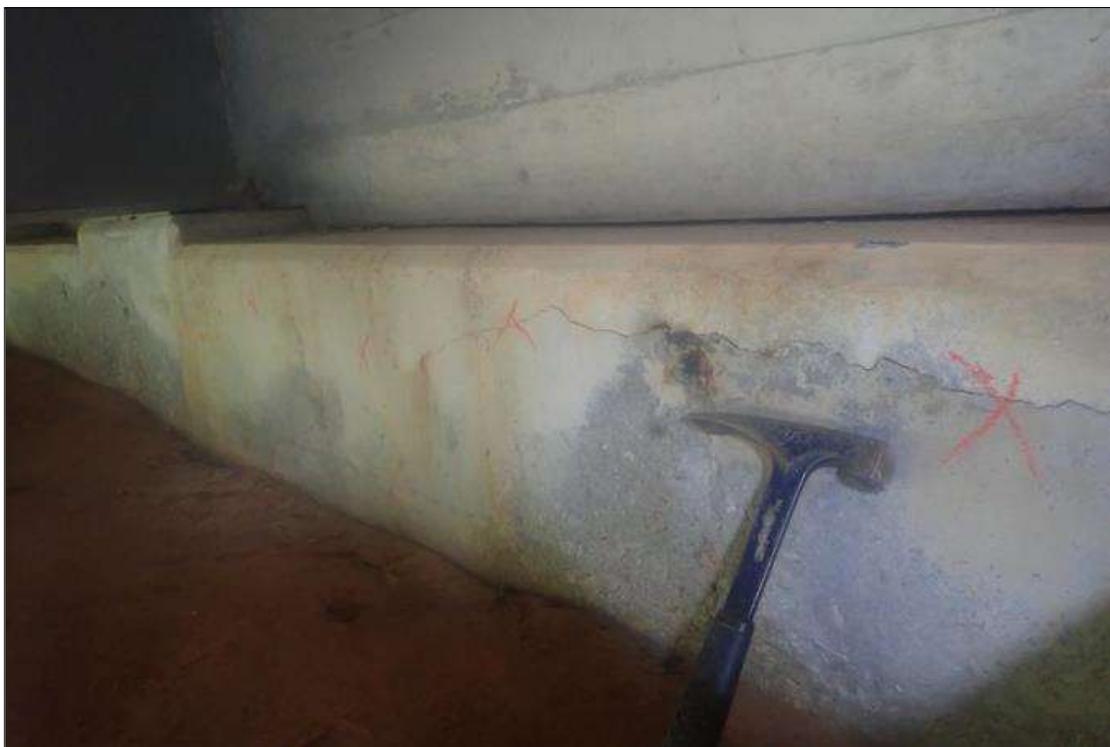
End Bent 1 Cap 1: bays 1 and 2, horizontal crack (up to 1/16" x 9') with rust stains

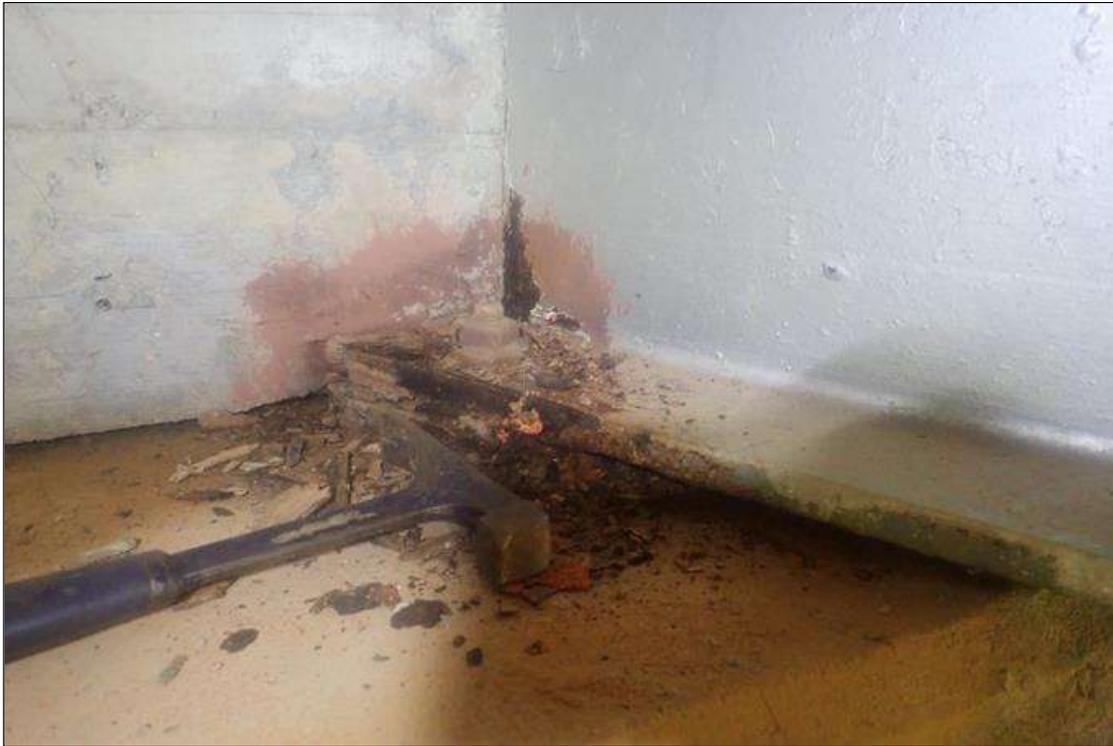
Span 1 Beam 1: at end bent 1, bottom flange and lower web, rust scale (1')

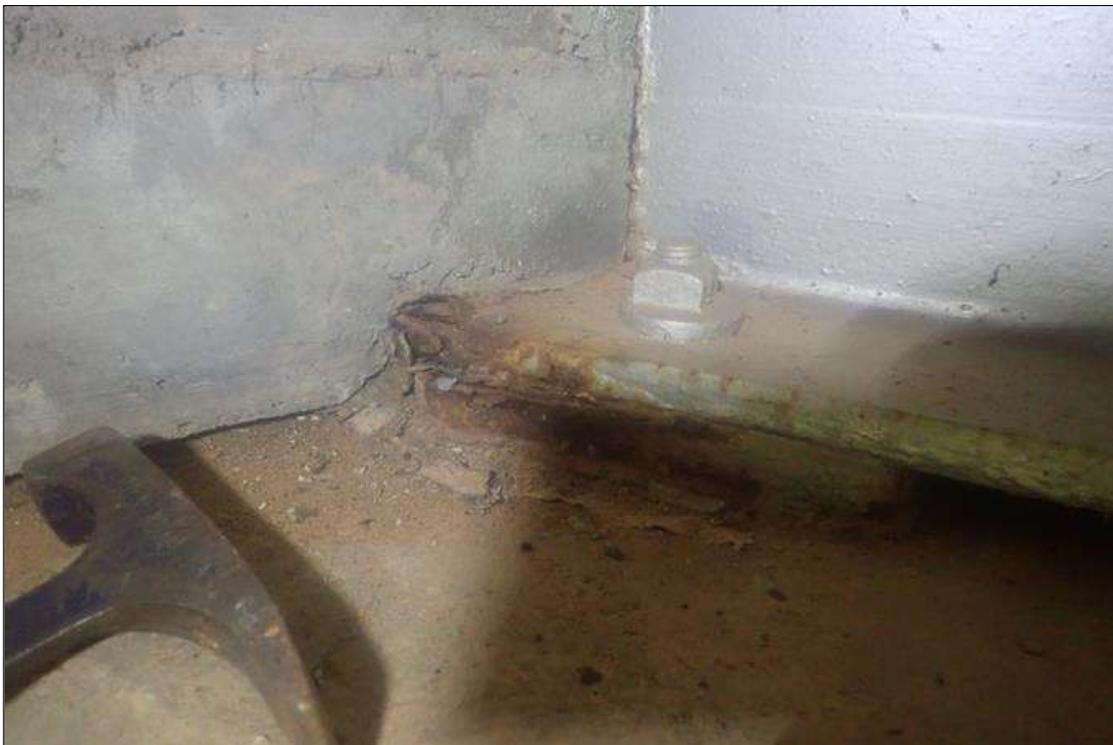
Span 1 Beam 2: at end bent 1, bottom flange, surface rust (6")

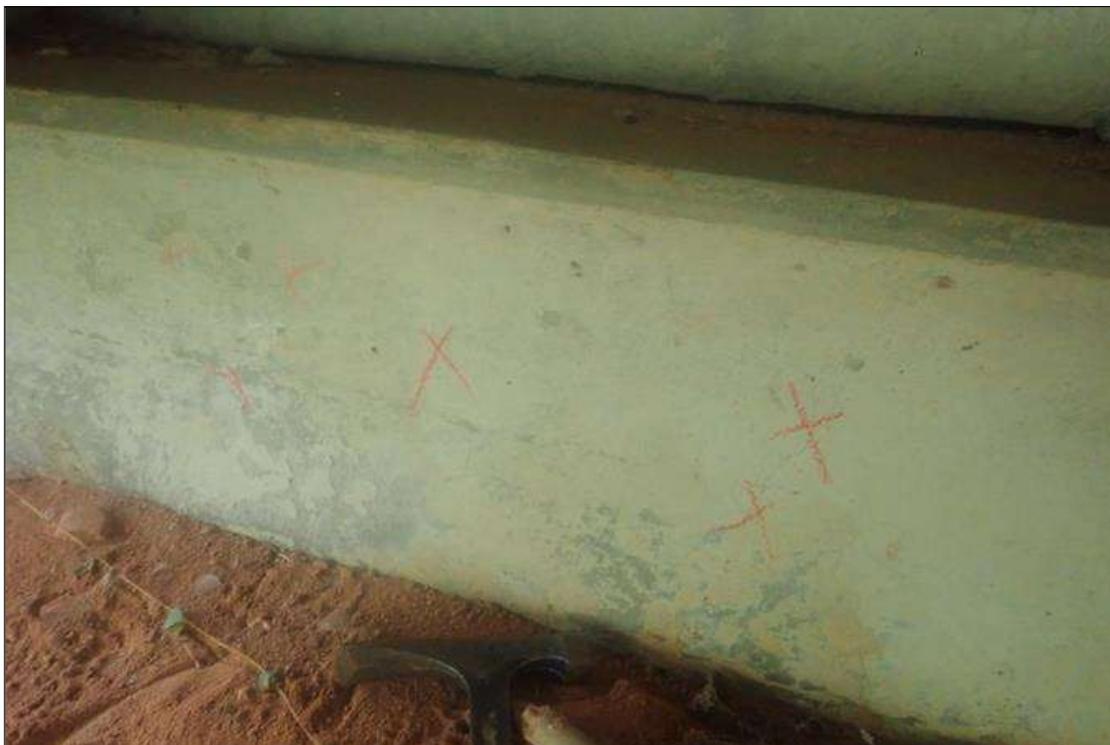
End Bent 1 Cap 1: bay 3, map cracks (hairline x 2' x 1')

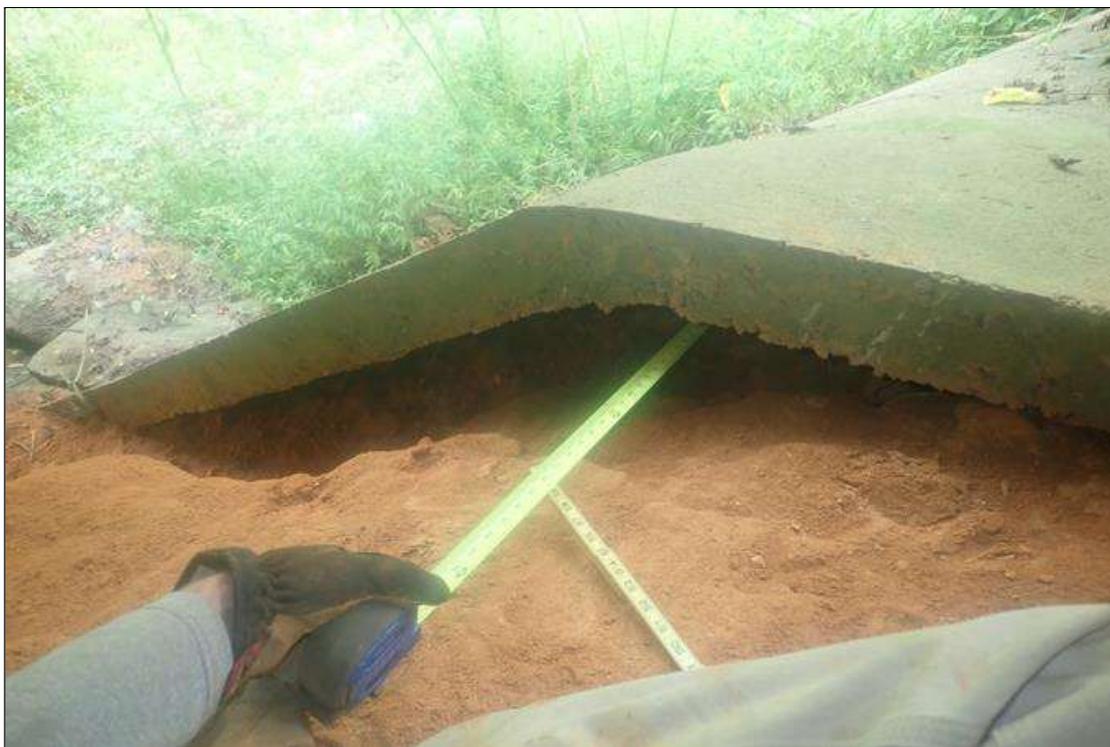
(PAR) end bent 1 slope protection, at east end, undermining (7.5' x up to 15" high x 3.5' deep)

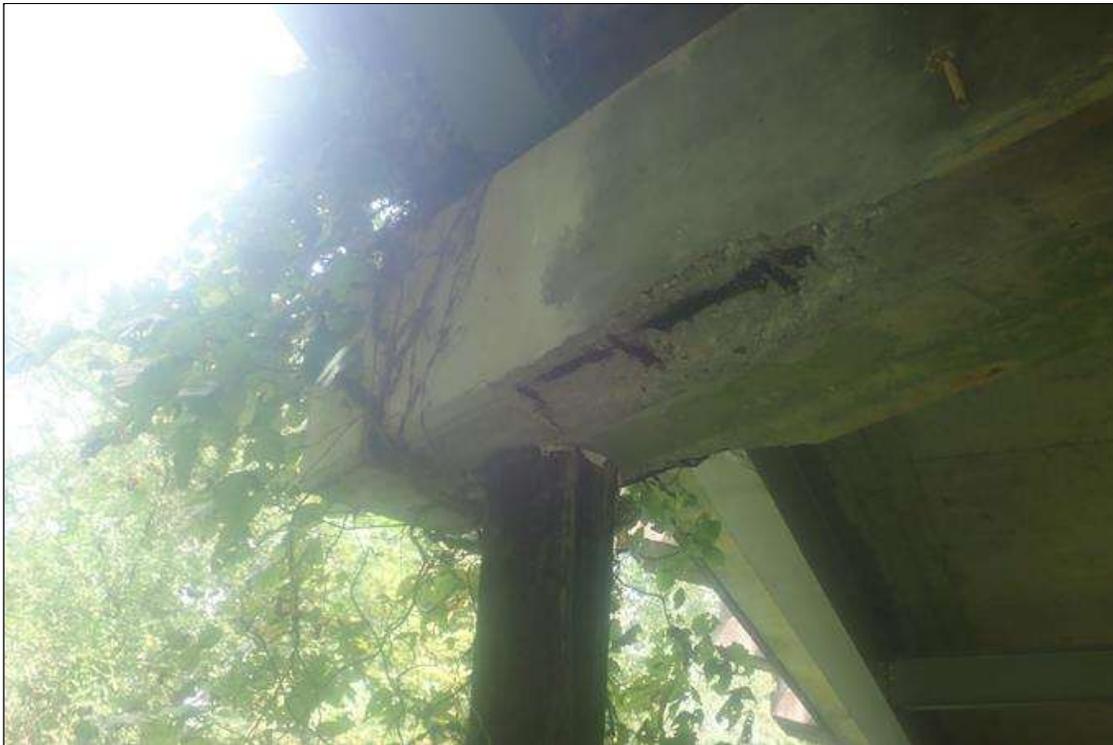
Bent 3 Cap 1: (PAR) at left end of cap, all faces, an area of spalls/delaminations (up to 7' x full height x up to 3" deep) with exposed rusted rebar; rebar with section loss (approximately 90% remaining)

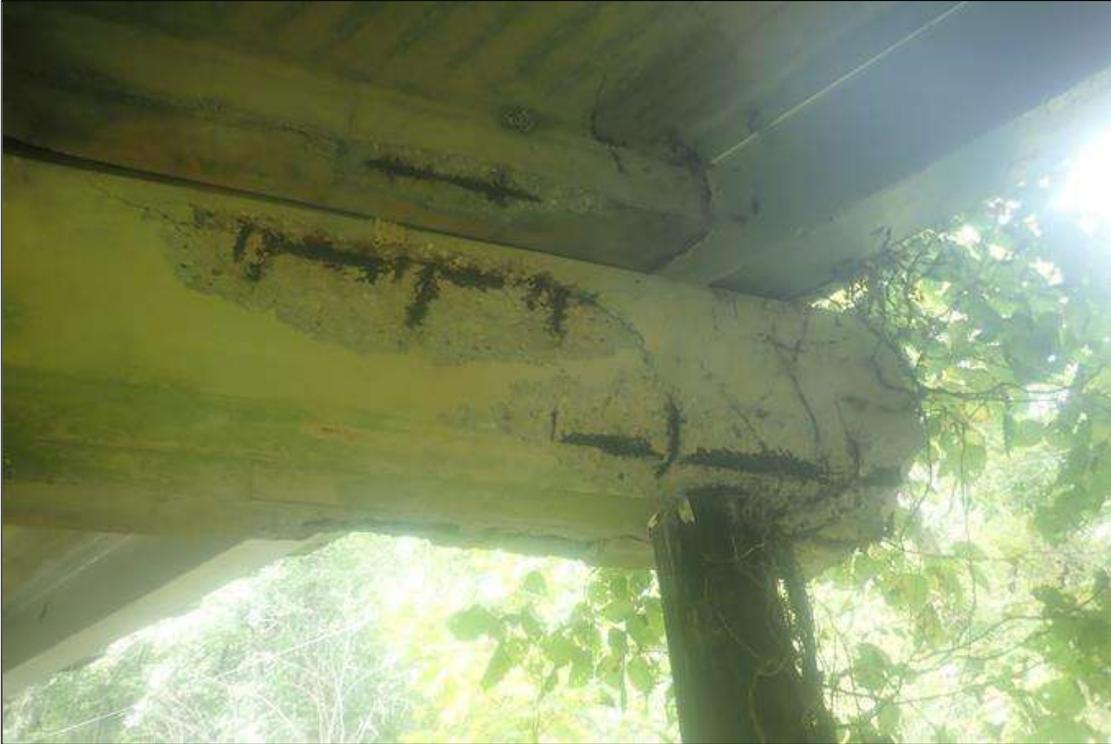
Bent 3 Cap 1: (PAR) at left end of cap, all faces, an area of spalls/delaminations (up to 7' x full height x up to 3" deep) with exposed rusted rebar; rebar with section loss (approximately 90% remaining)

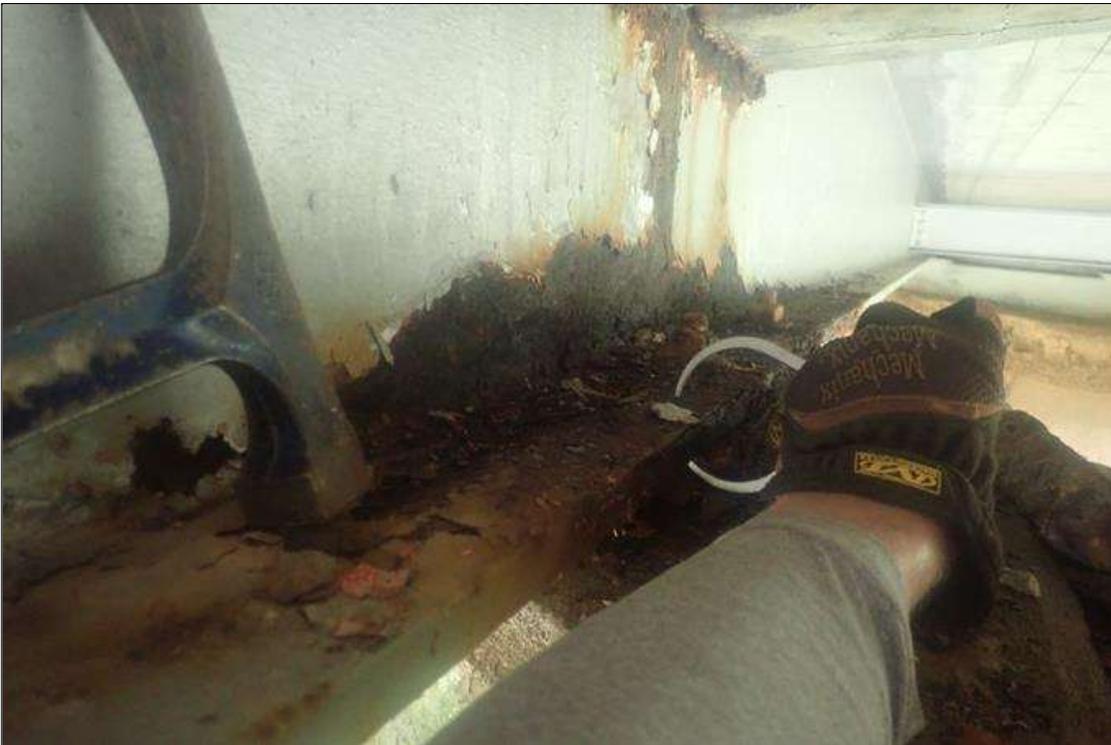
Span 3 Beam 2: (PAR) at bent 3, corrosion with section loss: bottom flange (0.60" average remaining x 16"); bottom 3" of web (1/4" average remaining x 18" x 2"); web adjacent to end diaphragm (7/16" average remaining x 1' x 1")

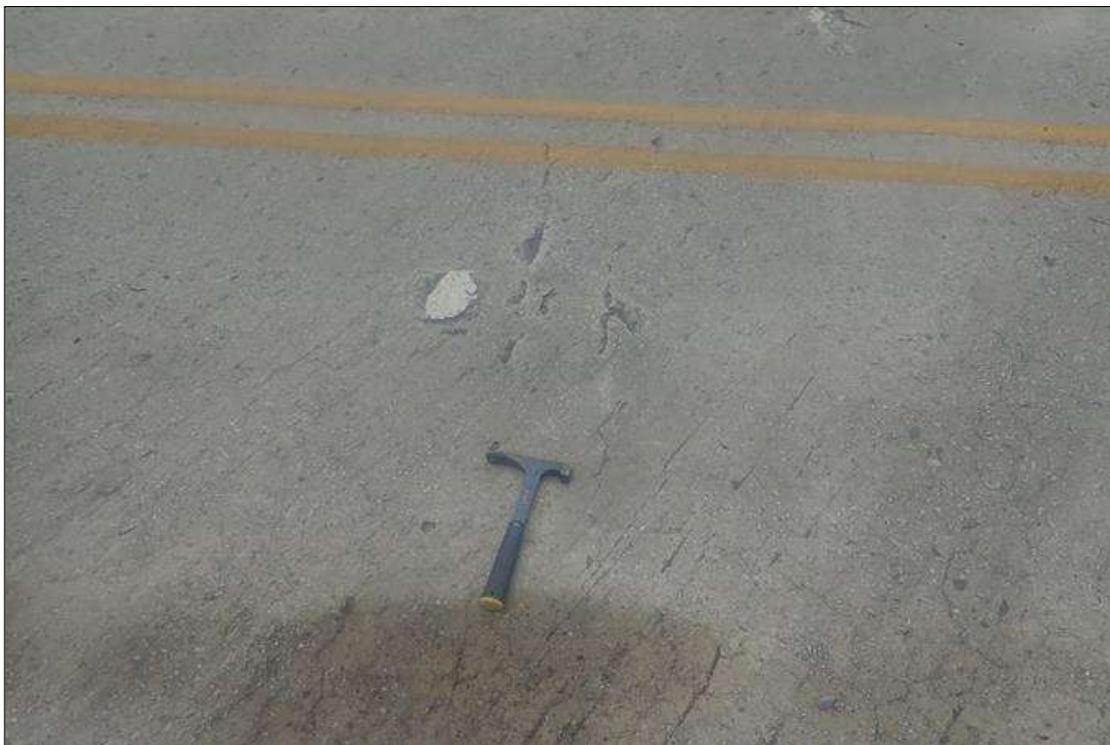
Span 2 Deck: (PAR) throughout top of deck, spalls/delaminations/unsound patches (up to 14" diameter x 1" deep)

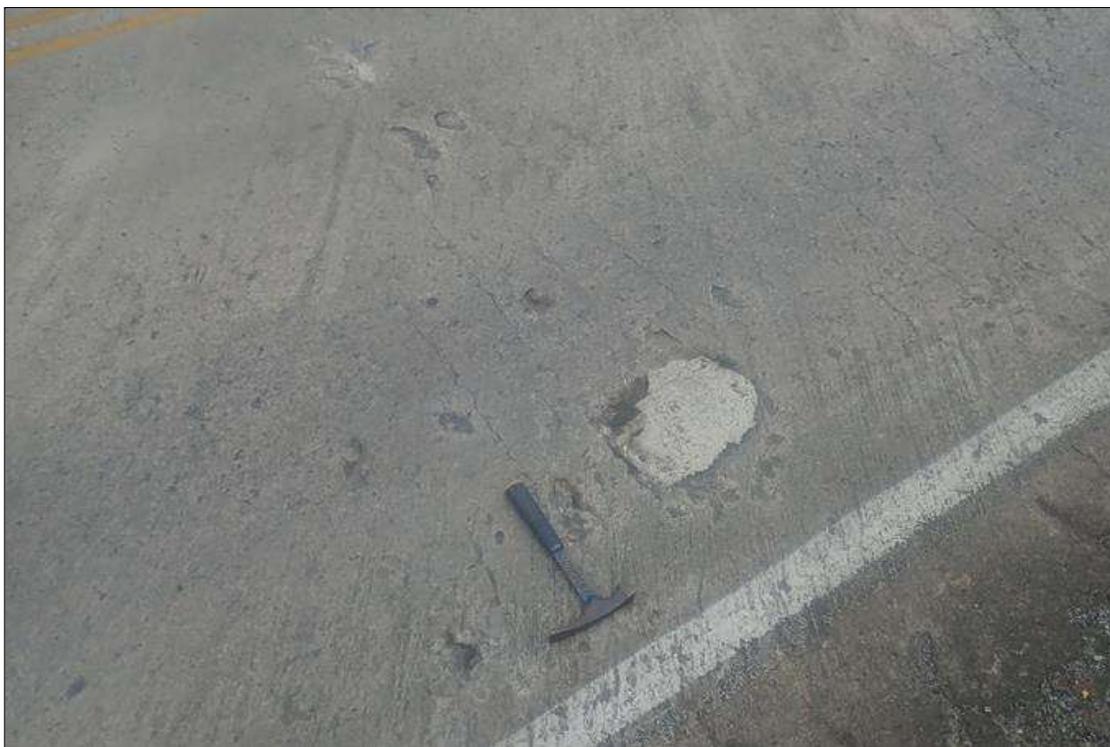
Span 2 Deck: (PAR) throughout top of deck, spalls/delaminations/unsound patches (up to 14" diameter x 1" deep)

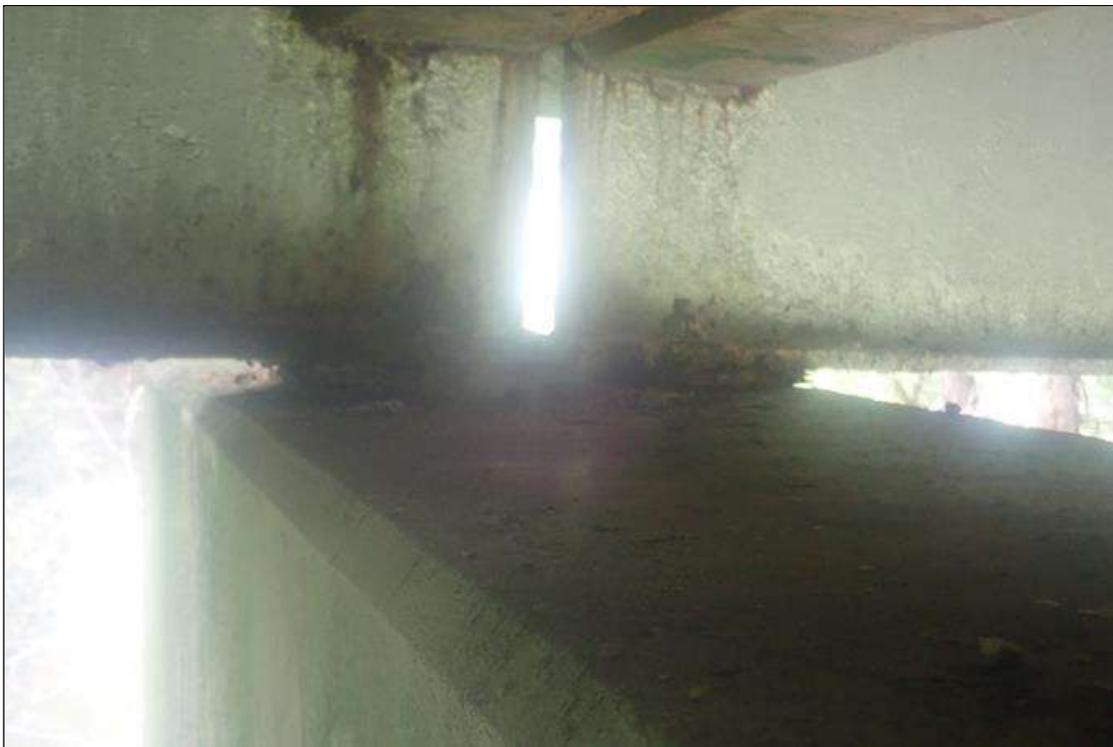
interior bearing assembly at bent 1

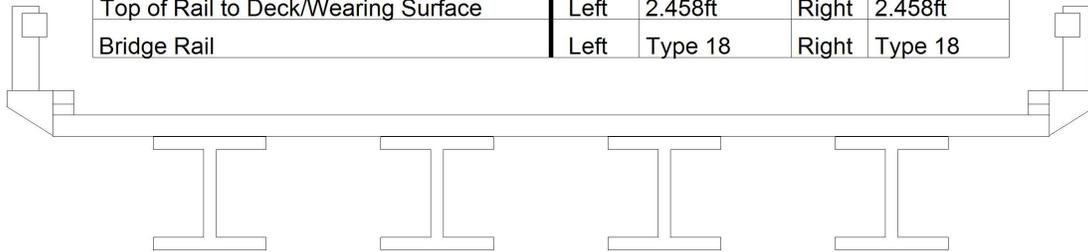
Measurements for Span #	1		
Deck Thickness	0.54	Left Overhang	4.04
Top of Rail to Bottom of Beam	5	Right Overhang	4.04

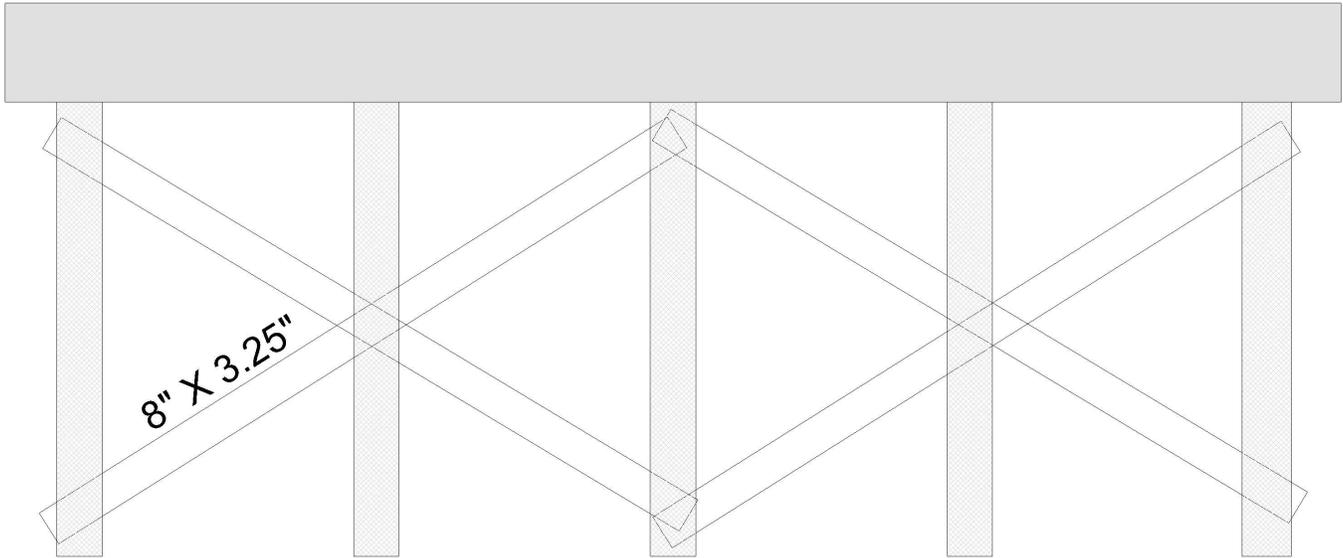
<b>Cap Information</b>			<b>Material</b> Cast-in-Place Concrete							
Length	Width	Height	Left Overhang	Right Overhang	Left Beam to End of Cap.	Right Beam to End of Cap.
