NC DEPARTMENT OF TRANSPORTATION  
 DIVISION OF HIGHWAYS  
 STRUCTURE MANAGEMENT UNIT

ATTENTION: **prompt action request, sketches revised**

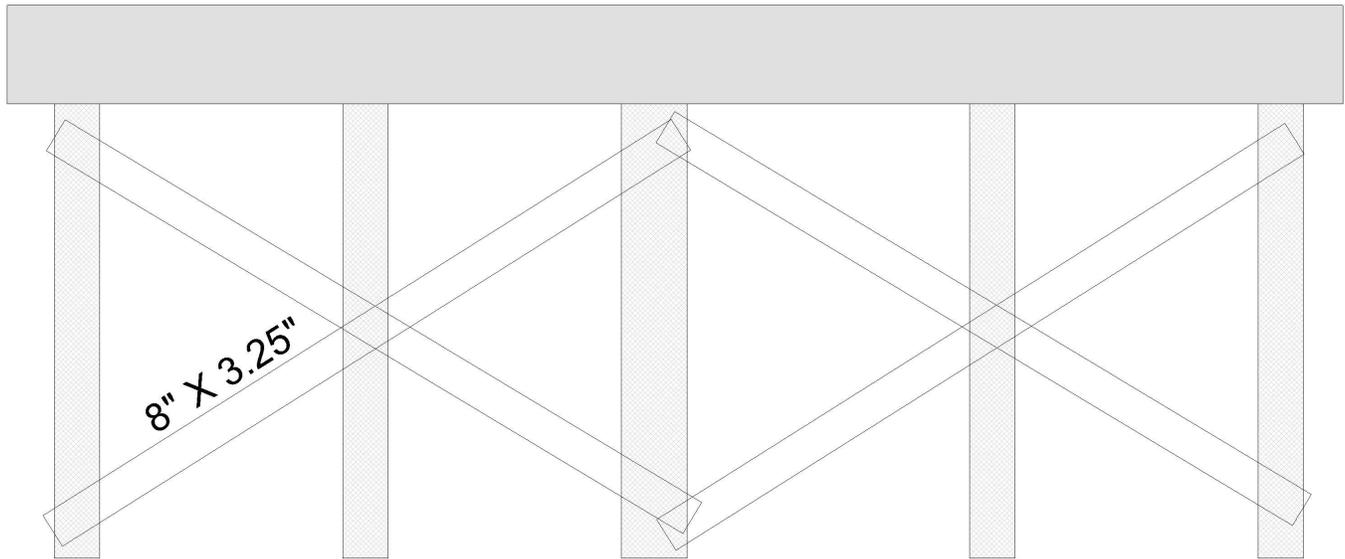
<b>Cap Information</b>			<b>Material</b> Cast-in-Place Concrete							
Length	Width	Height	Left Overhang	Right Overhang	Left Beam to End of Cap.	Right Beam to End of Cap.				
27.333 ft.	2.250 ft.	2.000 ft.	1.500 ft.	1.500 ft.	2.000 ft.	2.000 ft.				
<b>Subcap Information</b>			<b>Material</b>							
Length	Width	Height	Left Overhang	Right Overhang	Left Pile to Splice.					
<b>Sill Information</b>			<b>Material</b>							
Length	Width	Height								
Pile #	Material	Spacing	Width/Dia.	Height	Length	Orientation	Driven?	Replacement?	Removed?	Collar?
1	Timber	5.8333 ft.	0.917 ft.			Vertical	No	No	No	No
2	Timber	5.8333 ft.	0.917 ft.			Vertical	No	No	No	No
3	Timber	6.8333 ft.	1.333 ft.			Vertical	No	No	No	No
4	Timber	5.8333 ft.	0.917 ft.			Vertical	No	No	No	No
5	Timber		0.917 ft.			Vertical	No	No	No	No
<b>Bent/Abutment #:</b> 2			<b>Similar Bents:</b>
