Green River Bridge NDT Survey
Peter Guice Memorial Bridge
Hendersonville, North Carolina
S&ME Project No. 6105-18-008
Phase 340

Reference: **Green River Bridge NDT Survey**
Peter Guice Memorial Bridge
Hendersonville, North Carolina
S&ME Project No. 6105-18-008 Phase 340

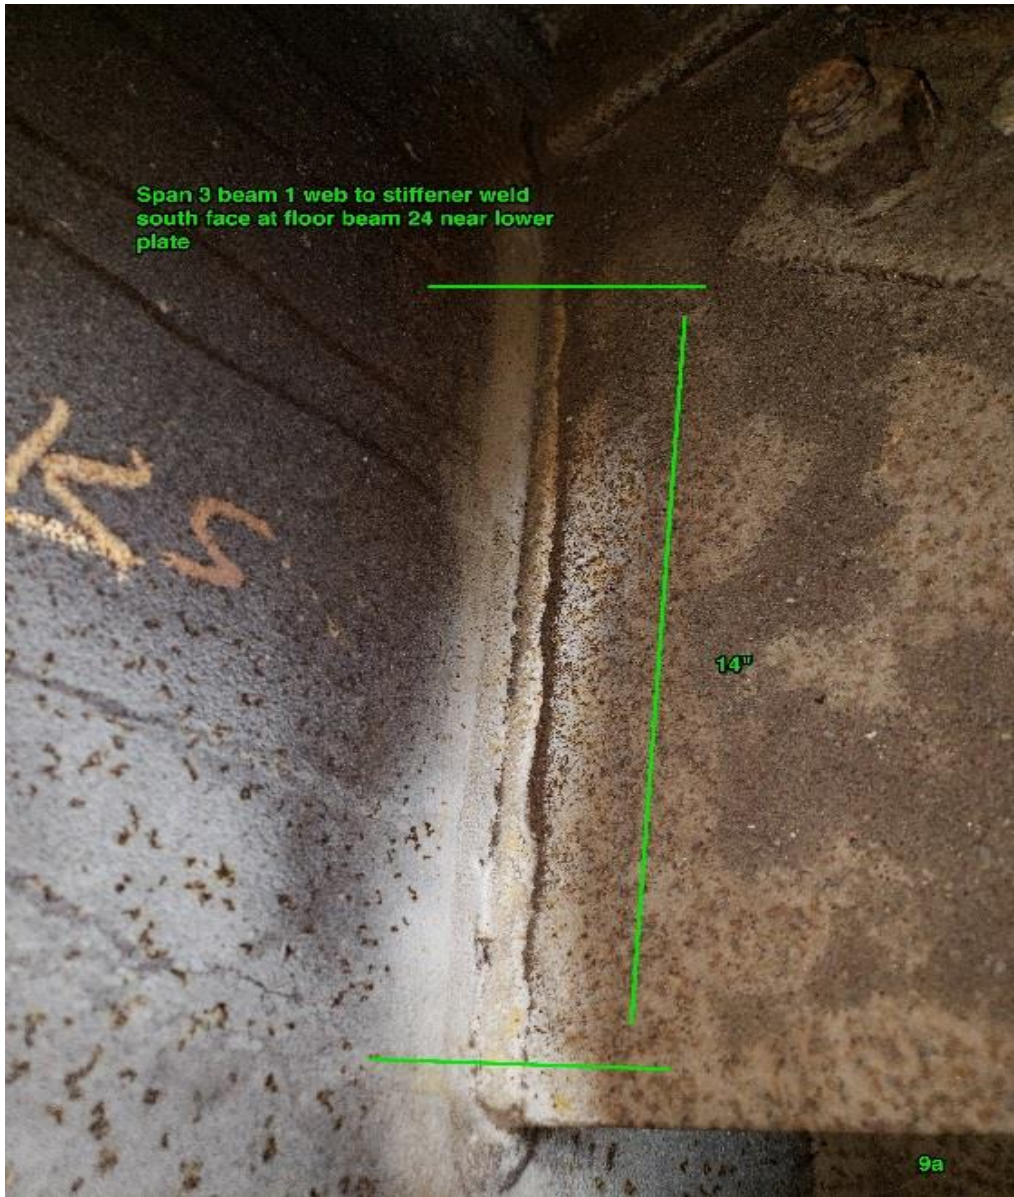
9. **Span 3, Beam 1 (QA Check Location)** - The web to web stiffener weld south facing at floor beam 24 near lower plate connection. A visual inspection was performed on the fillet weld and the following defects were noted: overlap, undercut and unacceptable weld profile over the entire length of the weld (see images #4 & #5). Because of the significant unacceptable visual defects, an MT inspection was not performed.

<p>Location / Orientation</p>	<p>440112 - Span 3, Beam 1, Location 9</p>
<p>Remarks</p>	<p>Image #4 - Visual Defects</p>

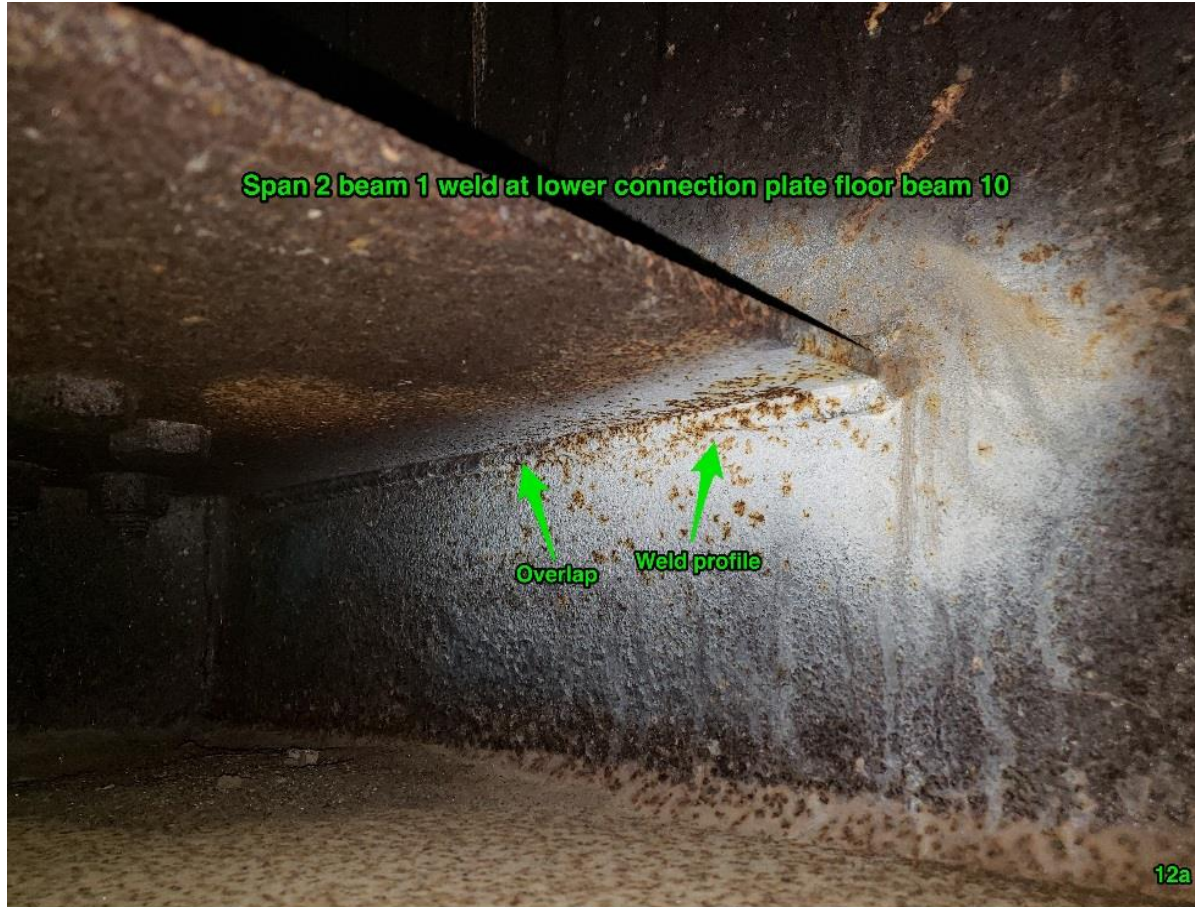
12. **Span 2, Beam 1 (QA Check Location)** - weld of lower connection plate at floor beam 10. A visual inspection was performed on the weld and the following defects were noted: overlap, unacceptable weld profile, and arc strikes on the upper and lower portion of weld joint (see images #7 & #8). An MT inspection was performed after power wire brushing. Other than the visible weld quality defects, there were no defects noted with MT inspection.

Location / Orientation	440112 - Span2, Beam 1, Location 12
Remarks	Image #7 - Visual defects

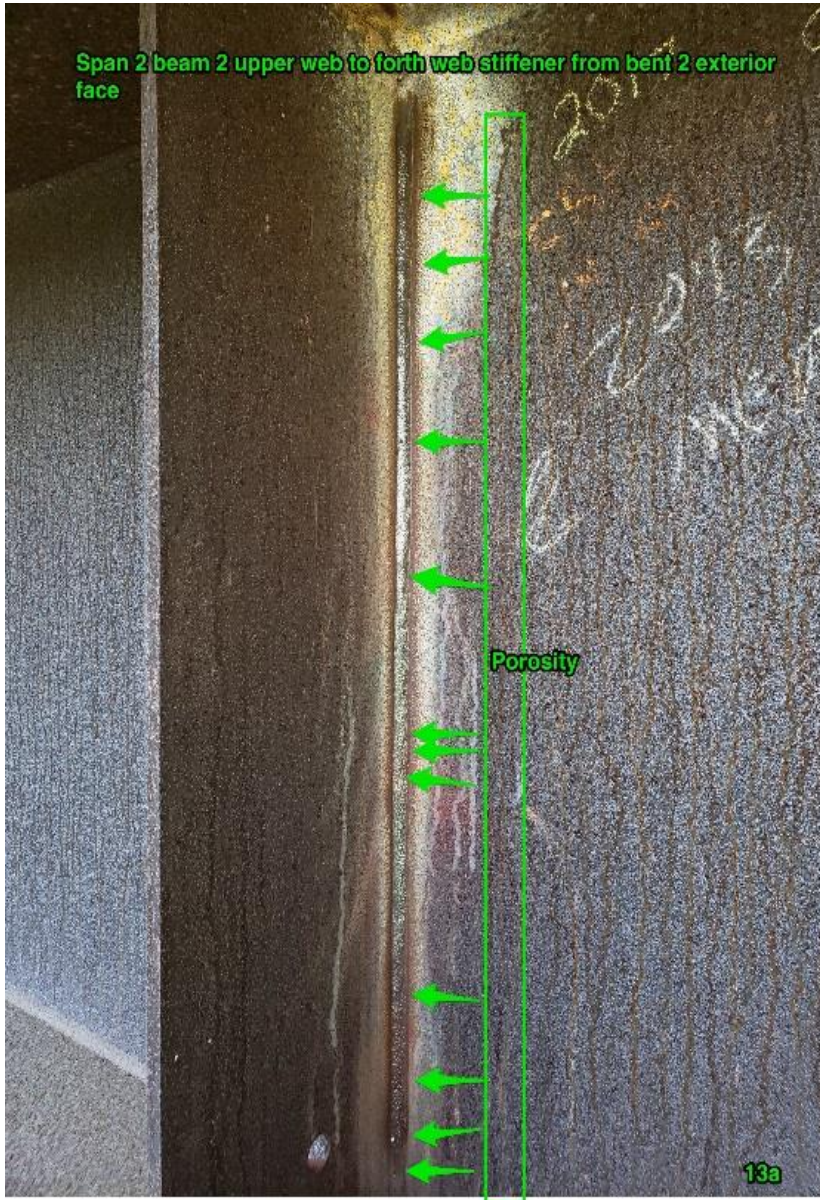
13. **Span 2, Beam 2 (NDT Test Location)** - upper web to 4th web stiffener from bent 2 on the exterior face. The weld was cleaned with the power wire wheel brush and MT inspection was performed. There were no defects noted. A visual inspection was performed. Twelve areas of porosity were noted in the 33-Inch length of weld (see images #9 & #10). The porosity does not exceed the AWS D1.5 acceptance criteria.

<p>Location / Orientation</p>	<p>440108 - Span 2, Beam 2, Location 13</p>
<p>Remarks</p>	<p>Image #9 - Porosity locations</p>

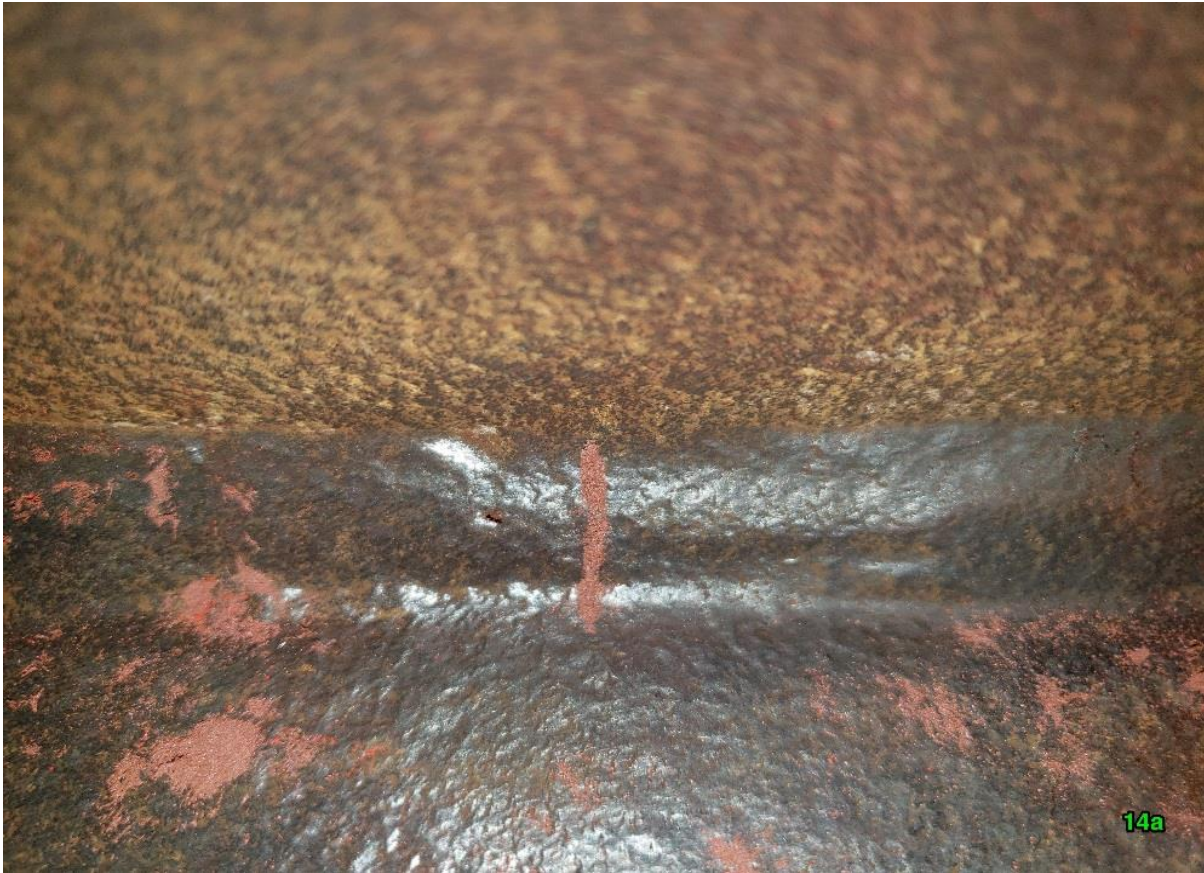
<p>Location / Orientation</p>	<p>440108 - Span 2, Beam 2, Location 13</p>
<p>Remarks</p>	<p>Image #10 - Porosity locations</p>

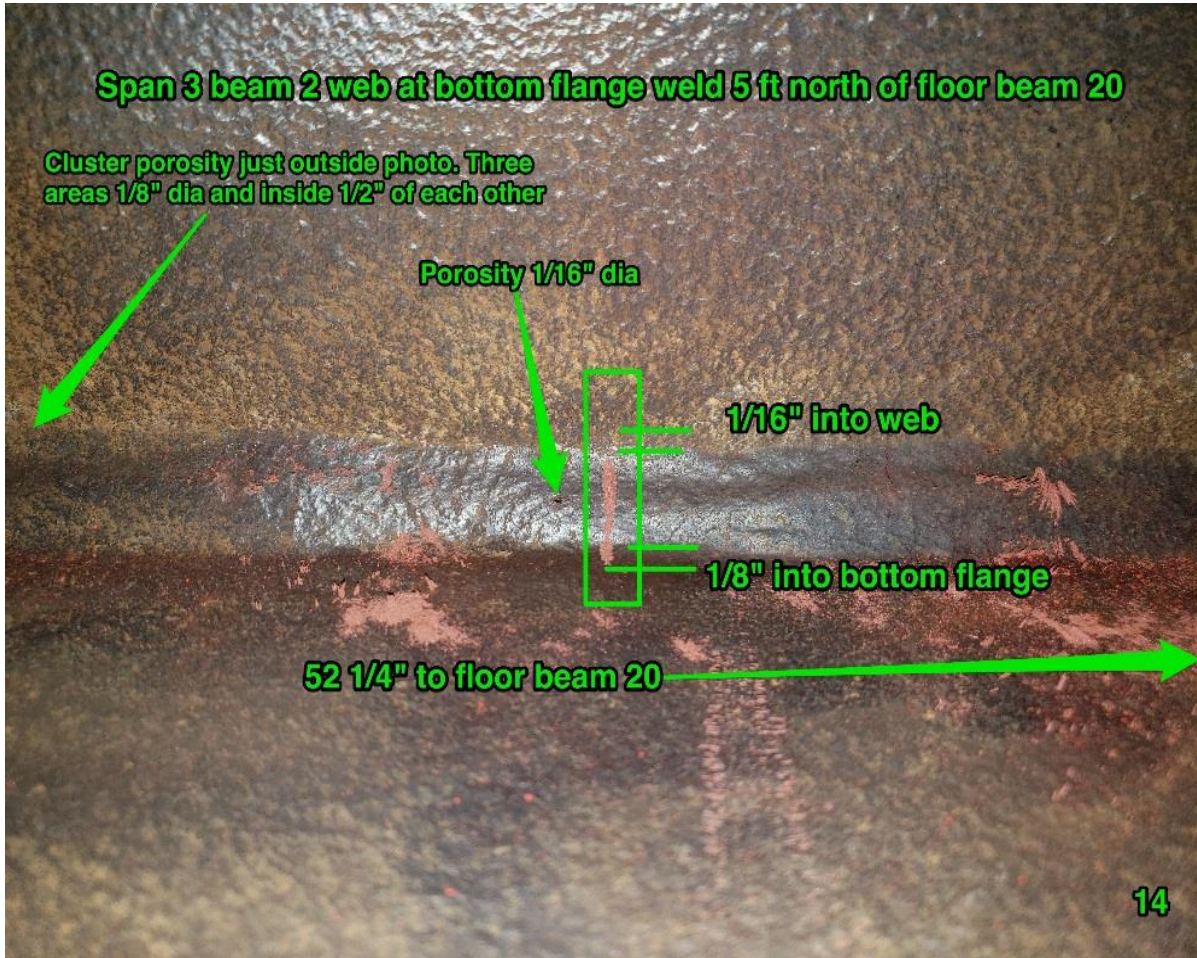
14. **Span 3, Beam 2 (NDT Test Location)** – The web at bottom flange weld 5 feet north of floor beam 20. The area was cleaned using a power wire wheel brush and MT inspection was performed. Noted a linear indication transverse to weld axis (see images #11, #12 & #13) in the lower flange to web weld. The linear indication extends through the entire face of the weld and into the base metal of the bottom flange by 1/8-Inch and extends into the web base metal 1/16-Inch. A UT inspection was performed to attempt to determine the depth that the indication extends into the base metal. Because of the orientation of the linear indication, UT did not reveal an indication in the base metal.

<p>Location / Orientation</p>	<p>440108 - Span 3, Beam 2, Location 14</p>
<p>Remarks</p>	<p>Image #11 - Transverse linear indication</p>

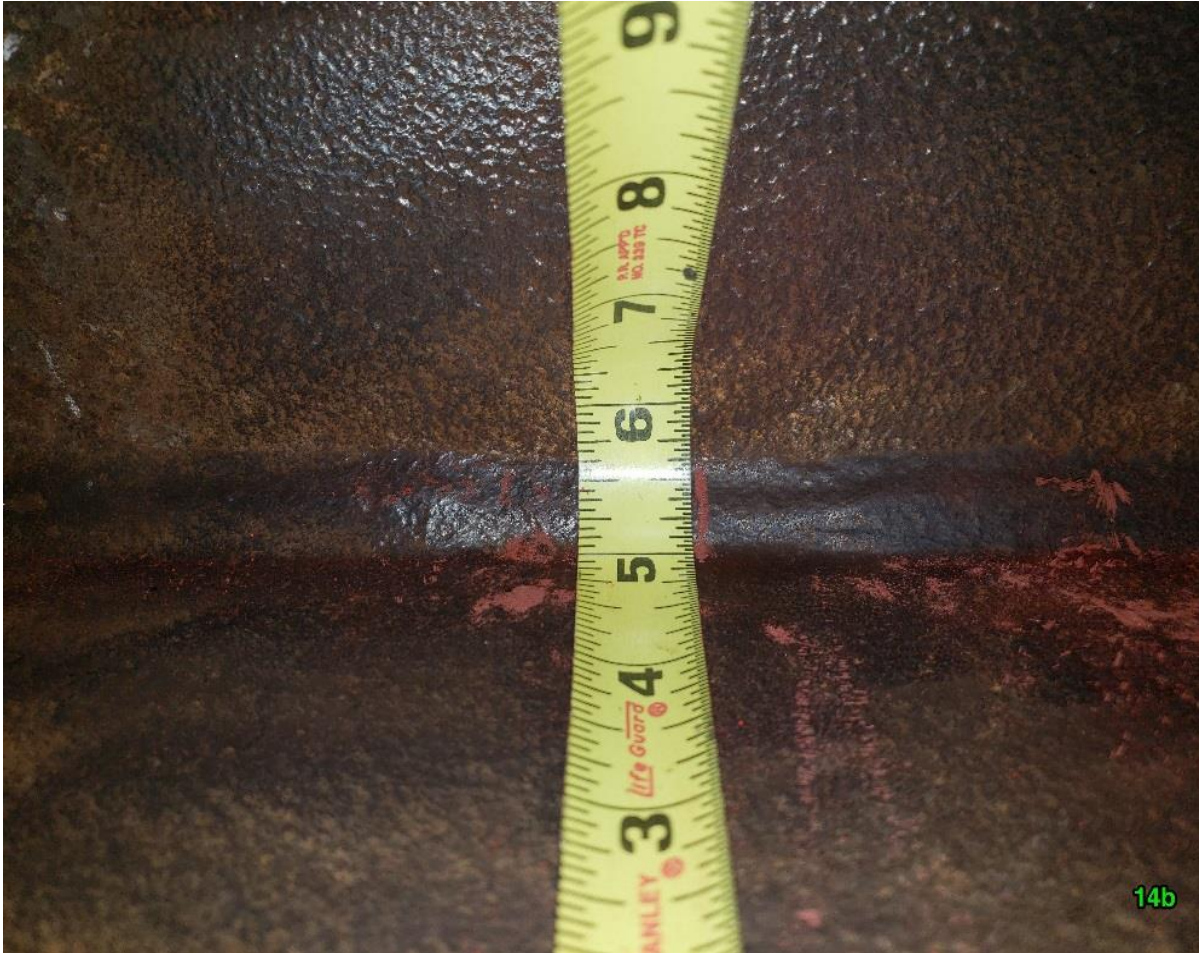
Location / Orientation	440108 - Span 3, Beam 2, Location 14
Remarks	Image #12 - Linear indication

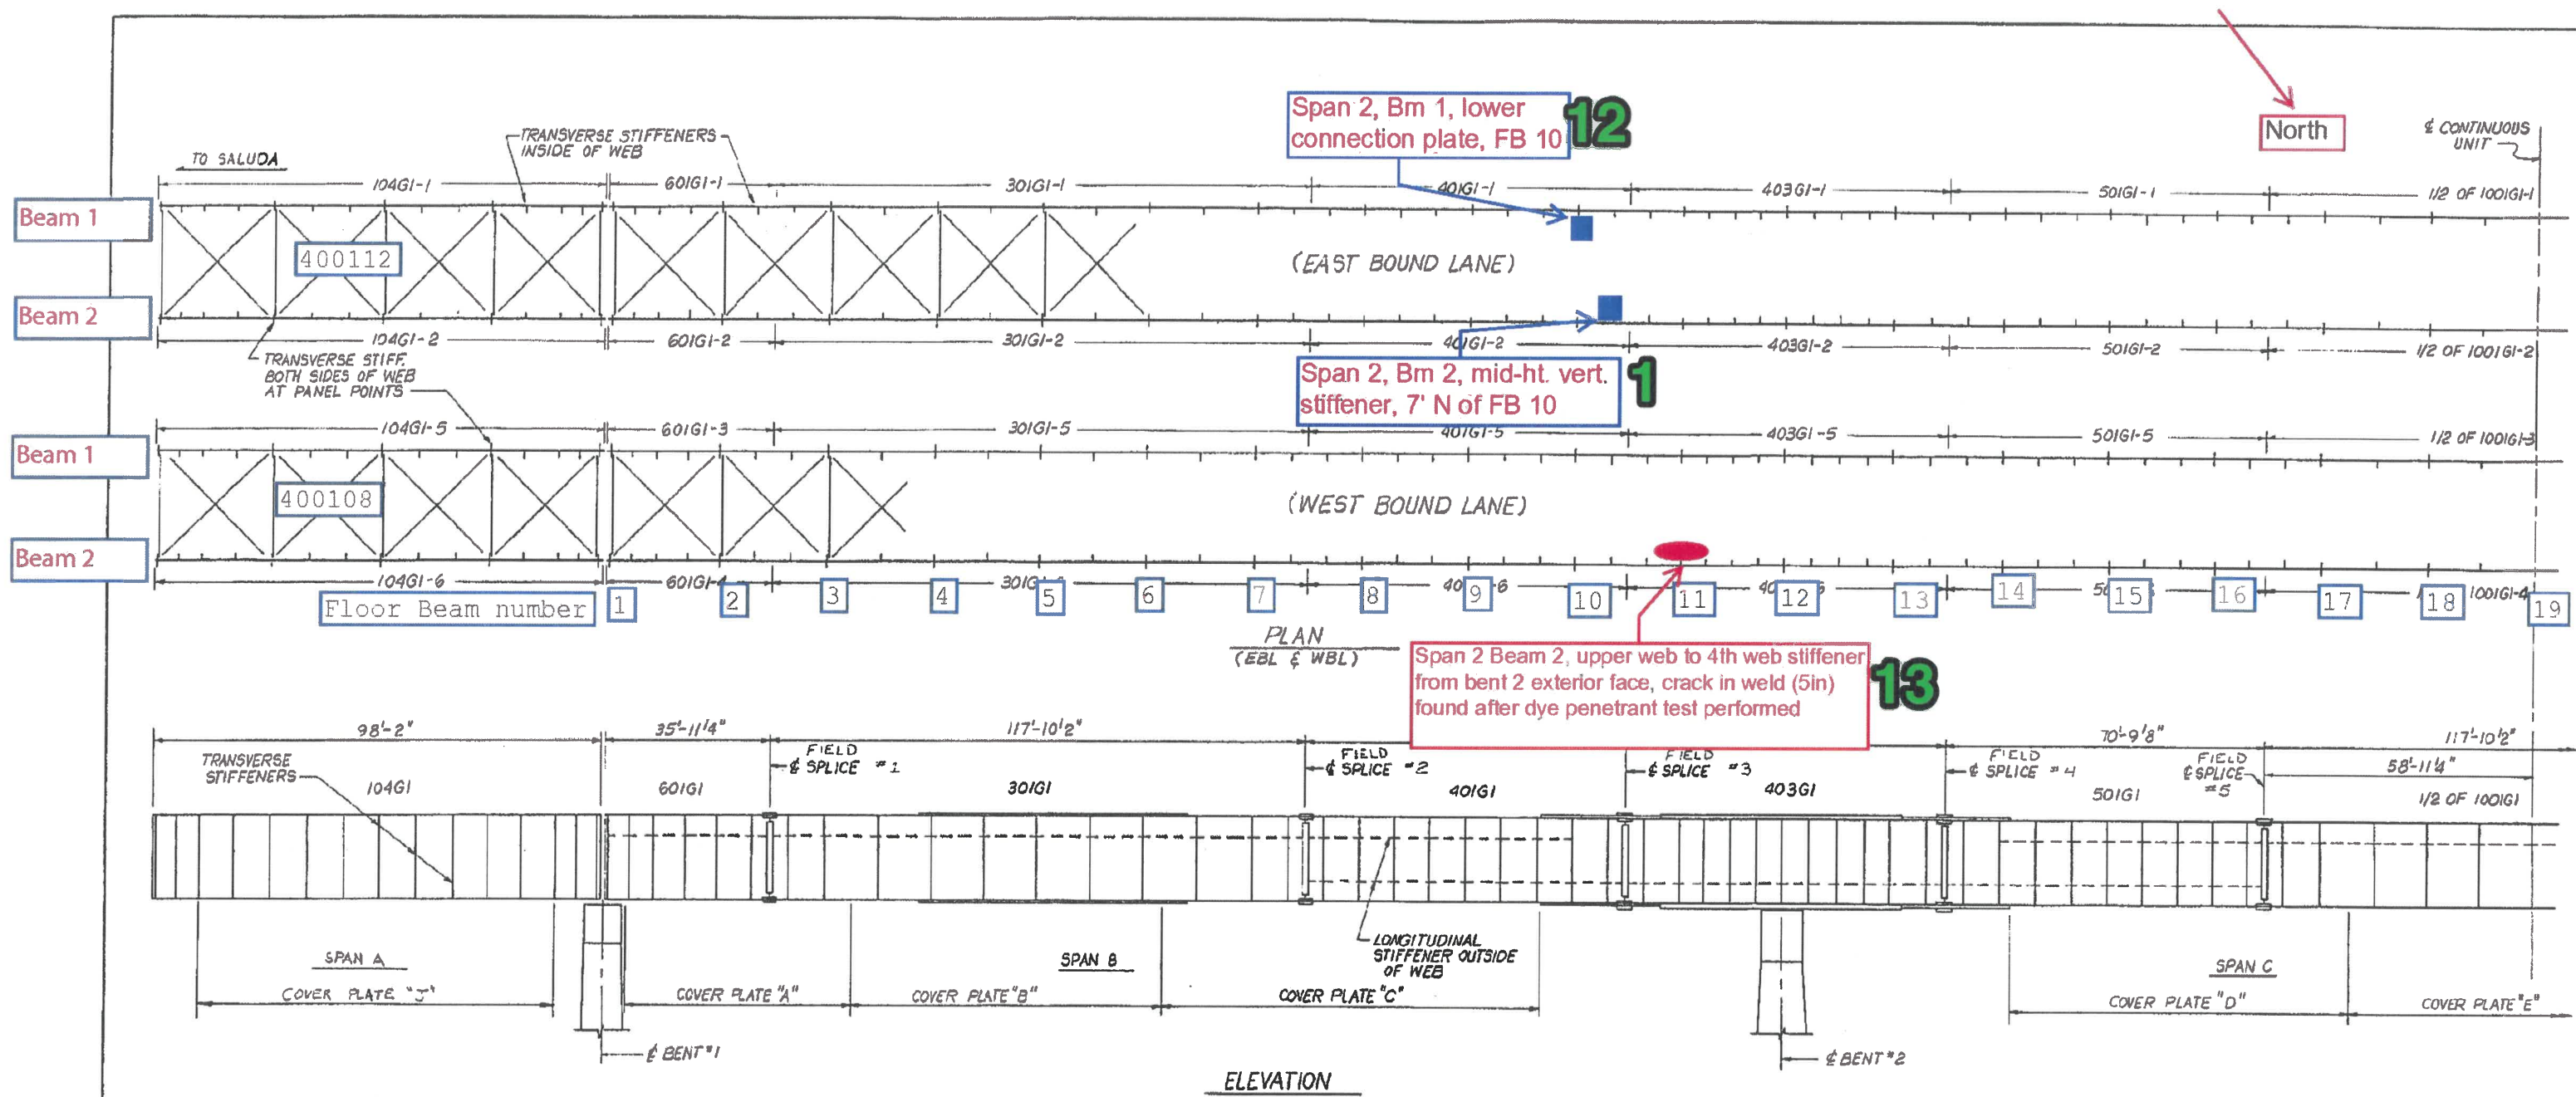
Span 2, Bm 1, lower connection plate, FB 10 **12**

Span 2, Bm 2, mid-ht. vert. stiffener, 7' N of FB 10 **1**

Span 2 Beam 2, upper web to 4th web stiffener from bent 2 exterior face, crack in weld (5in) found after dye penetrant test performed **13**
