NC DEPARTMENT OF TRANSPORTATION
 DIVISION OF HIGHWAYS
 STRUCTURE MANAGEMENT UNIT

ATTENTION: **PRIORITY MAINTENANCE, STRUCTURE DATA CHANGE**

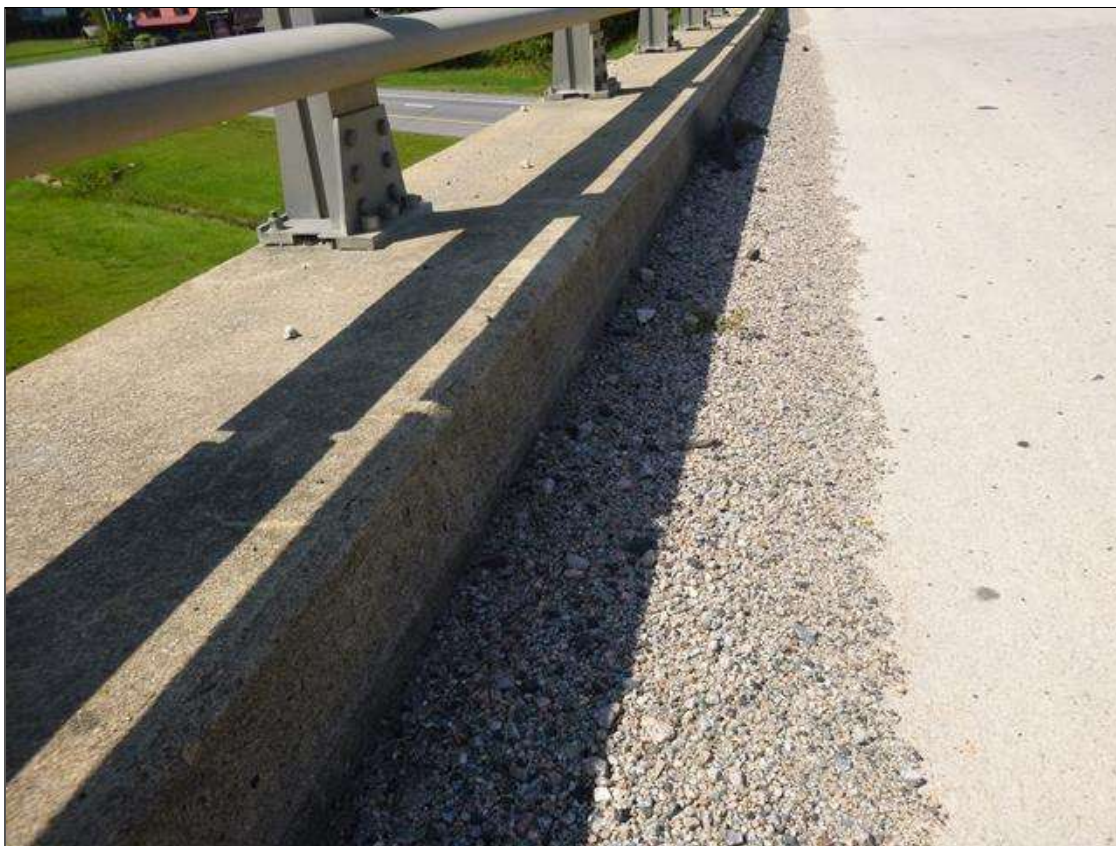
Deck Debris: 18" X 3" DEEP OF GRAVEL AND DEBRIS ALONG FULL LENGTH OF BOTH CURBS.

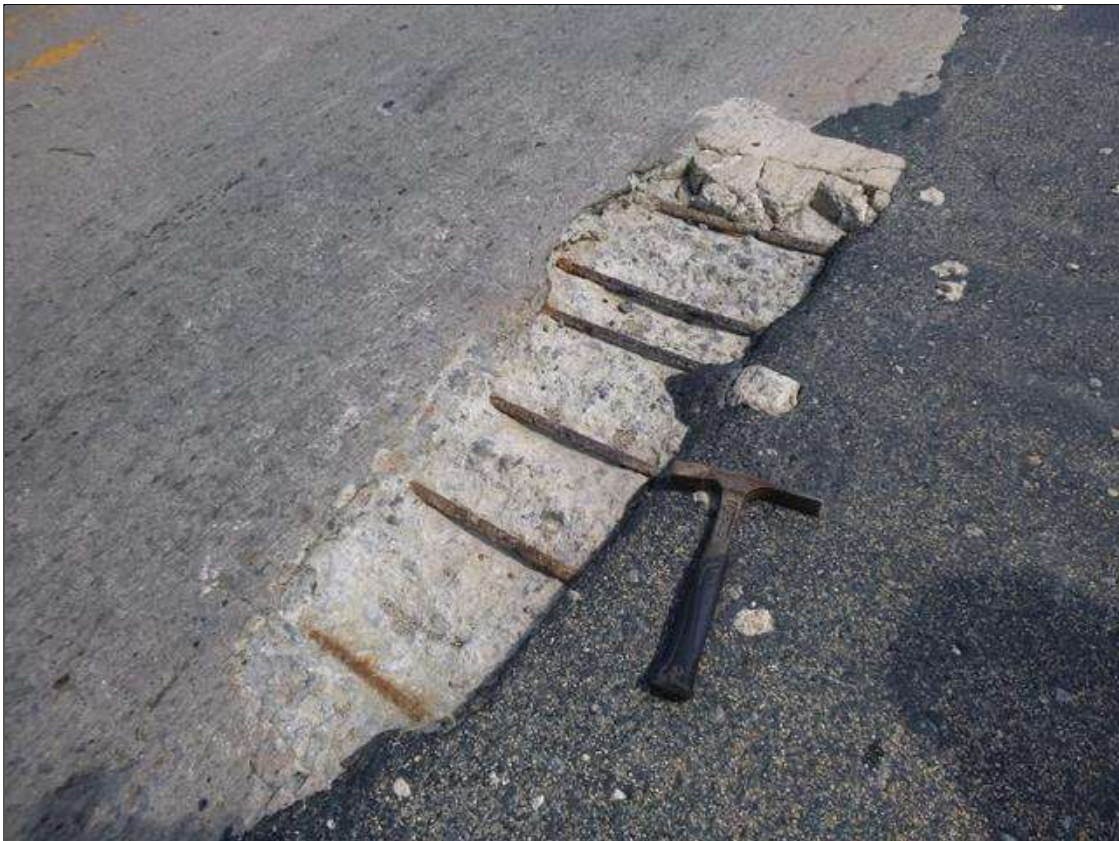
Span 1 Deck: 4' X 18" X 2" DEEP SPALL WITH EXPOSED REINFORCING, CENTER OF EAST BOUND LANE, NEAR MIDSPAN. (PM)

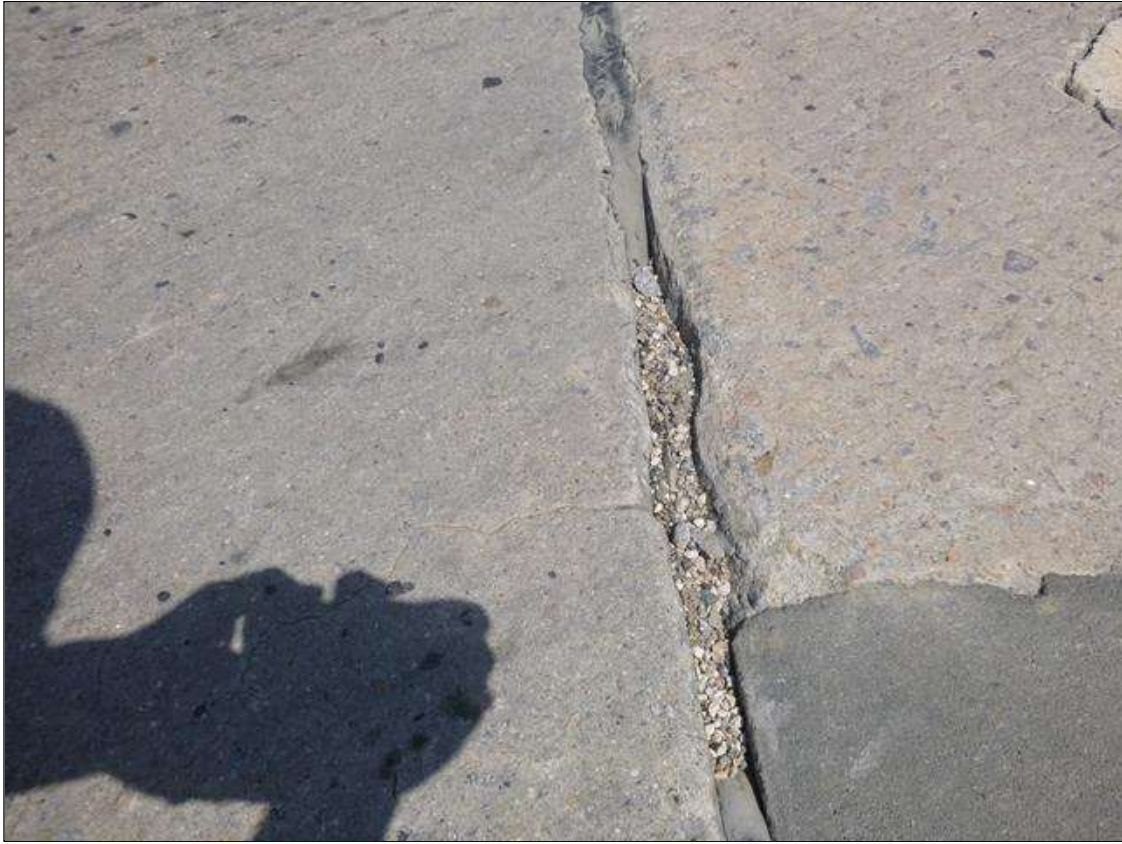
Expansion Joint, Bent 1 : 6' OF COMPLETE LOSS OF ADHESION AT RANDOM ALONG JOINT.

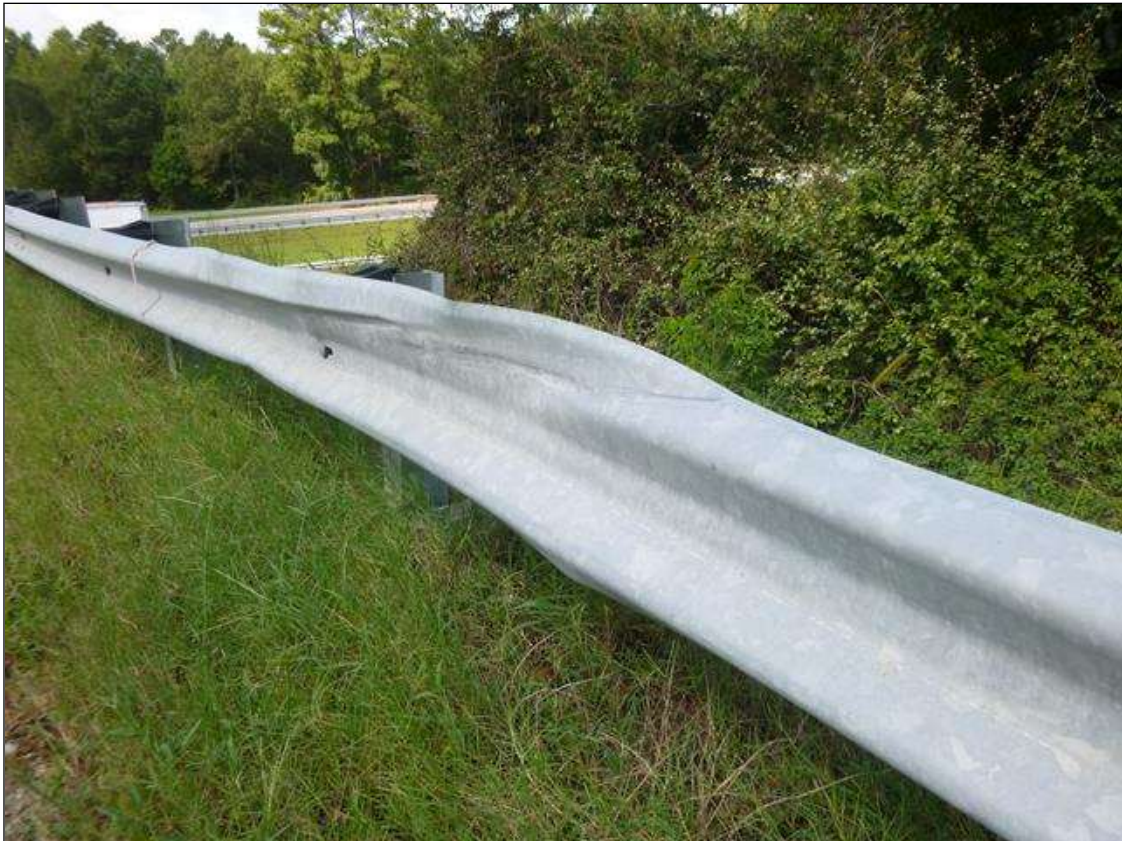
General Comments and Misc. Items: 8' OF IMPACT DAMAGE TO NORTHEAST GUARDRAIL.

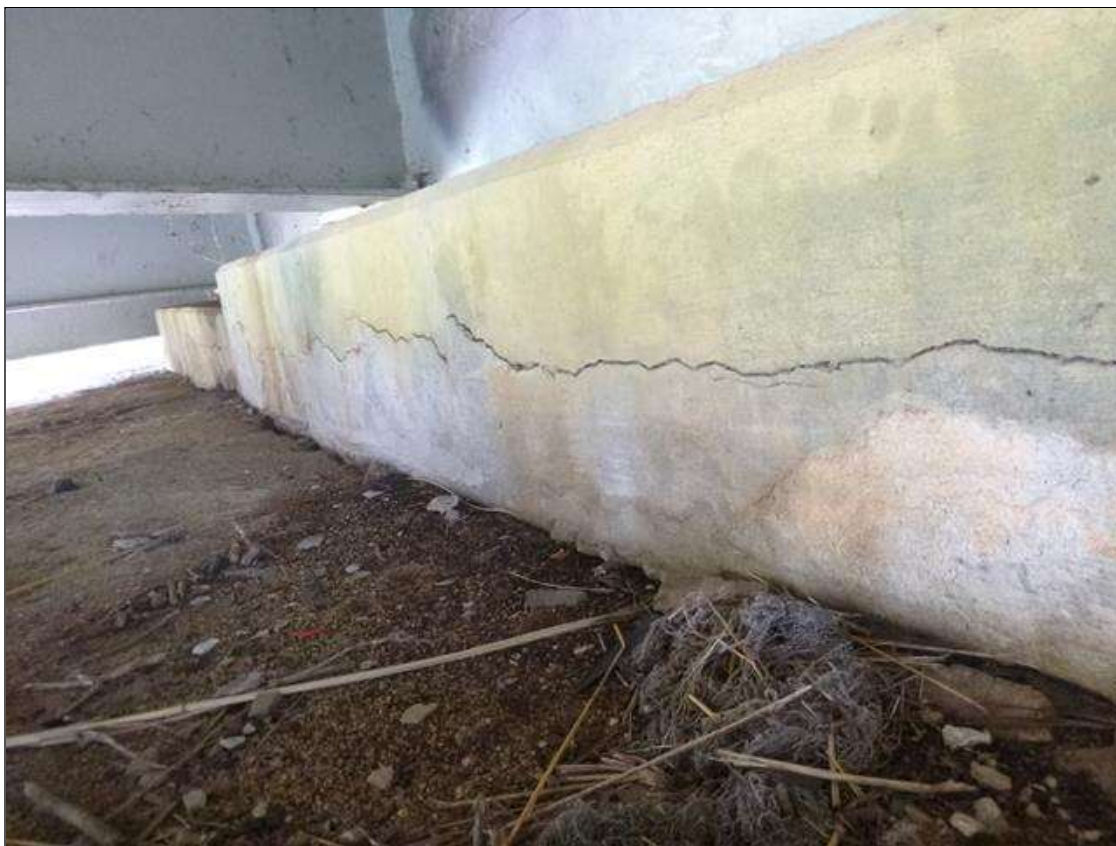
End Bent 1 Cap 1: 20 FT HORIZONTAL CRACK UP TO 1/8 IN, BETWEEN BEAMS 1 THROUGH 4.

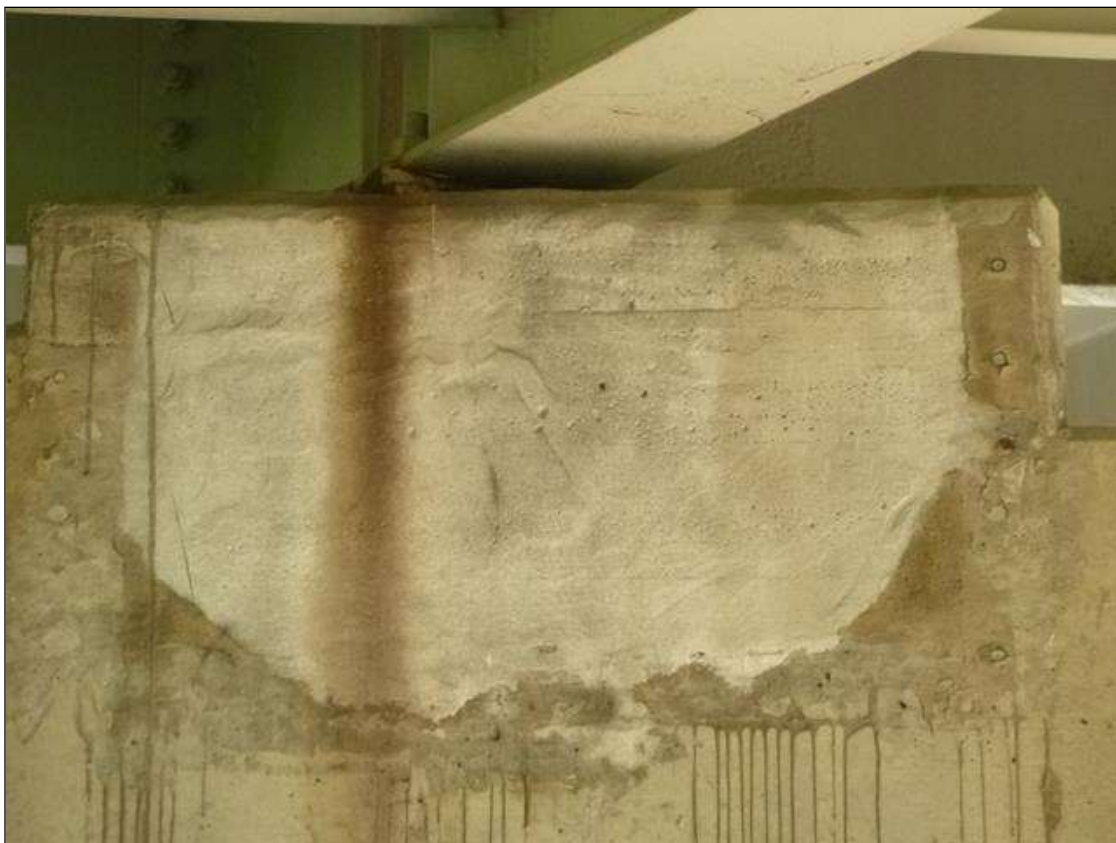
Bent 1 Cap 1: 30" X 2' SOUND PATCHED AREA, WEST FACE BELOW BEAM 3.

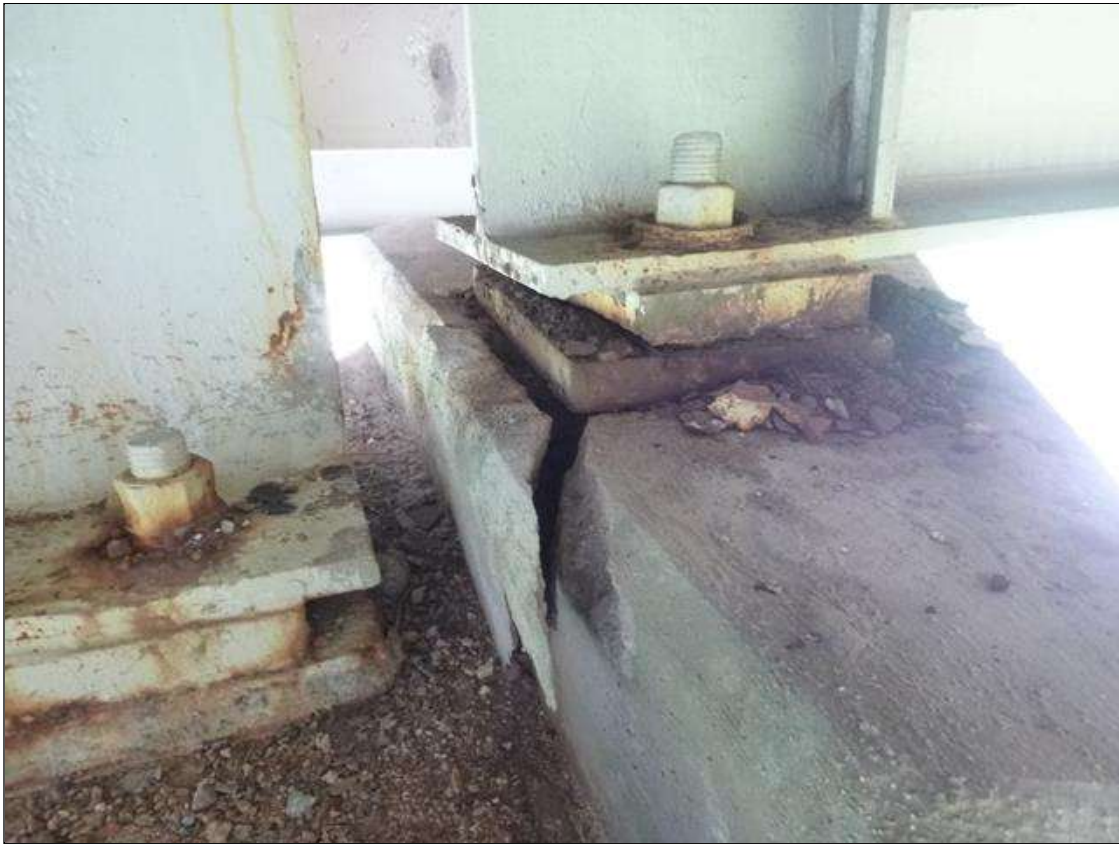
Bent 1 Cap 1: 15" X 7'X 3" SPALL, EAST FACE OF SPAN 1 BEAM 2 SEAT. NO LOSS OF BEARING AREA.

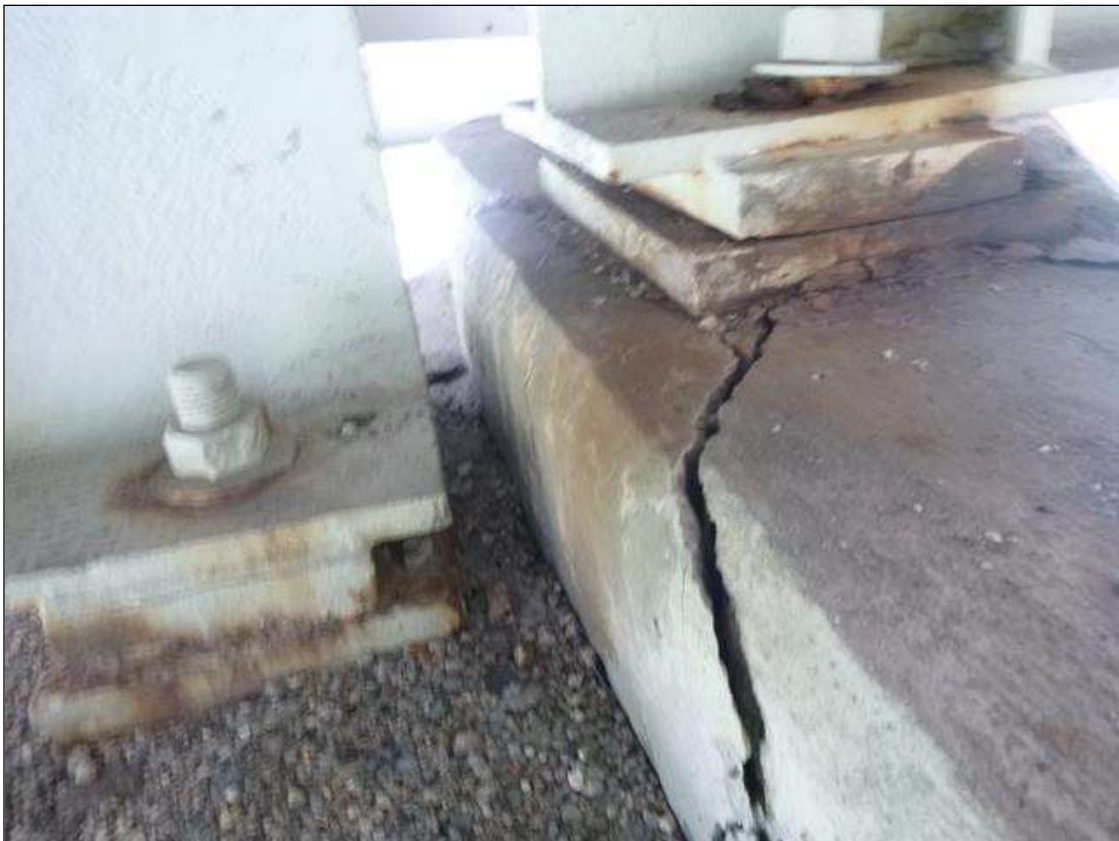
Bent 1 Cap 1: 20" X 6" DELAMINATION, EAST FACE OF SPAN 1 BEAM 3 SEAT.

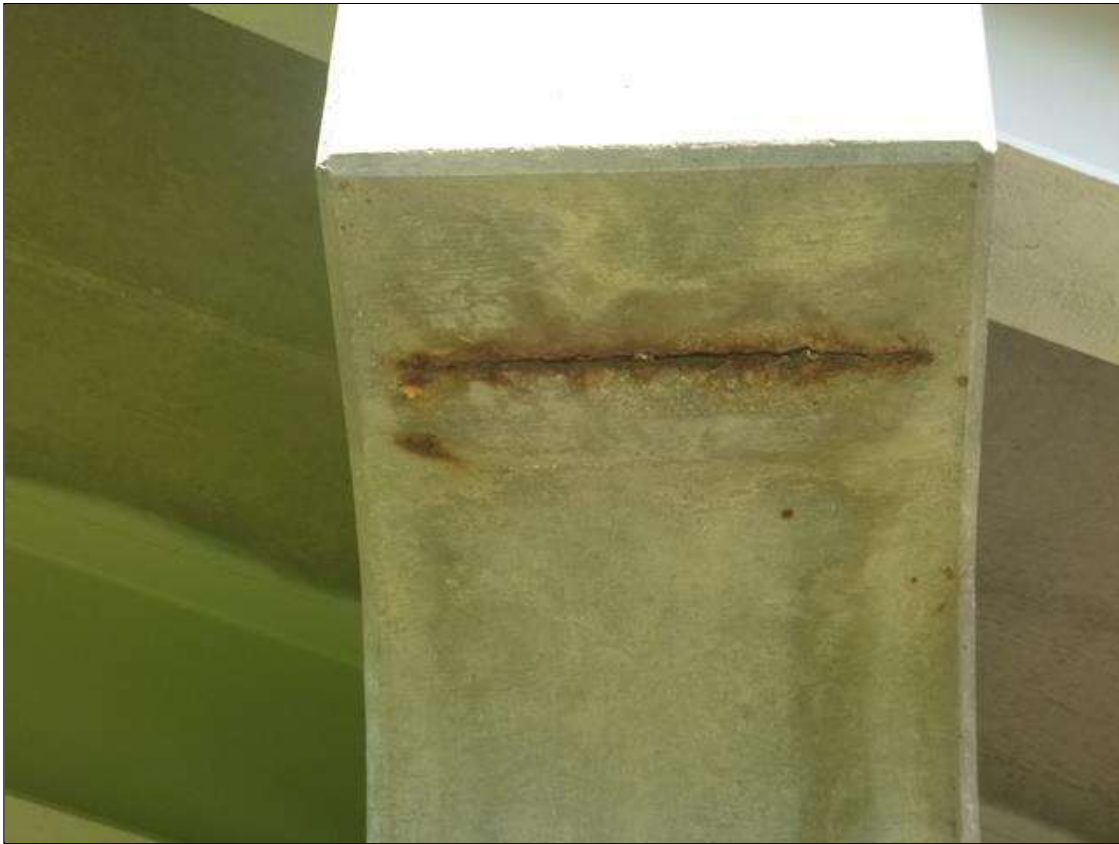
Bent 3 Cap 1: 2 FT X 6 IN SPALL WITH EXPOSED REINFORCEMENT ON UNDERSIDE OF RIGHT END OF CAP.

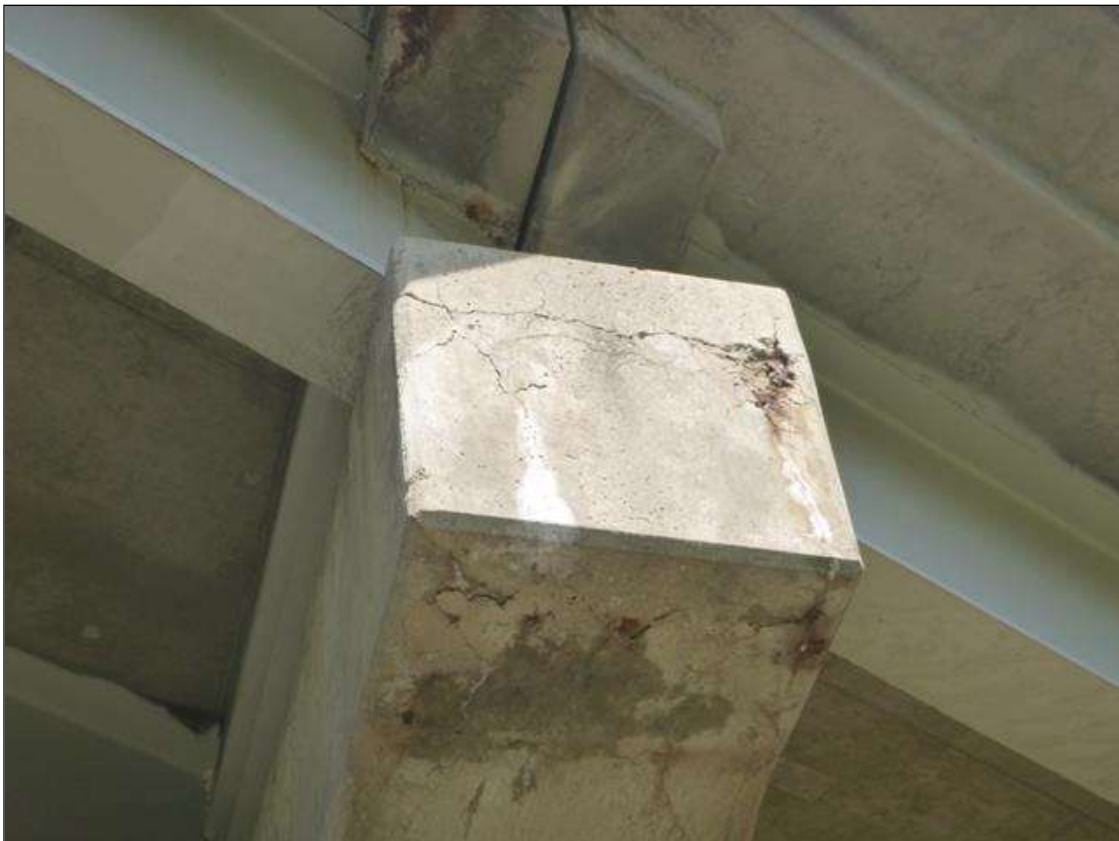
Bent 4 Cap 1: 3 FT X 3 FT AREA OF SPALLING AND DELAMINATION, SOUTH FACE OF BENT CAP.

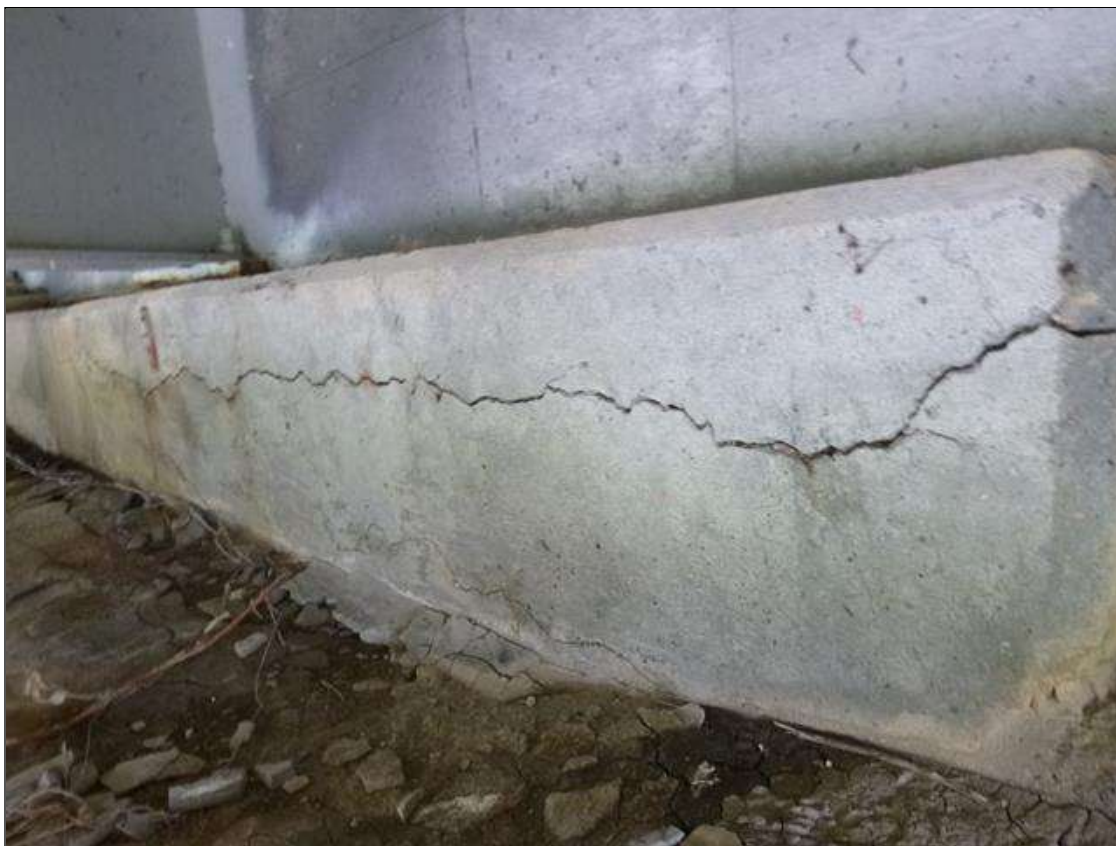
End Bent 5 Cap 1: 5 FT HORIZONTAL CRACK UP TO 1/8 IN, BELOW BAY 3.

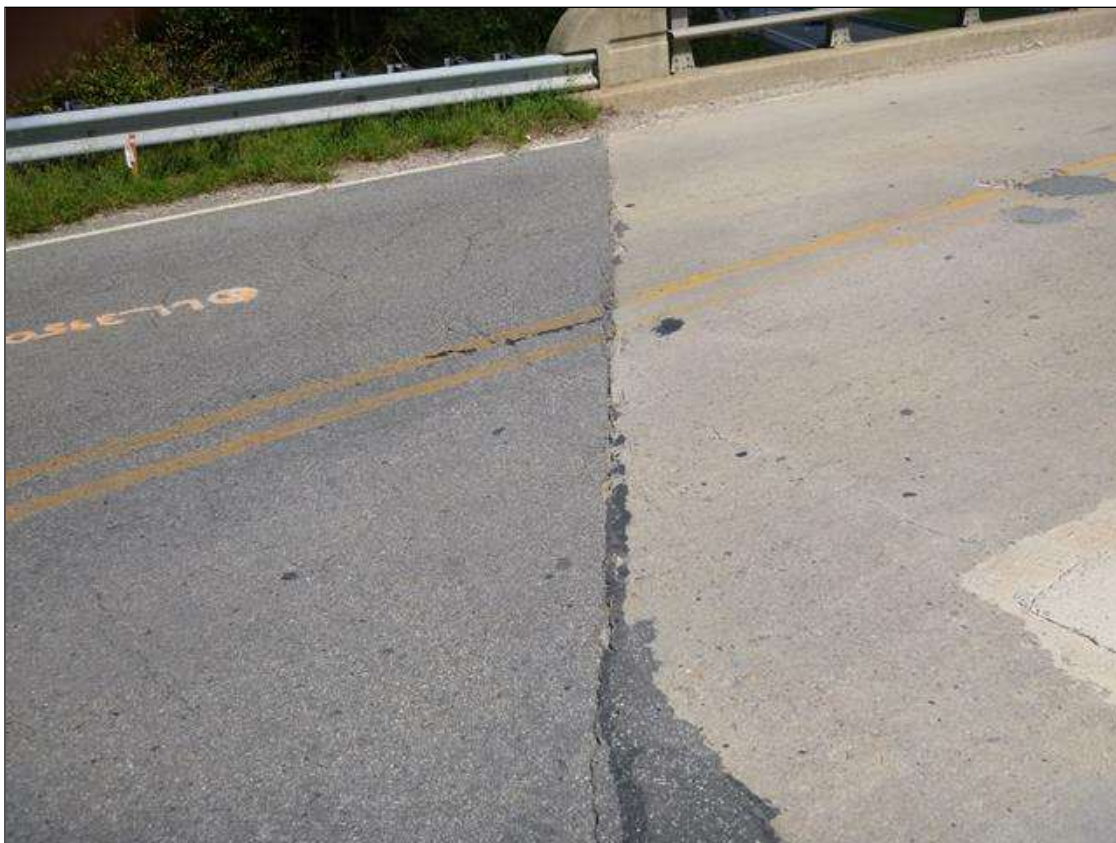
CRACK OVER END BENT 1, LOOKING NORTH

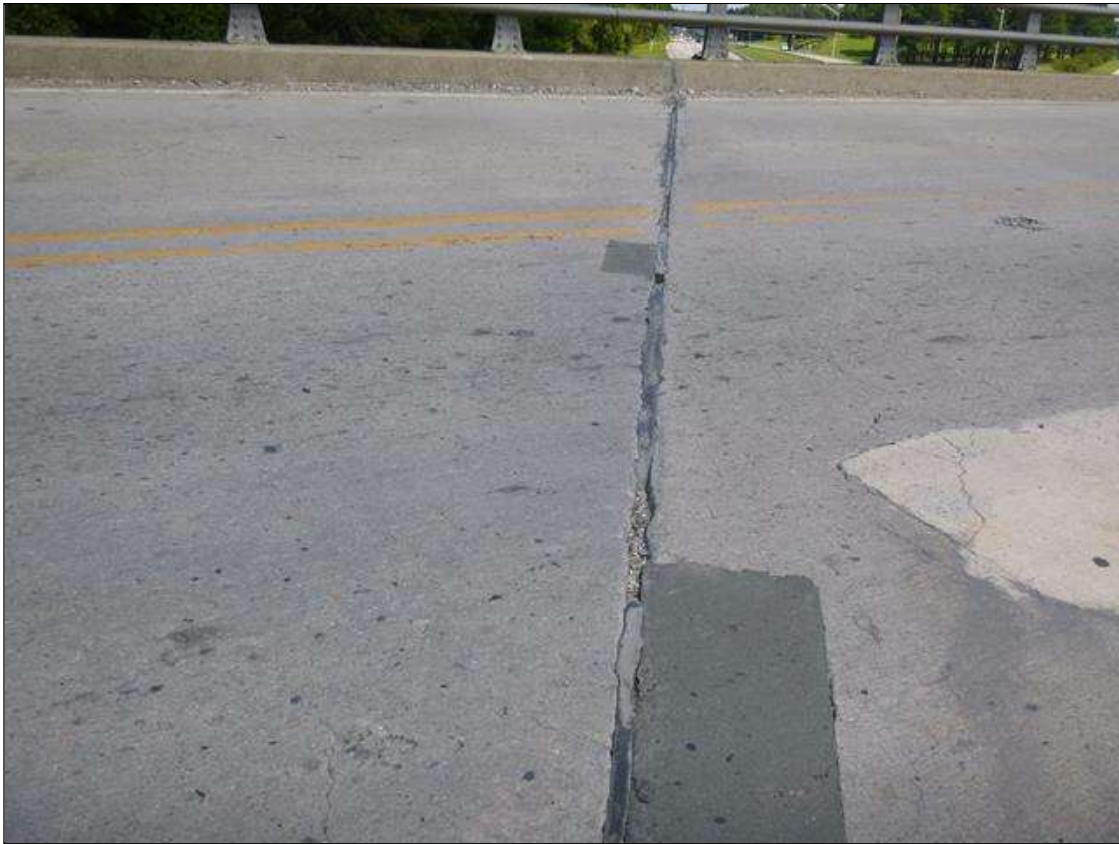
JOINT OVER BENT 1, LOOKING NORTH

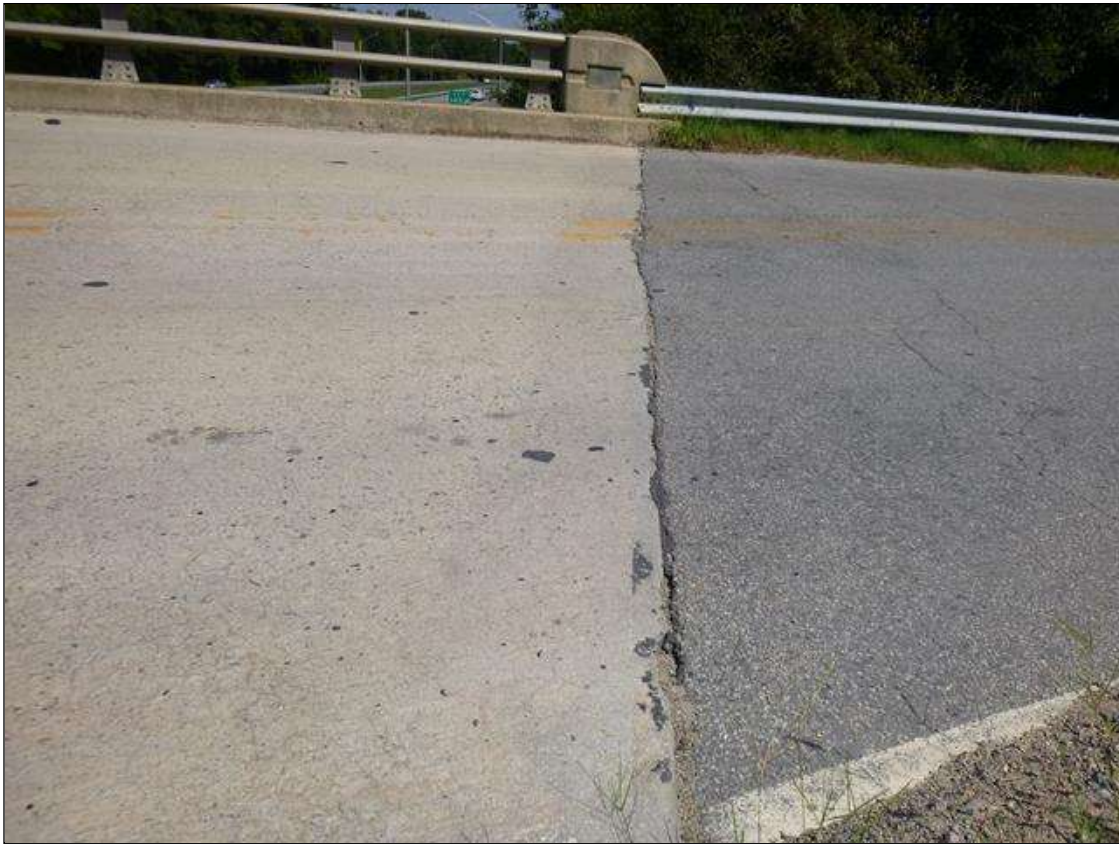
CRACK OVER END BENT 2, LOOKING NORTH

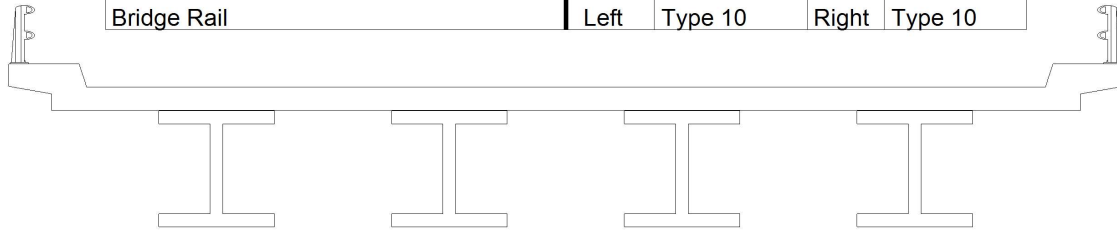
Measurements for Span #	1		
Deck Thickness	.583	Left Overhang	3.916
Top of Rail to Bottom of Beam	6.146	Right Overhang	3.916

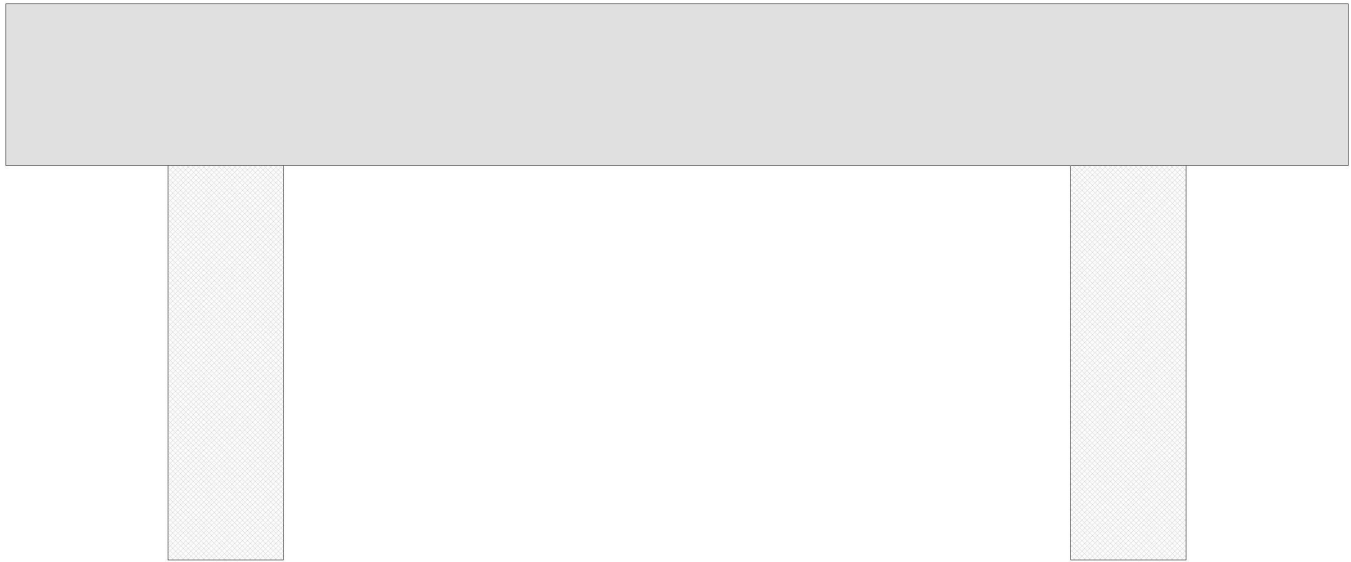
Cap Information			Material Cast-in-Place Concrete							
Length	Width	Height	Left Overhang	Right Overhang	Left Beam to End of Cap.	Right Beam to End of Cap.				
29.000 ft.	2.500 ft.	2.500 ft.	4.750 ft.	4.750 ft.	2.000 ft.	2.000 ft.				
Subcap Information			Material							
Length	Width	Height	Left Overhang	Right Overhang	Left Pile to Splice.					
Sill Information			Material							
Length	Width	Height								
Pile #	Material	Spacing	Width/Dia.	Height	Length	Orientation	Driven?	Replacement?	Removed?	Collar?
1	Concrete	19.5 ft.	2.5 ft.	2.5 ft.		Vertical	No	No	No	No
2	Concrete		2.5 ft.	2.5 ft.		Vertical	No	No	No	No
MODIFIED BY MRM, 9/19/2018										
Bent/Abutment #: 1			Similar Bents: Bents 2, 3, 4
