NC DEPARTMENT OF TRANSPORTATION
 DIVISION OF HIGHWAYS
 STRUCTURE MANAGEMENT UNIT

ATTENTION: PAR ISSUED ON PILES 1, 2 AND 6 AT END BENT 1,
 PILES 1 3 AND 4 AT PIER 1, PILES 1-6 AT PIER 2 AND
 PILES 1 AND 5 AT END BENT 2

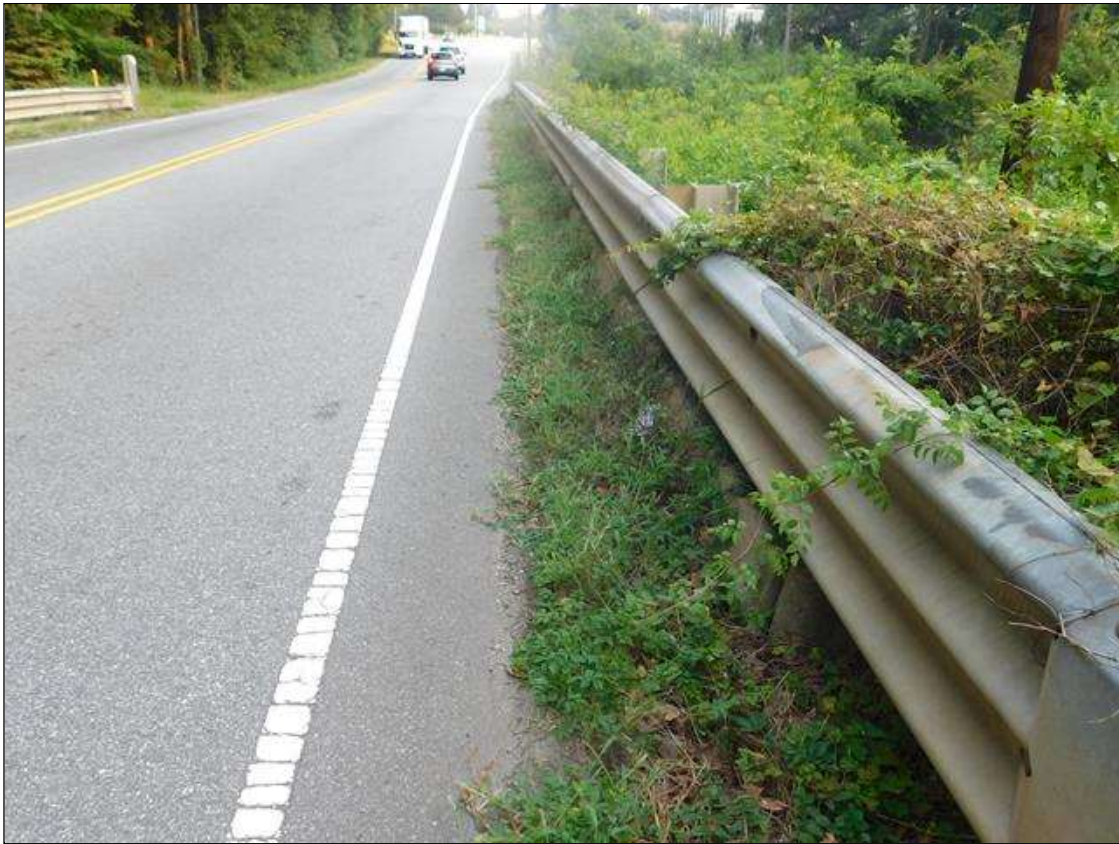
DEBRIS AND VEGETATION GROWING ALONG RAILS

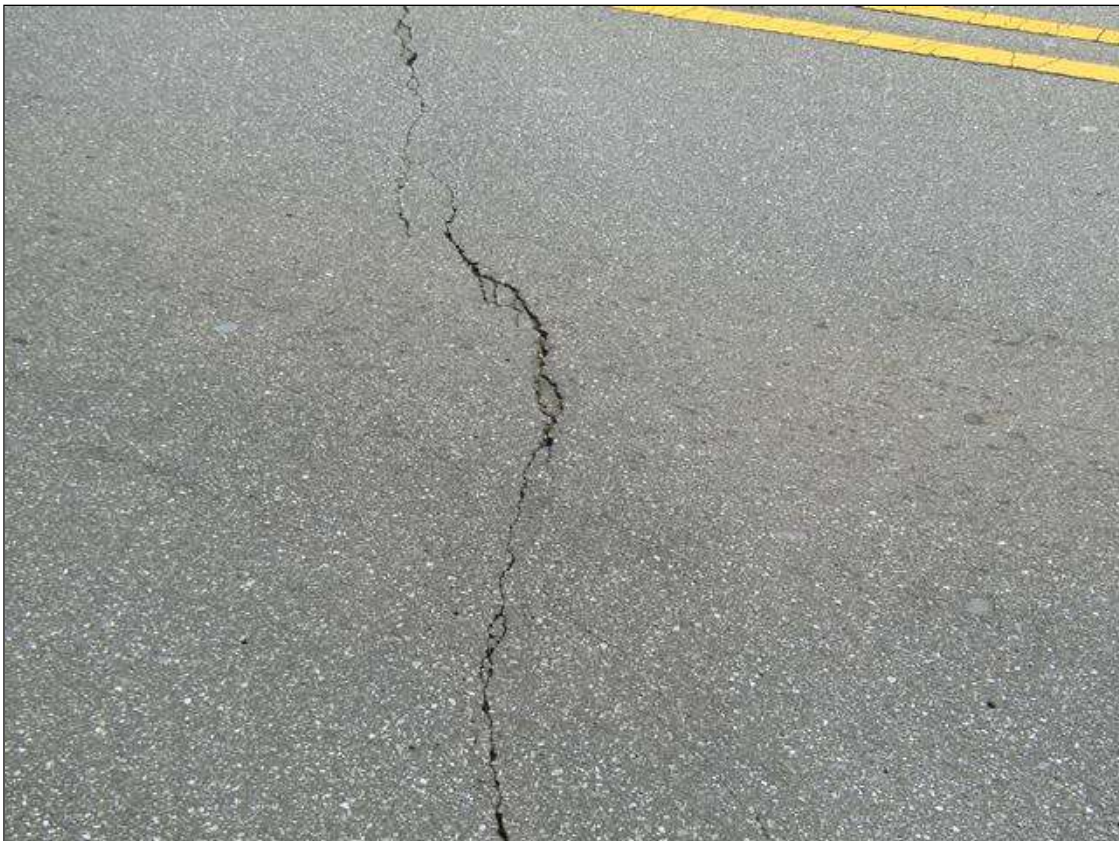
Span 1 Wearing Surface: TRANSVERSE CRACKING OVER END BENT 1 UP TO 1" WIDE

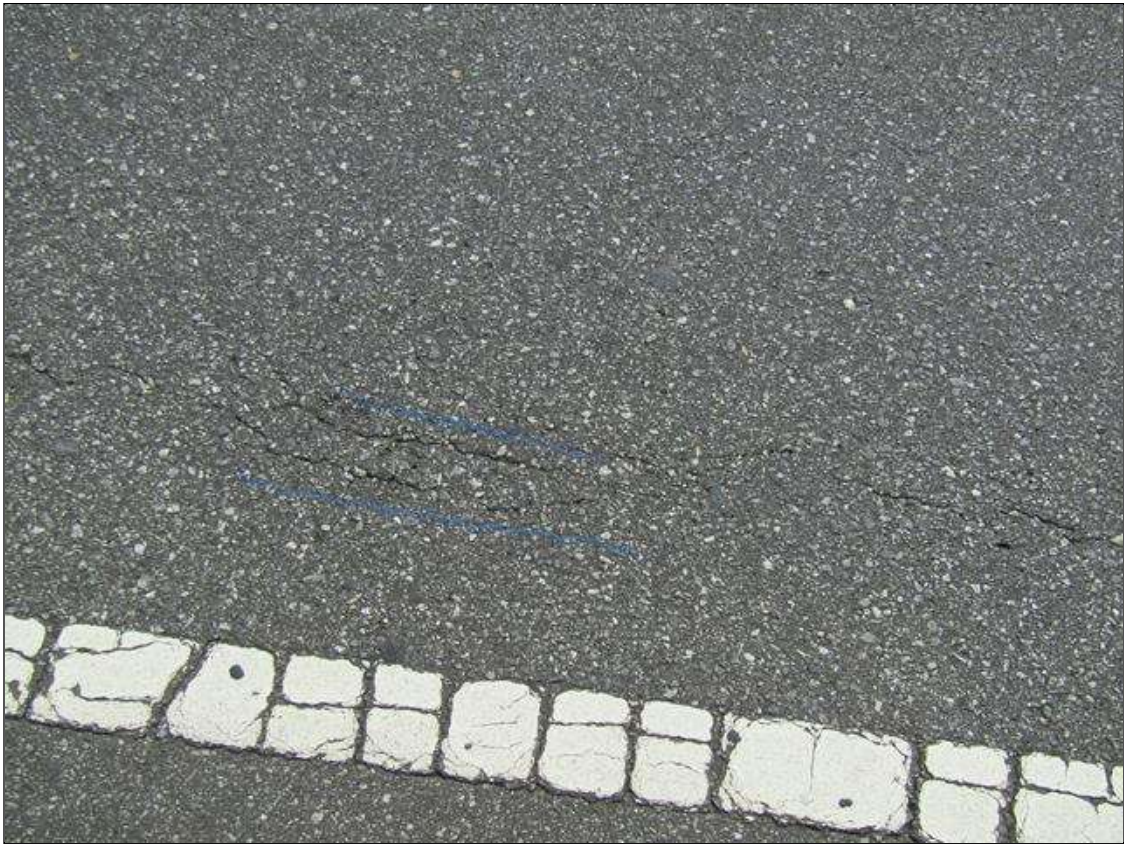
Span 1 Wearing Surface: LONGITUDINAL CRACK 1/16" WIDE IN SBL

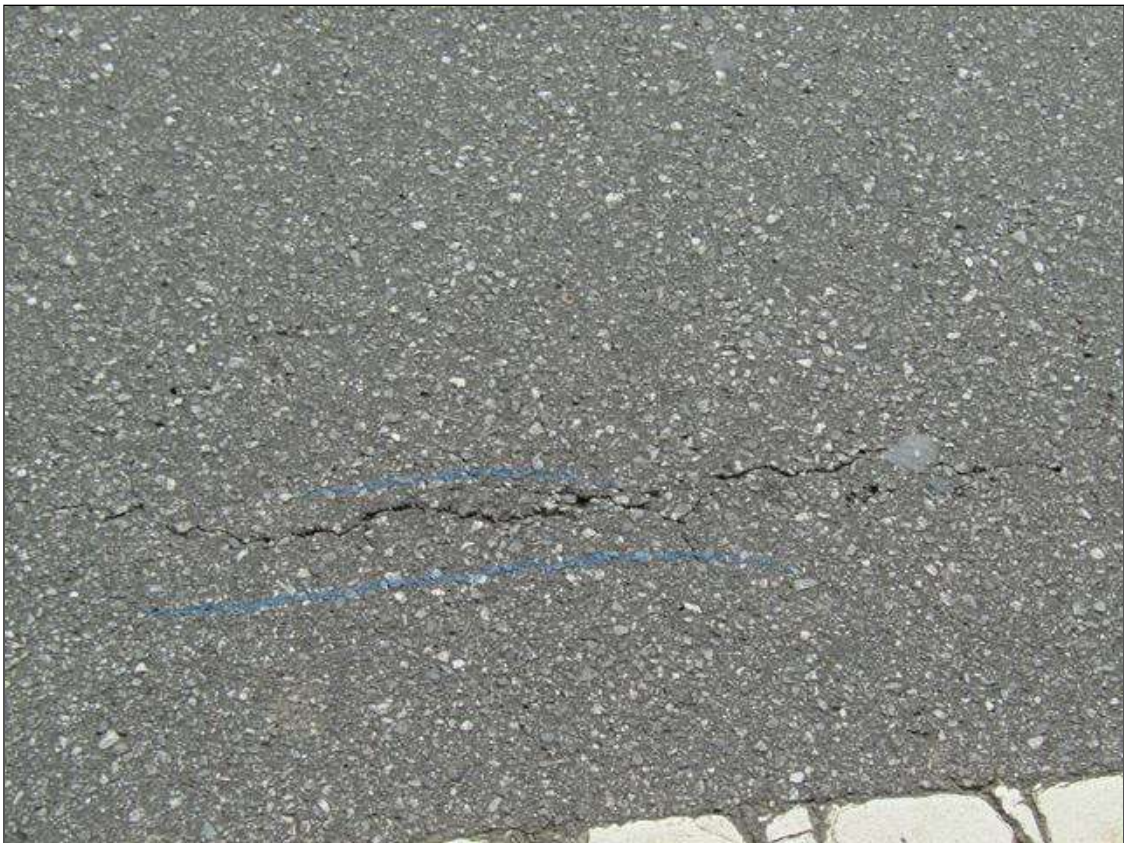
Span 2 Wearing Surface: LONGITUDINAL CRACK 1/16" WIDE IN SBL

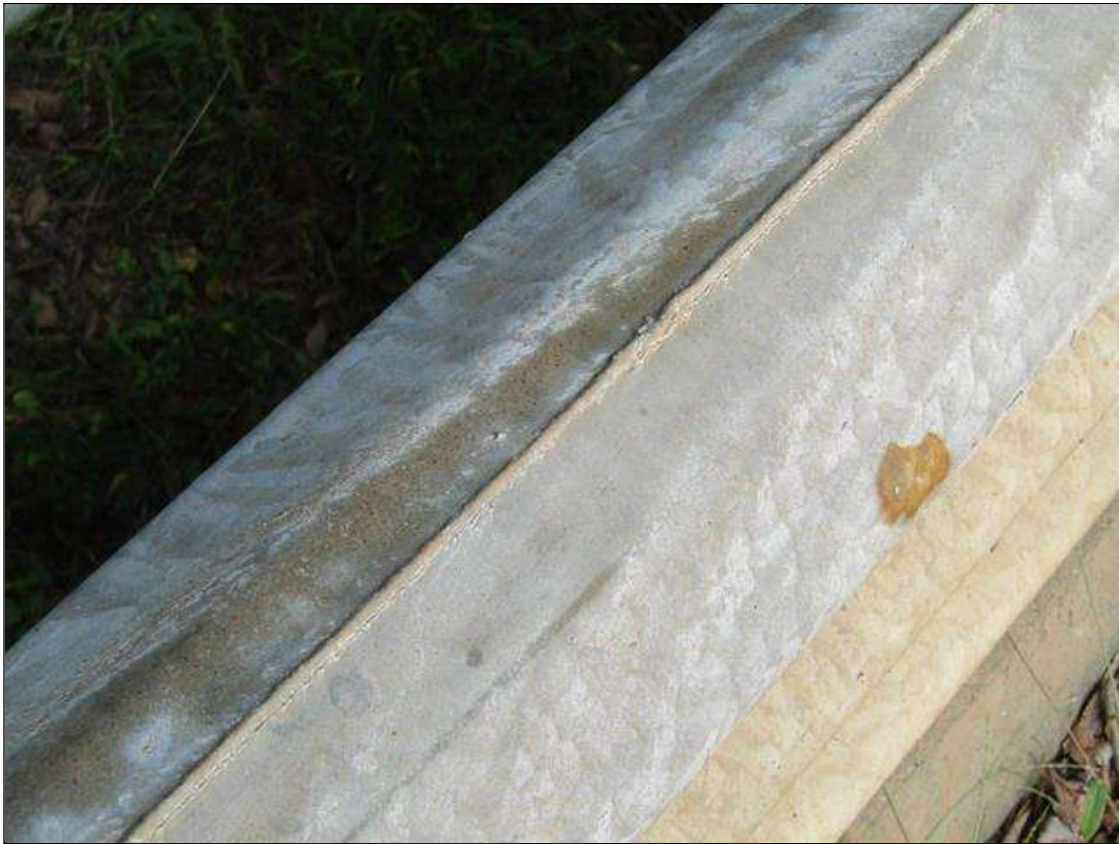
Span 3 Left Bridge Rail - Protective System: SUBSTANTIALLY EFFECTIVE ON TOP

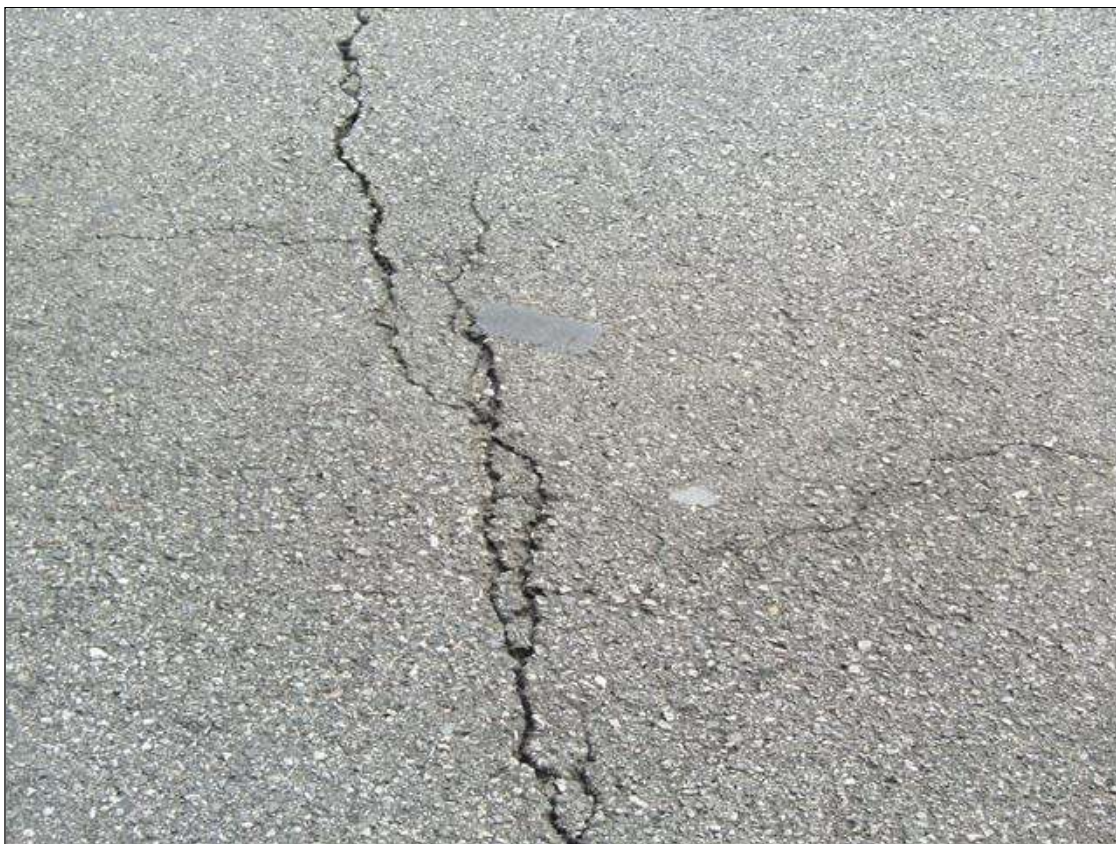
Span 3 Wearing Surface: TRANSVERSE CRACKING OVER END BENT 2 UP TO 1" WIDE

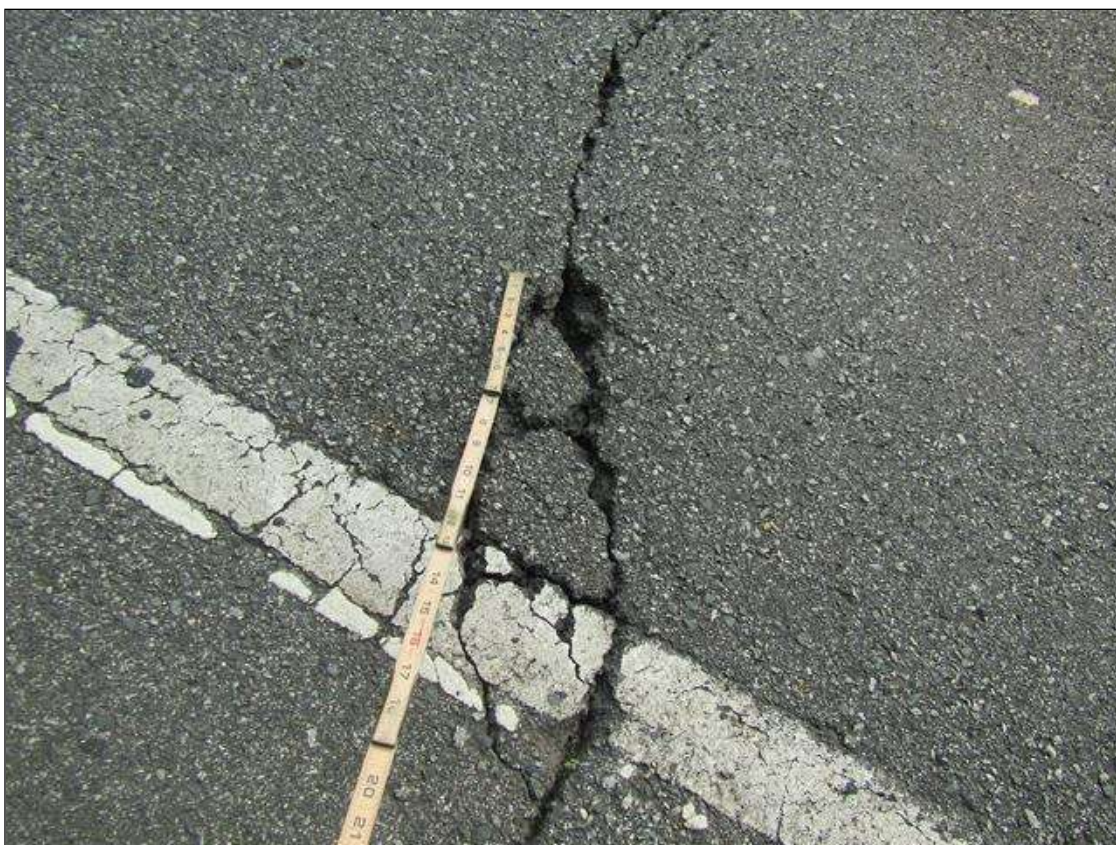
Span 3 Wearing Surface: ASPHALT BUSTING UP OVER END BENT 2 IN SBL NEAR WHITE LINE 18" x 5"

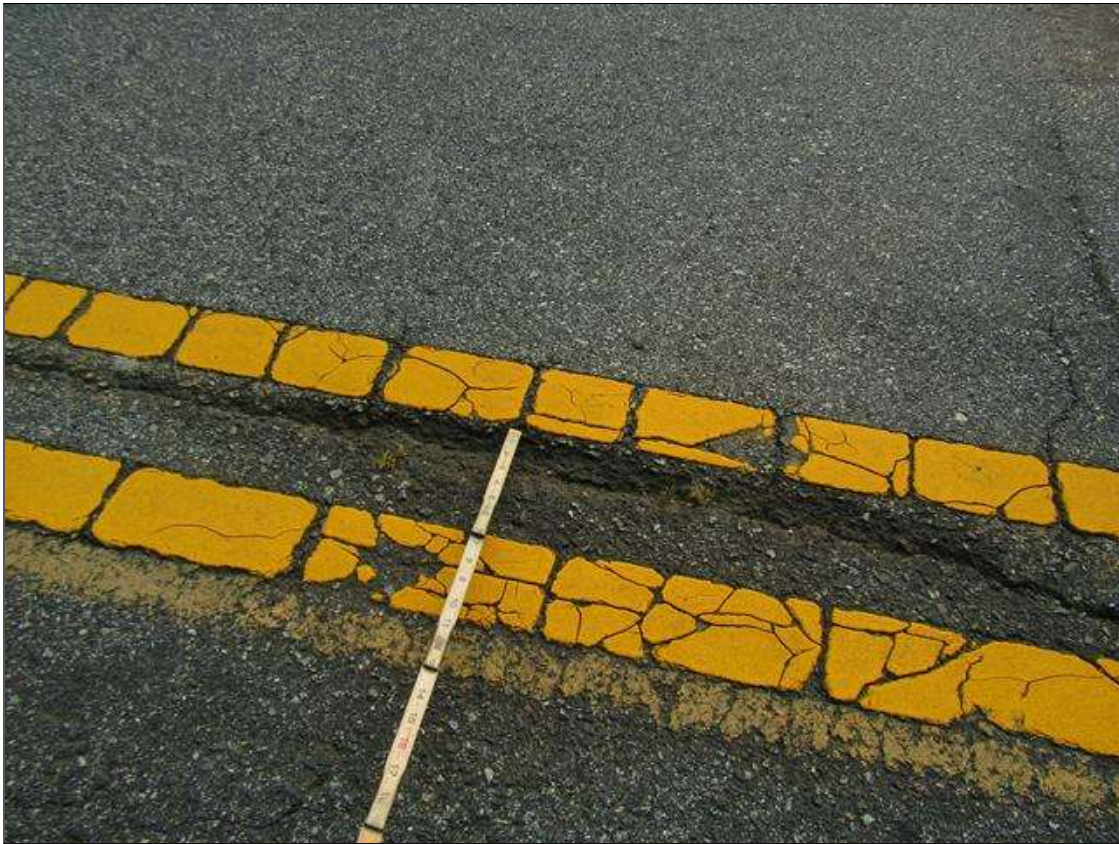
Span 3 Wearing Surface: ASPHALT SEPARATED IN CENTER NEAR END BENT 2 x 4" WIDE

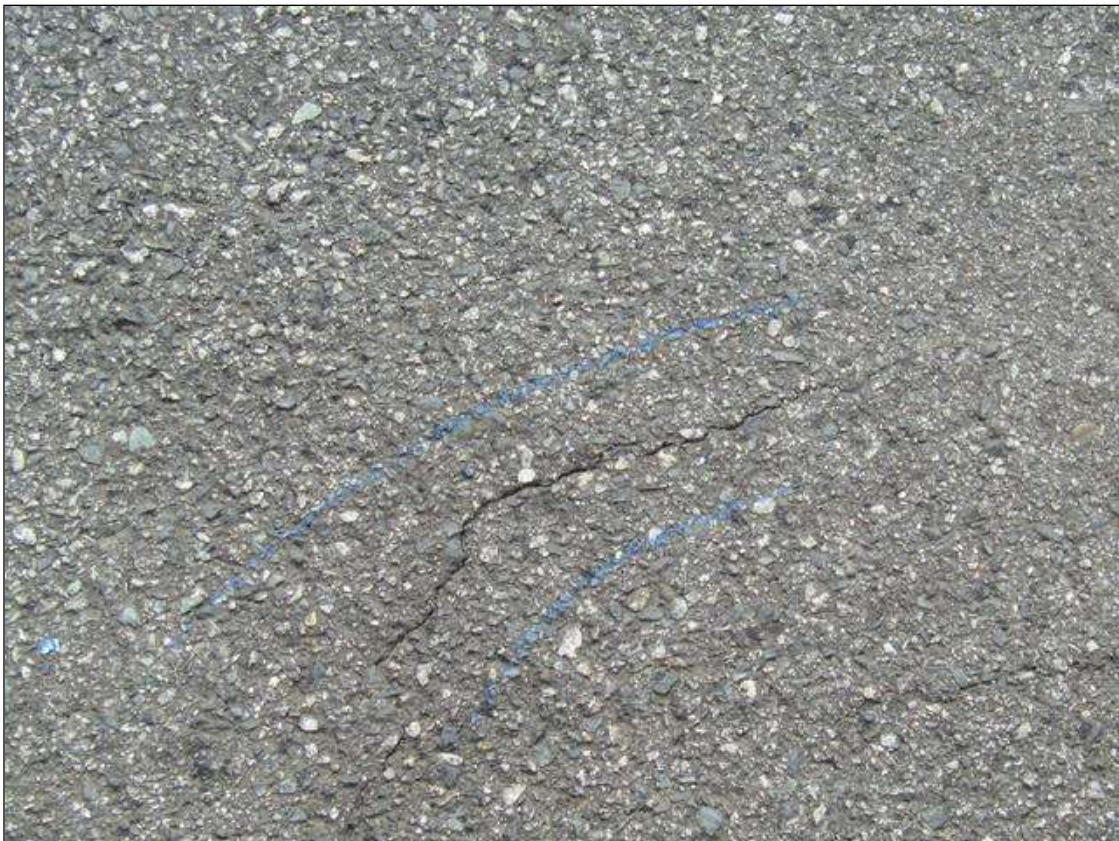
Span 3 Wearing Surface: LONGITUDINAL CRACKS 1/16" WIDE NEAR END BENT 2

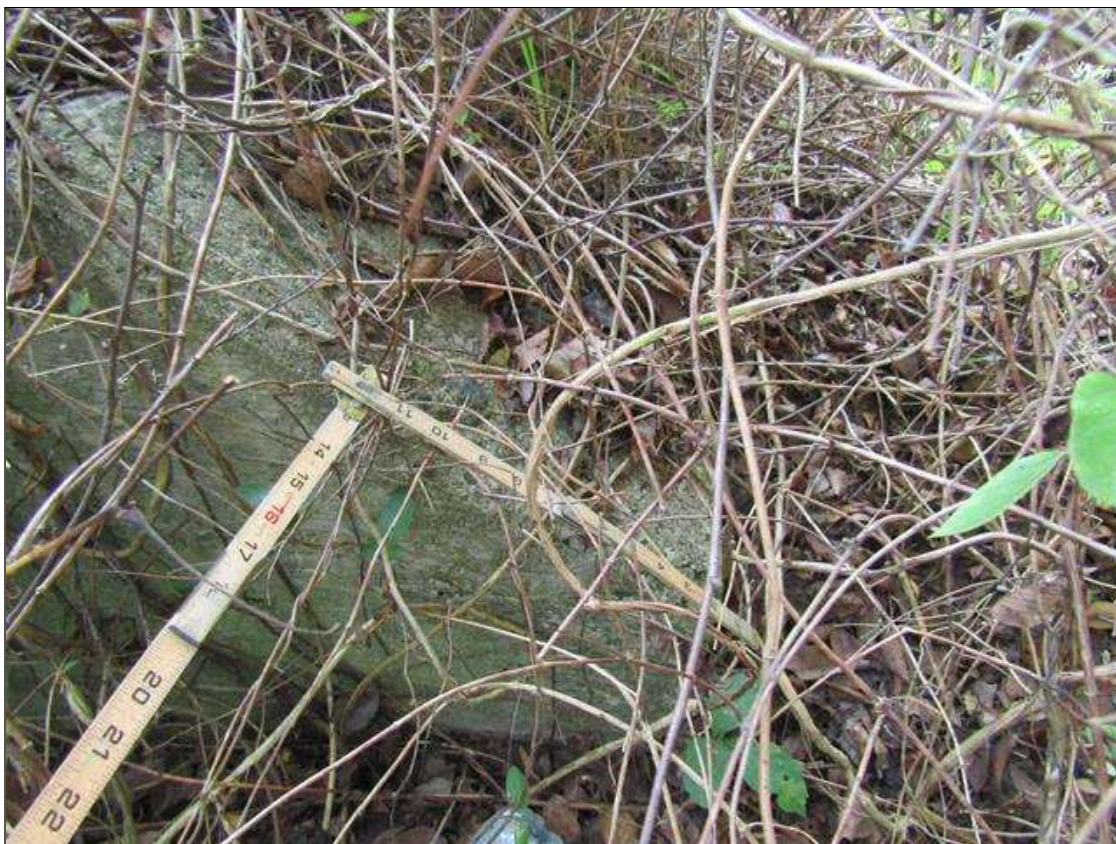
End Bent 1 Abutment: SPALL AT SOUTHWEST CORNER 12" LONG X 4" WIDE X 1" DEEP

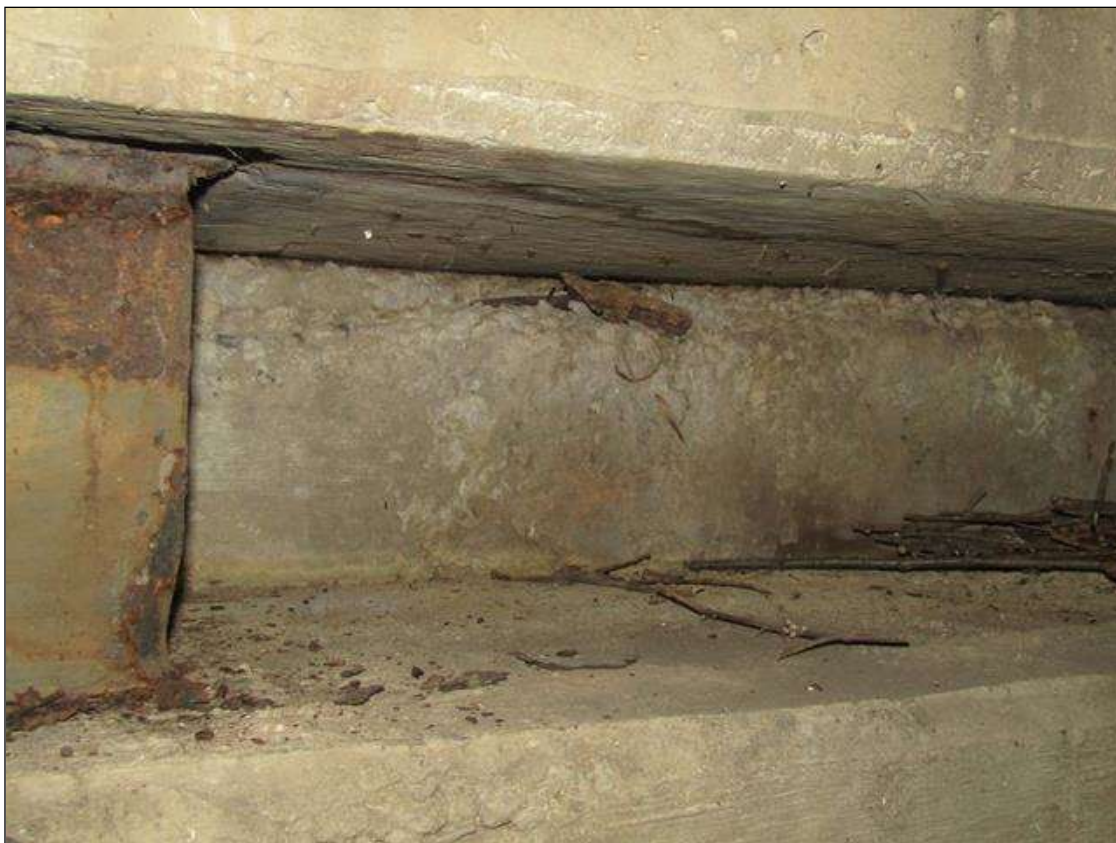
End Bent 1 Abutment: CONCRETE VOIDS IN TOP WHERE CONCRETE WAS POURED BETWEEN PILES 1-4

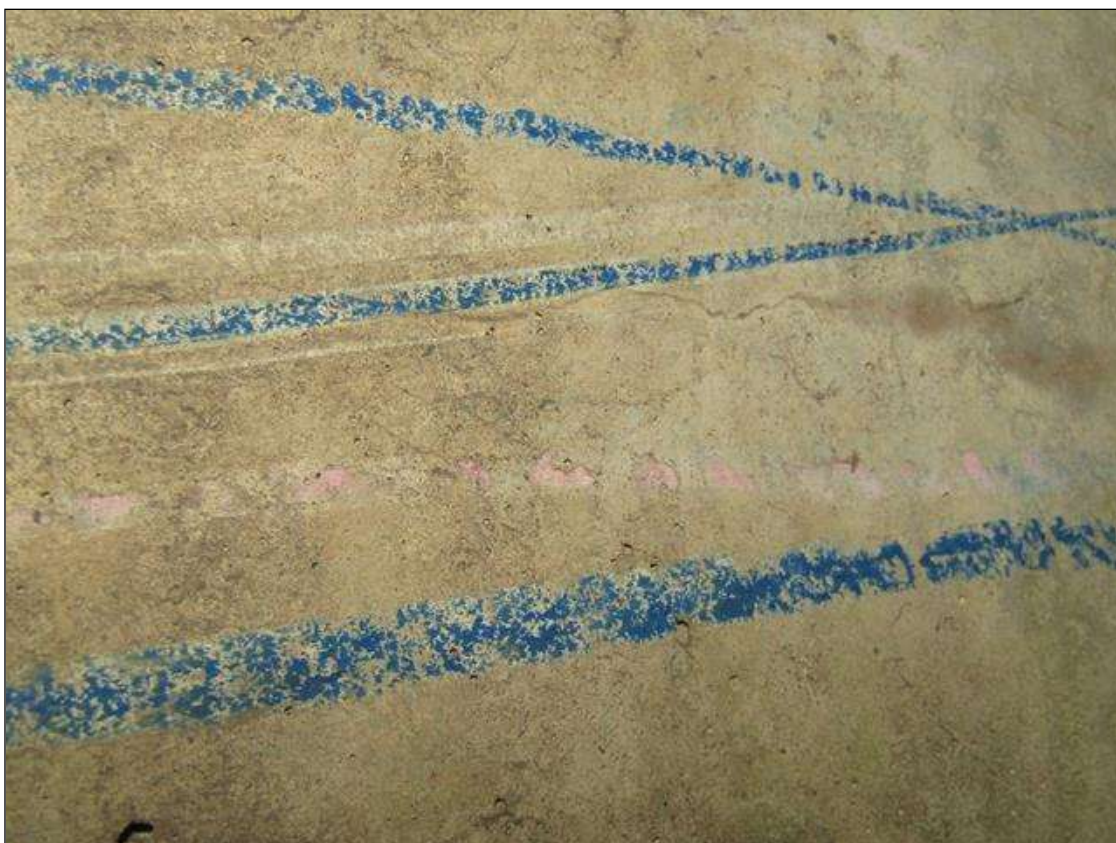
End Bent 1 Cap 1: HAIRLINE LONGITUDINAL CRACK ON FACE BETWEEN PILES 1-2

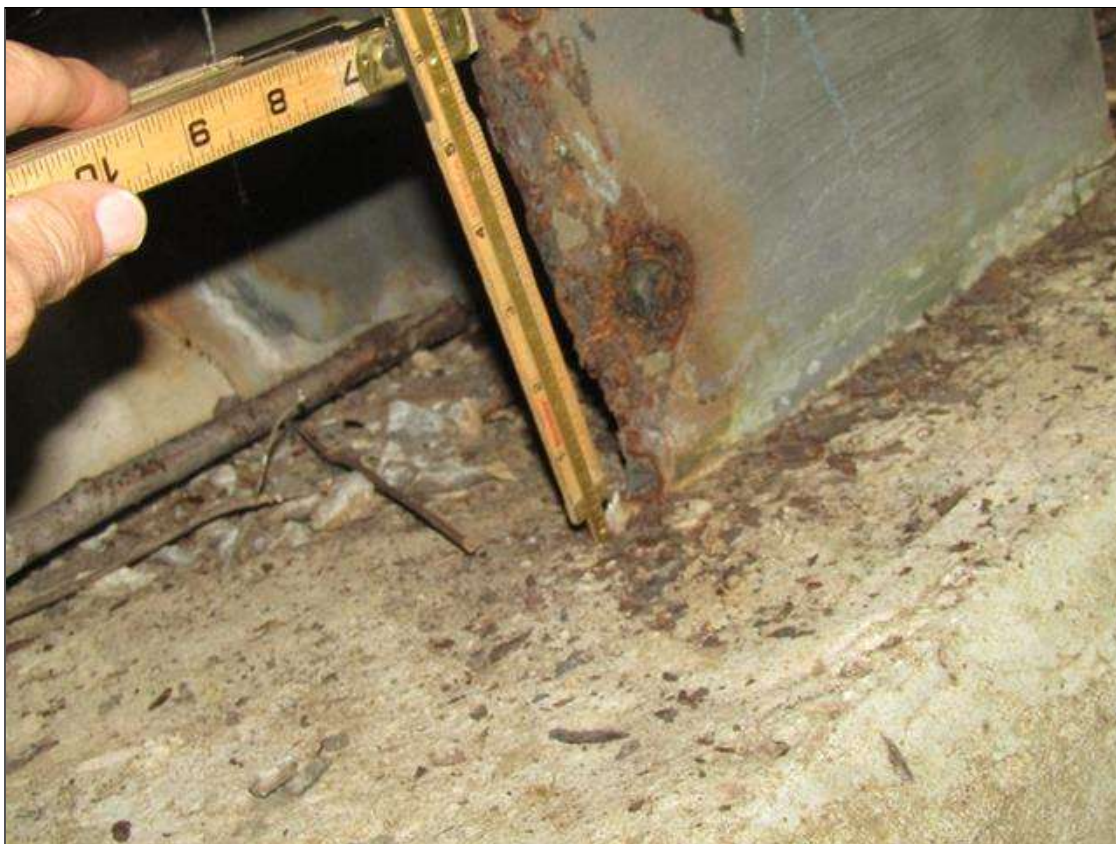
End Bent 1 Pile 1: RUST SCALE WITH STEEL DOWN TO KNIFE EDGE EAST SIDE OF FRONT FLANGE ABOVE FOOTING 46" HIGH x 2" WIDE/ PAR

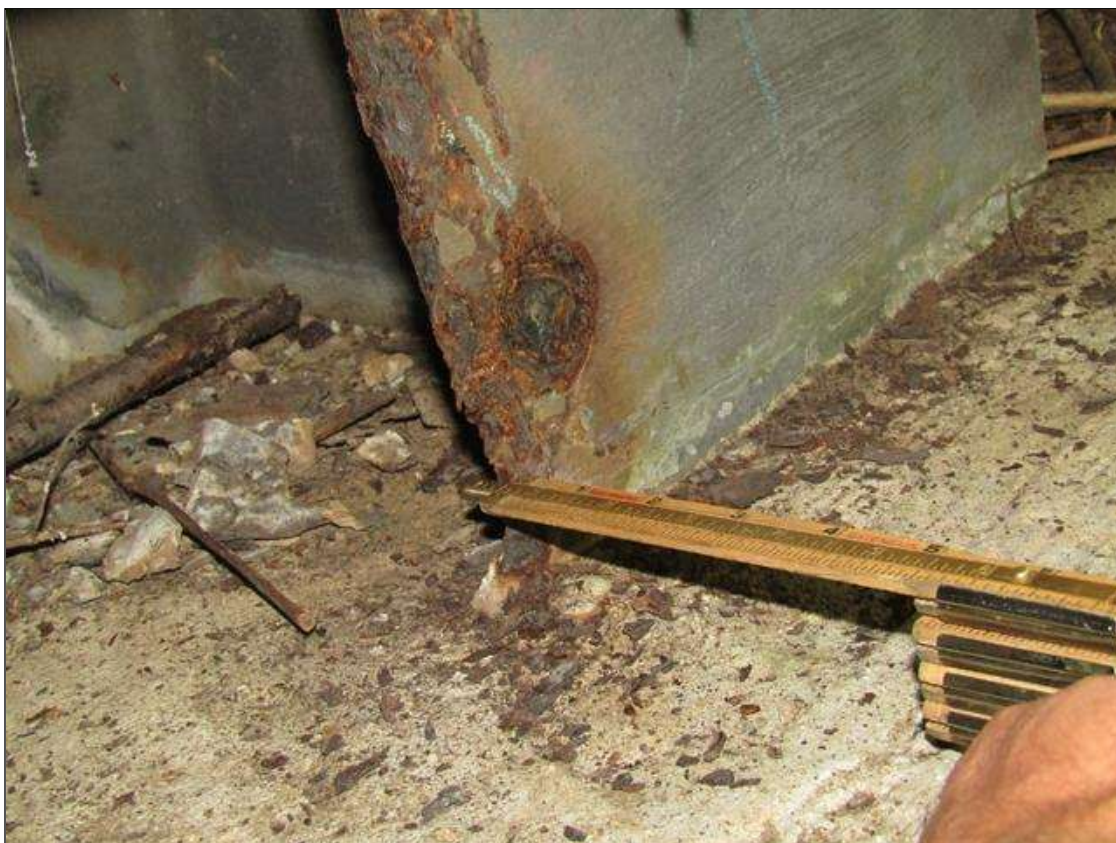
End Bent 1 Pile 1: RUST SCALE WITH STEEL DOWN TO KNIFE EDGE EAST SIDE OF FRONT FLANGE ABOVE FOOTING 46" HIGH x 2" WIDE/ PAR

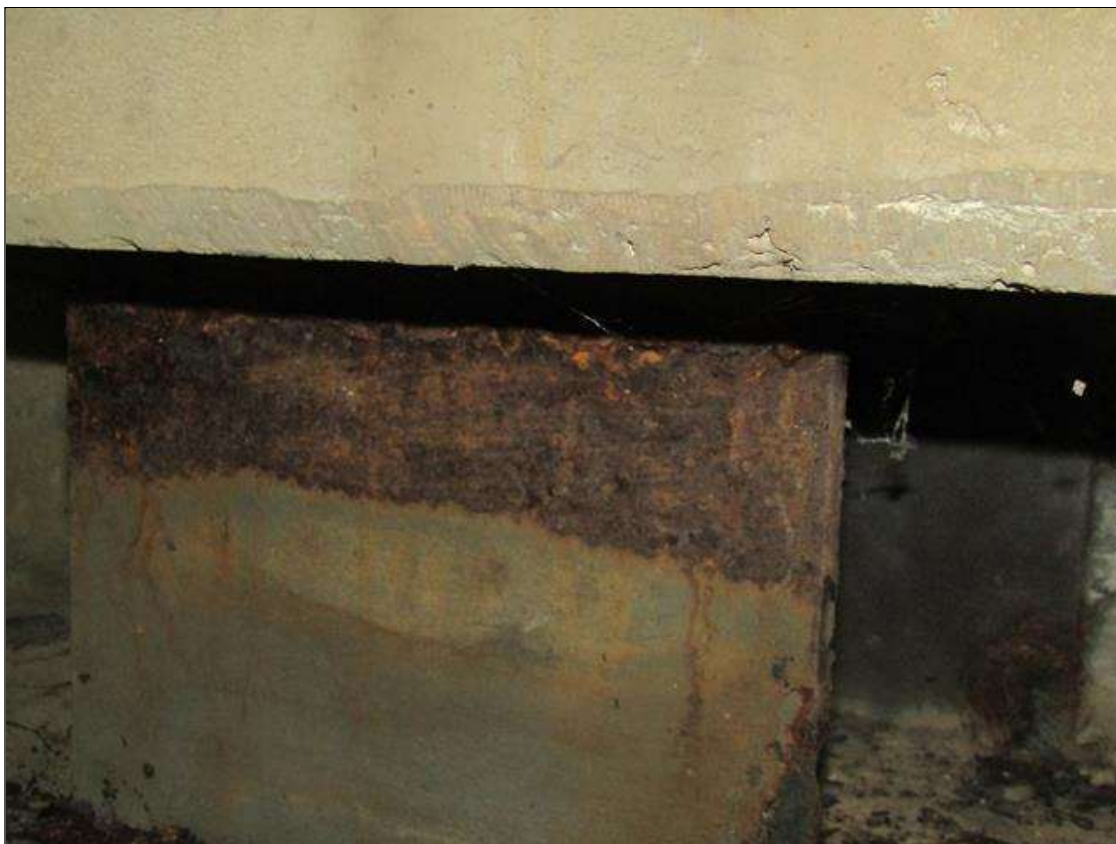
End Bent 1 Pile 2: SURFACE RUST ON PLATE AND TOP OF PILE

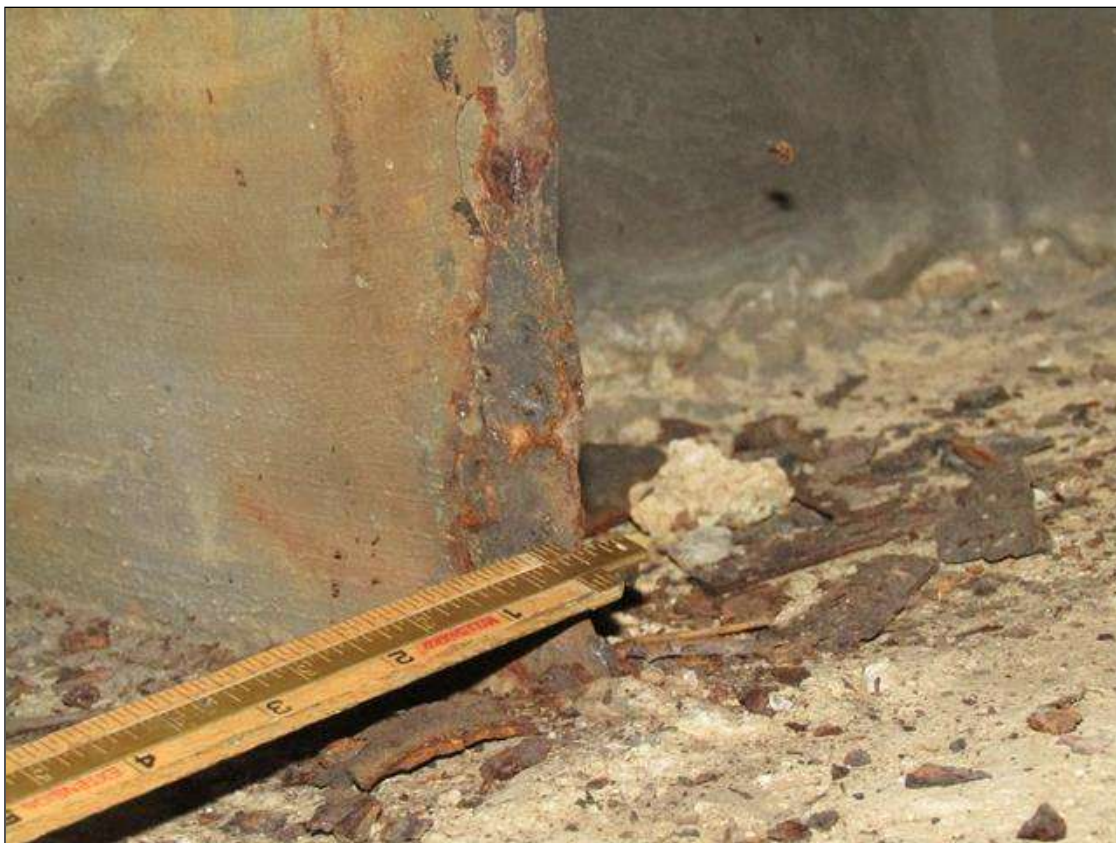
End Bent 1 Pile 2: 1/4" STEEL REMAINING ON FRONT WEST EDGE 3" HIGH X 1" WIDE/PAR

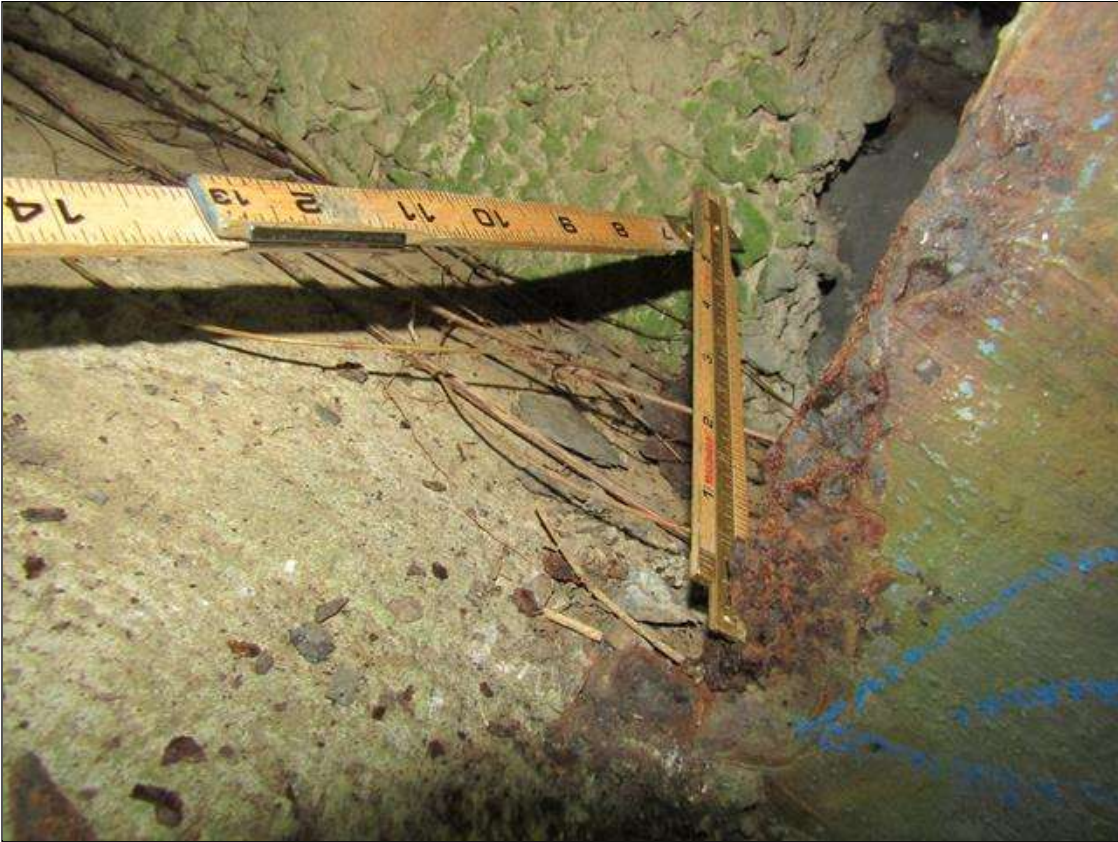
End Bent 1 Pile 6: RUST SCALE WITH REMAINING STEEL DOWN TO KNIFE EDGE ON EAST SIDE FRONT FLANGE UP 5" HIGH ABOVE FOOTING X 2" WIDE WITH EDGE BREAKING OFF/ PAR

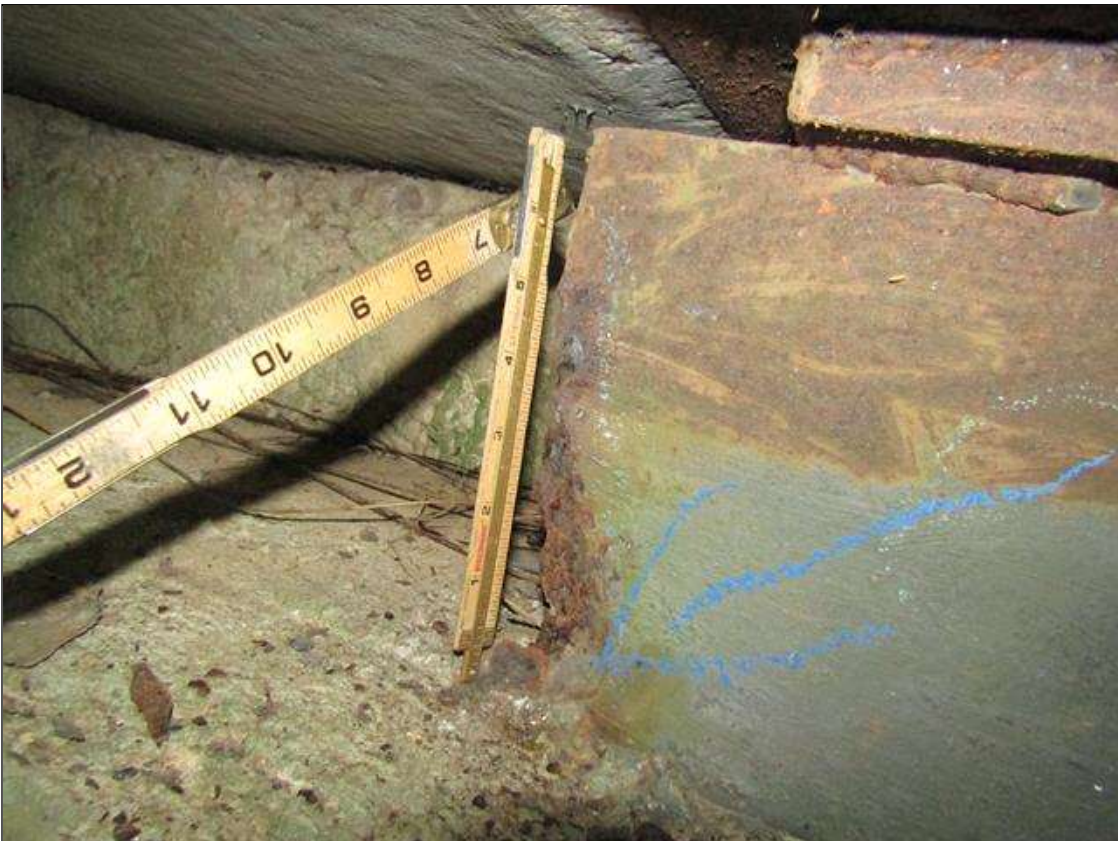
End Bent 1 Pile 6: RUST SCALE WITH REMAINING STEEL DOWN TO KNIFE EDGE ON EAST SIDE FRONT FLANGE UP 5" HIGH ABOVE FOOTING X 2" WIDE WITH EDGE BREAKING OFF/ PAR

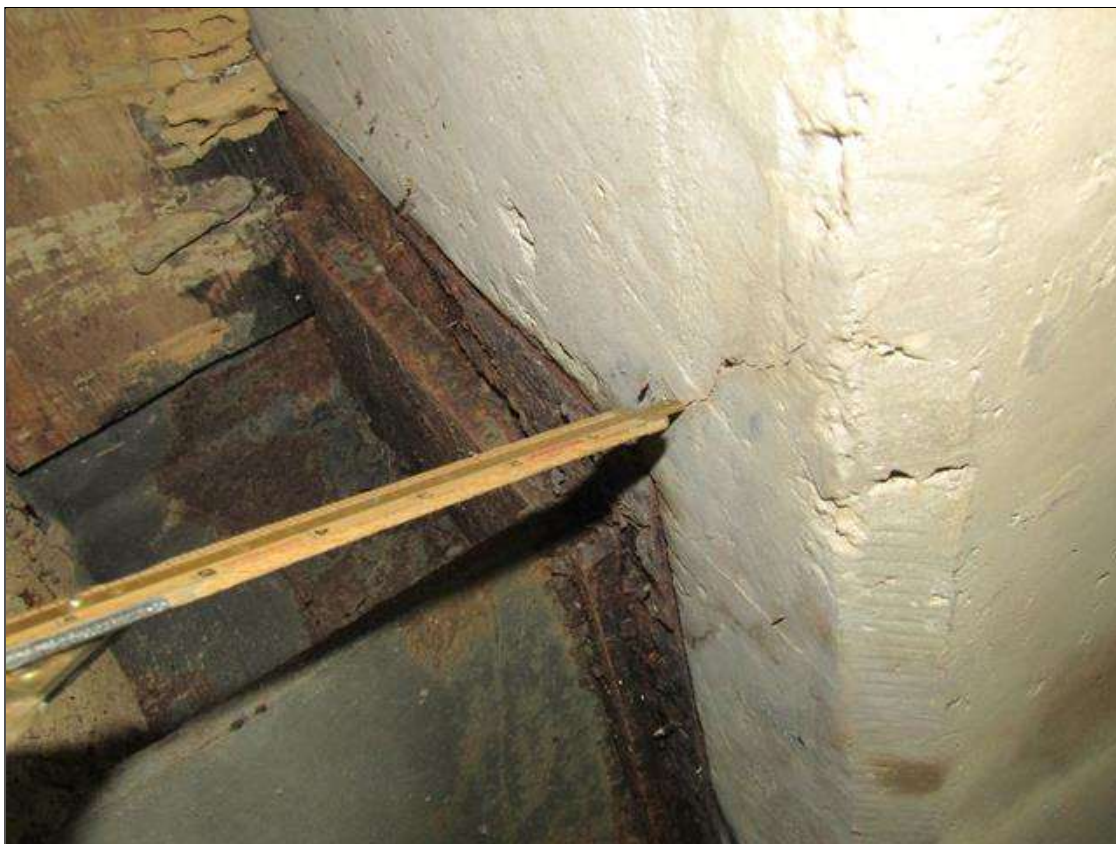
End Bent 1 Cap 1: CRACKING ON BOTTOM AROUND CORNERS OF PILES 1/64" WIDE UP TO 6" LONG

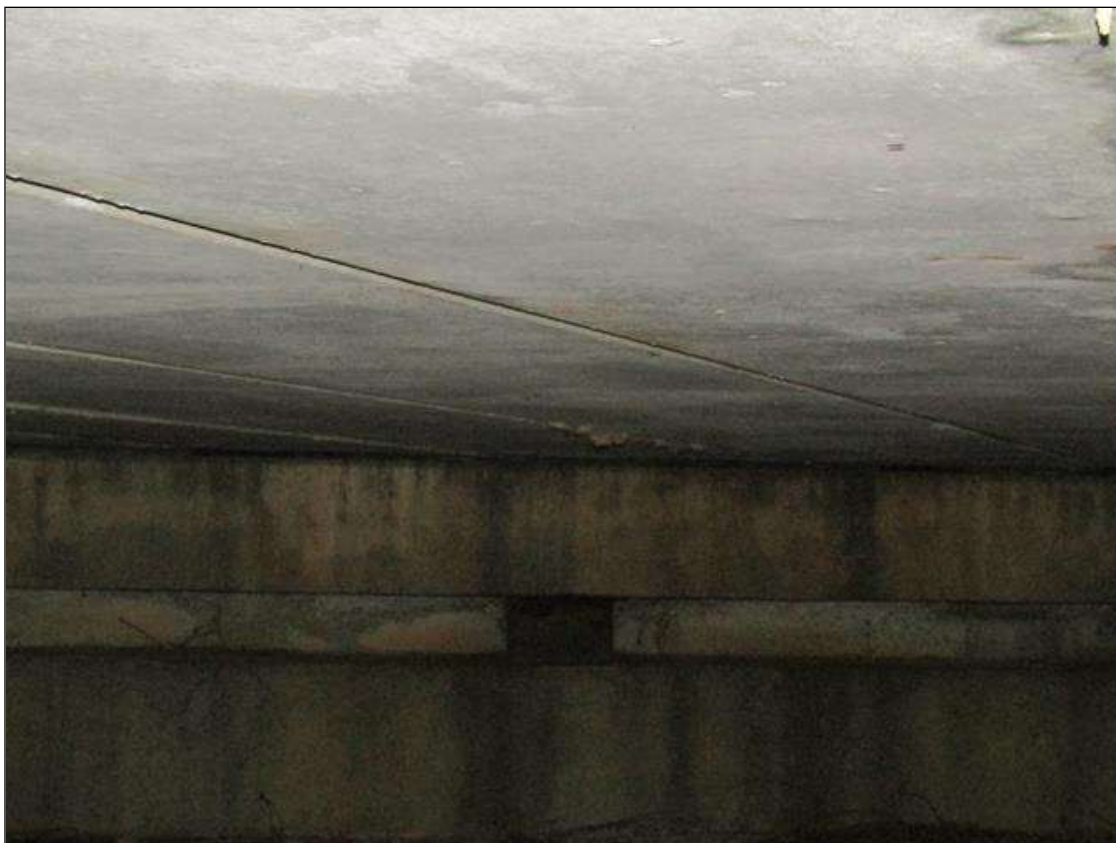
Span 1 Expansion Joint: OLD SEEPAGE STAIN ON END BENT 1 CAP

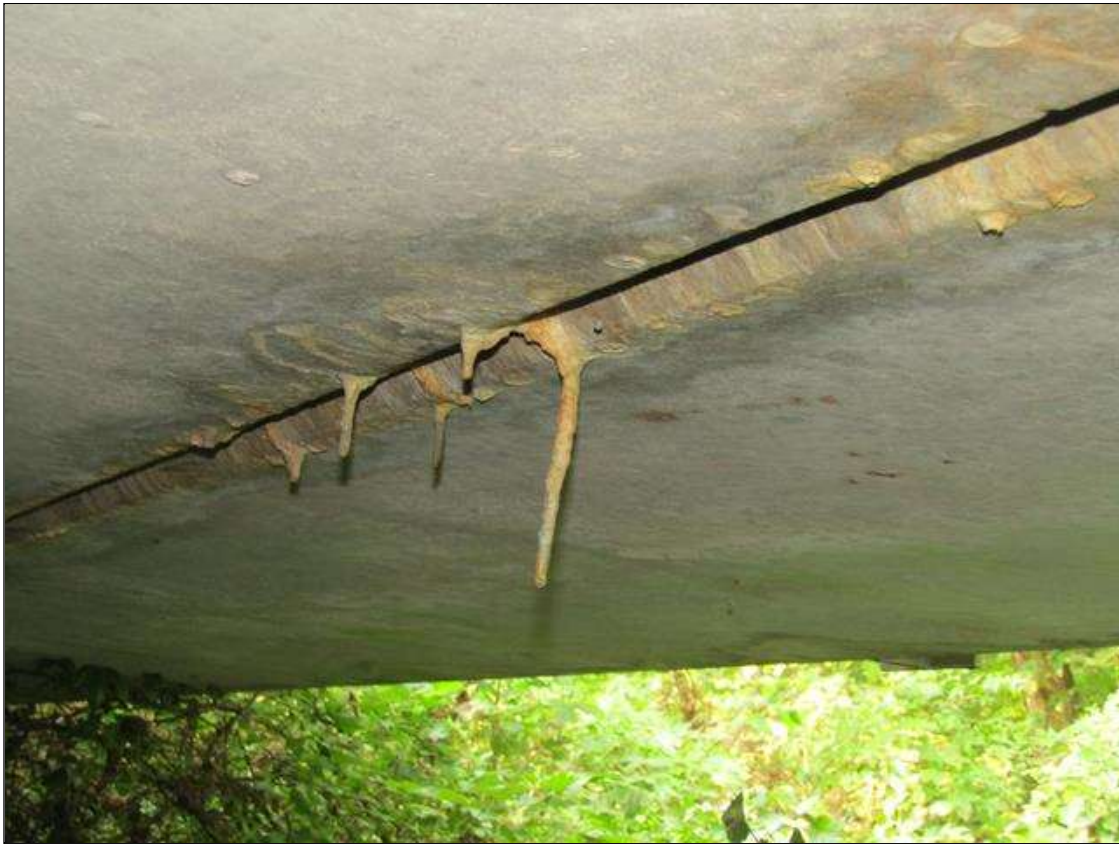
Span 1 Slab 1: EFFLO BUILT UP ON BOTTOM FROM BETWEEN SLABS

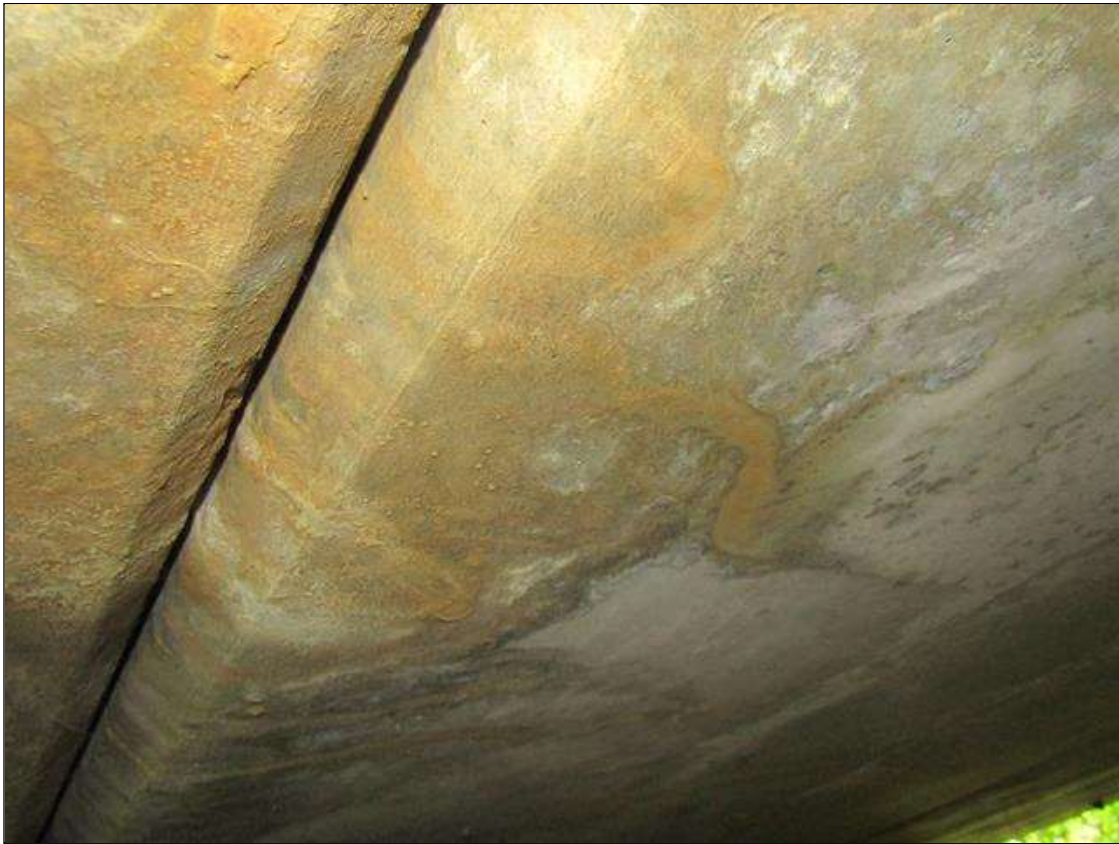
Span 1 Slab 4: EFFLO AND STAIN ON BOTTOM FROM BETWEEN SLABS

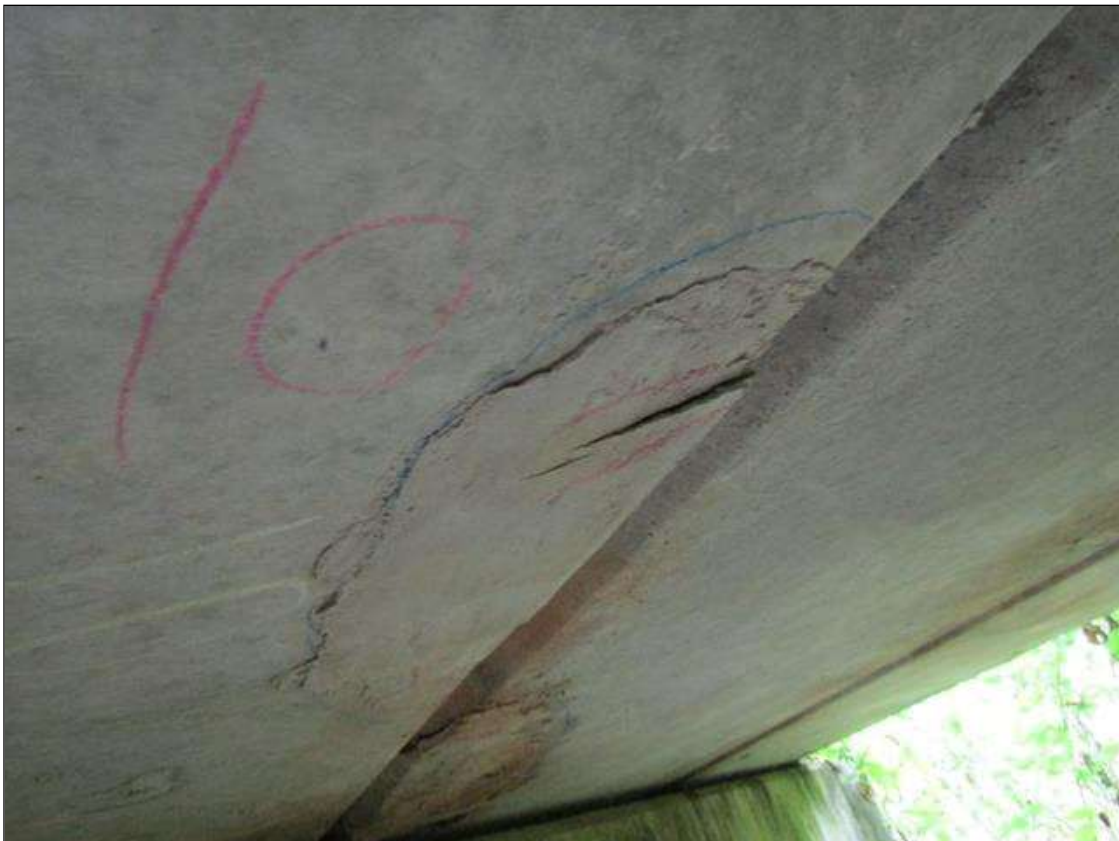
Span 1 Slab 10: PATCH AREA HAS CRACK ON BOTTOM NEAR PIER

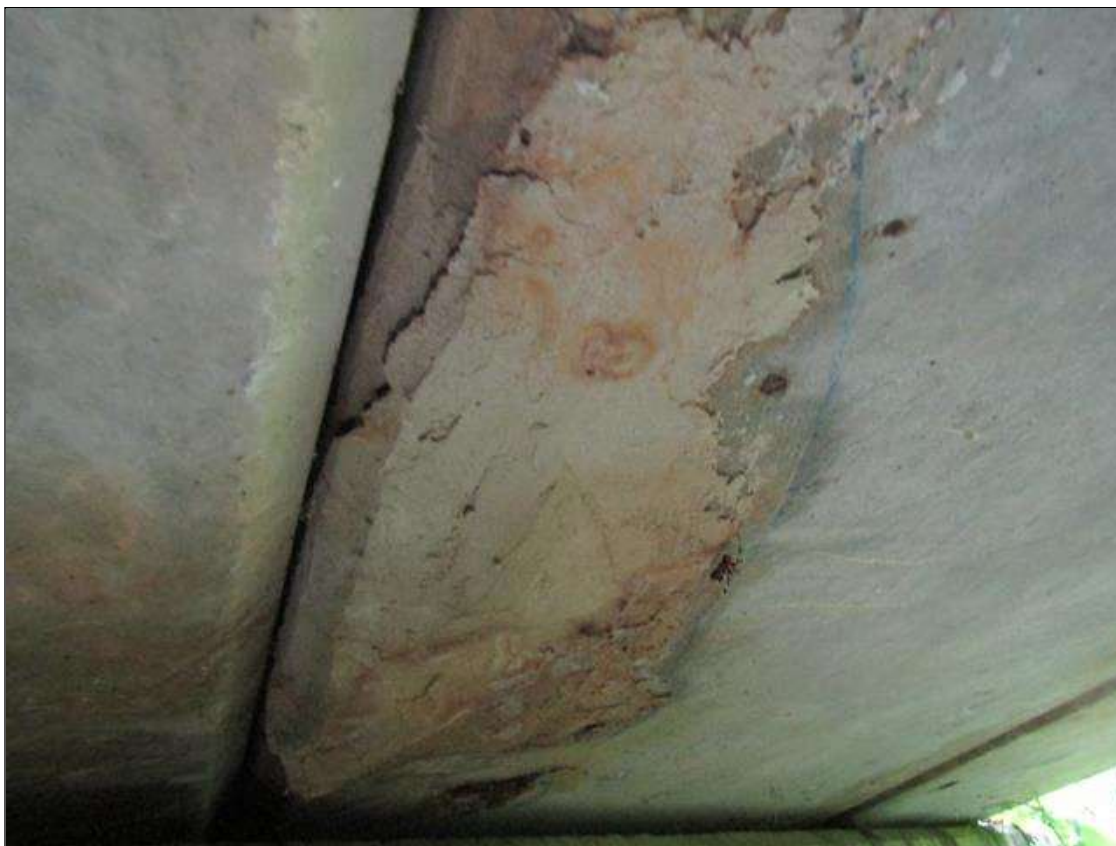
Span 1 Slab 11: PATCH AREA CRACKING ON BOTTOM NEAR PIER
