NC DEPARTMENT OF TRANSPORTATION
 DIVISION OF HIGHWAYS
 STRUCTURE MANAGEMENT UNIT

ATTENTION: PAR ISSUED ON PILES 1, 2 AND 6 AT END BENT 1,
 PILES 1 3 AND 4 AT PIER 1, PILES 1-6 AT PIER 2 AND
 PILES 1 AND 5 AT END BENT 2

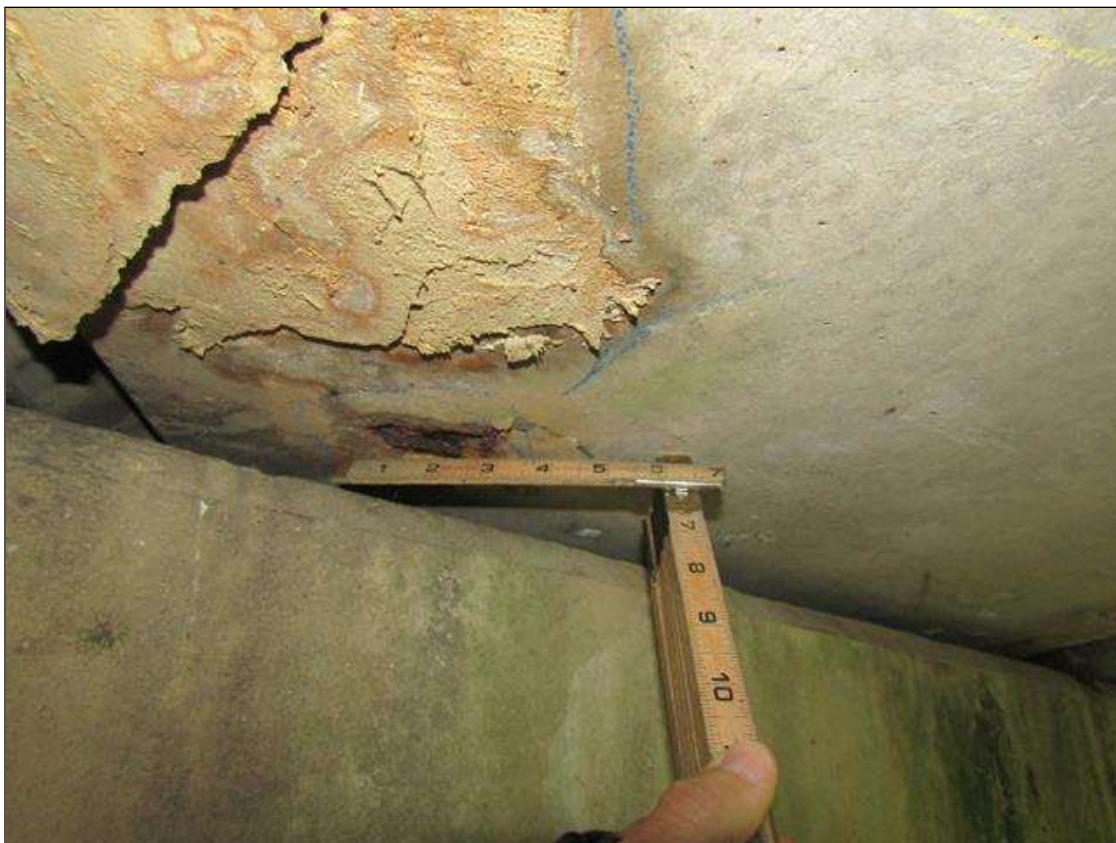
Span 1 Slab 11: POPOUT SPALL ON BOTTOM AT PIER 3" DIAMETER X 1/4" DEEP STEEL TO CLOSE TO SURFACE

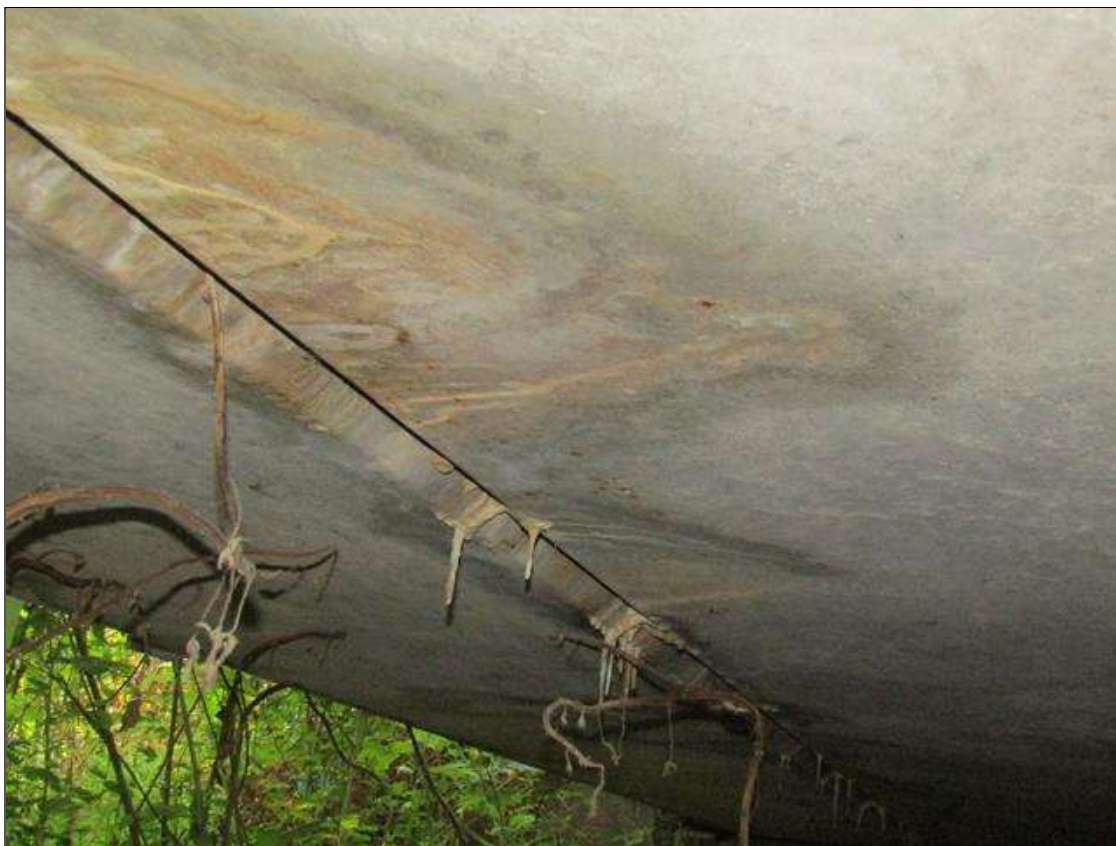
Span 1 Slab 11: EFFLO BUILT UP AND STAIN ON BOTTOM FROM BETWEEN SLABS

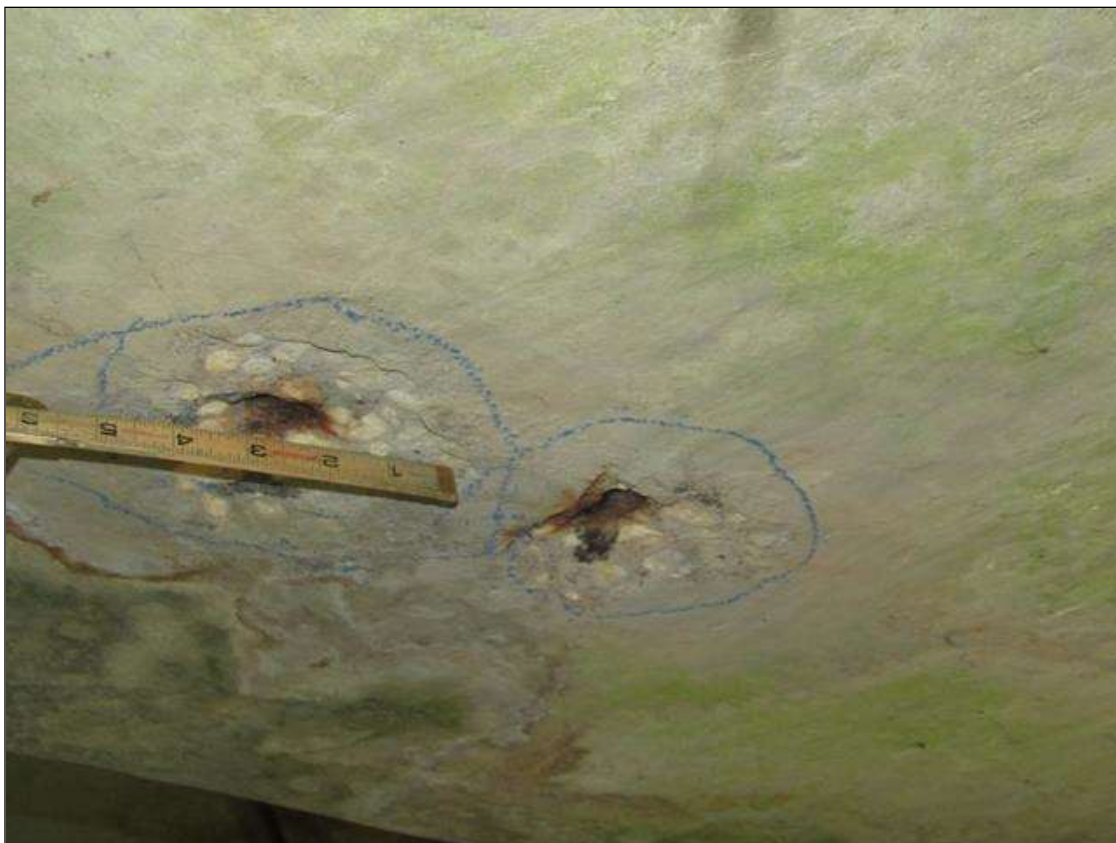
Bent 1 Cap 1: SPALLS ON BOTTOM AT EAST END AND ON BOTTOM BETWEEN PILES 6 -7 UP TO 4" DIAMETER X 1/2" DEEP WITH STEEL EXPOSED

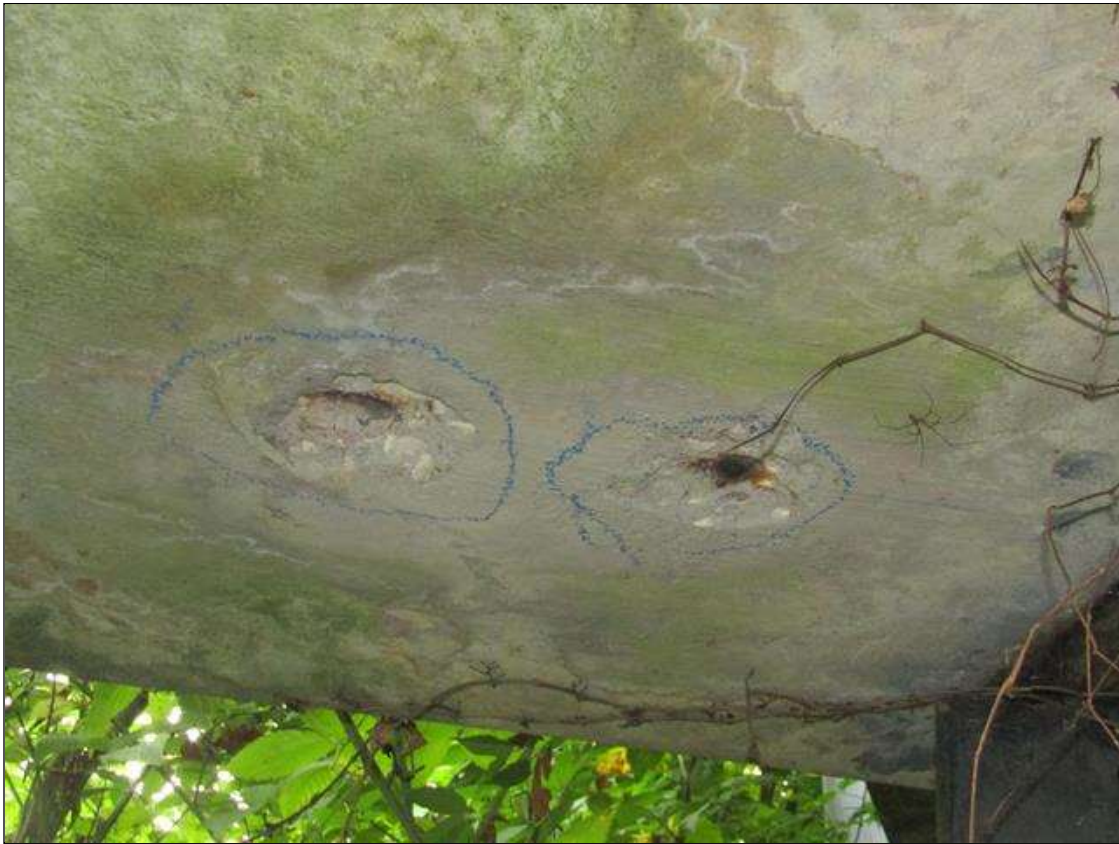
Bent 1 Cap 1: SPALLS ON BOTTOM AT EAST END AND ON BOTTOM BETWEEN PILES 6 -7 UP TO 4" DIAMETER X 1/2" DEEP WITH STEEL EXPOSED

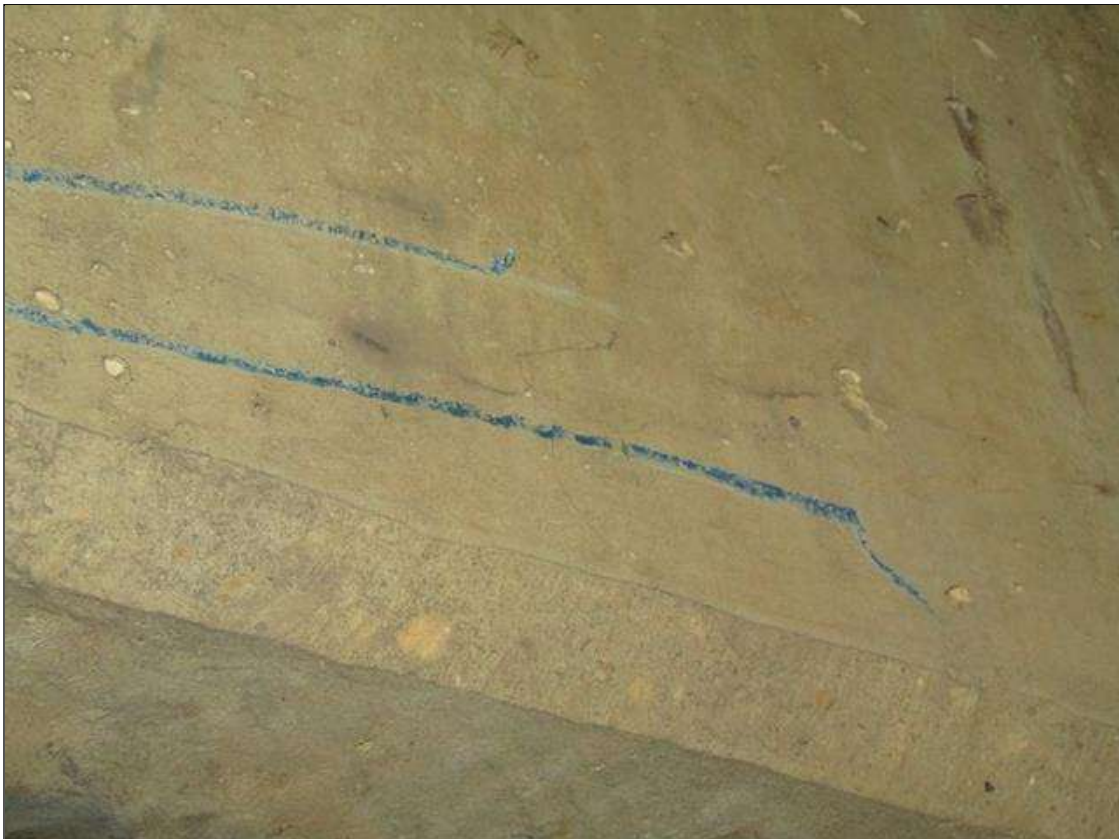
Bent 1 Cap 1: HAIRLINE LONGITUDINAL CRACKS ON BOTH FACES OVER PILES

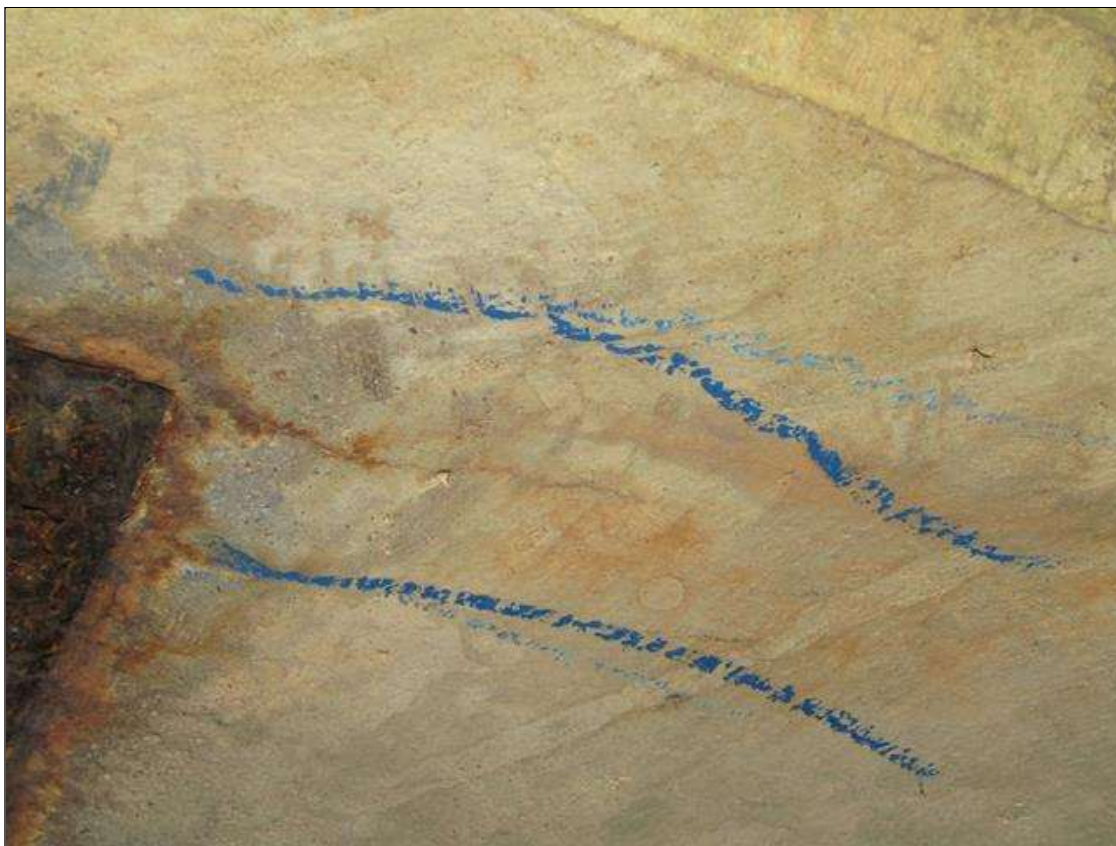
Bent 1 Cap 1: CRACKING ON BOTTOM AROUND CORNERS OF PILE PLATES 1/64" WIDE UP TO 7" LONG

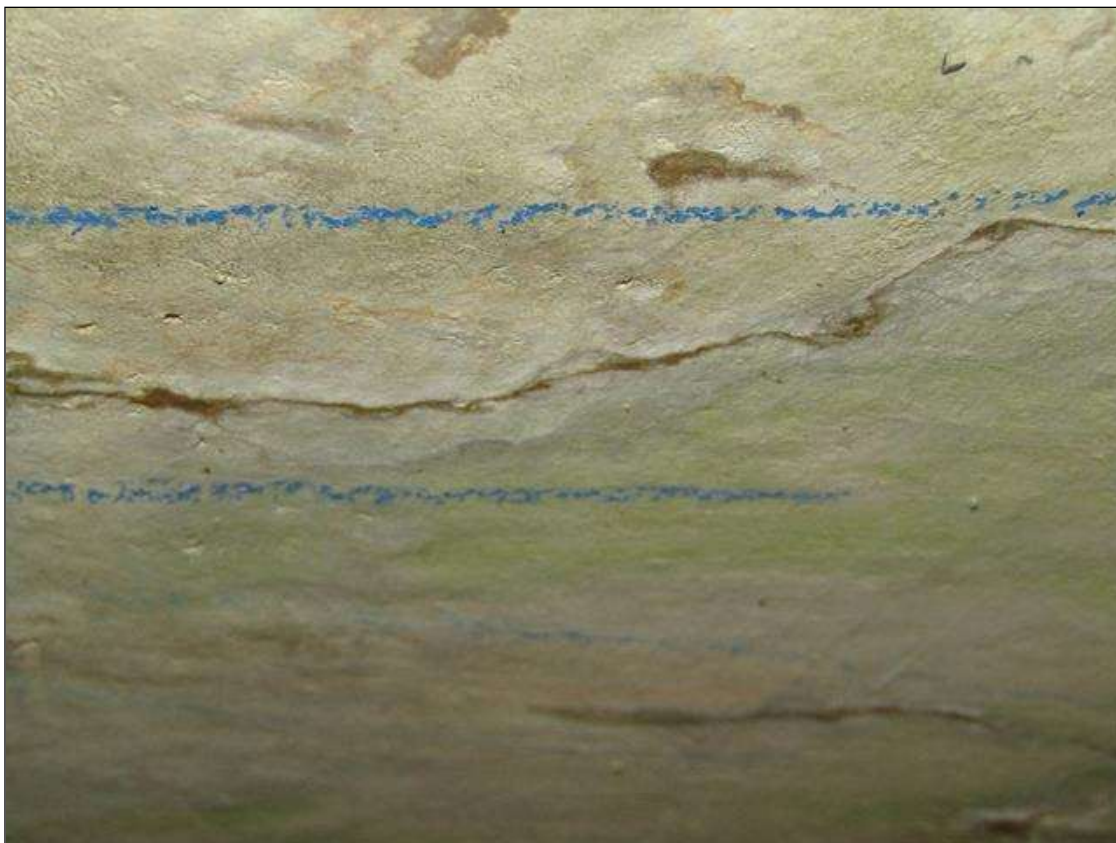
Bent 1 Cap 1: LONGITUDINAL CRACK ON BOTTOM 1/64" WIDE BETWEEN PILES 1-3

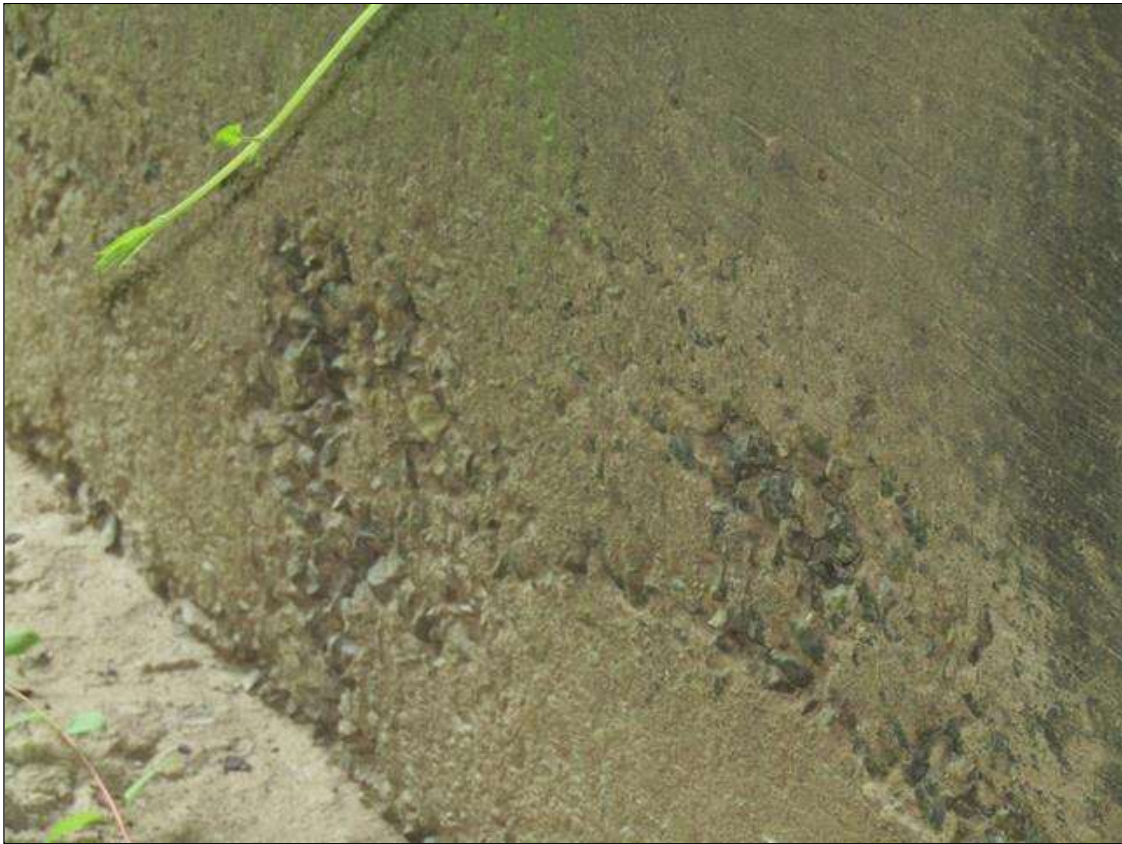
Bent 1 Footing: SCALE ALONG BOTTOM

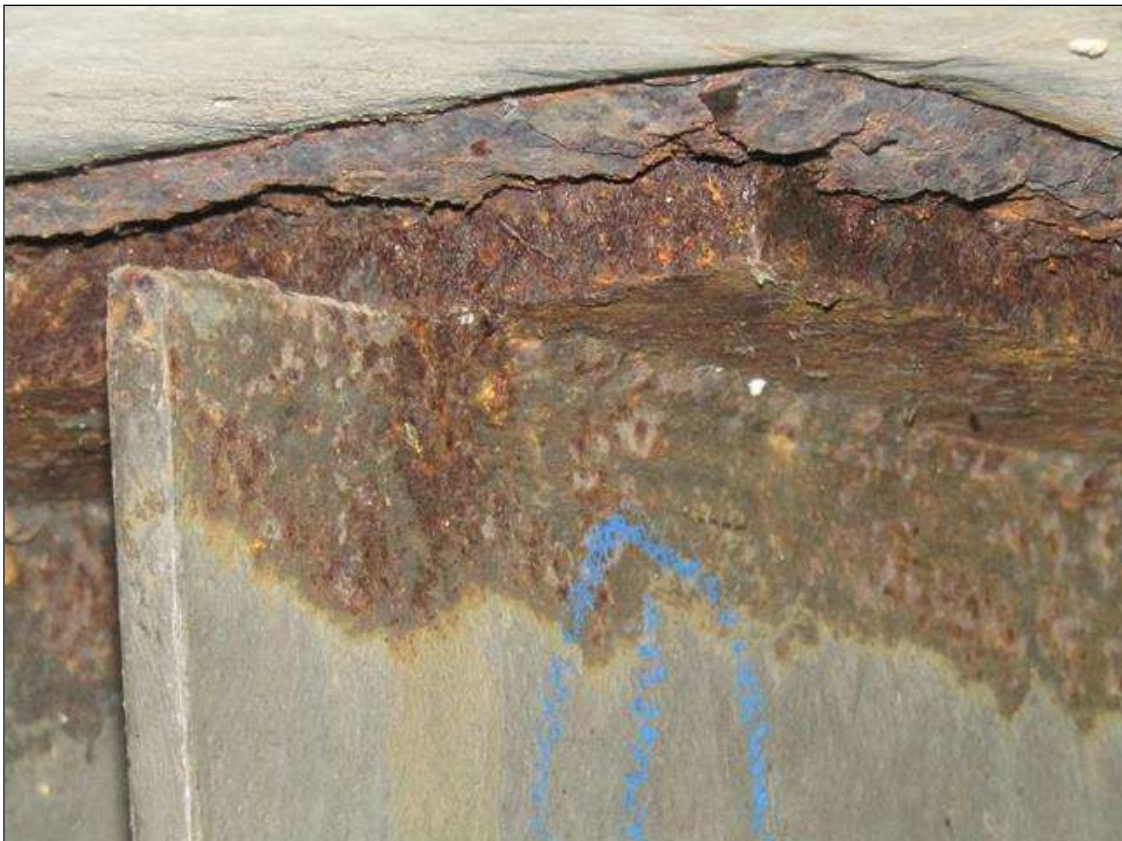
Bent 1 Pile 1: RUST SCALE ON PILE PLATE WITH SURFACE RUST ON TOP

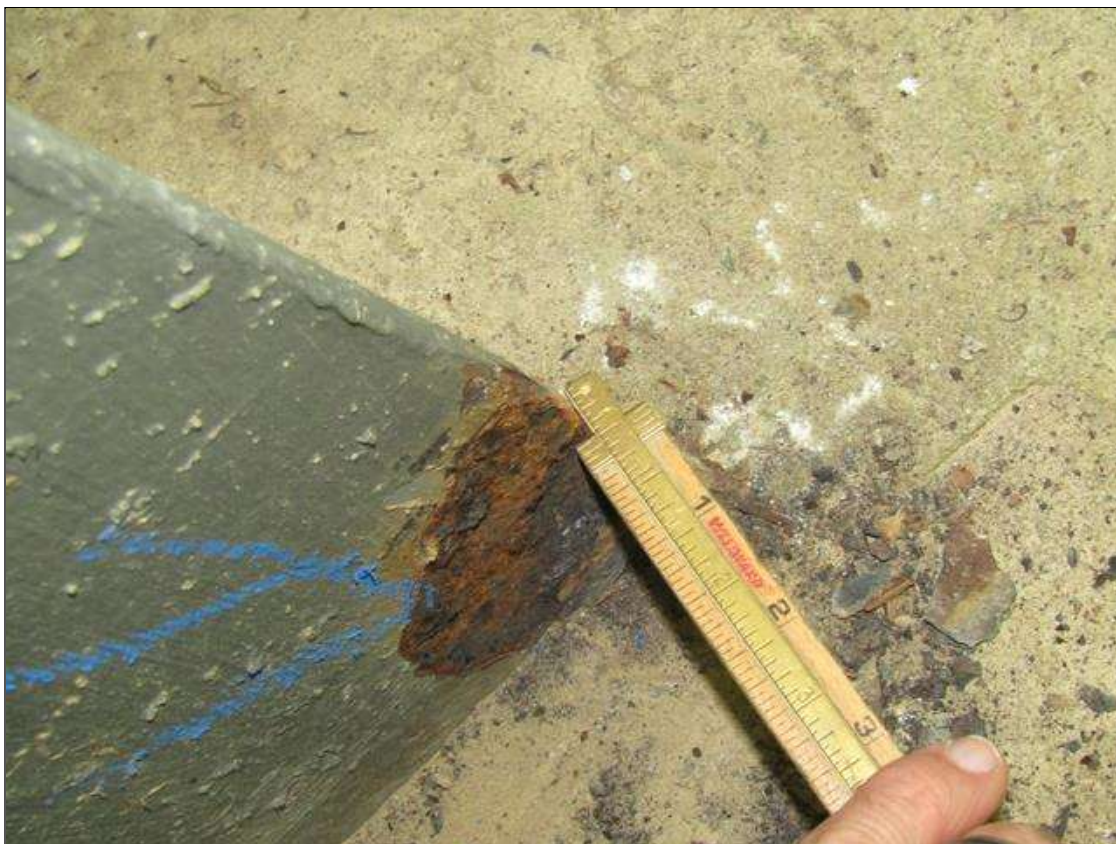
Bent 1 Pile 1: 1/4" STEEL REMAINING ON BOTTOM WEST SPAN 2 FLANGE UP 3" x 2" WIDE/PAR

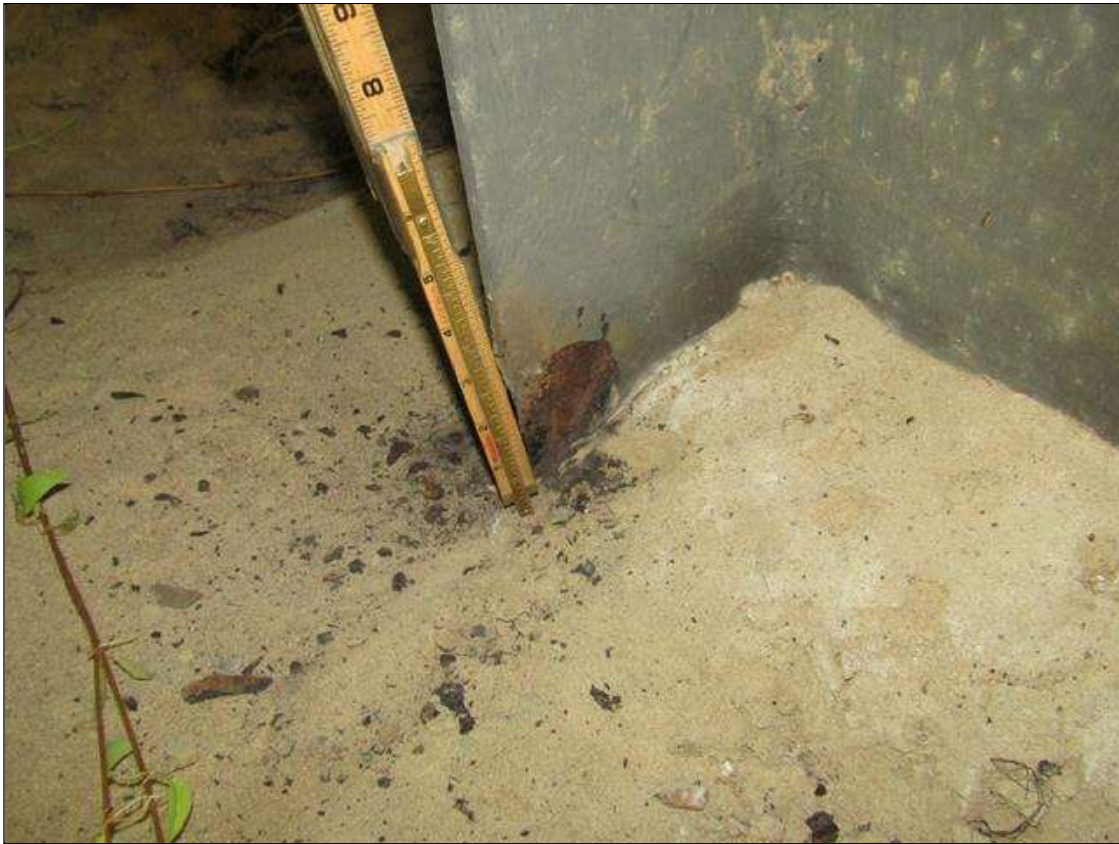
Bent 1 Pile 4: RUST SCALE ON PILE PLATE WITH SURFACE RUST ON TOP AND RUST SCALE ON BOTTOM OF FLANGE ON EAST SIDE ON SOUTH FACE UP 3" X 2" WIDE WITH 1/4" STEEL REMAINING ON 1/2" FLANGE/PAR

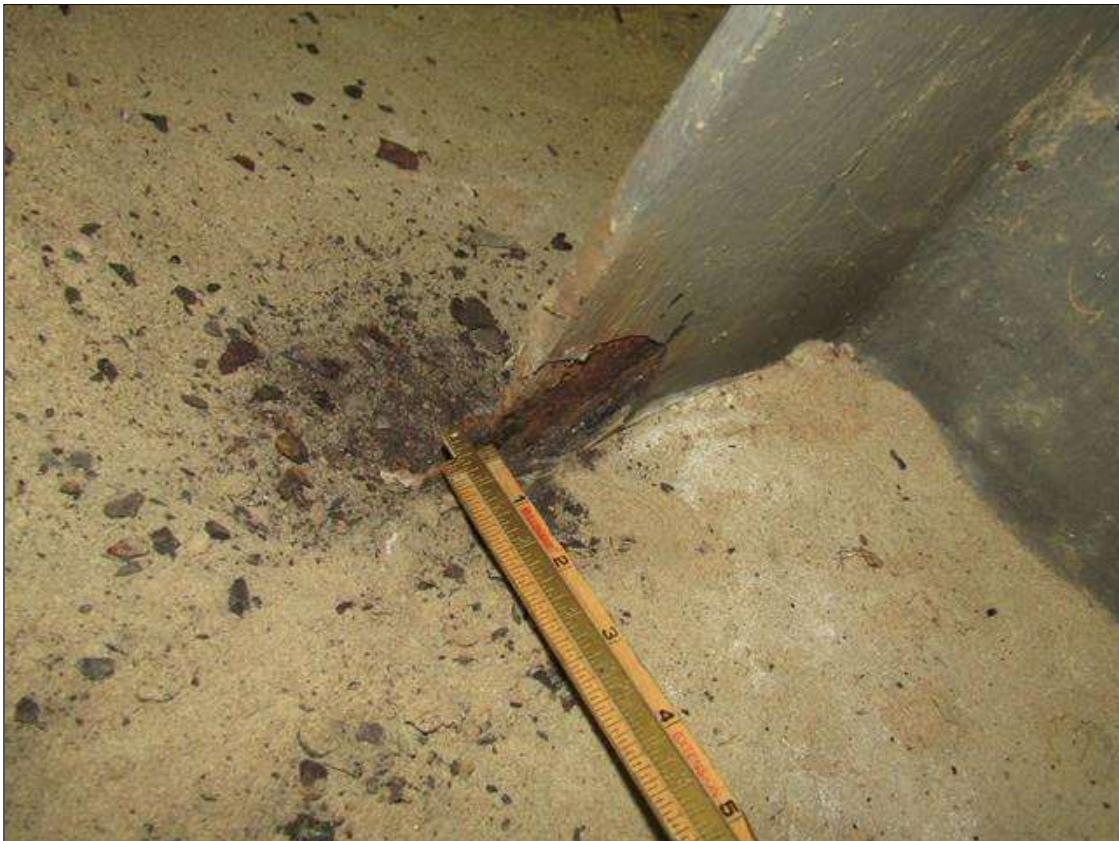
Bent 1 Pile 4: RUST SCALE ON PILE PLATE WITH SURFACE RUST ON TOP AND RUST SCALE ON BOTTOM OF FLANGE ON EAST SIDE ON SOUTH FACE UP 3" X 2" WIDE WITH 1/4" STEEL REMAINING ON 1/2" FLANGE/PAR

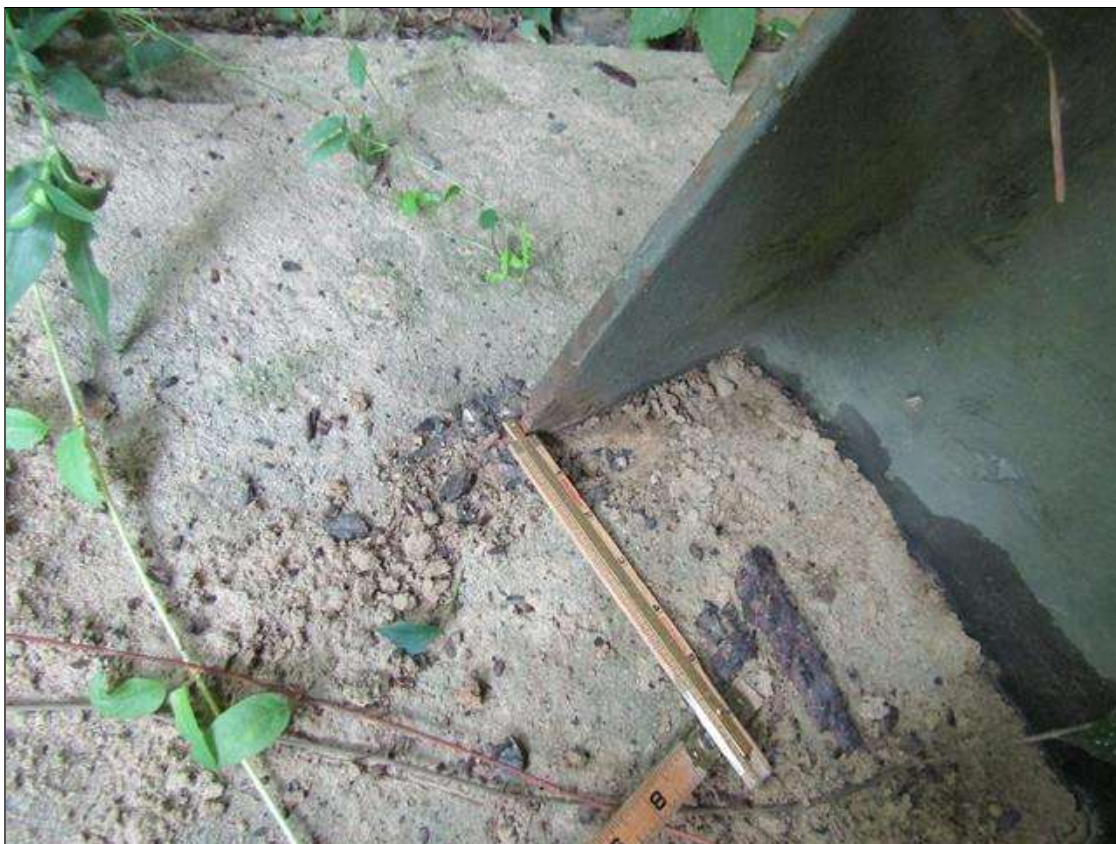
Bent 1 Pile 6: RUST SCALE ON PILE PLATE WITH SURFACE RUST ON TOP AND RUST SCALE ON BOTTOM OF FLANGE ON BOTH EAST SIDES WITH 7/16" STEEL REMAINING ON 1/2" FLANGE

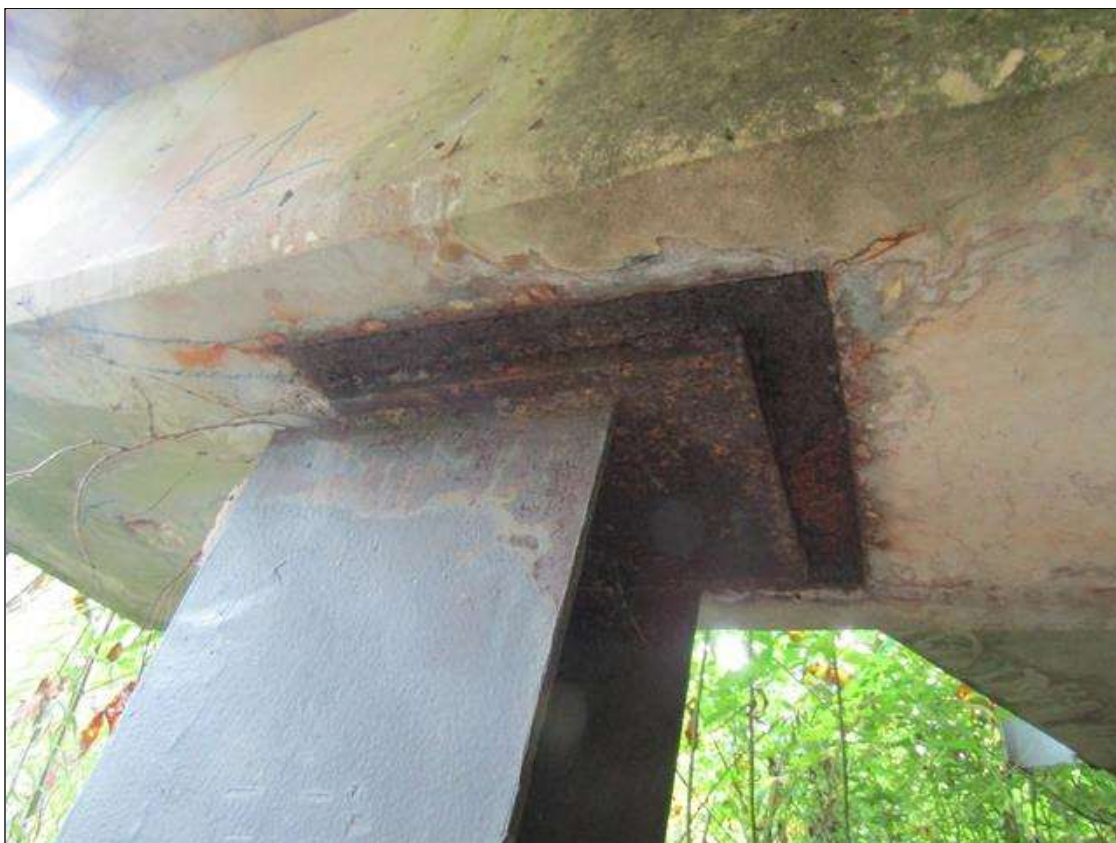
Bent 1 Pile 7: RUST SCALE ON PILE PLATE WITH SURFACE RUST ON TOP OF PILE

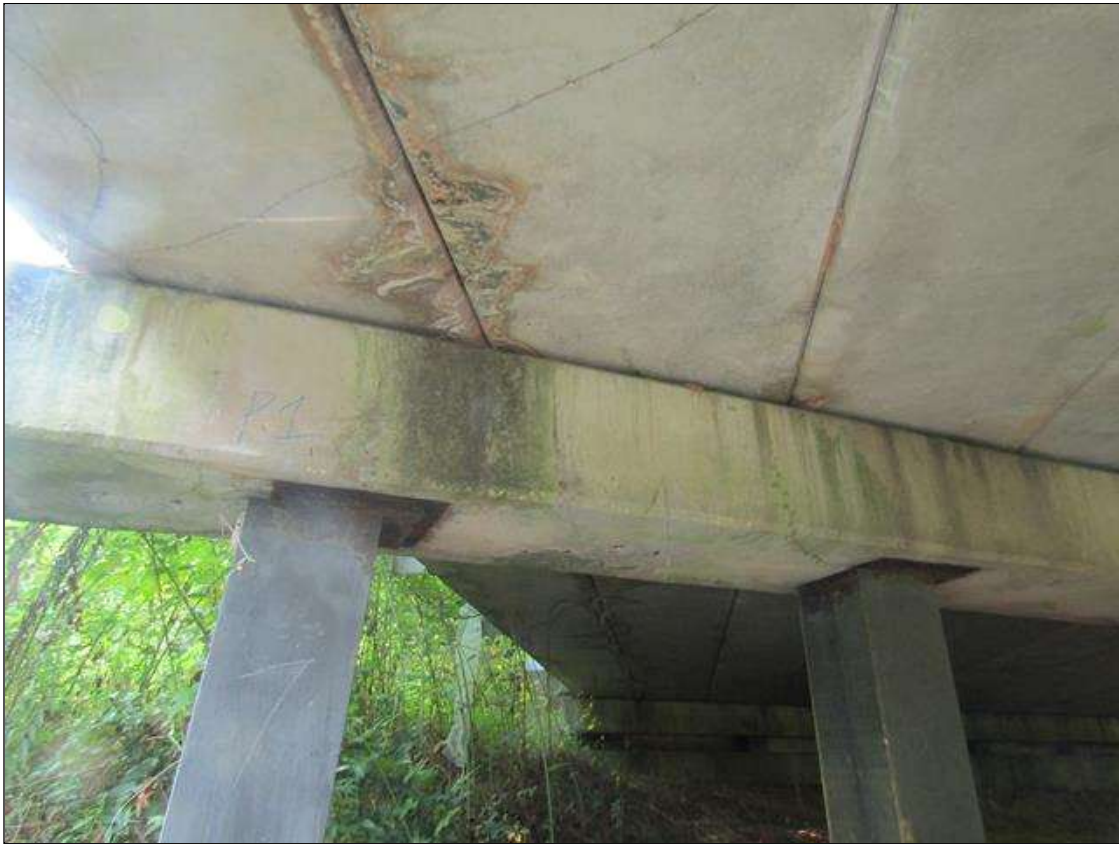
Span 2 Expansion Joint: OLD MOISTURE STAIN ON PIER 1 CAP

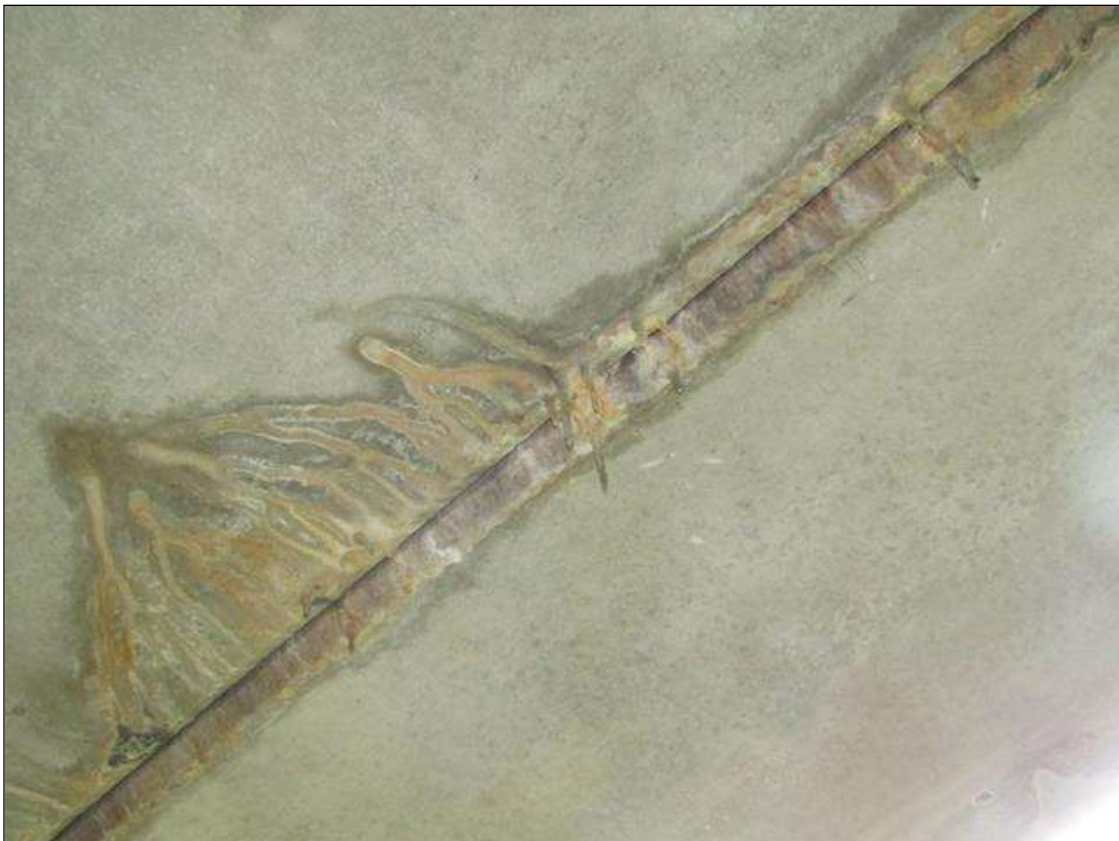
Span 2 Slab 12: EFFLO BUILT UP ON BOTTOM FROM BETWEEN SLABS

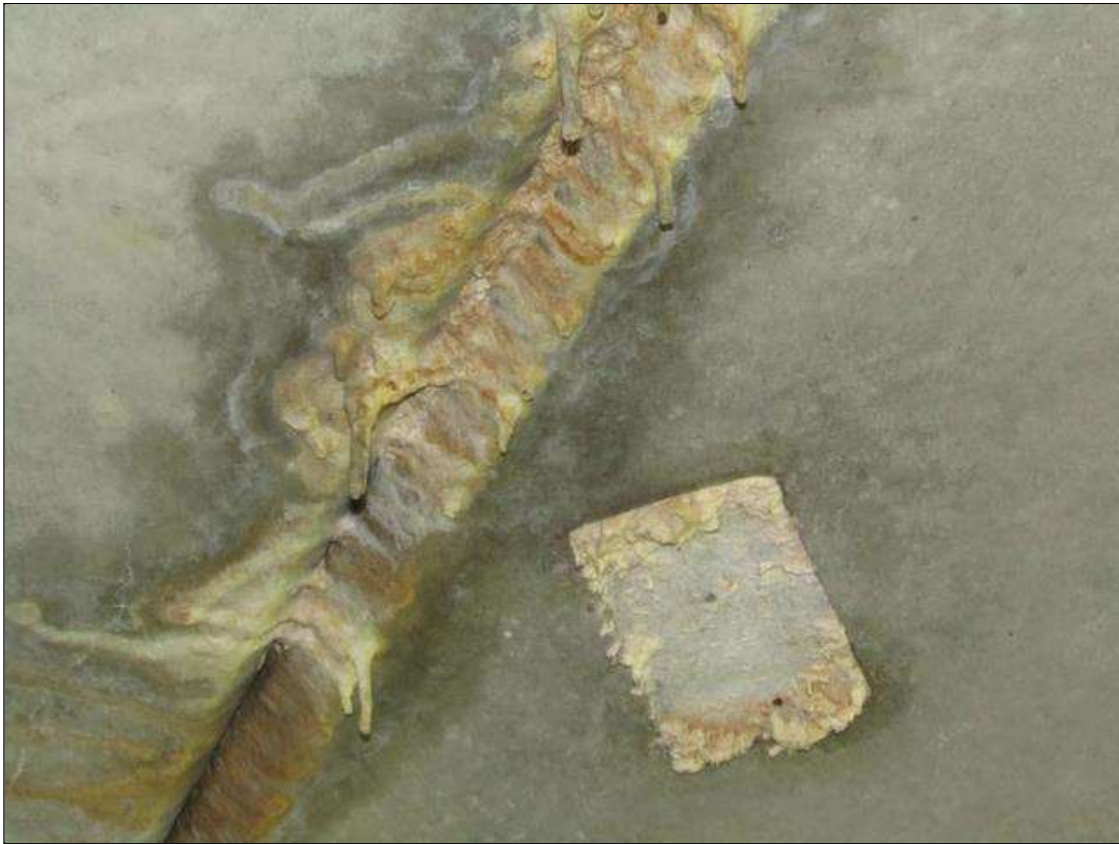
Span 2 Slab 1: EFFLO BUILT UP WITH STAIN ON BOTTOM FROM BETWEEN SLABS

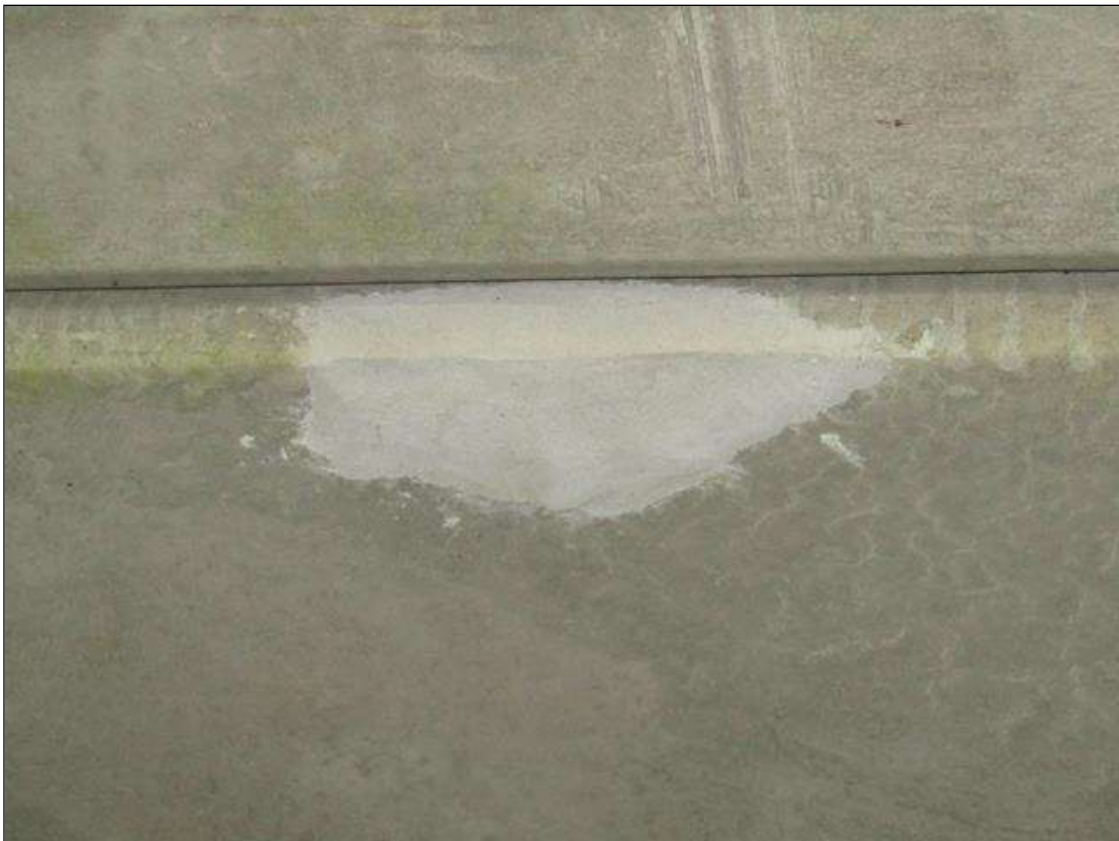
Span 2 Slab 4: PATCH AREA ON BOTTOM AT MID SPAN AND NEAR PIER 1

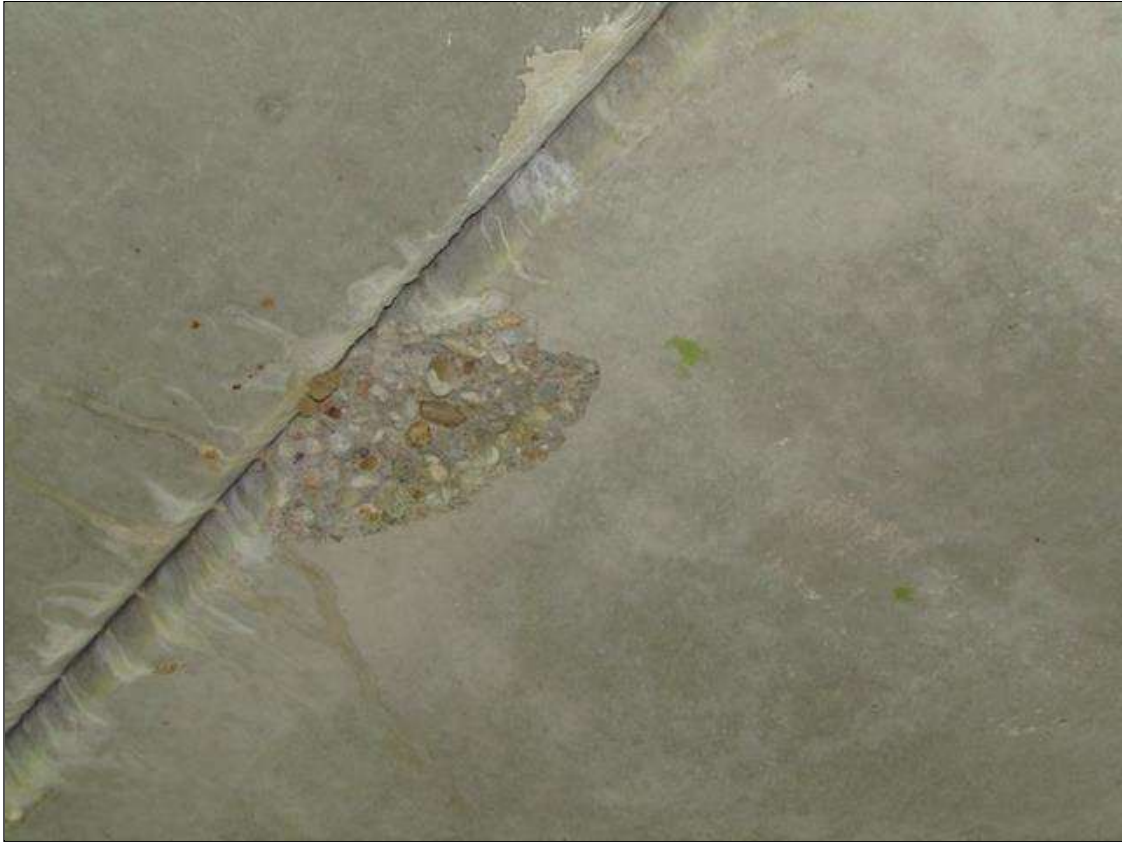
Span 2 Slab 5: SPALL ON LEFT BOTTOM CORNER MID SPAN 10" LONG X 5" WIDE X 1" DEEP

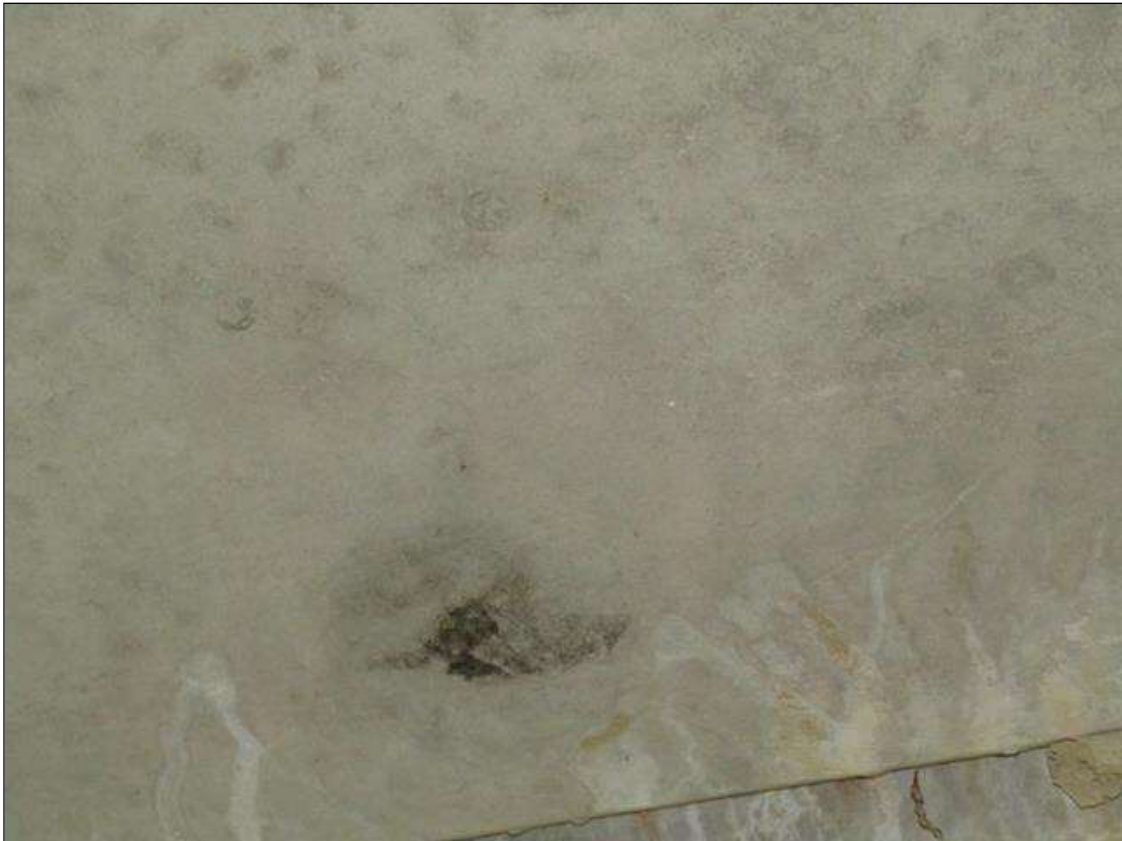
Span 2 Slab 7: 2" HONEYCOMB AREA ON BOTTOM MID SPAN

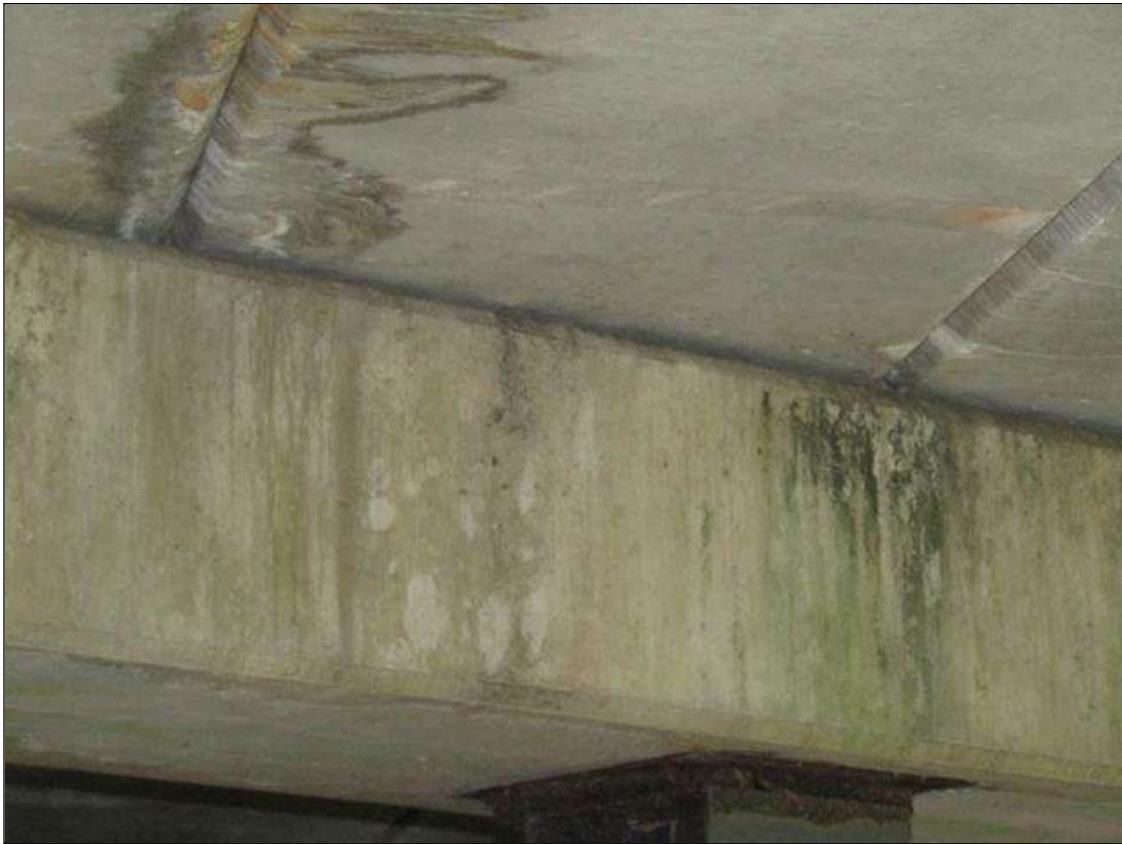
Span 3 Expansion Joint: OLD MOISTURE SEEPAGE STAIN ON PIER 2 CAP

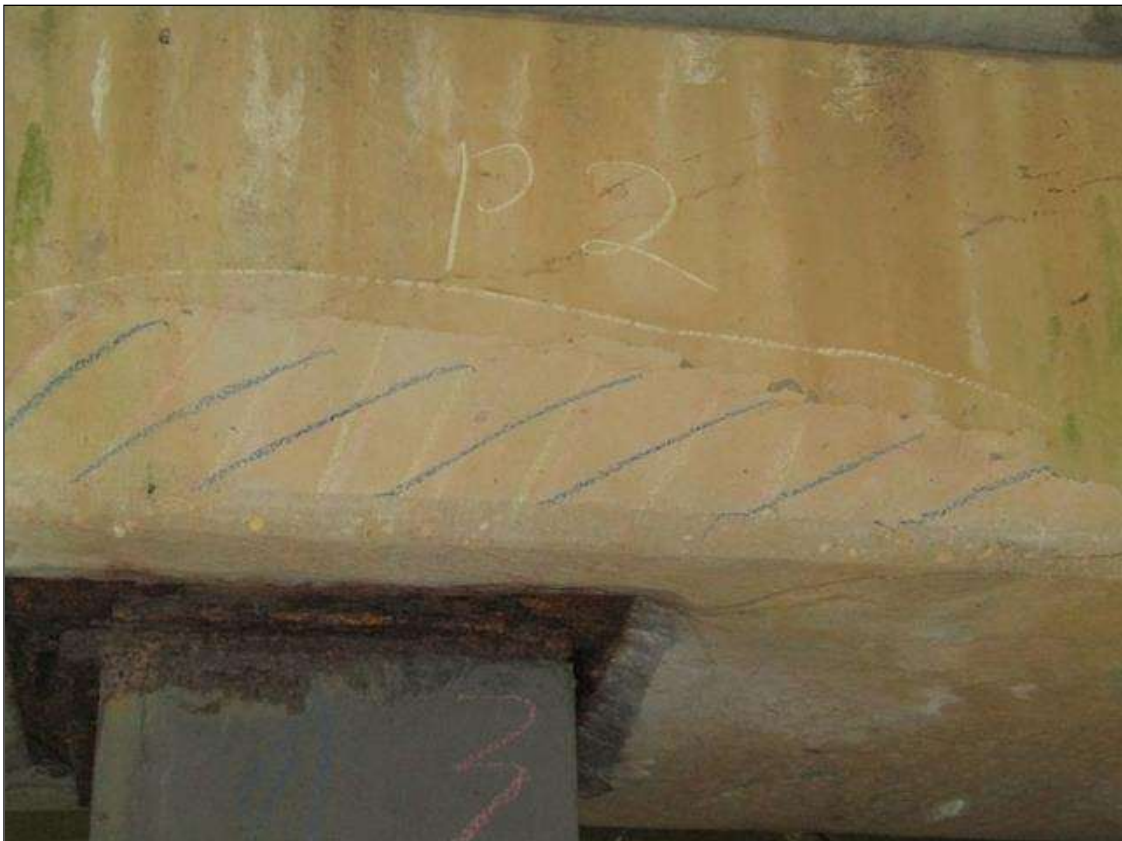
Bent 2 Cap 1: DELAM AREA 3' LONG X 5" WIDE OVER PILE 3 ON SOUTH FACE

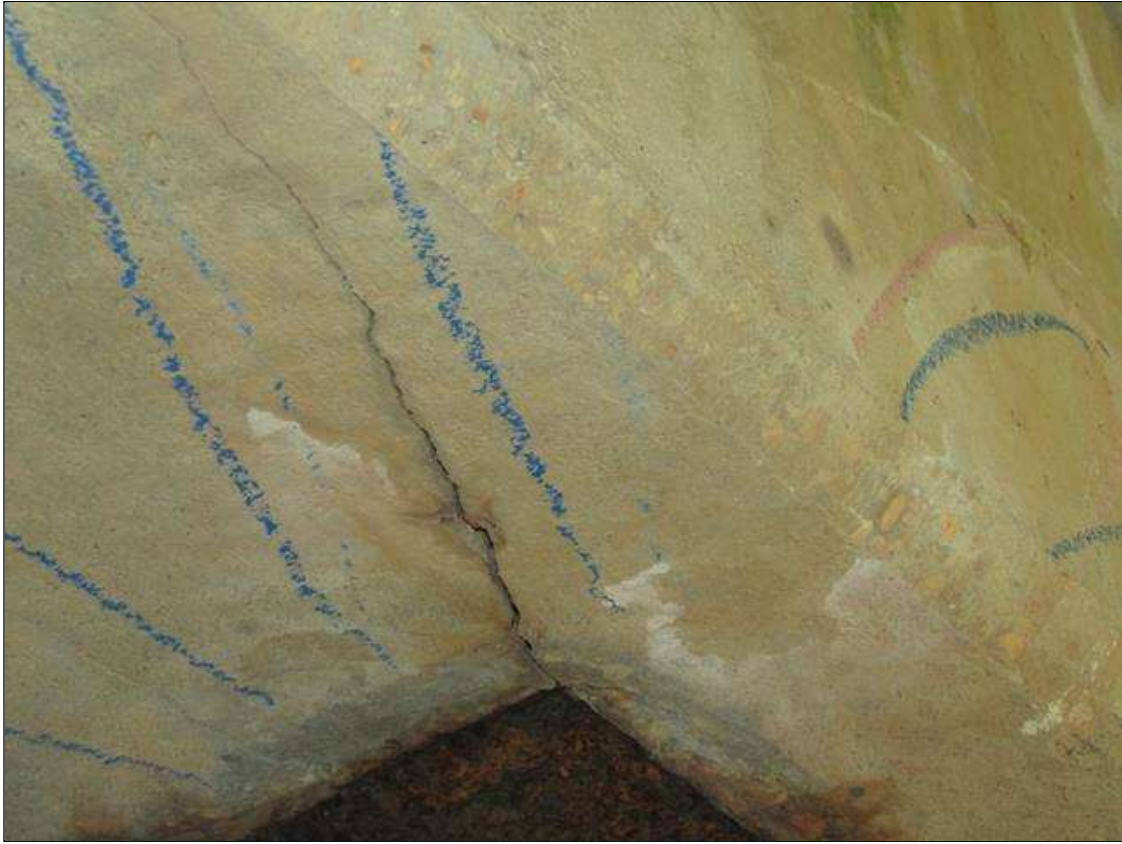
Bent 2 Cap 1: CRACKING ON BOTTOM AROUND CORNERS OF PILE PLATES 1/64" WIDE UP TO 8" LONG

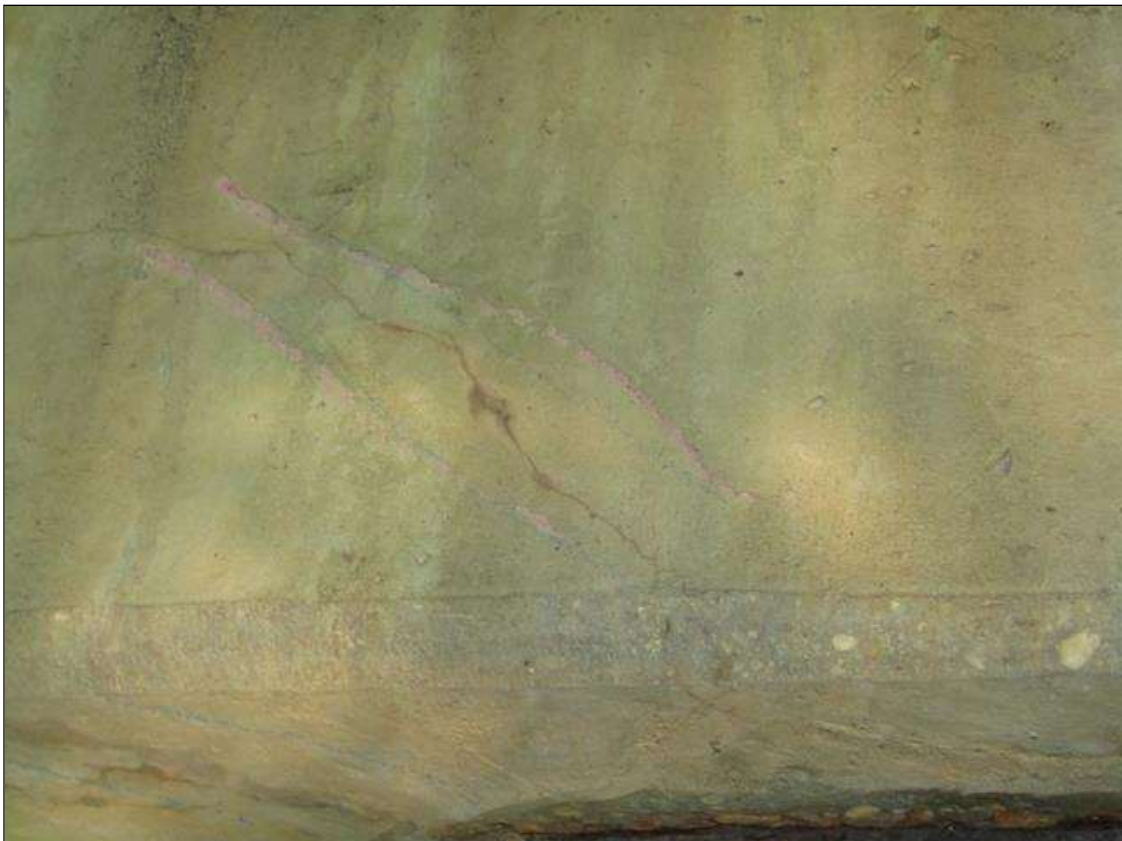
Bent 2 Cap 1: HAIRLINE DIAGONAL ON SOUTH FACE OVER PILE 2
