NC DEPARTMENT OF TRANSPORTATION
 DIVISION OF HIGHWAYS
 STRUCTURE MANAGEMENT UNIT

ATTENTION: PAR ISSUED ON PILES 1, 2 AND 6 AT END BENT 1,
 PILES 1 3 AND 4 AT PIER 1, PILES 1-6 AT PIER 2 AND
 PILES 1 AND 5 AT END BENT 2

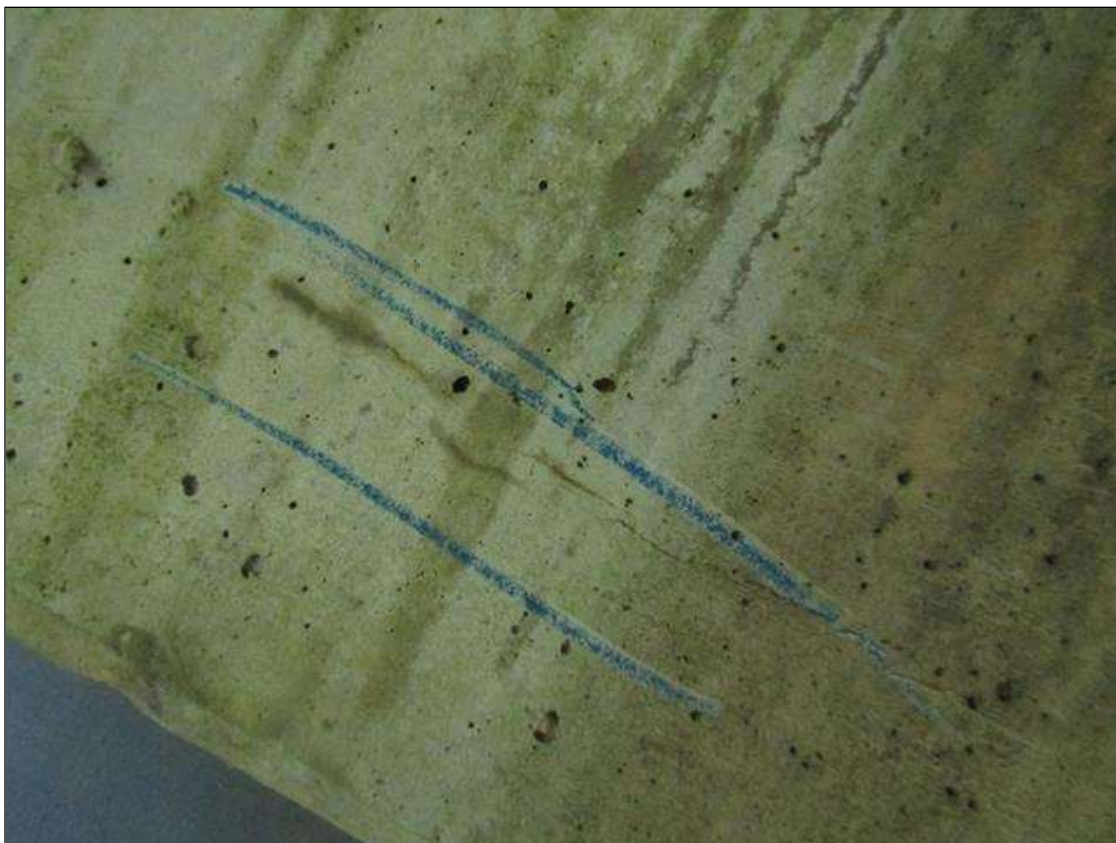
Bent 2 Cap 1: HAIRLINE LONGITUDINAL CRACK ON BOTH FACES ON EAST END AND OVER PILE 3

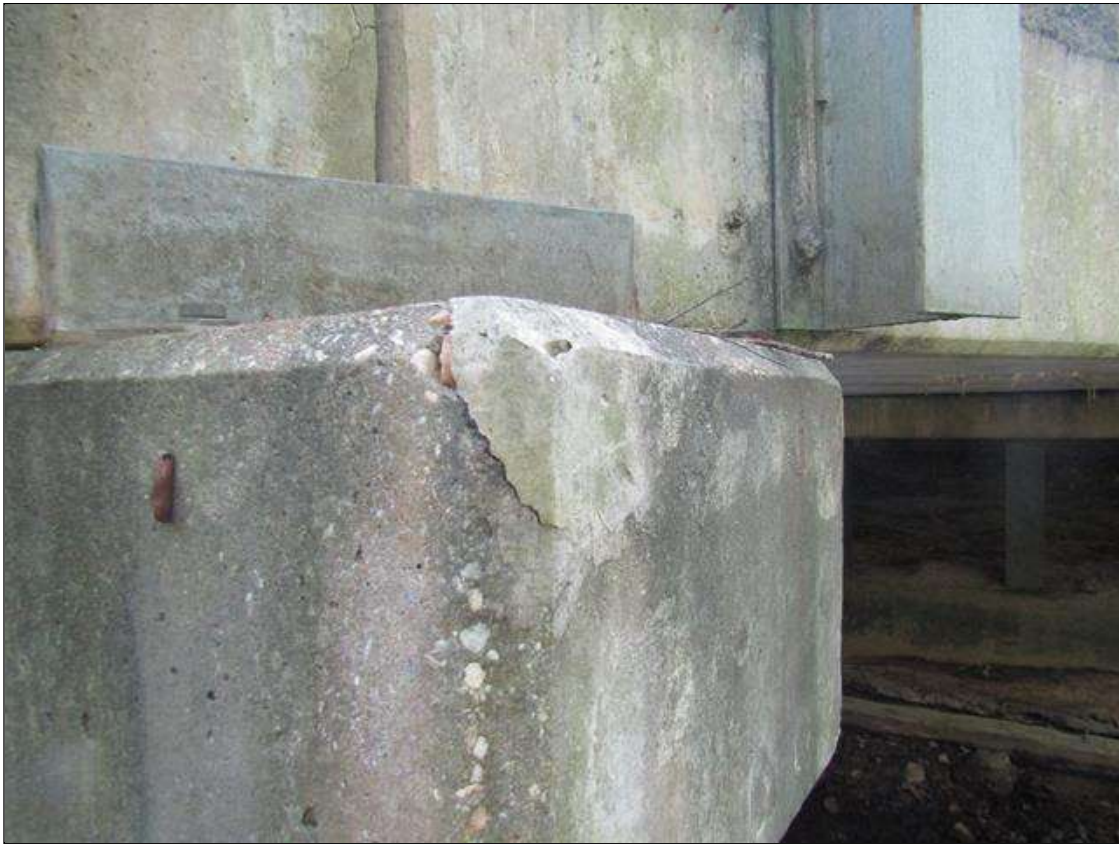
Bent 2 Cap 1: PATCH HAS CRACK ON TOP AT NORTHWEST CORNER

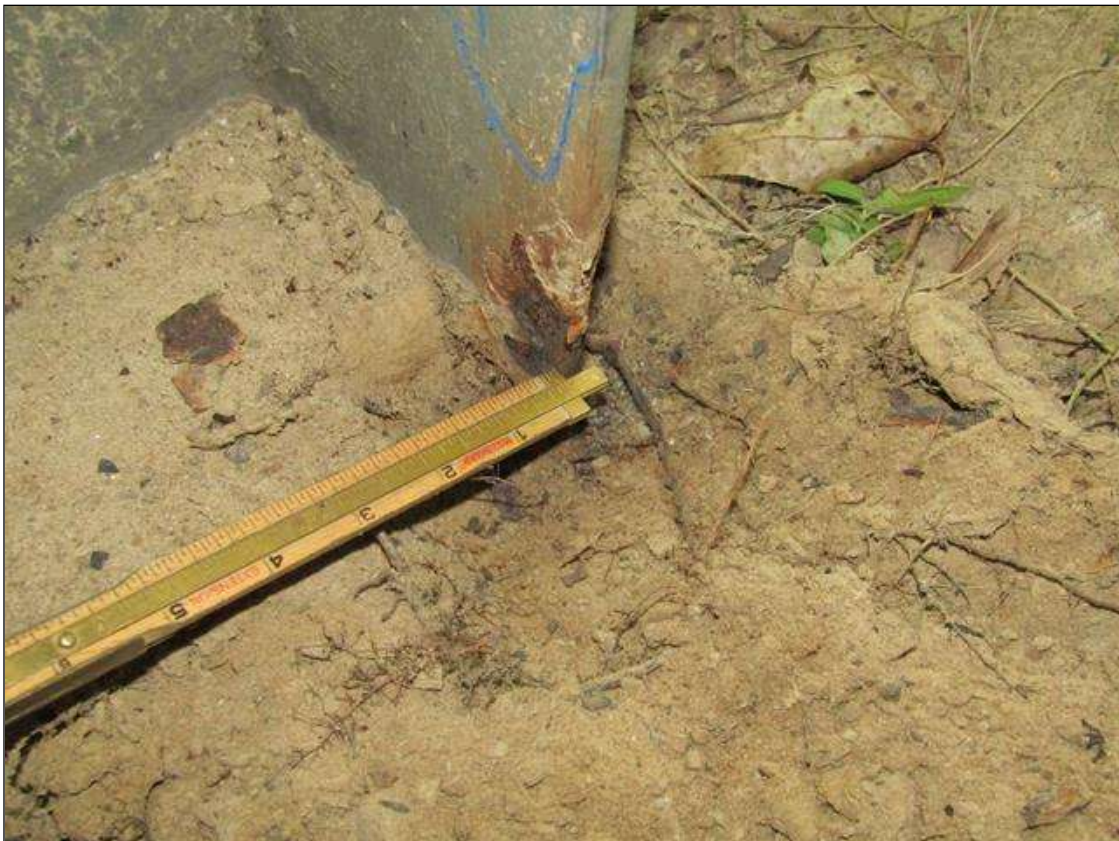
Bent 2 Pile 1: 1/4" STEEL REMAINING ON BOTTOM EAST NORTH FLANGE UP 2" FROM BOTTOM X 2" WIDE/PAR

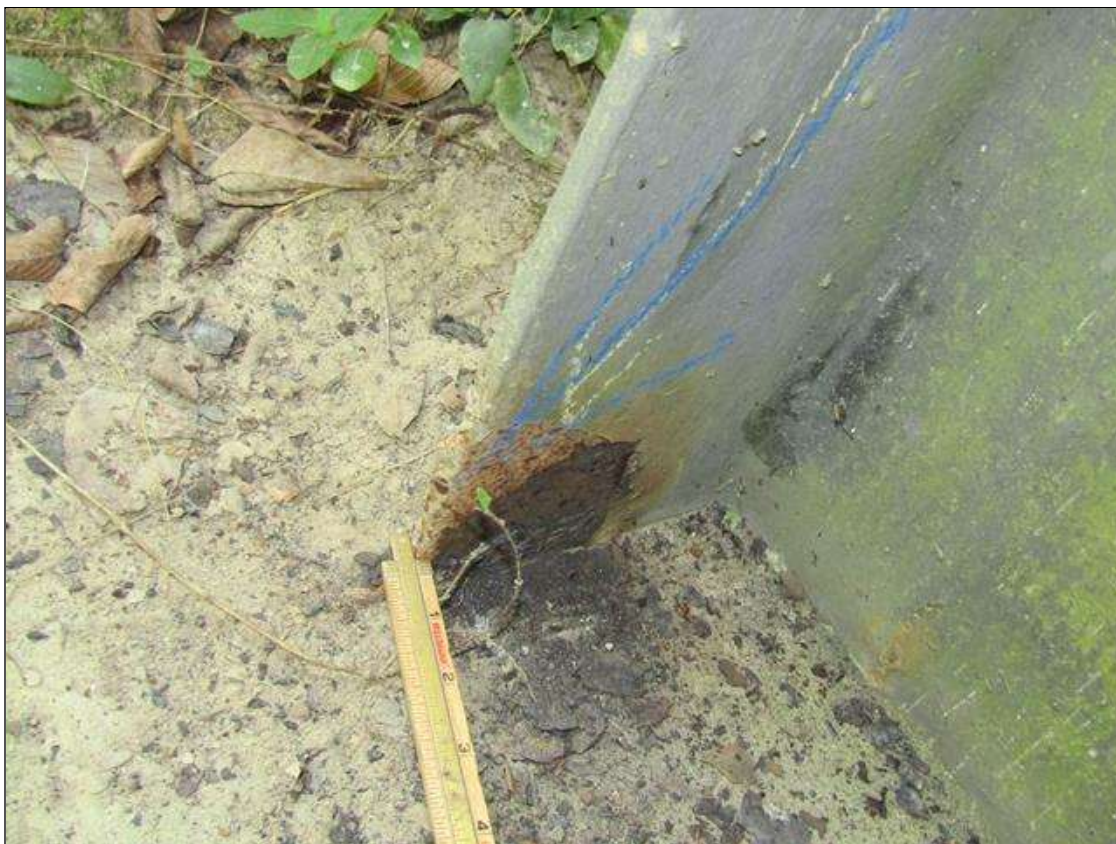
Bent 2 Pile 1: RUST SCALE ON TOP OF PLATE WITH SURFACE RUST ON TOP OF PILE, RUST SCALE ON BOTTOM WEST NORTH FLANGE WITH 1/4" STEEL REMAINING ON 1/2" FLANGE AREA STARTING AT BOTTOM 4" HIGH X 3" WIDE/PM

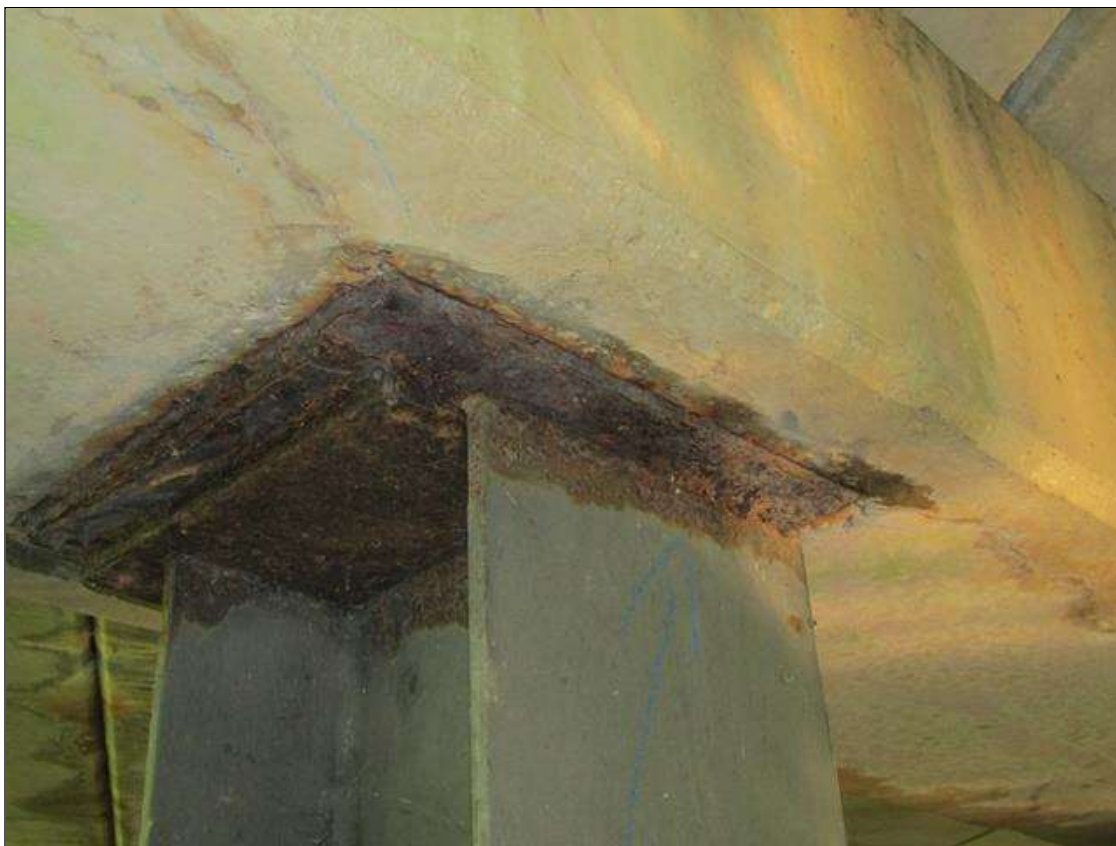
Bent 2 Pile 2: SURFACE AND RUST SCALE ON TOP OF PILE AND PLATE

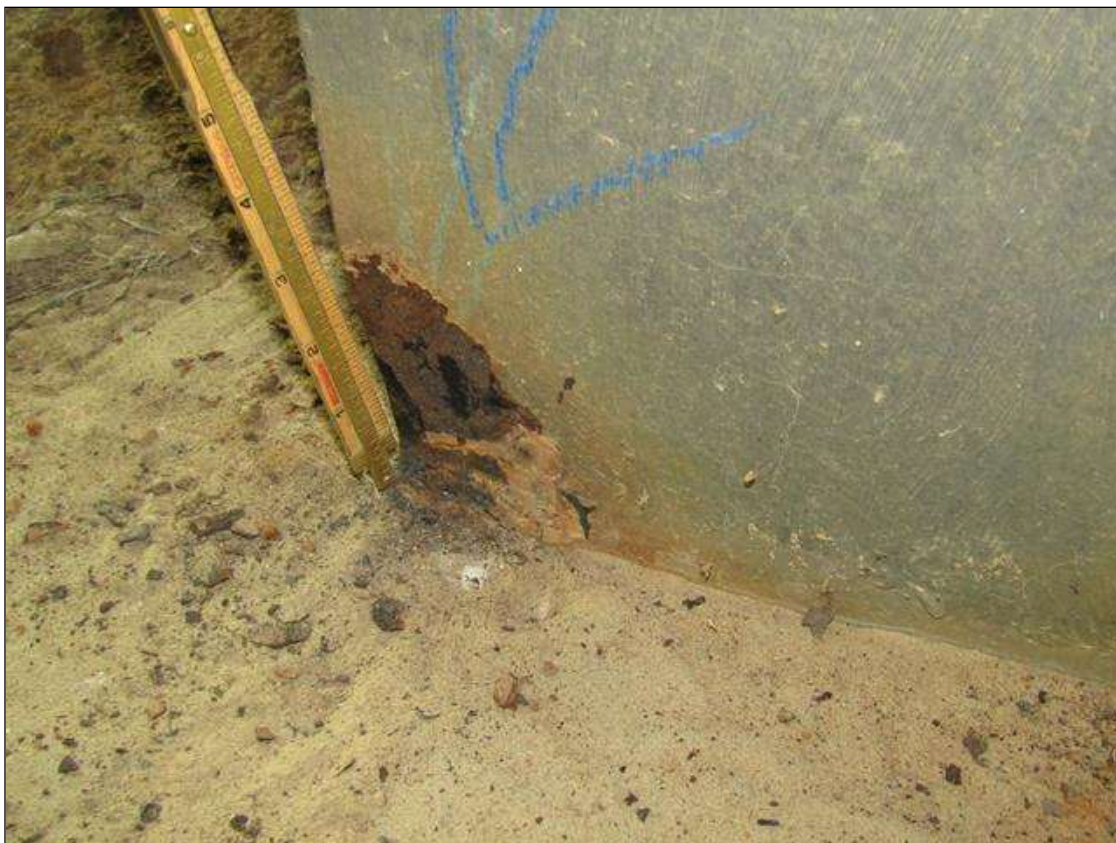
Bent 2 Pile 2: RUST SCALE ON BOTTOM WEST FLANGE ON SOUTH SIDE UP 3" HIGH X 2" WIDE WITH 1/8" STEEL REMAINING ON 1/2" FLANGE/PAR

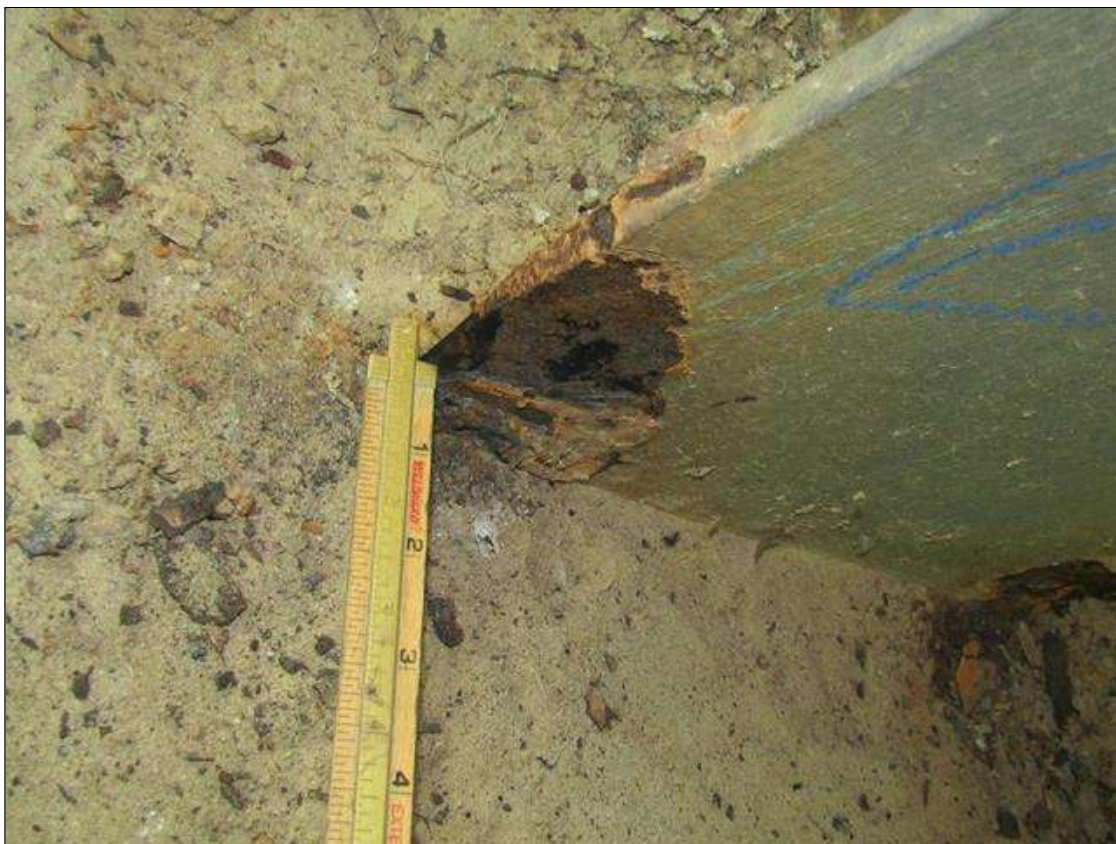
Bent 2 Pile 2: RUST SCALE ON BOTTOM WEST FLANGE ON SOUTH SIDE UP 3" HIGH X 2" WIDE WITH 1/8" STEEL REMAINING ON 1/2" FLANGE/PAR

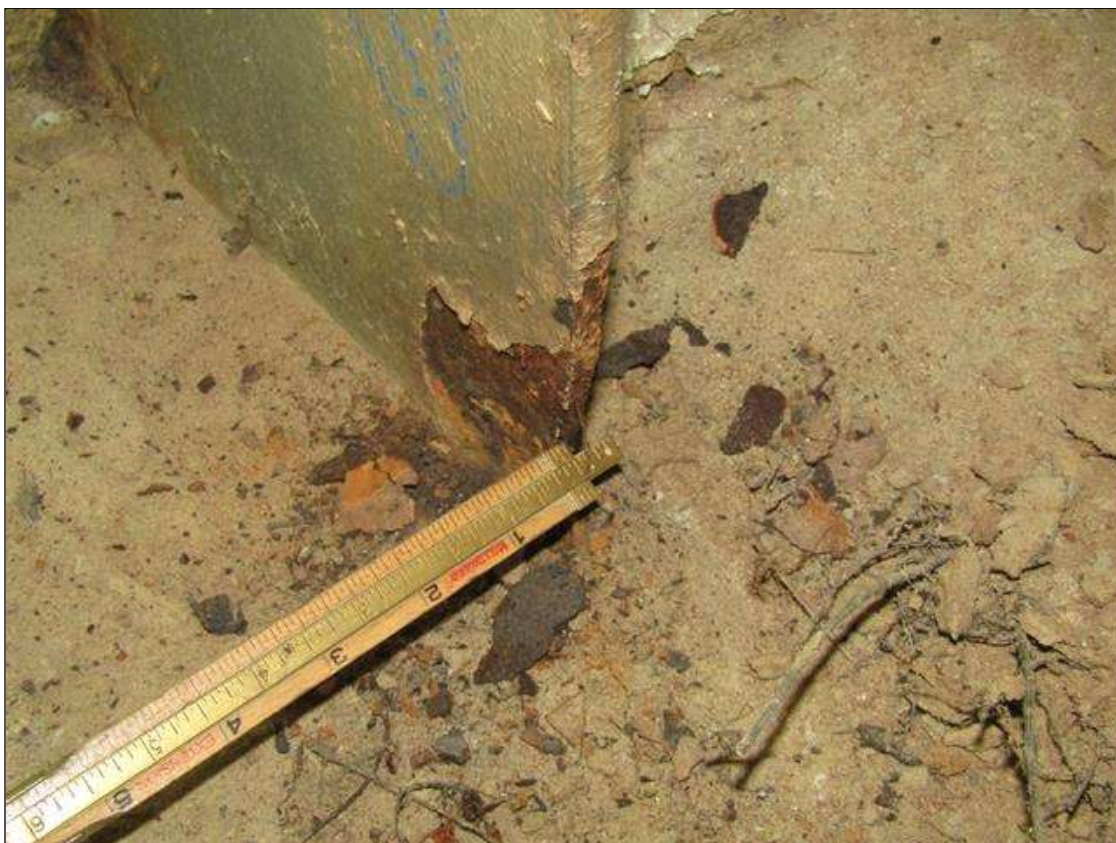
Bent 2 Pile 2: RUST SCALE ON BOTTOM EAST FLANGE ON SOUTH SIDE UP 3" HIGH X 2" WIDE WITH 1/8" STEEL REMAINING ON 1/2" FLANGE/PAR

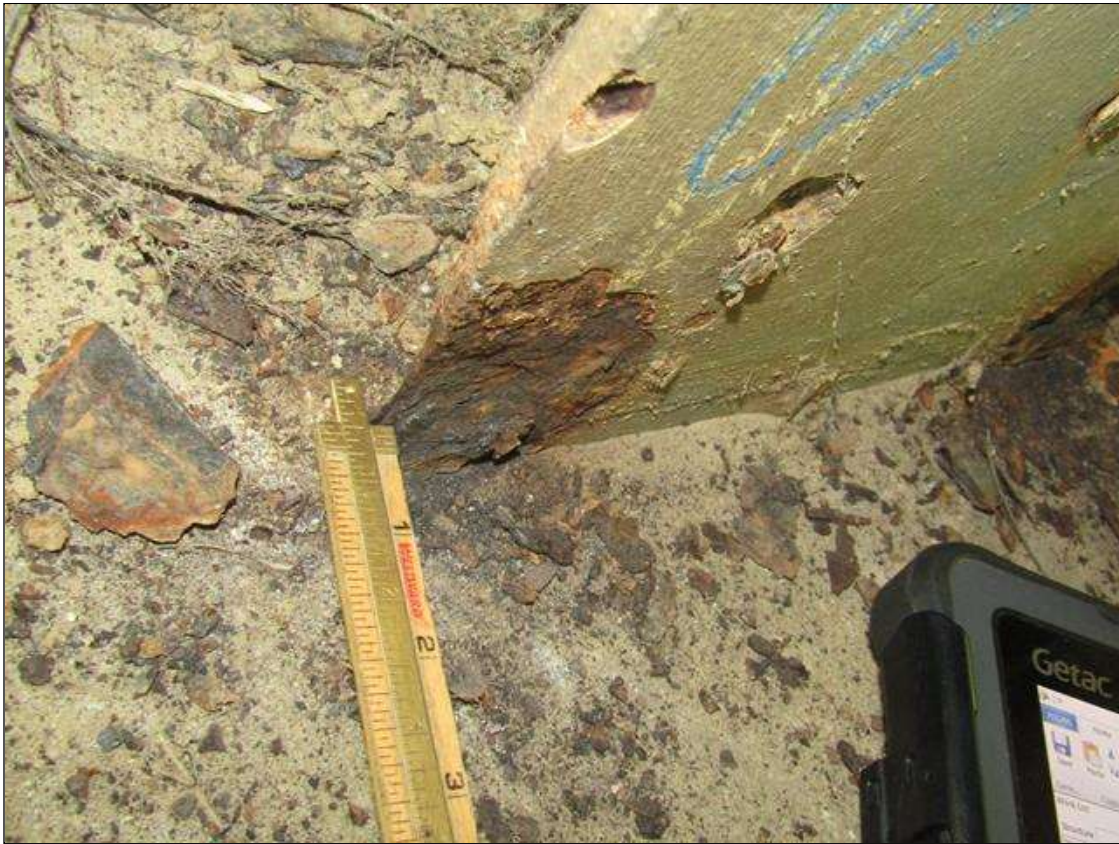
Bent 2 Pile 3: RUST SCALE ON BOTTOM WEST FLANGE ON SOUTH SIDE UP 3" HIGH X 2" WIDE WITH 1/8" STEEL REMAINING ON 1/2" FLANGE/PAR

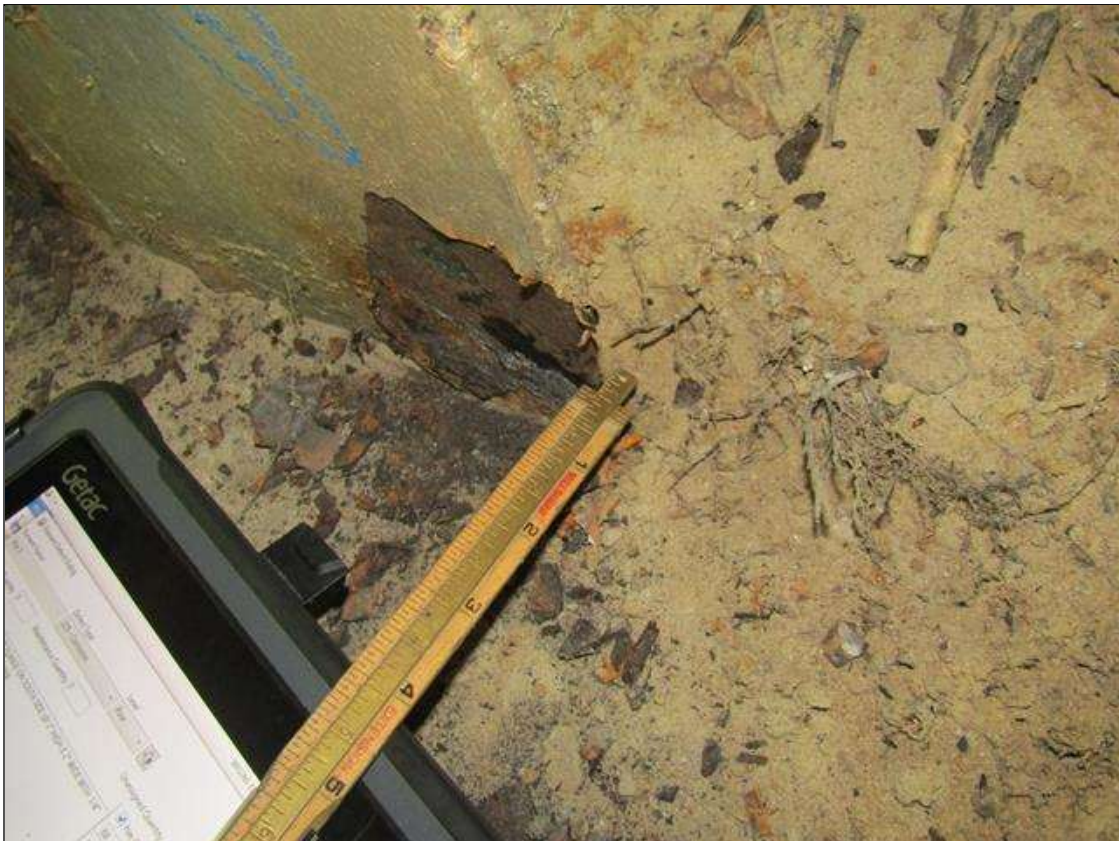
Bent 2 Pile 3: RUST SCALE ON BOTTOM EAST FLANGE ON SOUTH SIDE UP 3" HIGH X 2" WIDE WITH 1/4" STEEL REMAINING ON 1/2" FLANGE/PAR

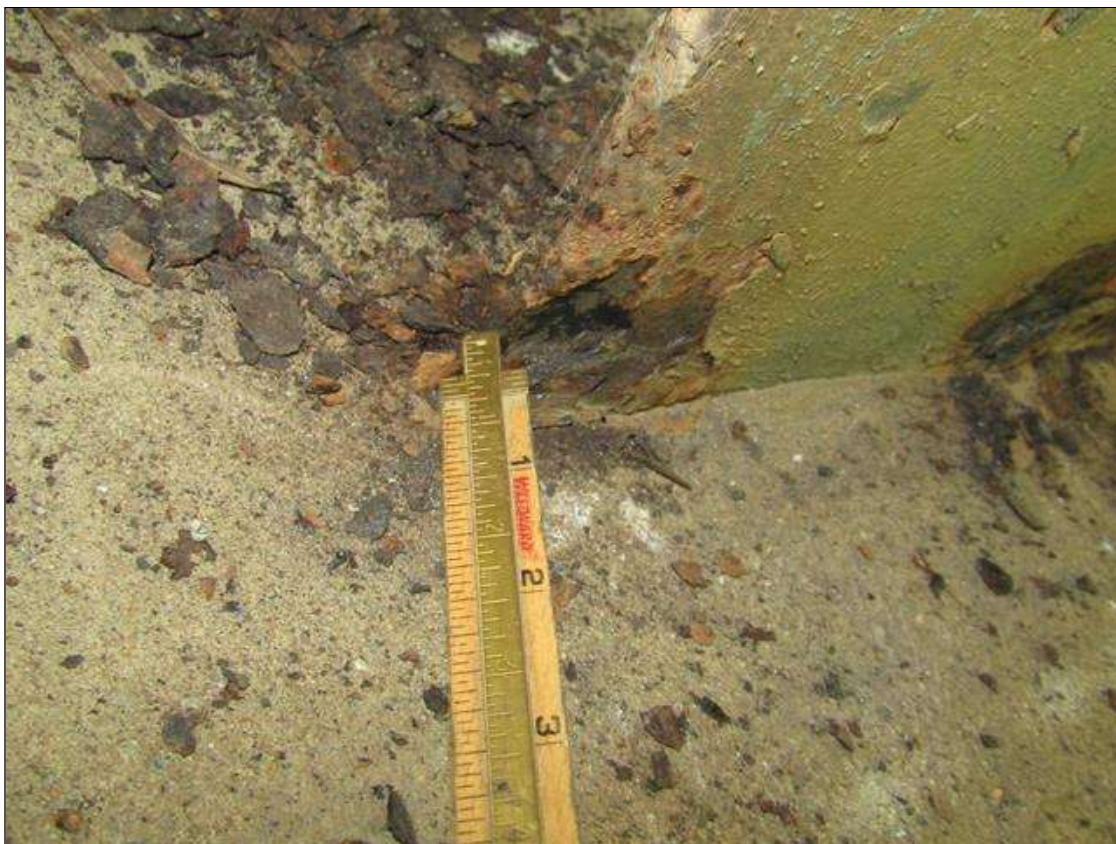
Bent 2 Pile 4: RUST SCALE ON BOTTOM OF SOUTH FLANGE ON WEST SIDE UP 4" X 2" WIDE WITH 1/8" STEEL REMAINING ON 1/2" FLANGE/PAR

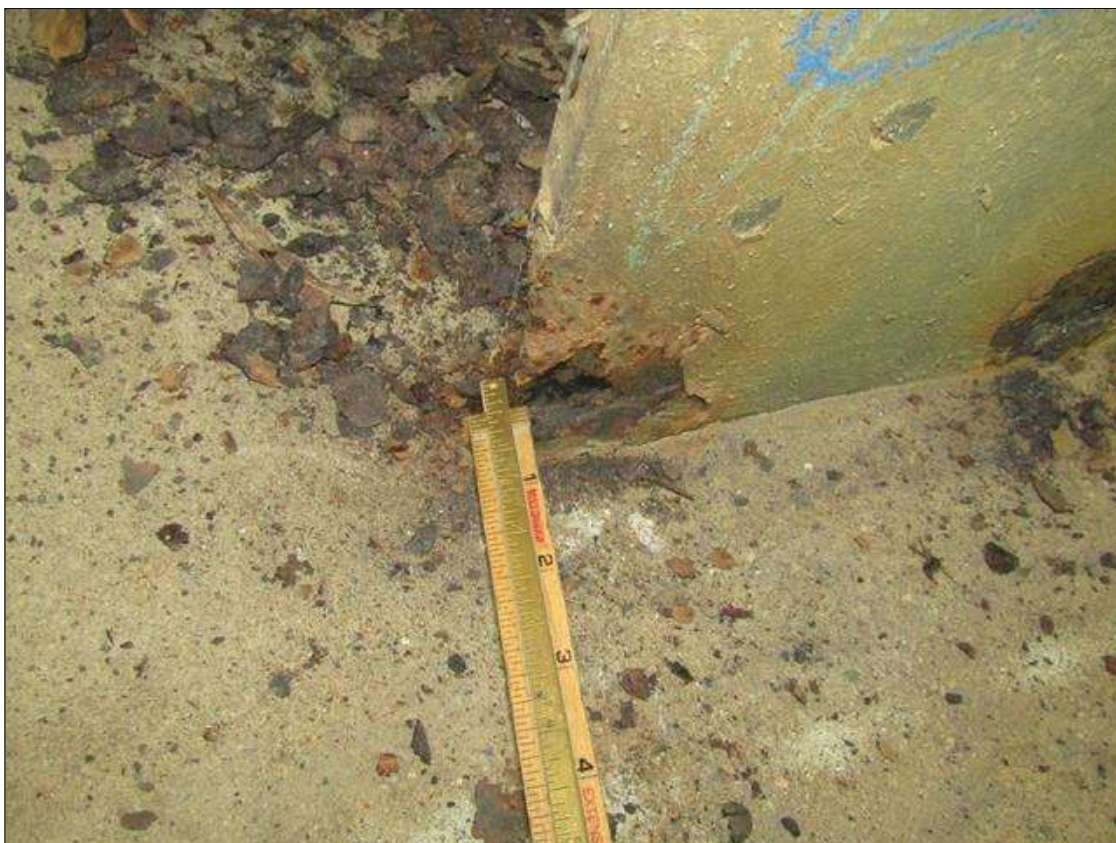
Bent 2 Pile 4: RUST SCALE ON BOTTOM OF SOUTH FLANGE ON WEST SIDE UP 4" X 2" WIDE WITH 1/8" STEEL REMAINING ON 1/2" FLANGE/PAR

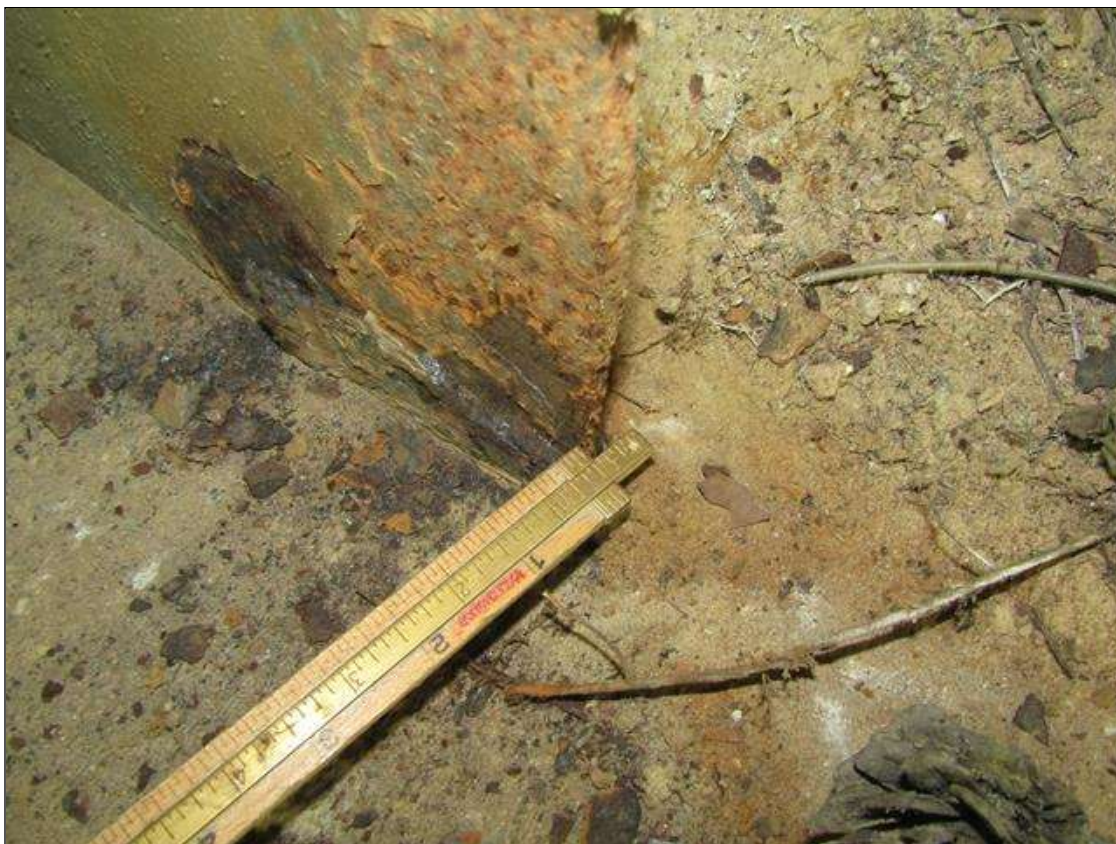
Bent 2 Pile 4: RUST SCALE ON BOTTOM OF SOUTH FLANGE ON EAST SIDE UP 4" WITH 1/8" STEEL REMAINING ON 1/2" FLANGE/PAR

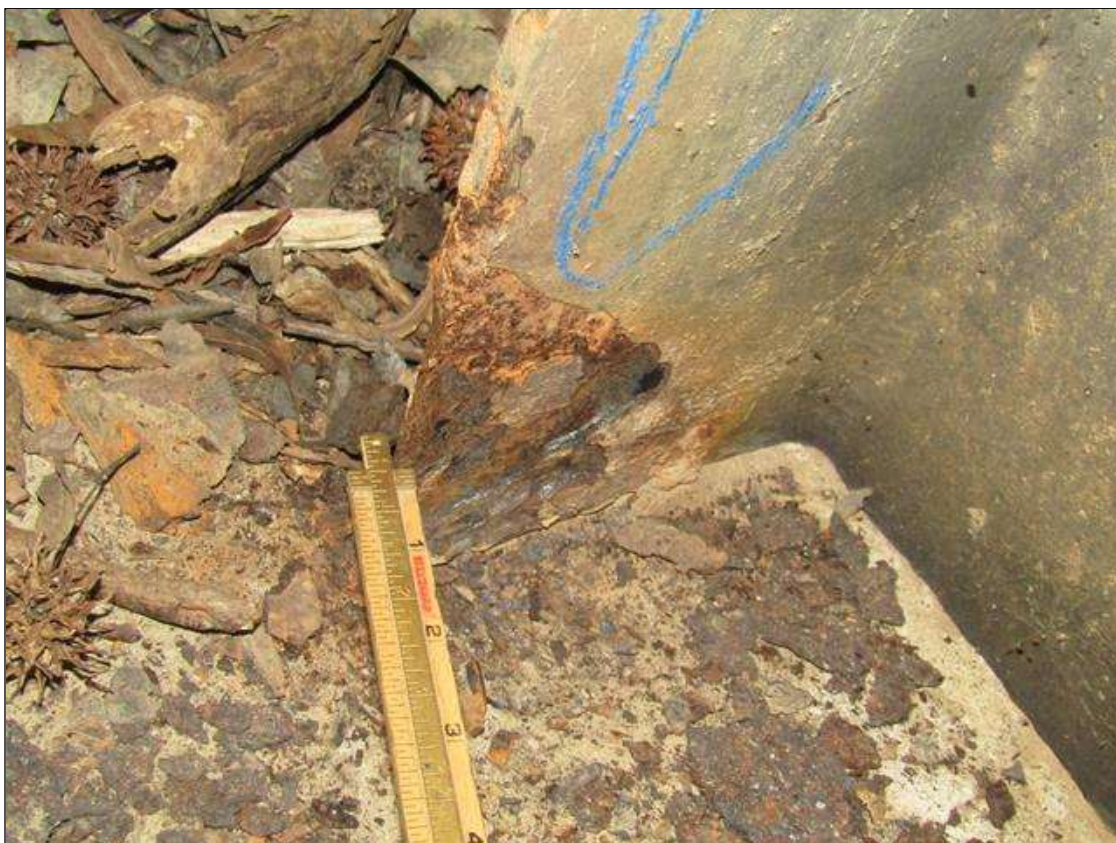
Bent 2 Pile 4: RUST SCALE ON BOTTOM OF NORTH FLANGE ON WEST SIDE UP 4" WITH 1/8" STEEL REMAINING ON 1/2" FLANGE/ PAR

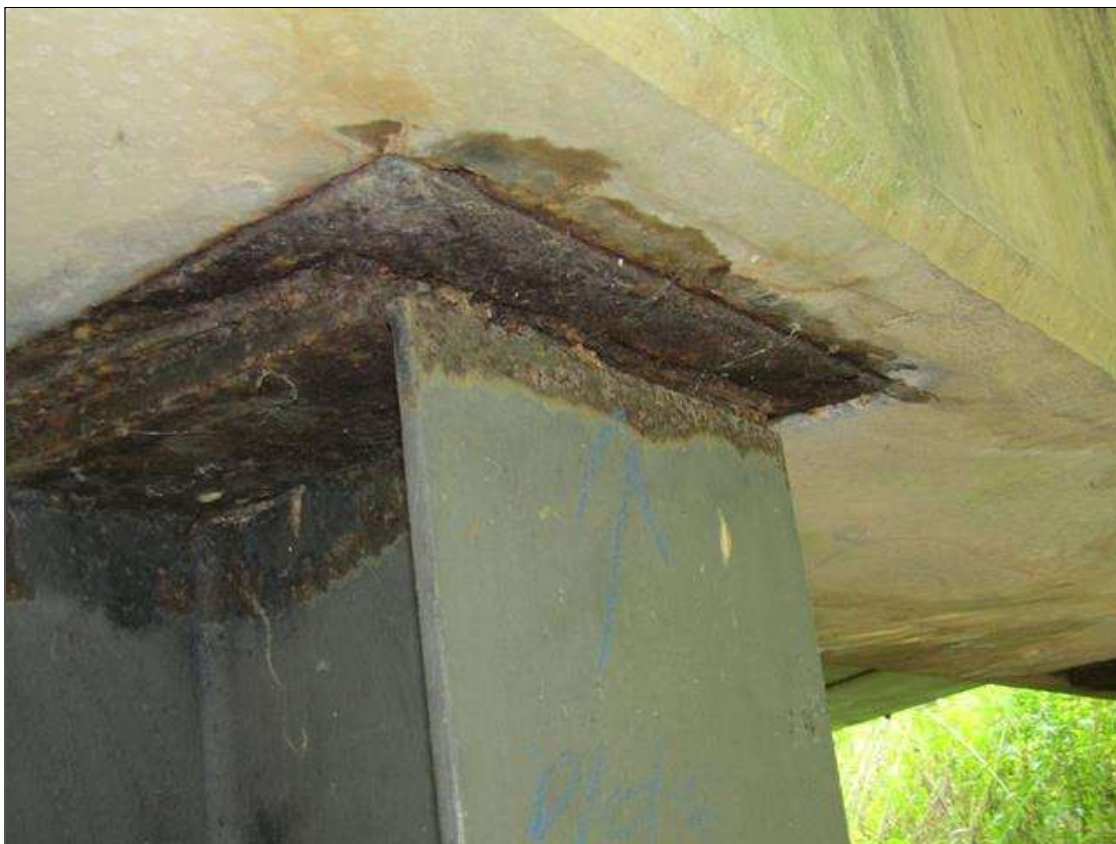
Bent 2 Pile 5: RUST SCALE ON TOP PLATE WITH SURFACE RUST ON TOP OF PILE

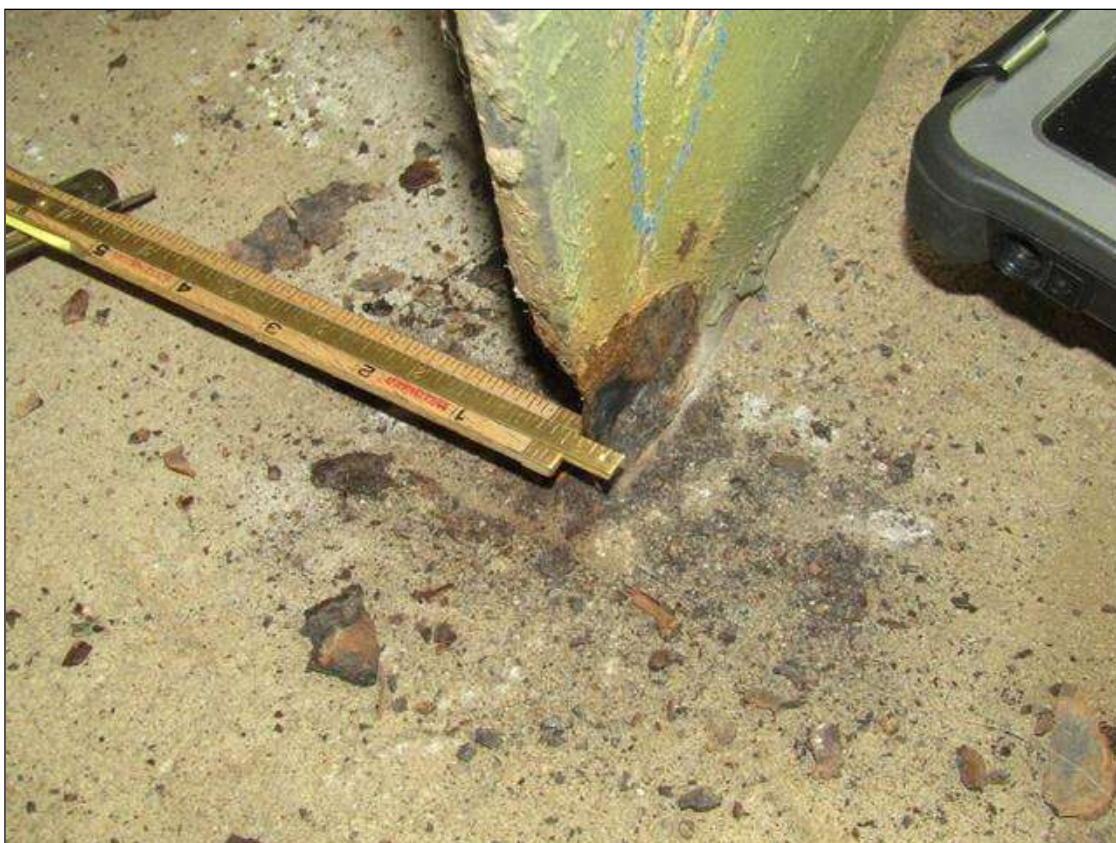
Bent 2 Pile 5: RUST SCALE ON BOTTOM OF SOUTH FLANGE ON WEST SIDE UP 2" X 2" WIDE WITH 1/8" STEEL REMAINING ON 1/2" FLANGE/PAR

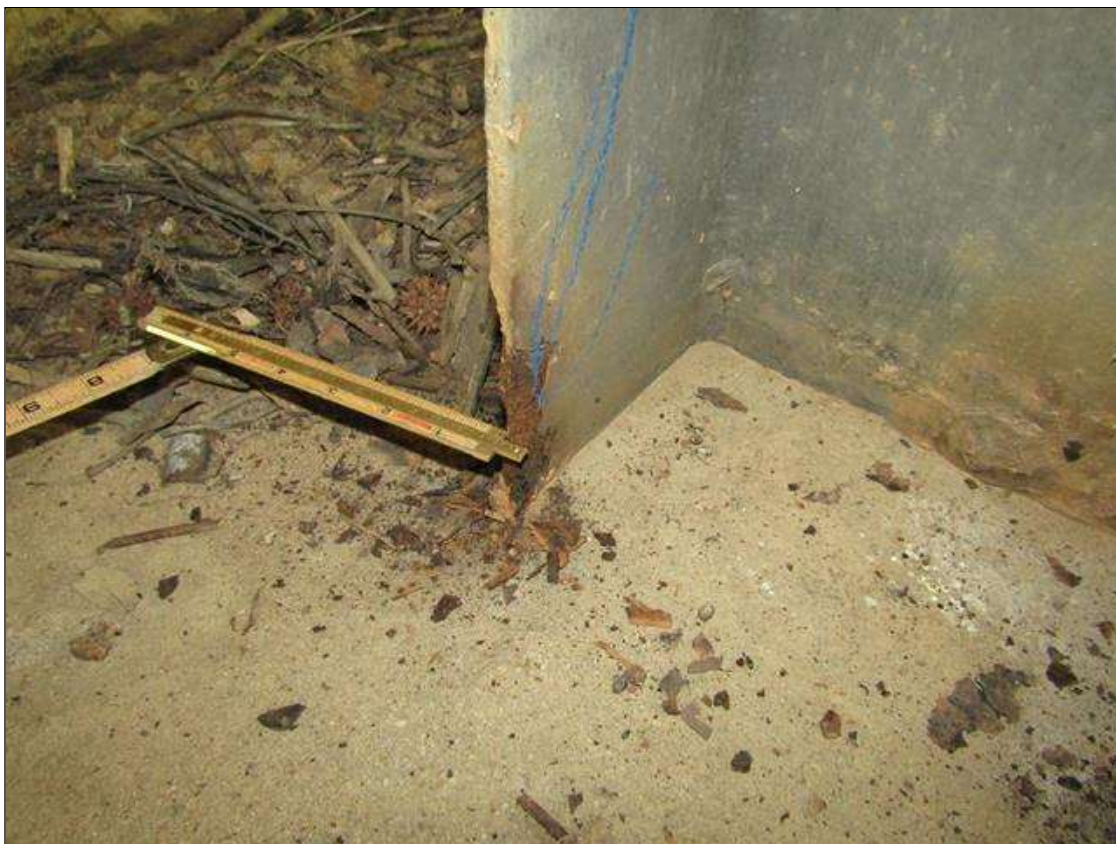
Bent 2 Pile 5: RUST SCALE ON BOTTOM OF NORTH FLANGE ON WEST SIDE UP 2" X 1" WIDE WITH 1/4" STEEL REMAINING ON 1/2" FLANGE/PAR

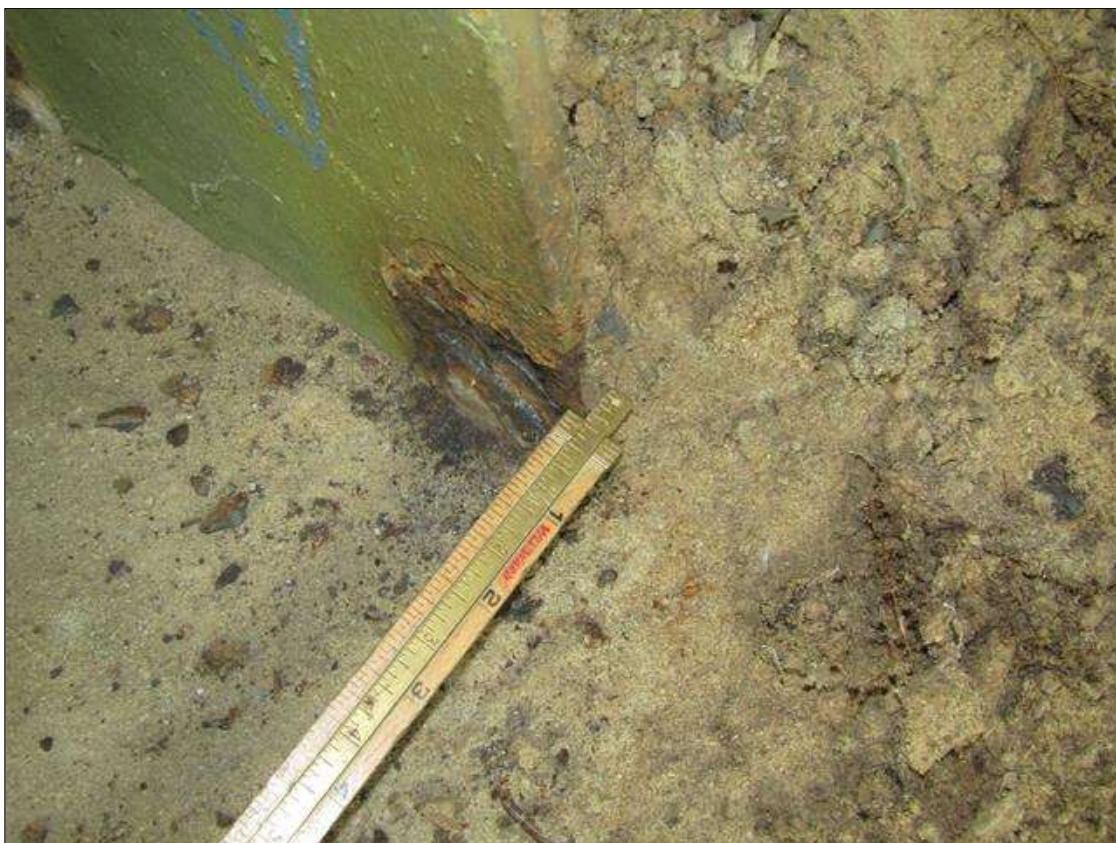
Bent 2 Pile 5: RUST SCALE ON BOTTOM OF SOUTH FLANGE ON EAST SIDE UP 3" X 2" WIDE WITH 1/8" STEEL REMAINING ON 1/2" FLANGE/PAR

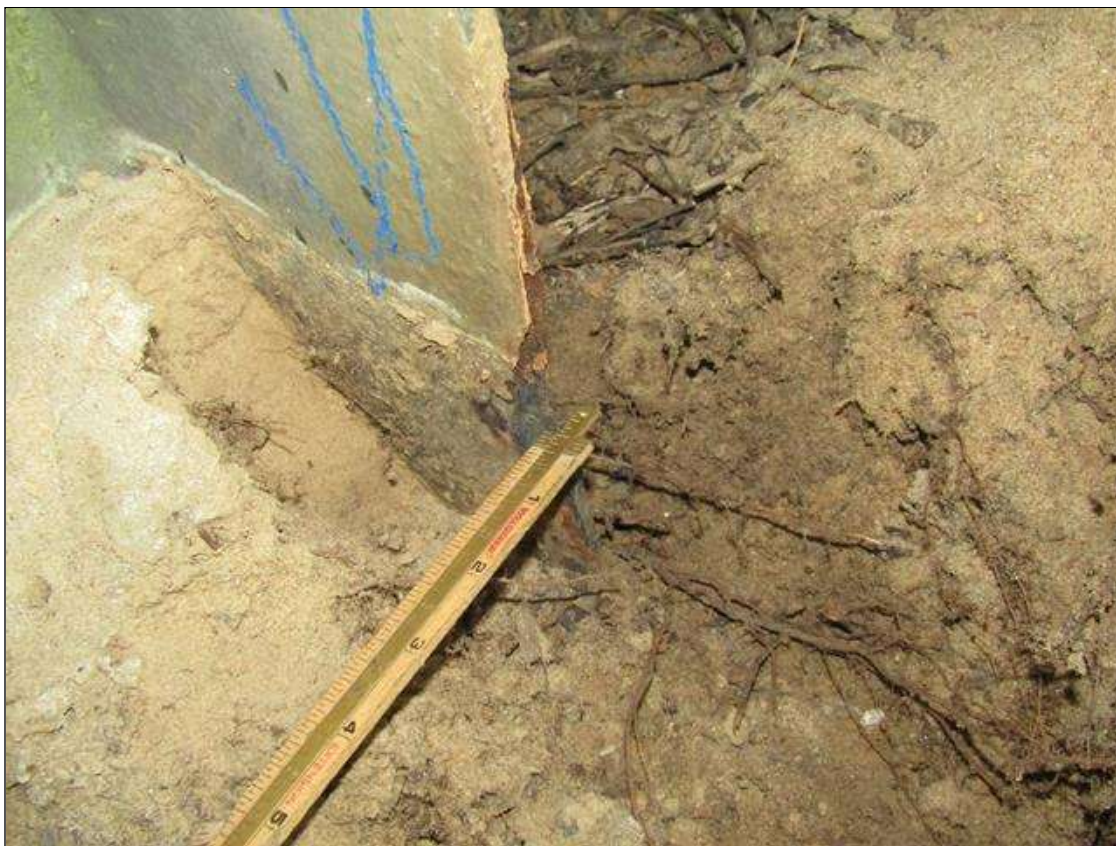
Bent 2 Pile 5: RUST SCALE ON BOTTOM OF NORTH FLANGE ON EAST SIDE UP 4" X 2" WIDE WITH 1/8" STEEL REMAINING ON 1/2" FLANGE/PAR

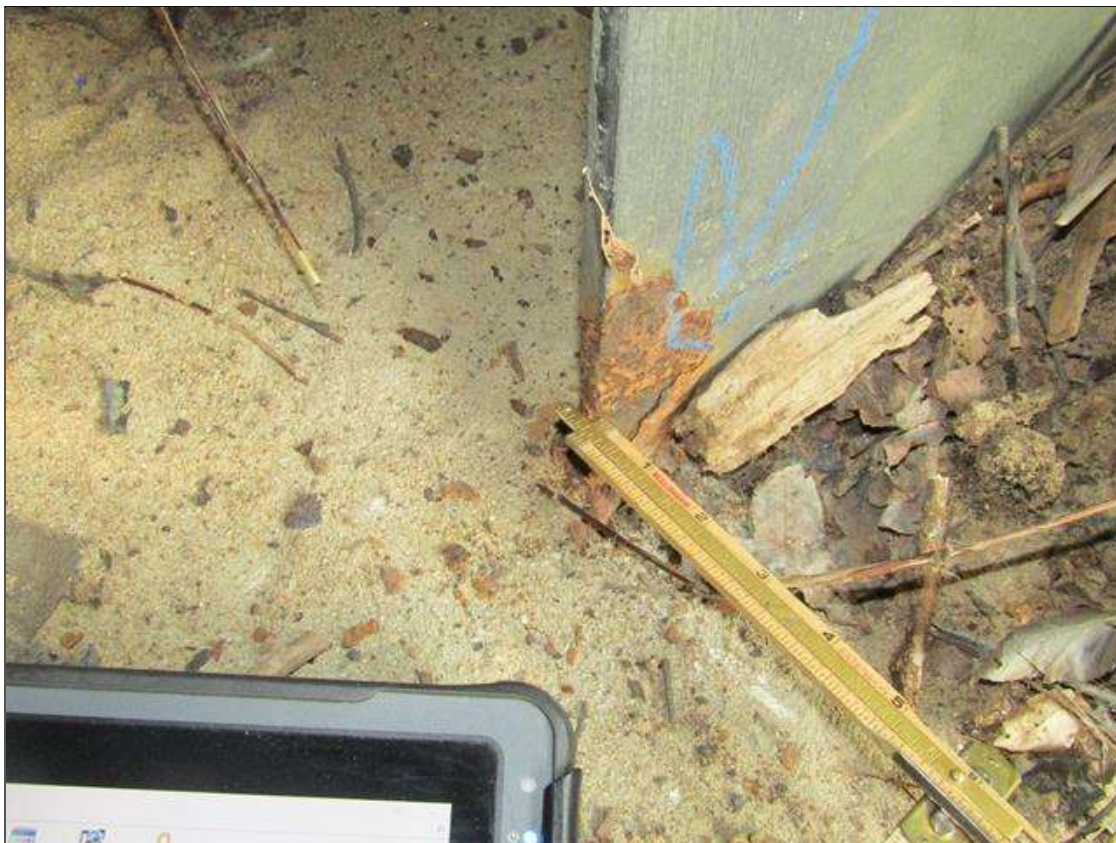
Bent 2 Pile 6: RUST SCALE ON BOTTOM OF SOUTH FLANGE ON WEST SIDE UP 3" X 2" WIDE WITH 1/4" STEEL REMAINING ON 1/2" FLANGE/PAR

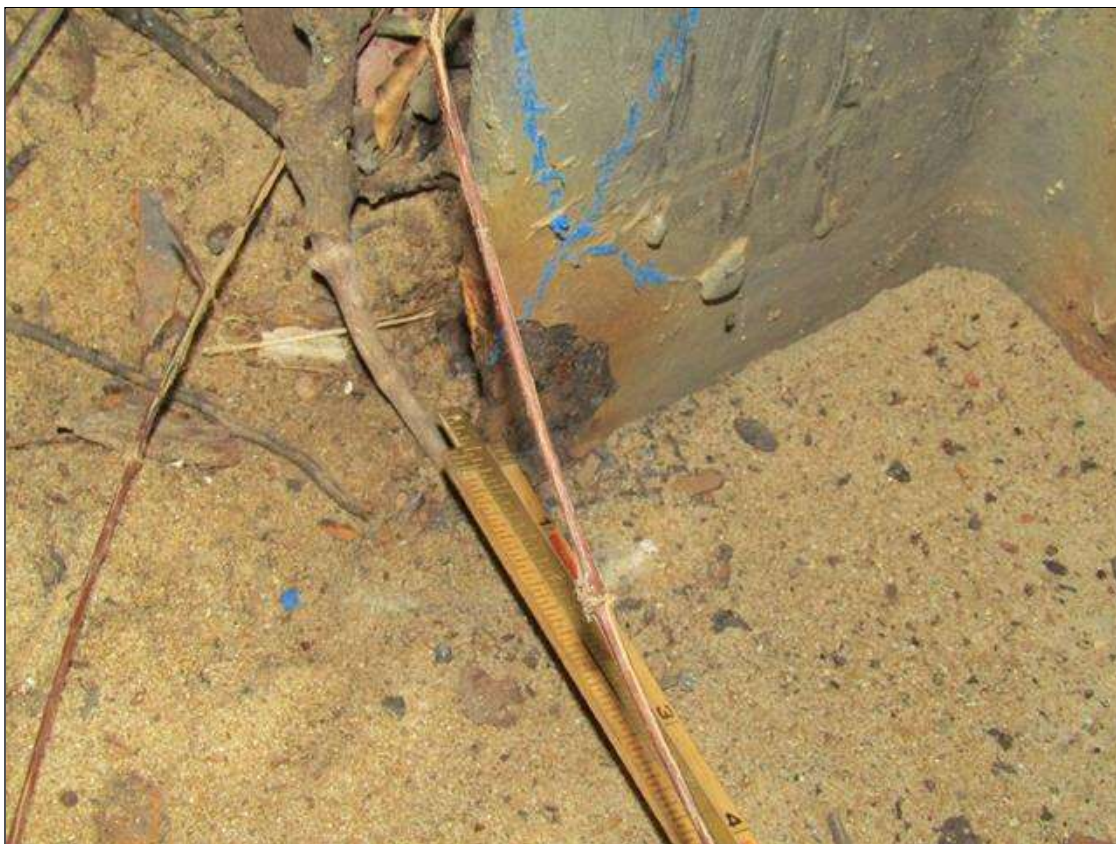
Bent 2 Pile 6: RUST SCALE ON BOTTOM OF SOUTH FLANGE ON EAST SIDE UP 3" X 2" WIDE WITH 1/8" STEEL REMAINING ON 1/2" FLANGE/PAR

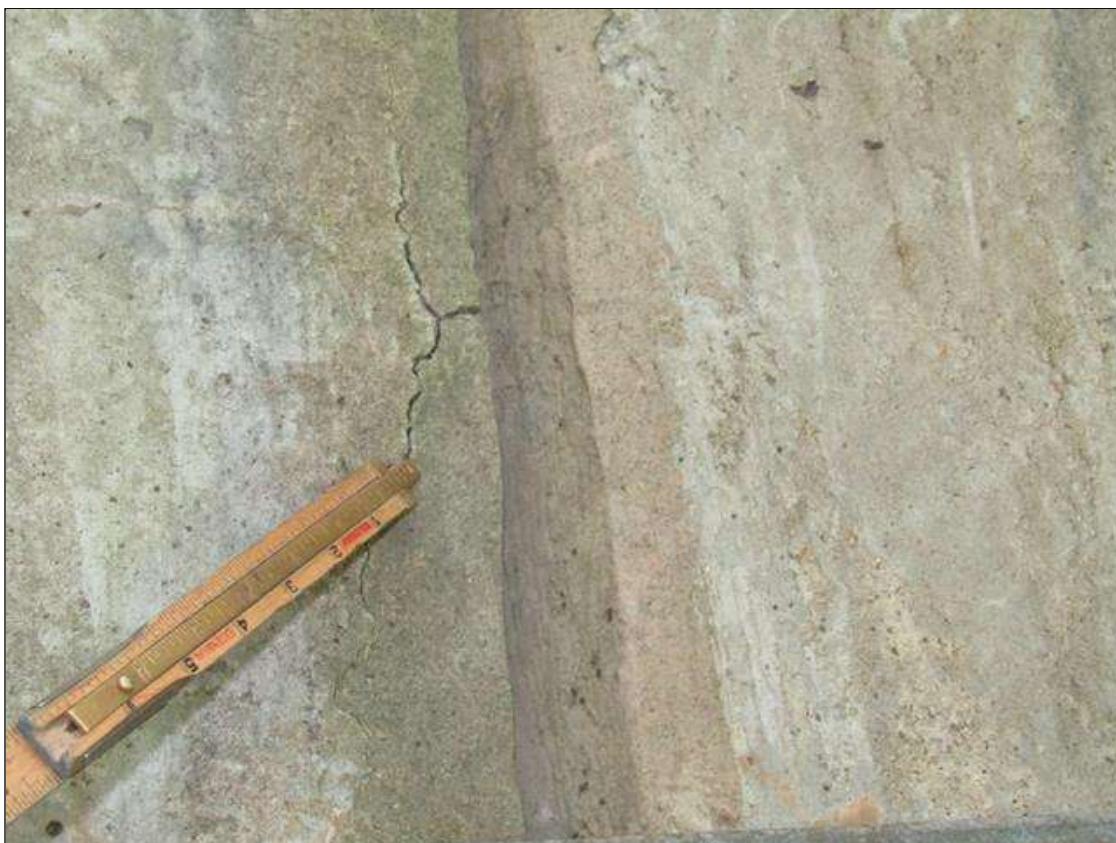
Span 3 Slab 1: CRACK ON END AT PIER 2 UP TO 1/8" WIDE X 6" LONG

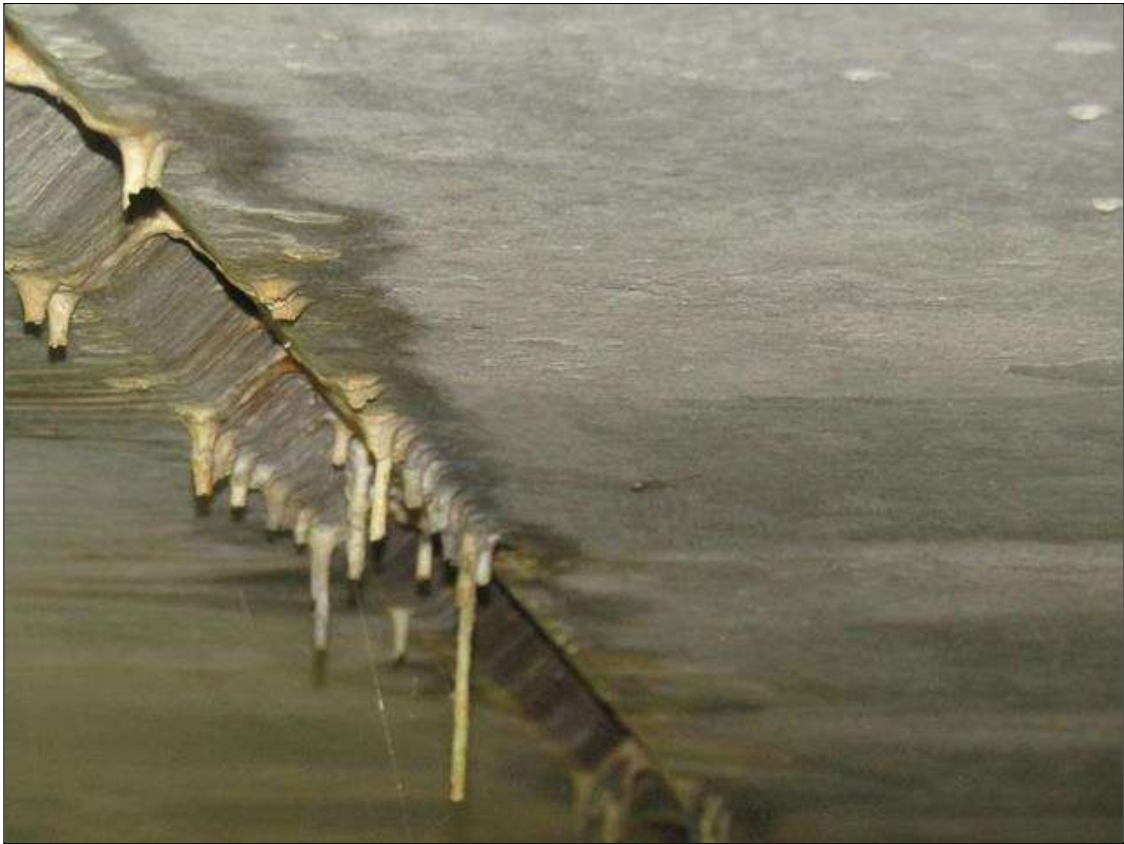
Span 3 Slab 1: EFFLO BUILT UP ON BOTTOM FROM BETWEEN SLABS
