NC DEPARTMENT OF TRANSPORTATION
 DIVISION OF HIGHWAYS
 STRUCTURE MANAGEMENT UNIT

ATTENTION: PAR ISSUED ON PILES 1, 2 AND 6 AT END BENT 1,
 PILES 1 3 AND 4 AT PIER 1, PILES 1-6 AT PIER 2 AND
 PILES 1 AND 5 AT END BENT 2

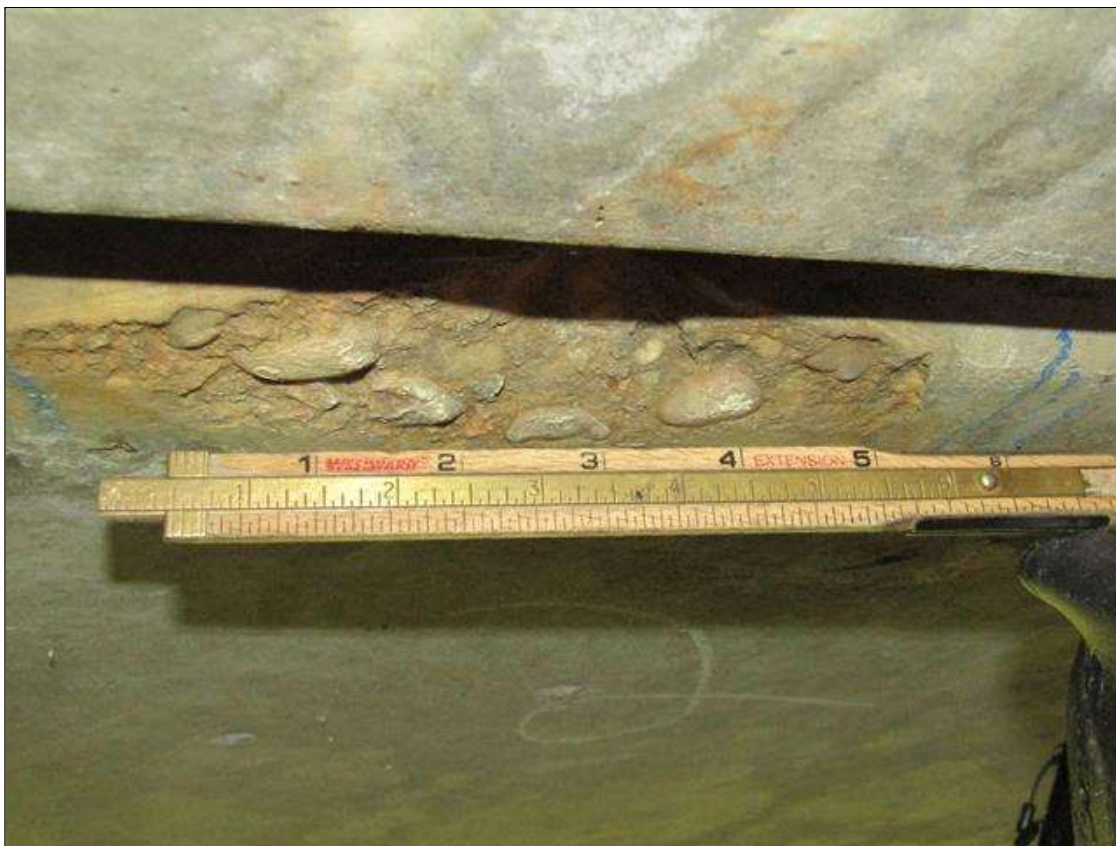
Span 3 Slab 2: TWO CHIP SPALLS ON RIGHT EDGE 5' FROM PIER 2, ONE 4" X 2" X 1/2" DEEP AND OTHER 3" X 2" X 1/2" DEEP

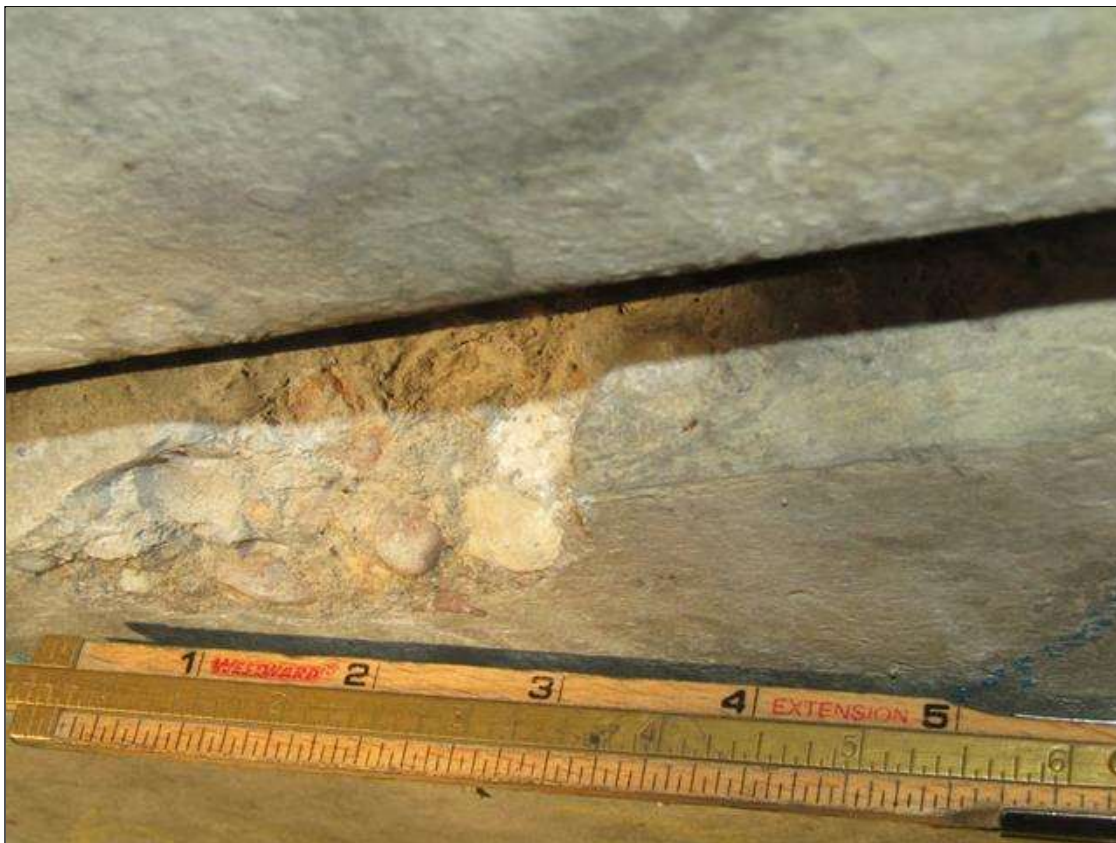
Span 3 Slab 2: TWO CHIP SPALLS ON RIGHT EDGE 5' FROM PIER 2, ONE 4" X 2" X 1/2" DEEP AND OTHER 3" X 2" X 1/2" DEEP

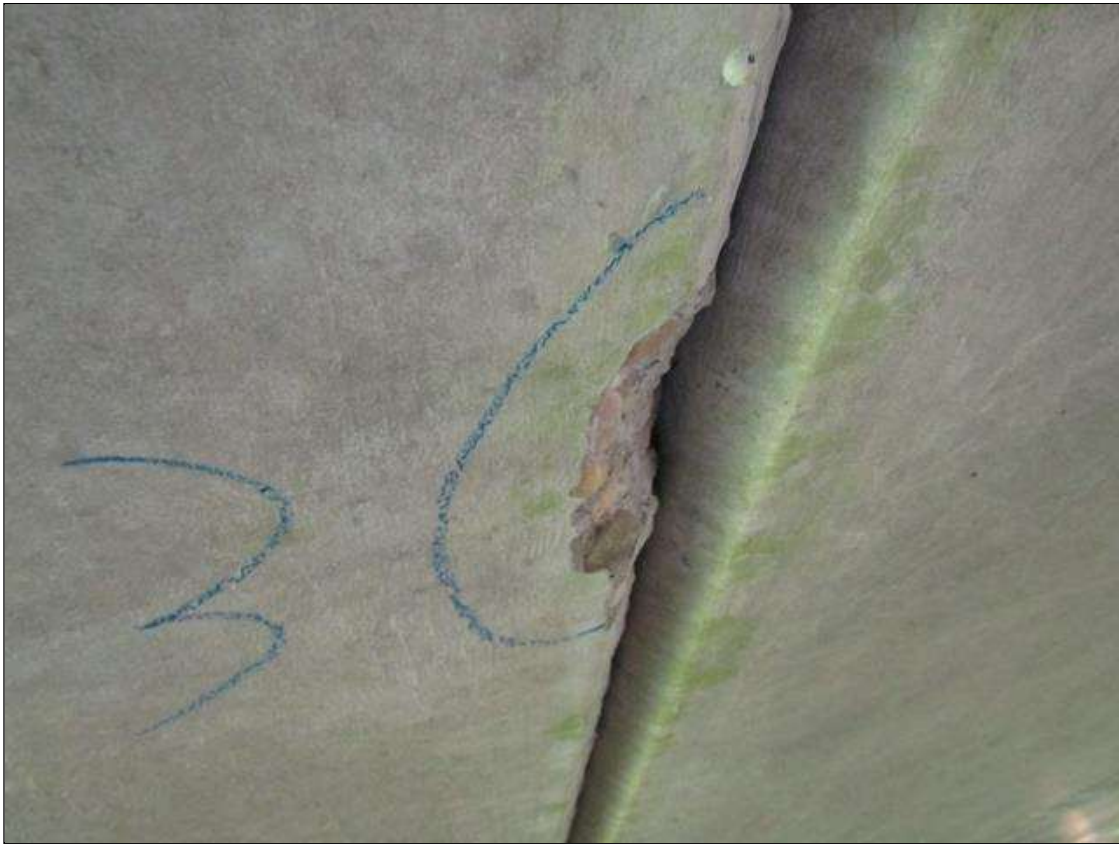
Span 3 Slab 3: SPALL ON RIGHT BOTTOM EDGE 4" LONG X 2" WIDE X 1/4" DEEP 6' FROM PIER 2

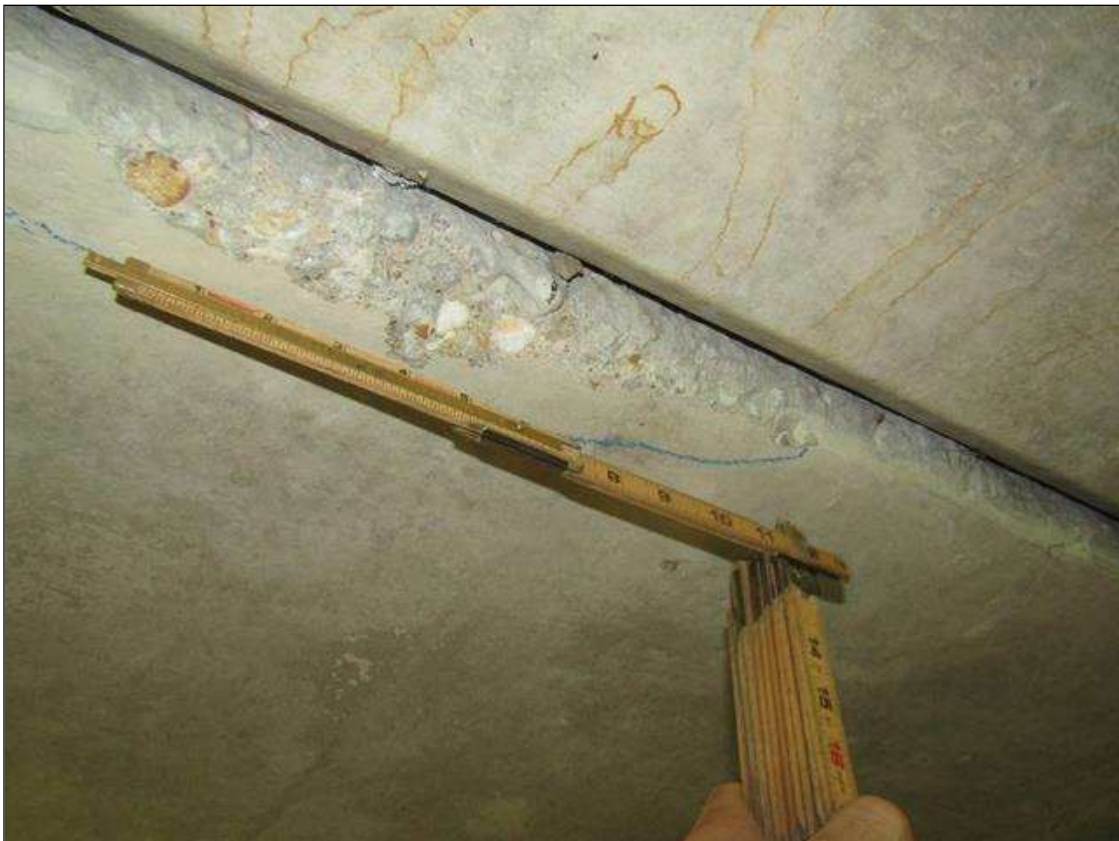
Span 3 Slab 5: SPALL ON RIGHT BOTTOM EDGE 10" LONG X 2" WIDE X 1/2" DEEP NEAR MID SPAN

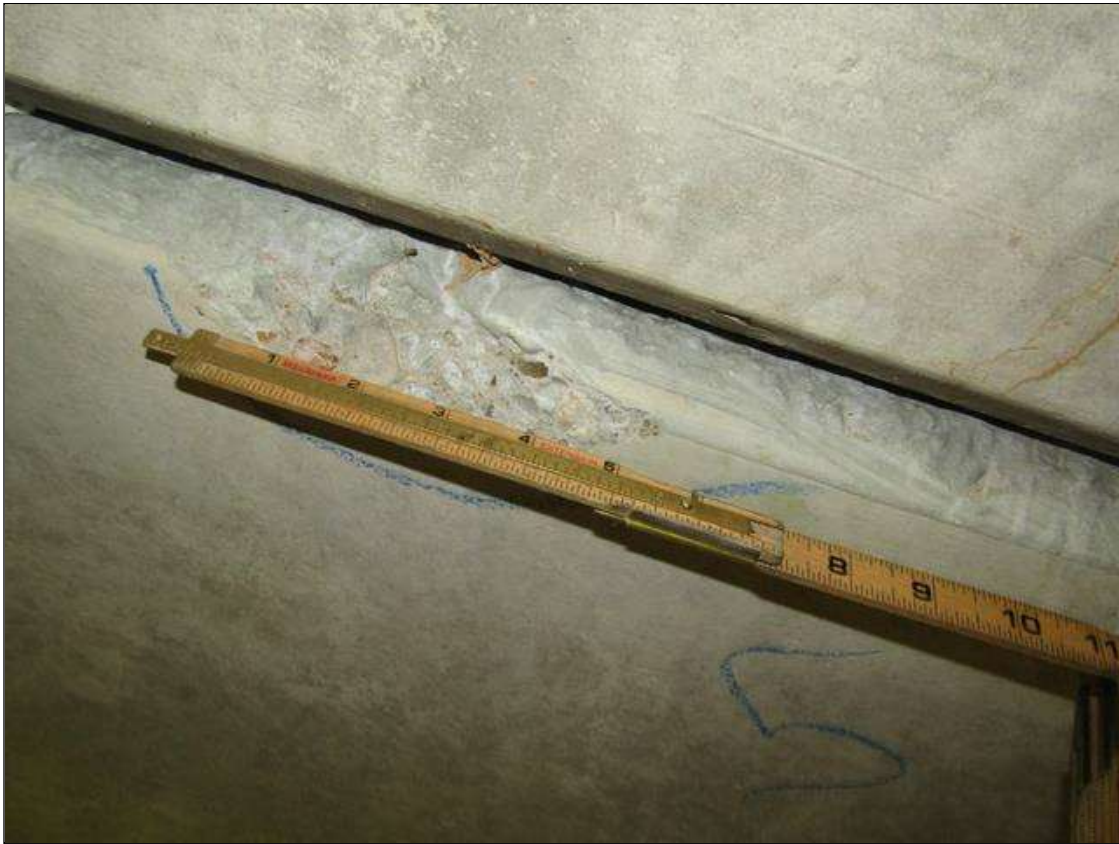
Span 3 Slab 5: SPALL ON RIGHT BOTTOM EDGE 5" LONG X 2" WIDE X 1/2" DEEP NEAR MID SPAN

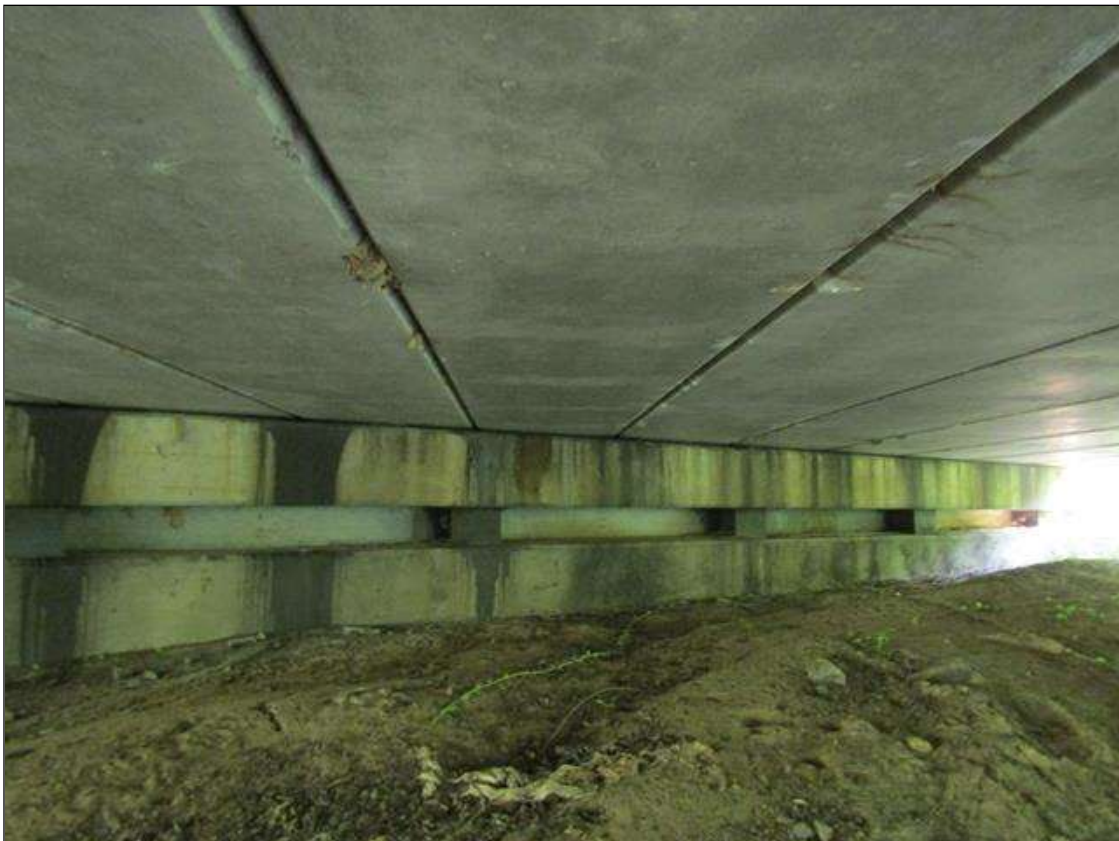
Span 3 Expansion Joint: OLD MOISTURE STAIN ON END BENT 2 CAP

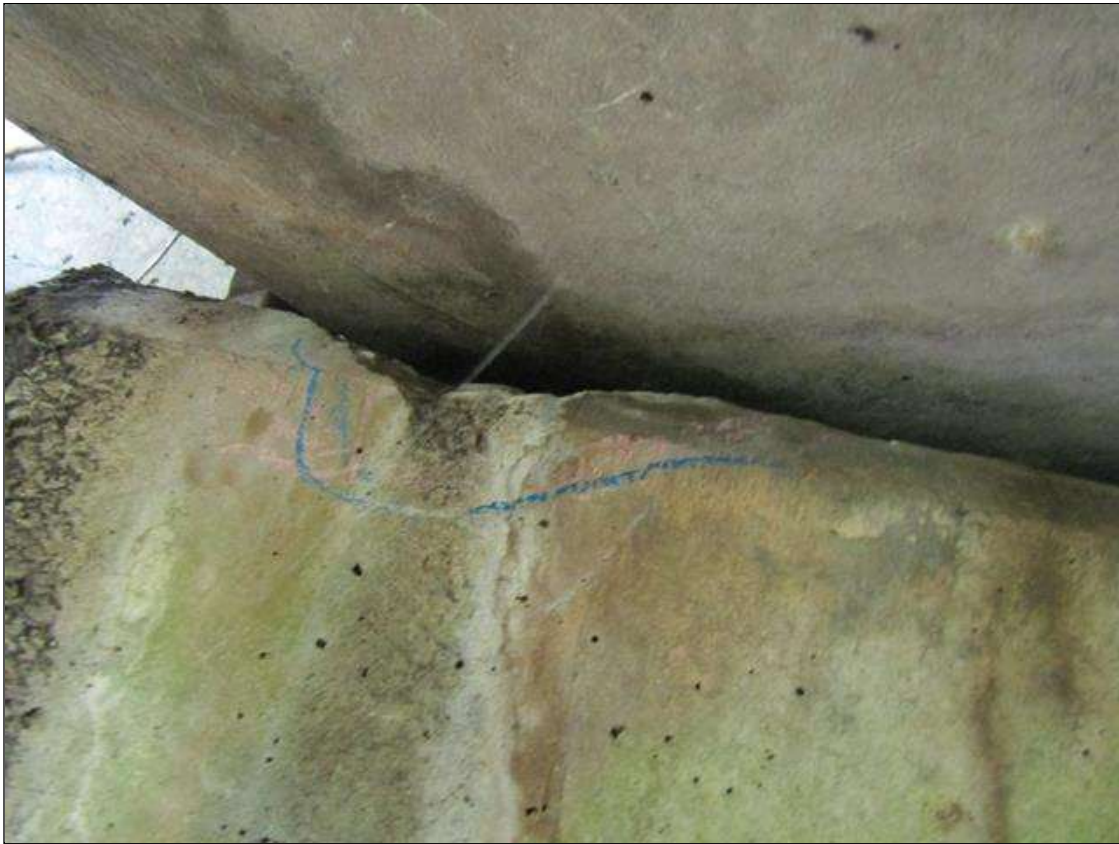
End Bent 2 Cap 1: SPALL ON TOP UNDER SLAB 1, 4" X 2" X 1/2" DEEP

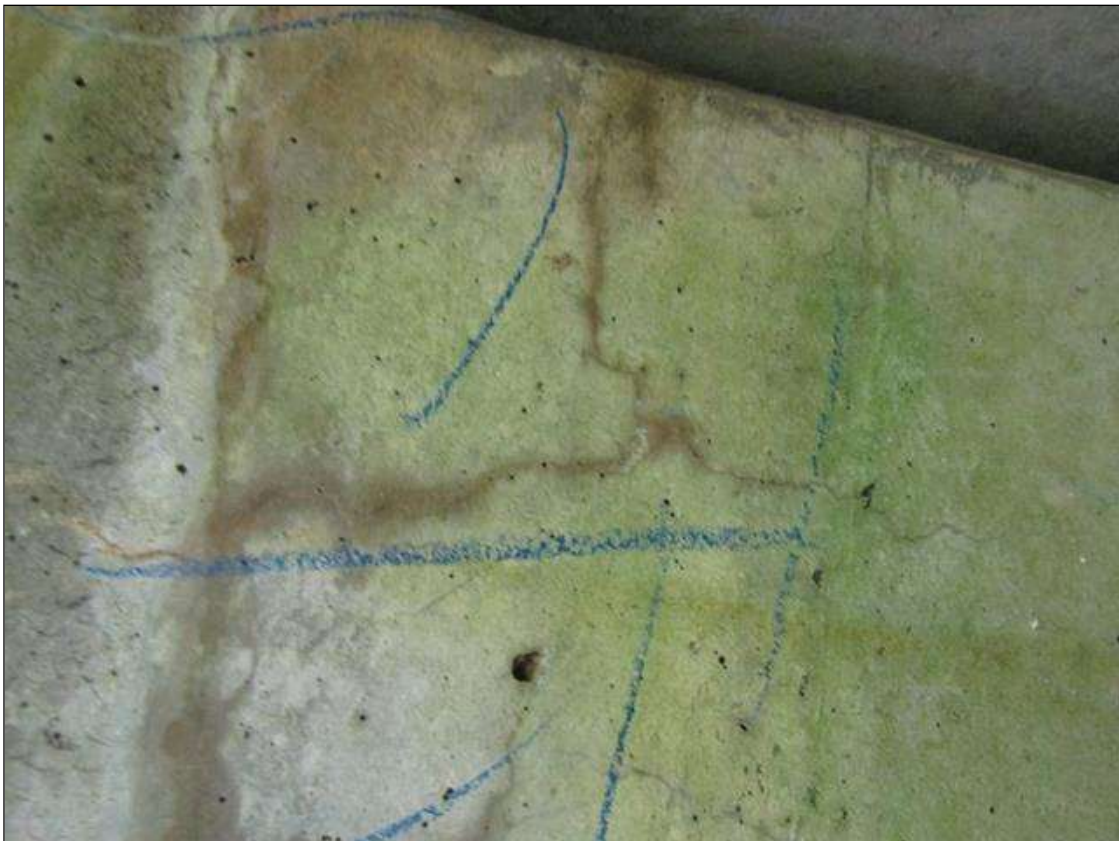
End Bent 2 Cap 1: HAIRLINE LONGITUDINAL AND MAP CRACKING ON ENDS

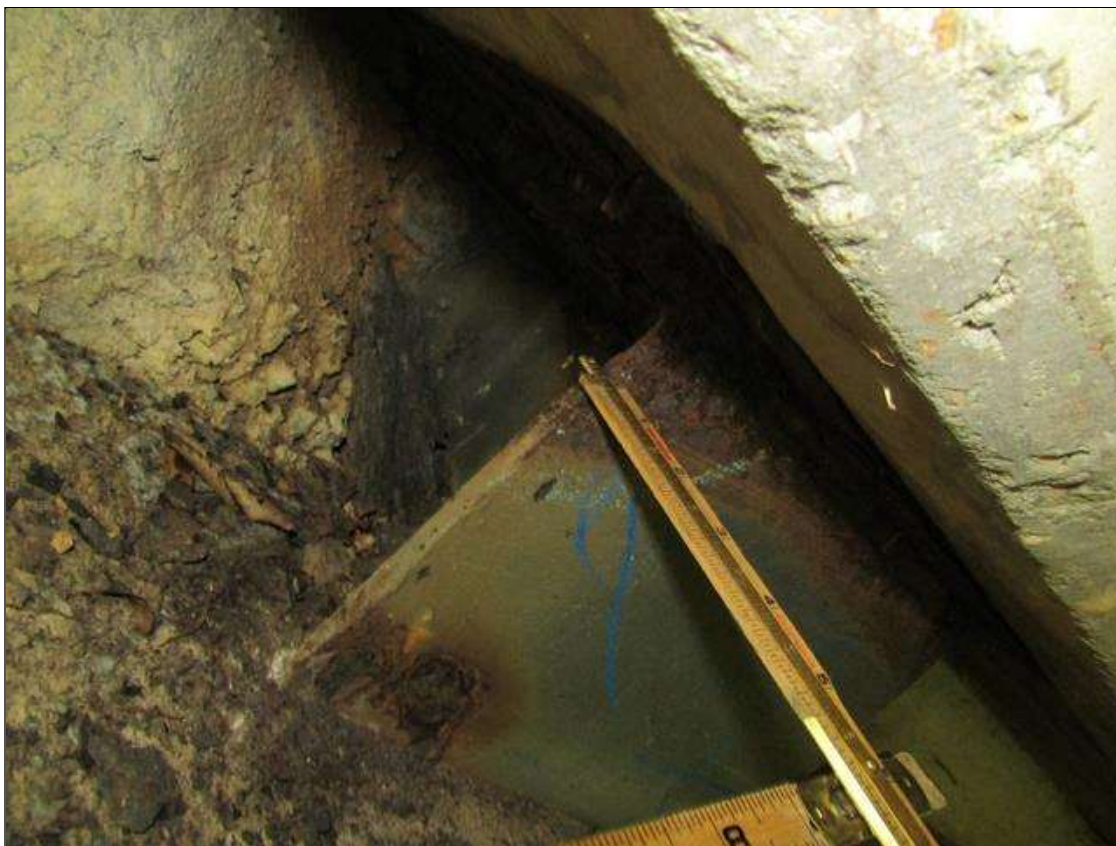
End Bent 2 Pile 1: RUST SCALE ON TOP OF SOUTH FLANGE ON WEST END 3" LONG X 2" WIDE WITH 1/4" STEEL REMAINING ON 1/2" FLANGE/PAR

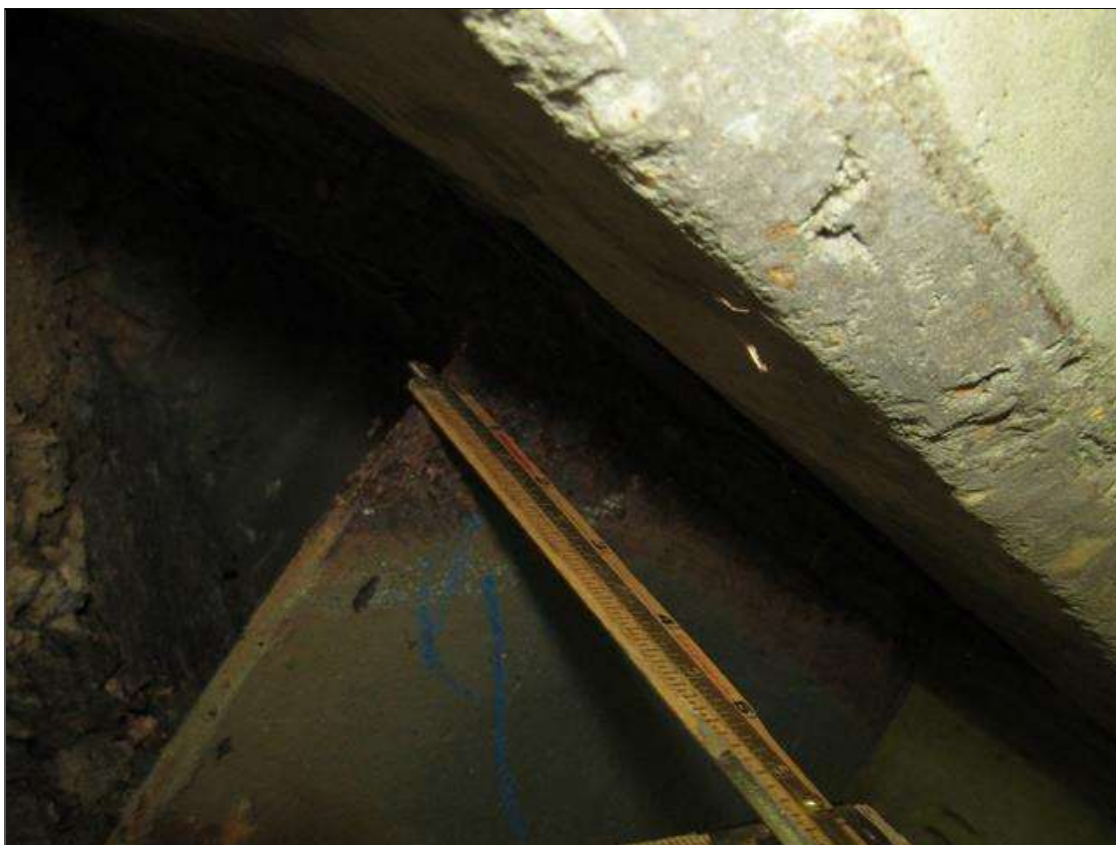
End Bent 2 Pile 1: RUST SCALE ON TOP OF SOUTH FLANGE ON WEST END 3" LONG X 2" WIDE WITH 1/4" STEEL REMAINING ON 1/2" FLANGE/PAR

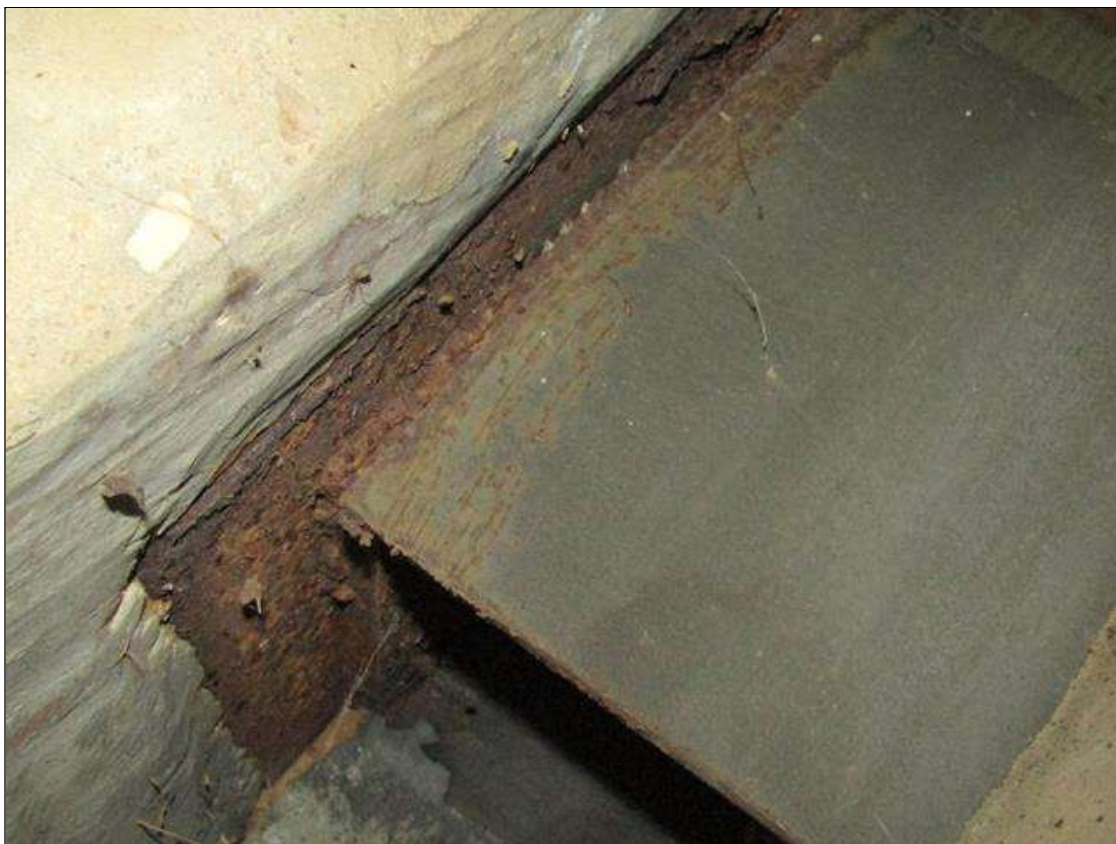
End Bent 2 Pile 2: RUST SCALE ON TOP AT PILE PLATE WITH SURFACE RUST ON TOP OF PILE

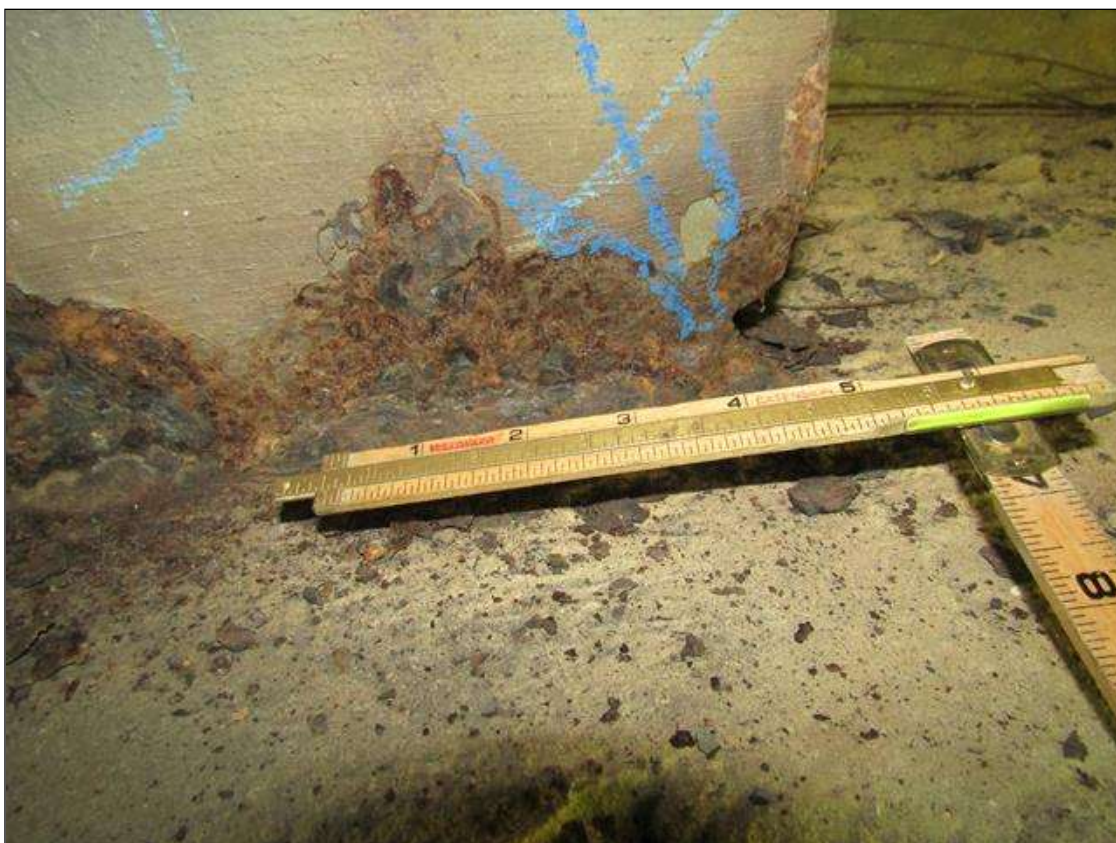
End Bent 2 Pile 5: RUST SCALE ON BOTTOM FRONT FLANGE ON ACROSS WIDTH WITH 1/4" SECTION LOSS AND COMPLETE SECTION LOSS ON BOTTOM EAST SIDE 2" X 1" AREA ON 1/2" FLANGE/PAR

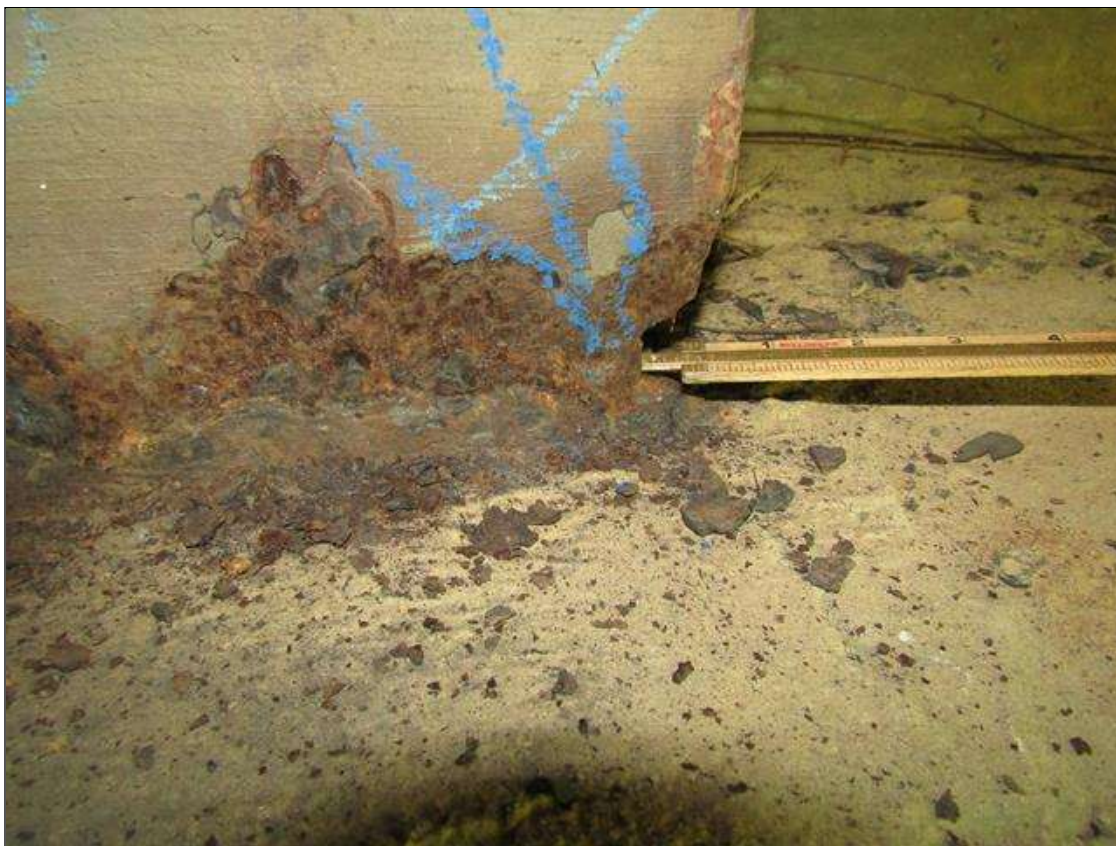
End Bent 2 Pile 5: RUST SCALE ON BOTTOM FRONT FLANGE ON ACROSS WIDTH WITH 1/4" SECTION LOSS AND COMPLETE SECTION LOSS ON BOTTOM EAST SIDE 2" X 1" AREA ON 1/2" FLANGE/PAR

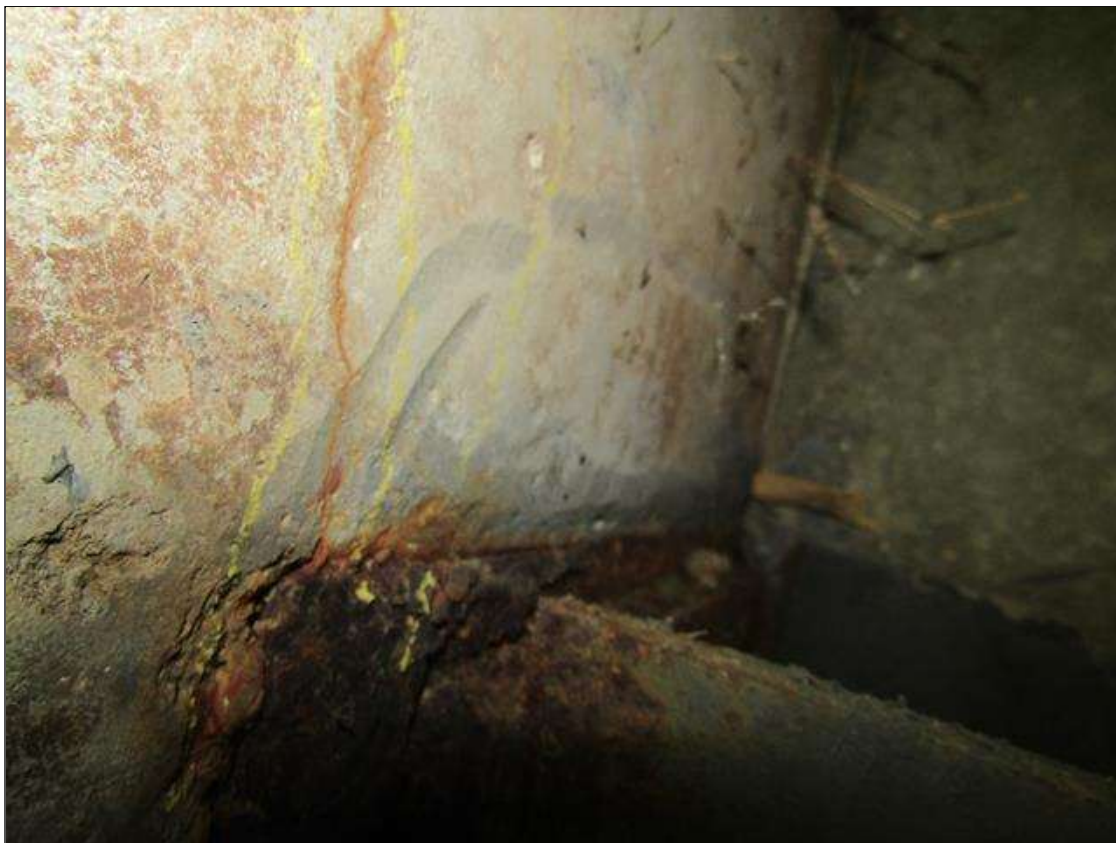
End Bent 2 Cap 1: CRACKING ON BOTTOM AROUND CORNERS OF PILES 1/64" WIDE UP TO 6" LONG

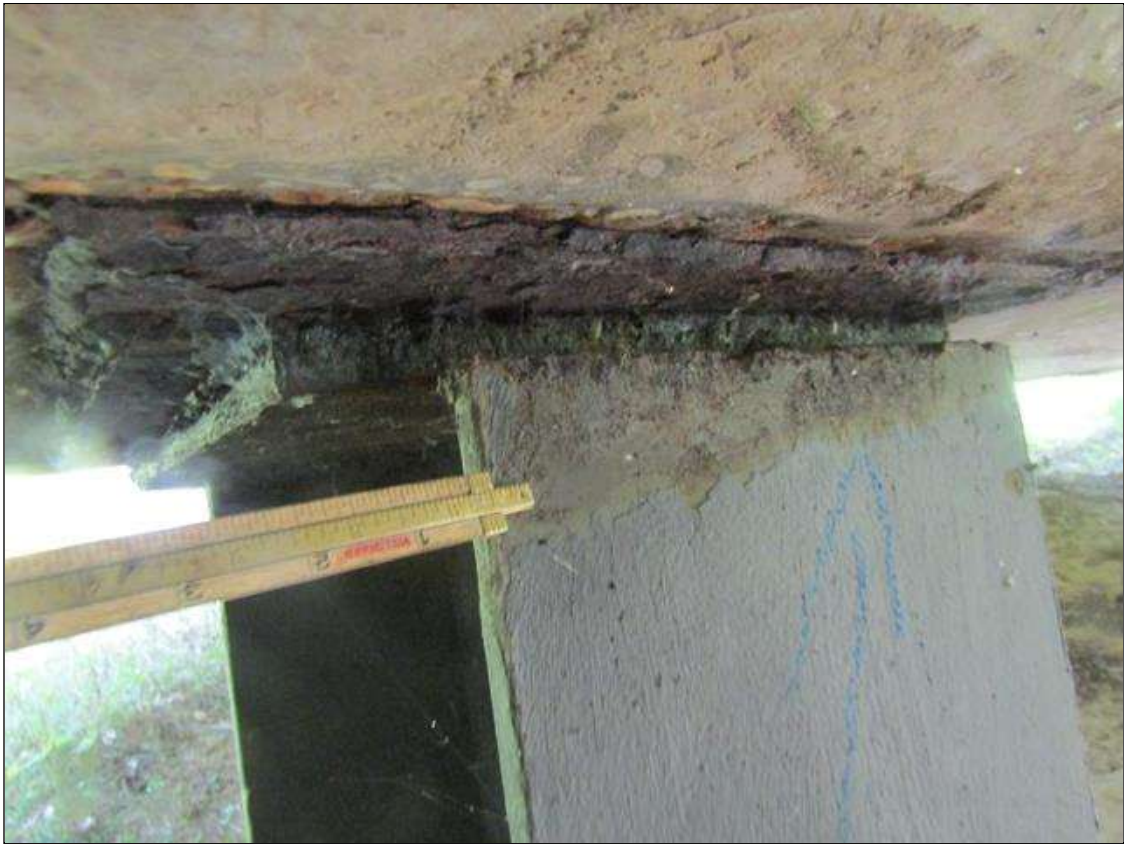
PILES NOT CENTERED ON PLATES ARE MISALIGNED

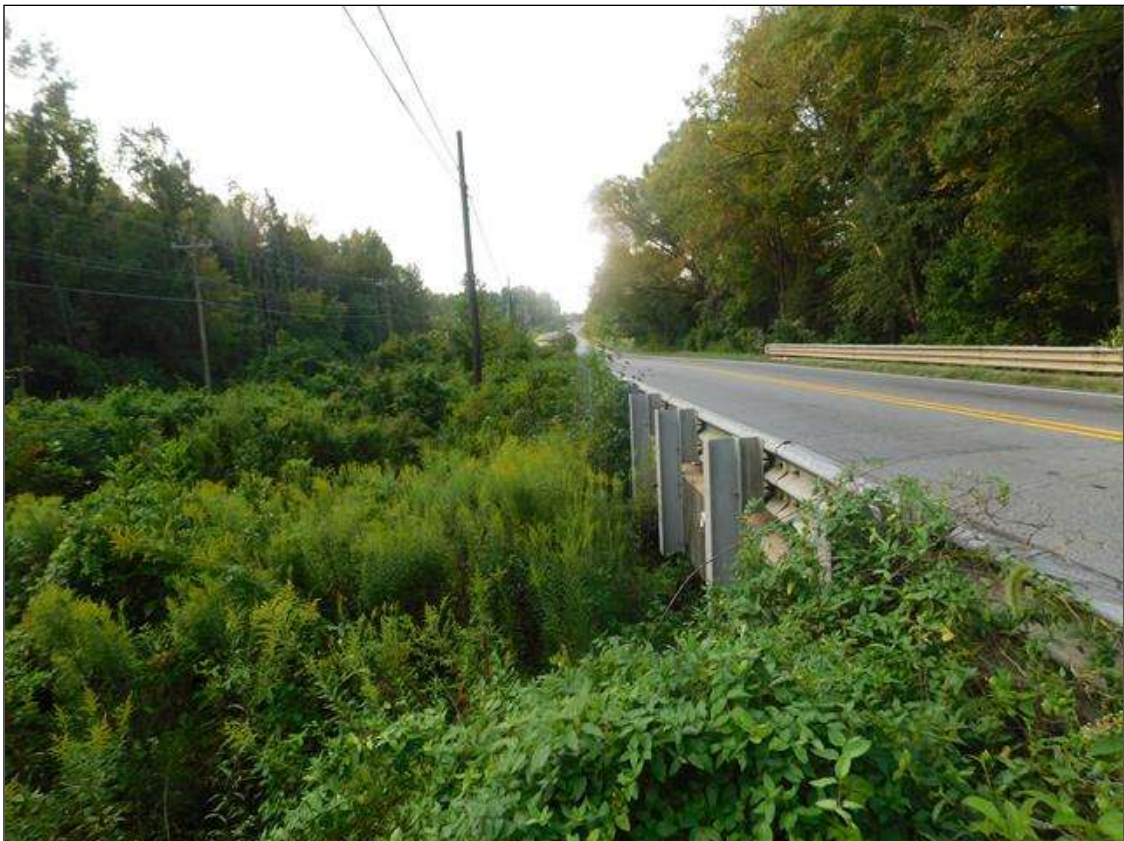
LOOKING UPSTREAM PROFILE

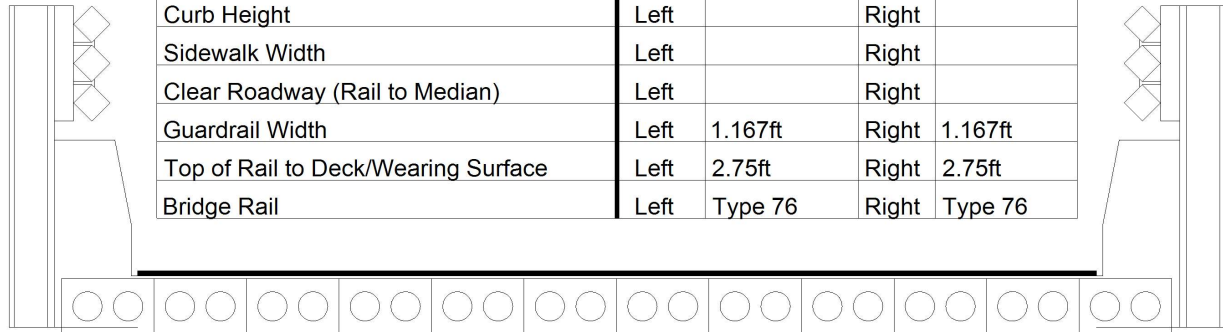
Measurements for Span #	1		
Deck Thickness		Left Overhang	0
Top of Rail to Bottom of Beam	4.5	Right Overhang	0

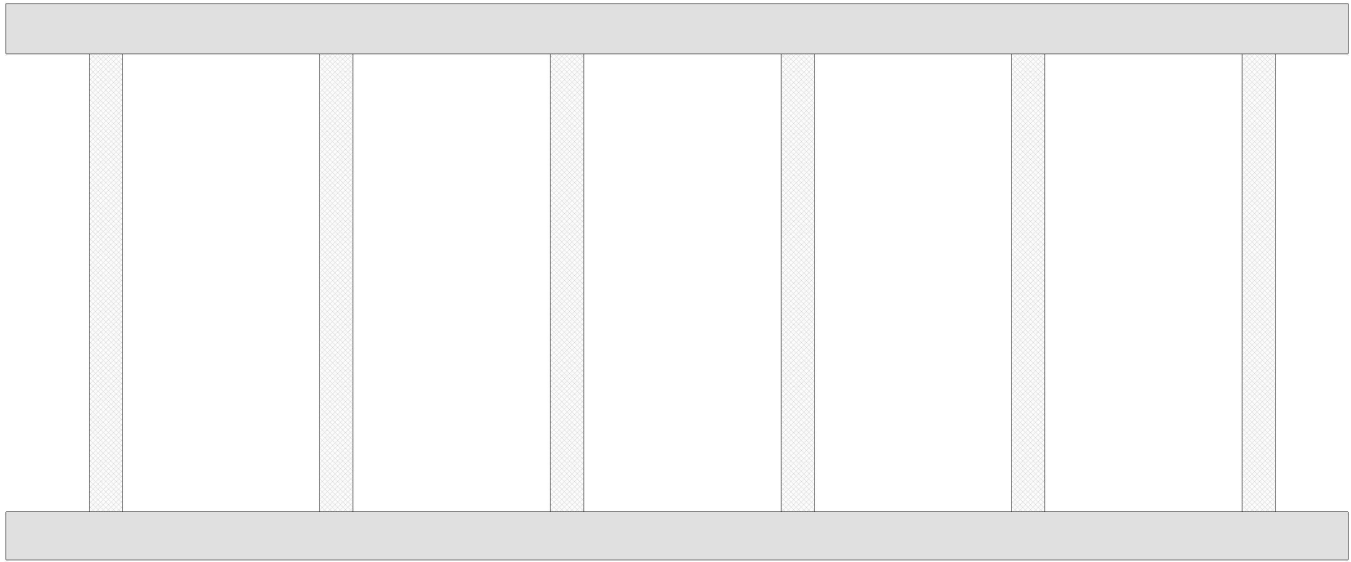
Cap Information			Material PRECAST CONCRETE							
Length	Width	Height	Left Overhang	Right Overhang	Left Beam to End of Cap.	Right Beam to End of Cap.				
40.270 ft.	2 ft.	1.5 ft.	3.000 ft.	2.670 ft.	2.875 ft.	2.375 ft.				
Subcap Information			Material							
Length	Width	Height	Left Overhang	Right Overhang	Left Pile to Splice.					
Sill Information			Material							
Length	Width	Height								
40.270 ft.	1.500 ft.	1.750 ft.								
Pile #	Material	Spacing	Width/Dia.	Height	Length	Orientation	Driven?	Replacement?	Removed?	Collar?
1	Steel	6.917 ft.	1 ft.				No	No	No	No
2	Steel	6.917 ft.	1 ft.				No	No	No	No
3	Steel	6.917 ft.	1 ft.				No	No	No	No
4	Steel	6.917 ft.	1 ft.				No	No	No	No
5	Steel	6.917 ft.	1 ft.				No	No	No	No
6	Steel		1 ft.				No	No	No	No
MEASUREMENTS VERIFIED BY DH 9/13/2021										
Bent/Abutment #: 1			Similar Bents: 2
