NC DEPARTMENT OF TRANSPORTATION
 DIVISION OF HIGHWAYS
 STRUCTURE MANAGEMENT UNIT

Structure Safety Report

Routine Element Inspection - Contract

DIVISION: 6 COUNTY: ROBESON STRUCTURE NUMBER: 770160 FREQUENCY: 24 MONTHS

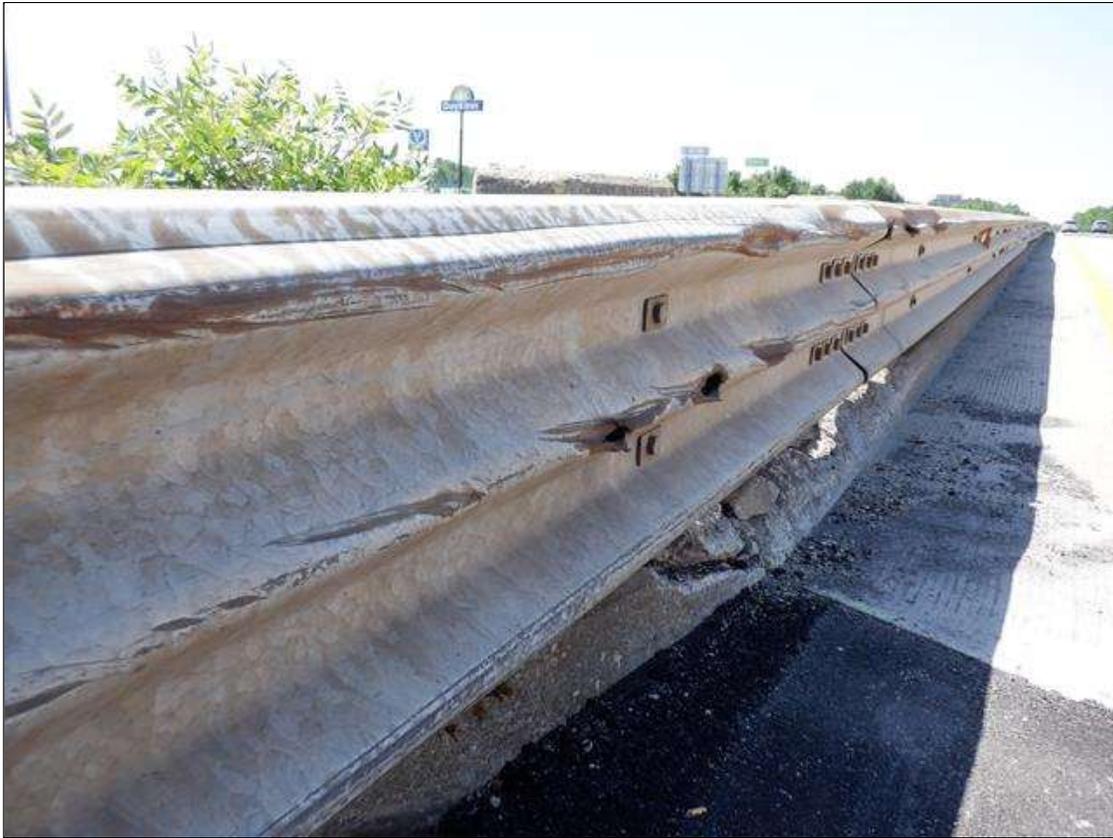
Span 3 Right Bridge Rail: MULTIPLE GOUGES UP TO 6" X 1" IN RAIL

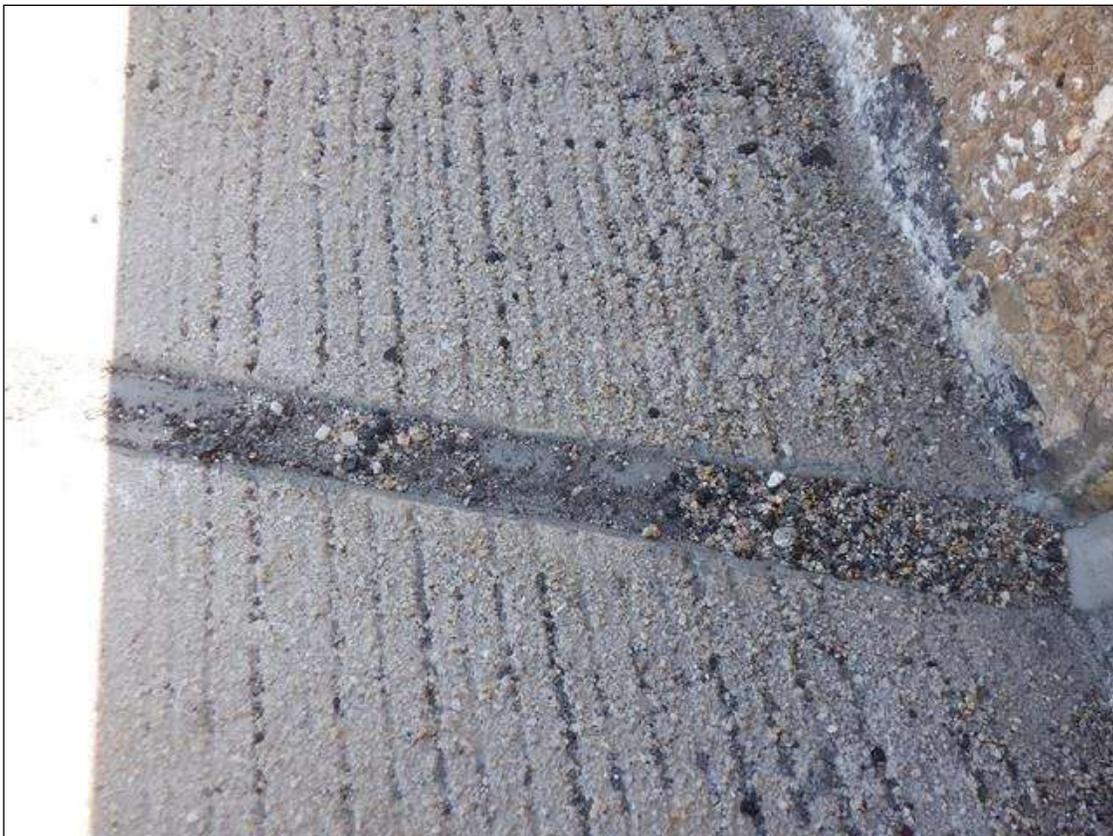
Expansion Joint : 3 FEET DEBRIS IMPACTION

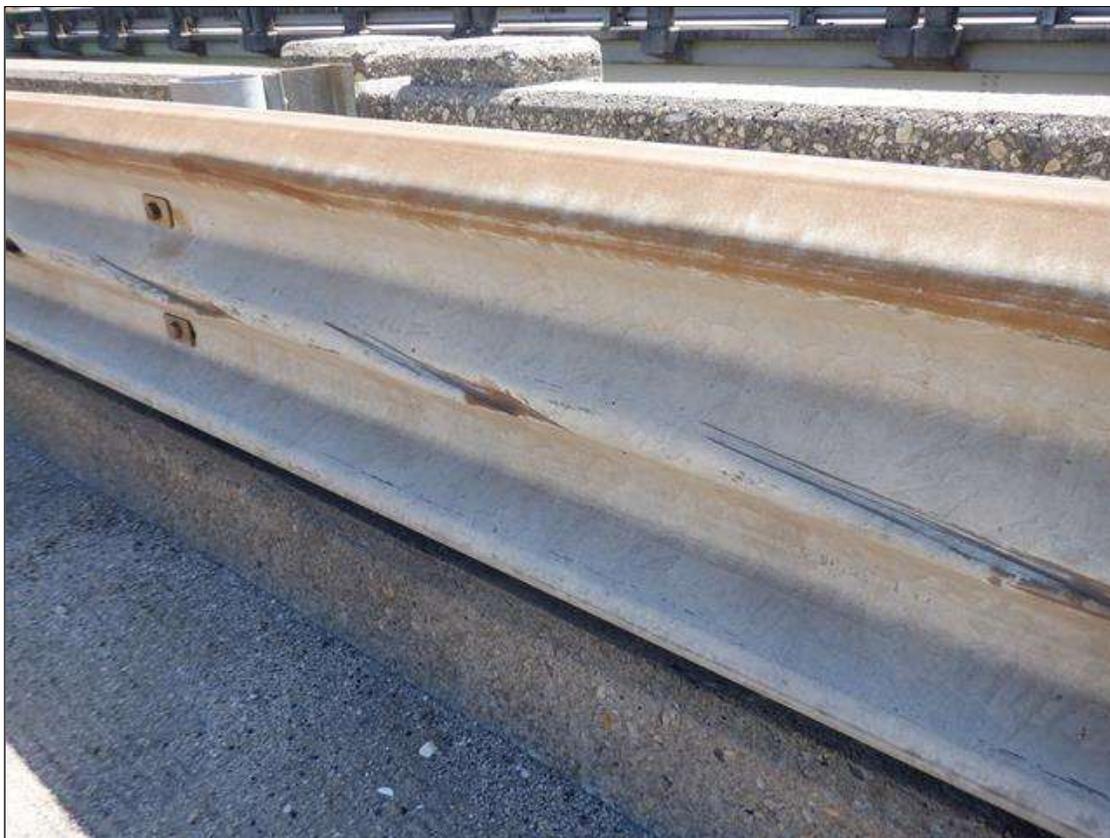
Span 2 Right Bridge Rail: MULTIPLE GOUGES UP TO 6" X 1" IN RAIL

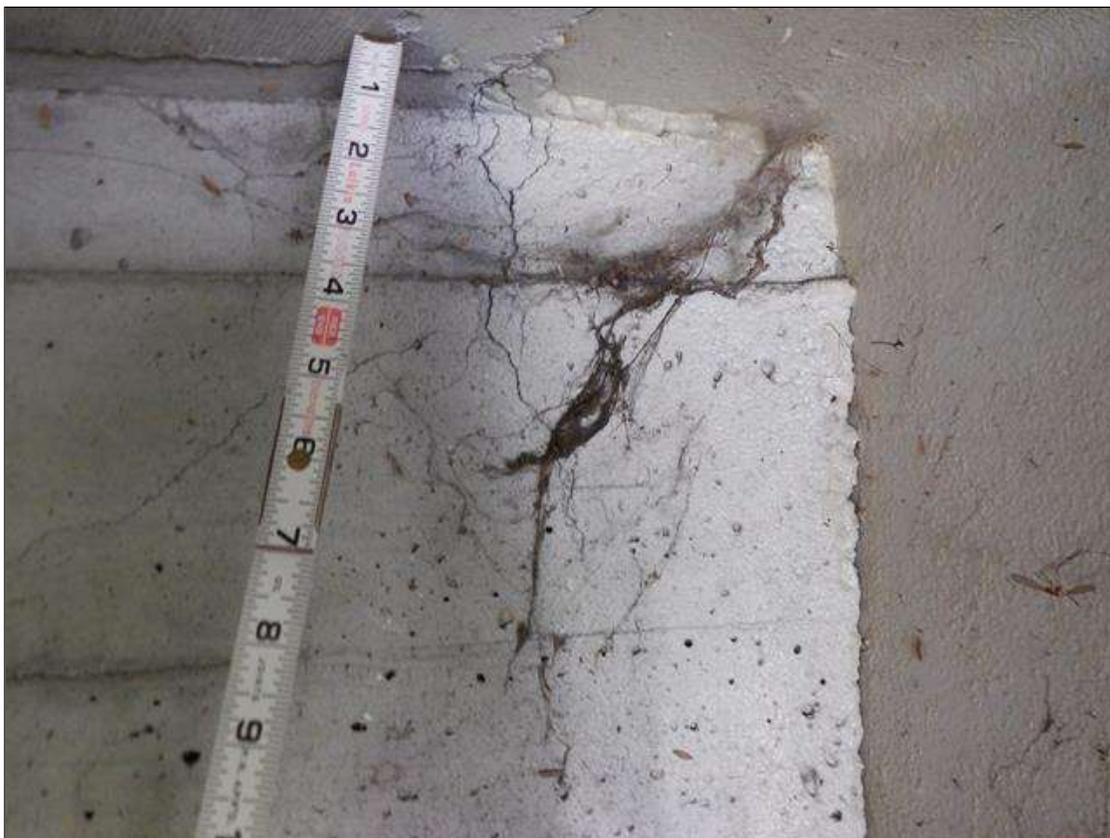
End Bent 1 Abutment/Backwall : 12" X 3" DELAMINATION IN BAY 3

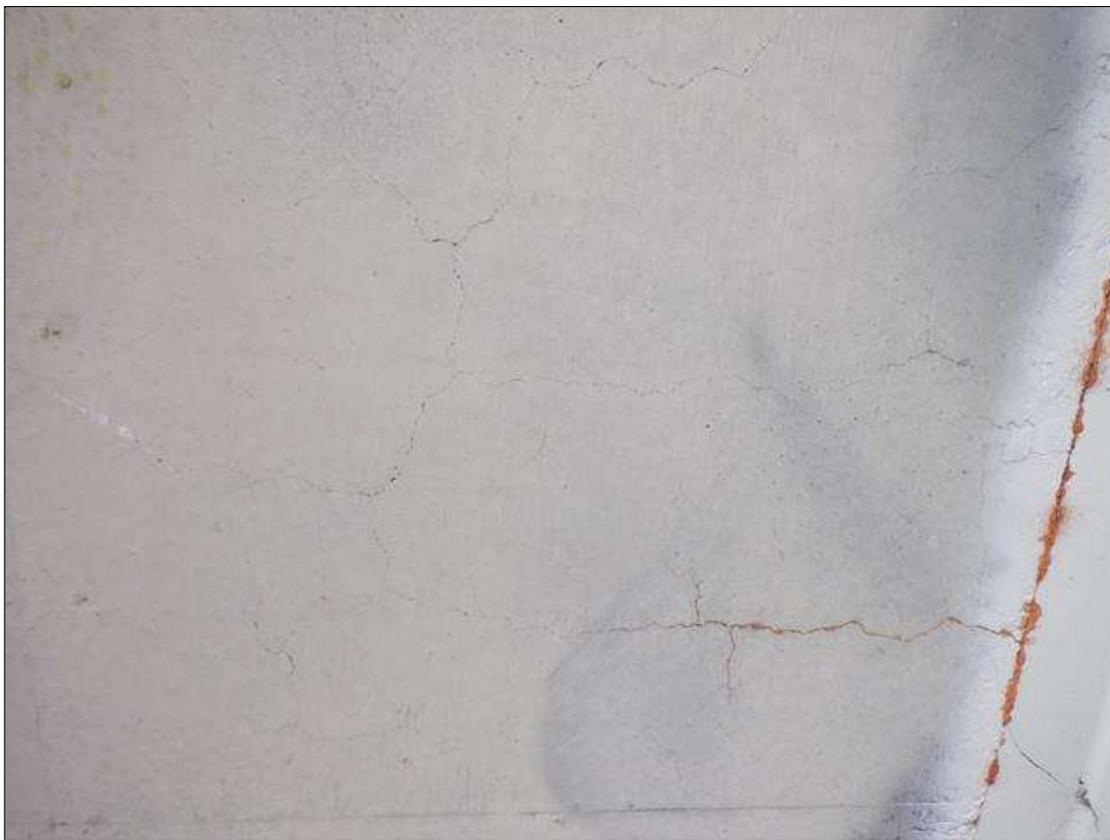
Element Number	Defect Type	Defect Description	CS	CS Qty	Maint Qty
12	Cracking (RC and Other)	500 SF. OF TRANSVERSE AND LONGITUDINAL CRACKS UP TO 1/16" WIDE WITH EFFLORESCENCE IN BOTTOM OF DECK	3	500	500 Square Feet
12	Cracking (RC and Other)	12 - 2 FT. TRANSVERSE HAIRLINE CRACKS WITH EFFLORESCENCE IN BOTTOM OF DECK WEST OVERHANG	2	12	12 Square Feet
12	Cracking (RC and Other)	13 - 2 FT. TRANSVERSE HAIRLINE CRACKS WITH EFFLORESCENCE IN BOTTOM OF DECK EAST OVERHANG	2	13	13 Square Feet

Span 1 Deck: 500 SF. OF TRANSVERSE AND LONGITUDINAL CRACKS UP TO 1/16" WIDE WITH EFFLORESCENCE IN BOTTOM OF DECK

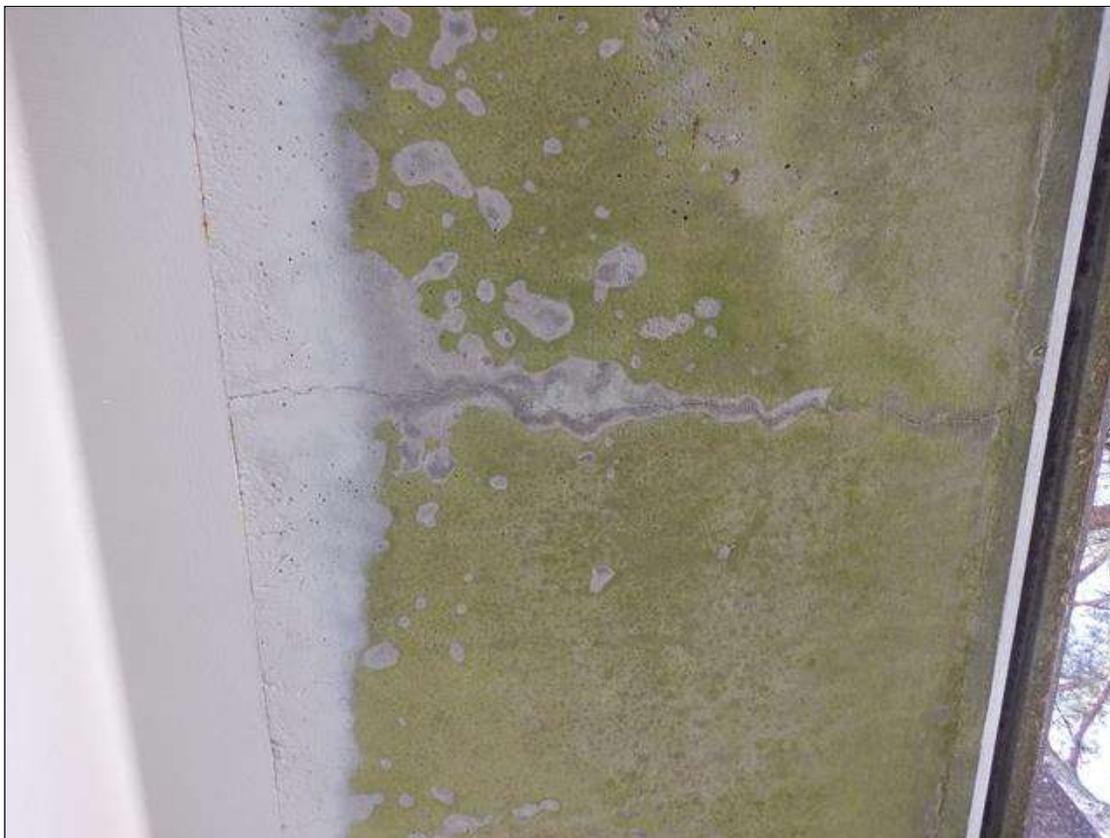
Span 1 Deck: 12 - 2 FT. TRANSVERSE HAIRLINE CRACKS WITH EFFLORESCENCE IN BOTTOM OF DECK WEST OVERHANG

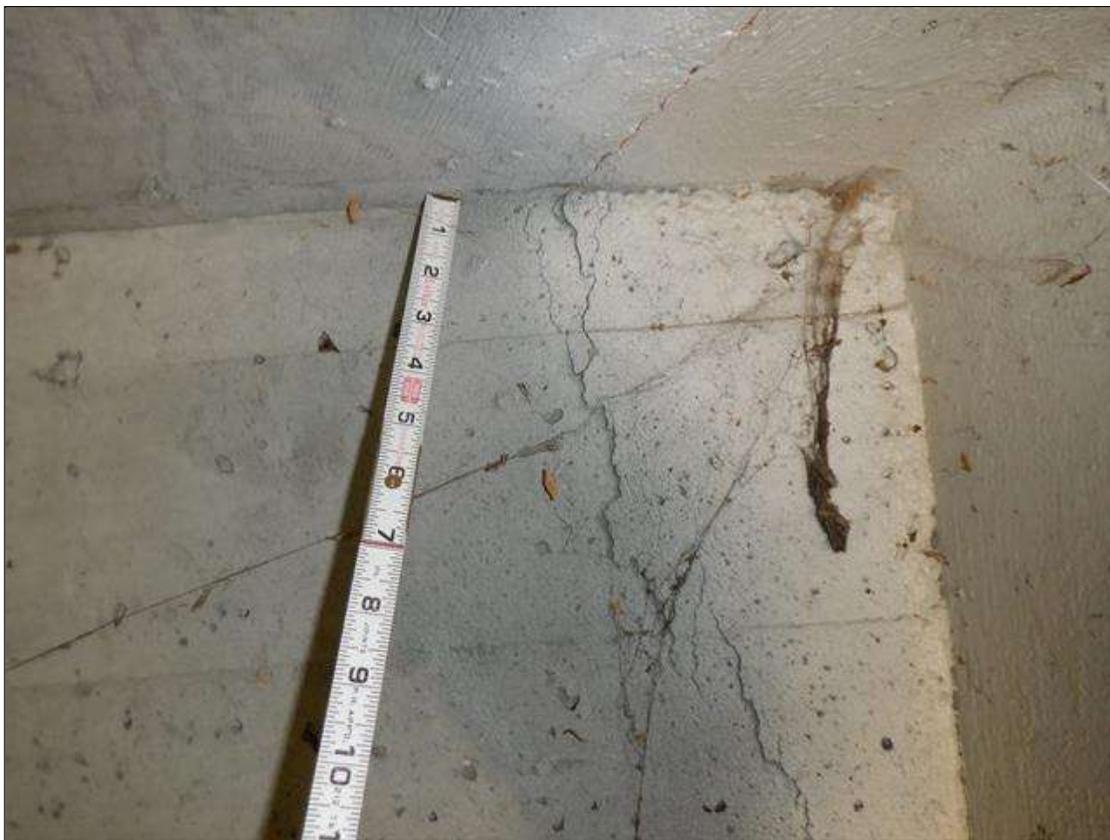
End Bent 1 Abutment/Backwall : 8" X 3" DELAMINATION IN BAY 1

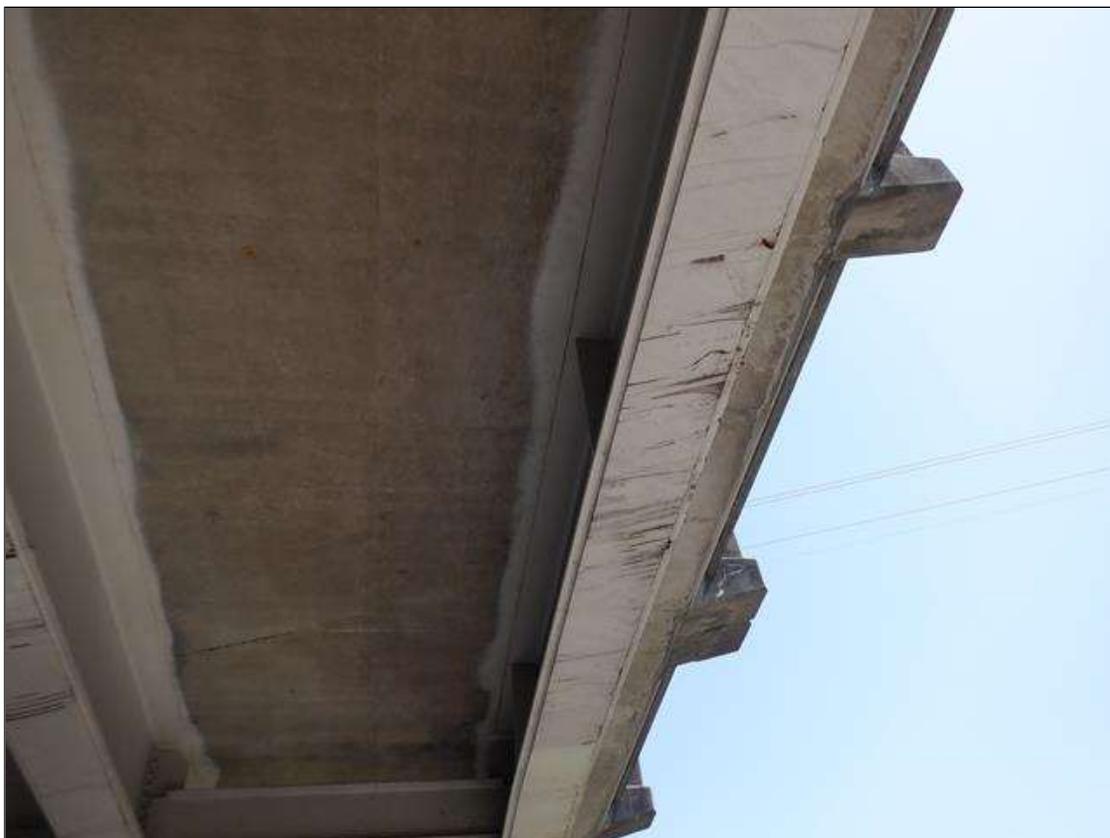
Span 2 Beam 4: 10 FEET OF VEHICLE SCRAPES WITH GOUGES UP TO 3" X 1/2" IN BOTTOM FLANGE AND BOTTOM FLANGE COVER PLATE 25 FEET FROM BENT 2

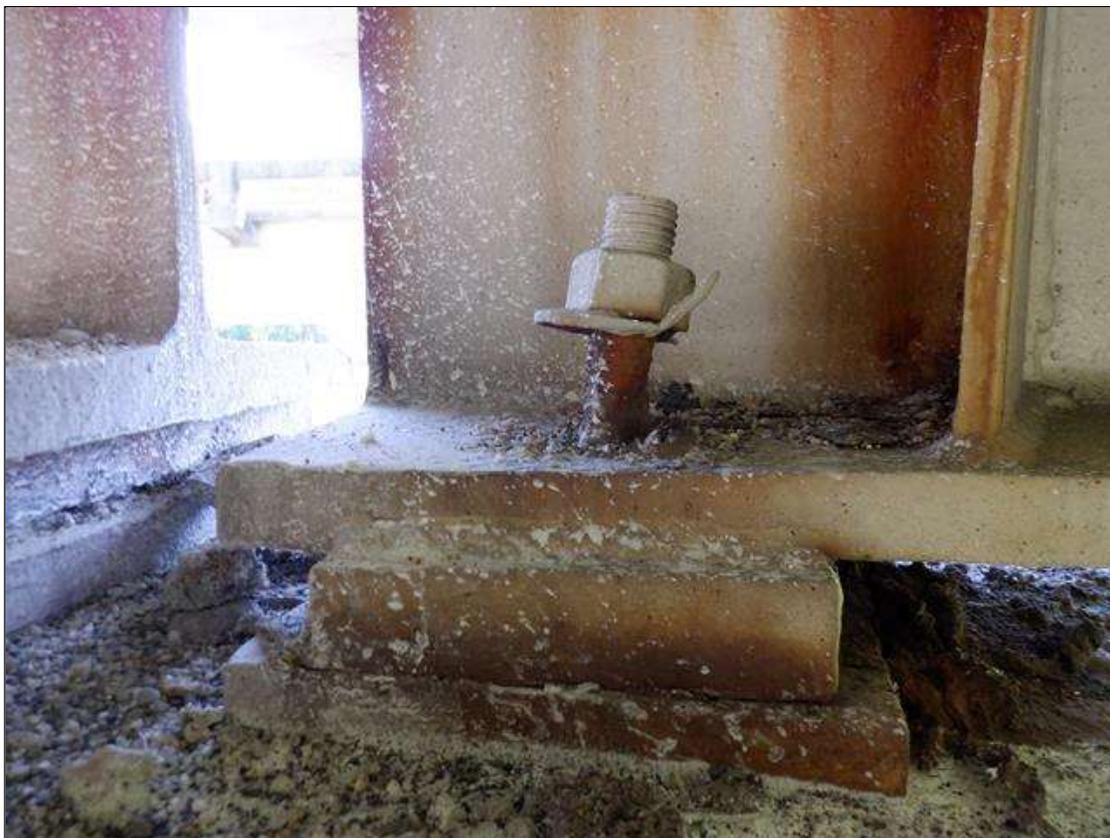
Priority Level	Defect Type	Quantity	Defect Description
②	Connection	1	Span 1 Beam 4 Far Bearing: WEST ANCHOR BOLT LEANING TOWARDS SOUTH PAR

Span 1 Beam 4 Far Bearing: WEST ANCHOR BOLT LEANING TOWARDS SOUTH PAR

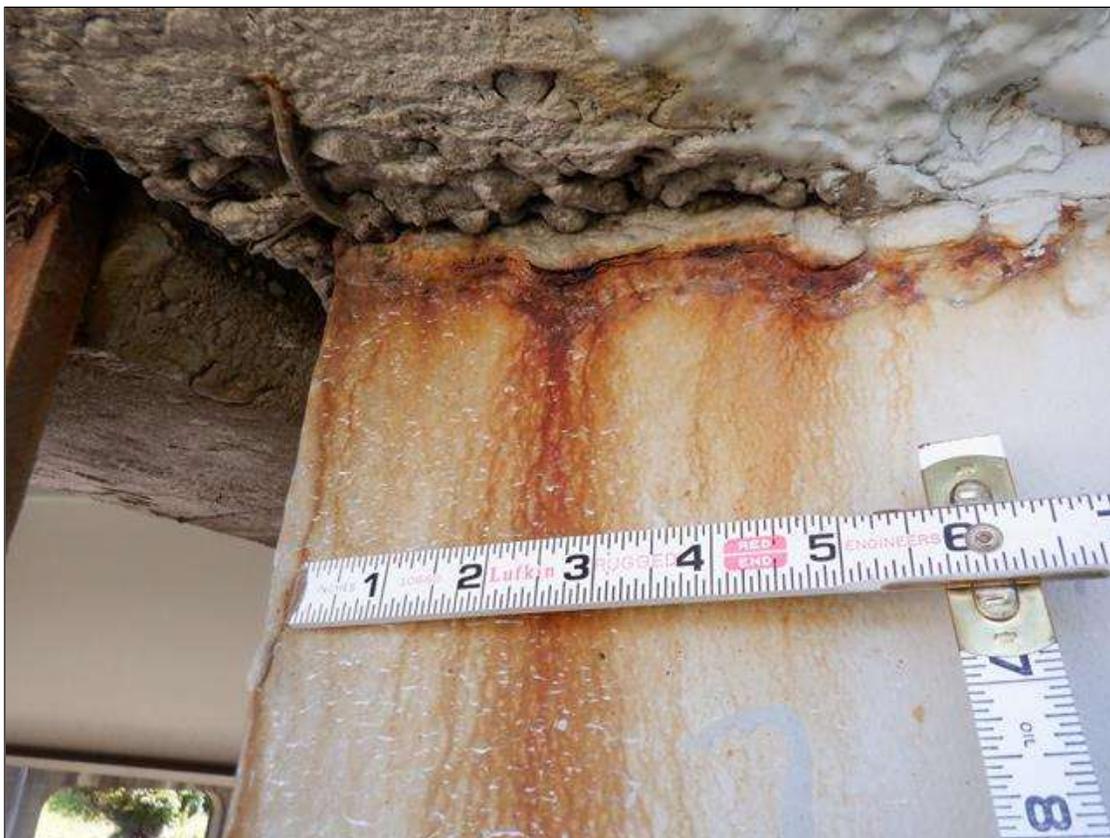
Priority Level	Defect Type	Quantity	Defect Description
①	Corrosion	1	Span 1 Beam 1: 1 FT. OF CORROSION WITH 11/16" REMAINING SECTION IN WEB AROUND END DIAPHRAGM AT BENT 1 PAR
②	Connection	1	Span 1 Beam 1 Far Bearing: EAST ANCHOR BOLT LEANING TOWARDS SOUTH PAR

Element Number	Defect Type	Defect Description	CS	CS Qty	Maint Qty
107	Corrosion	1 FOOT OF CORROSION WITH 11/16" REMAINING SECTION IN WEB AROUND END DIAPHRAGM AT BENT 1 PAR	3	1	1 Feet
515	Effectiveness (Steel Protective Coatings)	1 S.F. OF INEFFECTIVE PROTECTIVE COATING ON WEB AROUND END DIAPHRAGM AT BENT 1	4	1	1 Square Feet

Span 1 Beam 1: 1 FOOT OF CORROSION WITH 11/16" REMAINING SECTION IN WEB AROUND END DIAPHRAGM AT BENT 1 PAR

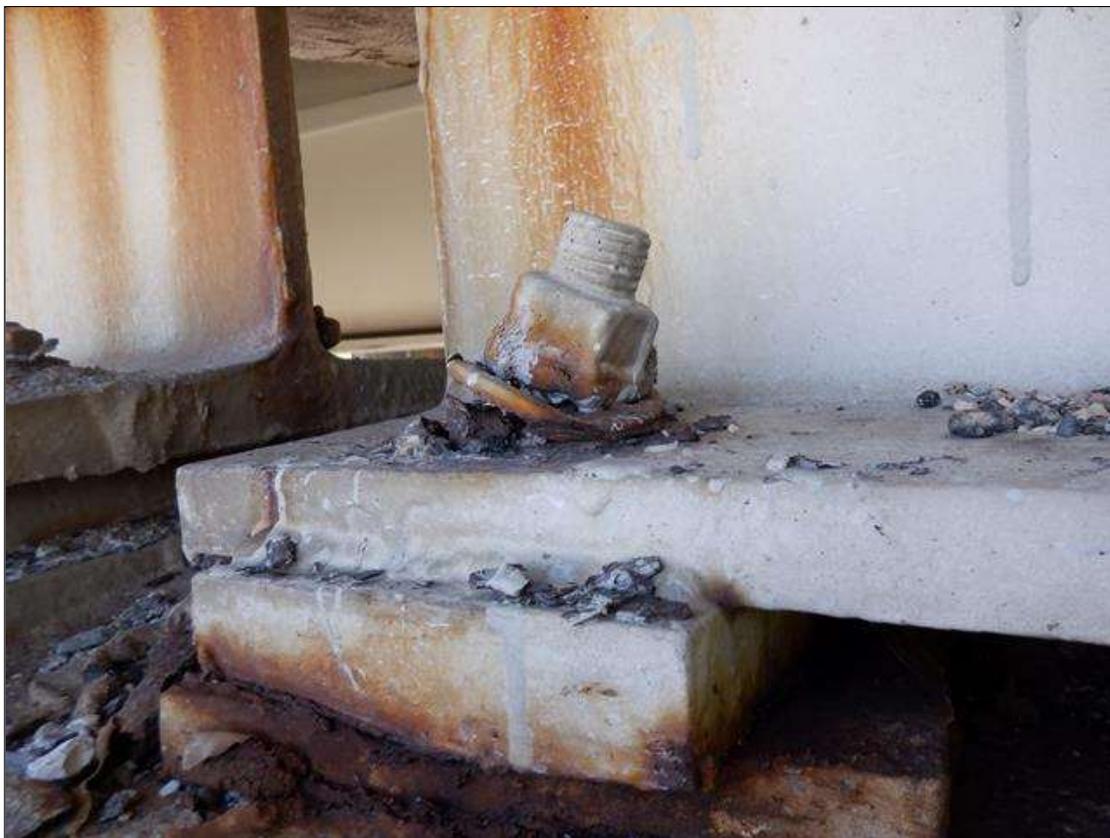
Span 1 Beam 1 Far Bearing: EAST ANCHOR BOLT LEANING TOWARDS SOUTH PAR

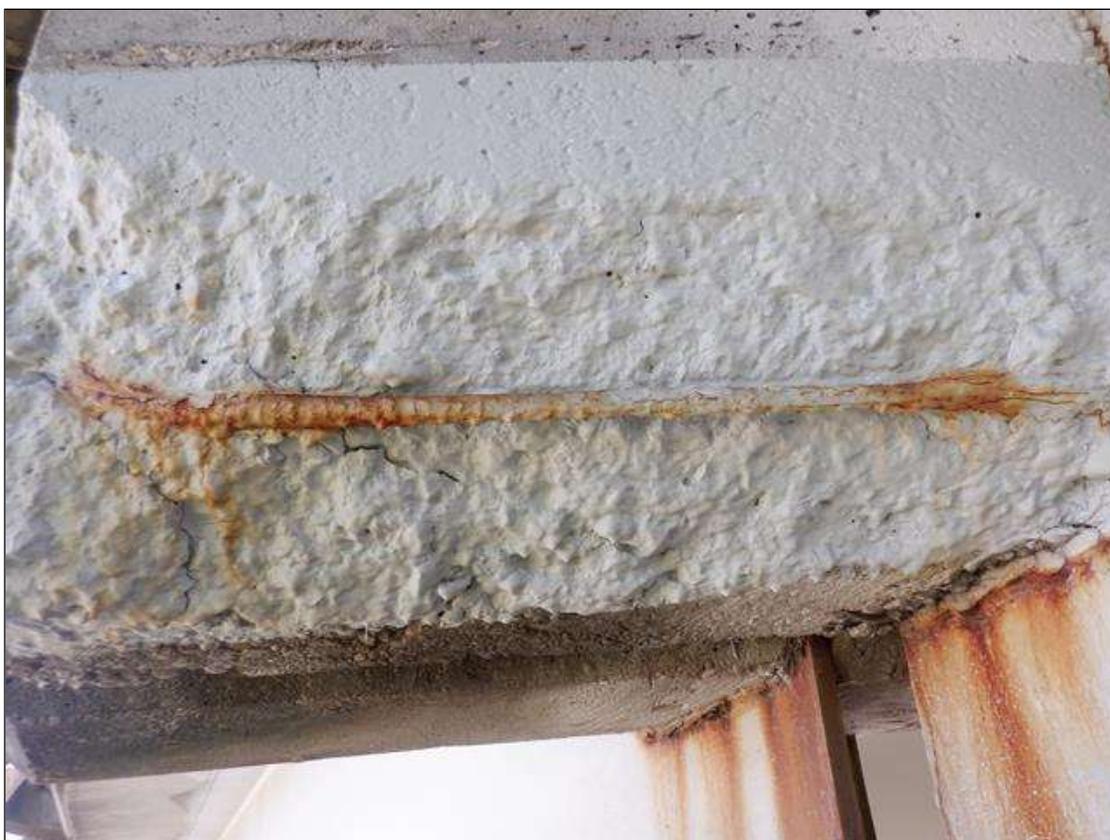
END DIAPHRAGM WEST OVERHANG AT BENT 1: 24" X 8" X 5" DEEP SPALL WITH EXPOSED REBAR IN SOUTH FACE
 END DIAPHRAGM BAY 1 AT BENT 1: 24" X 6" DELAMINATION IN SOUTH FACE

END DIAPHRAGM WEST OVERHANG AT BENT 1: 24" X 8" X 5" DEEP SPALL WITH EXPOSED REBAR IN SOUTH FACE

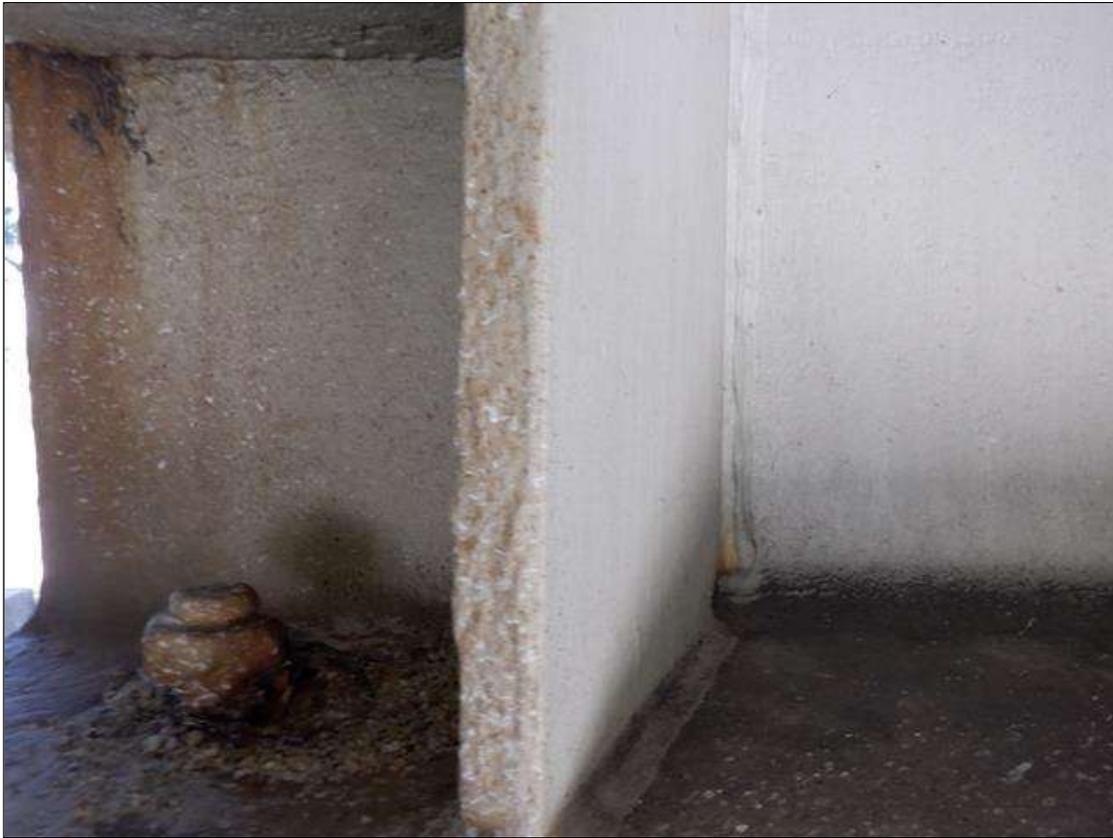
Span 2 Beam 1: 1 FOOT OF PAINTED OVER PITTING UP TO 1/16" DEEP WITH RUST BLEEDING IN WEB AROUND END DIAPHRAGM AND BEARING STIFFENER AT BENT 1

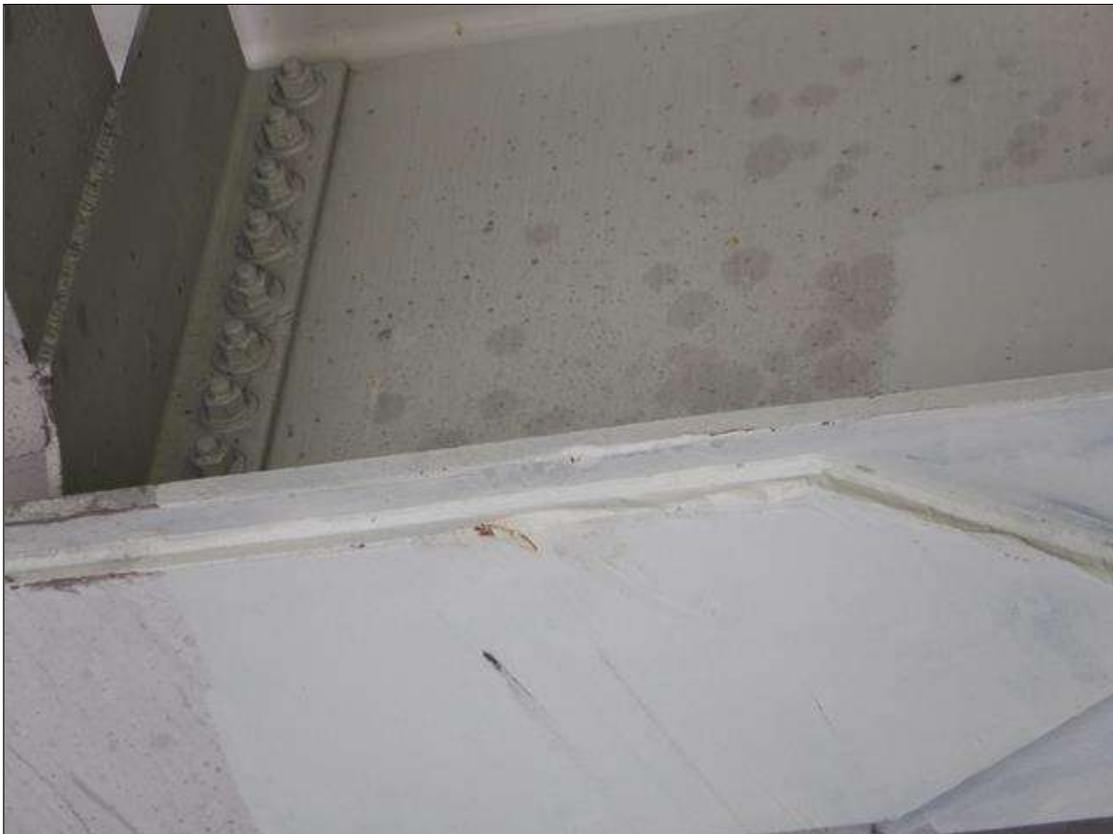
Span 2 Beam 3: BEAM 3 IN SPAN 2 OVER WEST BOUND LANE IS BOWED 1" @ POINT OF IMPACT OF 19FT FROM NORTH END OF BEAM.

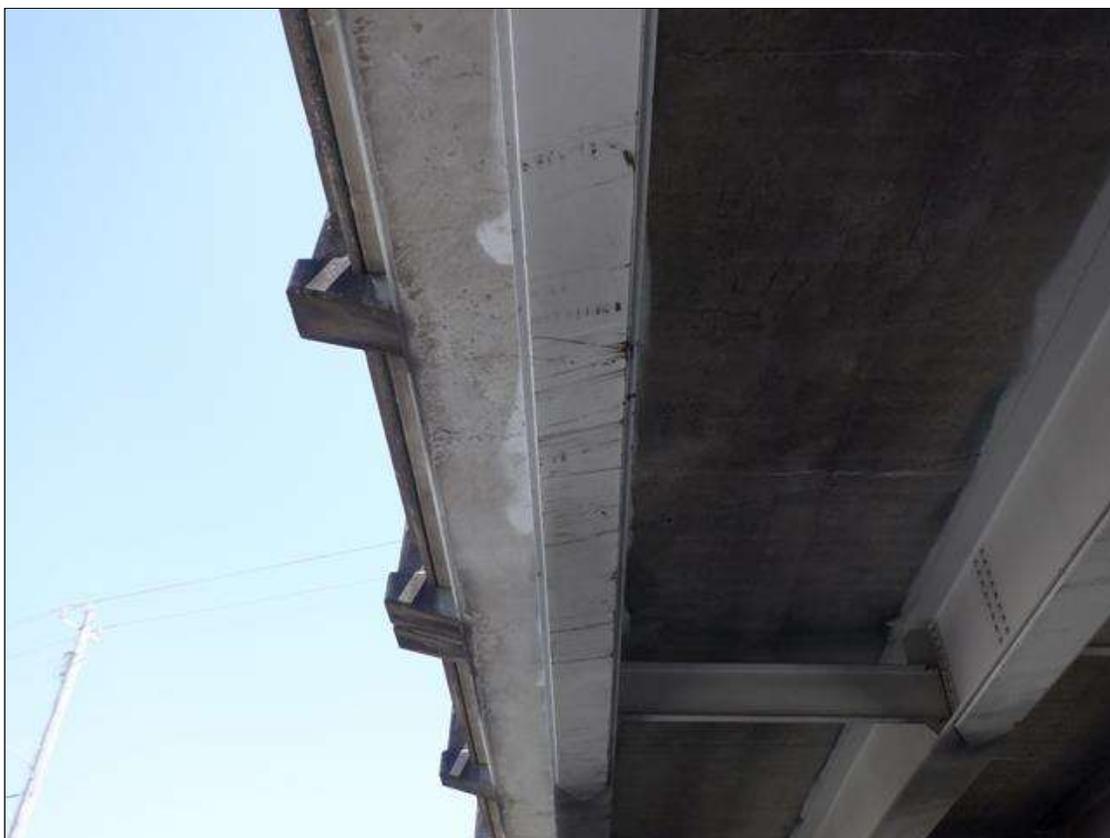
Span 2 Beam 1: 10 FT. OF VEHICLE SCRAPES WITH GOUGES UP TO 3" X 1/2" IN BOTTOM FLANGE AND BOTTOM FLANGE COVER PLATE 25 FT. FROM BENT 2

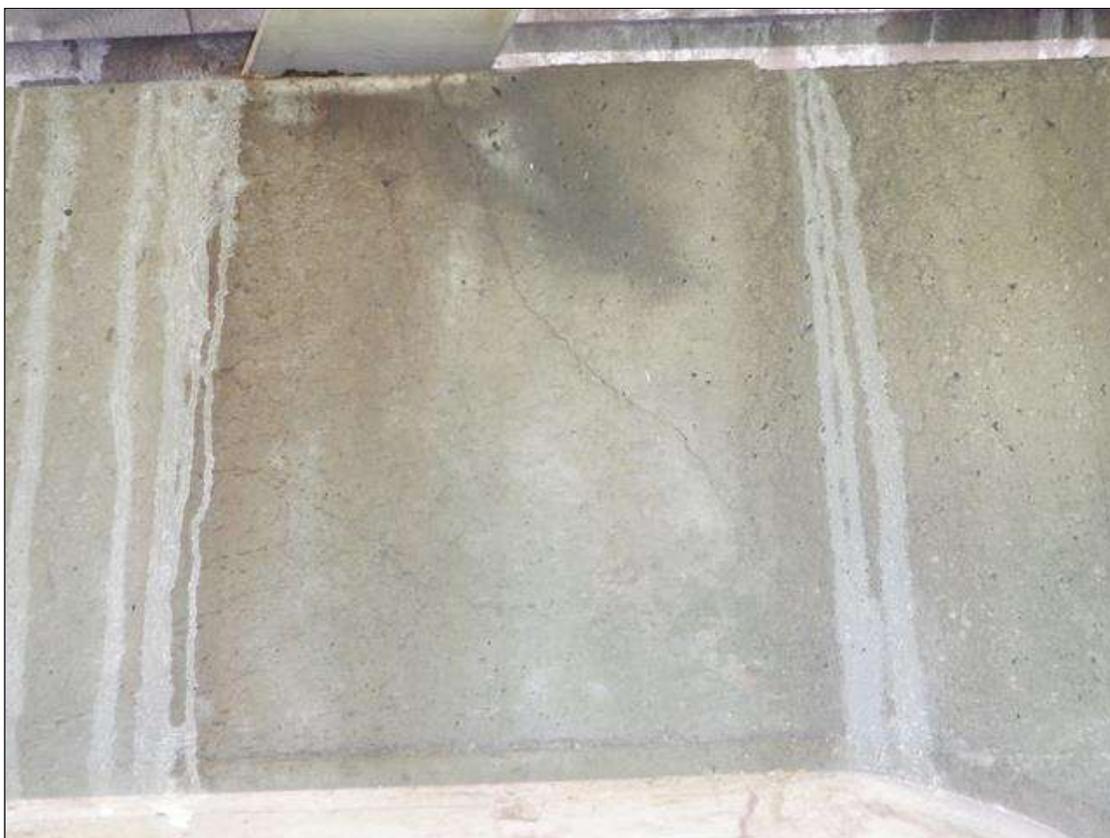
Bent 1 Cap 1: 36" DIAGONAL HAIRLINE CRACK IN SOUTH FACE UNDER BEAM 3

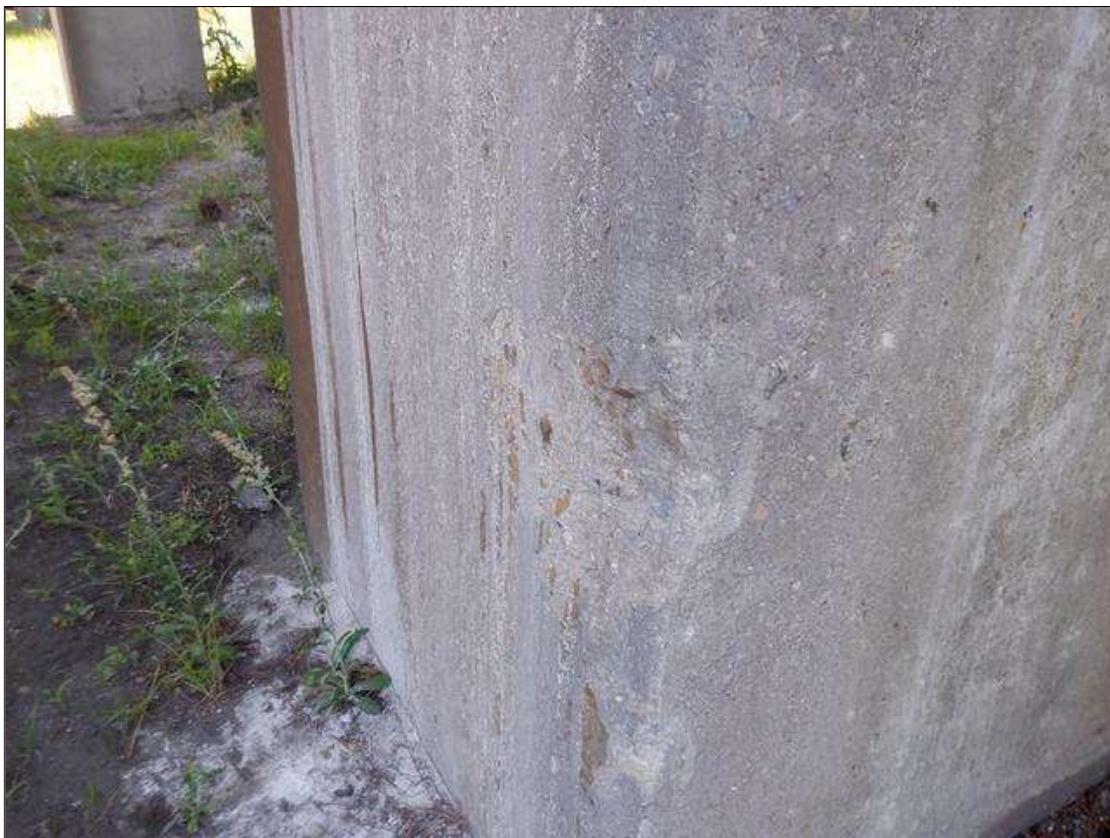
Element Number	Defect Type	Defect Description	CS	CS Qty	Maint Qty
205	Delamination/Spall	8" DIAMETER X 1" DEEP SPALL IN NORTHWEST CORNER	3	1	1 Each

Bent 1 Pile 1: 8" DIAMETER X 1" DEEP SPALL IN NORTHWEST CORNER

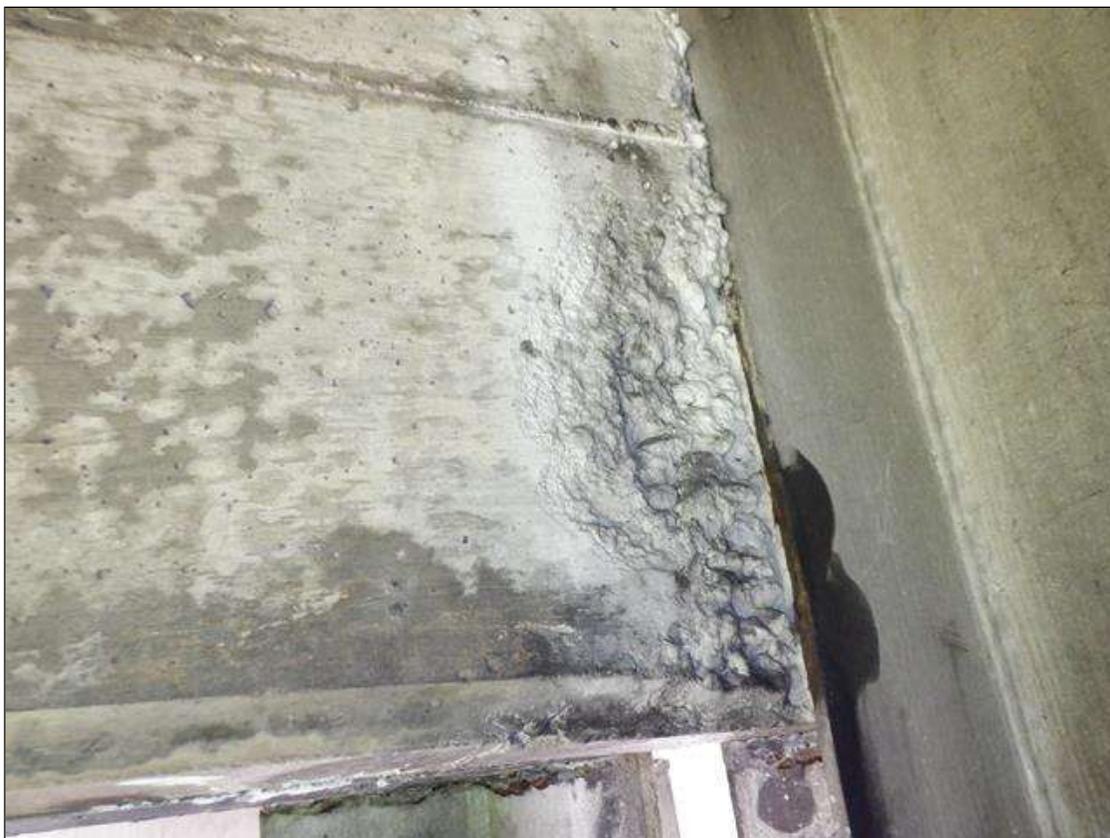
END DIAPHRAGM BAY 2 AT BENT 2: 12" X 4" X 1" DEEP SPALL IN NORTH FACE

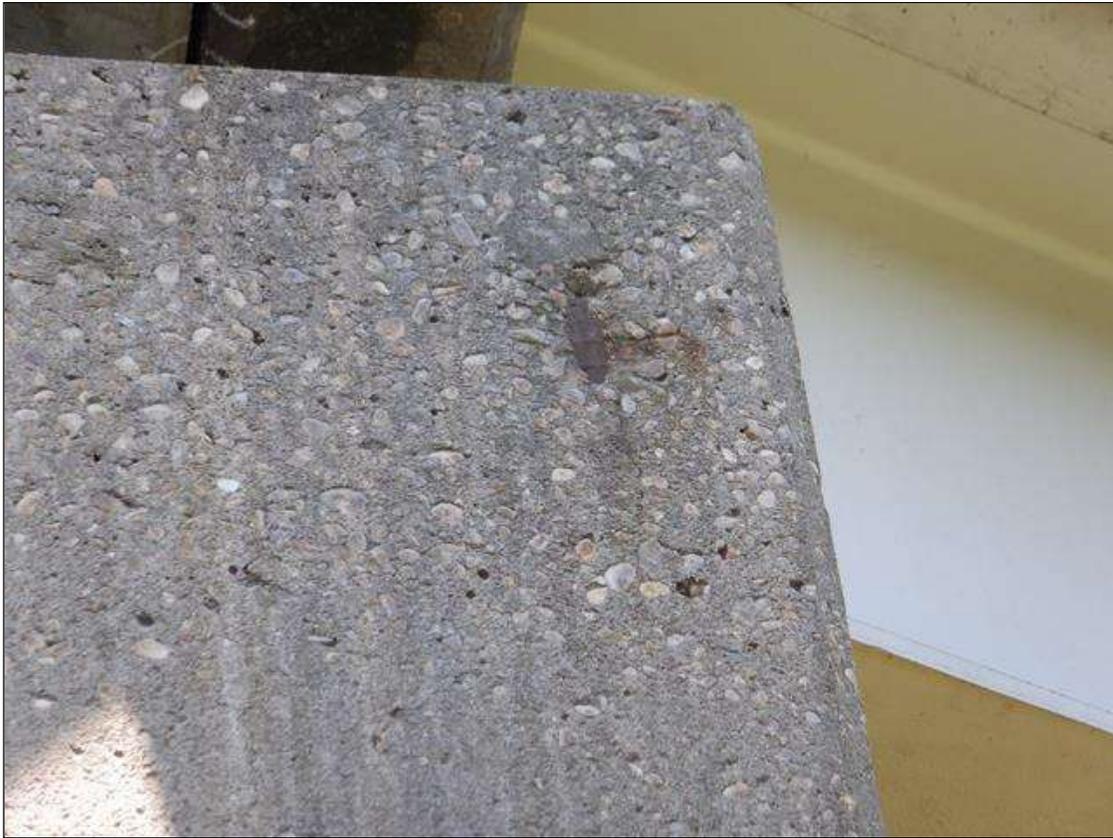
Bent 2 Cap 1: 3" DIAMETER X 1" DEEP SPALL WITH EXPOSED REBAR IN EAST FACE

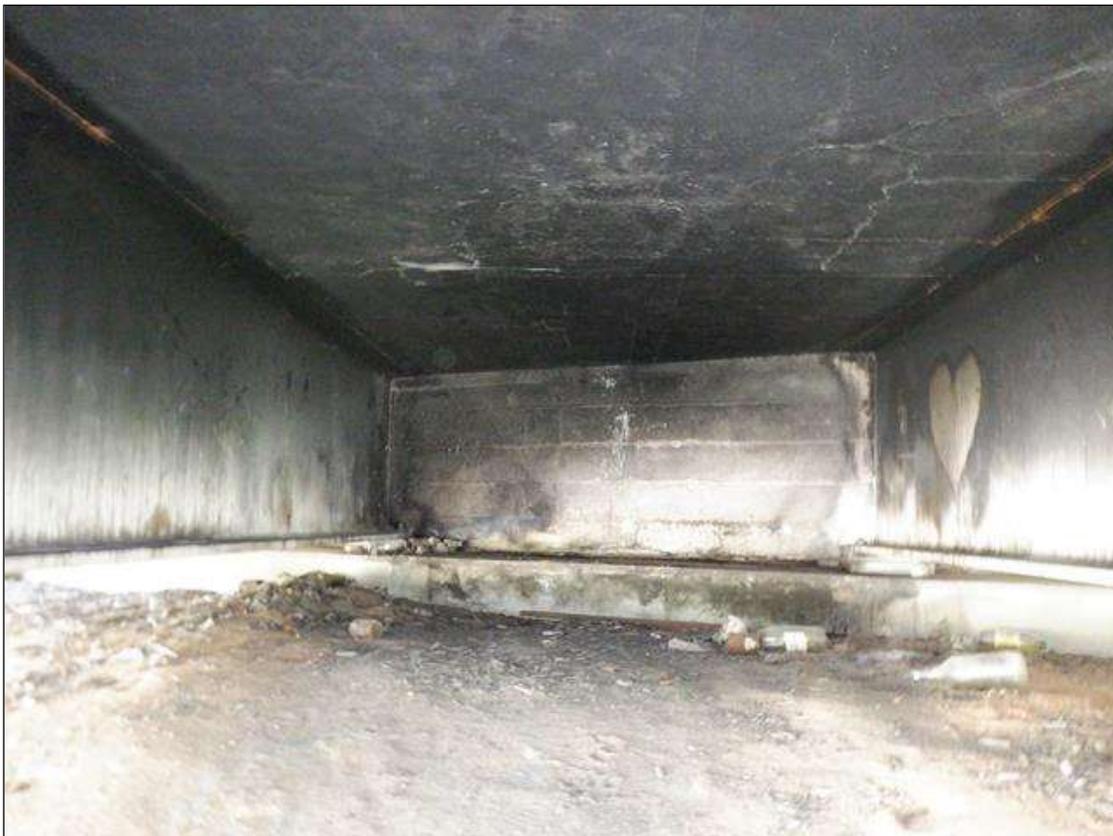
FIRE DAMAGE IN BAY 2

FIRE DAMAGE IN BAY 2 ABUTMENT 2

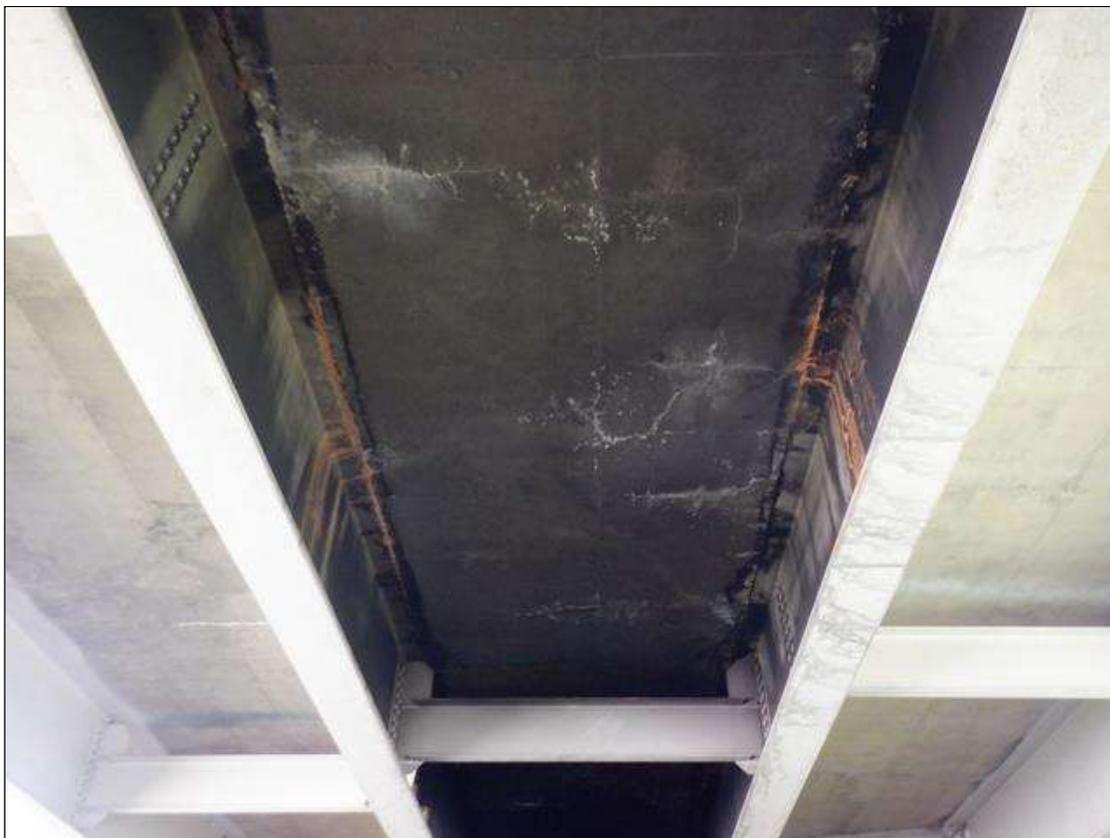
FIRE DAMAGE IN SPAN 3 BAY 2 BOTTOM OF DECK

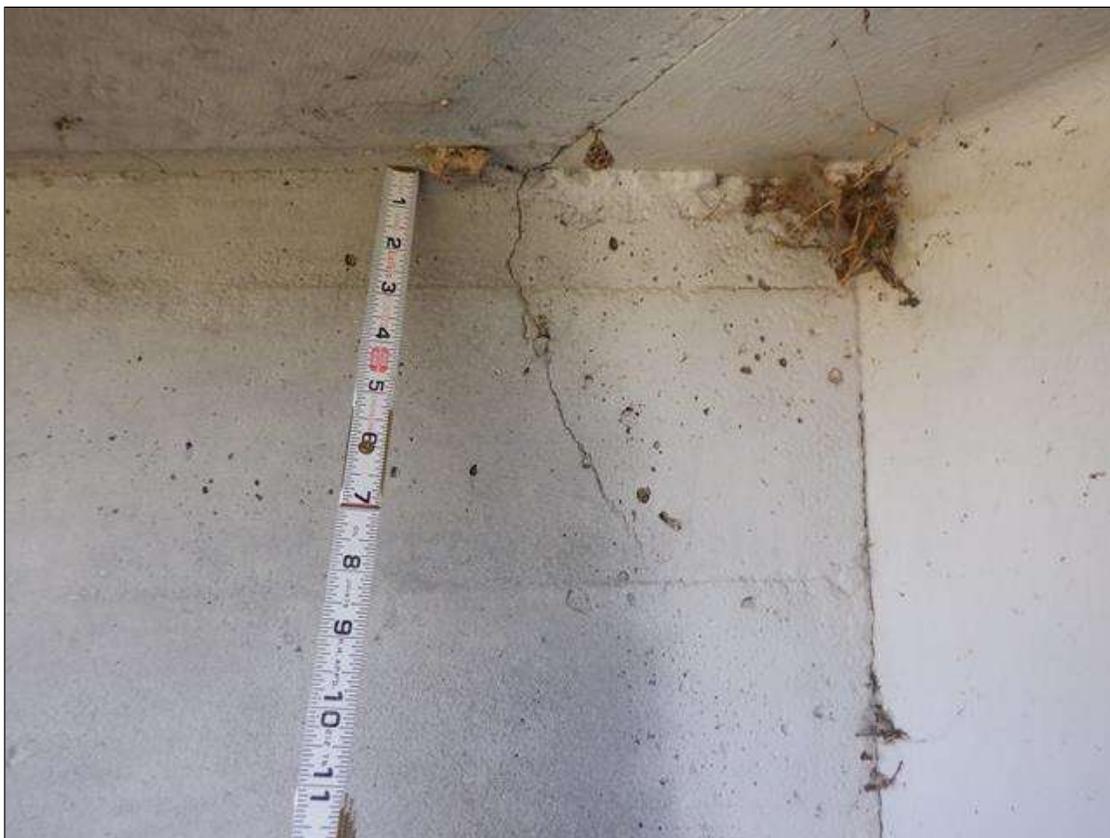
End Bent 2 Abutment/Backwall : 10" X 4" DELAMINATION UNDER WEST OVERHANG

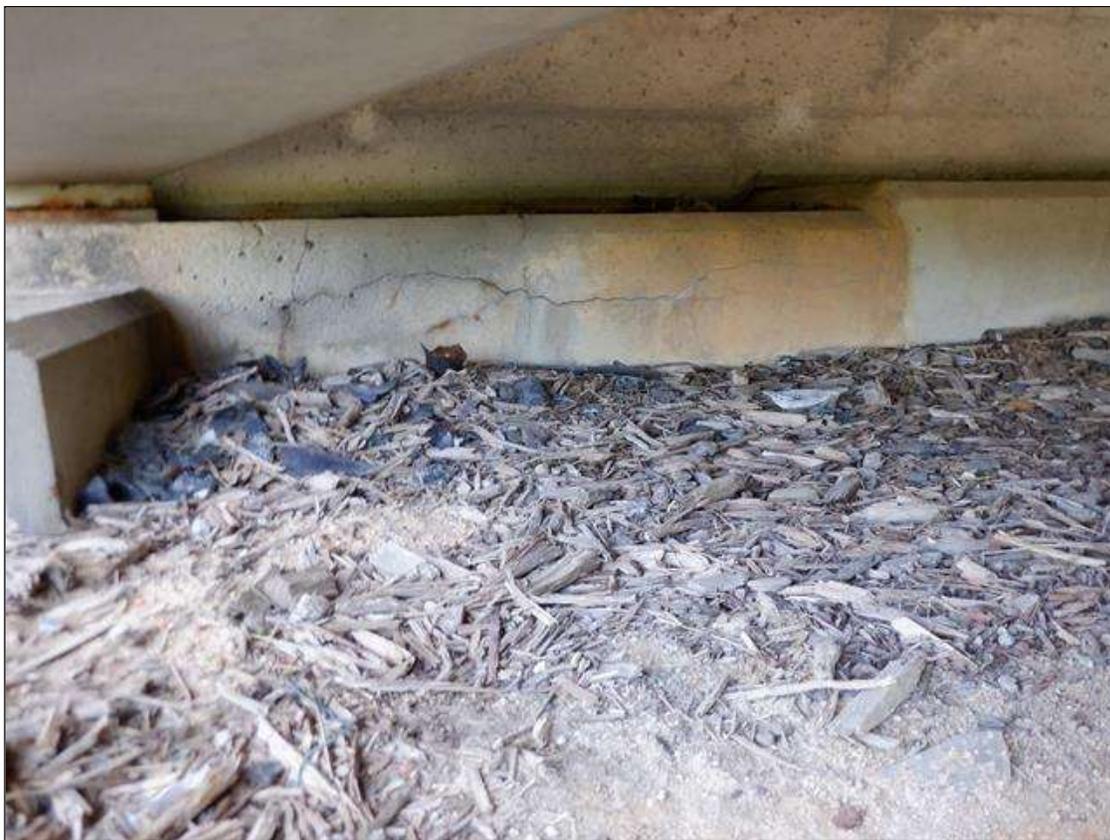
End Bent 2 Cap 1: 2 S.F. OF VERTICAL AND HORIZONTAL CRACKS UP TO 1/16" WIDE UNDER BAY 1
