AS-BUILT REPAIR QUANTITY TABLE BENT 1 CAP REPAIRS SF SHOTCRETE REPAIRS 12.0 SF | 6.0 CF EPOXY RESIN INJECTION 2.0 LF PILE REPAIRS PILE CONCRETE RESTORATION SF 15.3 SF | 6.3 CF FRP PROTECTIVE SYSTEM AWL 64.2 SF FRP PROTECTIVE SYSTEM BWL 49.5 SF BENT 2 CAP REPAIRS SF SHOTCRETE REPAIRS 16.4 SF | 8.2 CF - LF EPOXY RESIN INJECTION PILE REPAIRS PILE CONCRETE RESTORATION 36.0 SF | 14.4 CF SF FRP PROTECTIVE SYSTEM AWL 140.3 SF FRP PROTECTIVE SYSTEM BWL 66.0 SF

HB-0017 PROJECT NO. DARE COUNTY

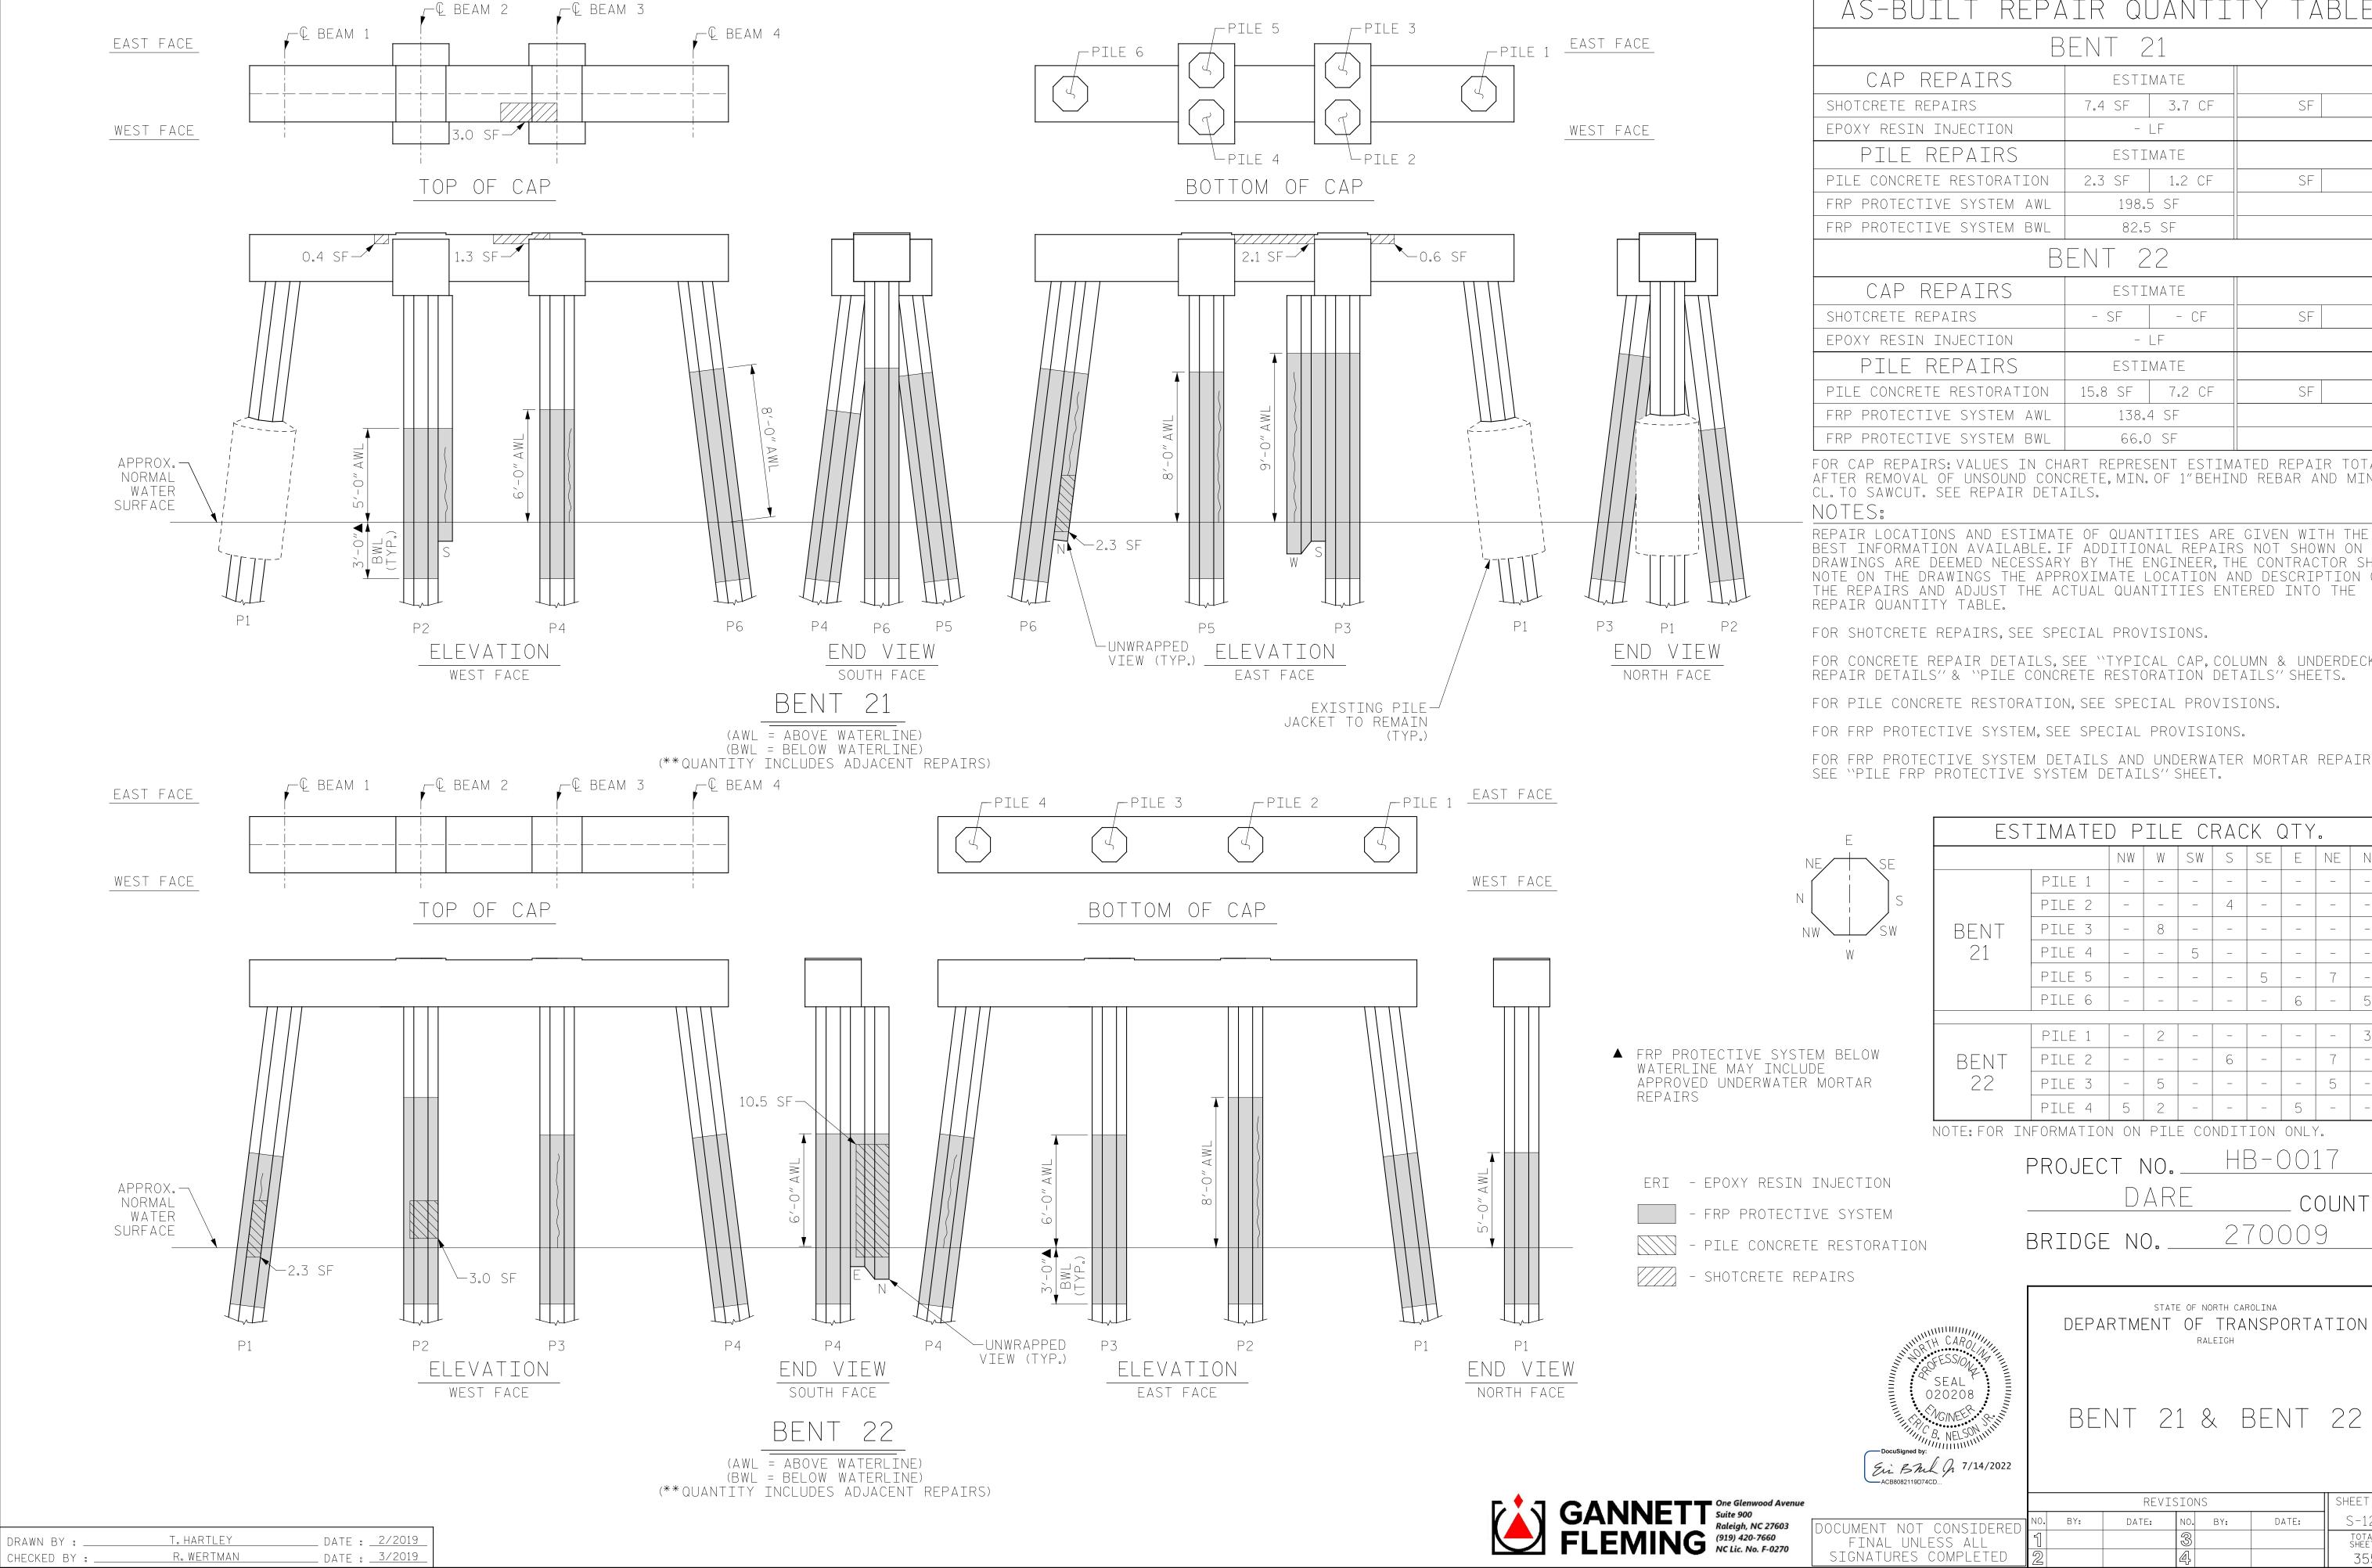
BENT 21 & BENT 22

BENI 21								
CAP REPAIRS	ESTI	MATE						
SHOTCRETE REPAIRS	7.4 SF	3.7 CF	SF	CF				
EPOXY RESIN INJECTION	_	LF		LF				
PILE REPAIRS	ESTI	MATE						
PILE CONCRETE RESTORATION	2.3 SF	1.2 CF	SF	CF				
FRP PROTECTIVE SYSTEM AWL	198.5 SF							
FRP PROTECTIVE SYSTEM BWL	82.5	SF

BENT 22								
CAP REPAIRS	ESTI	MATE						
SHOTCRETE REPAIRS	- SF	- CF	SF	CF				
EPOXY RESIN INJECTION	- LF			LF				
PILE REPAIRS	ESTI	MATE						
PILE CONCRETE RESTORATION	15.8 SF	7.2 CF	SF	CF				
FRP PROTECTIVE SYSTEM AWL	138.4 SF							
FRP PROTECTIVE SYSTEM BWL	66.0 SF

FOR CAP REPAIRS: VALUES IN CHART REPRESENT ESTIMATED REPAIR TOTALS AFTER REMOVAL OF UNSOUND CONCRETE, MIN. OF 1"BEHIND REBAR AND MIN. 2"

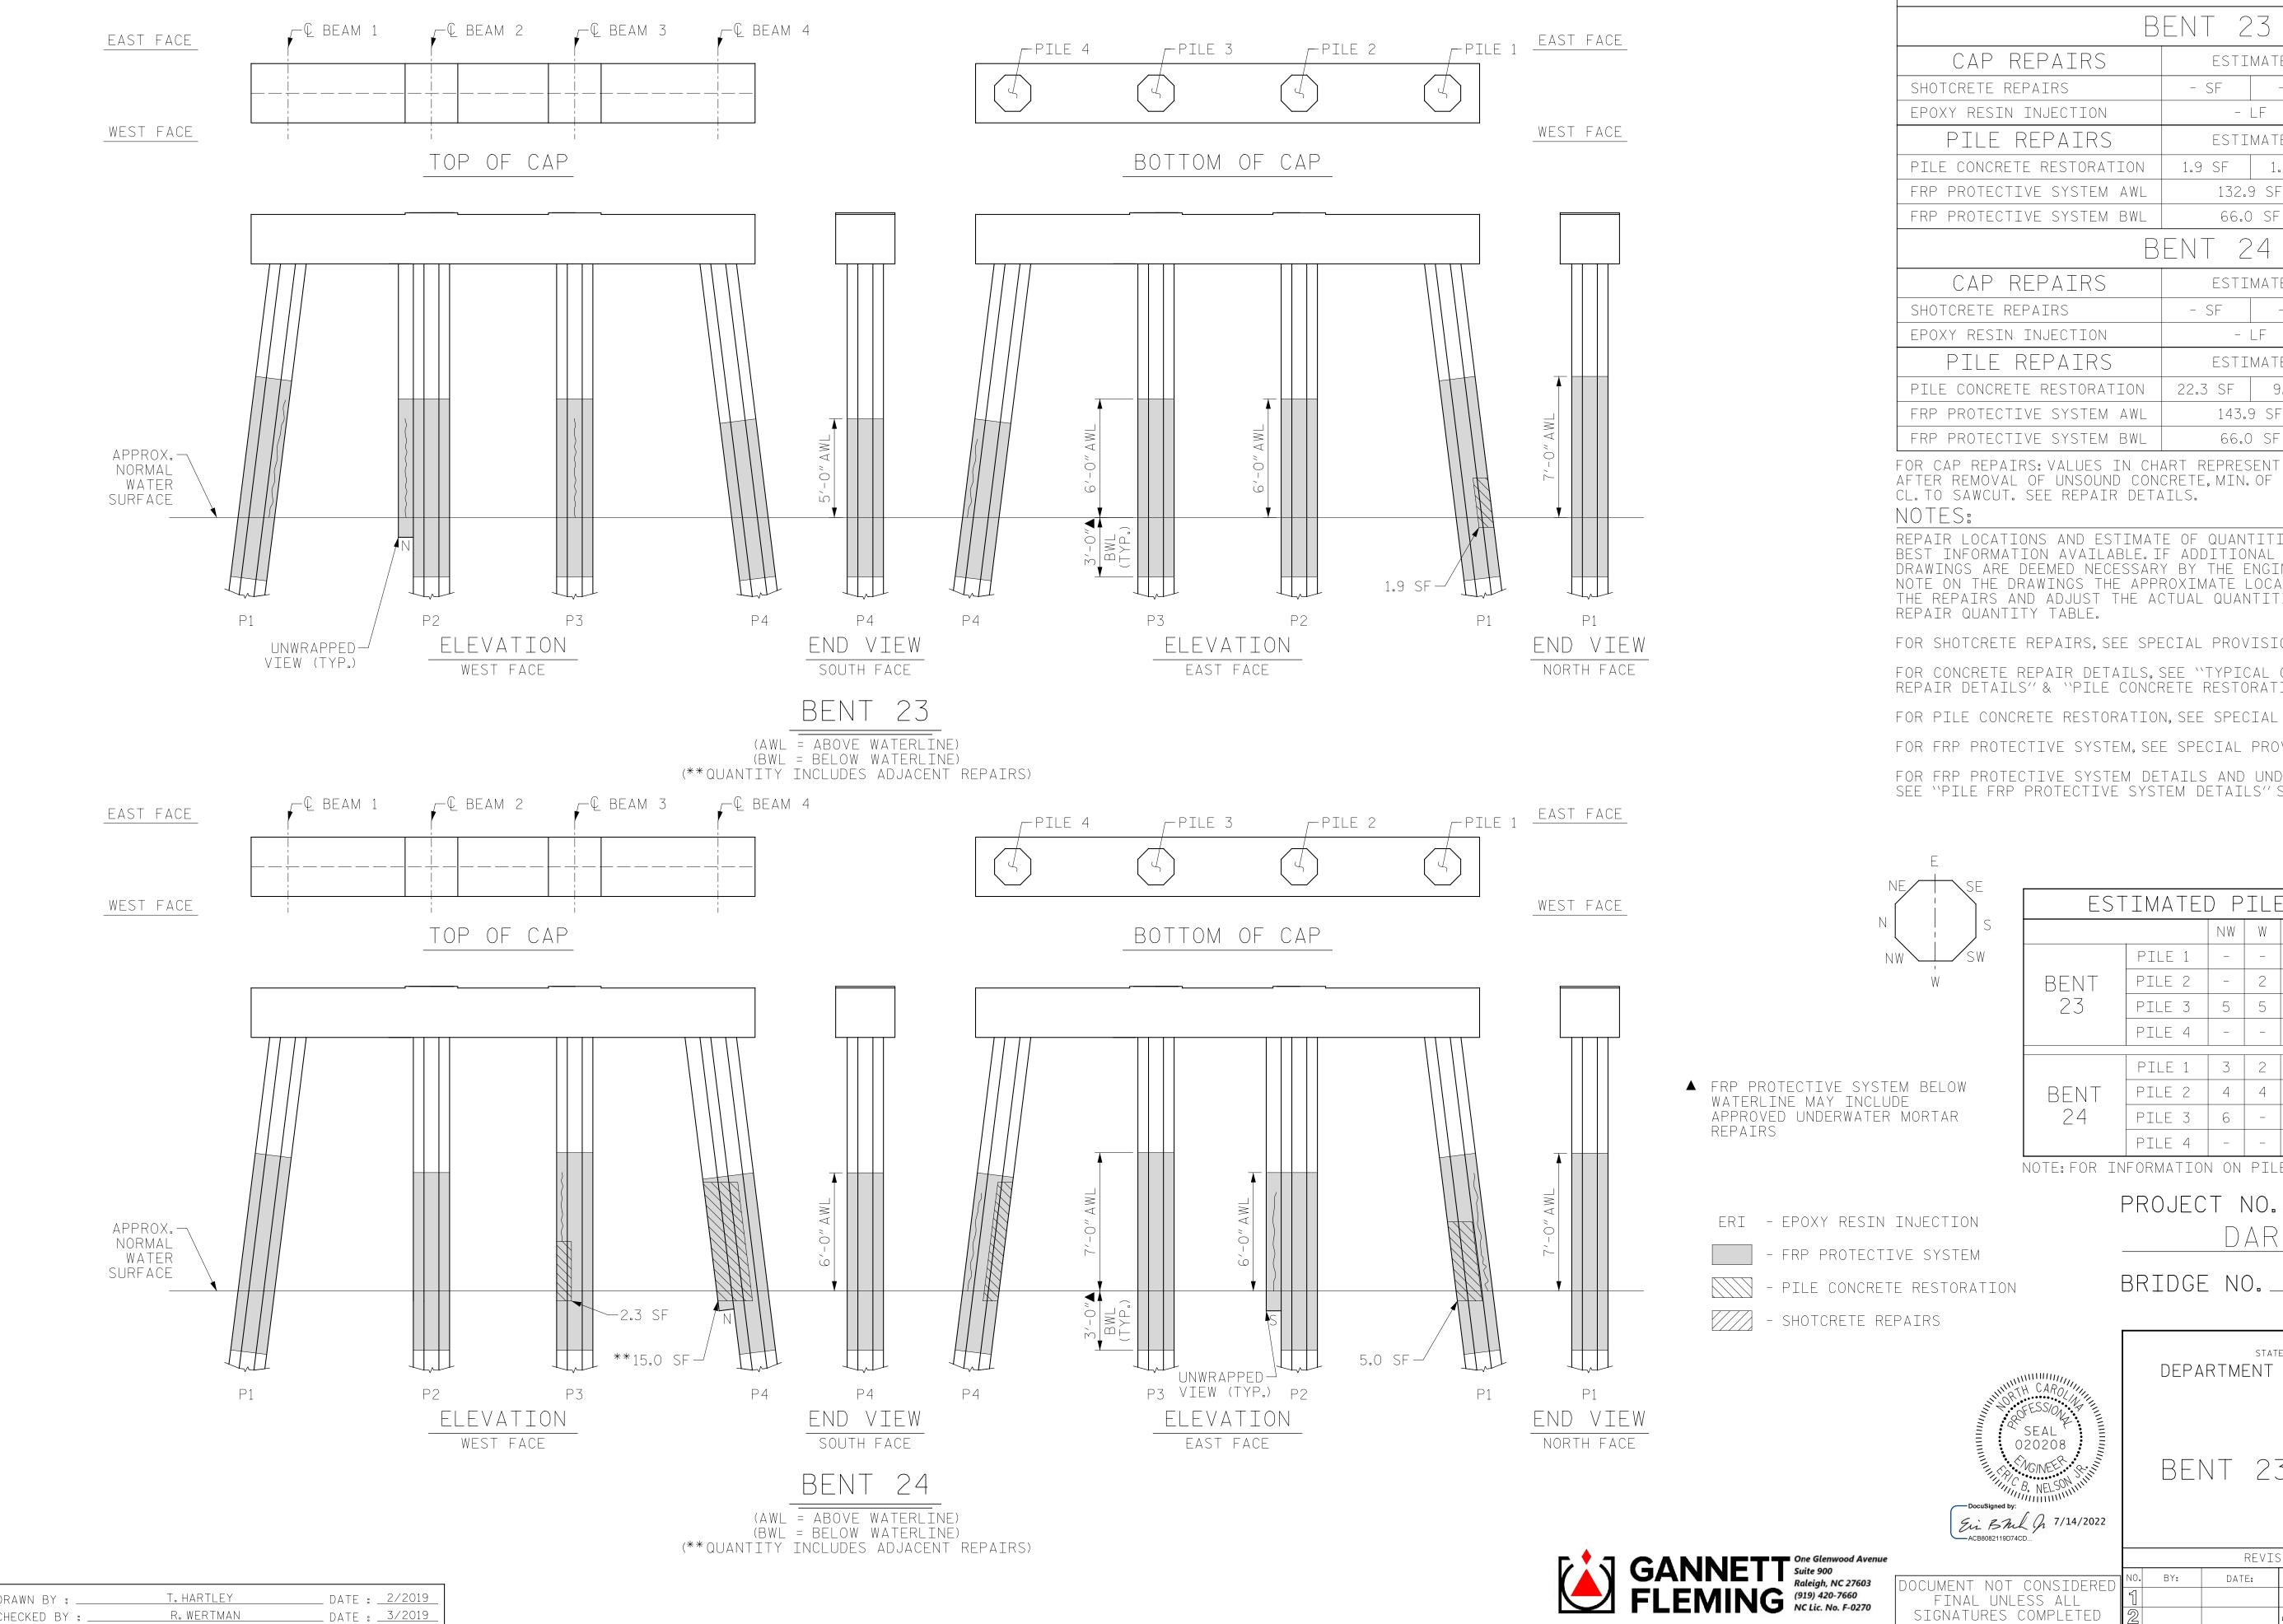
AS-BUILT REPAIR QUANTITY TABLE BENT 23 ESTIMATE SF - SF - CF - LF ESTIMATE SF PILE CONCRETE RESTORATION 1.9 SF | 1.0 CF 132.9 SF

BENT 24										
CAP REPAIRS	ESTI	MATE								
SHOTCRETE REPAIRS	- SF	- CF	SF	CF						
EPOXY RESIN INJECTION	_	LF		LF						
PILE REPAIRS	ESTI	MATE								
PILE CONCRETE RESTORATION	22.3 SF	9.1 CF	SF	CF						
FRP PROTECTIVE SYSTEM AWL	143.	9 SF								
FRP PROTECTIVE SYSTEM BWL	66.0) SF

ESTIMATED PILE CRACK QTY.											
		NW	W	SW	S	SE	Е	NE	Z		
F	PILE 1	_	_	6	_	_	_	3	_		
BENT	PILE 2	_	2	_	2	_	_	_	5		
23	PILE 3	5	5	_	_	_	_	_	5		
	PILE 4	_	_	_	_	4	_	-	_		
	PILE 1	3	2	_	_	_	_	6	_		
BENT	PILE 2	4	4	_	5	_	3	_	_		
24	PILE 3	6	_	_	_	3	_	_	_		
	PILE 4	_	_	_	_	-	5	-	-		
NOTE: FOR IN	FORMATION	NO N	PIL	E CO	NDIT	ION	ONL'	Y.

FOR CAP REPAIRS: VALUES IN CHART REPRESENT ESTIMATED REPAIR TOTALS AFTER REMOVAL OF UNSOUND CONCRETE, MIN. OF 1"BEHIND REBAR AND MIN. 2 CL. TO SAWCUT. SEE REPAIR DETAILS.

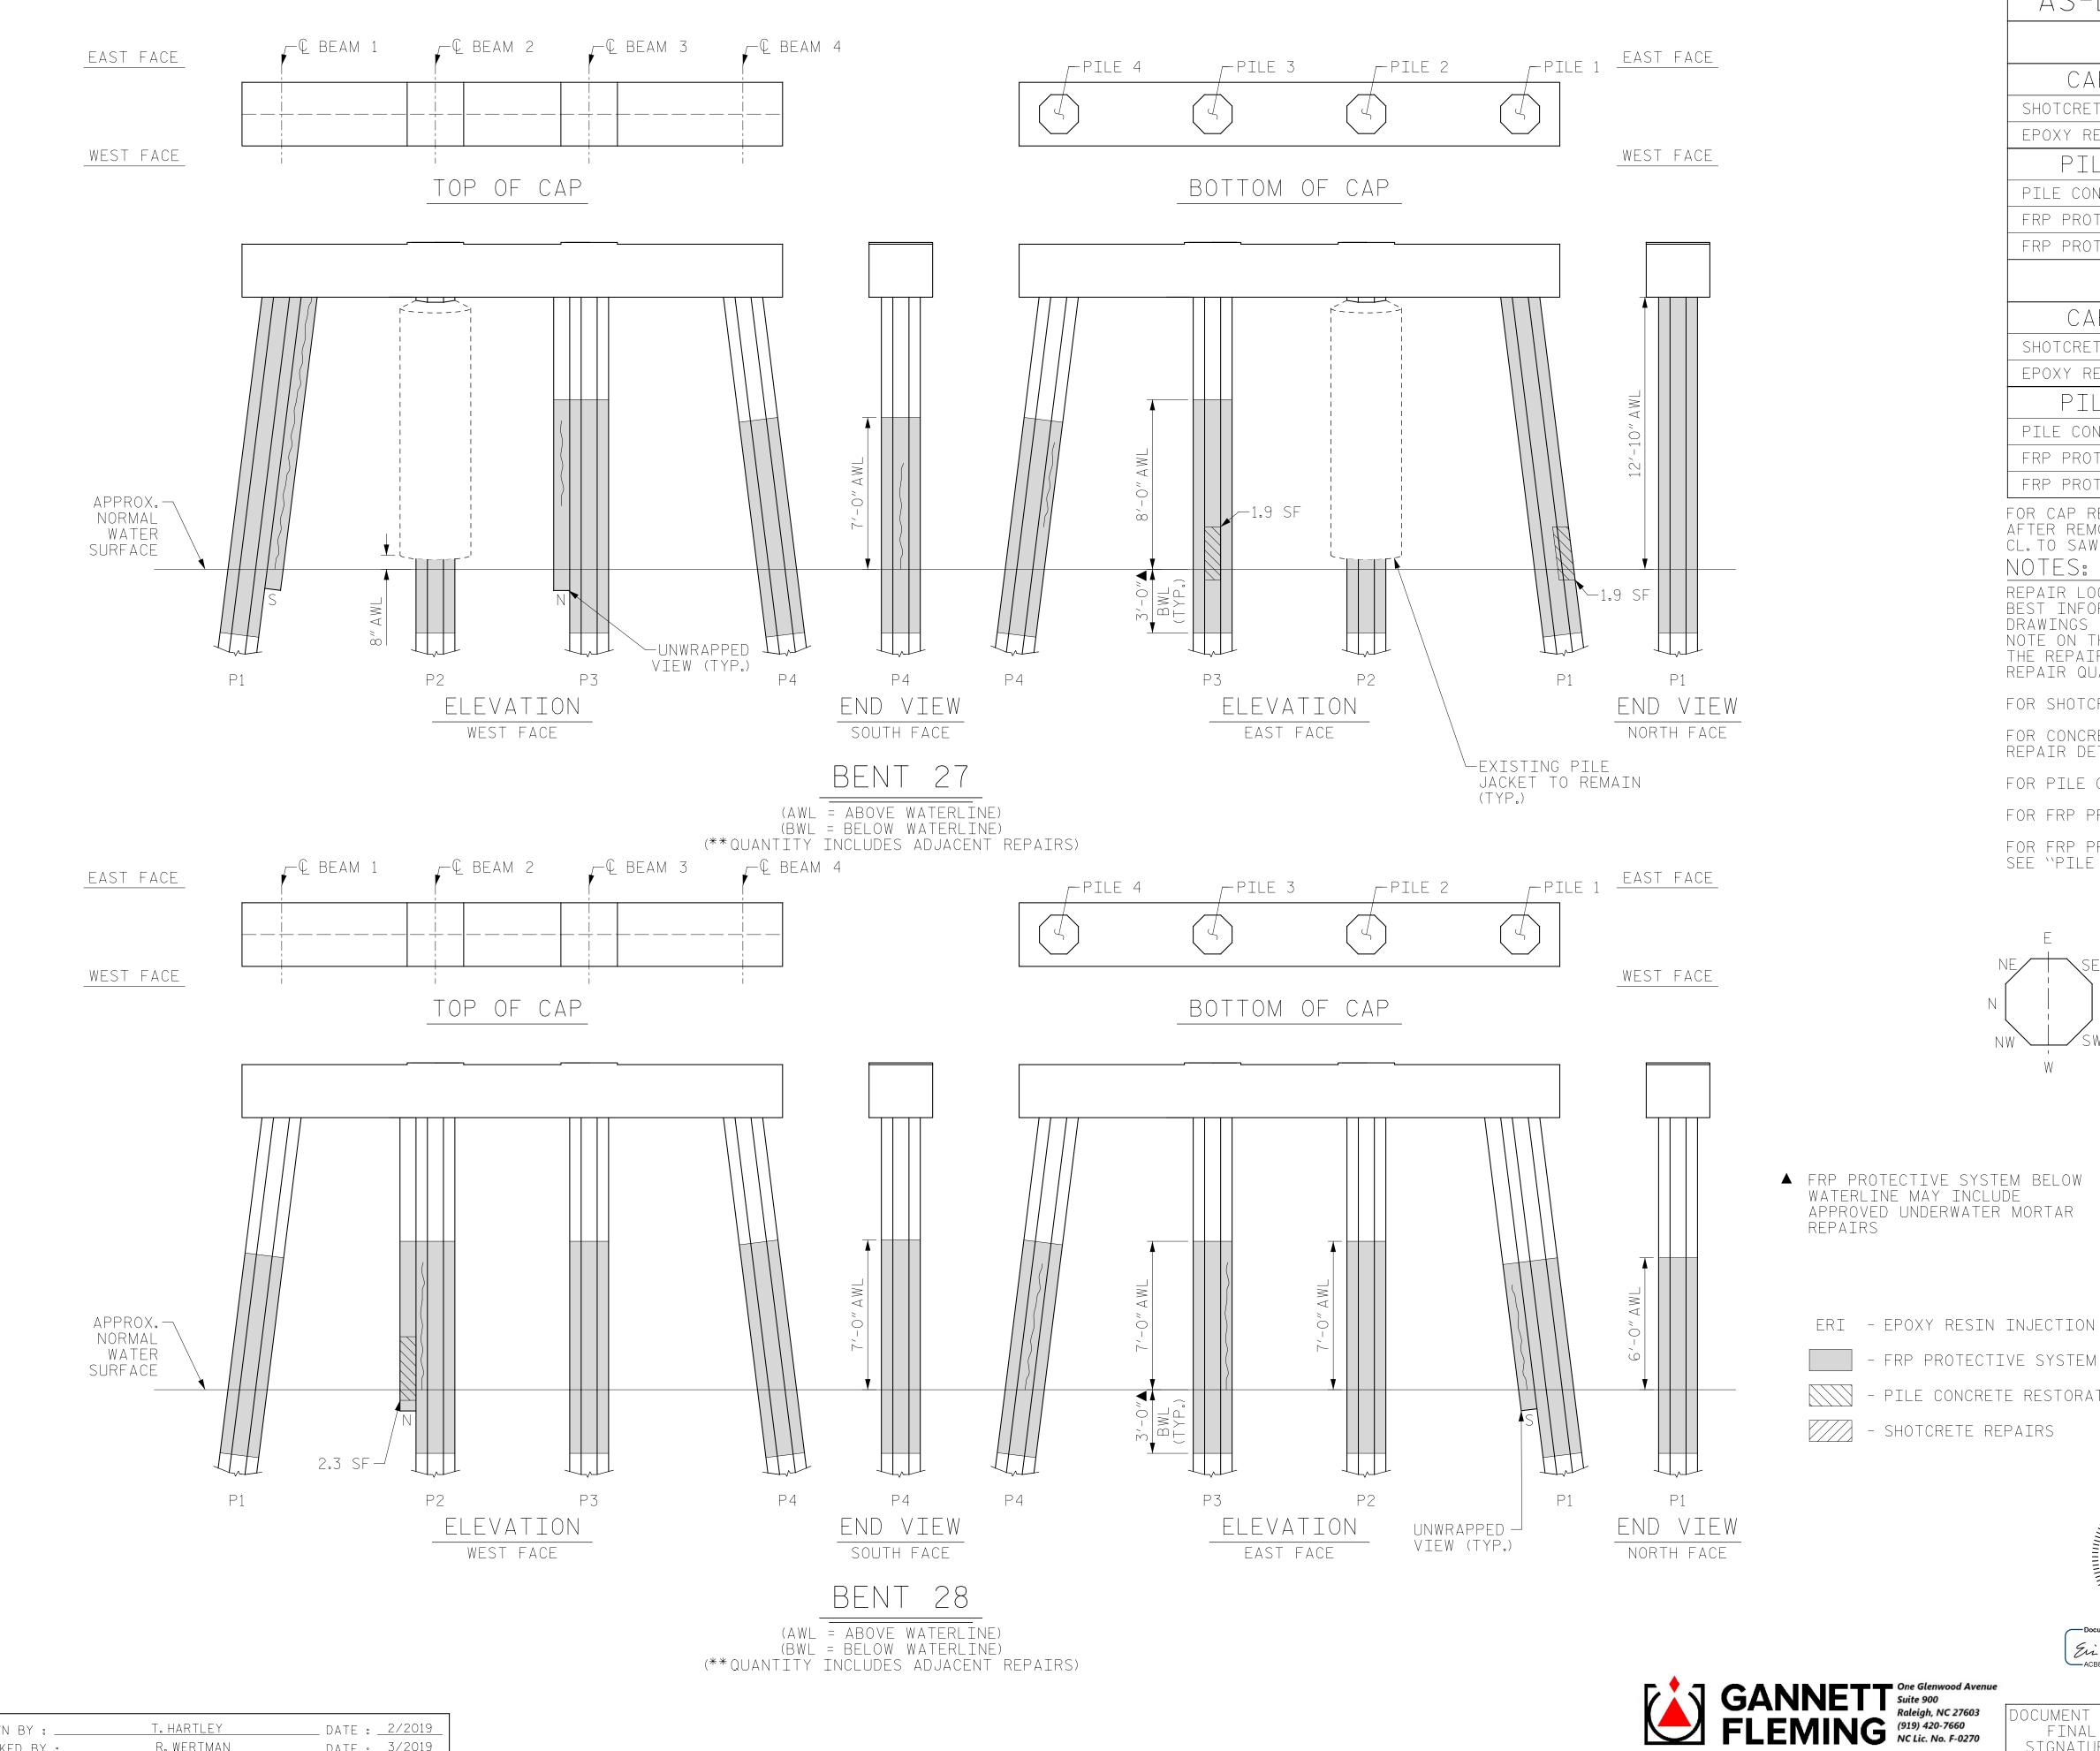
BENT 27										
CAP REPAIRS	ESTI	MATE								
SHOTCRETE REPAIRS	- SF	- CF	SF	CF						
EPOXY RESIN INJECTION	_	LF		LF						
PILE REPAIRS	ESTI	MATE								
PILE CONCRETE RESTORATION	3.8 SF	2.0 CF	SF	CF						
FRP PROTECTIVE SYSTEM AWL	153.	5 SF								
FRP PROTECTIVE SYSTEM BWL	66.0) SF								
	-			-

BENT 28										
CAP REPAIRS	ESTI	MATE								
SHOTCRETE REPAIRS	- SF	- CF	SF	CF						
EPOXY RESIN INJECTION	_	LF		LF						
PILE REPAIRS	ESTI	MATE								
PILE CONCRETE RESTORATION	2.3 SF	1.2 CF	SF	CF						
FRP PROTECTIVE SYSTEM AWL	149.4 SF									
FRP PROTECTIVE SYSTEM BWL	66.0 SF

FOR CAP REPAIRS: VALUES IN CHART REPRESENT ESTIMATED REPAIR TOTALS AFTER REMOVAL OF UNSOUND CONCRETE, MIN. OF 1"BEHIND REBAR AND MIN. 2 CL. TO SAWCUT. SEE REPAIR DETAILS.

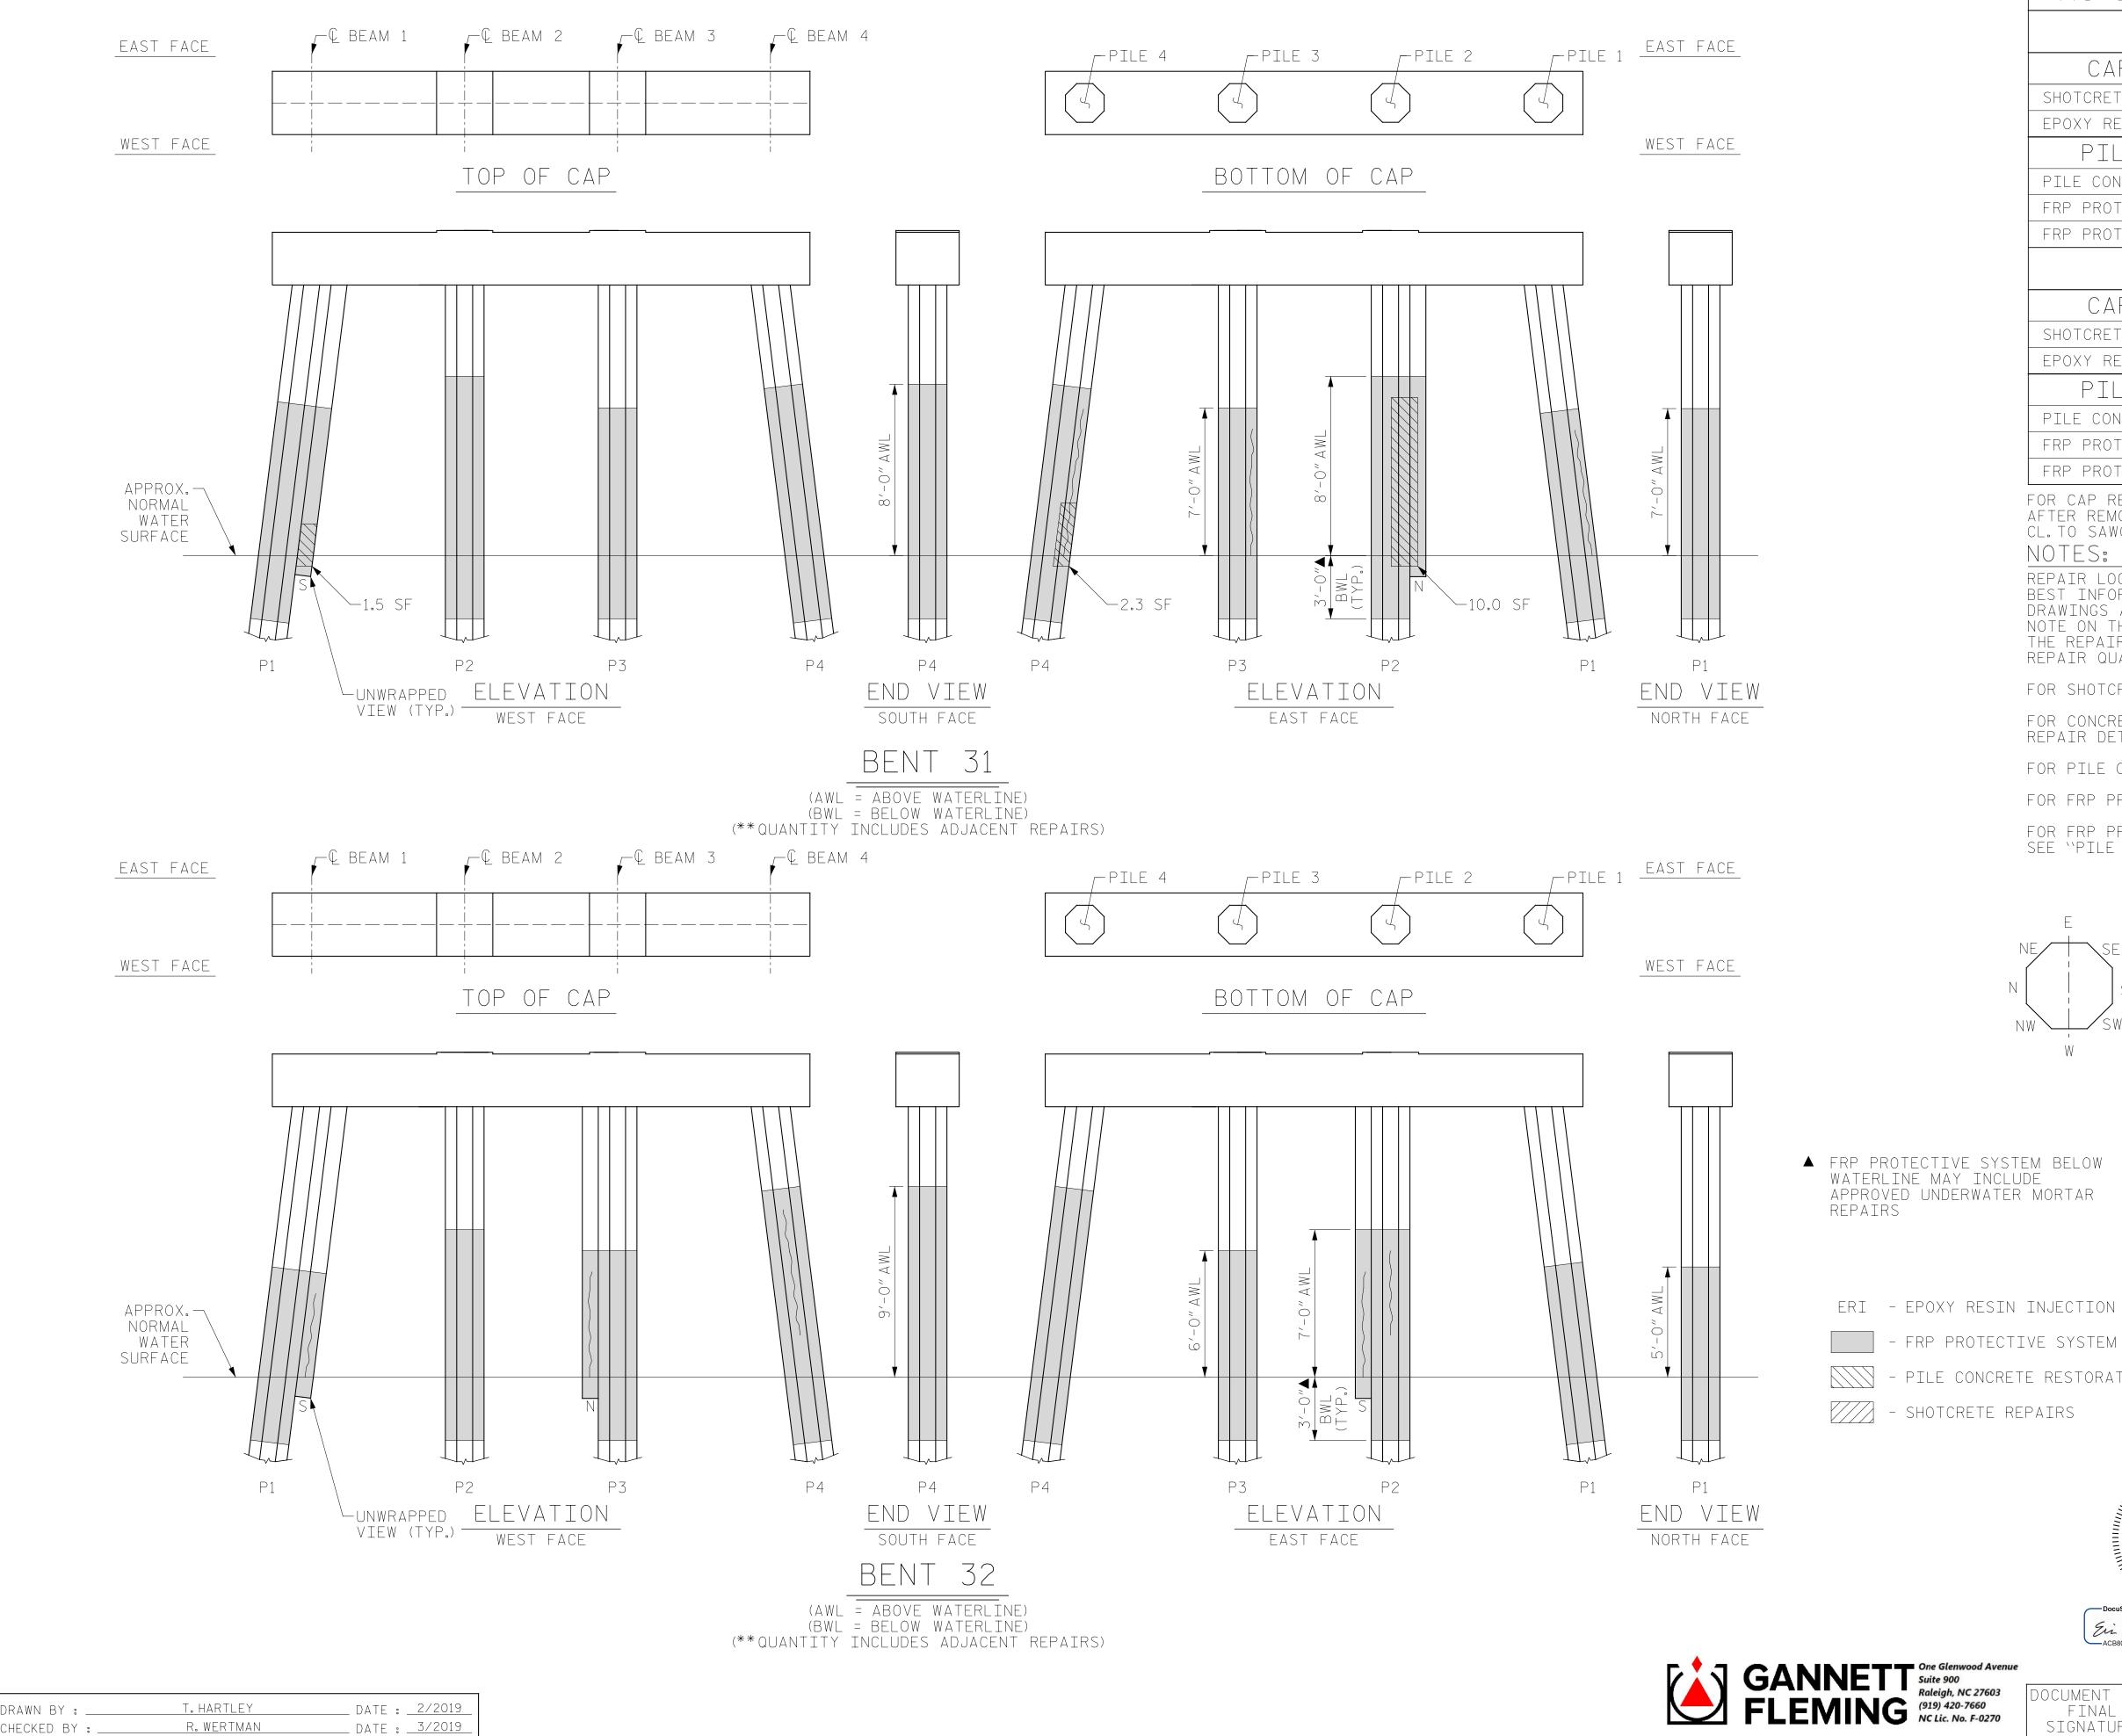
B	SENT 3	31		
CAP REPAIRS	ESTI	MATE		
SHOTCRETE REPAIRS	- SF	- CF	SF	CF
EPOXY RESIN INJECTION	_	LF		LF
PILE REPAIRS	ESTI	MATE		
PILE CONCRETE RESTORATION	13.8 SF 6.3 CF		SF	CF
FRP PROTECTIVE SYSTEM AWL	166.0 SF			
FRP PROTECTIVE SYSTEM BWL	66.0 SF

В	ENT 3	2		
CAP REPAIRS	ESTI	MATE		
SHOTCRETE REPAIRS	- SF	- CF	SF	CF
EPOXY RESIN INJECTION	-	LF		LF
PILE REPAIRS	ESTI	MATE		
PILE CONCRETE RESTORATION	- SF	- CF	SF	CF
FRP PROTECTIVE SYSTEM AWL	149.4 SF			
FRP PROTECTIVE SYSTEM BWL	66.0 SF

ESTIMATED PILE CRACK QTY.									
		NW	W	SW	S	SE	E	NE	Z
	PILE 1	_	_	_	_	_	5	6	_
BENT	PILE 2	_	_	_	_	_	_	_	_
31	PILE 3	_	=	_	_	3	-	6	_
	PILE 4	_	4	_	4	_	_	5	_
	PILE 1	_	_	_	4	_	_	_	_
BENT	PILE 2	_	_	5	5	_	4	_	_
32	PILE 3	_	_	_	_	3	3	_	5
	PILE 4	_	6	4	3	_	4	_	_
NOTE: FOR INFORMATION ON PILE CONDITION ONLY.

FOR CAP REPAIRS: VALUES IN CHART REPRESENT ESTIMATED REPAIR TOTALS AFTER REMOVAL OF UNSOUND CONCRETE, MIN. OF 1"BEHIND REBAR AND MIN. 2 CL. TO SAWCUT. SEE REPAIR DETAILS.

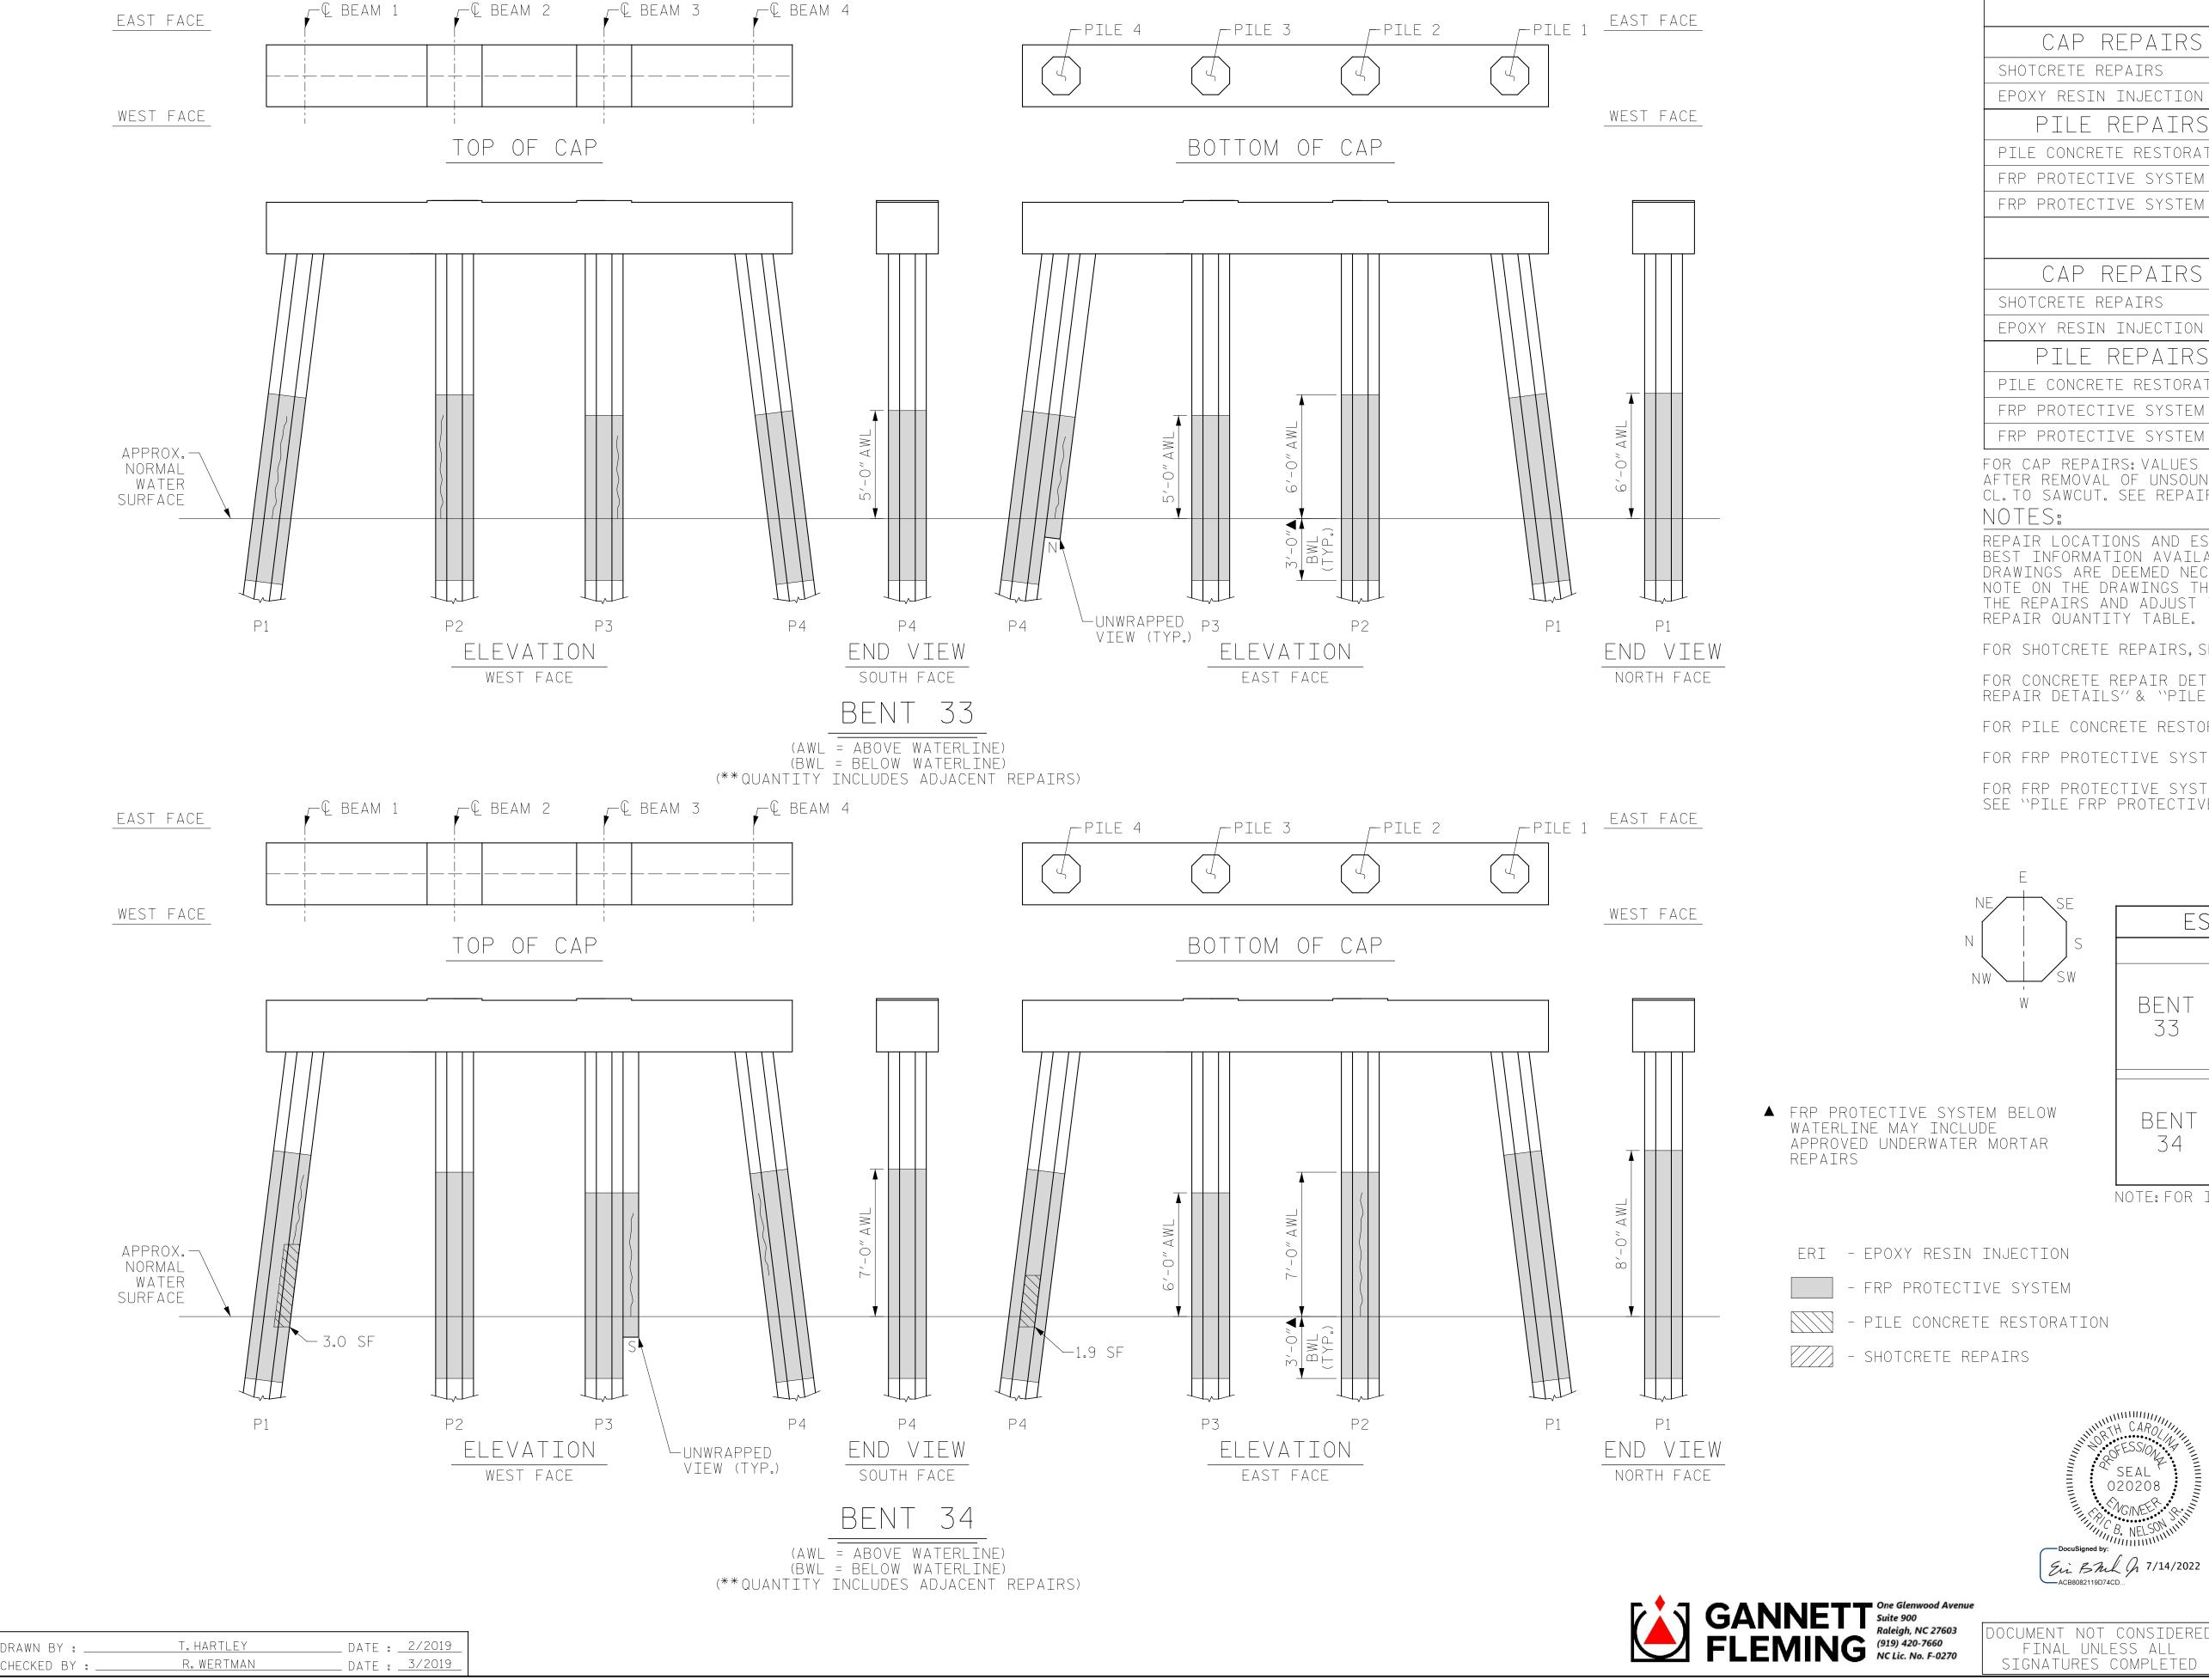
В	ENT 3	3		
CAP REPAIRS	ESTI	MATE		
SHOTCRETE REPAIRS	- SF	- CF	SF	CF
EPOXY RESIN INJECTION	_	LF		LF
PILE REPAIRS	ESTI	MATE		
PILE CONCRETE RESTORATION	- SF - CF		SF	CF
FRP PROTECTIVE SYSTEM AWL	121.9 SF			
FRP PROTECTIVE SYSTEM BWL	66.0 SF			
	·	·	·	·

В				
CAP REPAIRS	ESTI	MATE		
SHOTCRETE REPAIRS	- SF	- CF	SF	CF
EPOXY RESIN INJECTION	_	LF		LF
PILE REPAIRS	ESTI	MATE		
PILE CONCRETE RESTORATION	4.9 SF	2.2 CF	SF	CF
FRP PROTECTIVE SYSTEM AWL	154.	9 SF		
FRP PROTECTIVE SYSTEM BWL	66.0) SF

FOR CAP REPAIRS: VALUES IN CHART REPRESENT ESTIMATED REPAIR TOTALS AFTER REMOVAL OF UNSOUND CONCRETE, MIN. OF 1"BEHIND REBAR AND MIN. 2 CL. TO SAWCUT. SEE REPAIR DETAILS.
