AS-BUILT REPAIR QUANTITY TABLE BENT 1 CAP REPAIRS SF SHOTCRETE REPAIRS 12.0 SF | 6.0 CF EPOXY RESIN INJECTION 2.0 LF PILE REPAIRS PILE CONCRETE RESTORATION SF 15.3 SF | 6.3 CF FRP PROTECTIVE SYSTEM AWL 64.2 SF FRP PROTECTIVE SYSTEM BWL 49.5 SF BENT 2 CAP REPAIRS SF SHOTCRETE REPAIRS 16.4 SF | 8.2 CF - LF EPOXY RESIN INJECTION PILE REPAIRS PILE CONCRETE RESTORATION 36.0 SF | 14.4 CF SF FRP PROTECTIVE SYSTEM AWL 140.3 SF FRP PROTECTIVE SYSTEM BWL 66.0 SF

HB-0017 PROJECT NO. DARE COUNTY

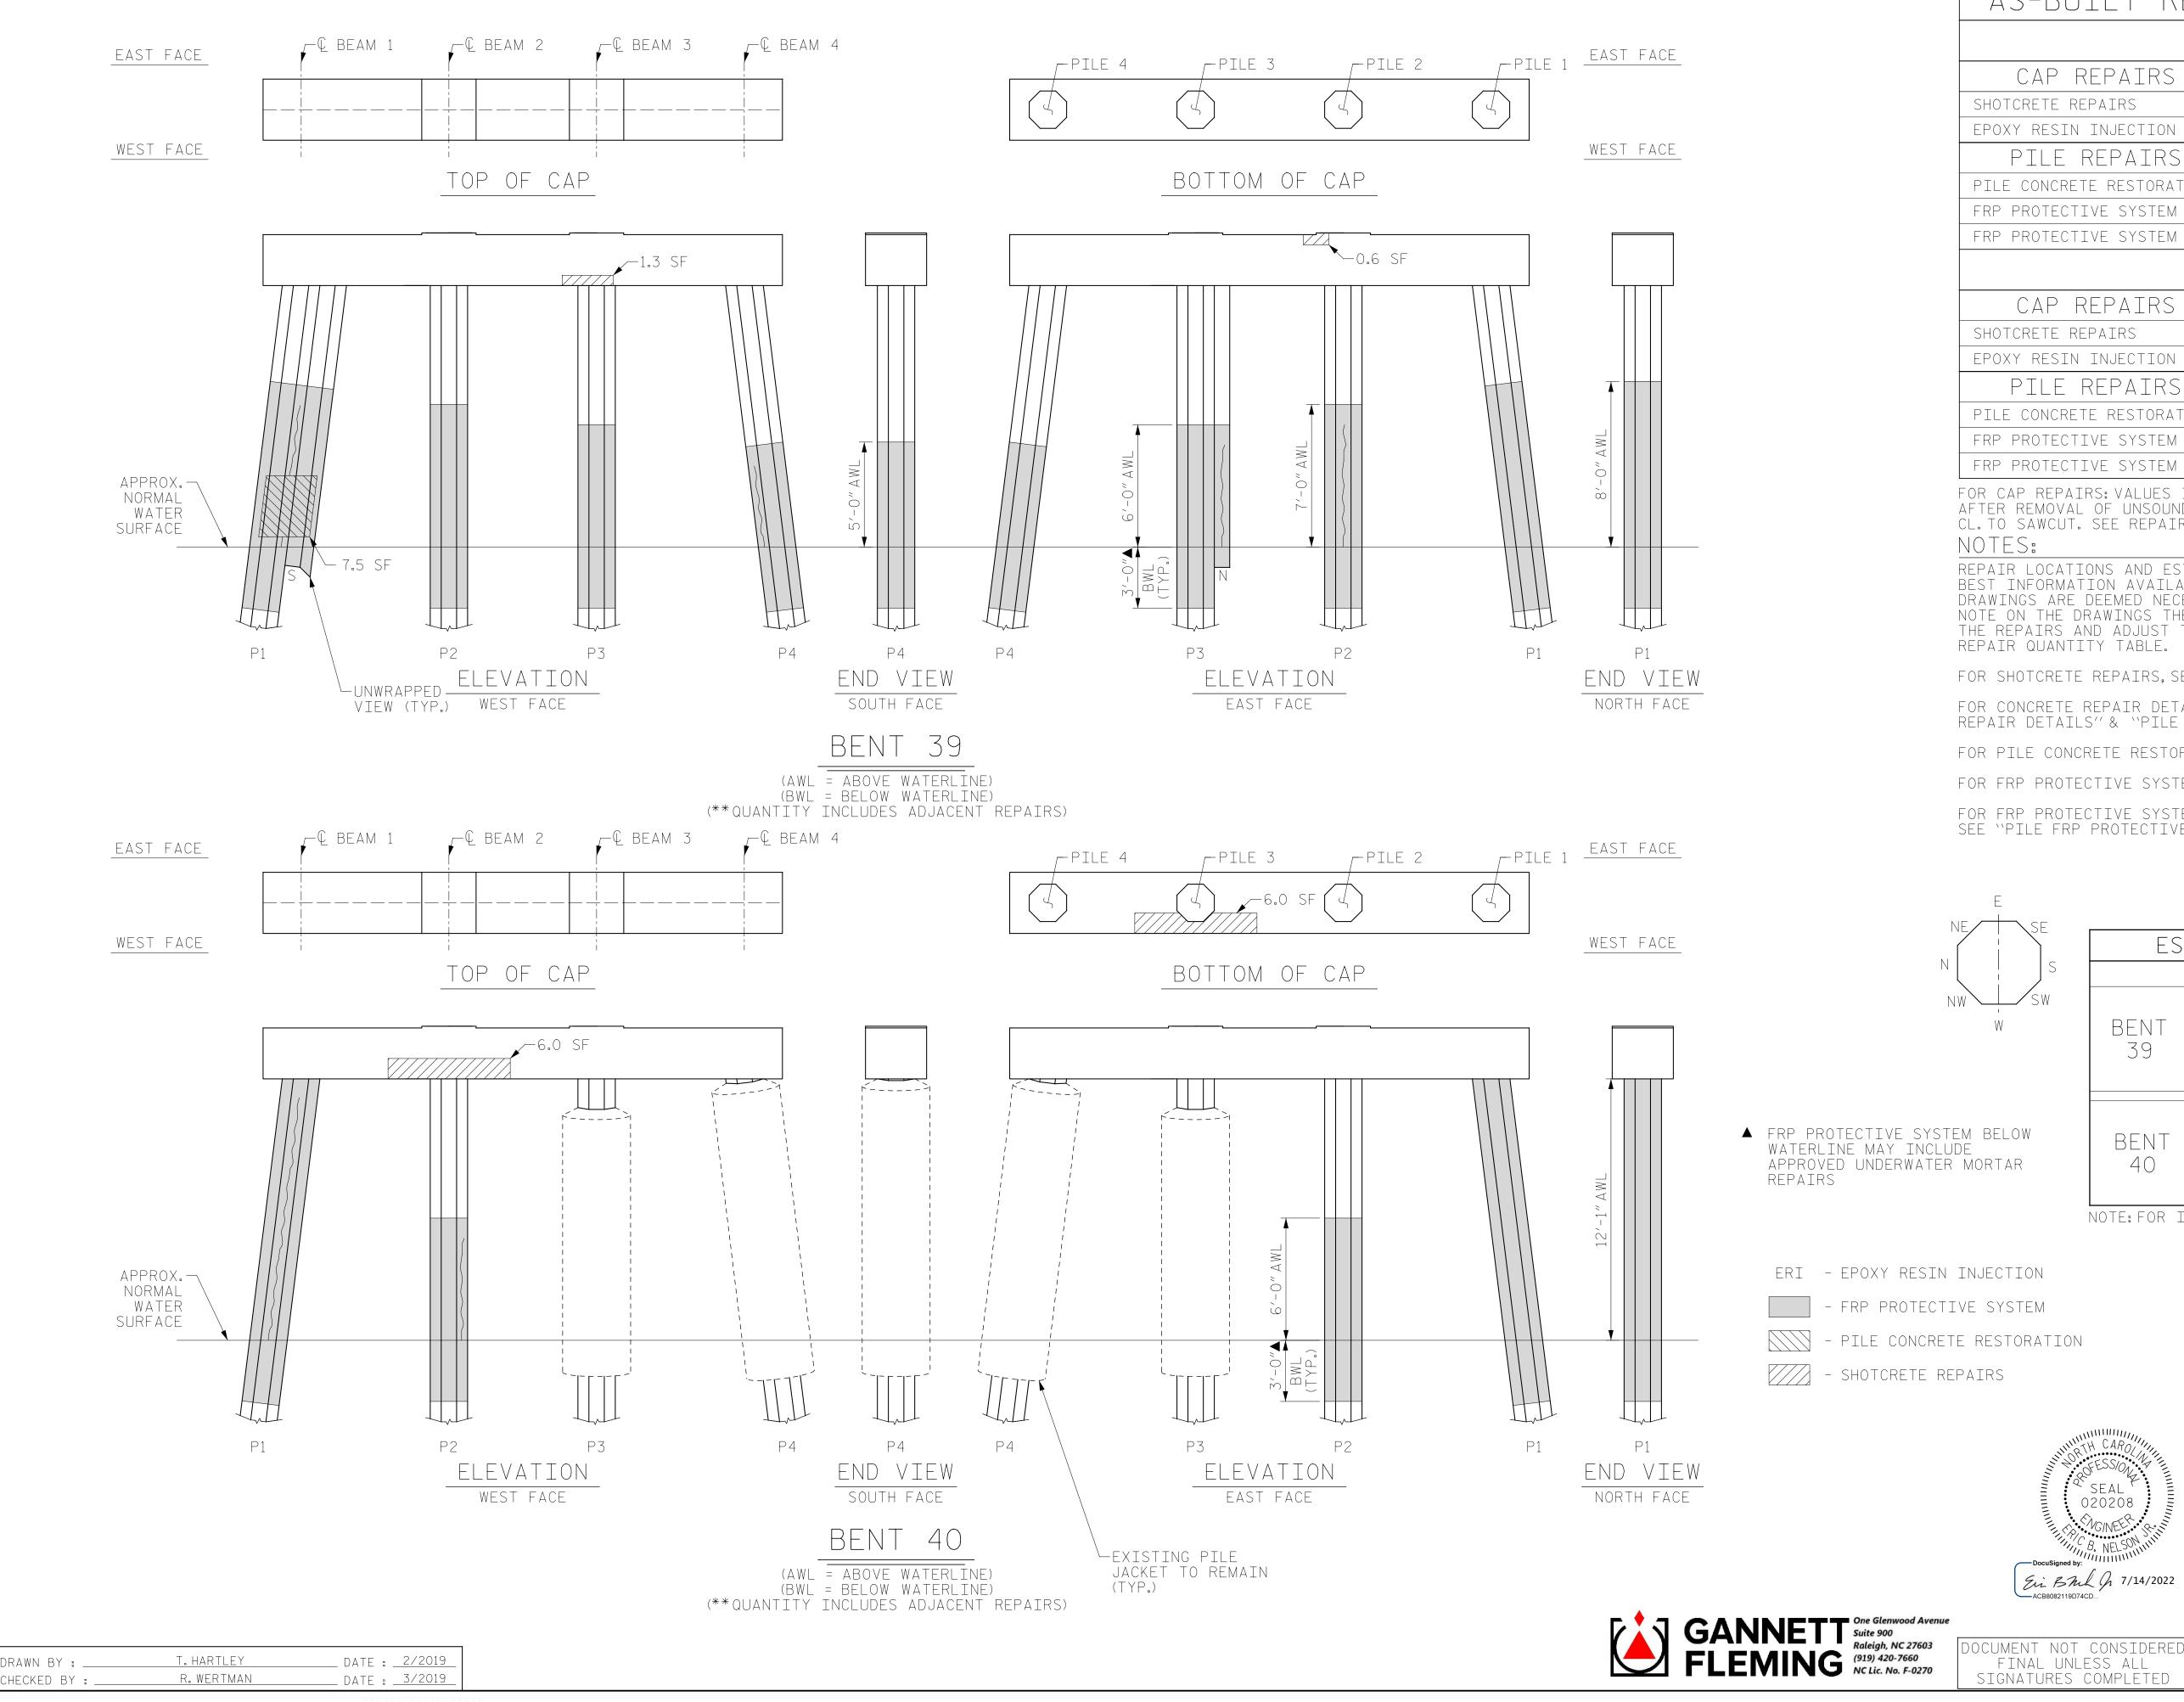
AS-BUILT REPAIR QUANTITY TABLE BENT 39 CAP REPAIRS ESTIMATE SF 1.9 SF | 1.0 CF EPOXY RESIN INJECTION - LF PILE REPAIRS ESTIMATE SF PILE CONCRETE RESTORATION 7.5 SF | 2.9 CF FRP PROTECTIVE SYSTEM AWL 143.9 SF FRP PROTECTIVE SYSTEM BWL 66.0 SF

BENI 4U								
CAP REPAIRS	ESTI	MATE						
SHOTCRETE REPAIRS	12.0 SF	6.0 CF	SF	CF				
EPOXY RESIN INJECTION	_	LF		LF				
PILE REPAIRS	ESTI	MATE						
PILE CONCRETE RESTORATION	- SF	- CF	SF	CF				
FRP PROTECTIVE SYSTEM AWL	99.5	SF						
FRP PROTECTIVE SYSTEM BWL	33.0) SF

ESTIMATED PILE CRACK QTY.										
NW W SW S SE E NE N										
	PILE 1	_	_	4	_	_	_	_	_	
BENT	PILE 2	_	_	_	_	_	6	6	6	
39	PILE 3	_	_	_	2	_	_	_	5	
	PILE 4	_	4	_	_	_	3	_	-	
	PILE 1	_	12	_	12	_	_	_	6	
BENT	PILE 2	_	-	5	2	-	-	_	_	
40	PILE 3	_	_	_	_	_	_	_	_	
	PILE 4	-	Ι	-	-	_	Ι	-	_	
JOTE, FOR TH	E O R M A T T O N	I ON	PTI	F CO	NDTT	TON	ONI V	_

FOR CAP REPAIRS: VALUES IN CHART REPRESENT ESTIMATED REPAIR TOTALS AFTER REMOVAL OF UNSOUND CONCRETE, MIN. OF 1"BEHIND REBAR AND MIN. 2 CL. TO SAWCUT. SEE REPAIR DETAILS.

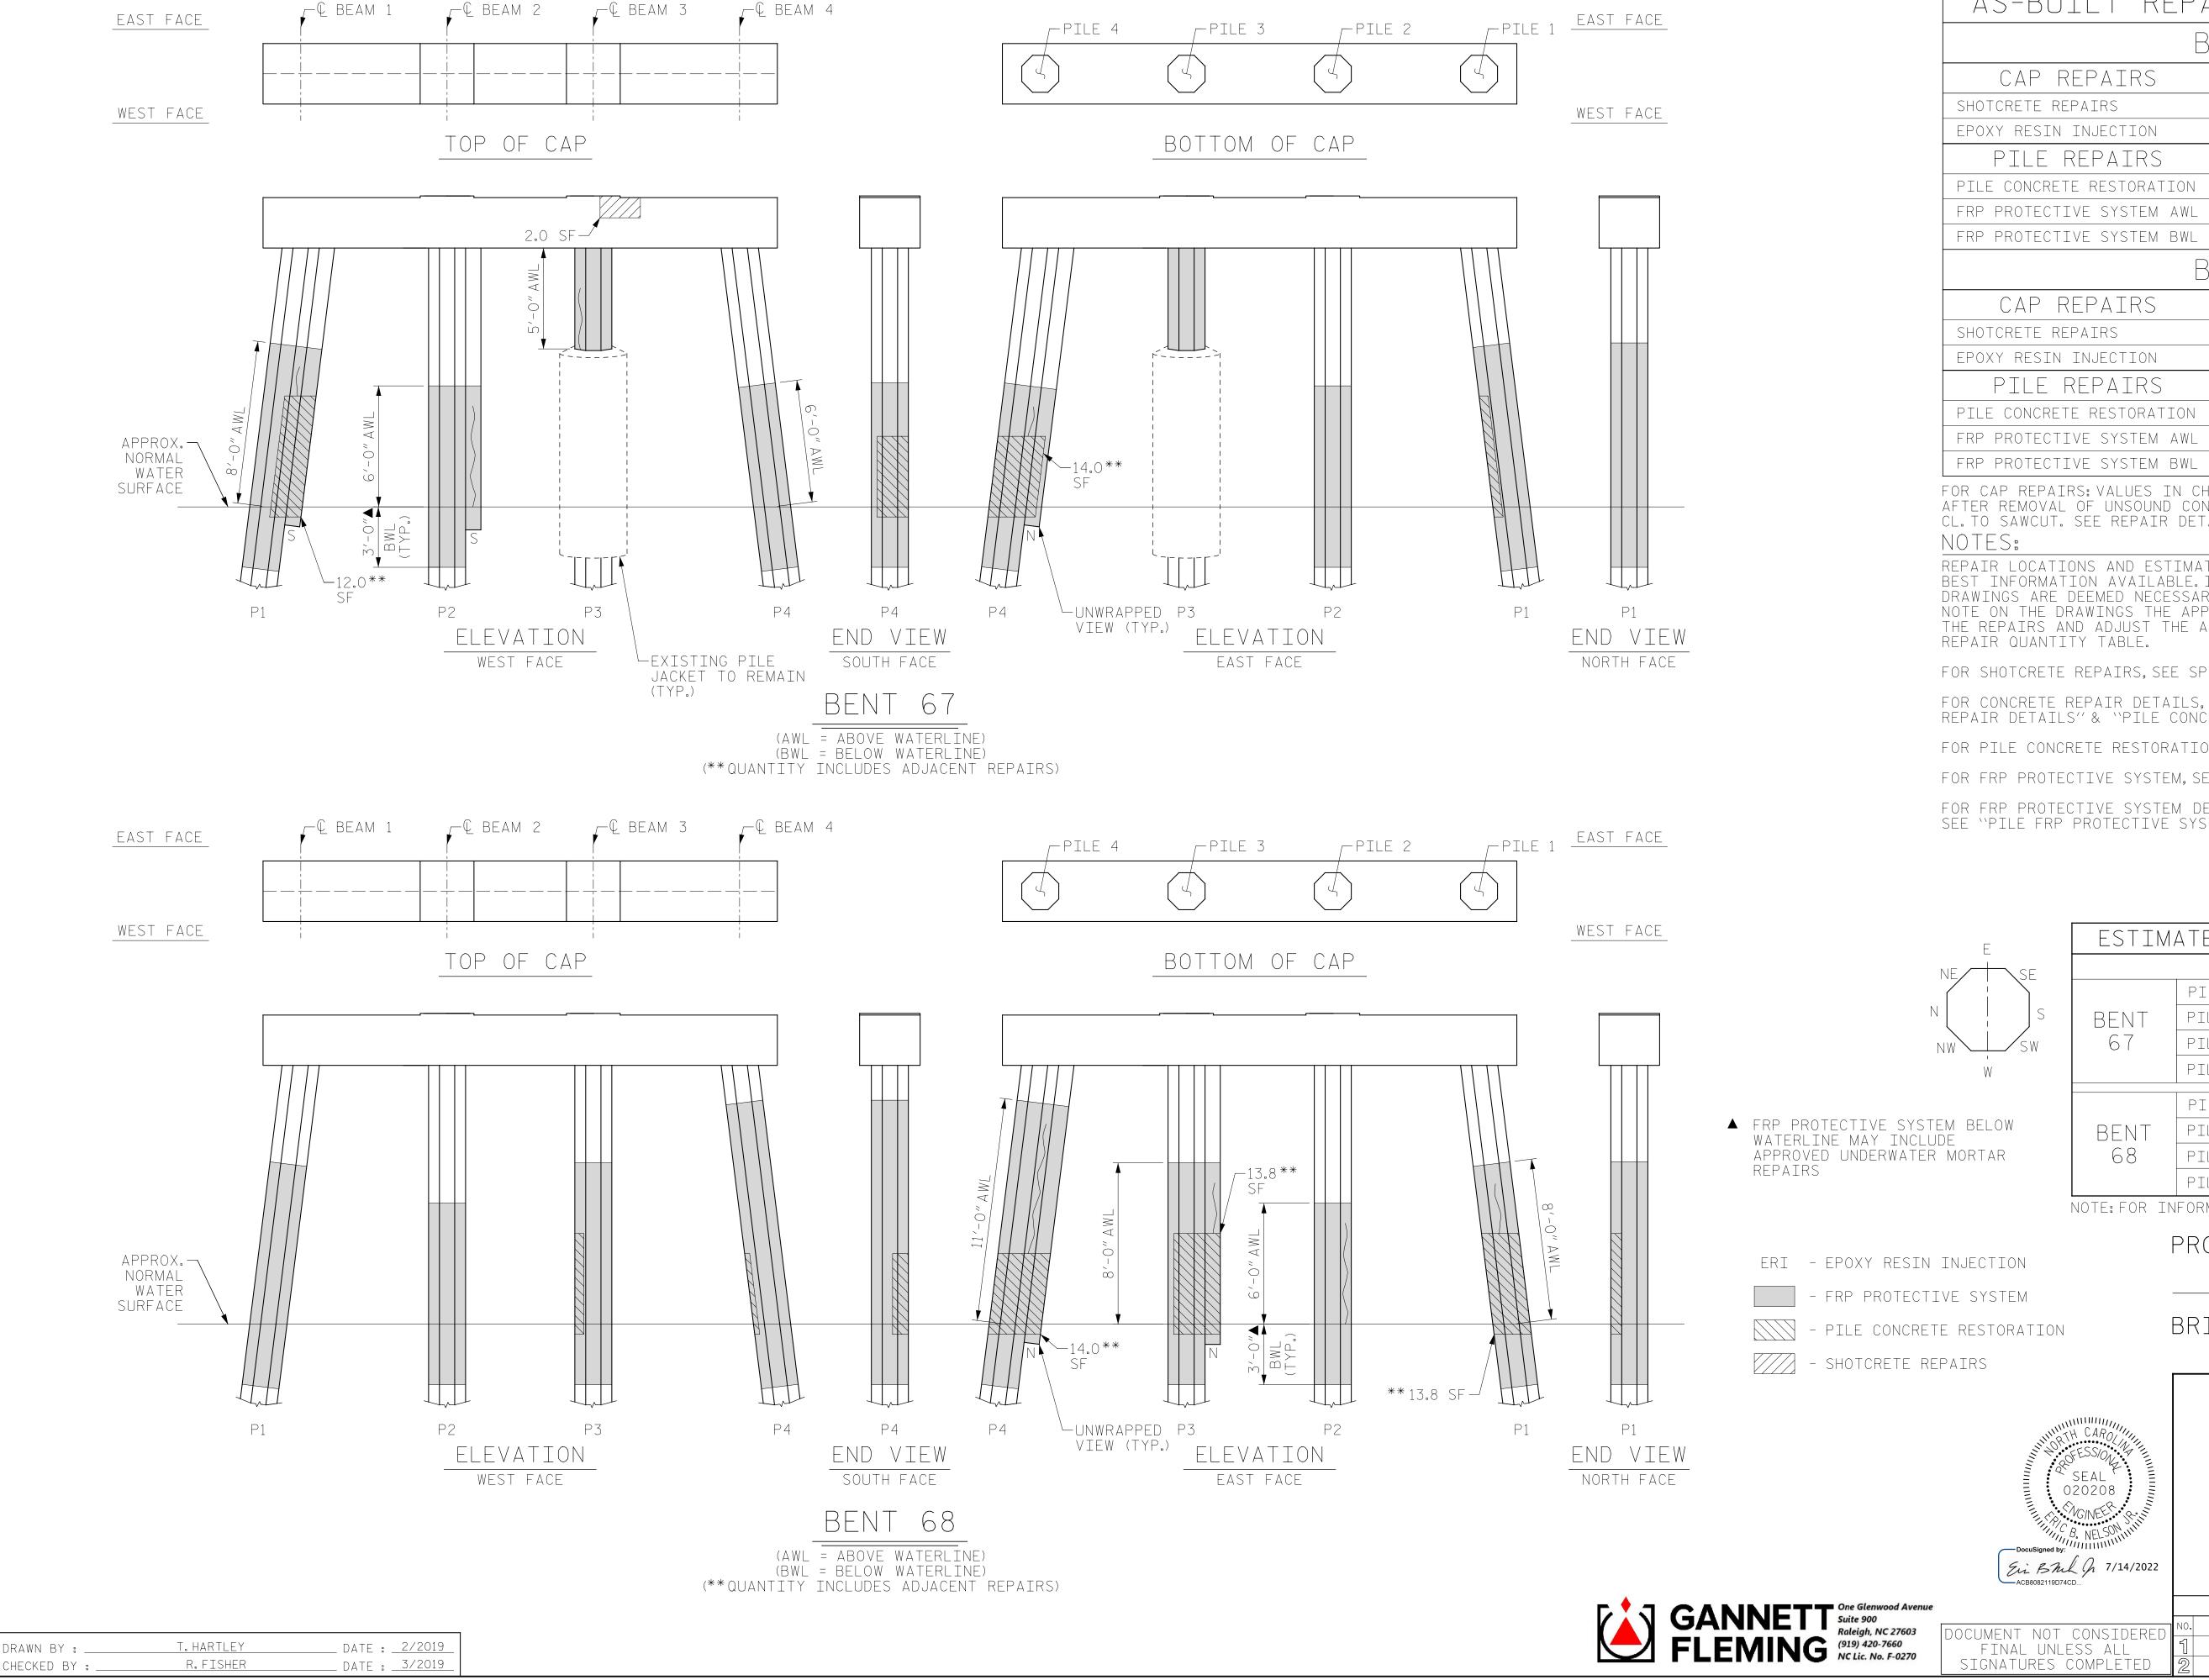
AS-BUILT REPAIR QUANTITY TABLE BENT 67 CAP REPAIRS SF SHOTCRETE REPAIRS 2.0 SF | 1.0 CF EPOXY RESIN INJECTION - LF PILE REPAIRS SF PILE CONCRETE RESTORATION | 26.0 SF | 9.9 CF FRP PROTECTIVE SYSTEM AWL 138.4 SF FRP PROTECTIVE SYSTEM BWL 49.5 SF BENT 68 CAP REPAIRS SF SHOTCRETE REPAIRS - SF - CF EPOXY RESIN INJECTION - LF PILE REPAIRS 41.6 SF | 16.0 CF SF

FOR CAP REPAIRS: VALUES IN CHART REPRESENT ESTIMATED REPAIR TOTALS AFTER REMOVAL OF UNSOUND CONCRETE, MIN. OF 1"BEHIND REBAR AND MIN. 2 CL. TO SAWCUT. SEE REPAIR DETAILS.

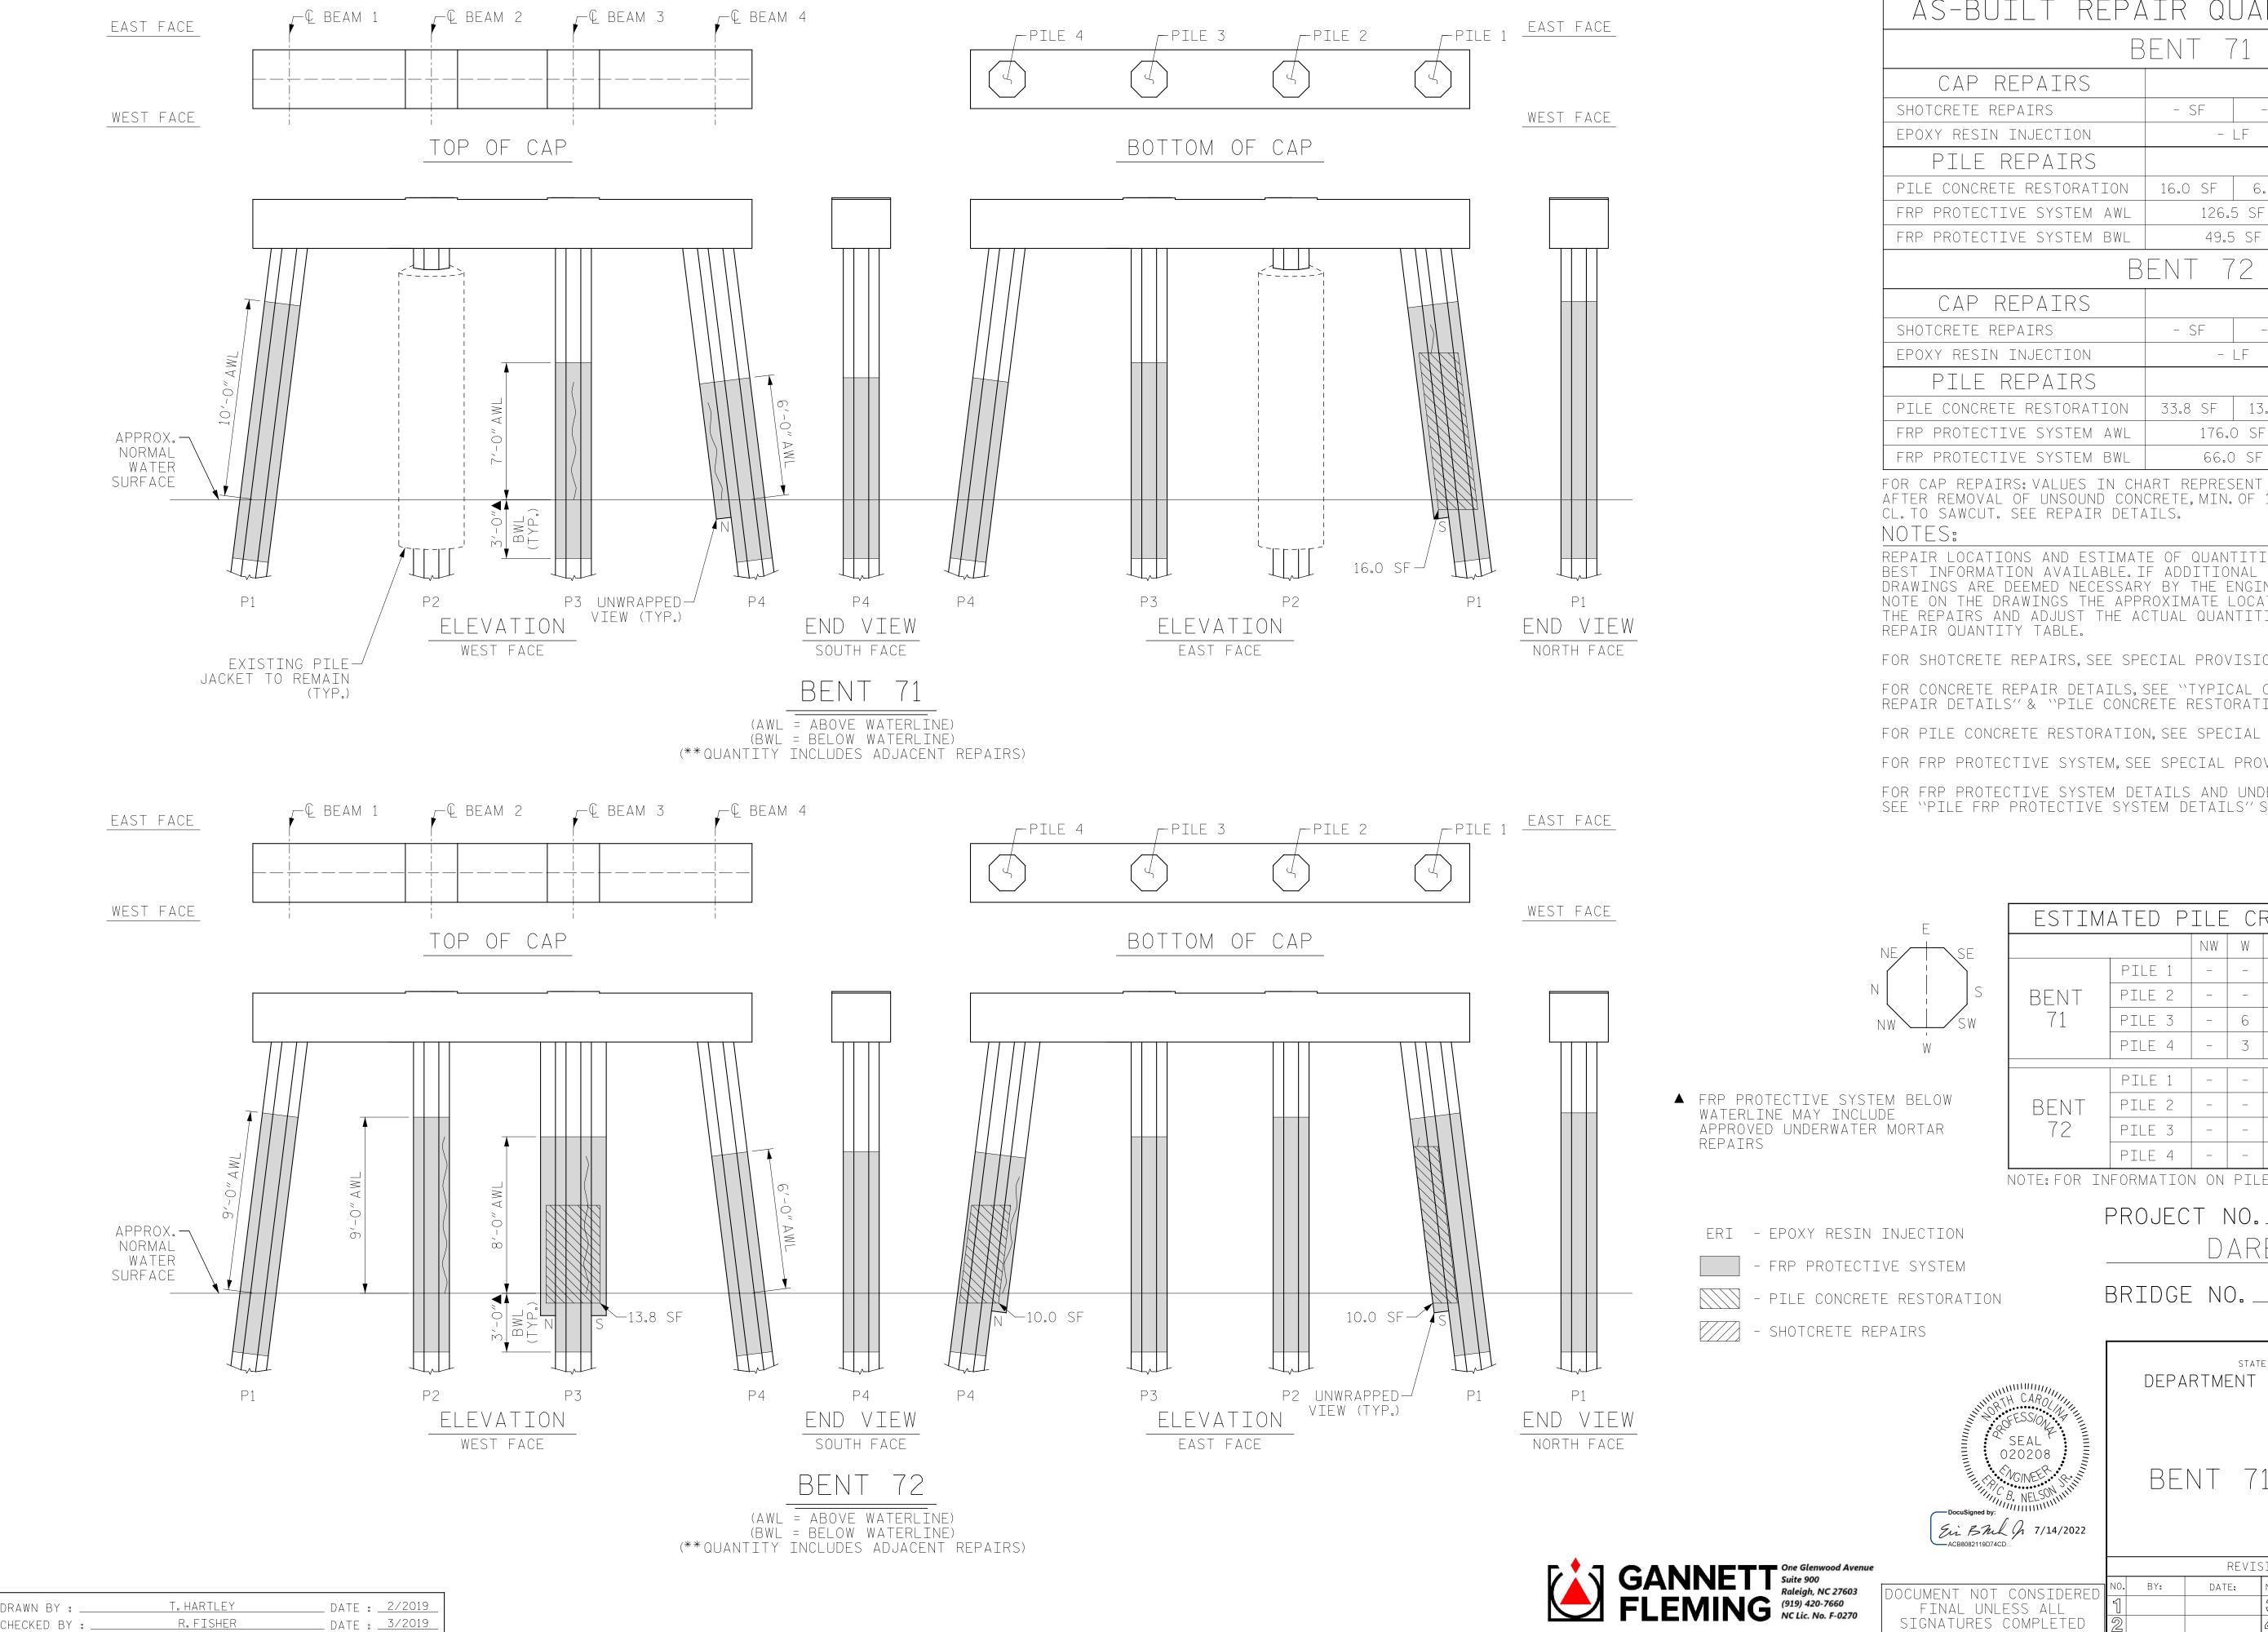
AS-BUILT REPAIR QUANTITY TABLE BENT 71 SF - SF - CF - LF SF PILE CONCRETE RESTORATION 16.0 SF | 6.3 CF FRP PROTECTIVE SYSTEM AWL 126.5 SF FRP PROTECTIVE SYSTEM BWL 49.5 SF RENIT 72

DENI 12						
CAP REPAIRS						
SHOTCRETE REPAIRS	- SF	- CF	SF	CF		
EPOXY RESIN INJECTION	_	LF		LF		
PILE REPAIRS						
PILE CONCRETE RESTORATION	33.8 SF	13.6 CF	SF	CF		
FRP PROTECTIVE SYSTEM AWL	176.0 SF					
FRP PROTECTIVE SYSTEM BWL	66.0) SF
