AS-BUILT REPAIR QUANTITY TABLE

PROJECT NO. HB-0017  
DARE COUNTY  
 BRIDGE NO. 270009

STATE OF NORTH CAROLINA  
 DEPARTMENT OF TRANSPORTATION  
 RALEIGH

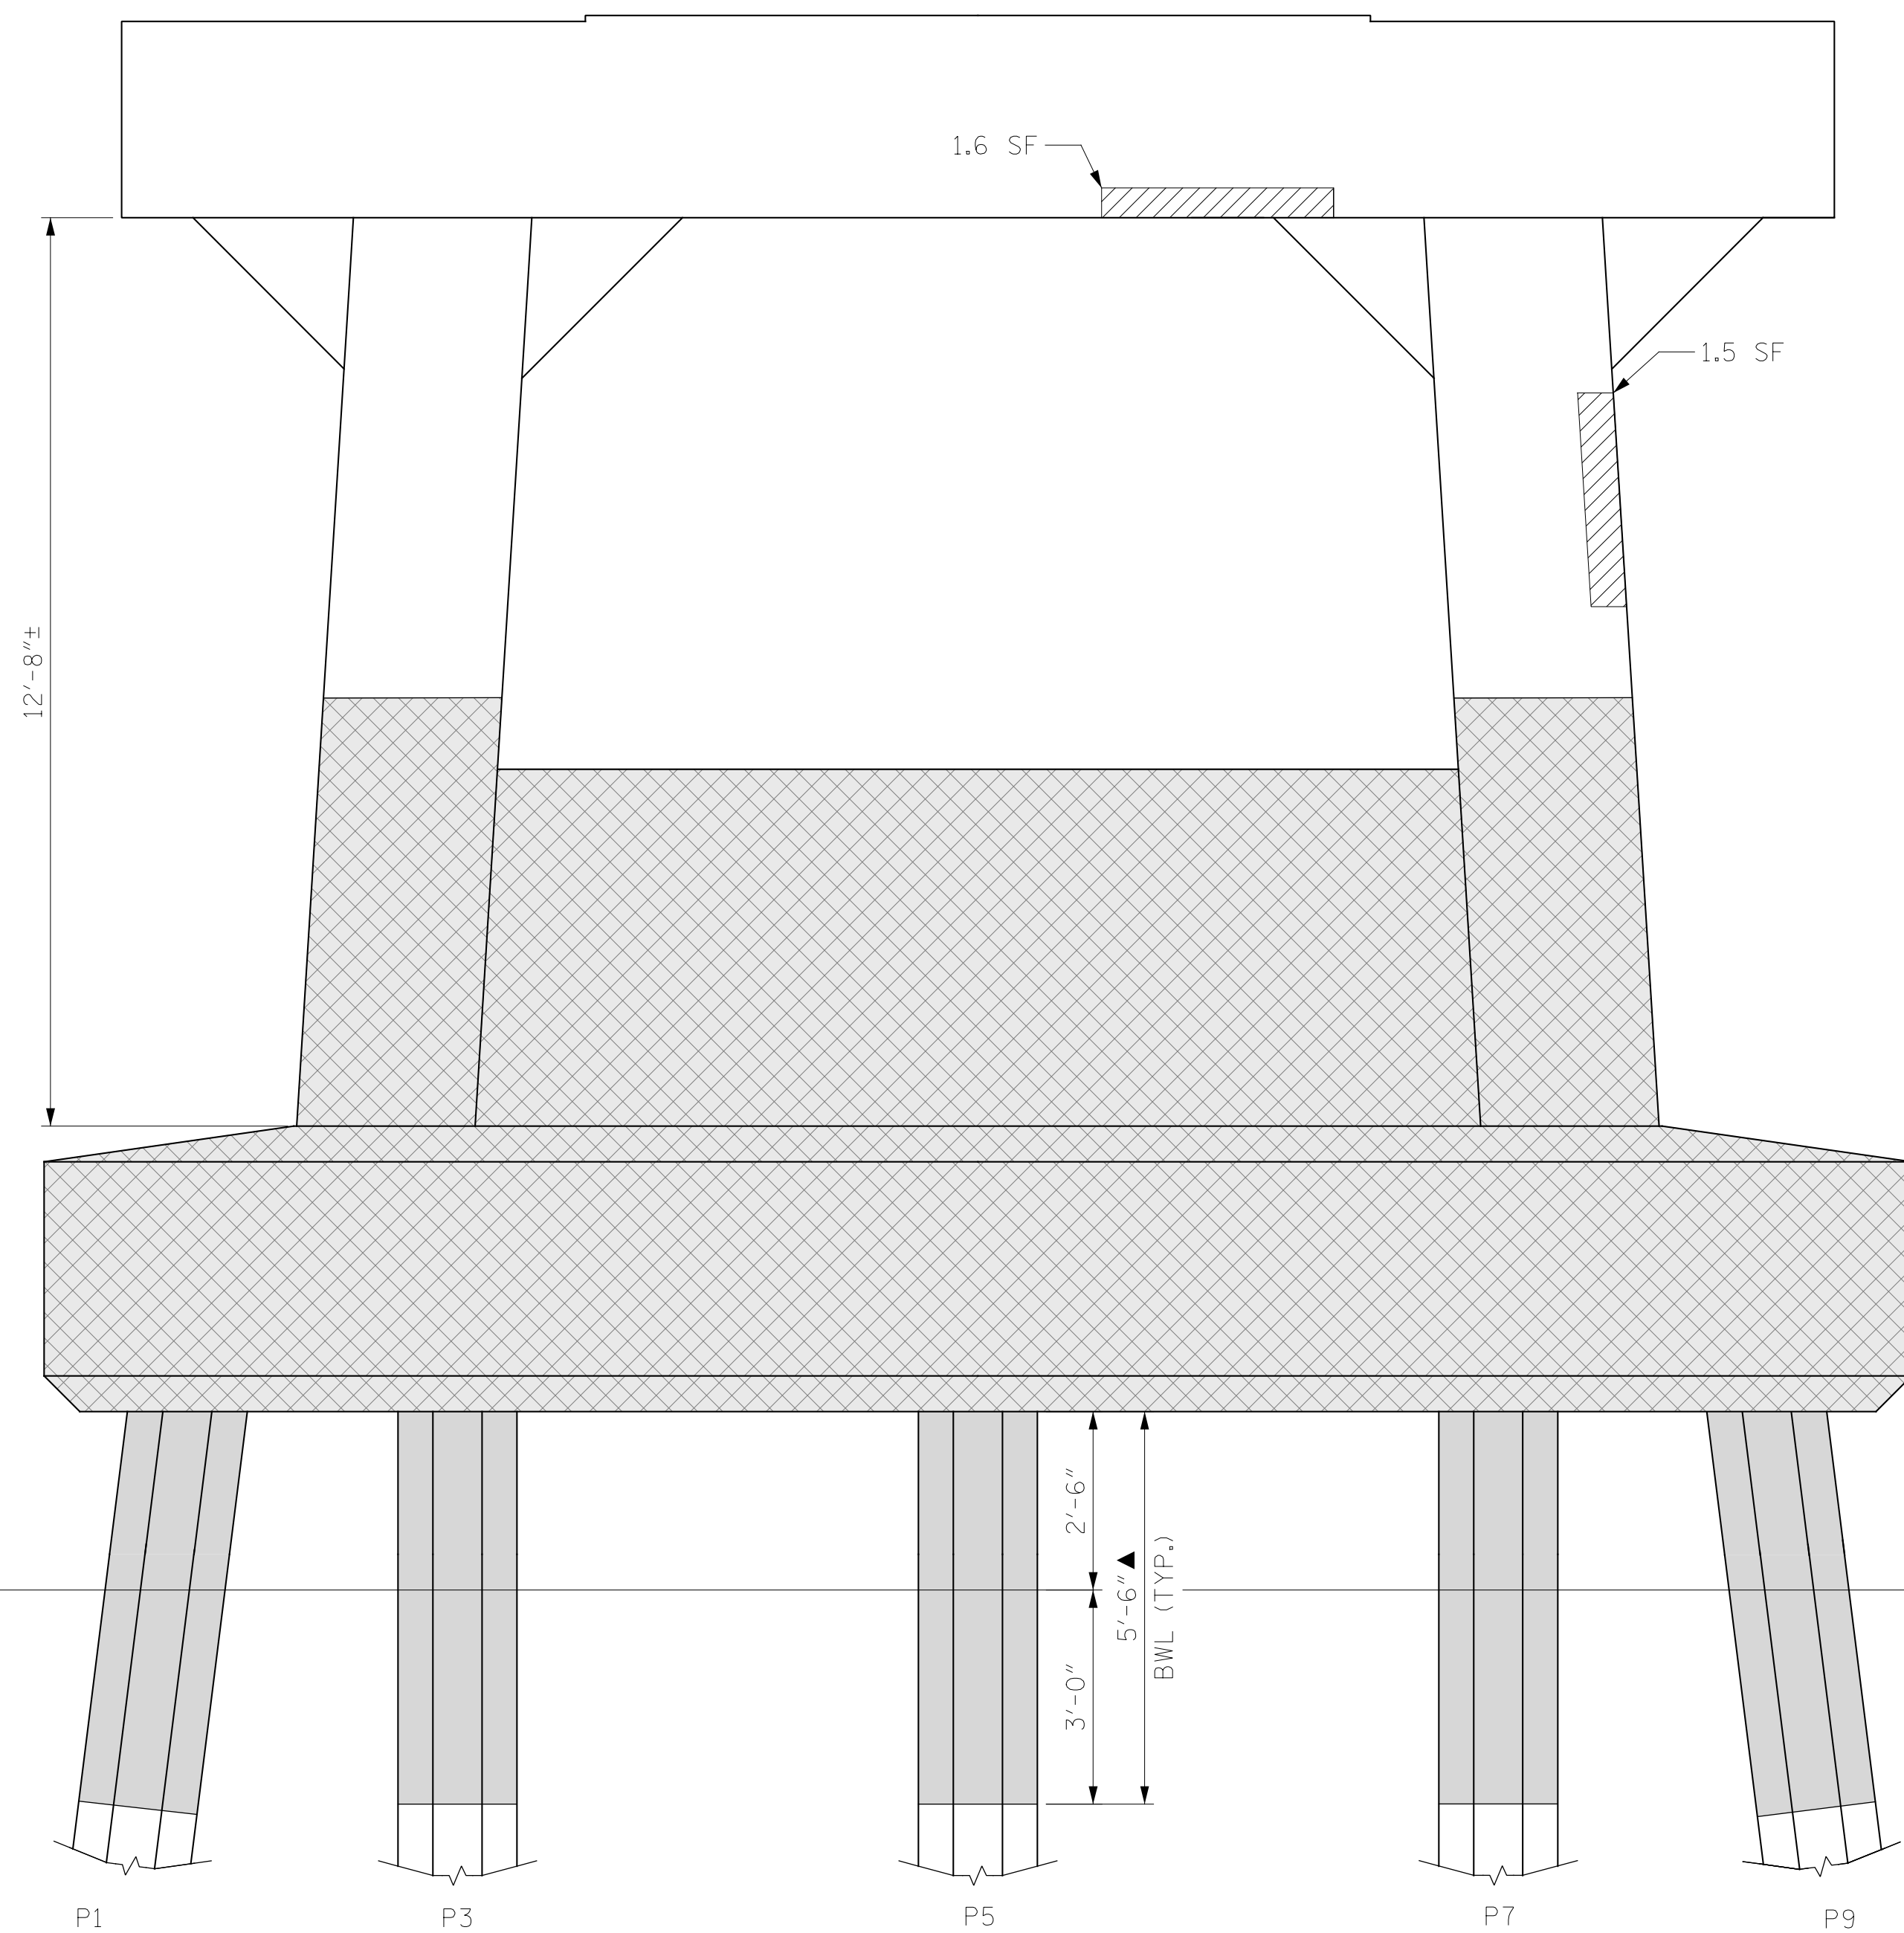
# AS-BUILT REPAIR QUANTITY TABLE BENT 152

CAP REPAIRS		ESTIMATE		ACTUAL	
SHOTCRETE REPAIRS	1.6 SF	0.8 CF	SF	CF	
EPOXY RESIN INJECTION	3.0 LF				LF
COLUMN REPAIRS		ESTIMATE		ACTUAL	
SHOTCRETE REPAIRS	11.2 SF	5.6 CF	SF	CF	
EPOXY RESIN INJECTION	- LF				LF
PILE REPAIRS		ESTIMATE		ACTUAL	
FRP PROTECTIVE SYSTEM AWL	- SF				SF
FRP PROTECTIVE SYSTEM BWL	302.5 SF				SF

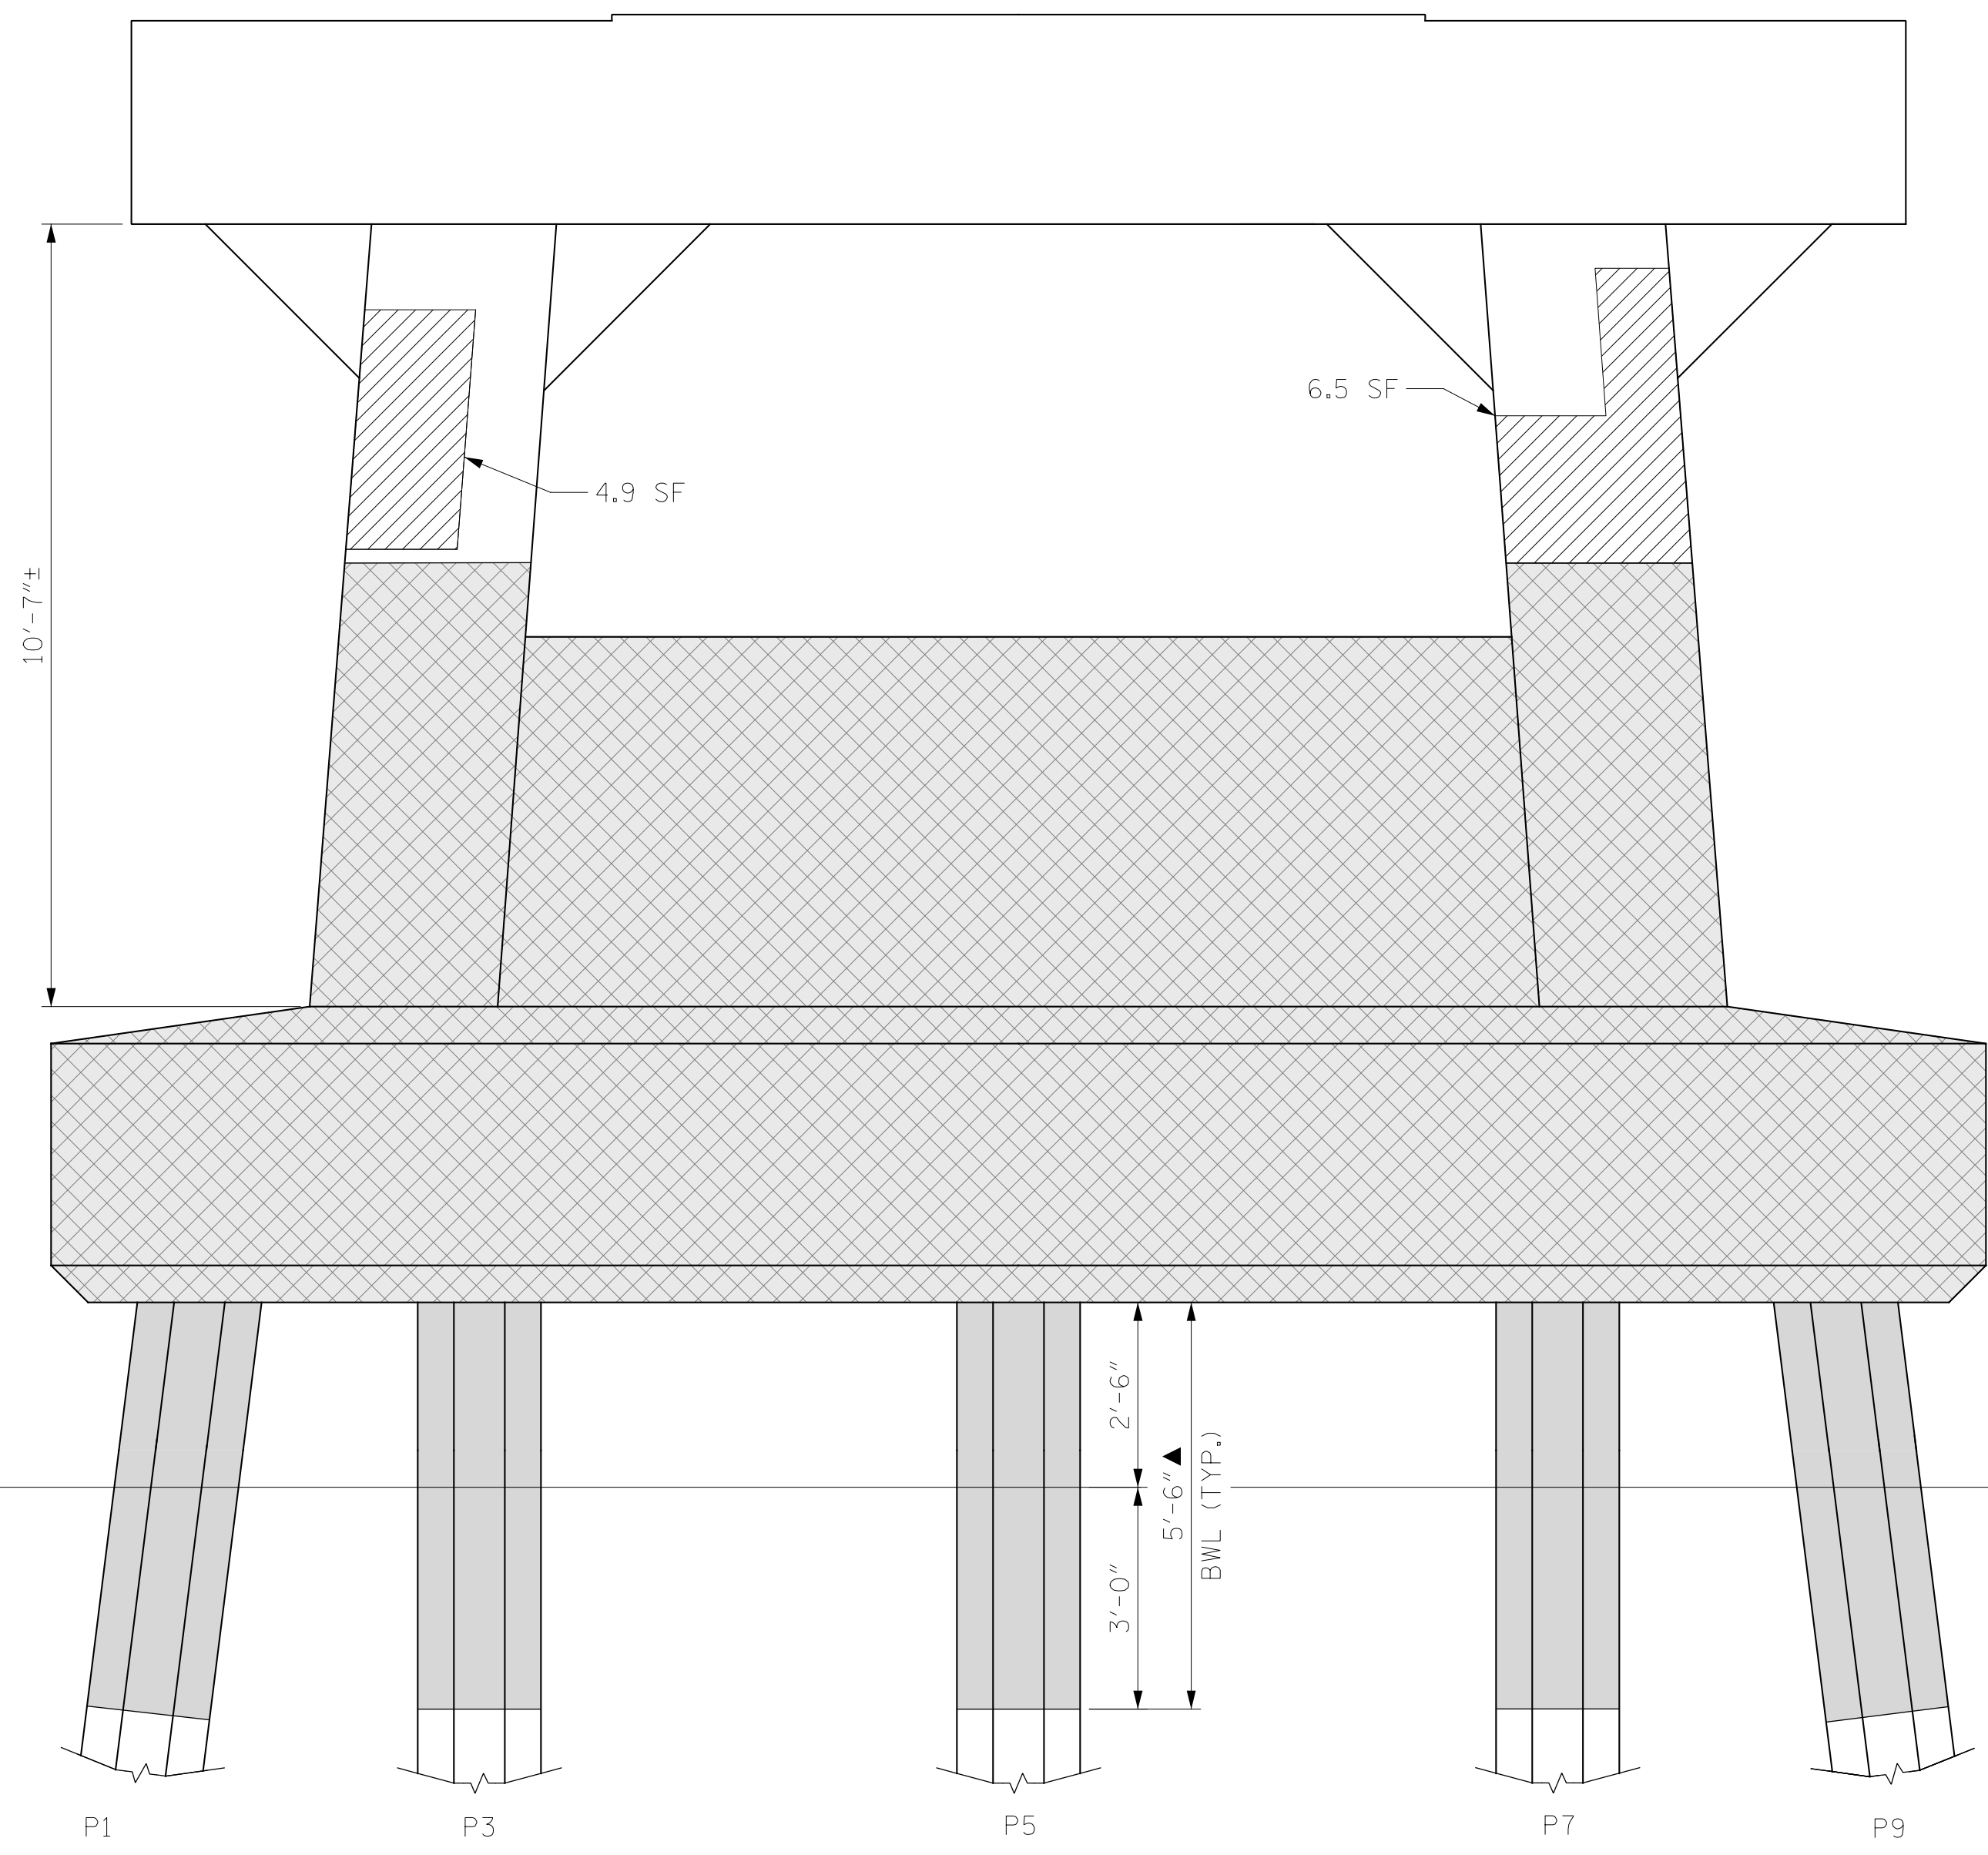
ELEVATION  
WEST FACE

CAP REPAIRS		ESTIMATE		ACTUAL	
SHOTCRETE REPAIRS	2.0 SF	1.0 CF	SF	CF	
EPOXY RESIN INJECTION	- LF				LF
COLUMN REPAIRS		ESTIMATE		ACTUAL	
SHOTCRETE REPAIRS	46.2 SF	23.1 CF	SF	CF	
EPOXY RESIN INJECTION	- LF				LF
PILE REPAIRS		ESTIMATE		ACTUAL	
FRP PROTECTIVE SYSTEM AWL	- SF				SF
FRP PROTECTIVE SYSTEM BWL	302.5 SF				SF

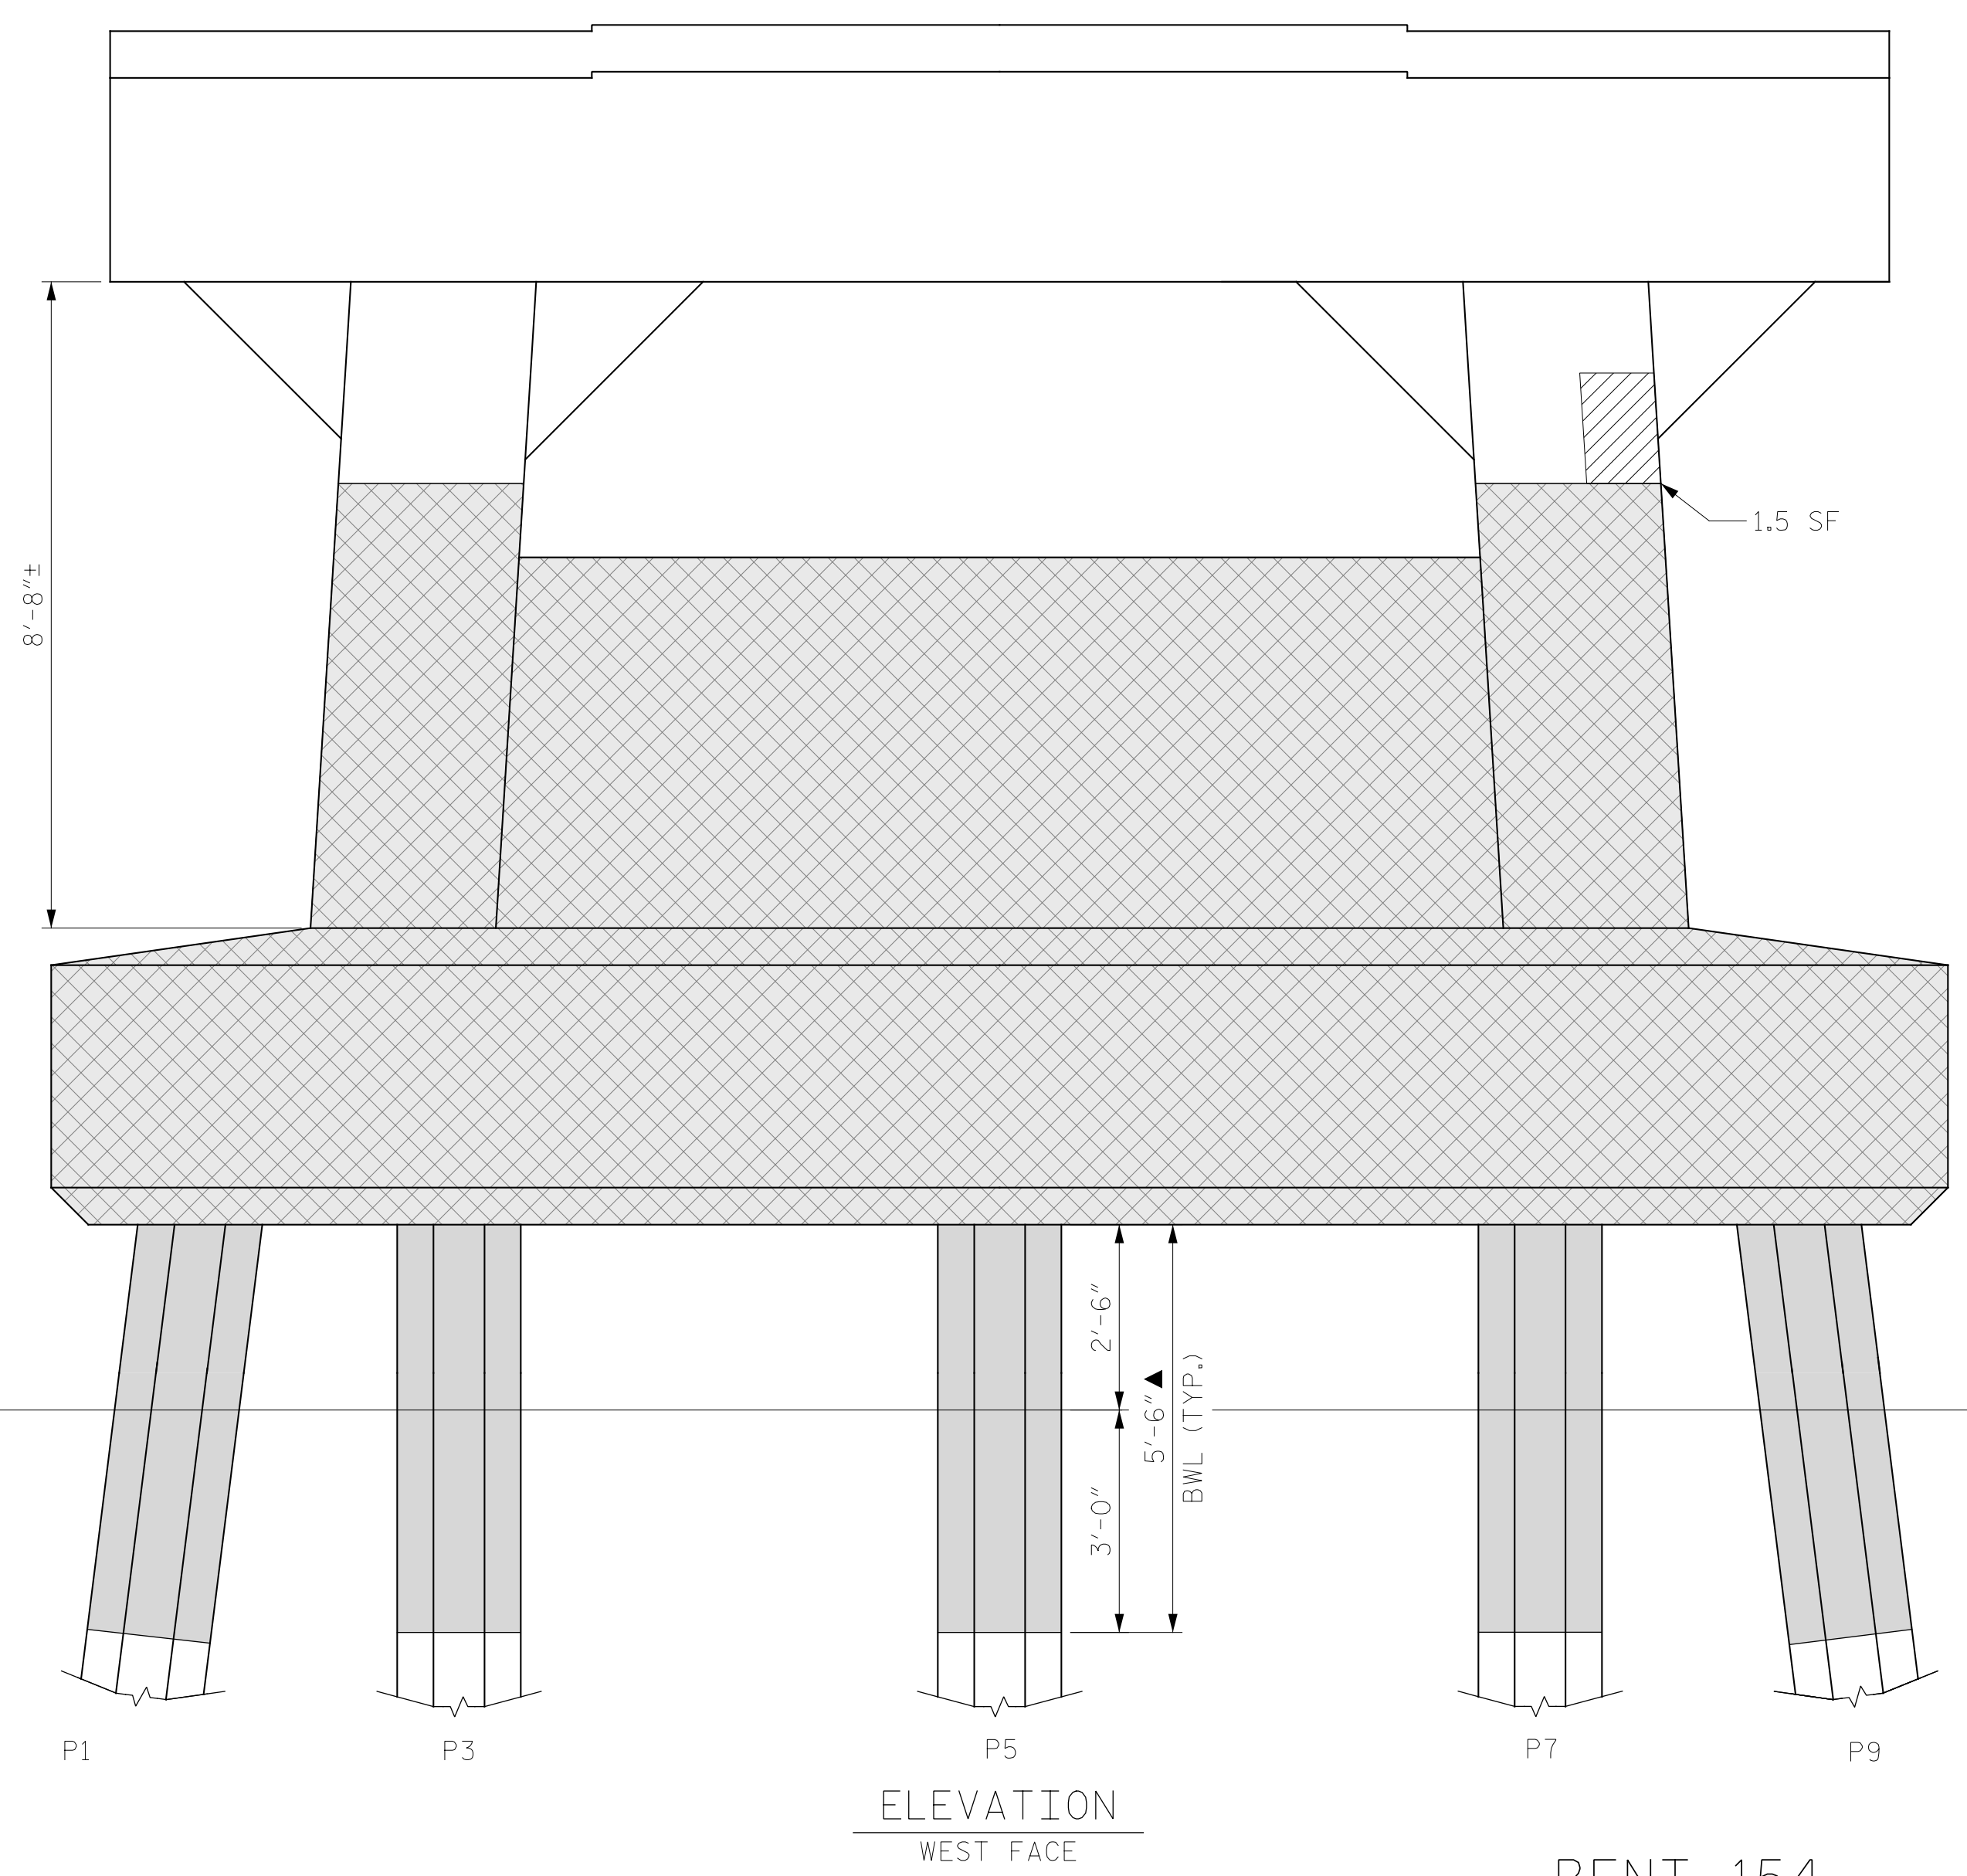
BENT 154				
CAP REPAIRS		ESTIMATE		ACTUAL
SHOTCRETE REPAIRS	- SF	- CF	SF	CF
EPOXY RESIN INJECTION	- LF		LF	
COLUMN REPAIRS		ESTIMATE		ACTUAL
SHOTCRETE REPAIRS	14.4 SF	7.2 CF	SF	CF
EPOXY RESIN INJECTION	- LF		LF	
PILE REPAIRS		ESTIMATE		ACTUAL
FRP PROTECTIVE SYSTEM AWL	- SF		SF	
FRP PROTECTIVE SYSTEM BWL	302.5 SF		SF

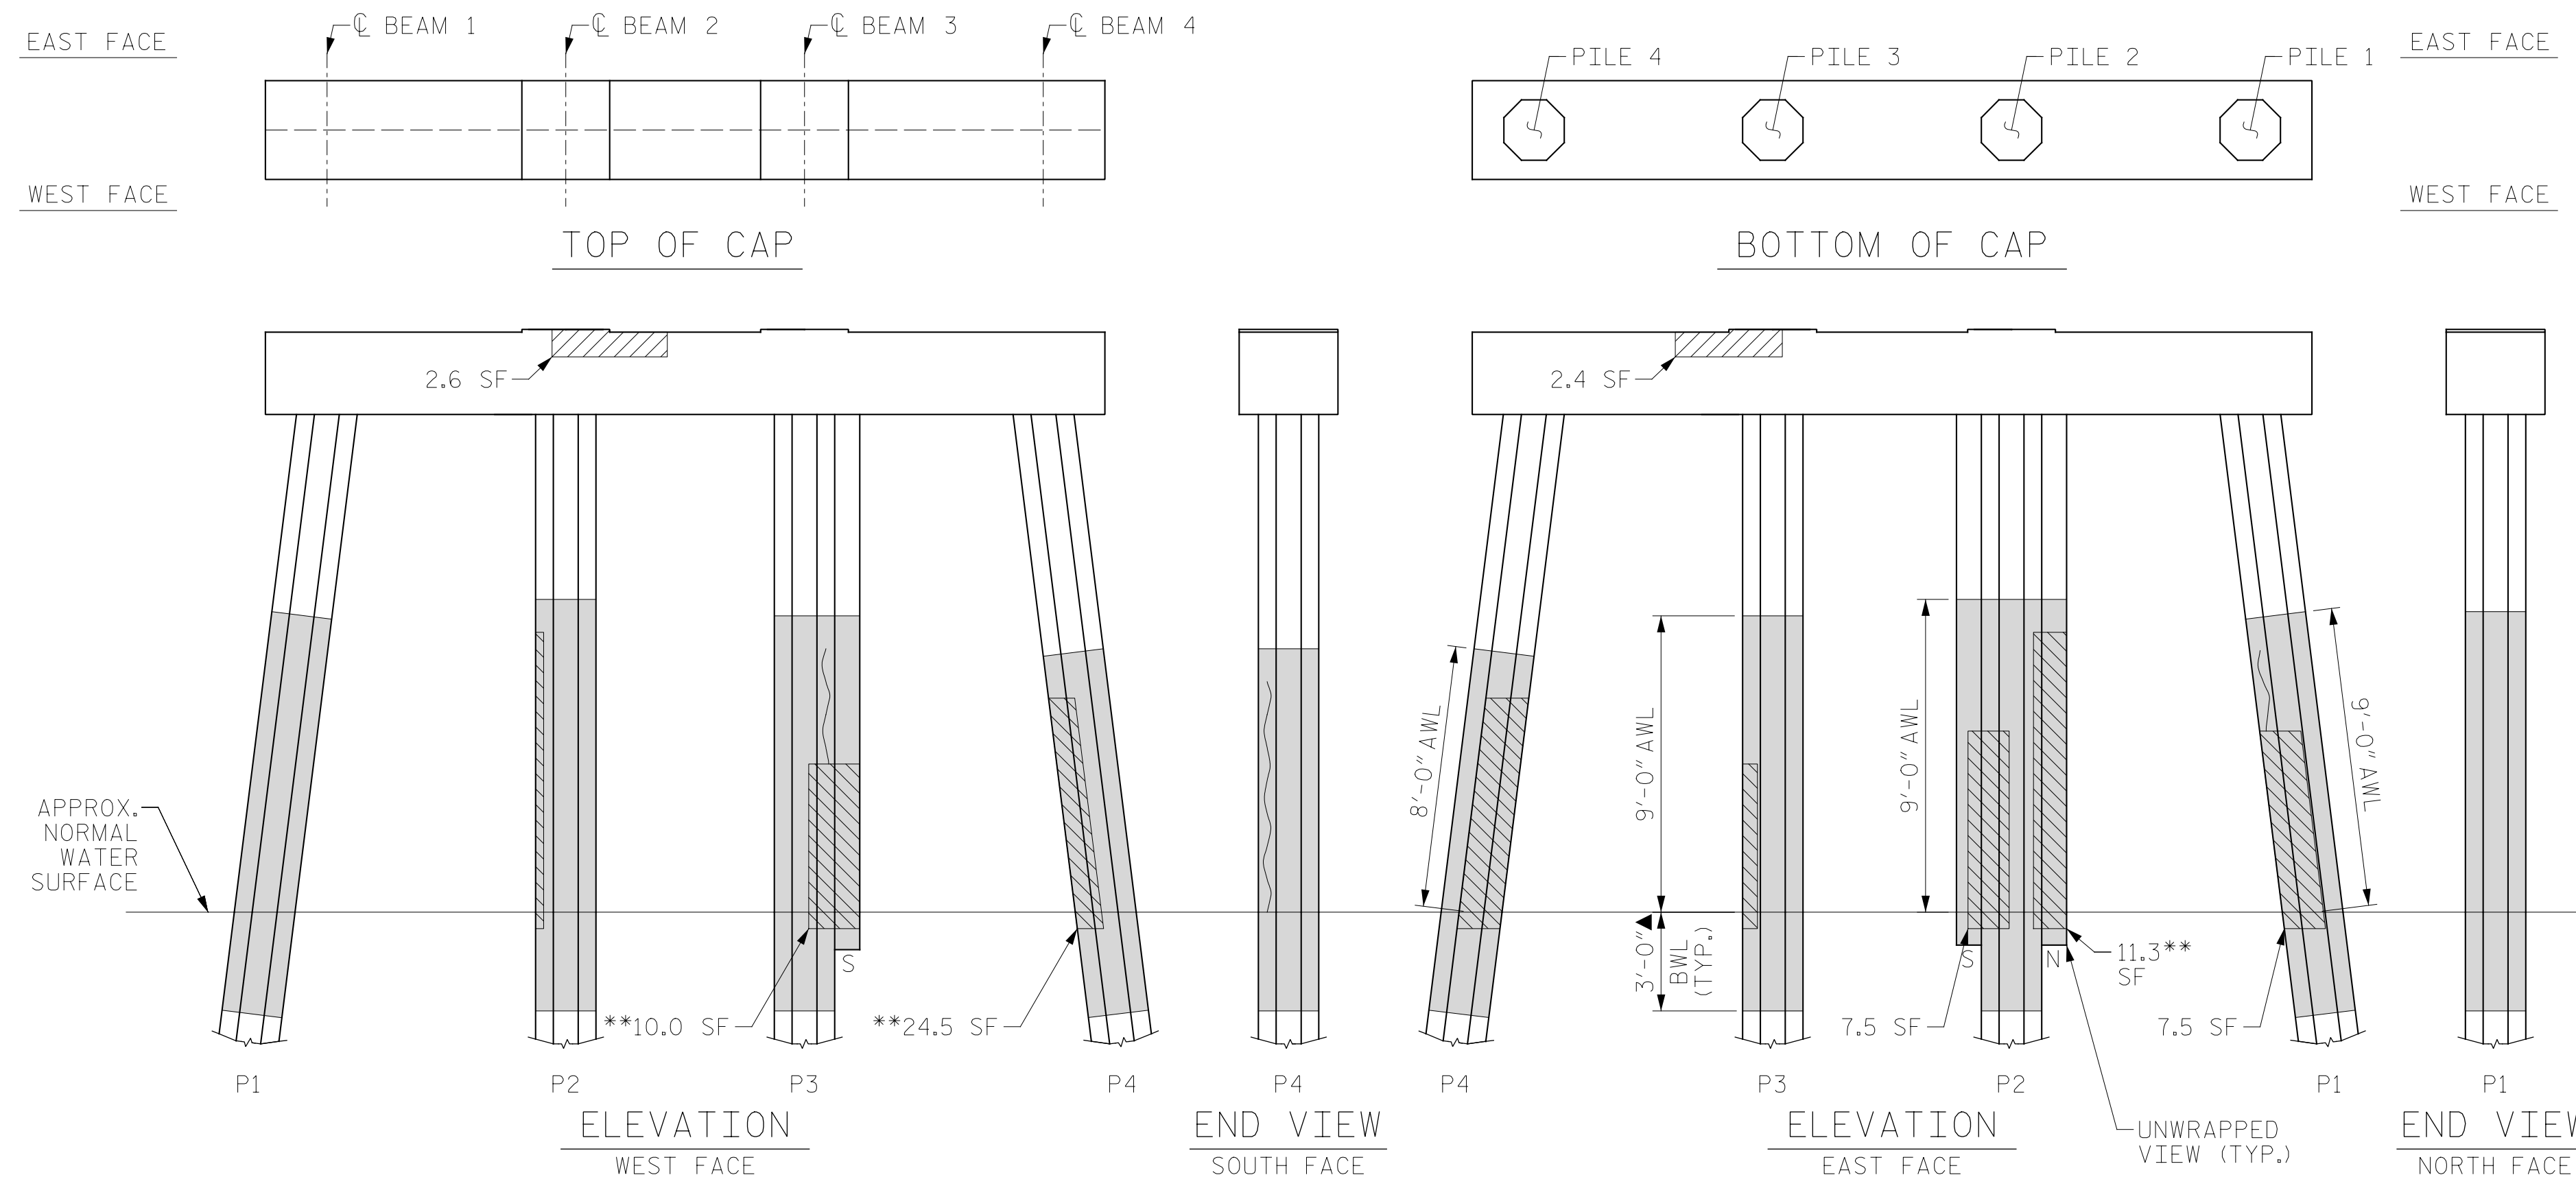
BENT 155

CAP REPAIRS			
SHOTCRETE REPAIRS	5.0 SF	2.5 CF	SF CF
EPOXY RESIN INJECTION	- LF		LF
PILE REPAIRS			
PILE CONCRETE RESTORATION	60.8 SF	25.3 CF	SF CF
FRP PROTECTIVE SYSTEM AWL	213.5 SF		
FRP PROTECTIVE SYSTEM BWL	73.2 SF

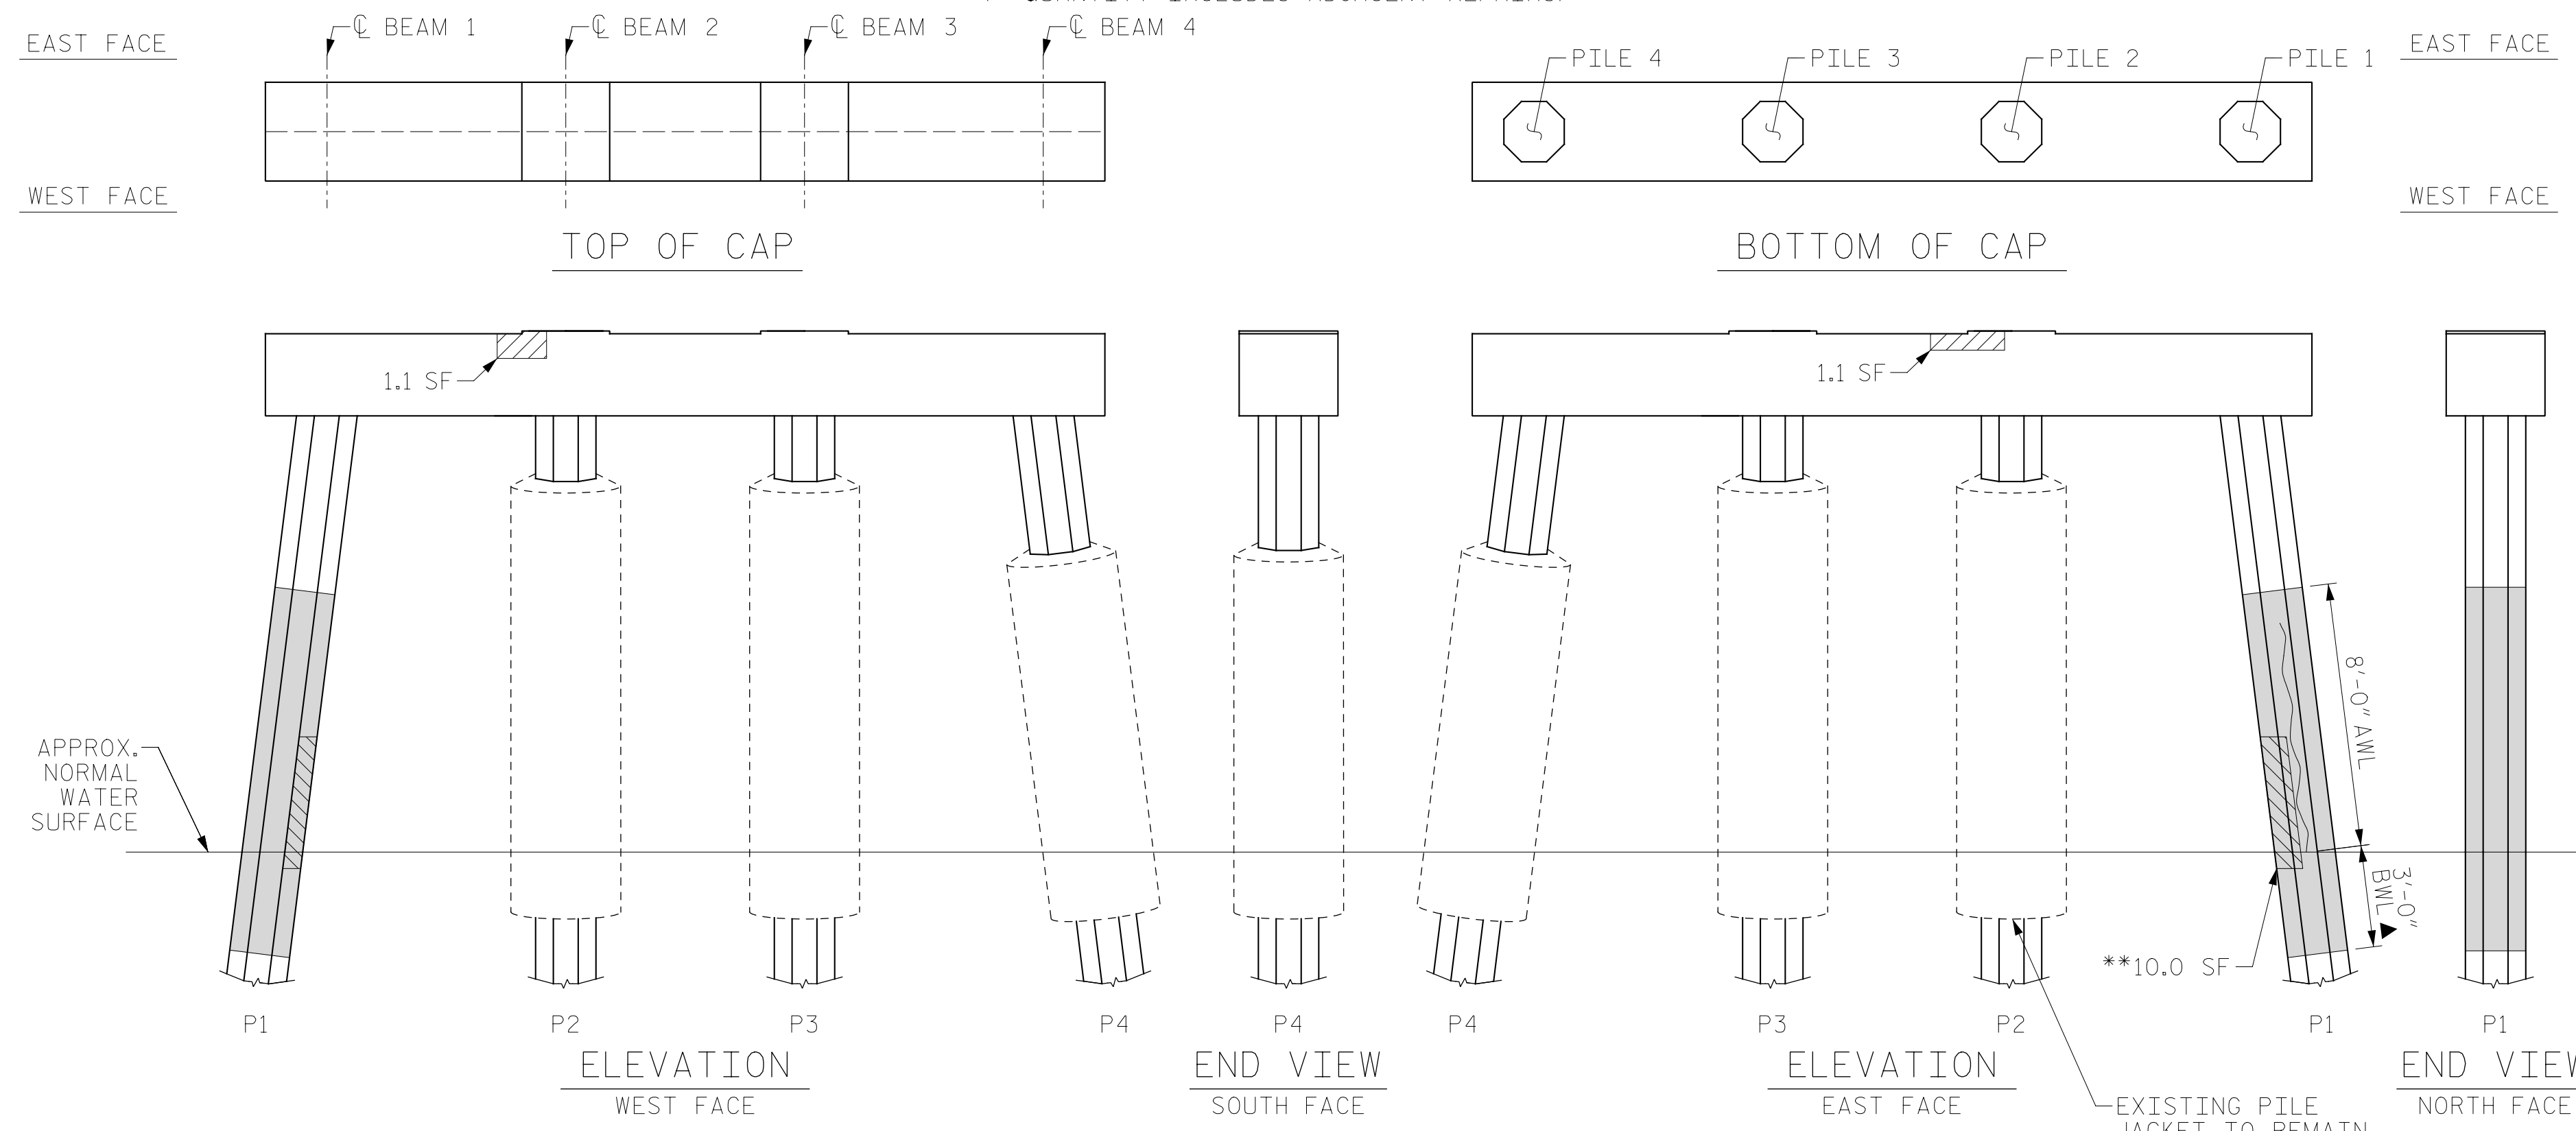
BENT 156

CAP REPAIRS			
SHOTCRETE REPAIRS	2.2 SF	1.1 CF	SF CF
EPOXY RESIN INJECTION	- LF		LF
PILE REPAIRS			
PILE CONCRETE RESTORATION	10.0 SF	3.8 CF	SF CF
FRP PROTECTIVE SYSTEM AWL	48.8 SF		
FRP PROTECTIVE SYSTEM BWL	18.3 SF

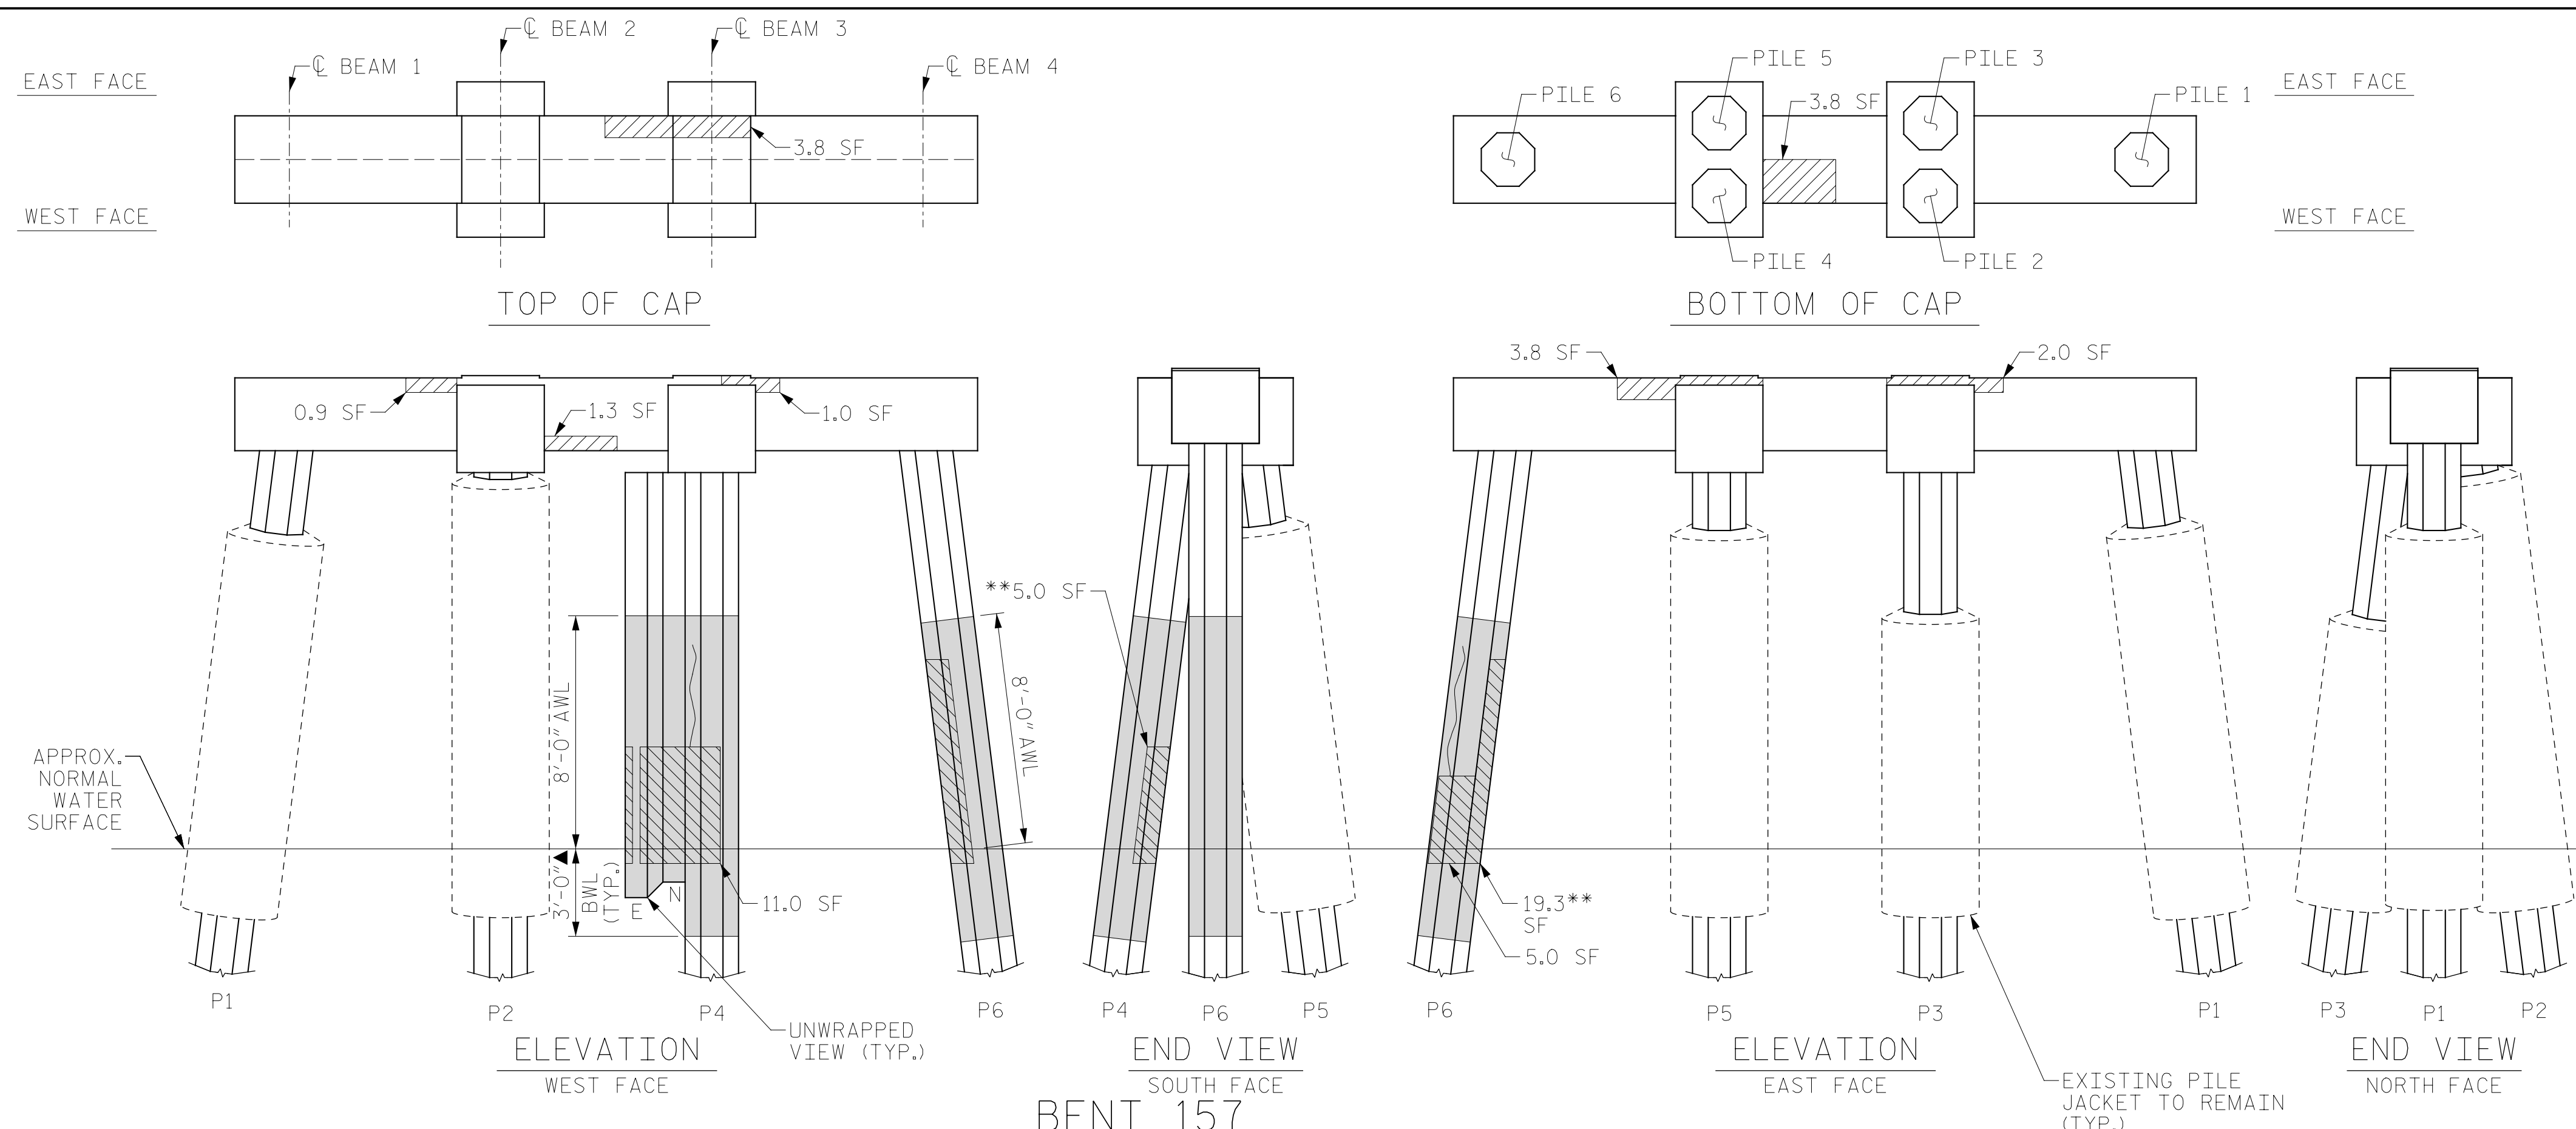
BENT 157

CAP REPAIRS			
SHOTCRETE REPAIRS	16.6 SF	6.6 CF	SF CF
EPOXY RESIN INJECTION	- LF		LF
PILE REPAIRS			
PILE CONCRETE RESTORATION	40.3 SF	15.6 CF	SF CF
FRP PROTECTIVE SYSTEM AWL	97.6 SF		
FRP PROTECTIVE SYSTEM BWL	36.6 SF

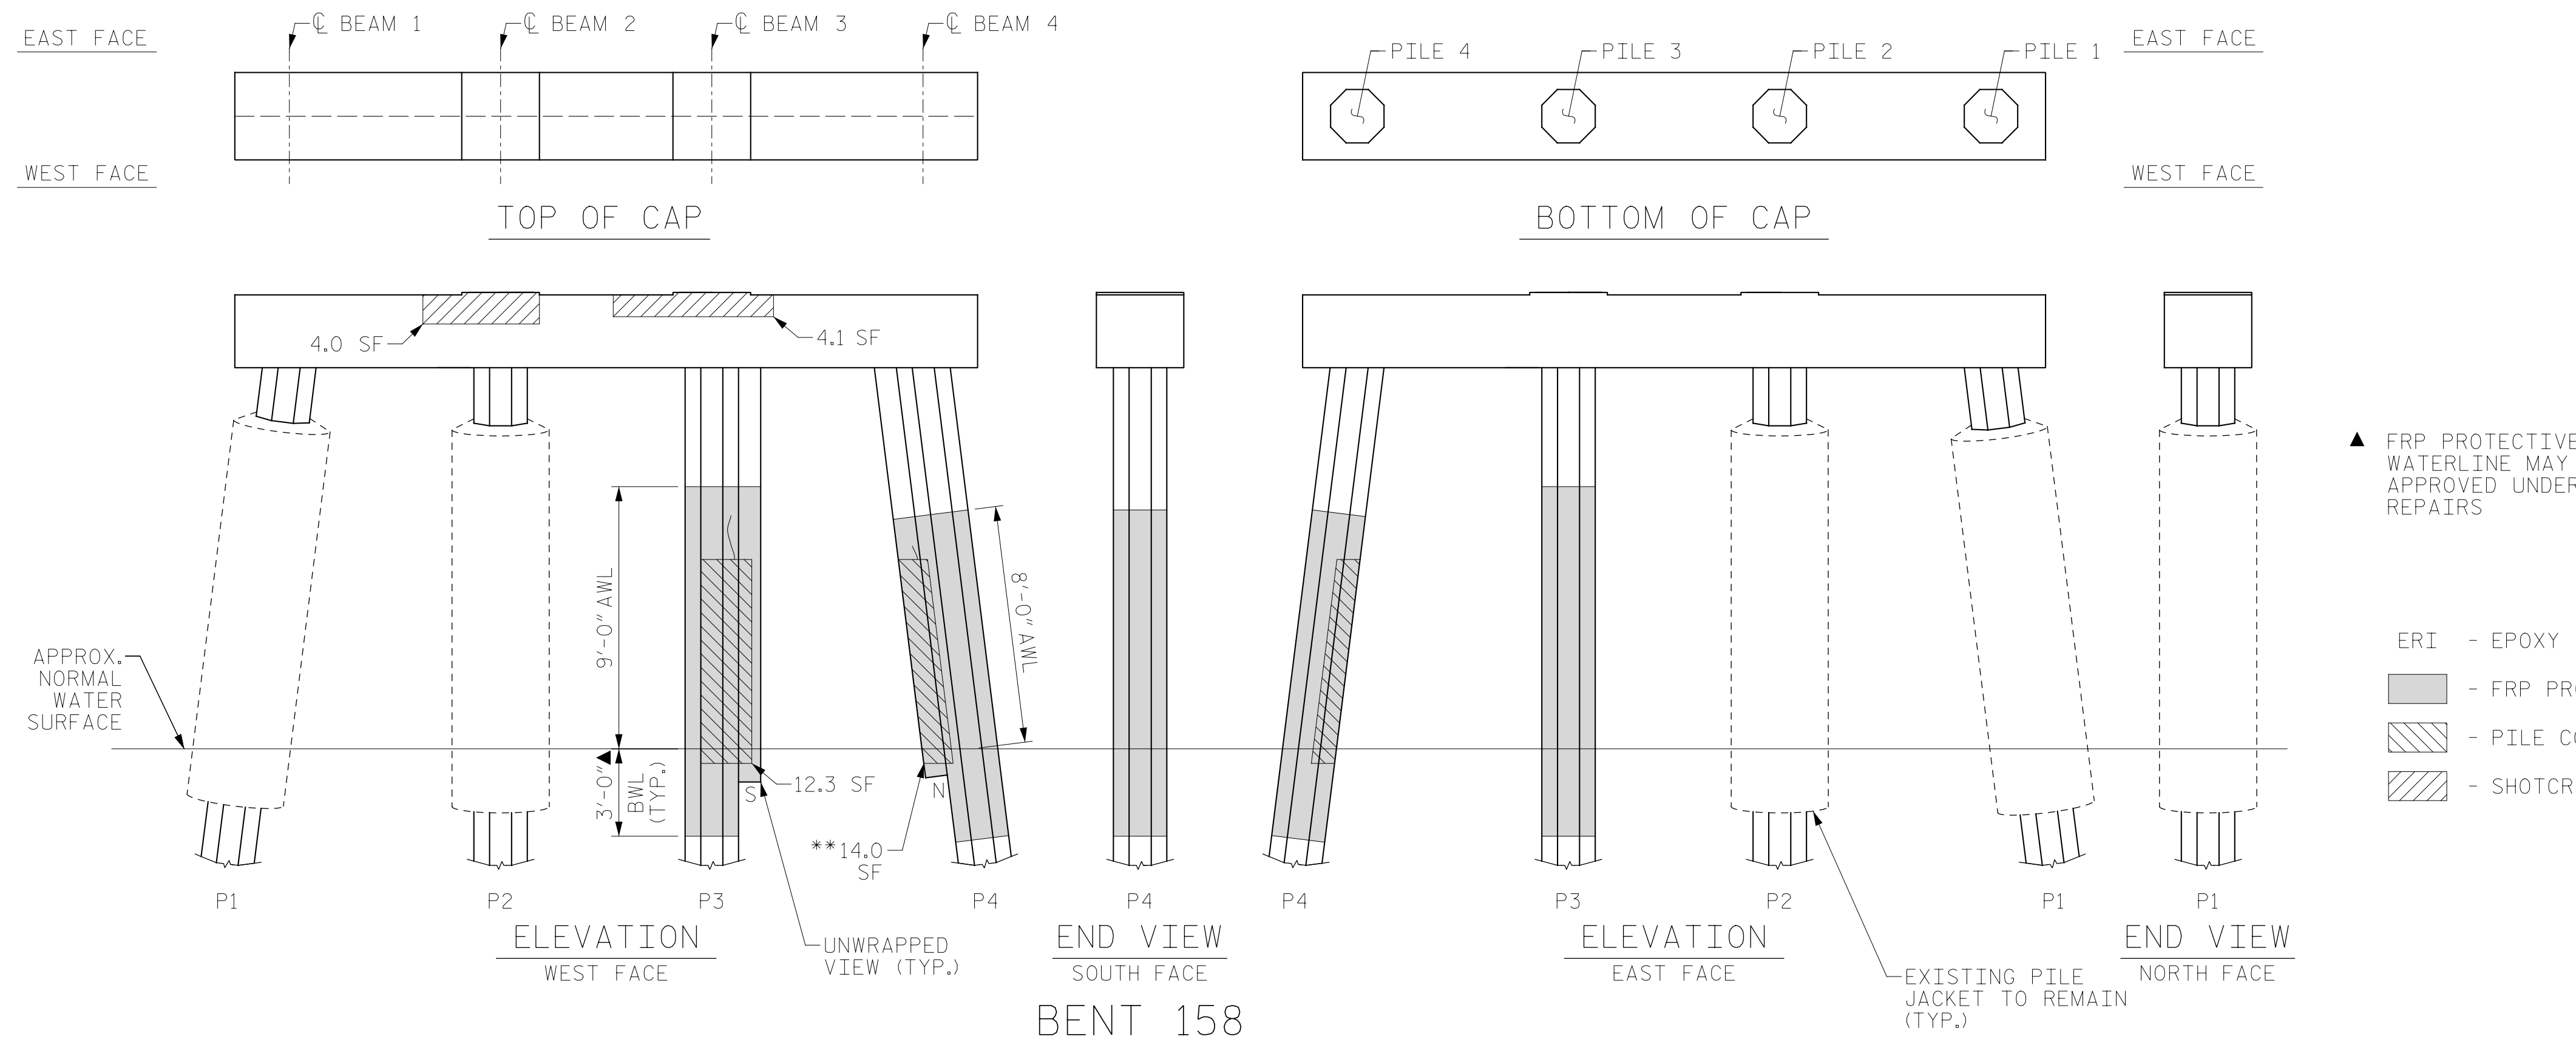
BENT 158

CAP REPAIRS			
SHOTCRETE REPAIRS	8.1 SF	4.1 CF	SF CF
EPOXY RESIN INJECTION	- LF		LF
PILE REPAIRS			
PILE CONCRETE RESTORATION	26.3 SF	10.6 CF	SF CF
FRP PROTECTIVE SYSTEM AWL	103.7 SF		
FRP PROTECTIVE SYSTEM BWL	36.6 SF
