NC DEPARTMENT OF TRANSPORTATION
 DIVISION OF HIGHWAYS
 STRUCTURE MANAGEMENT UNIT

ATTENTION: **PAR SUBMITTED
 SIGN NOTICE ISSUED
 CHANGES TO STRUCTURE DATA**

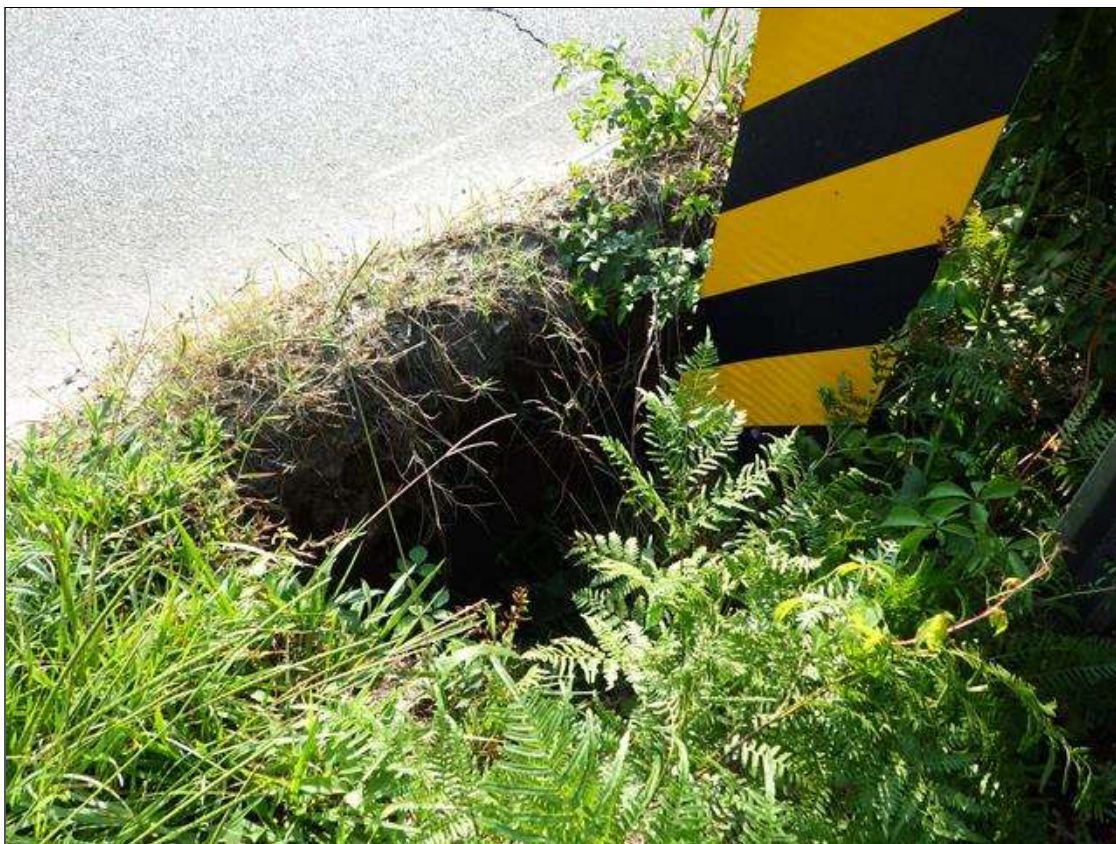
General Comments and Misc. Items: (PAR) southeast corner of bridge adjacent to roadway, erosion hole (3ft long x 2.5ft wide x up to 4ft deep) up to 1ft of undermining of roadway

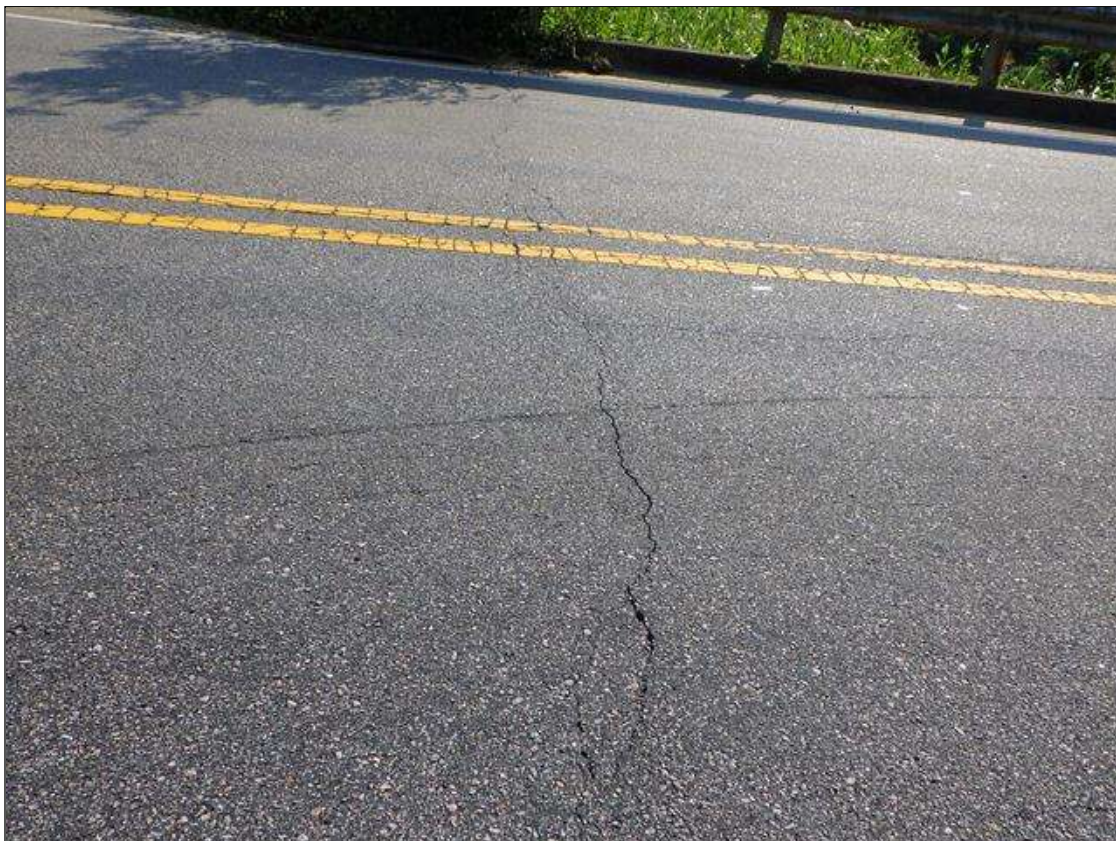
Span 1 Wearing Surface: over end bent 1, transverse crack (full width x up to 1/8in)

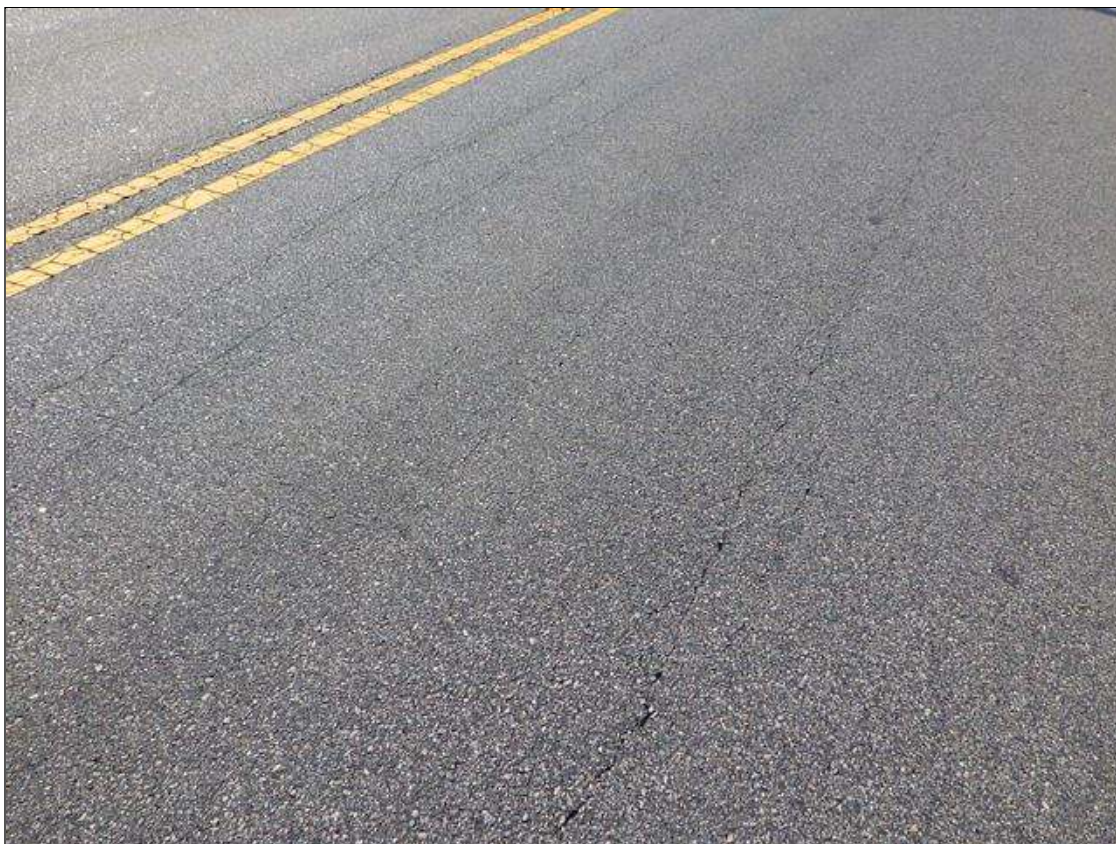
Span 1 Wearing Surface: along edges of channels, (5) longitudinal cracks (full length x 1/16in)

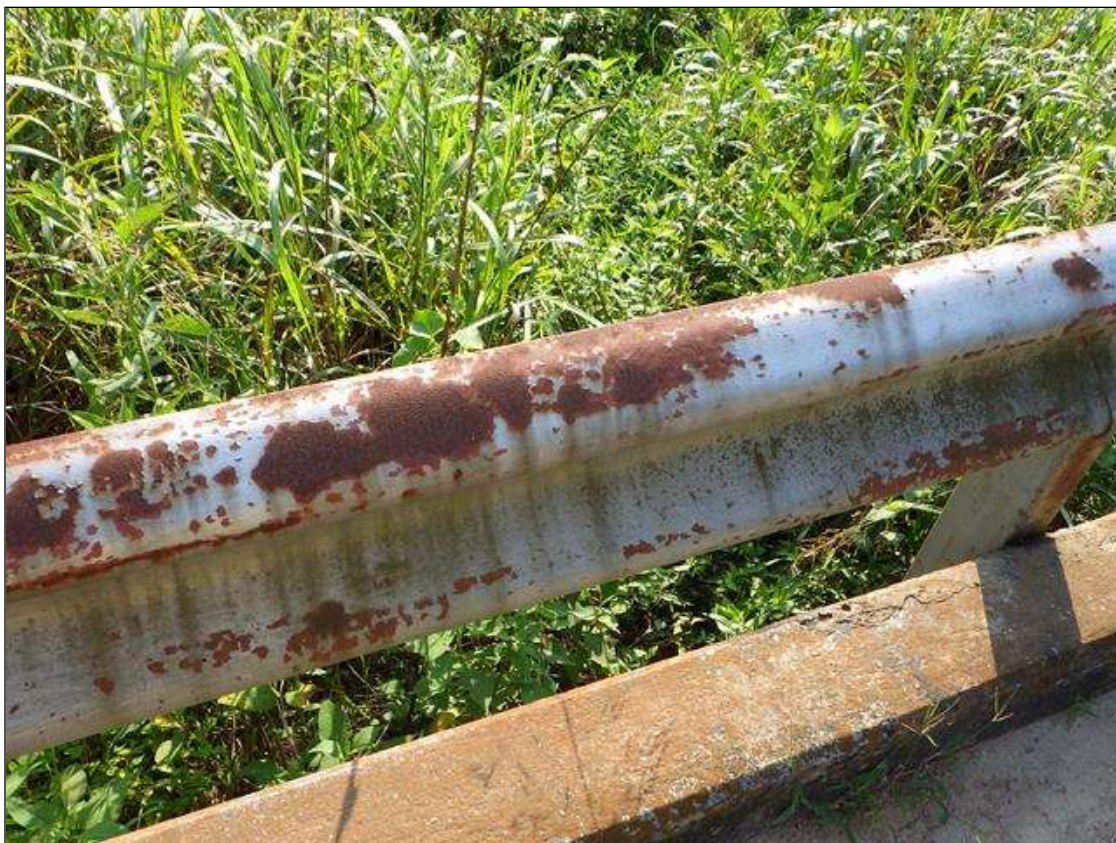
Span 1 Left Bridge Rail: along length of rail, active corrosion with no section loss noted

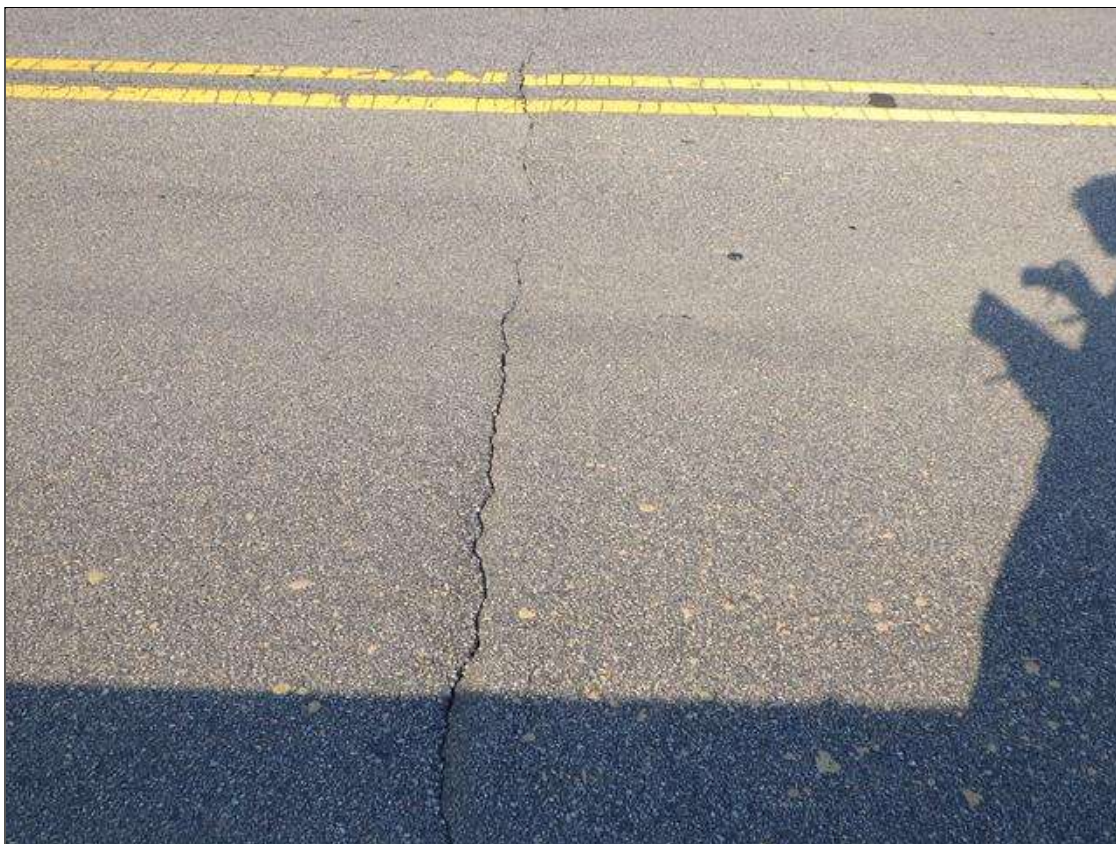
Span 2 Wearing Surface: UP TO 1/8" TRANSVERSE CRACKING OVER BENT 1

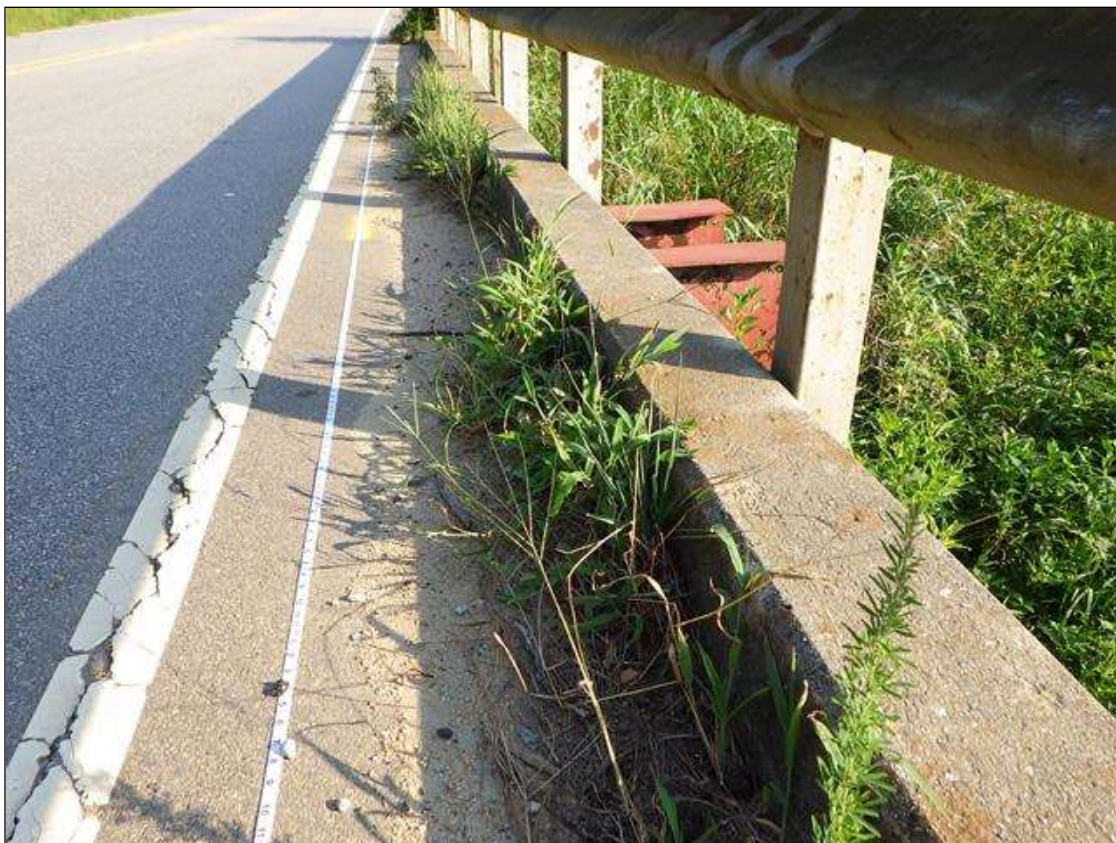
Deck Debris: along both curbs, debris and vegetation (full length x 1ft x up to 3in deep)

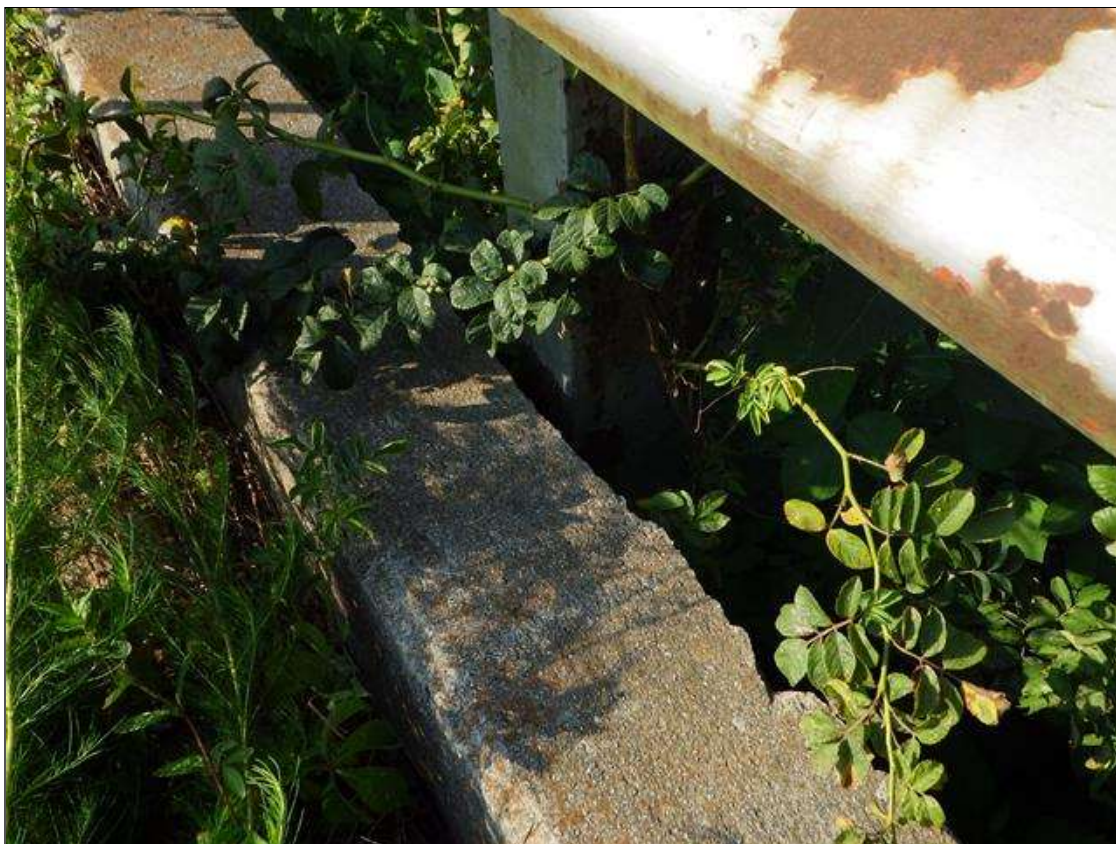
Span 1 Right Bridge Rail: at rail post 2, spall [3ft x 10in x 3in deep]

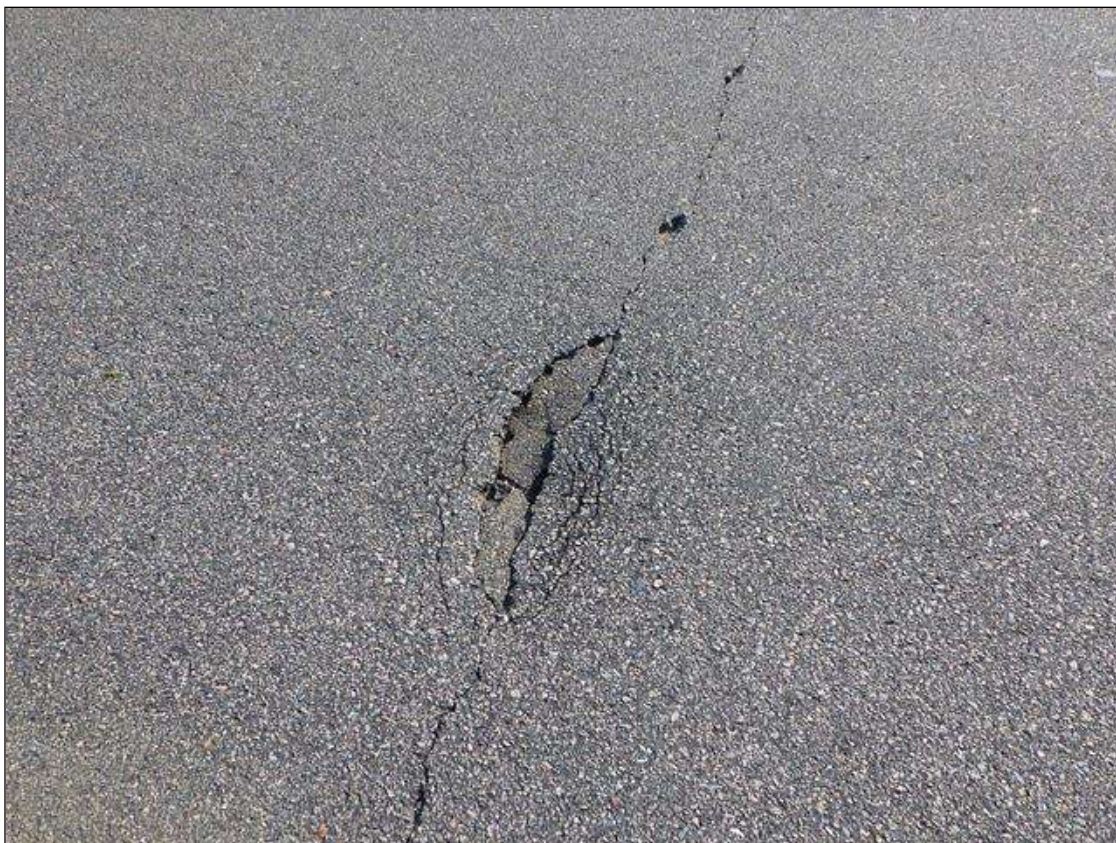
Span 1 Wearing Surface: northbound lane at bent 1, pothole (6in x 20in x up to 1-1/2in deep)

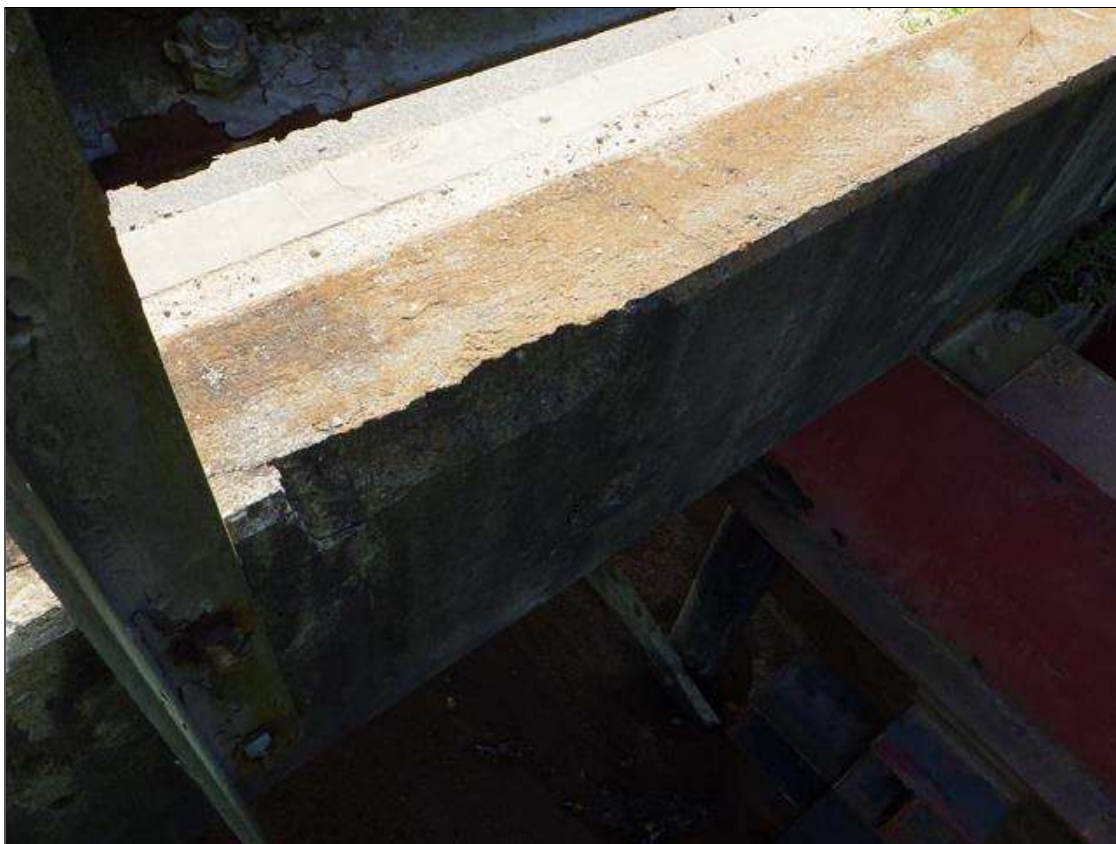
Span 2 Right Bridge Rail: at rail post 5, delamination/spall [2ft x 8in x 3in deep]

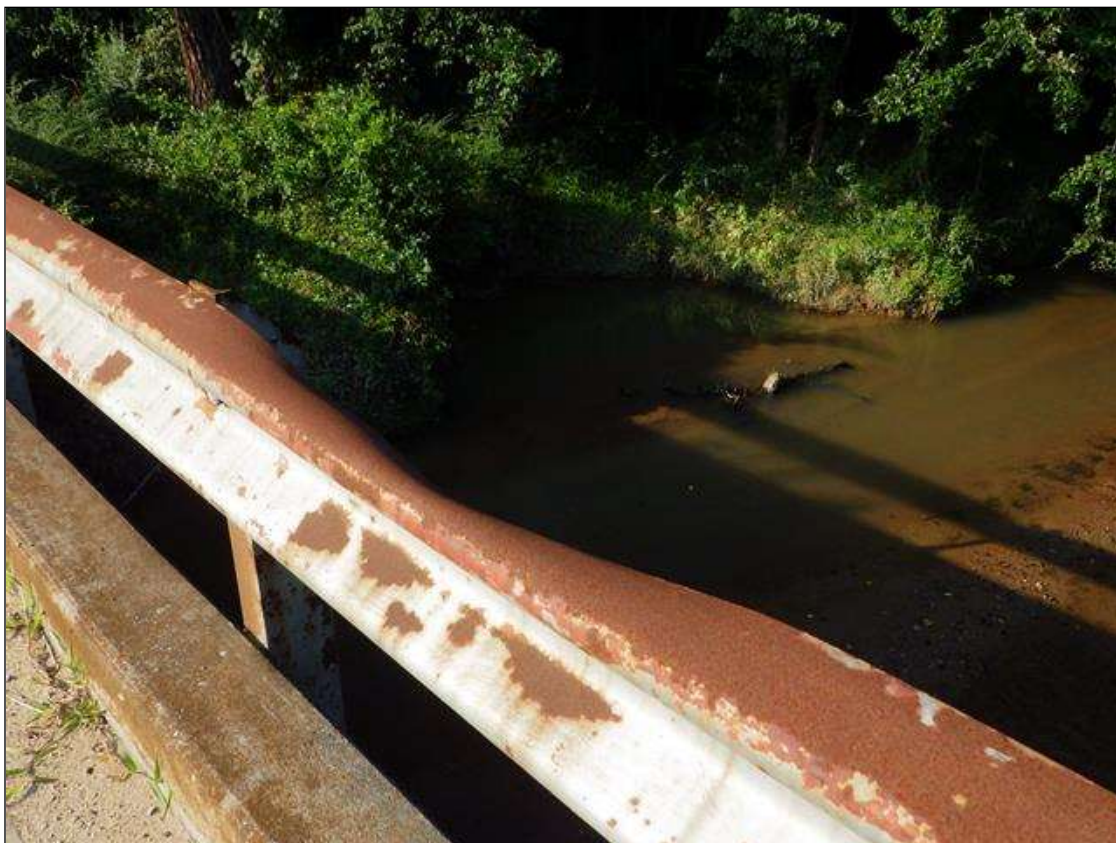
Span 3 Right Bridge Rail: along length of rail at top, three [3] areas of impact damage [up to 3ft x 3in]

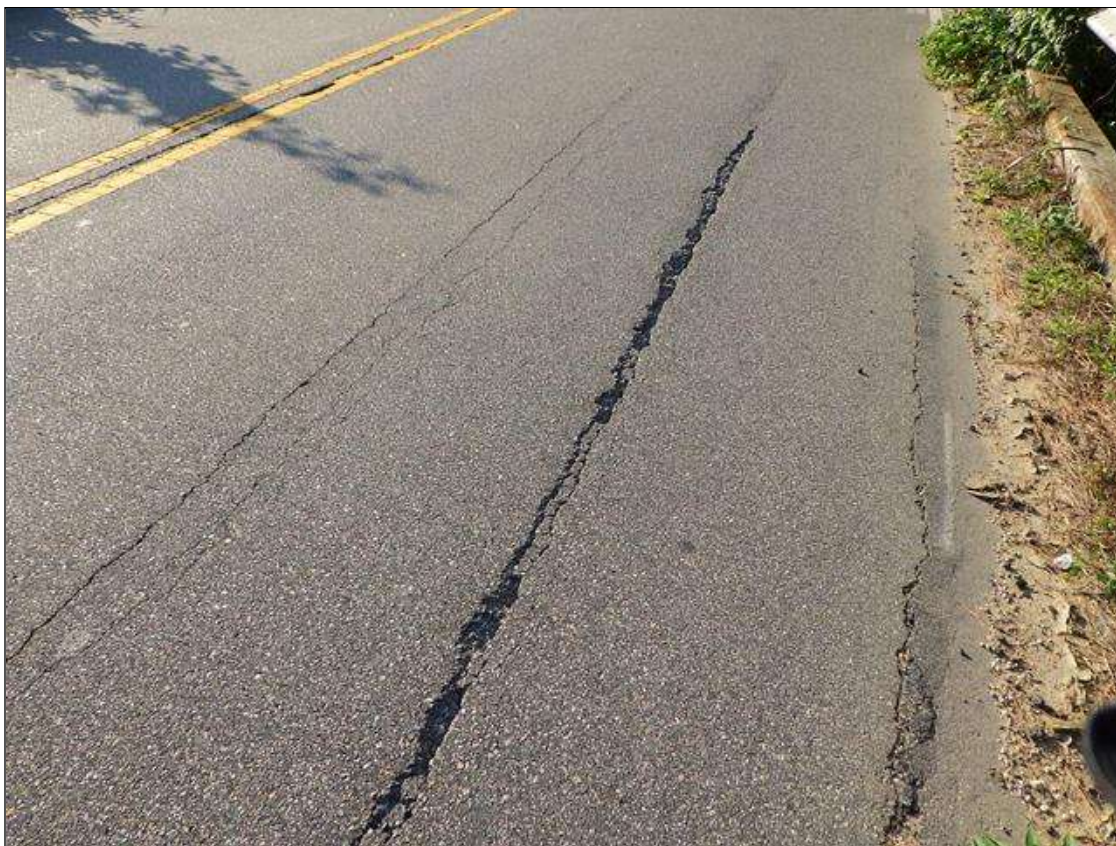
Span 4 Wearing Surface: northbound lane along edge of channels 8 and 9, pothole (20ft x 3in x 1in)

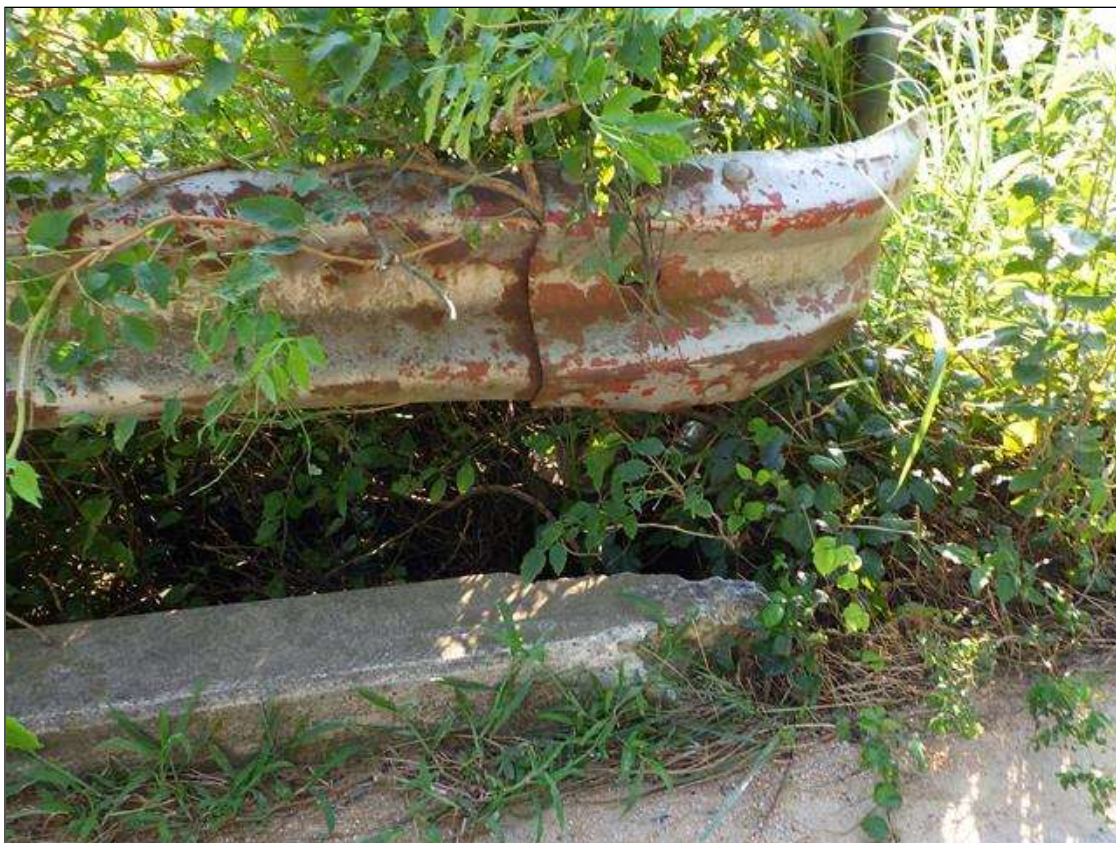
Span 4 Left Bridge Rail: [PAR] rail post 6 is missing

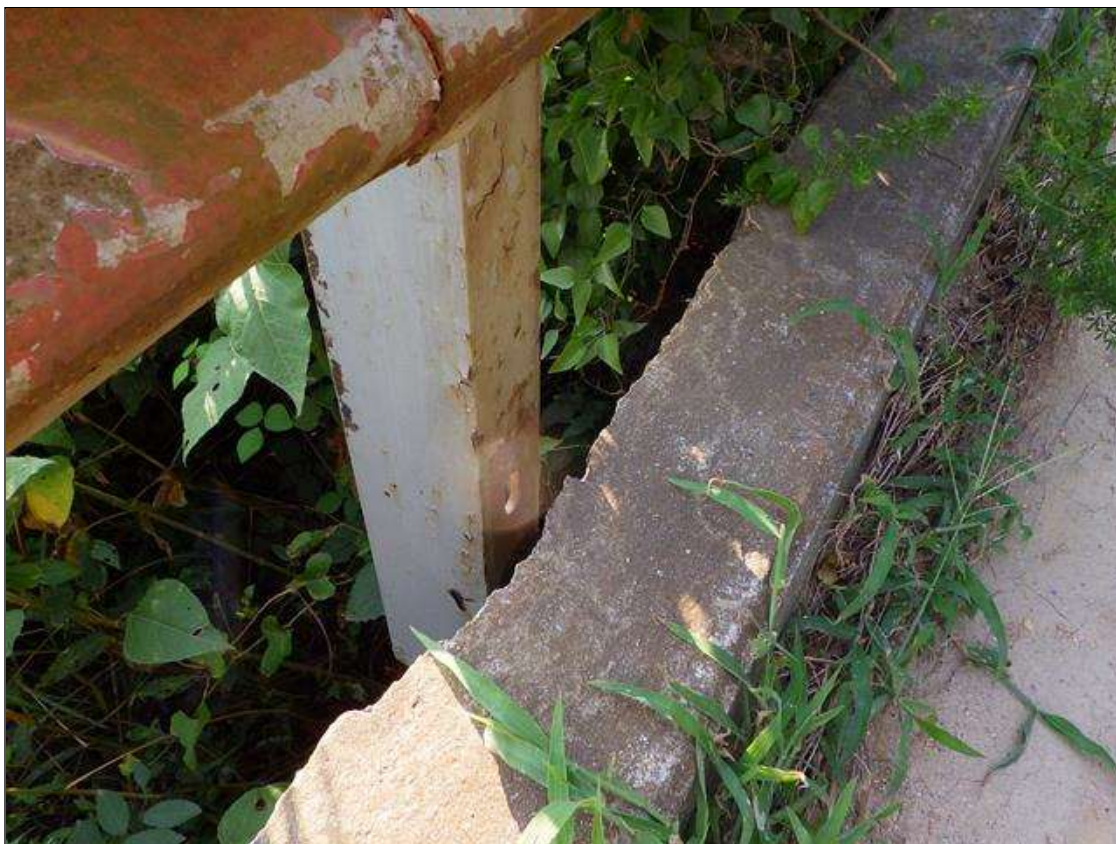
Span 4 Left Bridge Rail: (PAR) at rail posts 3,4 & 5, delamination/spall [up to 3ft x 11in x 3in deep] allowing excessive deflection of rail

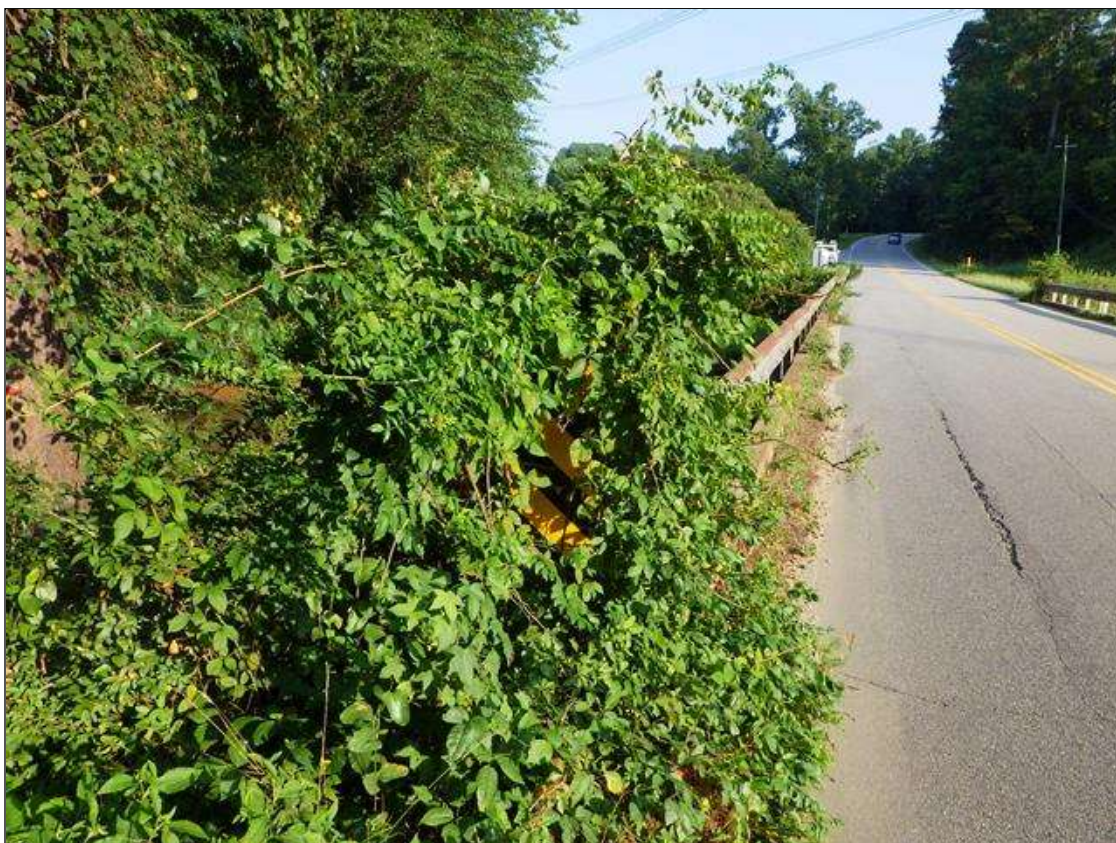
General Comments and Misc. Items: (PAR) northeast delineator covered by vegetation

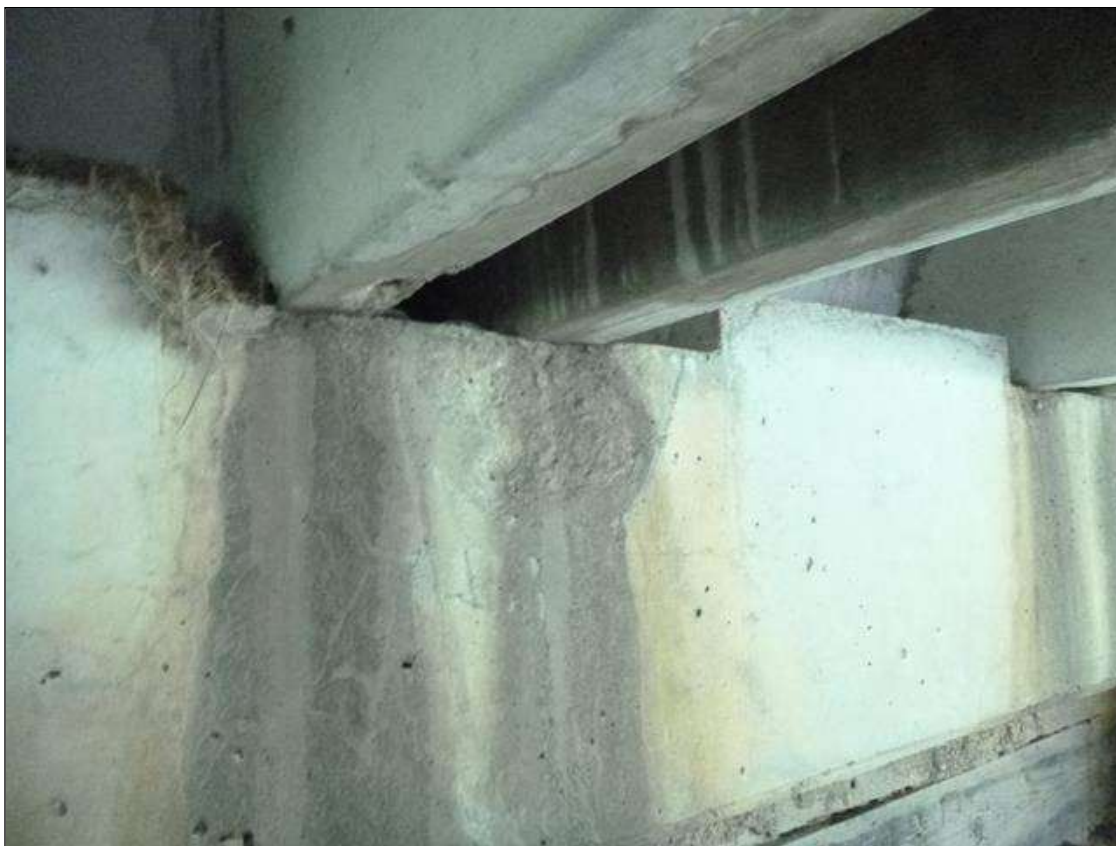
End Bent 1 Cap 1: over pile 3, spall/delamination [8in x 5in x 1/4in deep]

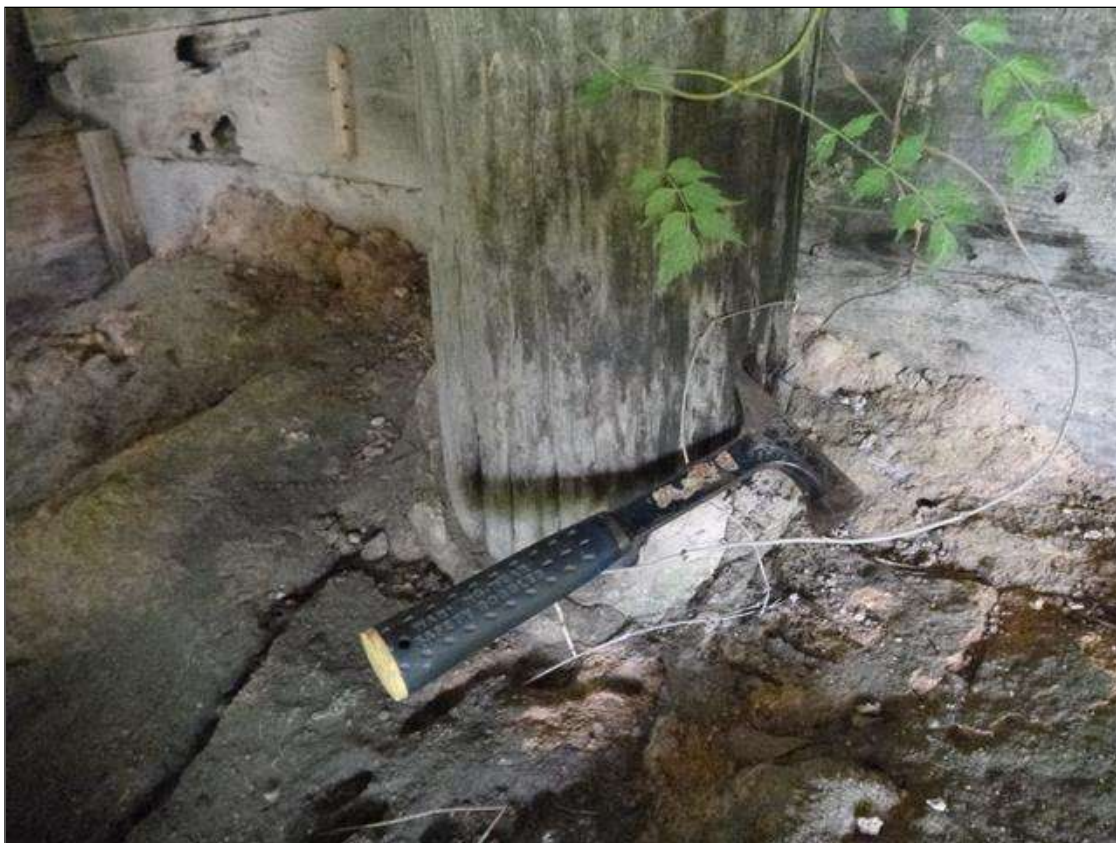
End Bent 1 Pile 3: (PAR) at base of pile, multiple checks [full height x up to 1/4in wide x up to 2in deep], decay [14in x 10in x 3in deep]

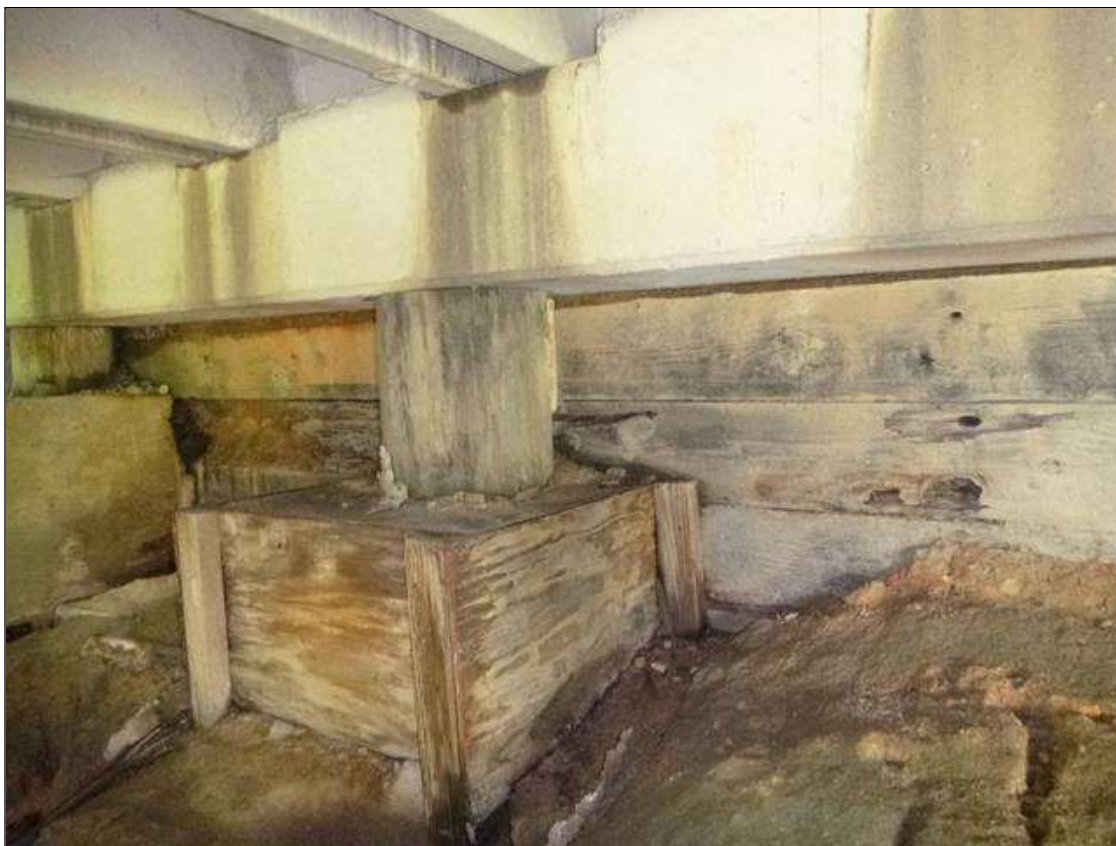
End Bent 1 Abutment: [PAR] between piles 3 and 5 second bulkhead board below cap, decay [10ft x up to full height x full width] with fill exposed

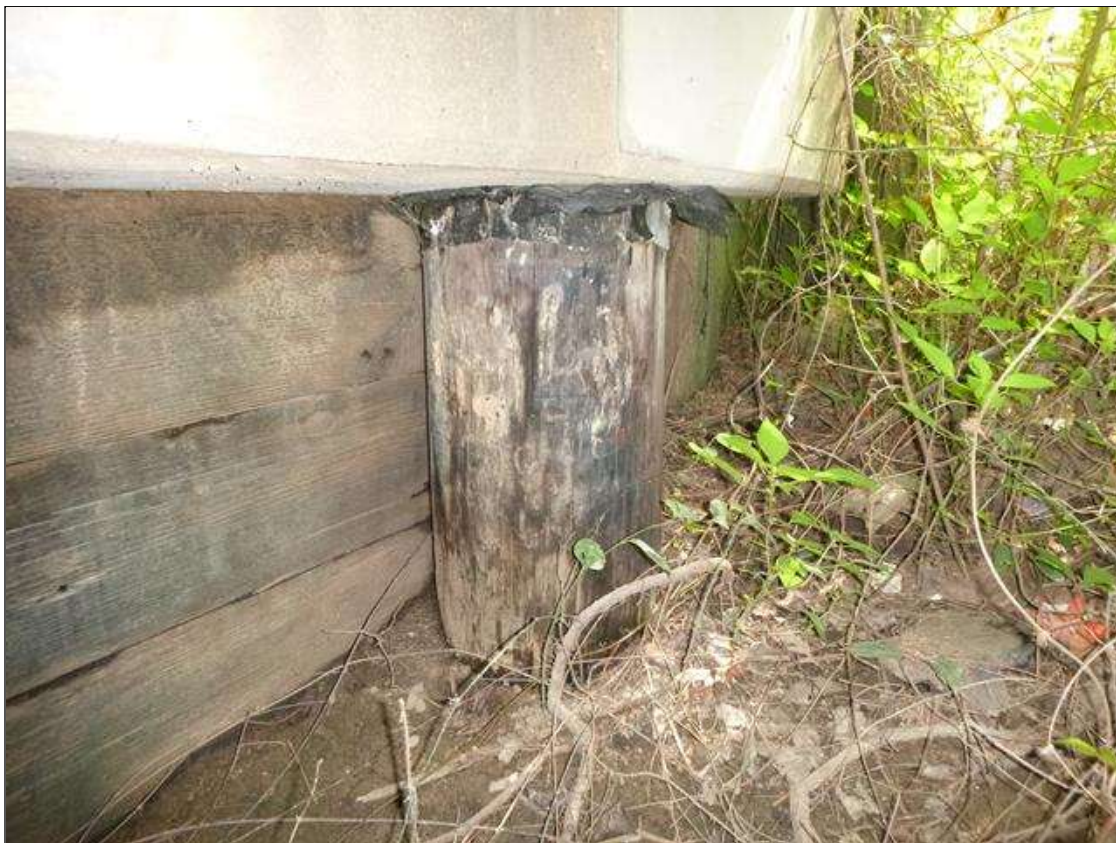
End Bent 1 Pile 1: (PAR) along height of exposed pile, multiple checks [full height x up to 1/8in], pile sounds hollow when hammered

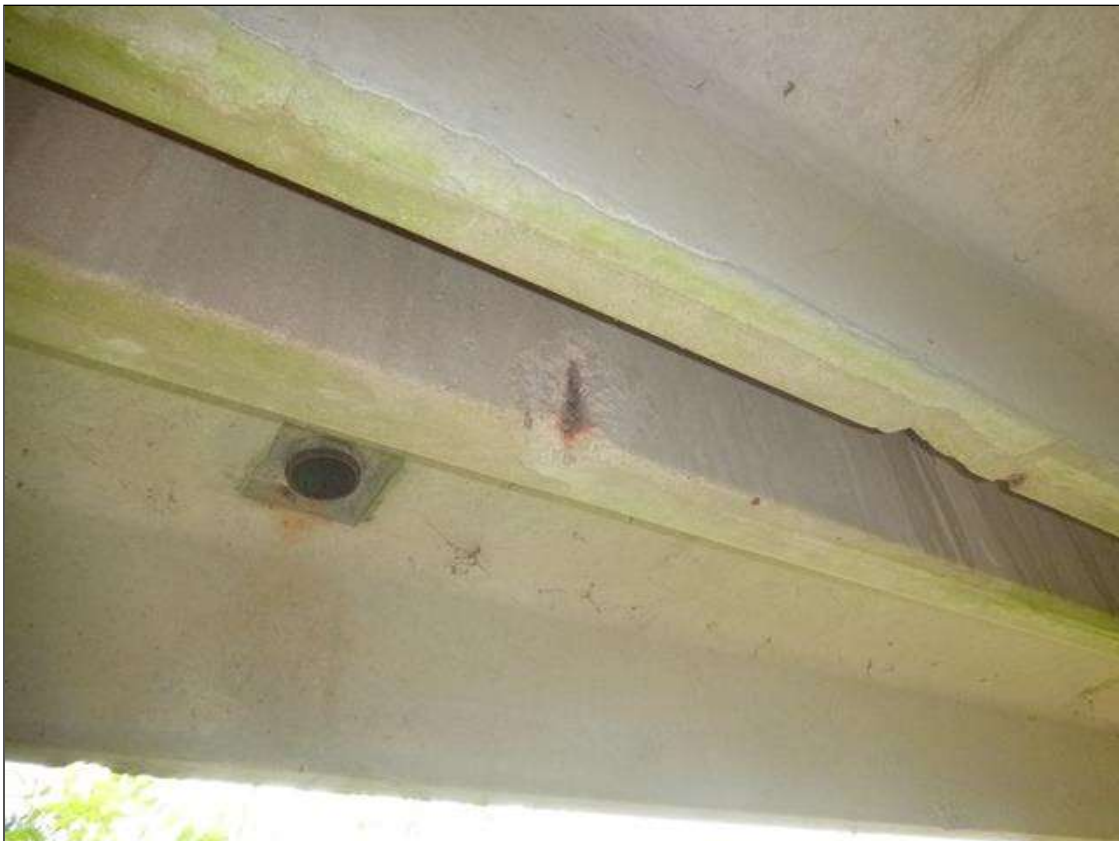
Span 1 Slab 1: left and right leg near midspan, multiple spalls/delaminations [up to 5in x 4in x 3/4in deep] with two exposed stirrups [no section loss noted]

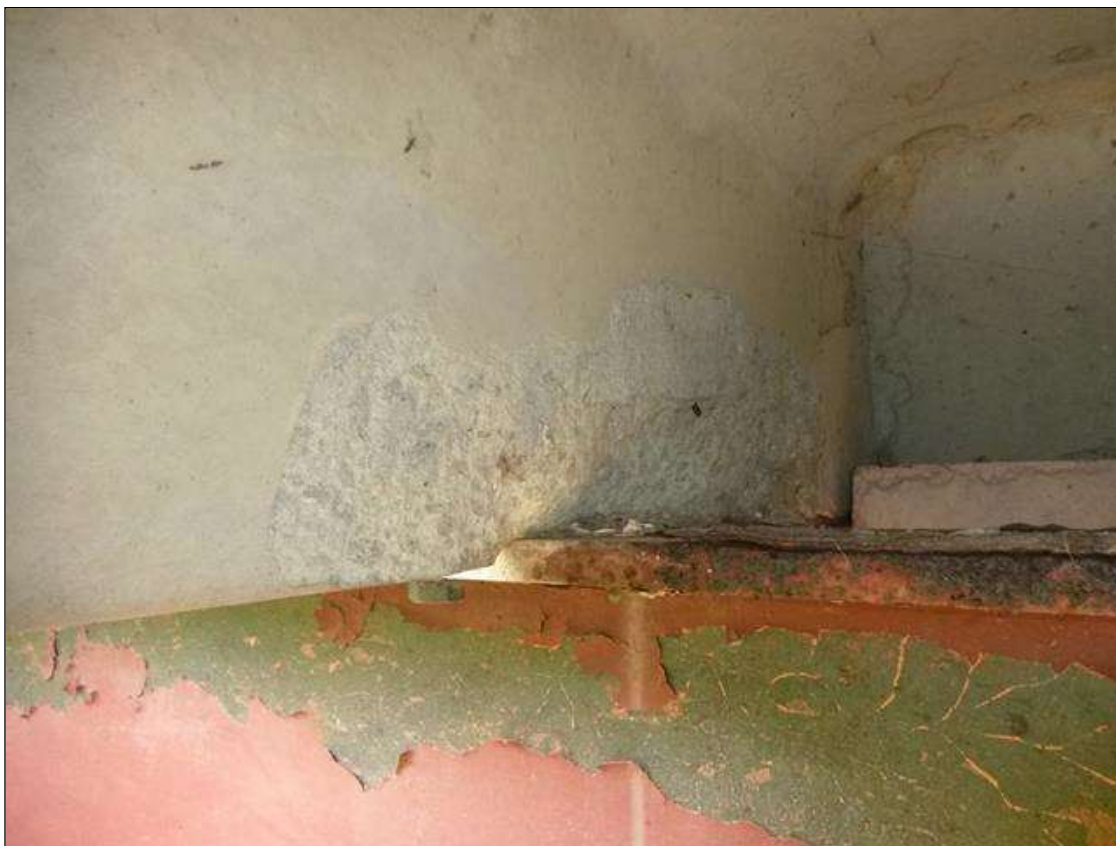
Span 1 Slab 1: (PAR) left and right leg at bent 1, four [4] spalls/delaminations [up to 12in x 5in x 1in deep] with loss of bearing area

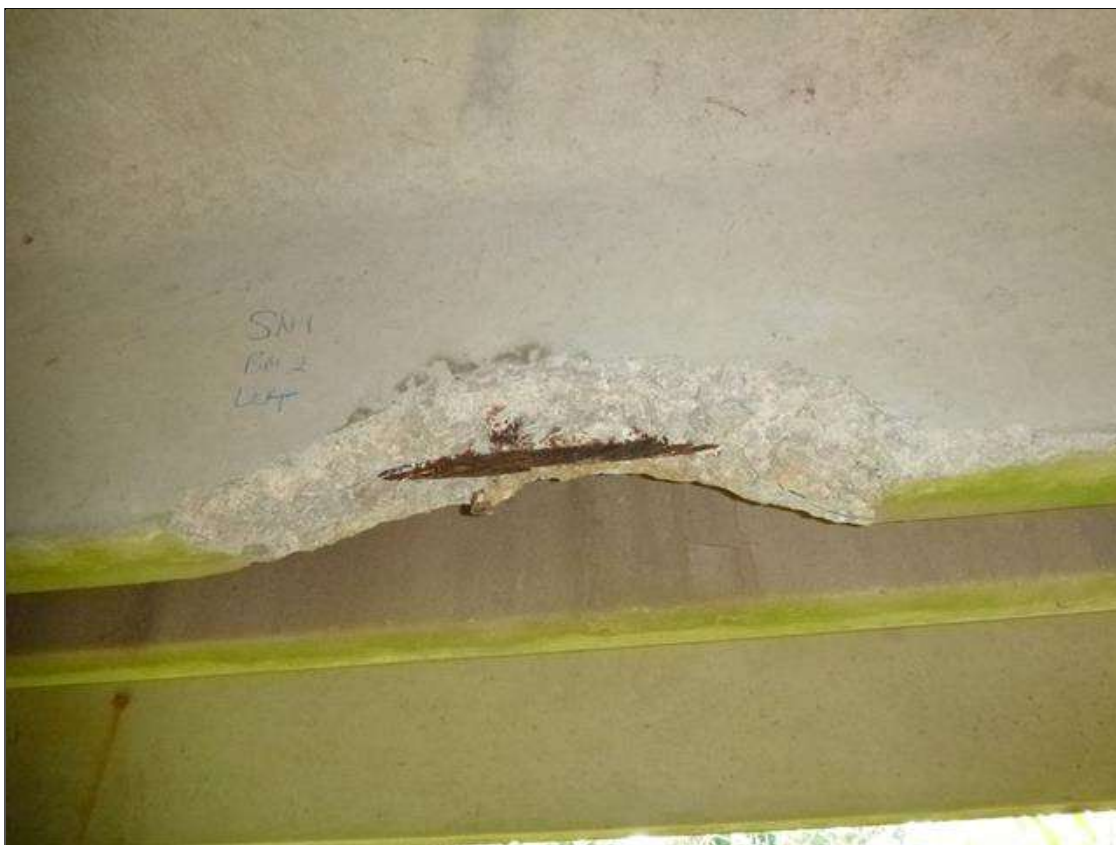
Span 1 Slab 2: [PAR] left leg near midspan, spall [16in x 5in x full width] with exposed strand that exhibits section loss [up to 25%]

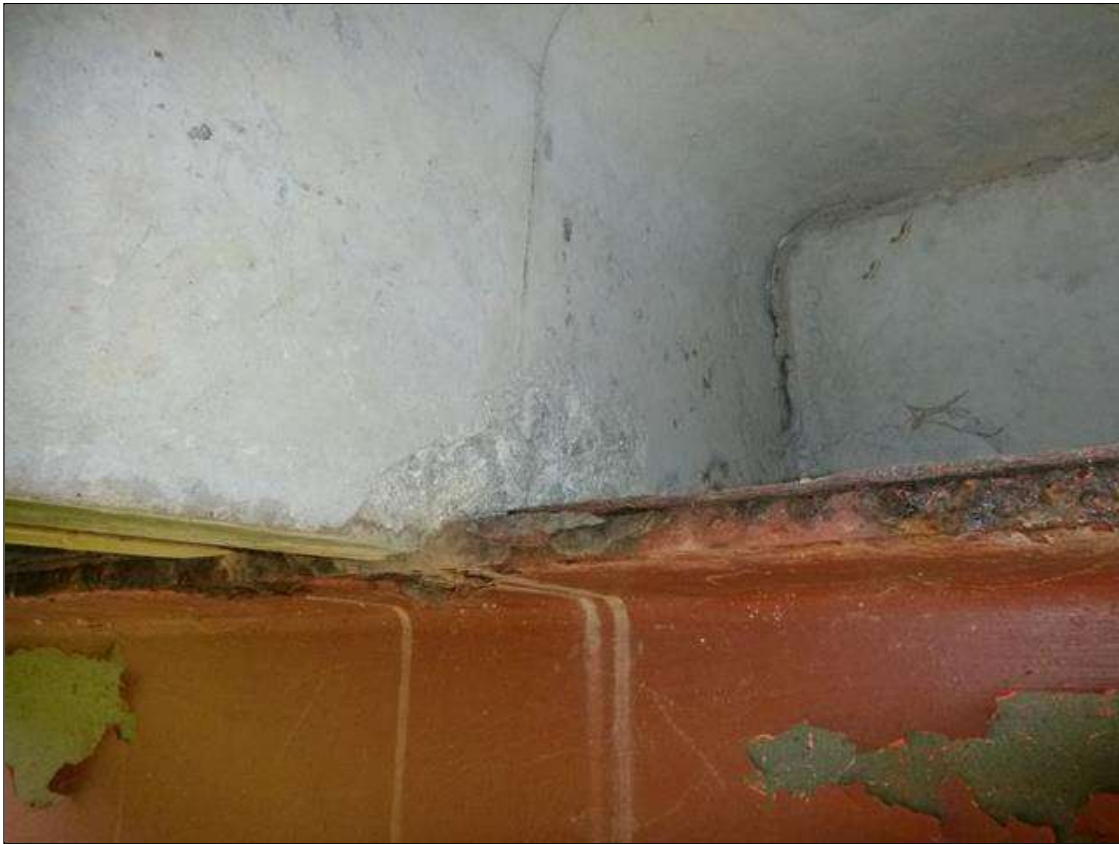
Span 1 Slab 2: (PAR) left and right leg at bent 1, three [3] spalls/delaminations [up to 10in x 6in x 1in deep] channel legs crushing and bottom of channel legs sits below top of crutch bent cap

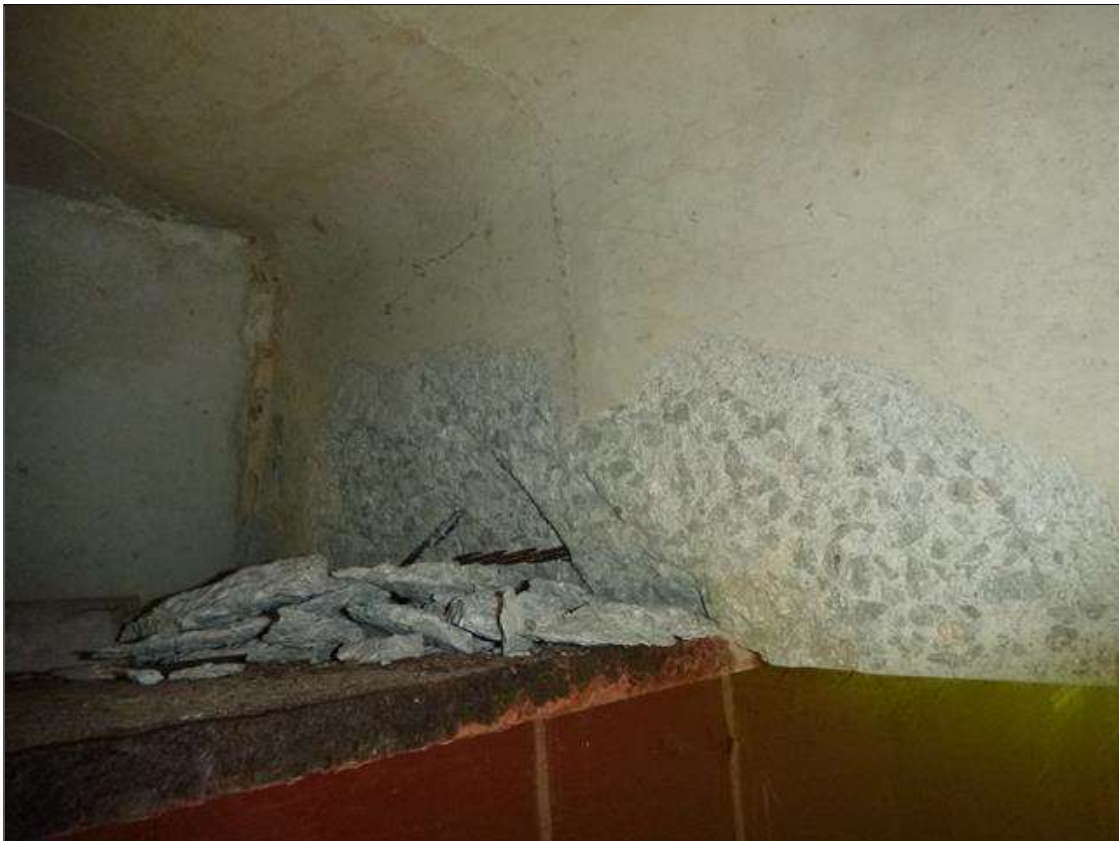
Span 1 Slab 3: (PAR) left and right leg at bent 1, two [2] spalls [up to 12in x 6in x 1in deep] with exposed strand, channel legs crushing and bottom of channel legs sits below top of crutch bent cap
