NC DEPARTMENT OF TRANSPORTATION
 DIVISION OF HIGHWAYS
 STRUCTURE MANAGEMENT UNIT

ATTENTION: **PAR SUBMITTED
 SIGN NOTICE ISSUED
 CHANGES TO STRUCTURE DATA**

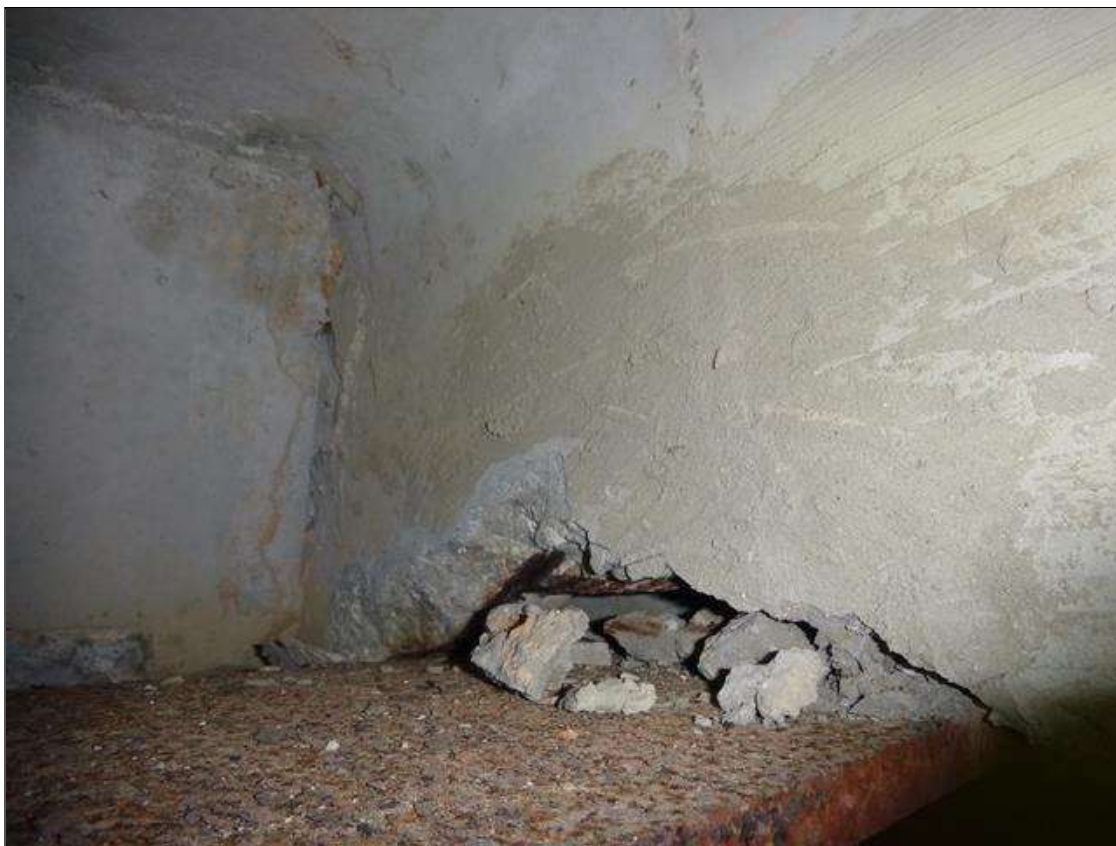
Span 1 Slab 4: (PAR) right leg at bent 1, spalled patched area [12in x full width x 5in high] with exposed strands

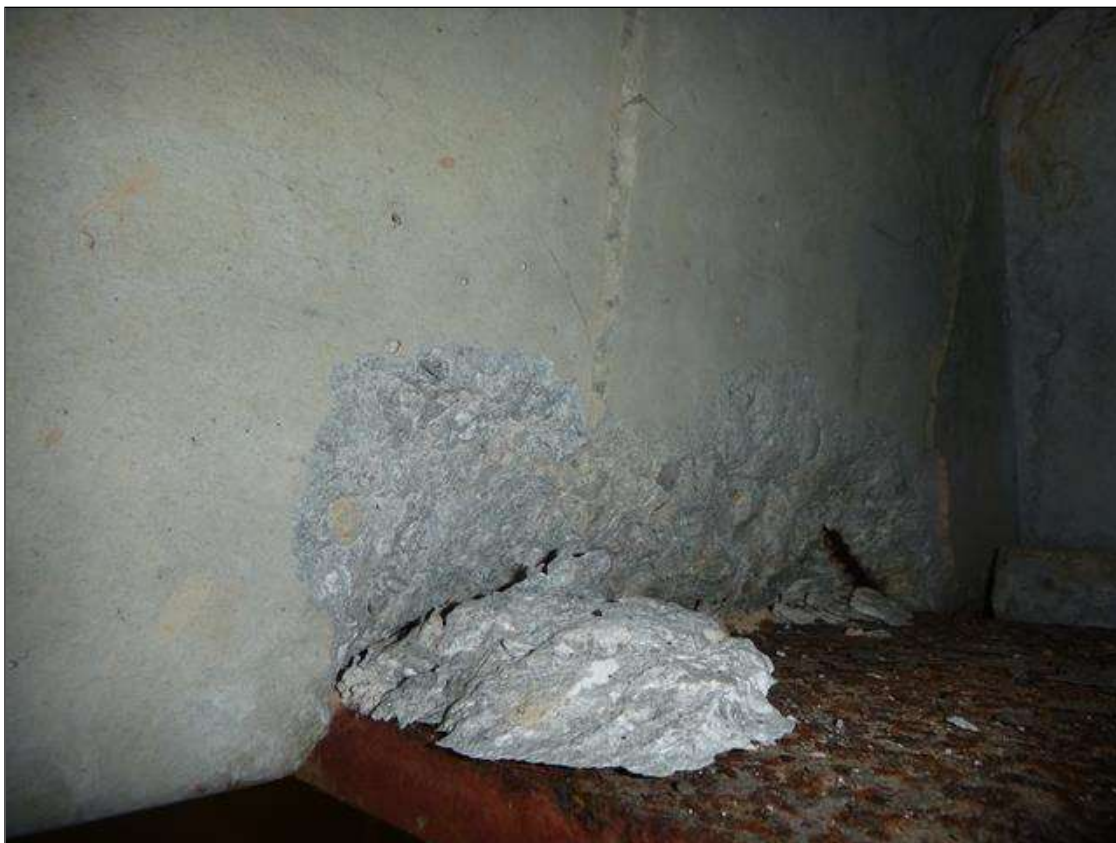
Span 1 Slab 4: left leg at bent 1, two [2] spalls [up to 12in x 4in x 1in deep]

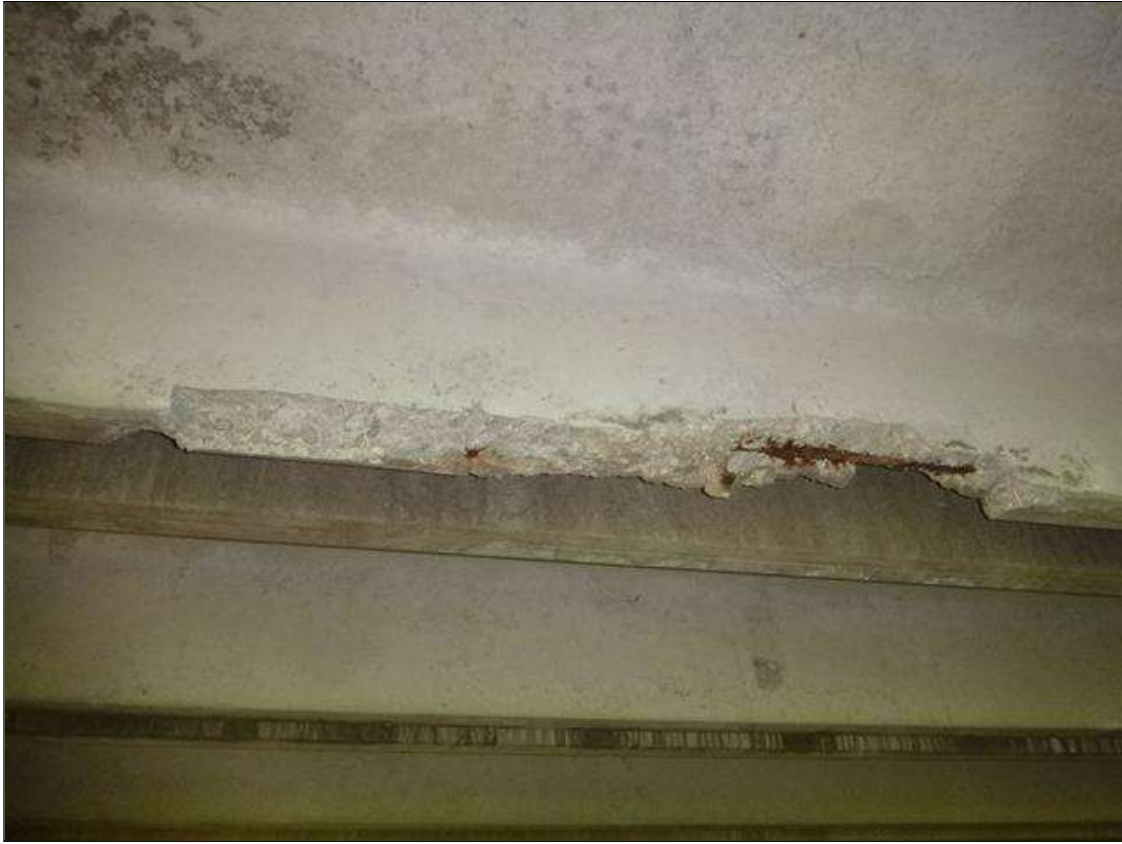
Span 1 Slab 5: (PAR) right leg at midspan, spall (40in x 3in deep) with exposed strand (25% section loss)

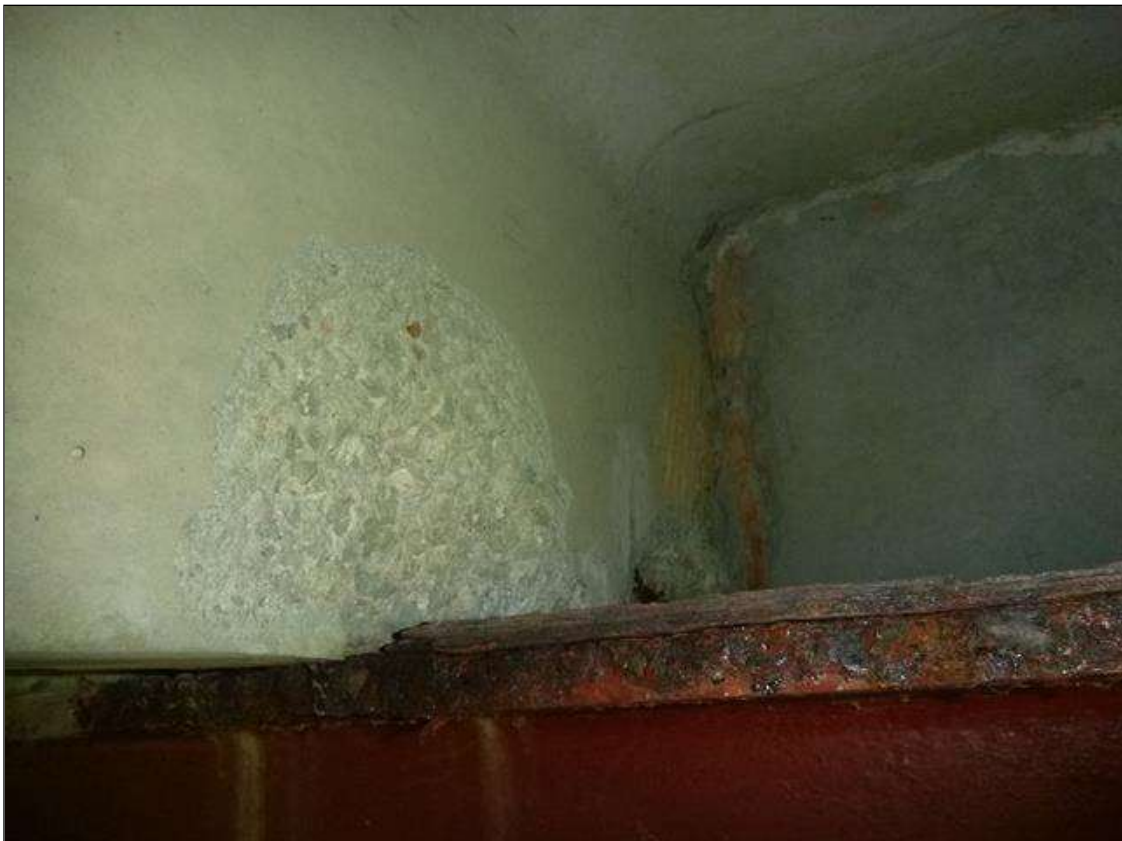
Span 1 Slab 9: left leg at far end, two [2] spalls [up to 4in diameter x 1in deep] with one [1] exposed stirrup [loss < 1/16in]

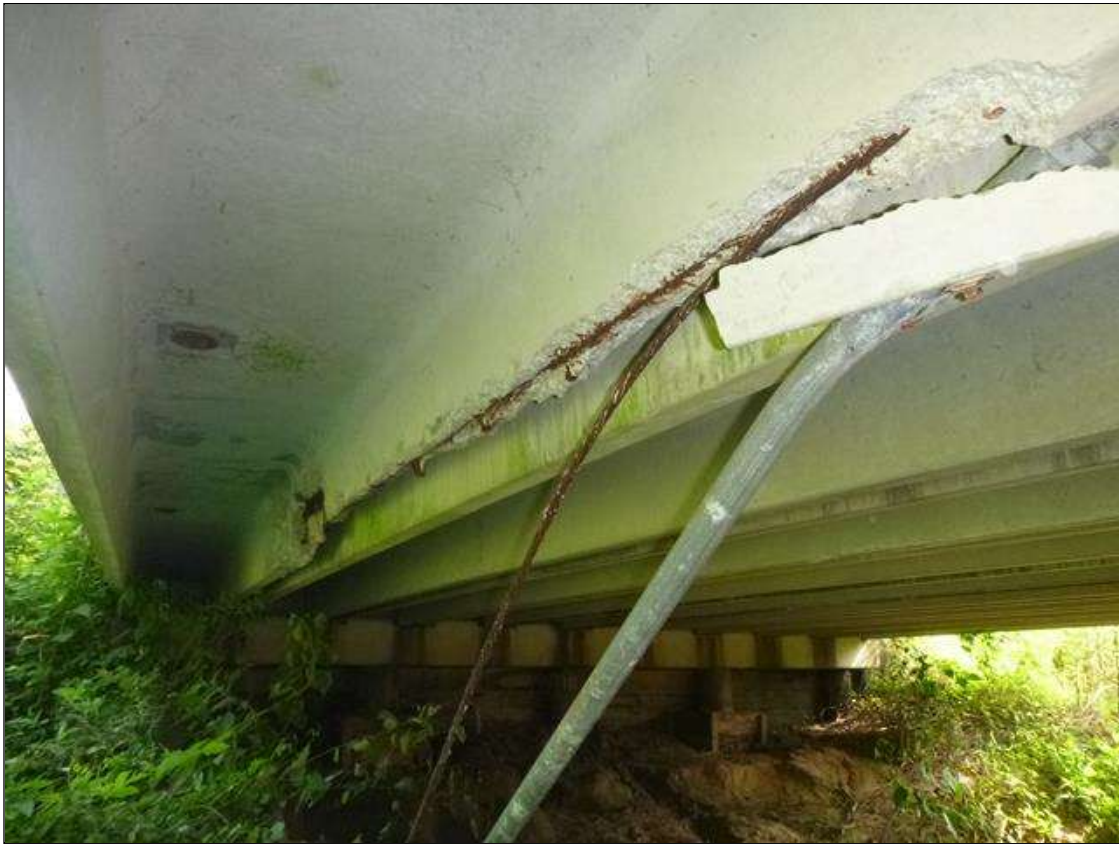
Span 1 Slab 10: [PAR] left leg at midspan, spall/delamination, [11ft x full width of leg x 11in high] with four [4] exposed prestressed strands, three [3] of the exposed strands have failed with remaining one [1] strand exhibiting section loss [up to 40%] (photo 1 of 2)

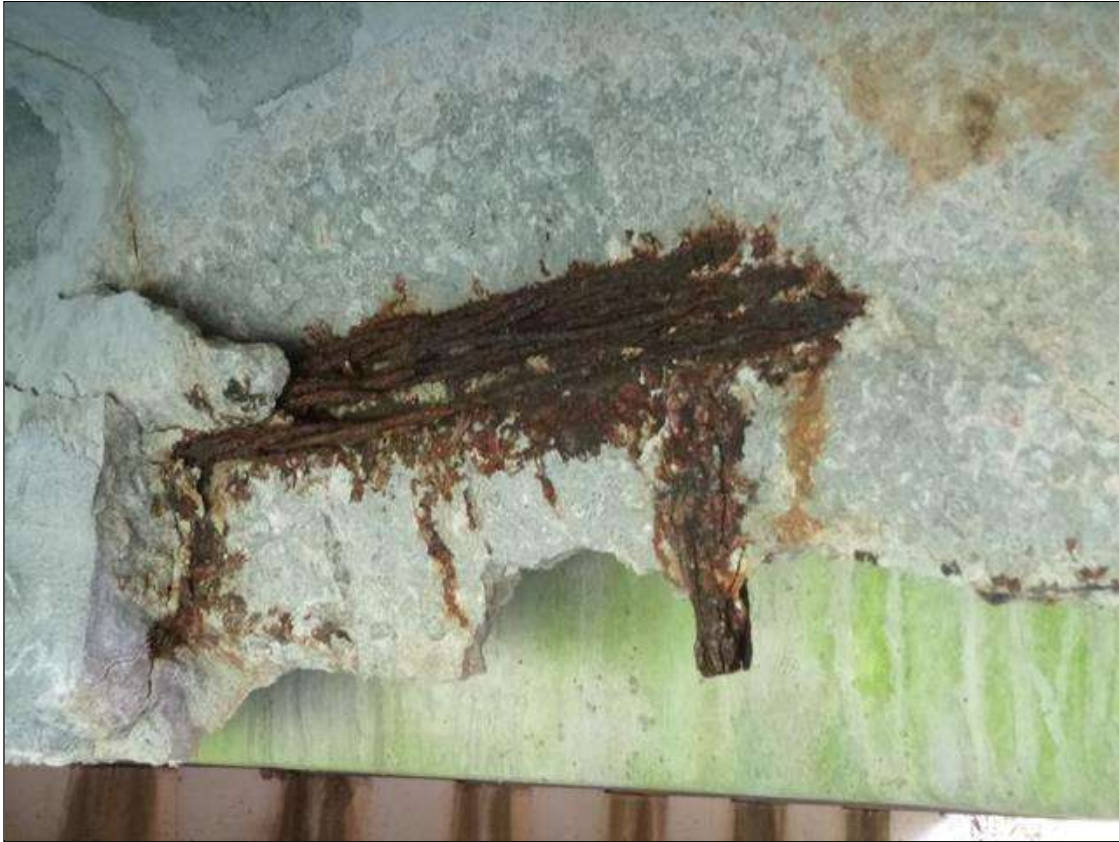
Span 1 Slab 10: [PAR] left leg at midspan, spall/delamination, [11ft x full width of leg x 11in high] with four [4] exposed prestressed strands, three [3] of the exposed strands have failed with remaining one [1] strand exhibiting section loss [up to 40%] (photo 2 of 2)

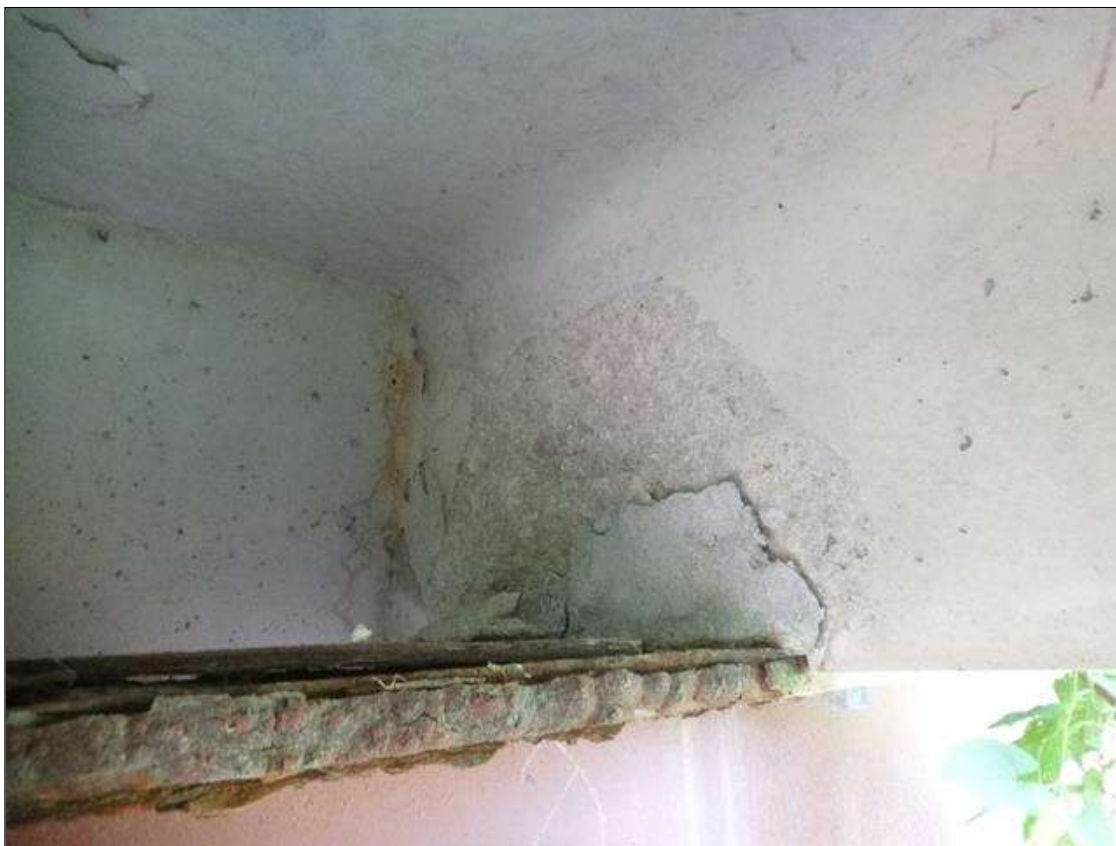
Span 1 Slab 10: right leg at far end over bearing, spall [18in x 9in x 1/2in deep]

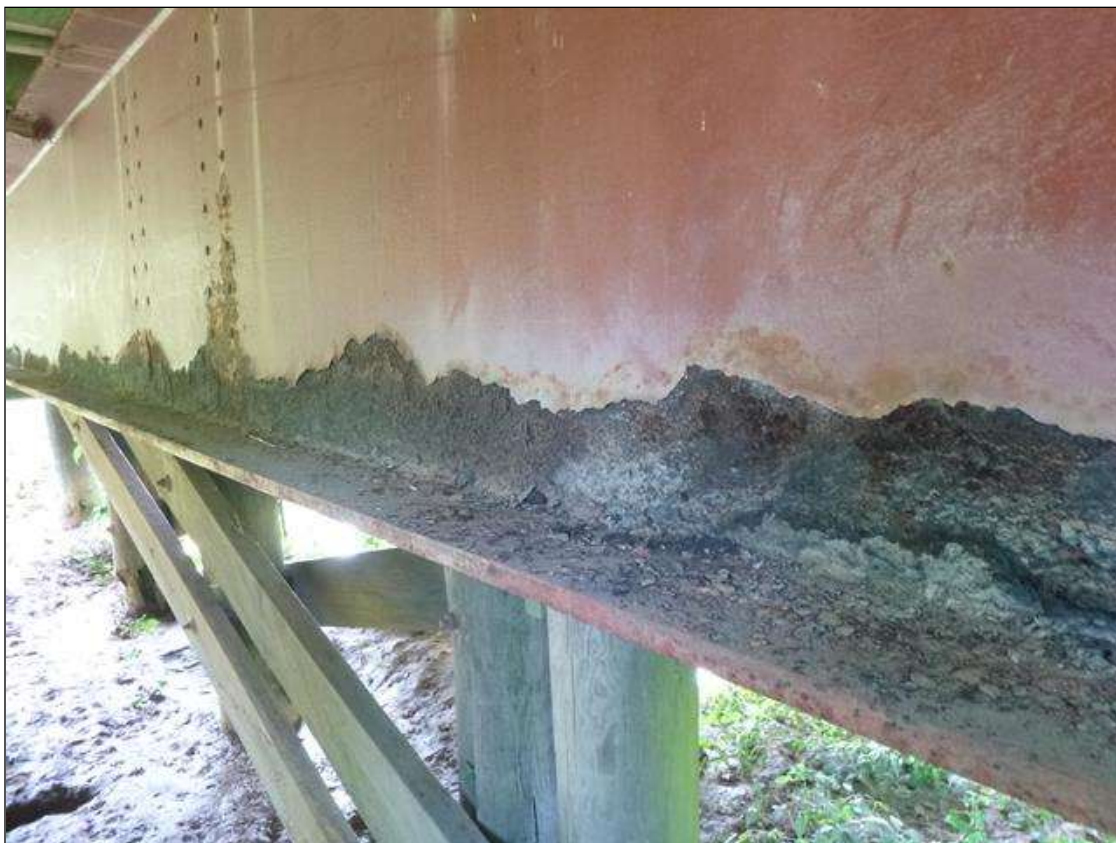
Span 1 Crutch Bent 1 Cap 1: along length of cap at lower web and top flange, corrosion with section loss [$<1/16$ in] with adjacent spot rust

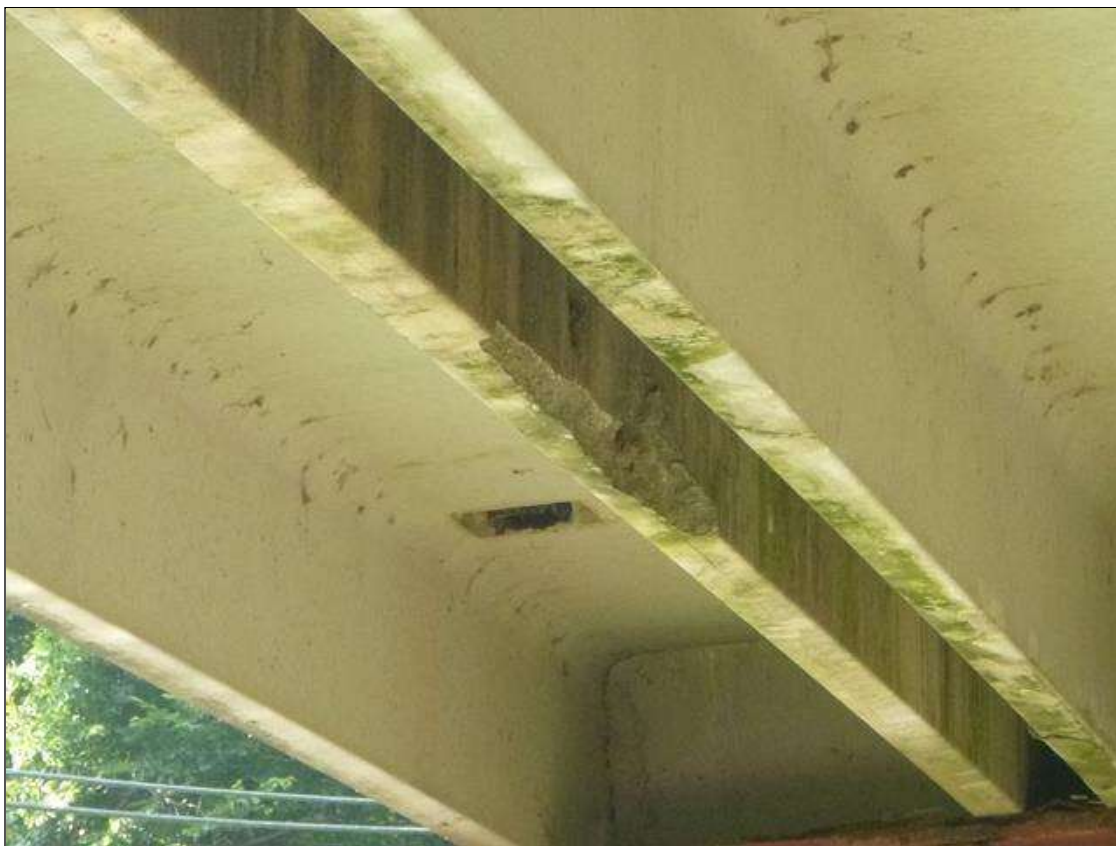
Span 2 Slab 1: right leg 6ft from bent 2, spall (30in x 3in x 3/4in) with exposed rusted rebar

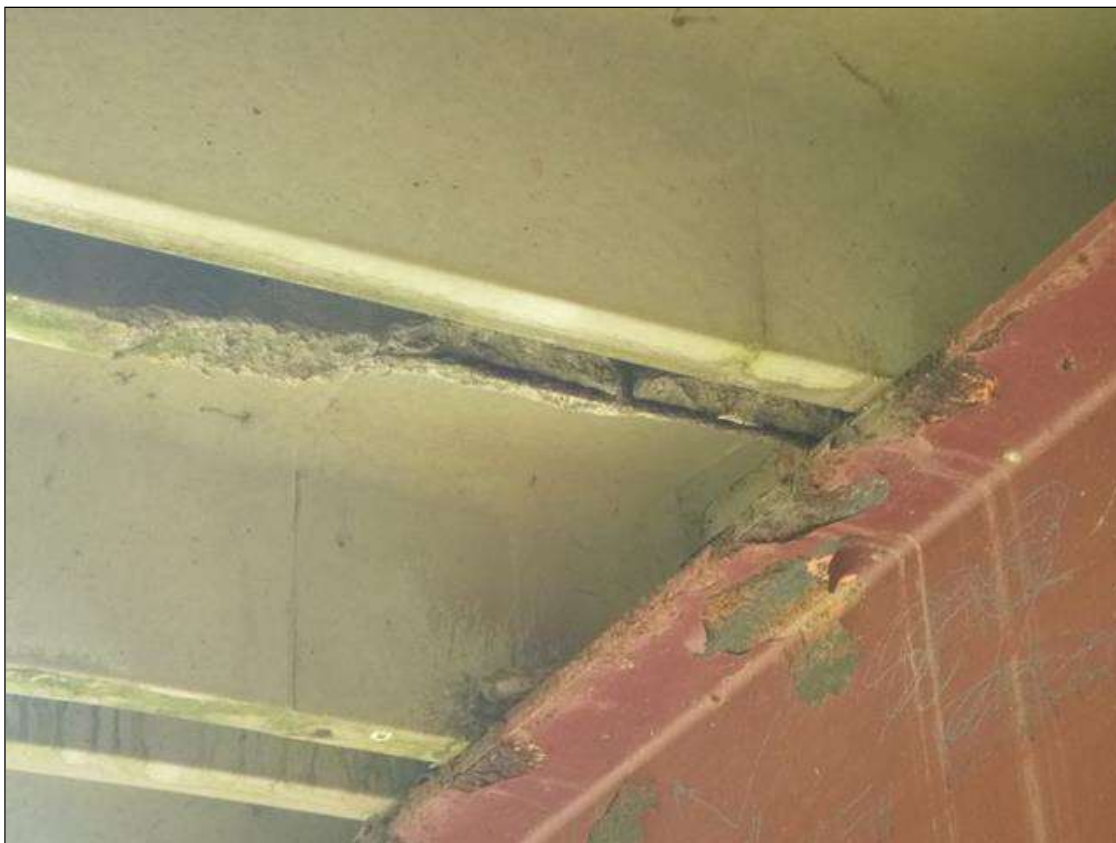
Span 2 Slab 2: [PAR] left and right leg at bent 2, two [2] spalls/delaminations [up to 36in x 6in x full width], with two [2] exposed stirrups [no section loss noted] and exposed strand [section loss up to 20%]

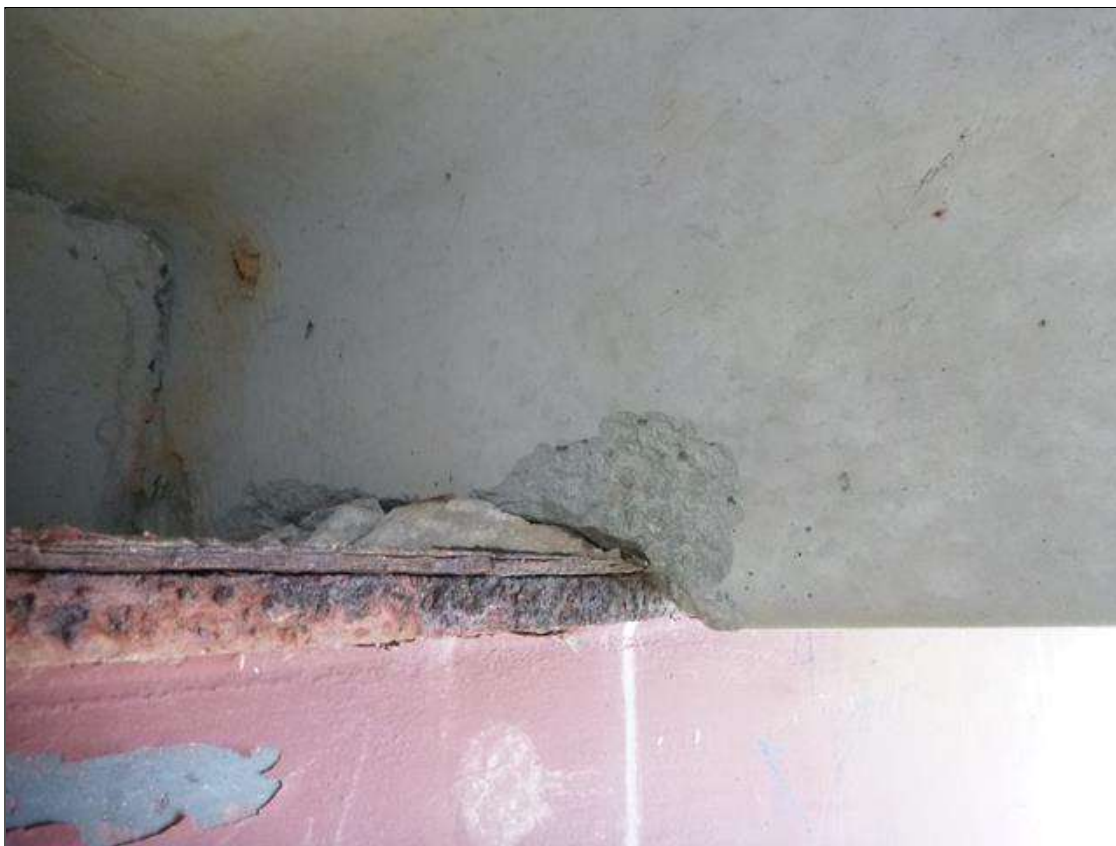
Span 2 Slab 5: (PAR) left and right leg at bent 1, two [2] spalls [up to 12in x 8in x up to full width], with exposed stirrup [no section loss noted] channel legs crushing and bottom of channel legs sits below top of crutch bent cap (photo 1 of 2)

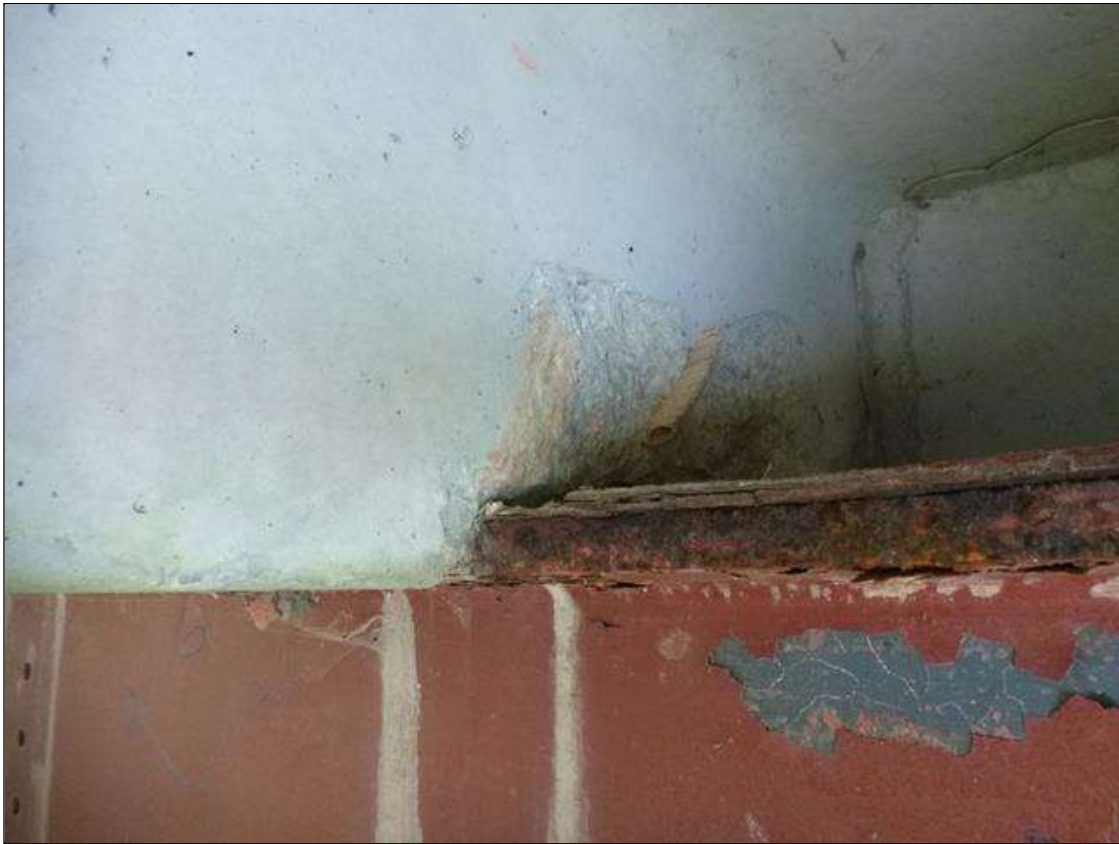
Span 2 Slab 5: (PAR) left and right leg at bent 1, two [2] spalls [up to 12in x 8in x up to full width], with exposed stirrup [no section loss noted] channel legs crushing and bottom of channel legs sits below top of crutch bent cap (photo 2 of 2)

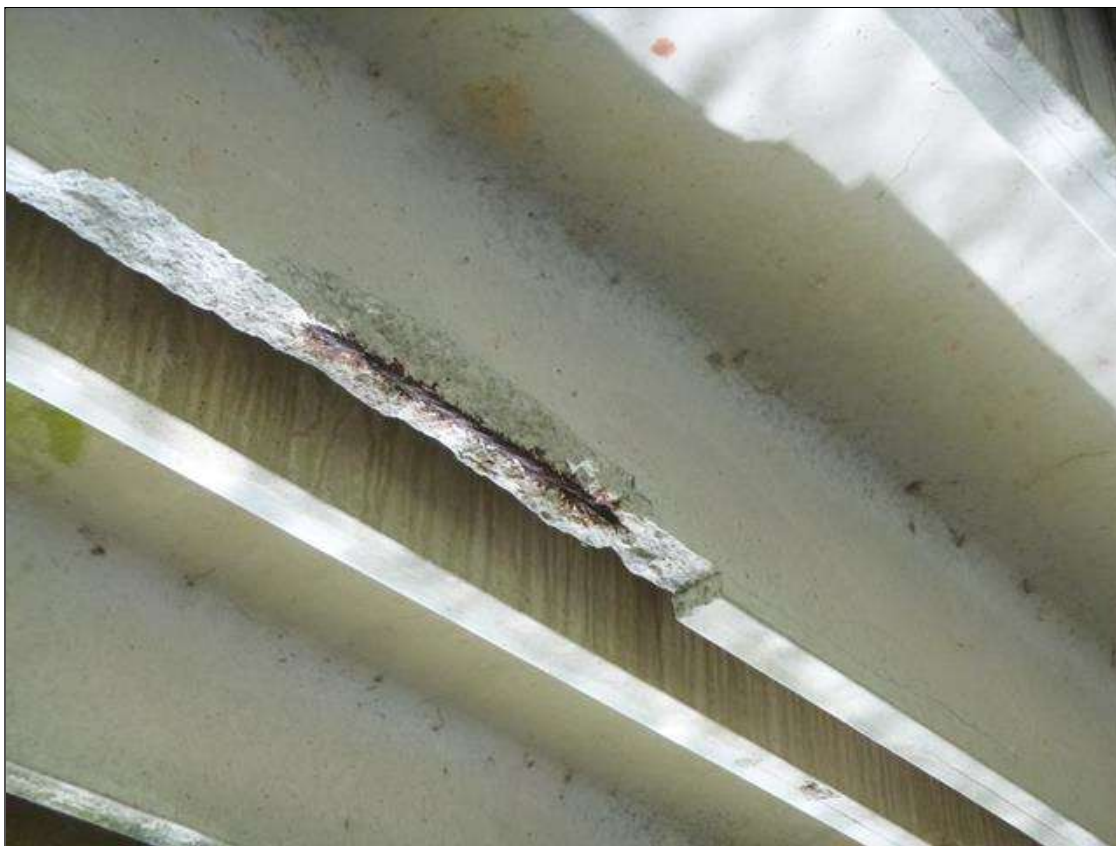
Span 2 Slab 7: [PAR] left leg near midspan, spall/delamination [30in x 4in x full width], with exposed strand [section loss up to 30%]

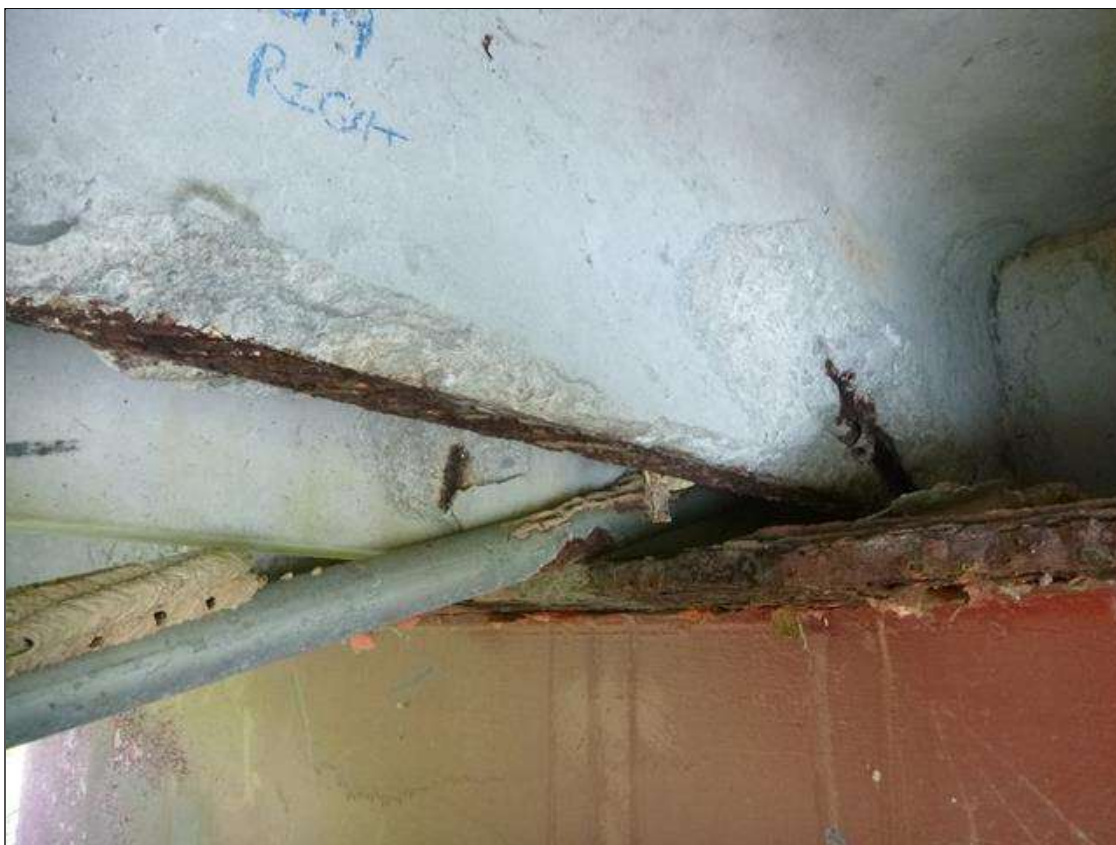
Span 2 Slab 9: [PAR] right leg at bent 1, spall/delamination [52in x 8in x up to full width] with one exposed strand (50% section loss on strand)

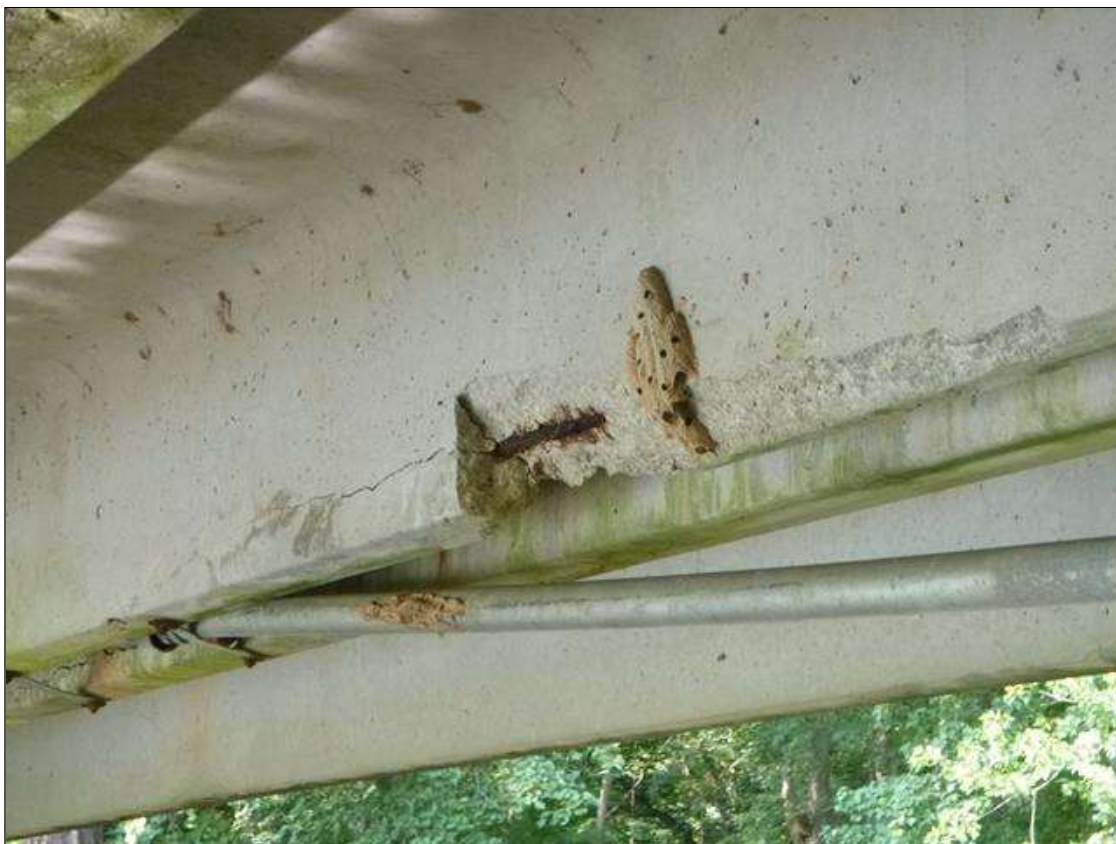
Span 2 Slab 9: [PAR] right leg 12ft from bent 1, spall/delamination [6ft x 3in x full width] with exposed strand (25% section loss)

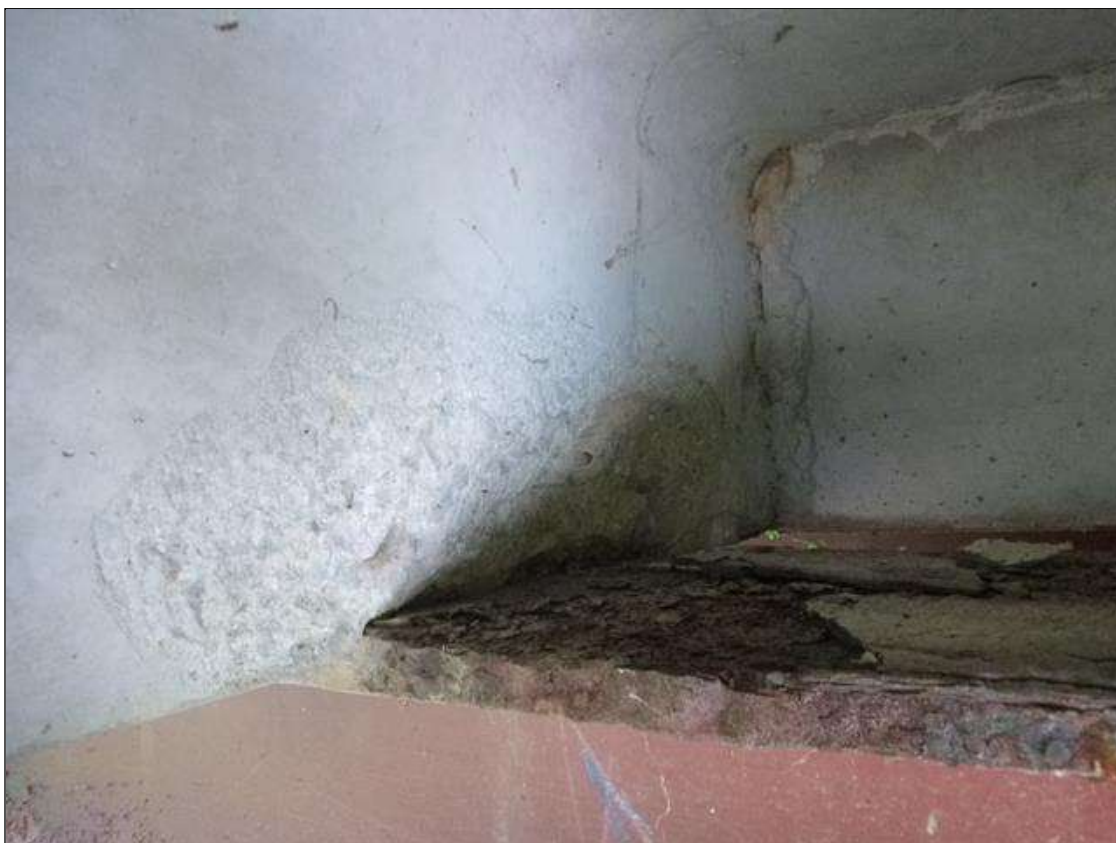
Span 2 Slab 10: left and right leg at bent 1, four [4] spalls [up to 18in x 6in x 1/2in]

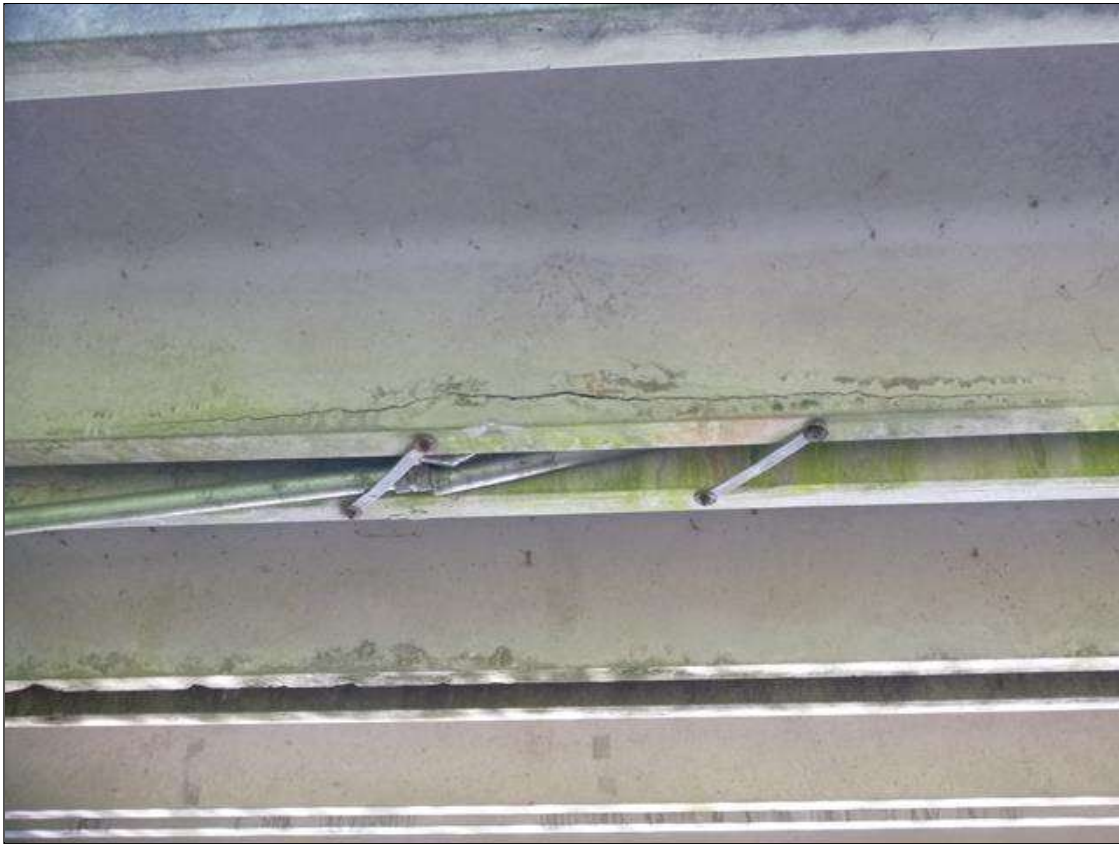
Span 2 Slab 10: left leg at midspan, delamination (4ft x 2in high) with longitudinal crack crack (up to 1/8in)

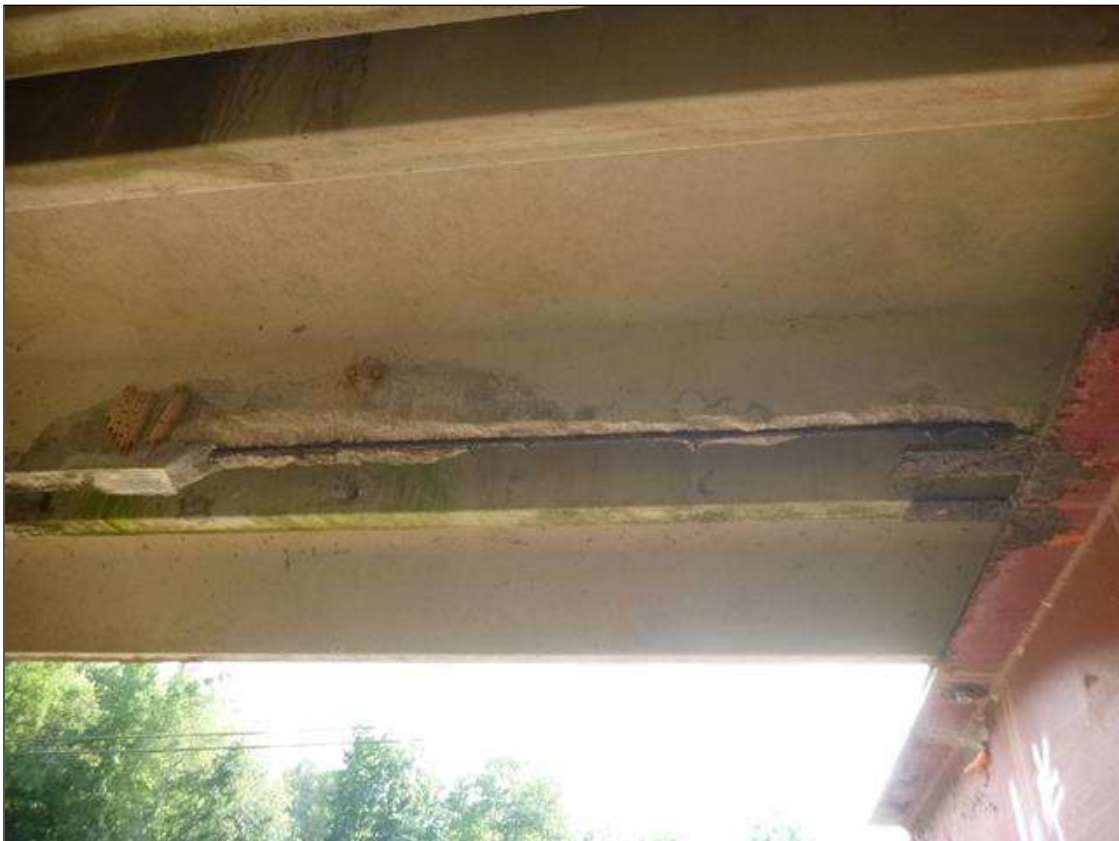
Span 3 Slab 2: [PAR] left leg at bent 3, spall [6ft x full width x 5in], with exposed strand (40% section loss)

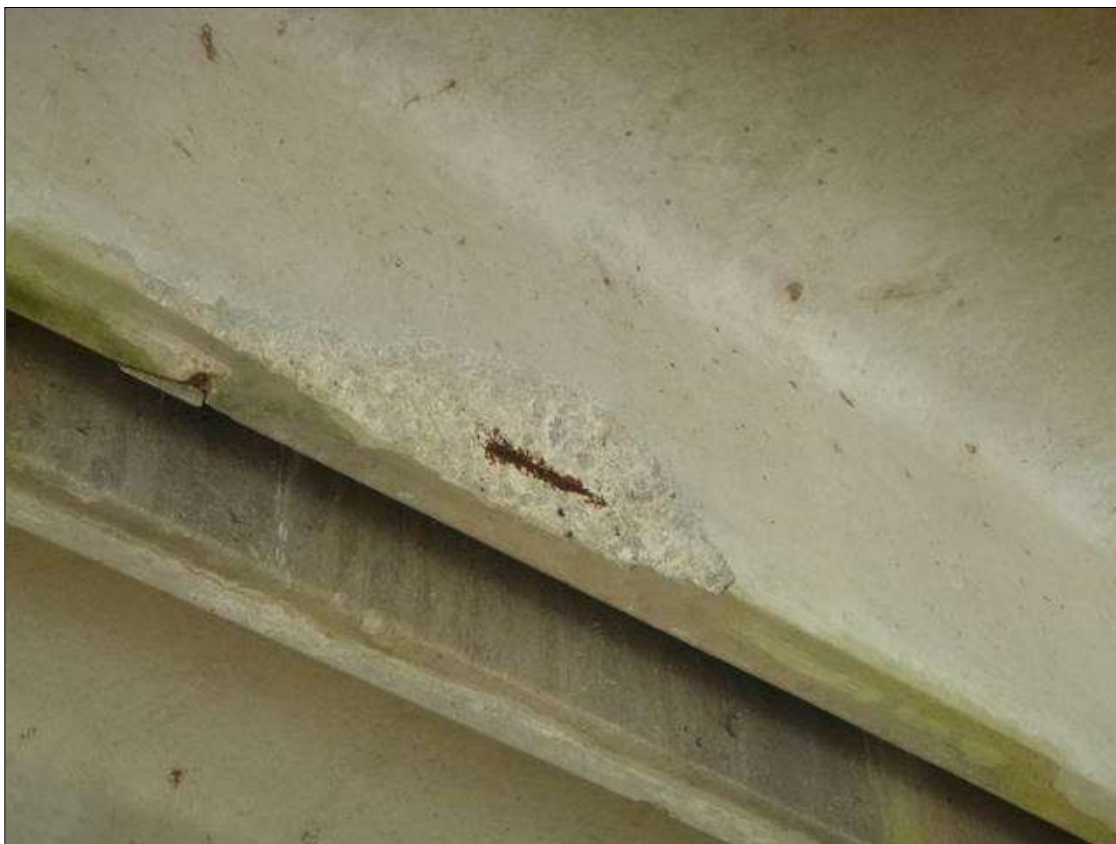
Span 3 Slab 2: (PAR) right leg at midspan, spall (20in x 5in x 3/4in) with exposed rusted strand

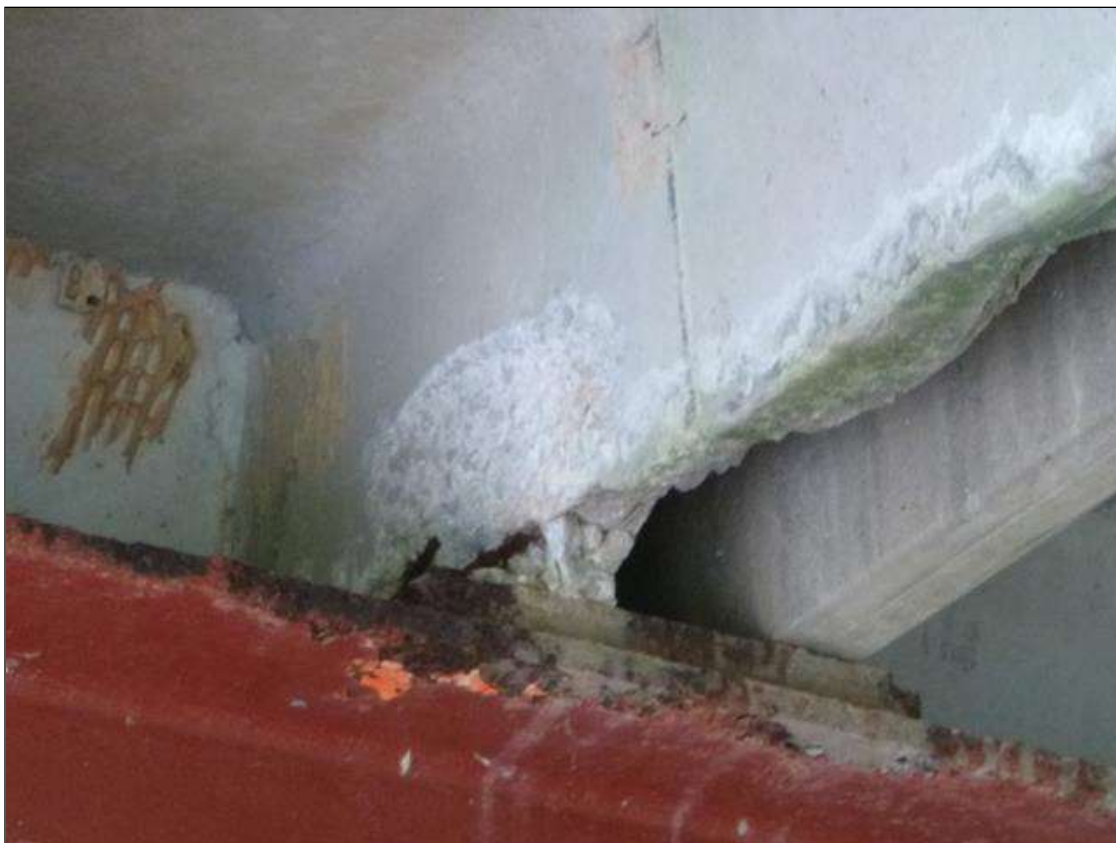
Span 3 Slab 5: (PAR) right leg at bent 3, spall [6in x 4in x full width], with exposed strand

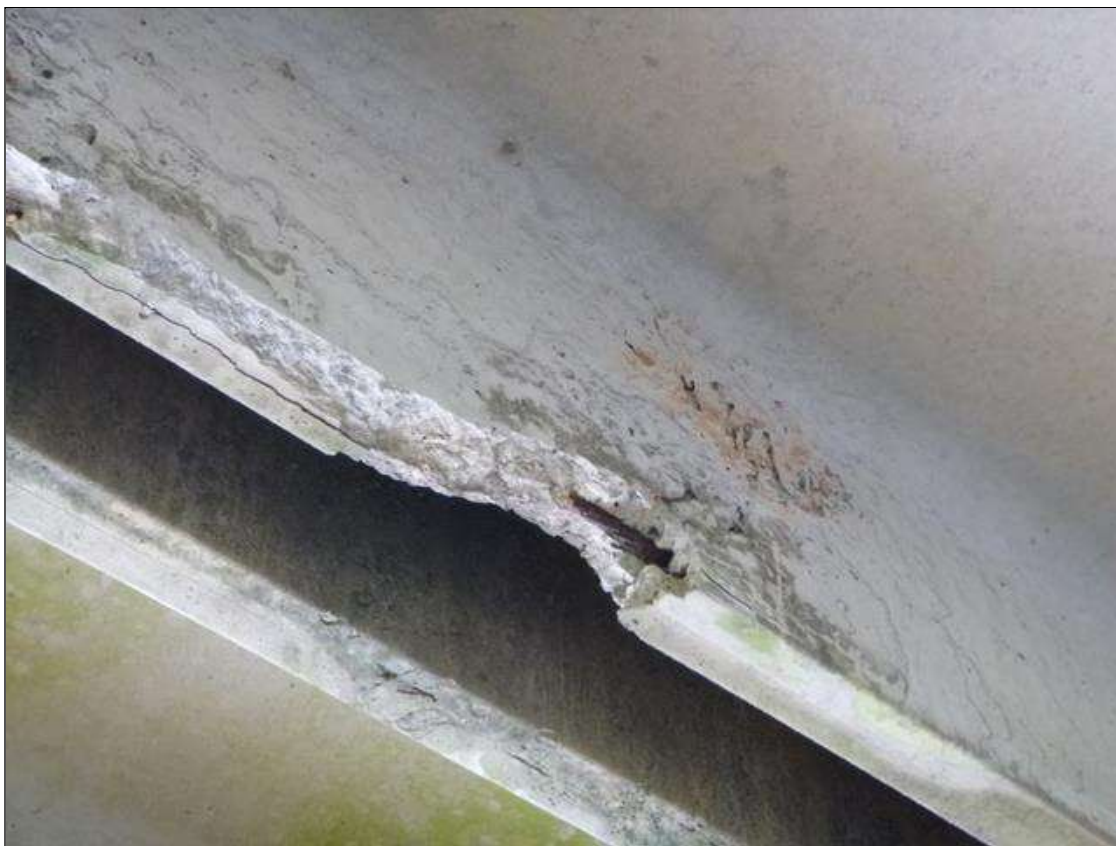
Span 3 Slab 6: [PAR] left leg at far third, spall [2ft x 5in] with exposed strand

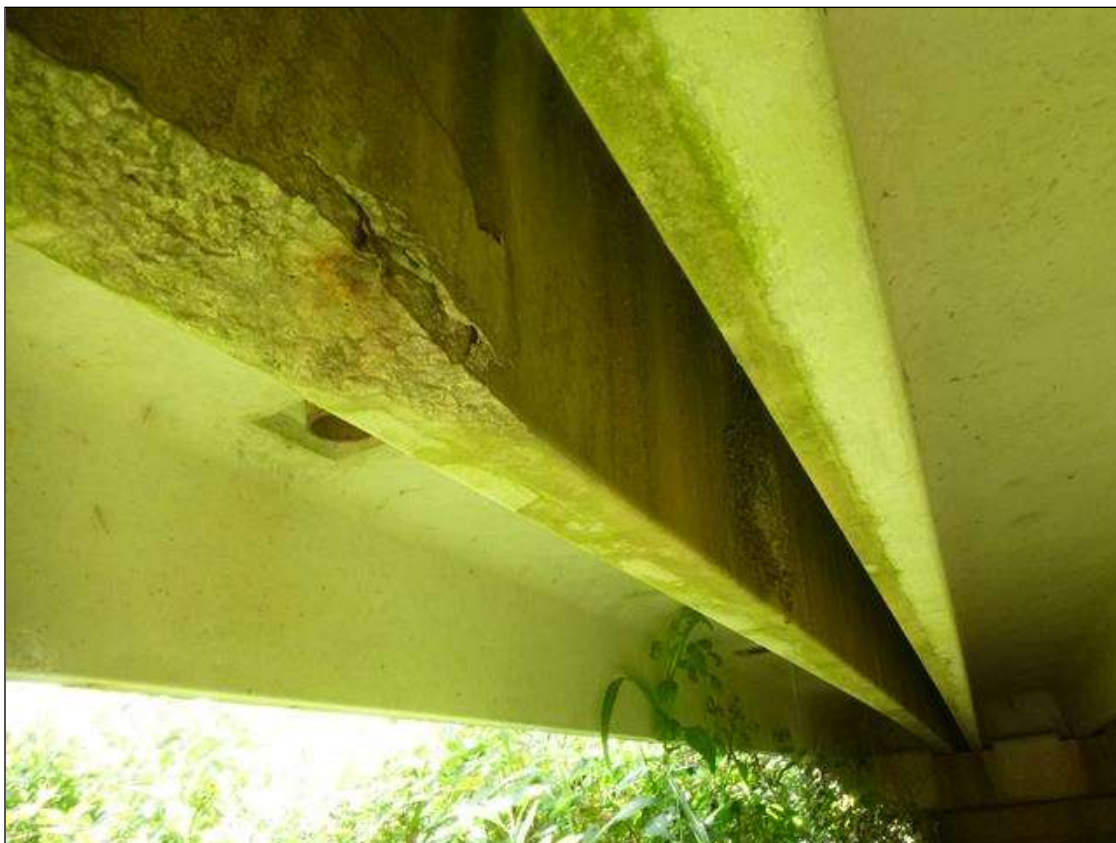
Span 4 Slab 1: right leg near midspan, spall [12in x 8in x 3/4in] with exposed stirrup [no section loss noted]

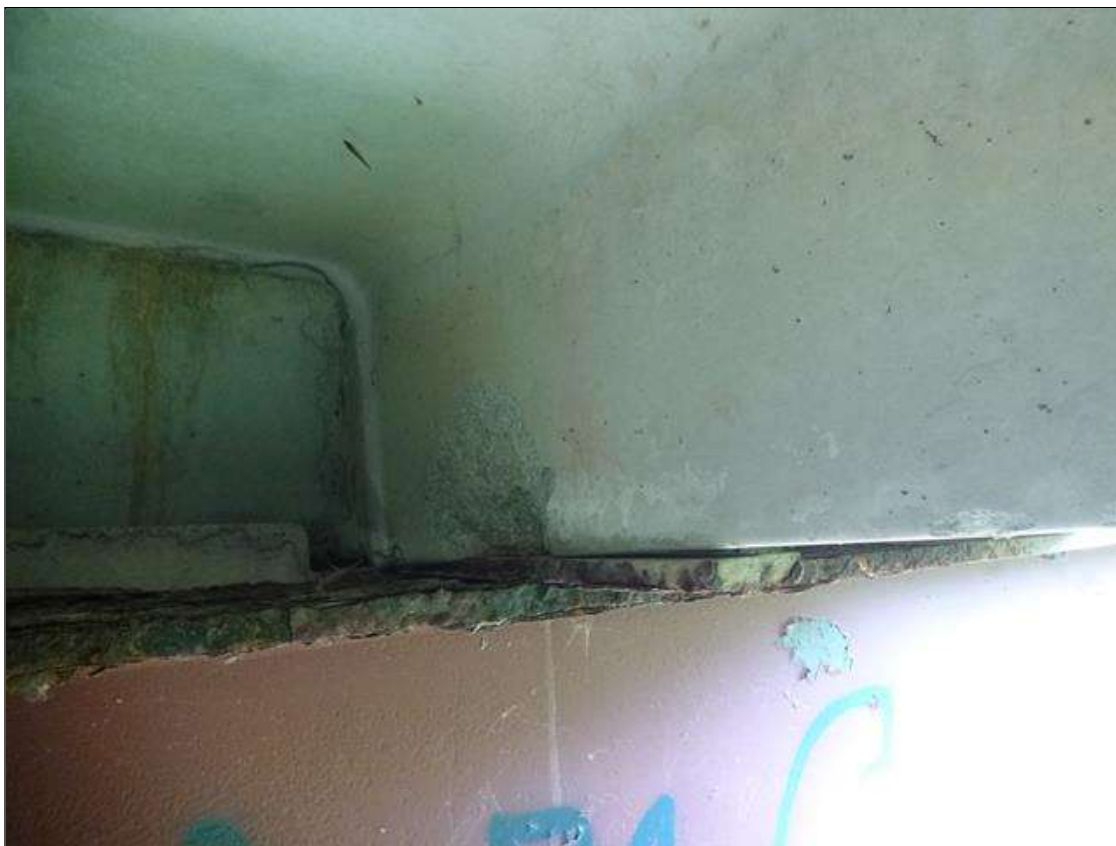
Span 4 Slab 2: left leg at bent 3, spall [6in x 6in x 1/2in deep]
