NC DEPARTMENT OF TRANSPORTATION
 DIVISION OF HIGHWAYS
 STRUCTURE MANAGEMENT UNIT

ATTENTION: **PAR SUBMITTED
 SIGN NOTICE ISSUED
 CHANGES TO STRUCTURE DATA**

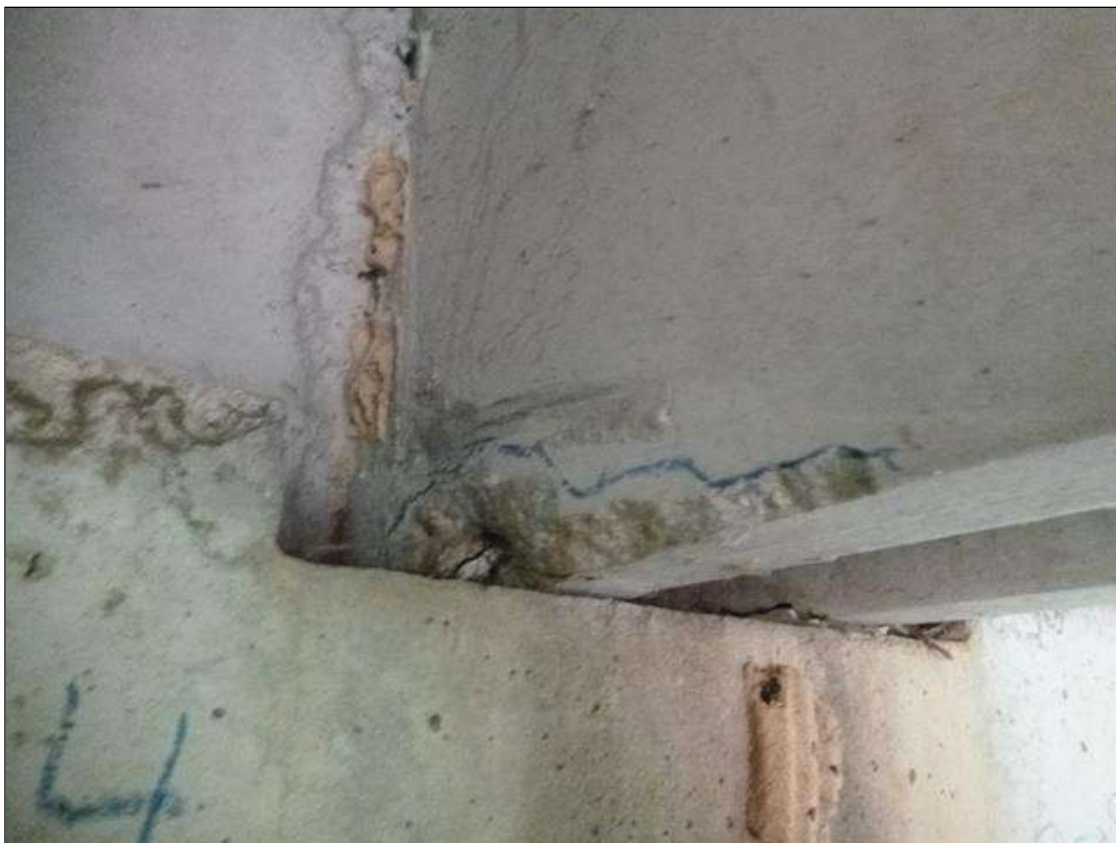
Span 4 Slab 4: (PAR) at far end of both legs, three [3] spalls/delaminations [6in x 6in x 1-1/2in deep] with one exposed strand [section loss up to 10%]

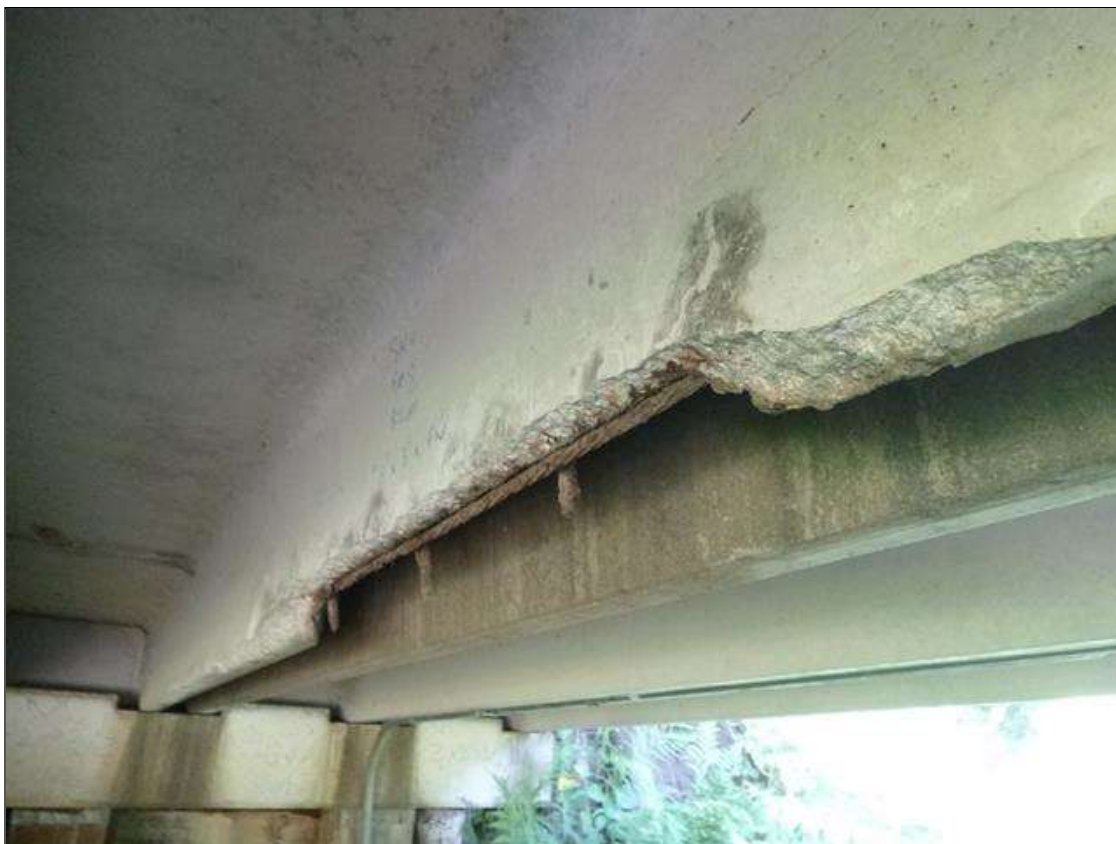
Span 4 Slab 8: [PAR] right leg at far third, spall [4ft x 3in x full width] with exposed strand

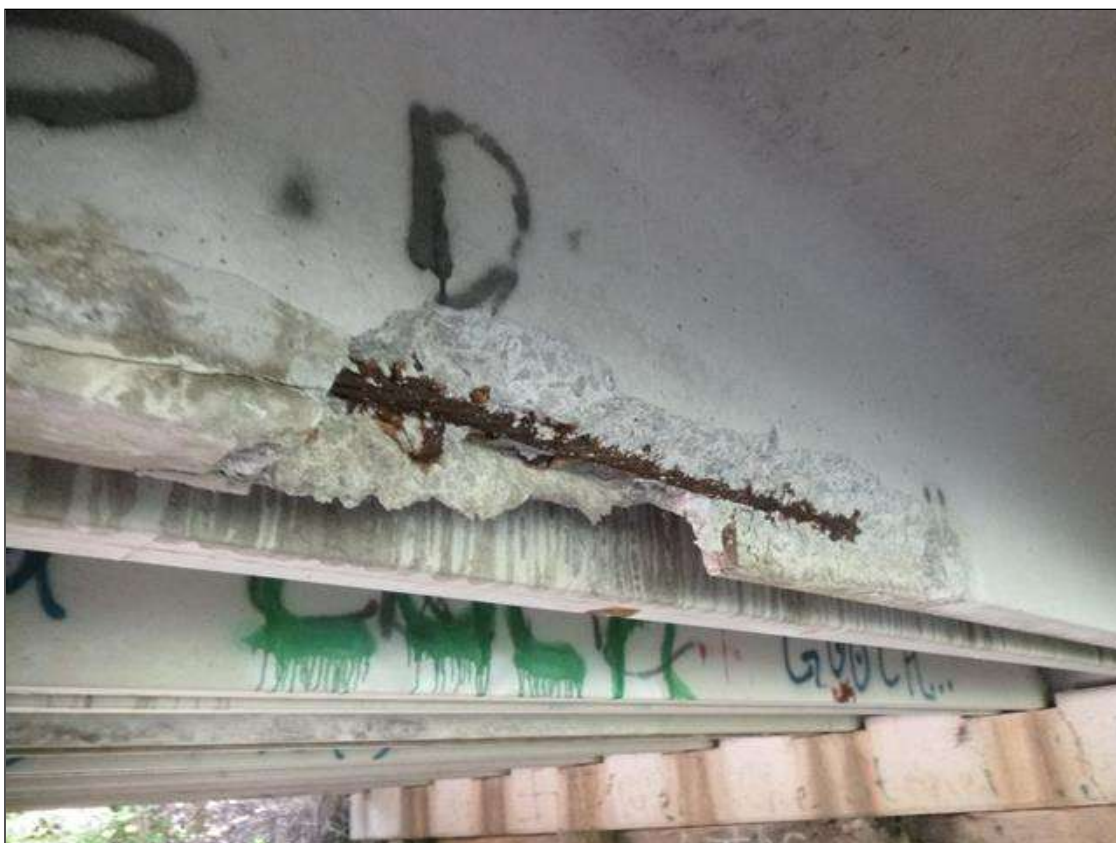
Span 4 Slab 8: (PAR) left leg at far third, spall/delamination [36in x 3in x 2in deep] with exposed rusted strand

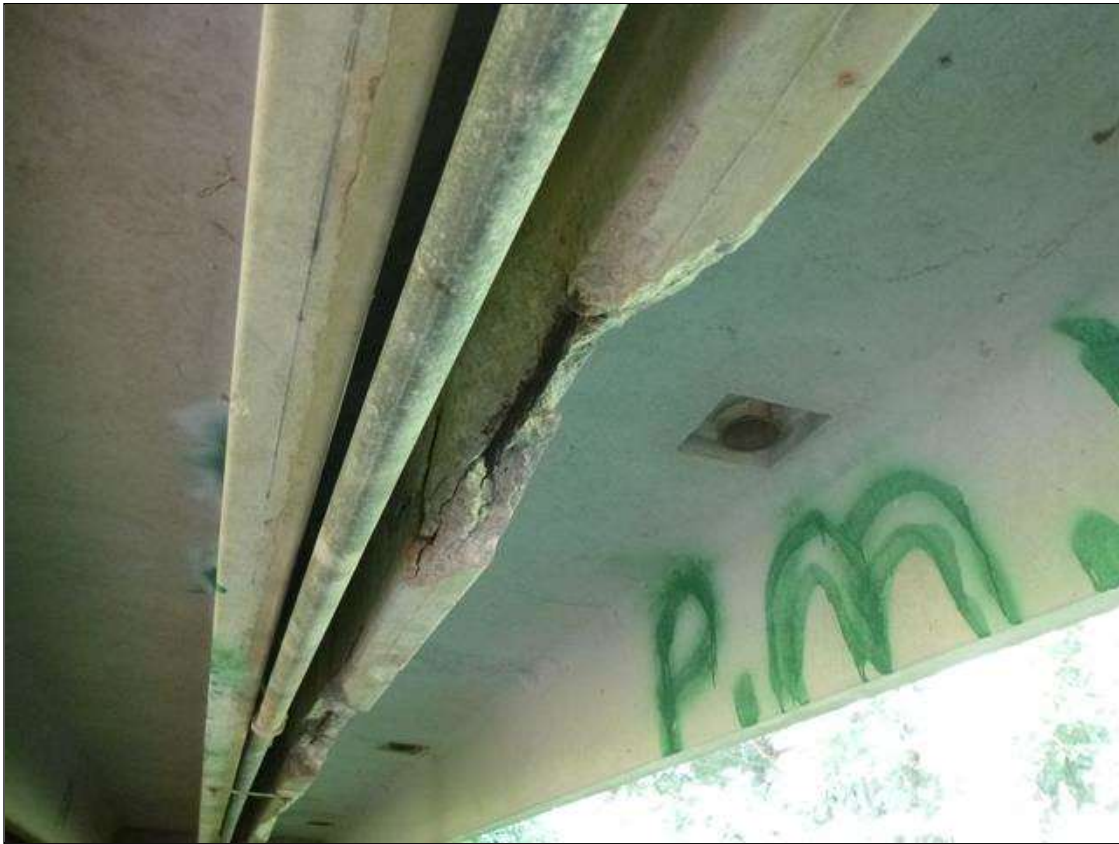
Span 4 Slab 10: [PAR] 5 TOTAL AREAS OF AREAS IN LEFT LEG OF FULL WIDTH X UP TO 6" HIGH SPALLS WITH EXPOSED STRANDS FOR 20' TOTAL (20% SECTION LOSS) (PHOTO 1 OF 4)

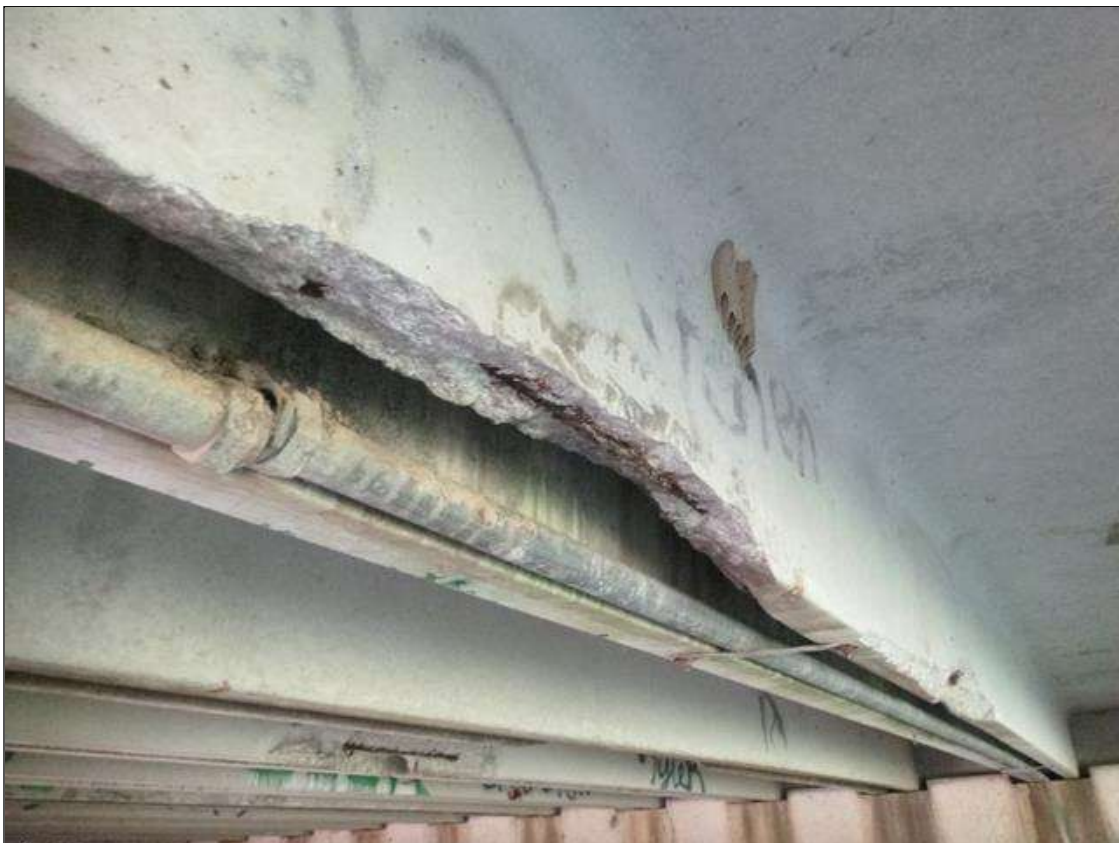
Span 4 Slab 10: [PAR] 5 TOTAL AREAS OF AREAS IN LEFT LEG OF FULL WIDTH X UP TO 6" HIGH SPALLS WITH EXPOSED STRANDS FOR 20' TOTAL (20% SECTION LOSS) (PHOTO 2 OF 4)

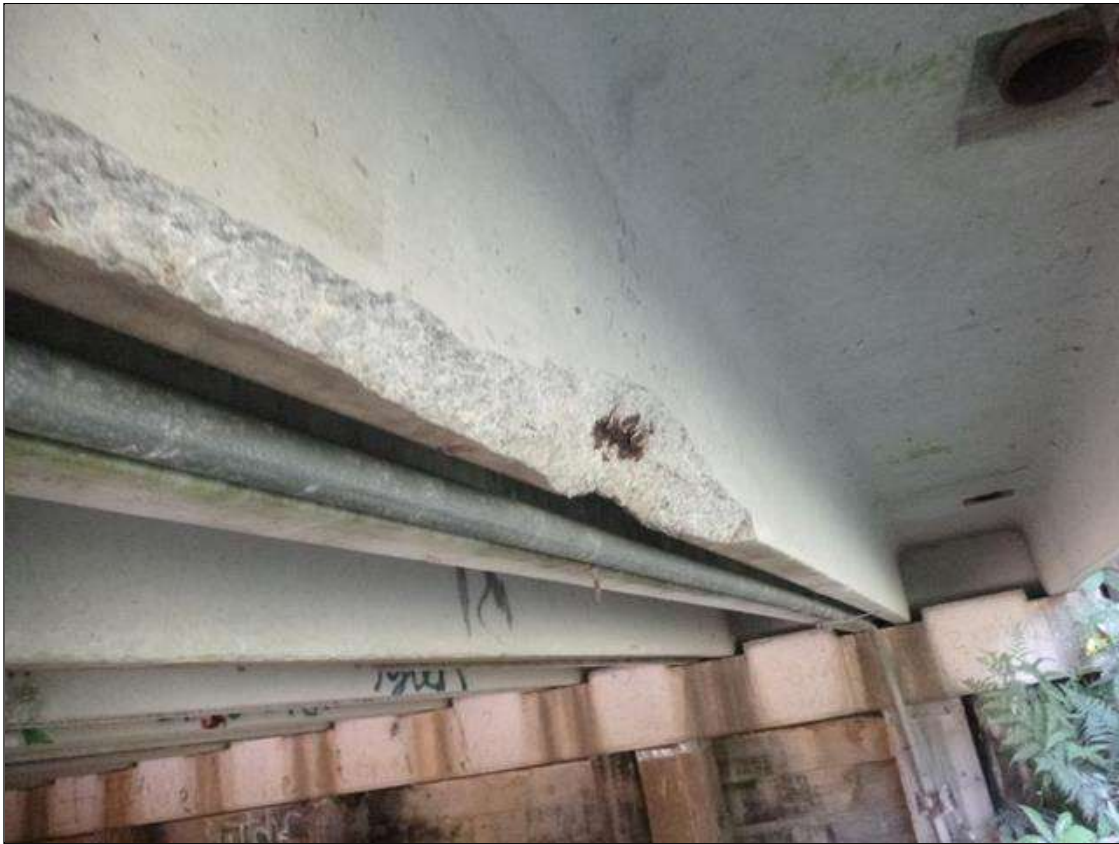
Span 4 Slab 10: [PAR] 5 TOTAL AREAS OF AREAS IN LEFT LEG OF FULL WIDTH X UP TO 6" HIGH SPALLS WITH EXPOSED STRANDS FOR 20' TOTAL (20% SECTION LOSS) (PHOTO 3 OF 4)

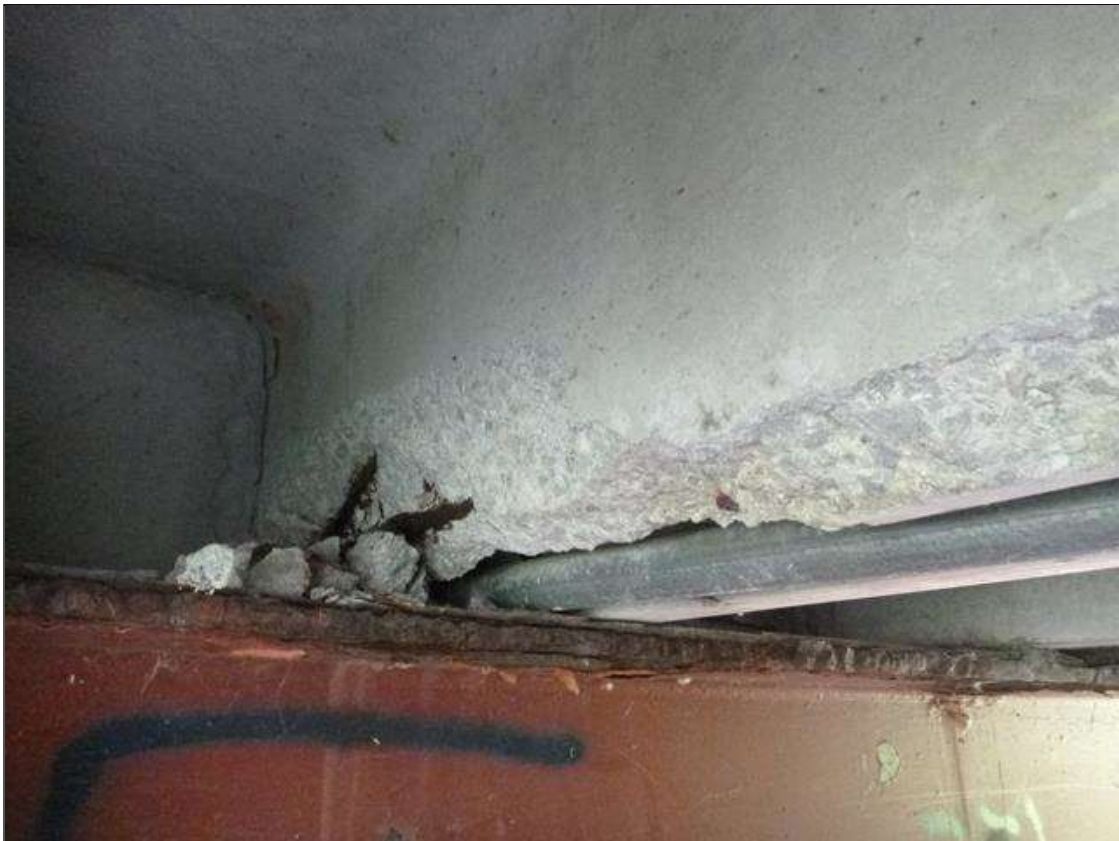
Span 4 Slab 10: [PAR] 5 TOTAL AREAS OF AREAS IN LEFT LEG OF FULL WIDTH X UP TO 6" HIGH SPALLS WITH EXPOSED STRANDS FOR 20' TOTAL (20% SECTION LOSS) (PHOTO 4 OF 4)

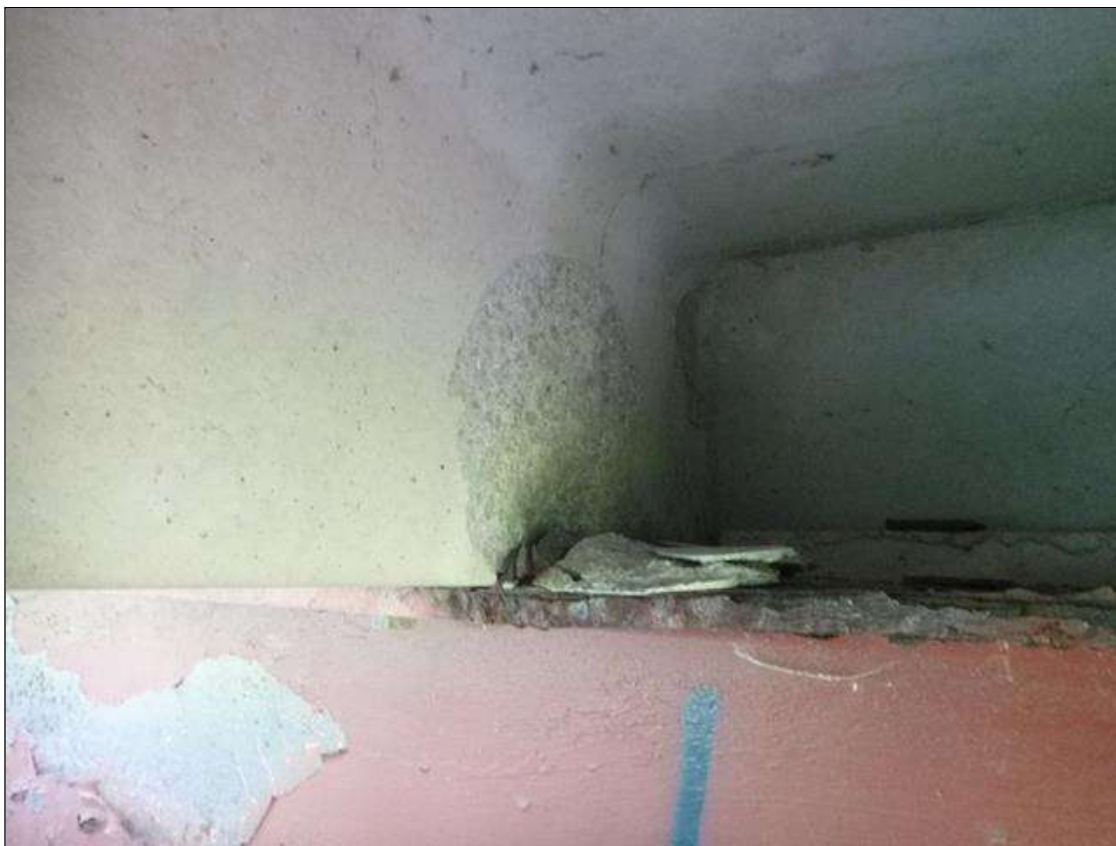
Span 4 Slab 10: right leg at bent 3, spall [10in x 4in x 3/4in deep]

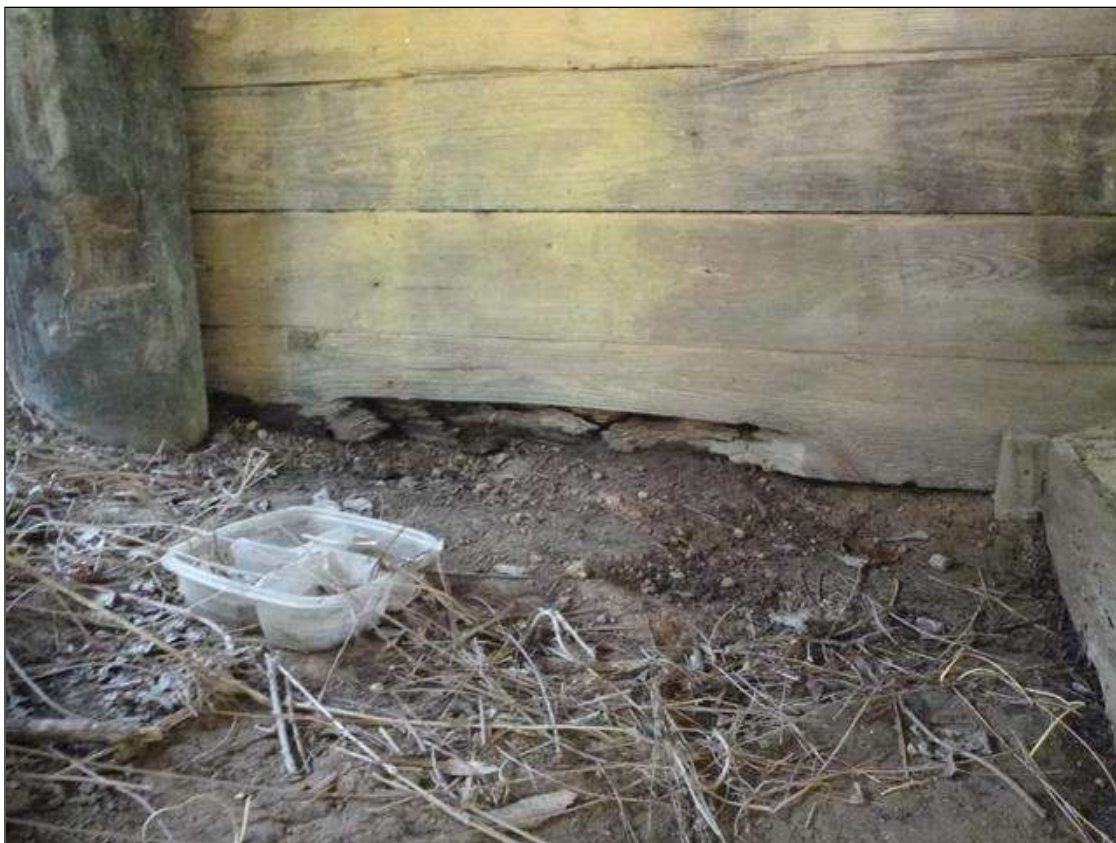
End Bent 2 Abutment: [PAR] between piles 1 and 2, lower board decay [3ft x 4in x full width] with exposed/missing backfill material

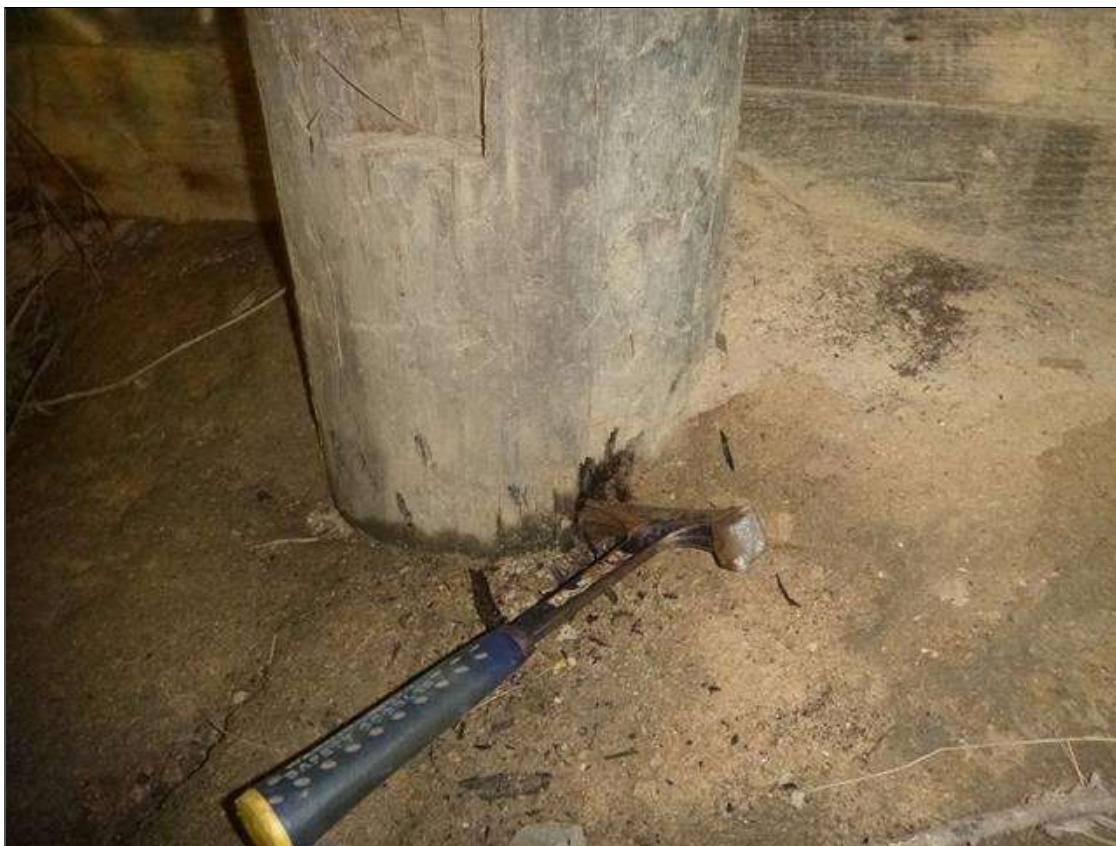
End Bent 2 Pile 3: at base of pile, decay (8in x 1in x 1-1/2in deep)

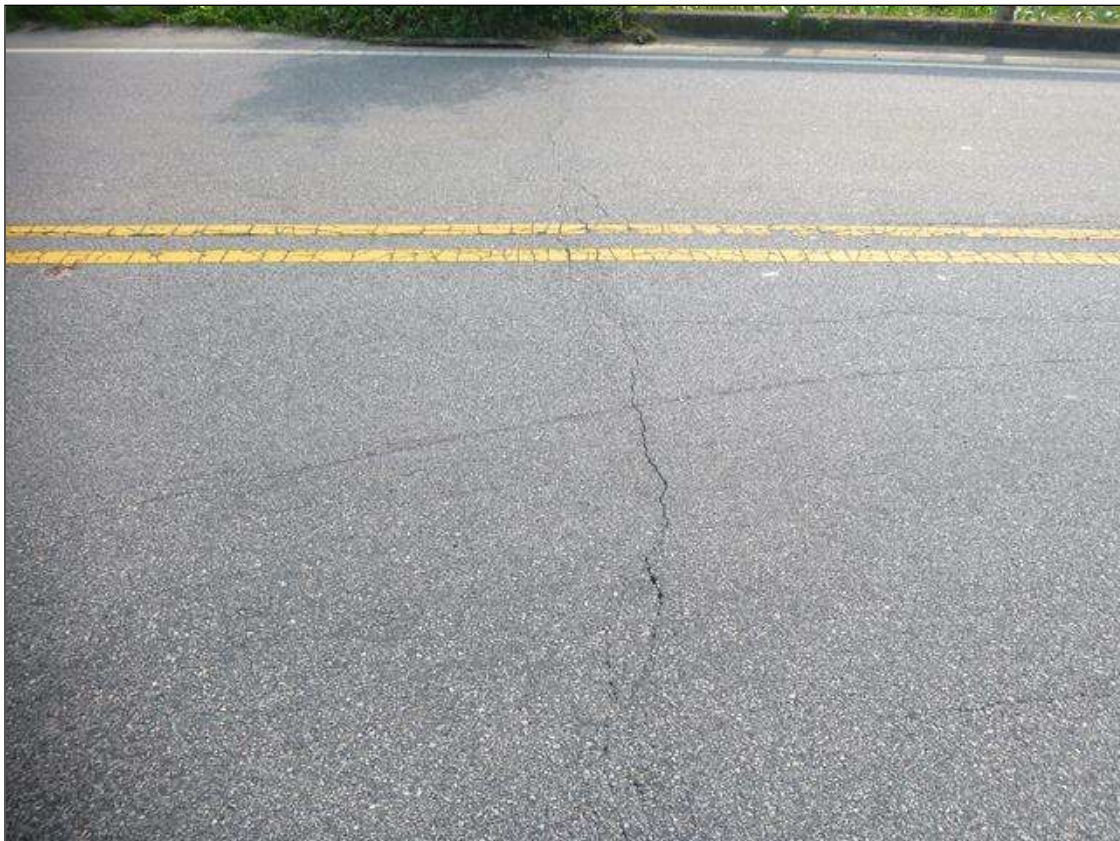
asphalt wearing surface over end bent 1

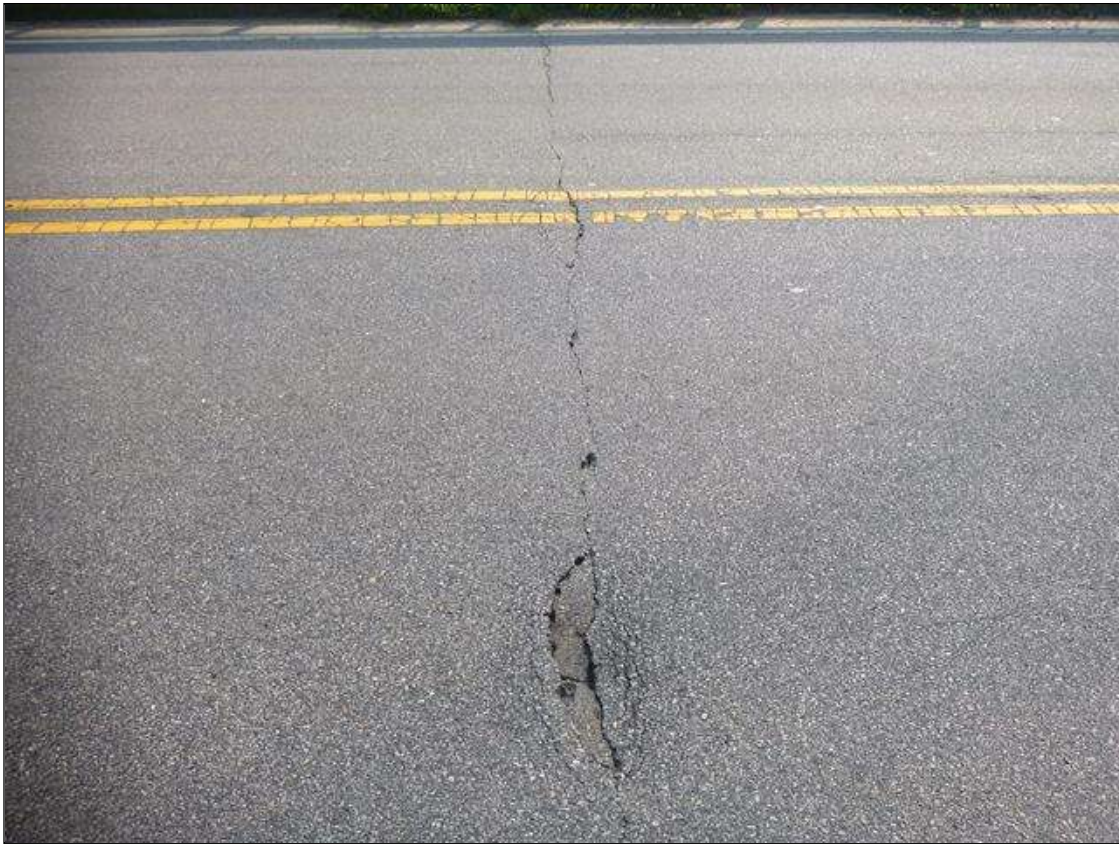
asphalt wearing surface over bent 1

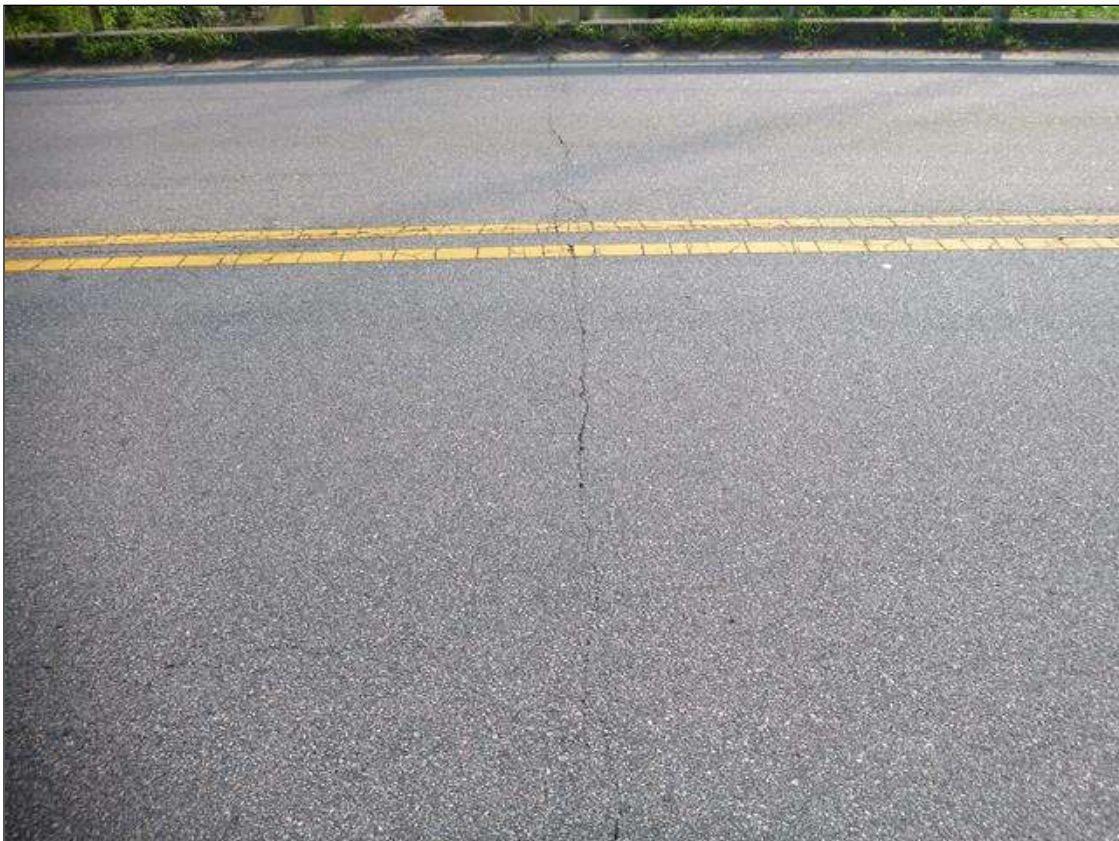
asphalt wearing surface over bent 2

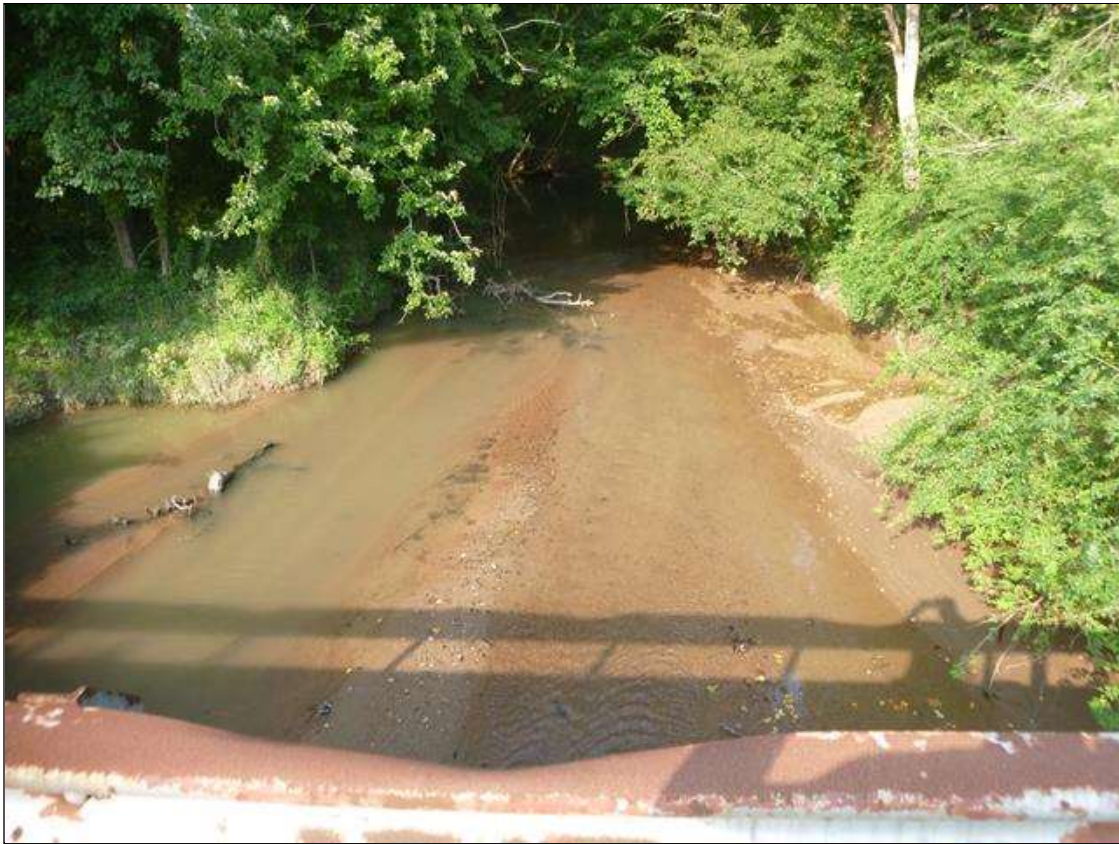
looking upstream, east

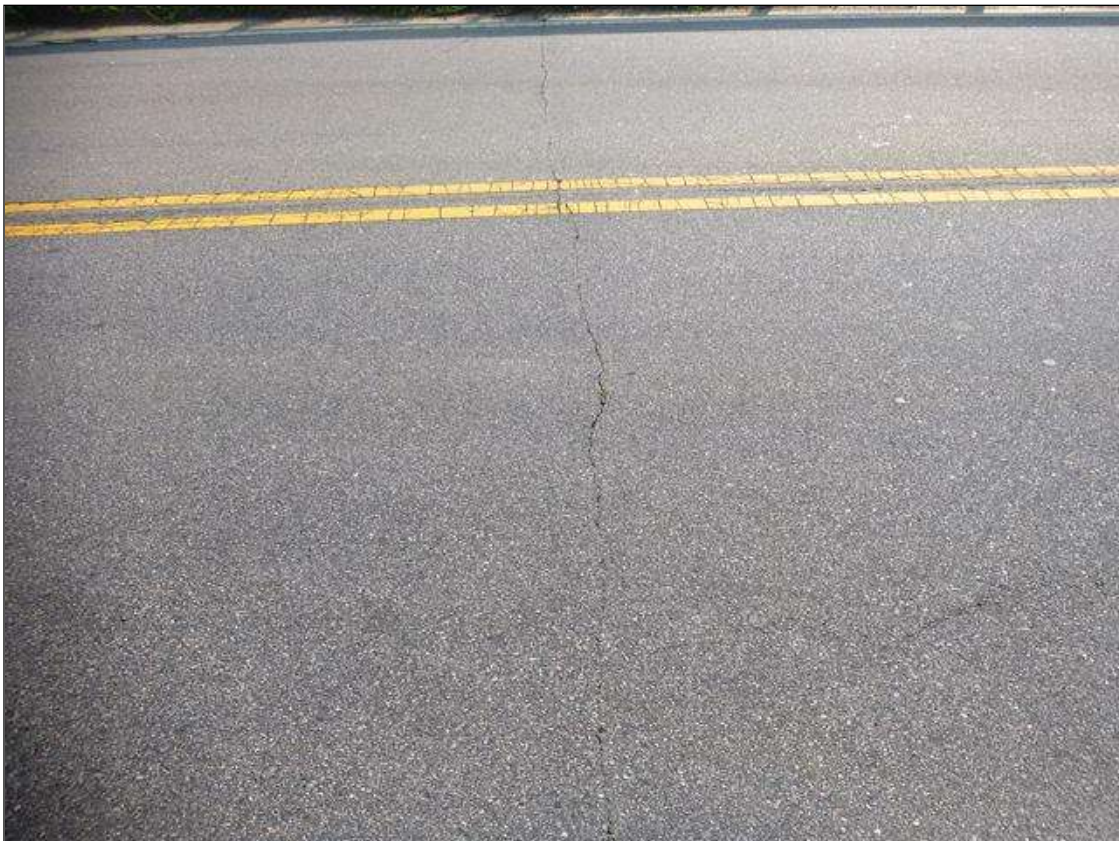
asphalt wearing surface over bent 3

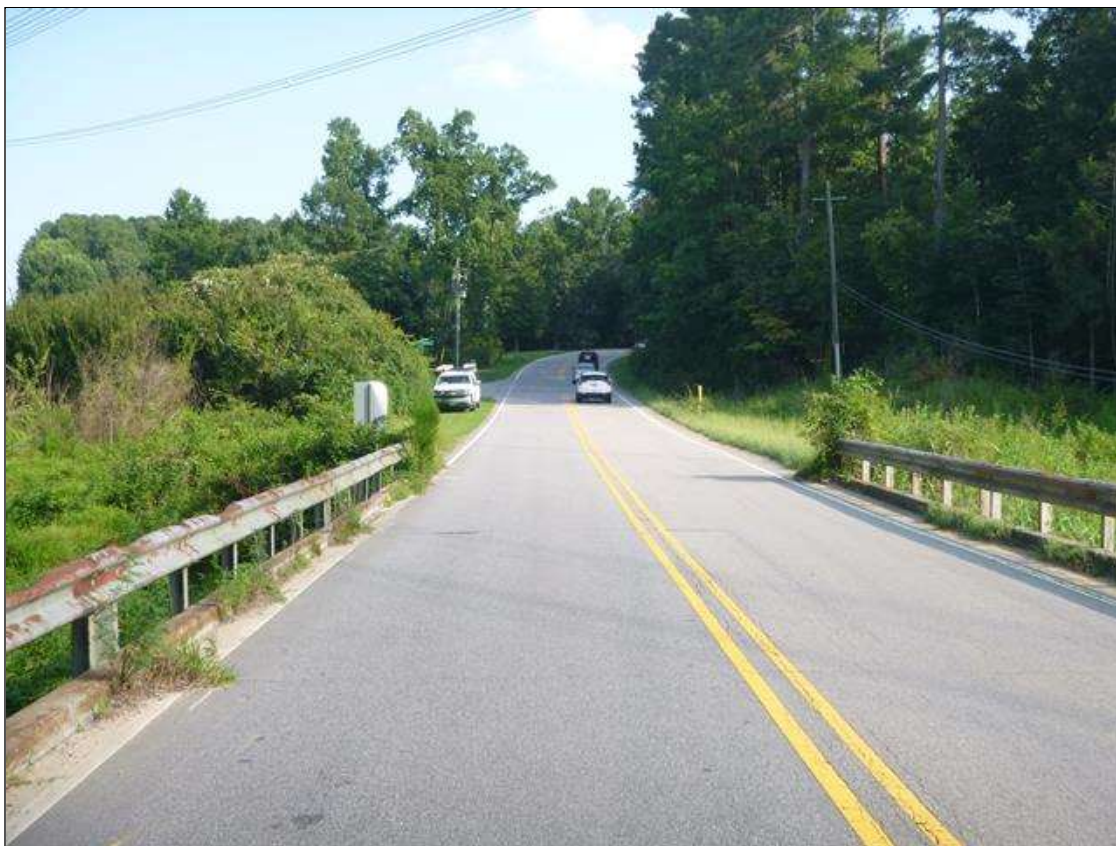
south approach, looking south (backstation)

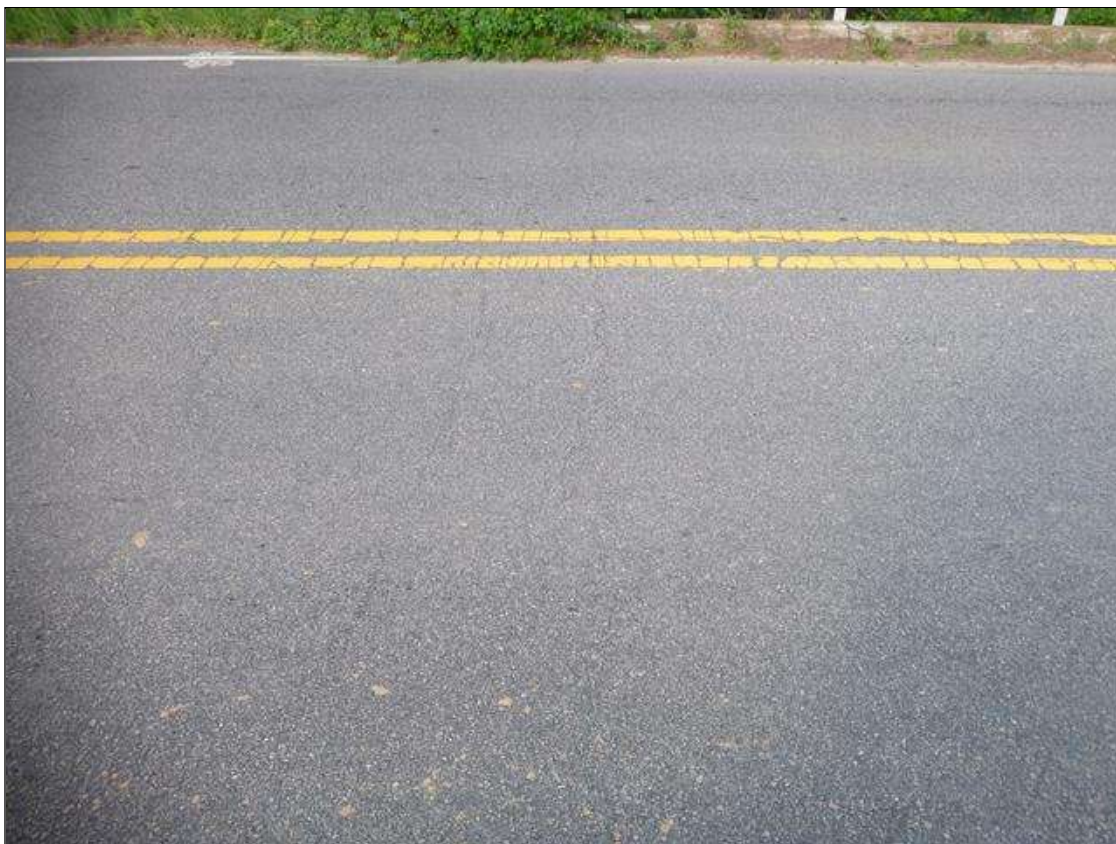
asphalt wearing surface over end bent 2

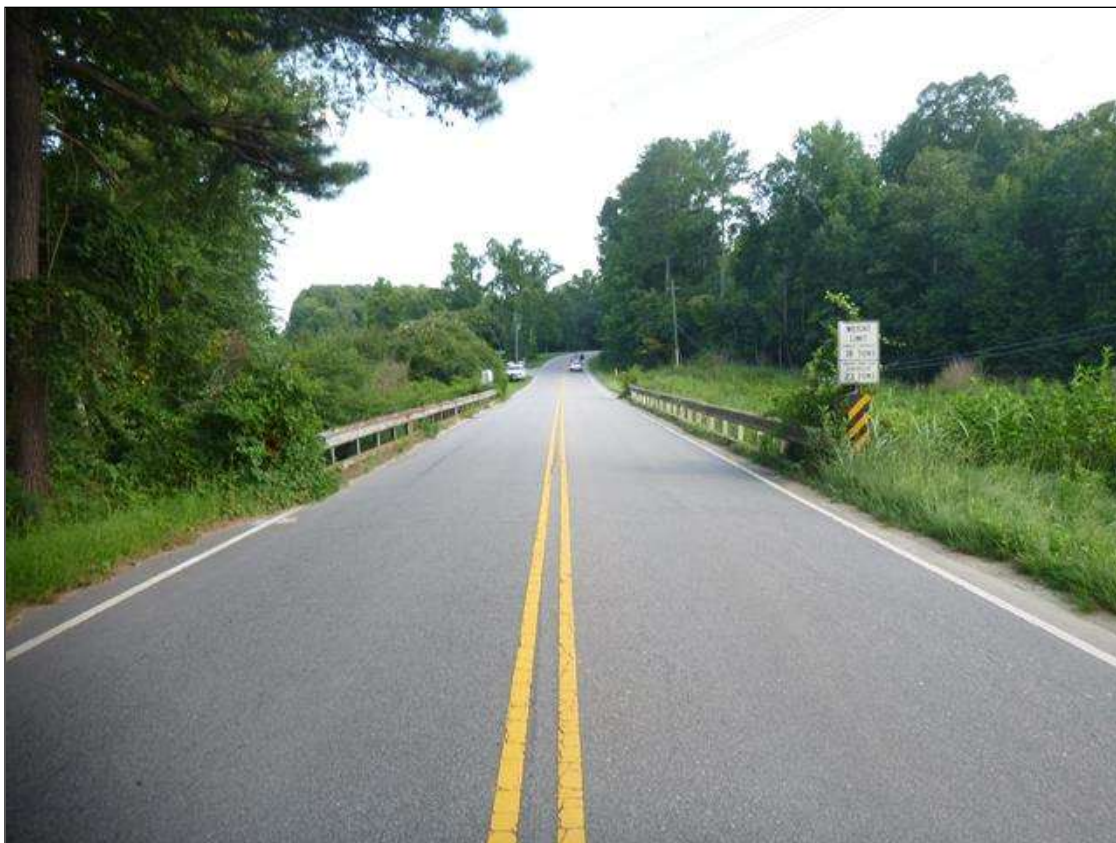
north approach, looking south

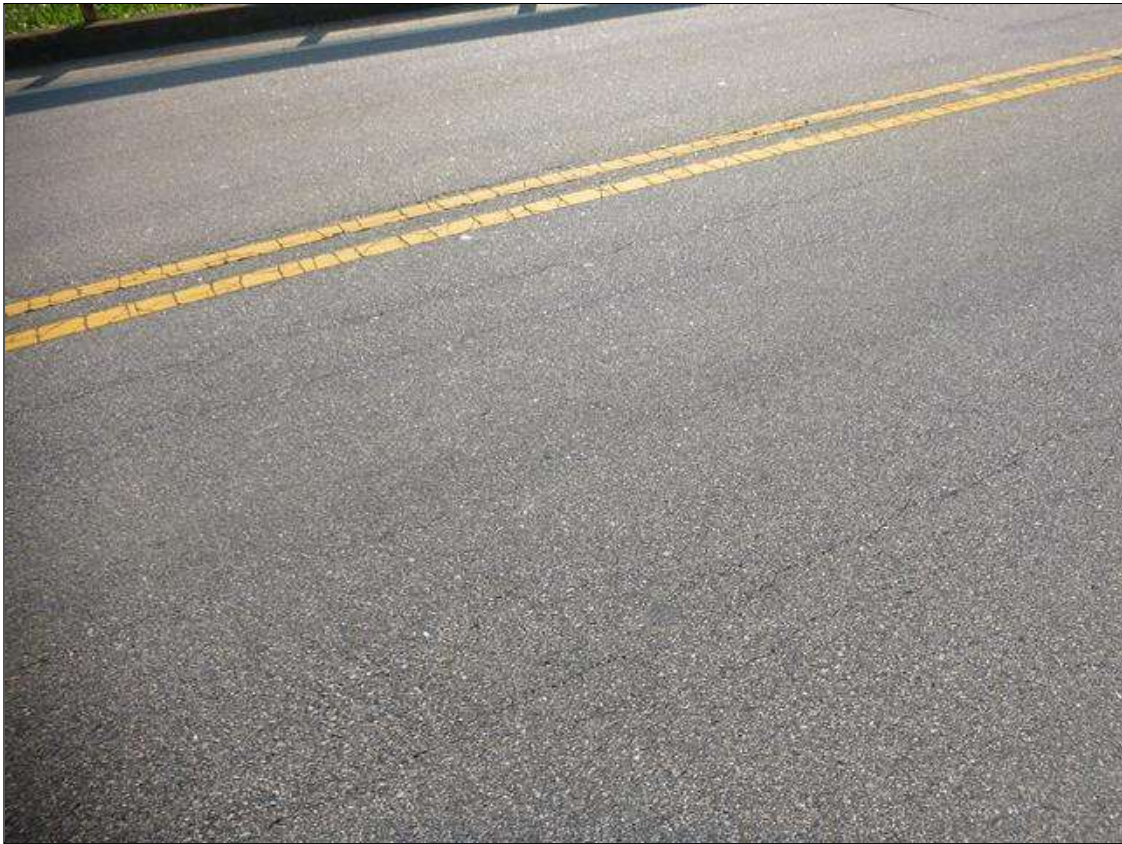
asphalt wearing surface

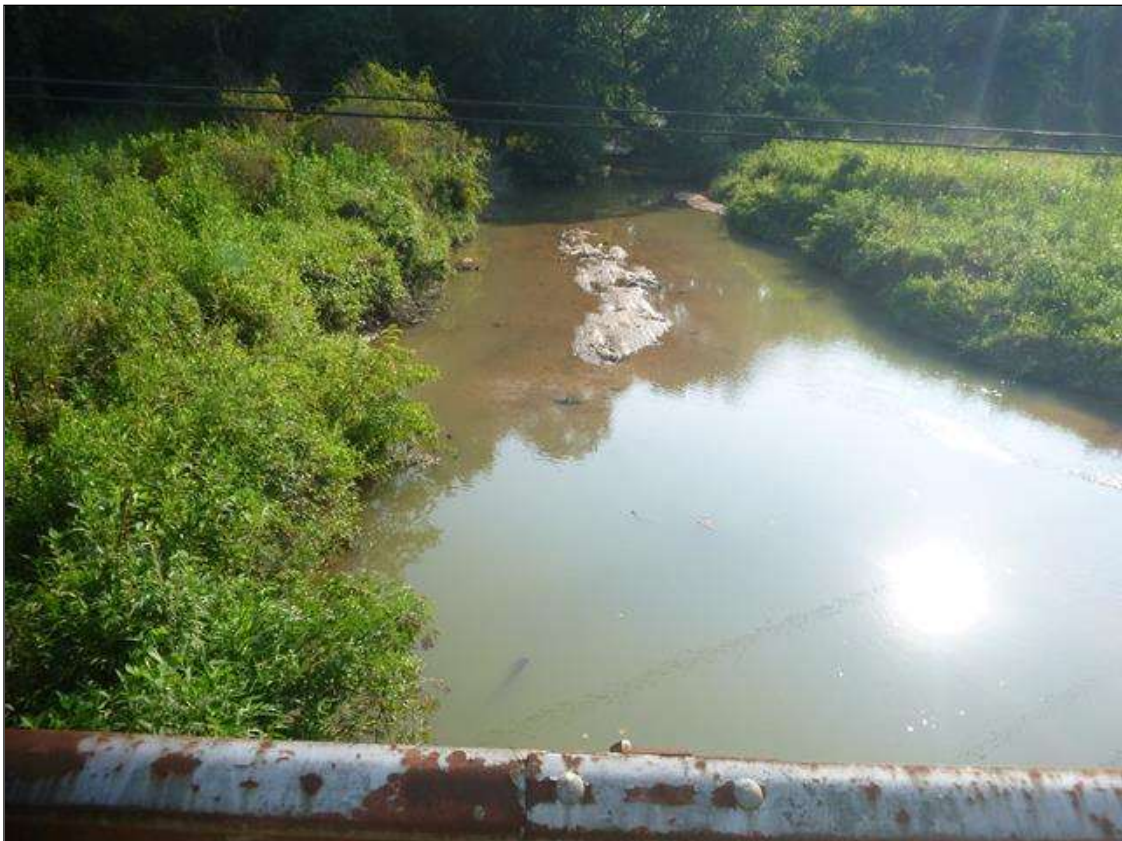
looking downstream, west

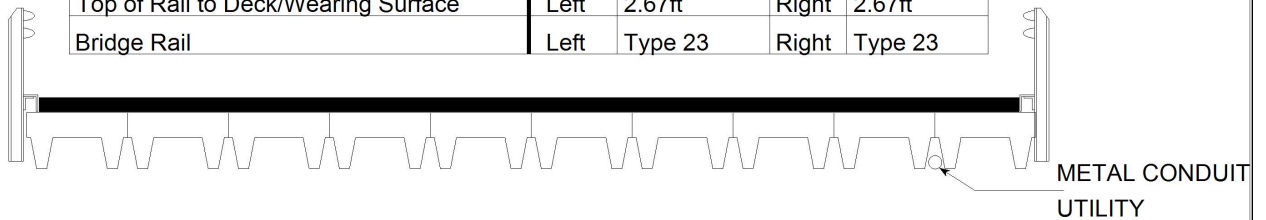
Measurements for Span #	1	ALL SPANS SIMILAR	
Deck Thickness	0.417ft	Left Overhang	0ft
Top of Rail to Bottom of Beam	4.333ft	Right Overhang	0ft

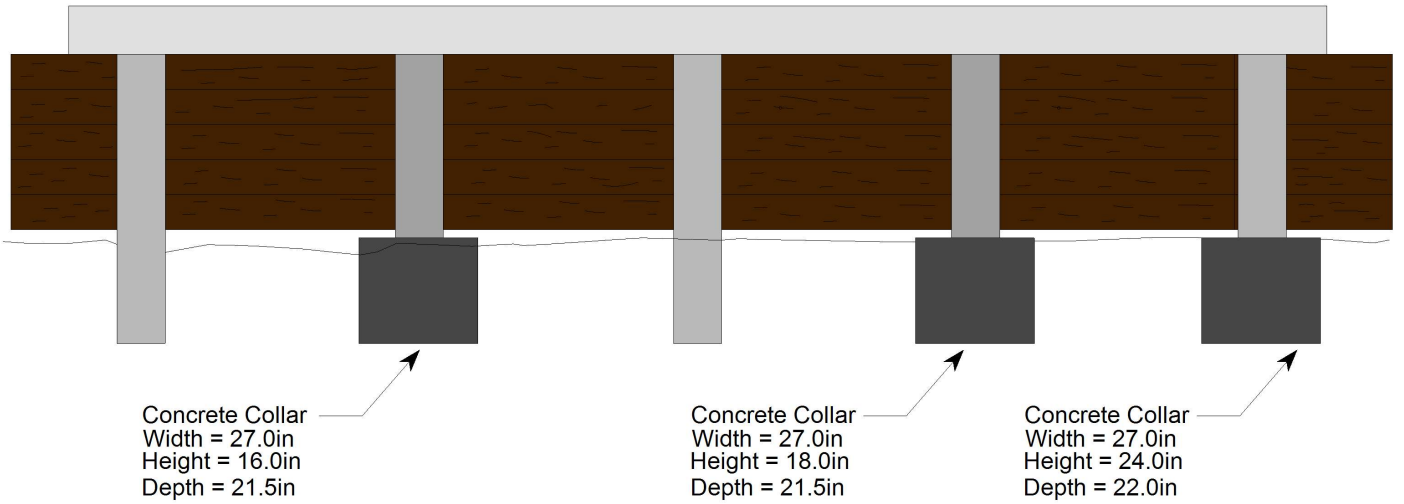
Cap Information			Material Precast Concrete							
Length	Width	Height	Left Overhang	Right Overhang	Left Beam to End of Cap.	Right Beam to End of Cap.				
26.000 ft.	1.333 ft.	1.000 ft.	1.500 ft.	1.500 ft.	.250 ft.	.250 ft.				
Subcap Information			Material							
Length	Width	Height	Left Overhang	Right Overhang	Left Pile to Splice.					
Sill Information			Material							
Length	Width	Height								
Pile #	Material	Spacing	Width/Dia.	Height	Length	Orientation	Driven?	Replacement?	Removed?	Collar?
1	Timber	5.75 ft.	1 ft.			Vertical	Yes	No	No	No
2	Timber	5.75 ft.	1 ft.			Vertical	Yes	No	No	Yes
3	Timber	5.75 ft.	1 ft.			Vertical	Yes	No	No	No
4	Timber	5.75 ft.	1 ft.			Vertical	Yes	No	No	Yes
5	Timber		1 ft.			Vertical	Yes	No	No	Yes
VERIFIED BY: S. GURME 8/10/2021										
Bent/Abutment #: 1			Similar Bents:

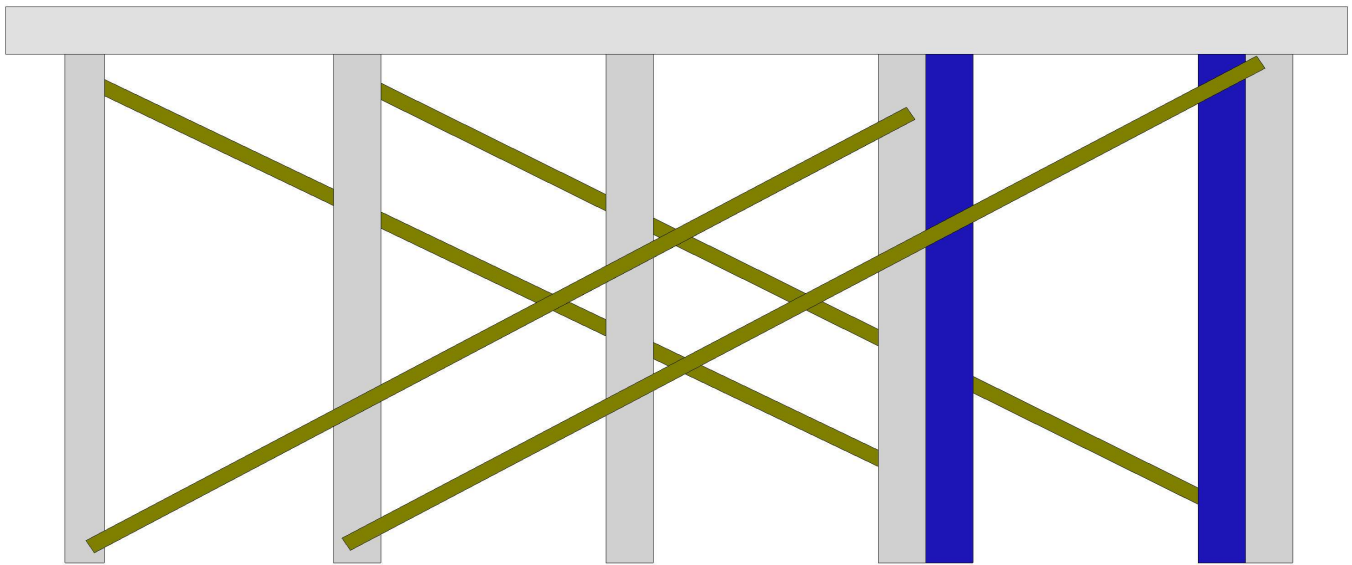
Bridge Inspection Field Sketch

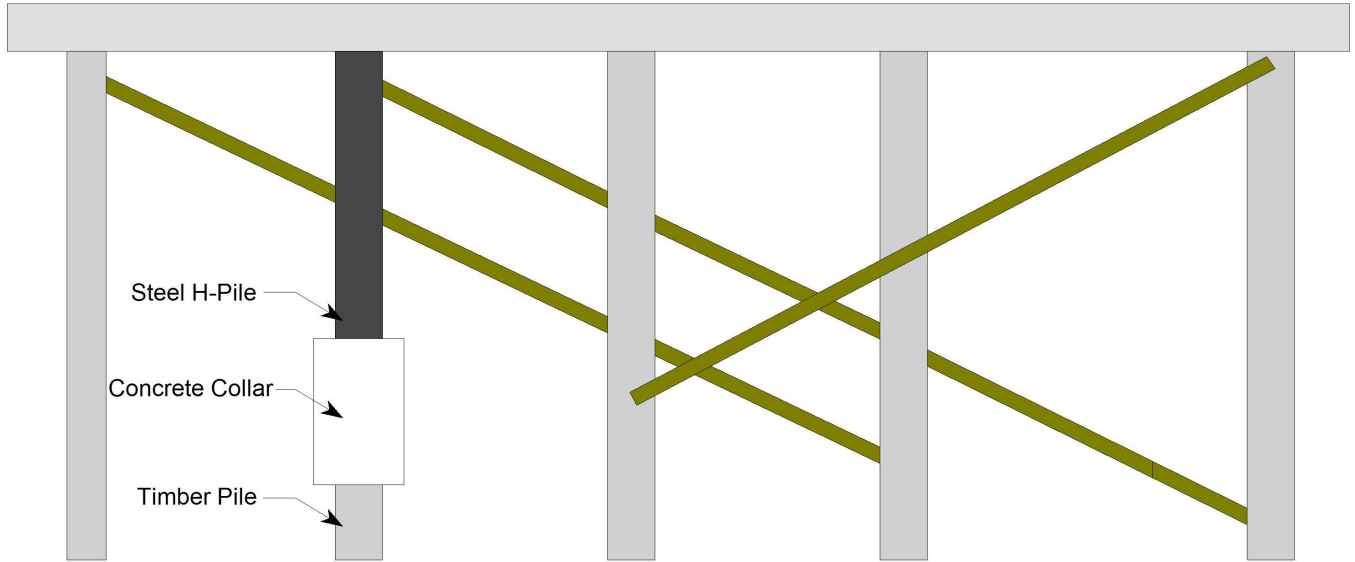
Cap Information			Material Precast Concrete							
Length	Width	Height	Left Overhang	Right Overhang	Left Beam to End of Cap.	Right Beam to End of Cap.				
26.000ft.	1.333 ft.	1.000 ft.	1.400 ft.	1.400 ft.	*.250 ft.	*.250 ft.				
Subcap Information			Material							
Length	Width	Height	Left Overhang	Right Overhang	Left Pile to Splice.					
Sill Information			Material							
Length	Width	Height								
Pile #	Material	Spacing	Width/Dia.	Height	Length	Orientation	Driven?	Replacement?	Removed?	Collar?
1	Timber	6.167 ft.	*1.000 ft.			Vertical	Yes	No	No	No
2	Steel/Timber	5.500 ft.	*1.000 ft.	*1.000 ft.		Vertical	Yes	Yes	No	Yes
3	Timber	5.750 ft.	*1.000 ft.			Vertical	Yes	No	No	No
4	Timber	5.750 ft.	*1.000 ft.			Vertical	Yes	No	No	No
5	Timber		*1.000 ft.			Vertical	Yes	No	No	No
NON-BEARING BENT										
*REVISED BY: S. GURME 8/10/2021										
Bent/Abutment #: 2			Similar Bents:
