NC DEPARTMENT OF TRANSPORTATION
 DIVISION OF HIGHWAYS
 STRUCTURE MANAGEMENT UNIT

ATTENTION: **PAR SUBMITTED
 SIGN NOTICE ISSUED
 CHANGES TO STRUCTURE DATA**

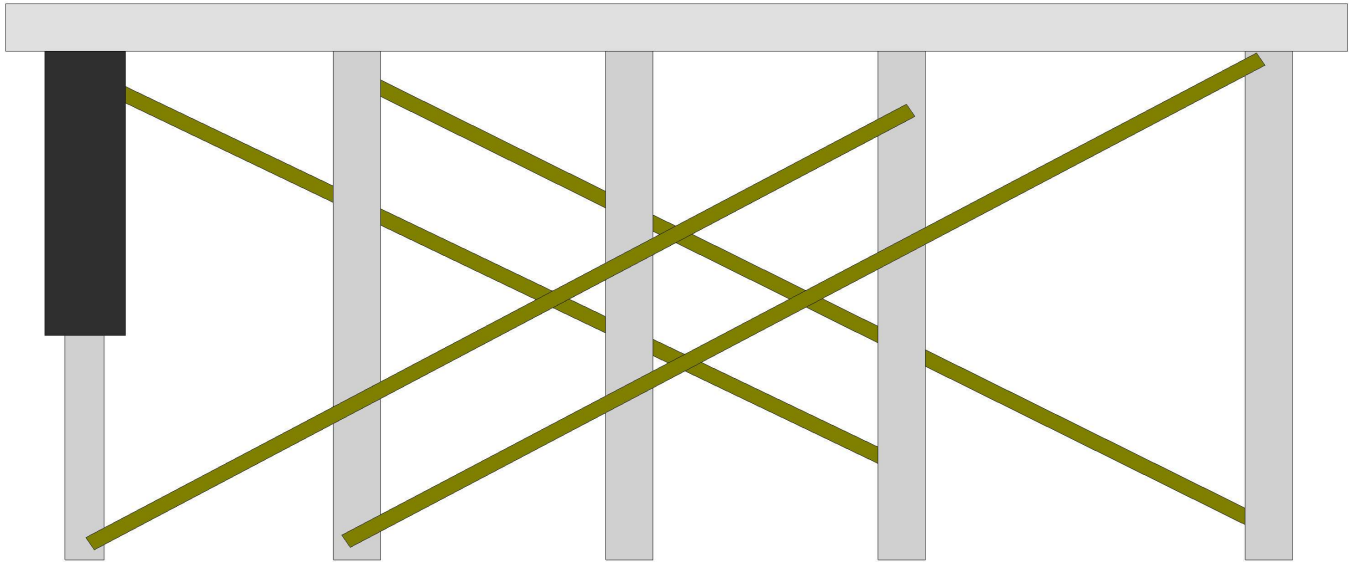
Cap Information			Material Precast Concrete							
Length	Width	Height	Left Overhang	Right Overhang	Left Beam to End of Cap.	Right Beam to End of Cap.				
26.000 ft.	1.333 ft.	1.000 ft.	1.300 ft.	1.300 ft.	*.250 ft.	*.250 ft.				
Subcap Information			Material							
Length	Width	Height	Left Overhang	Right Overhang	Left Pile to Splice.					
Sill Information			Material							
Length	Width	Height								
Pile #	Material	Spacing	Width/Dia.	Height	Length	Orientation	Driven?	Replacement?	Removed?	Collar?
1	Timber	6.000 ft.	*1.000 ft.			Vertical	Yes	No	No	Yes
2	Timber	5.750 ft.	*1.000 ft.			Vertical	Yes	No	No	No
3	Timber	5.670 ft.	*1.000 ft.			Vertical	Yes	No	No	No
4	Timber	6.000 ft.	*1.000 ft.			Vertical	Yes	No	No	No
5	Timber		*1.000 ft.			Vertical	Yes	No	No	No
<p>*REVISED BY: S. GURME 8/10/2021</p>										
Bent/Abutment #: 3			Similar Bents:
