NC DEPARTMENT OF TRANSPORTATION  
 DIVISION OF HIGHWAYS  
 STRUCTURE MANAGEMENT UNIT

ATTENTION: Prompt Action Request; Snooper

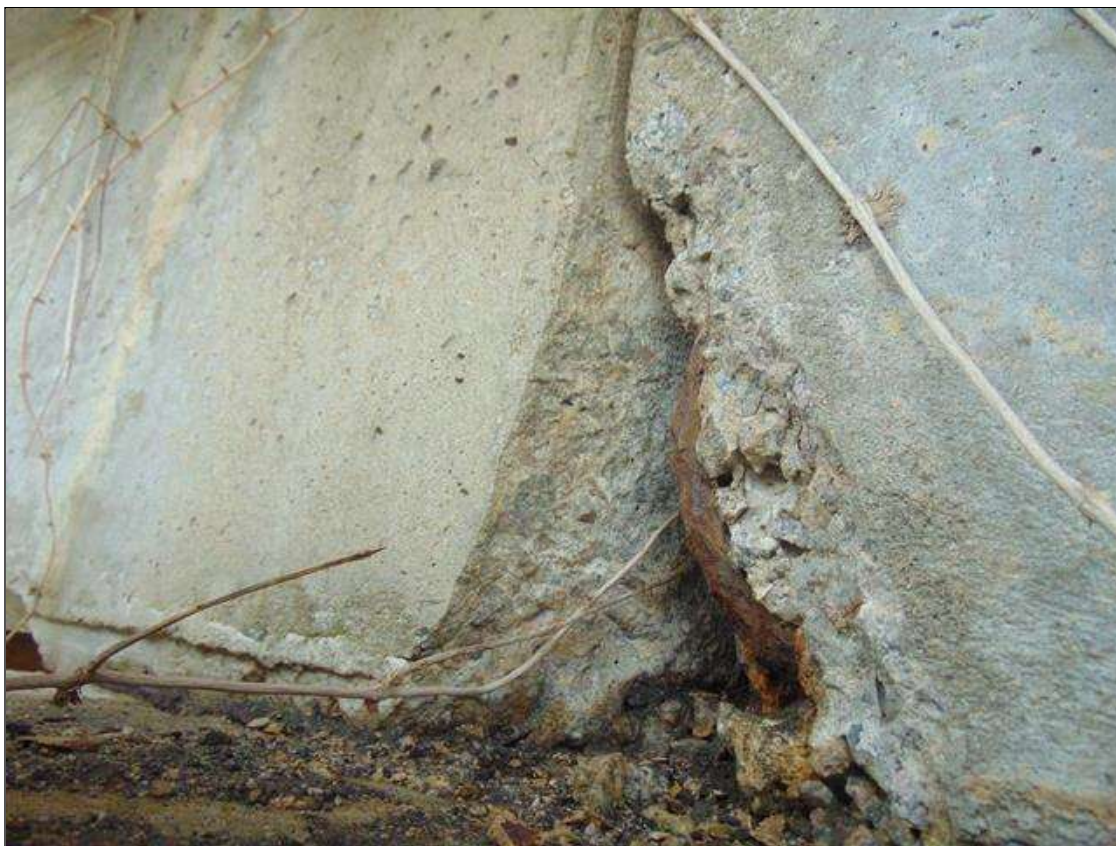
Span 7 Beam 1: 2" x 11" x 4" deep spall with exposed rebar on left side of beam at Bent 6 (PAR)

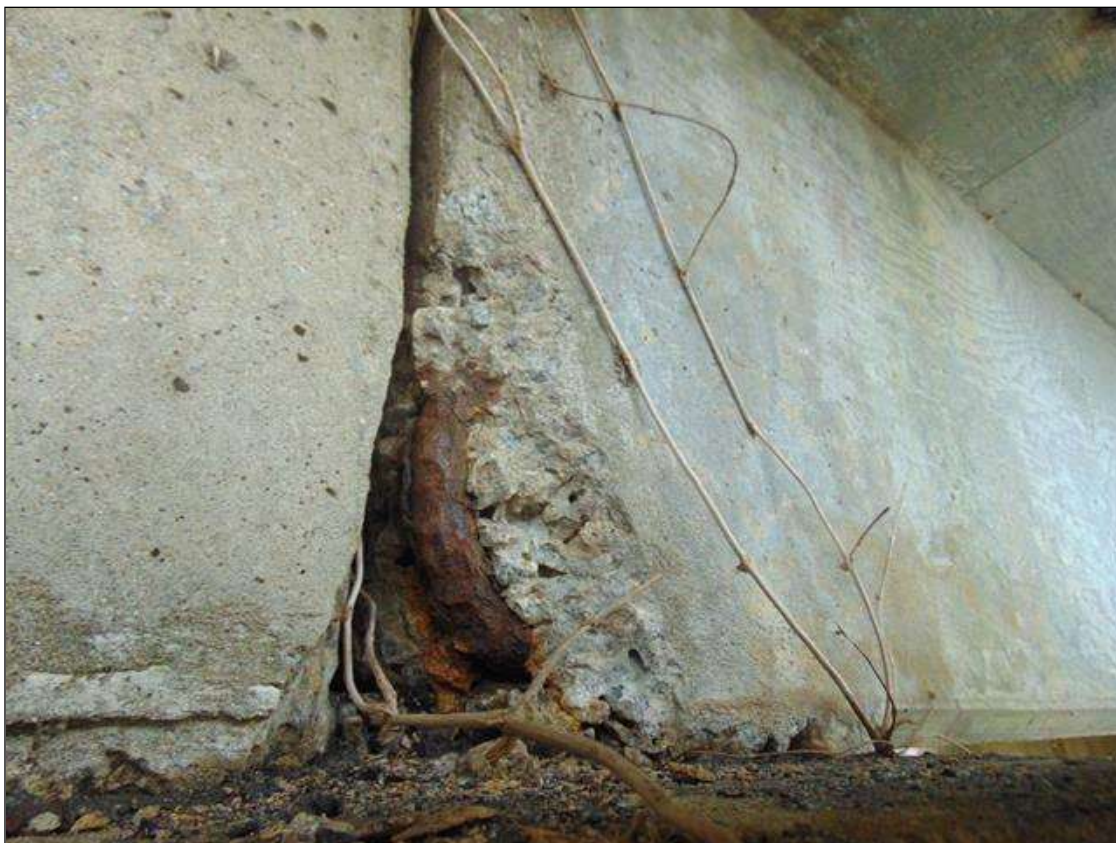
Span 6 Beam 1: [PROMPT ACTION REQUEST] 7" LONG x 12" TALL x 3" DEEP SPALL WITH EXPOSED REBAR ON LEFT SIDE OF BEAM END AT BENT 6, NO MEASURABLE SECTION LOSS

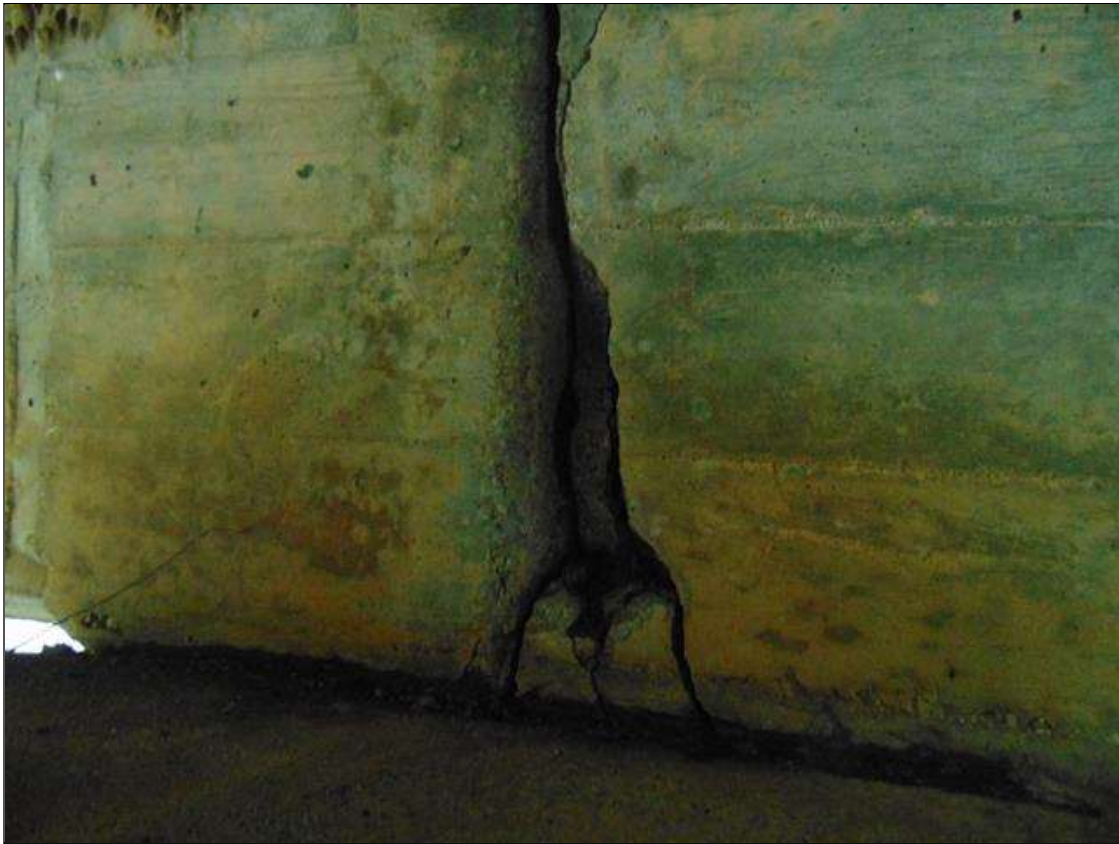
Span 6 Beam 2: [PROMPT ACTION REQUEST] 5" LONG x 19" TALL x 2 1/2" DEEP SPALL WITH EXPOSED REBAR ON BOTH SIDES OF BEAM END AT BENT 6, NO MEASURABLE SECTION LOSS

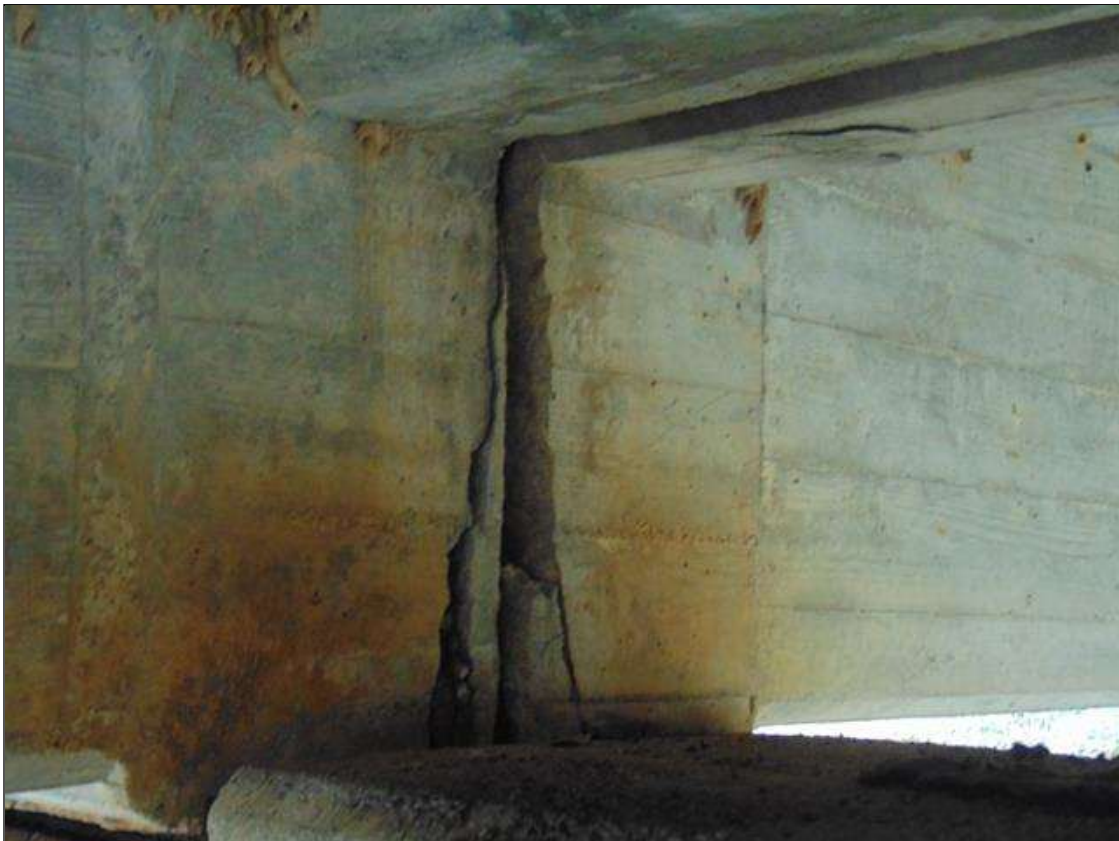
Span 7 Beam 2: 4" LONG x 19" TALL x 3 1/2" DEEP SPALL WITH EXPOSED REBAR ON RIGHT SIDE OF BEAM END AT BENT 6 (PAR)

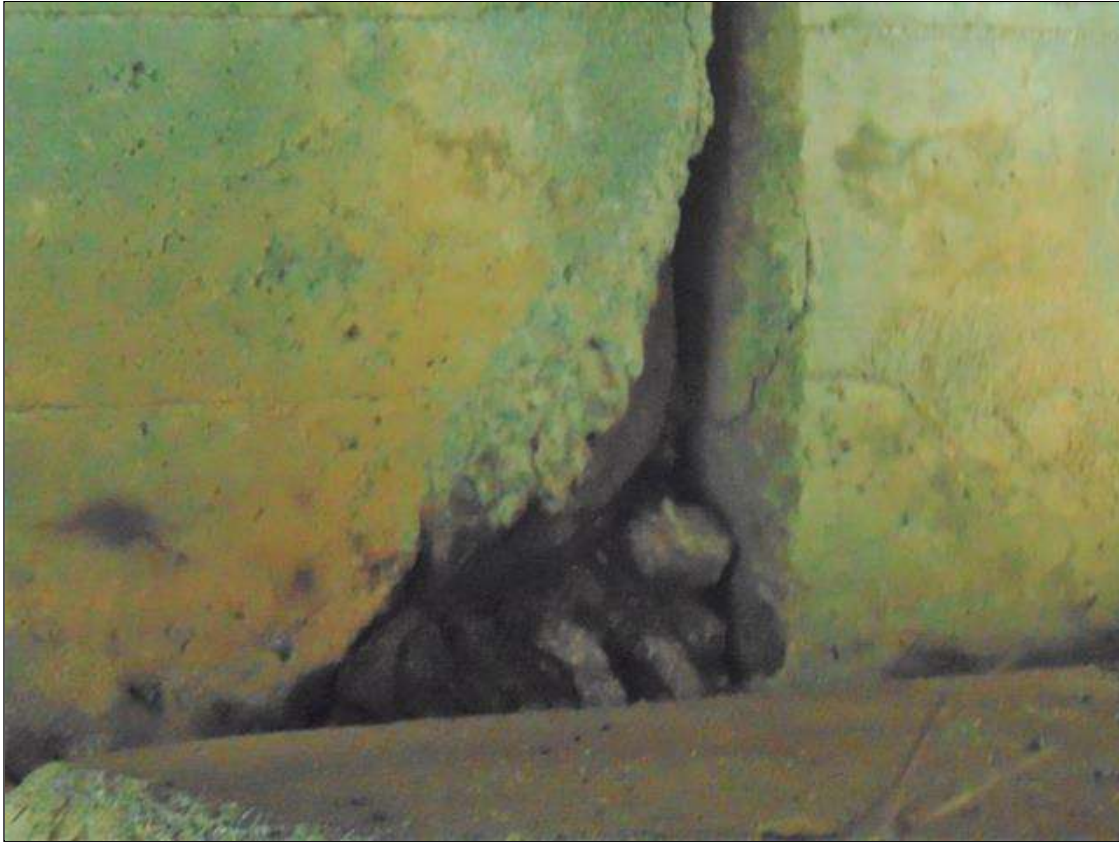
Span 6 Beam 3: [PROMPT ACTION REQUEST] 5" LONG x 19" TALL x 4" DEEP SPALL WITH EXPOSED REBAR [NO MEASURABLE SECTION LOSS] ON LEFT SIDE OF BEAM END AT BENT 6 AND 8" LONG x 10" TALL x 2 1/2" DEEP SPALL WITH EXPOSED REBAR [NO MEASURABLE SECTION LOSS] ON RIGHT SIDE OF BEAM END OVER BENT 6

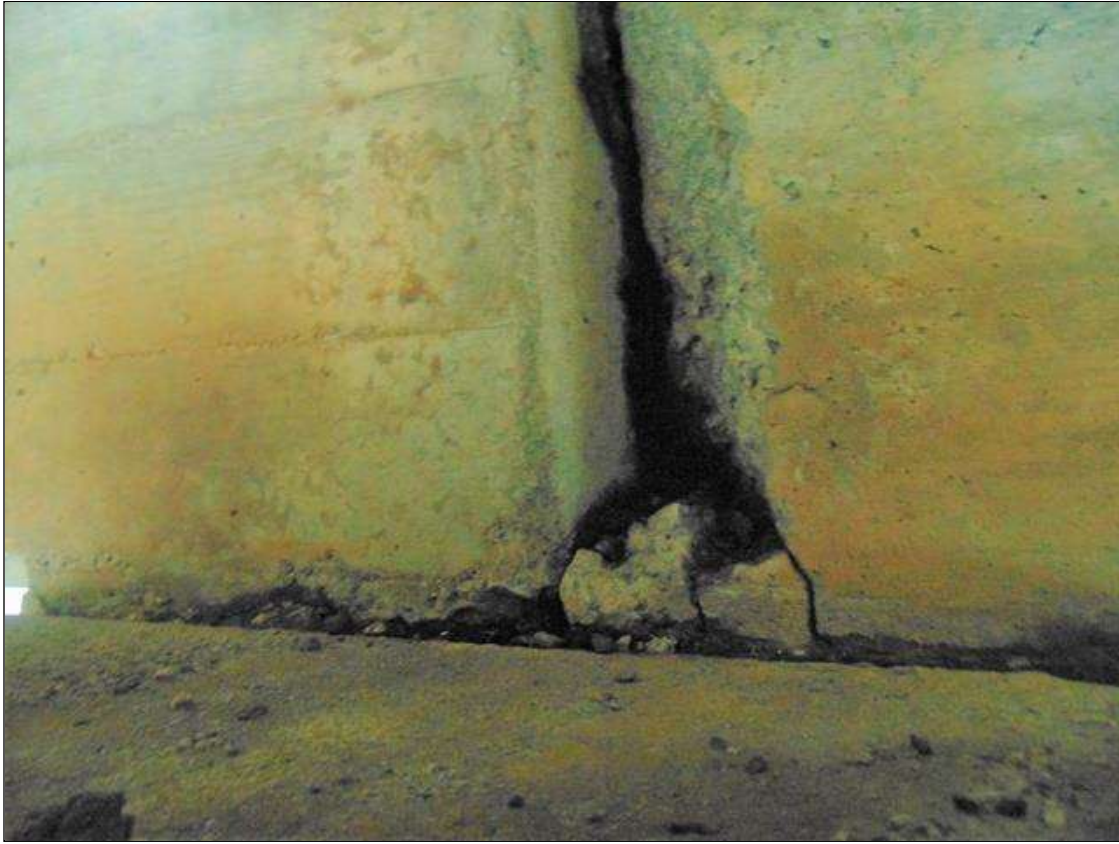
Span 6 Beam 3: [PROMPT ACTION REQUEST] 5" LONG x 19" TALL x 4" DEEP SPALL WITH EXPOSED REBAR [NO MEASURABLE SECTION LOSS] ON LEFT SIDE OF BEAM END AT BENT 6 AND 8" LONG x 10" TALL x 2 1/2" DEEP SPALL WITH EXPOSED REBAR [NO MEASURABLE SECTION LOSS] ON RIGHT SIDE OF BEAM END OVER BENT 6

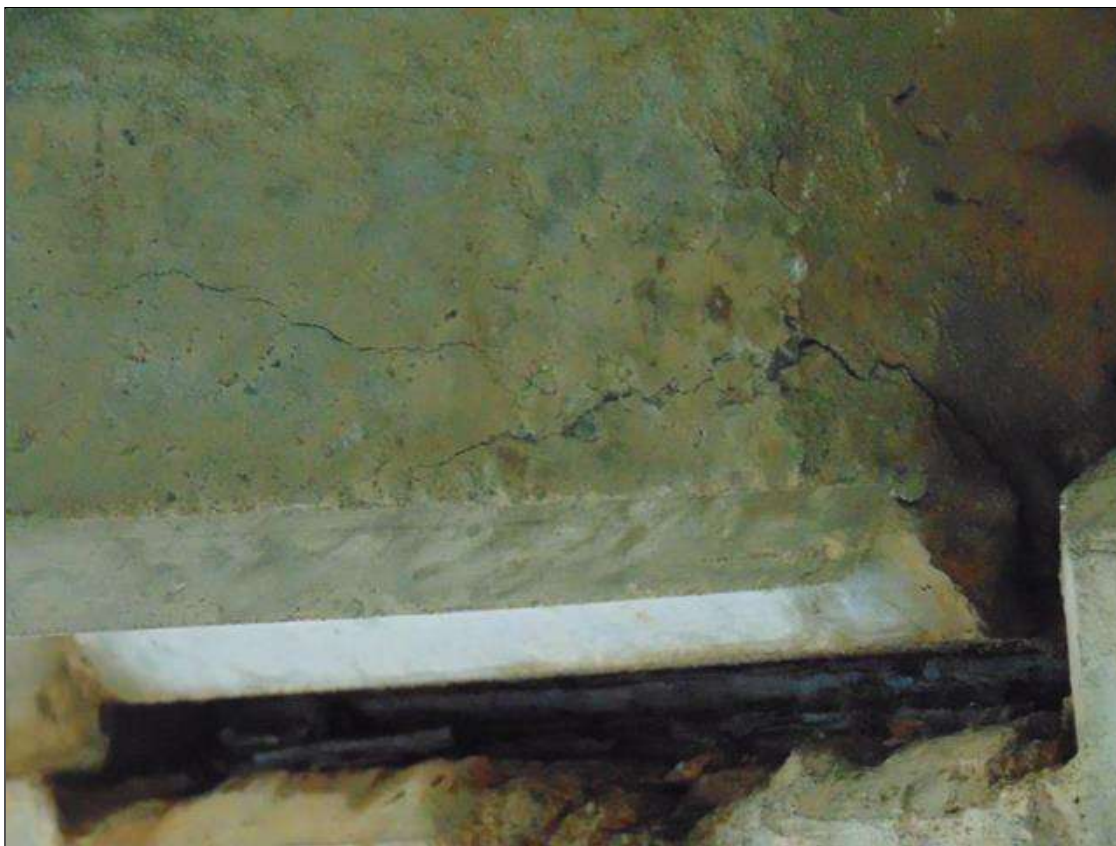
Span 6 Beam 3: (2) up to 11" long 1/16" horizontal cracks on right side of beam at Bent 6

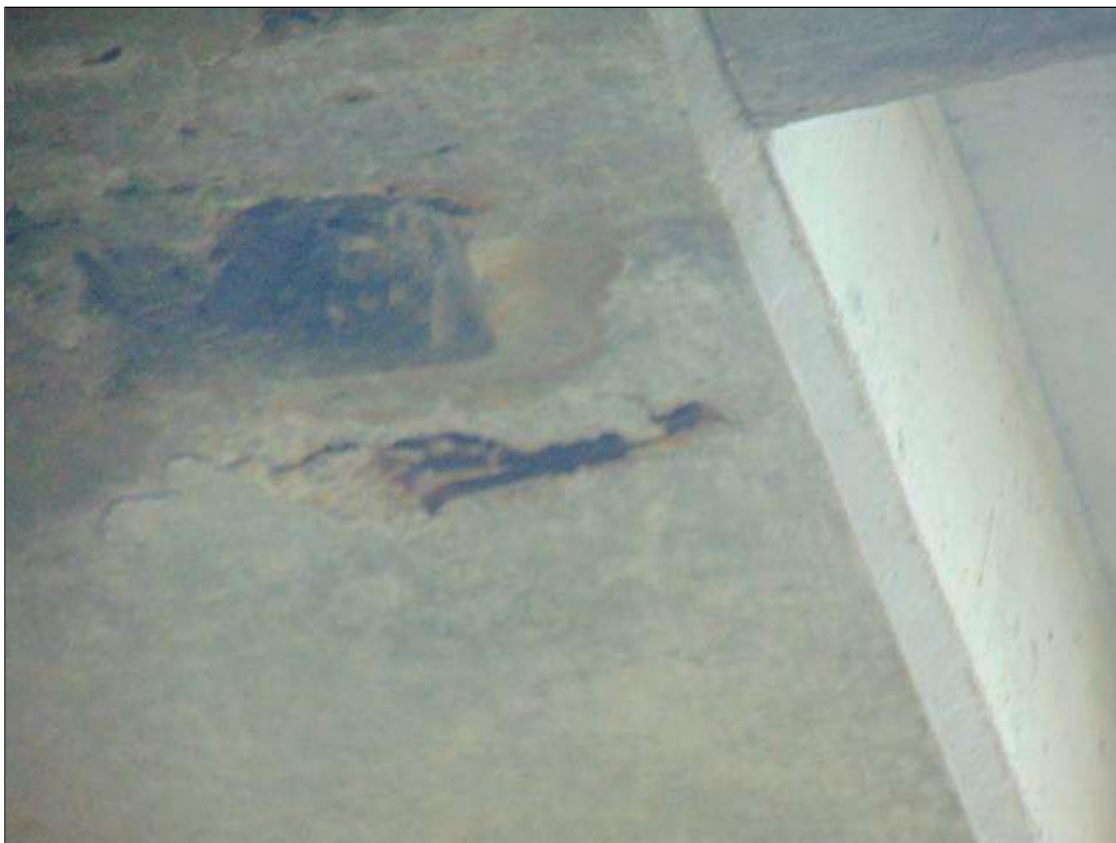
Span 7 Deck: 14" x 9" x 1" DEEP, 8" DIAMETER x 1 1/2" DEEP, AND 2" x 6" x 1/2" DEEP SPALLS ALL EXPOSING REBAR AND AREA OF DELAMINATION IN RIGHT OVERHANG AT DRAIN 4

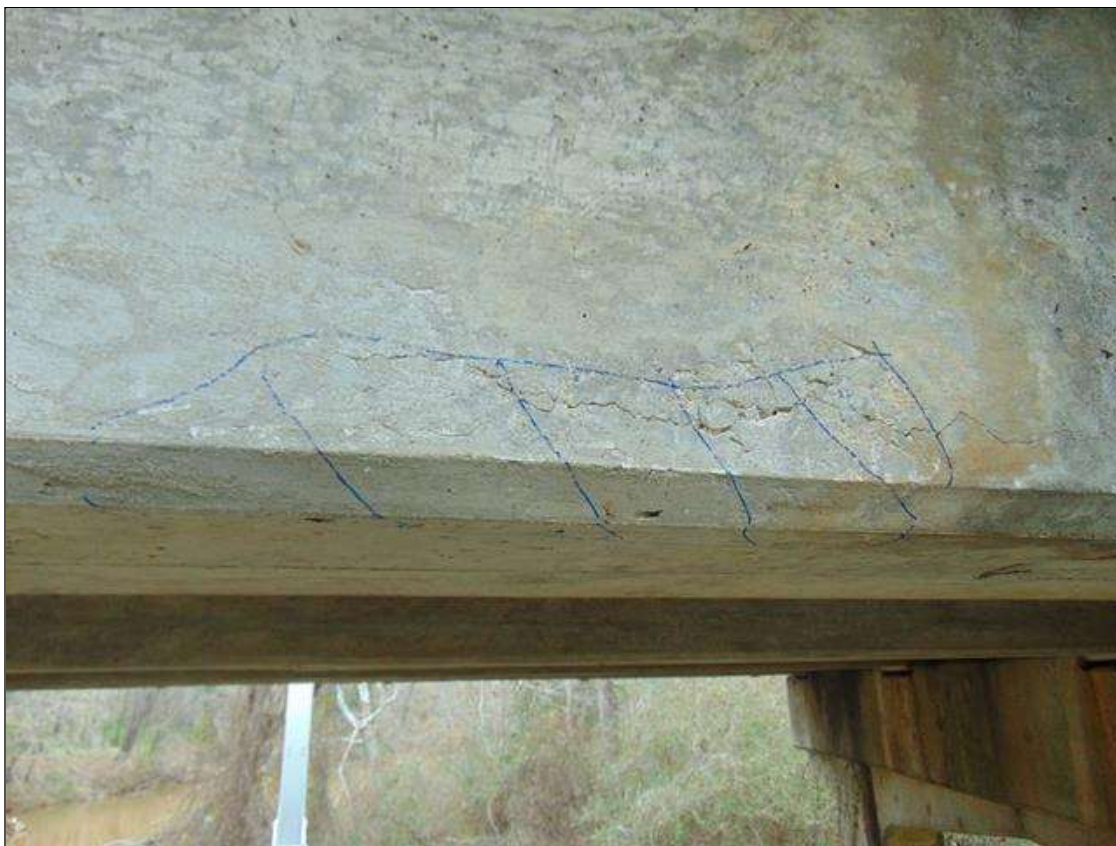
Span 6 Beam 4: 4' x 6" DELAMINATED AREA WITH 1/8" HORIZONTAL CRACKING

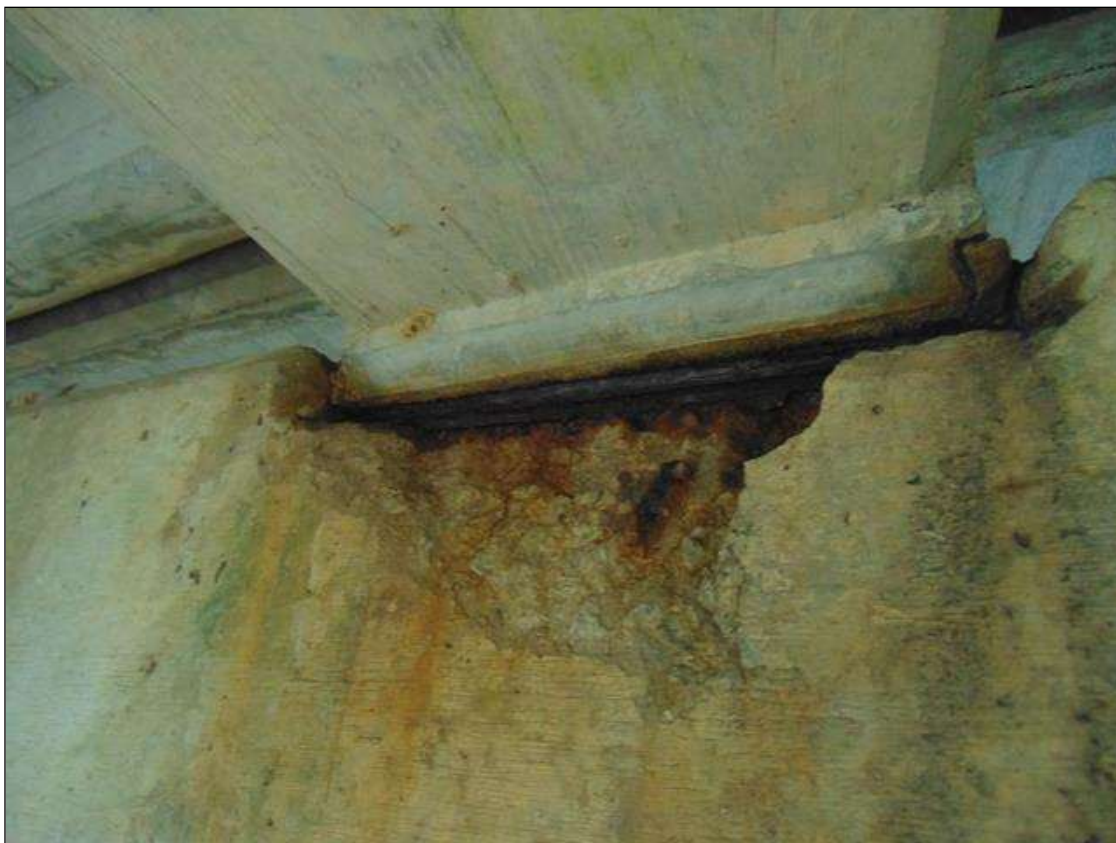
Bent 6 Cap 1: 18" x 9" x 3" DEEP SPALL WITH EXPOSED REBAR ON EAST FACE UNDER GIRDER 3 (PAR)

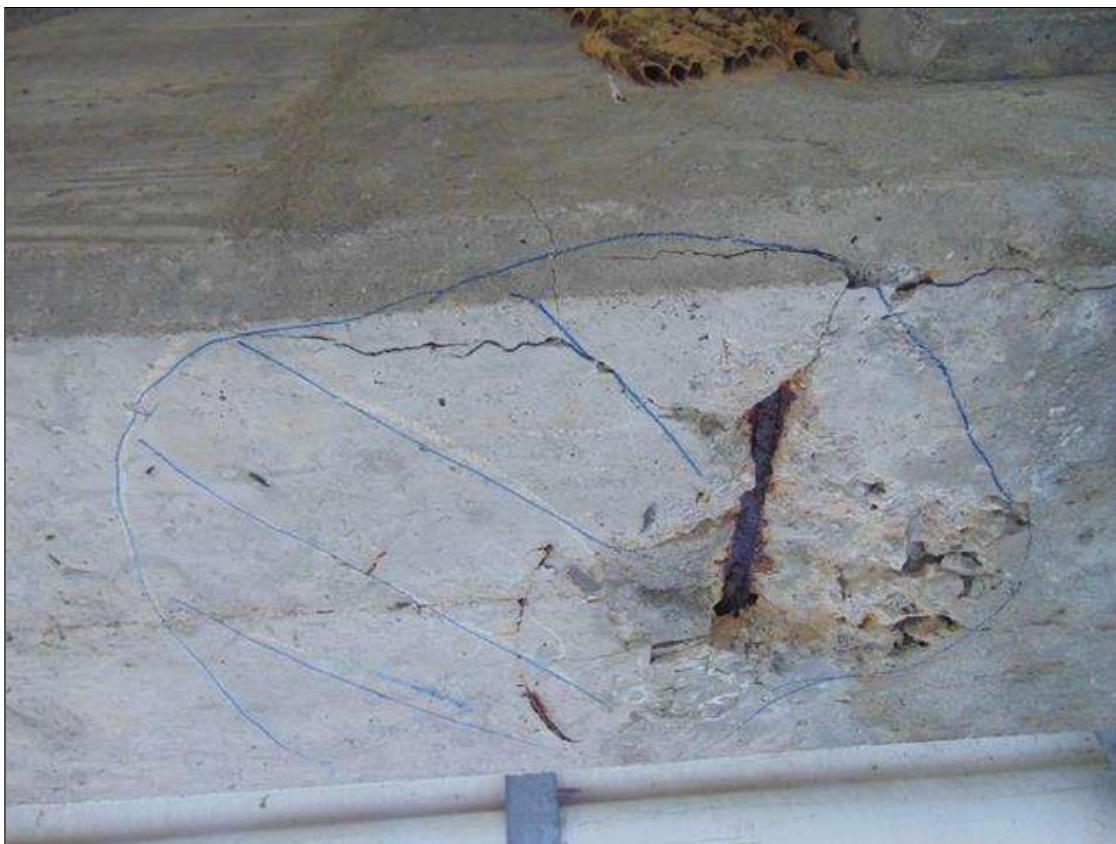
Span 6 Beam 1: 16" x 14" x 1" deep spall with exposed rebar and area of delamination on bottom of beam near midspan

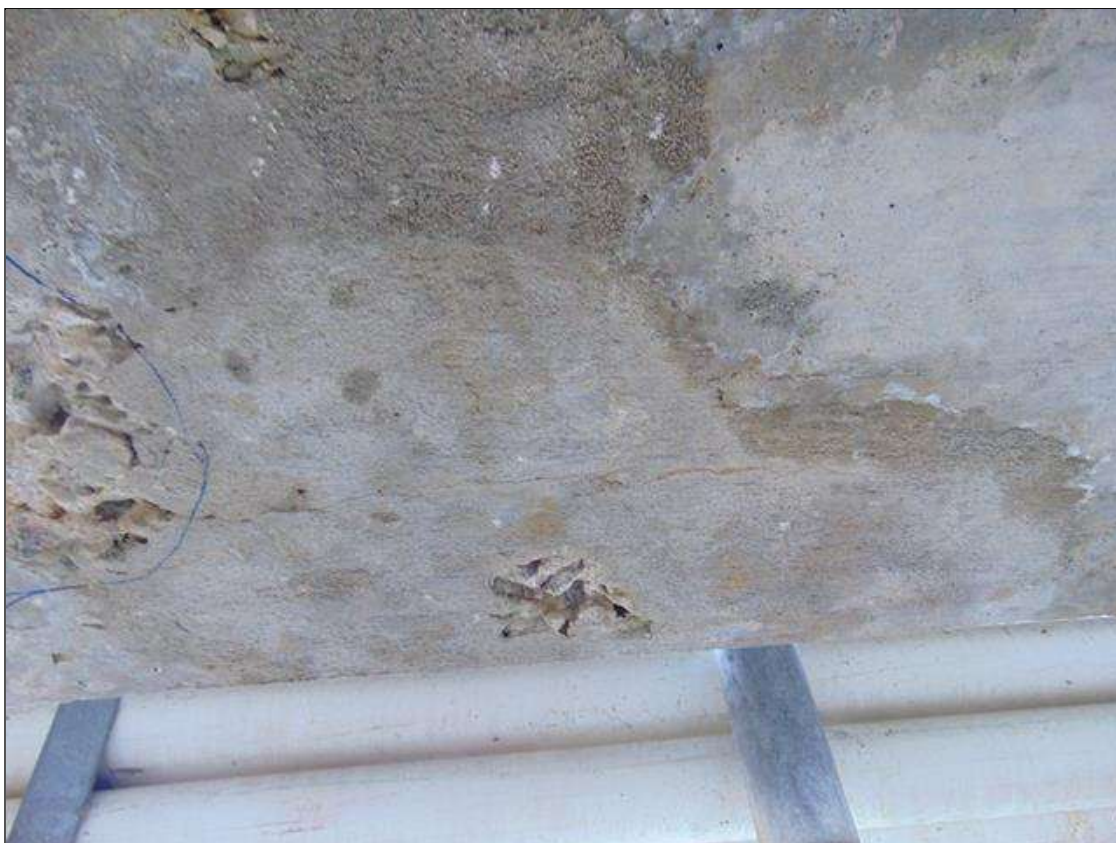
Span 6 Beam 1: 20" x 16" area of patch with 3 1/2" x 3" x 1/2" deep spall on bottom of beam near midspan

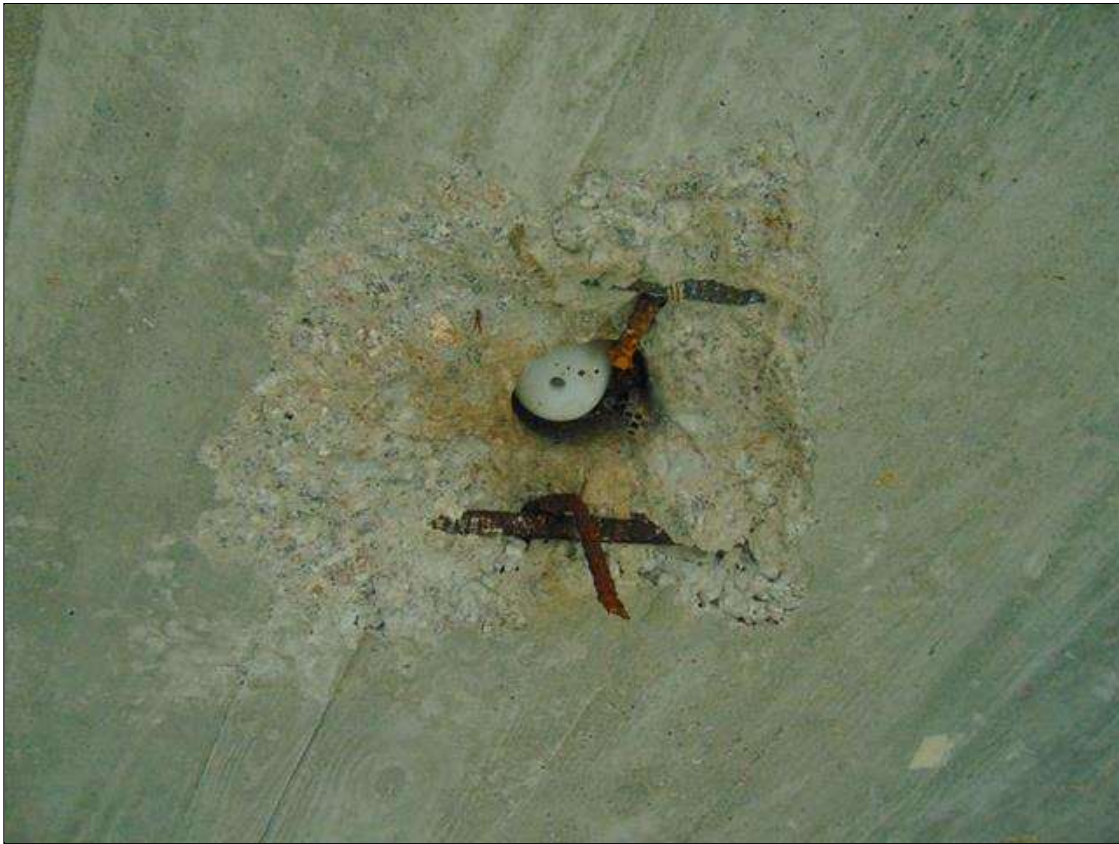
Span 6 Deck: 16" x 14" x 3" deep spall with exposed rebar on bottom of deck in Bay 3 near midspan (Bay 1 similar)

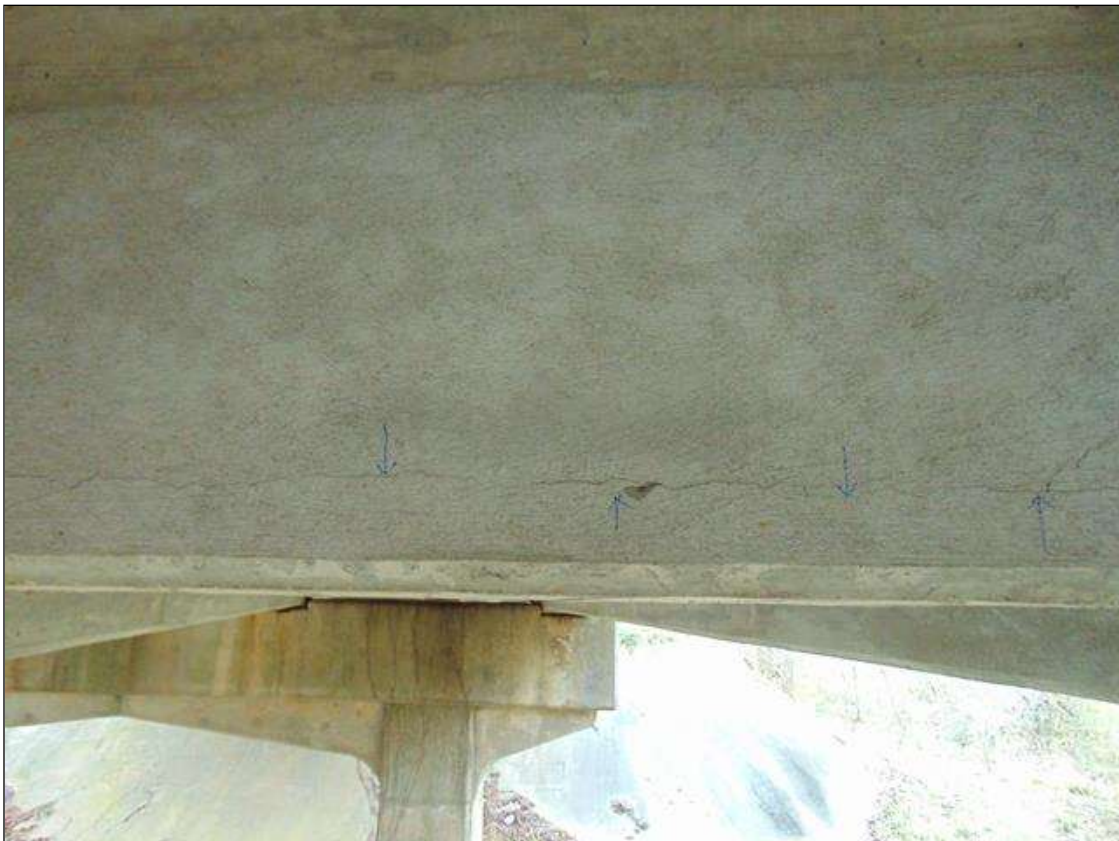
Span 6 Beam 3: 4' hairline horizontal crack on West face of intermediate diaphragm in Bay 3

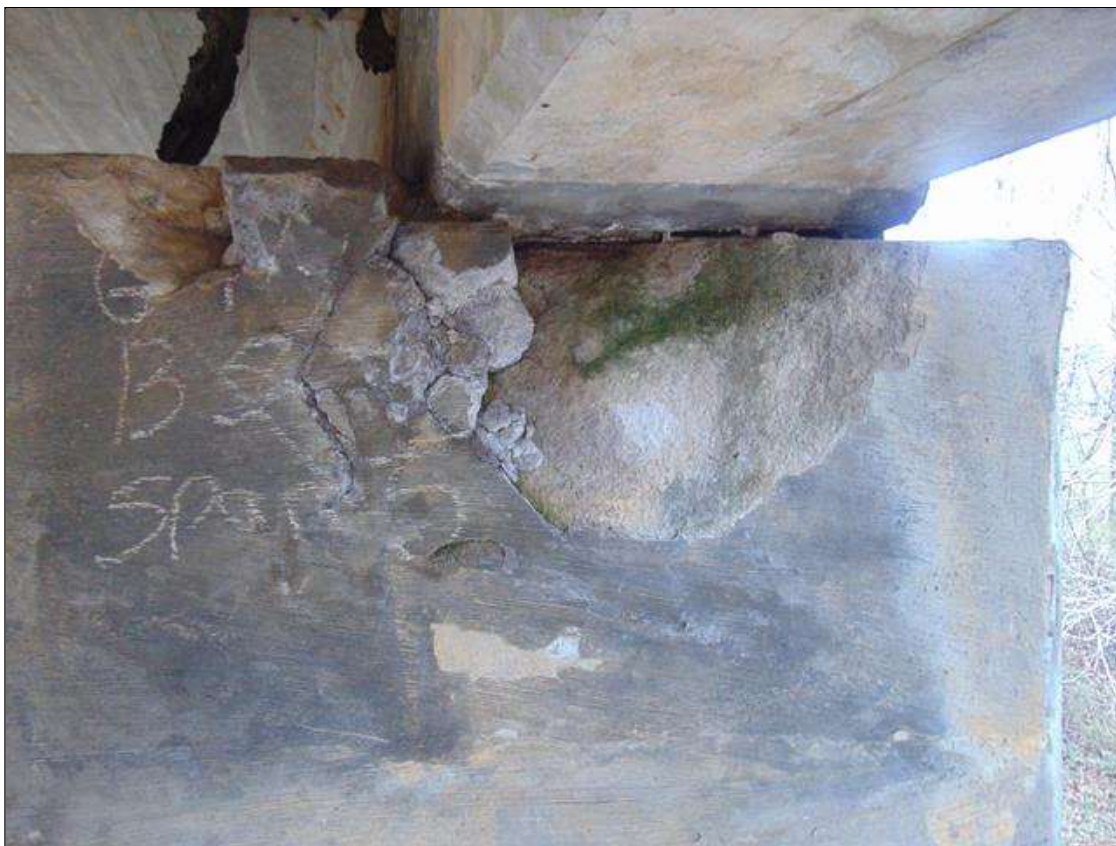
Bent 5 Cap 1: 32" x 14" x 3" DEEP SPALL AND DELAMINATED AREA ON WEST FACE UNDER GIRDER 4 (PAR)

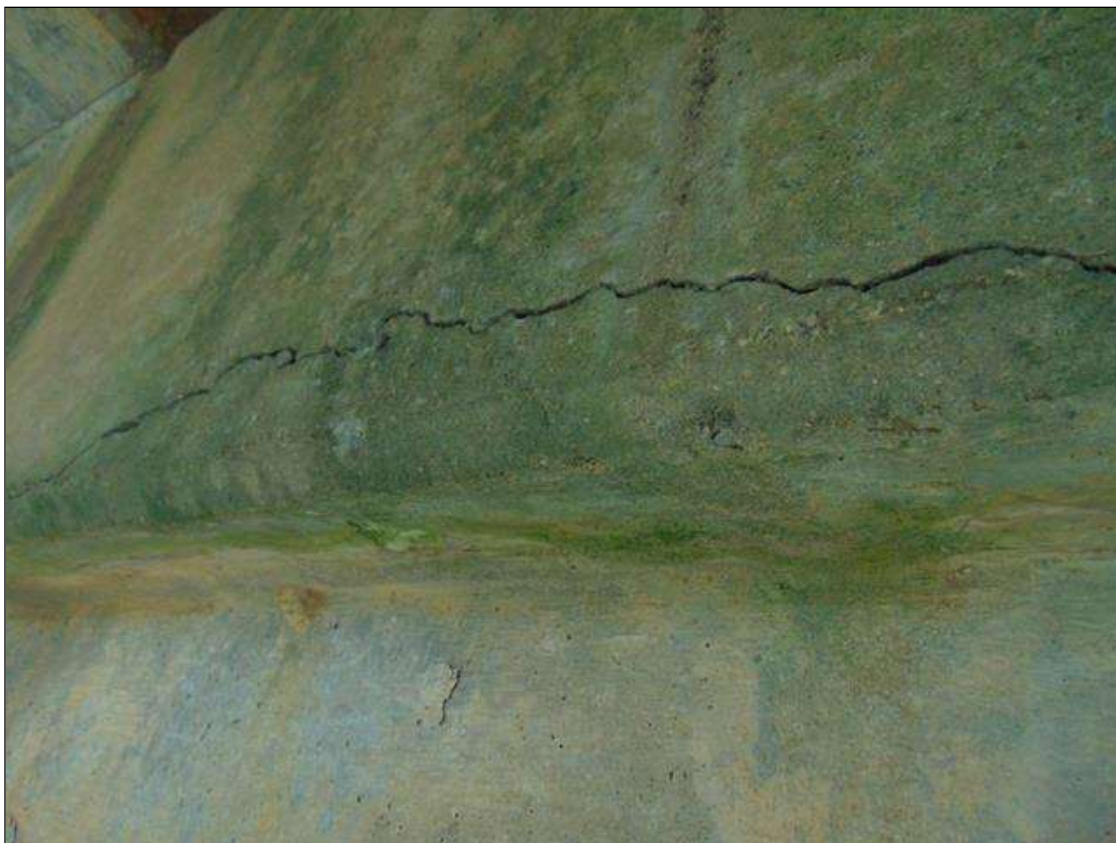
Bent 5 Cap 1: 40" x 7" AREA OF DELAMINATION WITH 1/8" HORIZONTAL CRACK ON EAST FACE UNDER Bay 2

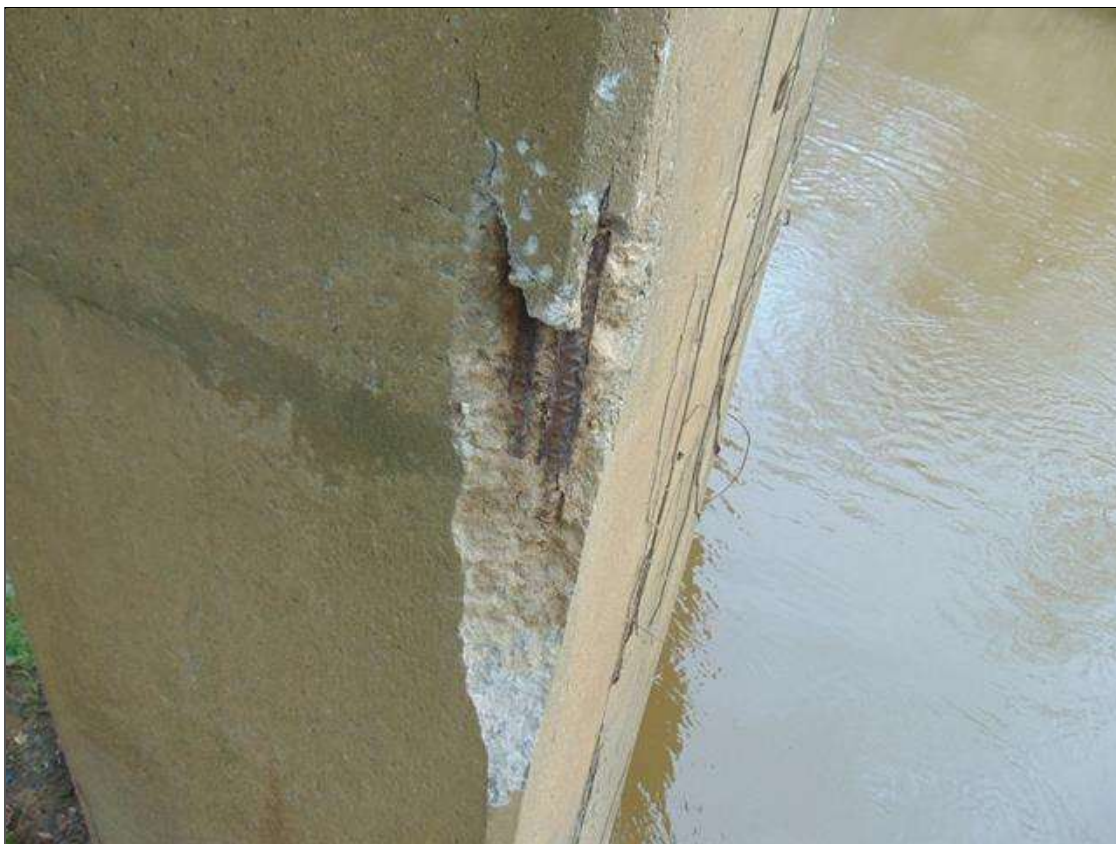
Bent 5 Pile 1: 37" x 5" x 2 1/2" deep spall with exposed rebar and area of delamination on Northeast corner (PAR)

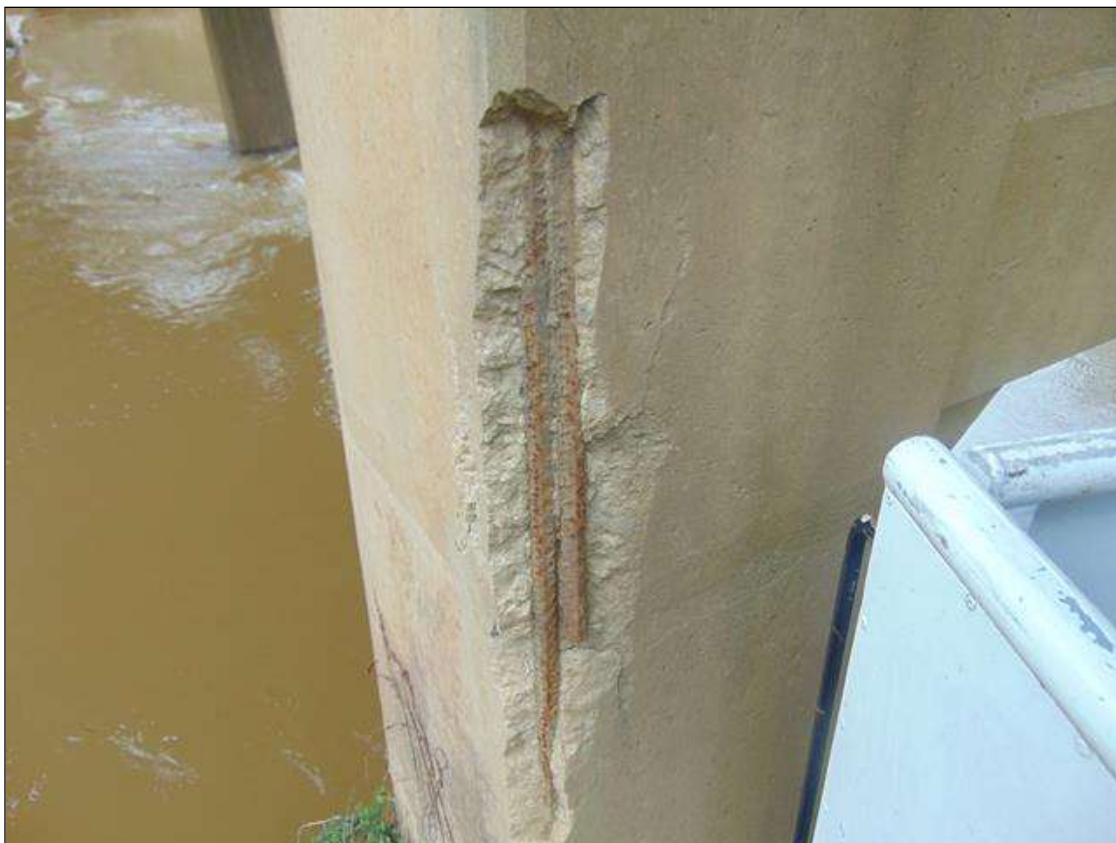
Bent 5 Pile 2: [PROMPT ACTION REQUEST] 4.75' x 8" x 8" SPALL WITH EXPOSED REBAR AND AREA OF DELAMINATION ON Southeast CORNER

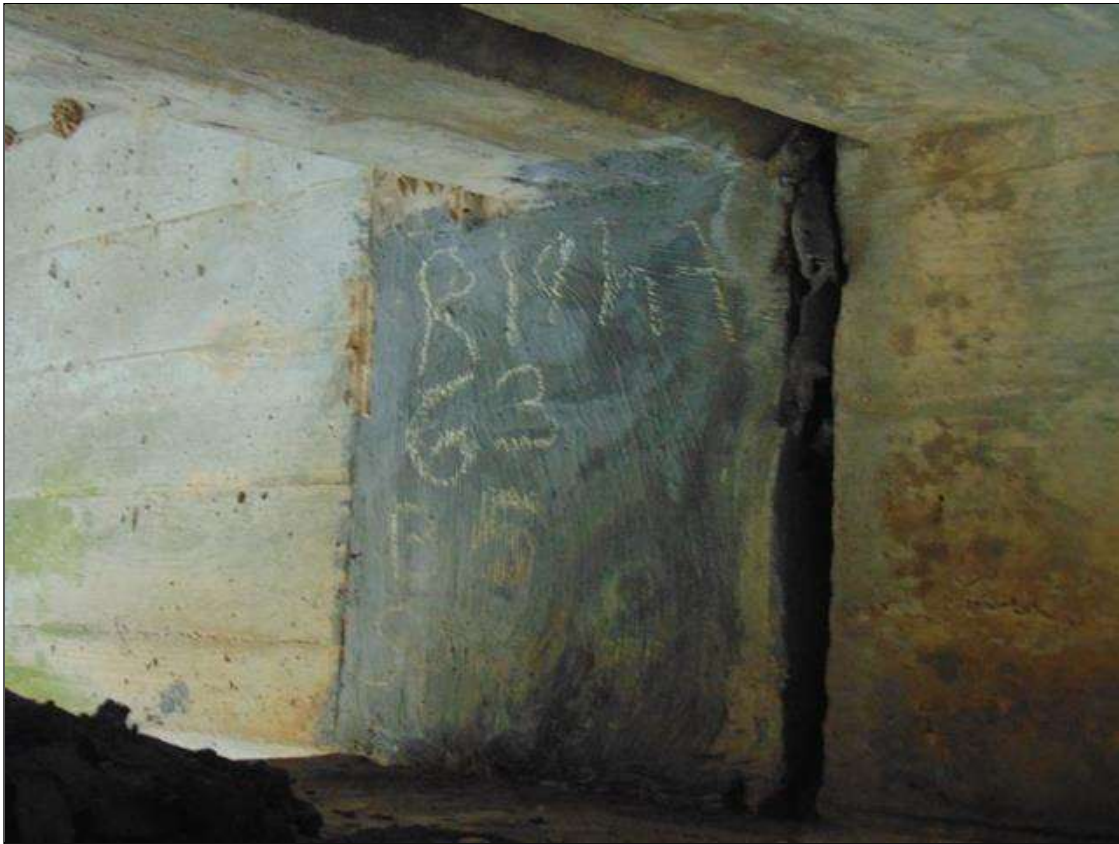
Span 5 Beam 3: 14" x 18" area of sound patch on right side of beam at Bent 5

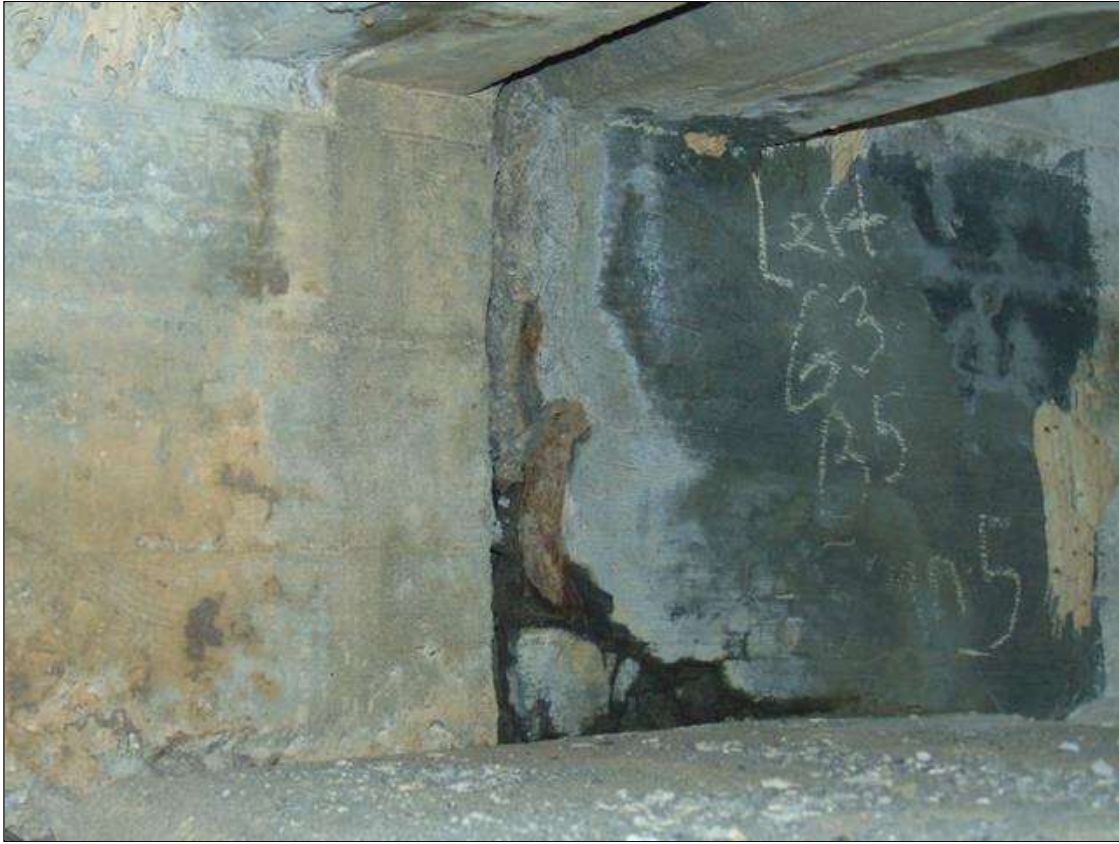
Span 5 Beam 3: [PROMPT ACTION REQUEST] 7" LONG x 18" TALL x 5" DEEP SPALL WITH EXPOSED REBAR WITH ADJACENT 16" x 20" AREA OF PATCH ON LEFT SIDE OF BEAM END AT BENT 5, NO MEASURABLE SECTION LOSS

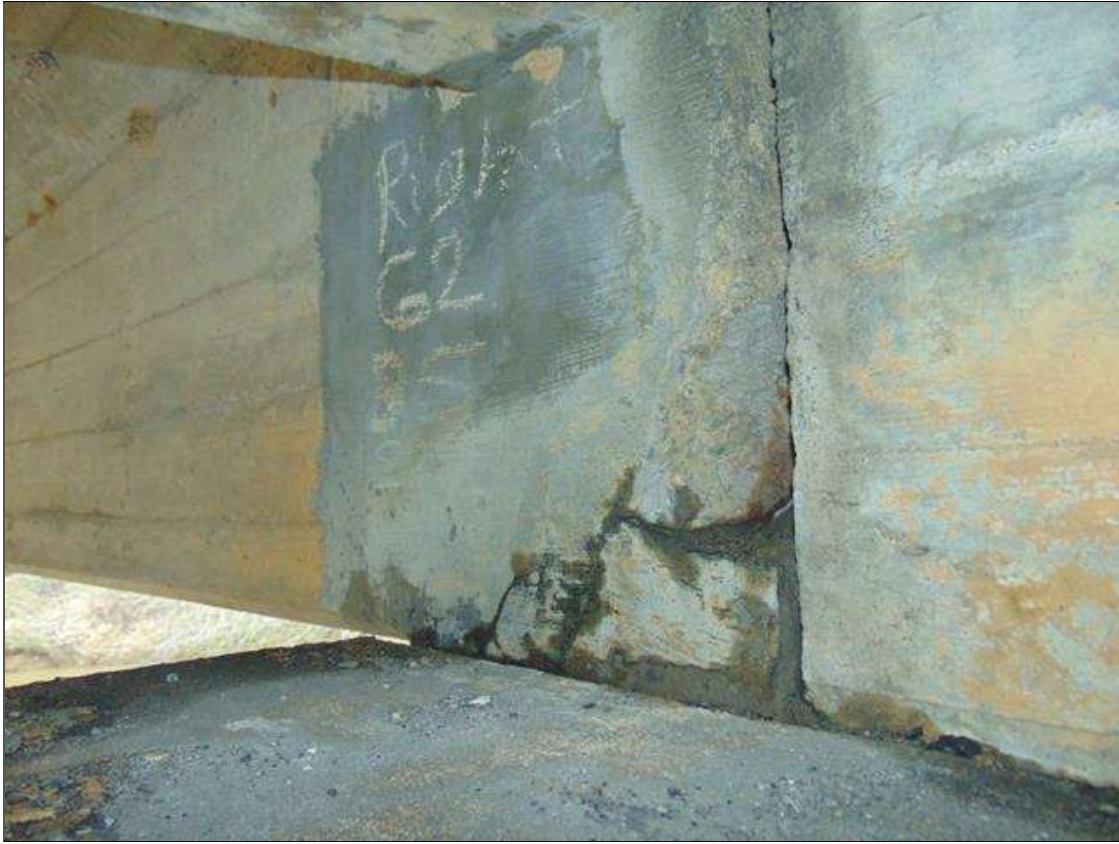
Span 5 Beam 2: [PROMPT ACTION REQUEST] 6" LONG x 18" TALL x 4" DEEP SPALL WITH EXPOSED REBAR WITH ADJACENT 16" x 10" AREA OF PATCH ON RIGHT SIDE OF BEAM END AT BENT 5, NO MEASURABLE SECTION LOSS

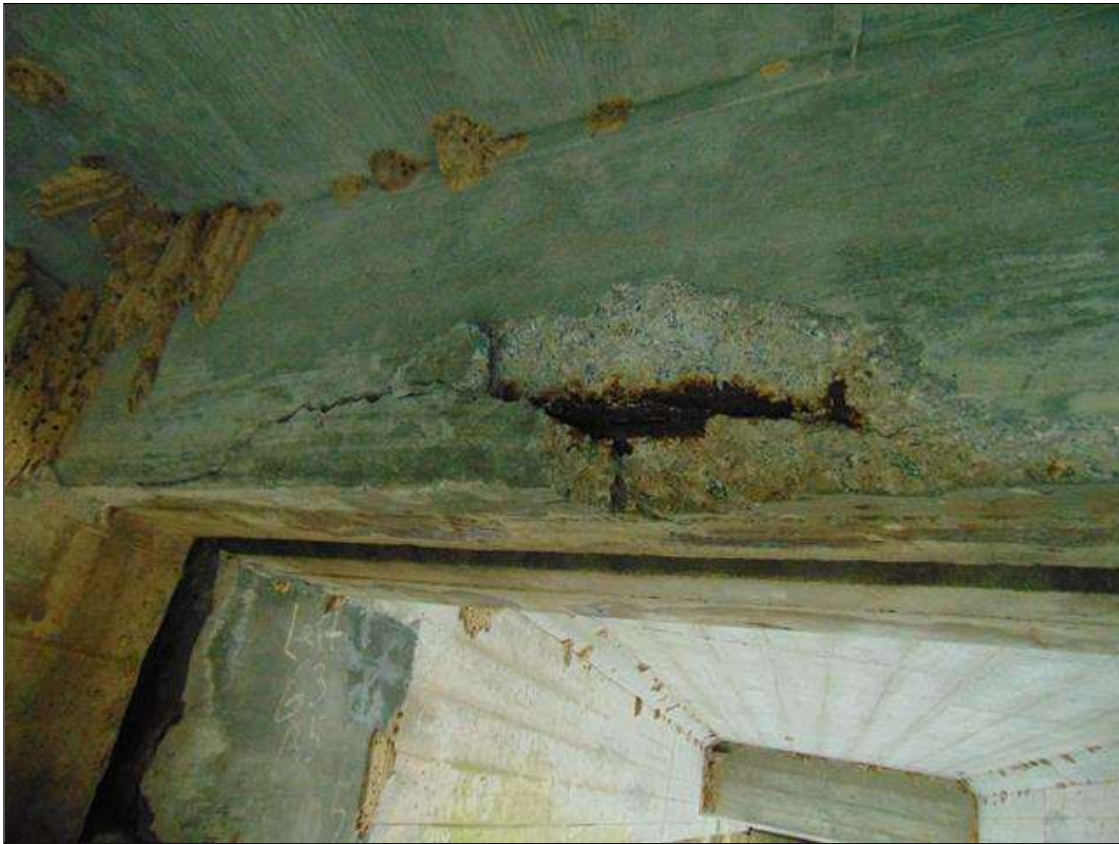
Span 6 Beam 2: 36" x 5" x 2" deep spall with exposed rebar and area of delamination on Bent 5 diaphragm in Bay 2

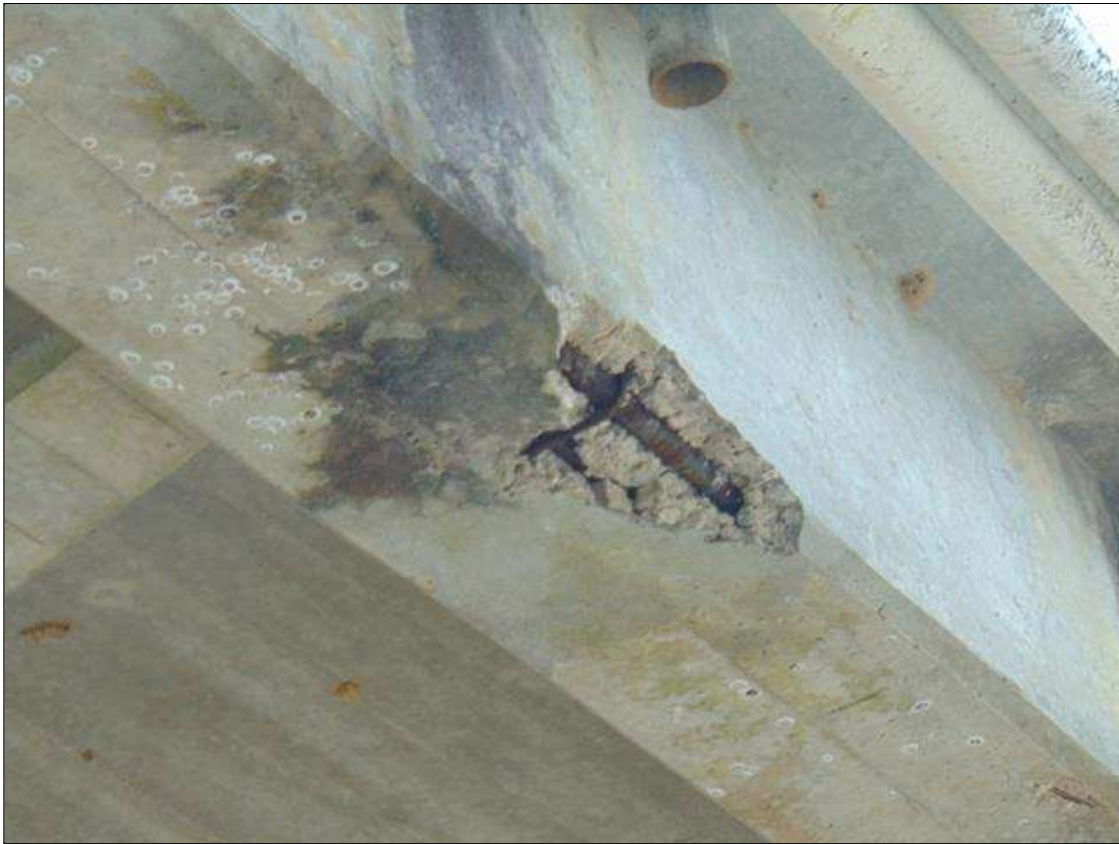
Span 5 Beam 1: [PROMPT ACTION REQUEST] 26" x 14" x 3 1/2" DEEP SPALL WITH EXPOSED REBAR ON UNDERSIDE AT MIDSPAN. THERE ARE VOIDS AROUND THE REBAR AS A RESULT OF POOR CONSOLIDATION. THE SECONDARY REINFORCING HAS UP TO 50% SECTION LOSS.
