NC DEPARTMENT OF TRANSPORTATION  
 DIVISION OF HIGHWAYS  
 STRUCTURE MANAGEMENT UNIT

ATTENTION: Prompt Action Request; Snooper

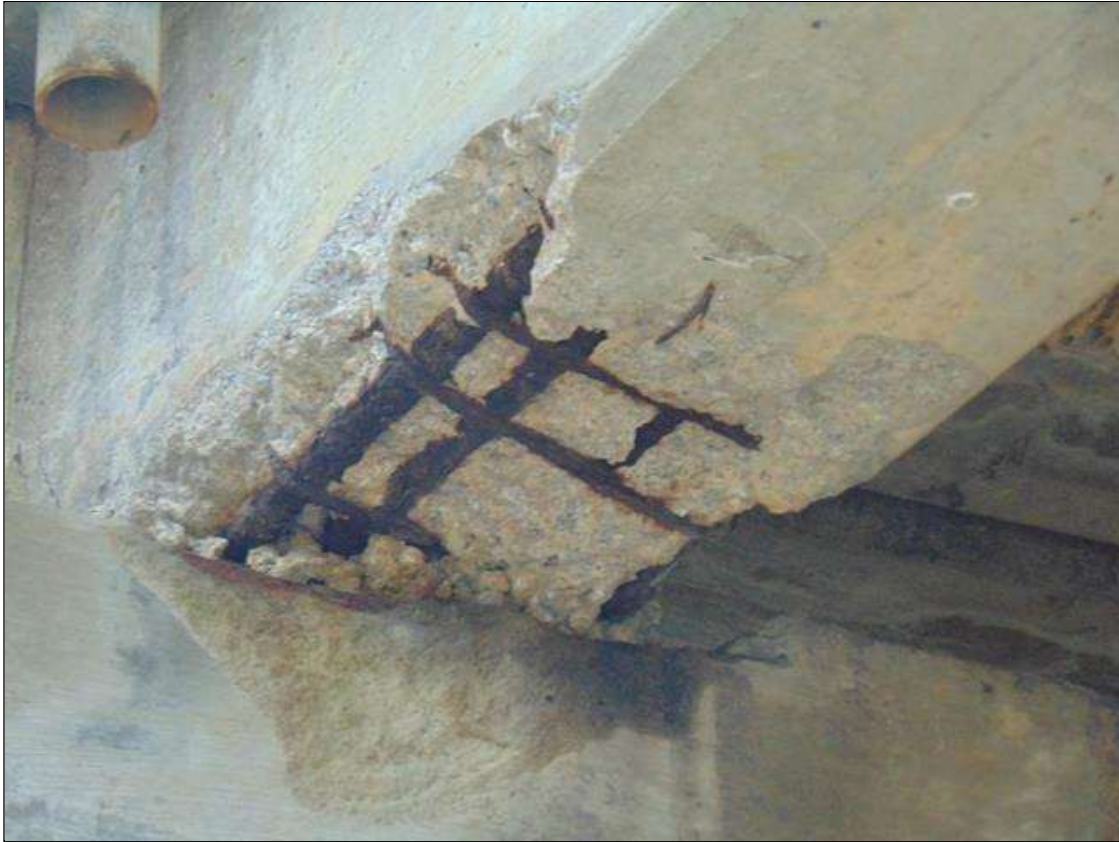
Span 5 Beam 1: [PROMPT ACTION REQUEST] 32" x 18" x 3" DEEP SPALL WITH EXPOSED REBAR ON BOTTOM OF GIRDER WITH 12" x 4" x 5" DEEP SPALL ON LEFT SIDE OF BEAM END AT BENT 5 WITH VOIDS RESULTING FROM POOR CONSOLIDATION. APPROXIMATELY 50% OF BEARING AREA HAS BEEN LOST. THERE IS UP TO 50% SECTION LOSS ON THE SECONDARY REINFORCING.

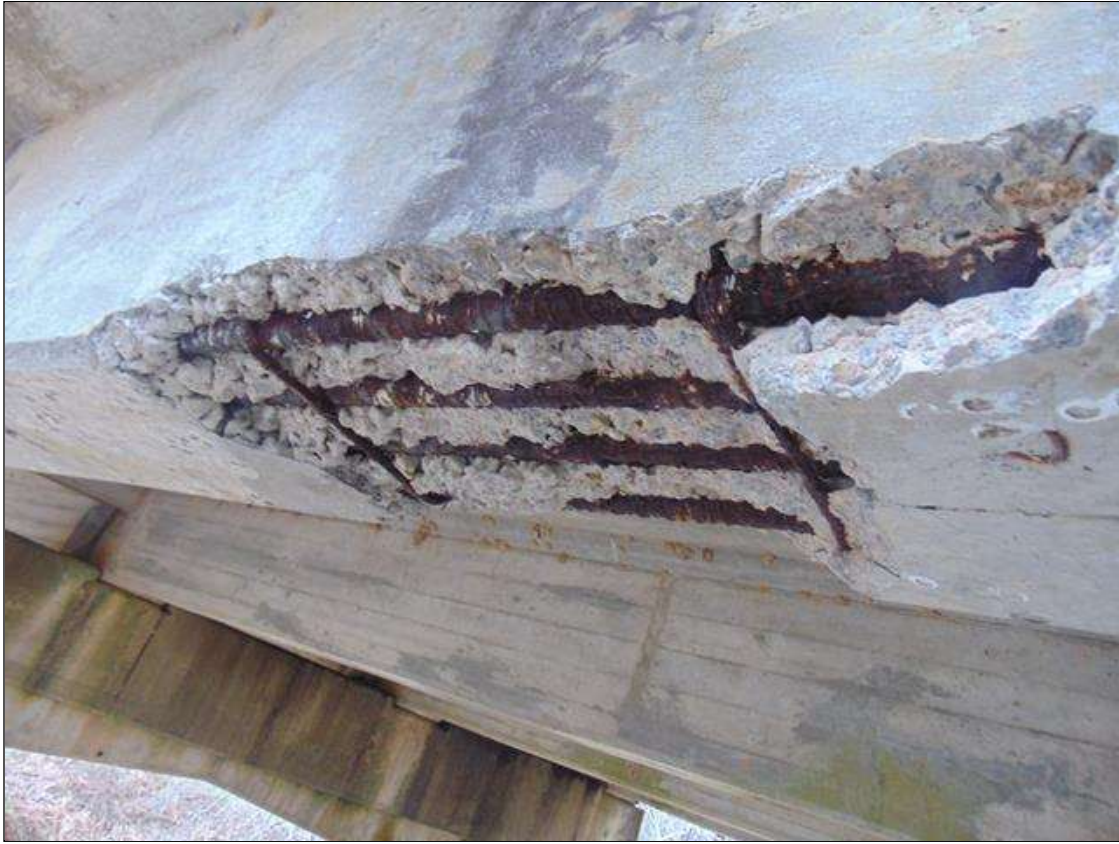
Span 5 Beam 4: [PROMPT ACTION REQUEST] 3.5' x 18" x 4" DEEP SPALL WITH EXPOSED REBAR ON UNDERSIDE AT MIDSPAN. THERE ARE VOIDS IN THE CONCRETE RESULTING FROM POOR CONSOLIDATION. THE SECONDARY REINFORCING HAS UP TO 50% SECTION LOSS.

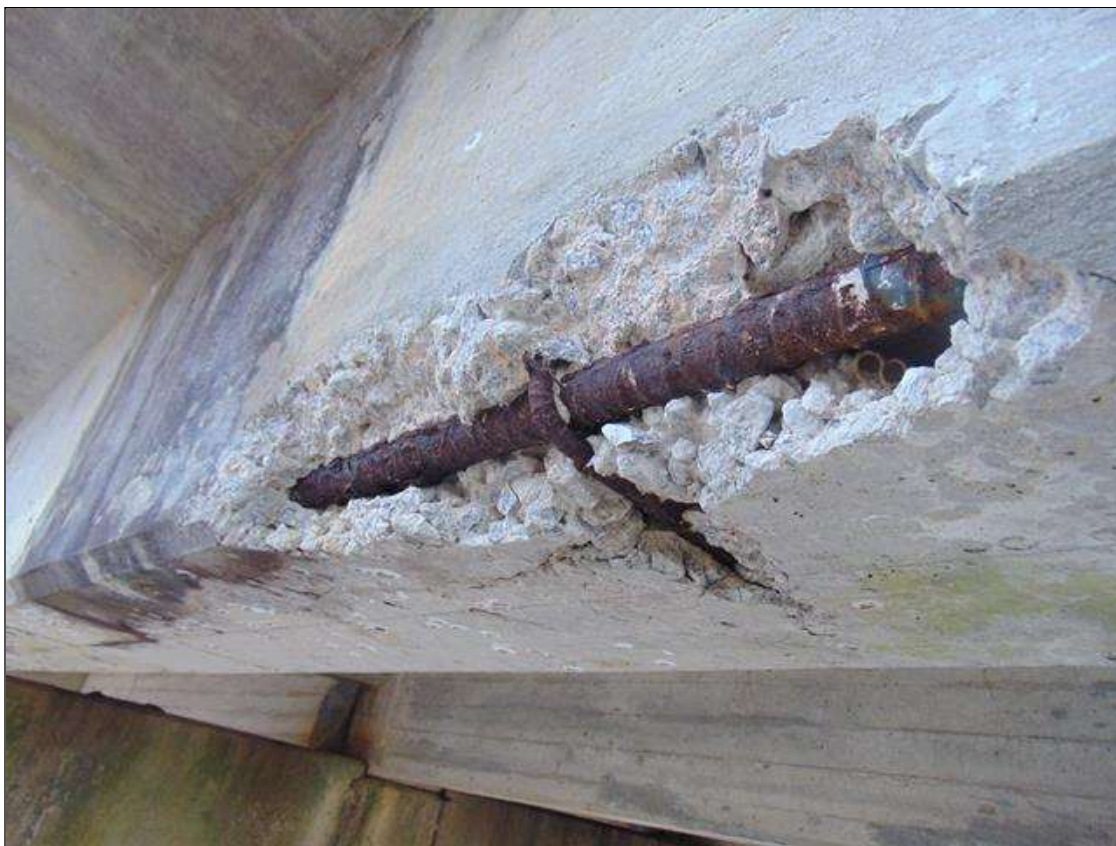
Span 5 Beam 4: [PROMPT ACTION REQUEST] 3' x 15" x 5" DEEP SPALL WITH EXPOSED REBAR ON UNDERSIDE AT 15' FROM BENT 4, NO MEASURABLE SECTION LOSS

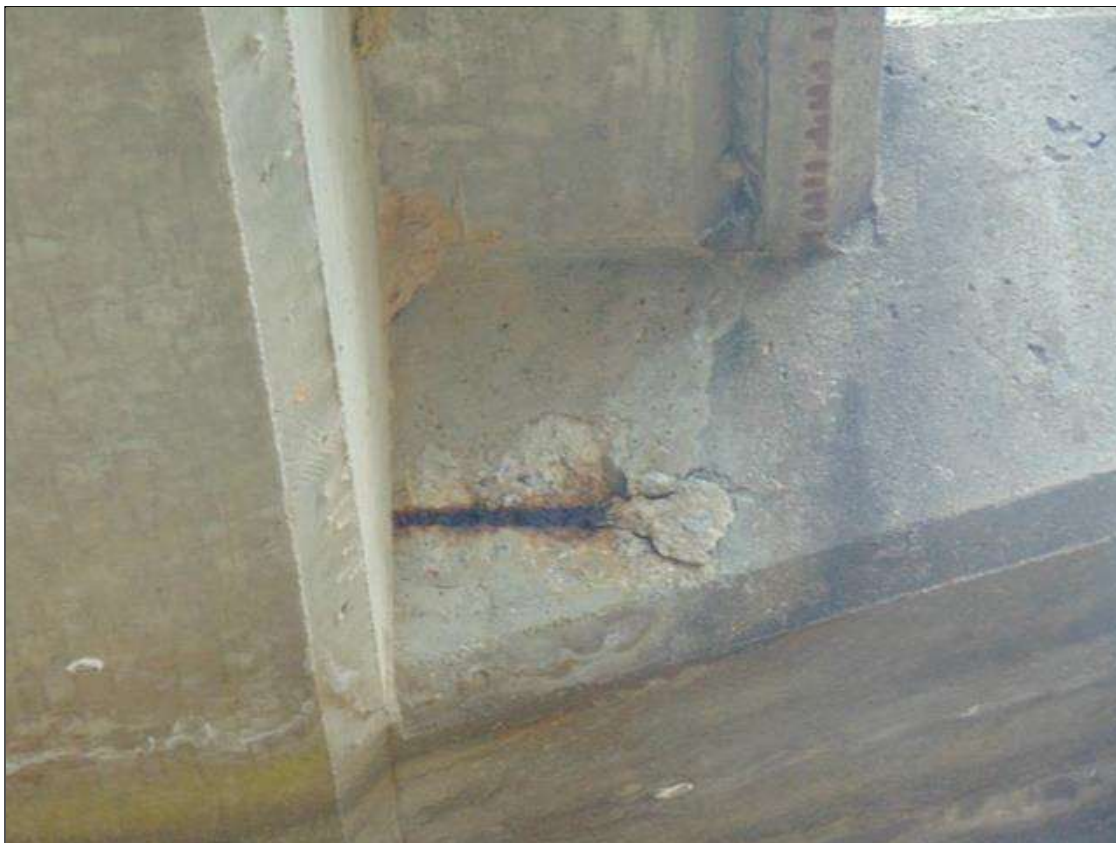
Span 5 Right Bridge Rail: 8" x 3" x 1/2" deep spall with exposed rebar on West face of Post 6 bracket

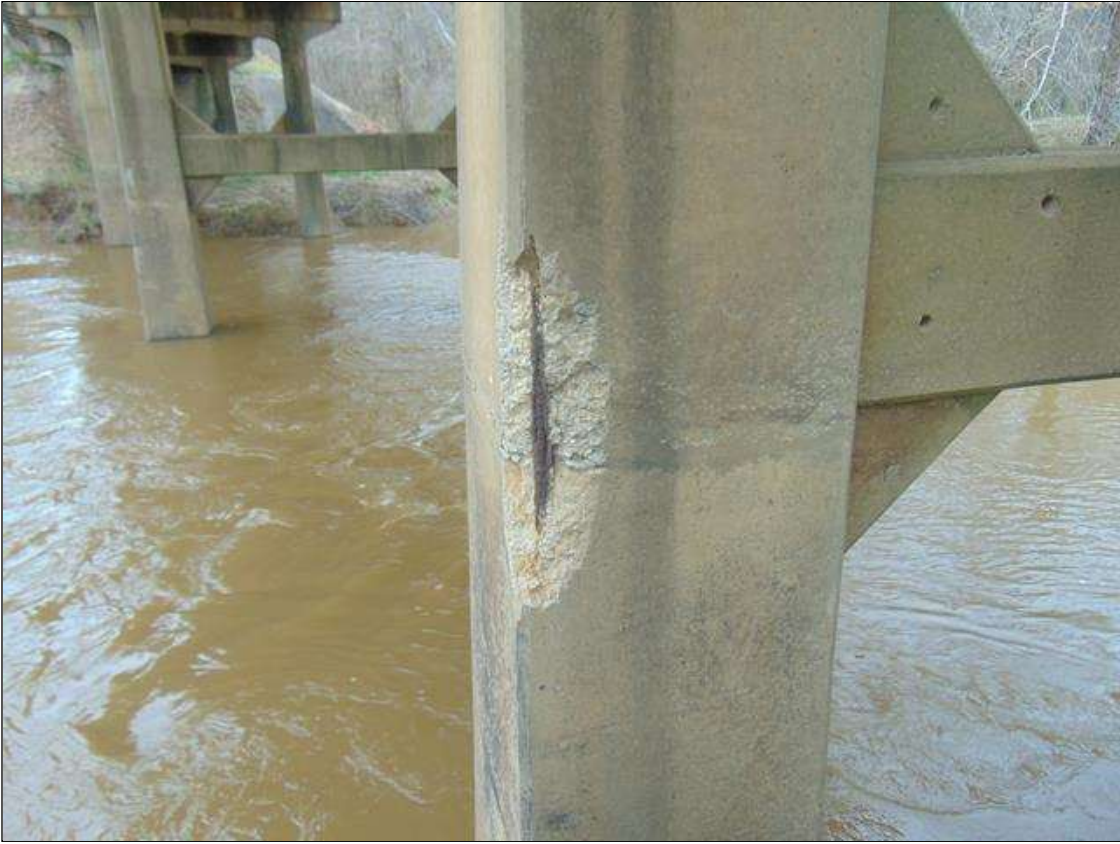
Bent 4 Pile 2: [PROMPT ACTION REQUEST] 4.5' x 7" x 8" DEEP SPALL WITH EXPOSED REBAR ON Southeast CORNER

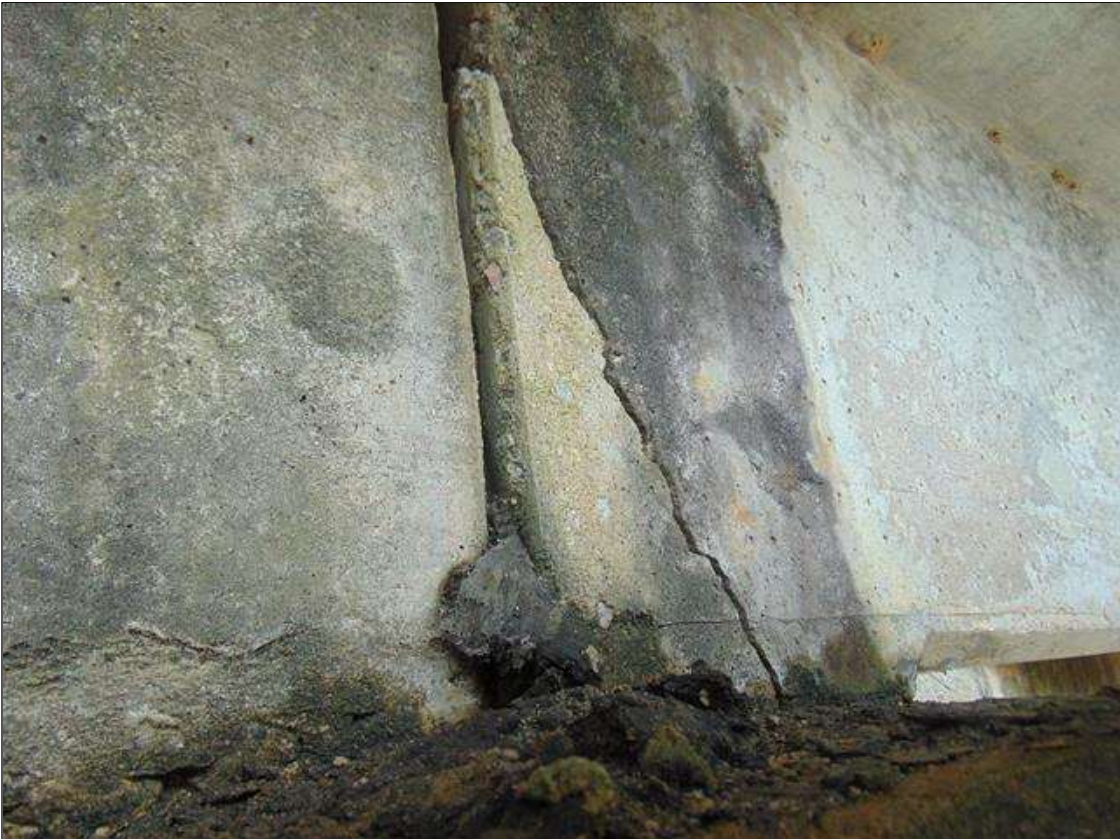
Span 4 Beam 1: GIRDER END AT BENT 4, LEFT SIDE, DIAGONAL CRACKING TO 3/16" WIDE x APPROXIMATELY 15" LONG WITH ASSOCIATED DELAMINATION

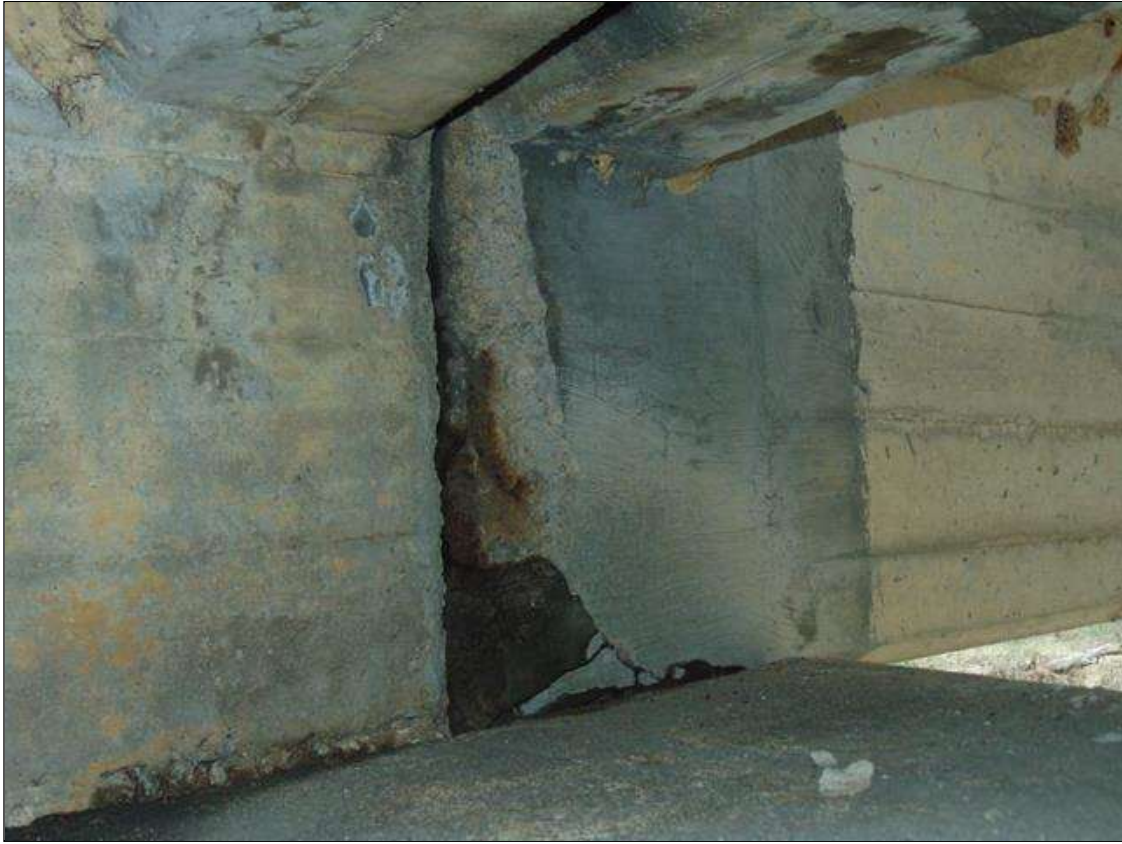
Span 4 Beam 2: [PROMPT ACTION REQUEST] 8" x 18" x 4 1/2" DEEP SPALL WITH EXPOSED REBAR WITH 19" x 19" AREA OF PATCH ON LEFT SIDE OF BEAM END AT BENT 4; RIGHT SIDE SIMILAR

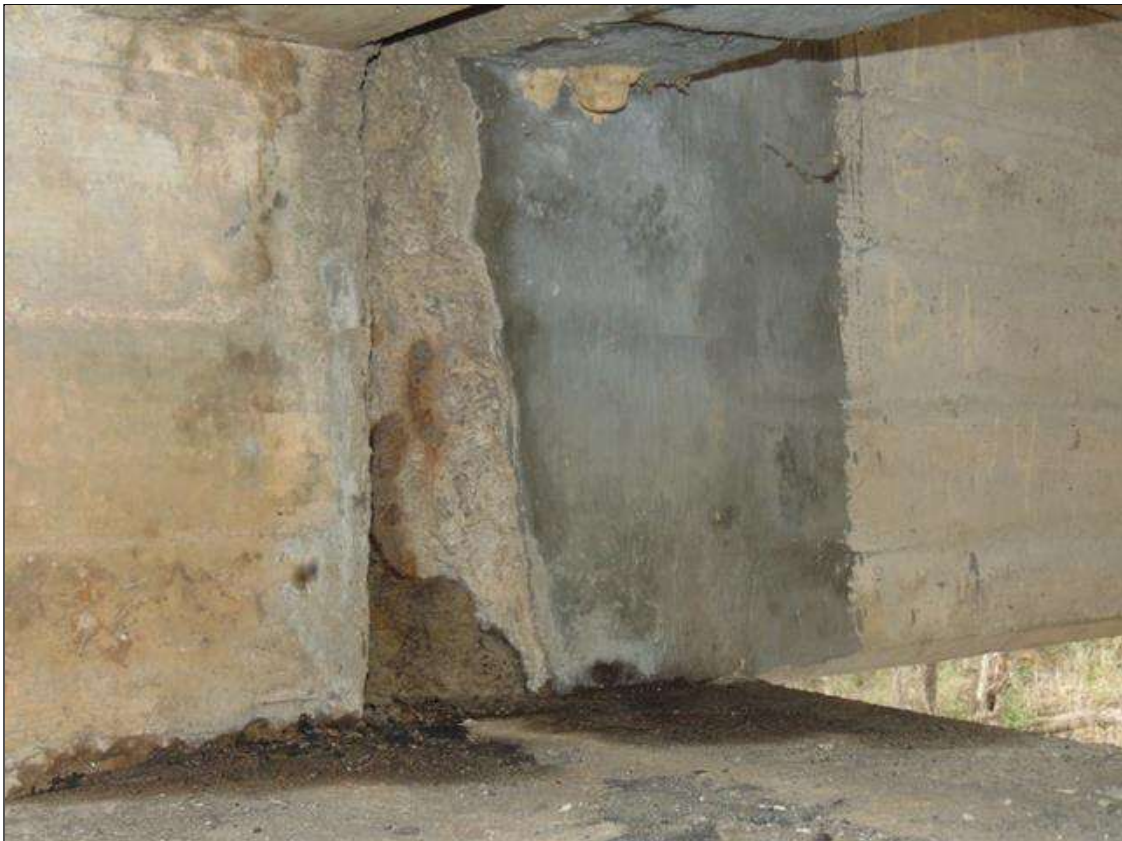
Span 4 Beam 3: [PROMPT ACTION REQUEST] 7" x 9" x 5" DEEP SPALL WITH EXPOSED REBAR WITH 19" x 19" AREA OF PATCH ON LEFT SIDE OF BEAM END AT BENT 4; RIGHT SIDE SIMILAR

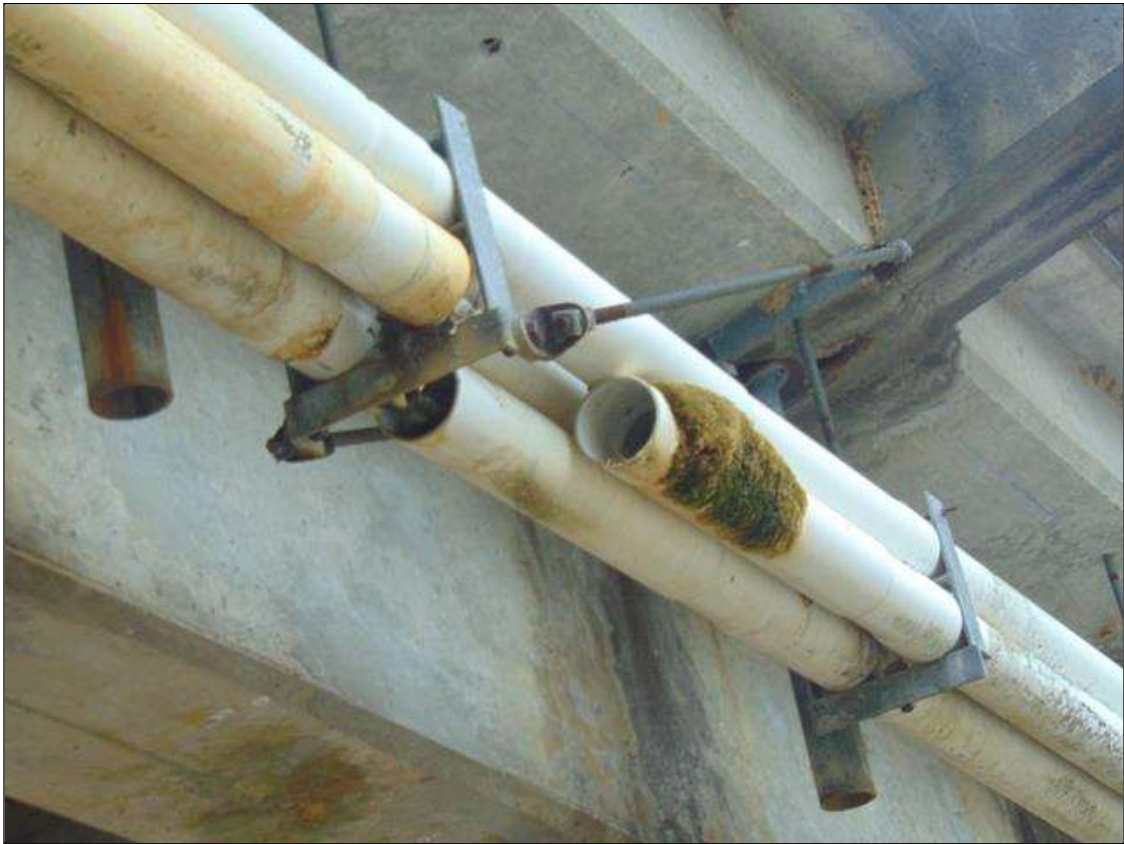
Disconnected utility in Span 5 (Span 4 similar)

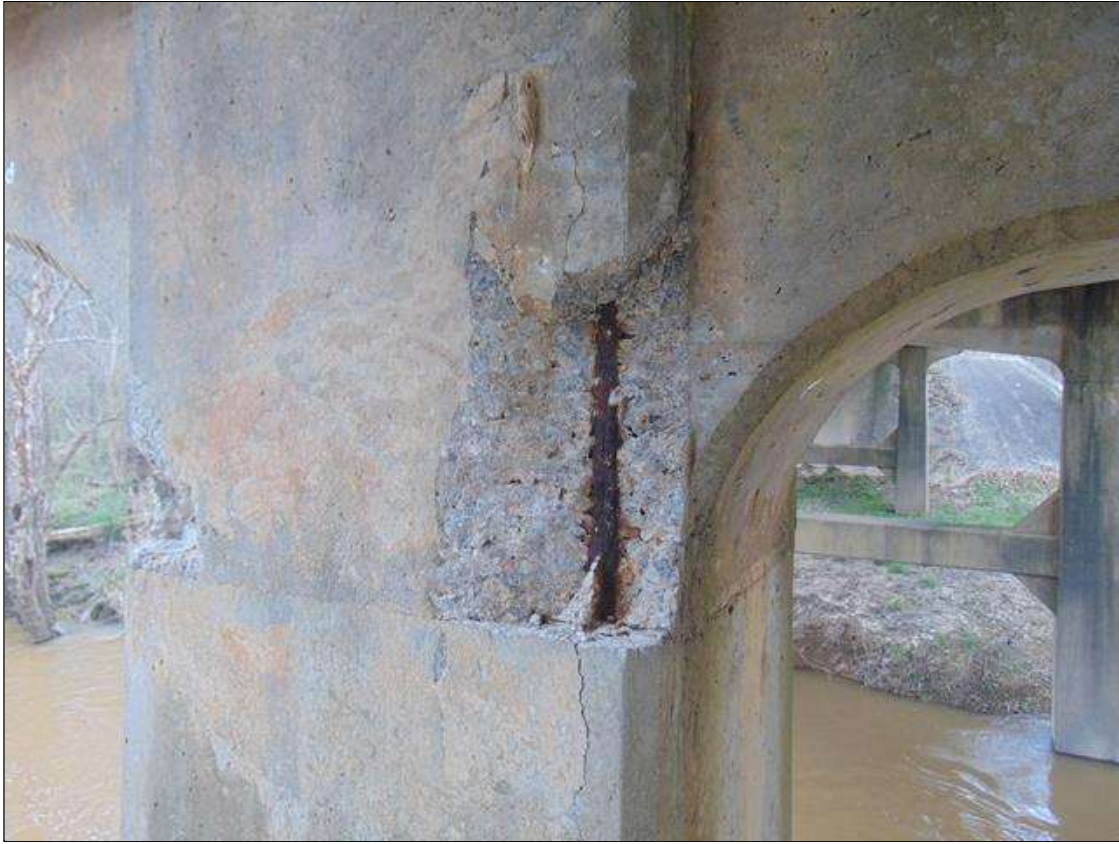
Bent 3 Pile 2: [PROMPT ACTION REQUEST] 2' DOWN FROM CAP, [2] AREAS OF SPALLING WITH EXPOSED REBAR AND AREA OF DELAMINATION UP TO 3' HIGH x 12" WIDE x 3" DEEP WITH NO MEASURABLE SECTION LOSS ON Span 4 FACE

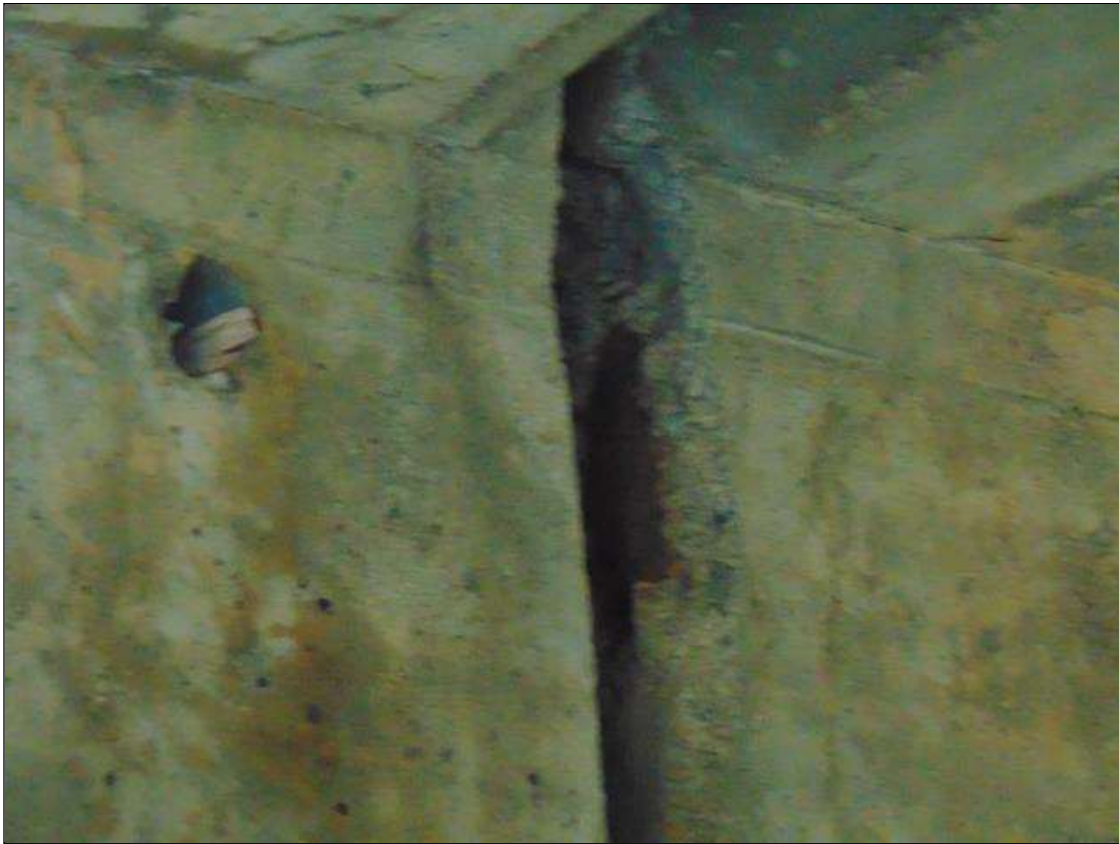
Span 2 Beam 4: 2 1/2" x 5" x 1/2" deep spall with exposed rebar on left side of beam at Bent 2 (PAR)

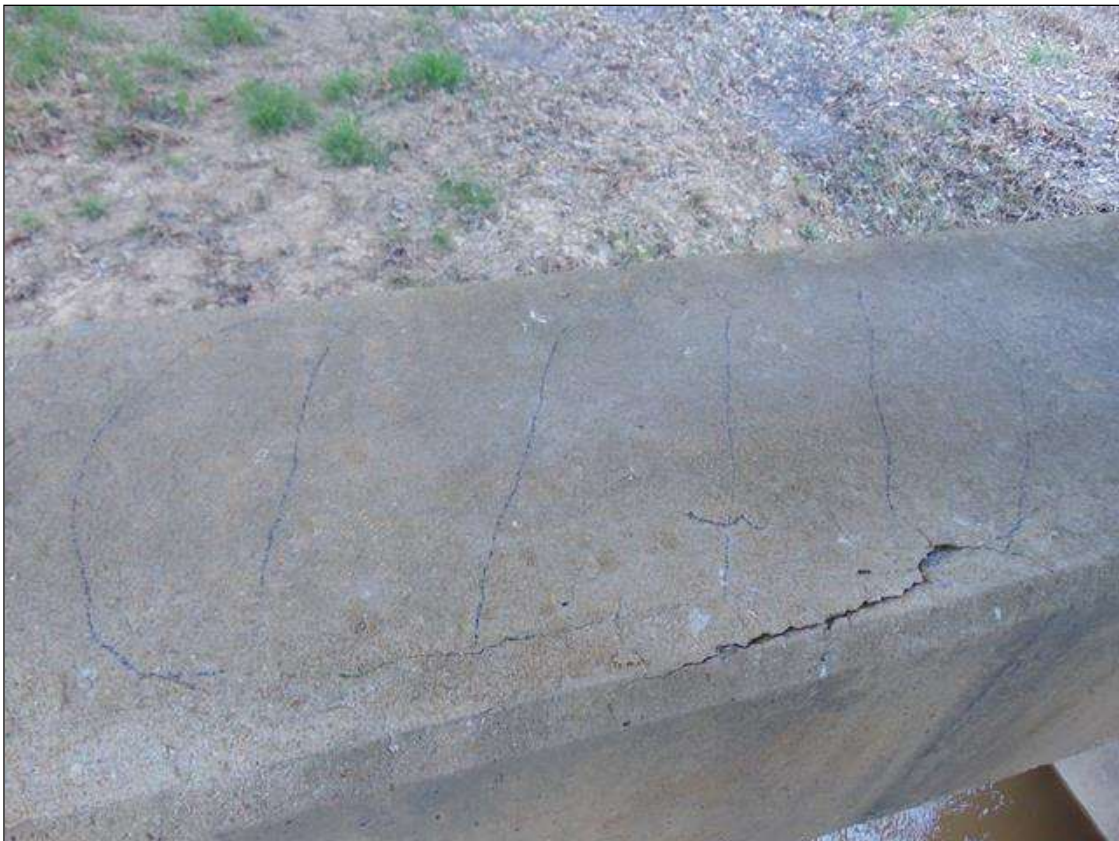
Bent 2 Pile 2: 38" x 18" area of delamination with 1/16" transverse cracks on top of strut between Columns 1 and 2

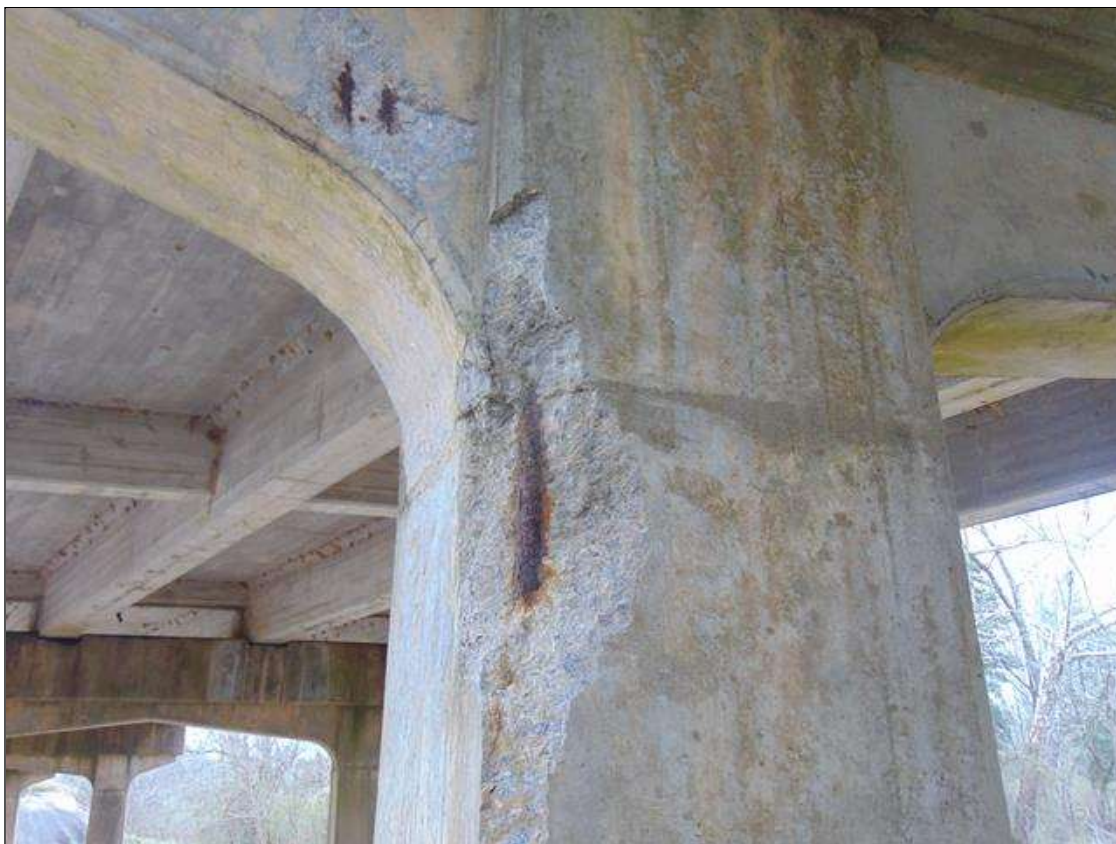
Bent 2 Pile 1: 44" x 9" x 8" SPALL WITH EXPOSED REBAR ON Northwest CORNER (PAR)

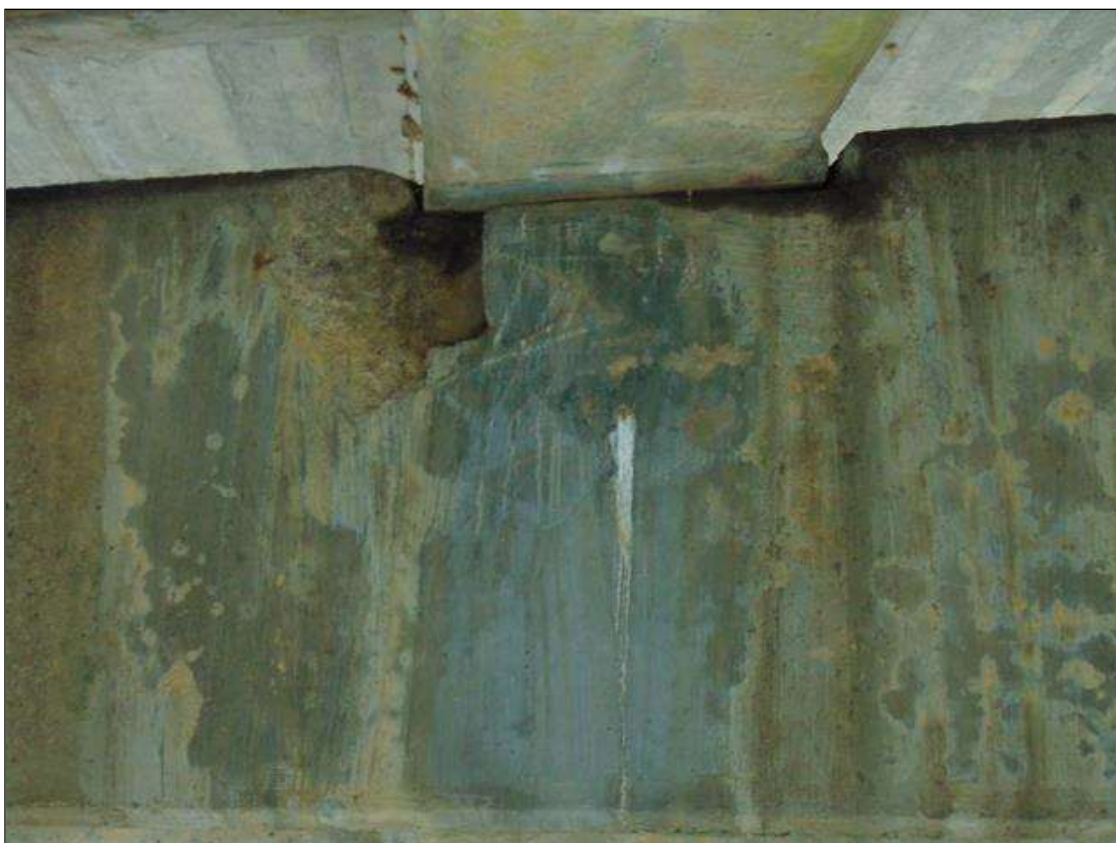
Bent 2 Cap 1: 20" x 12" x 8" DEEP SPALL AND DELAMINATED AREA ON WEST FACE UNDER GIRDER 3

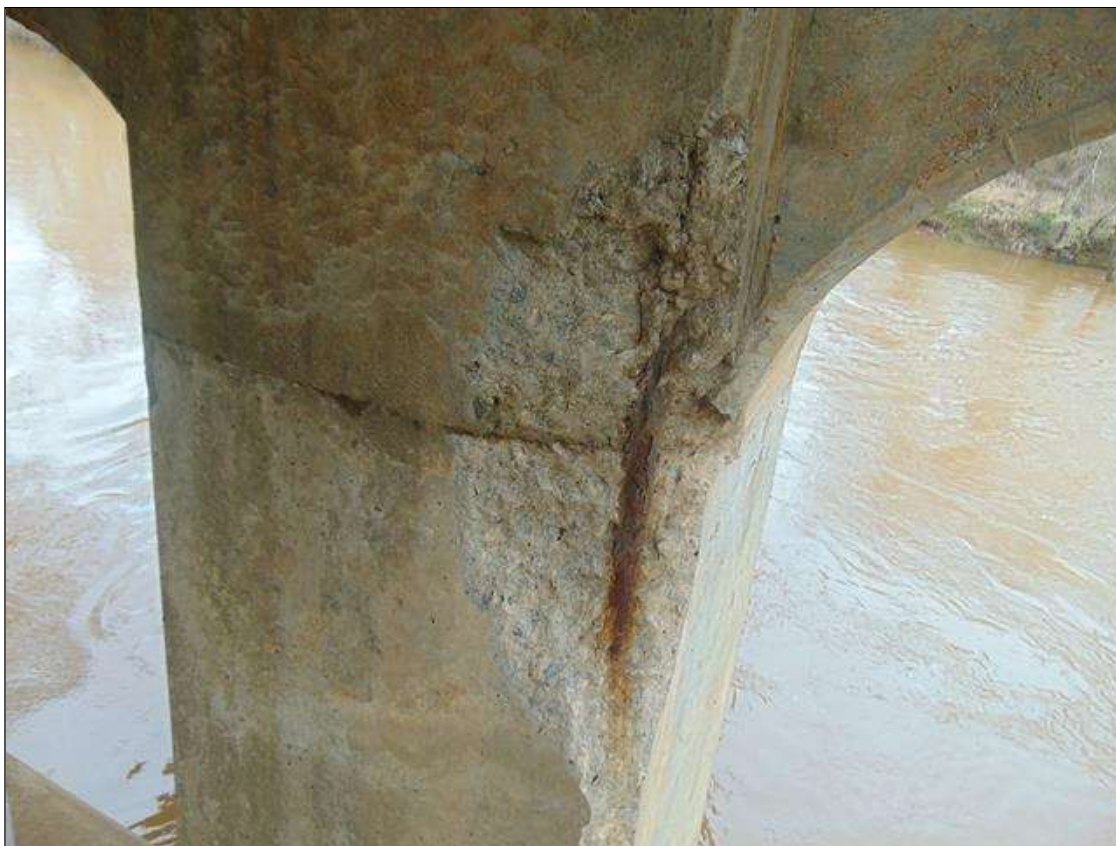
Bent 2 Pile 2: [PROMPT ACTION REQUEST] 50" x 10" x 8" SPALL WITH EXPOSED REBAR ON Southwest CORNER

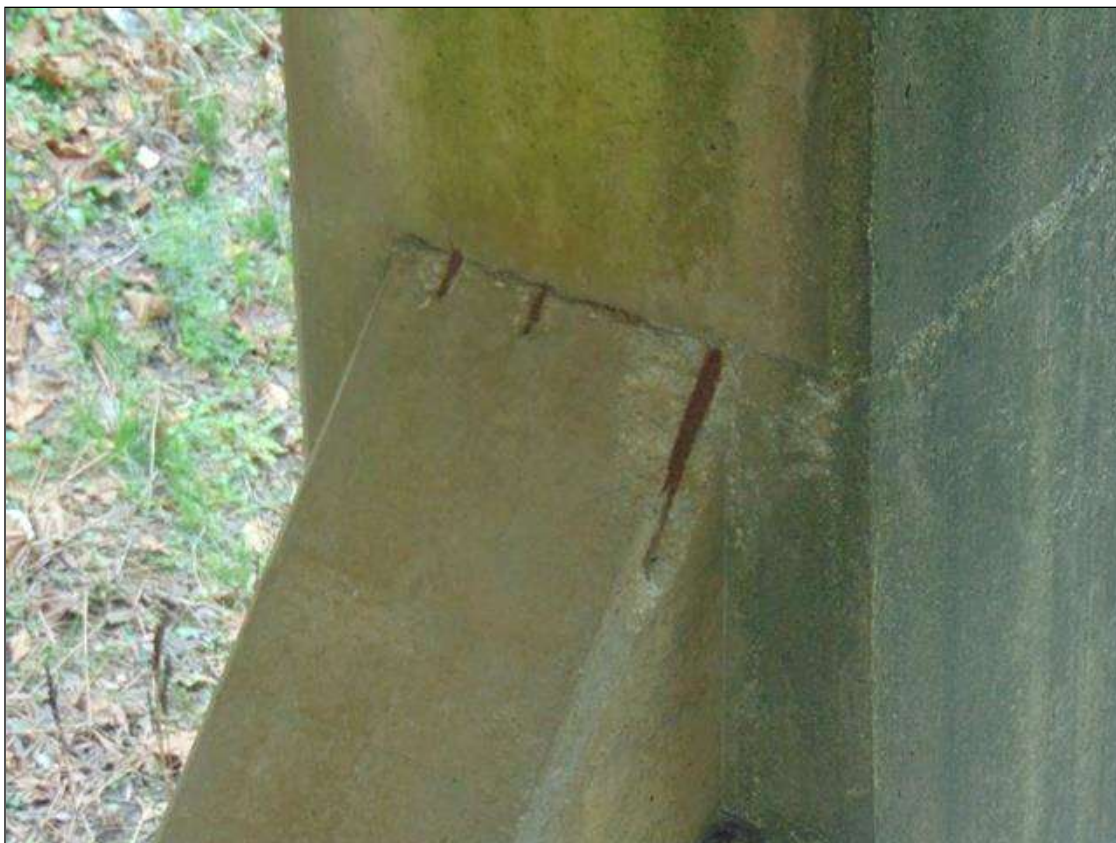
Bent 1 Pile 1: EAST FACE ON THE STRUCT, SPALLING WITH EXPOSED REBAR [APPROXIMATELY (3) UP TO 12" x 4" x 1" DEEP], NO MEASURABLE SECTION LOSS

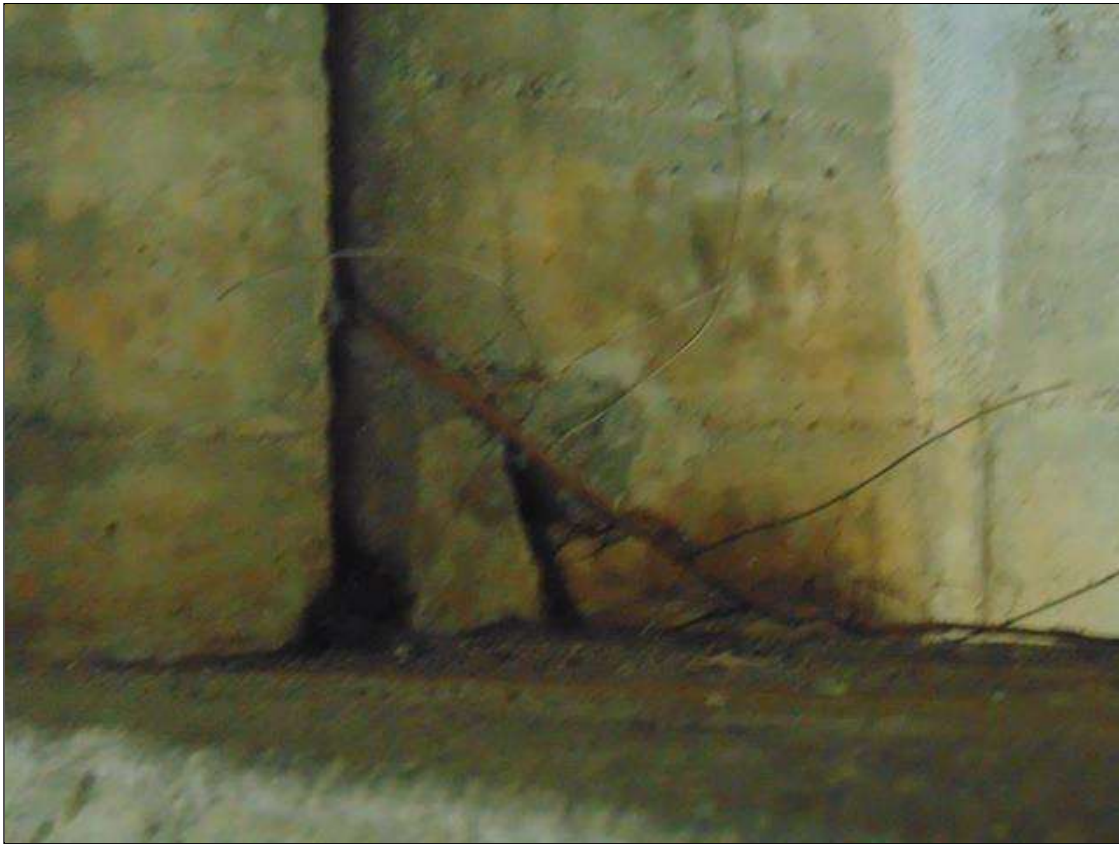
Span 1 Beam 4: 6" LONG x 6" TALL SPALLING UP TO 2" DEEP AND ARE OF DELAMINATION ON BEAM END OVER BENT 1, LEFT SIDE

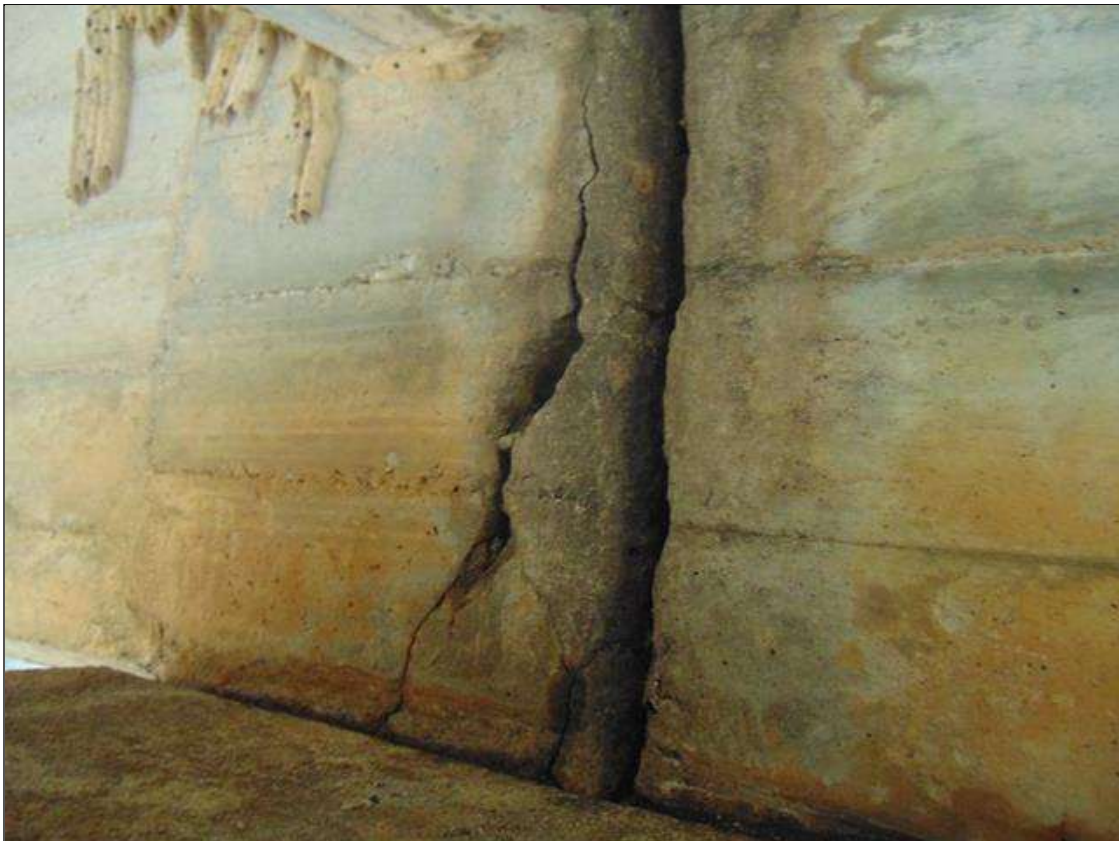
Span 1 Beam 3: 6" LONG x 19" TALL SPALLING AND AREA OF DELAMINATION ON BEAM END OVER BENT 1, RIGHT (PAR)

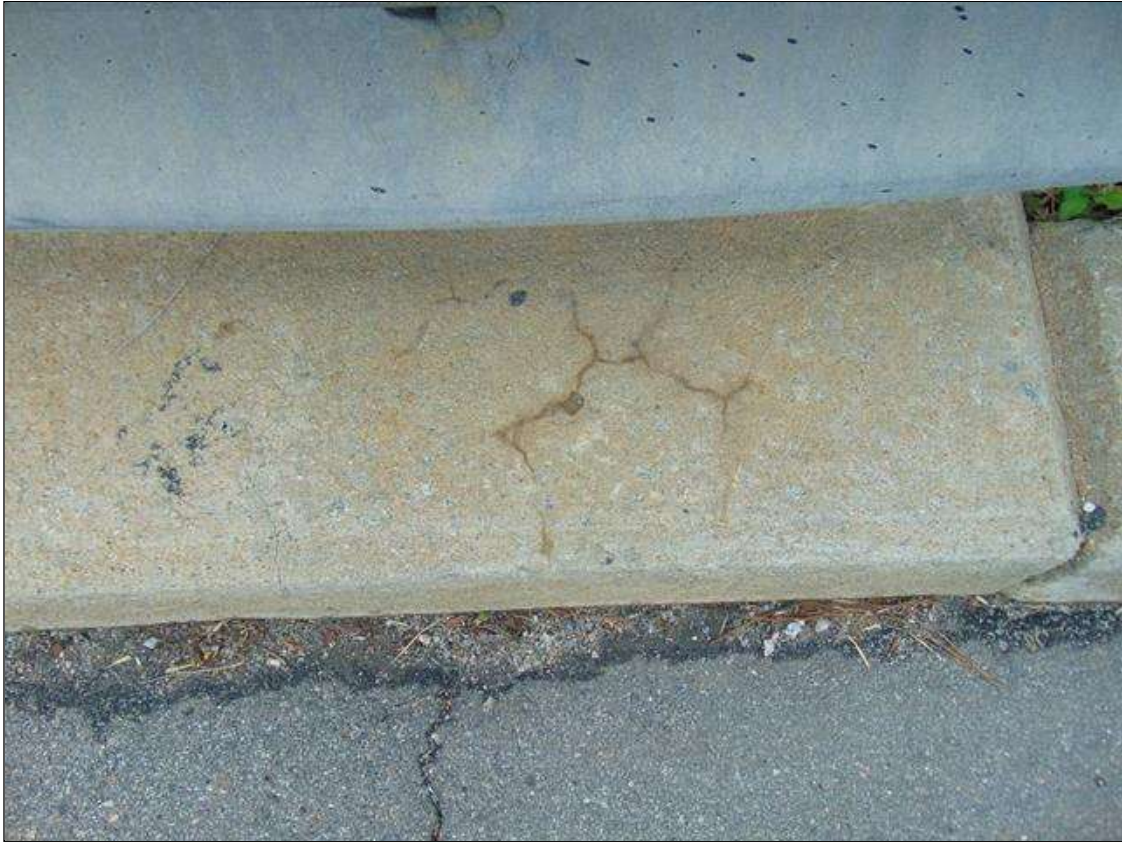
Span 7 Left Bridge Rail: 18" x 12" area of hairline map cracking on curb at End Bent 2

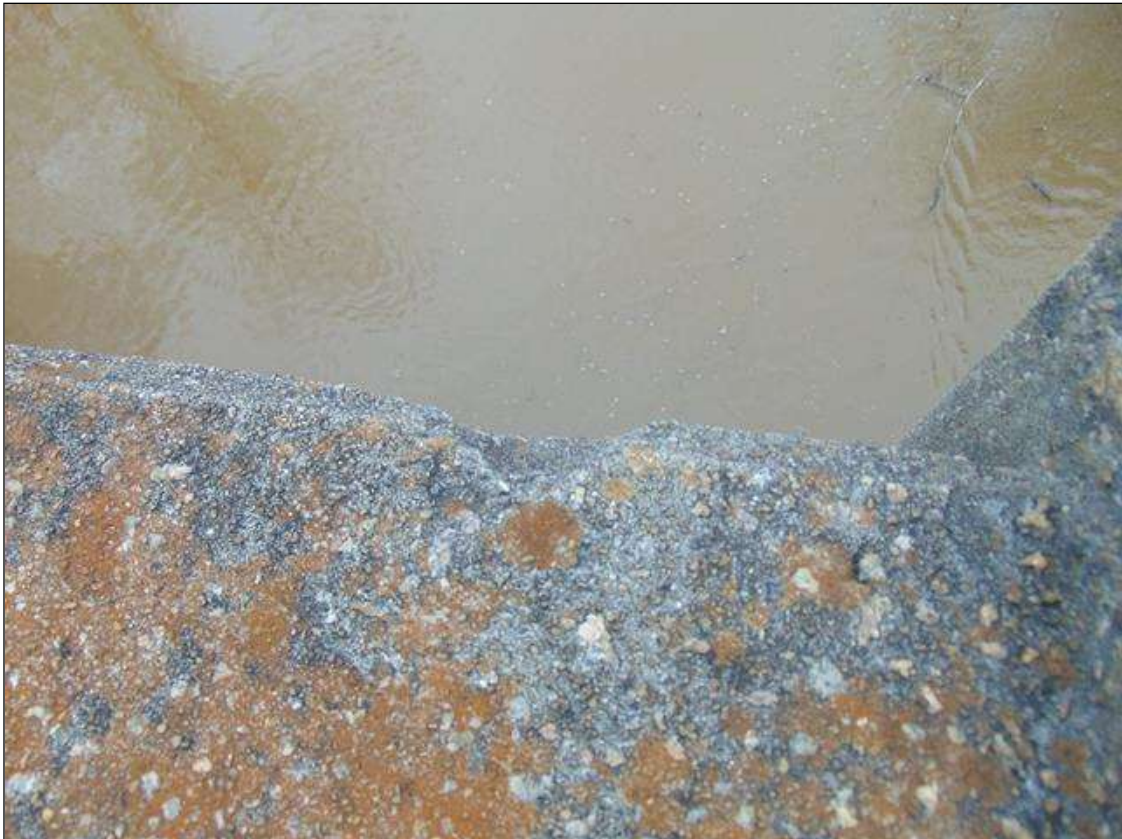
Span 5 Left Bridge Rail: 5" x 4" x 1" deep spall on rail near Post 1

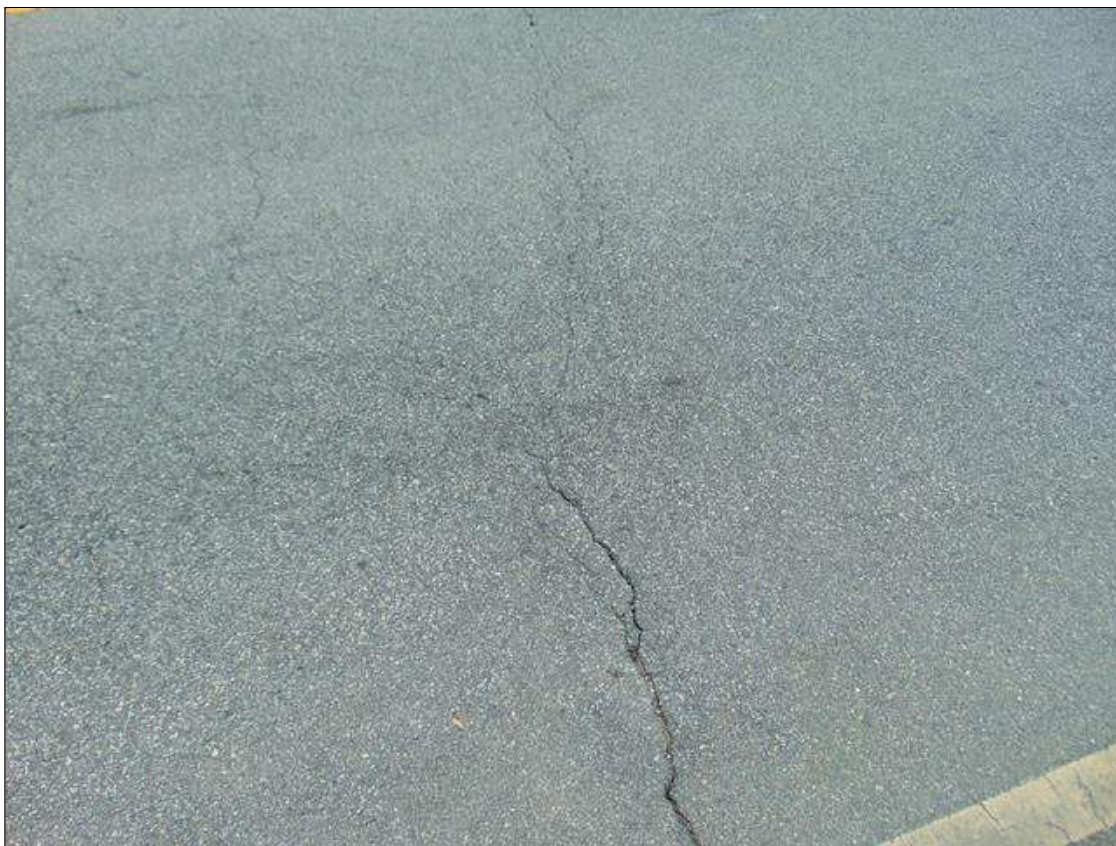
Span 7 Wearing Surface: 30 square feet up to 1/8" transverse crack at End Bent 2

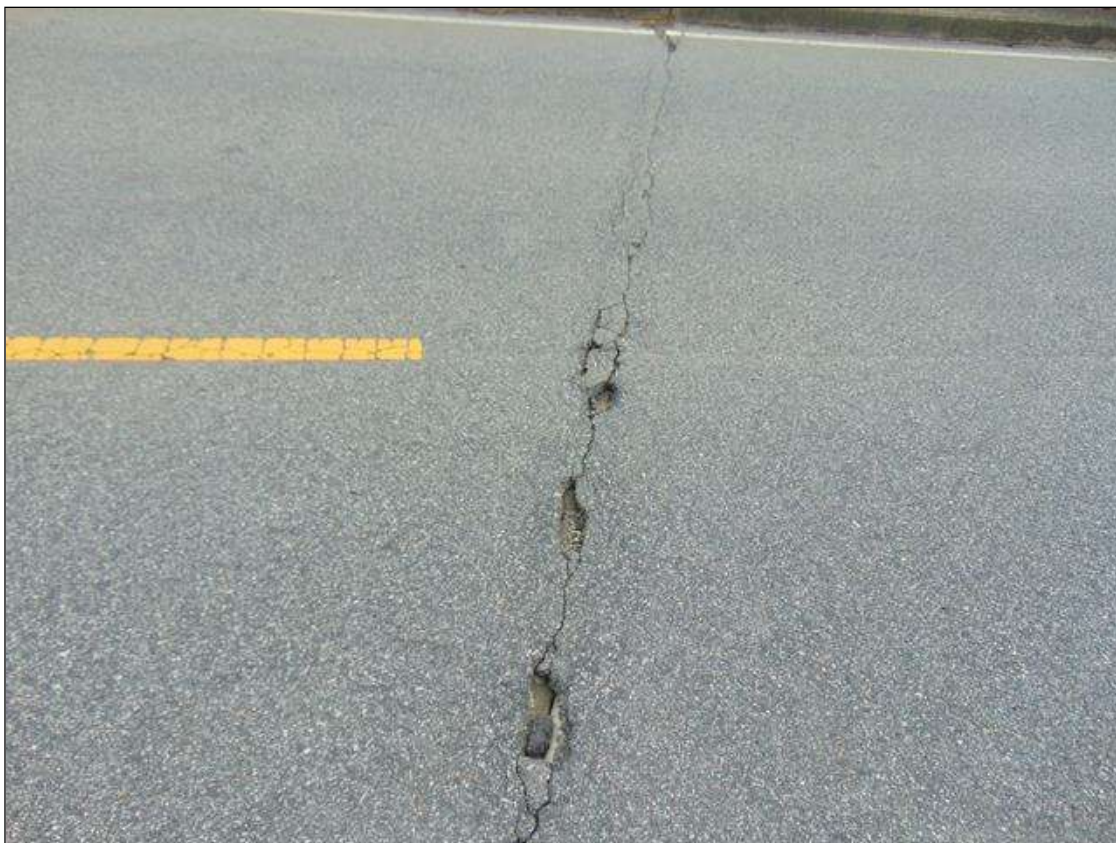
Span 7 Wearing Surface: 30 square feet up to 1/8" transverse crack with (4) up to 12" x 3" x 2" deep area of missing asphalt wearing surface at Bent 6

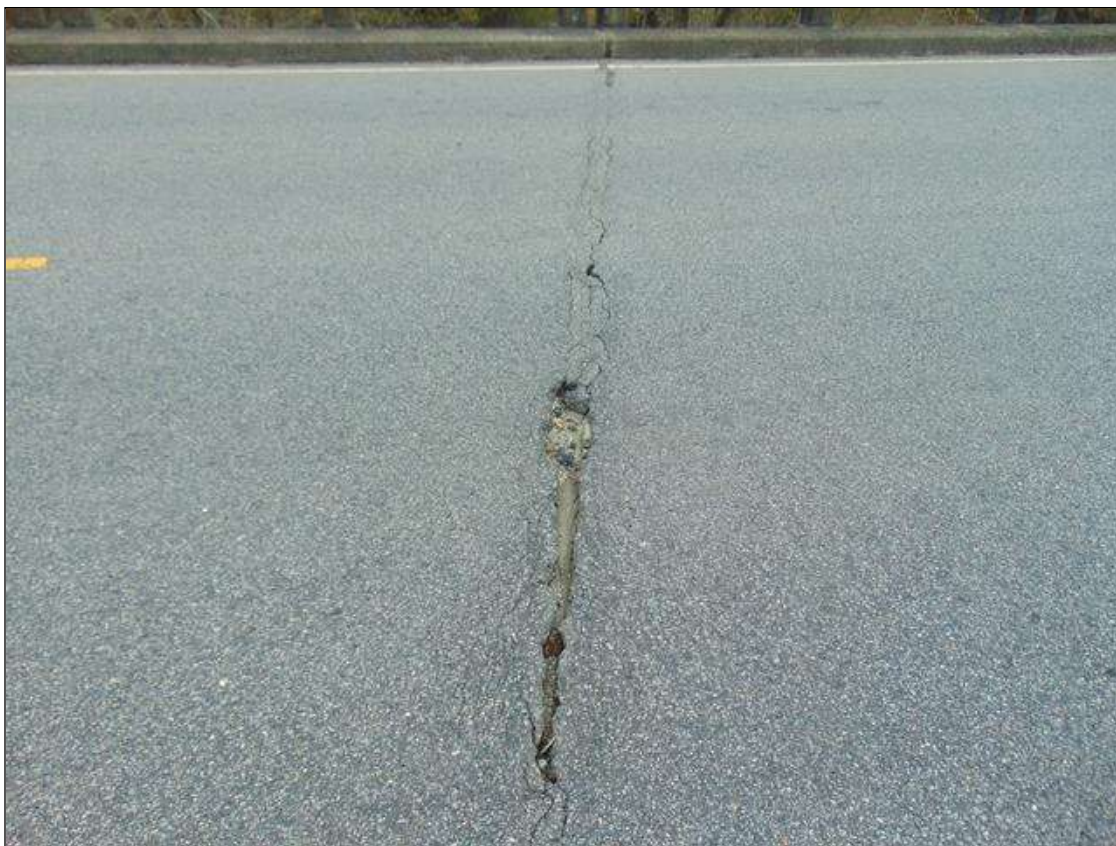
Span 6 Wearing Surface: Full width transverse crack with (2) up to 56" x 6" x 2" deep area of missing asphalt wearing surface at Bent 5
