NC DEPARTMENT OF TRANSPORTATION  
 DIVISION OF HIGHWAYS  
 STRUCTURE MANAGEMENT UNIT

ATTENTION: Prompt Action Request; Snooper

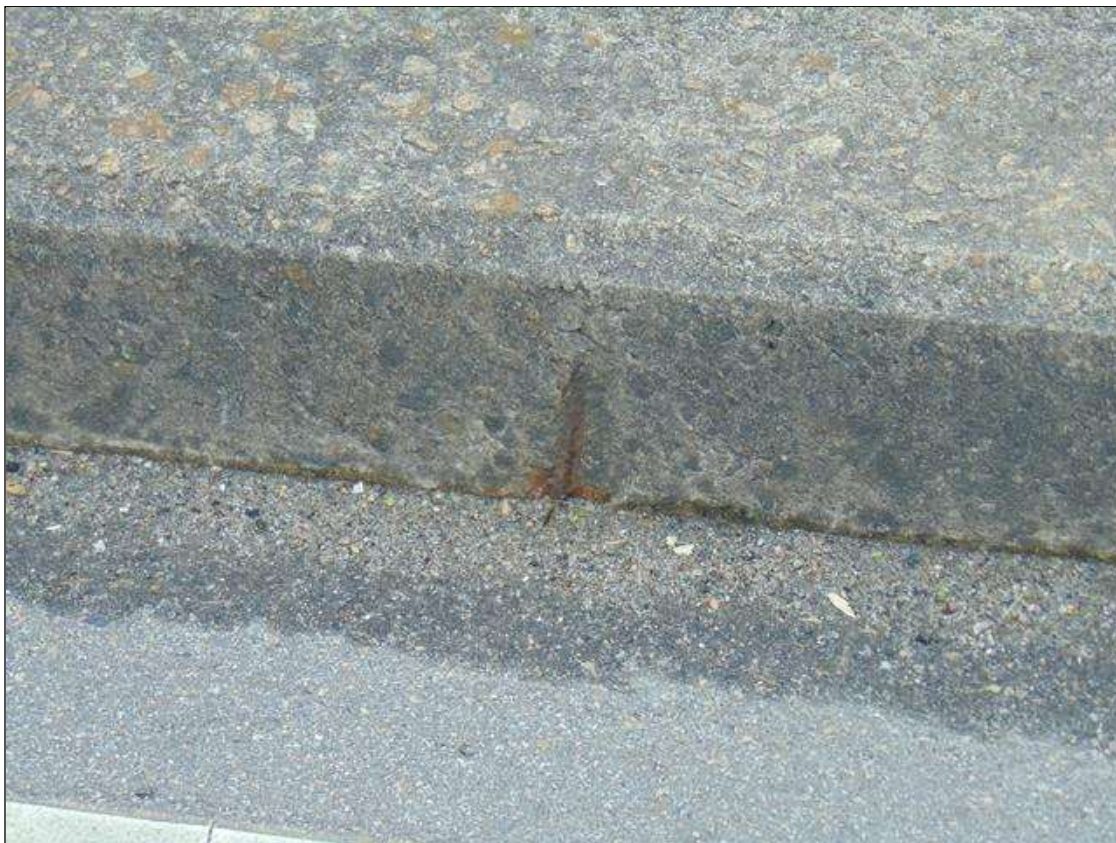
Span 5 Right Bridge Rail: (5) up to 4 1/2" x 2" x 1/2" deep spalls with exposed rebar on curb face

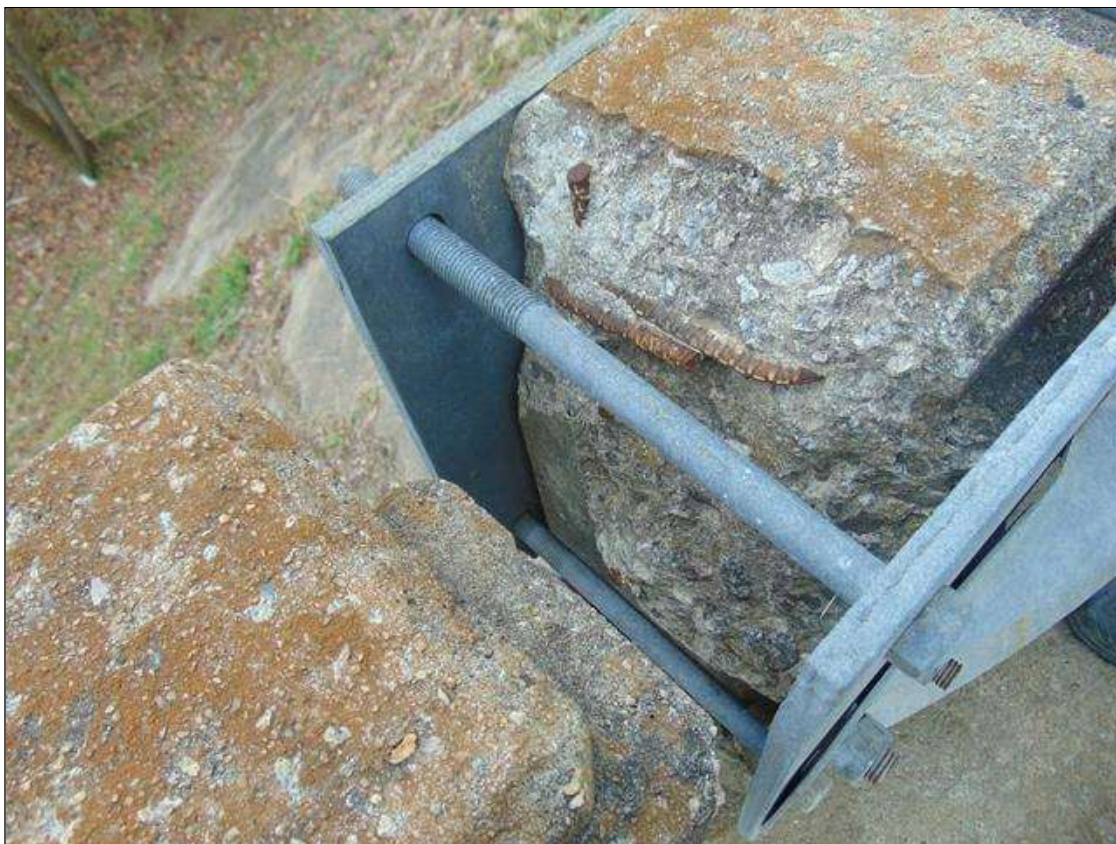
Span 1 Right Bridge Rail: 12" x 11" x 5" DEEP SPALL WITH EXPOSED REBAR ON POST 2

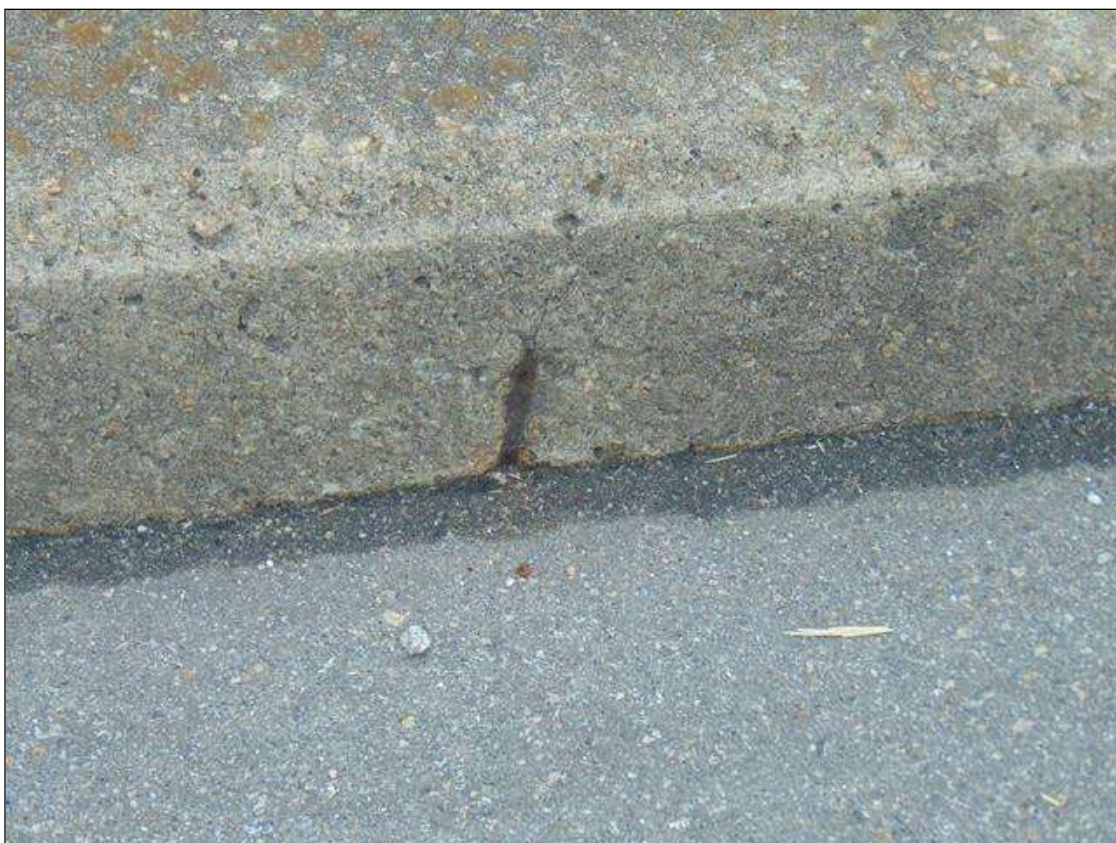
Span 1 Left Bridge Rail: (3) UP TO 5" x 1" x 1/4" DEEP SPALLS WITH EXPOSED REBAR ON CURB NEAR POST 7

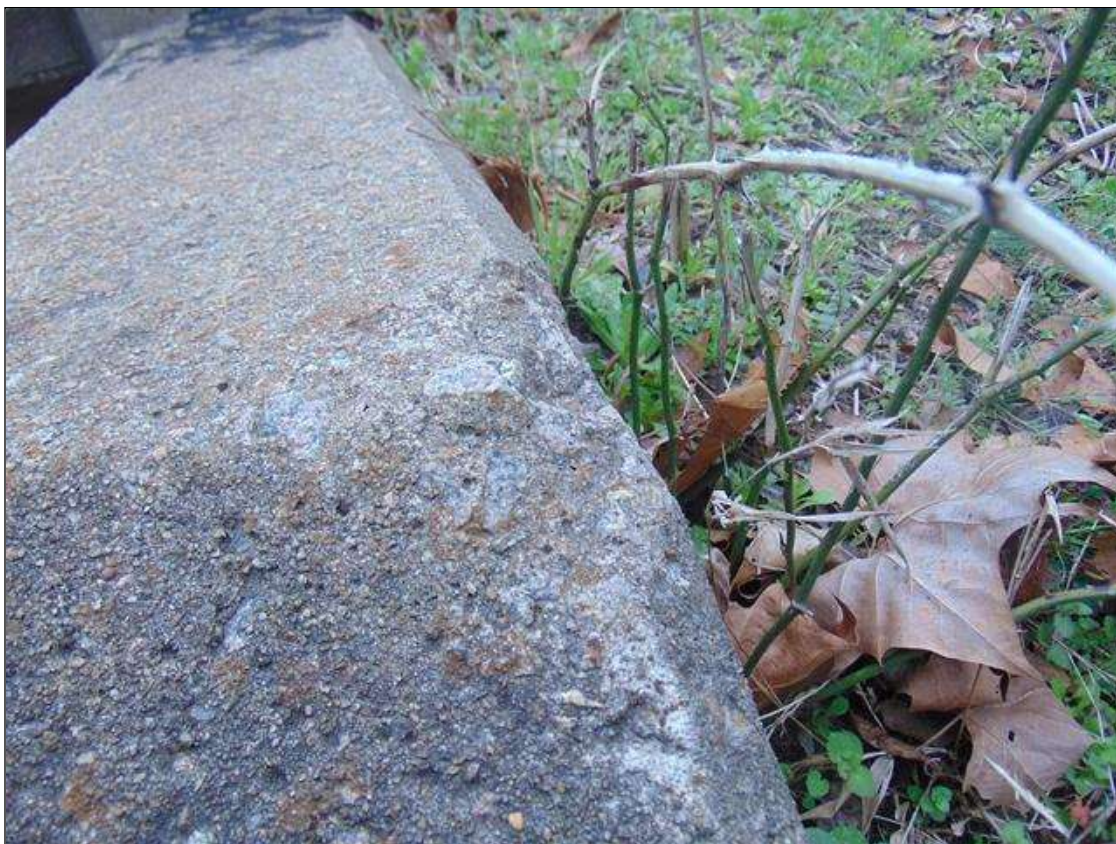
(2) up to 5" x 2" x 1" deep spalls on Northwest wingwall

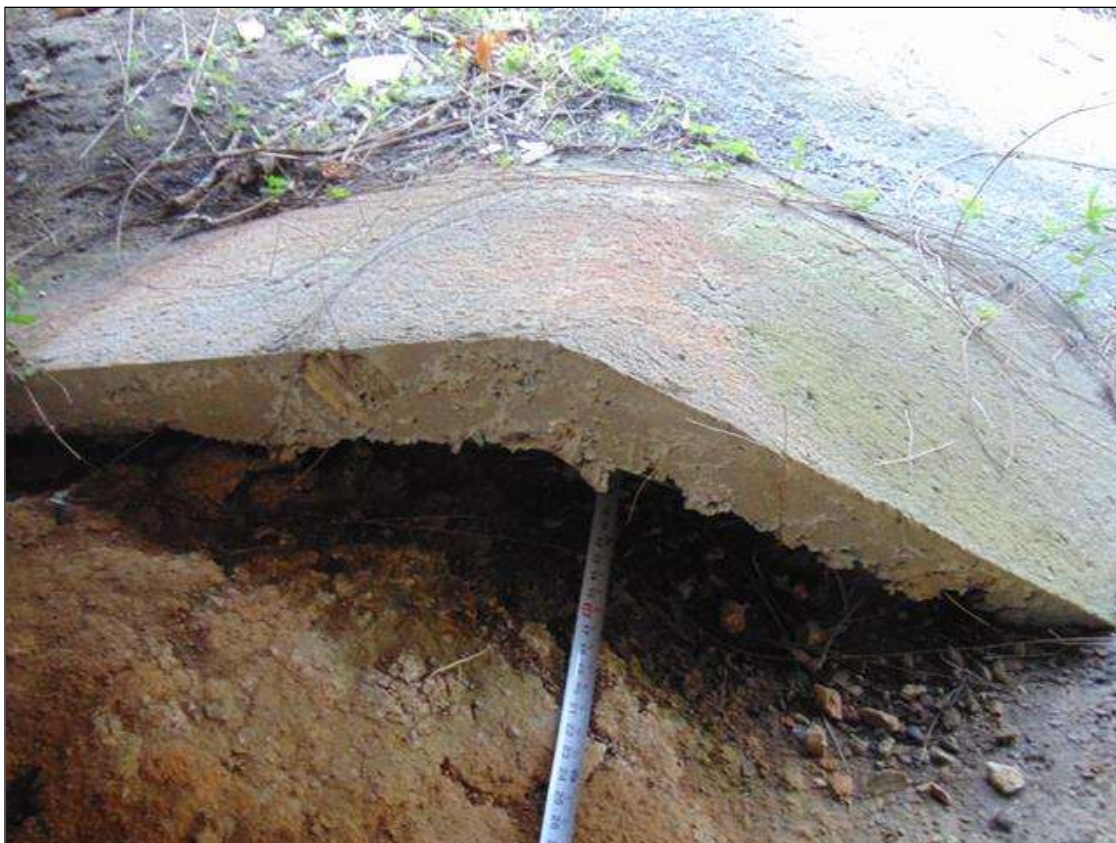
4' x 1' deep undermining under End Bent 1 slope protection at North end (South end similar) (PAR)

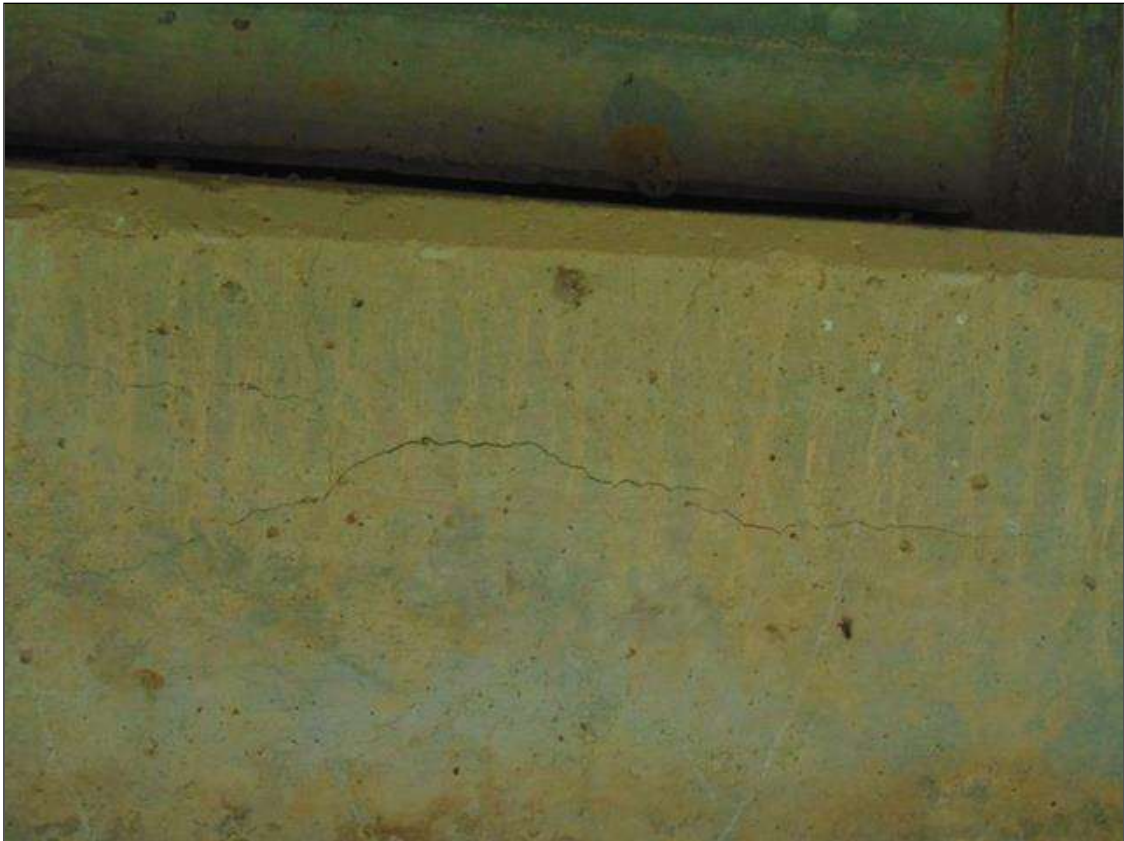
End Bent 2 Cap 1: 2.5' x 8" x 5" DELAMINATION AND 1/16" CRACKING IN Bay 1

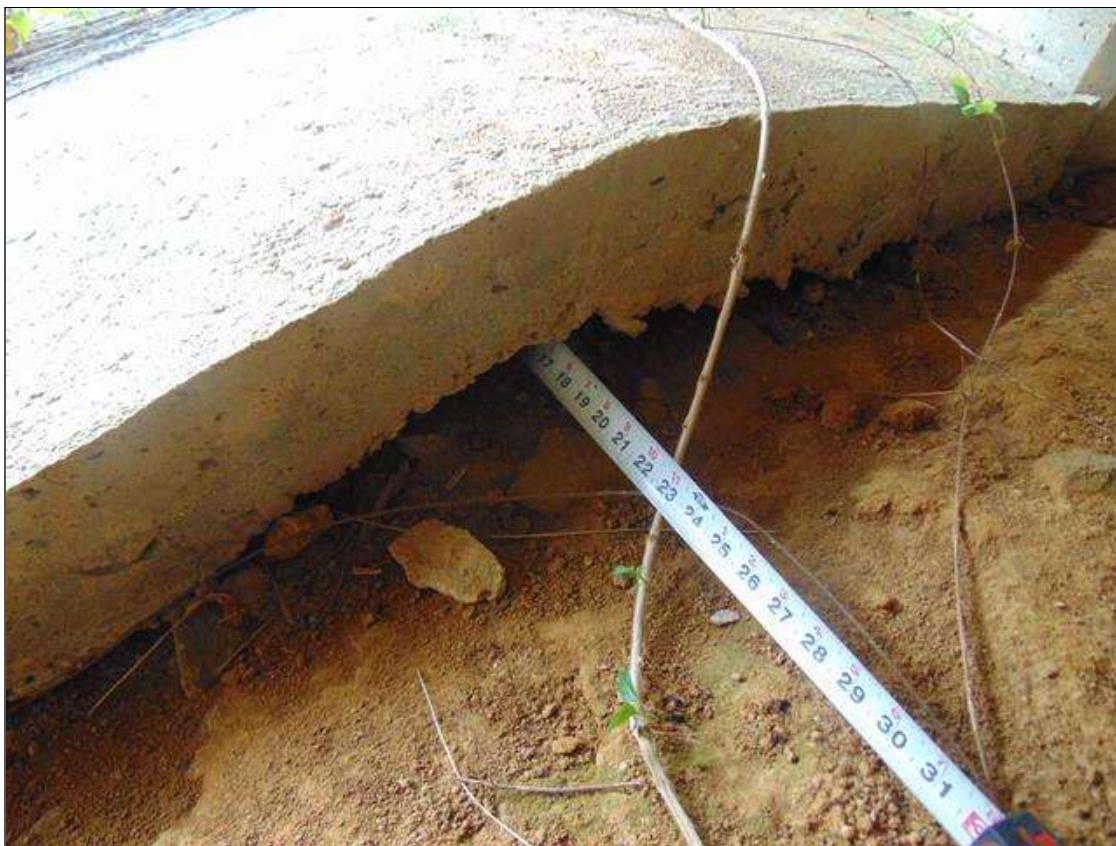
2' x 18" deep undermining under End Bent 2 slope protection at North end (South end similar) (PAR)

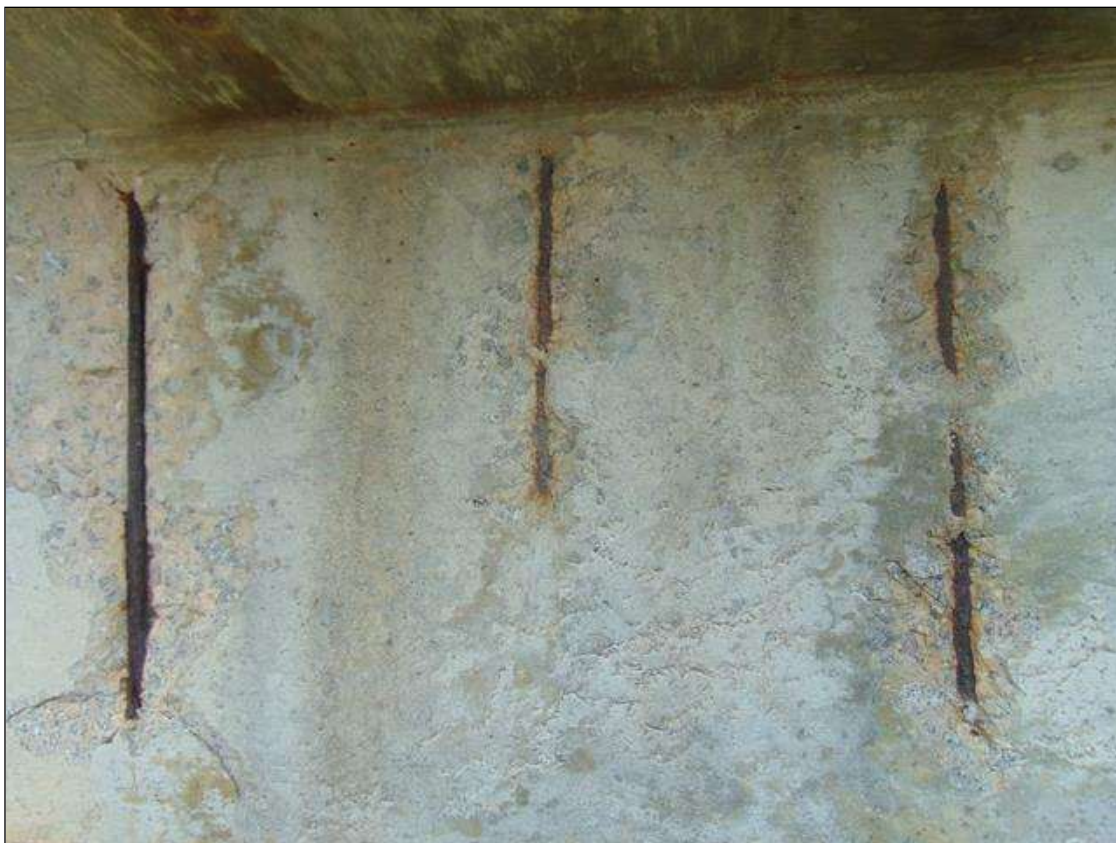
Span 7 Beam 4: 3.5' x 24" x 3/4" DEEP SPALL WITH EXPOSED REBAR ON RIGHT SIDE AT 6' FROM END BENT 2, NO MEASURABLE SECTION LOSS

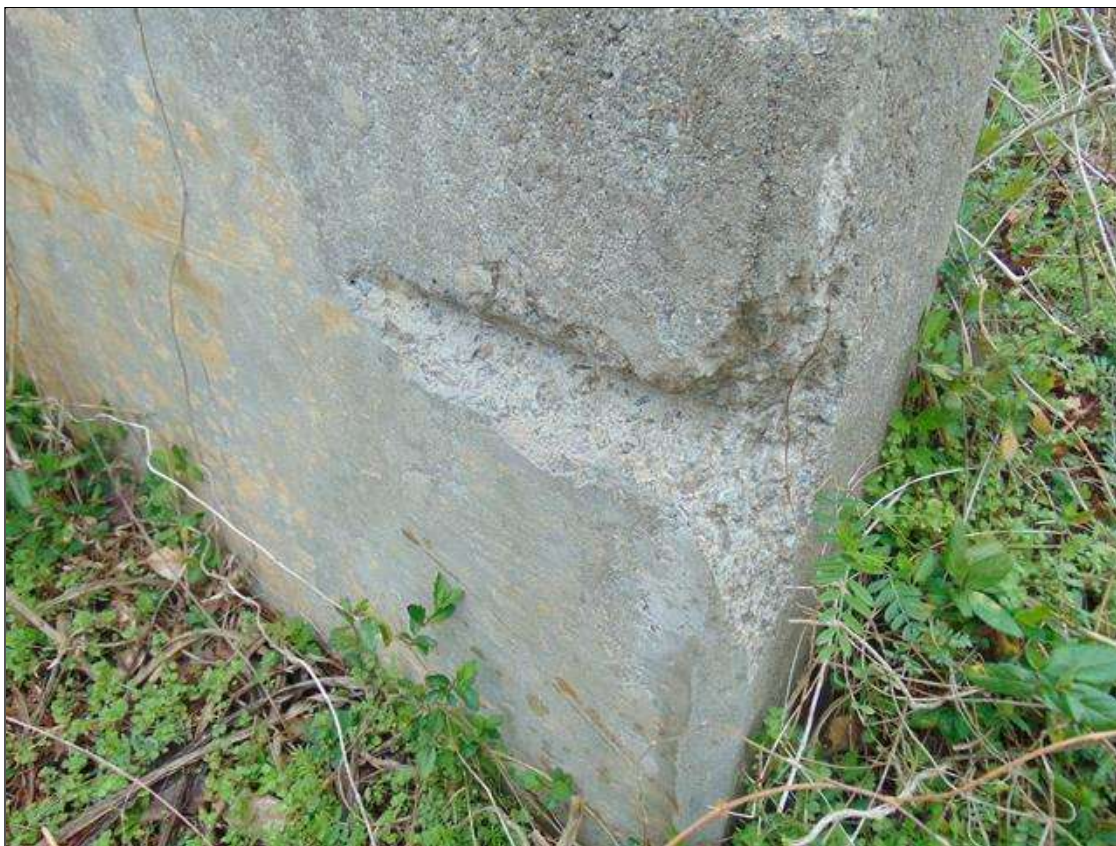
14" x 13" x 1 1/2" deep spall on Southeast wingwall

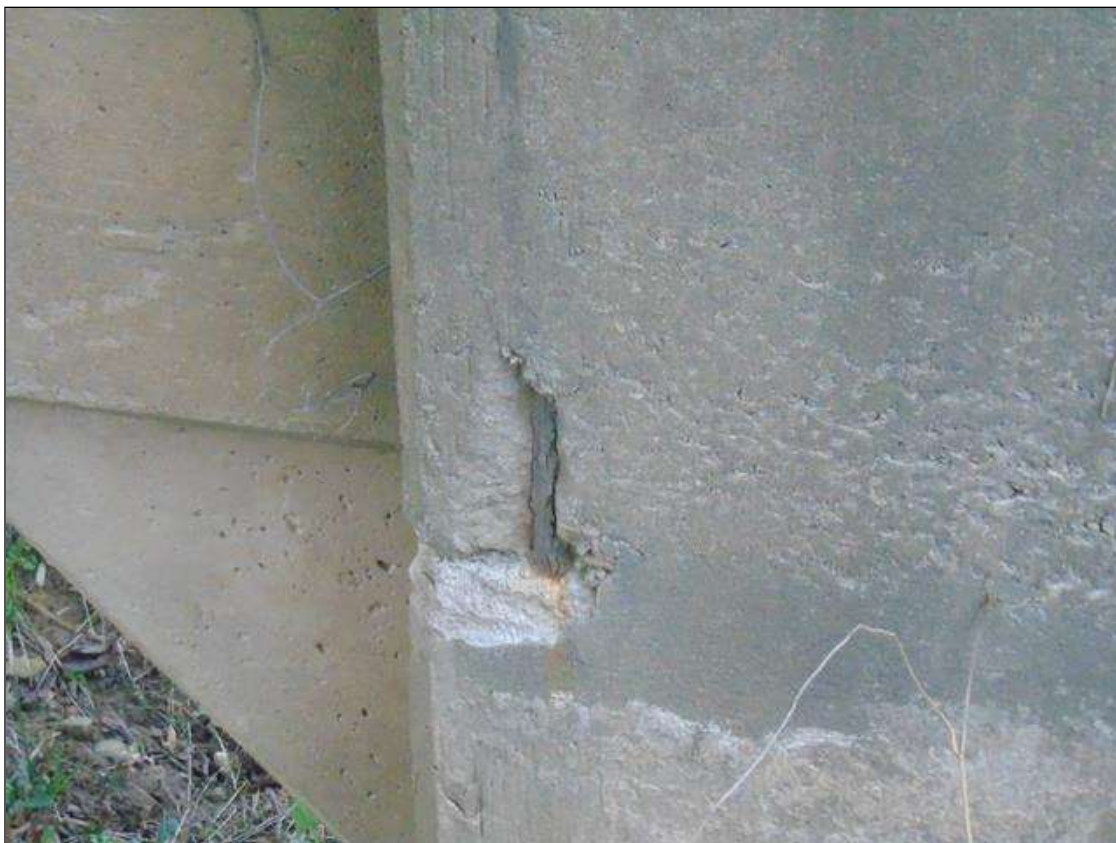
Bent 6 Pile 2: 12" x 6" x 1 1/2" DEEP SPALL WITH EXPOSED REBAR AND AREA OF DELAMINATION ON Northwest CORNER AT STRUT (PAR)

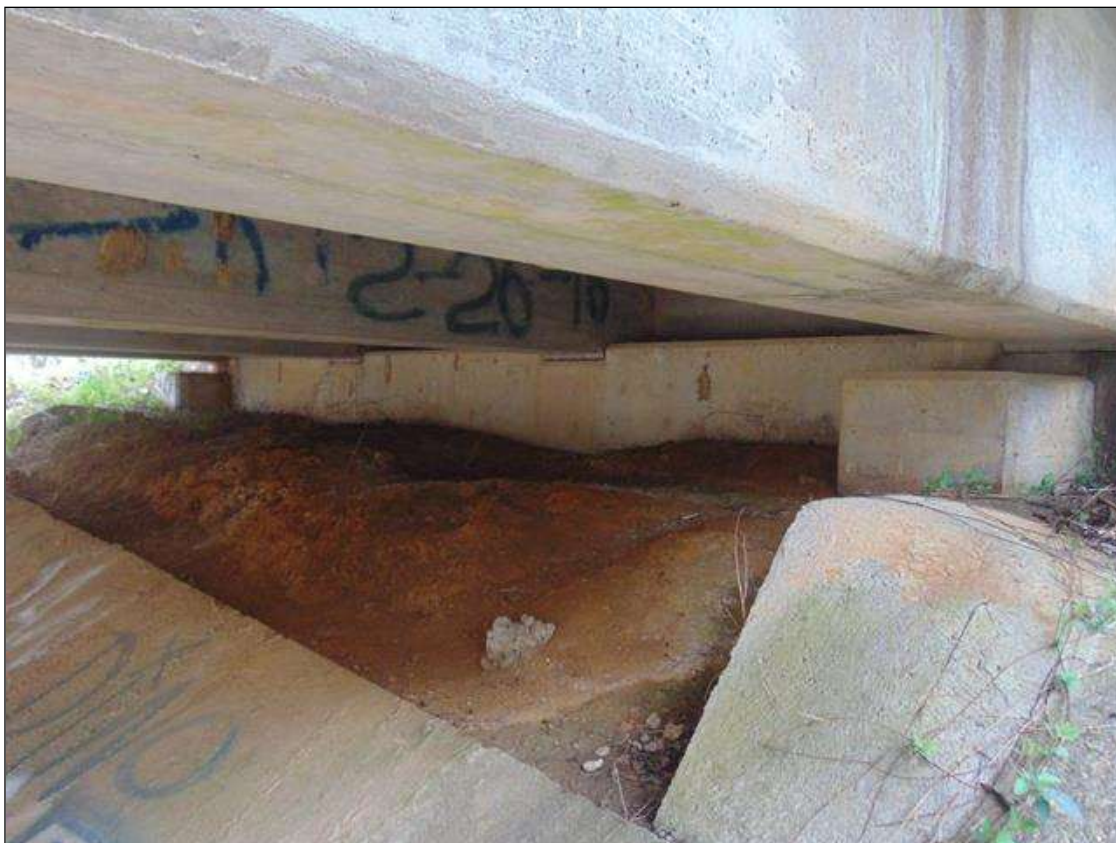
End Bent 1 (End Bent 2 similar)

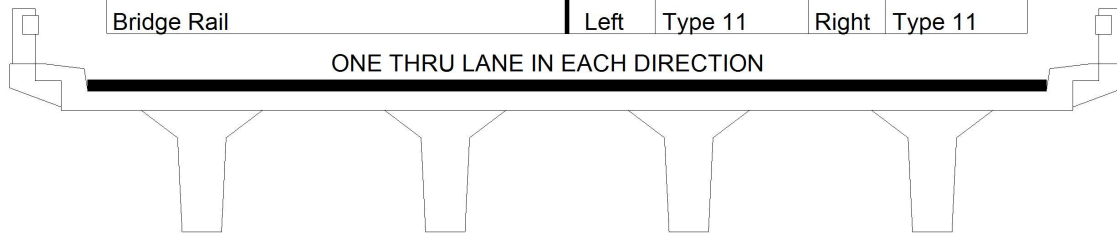
Measurements for Spans	1 thru 7		
Deck Thickness	0.563	Left Overhang	4.75
Top of Rail to Bottom of Beam	5.667	Right Overhang	4.75

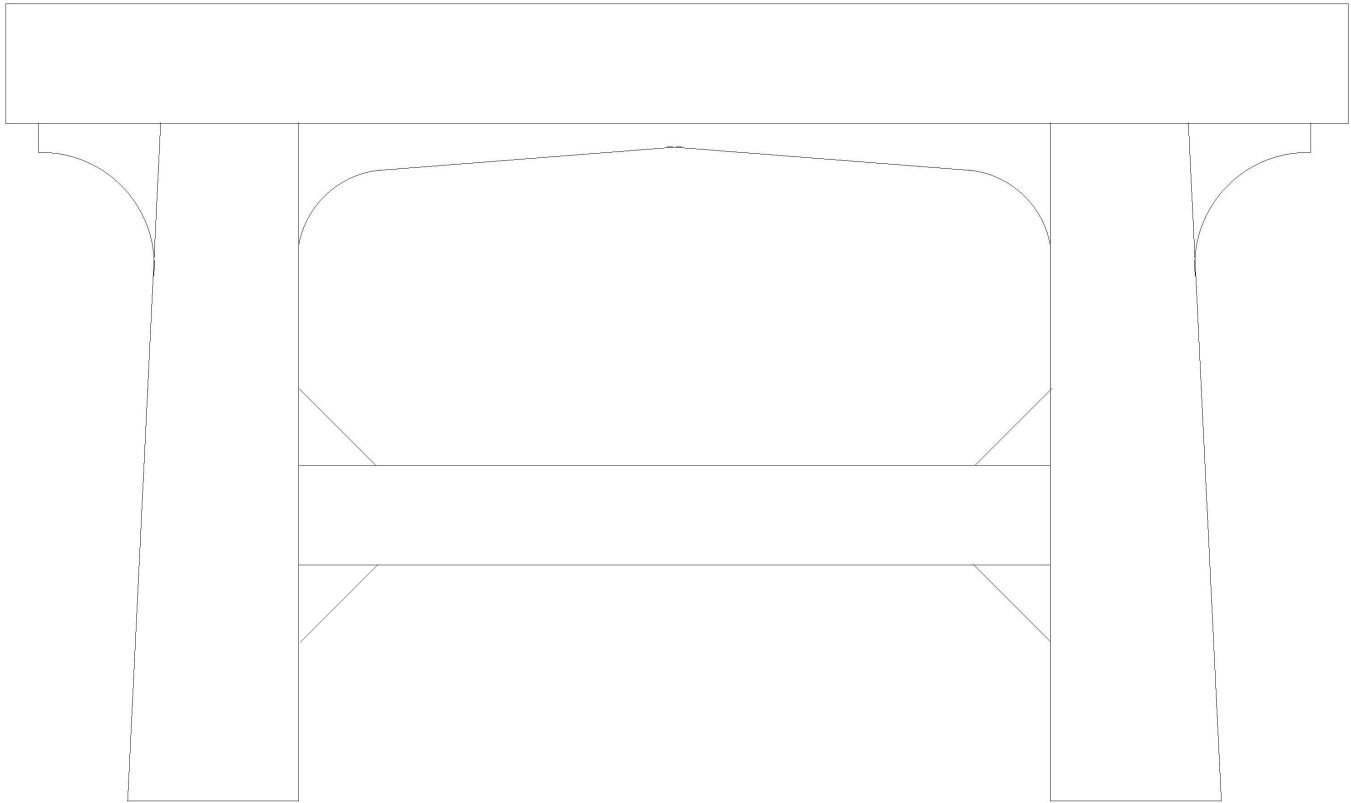
<b>Cap Information</b>			Material Cast-in-Place Concrete							
Length	Width	Height	Left Overhang	Right Overhang	Left Beam to End of Cap.	Right Beam to End of Cap.				
28.0 ft.	2.5 ft.	2.5 ft.	5.0 ft.	5.0 ft.	1.58 ft.	1.58 ft.				
<b>Subcap Information</b>			Material							
Length	Width	Height	Left Overhang	Right Overhang	Left Pile to Splice.					
<b>Sill Information</b>			Material							
Length	Width	Height								
<b>Pile #</b>	<b>Material</b>	<b>Spacing</b>	<b>Width/Dia.</b>	<b>Height</b>	<b>Length</b>	<b>Orientation</b>	<b>Driven?</b>	<b>Replacement?</b>	<b>Removed?</b>	<b>Collar?</b>
1	Concrete	18.0 ft.	2.5 ft.			Vertical	No	No	No	No
2	Concrete		2.5 ft.			Vertical	No	No	No	No
<b>Bent: 1</b>			Similar Bents: 2 thru 6
