PROJECT NO. I-5927 POLK COUNTY BRIDGE NO. 740023

DEPARTMENT OF TRANSPORTATION

STATE OF NORTH CAROLINA

BEAM REPAIR LOCATIONS

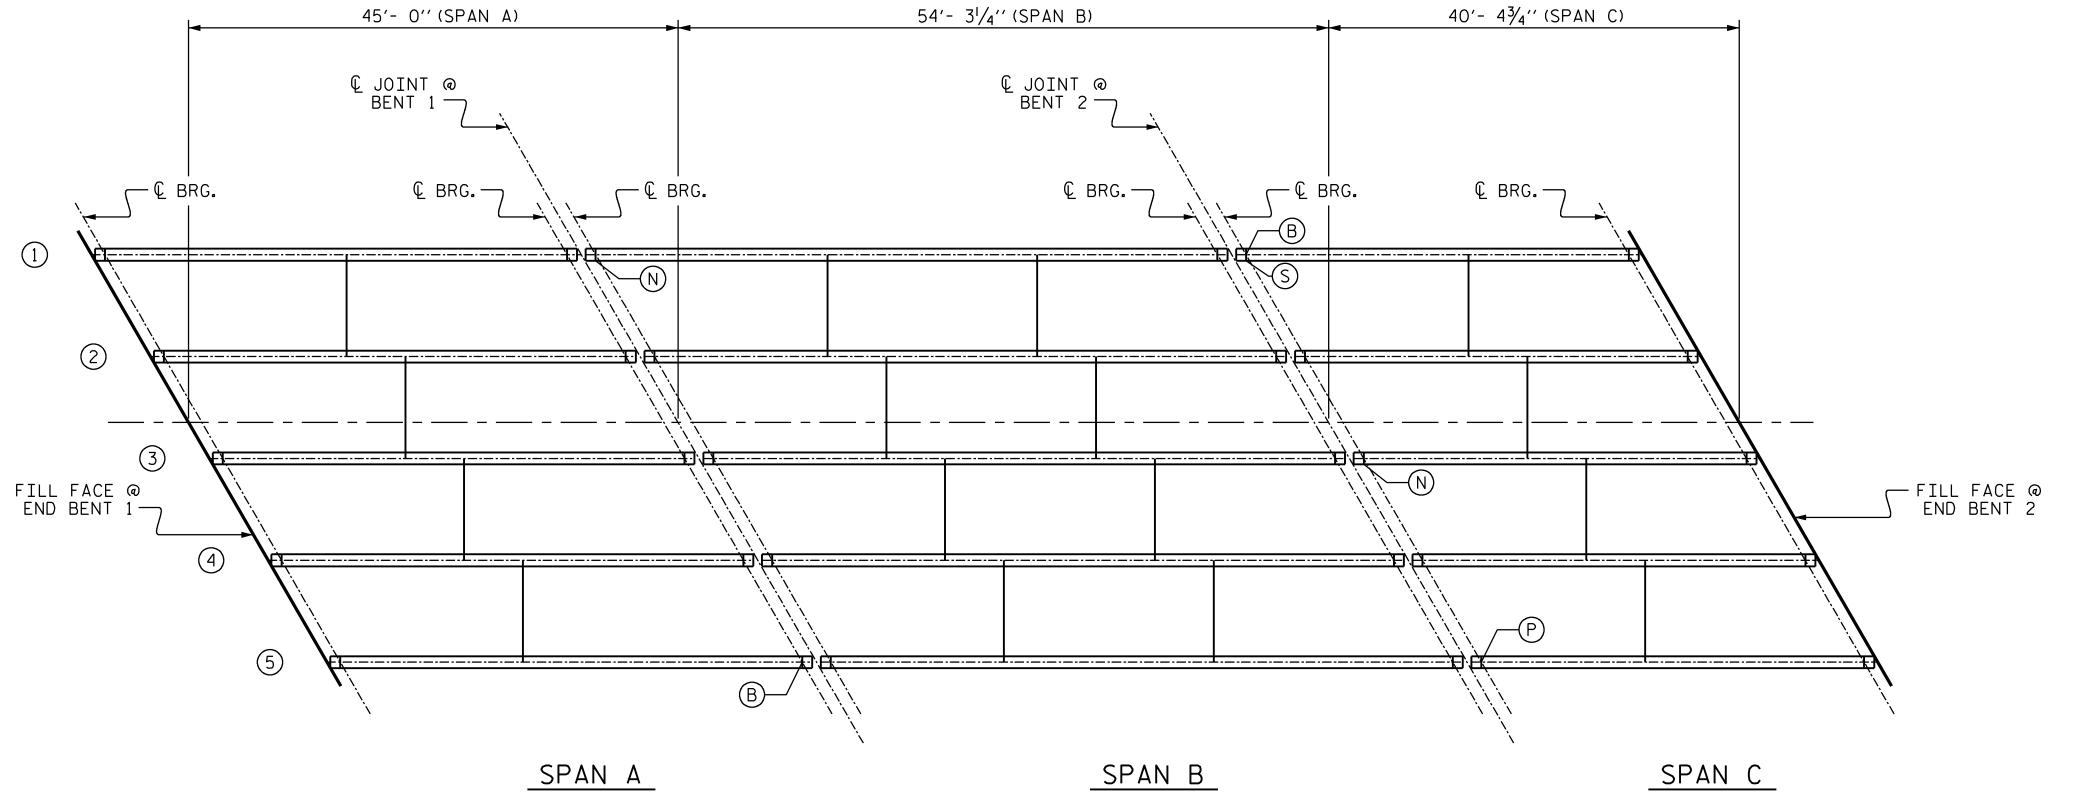
ANTICIPATED BEAM REPAIR LOCATIONS LOCATION DIM 'A' DIM 'B' DIM 'C' DIM 'D' SPAN BEAM TYPE BENT 1 BENT 2 7" 50" BENT 2 7" 16" 4" BENT 2

* PLATE REPAIR IS AT TOP OF WEB

FOR BEAM PLATE REPAIRS, SEE "BEAM REPAIR PLATING DETAILS" SHEET.

FOR BEAM CUT-OUT REPAIRS, SEE "BEAM REPAIR CUT-OUT DETAILS" SHEET.
