NC DEPARTMENT OF TRANSPORTATION  
 DIVISION OF HIGHWAYS  
 STRUCTURE MANAGEMENT UNIT

ATTENTION: **PAR Submitted, Newly structure deficient, Change to structure data**

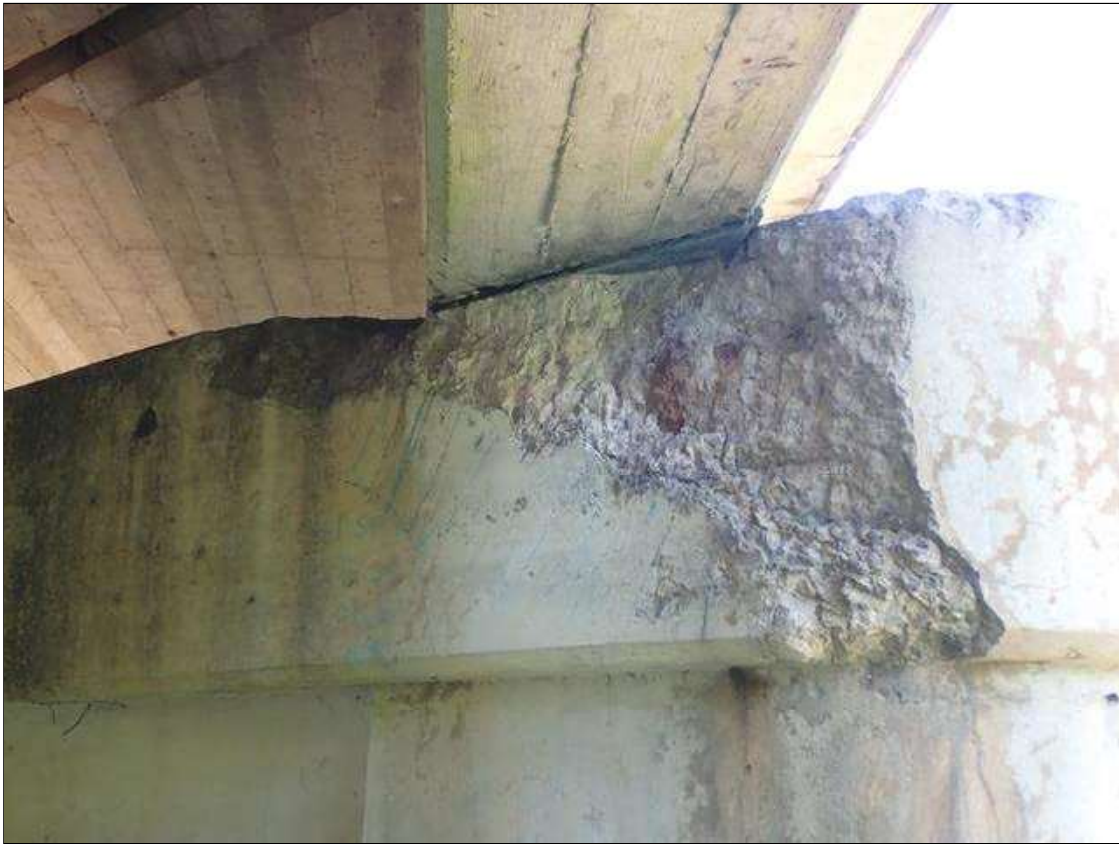
Bent 1 Cap 1: [PAR] SOUTH FACE AT GIRDER 4, SPALLING WITH EXPOSED REBAR [5' x up to full height x up to 8' deep] WITH APPROXIMATELY 20% LOSS OF BEARING AREA, NO MEASURABLE SECTION LOSS

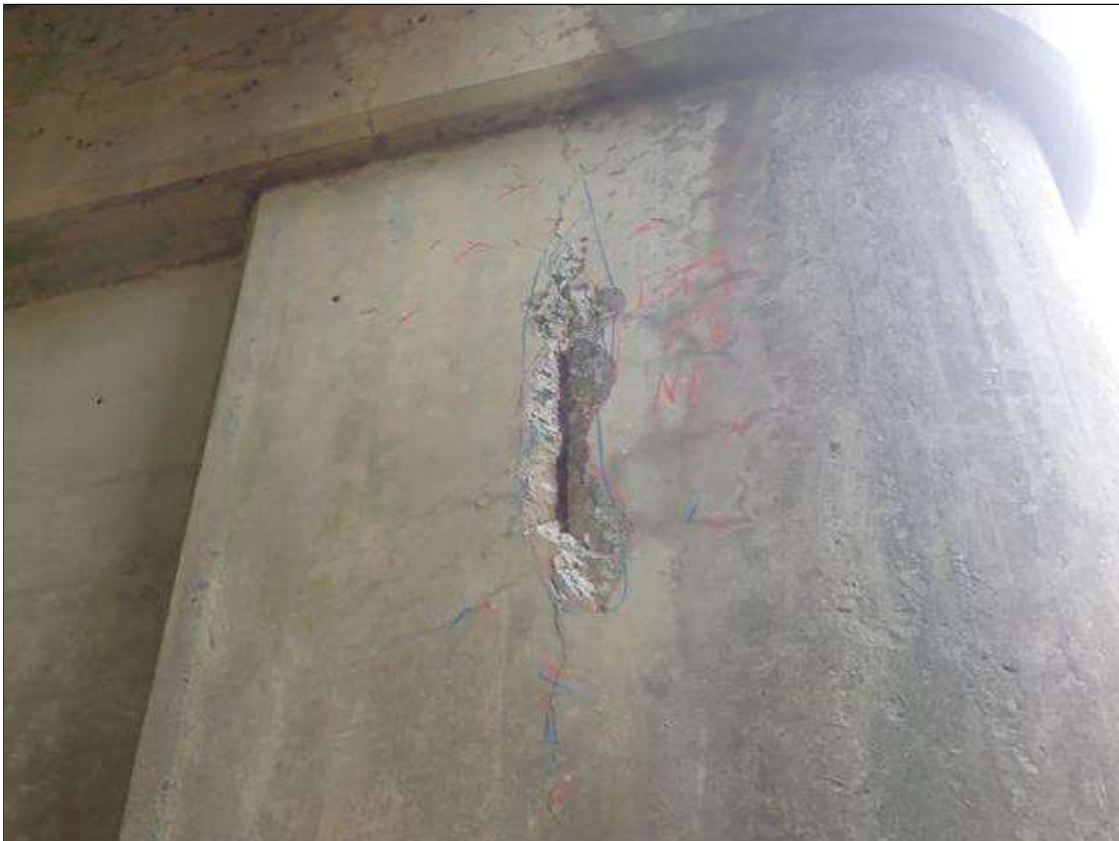
Bent 1 Pile 1: [PAR] North face, approximately 3' below cap, spall [32" x 4" x 1" deep] with exposed rusted reinforcing with no measurable section loss

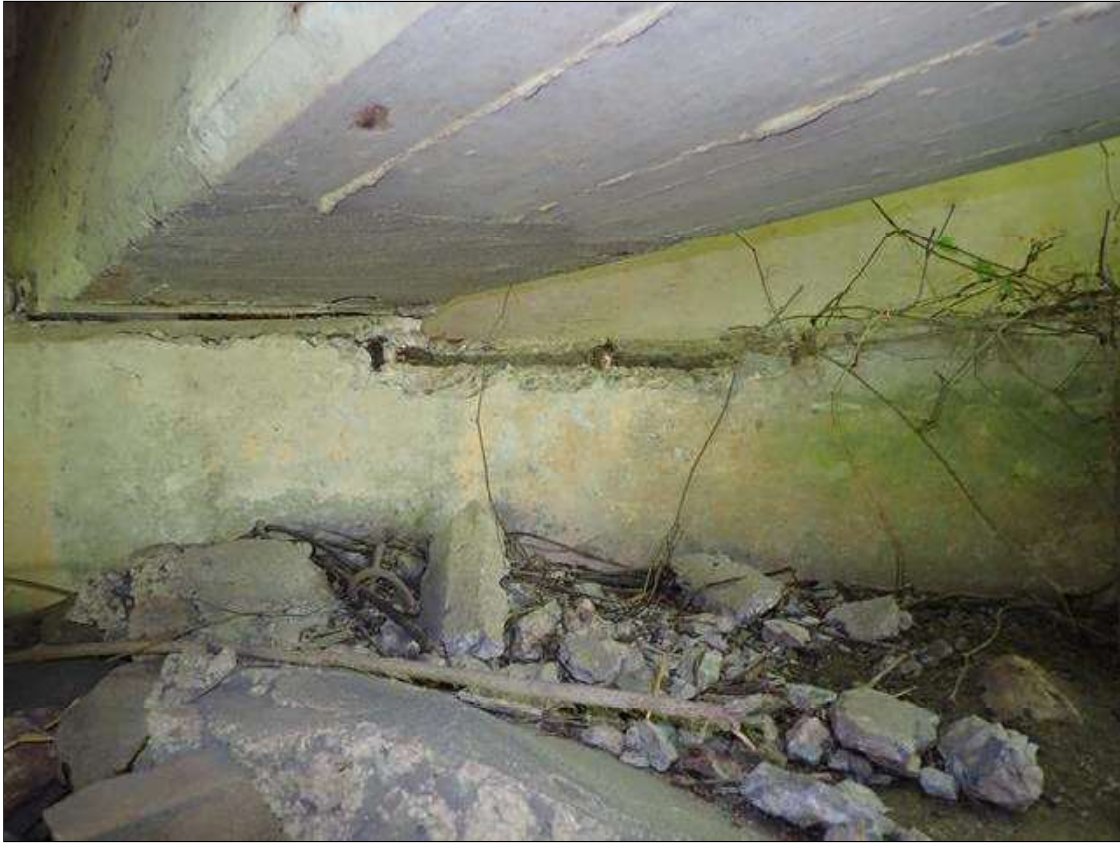
End Bent 1 Cap 1: [PAR] LEFT OUTBOARD END AT THE TOP EXTENDING TO GIRDER 1, SPALLING WITH EXPOSED REBAR, DELAMINATION AND HORIZONTAL CRACKING TO 1/4" WIDE [APPROXIMATELY 3' LONG X UP TO 1' WIDE X UP TO 3" DEEP] WITH FLAKING RUST AND PITTING UP TO 1/16" DEEP, APPROXIMATELY 5% LOSS OF BEARING AREA

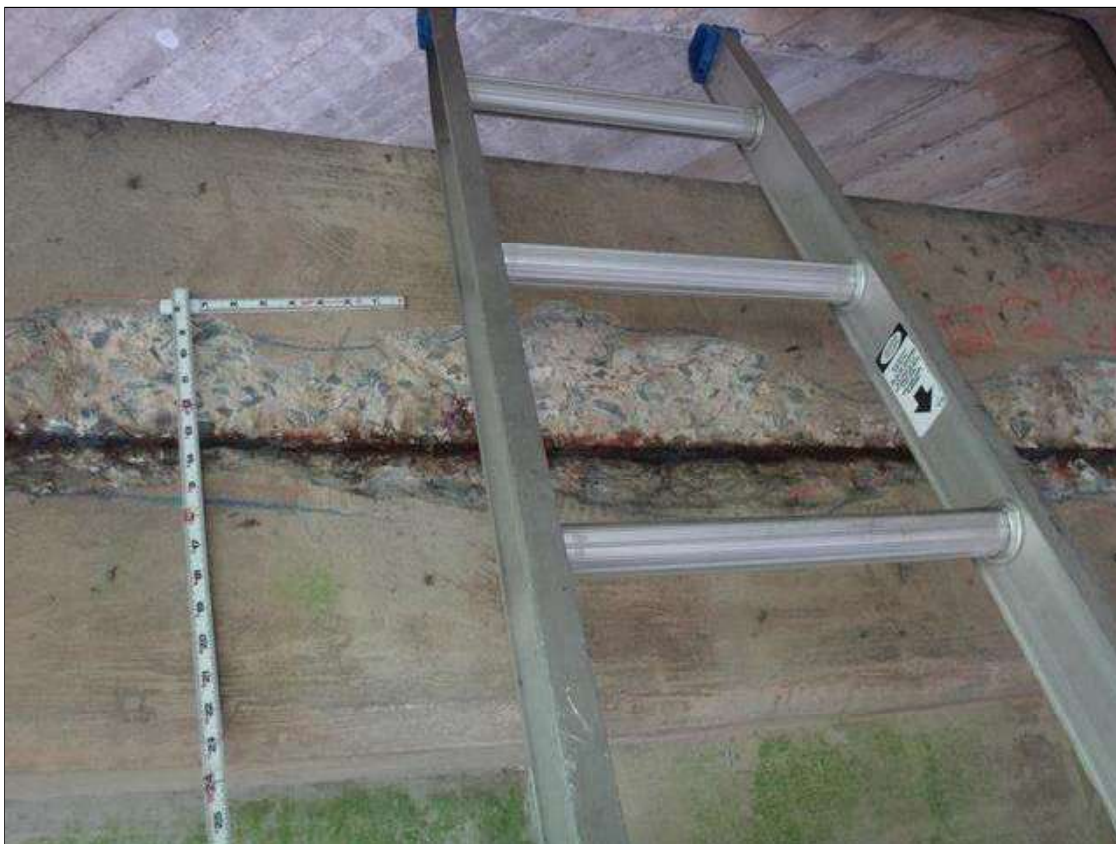
Bent 2 Cap 1: [PAR] north face at bay 2, spall (5' x 10" x 1.75") with exposed rusted rebar [section loss up to 1/8"]

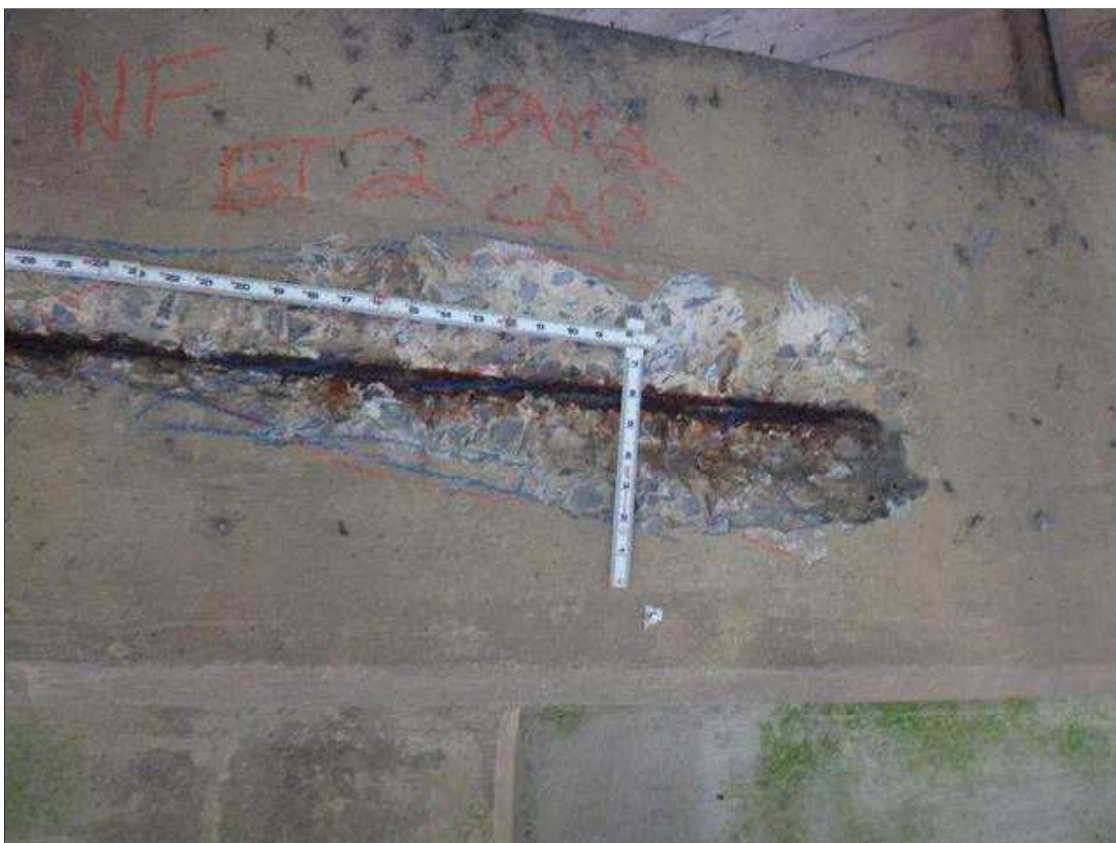
Bent 2 Cap 1: [PAR] north face at bay 2, spall (5' x 10" x 1.75") with exposed rusted rebar [section loss up to 1/8"]

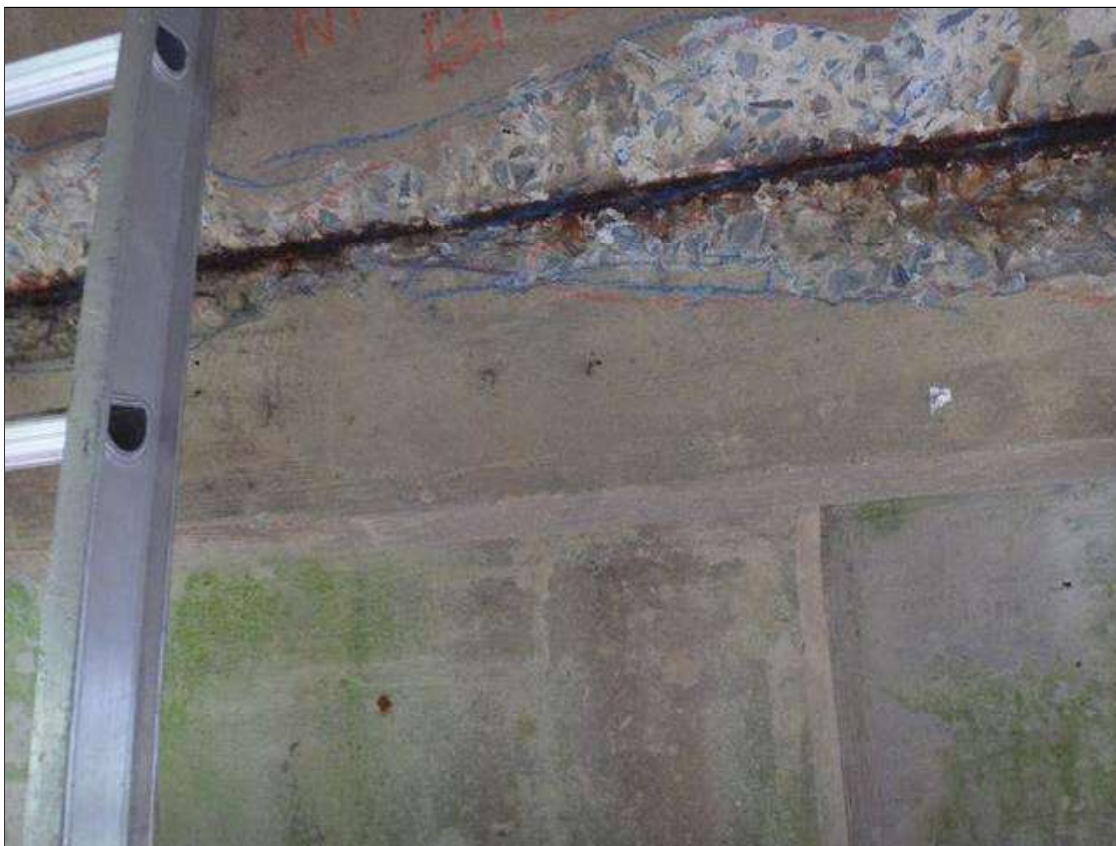
Bent 2 Cap 1: [PAR] north face at bay 2, spall (5' x 10" x 1.75") with exposed rusted rebar [section loss up to 1/8"]

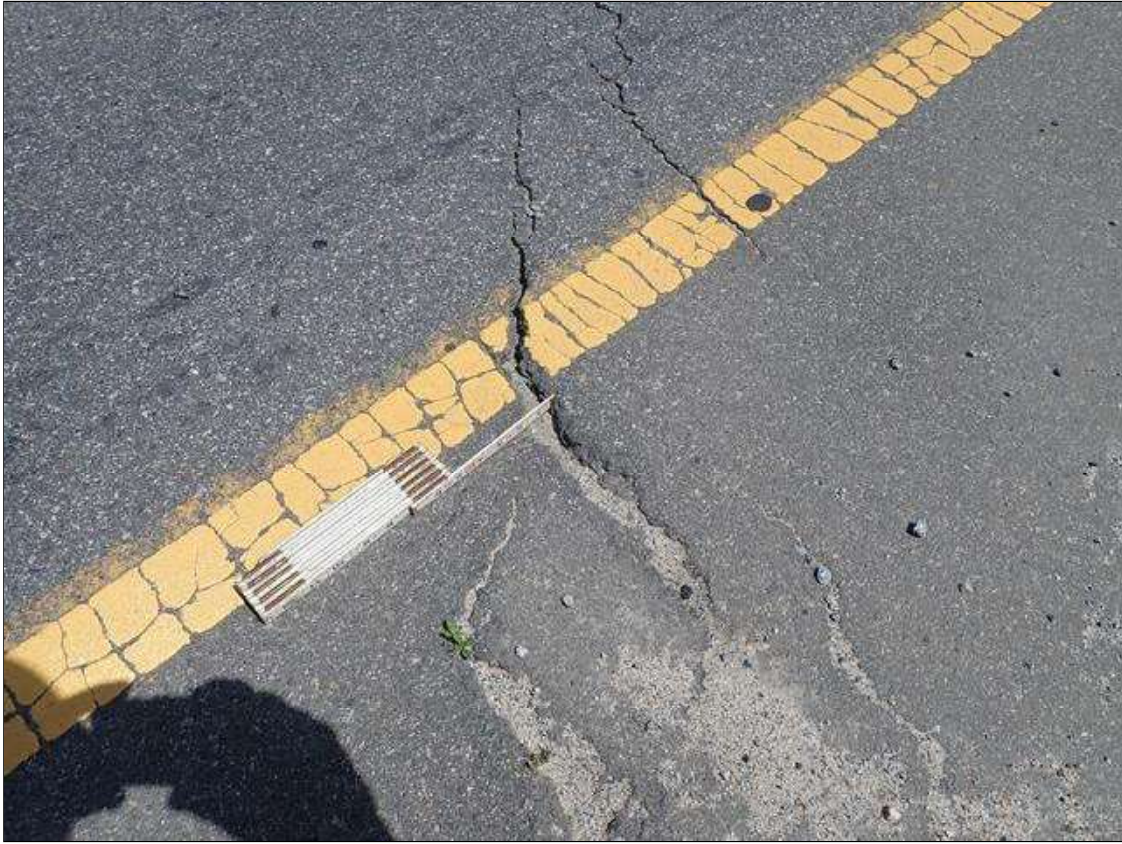
Span 1 Wearing Surface: AT THE SPAN ENDS, SCATTERED TRANSVERSE CRACKING UP TO 1" WIDE

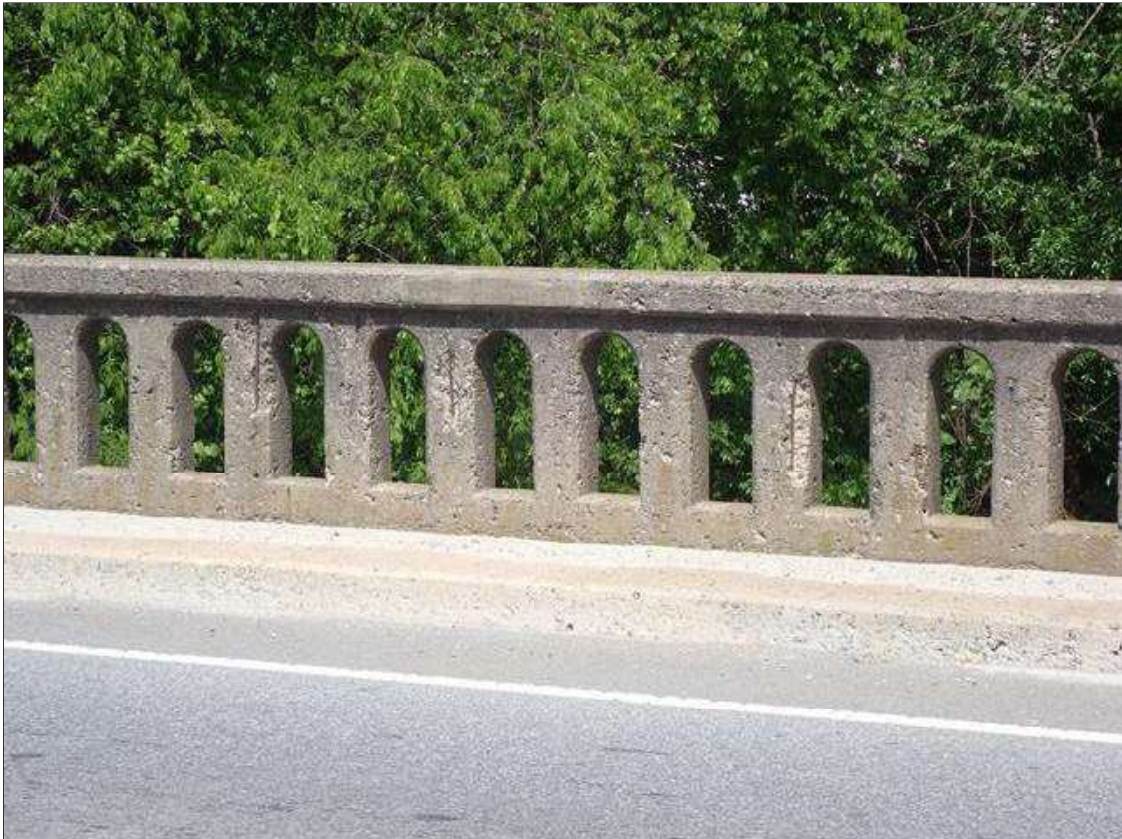
Span 1 Right Bridge Rail: near bent 1, (3) spalls (up to 15" x 5" x 1") with exposed rusted rebar, [loss up to 1/8"]

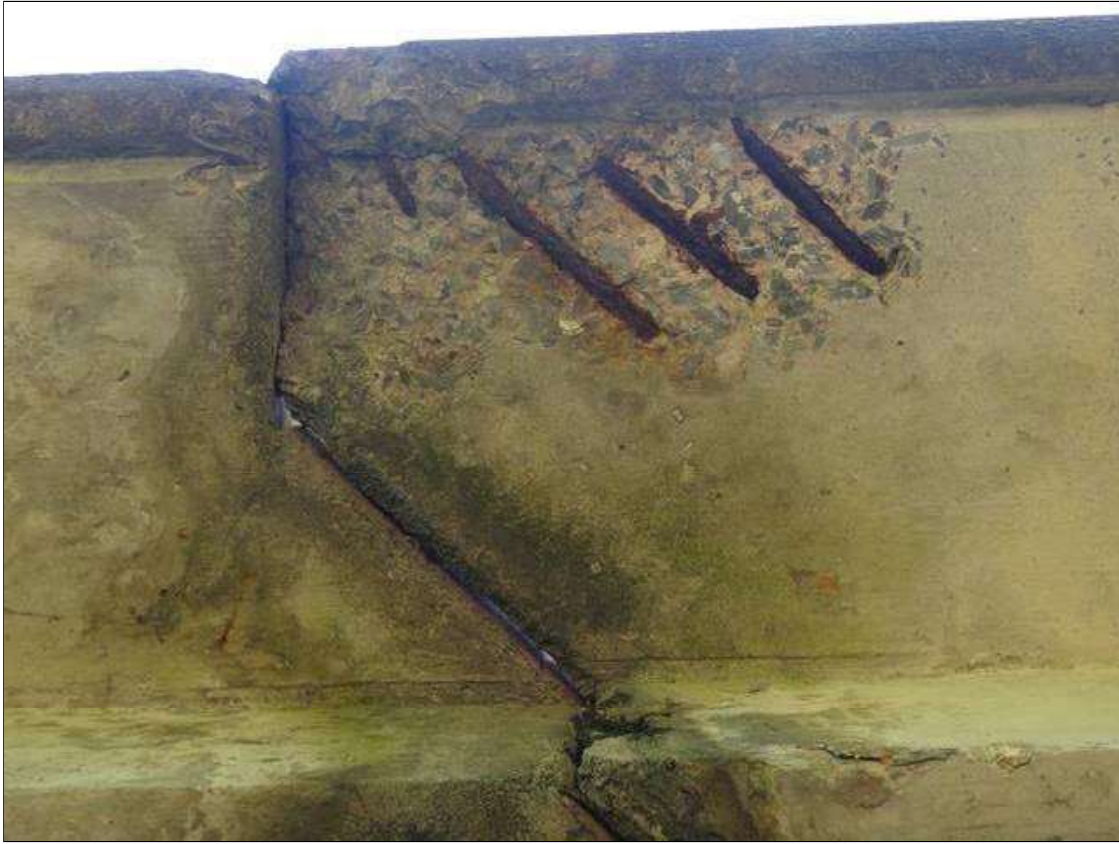
Span 2 Deck: underside east overhang at bent 1, spalls (up to 1' x 8" x 1") with exposed rusted rebar, NO MEASURABLE SECTION LOSS

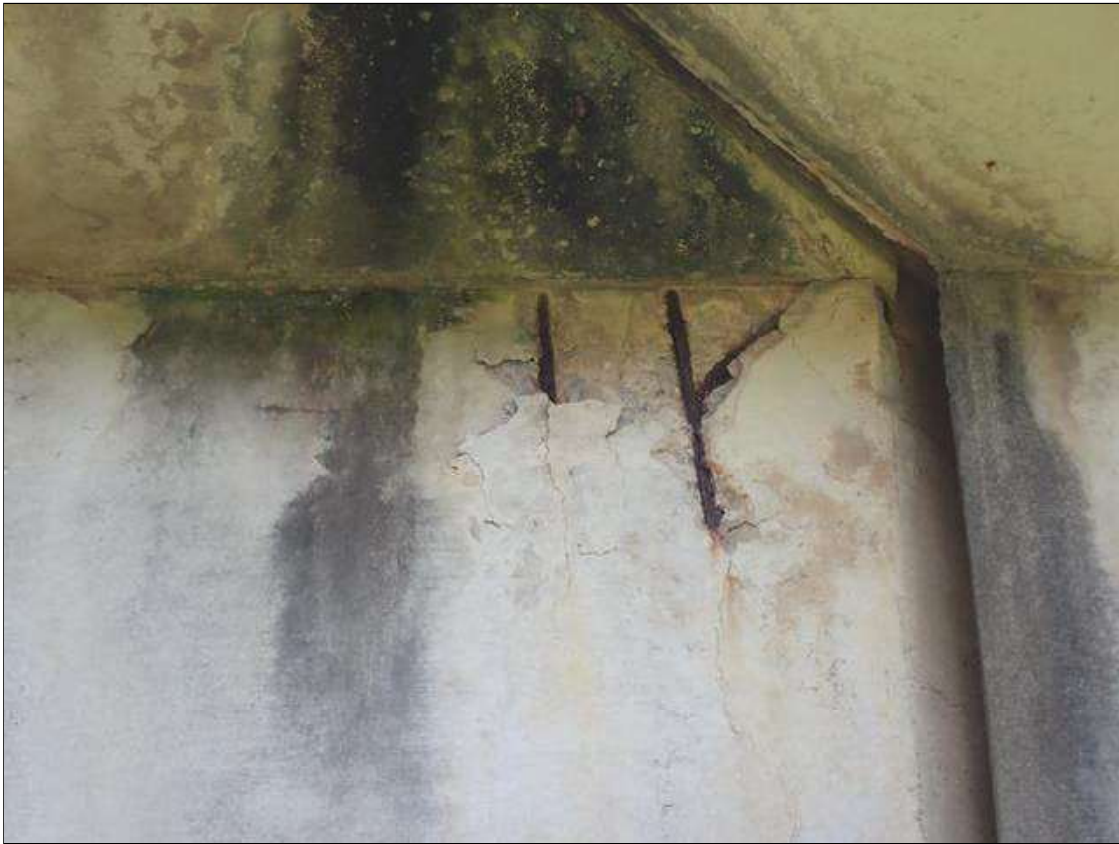
Span 2 Beam 1: GIRDER END AT BENT 1, LEFT SIDE AT THE TOP, SPALL WITH EXPOSED REBAR [APPROXIMATELY 18" DIAMETER X UP TO 3/4" DEEP], NO MEASURABLE SECTION LOSS. adjacent delamination [2' x up to 18" high]

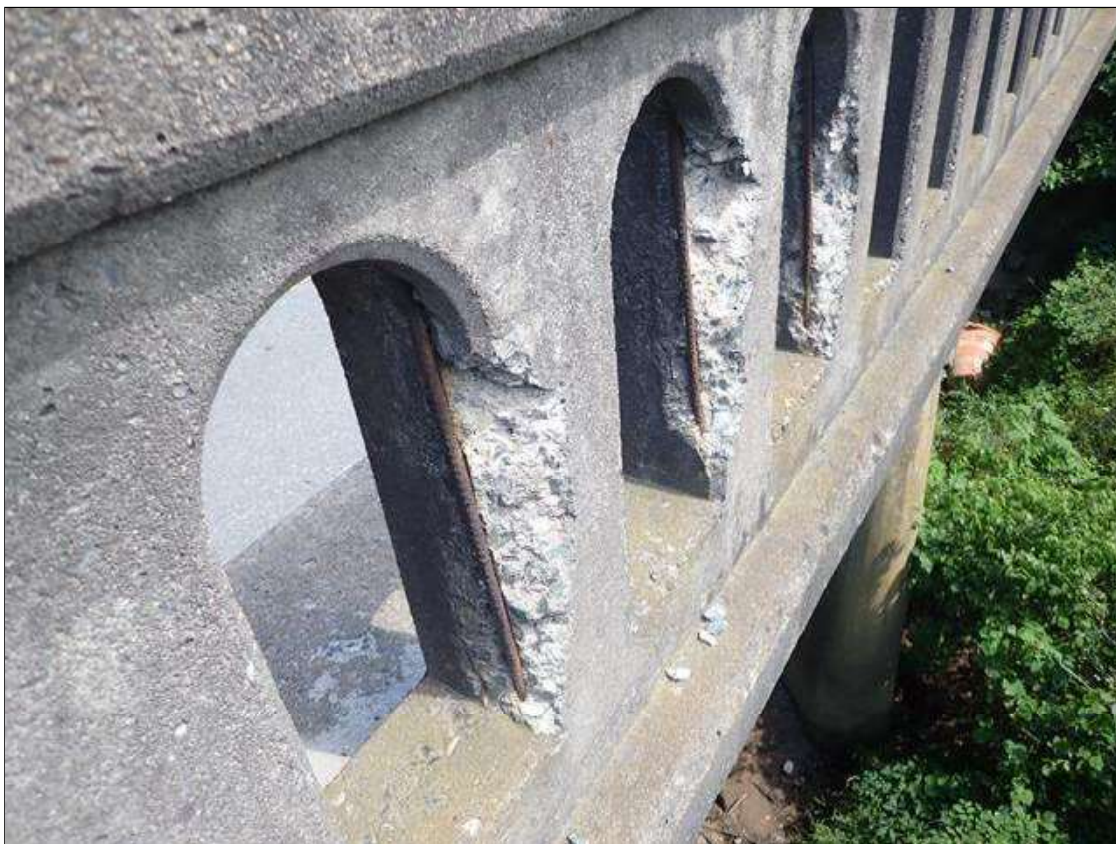
Span 2 Left Bridge Rail: exterior face at 13ft from bent 1, (3) spalls (up to 15" x 4" x 1") with exposed rusted rebar, NO MEASURABLE SECTION LOSS

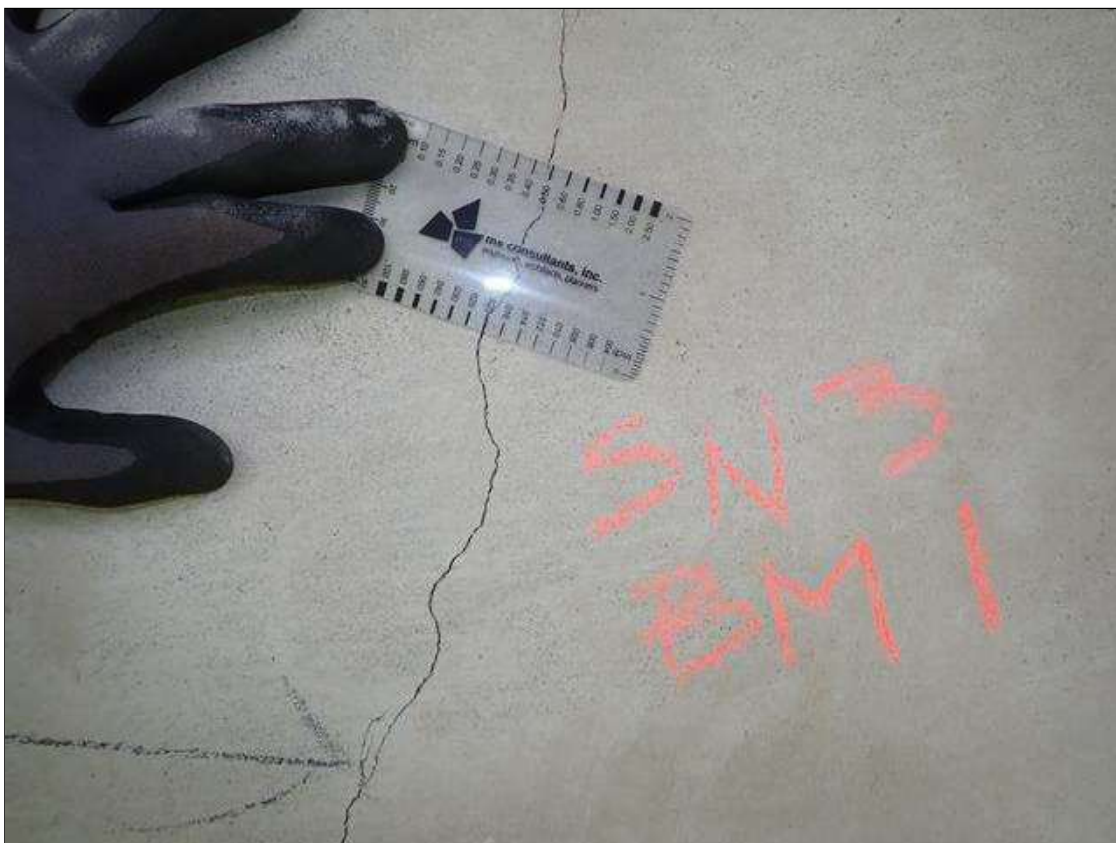
Span 3 Beam 1: along exterior face multiple vertical and diagonal cracks (full height x 0.02")

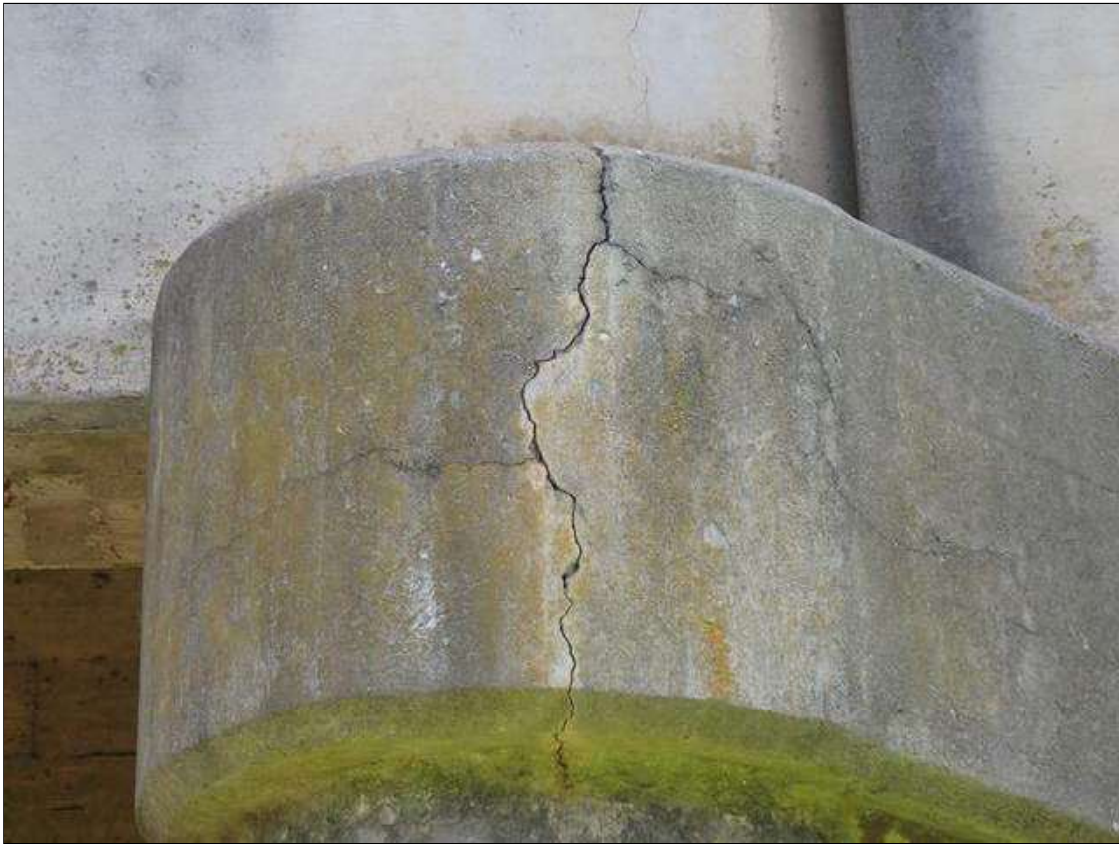
Bent 1 Cap 1: east face, map cracking (full height x full width x 1/8")

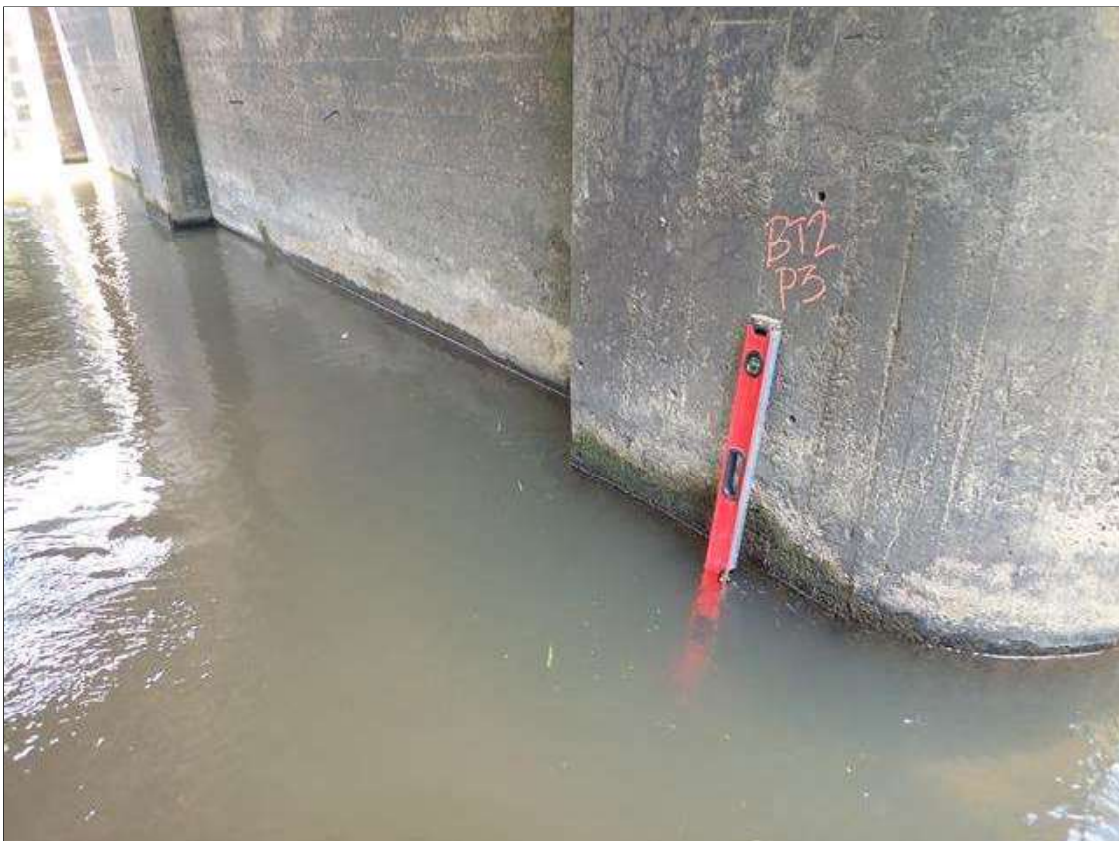
bent 2 near face from pile 2 to pile 3, localized scour along face [25' long x up to 6' wide x up to 2' deep]

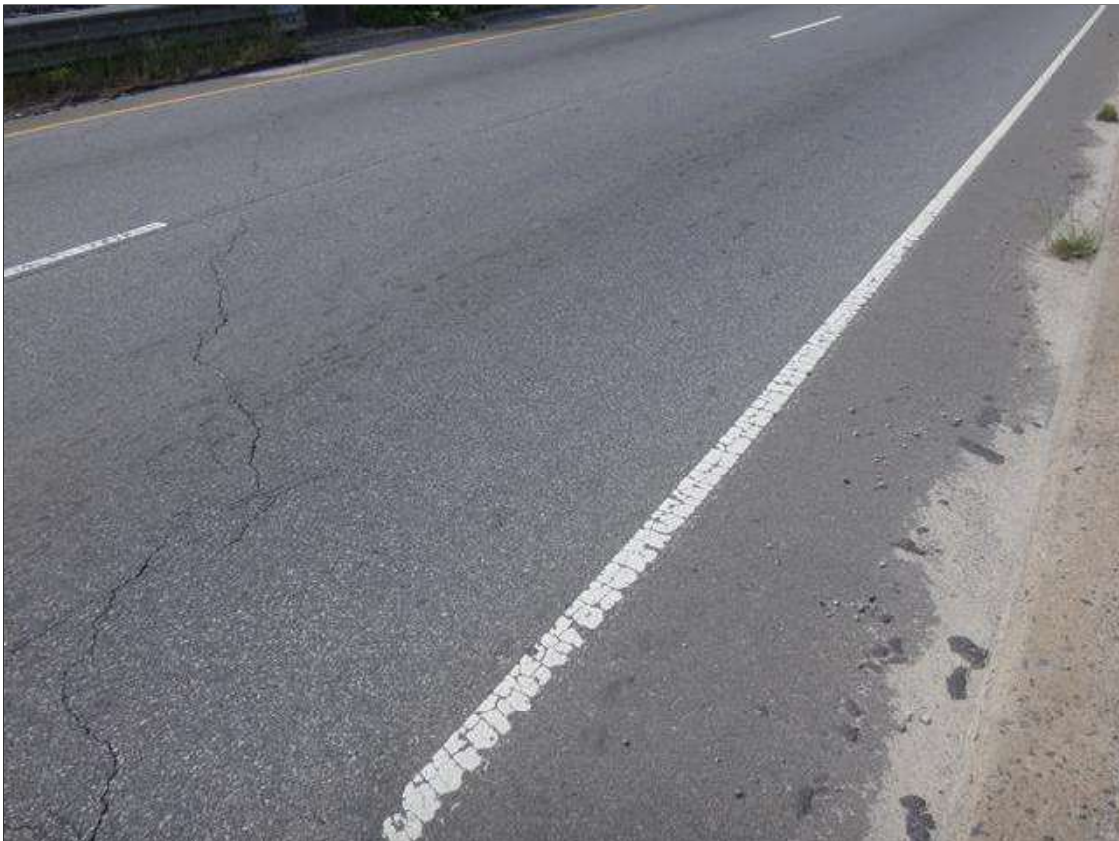
typical asphalt wearing surface

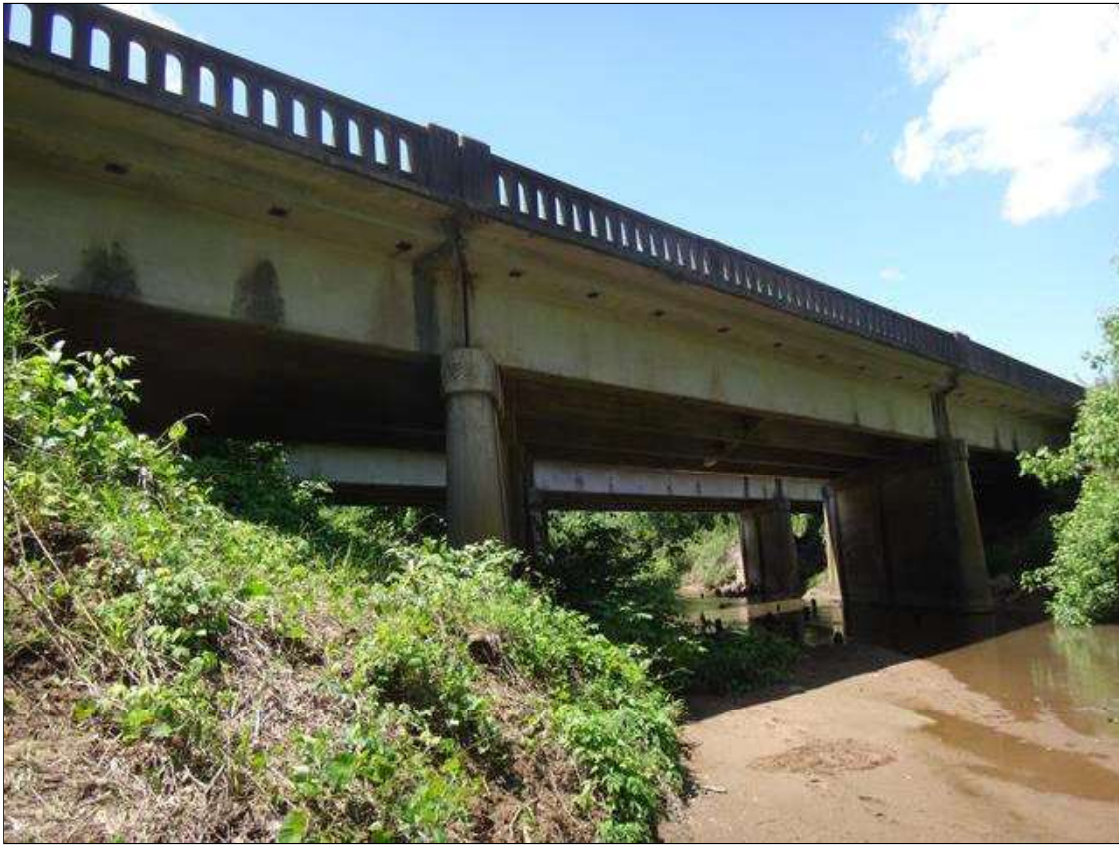
profile looking West

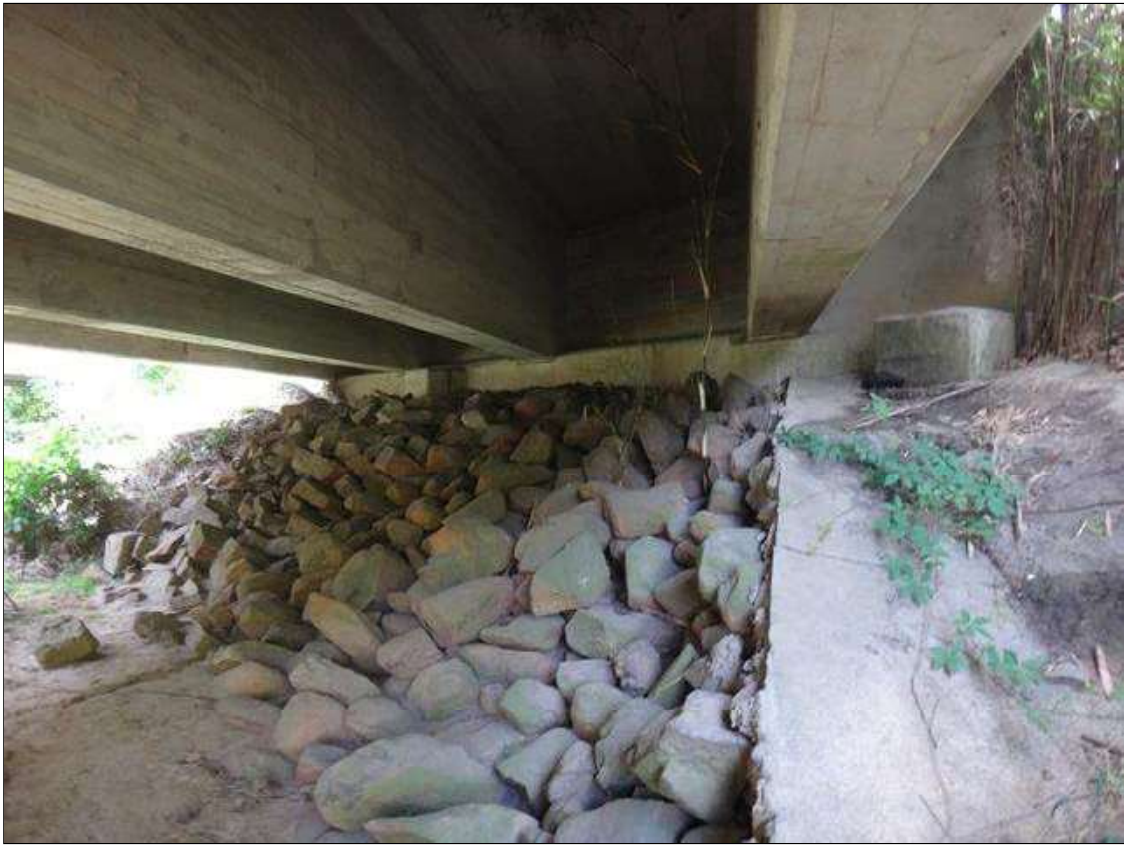
asphalt over end bent 2

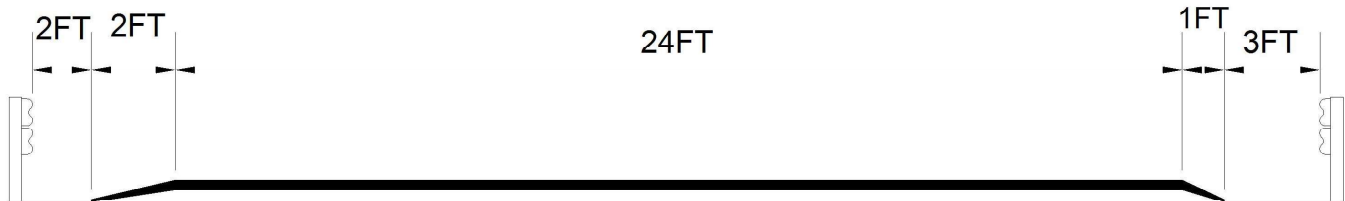
Roadway	24ft Wide	2 Paved Lanes	Looking North
Left Shoulder	4ft Wide	2ft Paved	2ft Unpaved
Right Shoulder	4ft Wide	1ft Paved	3ft Unpaved
Left Guardrail	4ft from road		
Right Guardrail	4ft from road

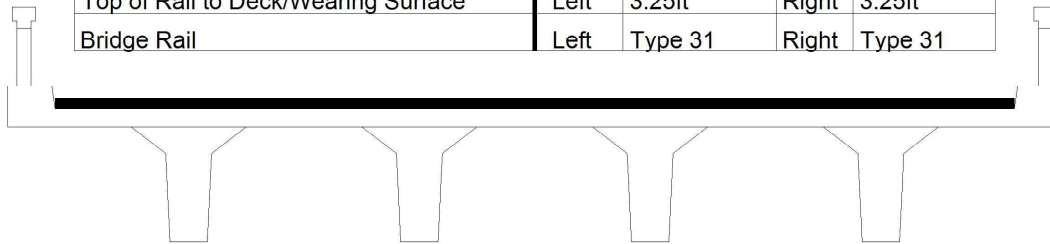
Measurements for Span #	1	SPANS 2 AND 3 SIMILAR	
Deck Thickness	0.542	Left Overhang	4.625
Top of Rail to Bottom of Beam	8.9	Right Overhang	4.625

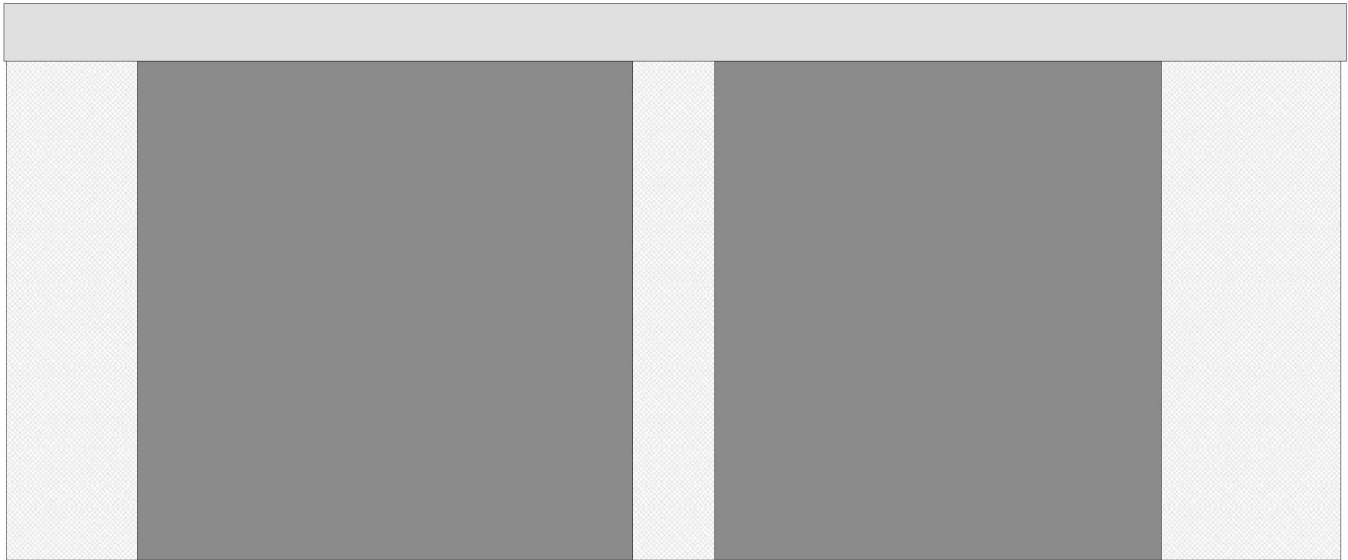
<b>Cap Information</b>			Material Cast-in-Place Concrete							
Length	Width	Height	Left Overhang	Right Overhang	Left Beam to End of Cap.	Right Beam to End of Cap.				
41.083 ft.	2.500 ft.	1.750 ft.	2.125 ft.	2.875 ft.	3.417 ft.	3.417 ft.				
<b>Subcap Information</b>			Material							
Length	Width	Height	Left Overhang	Right Overhang	Left Pile to Splice.					
<b>Sill Information</b>			Material							
Length	Width	Height								
<b>Pile #</b>	<b>Material</b>	<b>Spacing</b>	<b>Width/Dia.</b>	<b>Height</b>	<b>Length</b>	<b>Orientation</b>	<b>Driven?</b>	<b>Replacement?</b>	<b>Removed?</b>	<b>Collar?</b>
1	Concrete	18.417 ft.	4 ft.	2 ft.		Vertical	No	No	No	No
2	Concrete	17.667 ft.	2.5 ft.	2 ft.		Vertical	No	No	No	No
3	Concrete		5.5 ft.	2 ft.		Vertical	No	No	No	No
VERIFIED: TDG 5/5/21										
Bent/Abutment #: 1			Similar Bents: 2
