NC DEPARTMENT OF TRANSPORTATION
 DIVISION OF HIGHWAYS
 STRUCTURE MANAGEMENT UNIT

ATTENTION: **CHANGE TO STRUCTURE DATA, PAR SUBMITTED, REQUEST LIDAR, NEWLY STRUCTURALLY DEFICIENT**

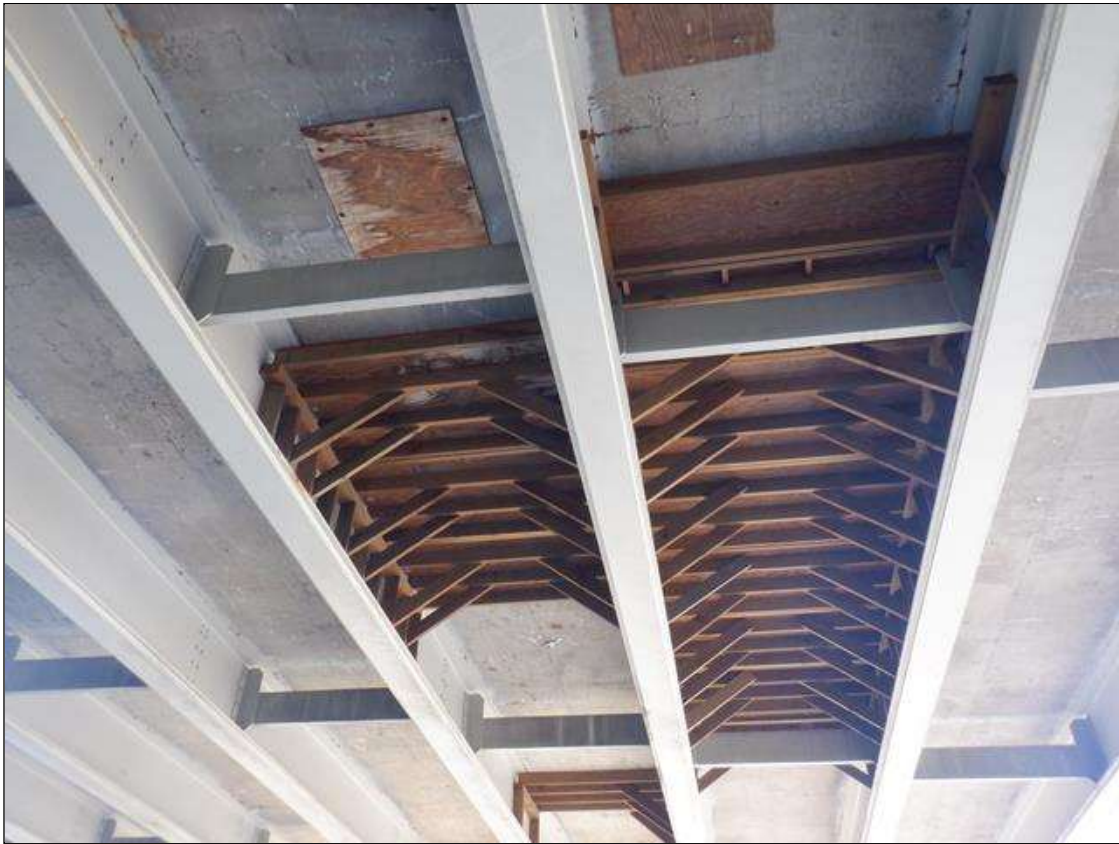
Span 3 Deck: IN BAYS 2 AND 3, SCATTERED FORMWORK LEFT IN PLACE

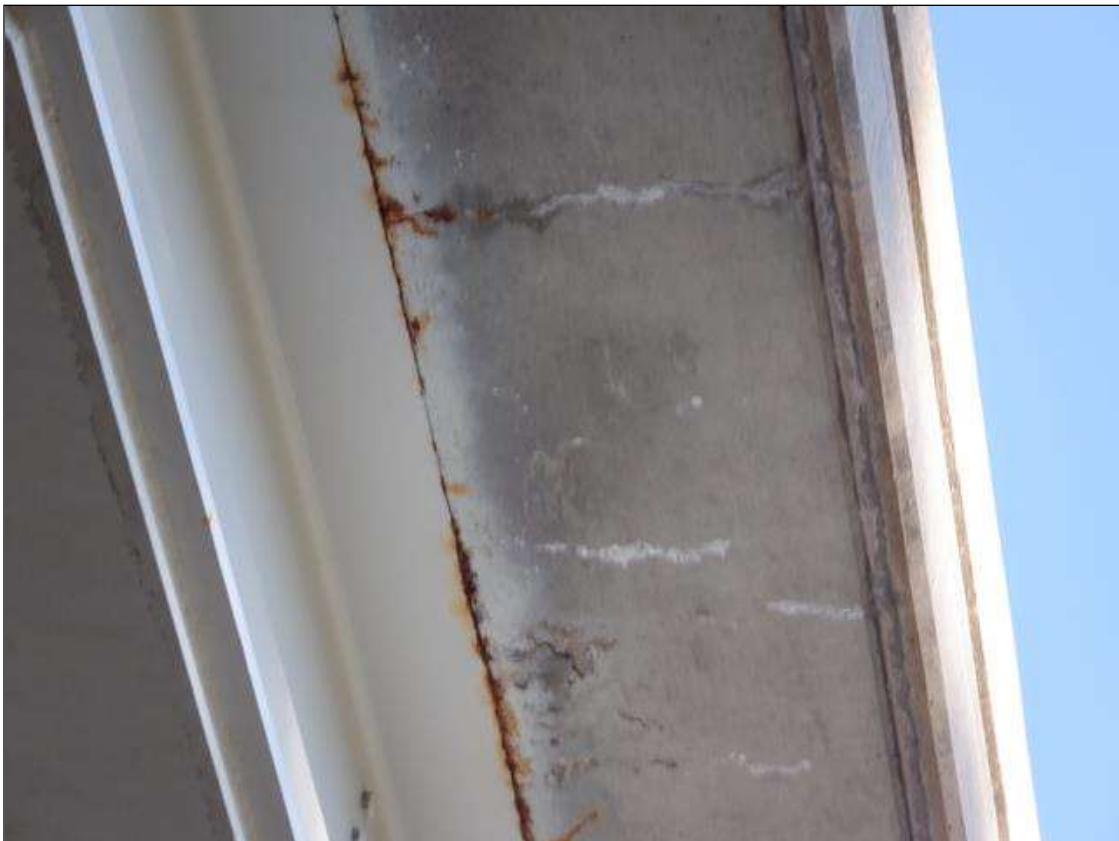
Span 3 Deck: SCATTERED THROUGHOUT BOTH OVERHANGS, HAIRLINE TRANSVERSE CRACKS WITH EFFLORESCENCE

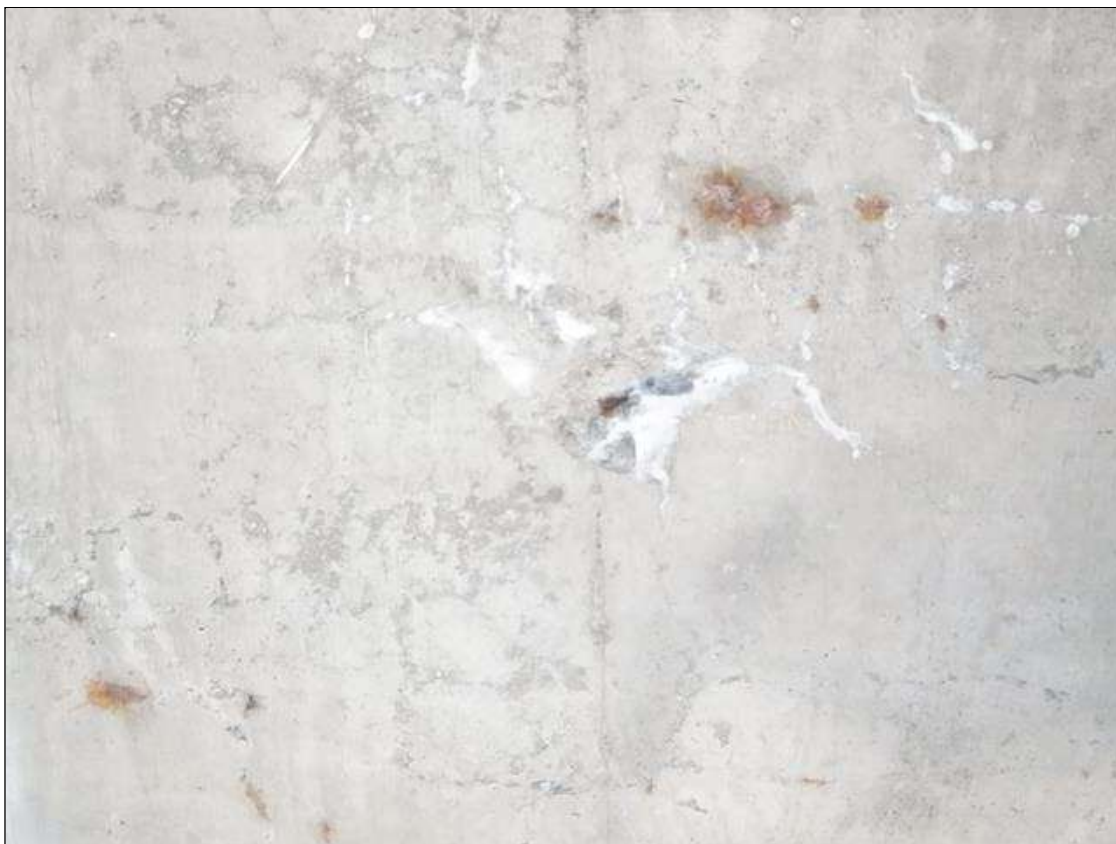
Span 3 Deck: PAR: 10 INCH DIAMETER X 1 INCH DEEP SPALL WITH EXPOSED REBAR, 5 PERCENT SECTION LOSS, IN UNDERSIDE BAY 3 AT 3 FEET PAST CENTER DIAPHRAGM, NO SECTION LOSS

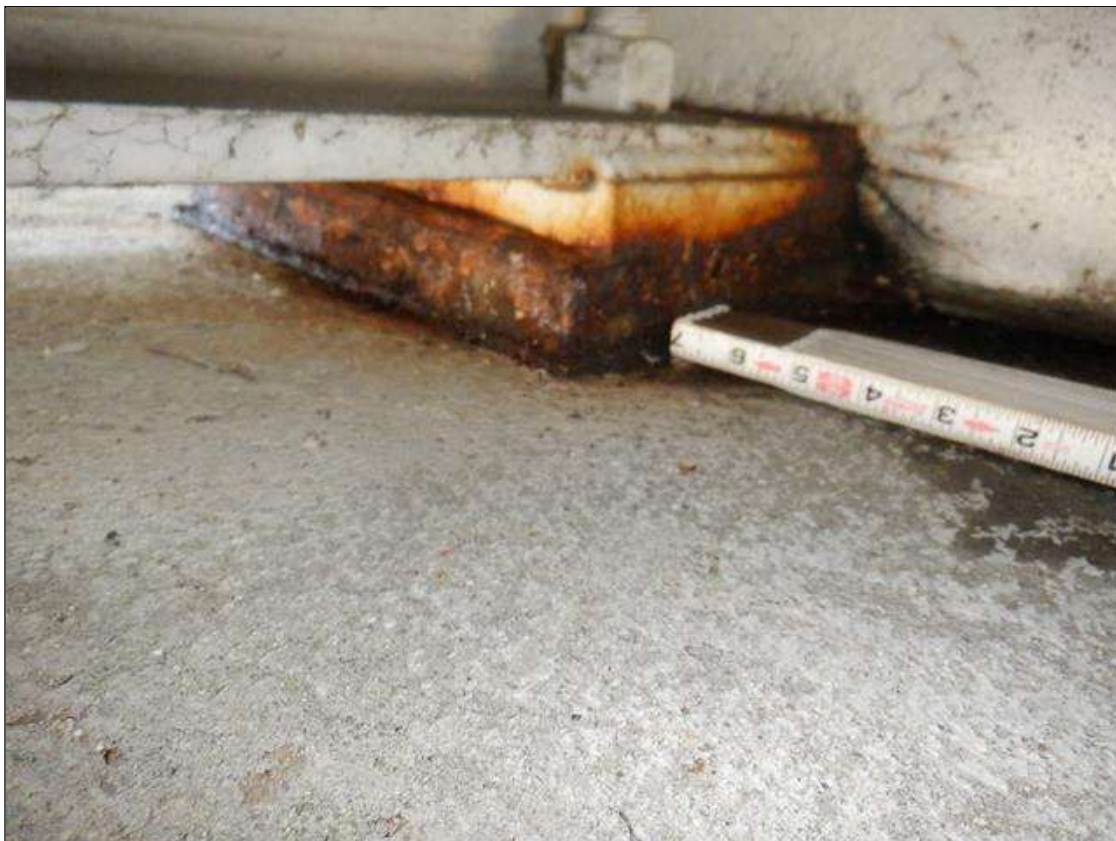
Span 4 Beam 1 - Far Bearing: CORROSION WITH PACK RUST, NO SECTION LOSS

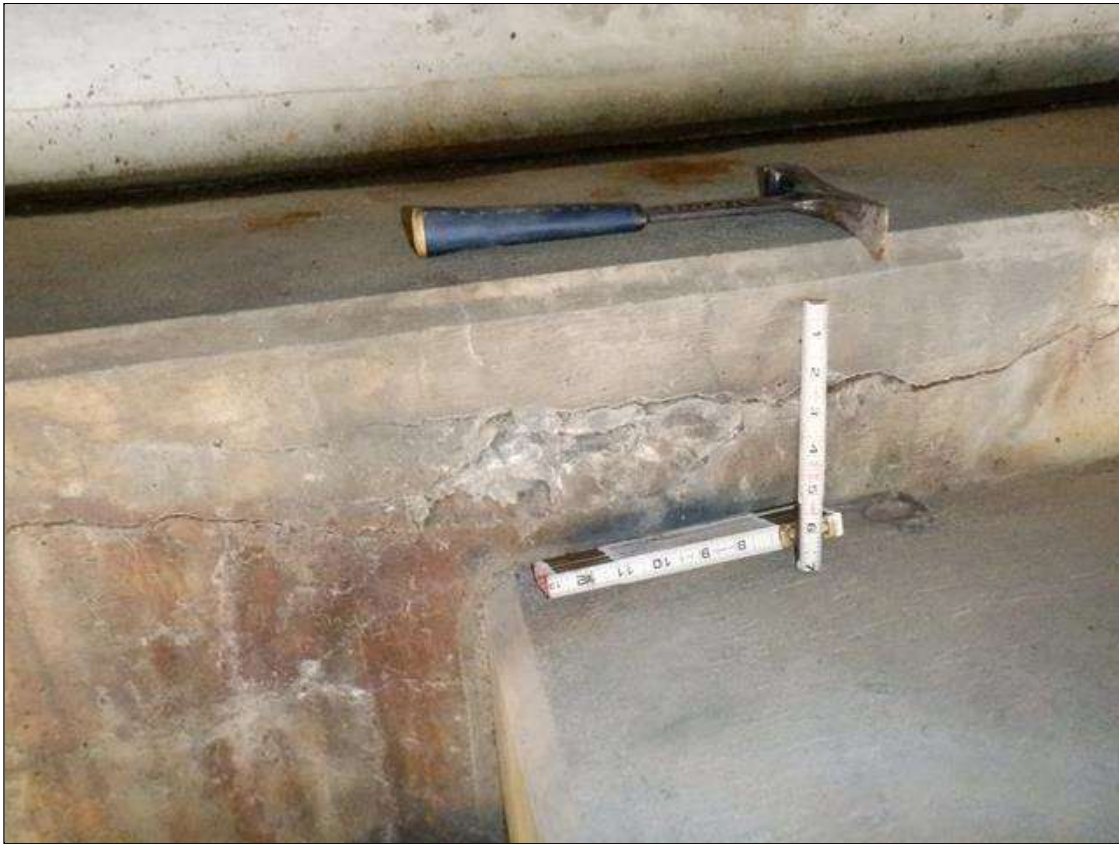
End Bent 2 Cap 1: 6 FEET LONG X 8 INCH HIGH DELAMINATION WITH RUST STAINING IN FACE OF CAP BELOW BAY 1 AND BAY 3 WITH 12 INCH X 3 INCH X 1/2 INCH DEEP SPALL BELOW BAY 3, NO EXPOSED REINFORCEMENT

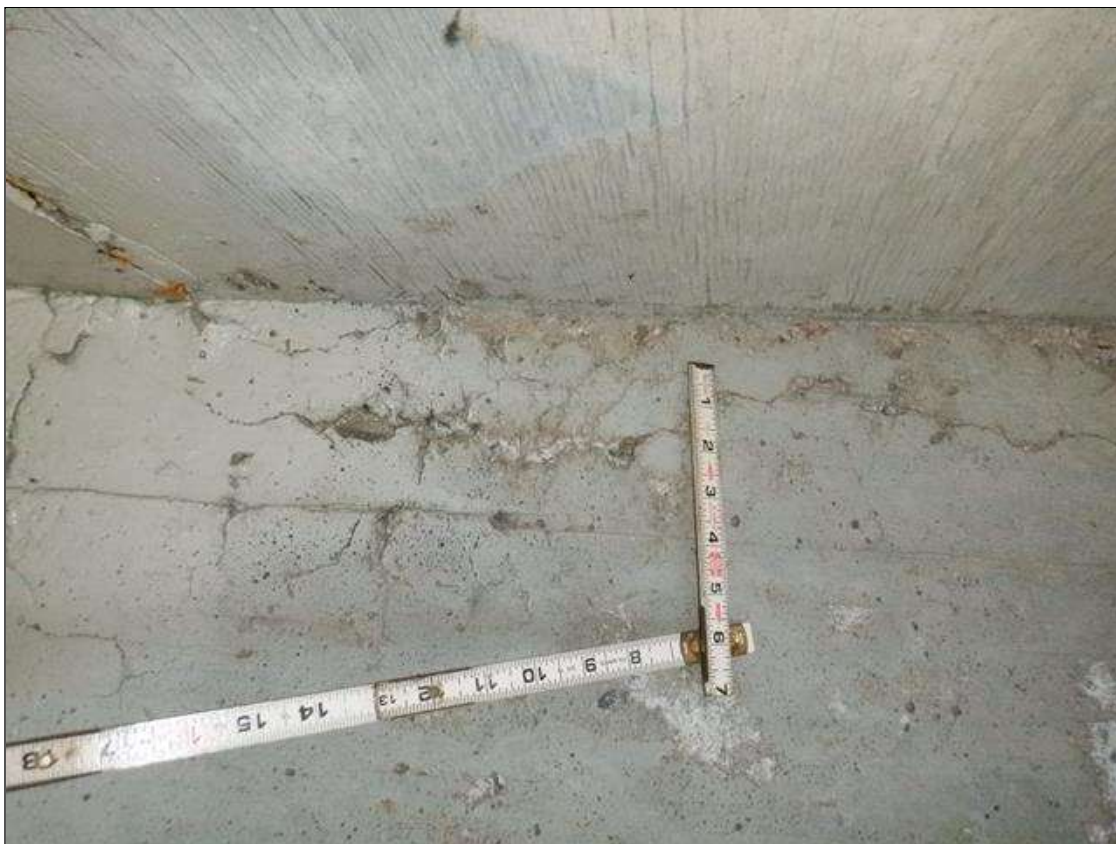
End Bent 2 Abutment: SCATTERED HAIRLINE MAP CRACKING IN BACKWALL OF BAY 3 AND BAY 4, FULL WIDTH X UP TO 2 FEET HIGH

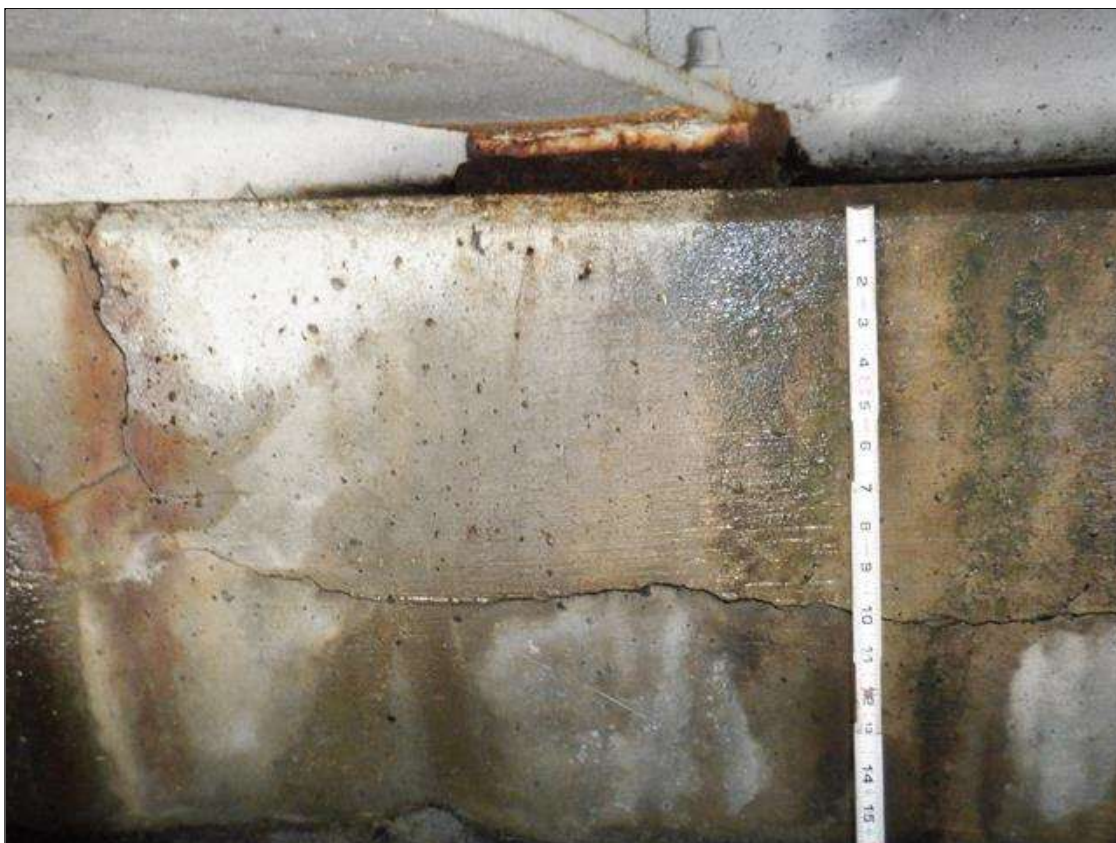
End Bent 2 Cap 1: BEAM 2 BEARING SEAT IS DELAMINATED FOR 1 FOOT LONG

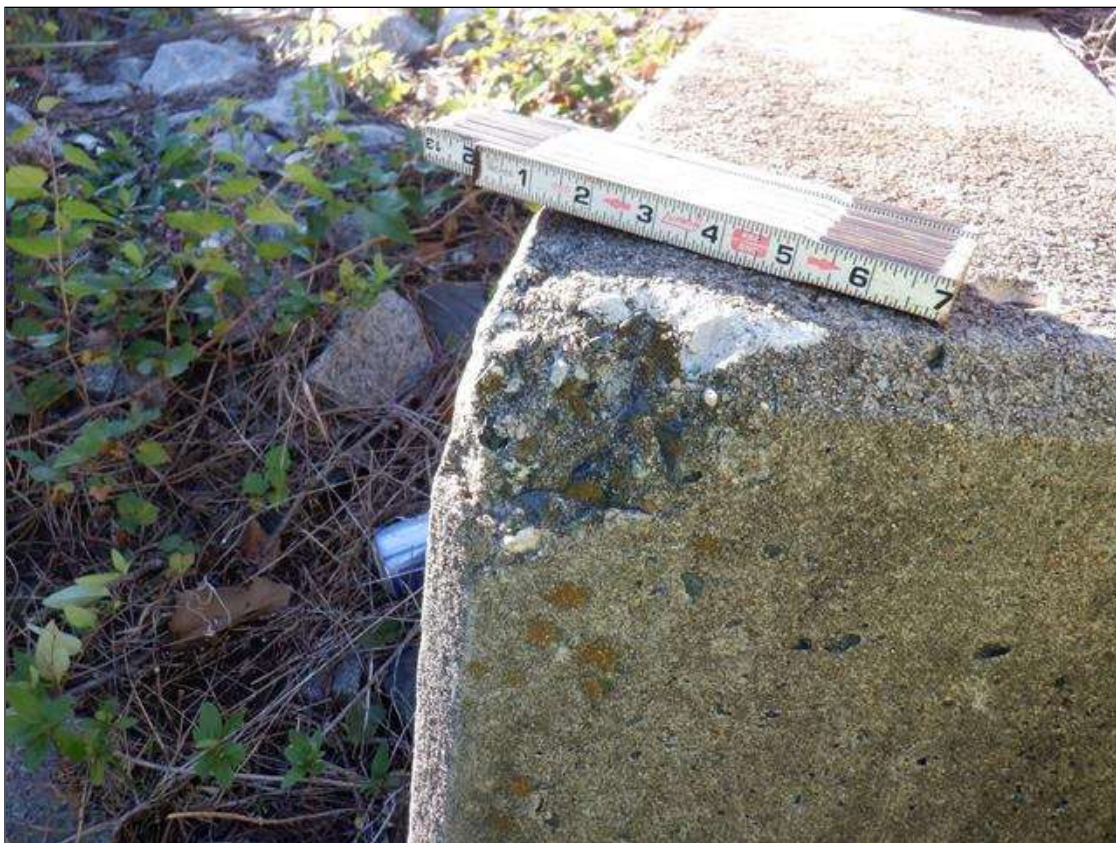
NORTHEAST WINGWALL AT TOP LEFT CORNER, SPALL, 4 INCH DIAMETER X 1/4 INCH DEEP

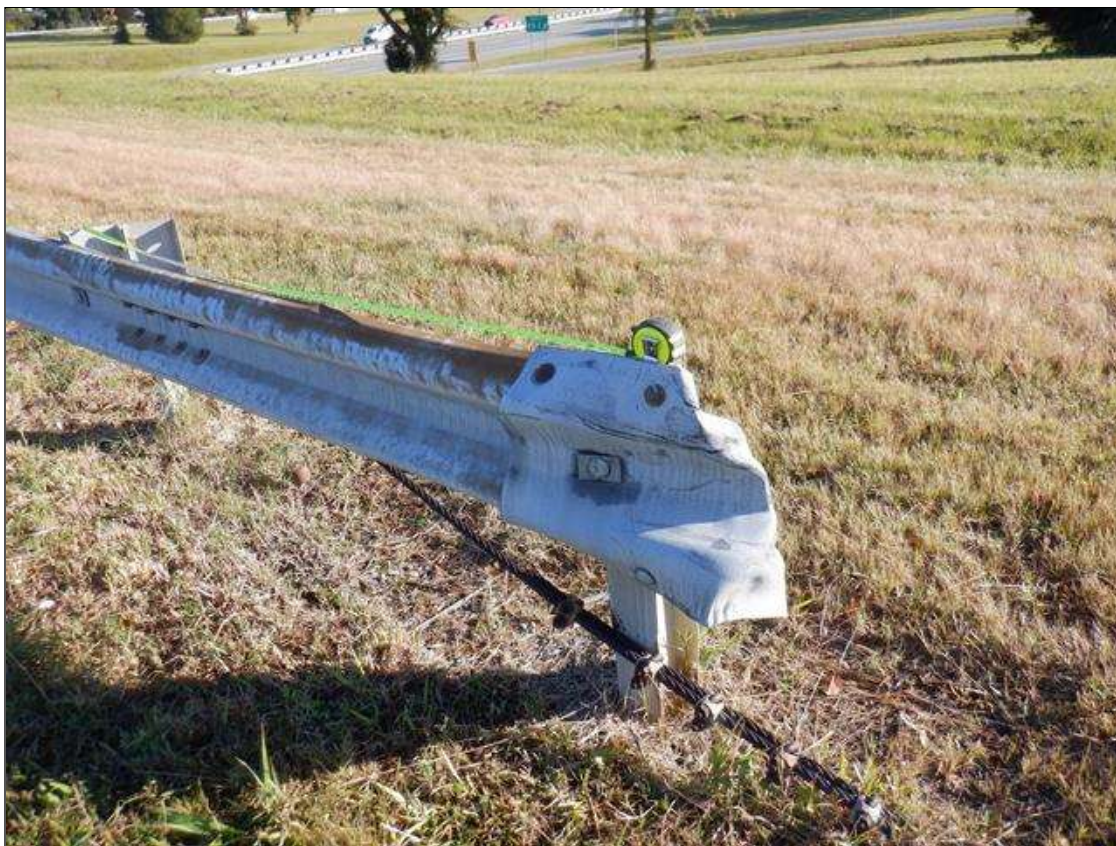
NORTHEAST GUARDRAIL TERMINAL, 1 FOOT OF IMPACT DAMAGE

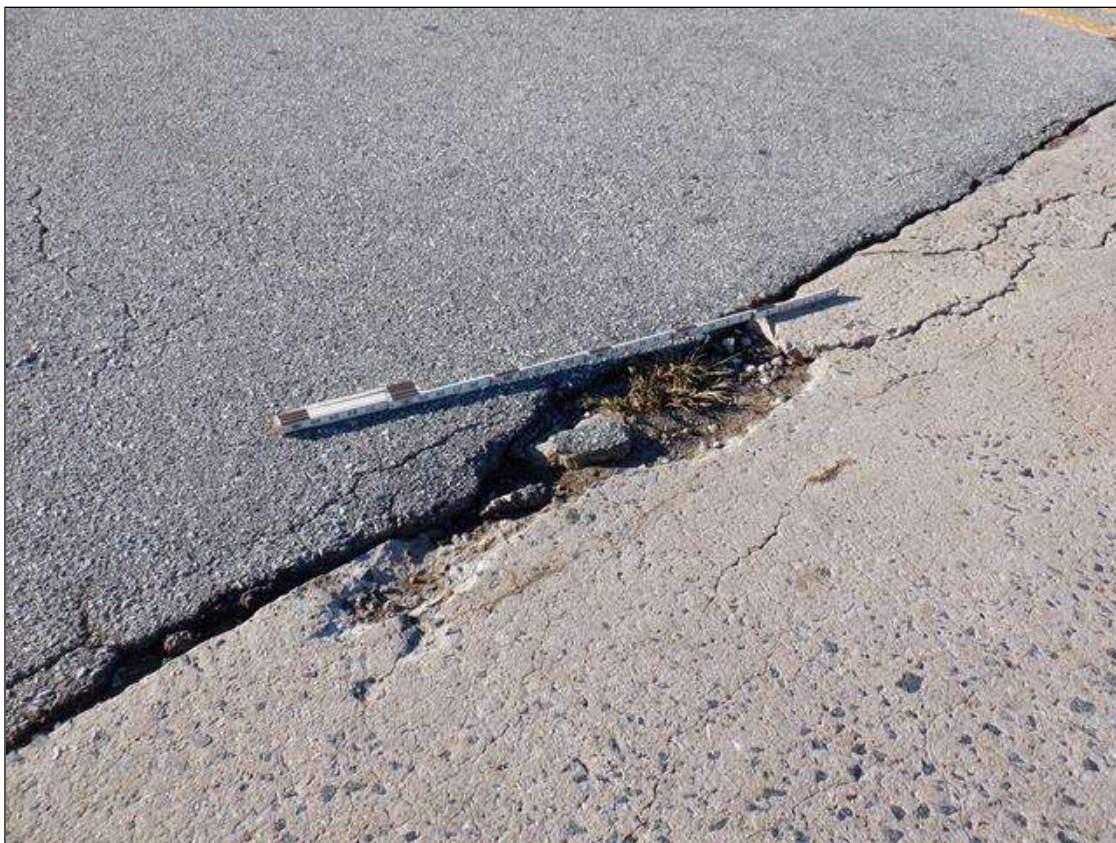
Span 4 Deck: 26 FEET X 3 FEET DELAMINATION AT CENTERLINE AND WESTBOUND LANES AT END BENT 2 WITH (2) SPALLS UP TO 2 FEET X 9 INCH X 1 1/2 INCH DEEP, NO EXPOSED REINFORCEMENT

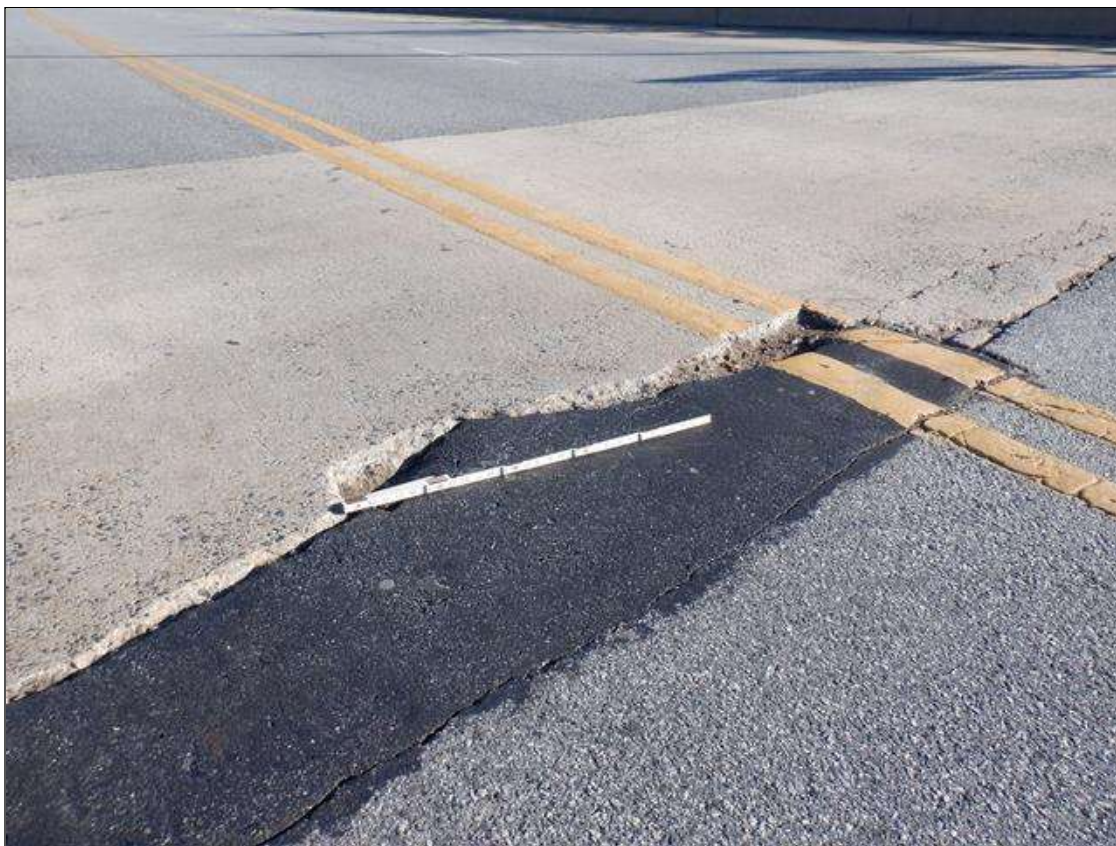
Span 4 Deck: NEAR CENTERLINE OF ROAD IN EASTBOUND LANE, UNSOUND ASPHALT PATCH, 5 FEET WIDE X 2 FEET LONG WITH AREAS OF SPALLS UP TO 2 INCH DEEP

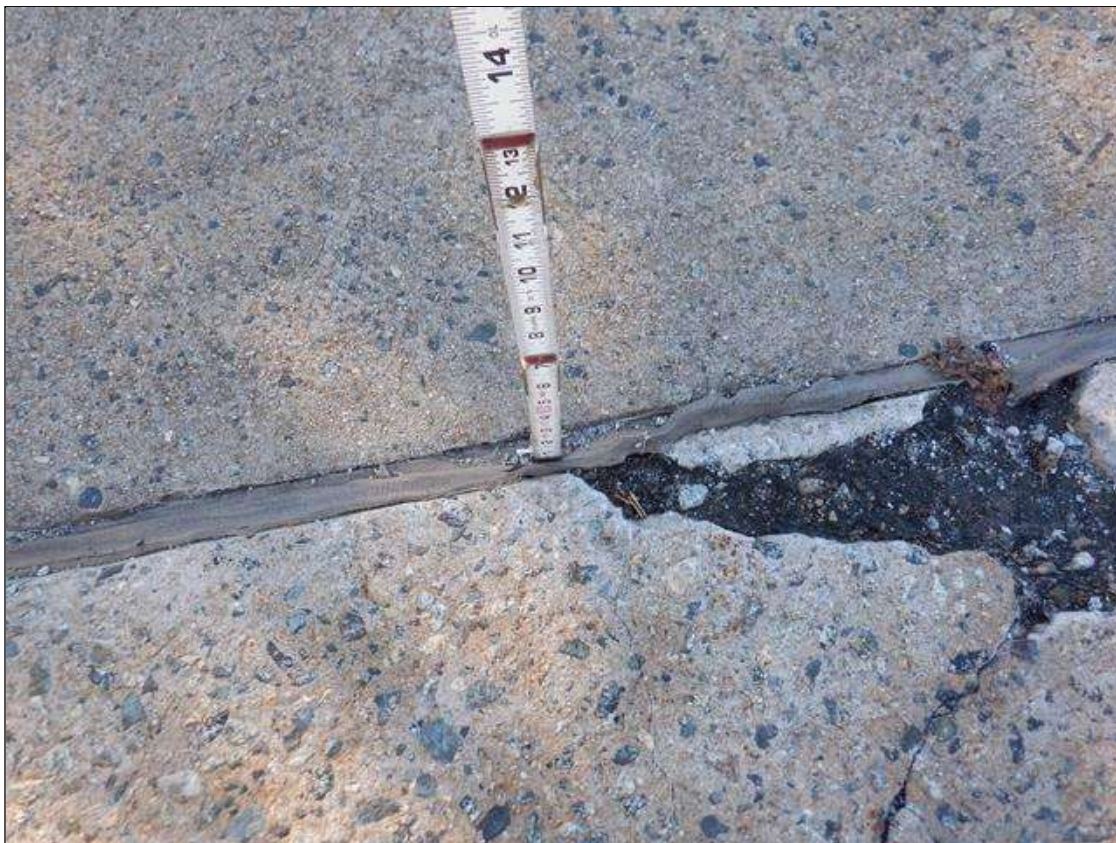
Span 4 Expansion Joint: LOSS OF SEAL ADHESION ALONG EXPOSED JOINT IN SHOULDERS

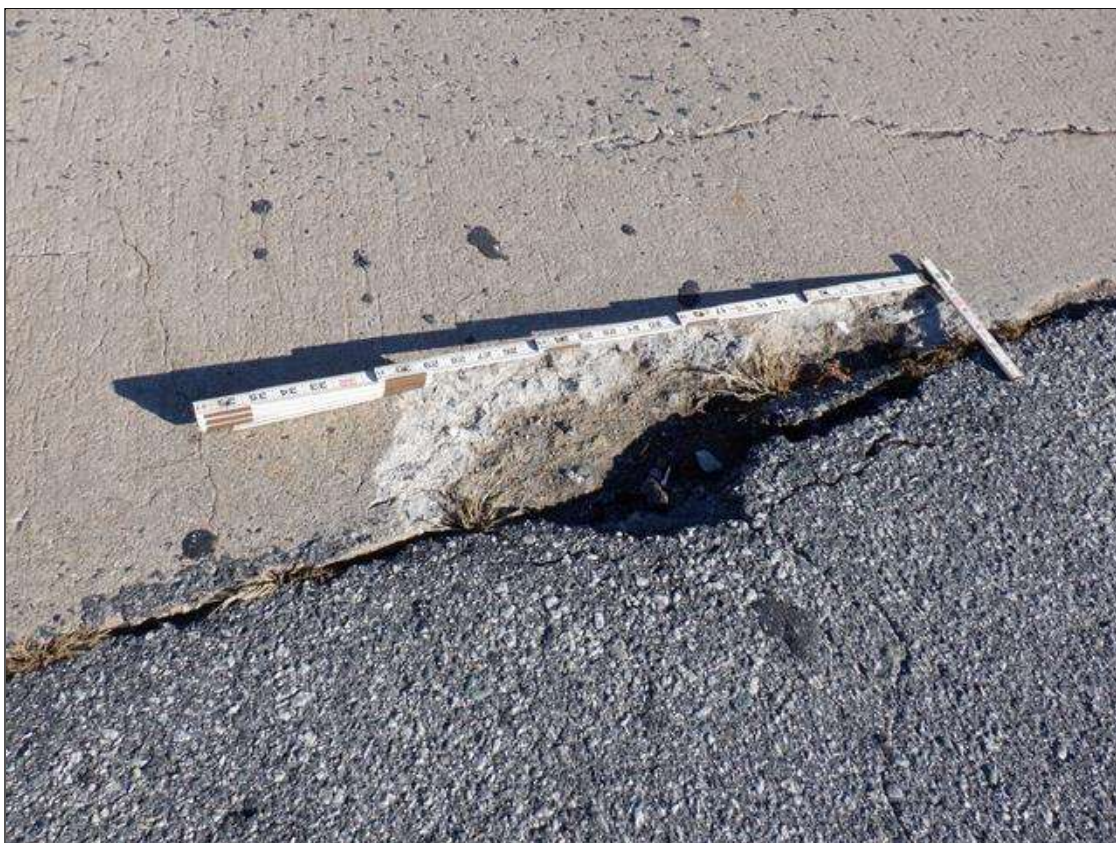
Span 4 Deck: EASTBOUND LANE AT END BENT 2, SPALL, 18 INCH WIDE X 8 INCH LONG X UP TO 1 INCH DEEP

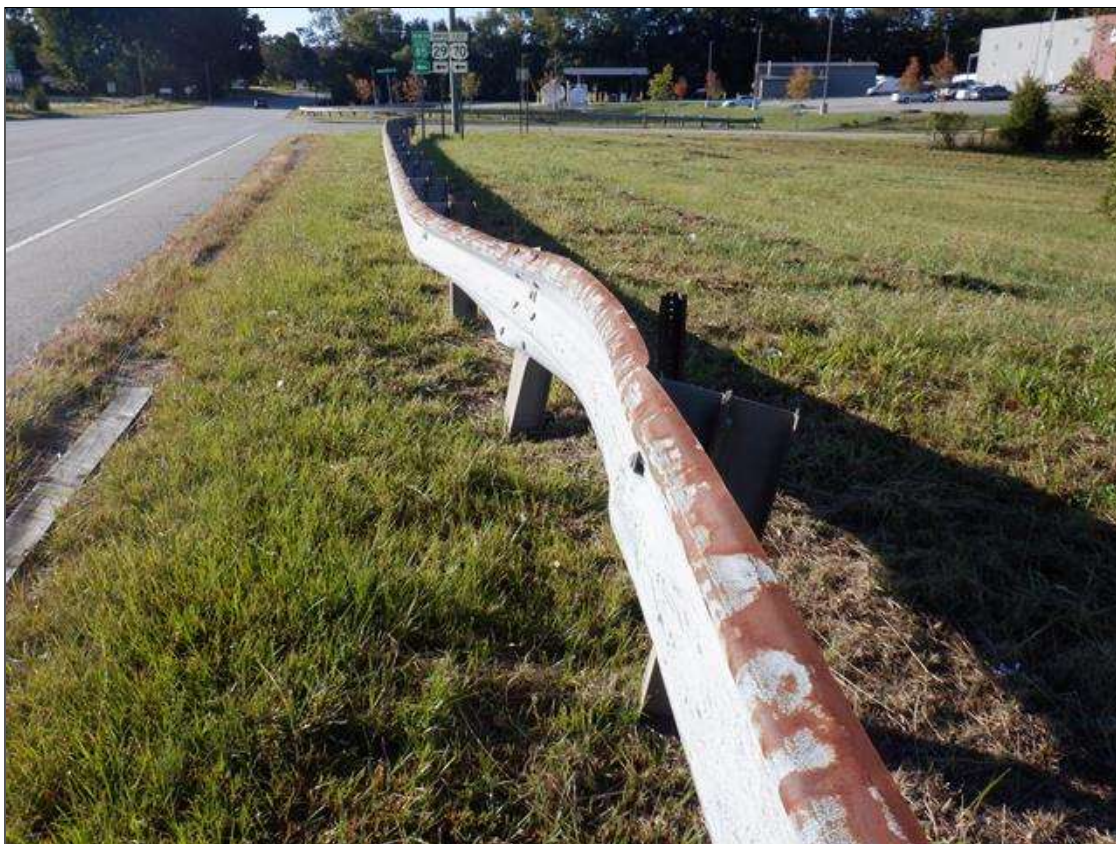
SOUTHEAST GUARDRAIL, STARTING 27 FEET FROM END BENT 2, 15 FEET OF IMPACT DAMAGE WITH UP TO 1 FOOT OF HORIZONTAL DISPLACEMENT

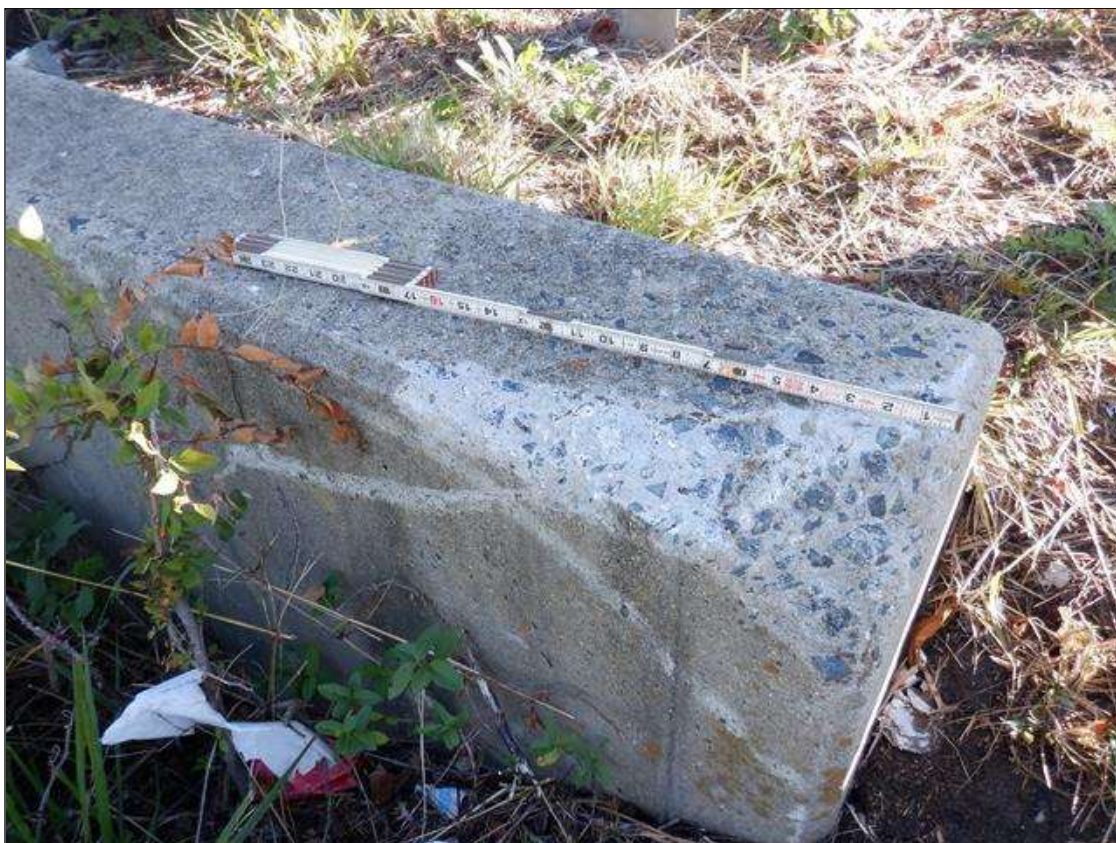
SOUTHEAST WINGWALL, ALONG TOP, 4 SPALLS UP TO 16 INCH LONG X 6 INCH WIDE X 1 INCH DEEP

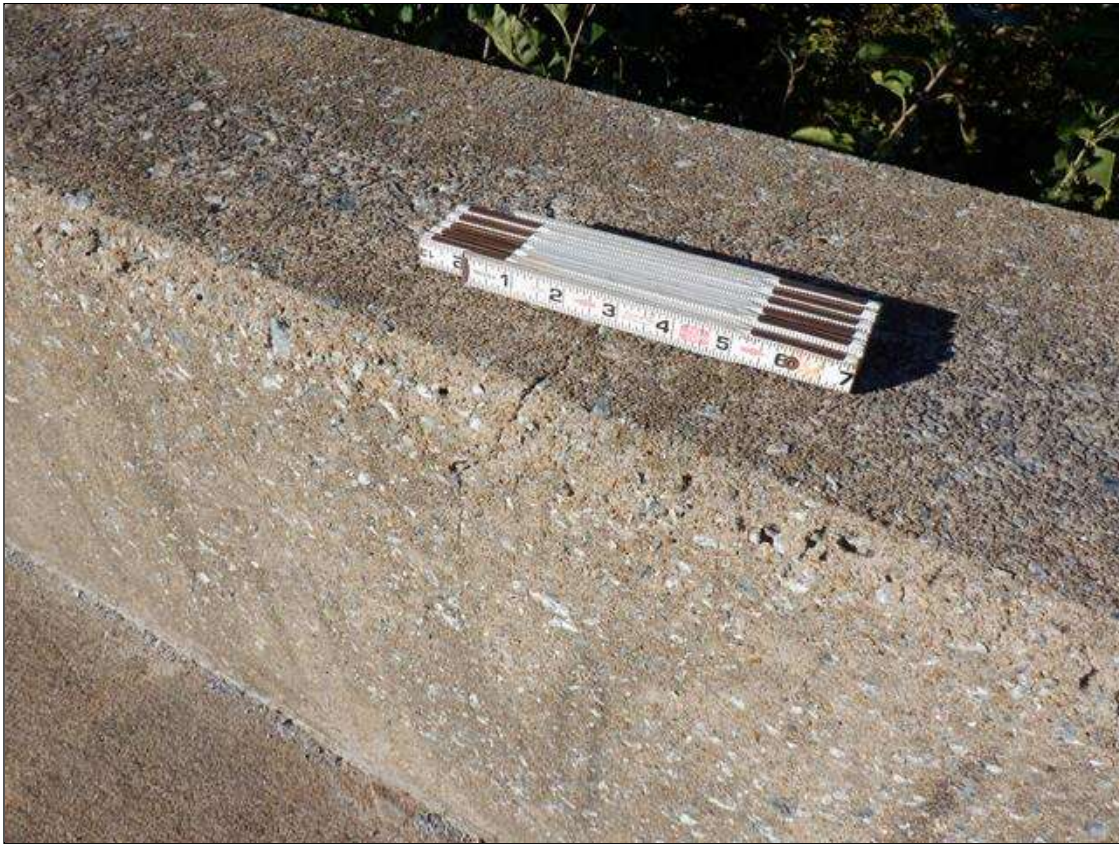
Span 4 Right Bridge Rail: SCATTERED HAIRLINE VERTICAL CRACKING THROUGHOUT, UP TO FULL HEIGHT

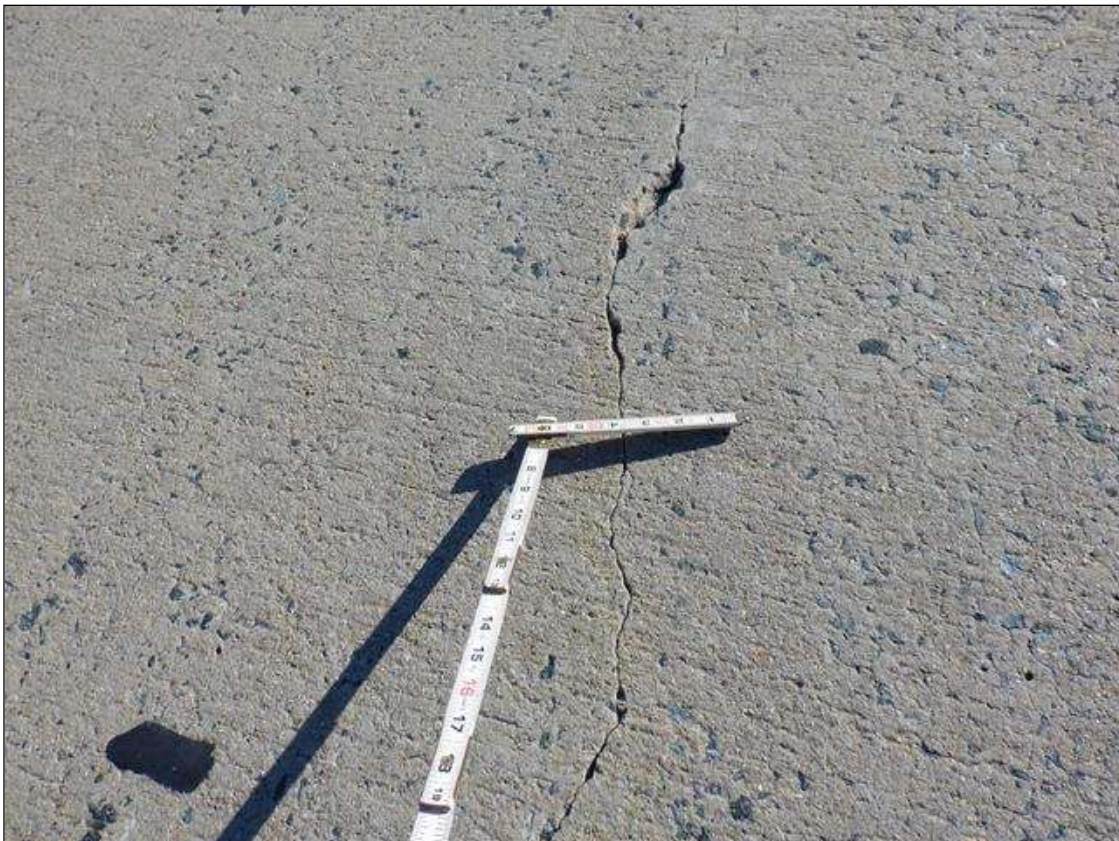
Span 4 Deck: 8 FEET TRANSVERSE CRACK UP TO 1/16 INCH WIDE IN FAR RIGHT EASTBOUND TRAVEL LANE NEAR END BENT 2

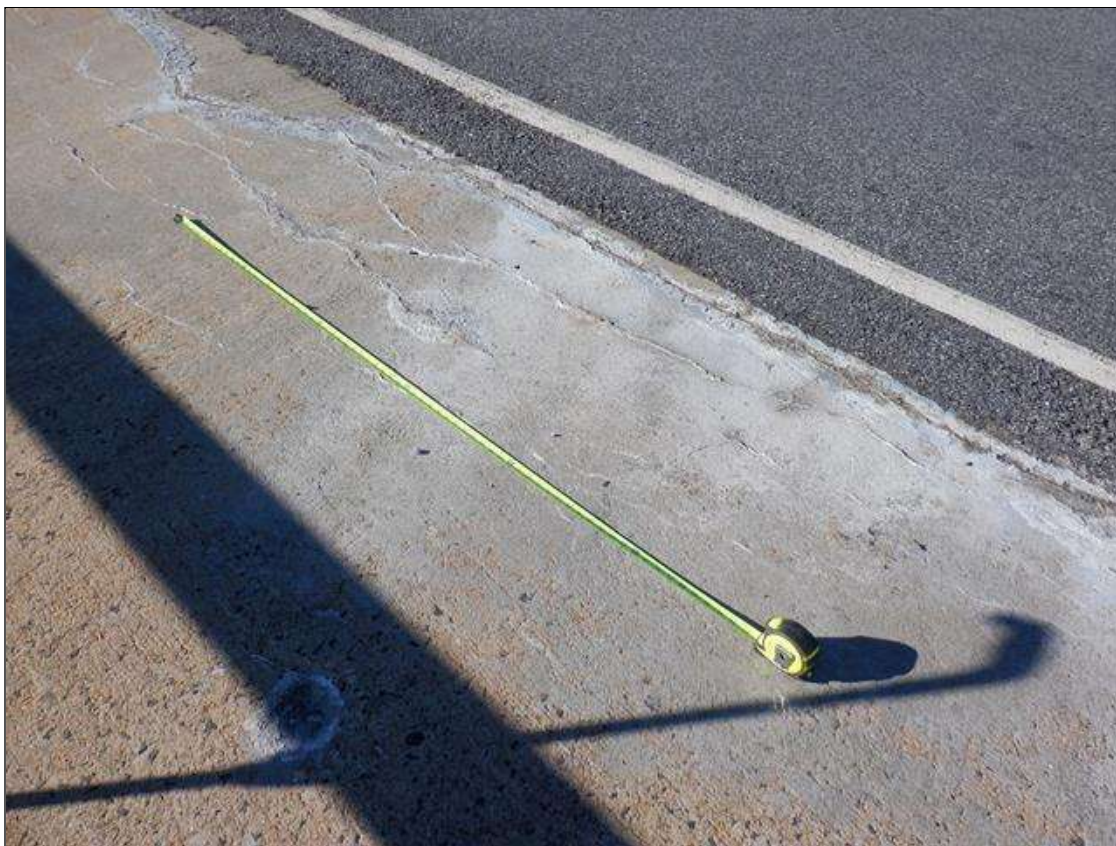
Span 3 Deck: LEFT SHOULDER, UP TO 50 SQUARE FEET OF UNSOUND PATCHED AREAS WITH CRACKS UP TO 1/16 INCH WIDE WITH EFFLORESCENCE

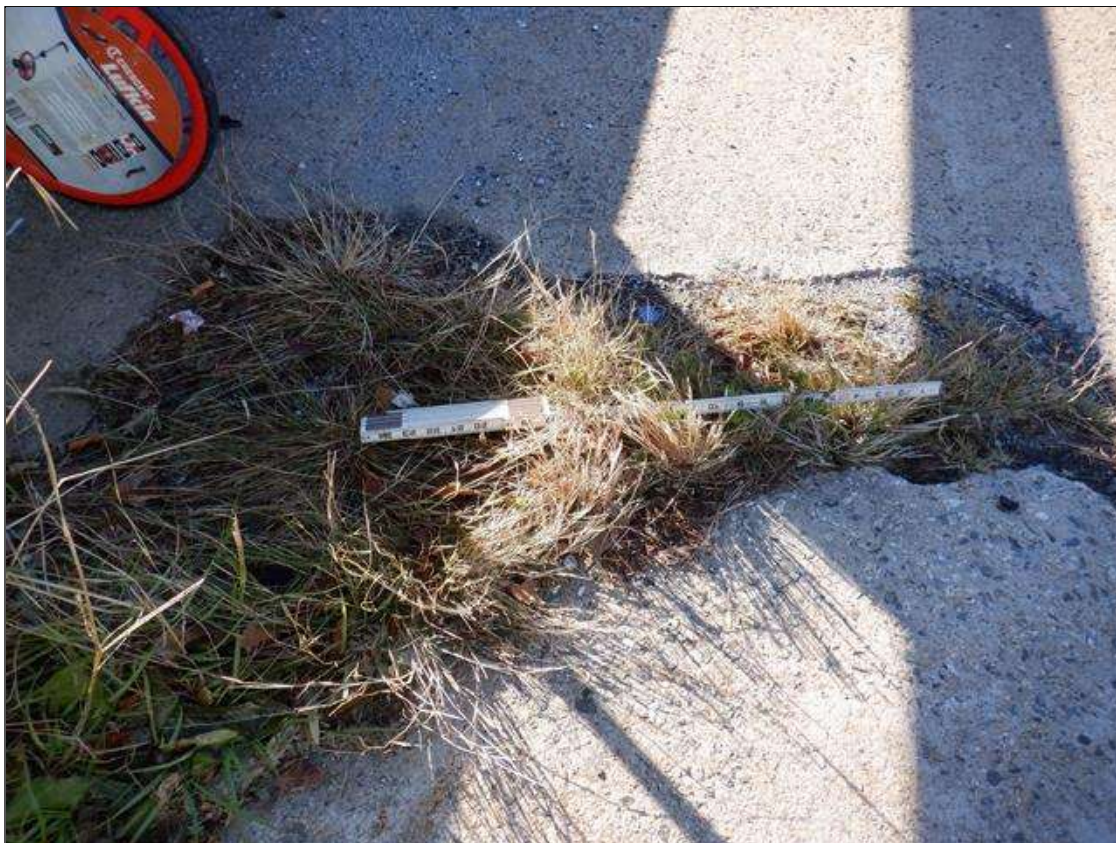
Span 3 Expansion Joint: LEFT SHOULDER, JOINT IS COMPLETELY FILLED WITH VEGETATION GROWTH

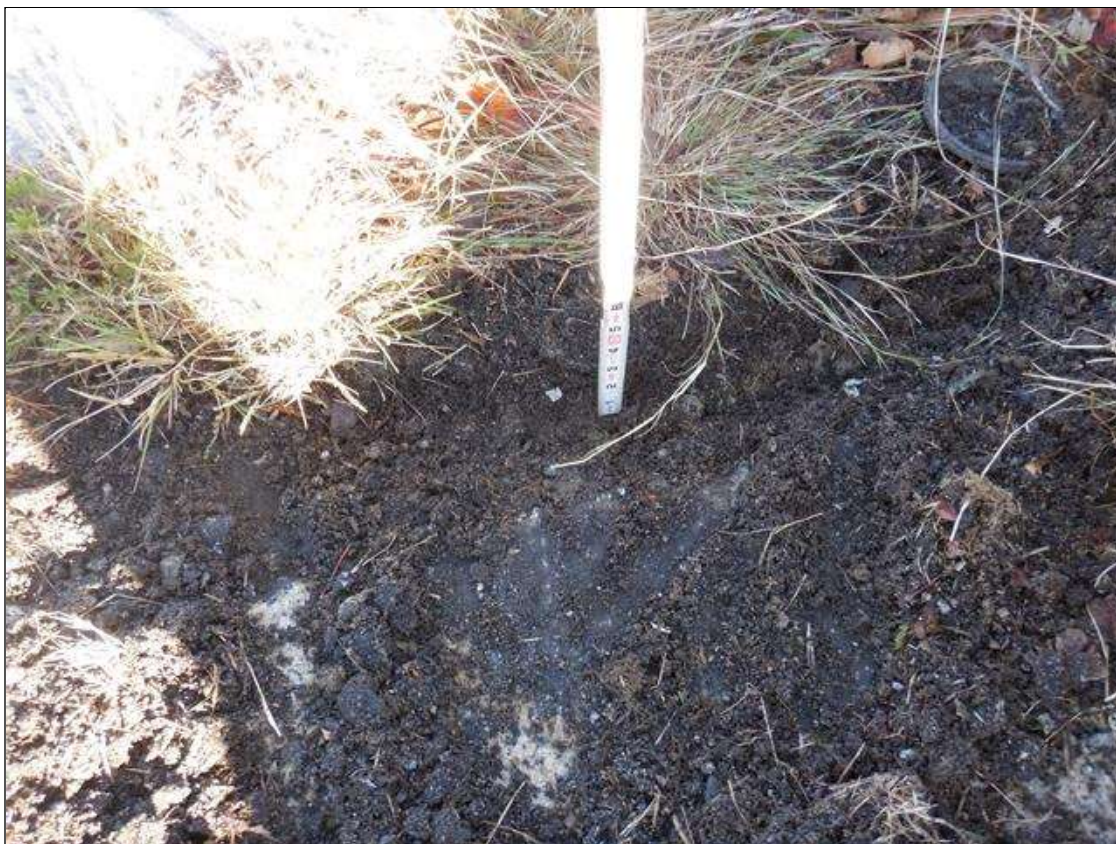
Span 3 Deck: UP TO 4 FEET X 1 FOOT X 5 INCH DEEP SPALL ON LEFT SHOULDER AT BENT 2 JOINT, REBAR COVERED BY PACKED DEBRIS

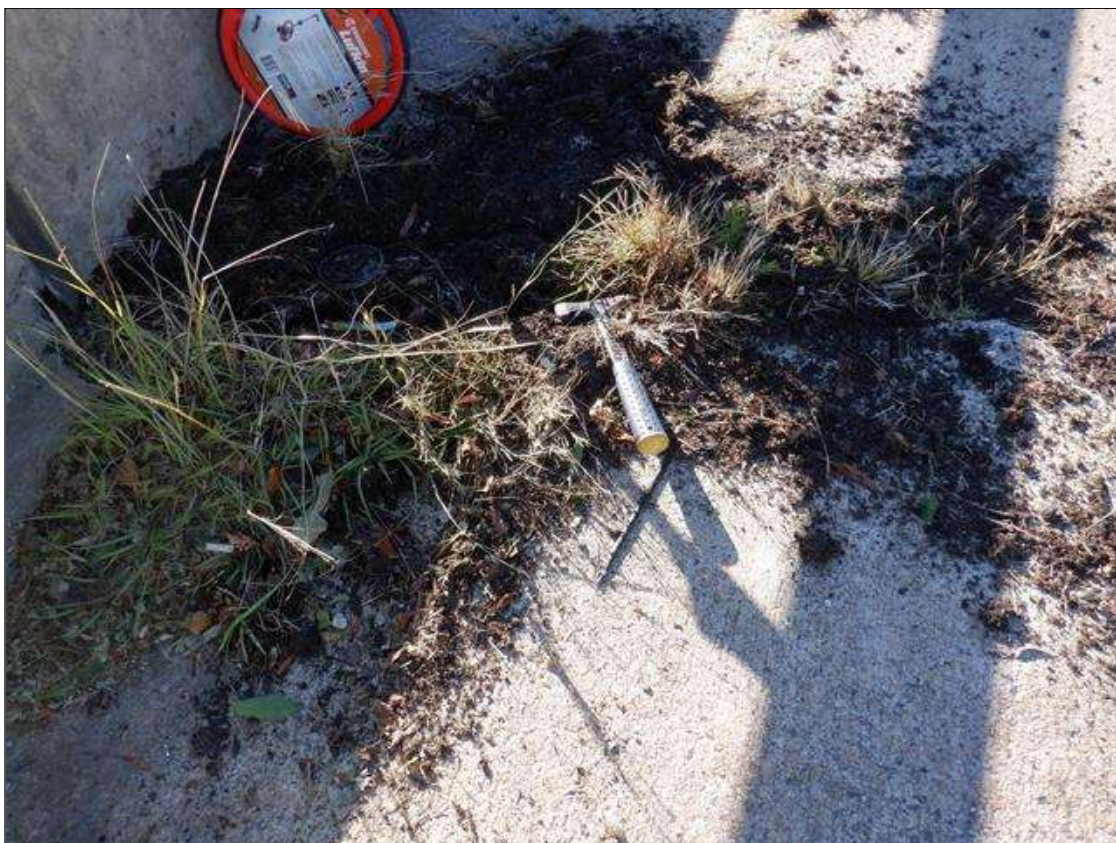
Span 2 Deck: 6 FEET X 6 INCH X 5 INCH DEEP SPALL ON LEFT SHOULDER AT BENT 2 JOINT, REBAR COVERED BY PACKED DEBRIS

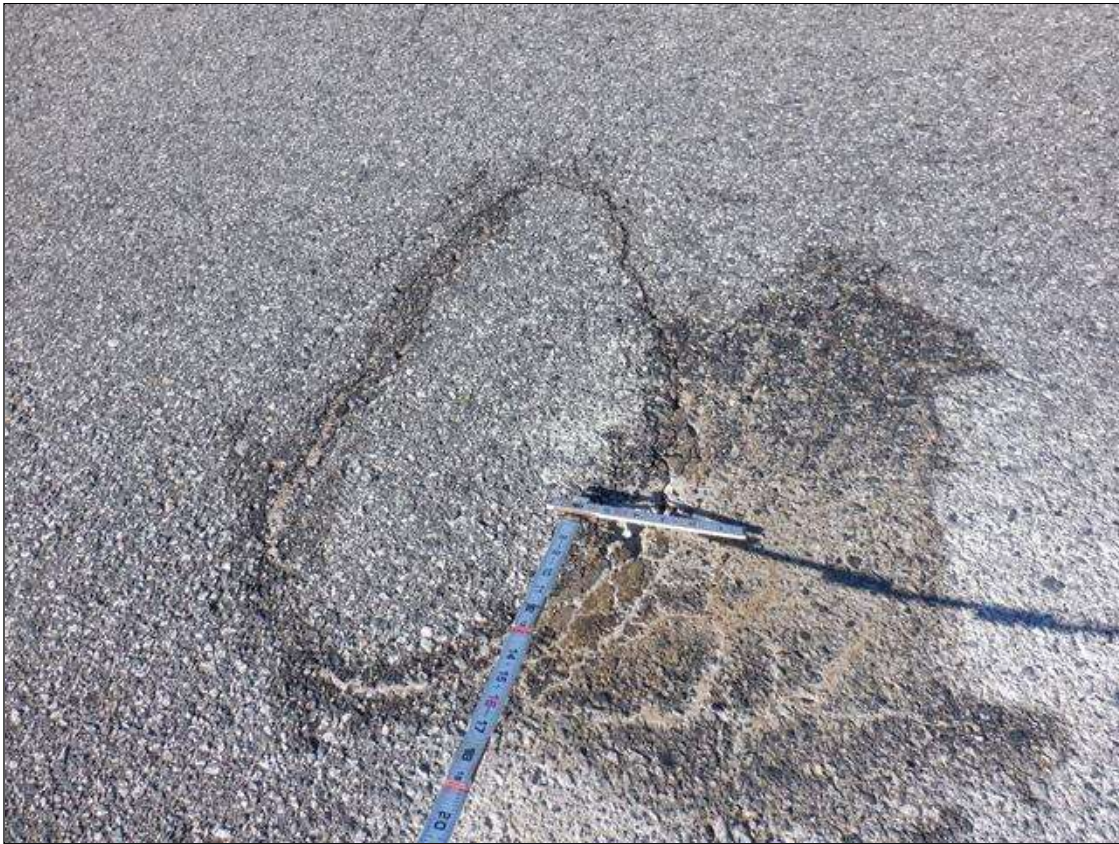
Span 3 Wearing Surface: WESTBOUND LANE, 10 FEET FROM BENT 2, 2 POTHOLES UP TO 2 FOOT DIAMETER WITH ADJACENT CRACKS UP TO 1/16 INCH WIDE

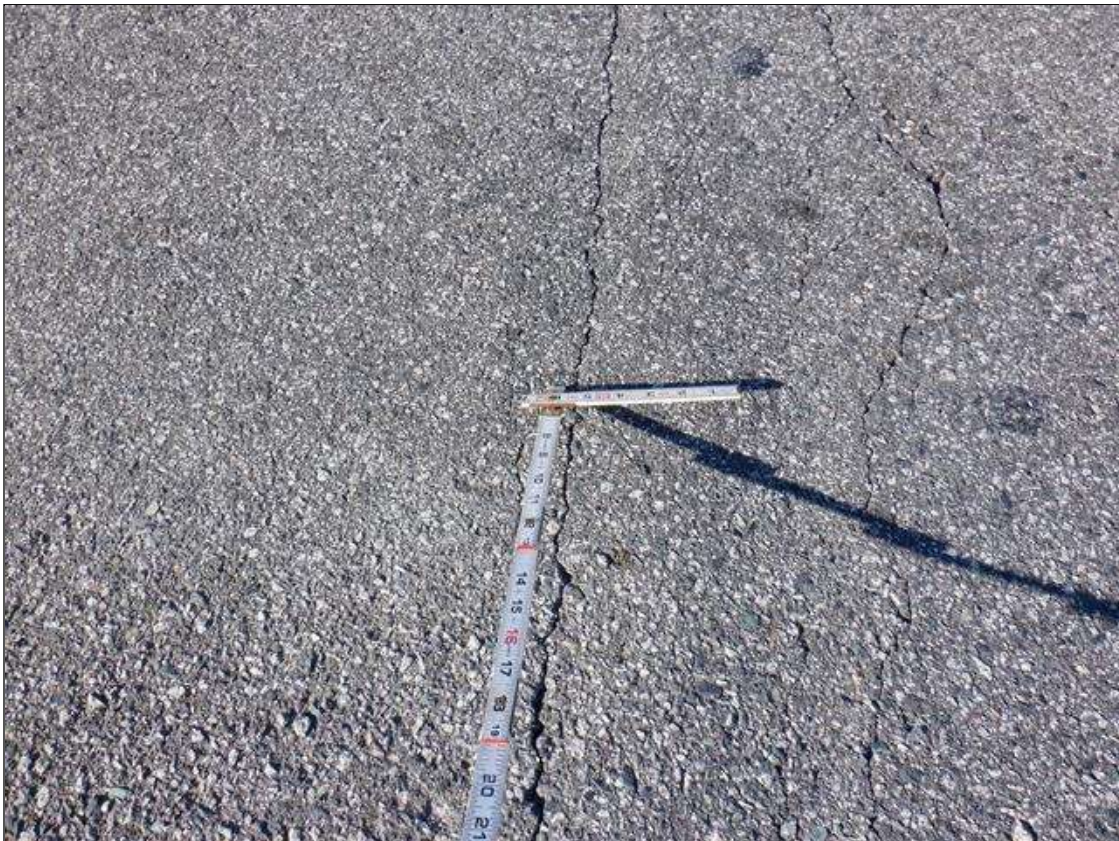
Span 3 Wearing Surface: SCATTERED TRANSVERSE CRACKING UP TO 1/16 INCH WIDE FOR 50 PERCENT OF PAVED JOINT LENGTH AT BENT 2

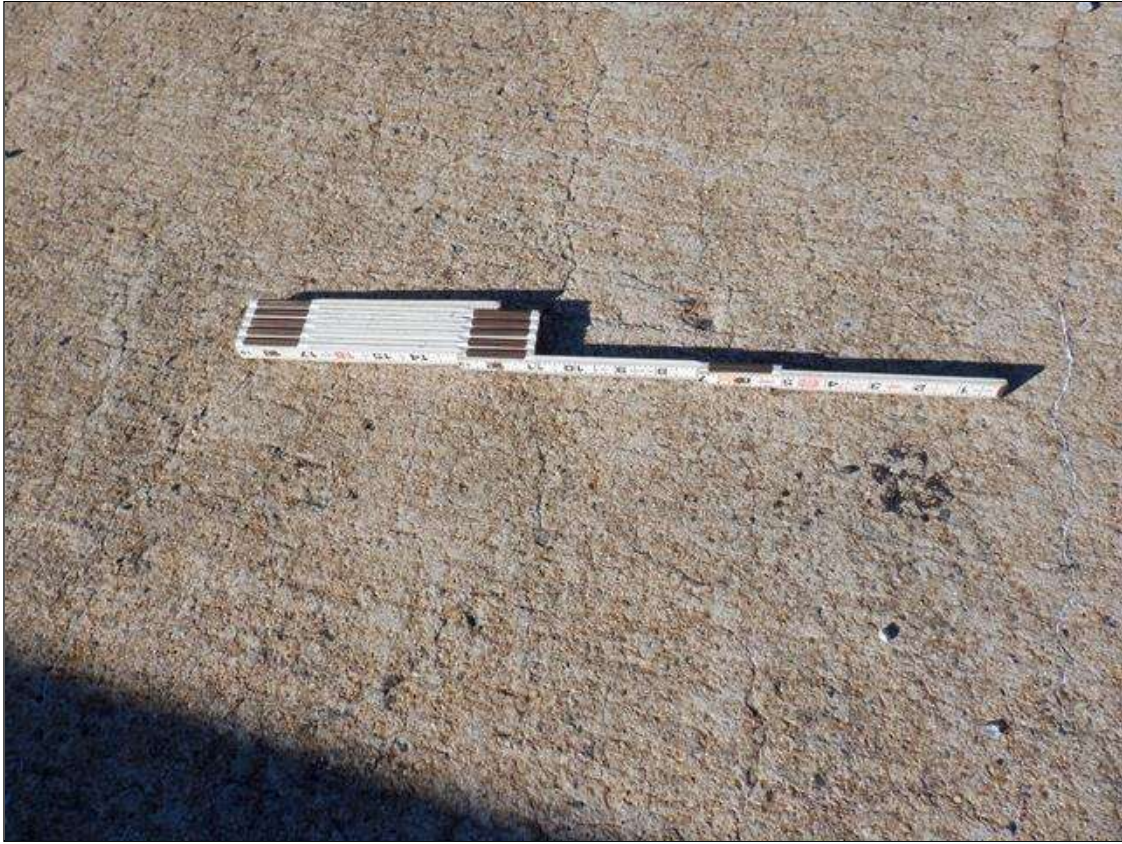
Span 2 Deck: HAIRLINE MAP CRACKING IN TOP OF LEFT AND RIGHT SHOULDERS FOR FULL WIDTH OF SHOULDER X FULL LENGTH OF SPAN
