NC DEPARTMENT OF TRANSPORTATION
 DIVISION OF HIGHWAYS
 STRUCTURE MANAGEMENT UNIT

ATTENTION: **CHANGE TO STRUCTURE DATA, PAR SUBMITTED, REQUEST LIDAR, NEWLY STRUCTURALLY DEFICIENT**

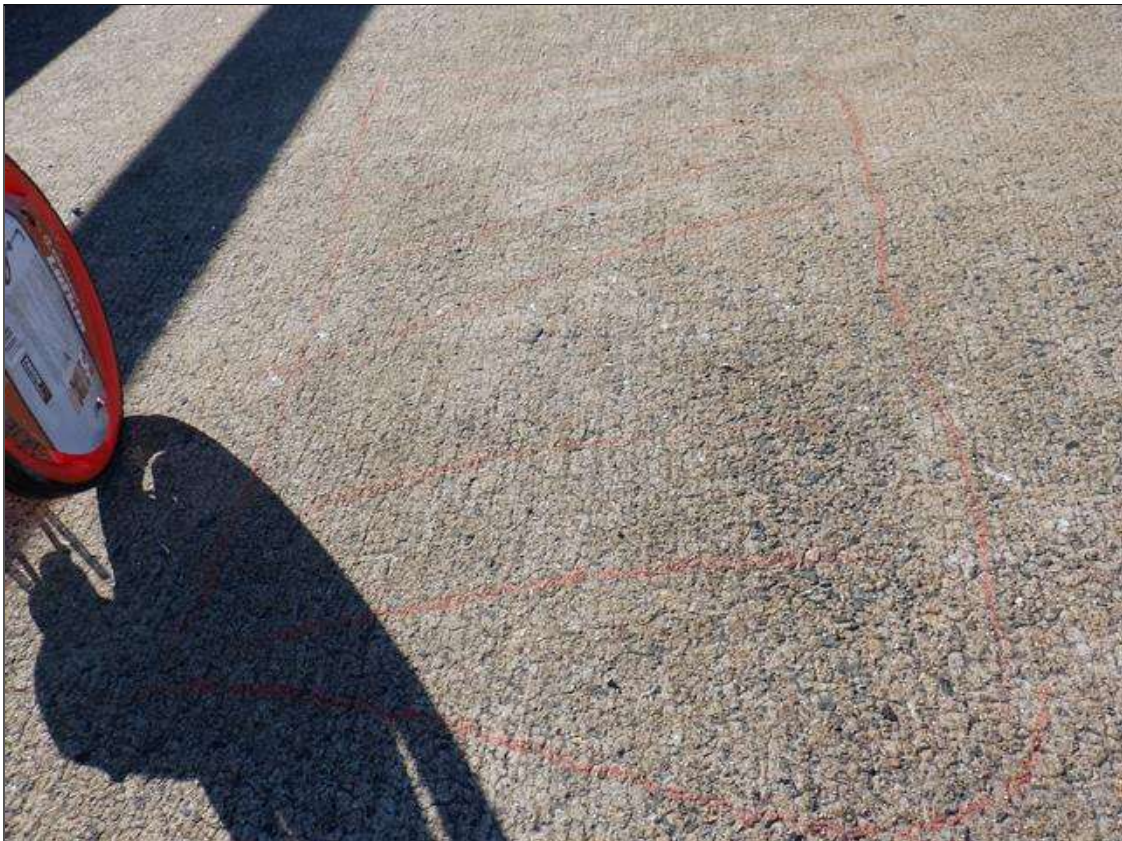
Span 2 Deck: 3 FEET WIDE DELAMINATION ALONG LEFT SHOULDER FOR ENTIRE SPAN LENGTH

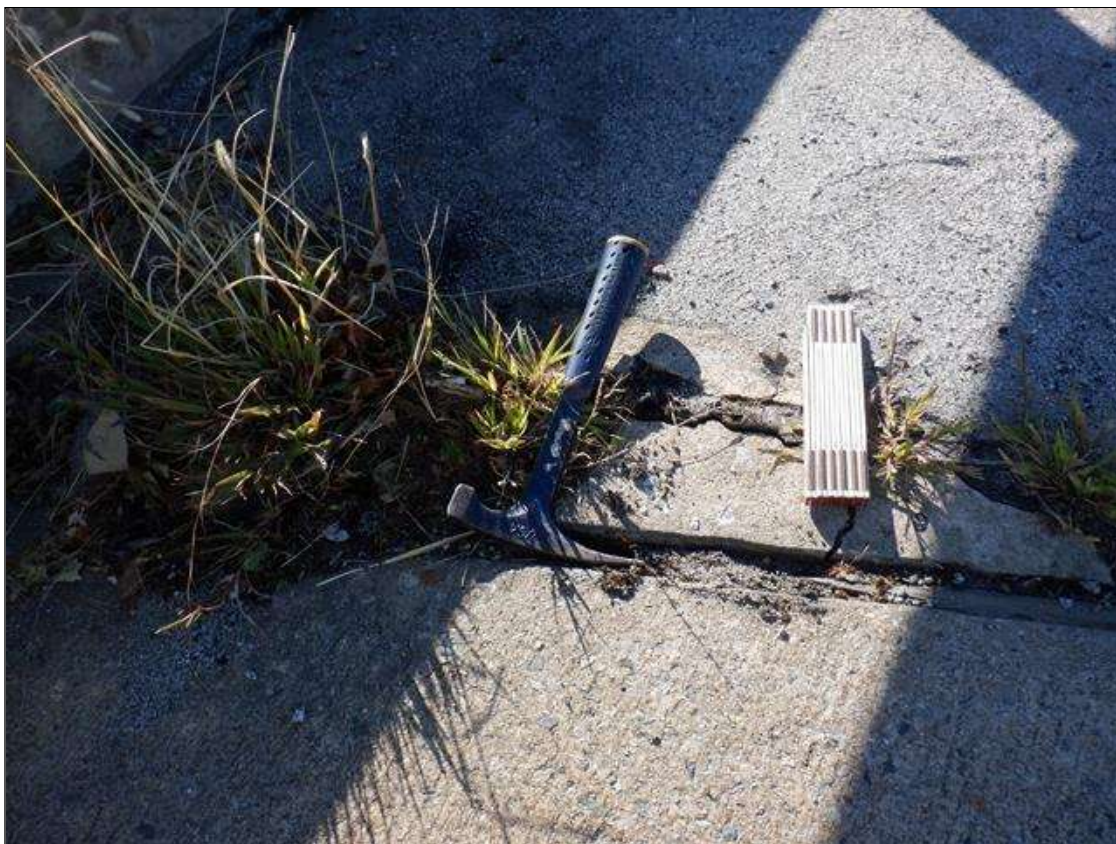
Span 2 Deck: 5 INCH X 9 INCH X 5 INCH DEEP SPALL ON LEFT SHOULDER AT BENT 1 JOINT, REBAR COVERED BY PACKED DEBRIS

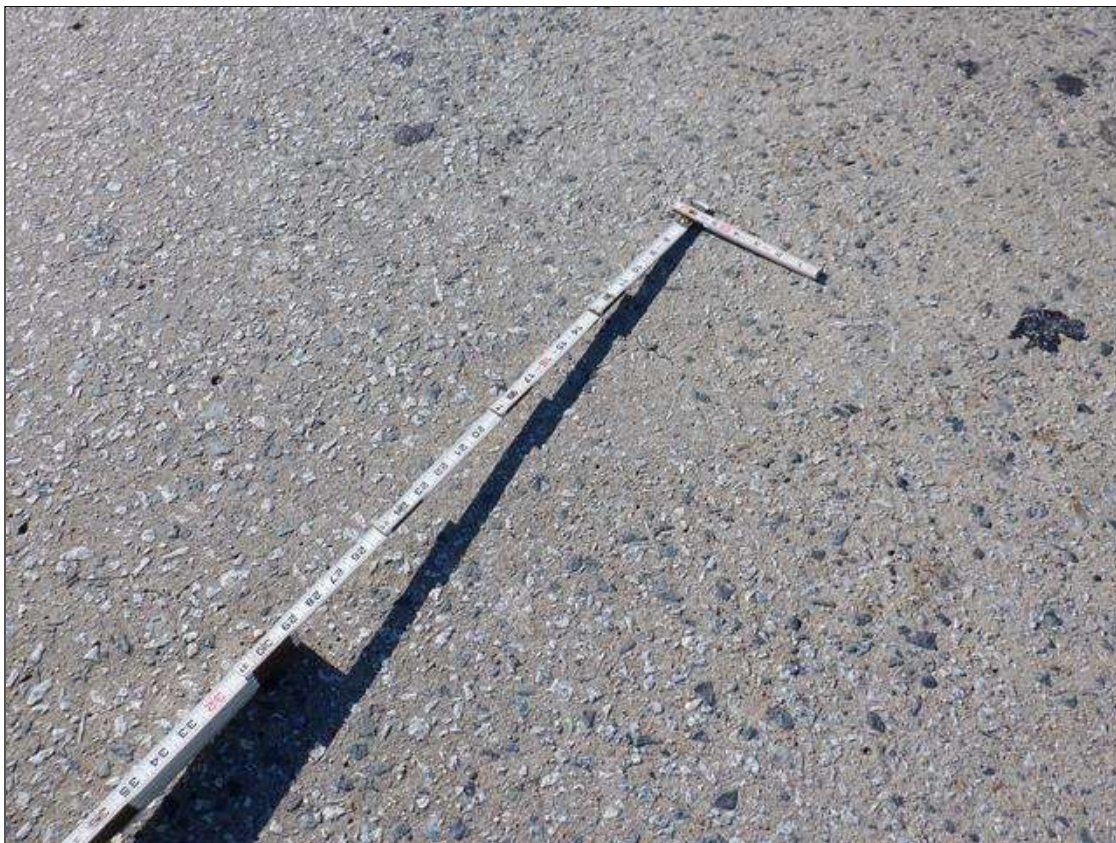
Span 1 Deck: HAIRLINE MAP CRACKING TOPSIDE WITH WEARING SCATTERED THROUGHOUT

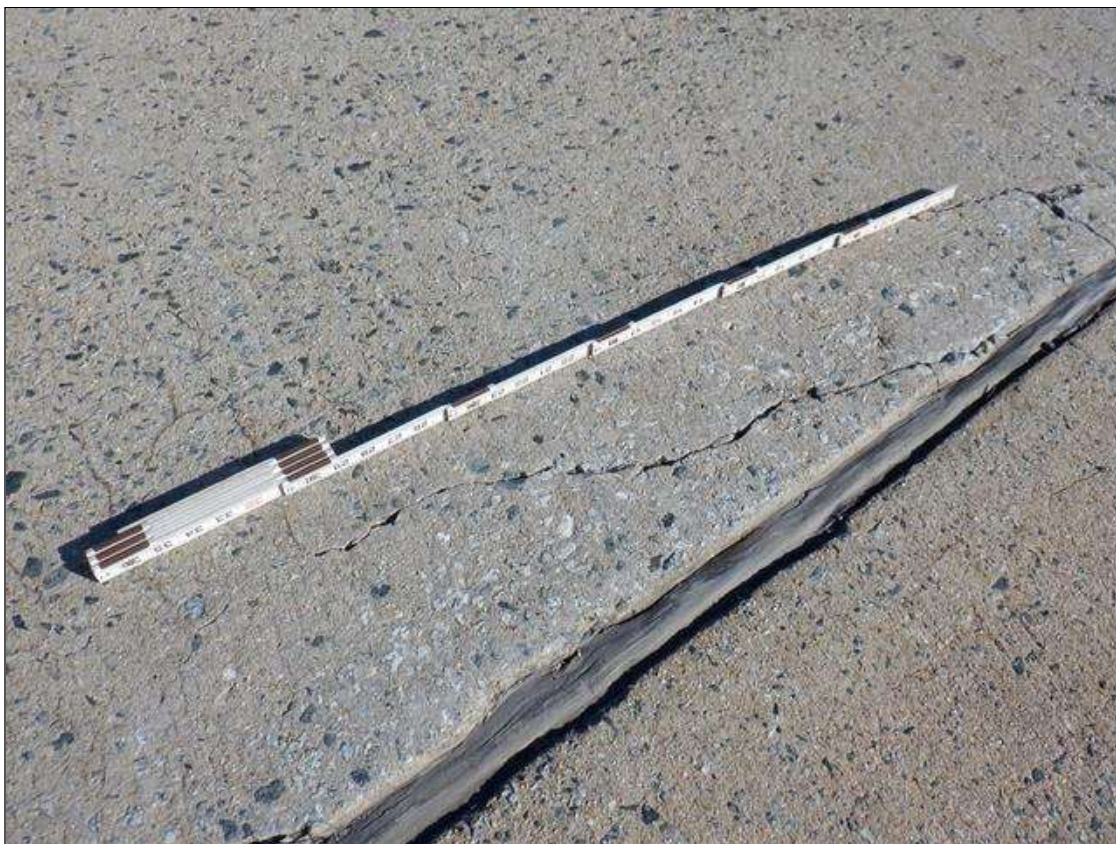
Span 1 Deck: TOP OF DECK IN FAR RIGHT EASTBOUND LANE AT BENT 1, 6 FEET X 1 FOOT DELAMINATION WITH CRACKING UP TO 1/8 INCH WIDE

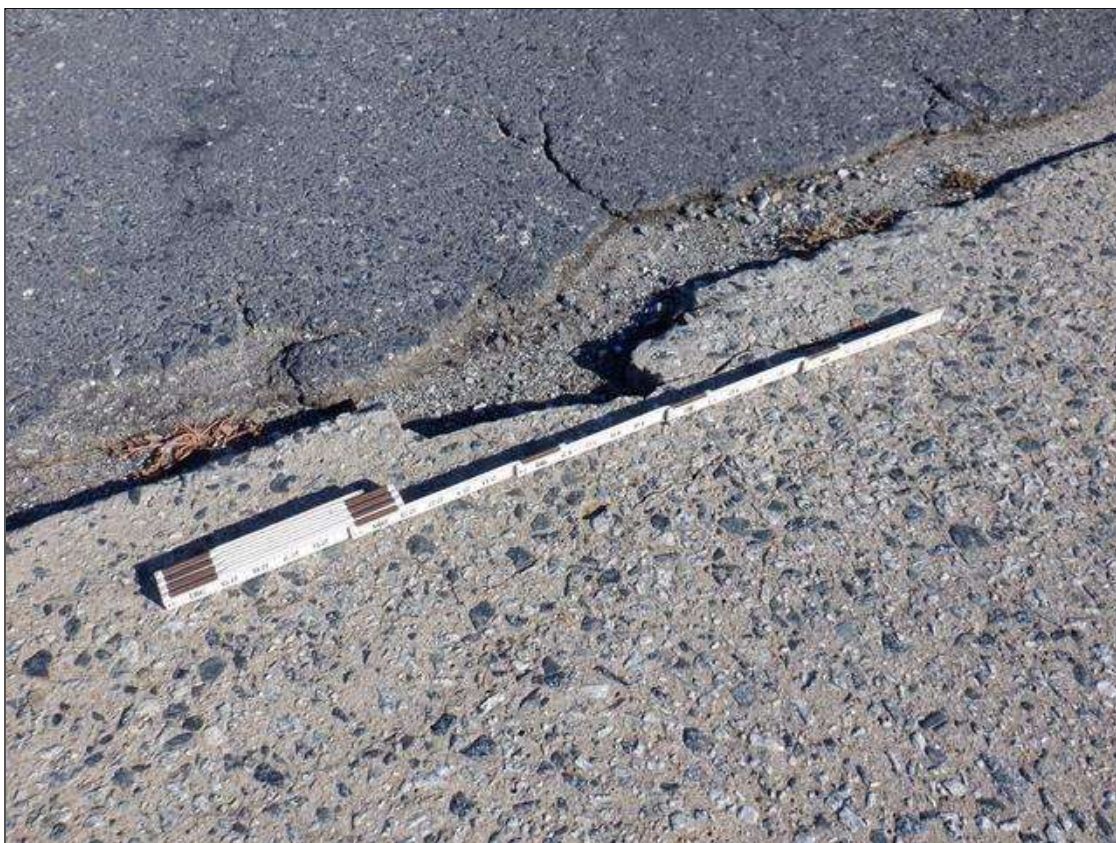
Span 1 Deck: LEFT EASTBOUND LANE, SPALL, 1 FOOT WIDE X 4 INCH LONG X 1 1/2 DEEP

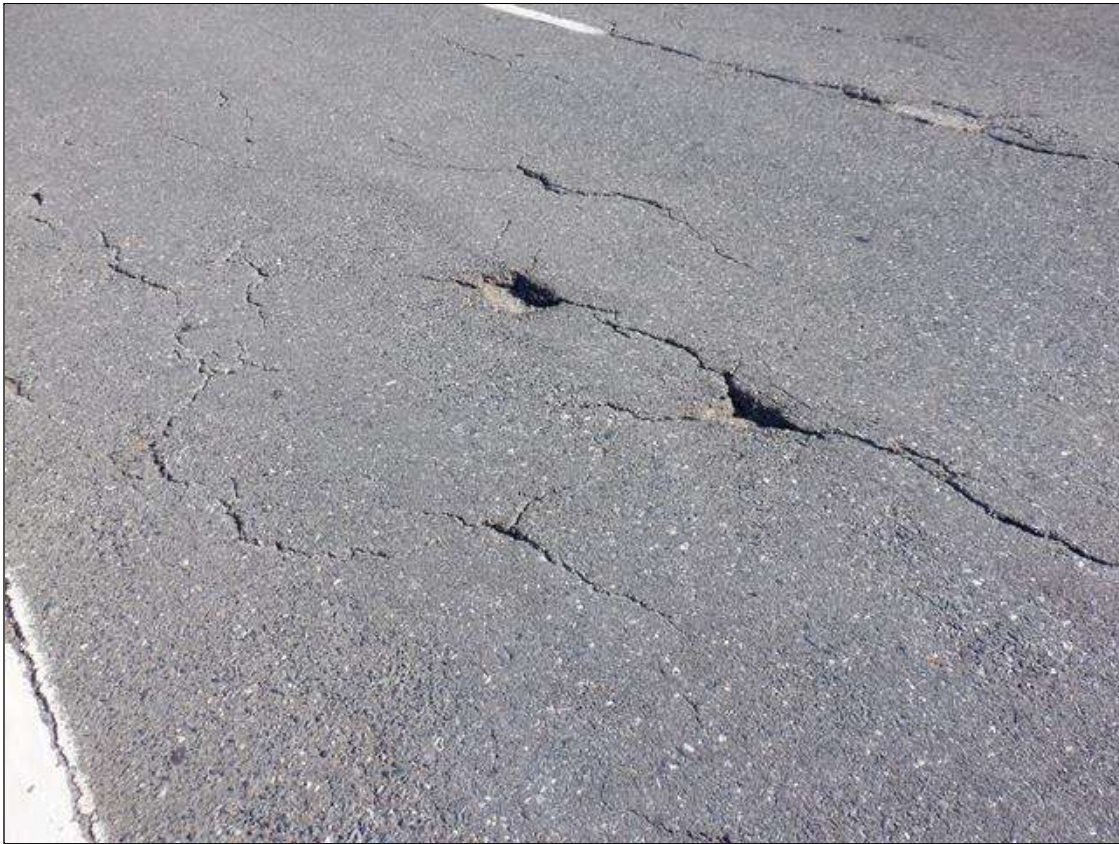
WEST APPROACH ASPHALT WEARING SURFACE HAS LONGITUDINAL CRACKS UP TO 1/4 INCH WIDE WITH POTHOLES UP TO 6 INCH DIAMETER X 1 INCH DEEP

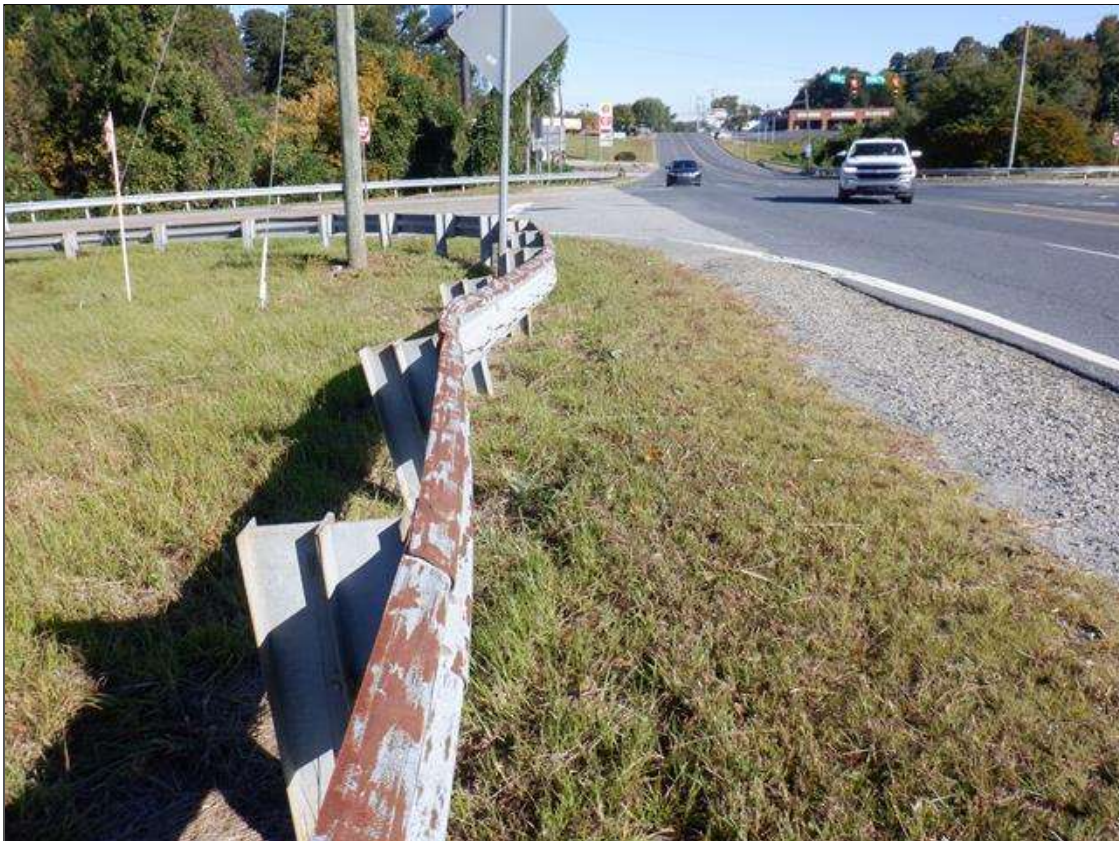
SOUTHWEST GUARDRAIL, STARTING 115 FEET FROM BRIDGE, 20 FEET OF GUARDRAIL DAMAGE WITH UP TO 1 FOOT HORIZONTAL DISPLACEMENT

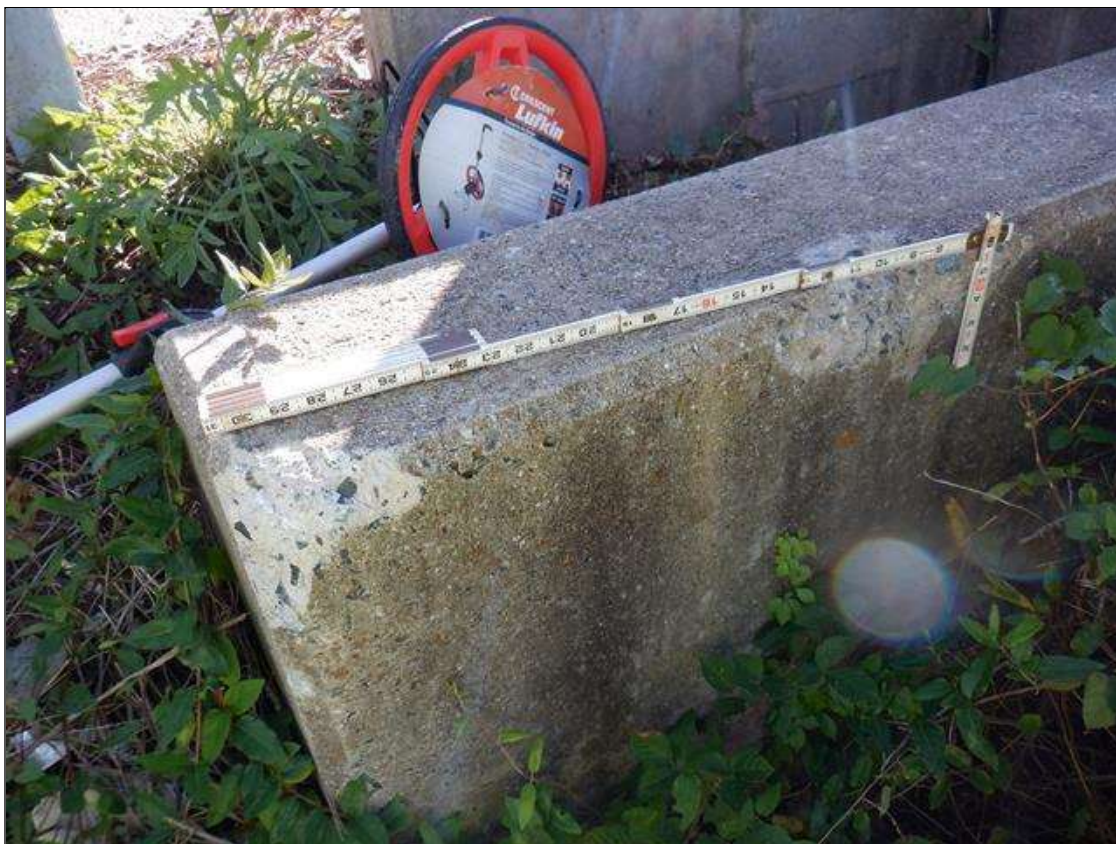
SOUTHWEST WINGWALL AT TOP CORNER, 2 SPALLS, UP TO 1 FOOT LONG X 5 INCH HIGH X 1 INCH DEEP

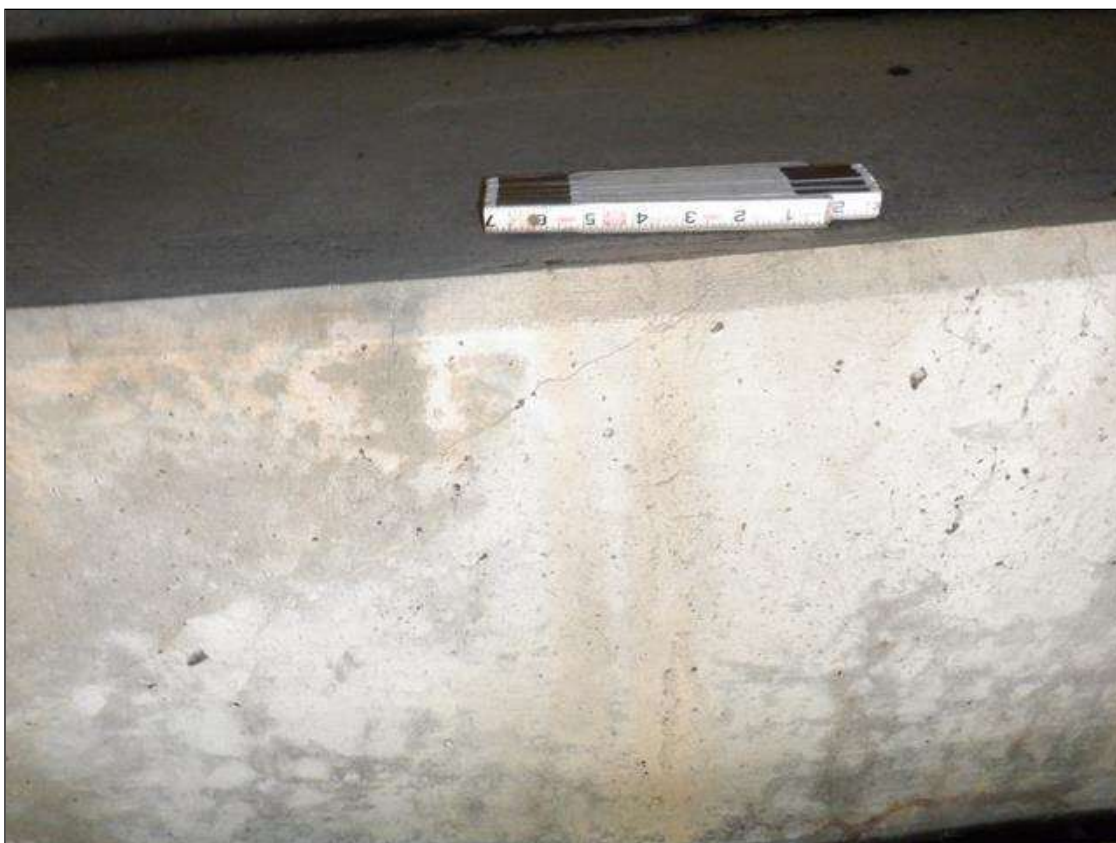
End Bent 1 Cap 1: SCATTERED VERTICAL HAIRLINE CRACKS UP TO 1 FOOT HIGH ALONG FACE OF END BENT CAP

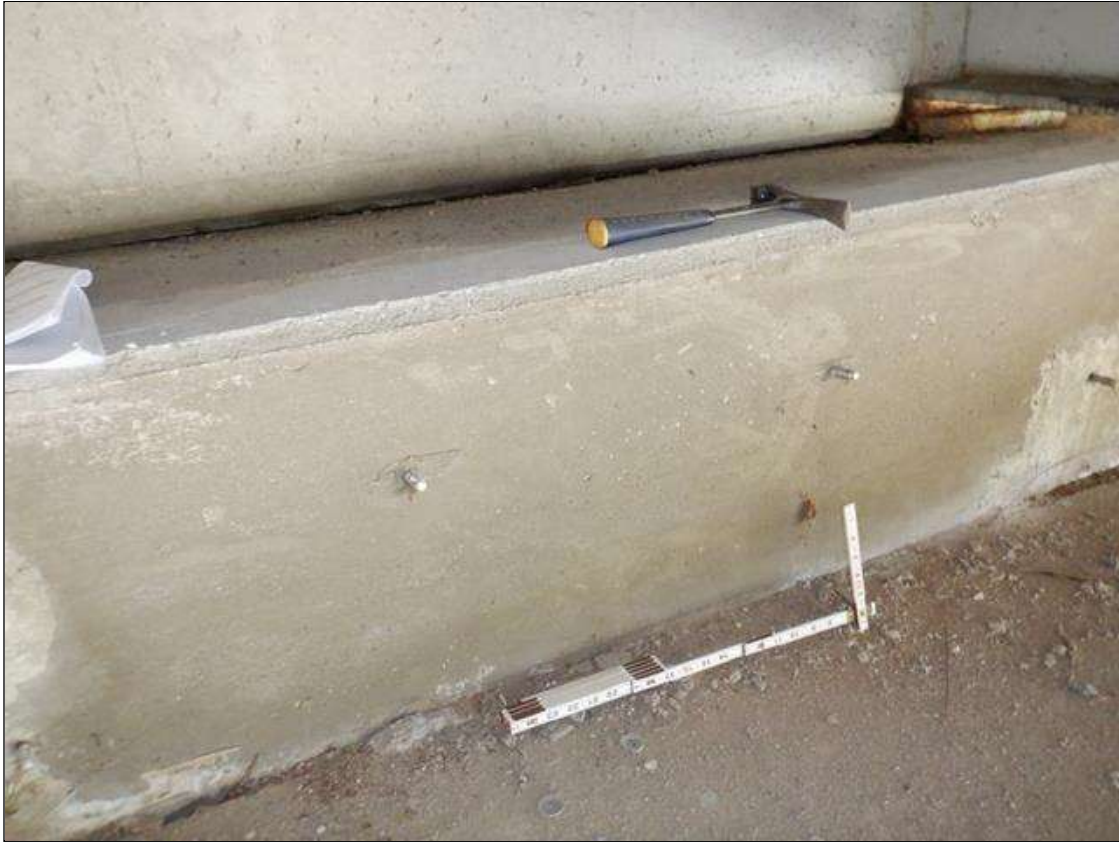
End Bent 1 Cap 1: SOUND PATCHED AREA UNDER BAY 2 AND GIRDER 2, 10 FEET LONG X FULL HEIGHT OF CAP

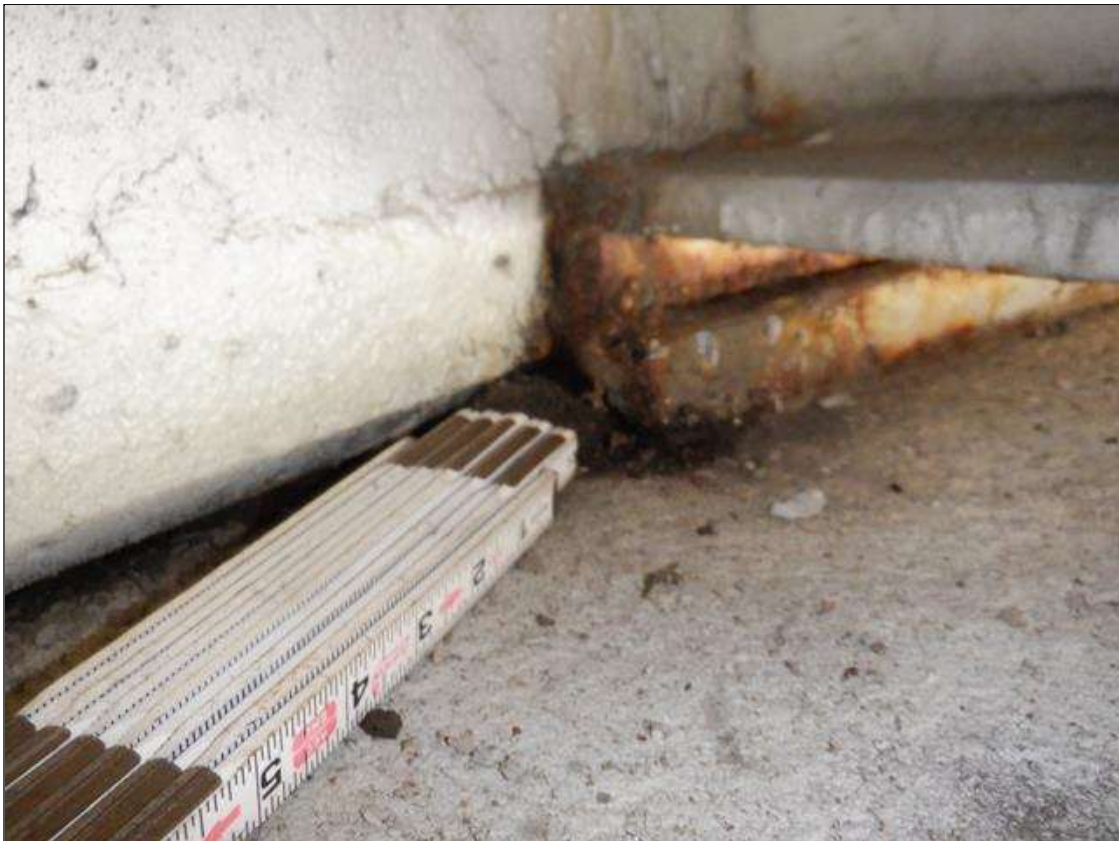
Span 1 Beam 2 - Near Bearing: SURFACE CORROSION ON BEARING PLATES

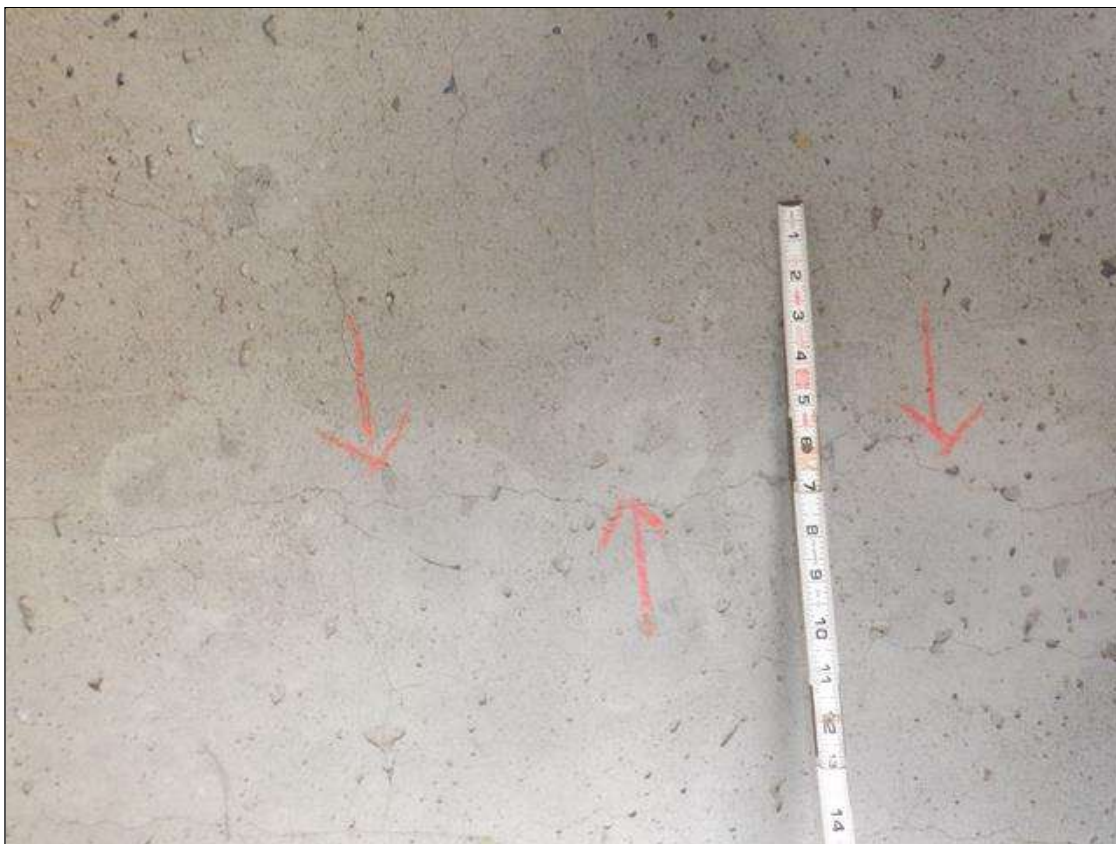
End Bent 1 Abutment: HAIRLINE MAP CRACKING THROUGHOUT FULL LENGTH OF BACKWALL

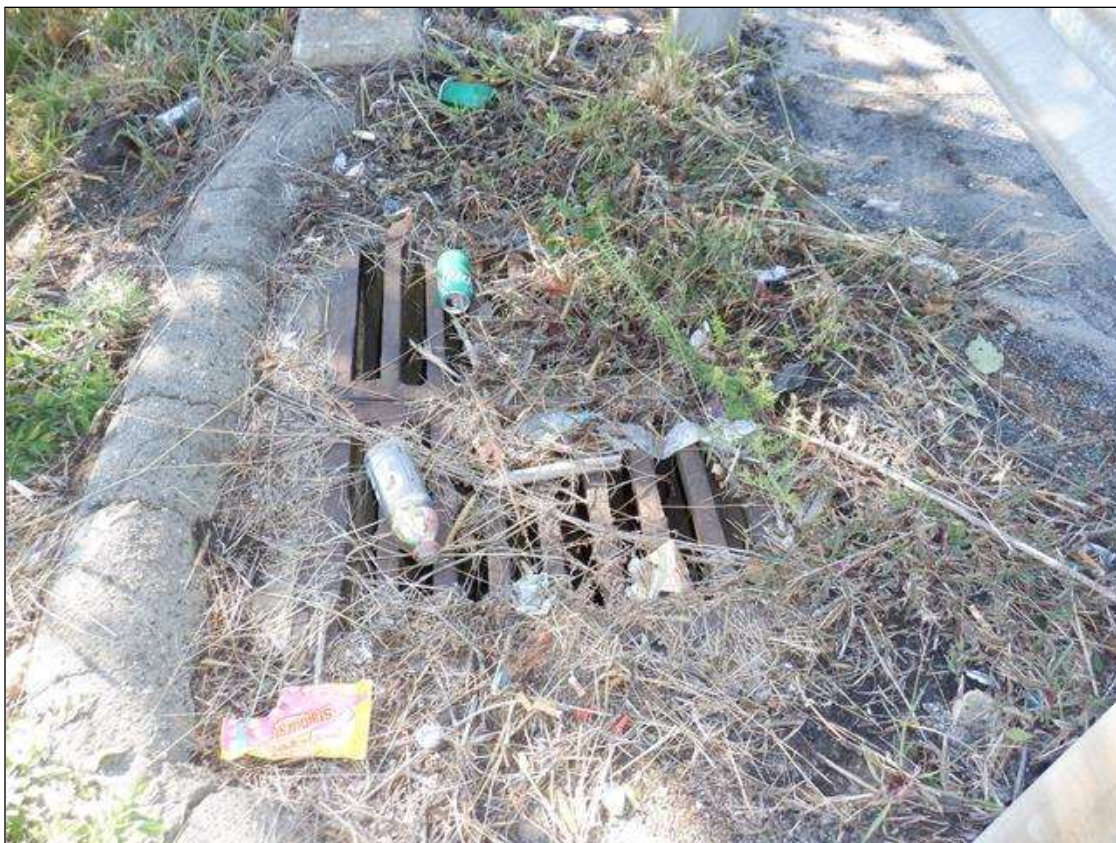
NORTHWEST CATCH BASIN CLOGGED WITH DEBRIS

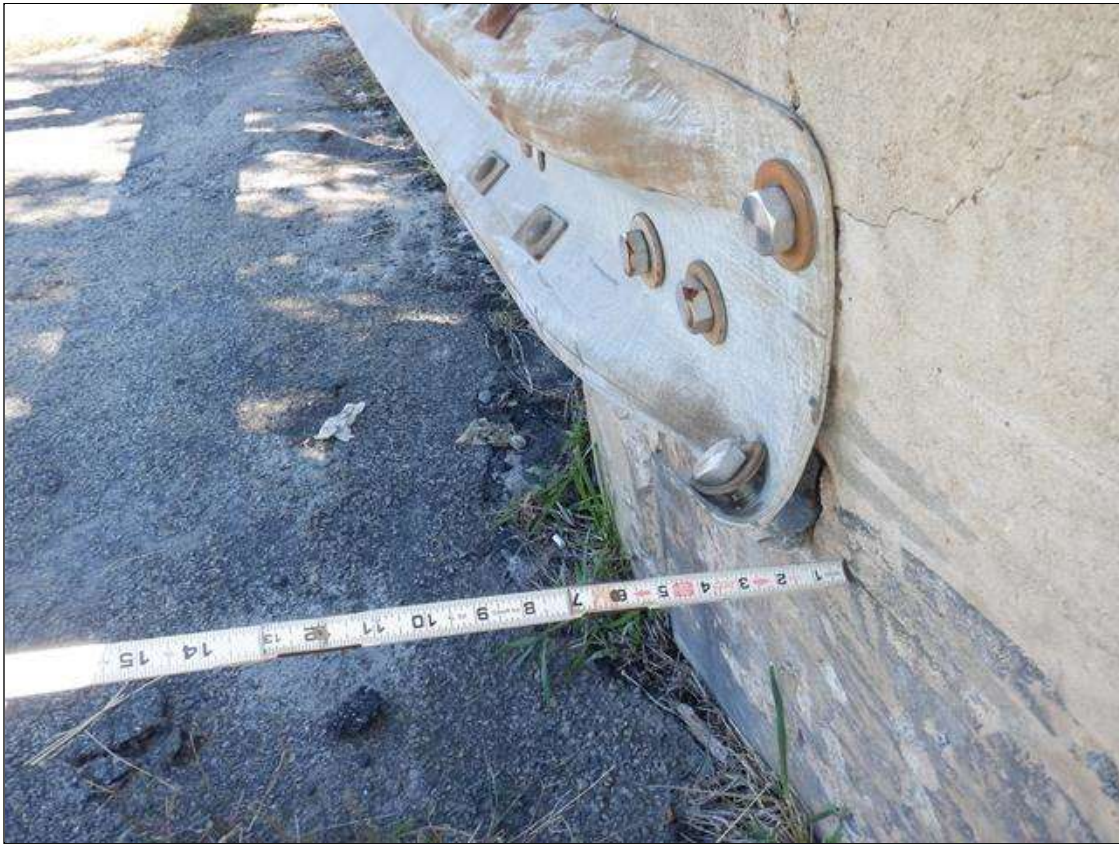
Span 1 Left Bridge Rail: PAR: 1 BOLT OF LEFT GUARDRAIL CONNECTION AT END BENT 1 HAS FAILED, CONNECTION STILL FUNCTIONING

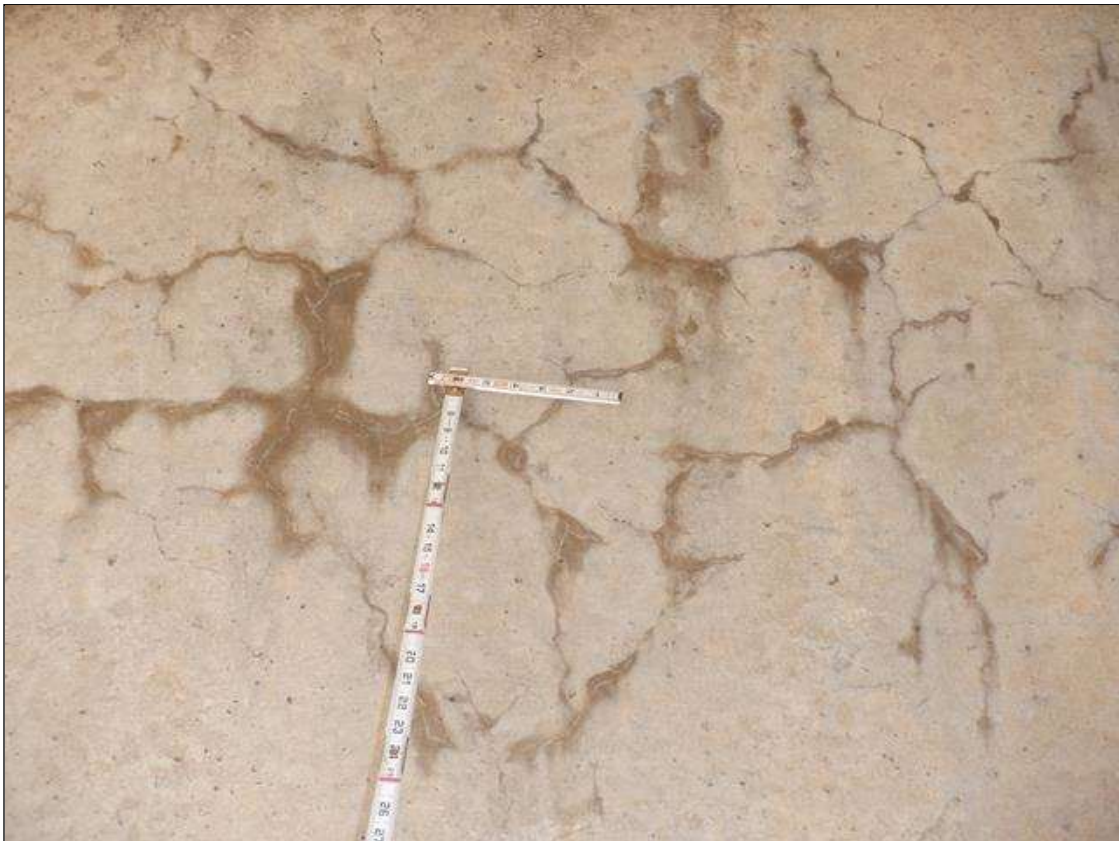
Bent 1 Cap 1: SCATTERED HAIRLINE MAP CRACKING THROUGHOUT FULL LENGTH OF CAP, UP TO FULL HEIGHT

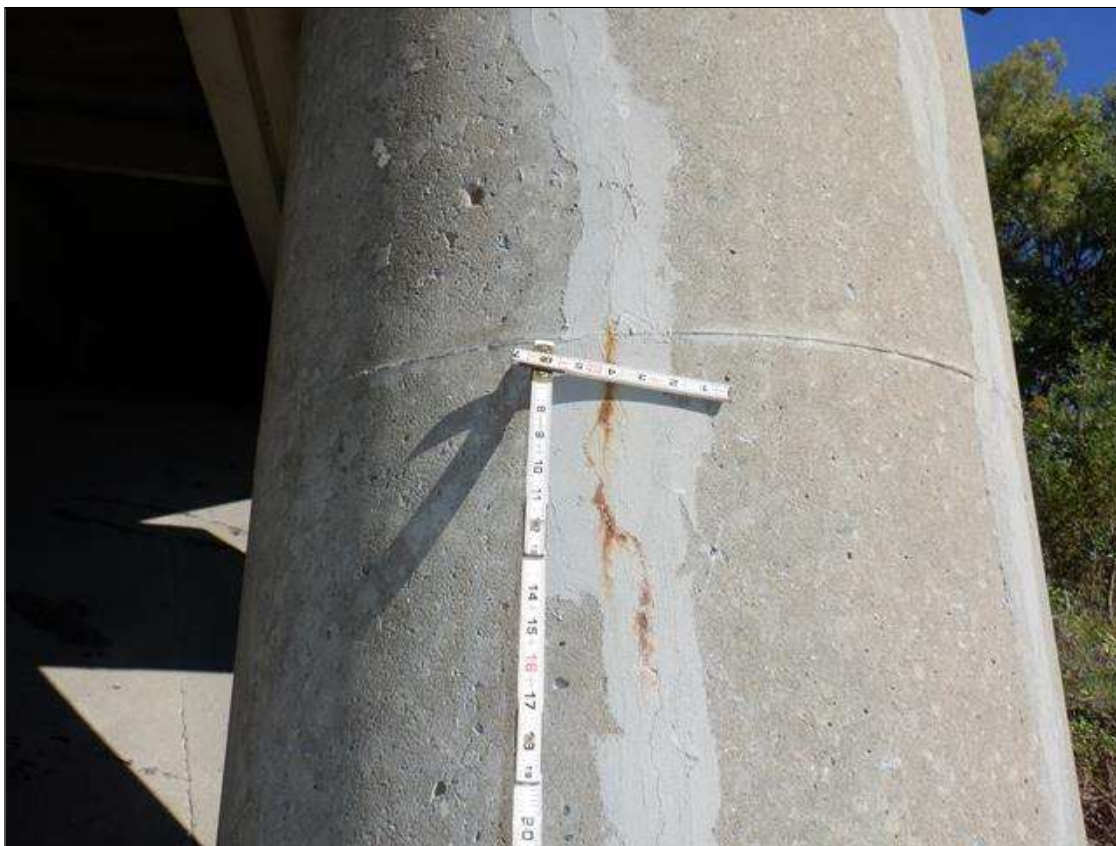
Bent 1 Pile 1: 15 FEET OF SEALED CRACK, SOME WITH RUST STAINING

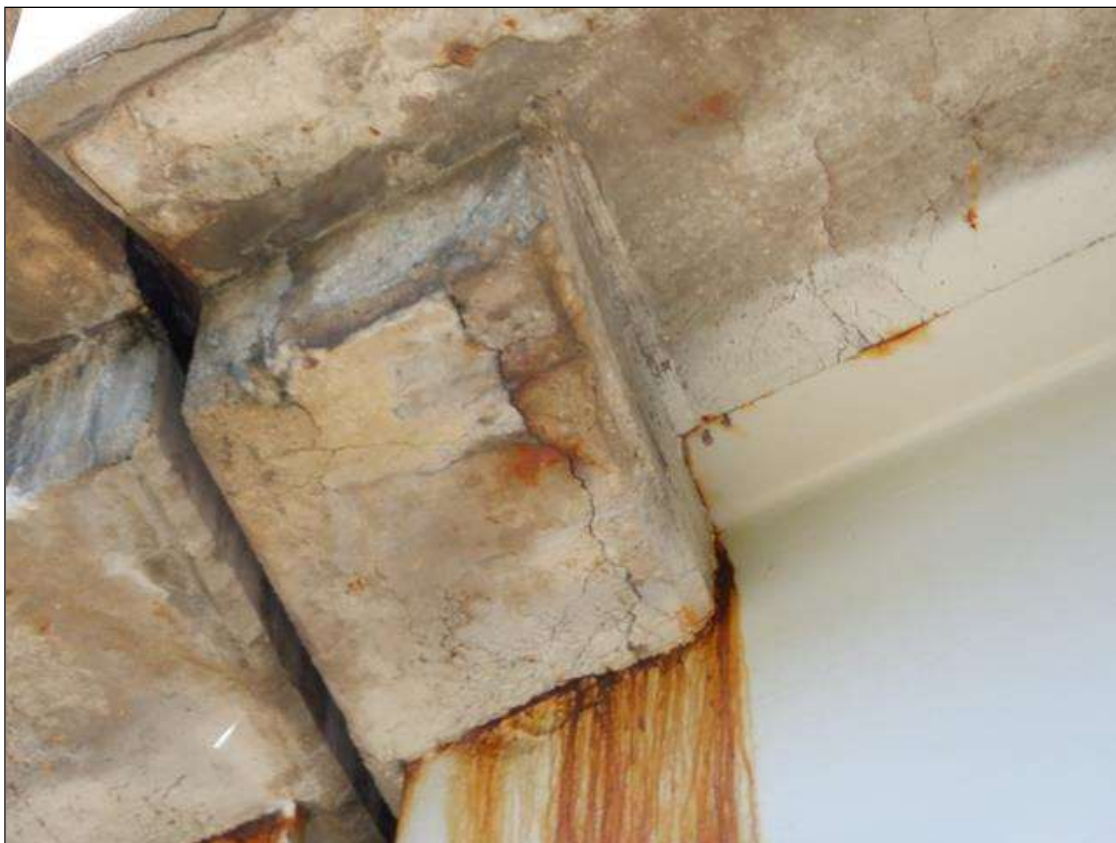
Span 1 Beam 1: AT BENT 1 LEFT OVERHANG DIAPHRAGM, DELAMINATION, 12 INCH X 6 INCH WITH RUST STAINS

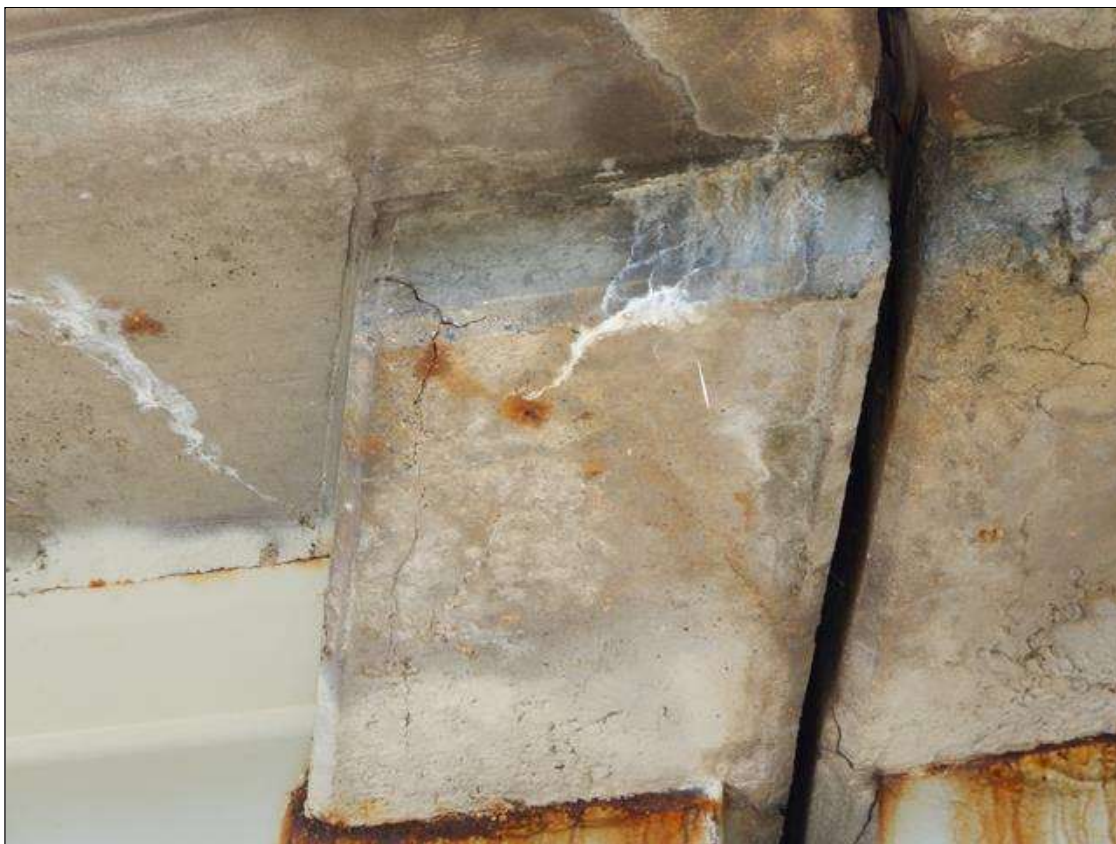
Span 2 Beam 1: AT BENT 1 LEFT OVERHANG DIAPHRAGM, DELAMINATION, 12 INCH X 6 INCH WITH EFFLORESCENCE

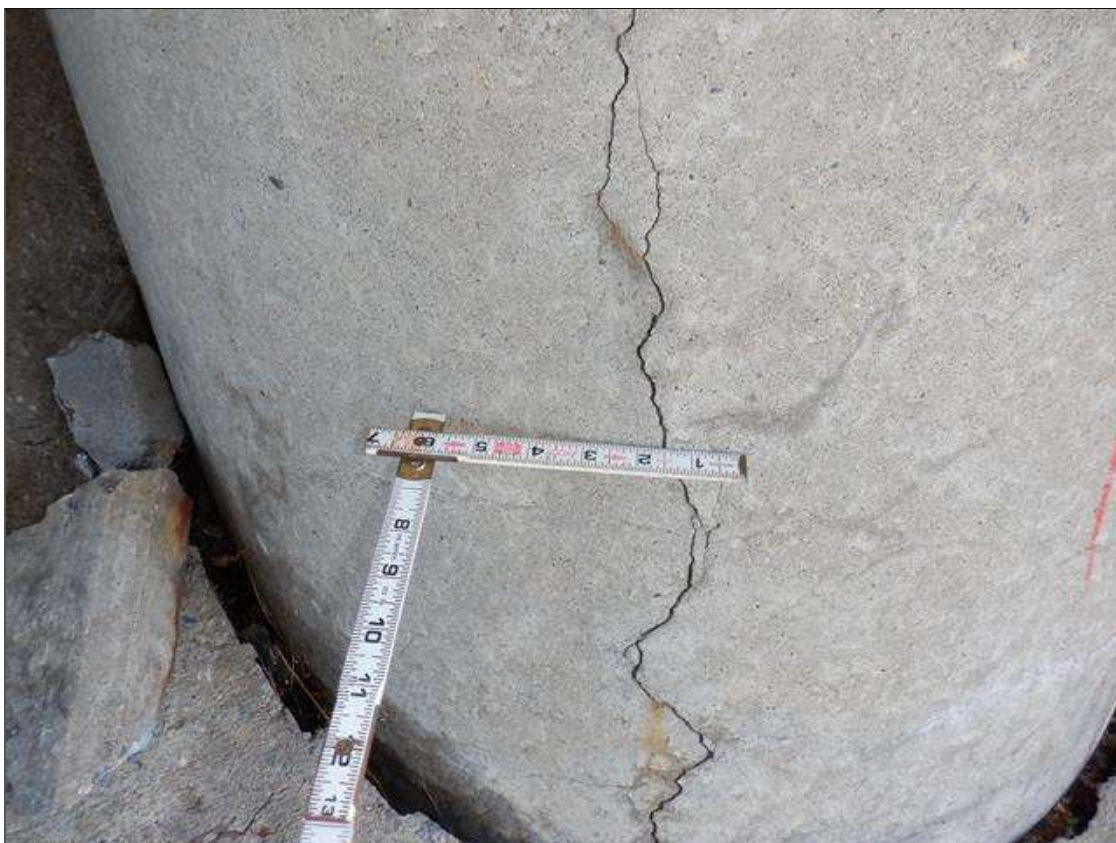
Bent 1 Pile 2: 1/4 INCH VERTICAL CRACKING UP TO 8 FEET HIGH

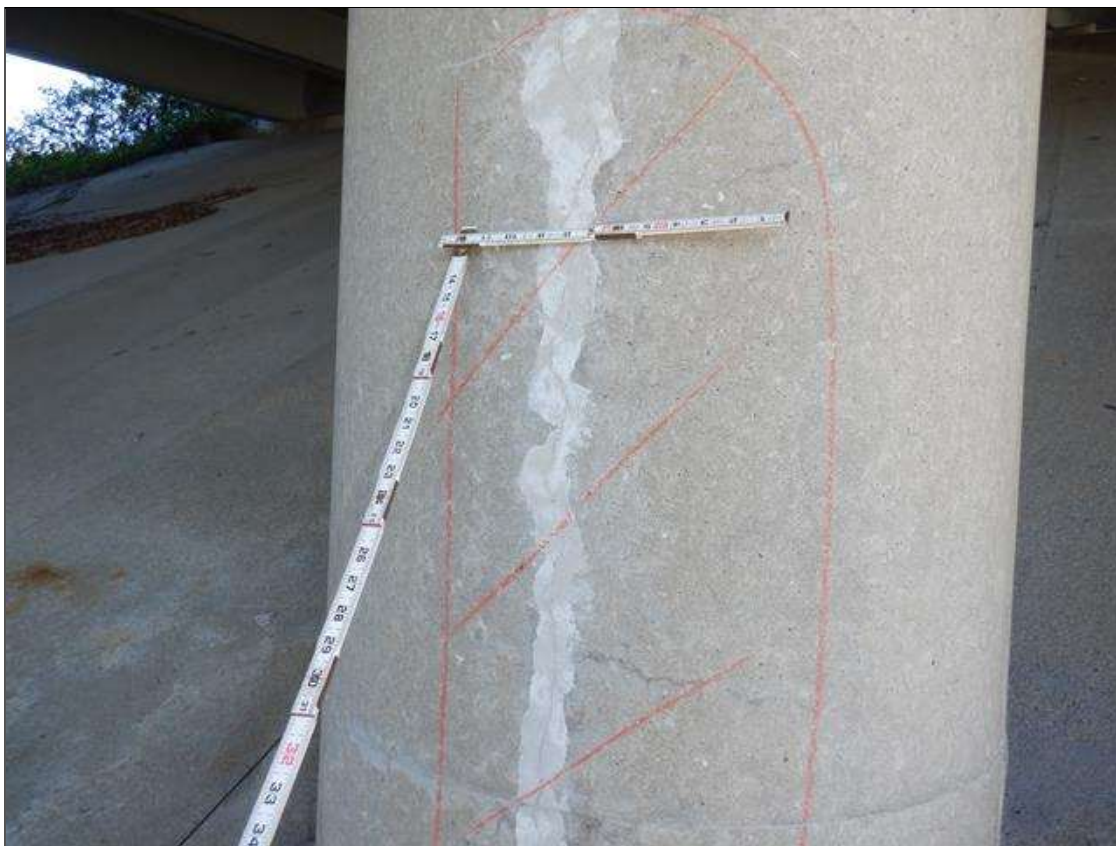
Bent 1 Pile 2: STARTING AT BOTTOM OF PILE ON EAST FACE, DELAMINATION 4 FOOT HIGH X 1 FOOT WIDE

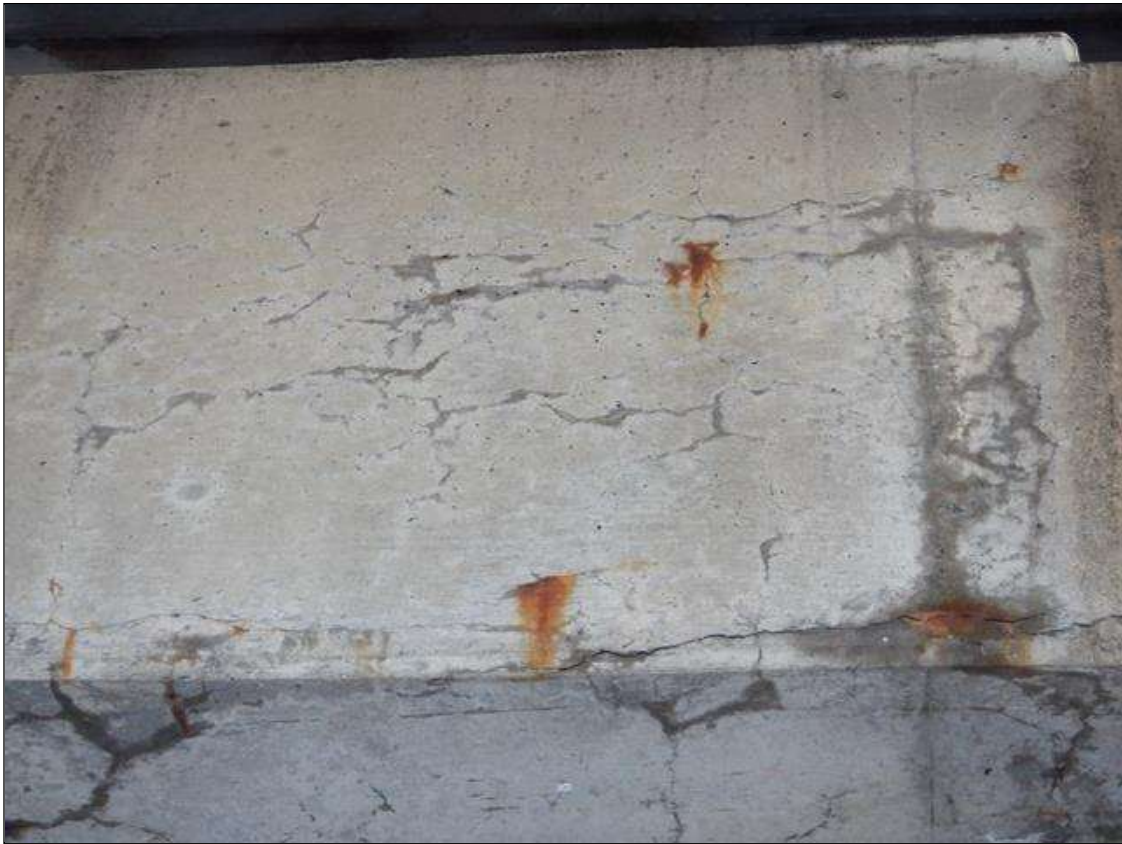
Bent 1 Cap 1: EAST FACE, BELOW GIRDER 7, DELAMINATED AREA UP TO 6 FOOT LONG X 2 FOOT HIGH WITH HAIRLINE CRACKS AND RUST STAINING

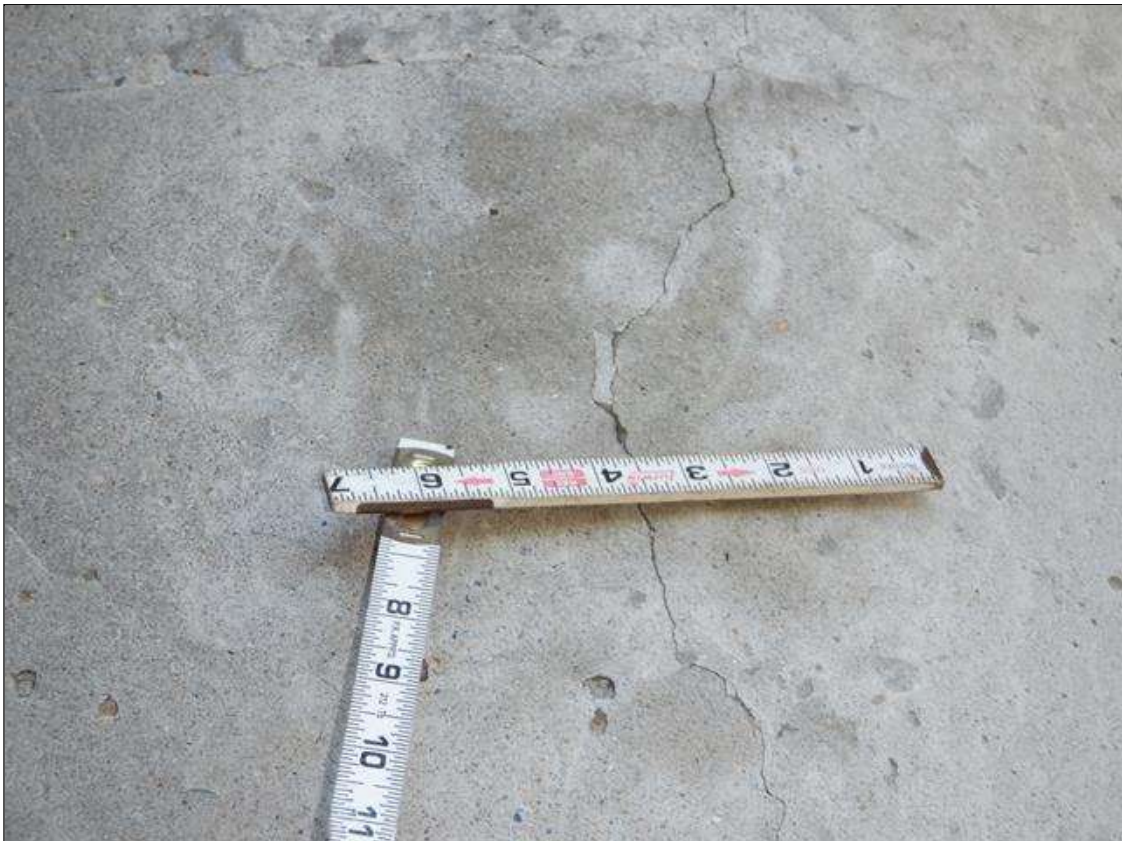
Bent 1 Pile 4: 8 FEET OF CRACKING UP TO 1/16 INCH WIDE

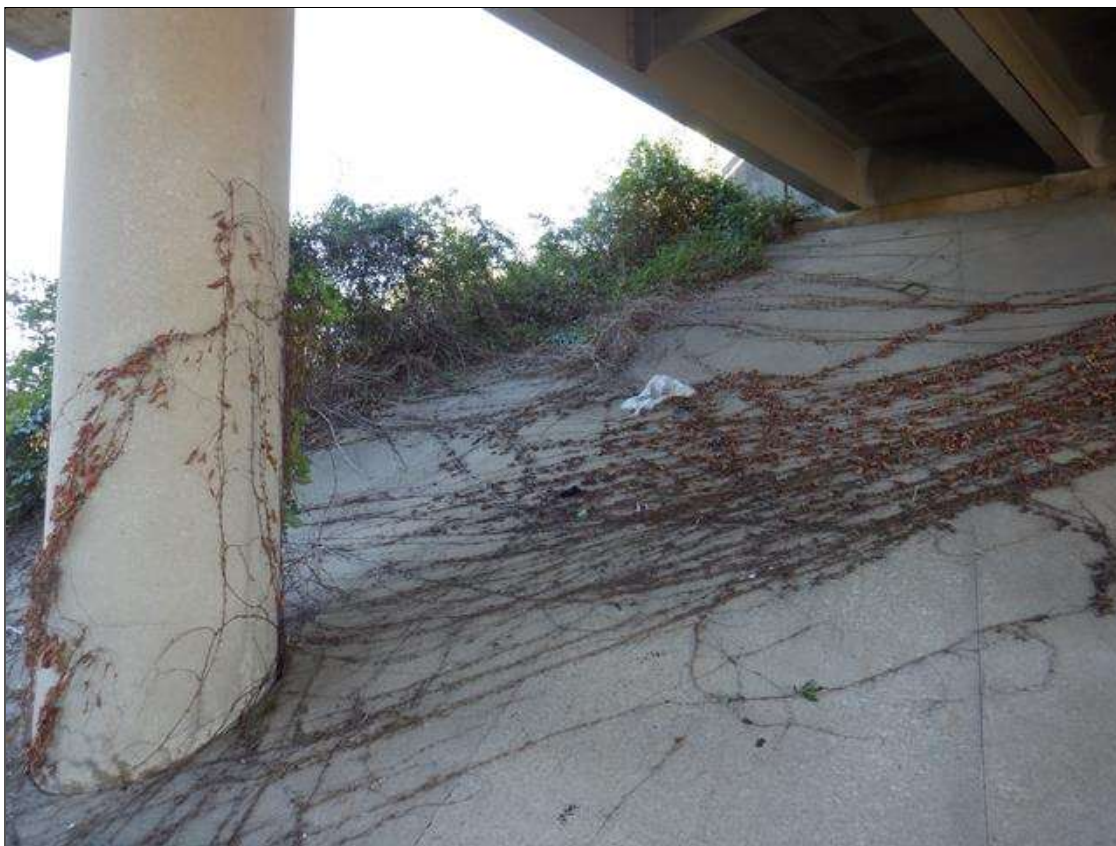
END BENT 1 SLOPE PROTECTION AT PILE 4, 250 SQUARE FEET OF VEGETATION GROWTH

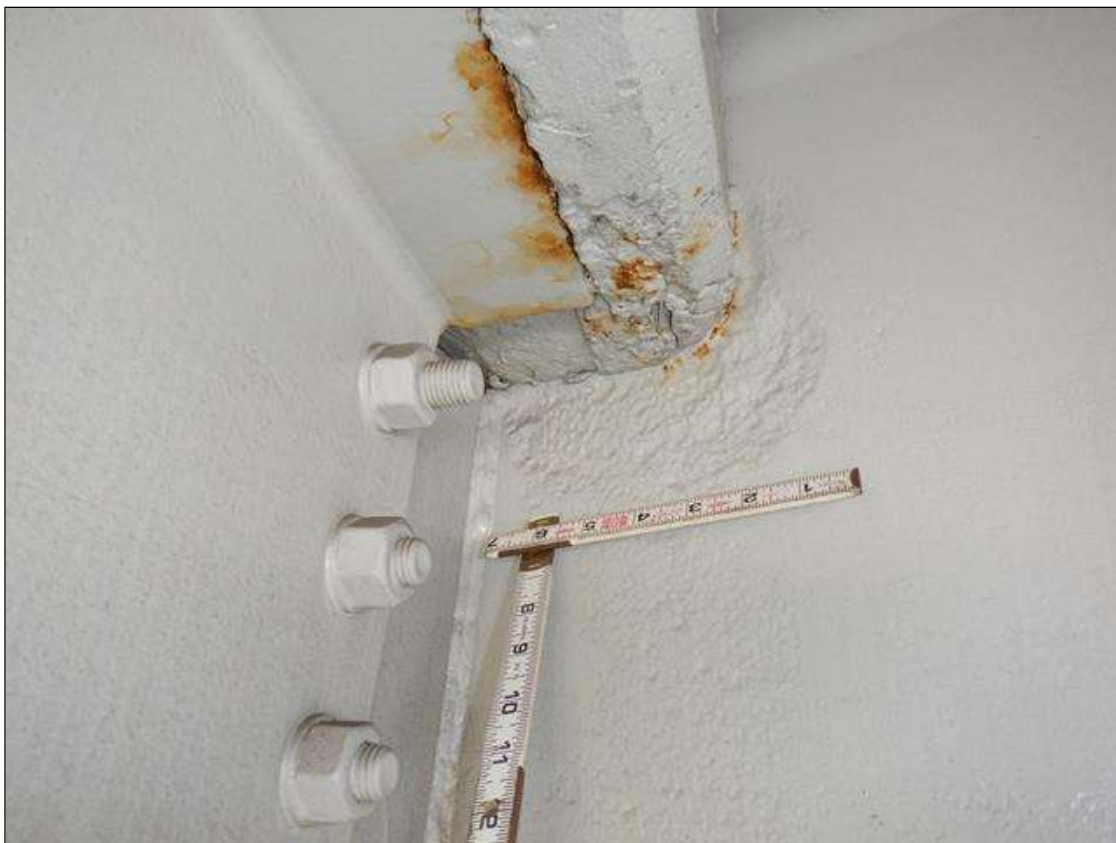
Span 2 Beam 5: 3/16 INCH SECTION LOSS (9/16 INCH REMAINING) ON LOWER 10 INCH AND TOP 3 INCH OF WEB FOR 10 INCH LONG AT BENT 1. CORROSION HAS BEEN ARRESTED
