NC DEPARTMENT OF TRANSPORTATION
 DIVISION OF HIGHWAYS
 STRUCTURE MANAGEMENT UNIT

ATTENTION: **CHANGE TO STRUCTURE DATA, PAR SUBMITTED, REQUEST LIDAR, NEWLY STRUCTURALLY DEFICIENT**

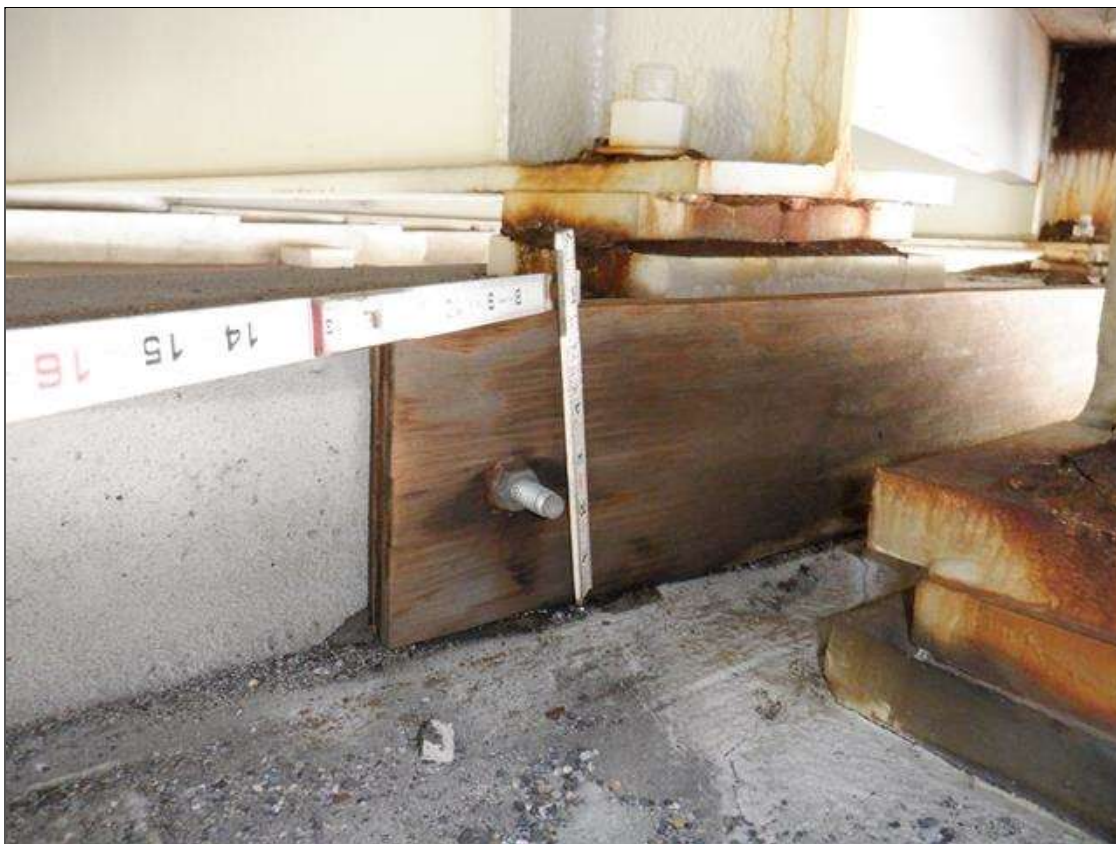
Bent 1 Cap 1: PATCHED PREVIOUS PRIORITY MAINTENANCE UNDER GIRDER 5 SPAN 1

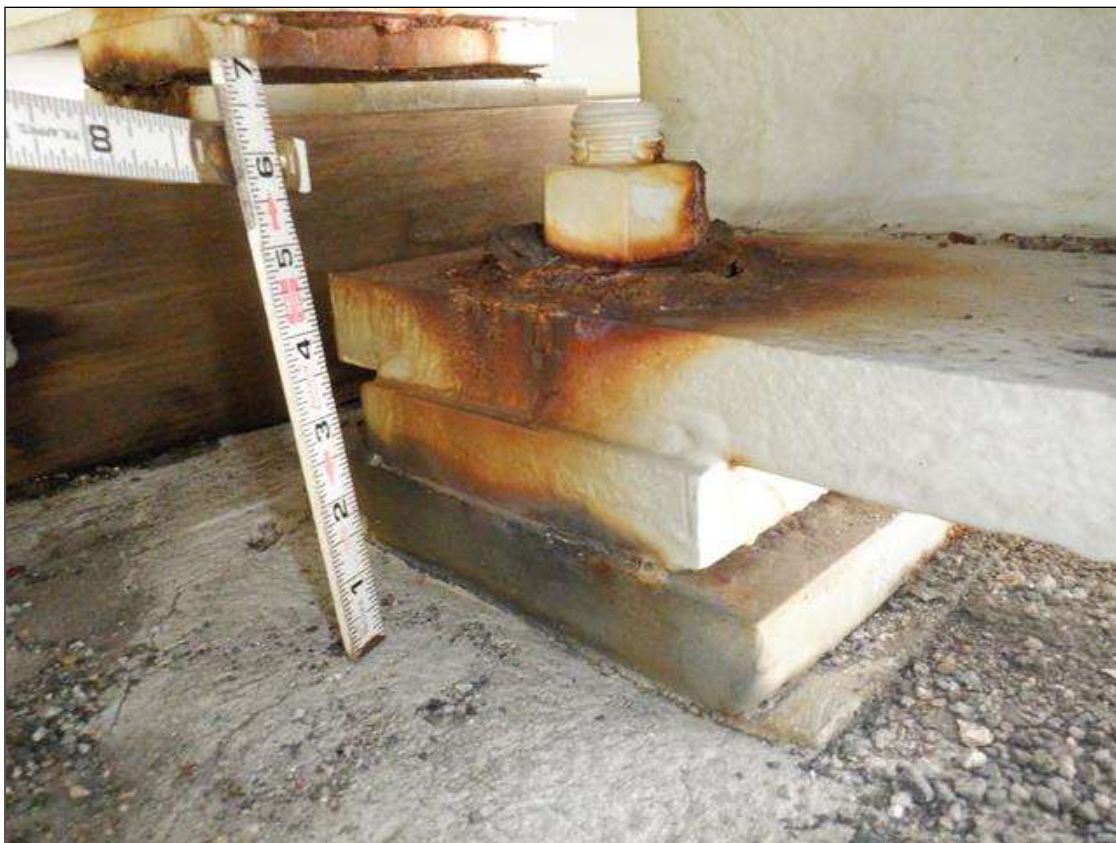
Span 2 Beam 5 - Near Bearing: FRECKLED RUST ON BEARING PLATES

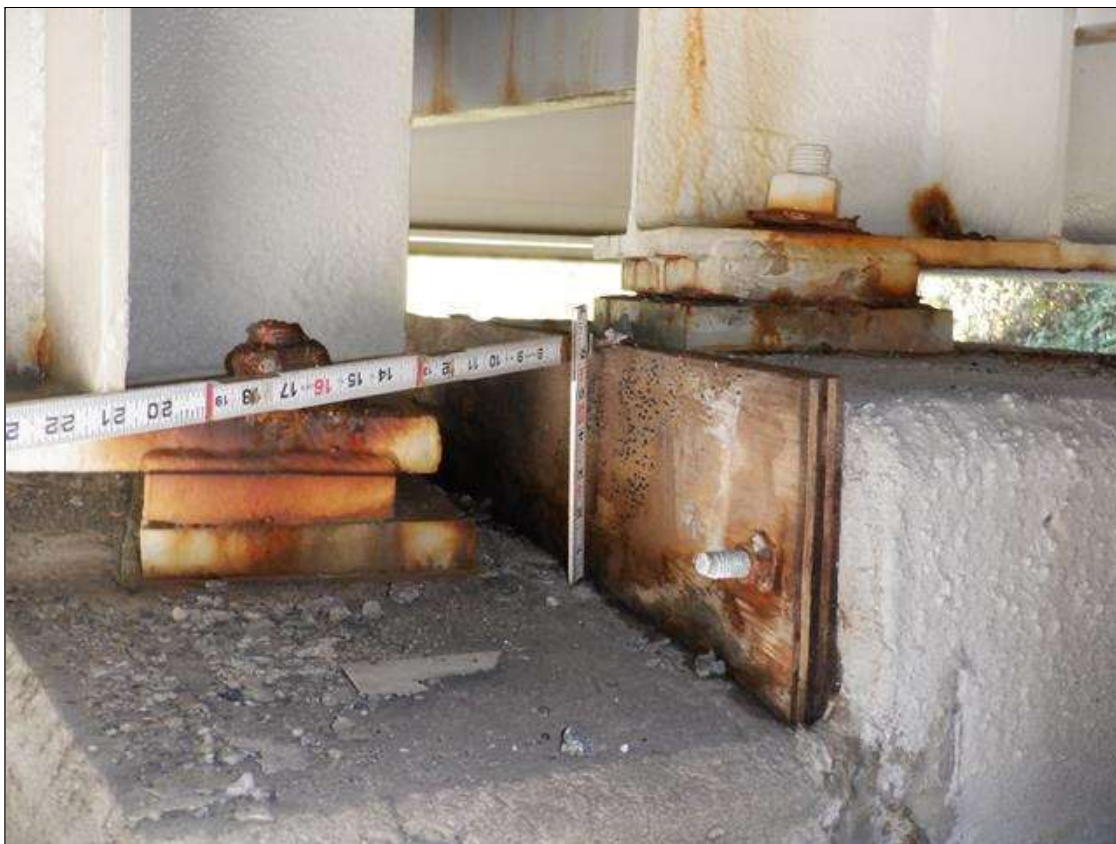
Bent 1 Cap 1: PATCHED PREVIOUS PRIORITY MAINTENANCE UNDER GIRDER 6 SPAN 1

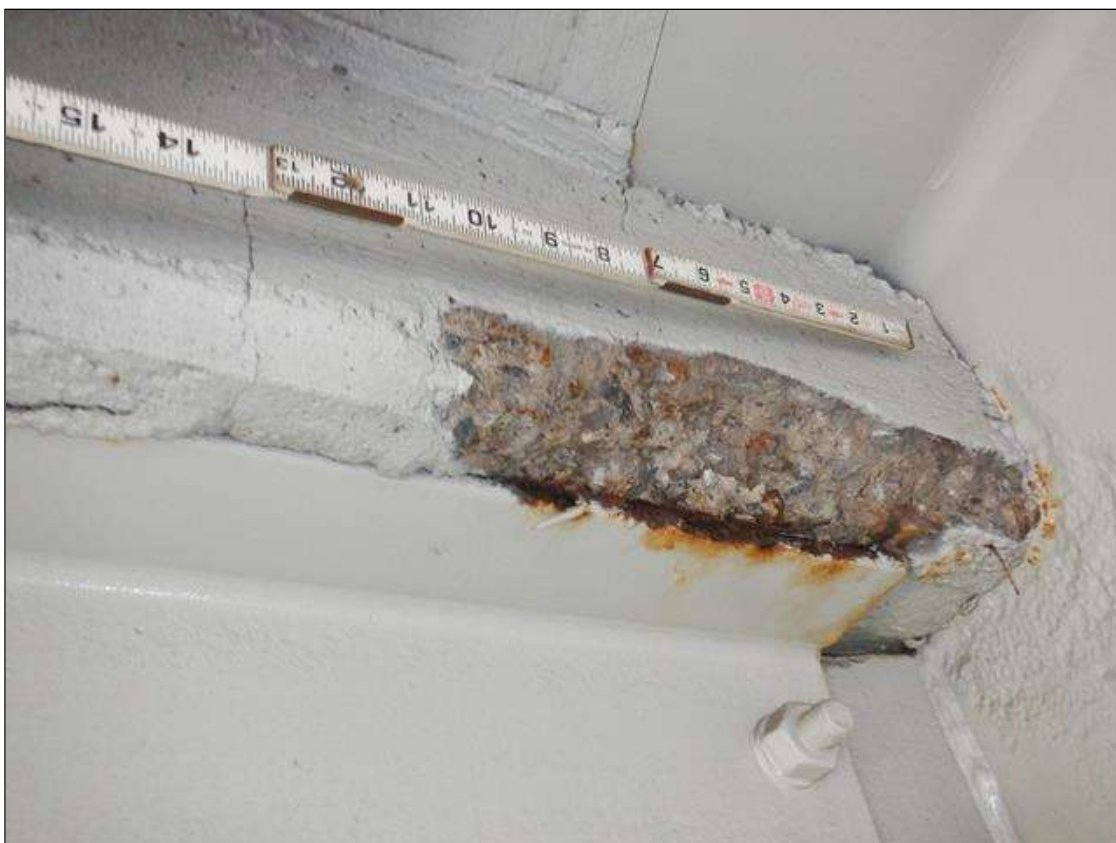
Span 2 Beam 5: BENT 1 BAY 5 DIAPHRAGM, SPALL, 10 INCH X 3 INCH X 1 INCH DEEP

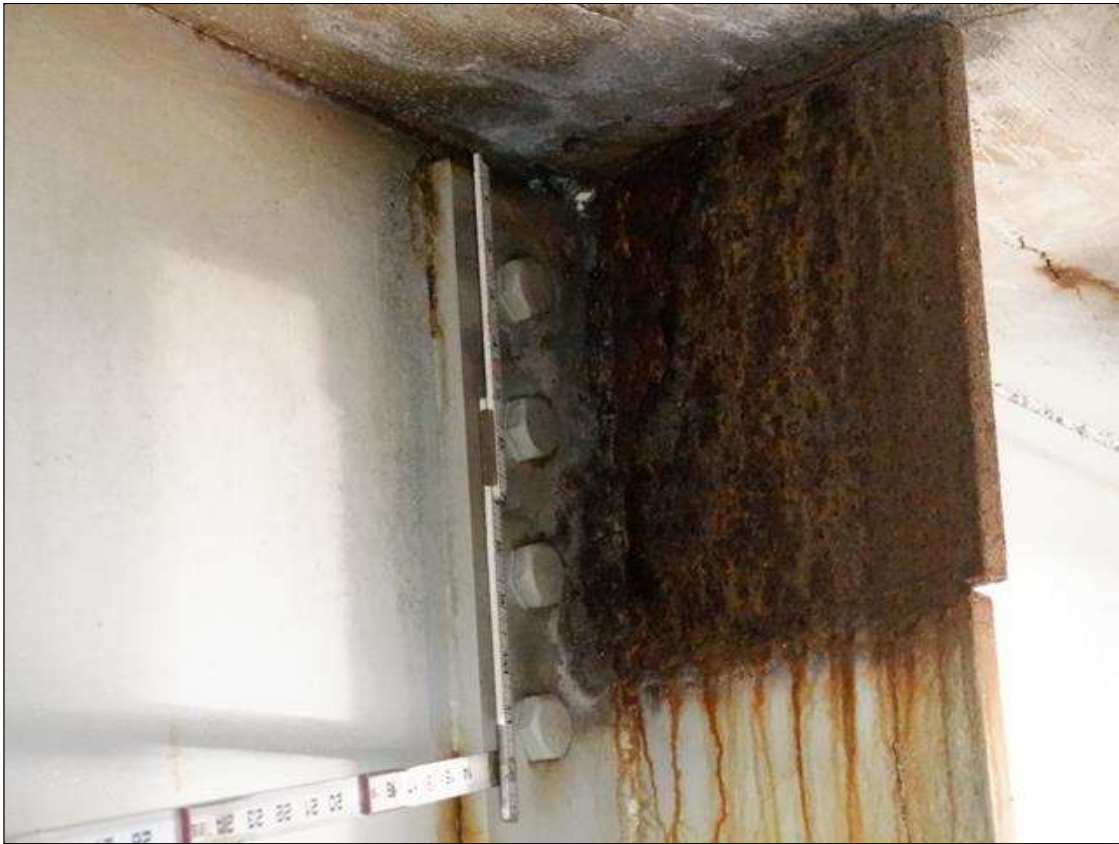
Span 1 Beam 4: AT BENT 1, TOP 9 INCHES OF WEB HAS A REPAIR PLATE, 9 INCH HIGH X 9 INCH LONG X 1/2 INCH THICK WITH RUST SCALE

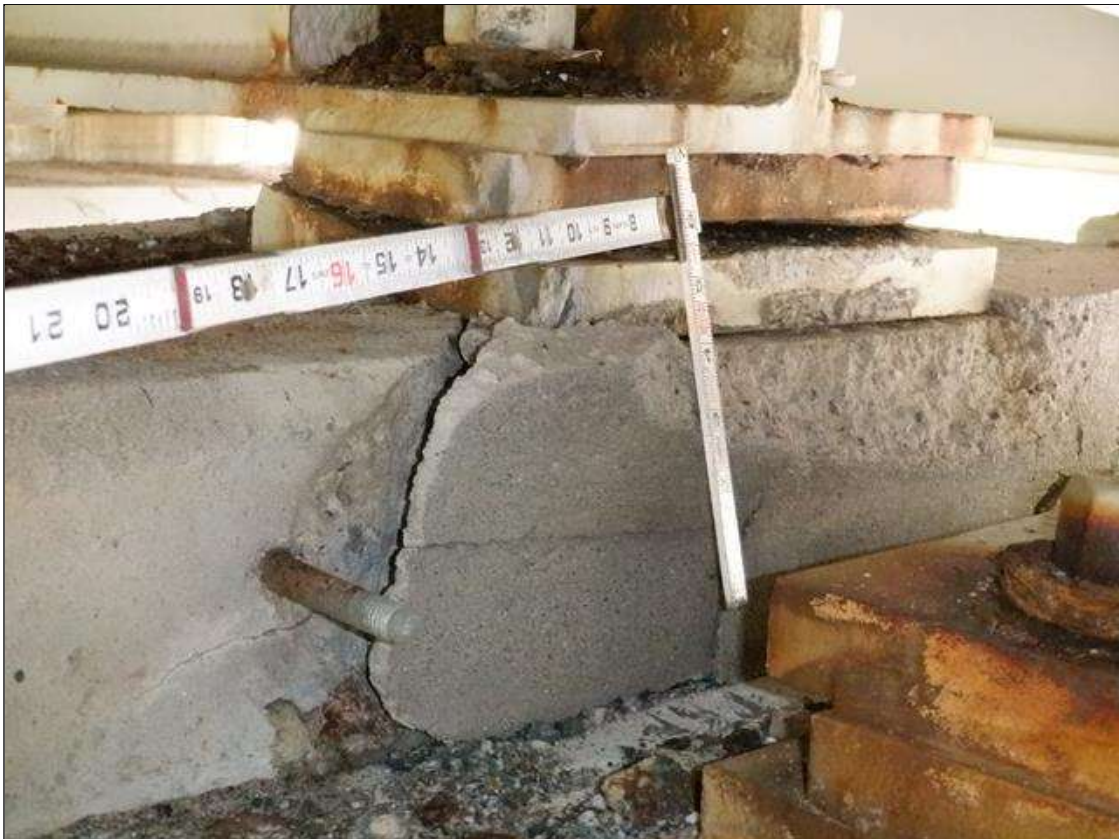
Bent 1 Cap 1: 14 INCH X 3 INCH X 1 INCH DEEP SPALL ON PEDESTAL UNDER GIRDER 4 SPAN 1 WITH NO LOSS OF BEARING AT EAST END OF BEAM, NO EXPOSED REINFORCEMENT

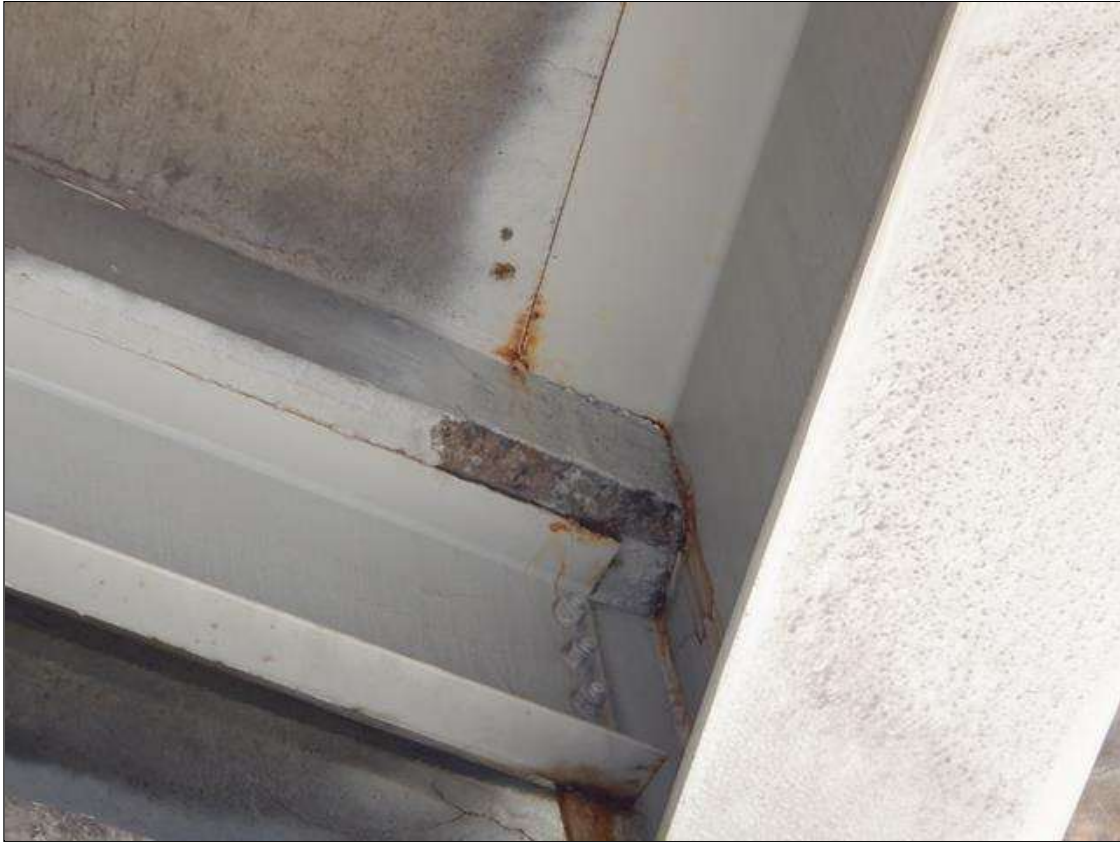
Span 2 Beam 1: AT BENT 1 BAY 1 DIAPHRAGM, SPALL, 1 FOOT LONG X 2 INCH HIGH X 1 INCH DEEP

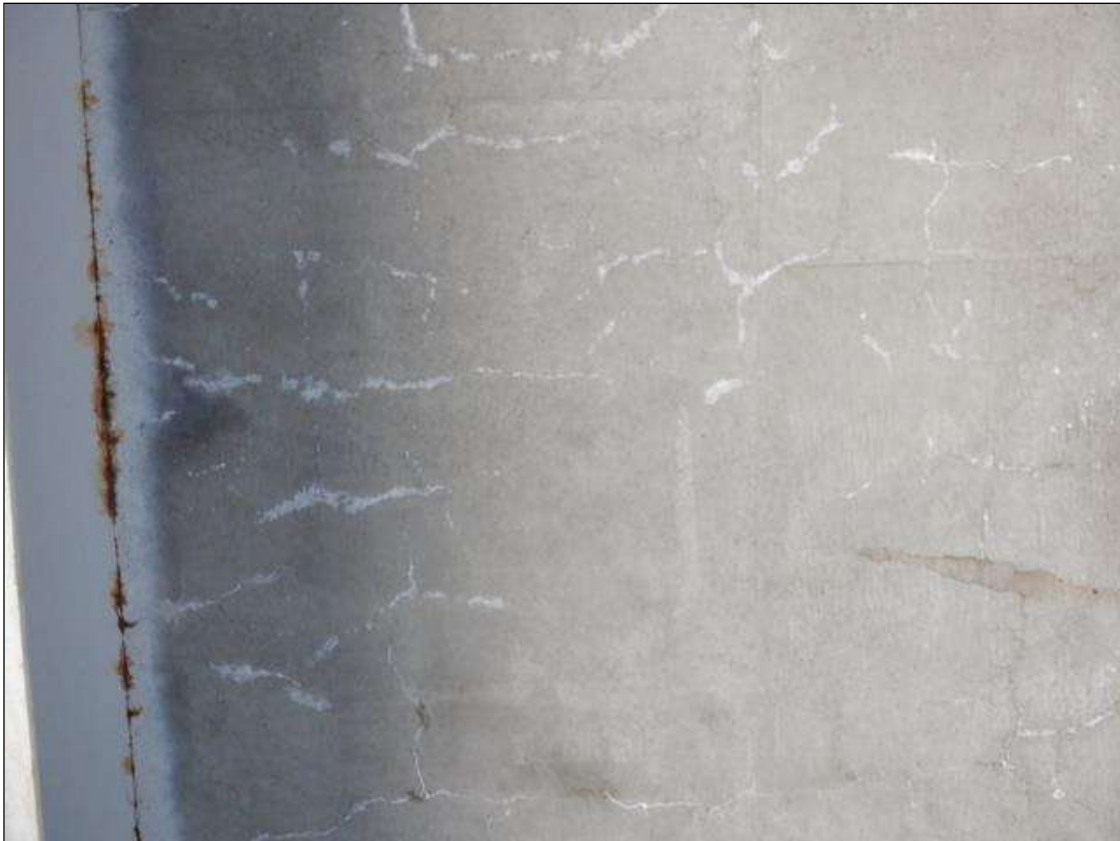
Span 2 Deck: HAIRLINE MAP CRACKING WITH EFFLORESCENCE SCATTERED THROUGHOUT UNDERSIDE

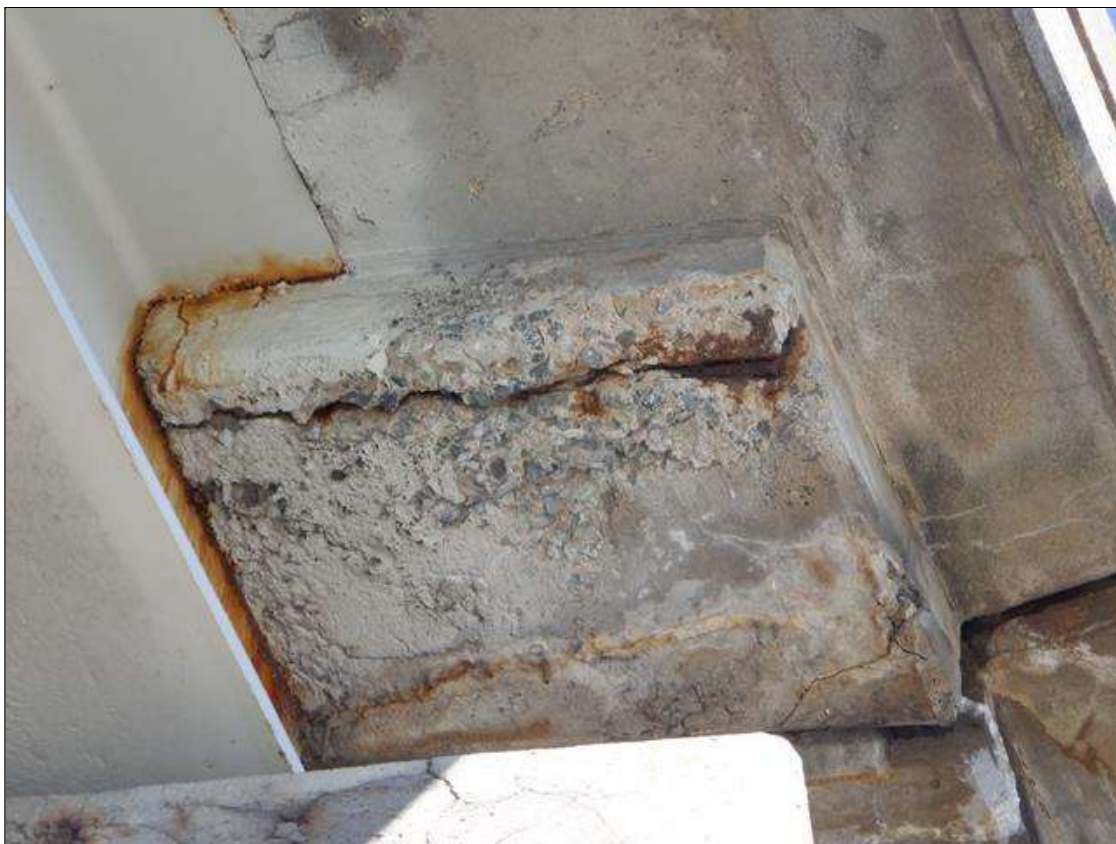
Span 3 Beam 1: PAR: AT BENT 2 LEFT OVERHANG DIAPHRAGM, SPALL 2 FOOT WIDE X 8 INCH LONG X 2 INCH DEEP WITH EXPOSED REBAR, 5 PERCENT SECTION LOSS

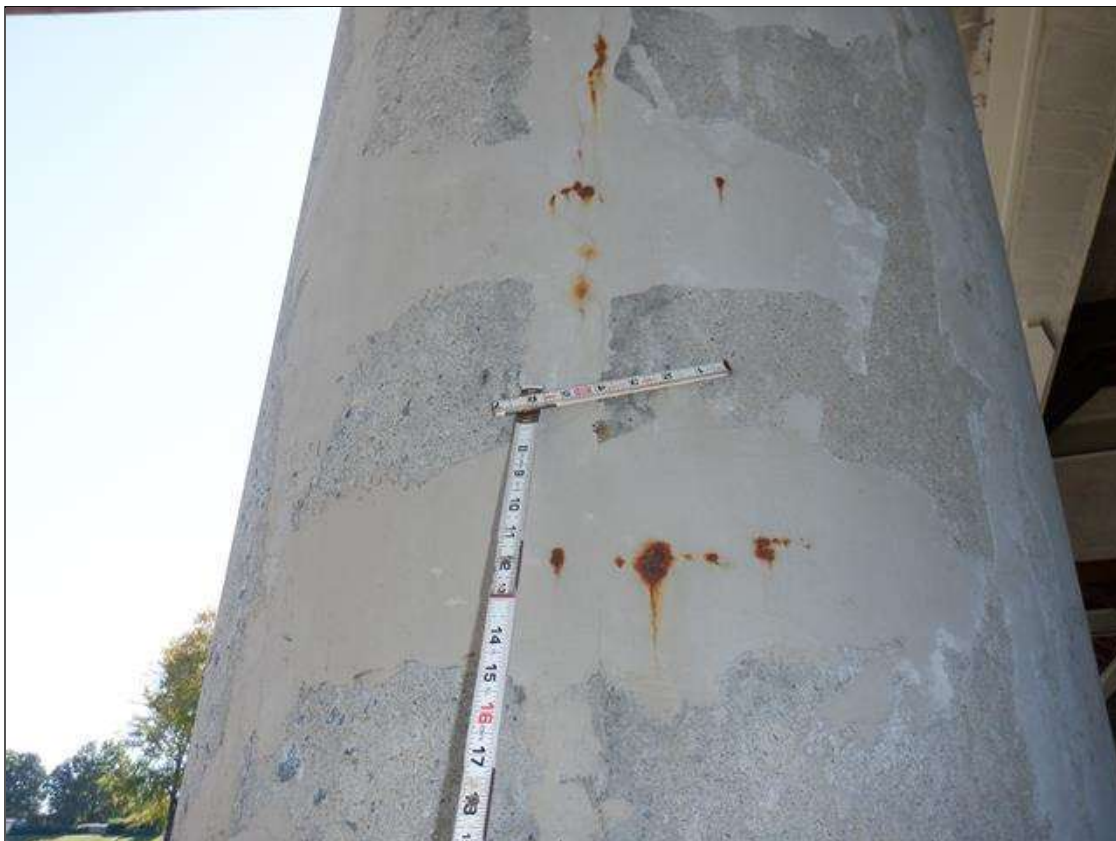
Bent 2 Pile 1: FULL HEIGHT PATCHED AREAS ON WEST FACE WITH RUST STAINS

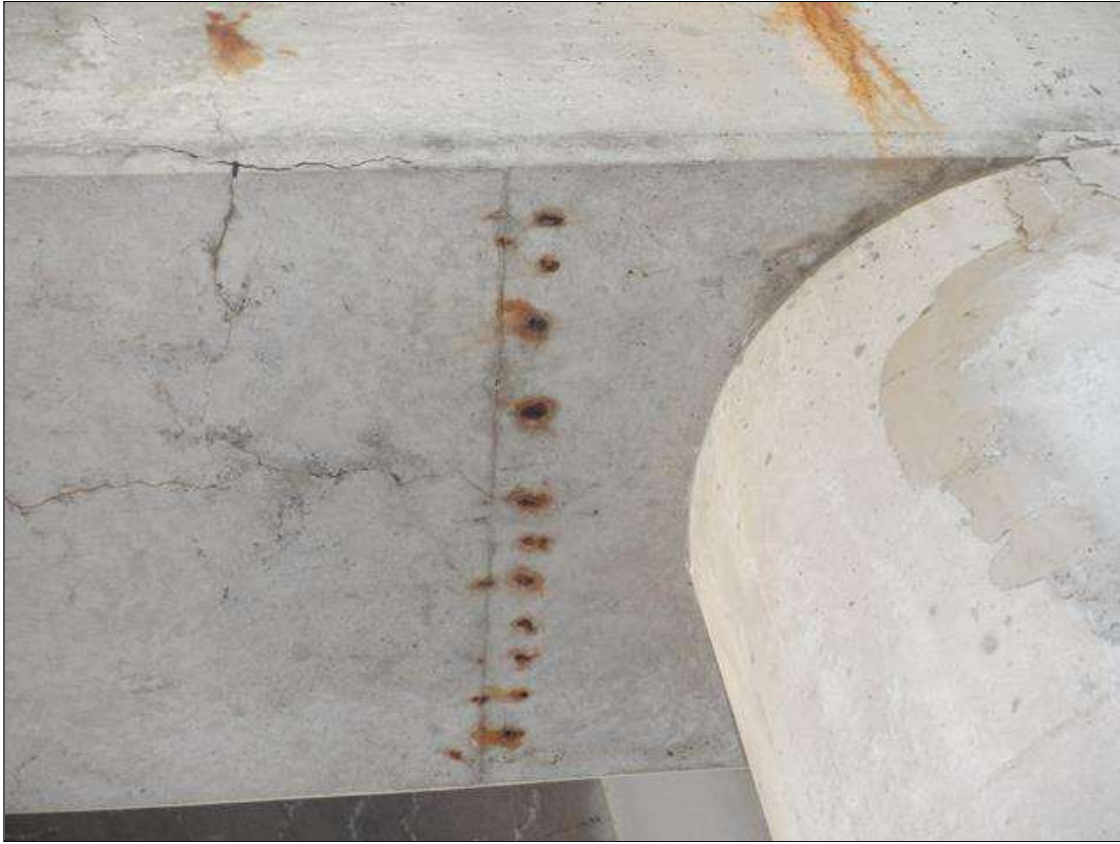
Bent 2 Cap 1: ALONG CAP SOFFIT, 12 FEET OF EXPOSED REBAR CHAIRS

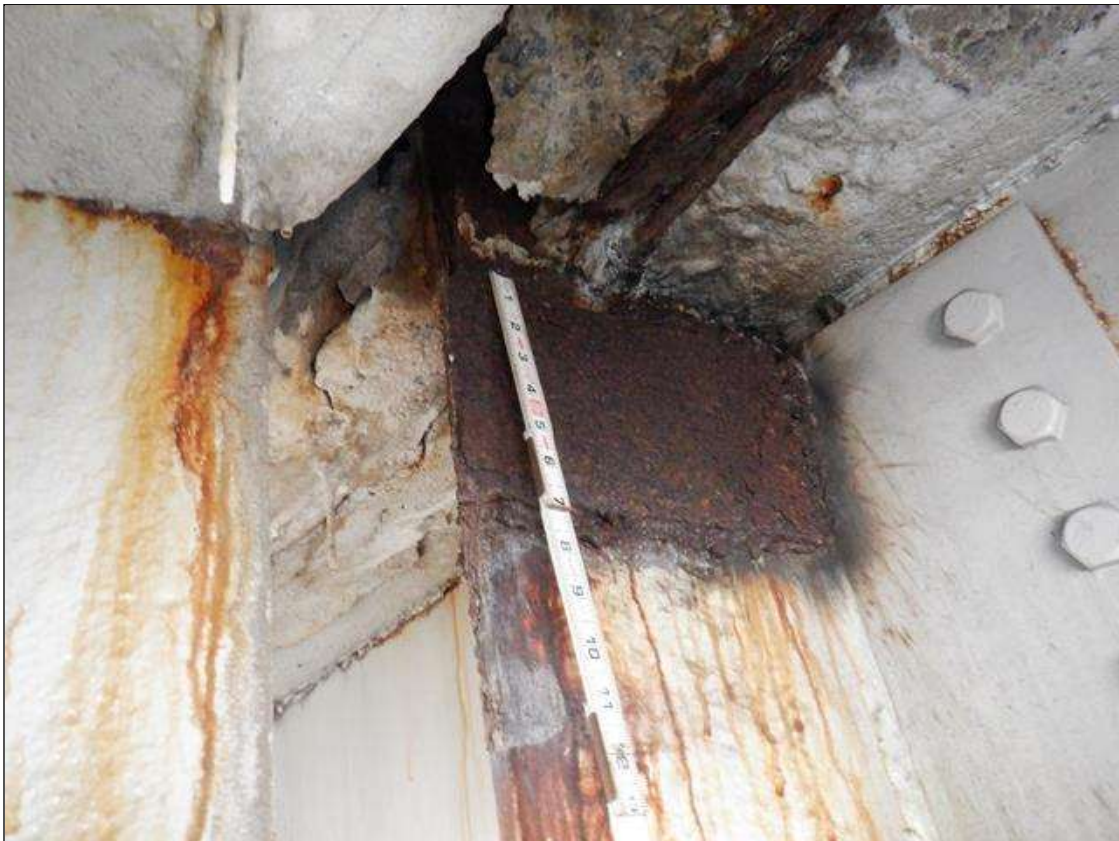
Span 3 Beam 5: AT BENT 2, TOP 6 INCHES OF WEB HAS A REPAIR PLATE, 6 INCH X 6 INCH X 1/2 INCH THICK WITH RUST SCALE

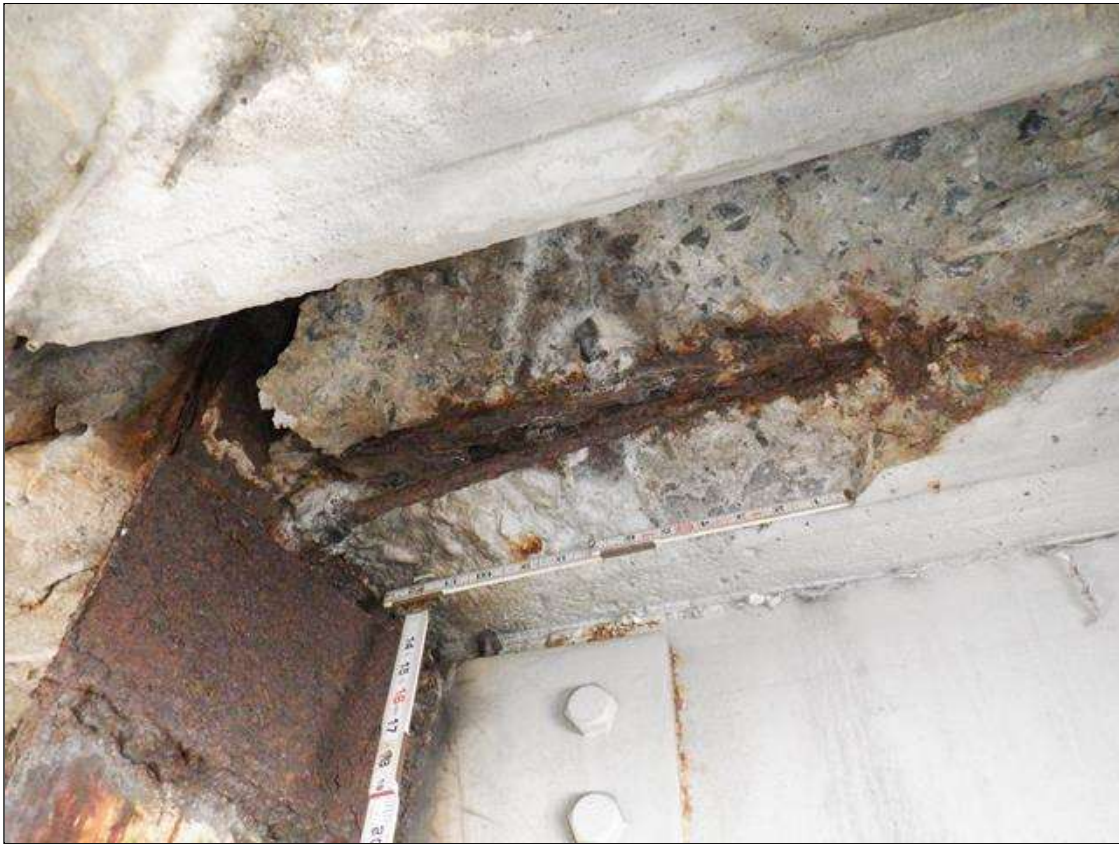
Span 3 Deck: PAR: 2 FEET X 10 INCH X 5 INCH DEEP SPALL WITH EXPOSED REBAR, 5 PERCENT SECTION LOSS, IN UNDERSIDE OF BAY 5 OVER BENT 2

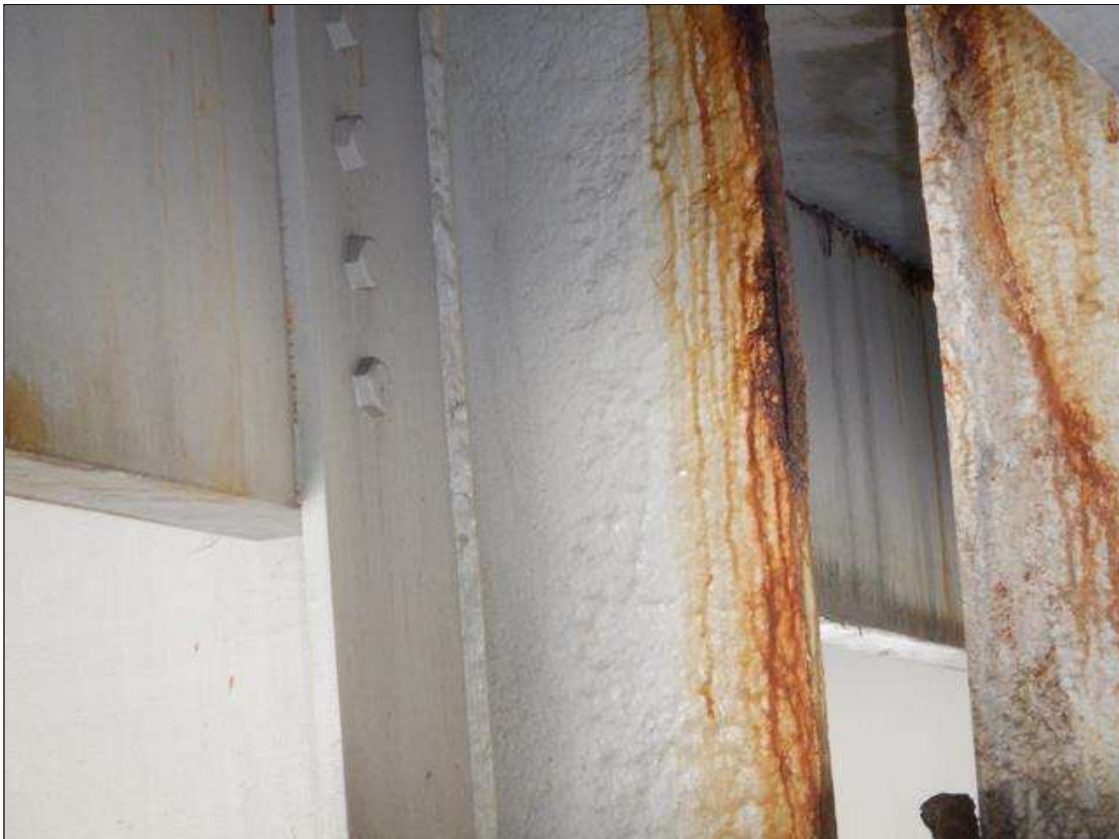
Span 3 Beam 6: CORROSION WITH 1/16 INCH PITTING (11/16 INCH REMAINING) ON FULL HEIGHT OF WEB AT BENT 2

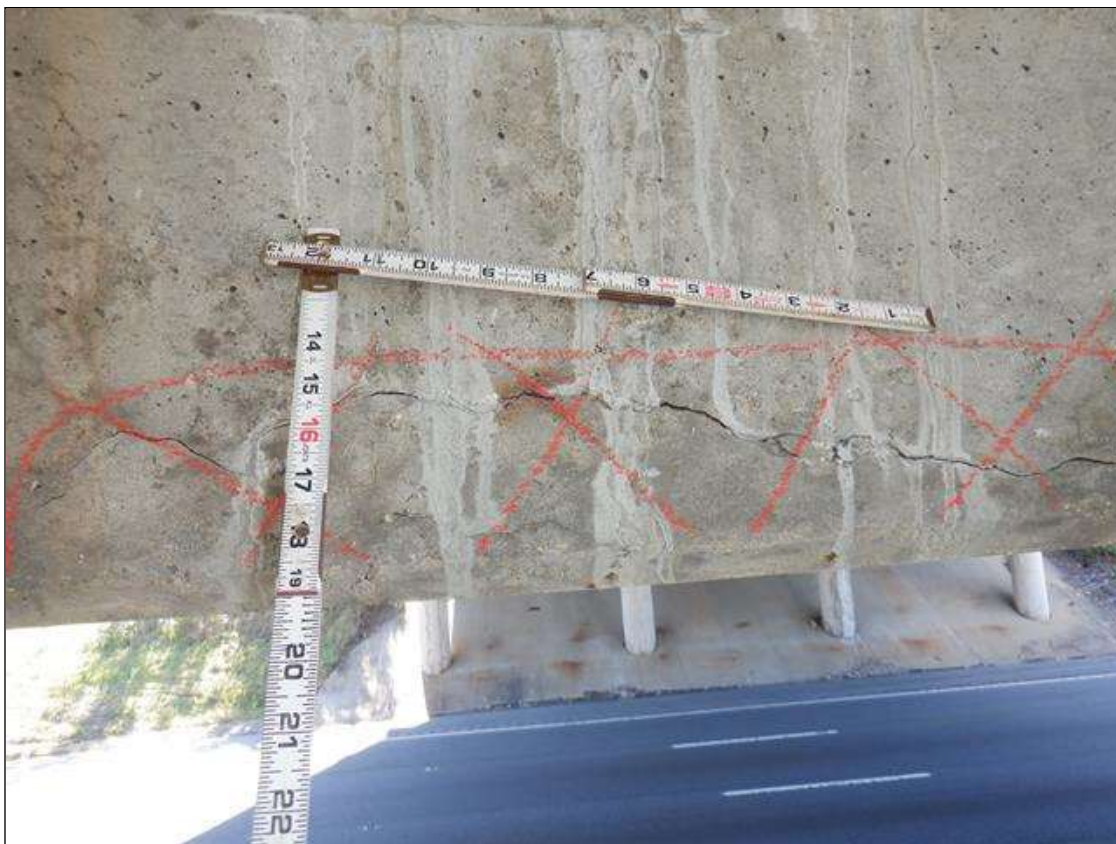
Bent 2 Cap 1: WEST FACE BELOW GIRDER 5 AT BOTTOM OF CAP, DELAMINATION 2 FOOT LONG X 6 INCH HIGH

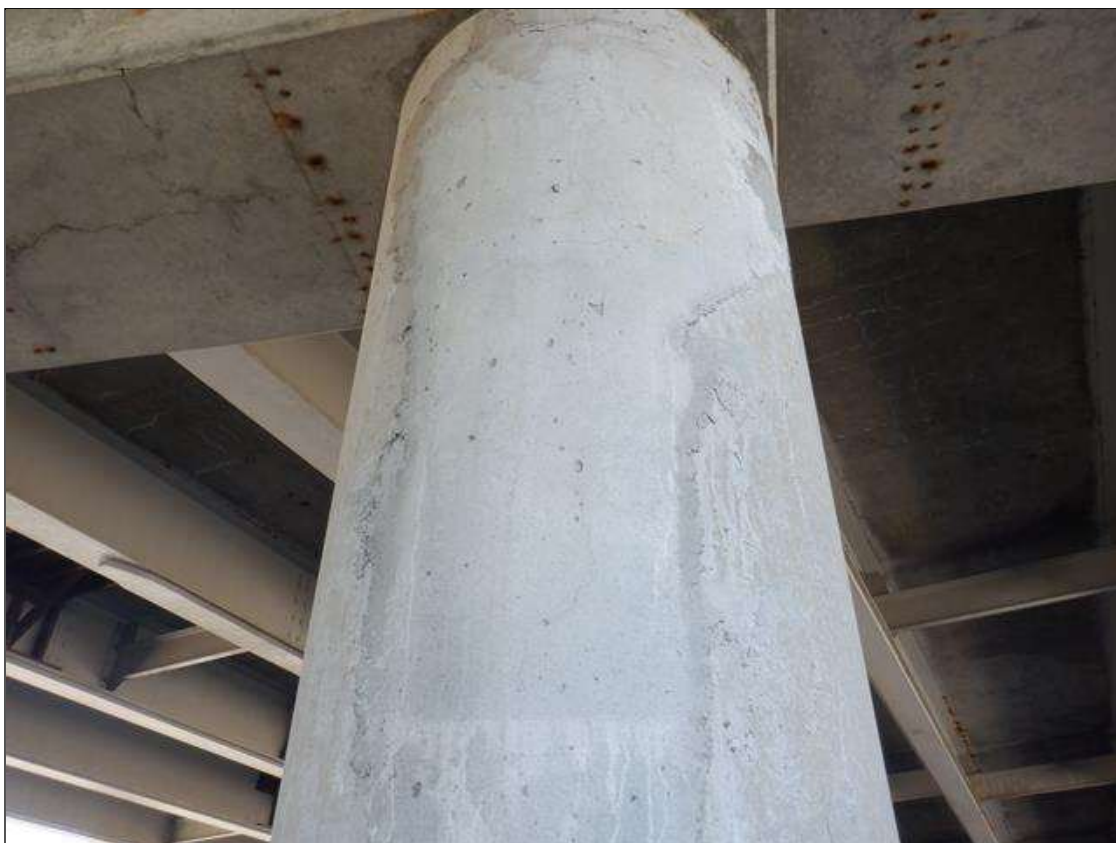
Bent 2 Pile 3: PATCHED AREAS WITH HAIRLINE CRACKS ON WEST FACE AND SOUTH FACE, 4 FEET WIDE X 7 FEET HIGH

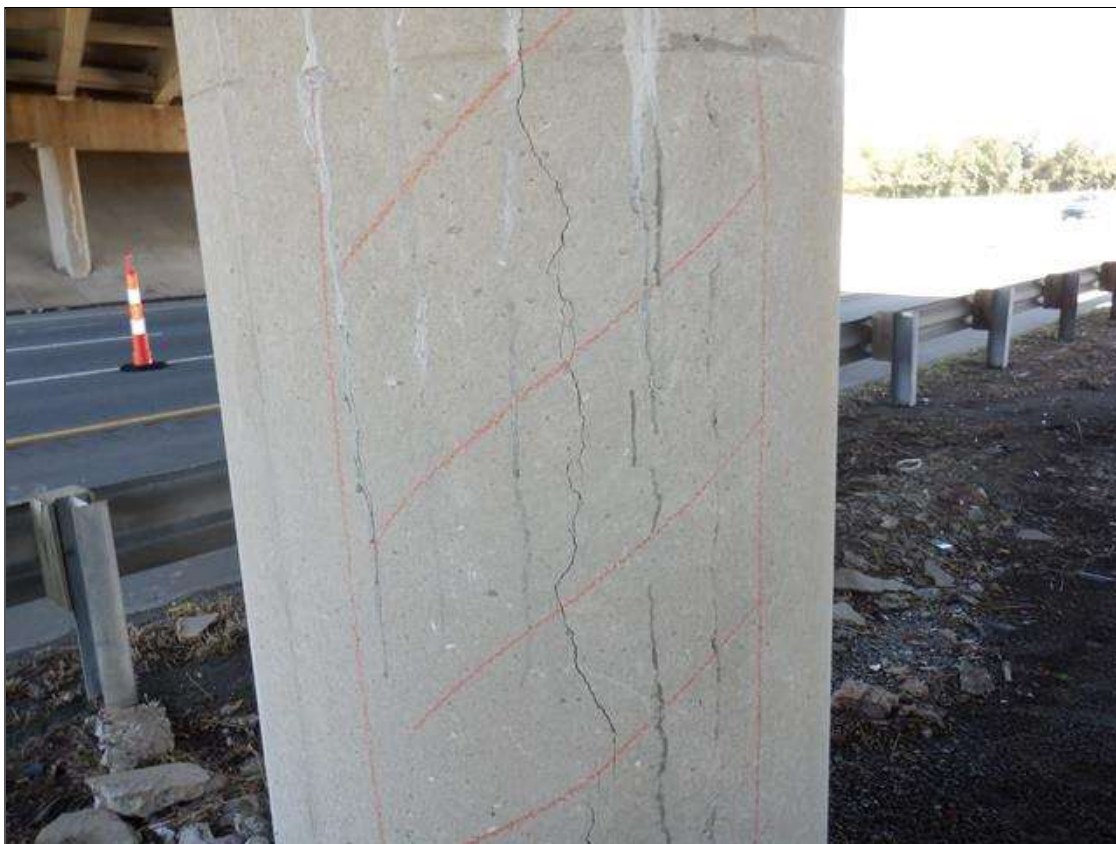
Bent 2 Pile 3: SOUTHEAST FACE STARTING AT GROUND LINE, 6 FOOT HIGH X 2 FOOT WIDE DELAMINATION WITH CRACK UP TO 1/8 INCH WIDE

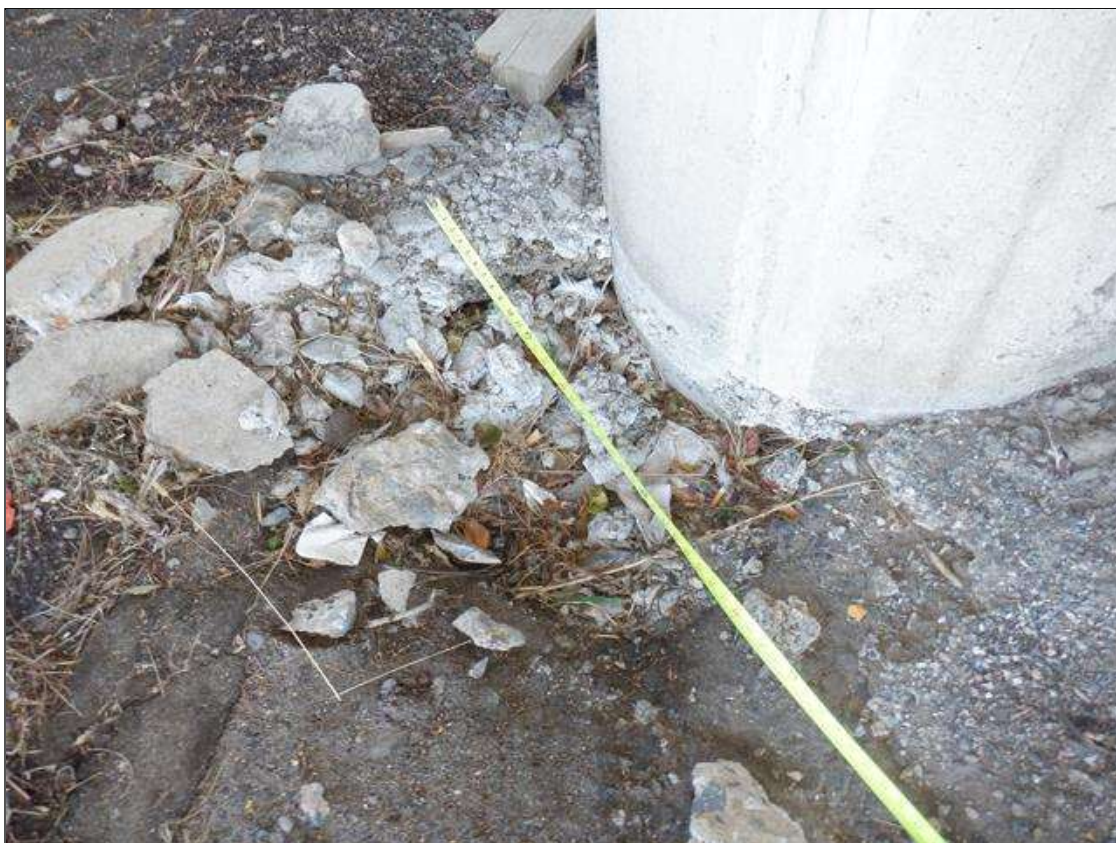
Bent 2 Pile 3: 20 INCH X 24 INCH X 10 INCH DEEP HOLE AT BASE OF PILE 3 ON WEST FACE

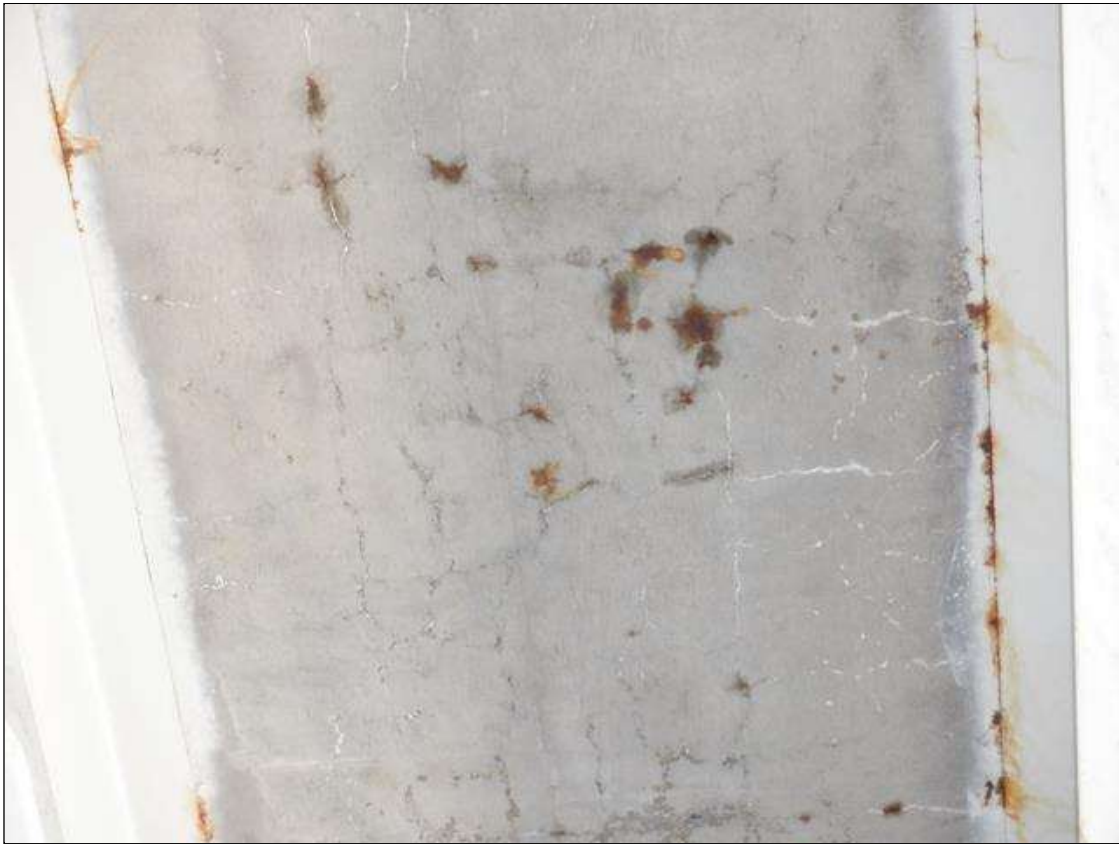
Span 2 Deck: BAY 4 STARTING 15 FEET FROM BENT 2, 2 AREAS UP TO 20 SQUARE FEET OF CRACKING UP TO 1/16 INCH WIDE WITH RUST STAINING

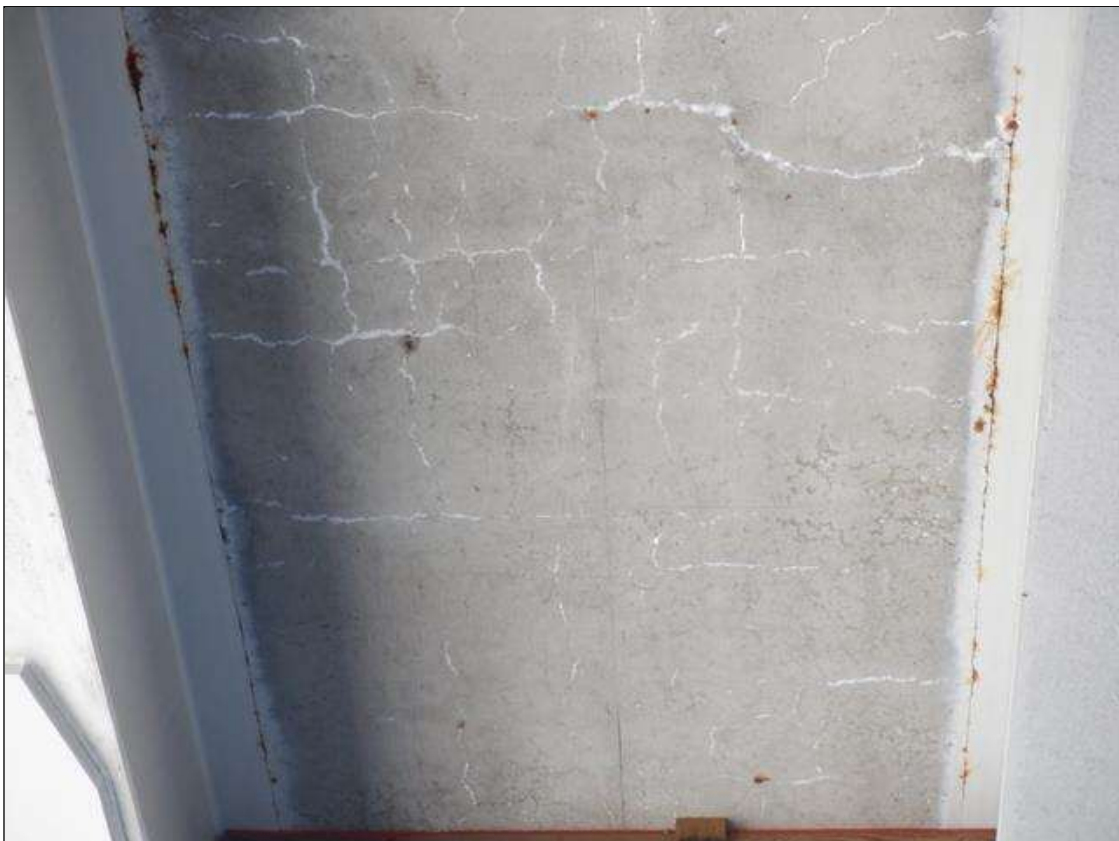
Span 3 Deck: THROUGHOUT UNDERSIDE IN ALL BAYS, HAIRLINE CRACKS WITH EFFLORESCENCE

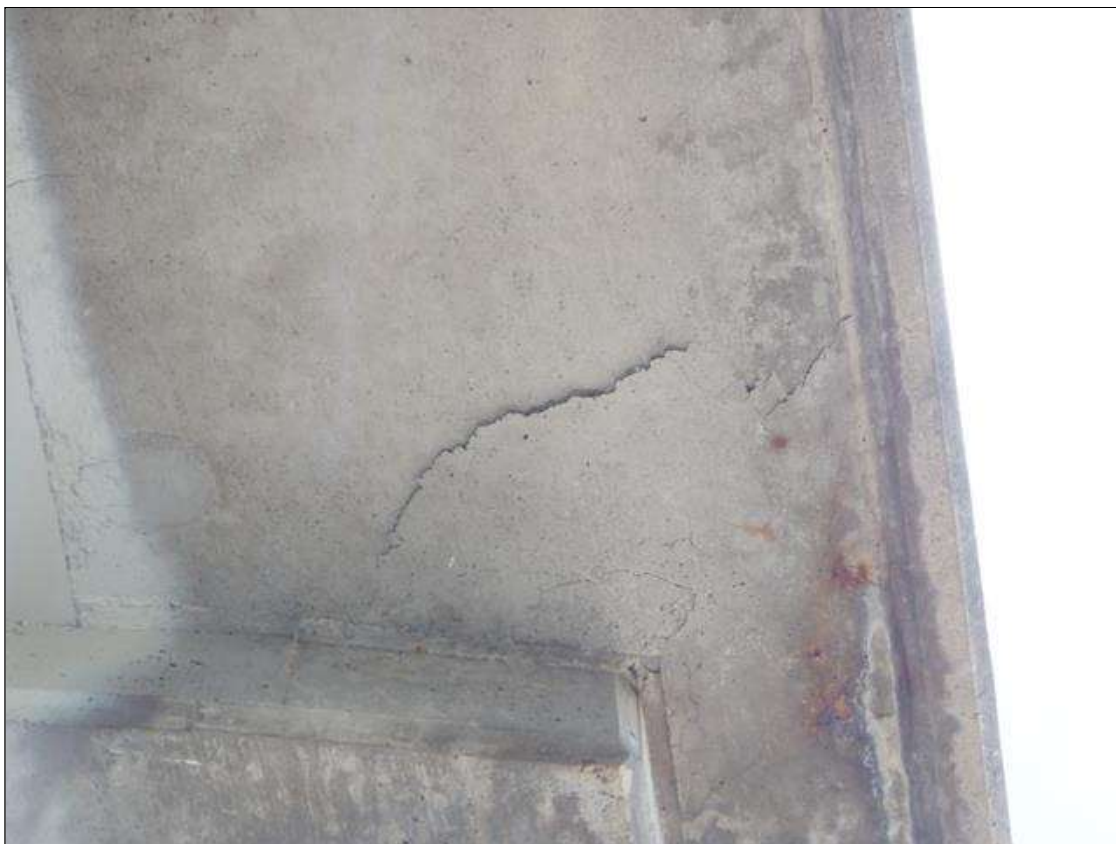
Span 4 Deck: BENT 3 LEFT OVERHANG SOFFIT, 8 INCH DIAMETER DELAMINATION

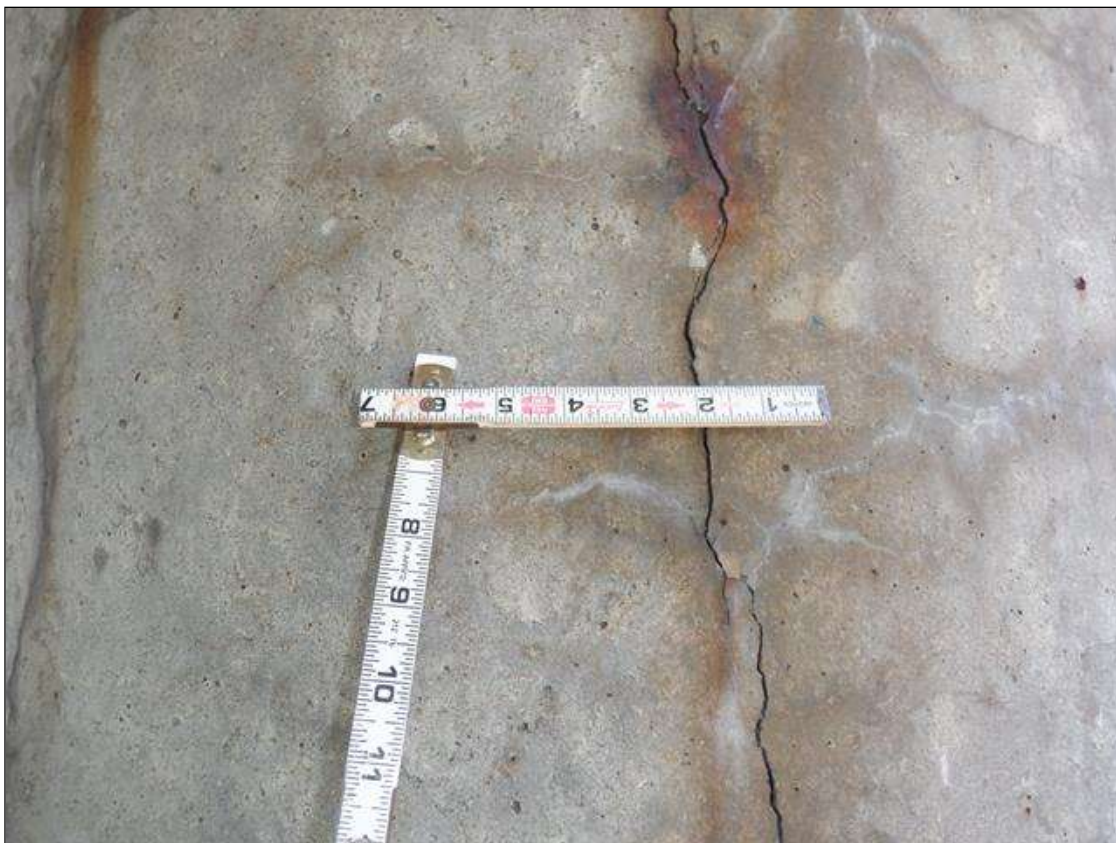
Bent 3 Pile 1: FULL HEIGHT 1/8 INCH WIDE VERTICAL CRACK

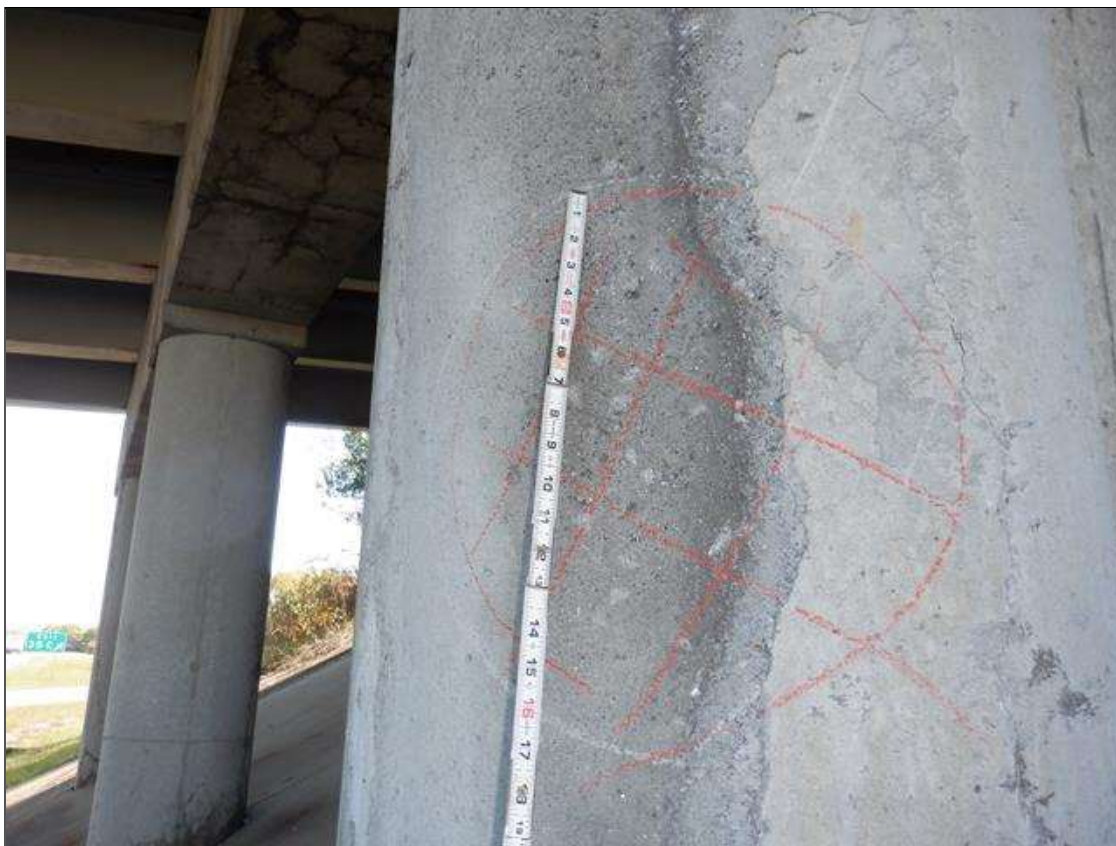
Bent 3 Pile 3: PATCHED AREA, WEST FACE, 2 FEET WIDE X FULL HEIGHT WITH AREA OF DELAMINATION 4 FEET ABOVE GROUND, 16 INCH IN DIAMETER

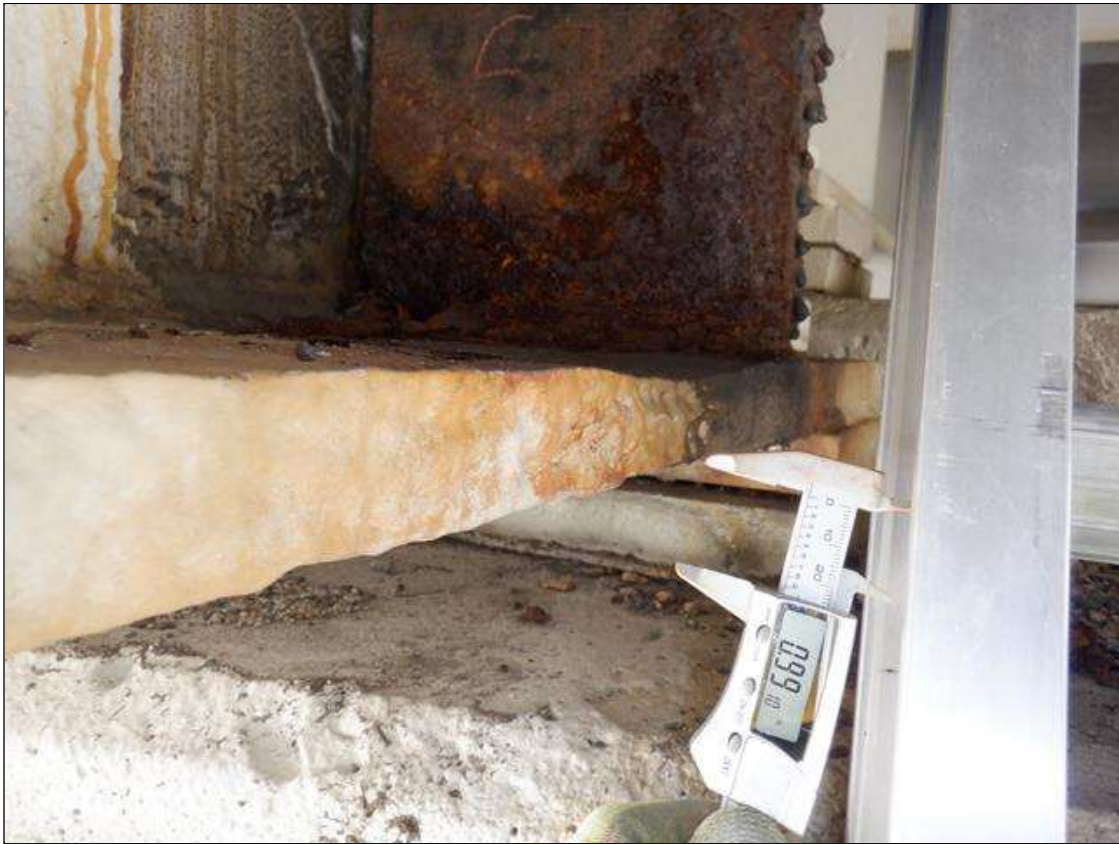
Span 3 Beam 2: CORROSION WITH SECTION LOSS (0.99 INCH REMAINING) ON BOTH BOTTOM FLANGES FOR OUTER 2 INCH FOR 1 FOOT AT BENT 3
