NC DEPARTMENT OF TRANSPORTATION
 DIVISION OF HIGHWAYS
 STRUCTURE MANAGEMENT UNIT

ATTENTION: **CHANGE TO STRUCTURE DATA, PAR SUBMITTED, REQUEST LIDAR, NEWLY STRUCTURALLY DEFICIENT**

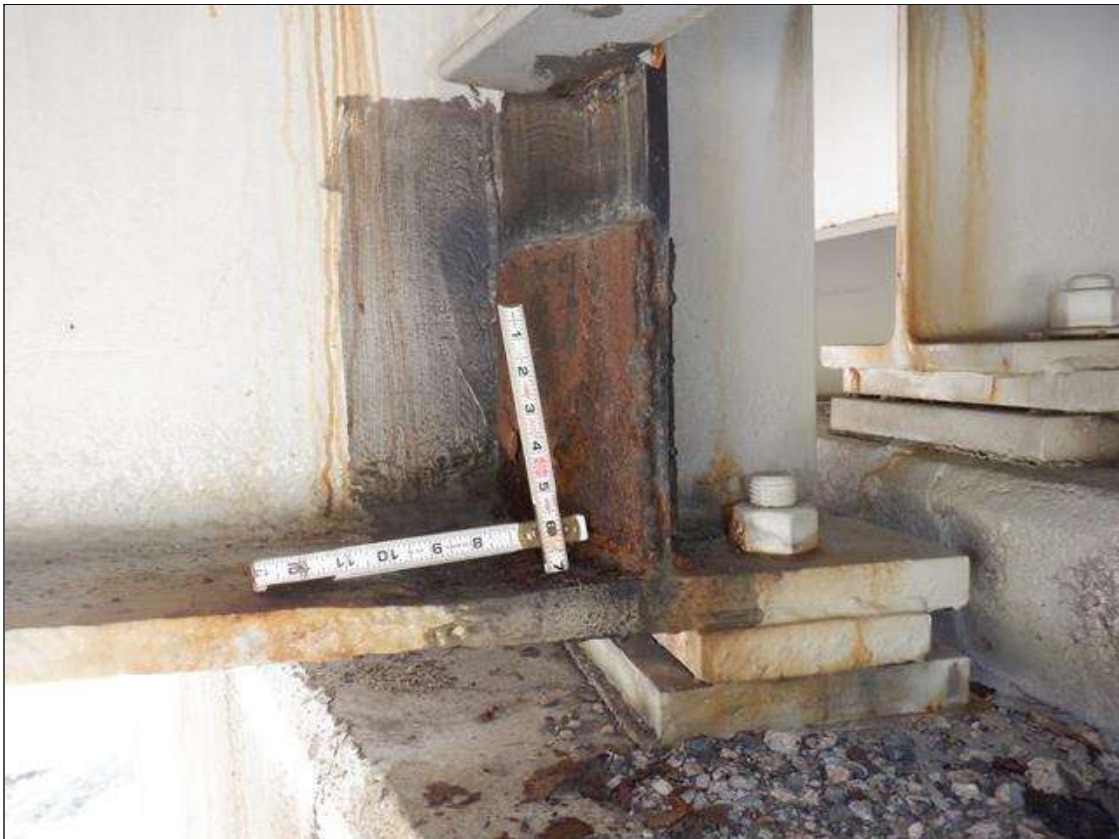
Span 3 Beam 2: WELDED REPAIR TO BOTH SIDES OF BOTH BEARING STIFFENERS AT BENT 3, 9 INCH X 8 INCH X 3/8 INCH THICK STEEL PLATE

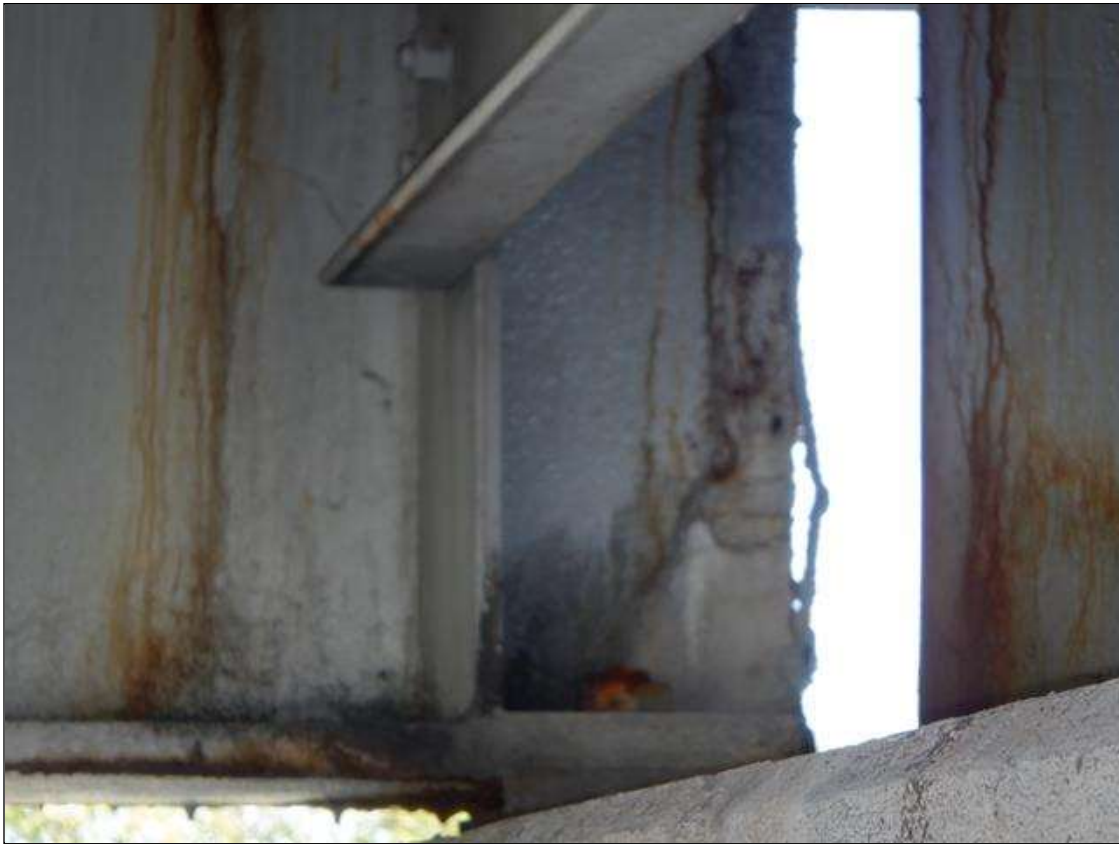
Span 3 Beam 1: CORROSION WITH 1/16 INCH SECTION LOSS FULL HEIGHT OF WEB AT END OF BEAM

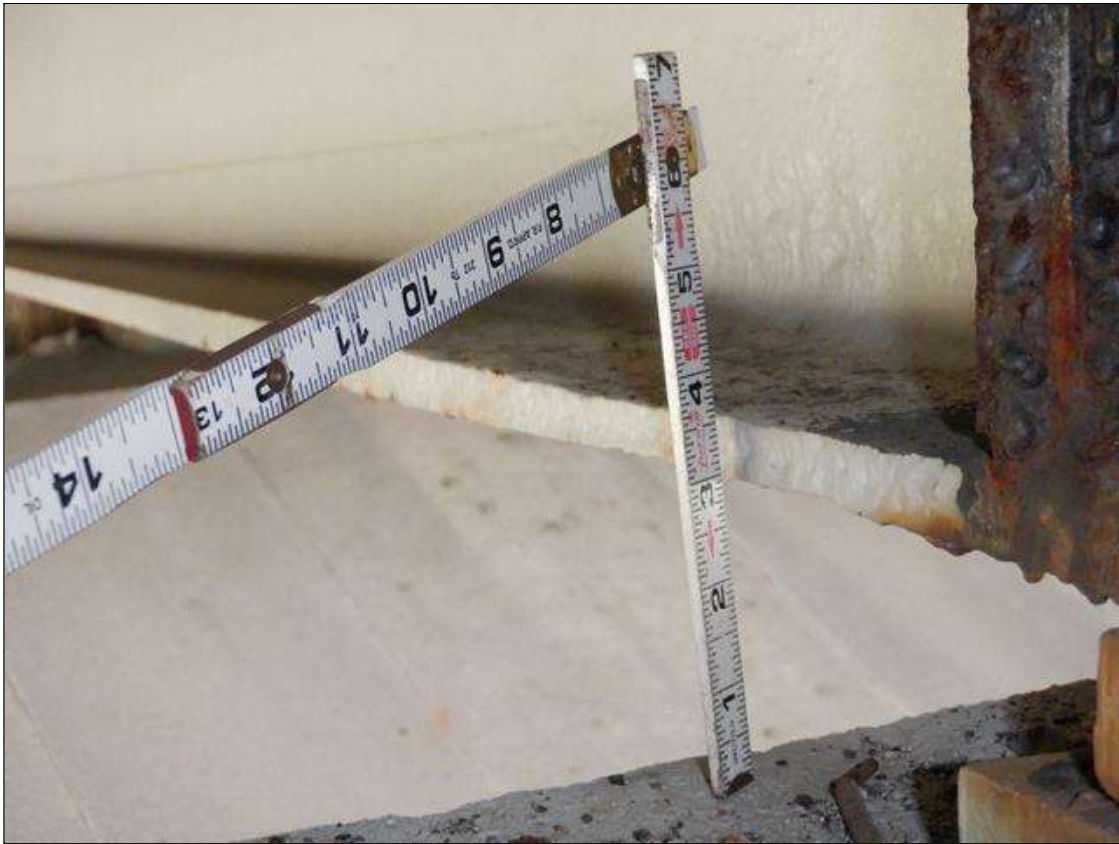
Span 4 Beam 3: CORROSION ARRESTED WITH PAINT, 3/16 INCH SECTION LOSS (9/16 INCH REMAINING) ON BOTH BOTTOM FLANGES FOR OUTER 2 INCH FOR 3 FEET STARTING 1.5 FEET FROM BENT 3 WITH 1/8 INCH SECTION LOSS (7/16 INCH REMAINING) ON LOWER 4 INCH OF WEB IN SAME AREA

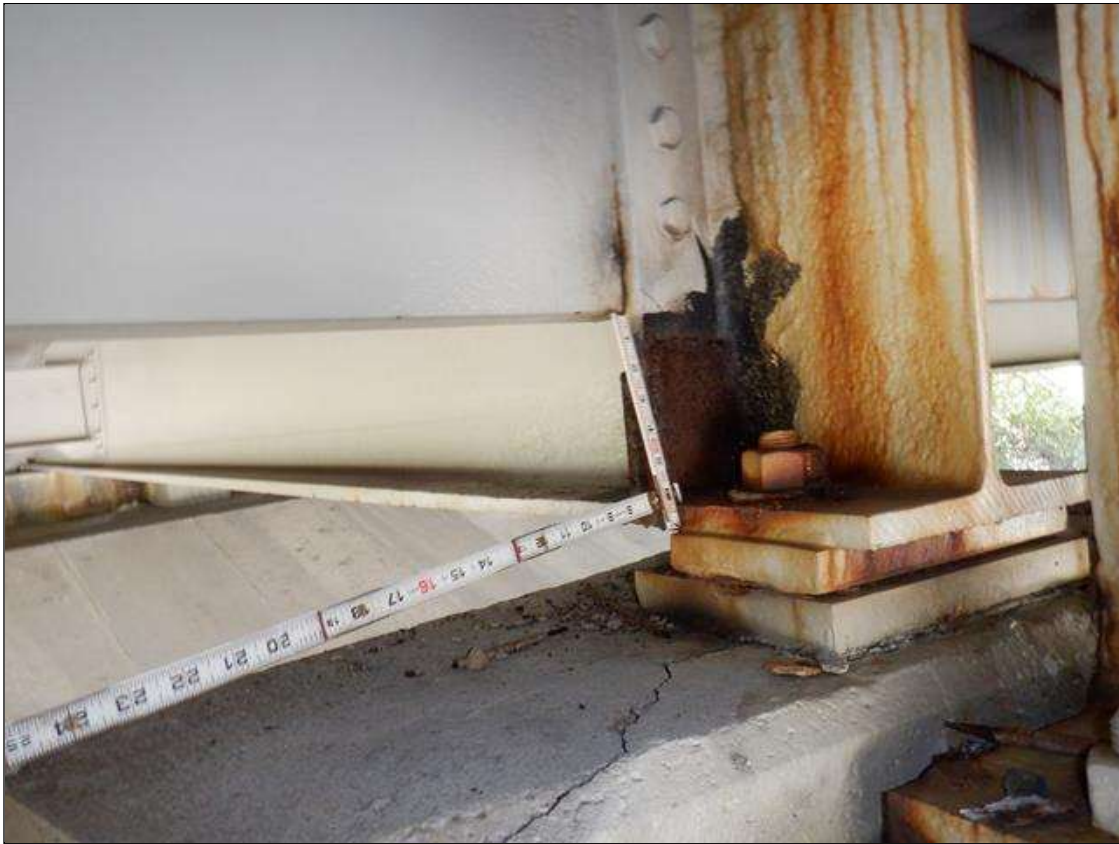
Span 4 Beam 3: AT BENT 3, LEFT BEARING STIFFENER HAS WELDED REPAIR PLATE, 5 INCH X 5 INCH X 1/2 INCH THICK WITH RUST SCALE

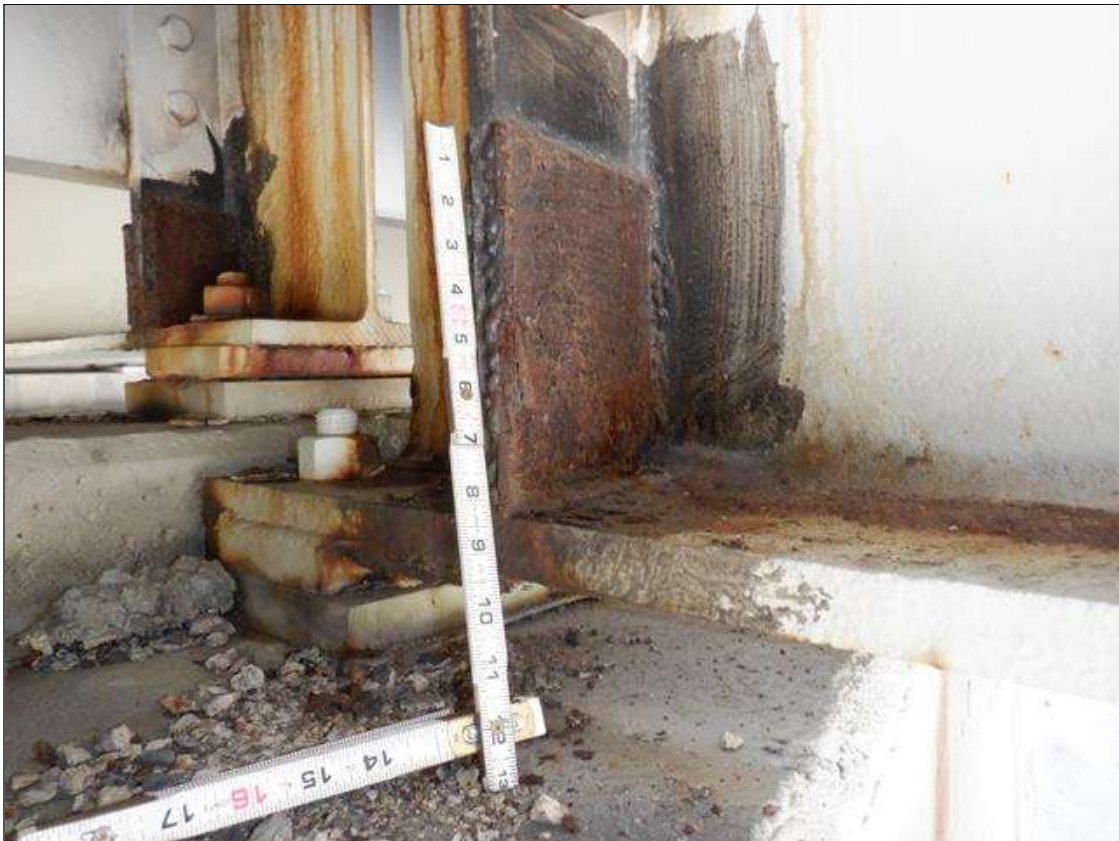
Span 3 Beam 3: WELDED REPAIR TO BOTH SIDES OF BOTH BEARING STIFFENERS AT BENT 3, 9 INCH X 8 INCH X 3/8 INCH THICK STEEL PLATE

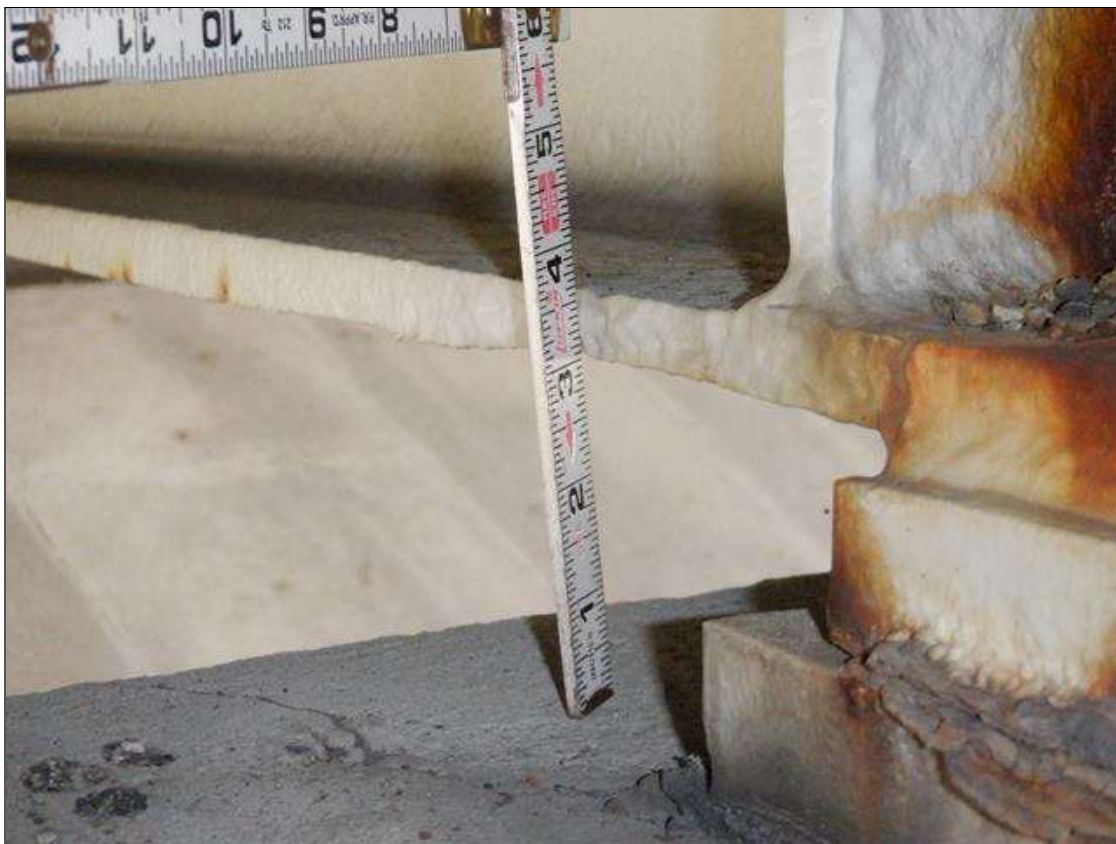
Span 4 Beam 4: CORROSION HAS BEEN ARRESTED WITH PAINT, 3/4 INCH SECTION LOSS (1/2 INCH REMAINING) ON BOTTOM LEFT FLANGE FOR OUTER 2 INCH FOR 18 INCH LONG STARTING 8 INCH FROM BENT 3

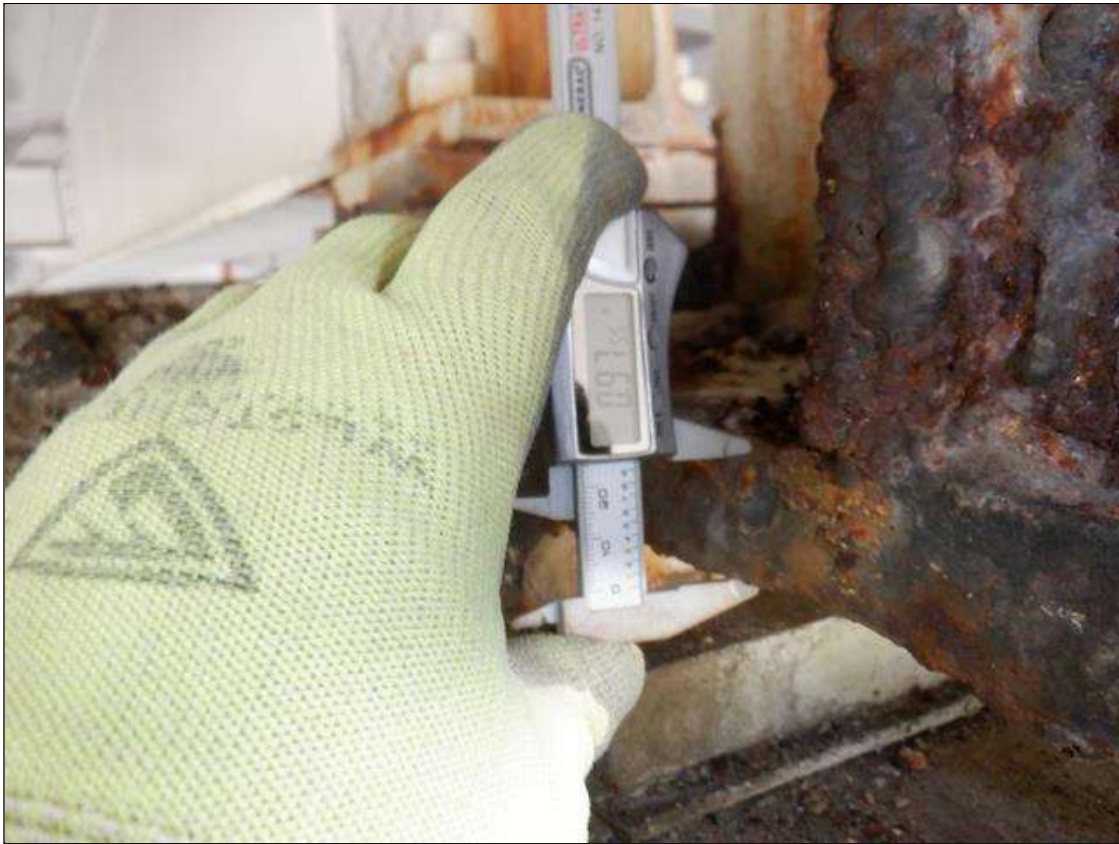
Span 3 Beam 4: PAR: CORROSION WITH 5/16 INCH SECTION LOSS (15/16 INCH REMAINING) ON LEFT BOTTOM FLANGE FOR OUTER 2 INCH FOR 9 INCH LONG STARTING 7 INCH FROM BENT 3

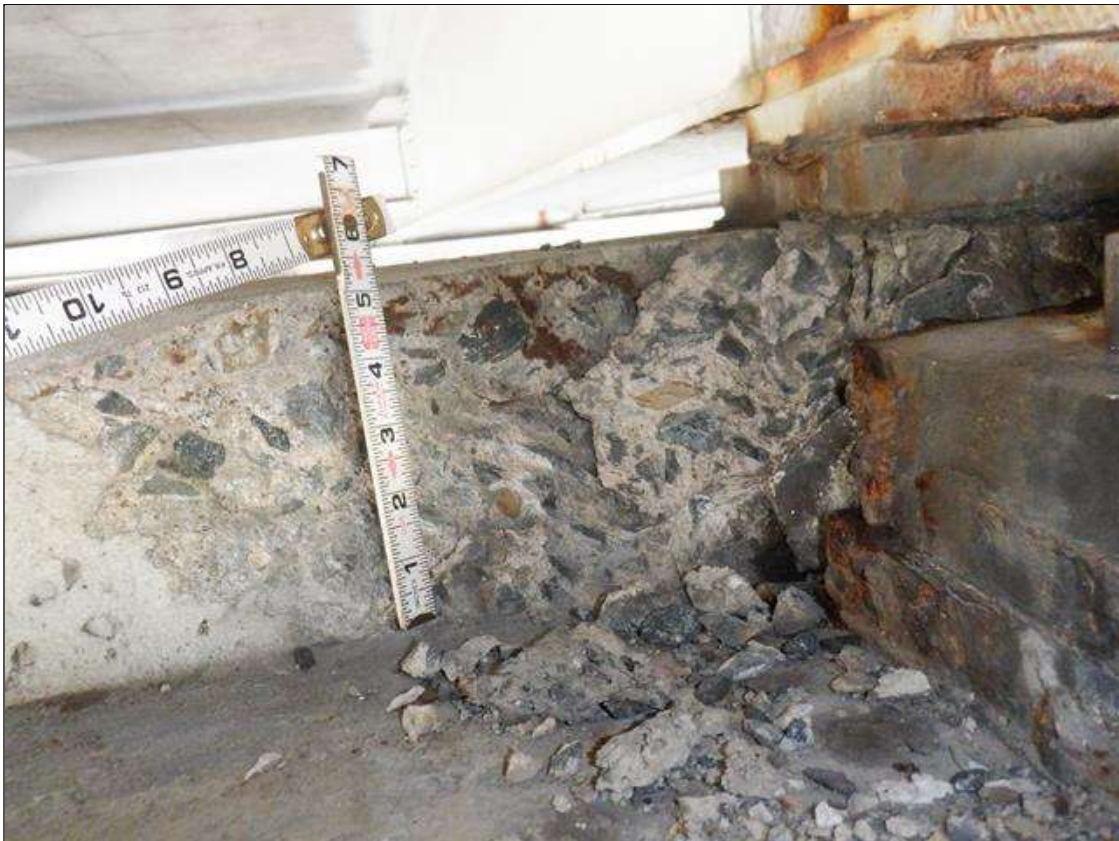
Bent 3 Cap 1: 18 INCH X 6 INCH X 5 INCH SPALL ON PEDESTAL UNDER END OF SPAN 4 GIRDER 4, NO EXPOSED REBAR, NO BEARING LOSS

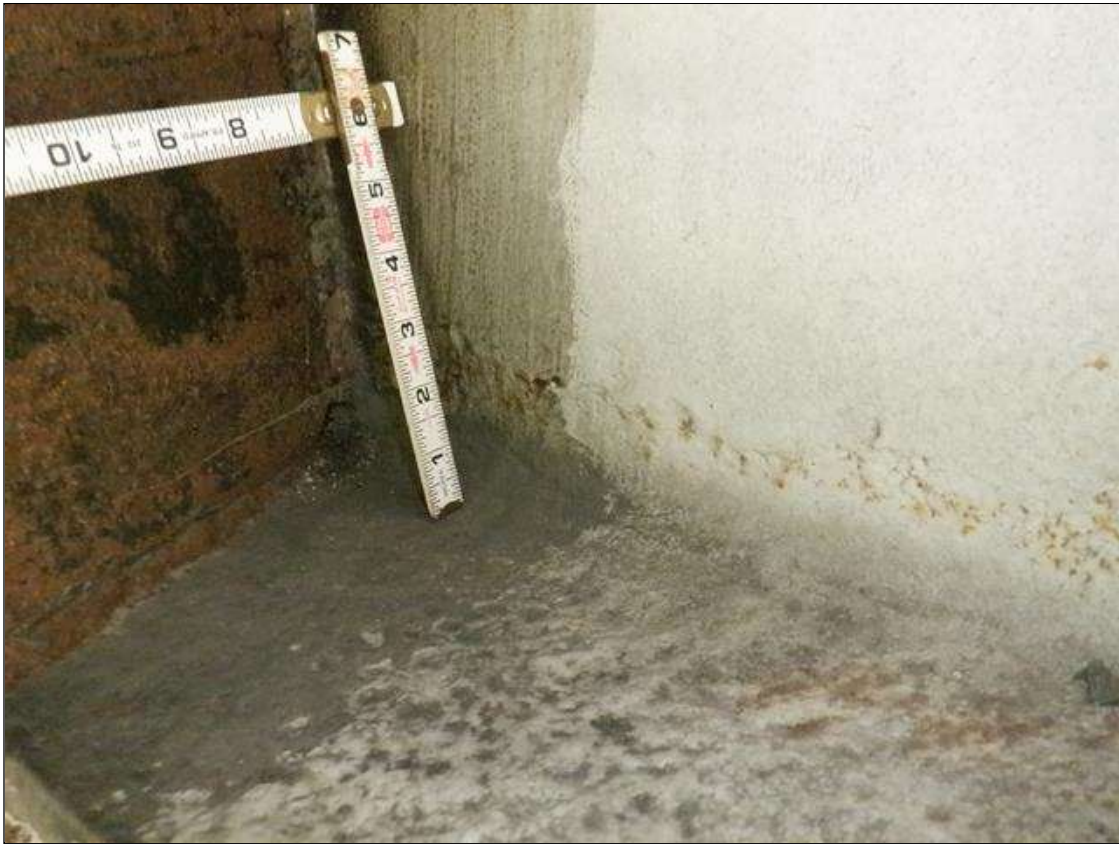
Span 3 Beam 5: CORROSION ARRESTED WITH PAINT, 1/2 INCH SECTION LOSS (3/4 INCH REMAINING) ON BOTH BOTTOM FLANGES FOR OUTER 2 INCH FOR 1 FOOT STARTING AT BENT 3

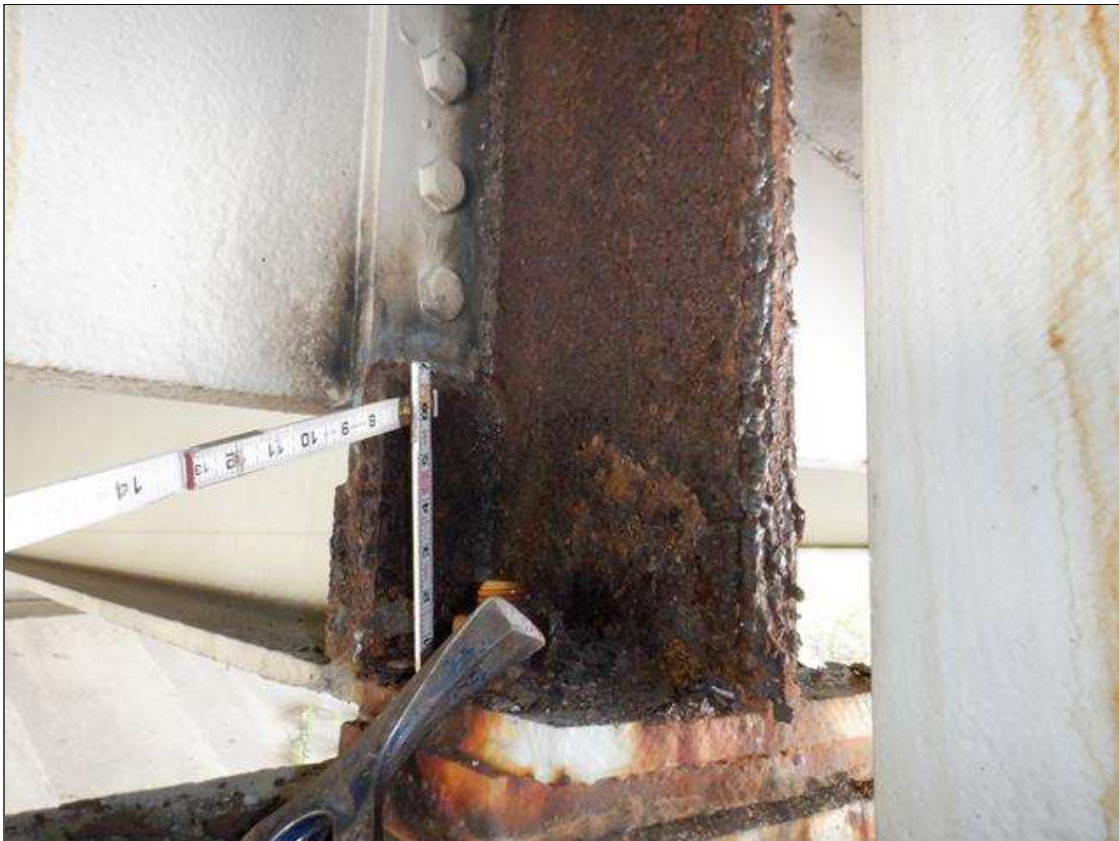
Span 4 Beam 5: WELDED STEEL PLATE REPAIR AT END OF BEAM BEHIND BEARING STIFFENER AT BENT 3, 6 INCH LONG X FULL HEIGHT

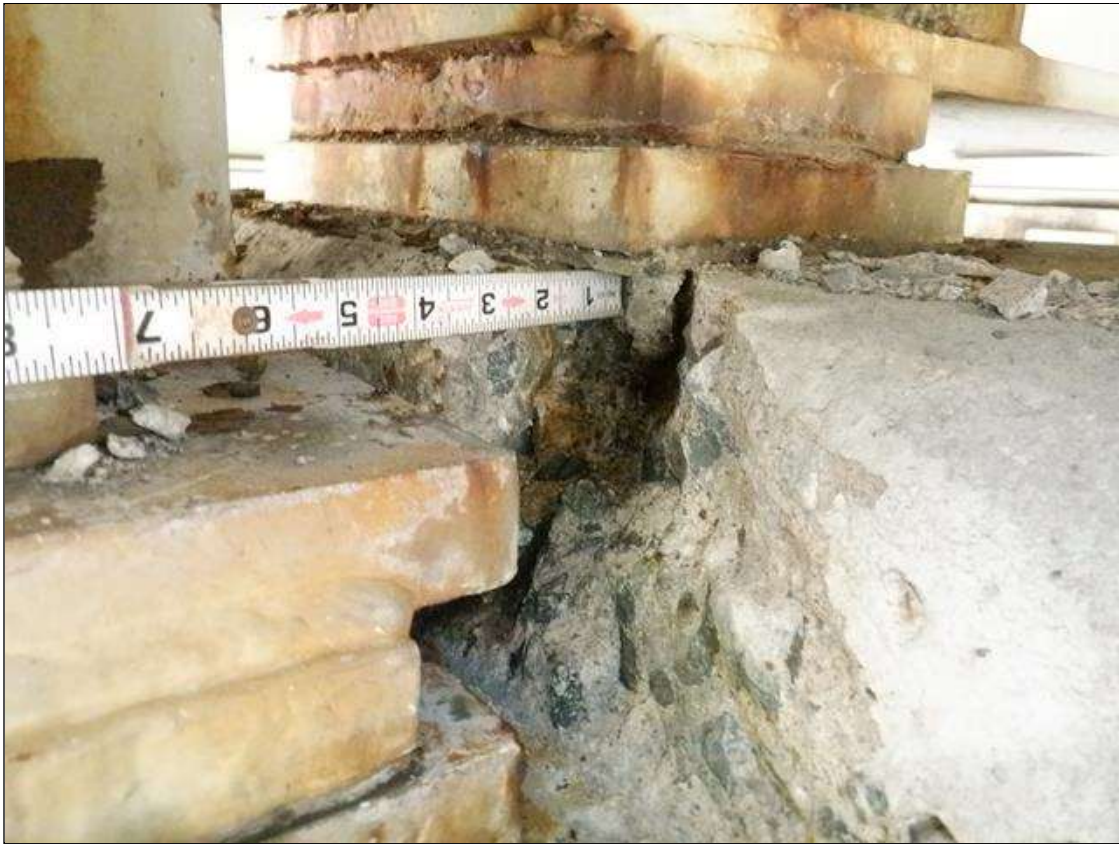
Bent 3 Cap 1: PAR: 6 INCH X 4 INCH X 5 INCH SPALL ON PEDESTAL UNDER GIRDER 5 SPAN 4 WITH 1 INCH X 1 1/2 INCH UNDER BEARING, NO EXPOSED REINFORCEMENT

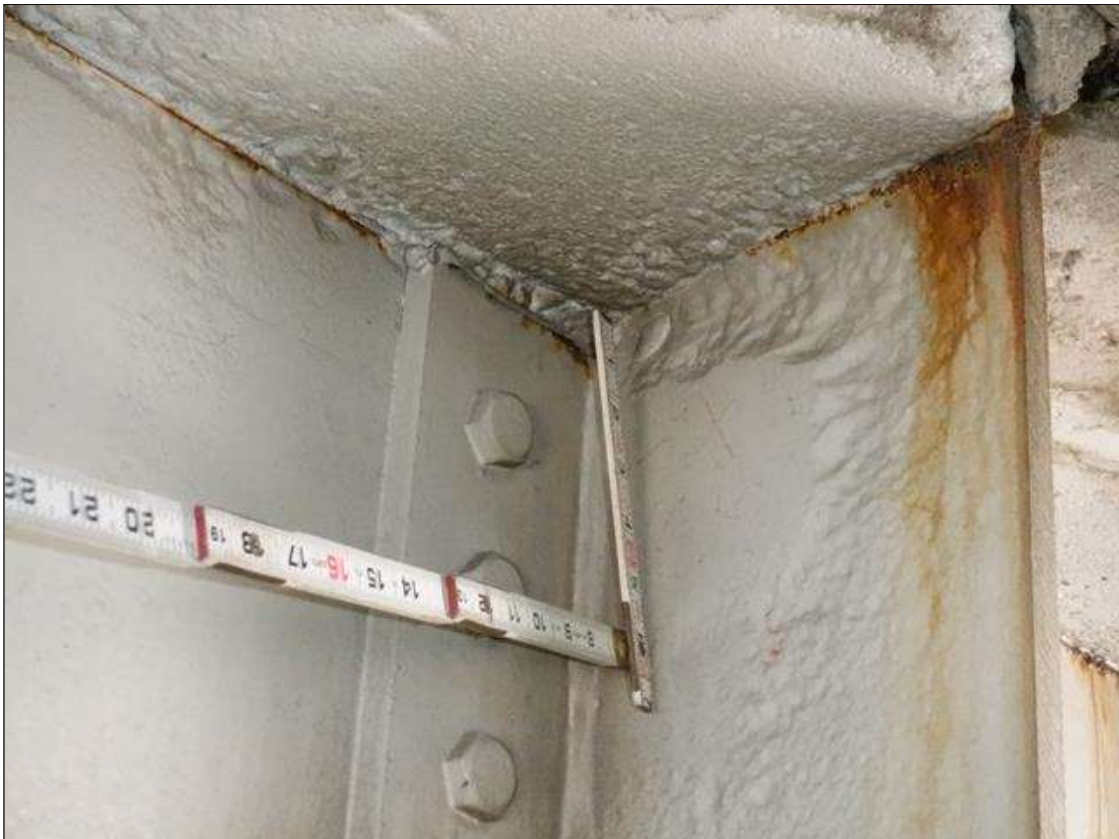
Span 4 Beam 6: CORROSION HAS BEEN ARRESTED WITH PAINT, 3/16 INCH SECTION LOSS (9/16 INCH REMAINING) ON TOP 6 INCH OF WEB FOR 10 INCH LONG AT BENT 3

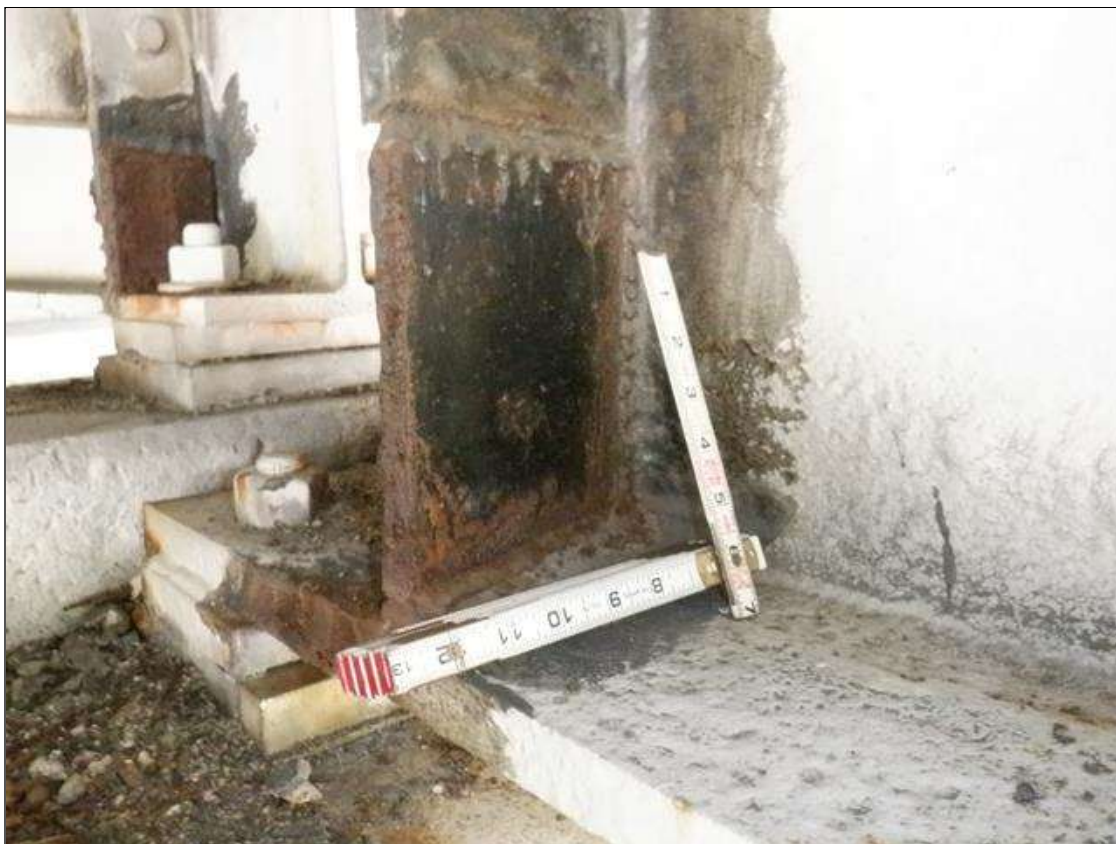
Span 3 Beam 6: WELDED PLATE REPAIR TO BOTH SIDES OF LEFT BEARING STIFFENER AT BENT 3, 5 INCH HIGH X 4 INCH WIDE X 3/8 INCH THICK WITH RUST SCALE

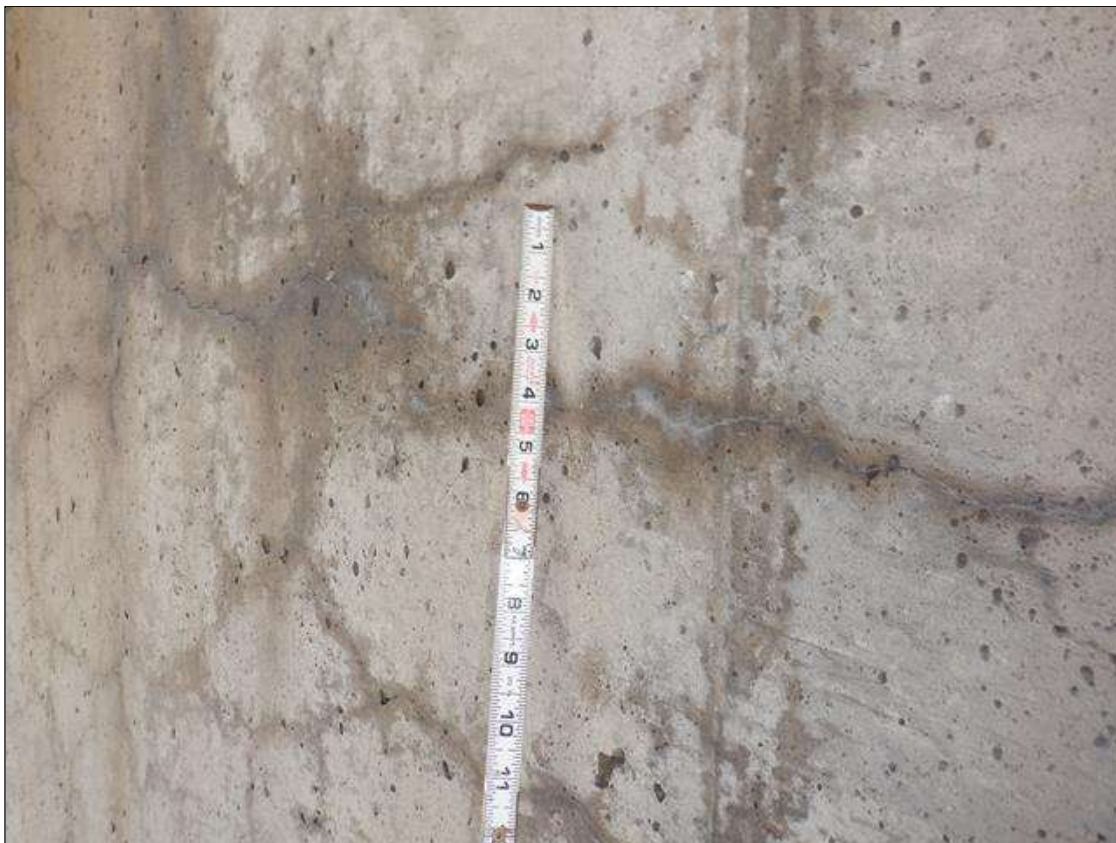
Bent 3 Cap 1: MAP CRACKING UP TO 1/16 INCH WIDE THROUGHOUT

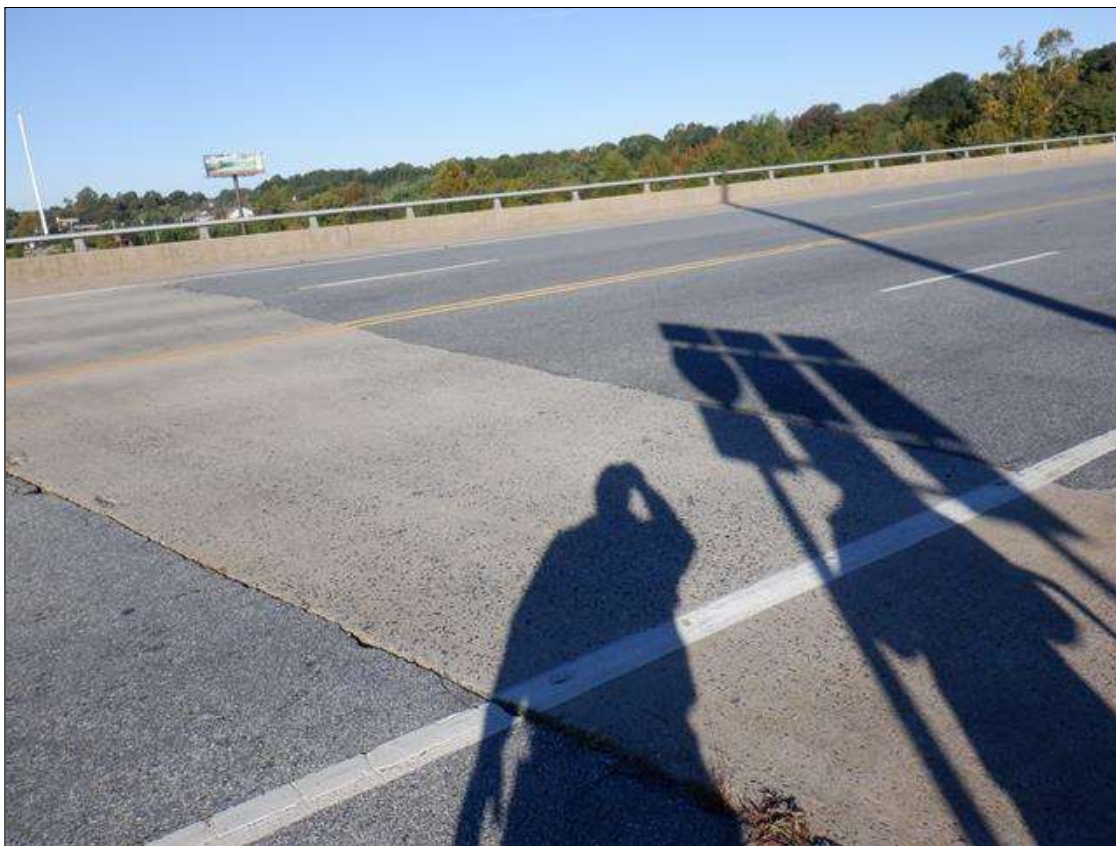
SPAN 4 DECK/WEARING SURFACE

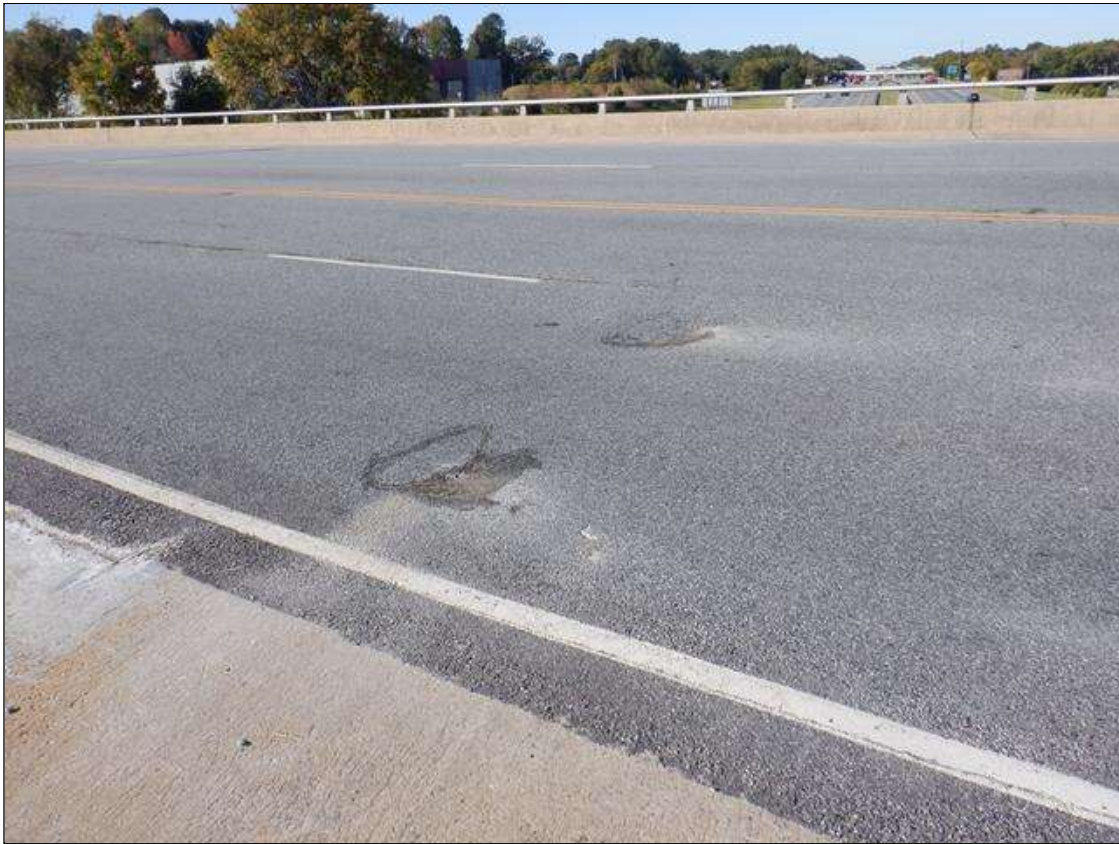
SPAN 3 WEARING SURFACE
