NC DEPARTMENT OF TRANSPORTATION
 DIVISION OF HIGHWAYS
 STRUCTURE MANAGEMENT UNIT

ATTENTION: PAR, NEW REPAIRS, DATA CHANGES

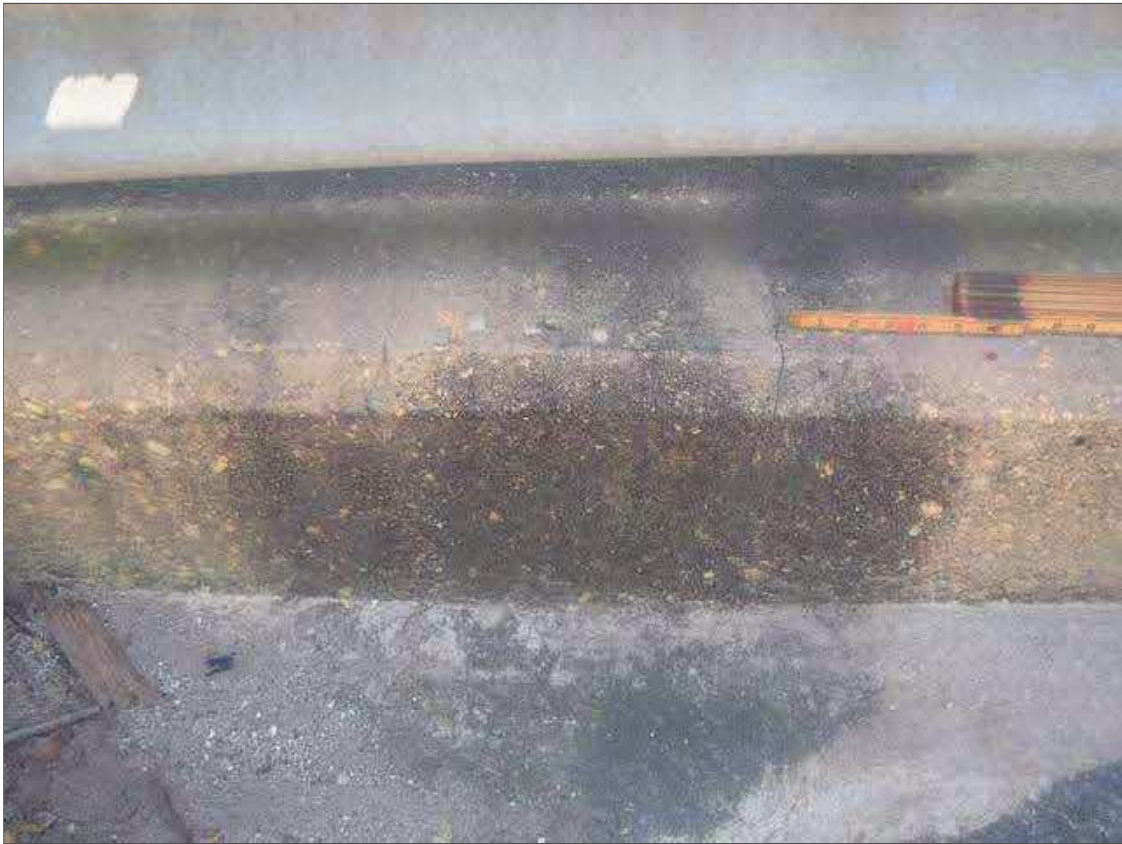
Span 1 Left Bridge Rail: UP TO 0.025" TRANSVERSE AND VERTICAL CRACKS IN TOP AND FACE OF CURB NEAR ABUTMENT 1 FILL FACE

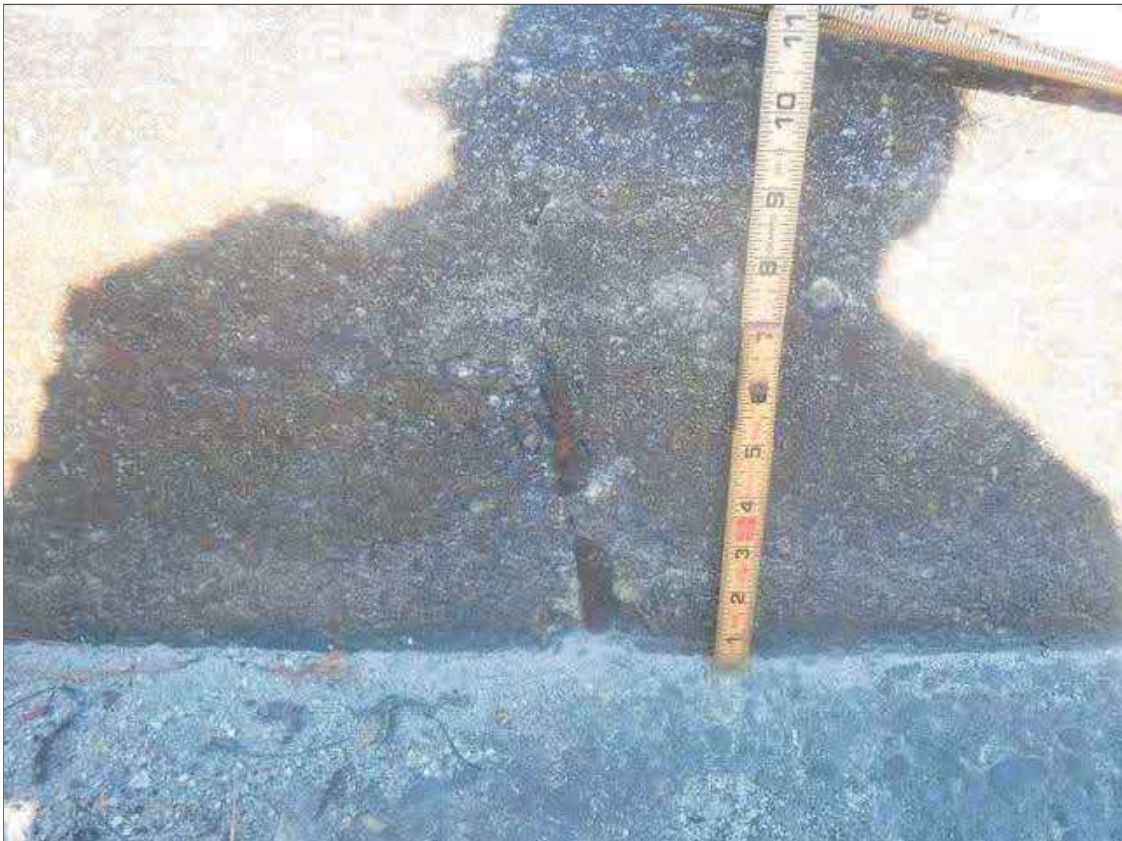
Span 2 Right Bridge Rail: (3) AREAS OF EXPOSED REBAR UP TO 7" X 1" IN FACE OF RAIL APPROXIMATELY 7', 12', AND 13' FROM PIER 1 JOINT, CONDITION 12' FROM PIER 1 JOINT SHOWN

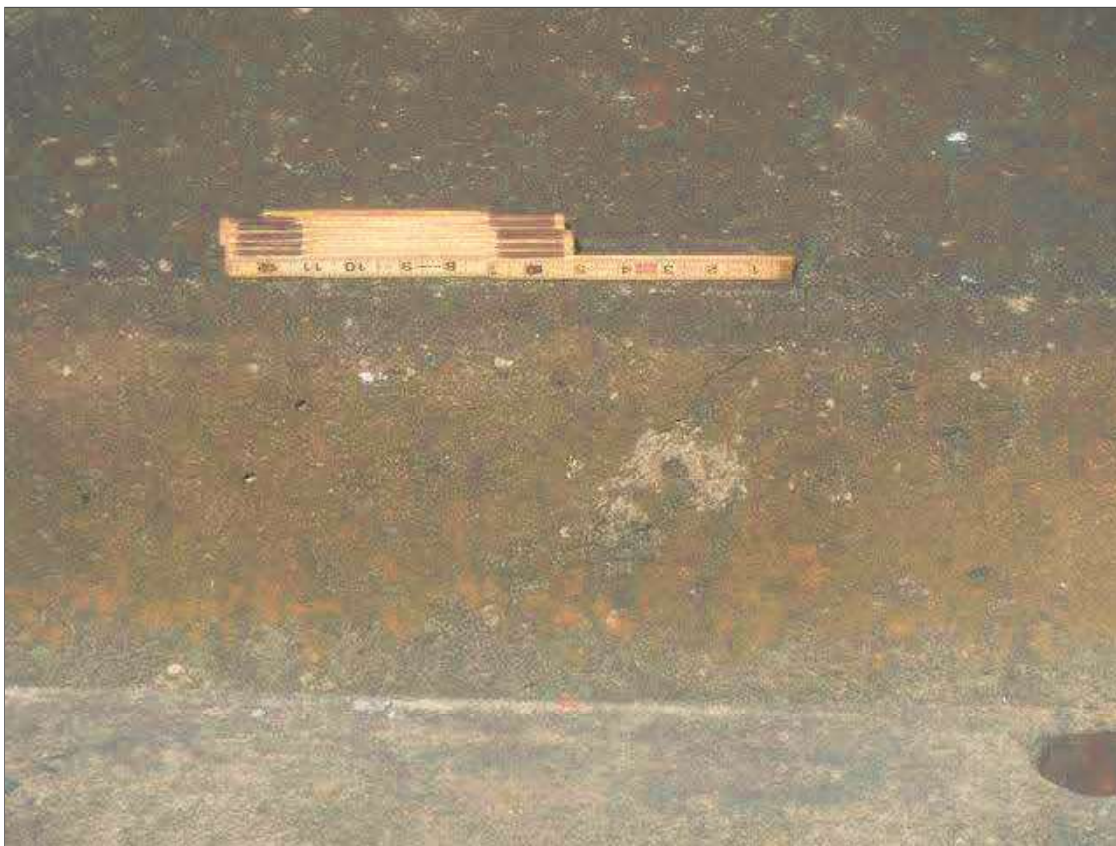
Span 3 Right Bridge Rail: UP TO 1/16" DIAGONAL CRACK IN TOP AND FACE OF CURB, APPROXIMATELY 4' FROM PIER 3 JOINT

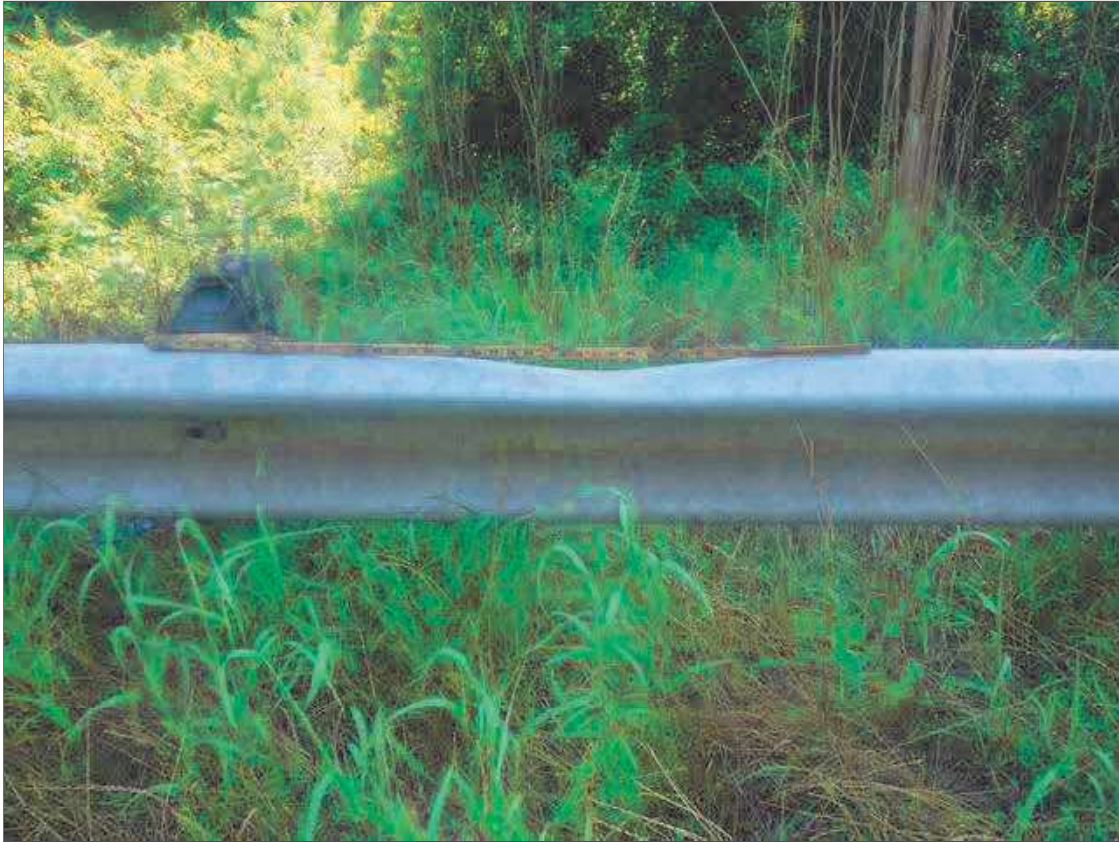
(2) AREAS OF DISTORTION UP TO 33" LONG X 2" ALONG TOP OF NORTHEAST APPROACH GUARDRAIL, APPROXIMATELY 23' AND 32' FROM ABUTMENT 2 FILL FACE, CONDITION APPROXIMATELY 32' FROM ABUTMENT 2 FILL FACE SHOWN; PREVIOUSLY NOTED IN SPAN 4 RIGHT RAIL

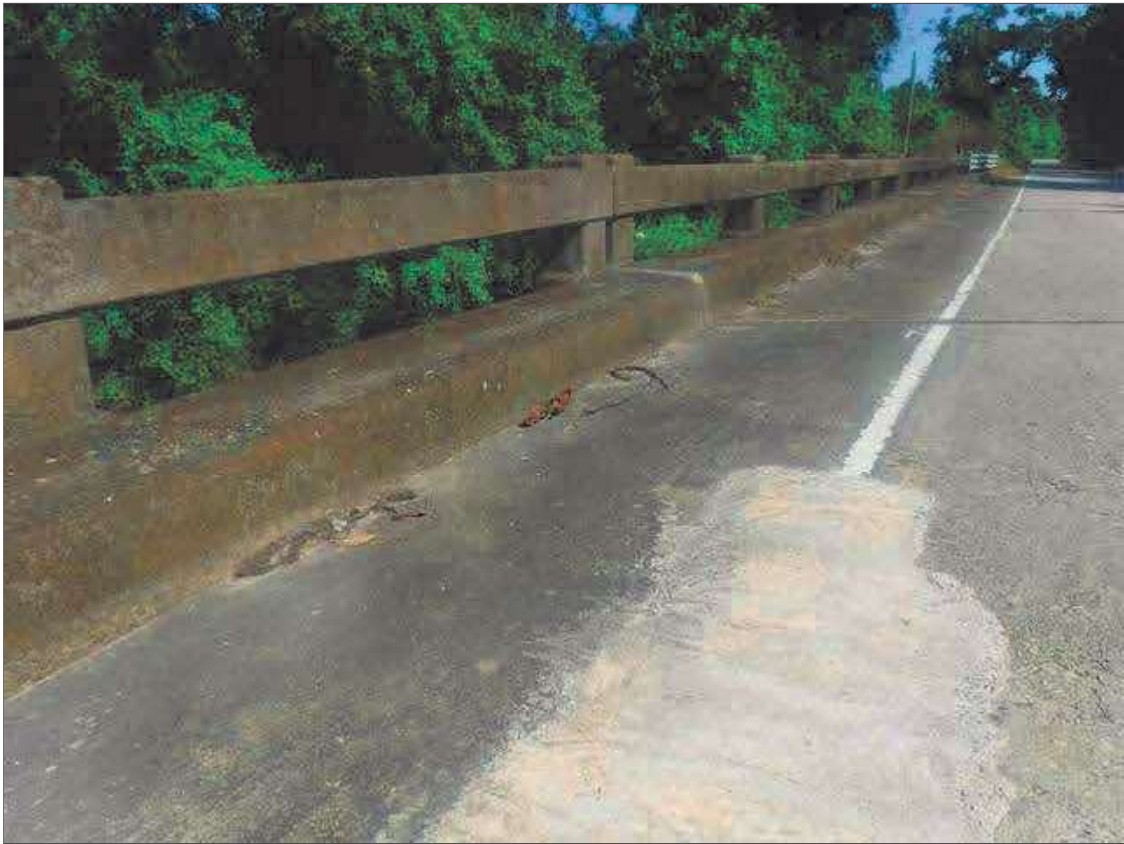
DIRT AND DEBRIS ACCUMULATION IN BOTH SHOULDERS, ACCUMULATION IN LEFT SHOULDER SHOWN

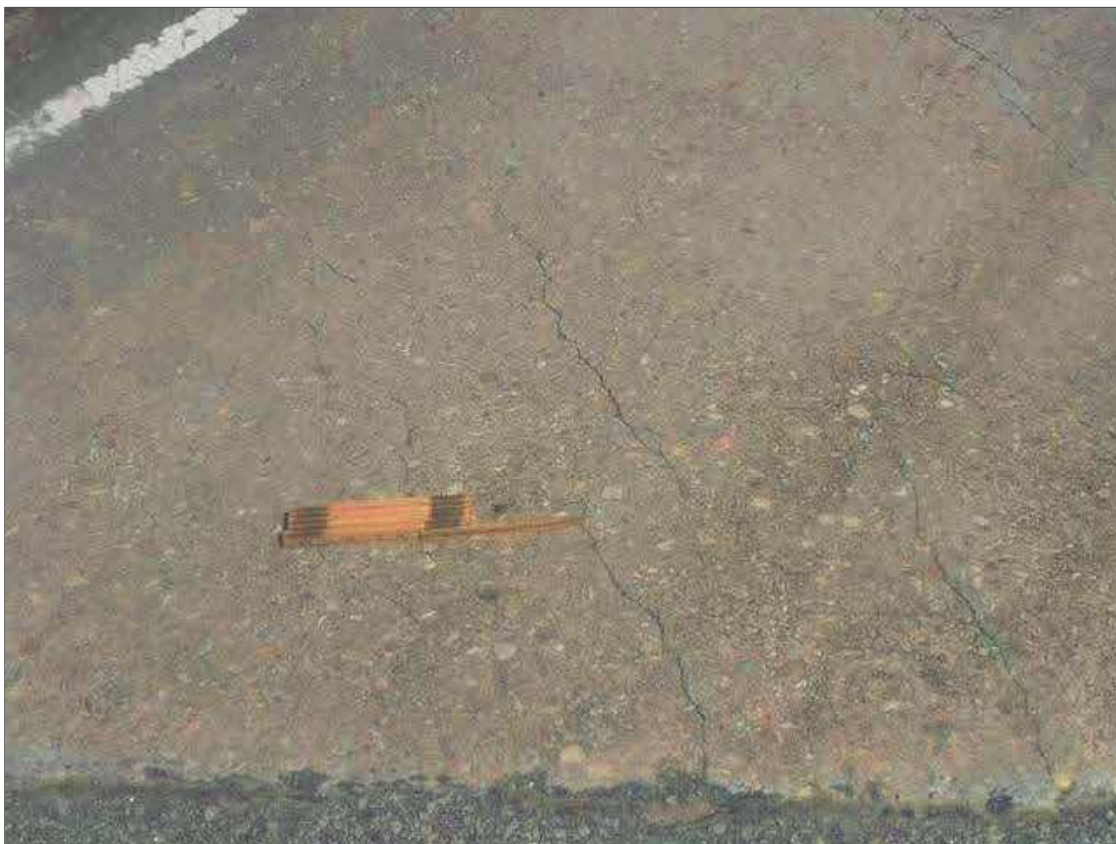
Span 1 Deck: UP TO 1/16" DIAGONAL CRACKS IN TOP OF DECK IN WESTBOUND LANE NEAR ABUTMENT 1 FILL FACE

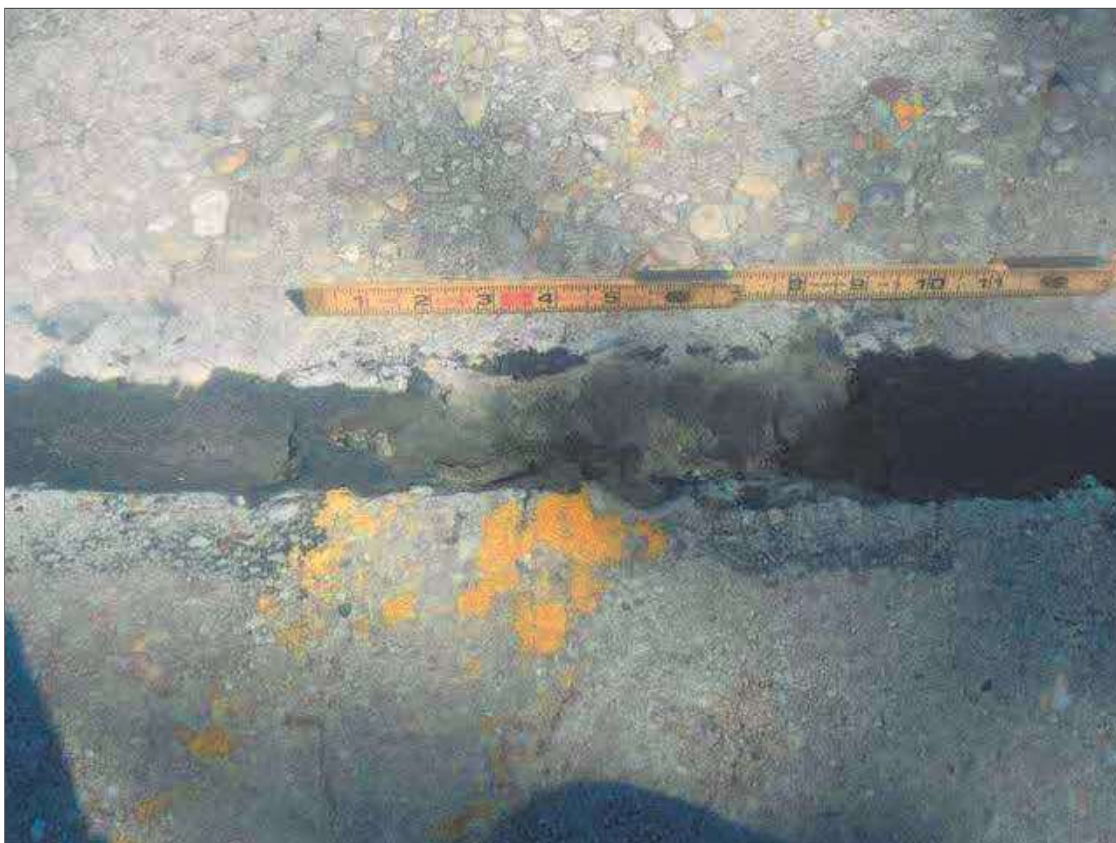
Span 3 Expansion Joint 2: 9" SECTION OF MISSING JOINT MATERIAL ALONG PIER 2 JOINT AT CENTERLINE OF ROADWAY

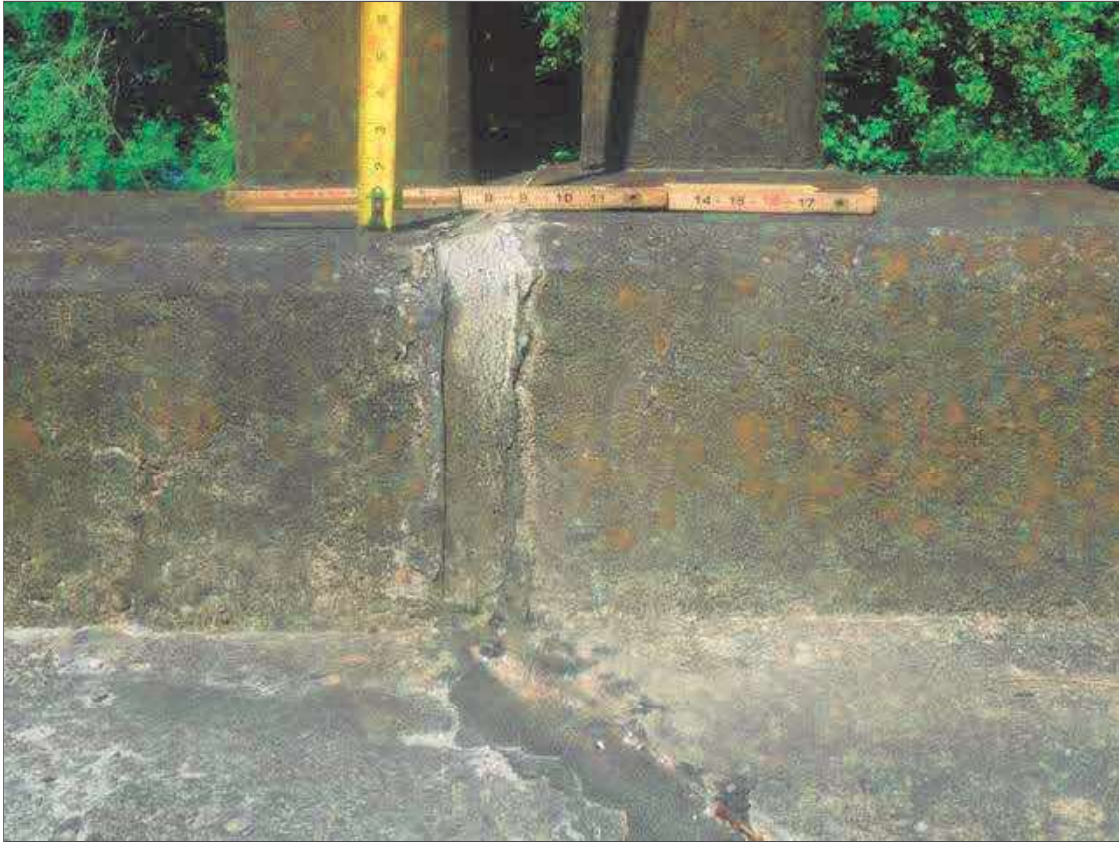
Span 2 Deck: UP TO 1/2" VERTICAL MISALIGNMENT BETWEEN SPAN 2 AND 3 DECKS ALONG PIER 2 JOINT, CONDITION AT LEFT CURB SHOWN

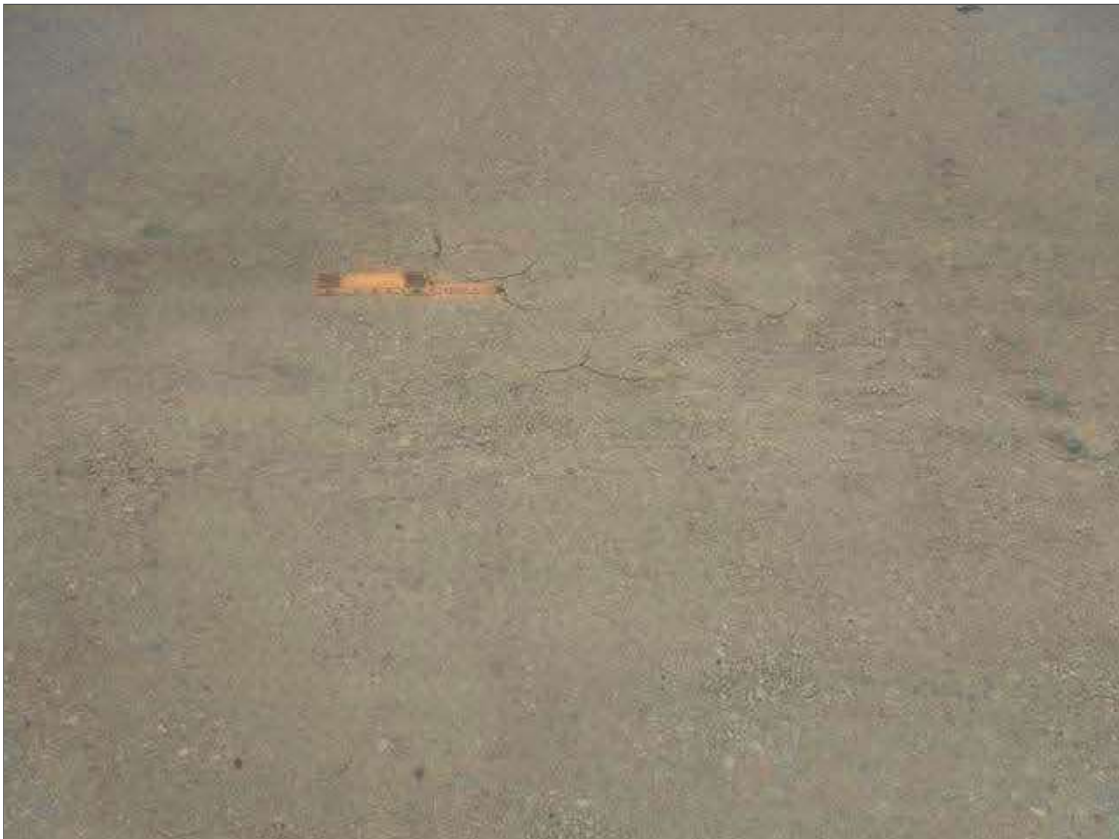
Span 3 Deck: UP TO 1/16" MAP CRACKS IN TOP OF DECK PRIMARILY IN TRAVEL LANES

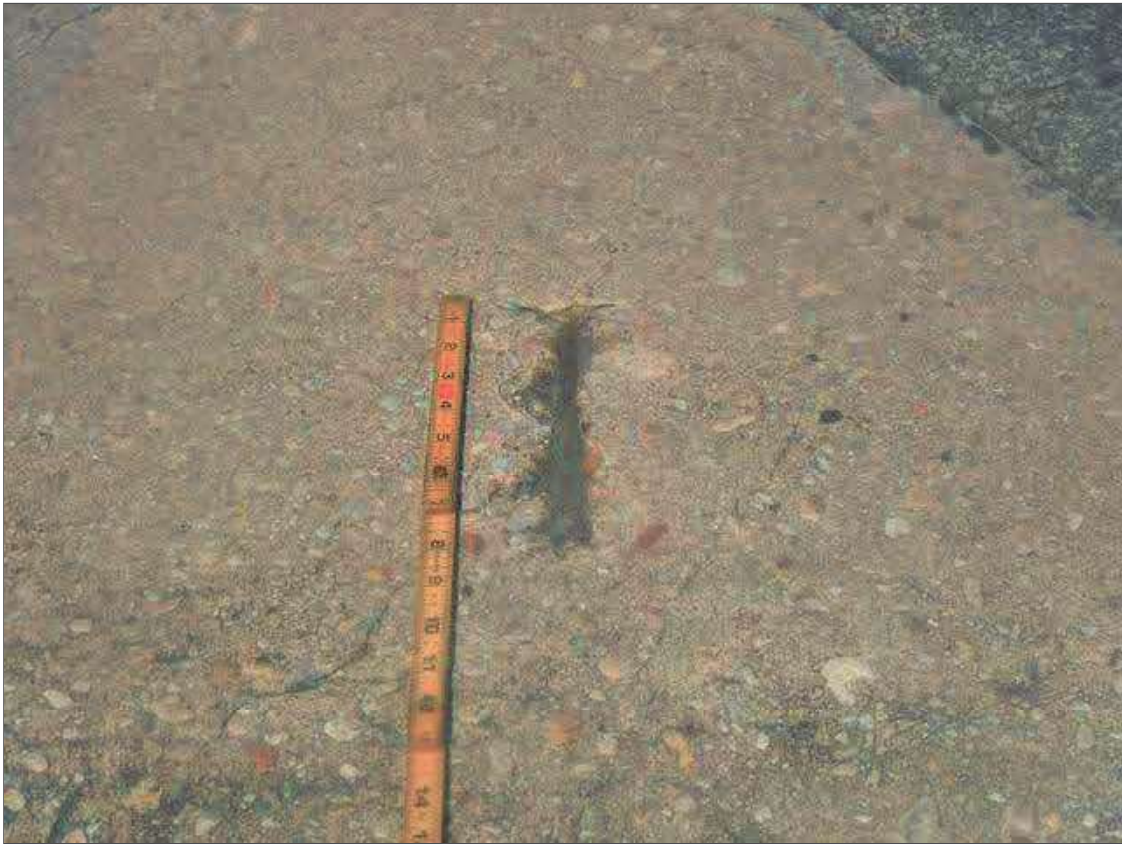
Span 4 Deck: PAR: 8" X 3" X 1/2" DEEP SPALL WITH EXPOSED REBAR IN TOP OF DECK IN WHEEL LINE OF EASTBOUND LANE, APPROXIMATELY 16" FROM ABUTMENT 2 FILL FACE

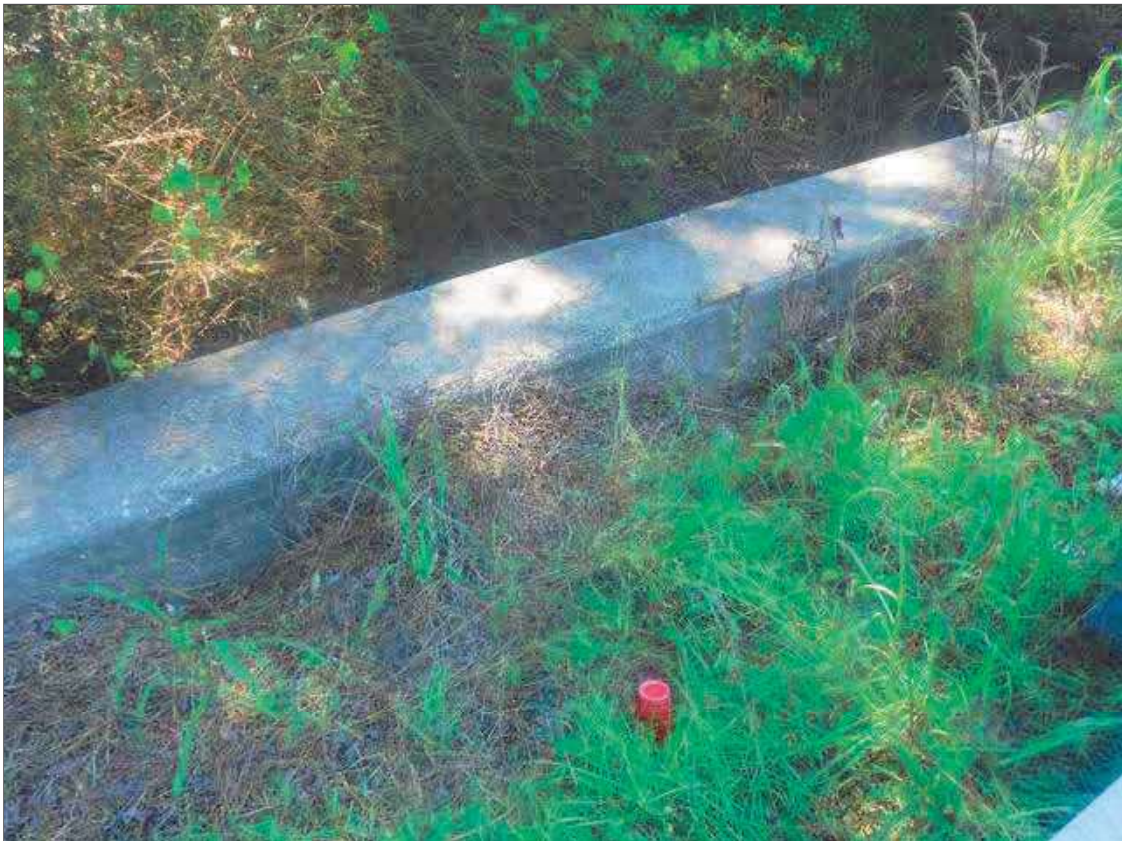
(2) AREAS OF SHOULDER EROSION UP TO 55" X 26" X 21" DEEP BEHIND SOUTHEAST WINGWALL, APPROXIMATELY 20' AND 24' FROM ABUTMENT 2 FILL FACE

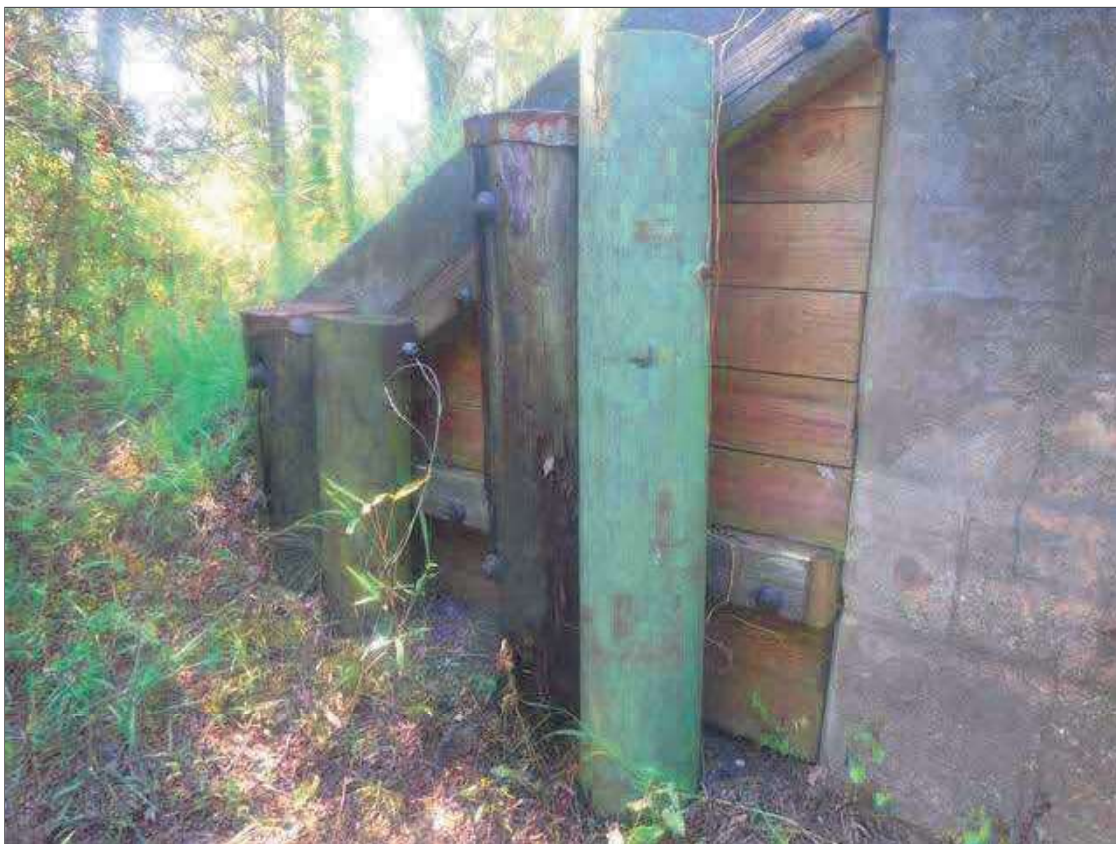
PRIORITY MAINTENANCE REPAIR TO SOUTHWEST WINGWALL SINCE 2018 INSPECTOIN

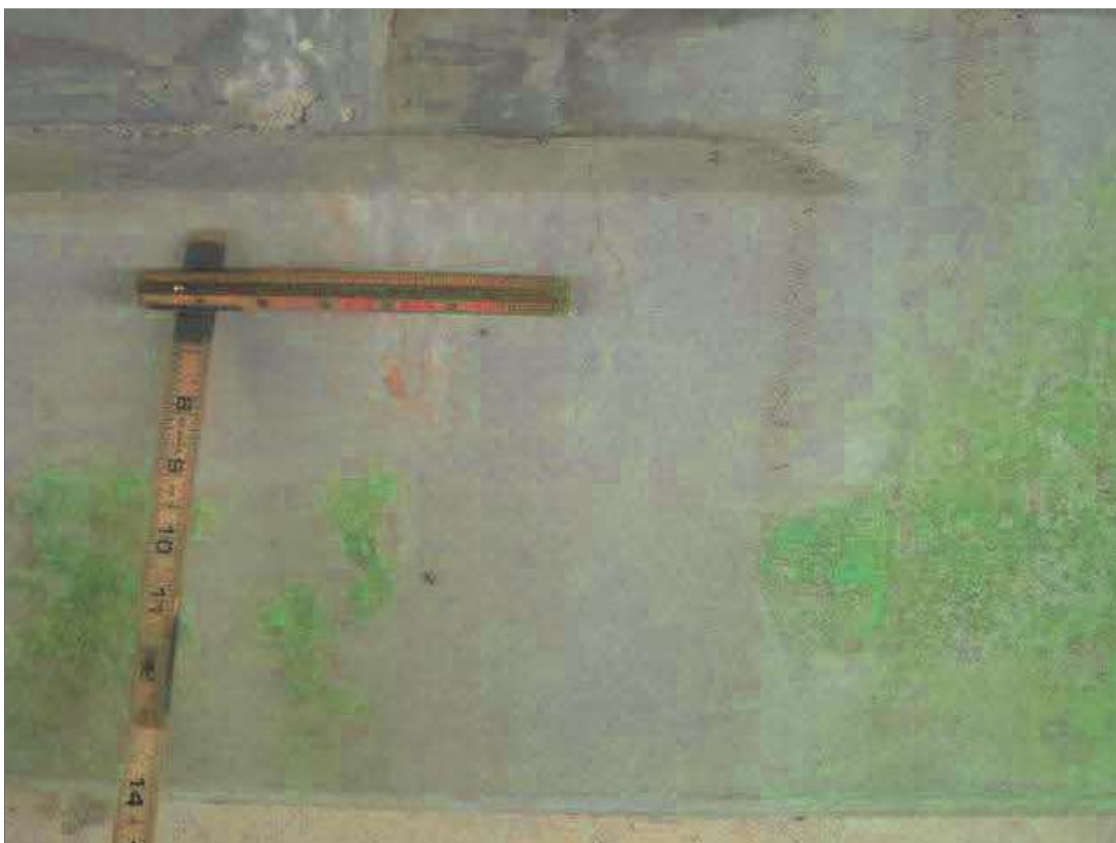
End Bent 1 Cap 1: UP TO 0.012" VERTICAL CRACKS IN FACE OF CAP IN VARIOUS LOCATIONS THROUGHOUT, CRACK IN BAY 2 TO LEFT OF GIRDER 3 SHOWN

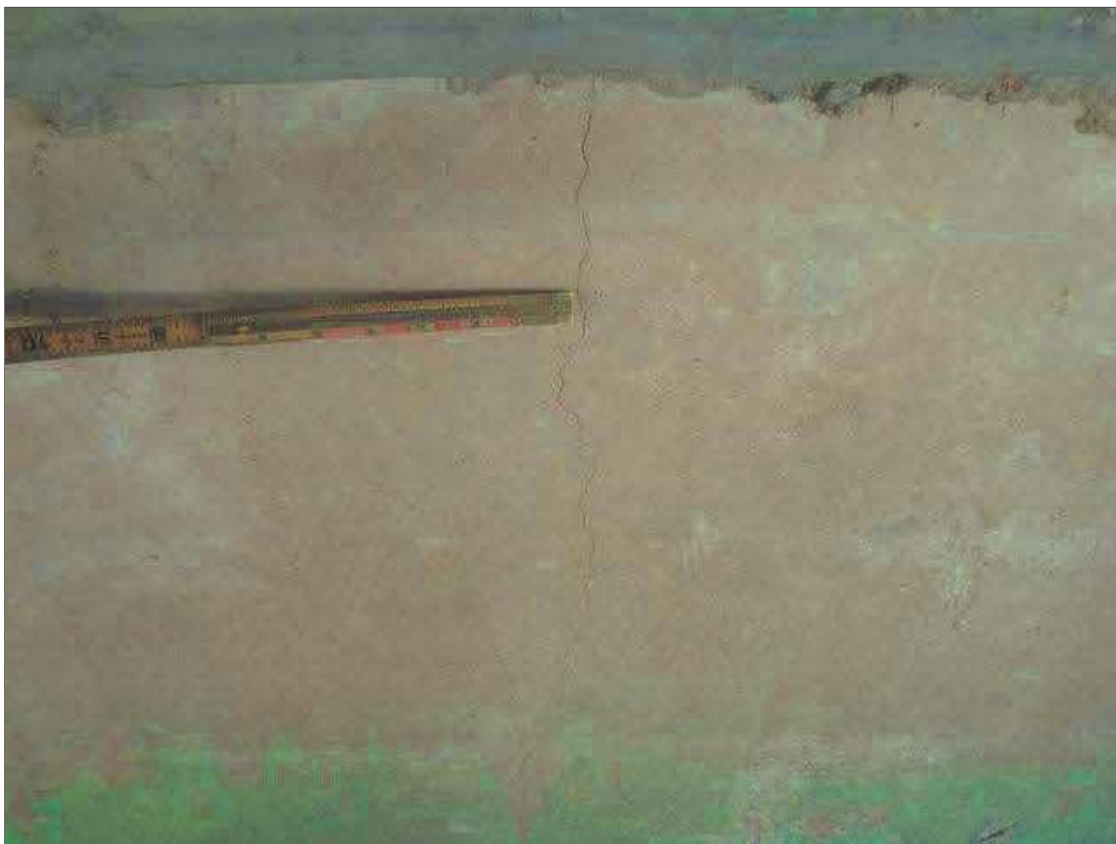
End Bent 1 Abutment: UP TO 0.016" VERTICAL CRACKS IN FACE OF ABUTMENT IN VARIOUS LOCATIONS, CRACK BENEATH BAY 2 SHOWN

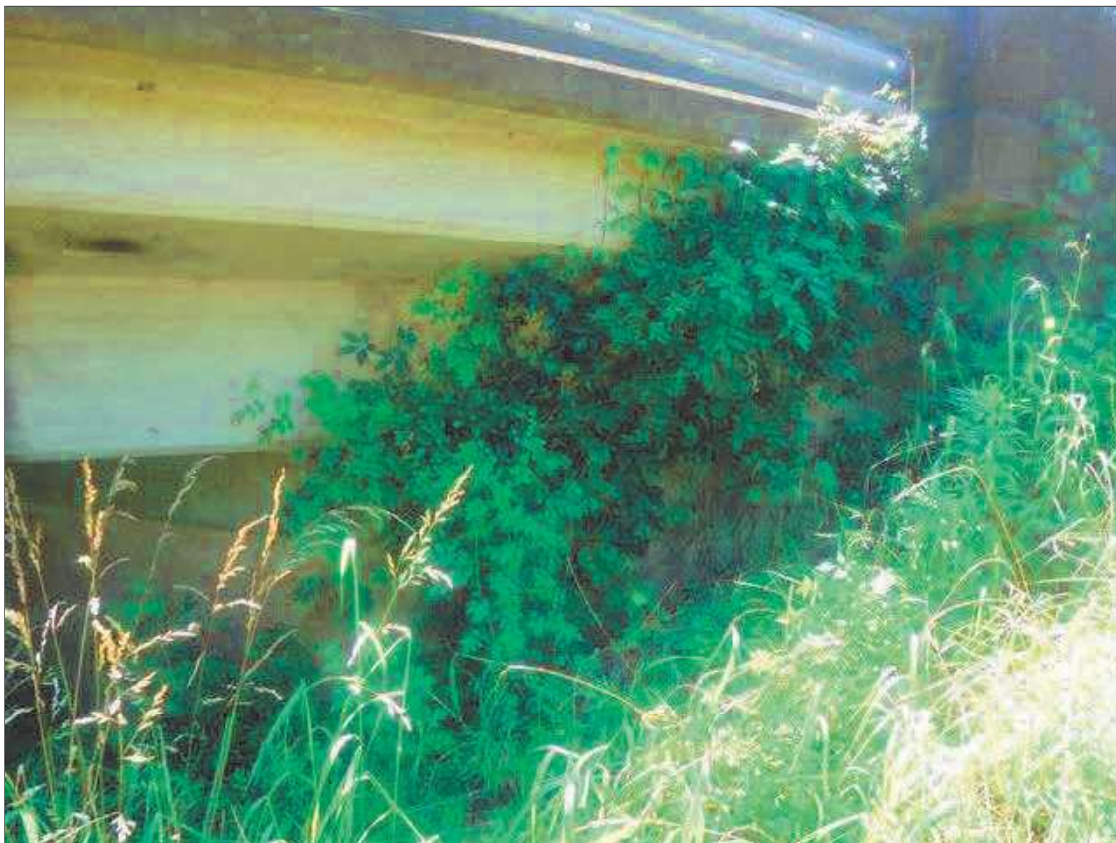
Span 1 Deck: VEGETATION GROWTH ALONG ABUTMENT 1 AT LEFT END, EXTENDING TO BOTTOM OF DECK

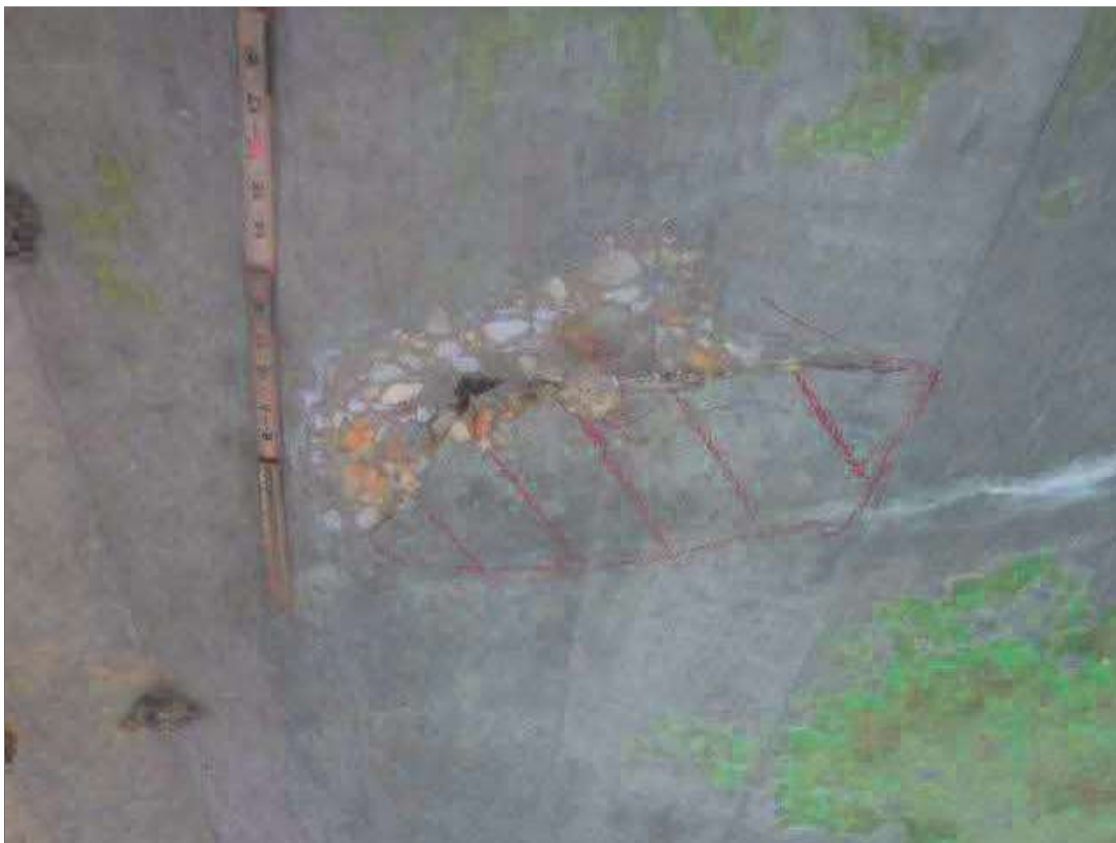
Span 1 Deck: 13" X 4" X 1" DEEP SPALL WITH EXPOSED REBAR AND 16" X 7" AREA OF DELAMINATION WITH UP TO 0.02" MAP CRACKS IN BOTTOM OF DECK IN BAY 1, APPROXIMATELY 7' FROM ABUTMENT 1

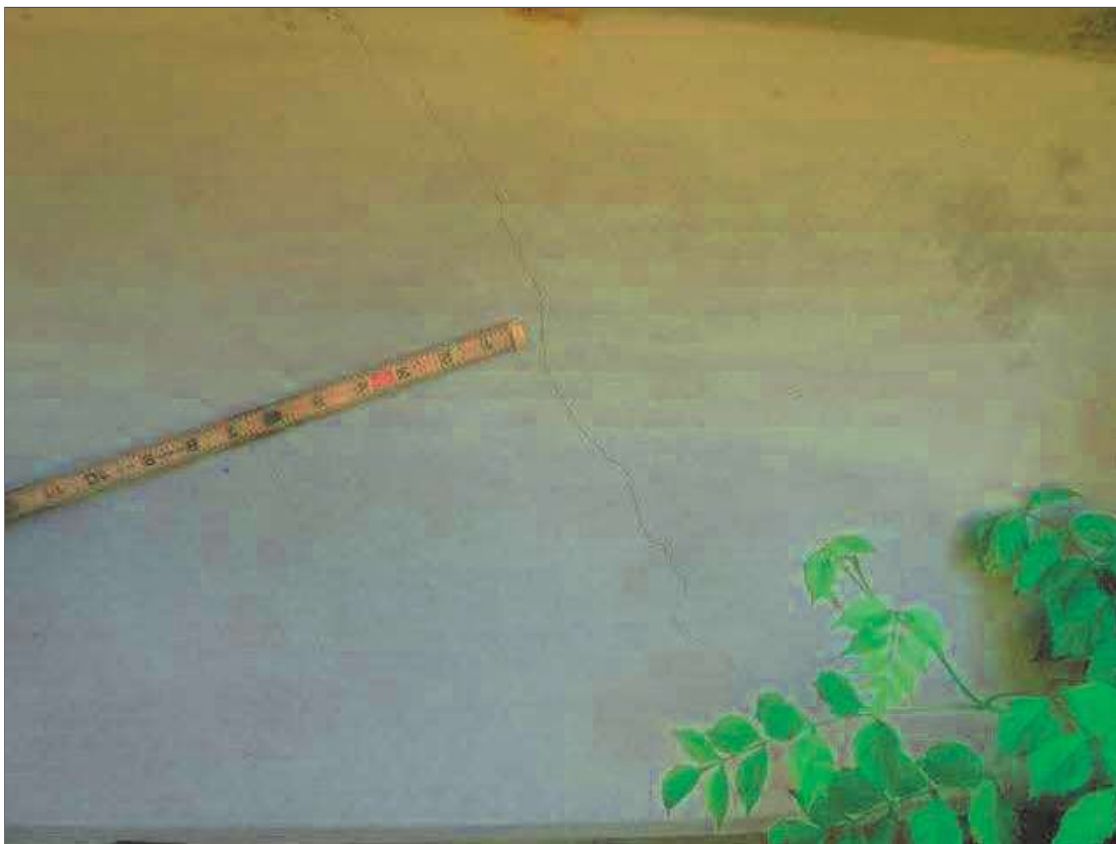
Span 1 Beam 1: 6' SECTION OF UP TO 0.012" DIAGONAL CRACKS IN LEFT FACE OF GIRDER EXTENDING FROM ABUTMENT 1, CRACK APPROXIMATELY 18" FROM ABUTMENT 1 SHOWN

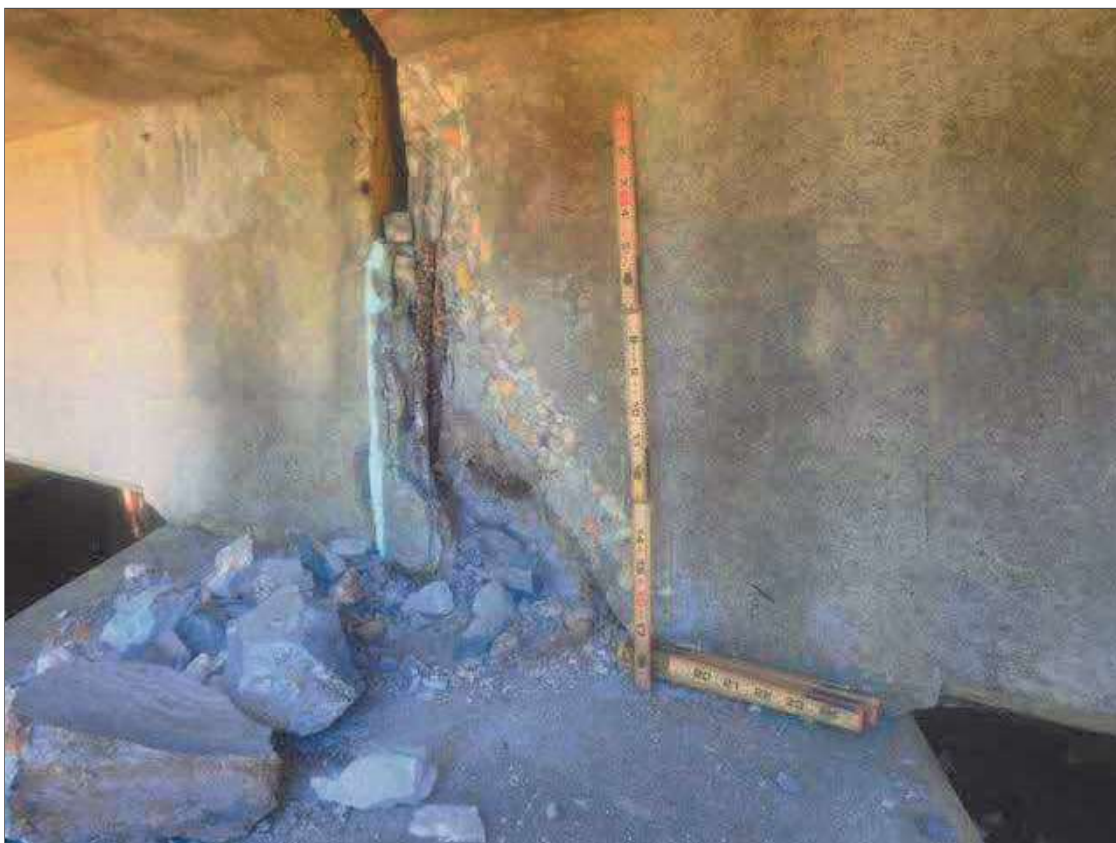
Span 1 Beam 1: PAR: 21" X 10" X 4" DEEP SPALL WITH EXPOSED REBAR IN LEFT FACE OF GIRDER AT PIER 1

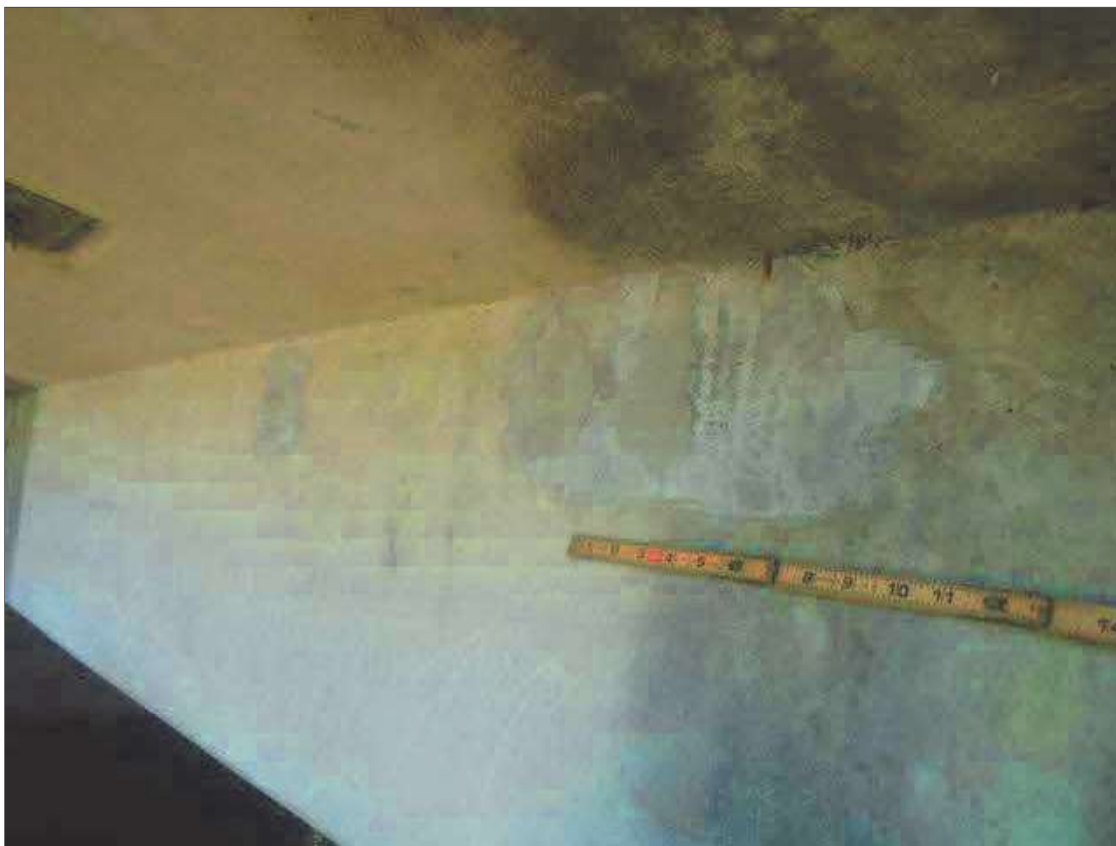
Span 2 Beam 1: (2) REPAIRS UP TO 14" X 6" IN LEFT FACE OF GIRDER, APPROXIMATELY 1' AND 3' FROM PIER
1

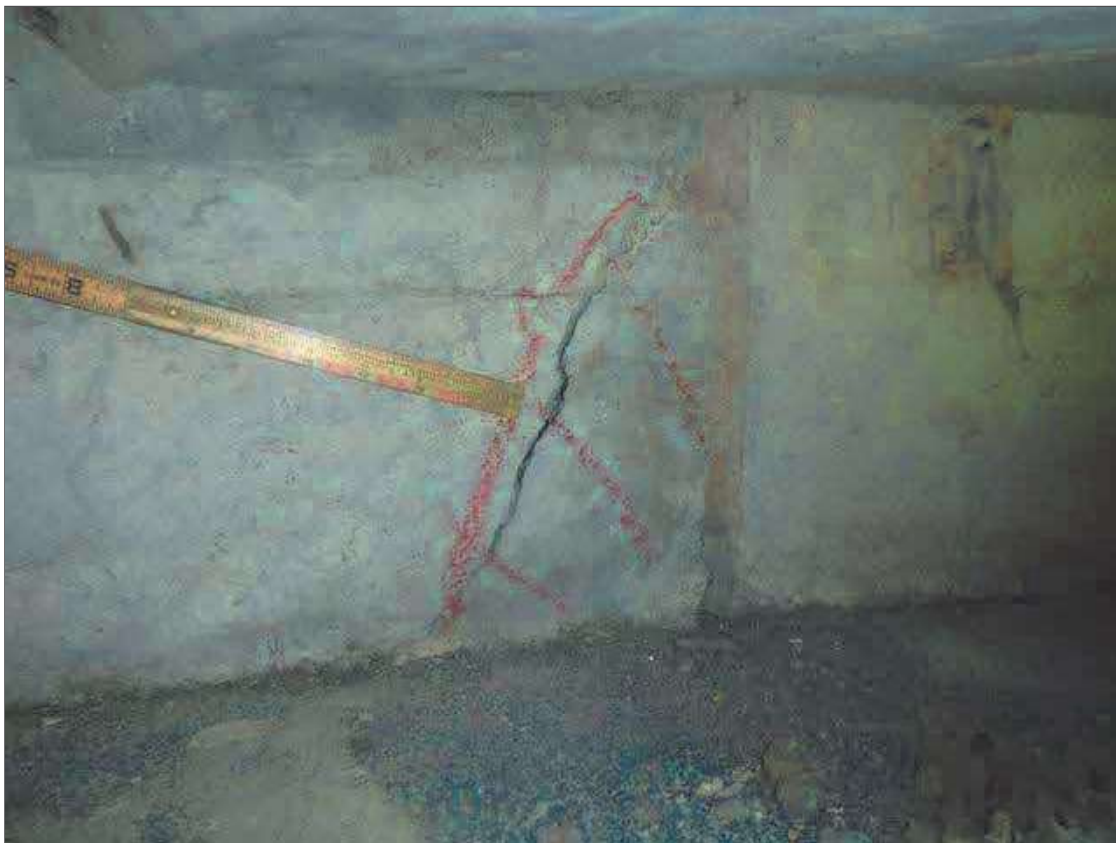
Span 1 Beam 1: 10" X 5" AREA OF DELAMINATION WITH UP TO 1/4" DIAGONAL CRACK IN RIGHT FACE OF GIRDER AT PIER 1

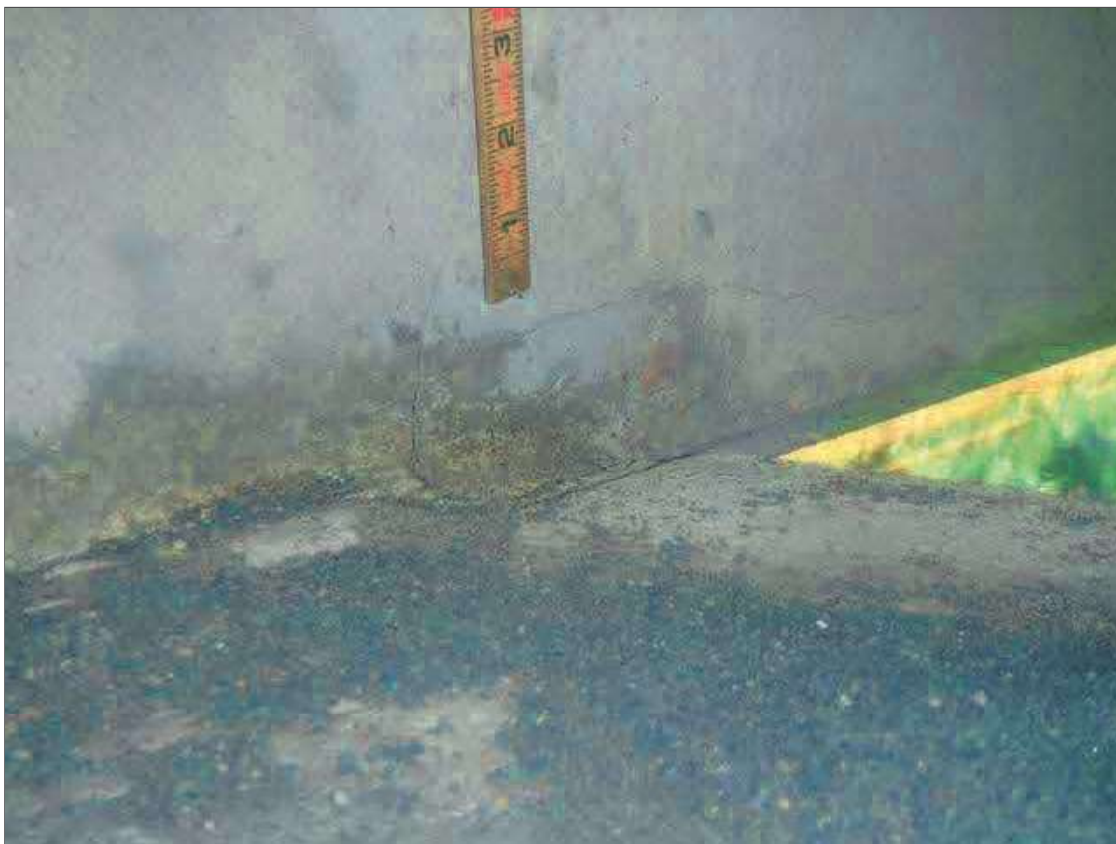
Span 2 Beam 2: 16" X 4" X 4" AREA OF DELAMINATION WITH UP TO 0.025" LONGITUDINAL AND HORIZONTAL CRACKS IN BOTTOM AND RIGHT FACE OF GIRDER AT PIER 1

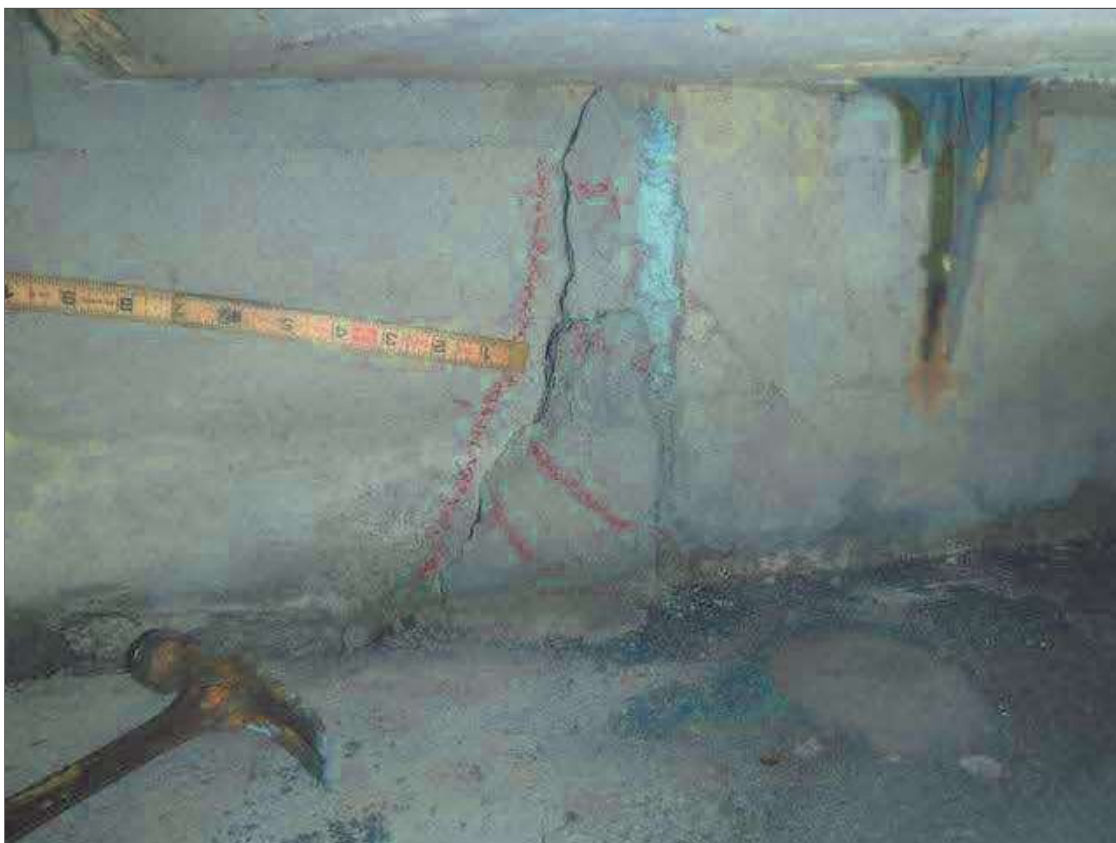
Span 1 Beam 2: 12" X 5" FAILED REPAIR WITH UP TO 1/8" DIAGONAL CRACKS IN RIGHT FACE OF GIRDER AT PIER 1

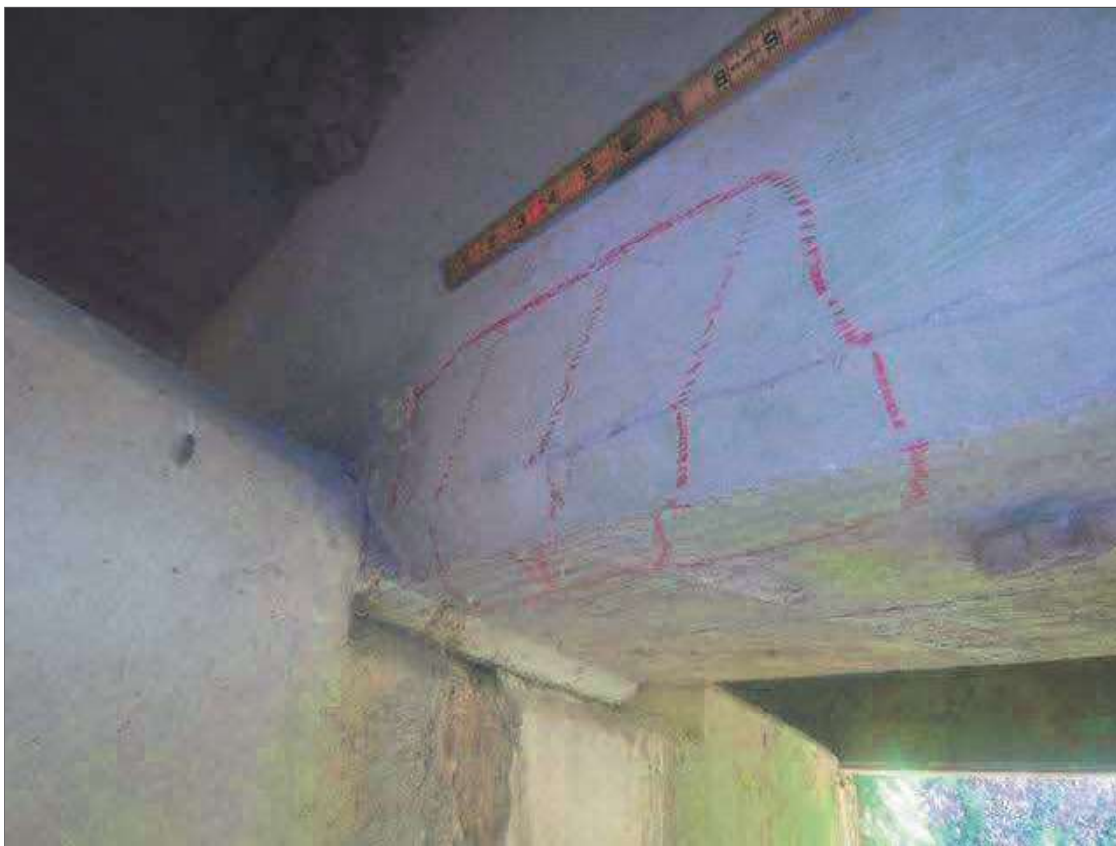
Span 1 Beam 3: 12" X 4" X 5" AREA OF DELAMINATION WITH UP TO 0.02" LONGITUDINAL AND HORIZONTAL CRACKS IN BOTTOM AND LEFT FACE OF GIRDER AT PIER 1
