NC DEPARTMENT OF TRANSPORTATION
 DIVISION OF HIGHWAYS
 STRUCTURE MANAGEMENT UNIT

ATTENTION: PAR, NEW REPAIRS, DATA CHANGES

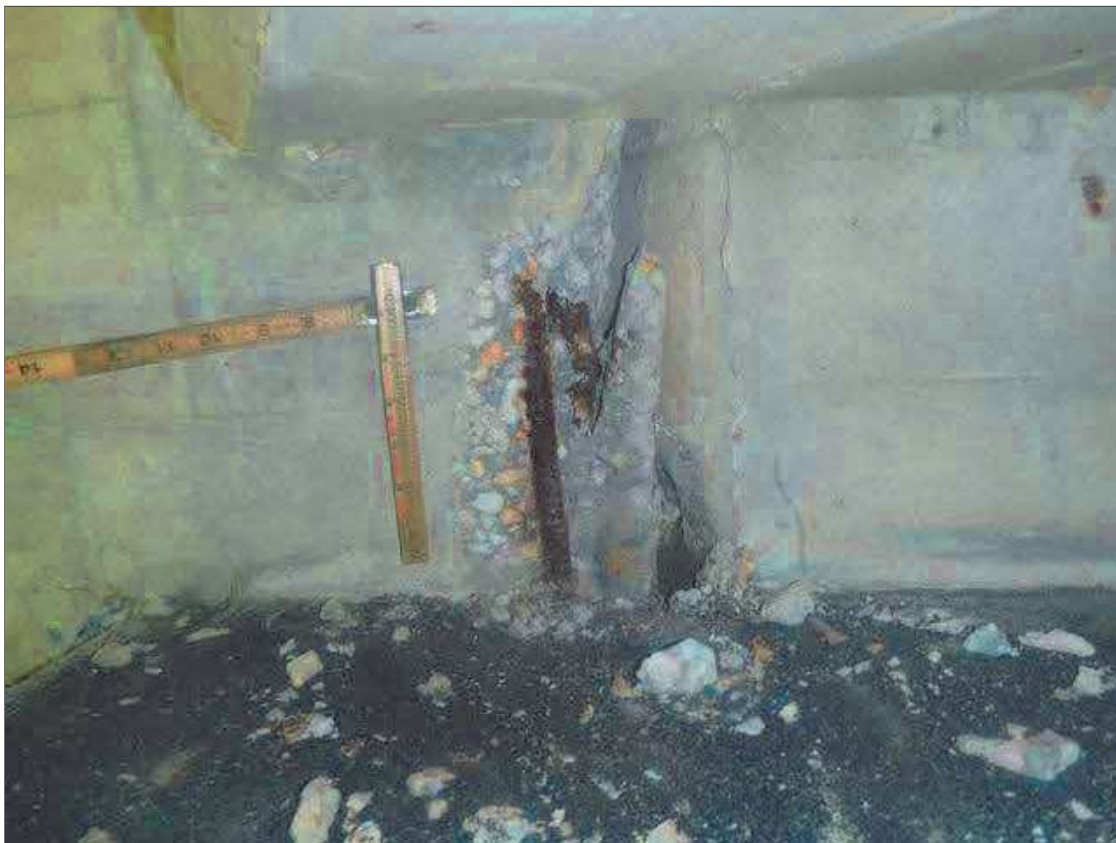
Span 1 Beam 3: PAR: 11" X 6" X 3" DEEP SPALL WITH EXPOSED REBAR IN RIGHT FACE OF GIRDER AT PIER 1

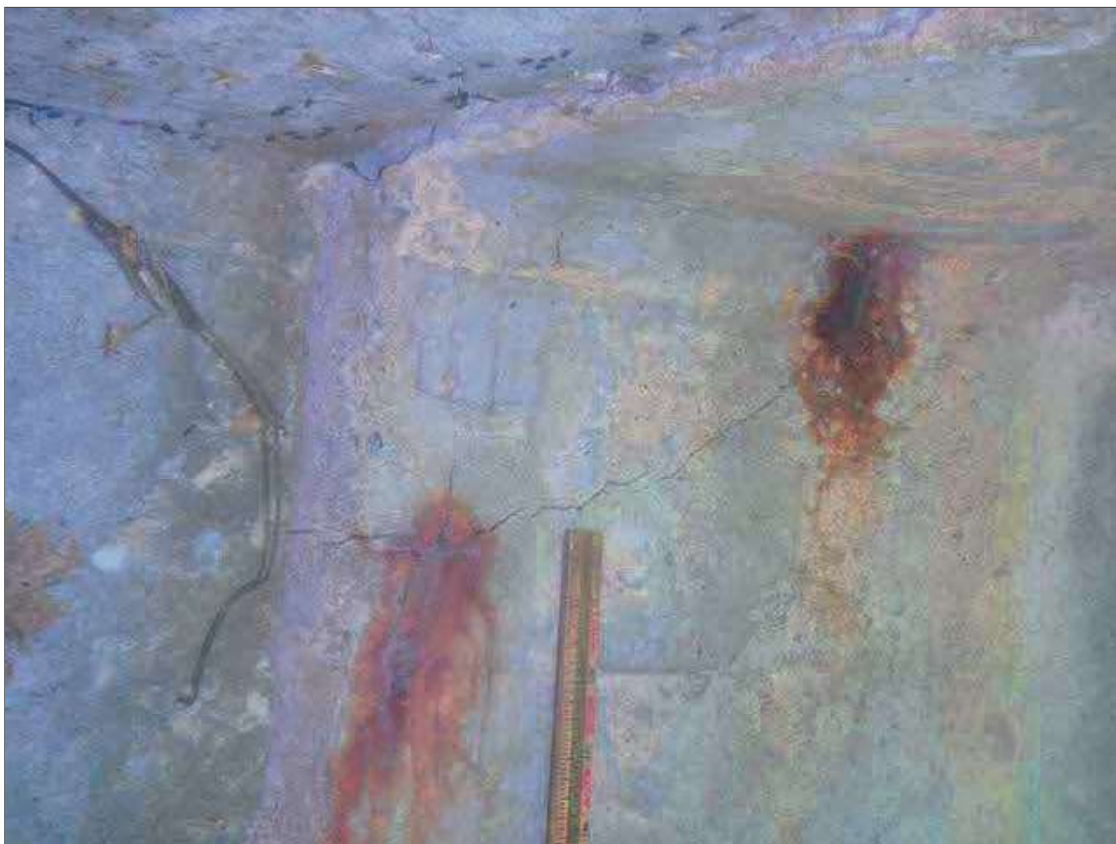
Span 2 Beam 4: UP TO 0.025" DIAGONAL CRACKS WITH RUST STAINING AND 2" X 1" AREA OF EXPOSED REBAR IN RIGHT FACE OF GIRDER AT PIER 1

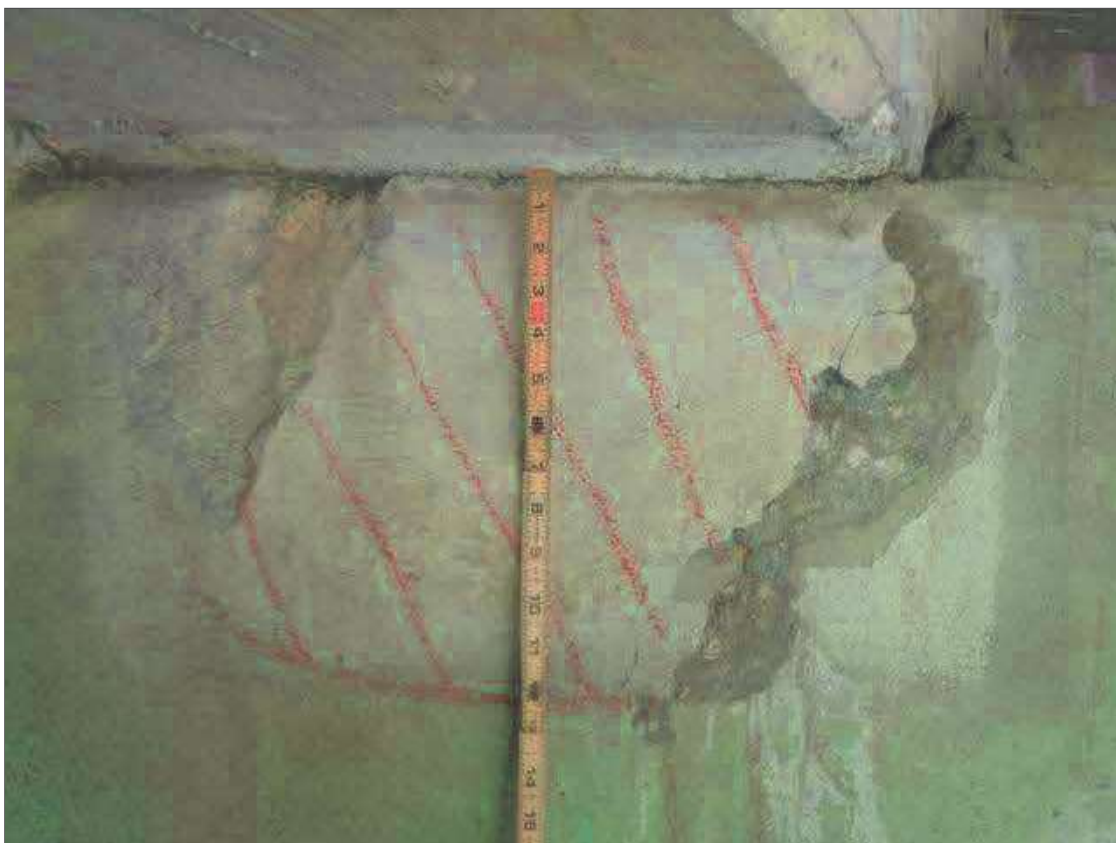
Bent 1 Cap 1: 21" X 12" FAILED REPAIR WITH UP TO 0.012" MAP CRACKS AND (2) SPALLS UP TO 12" X 4" X 1/2" DEEP IN SPAN 1 FACE OF CAP BENEATH GIRDER 3

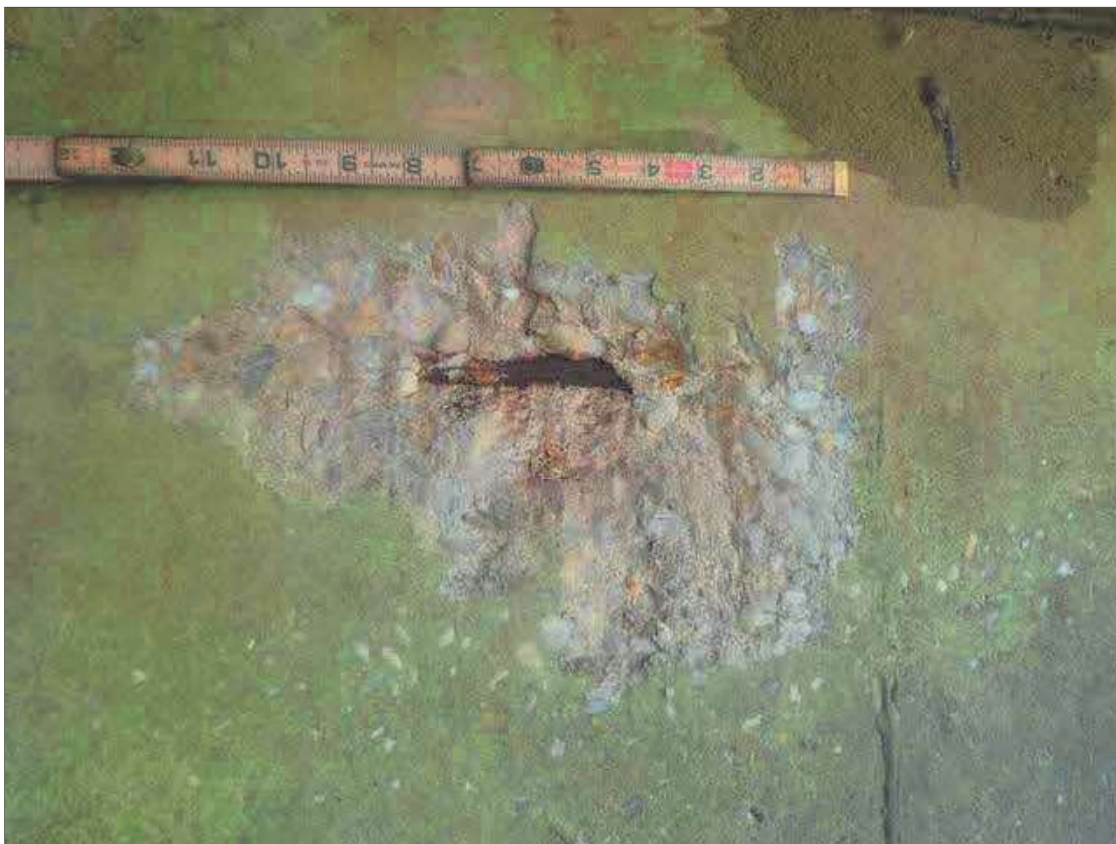
Bent 1 Pile 1: 12" X 6" X 1" DEEP SPALL WITH EXPOSED REBAR IN SPAN 1 FACE OF PIER WALL, APPROXIMATELY 1' FROM BOTTOM OF CAP

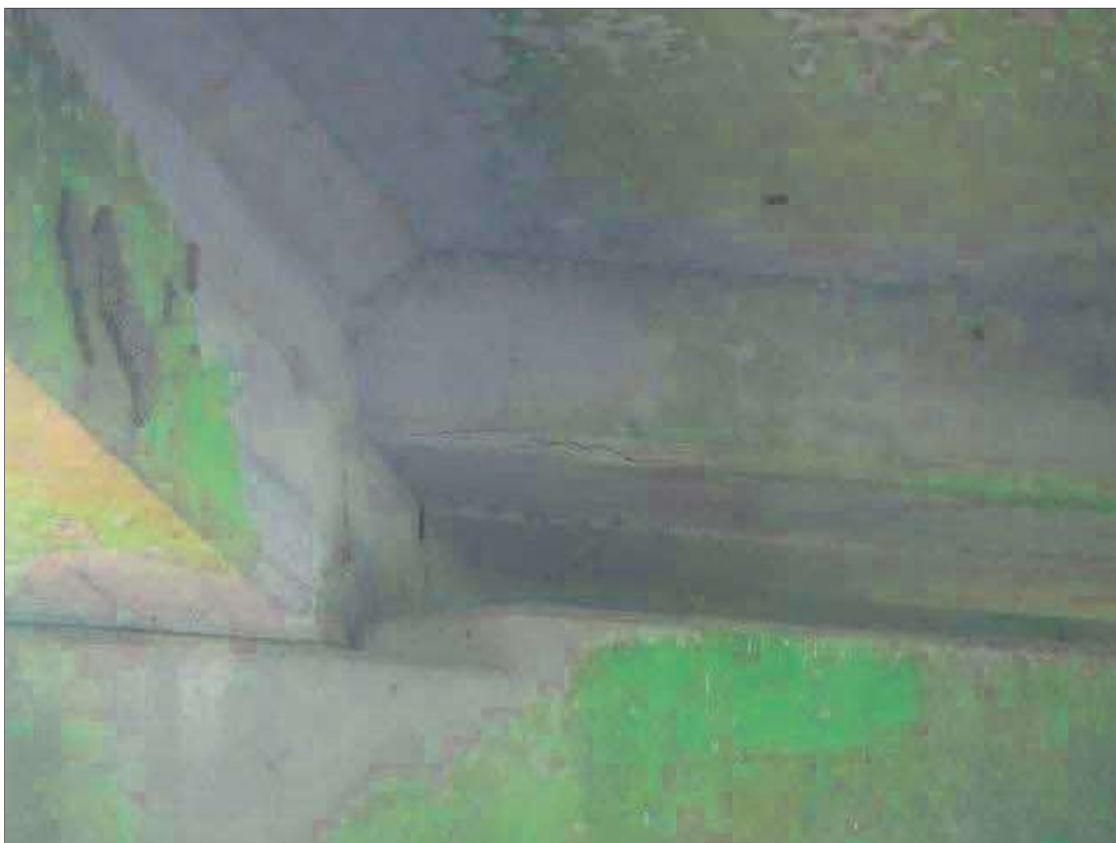
Span 2 Beam 3: UP TO 1/16" HORIZONTAL CRACKS IN FACE OF PIER 1 DIAPHRAGM IN BAY 3, ADJACENT TO GIRDER 4

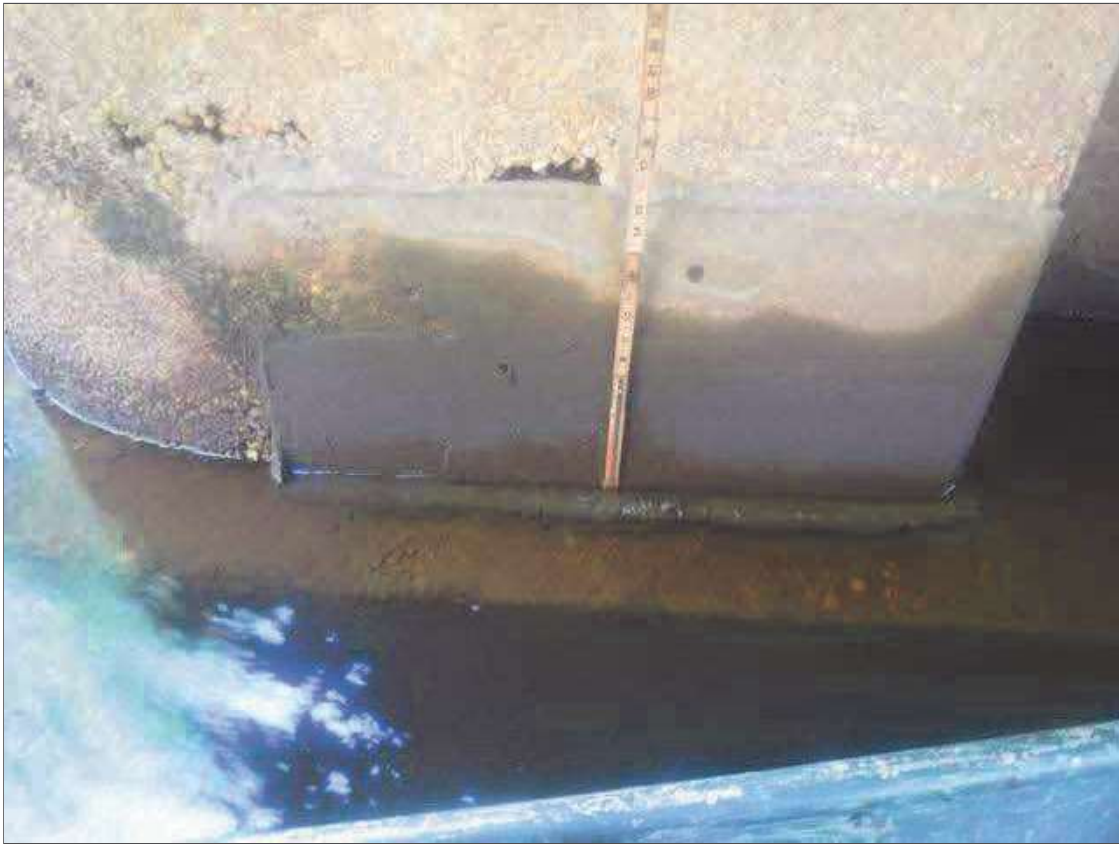
Bent 2 Pile 1: 33" X 16" REPAIR IN SPAN 3 FACE OF PIER WALL AT TOP OF FOOTING BENEATH GIRDER 4

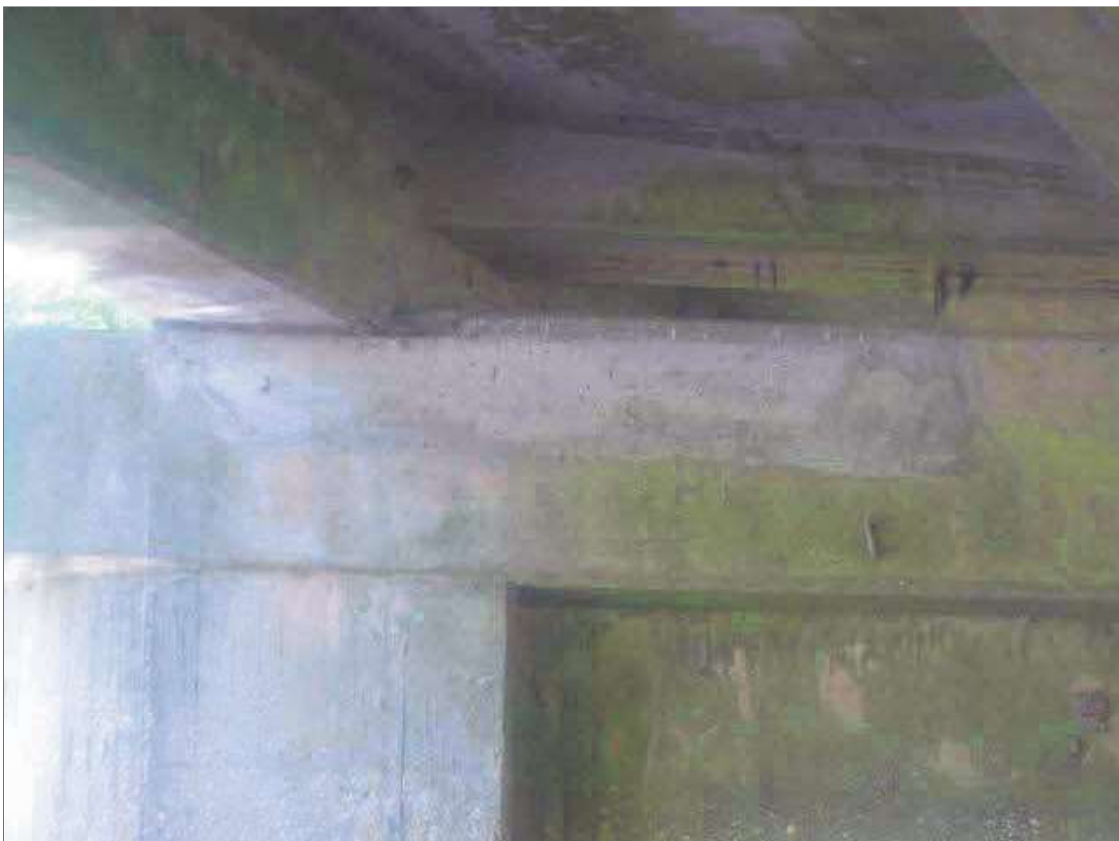
Bent 2 Cap 1: APPROXIMATELY 7' X 12" REPAIR IN SPAN 2 FACE OF CAP BENEATH BAY 1

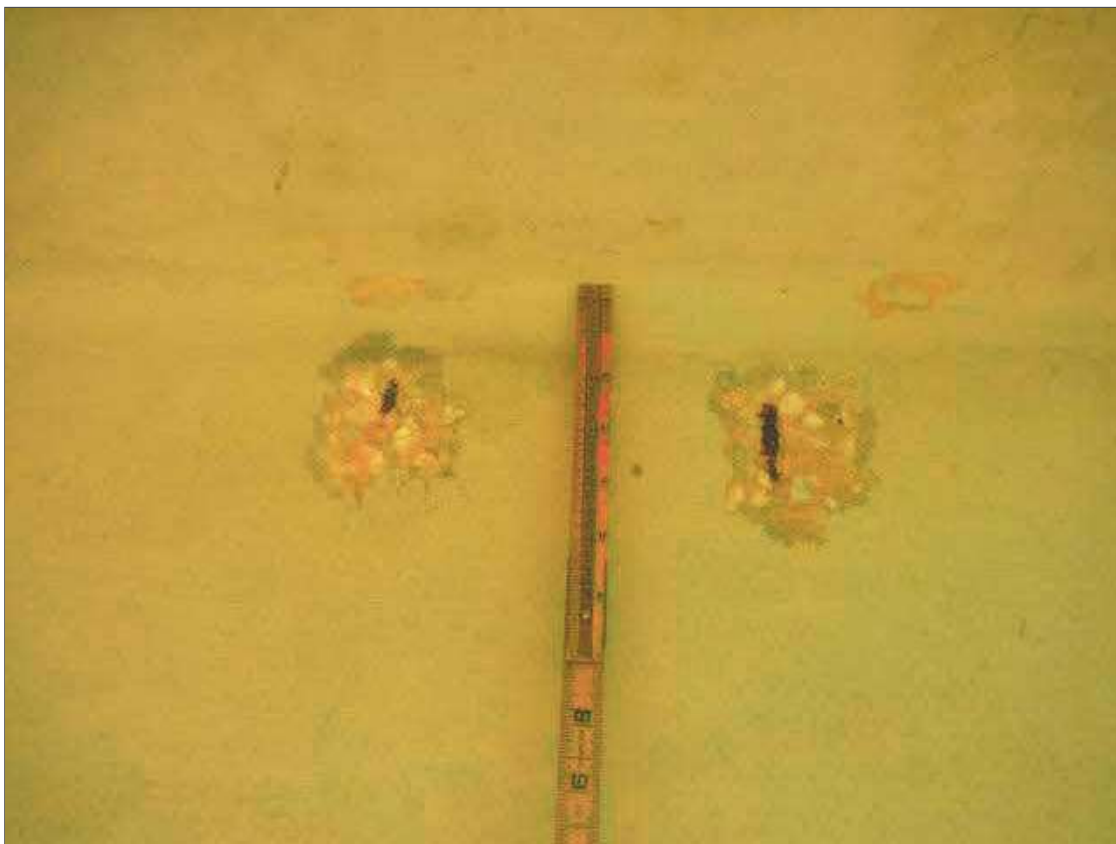
Span 4 Beam 1: (2) SPALLS WITH EXPOSED REBAR UP TO 3" DIAMETER X 1/2" DEEP IN LEFT FACE OF GIRDER, APPROXIMATELY 3' FROM PIER 3

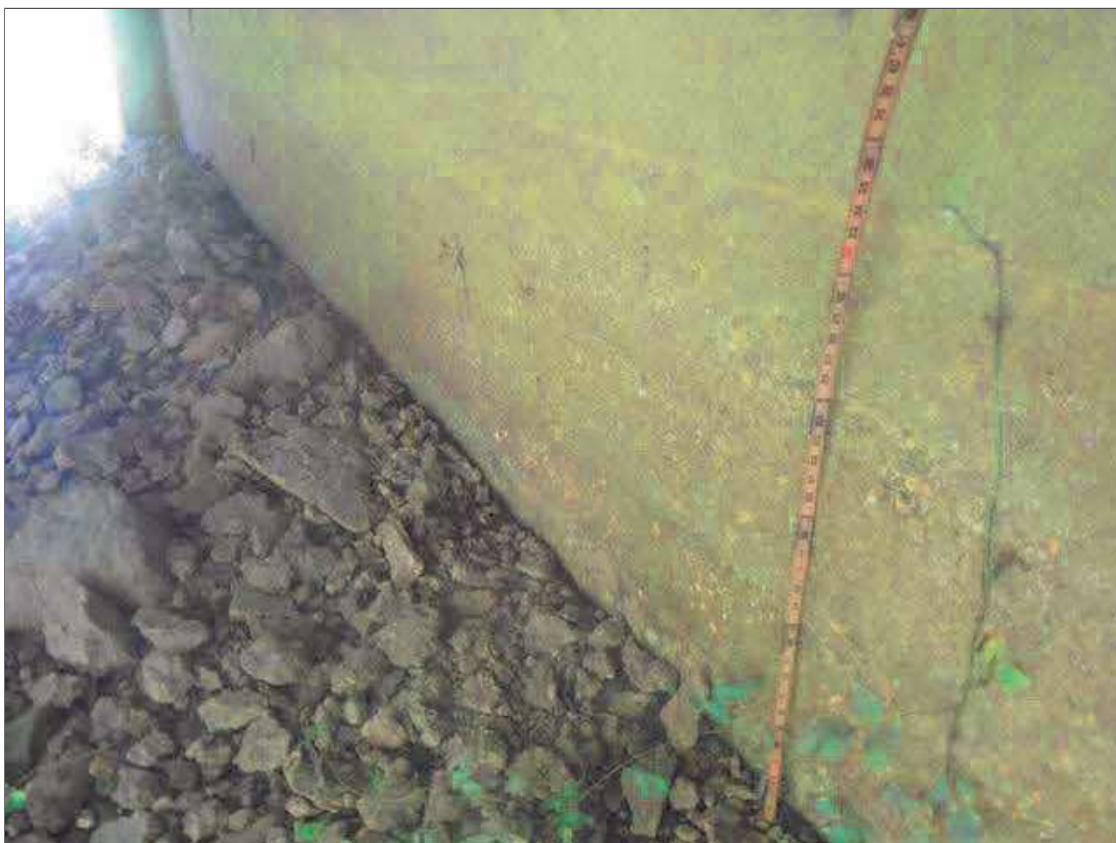
Bent 3 Pile 1: UP TO 38" HIGH SCALING WITH EXPOSED AGGREGATE THROUGHOUT PIER WALL, CONDITION IN SPAN 3 FACE SHOWN

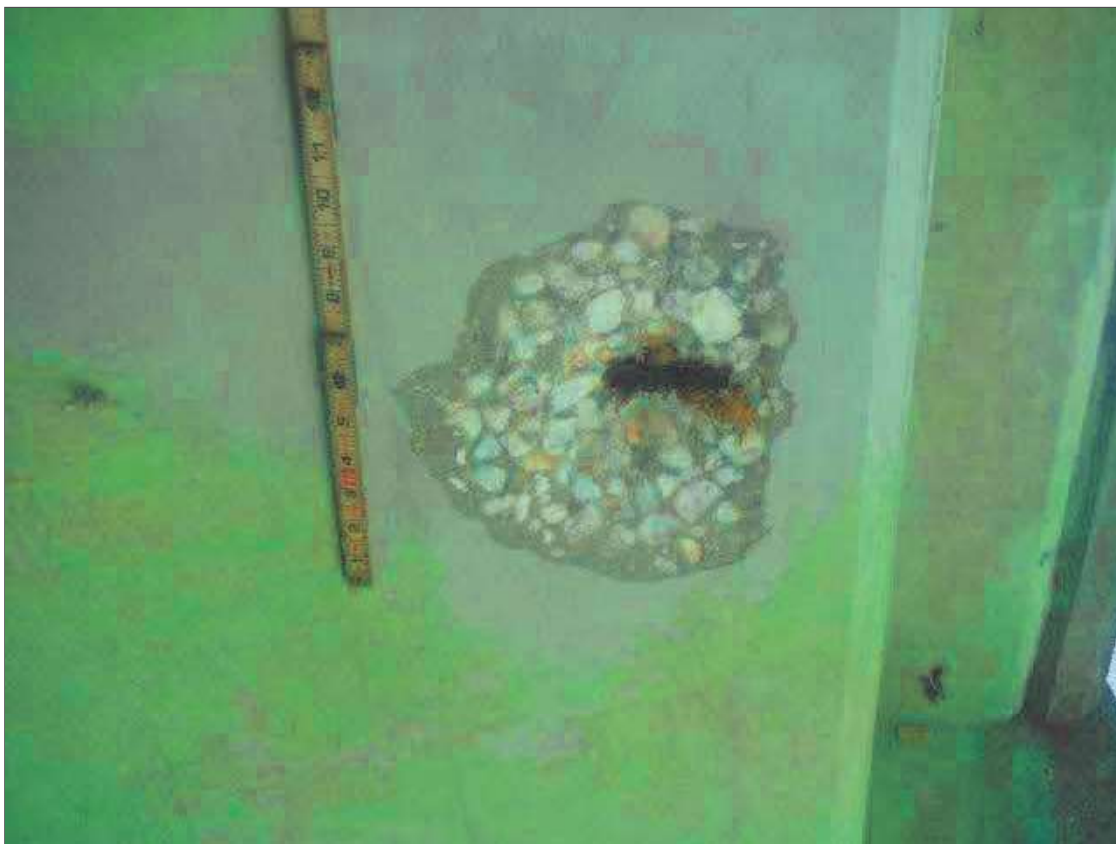
Span 3 Deck: 10" X 8" X 1" DEEP SPALL WITH EXPOSED REBAR IN BOTTOM OF RIGHT OVERHANG NEAR PIER
3

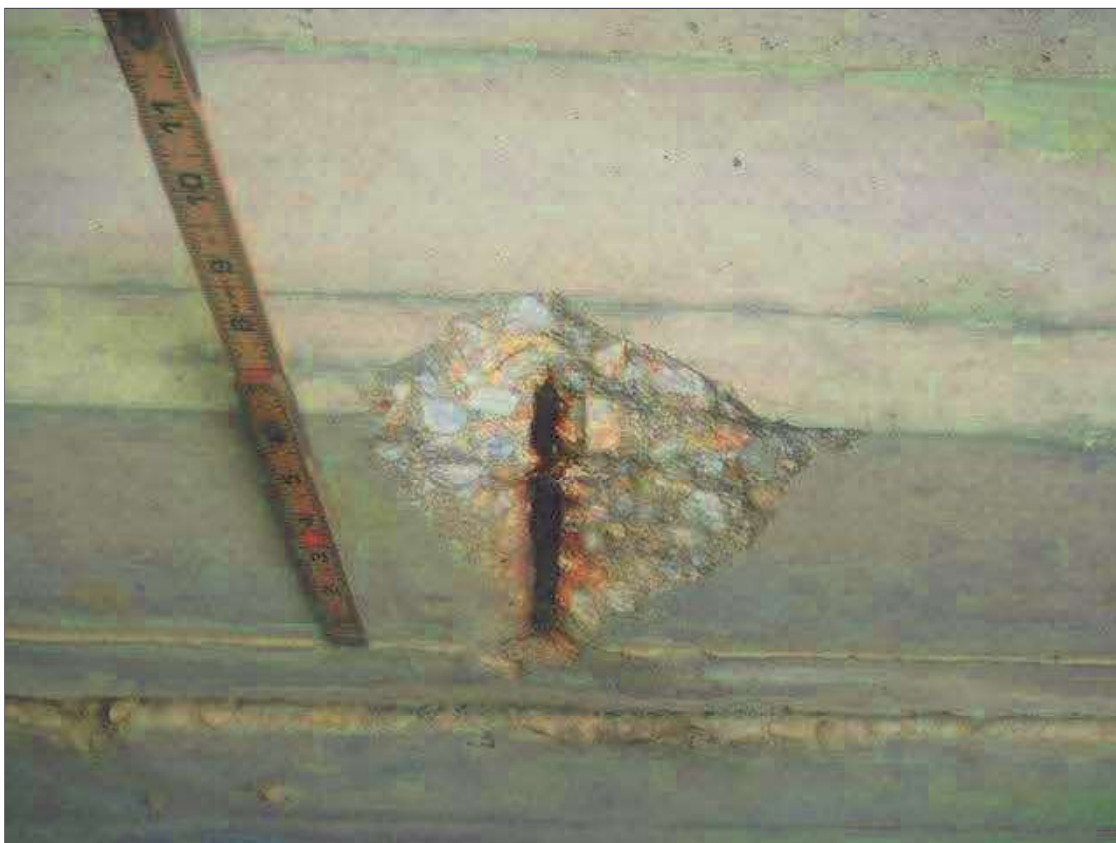
Span 4 Beam 1: 8" X 5" X 1" DEEP SPALL WITH EXPOSED REBAR IN BOTTOM OF PIER 3 DIAPHRAGM IN BAY 1

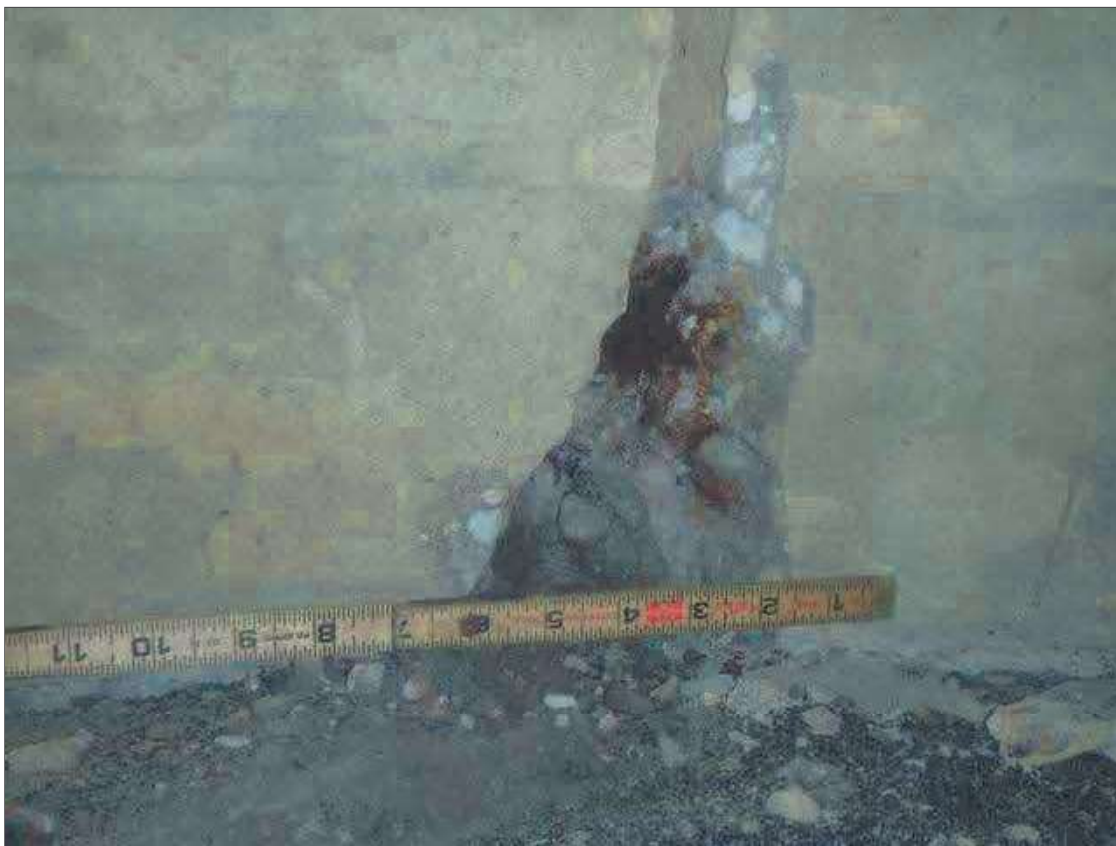
Span 3 Beam 2: PAR: 9" X 2" X 2" DEEP SPALL WITH EXPOSED REBAR IN LEFT FACE OF GIRDER AT PIER 3

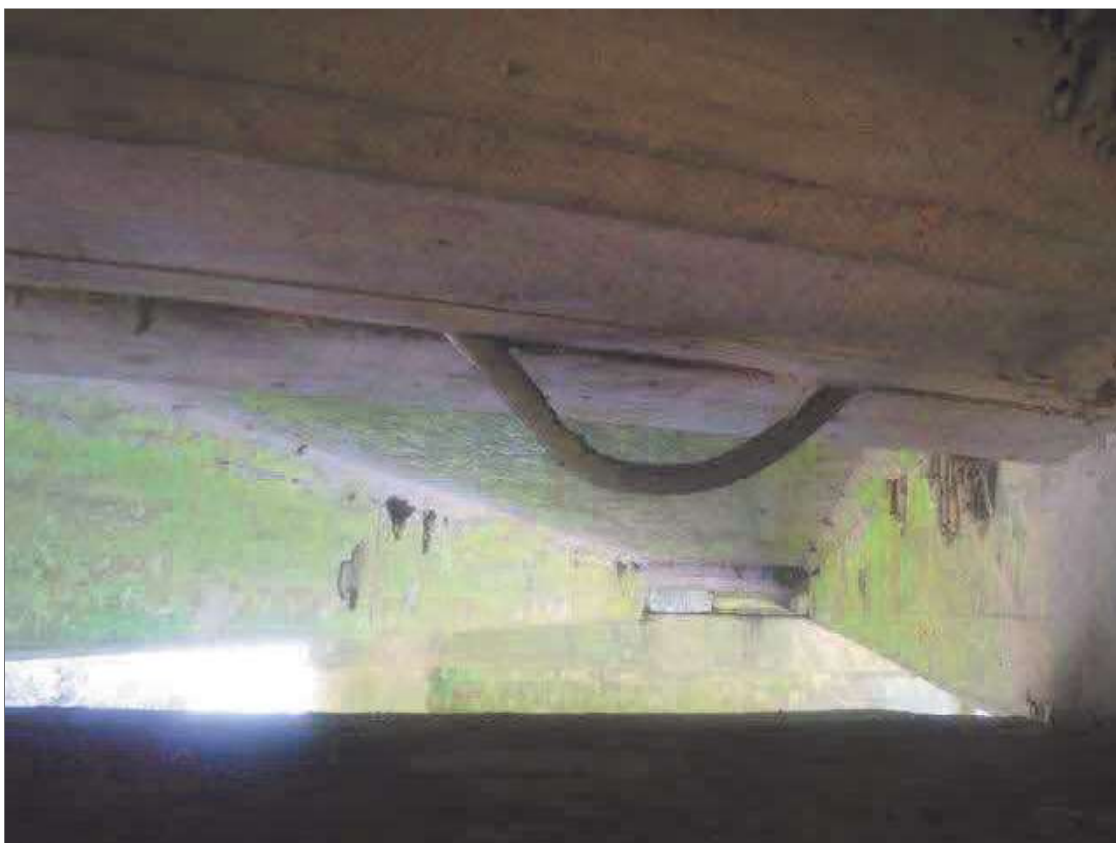
Span 4 Expansion Joint 3: BROKEN AND HANGING BACKER ROD ALONG PIER 3 JOINT IN VARIOUS LOCATIONS THROUGHOUT BAYS, CONDITION IN BAY 2 SHOWN

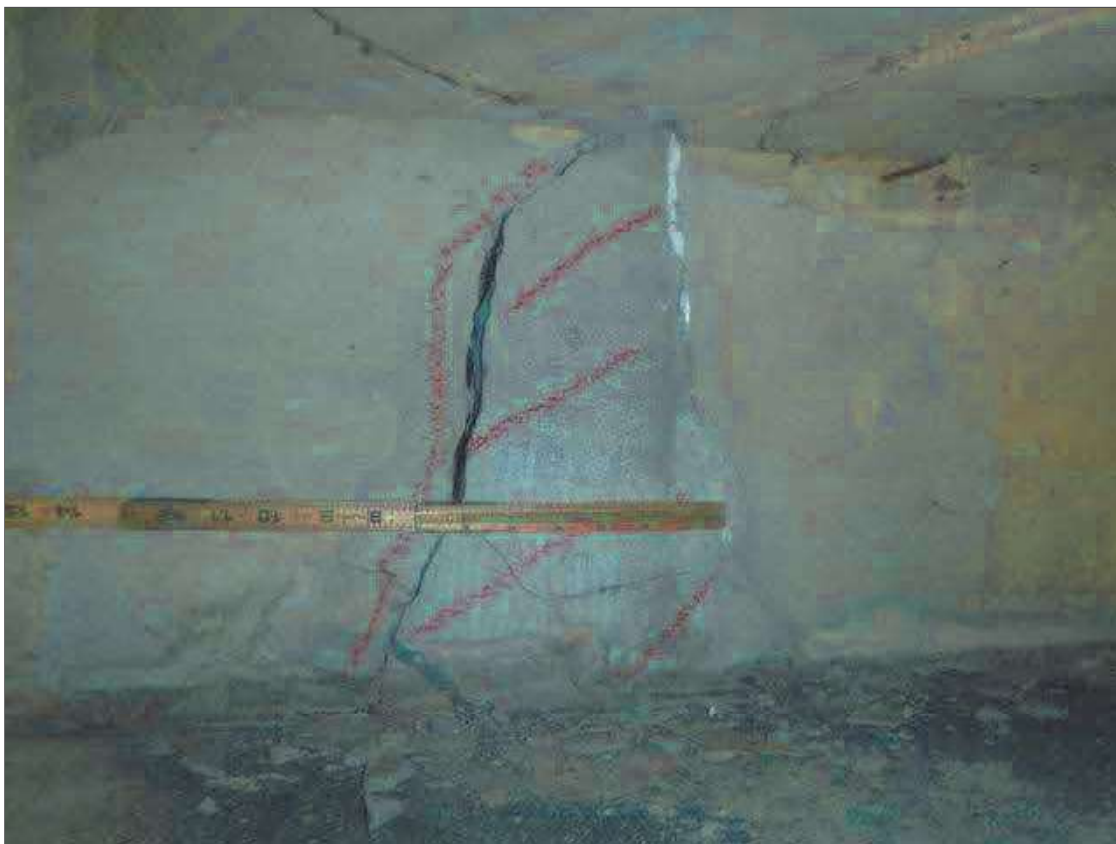
Span 3 Beam 2: 13" X 8" FAILED REPAIR WITH UP TO 1/4" DIAGONAL CRACK IN RIGHT FACE OF GIRDER AT PIER 3

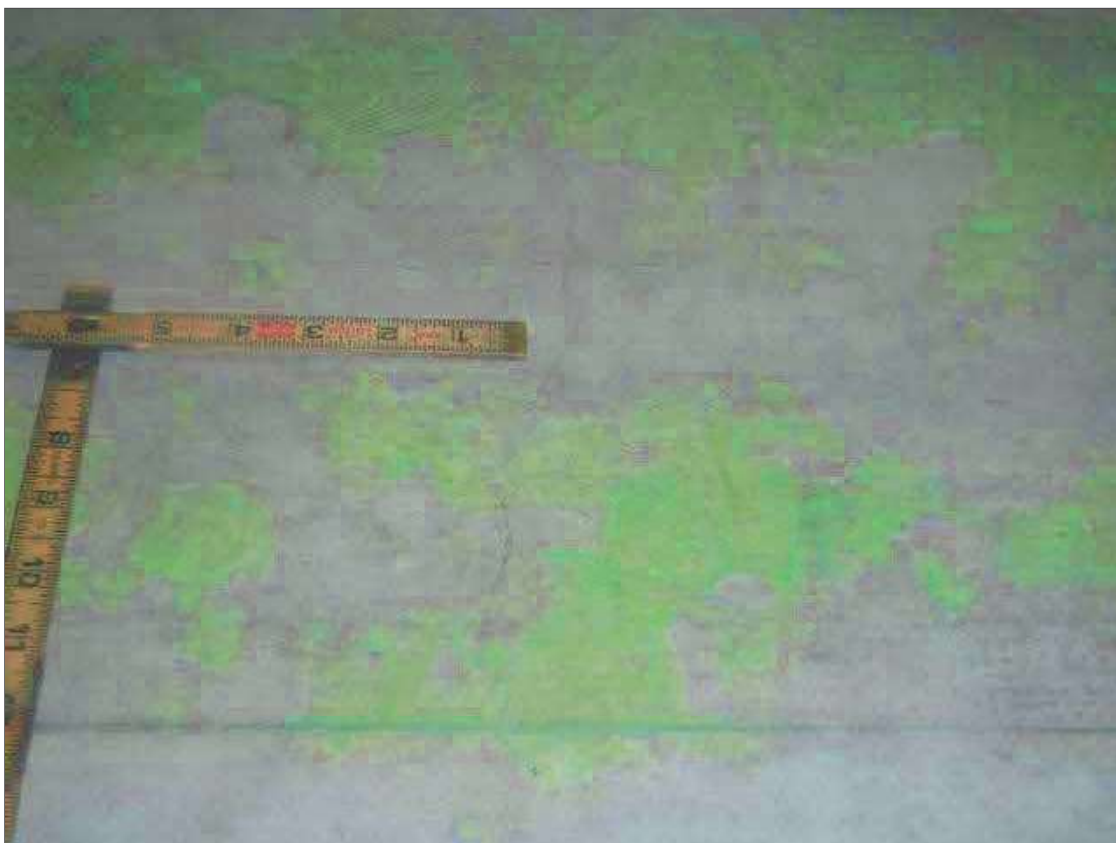
Span 4 Beam 1: UP TO 0.012" TRANSVERSE AND VERTICAL CRACKS IN BOTTOM AND BOTH FACES OF GIRDER IN VARIOUS LOCATIONS THROUGHOUT, CONDITION ON RIGHT SIDE NEAR MIDSPAN SHOWN

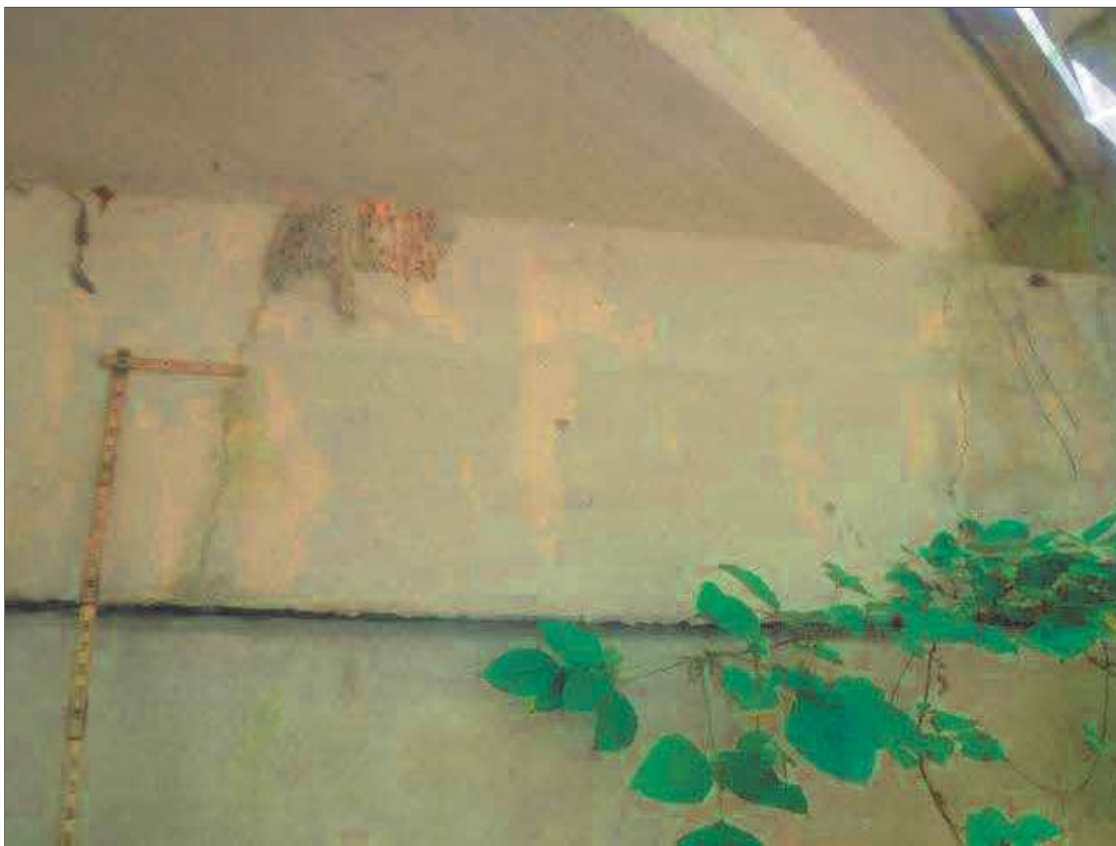
End Bent 2 Abutment: UP TO 0.025" VERTICAL CRACKS IN FACE OF CURTAIN WALL AT RIGHT END

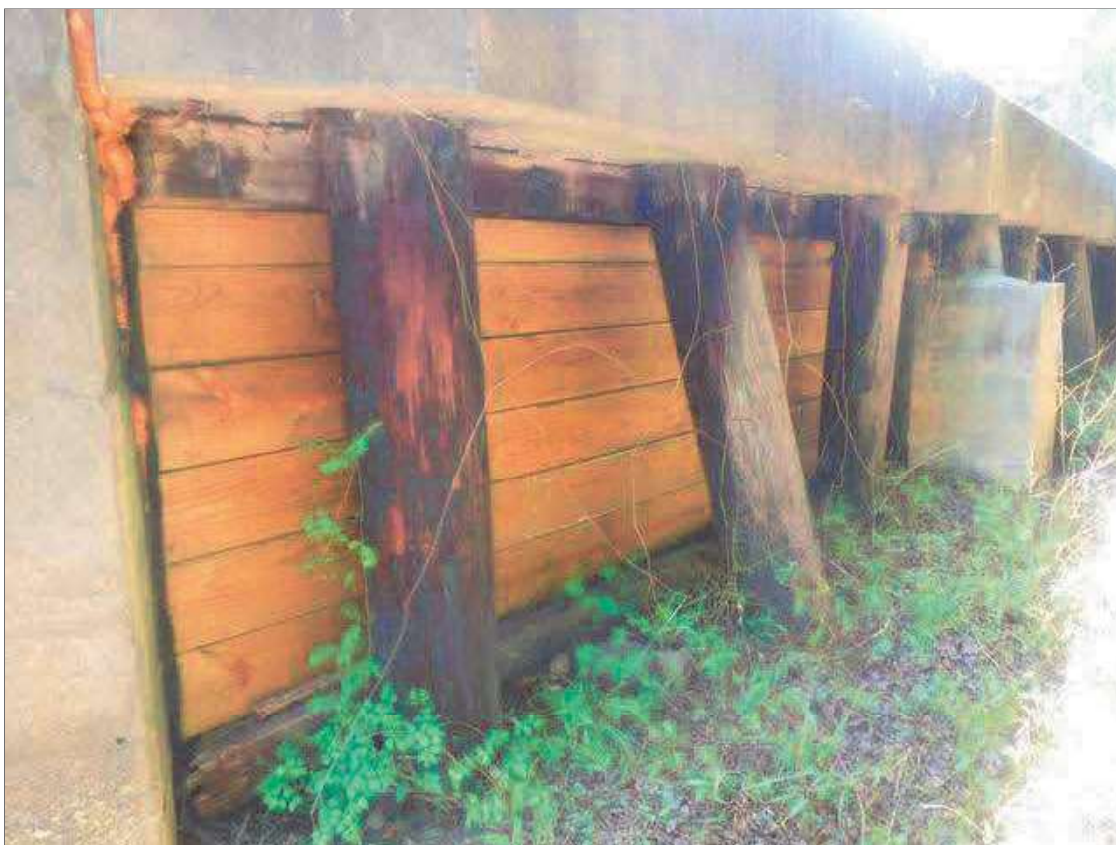
PRIORITY MAINTENANCE REPAIR TO SOUTHEAST WINGWALL SINCE 2018 INSPECTOIN

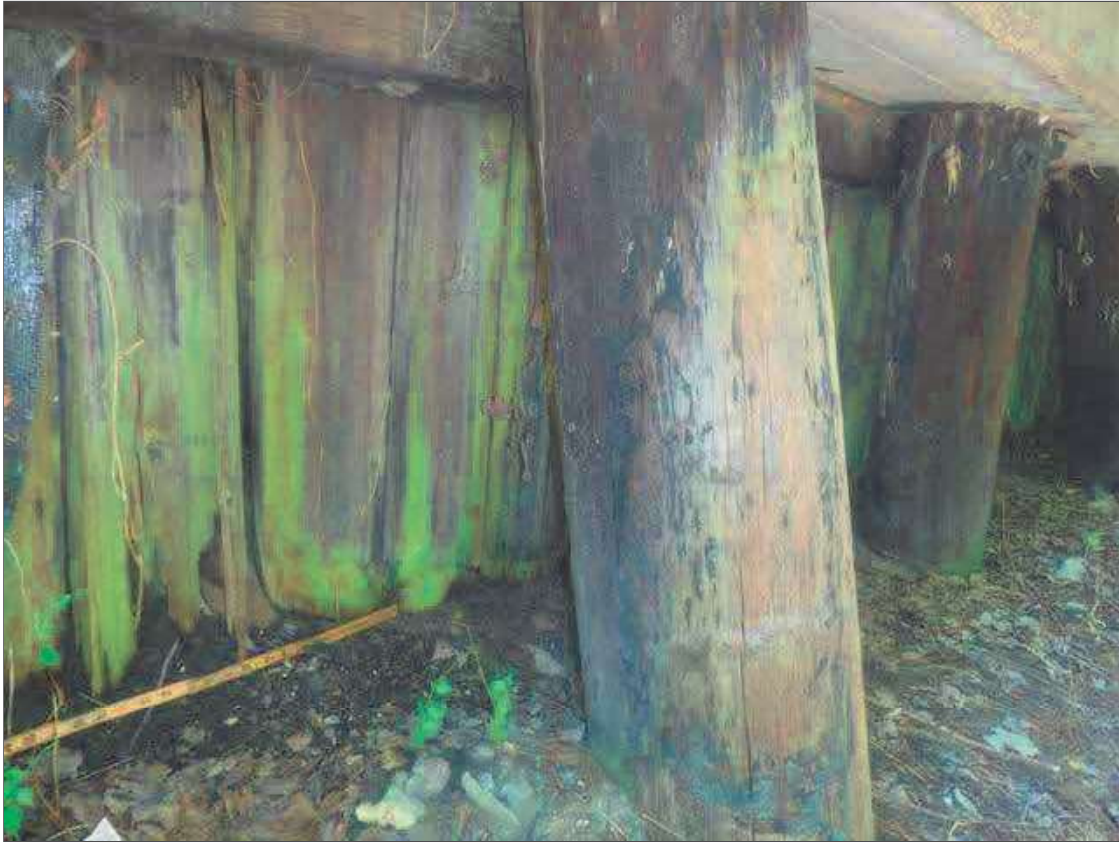
PAR: 50' SECTION WITH AREAS OF DECAY UP TO FULL DEPTH WITH EXPOSED FILL THROUGHOUT FACE OF SOUTHEAST WINGWALL, BEGINNING APPROXIMATELY 18' FROM NEAR END OF WINGWALL, CONDITION APPROXIMATELY 20' FROM NEAR END OF WINGWALL SHOWN

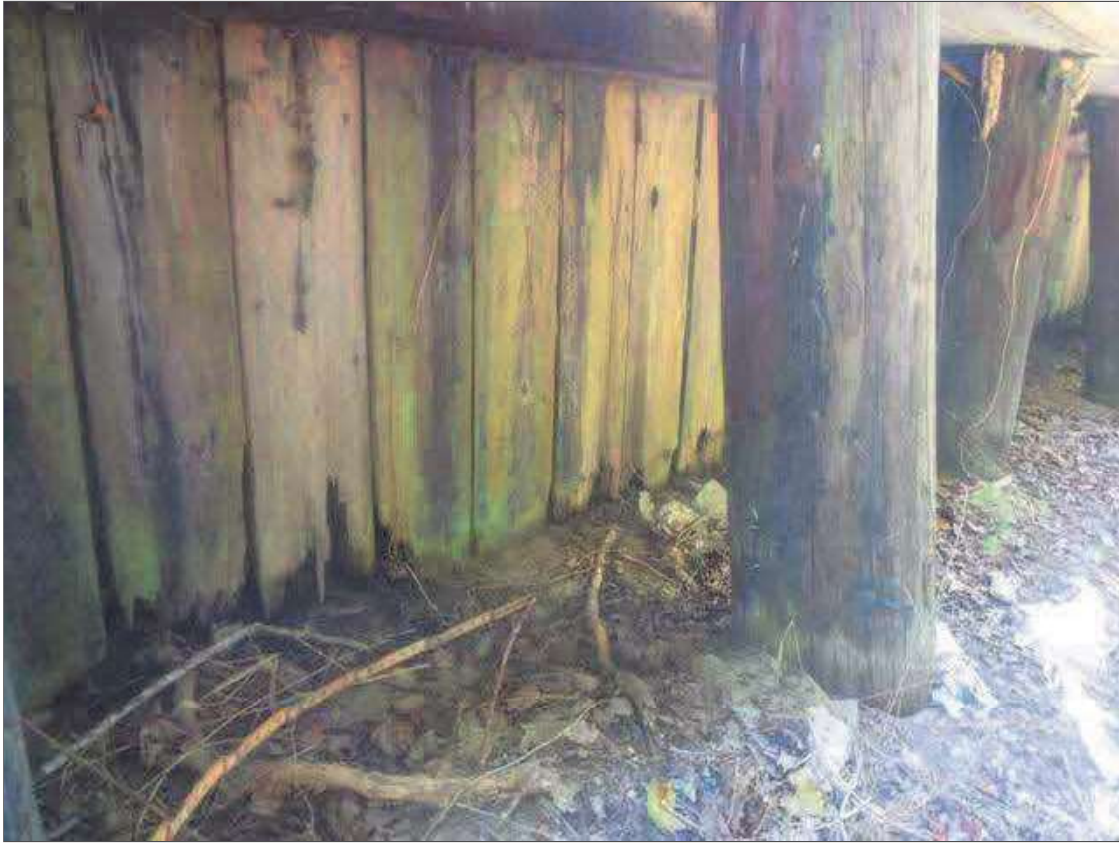
PAR: 50' SECTION WITH AREAS OF DECAY UP TO FULL DEPTH WITH EXPOSED FILL THROUGHOUT FACE OF SOUTHEAST WINGWALL, BEGINNING APPROXIMATELY 18' FROM NEAR END OF WINGWALL, CONDITION APPROXIMATELY 40' FROM NEAR END OF WINGWALL SHOWN

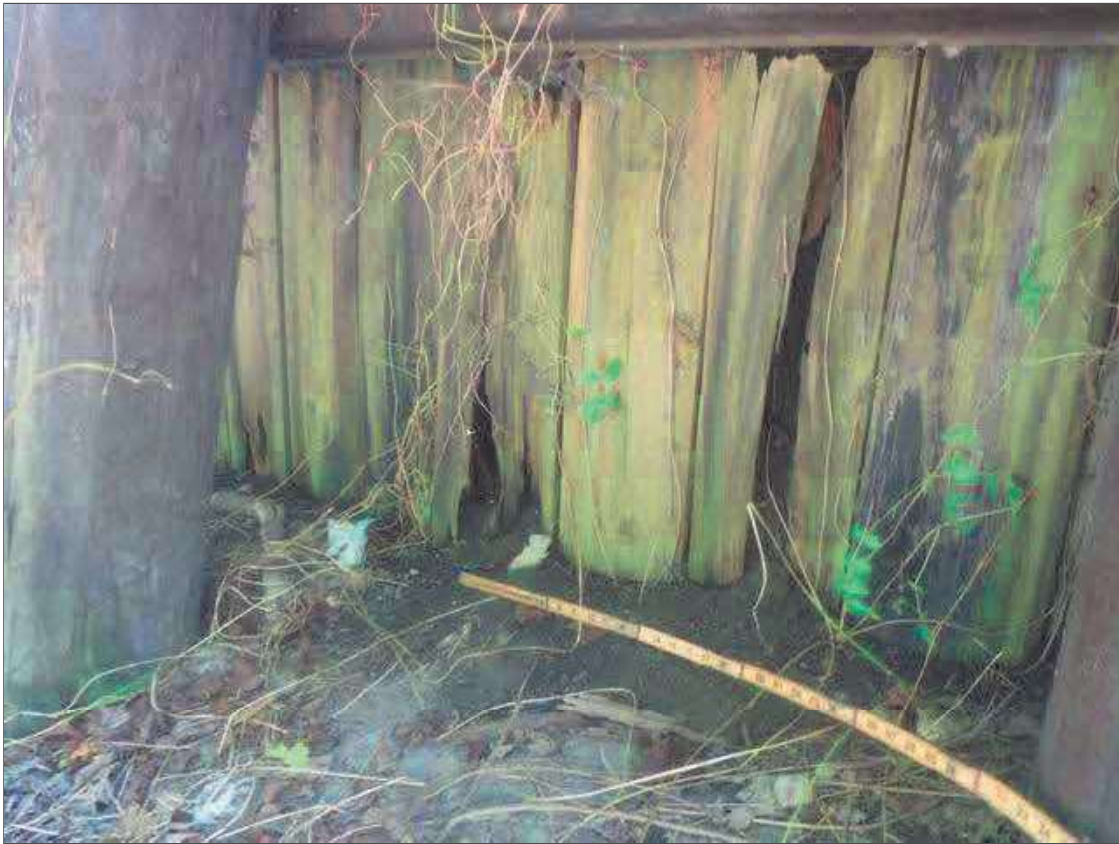
PAR: 50' SECTION WITH AREAS OF DECAY UP TO FULL DEPTH WITH EXPOSED FILL THROUGHOUT FACE OF SOUTHEAST WINGWALL, BEGINNING APPROXIMATELY 18' FROM NEAR END OF WINGWALL, CONDITION APPROXIMATELY 60' FROM NEAR END OF WINGWALL SHOWN

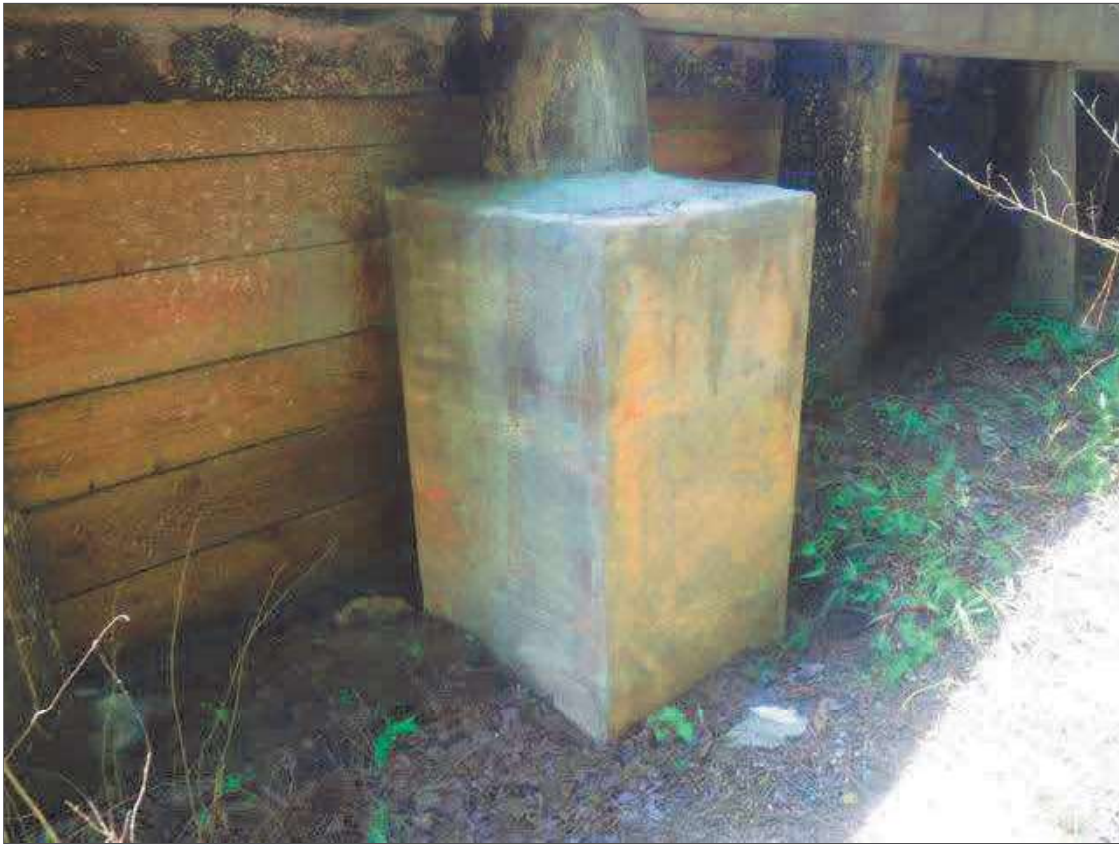
PRIORITY MAINTENANCE REPAIR TO SOUTHEAST WINGWALL BRACE PILE 4 SINCE 2018 INSPECTOIN, APPROXIMATELY 13' FROM NEAR END OF SOUTHEAST WINGWALL

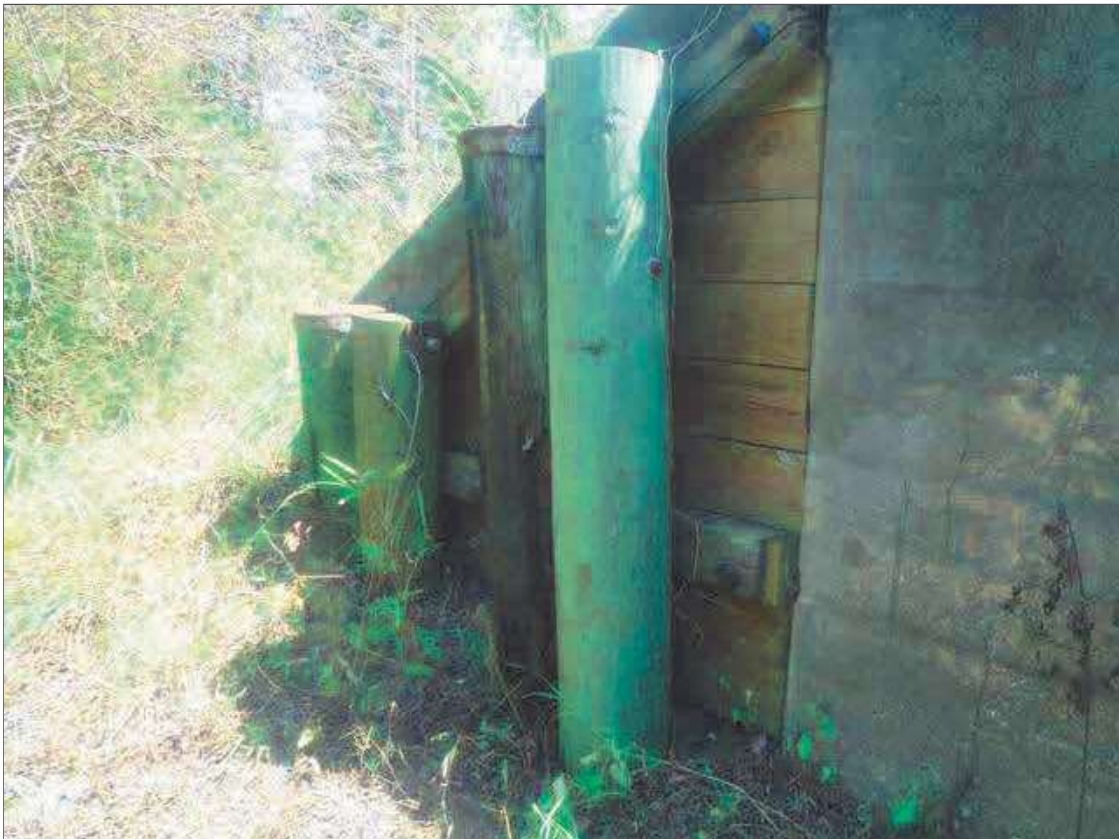
PRIORITY MAINTENANCE REPAIR TO SOUTHWEST WINGWALL BRACE PILE 1 WITH ADDITION OF PILE TO RIGHT OF ORIGINAL PILE SINCE 2018 INSPECTOIN

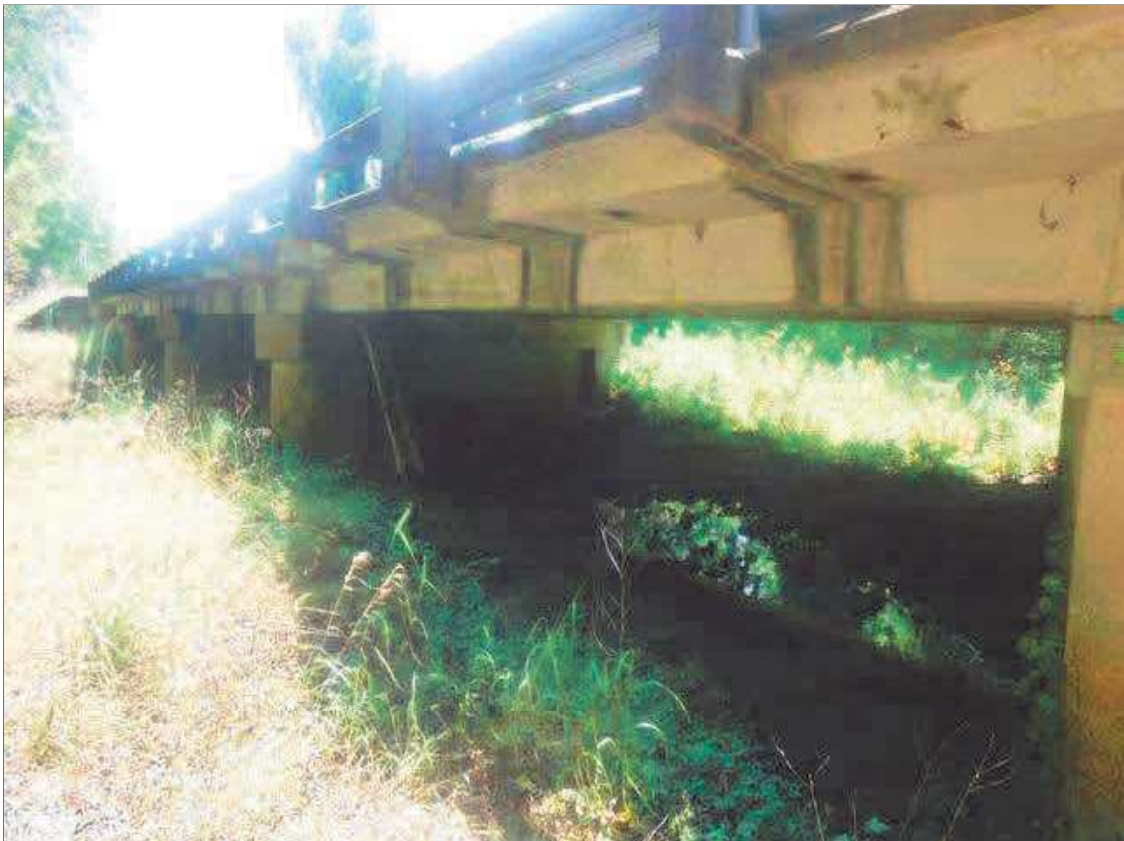
UPSTREAM PROFILE, LOOKING NORTHWEST

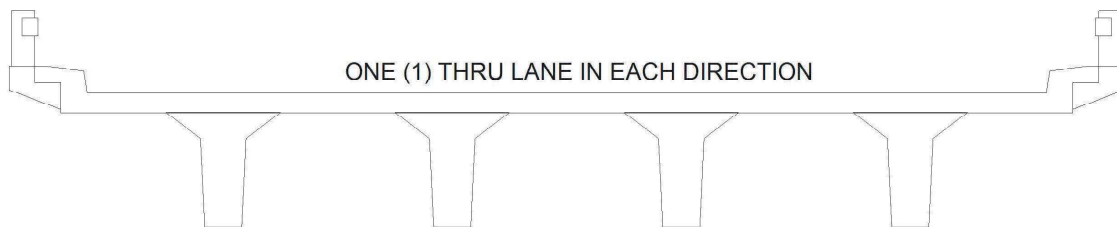
Measurements for Spans	1 thru 4		
Deck Thickness	0.562	Left Overhang	4.75*
Top of Rail to Bottom of Beam	5.229	Right Overhang	4.75*
