NC DEPARTMENT OF TRANSPORTATION
 DIVISION OF HIGHWAYS
 STRUCTURE MANAGEMENT UNIT

ATTENTION: PAR, NEW REPAIRS, DATA CHANGES

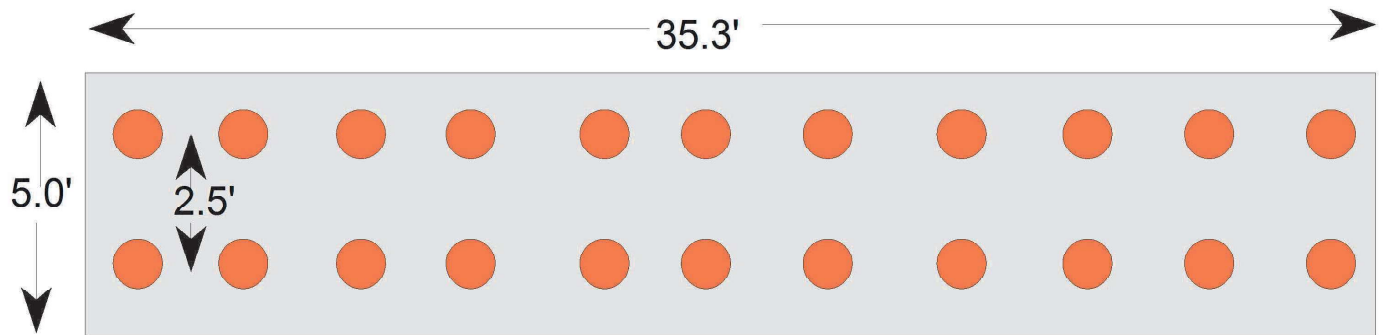
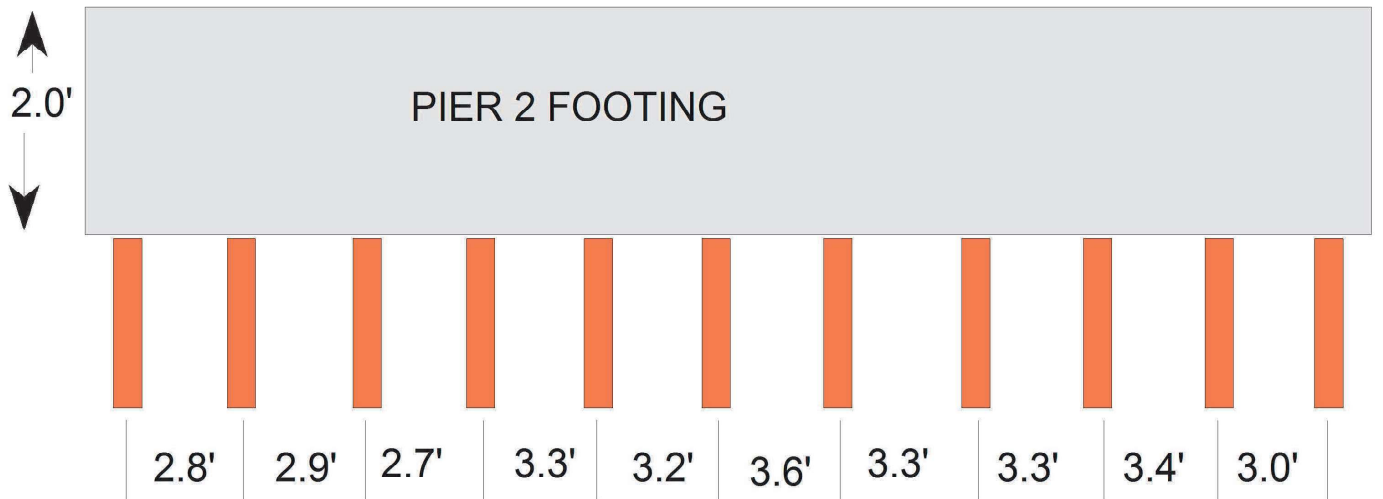
PIER 2 FOUNDATION PILE LAYOUT
