NC DEPARTMENT OF TRANSPORTATION
 DIVISION OF HIGHWAYS
 STRUCTURE MANAGEMENT UNIT

ATTENTION: **NEWLY STRUCTURAL DEFICIENT. PARS ISSUED:
 BENT COLUMNS AND BENT LATERAL BRACING.
 CHANGES TO APPROACH ROADWAY AND TYPICAL
 SECTION SKETCHES**

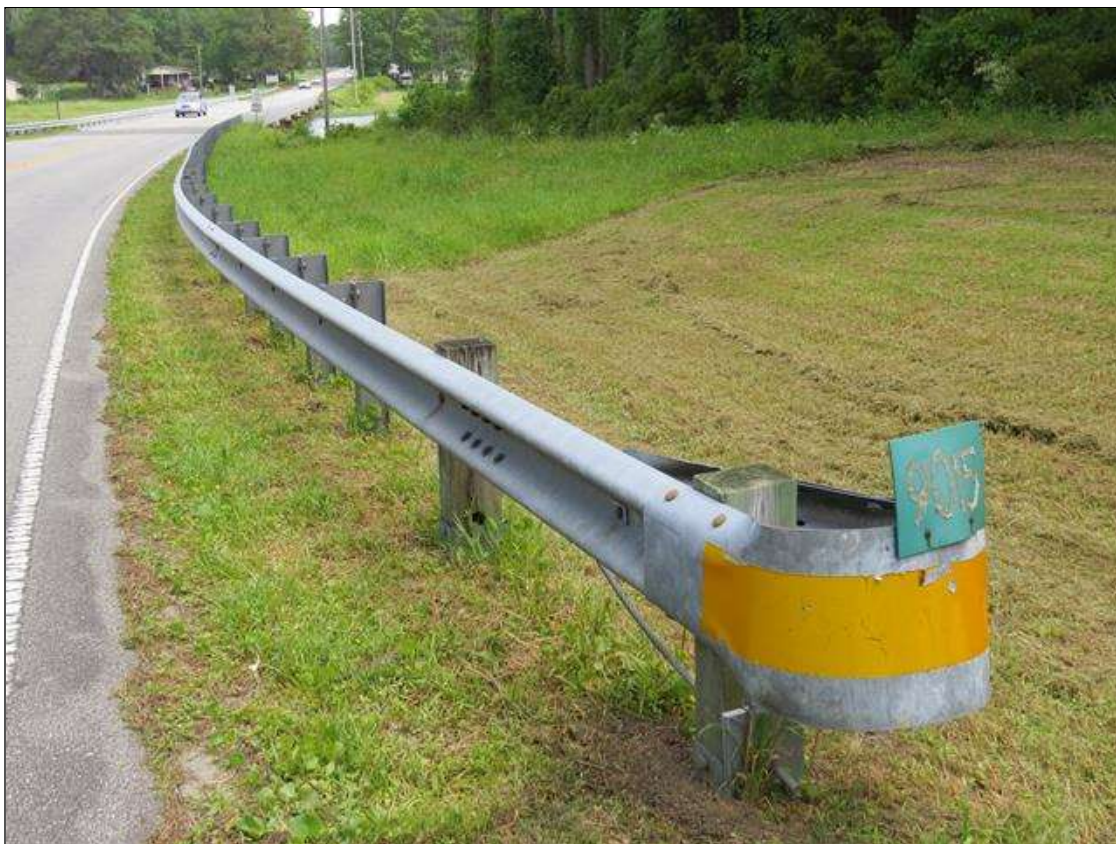
TYPICAL DELINEATOR END TREATMENT, MINOR COLLISION DAMAGE AT FAR LEFT

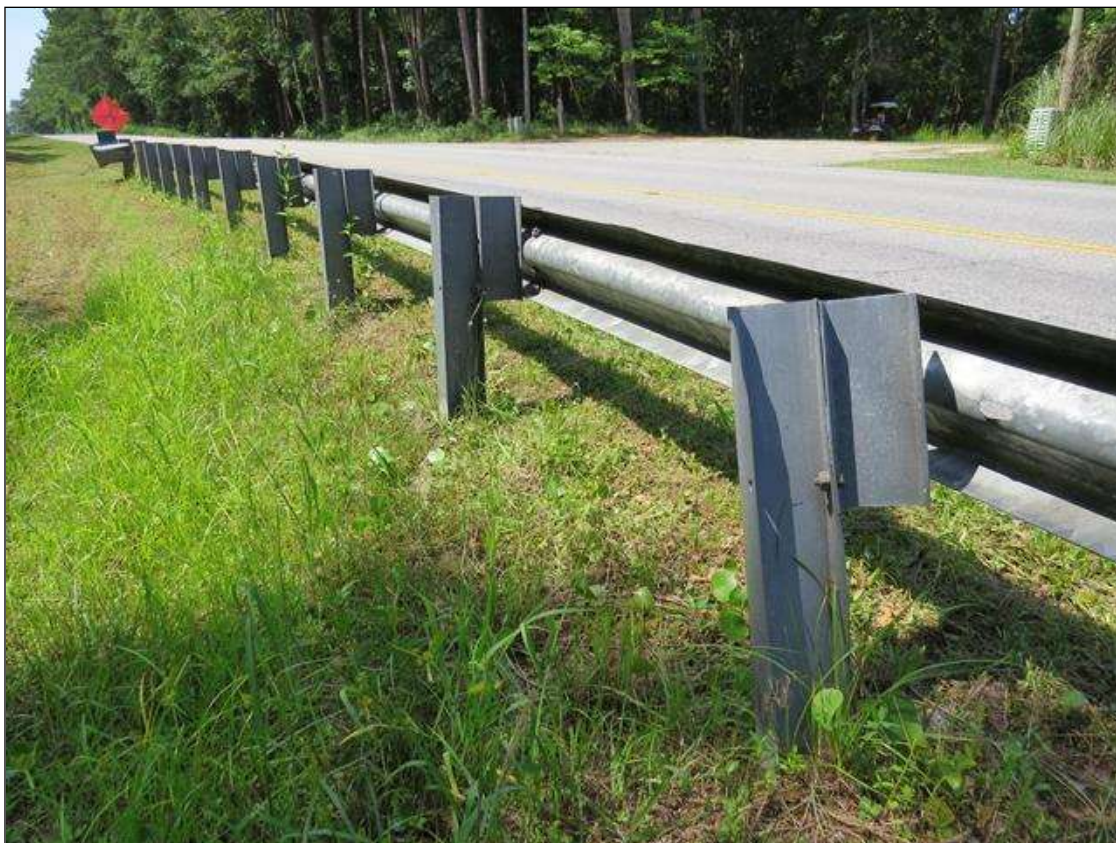
FAR LEFT APPROACH GUARDRAIL- DISCONNECTED & DAMAGED POST 50FT FROM END TREATMENT

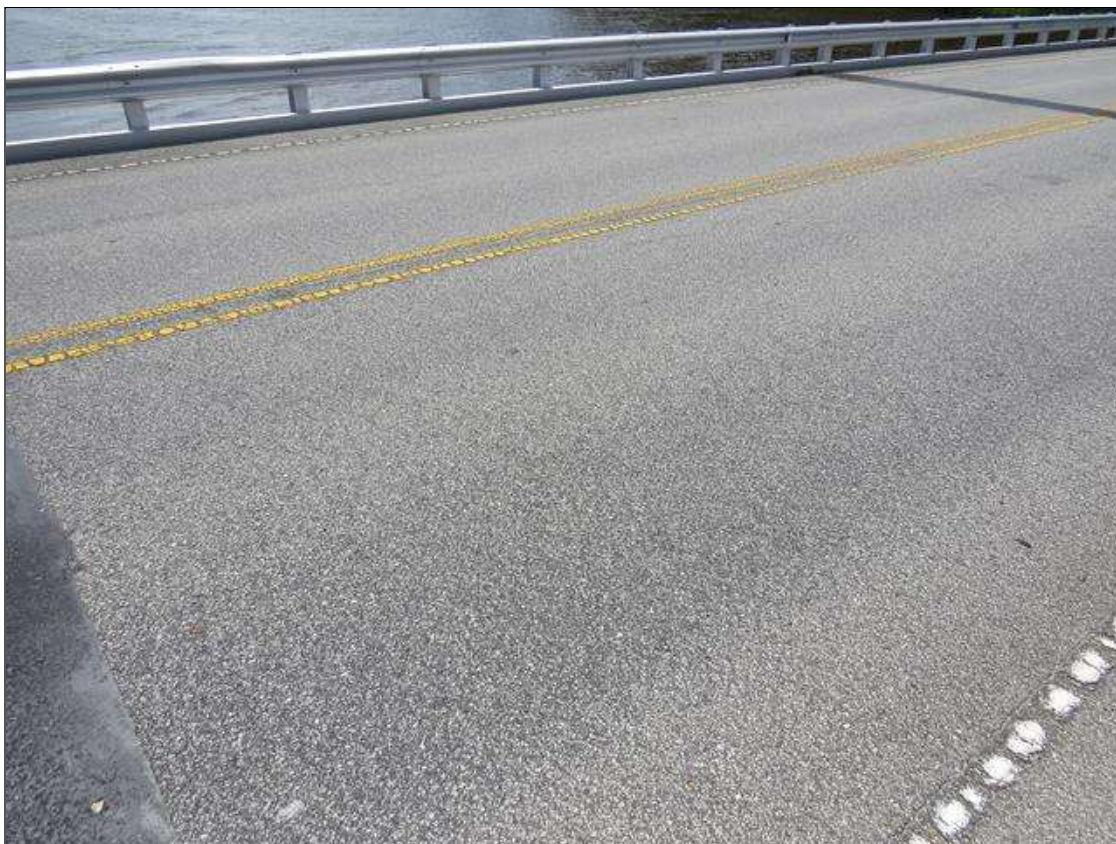
TYPICAL AWS, MODERATE TO HEAVY WEAR THROUGHOUT, SPAN 2

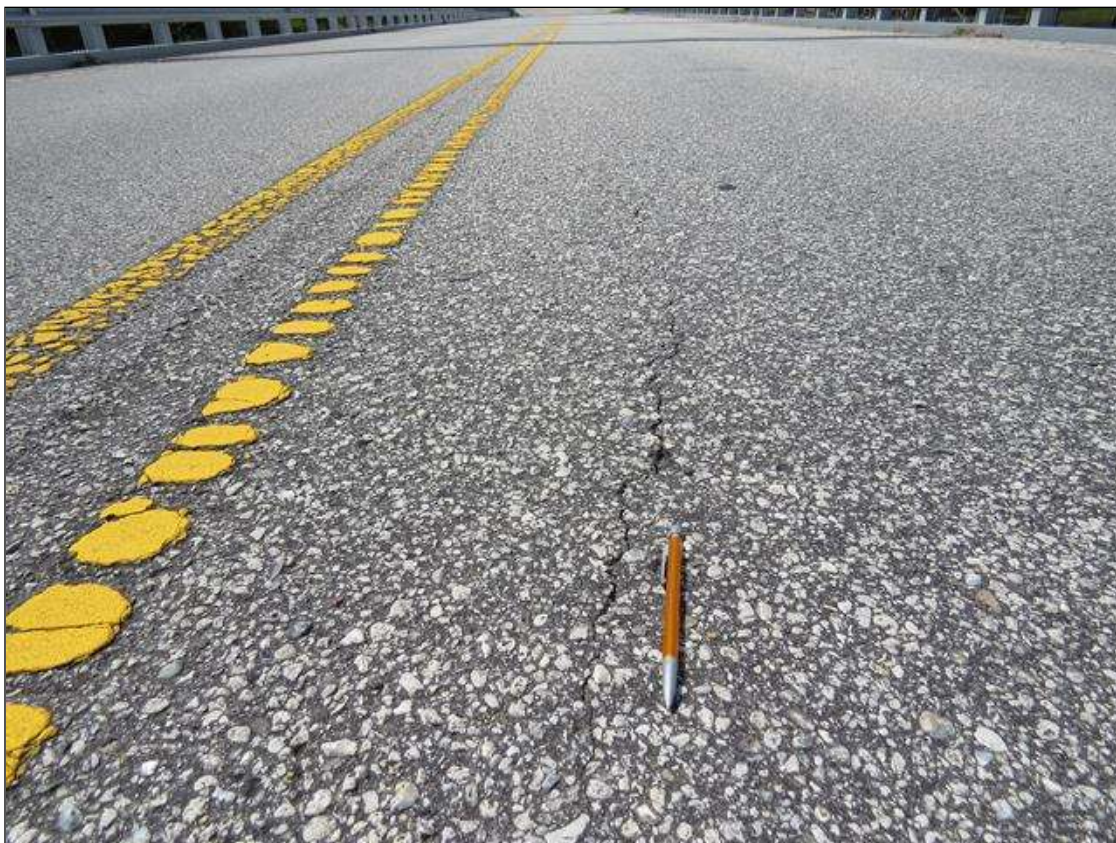
SPAN 2 AWS, OPEN LONGITUDINAL CRACK (1/8IN X 5FT) CENTER OF SPAN IN RIGHT LANE

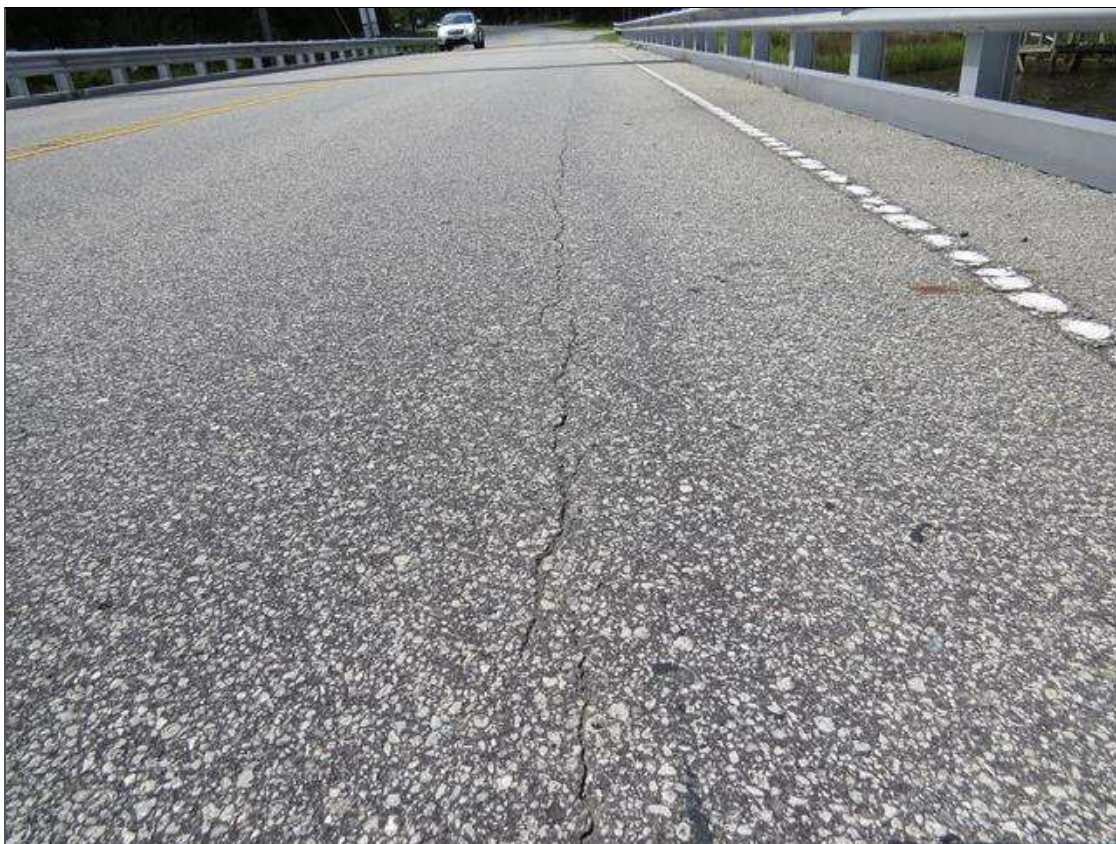
SPAN 5 AWS - FULL LENGTH OPEN LONGITUDINAL CRACK (1/4IN), 2.5FT FROM RIGHT LINE

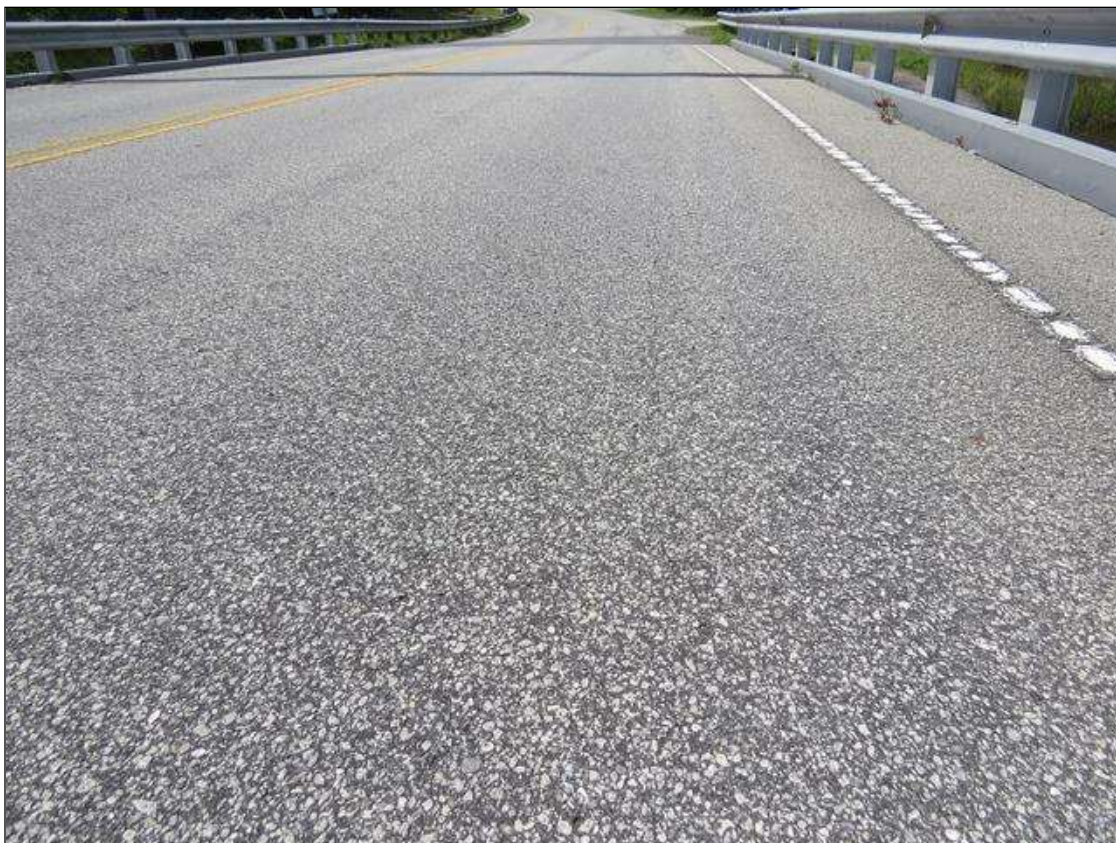
SPAN 6 AWS - HALF LENGTH HAIRLINE CRACK IN FAR HALF OF SPAN

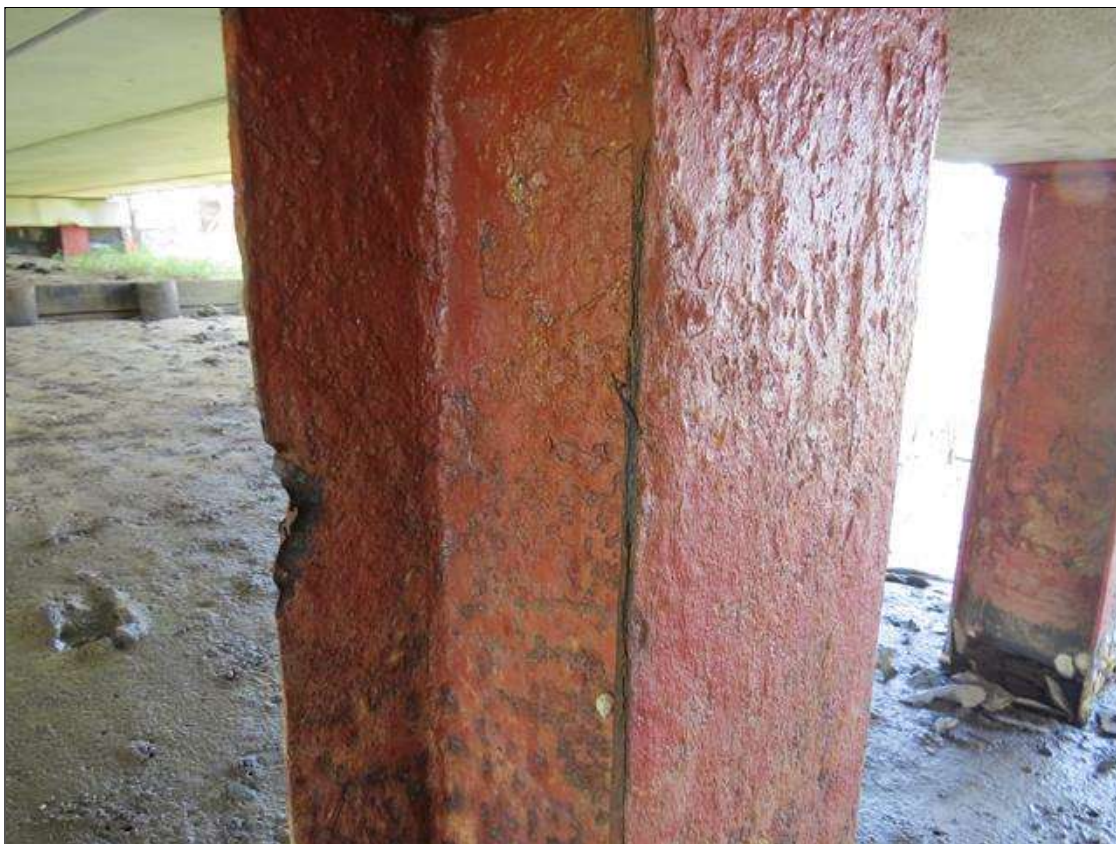
BENT 1 COLUMN 3 - KNIFE EDGING TO NEAR RIGHT FLANGE. 1/8IN TAPERED SECTION LOSS 3/8IN REMAINING AT OTHER FLANGES. (PAR PHOTO)

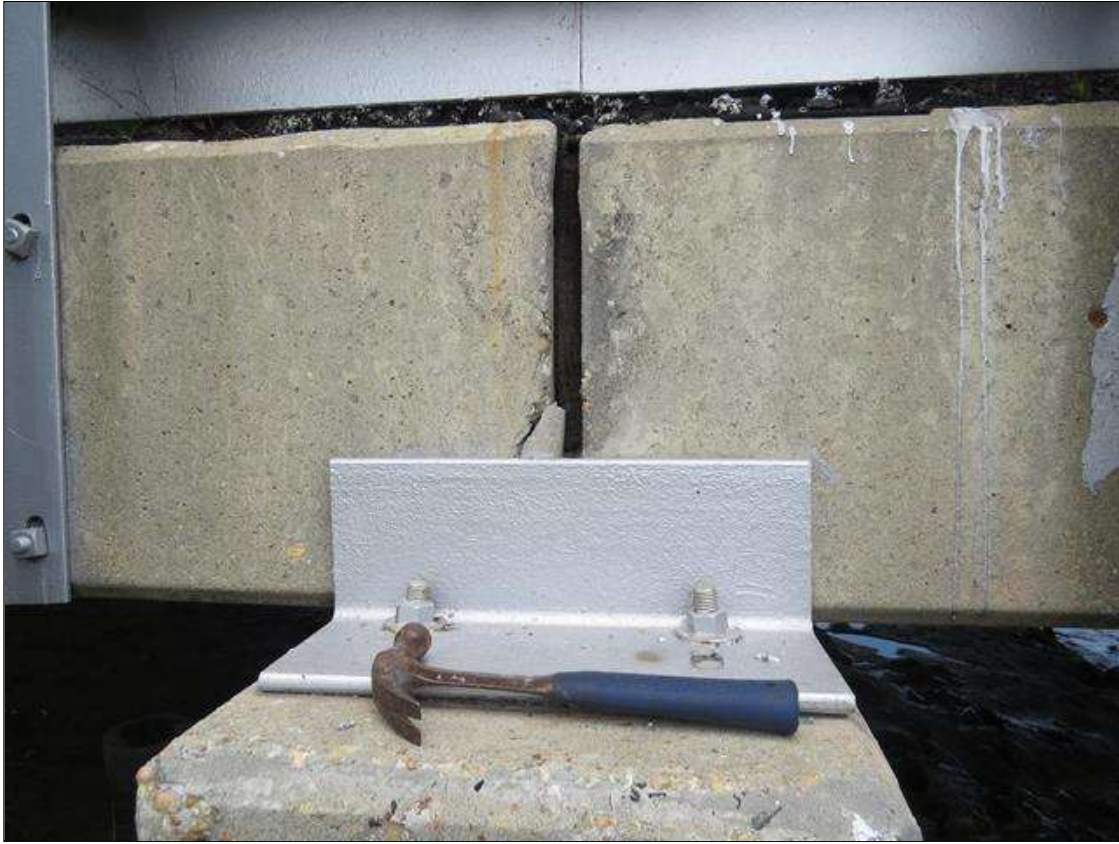
SPAN 1 BEAM 11 - SPALL (9IN H X 3IN W) AT FAR END ON RIGHT SIDE

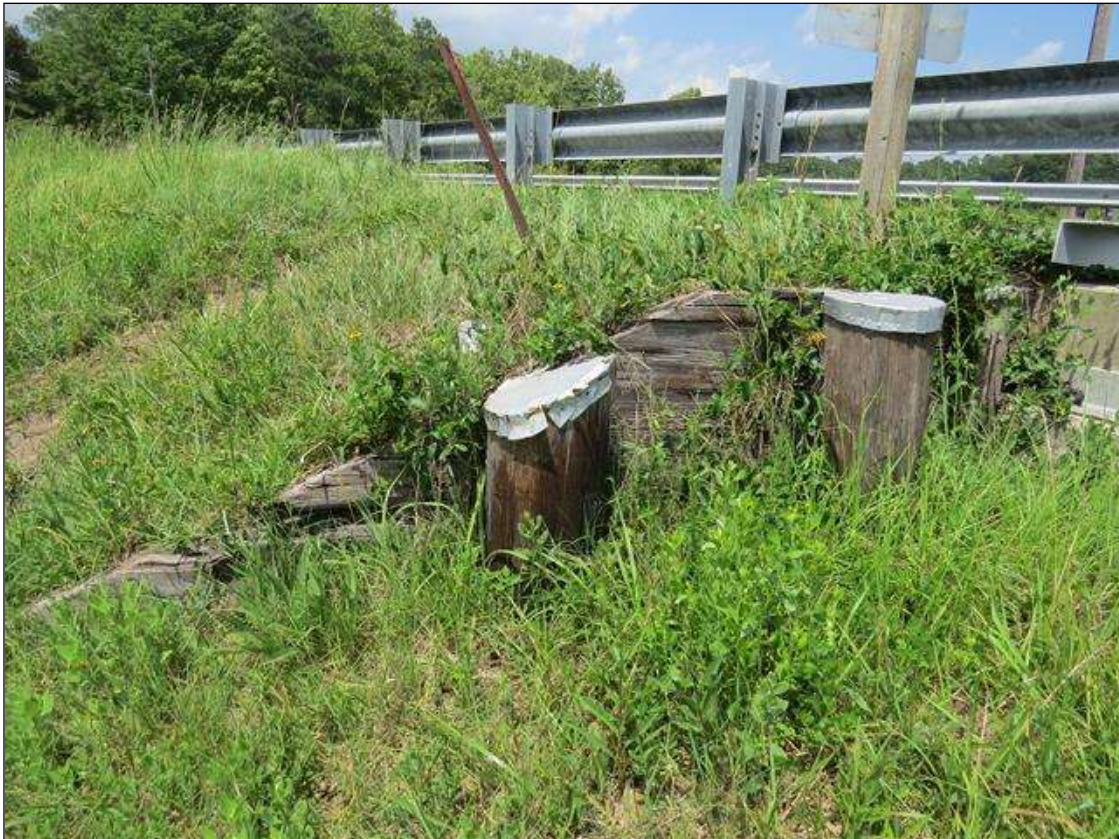
NEAR RIGHT WINGWALL - HEAVY DETERIORATION TO HORIZONTAL TIMBER LAGGING AT ENDS

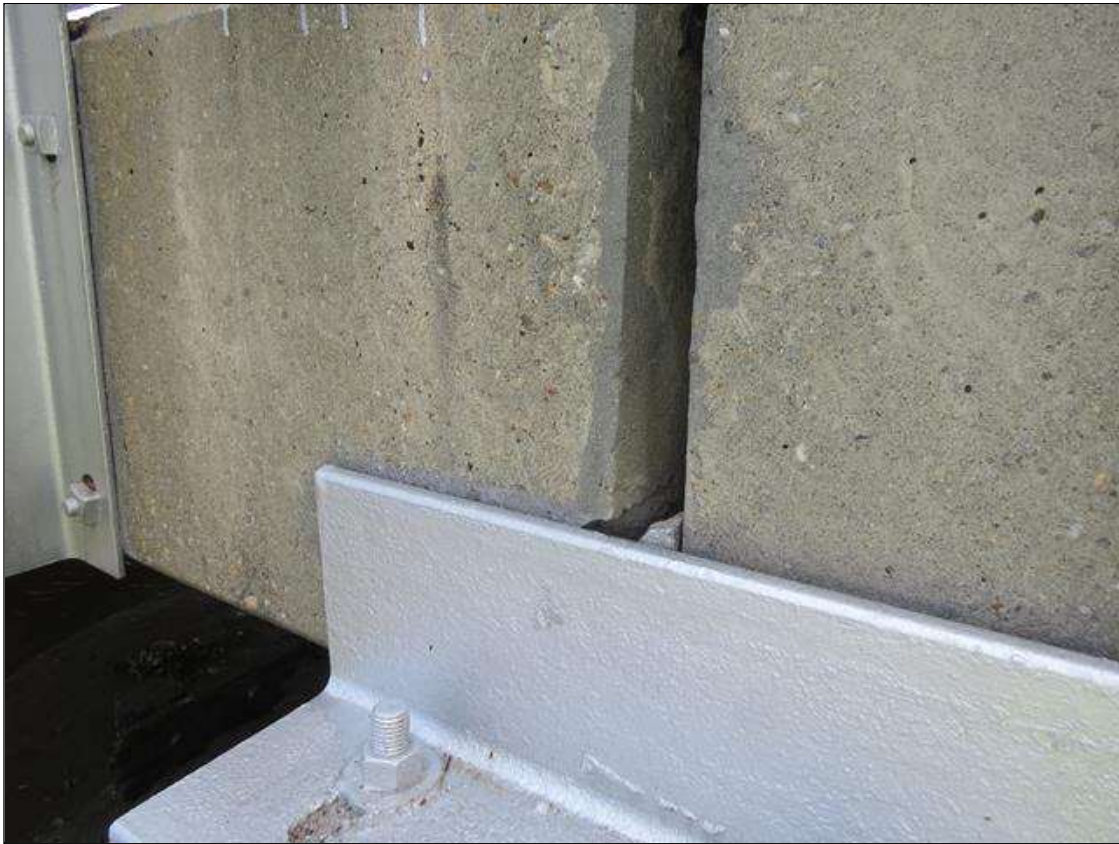
SPAN 2 BEAM 1 - SPALL (6IN H X 3IN W) AT NEAR LEFT END

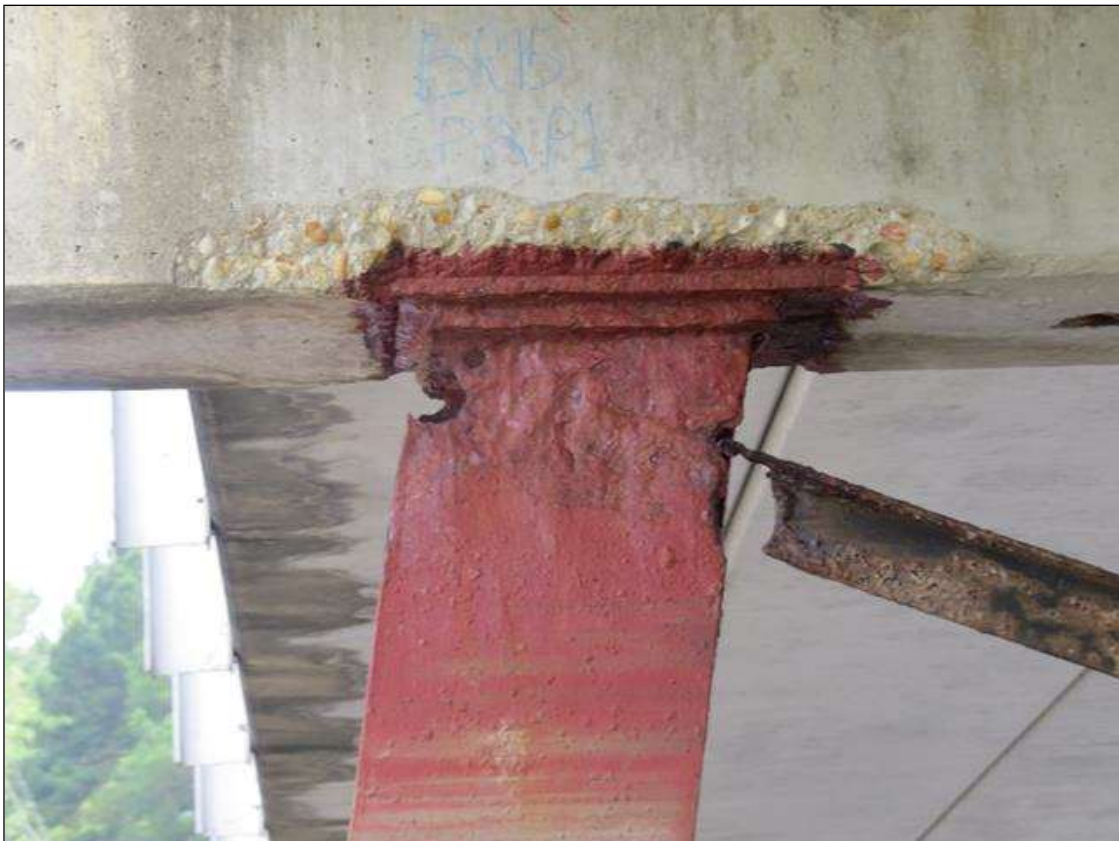
TYPICAL 100% DETERIORATION OF LATERAL BRACING, BENT 2 COLUMN 1 (PAR PHOTO)

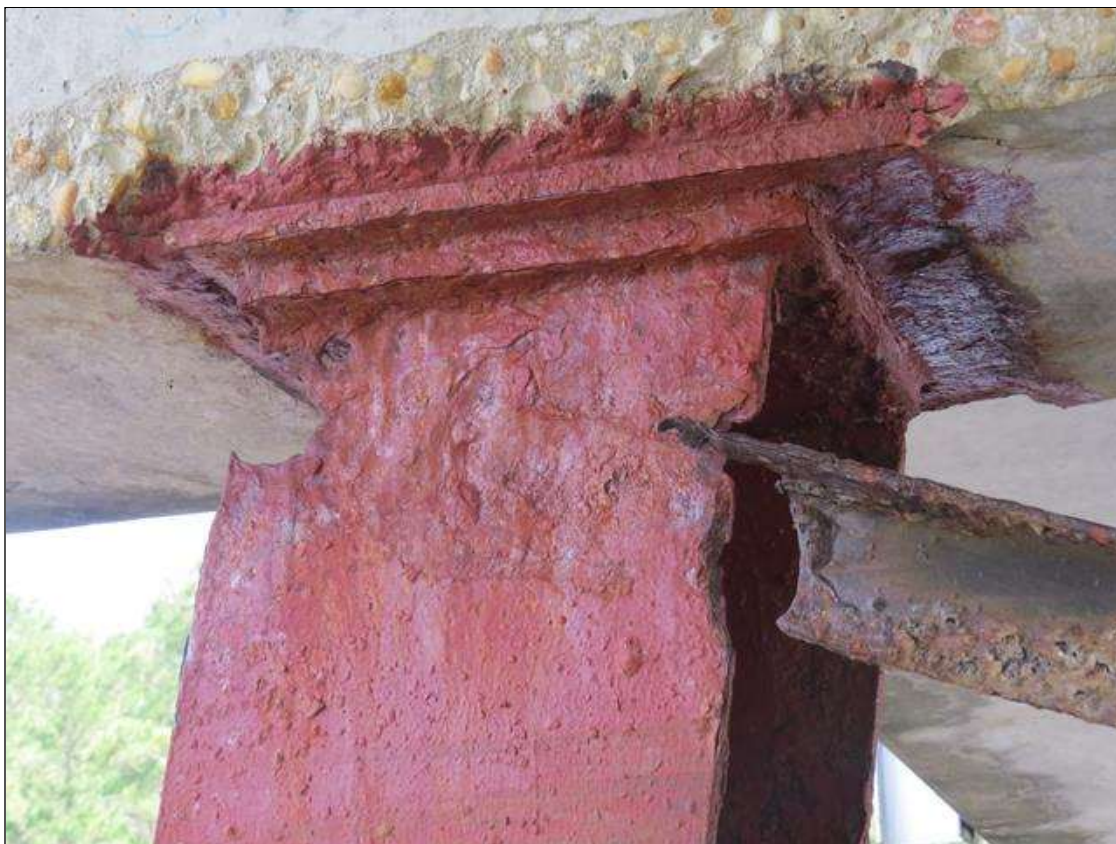
BENT 2 COLUMN 1 - UP TO 65% SECTION LOSS TO NEAR FLANGE, FAR FLANGE UP TO 50% SECTION LOSS ON LEFT SIDE. (PAR PHOTO)

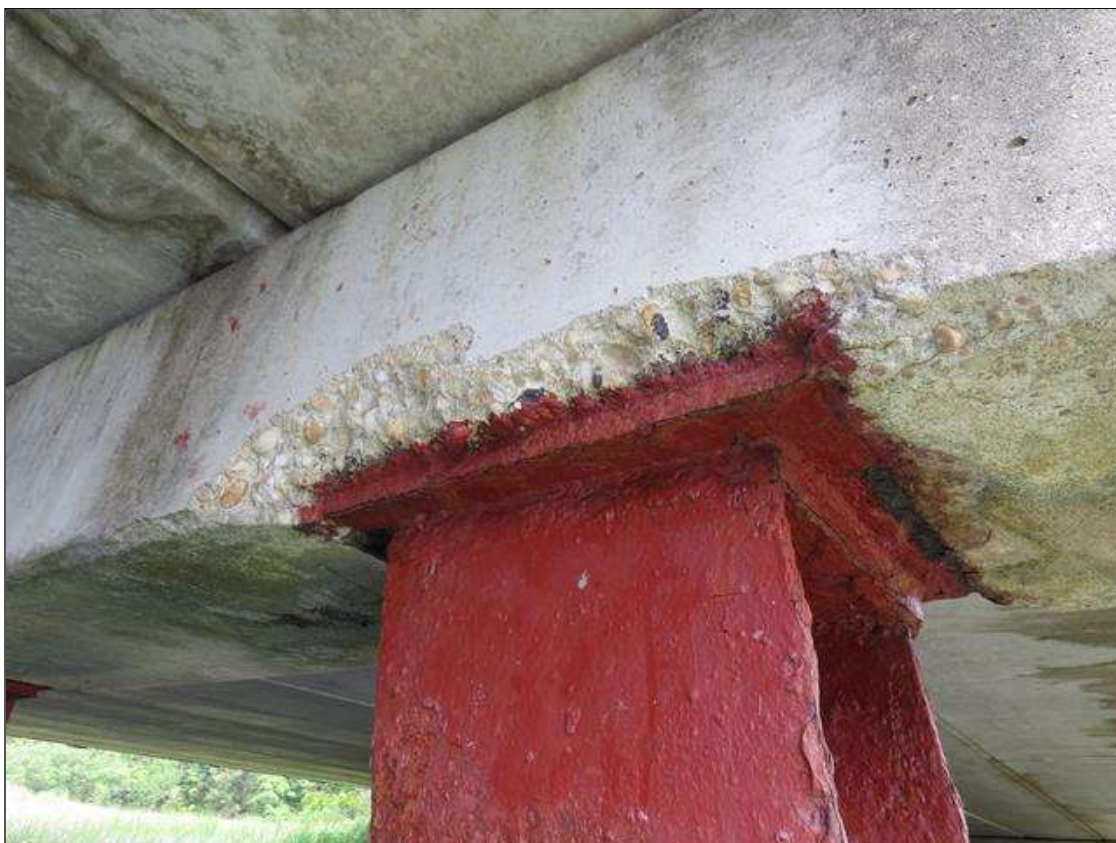
TYPICAL SPALLING (UP TO 24IN X 3IN X 2IN) TO BOTH SIDES OF ALL CAPS AT ALL INTERIOR BENTS, BENT 1 COLUMN 1 FAR SIDE SHOWN

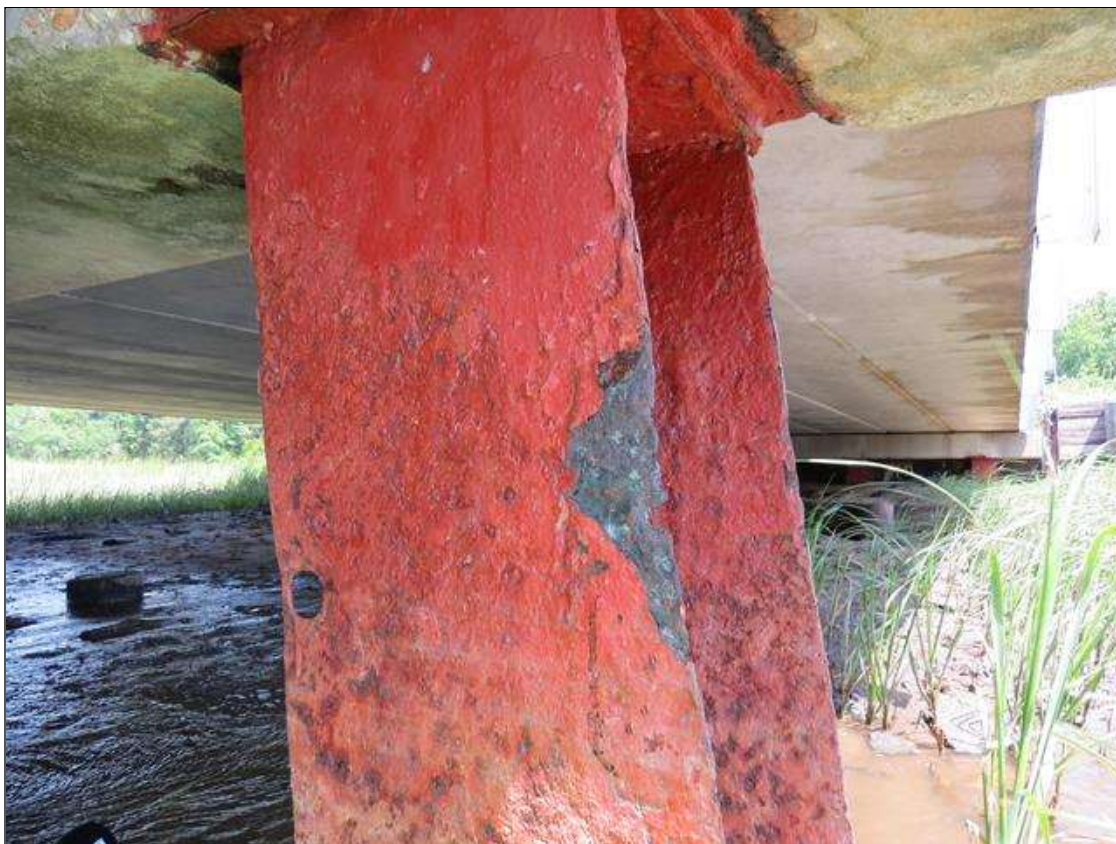
BENT 1 COLUMN 1 - KNIFE EDGING TO FAR FLANGES EDGES (50% SECTION LOSS), 1/8IN TAPERED SECTION LOSS 3/8IN REMAINING TO NEAR FLANGES. (PAR PHOTO)

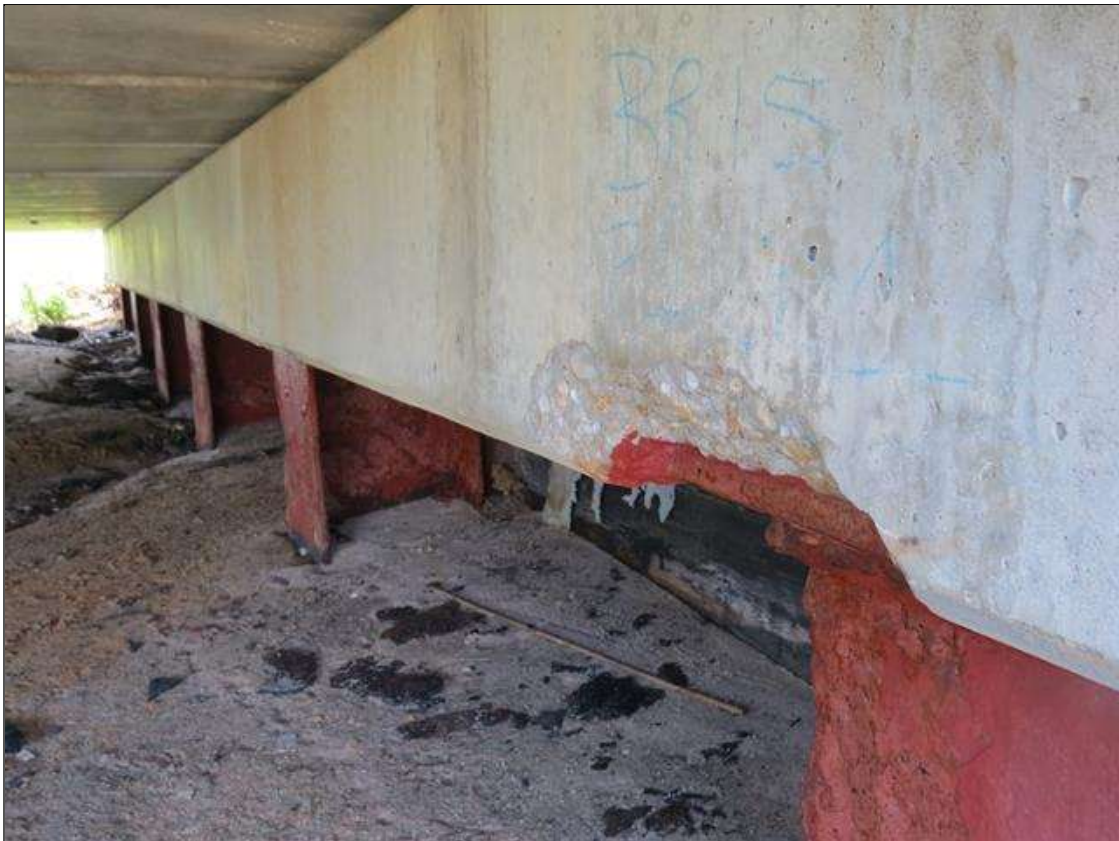
END BENT 1 CAP - SPALLS (14IN X 3IN X 1IN) TO BOTTOM OF CAP AT COLUMNS 1 & 6.

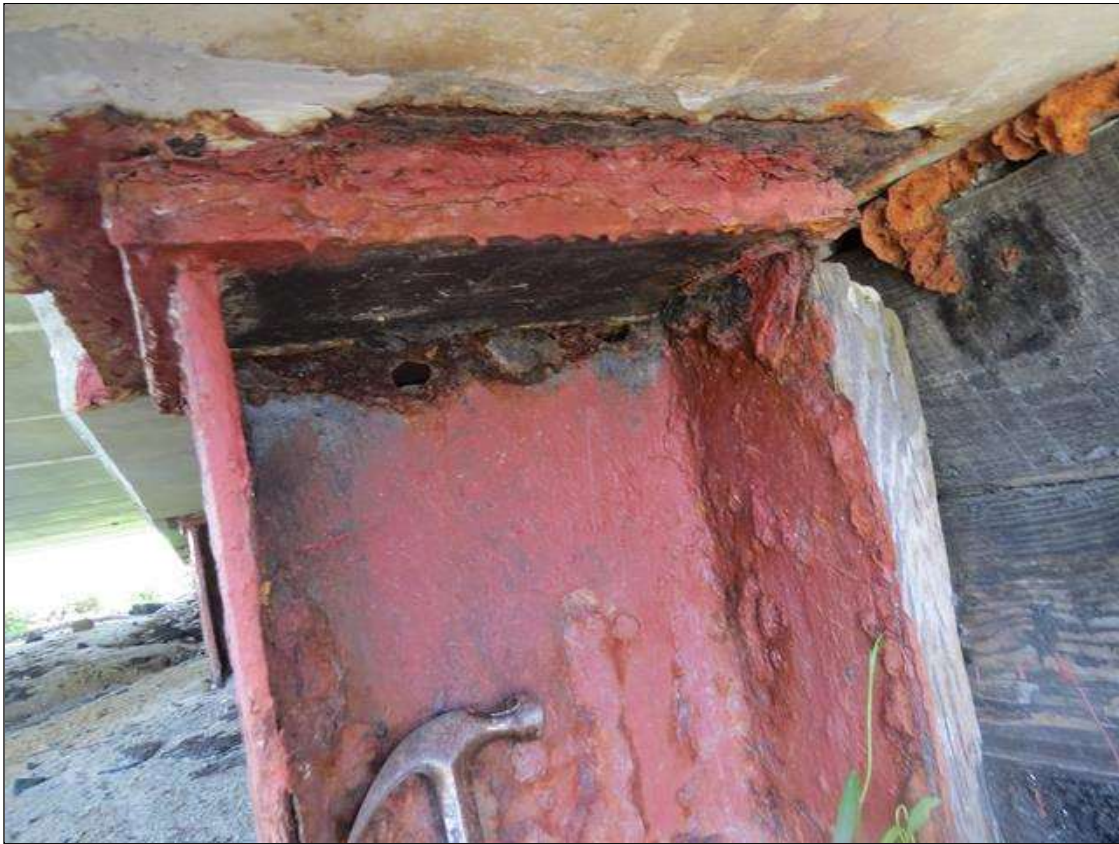
END BENT 1 COLUMN 1 - 1/8IN TAPERED SECTION LOSS 3/8IN REMAINING TO FLANGE EDGES. 50% SECTION LOSS TO TOP OF WEB. (PAR PHOTO)

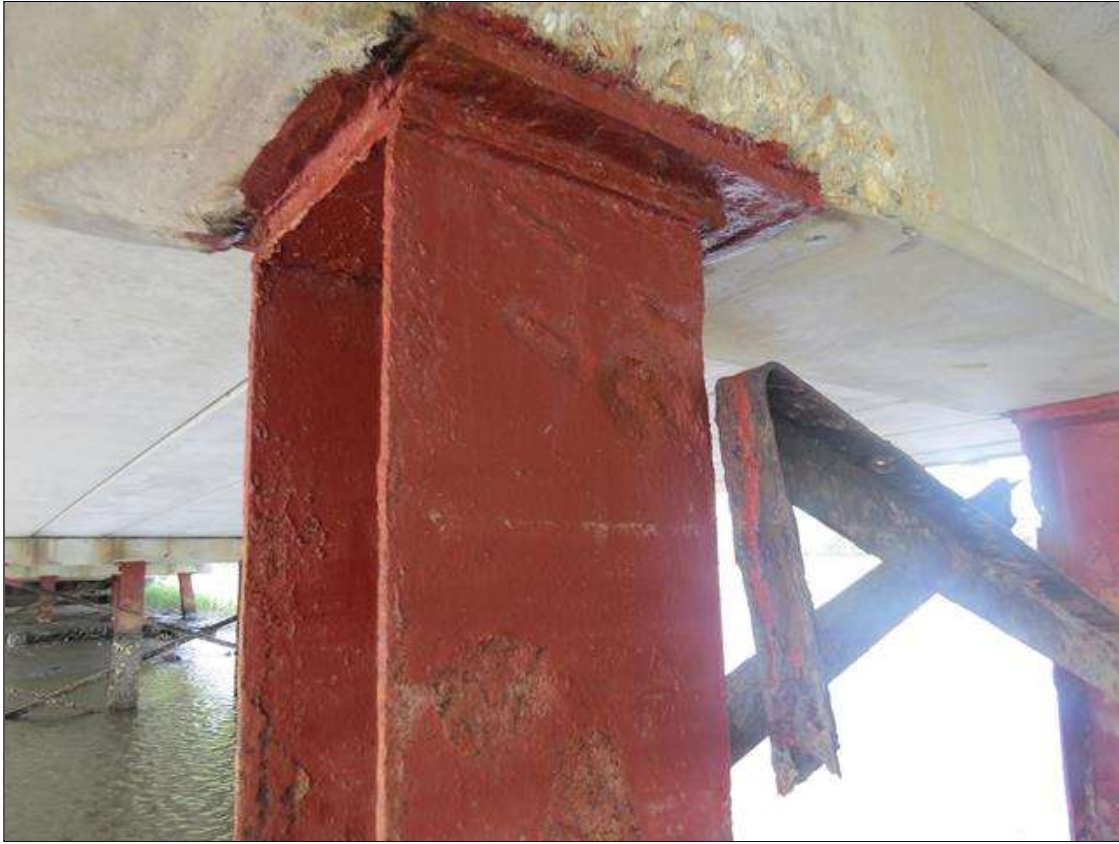
BENT 3 COLUMN 4 - 1/16IN TAPERED SECTION LOSS, 7/16IN REMAINING AT ALL FLANGE EDGES 2FT FROM TOP. TYPICAL 100% DETERIORATION OF LATERAL BRACING. (PAR PHOTO)

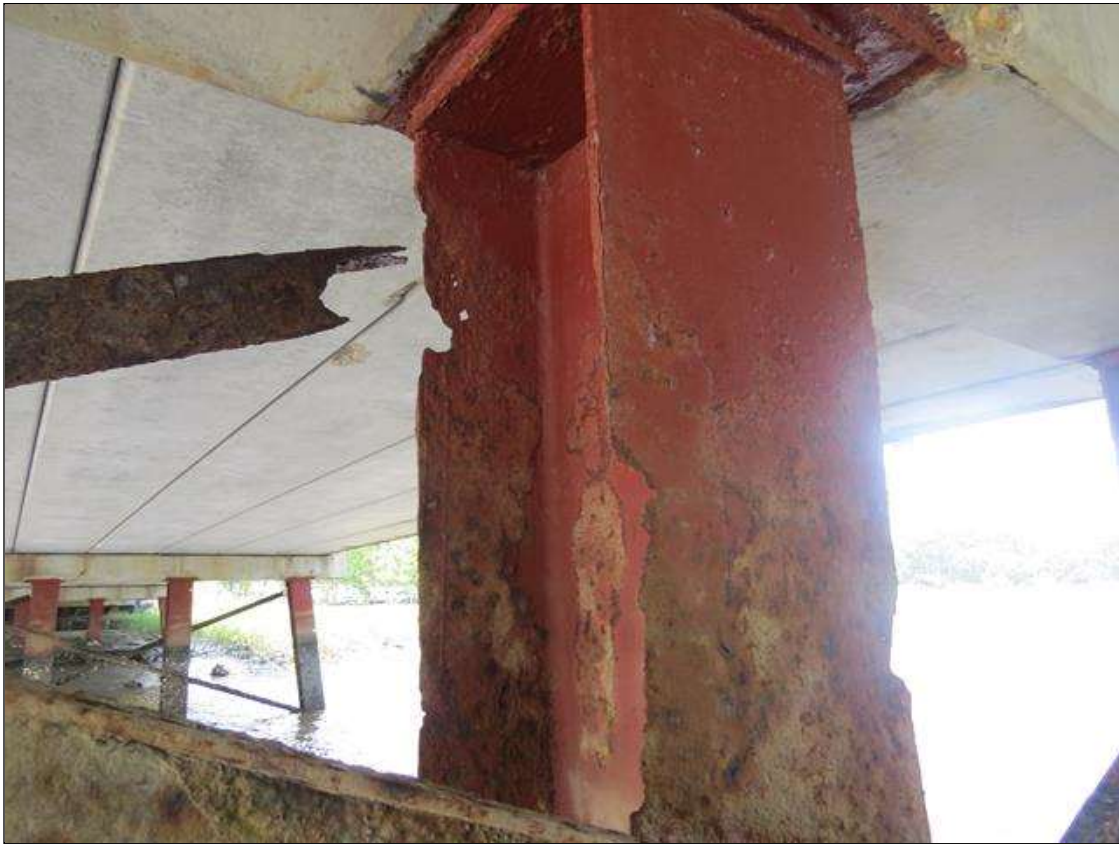
BENT 3 COLUMN 3 - 60% SECTION LOSS TO BOTH SIDES (UP TO 100% SECTION LOSS TO FLANGE EDGES FOR 2IN W X 12IN H) OF FAR FLANGE AND NEAR RIGHT FLANGE IN TOP 2FT OF COLUMN. 1/4IN TAPERED SECTION LOSS, 1/4IN REMAINING AT NEAR LEFT FLANGE EDGE 2FT FROM TOP. (PAR PHOTO)

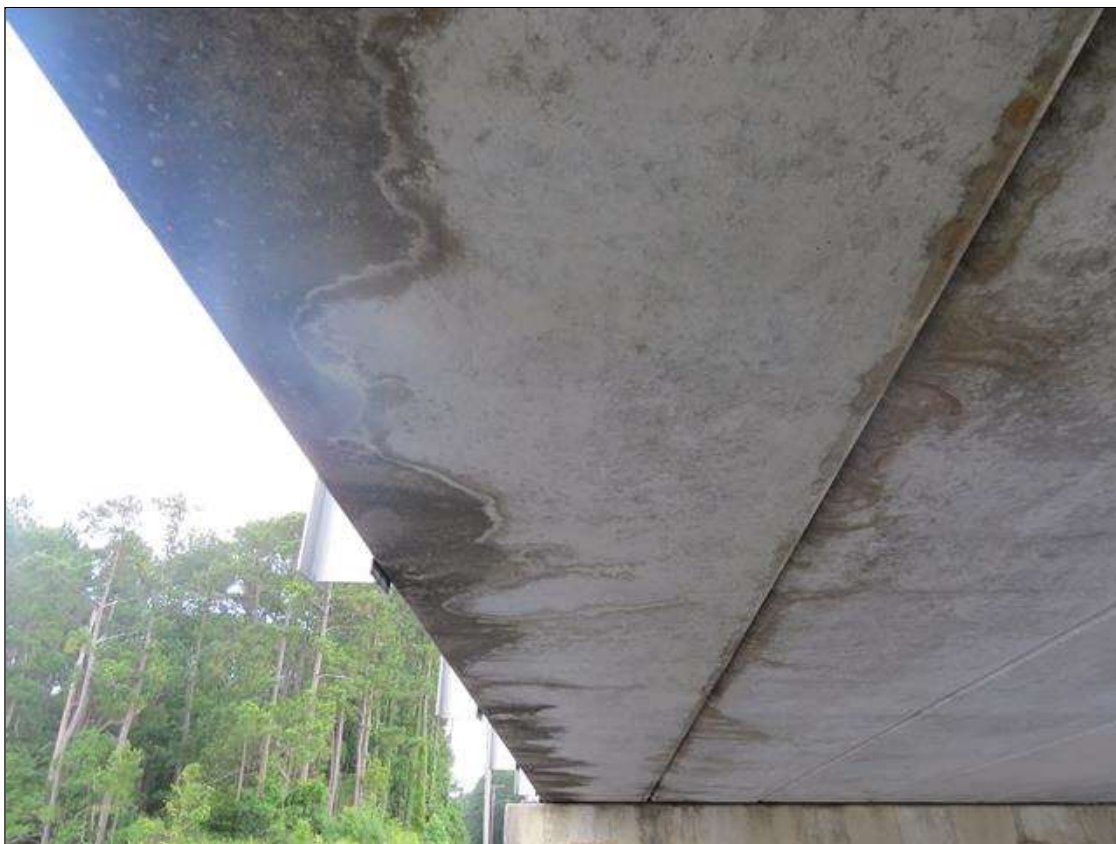
TYPICAL WATER STAINING TO LEFT FASCIA BEAM, SPAN 4 LOOKING AHEAD

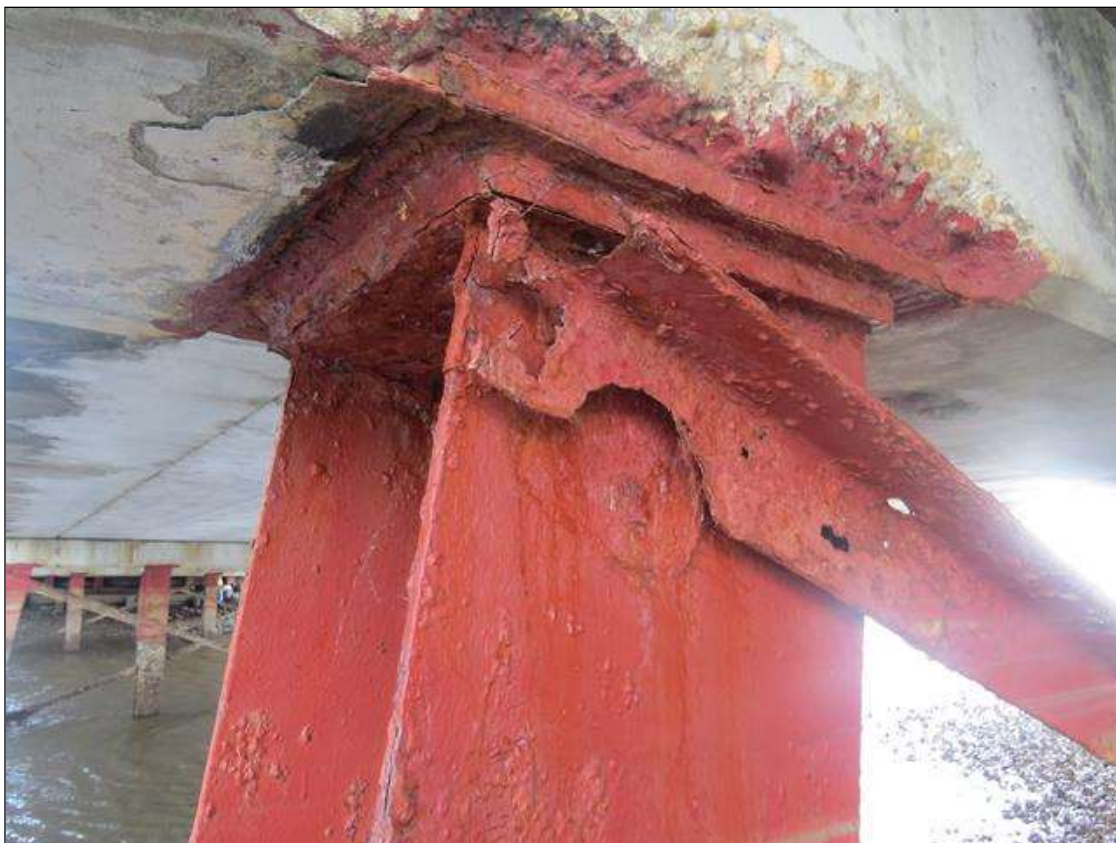
TYPICAL DETACHED LATERAL BRACING, BENT 4 AT COLUMN 2 (PAR PHOTO)

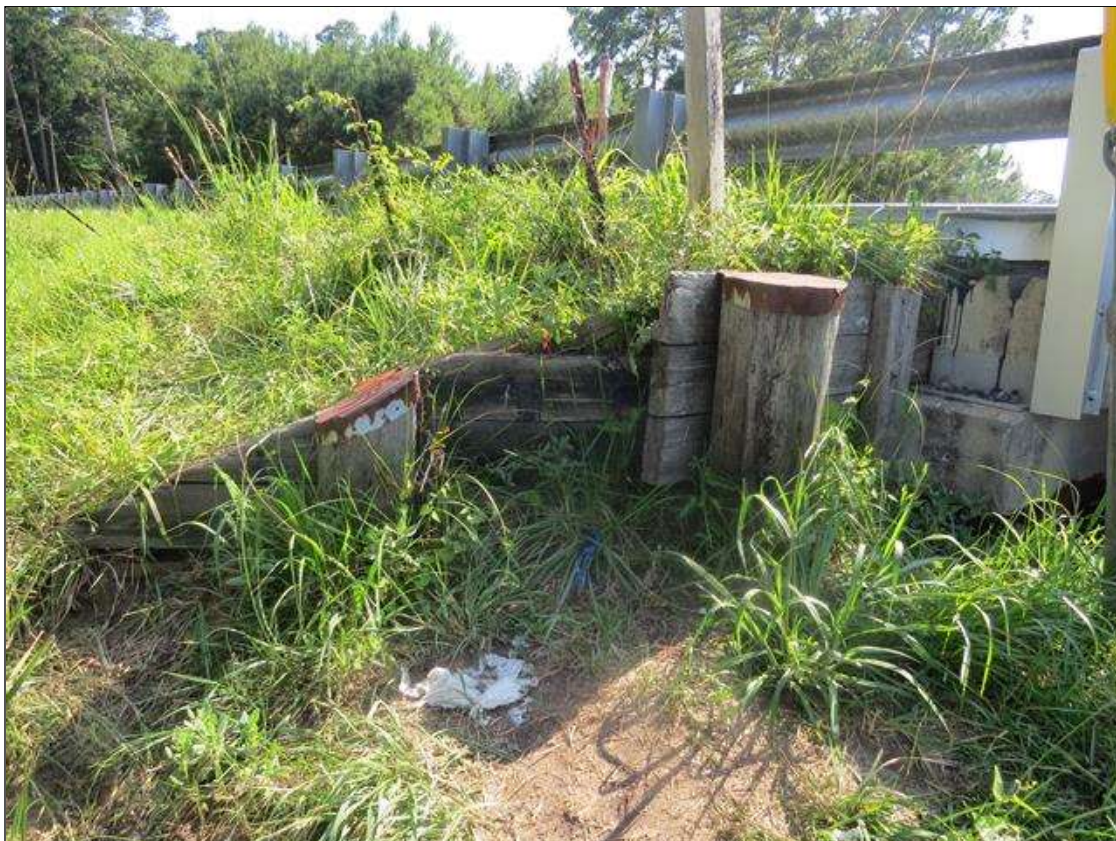
FAR LEFT WINGWALL, MODERTE DETERIORATION TO HORIZONTAL TIMBER LAGGING.

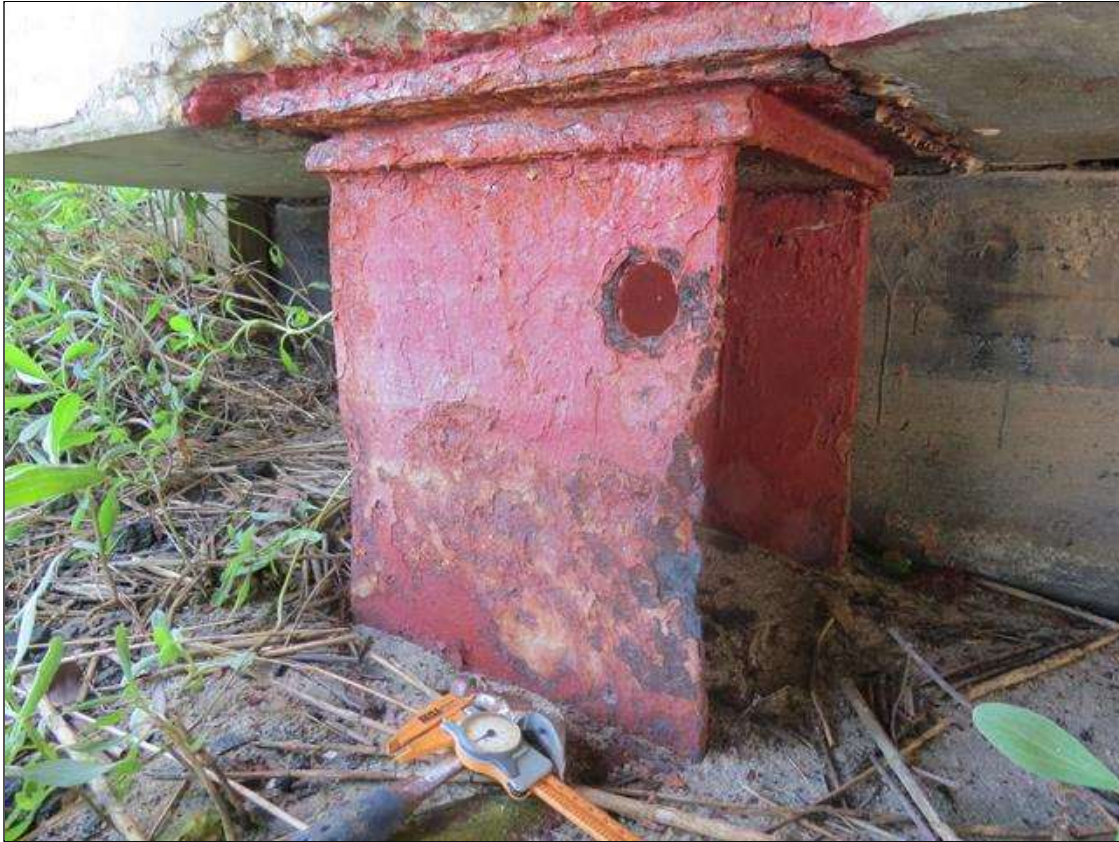
END BENT 2 COLUMN 1 - KNIFE EDGING WITH UP TO 50% SECTION LOSS TO THE NEAR RIGHT FLANGE. 1/4IN TAPERED SECTION LOSS 1/4IN REMAINING AT NEAR LEFT FLANGE EDGE. 1/16IN SECTION LOSS AT FAR FLANGE EDGES. (PAR PHOTO)

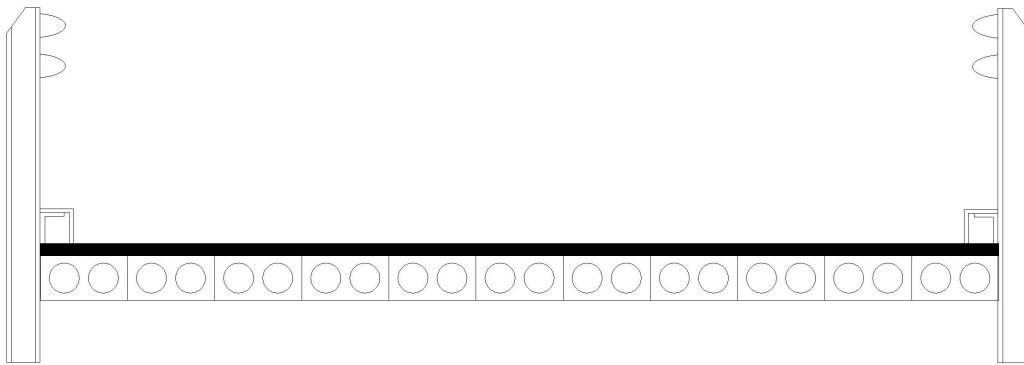
Measurements for Span #	1		
Deck Thickness	0	Left Overhang	0
Top of Rail to Bottom of Beam	4.12	Right Overhang	0
