NC DEPARTMENT OF TRANSPORTATION
 DIVISION OF HIGHWAYS
 STRUCTURE MANAGEMENT UNIT

ATTENTION: **partial inspection, awaiting railroad entry permit; prompt action request, sketches revised, temporary repairs to caps**

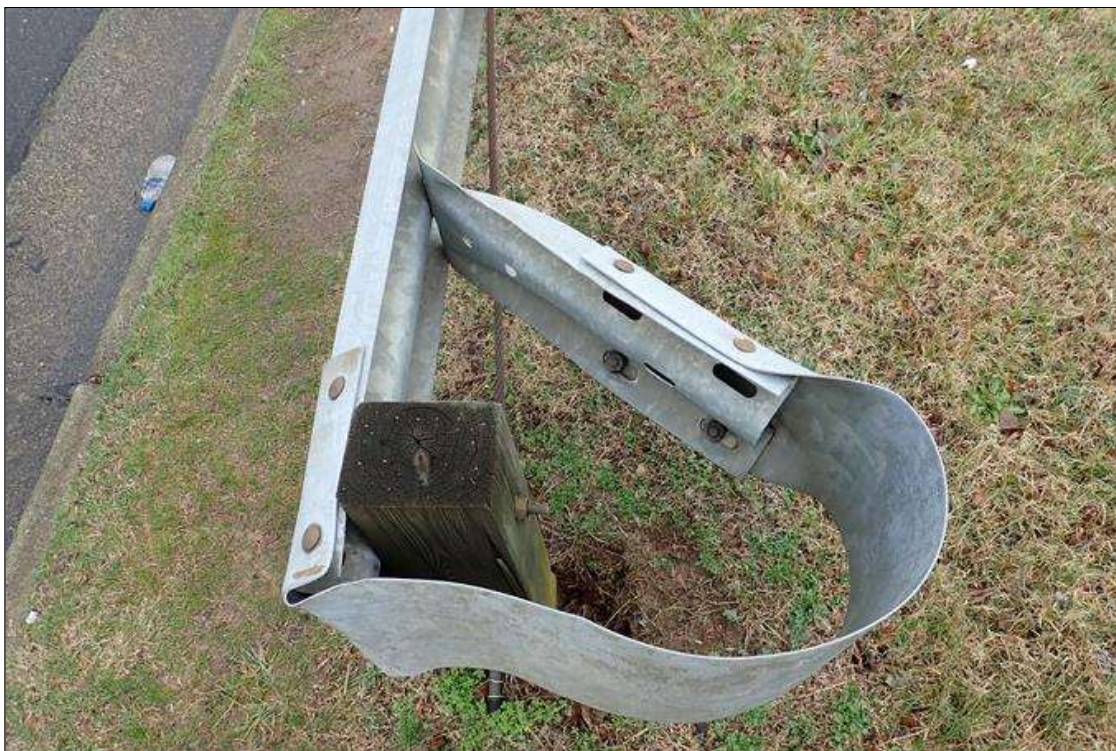
(PAR) southwest guardrail termination, impact damage (3')

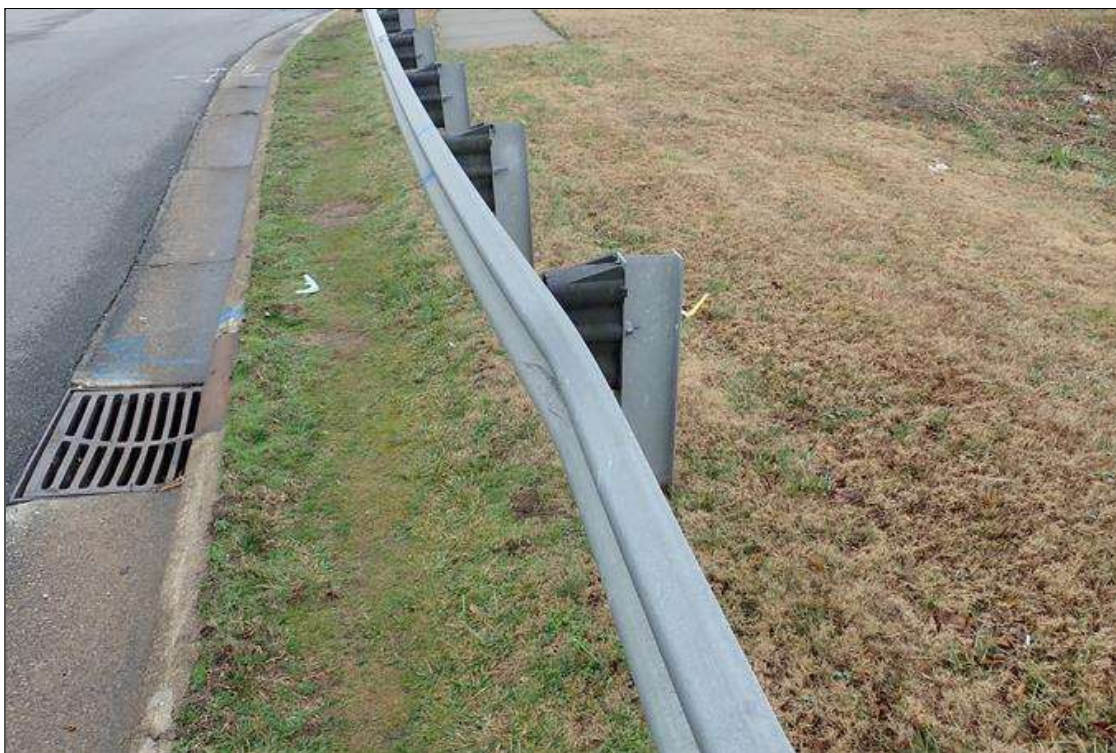
(PAR) southeast guardrail, at center, impact damage (15')

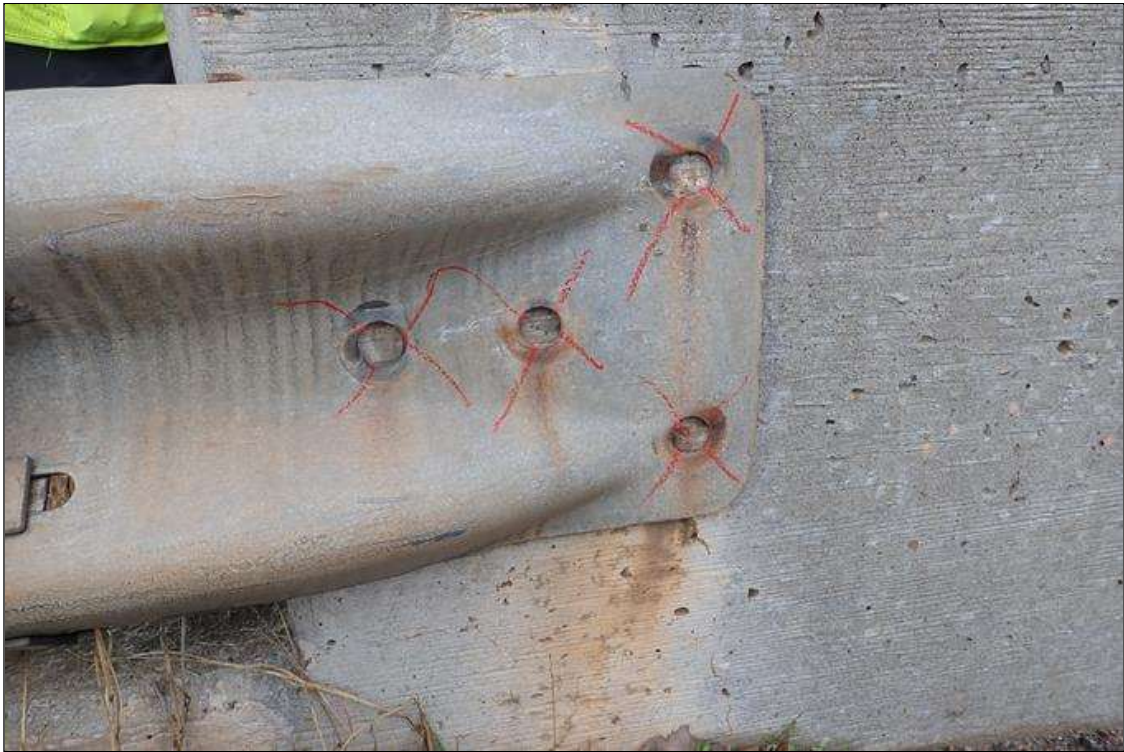
(PAR) northwest guardrail attachment not connected to bridge rail

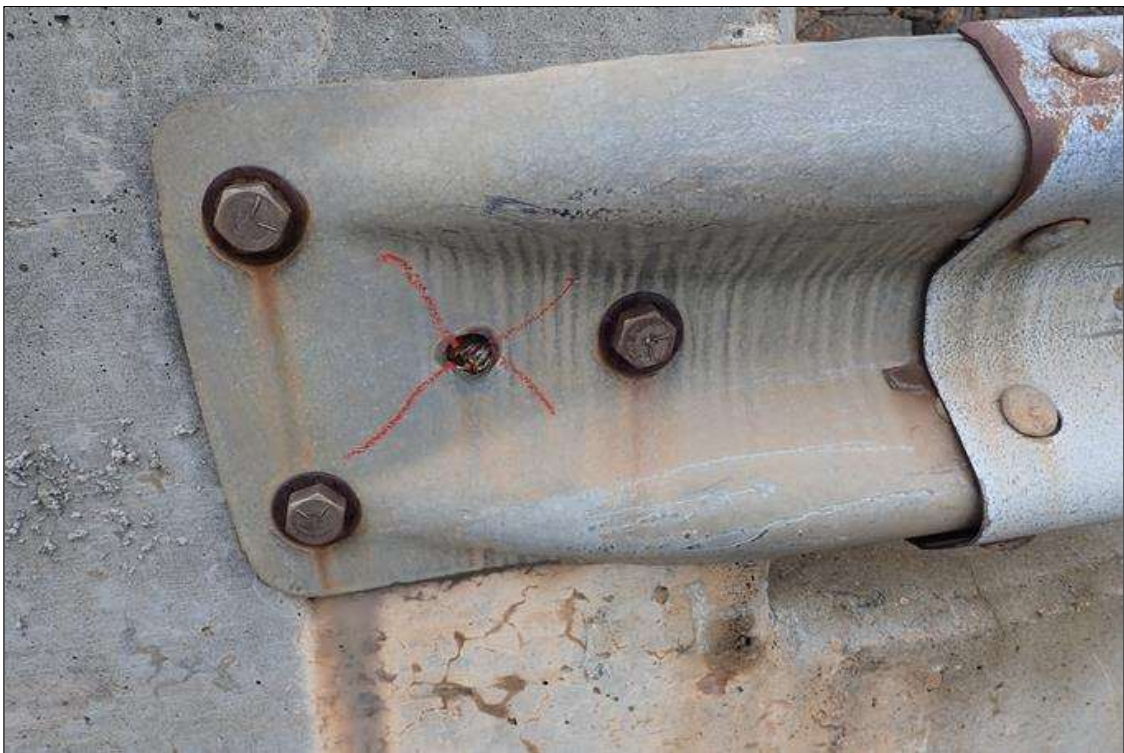
(PAR) northeast guardrail attachment, (1) bolt missing

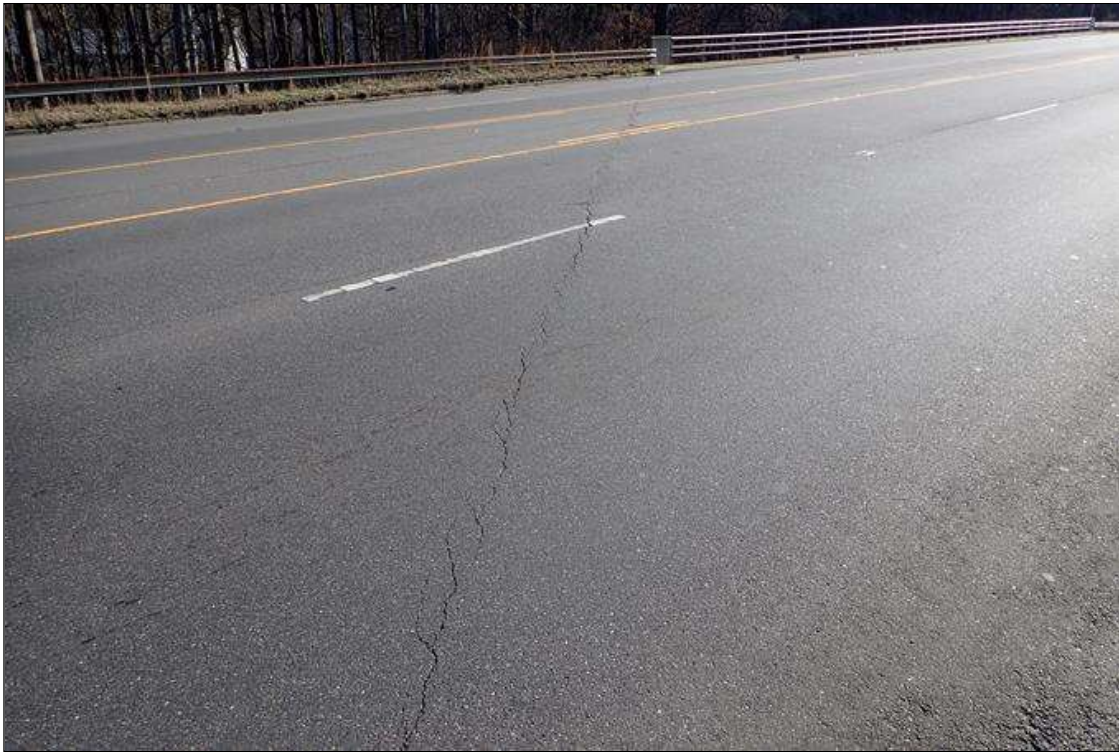
Span 1 Wearing Surface: UP TO 0.25" TRANSVERSE CRACKS IN ASPHALT WEARING SURFACE OVER END BENT 1

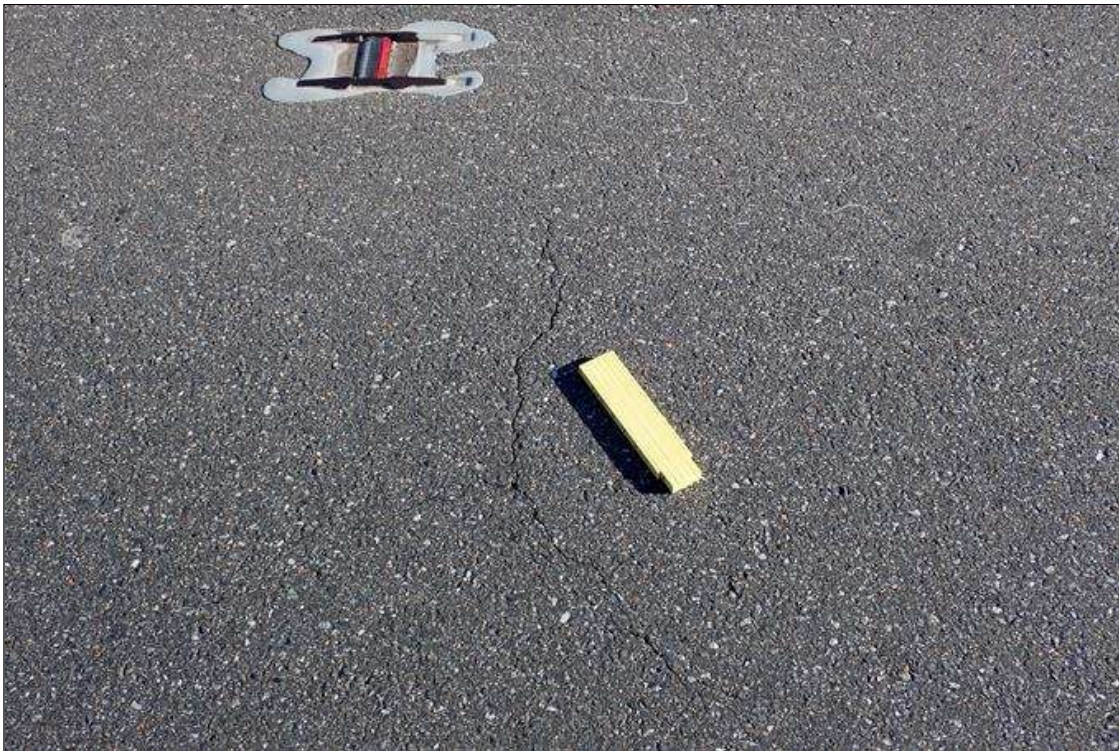
Span 1 Wearing Surface: at random, transverse cracks (up to 1/8" x 3')

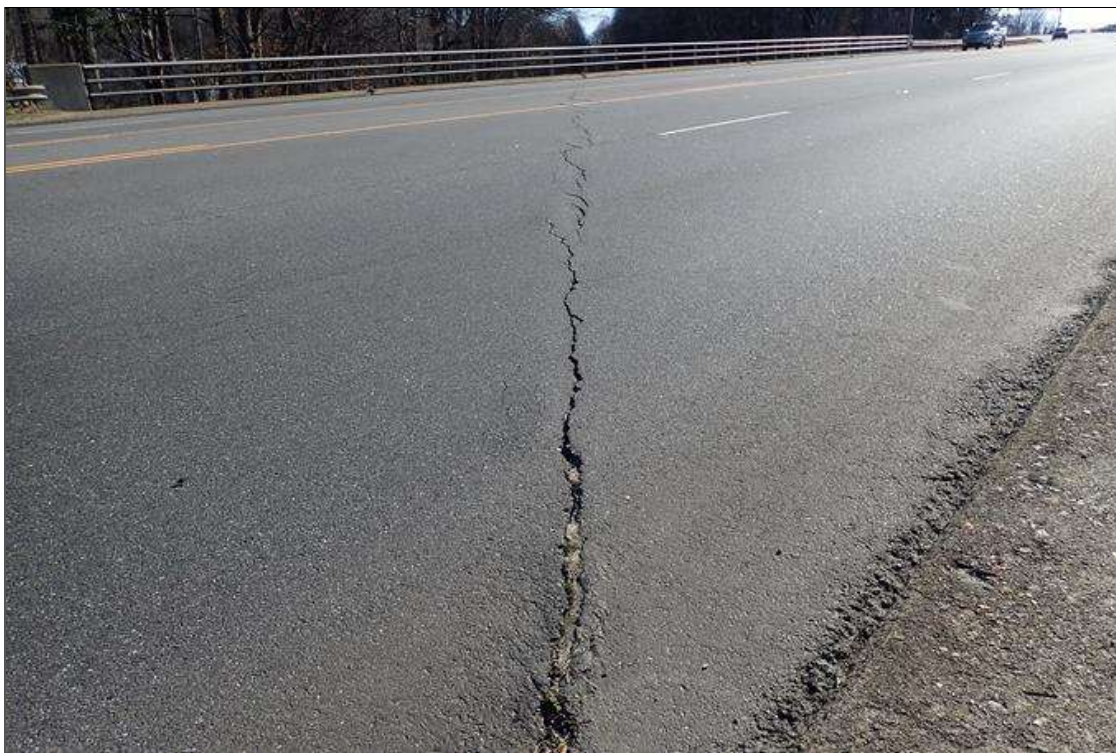
Span 2 Wearing Surface: UP TO 0.5" TRANSVERSE CRACKS OVER BENT 2

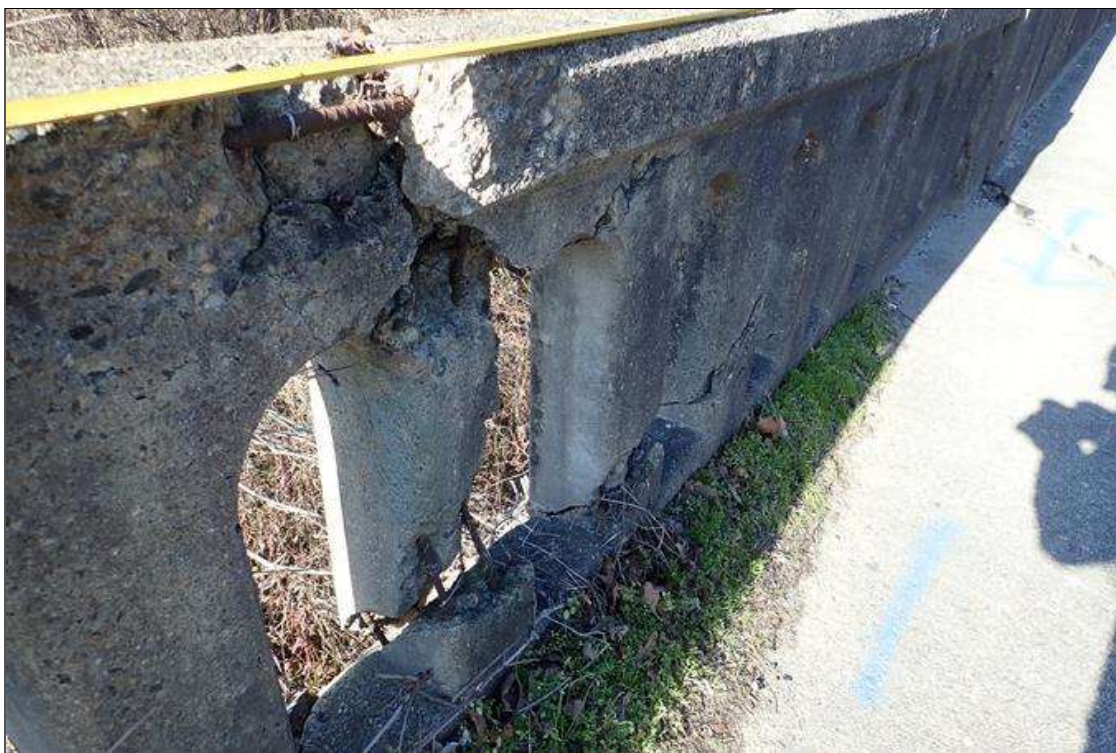
Span 5 Right Bridge Rail: (PAR) at bent 4, impact damage (14') with multiple broken posts and exposed rusted rebar

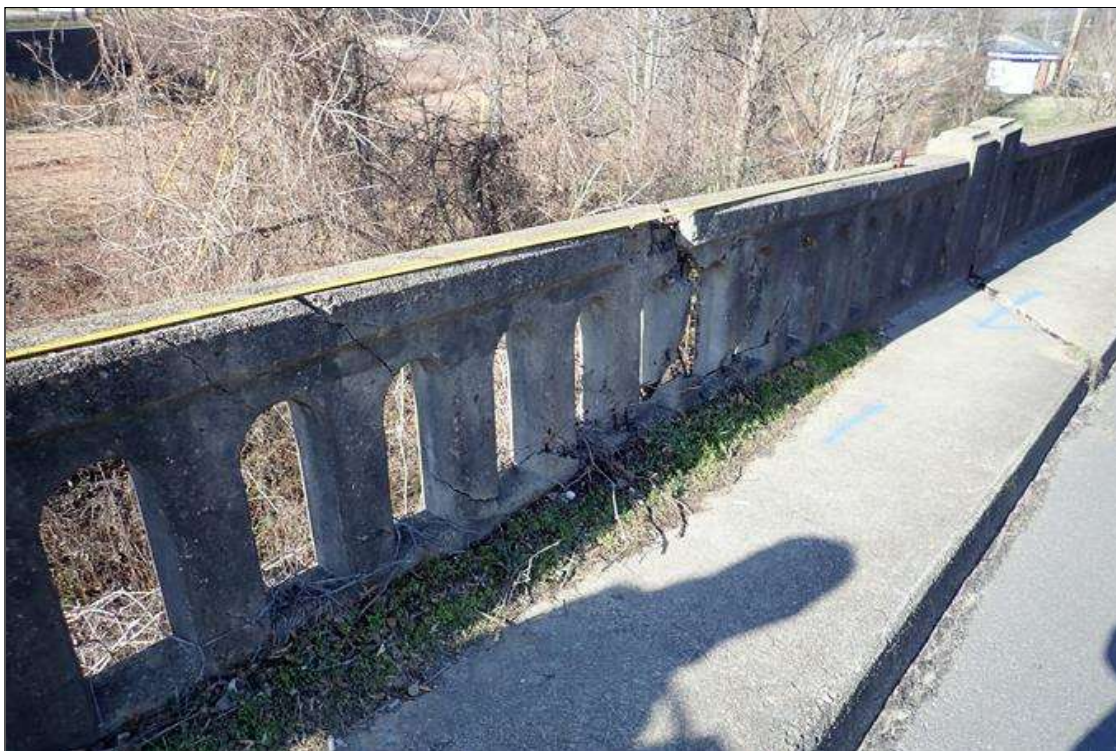
Span 5 Right Bridge Rail: (PAR) at bent 4, impact damage (14') with multiple broken posts and exposed rusted rebar

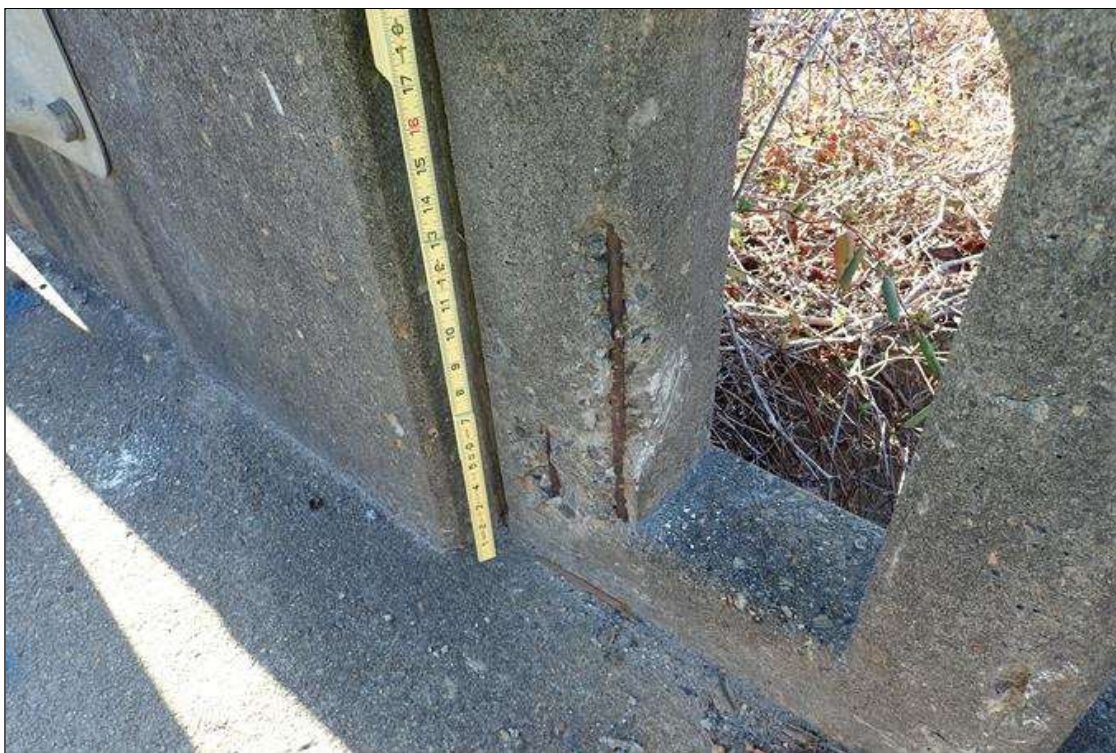
Span 5 Right Bridge Rail: at end bent 2, rail post, spall (12" x 5" x 1") with exposed rusted rebar

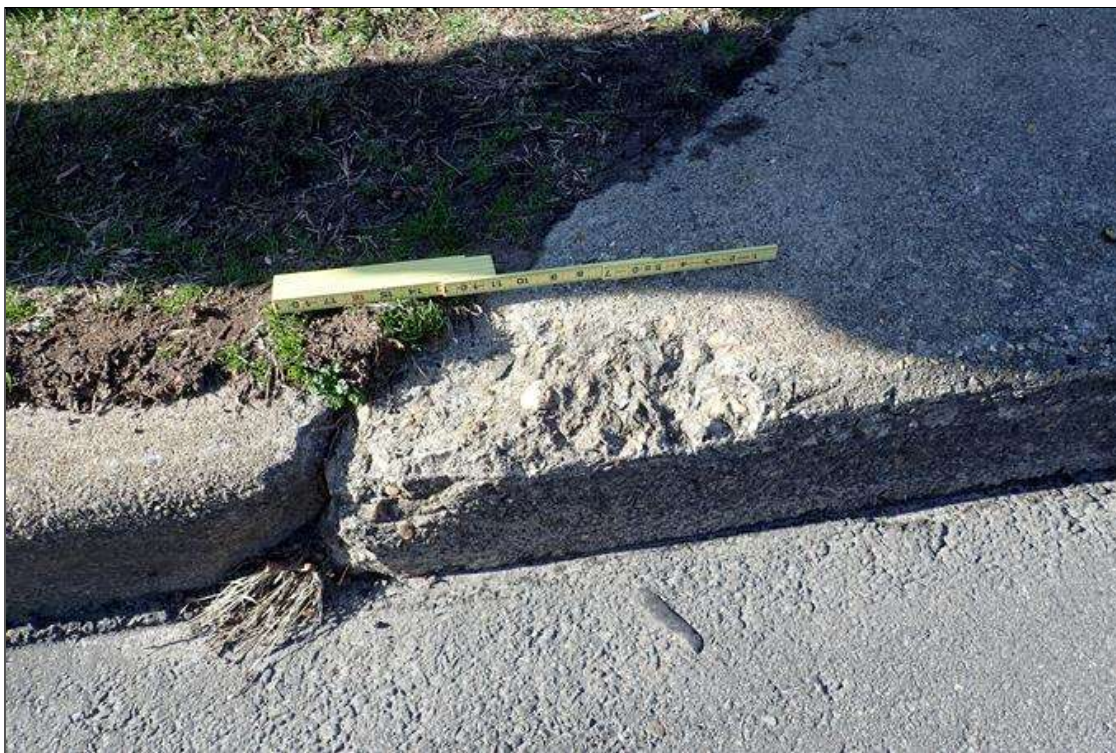
Span 5 Right Bridge Rail: at end bent 2, corner of sidewalk, spall (16" x 5" x 1.5")

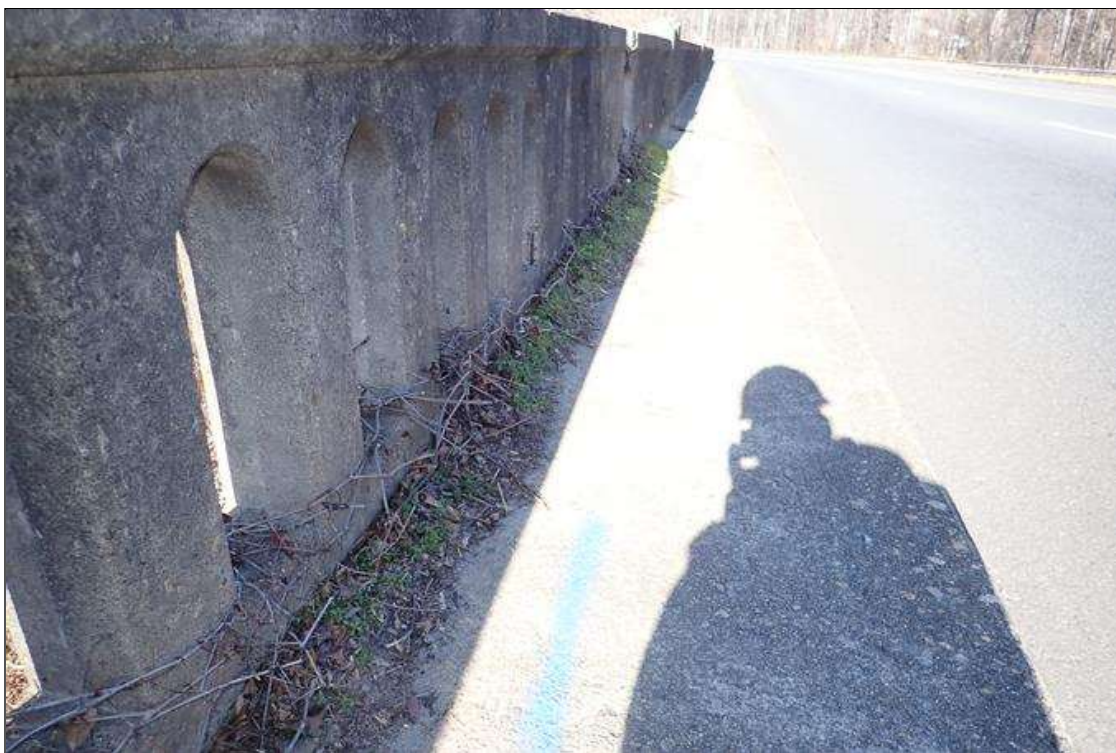
Span 5 Right Bridge Rail: along top of sidewalk, vegetation (1' wide x 20')

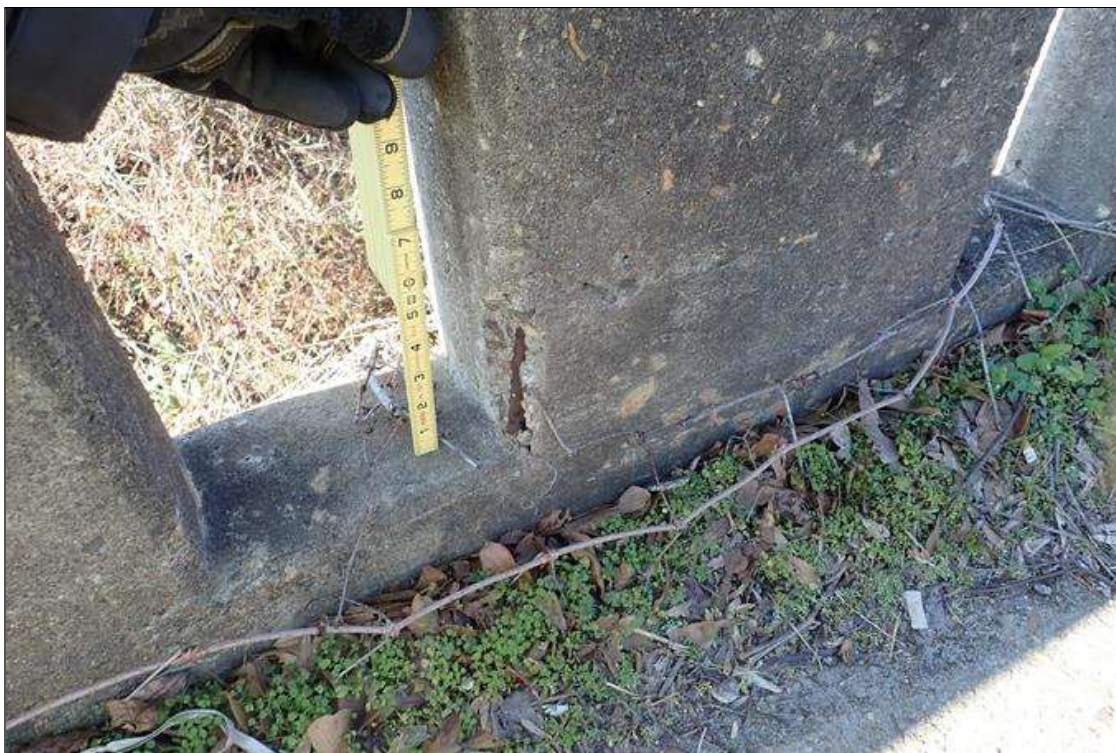
Span 5 Right Bridge Rail: rail post at random, (3) spalls (up to 5" x 2" x 1/2") with exposed rusted rebar

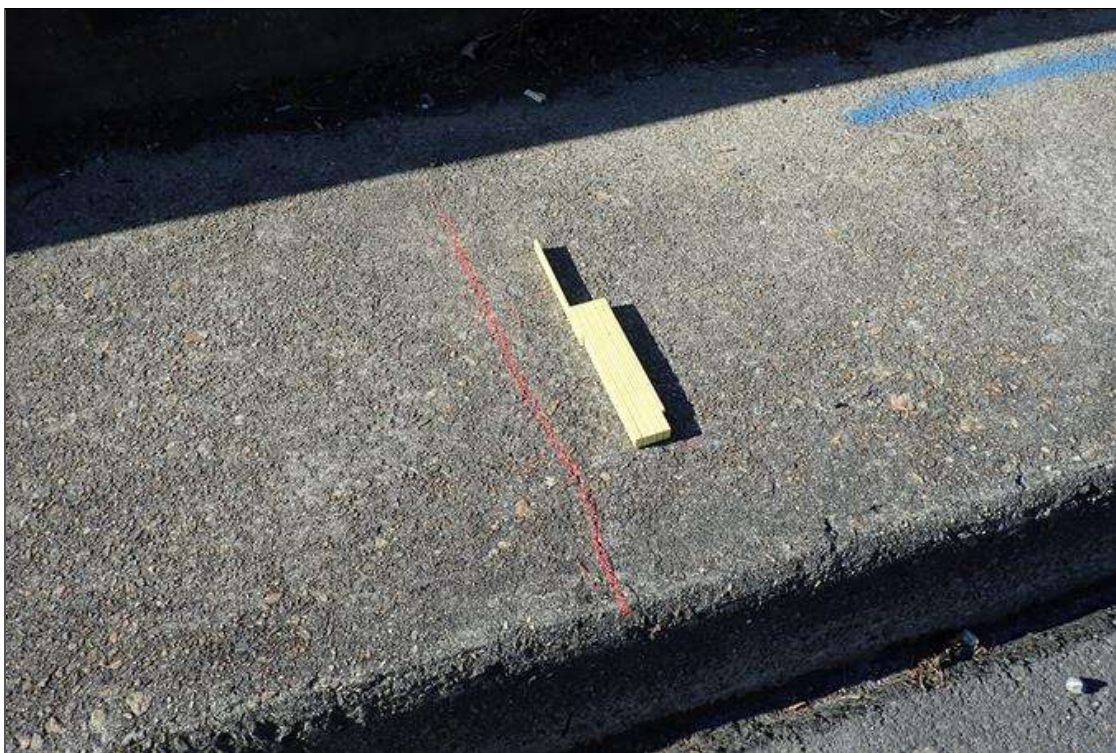
Span 5 Right Bridge Rail: at midspan, sidewalk, transverse crack (1/32" x 3')

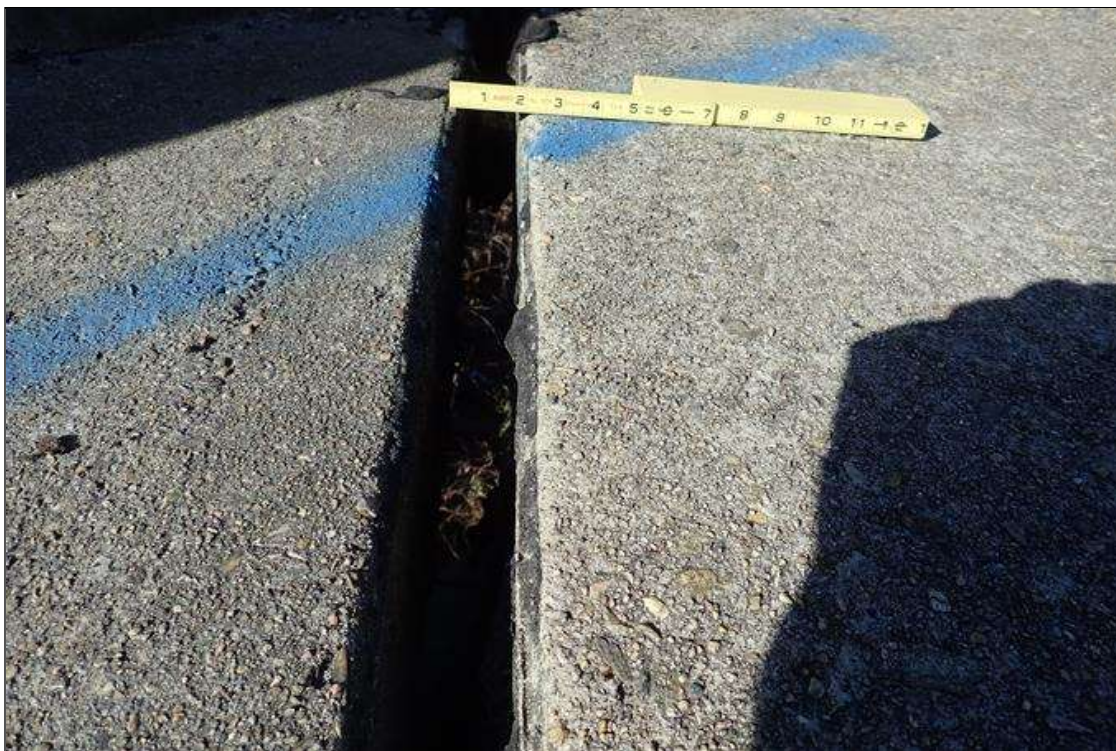
Bent 4 Joint : at right sidewalk, joint material missing

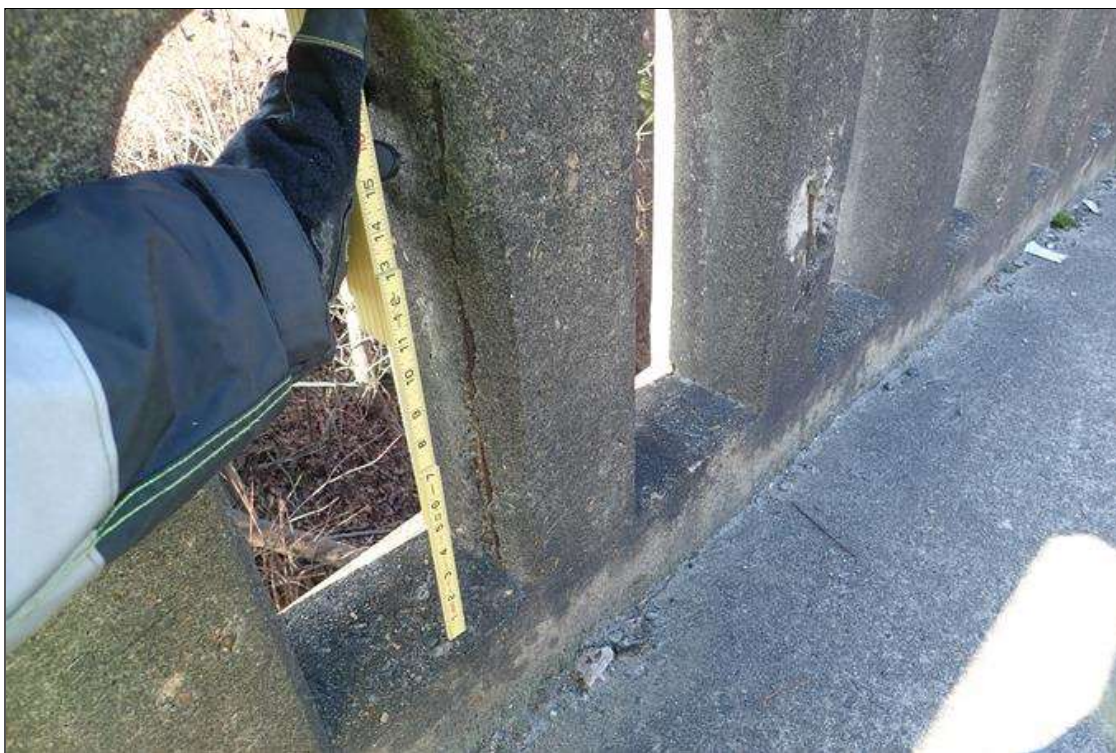
Span 4 Right Bridge Rail: rail posts at random, (4) spalls (up to 16" x 1" x 1/2") with exposed rusted rebar

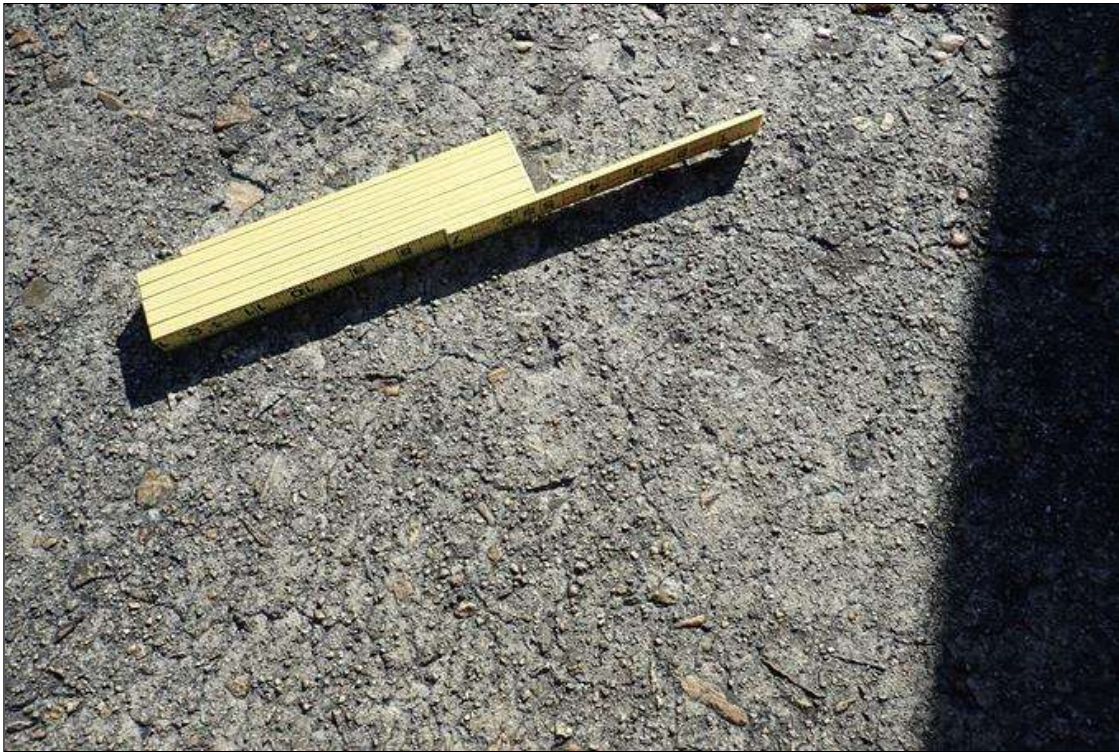
Span 4 Right Bridge Rail: throughout sidewalk and end post, map cracks (up to 1/32")

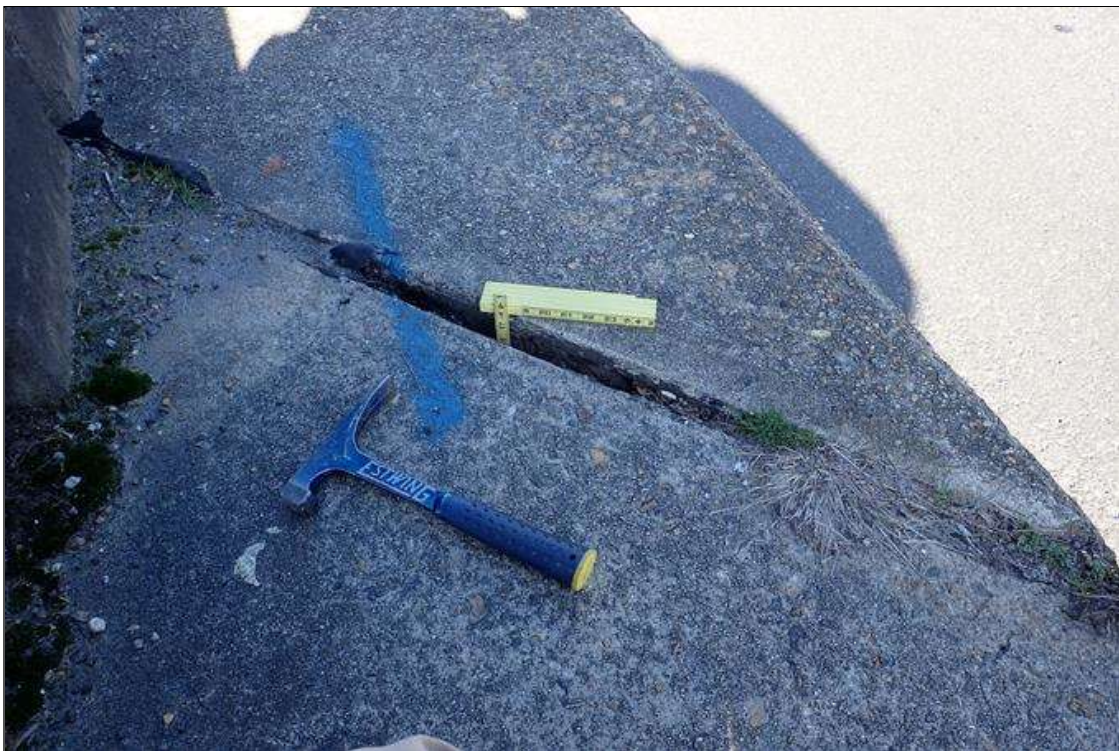
Bent 3 Joint : at right sidewalk, joint material missing (2') with debris and vegetation

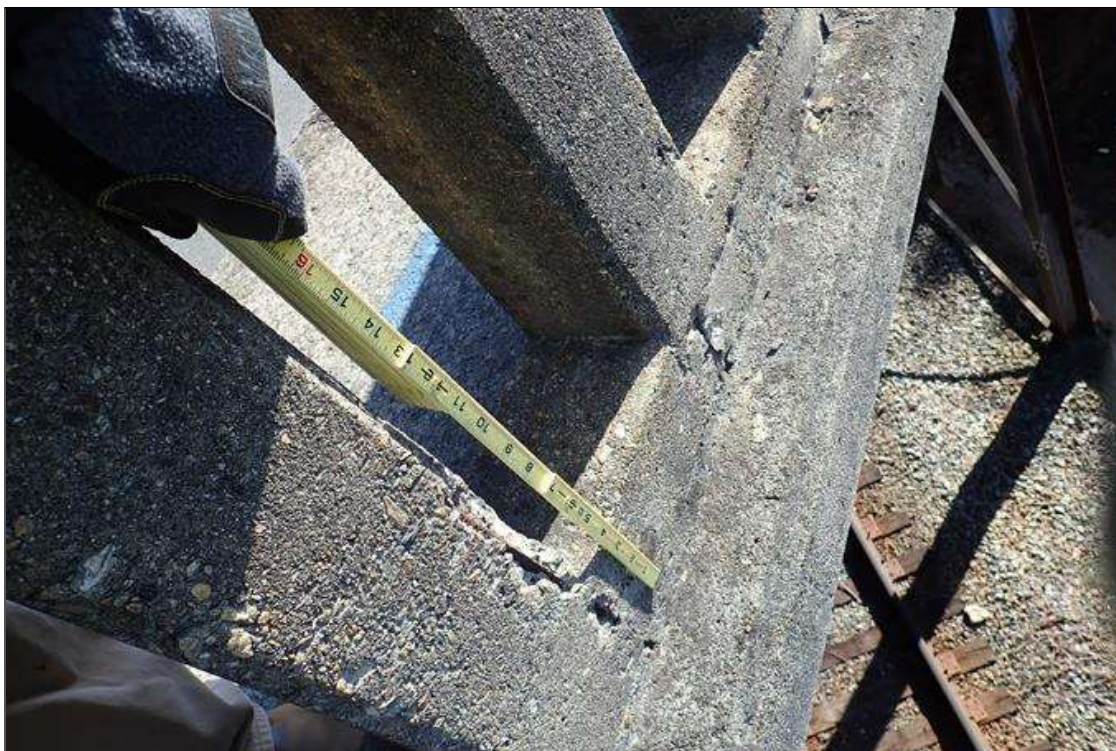
Span 3 Right Bridge Rail: rail posts at random, (10) spalls (up to 16" x 2" x 1/2") with exposed rusted rebar

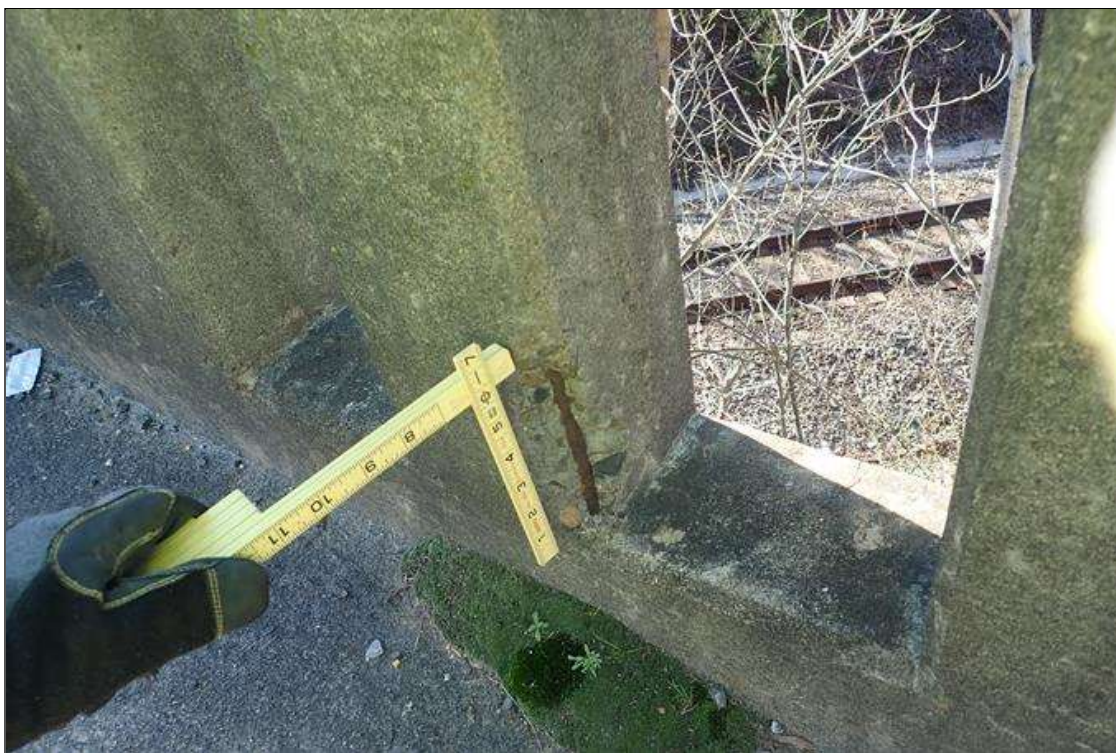
Span 1 Right Bridge Rail: rail posts at random, (6) spalls (up to 6" x 2" x 1") with exposed rusted rebar

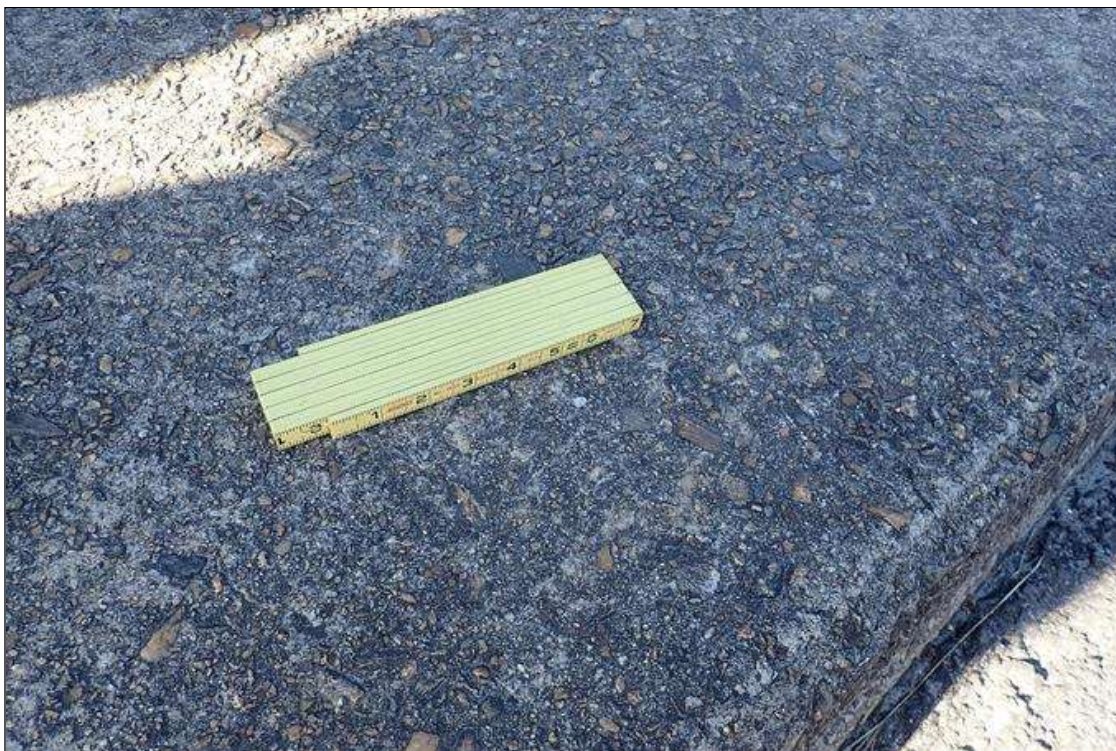
Span 4 Right Bridge Rail: throughout sidewalk and rail, scale with secure aggregate

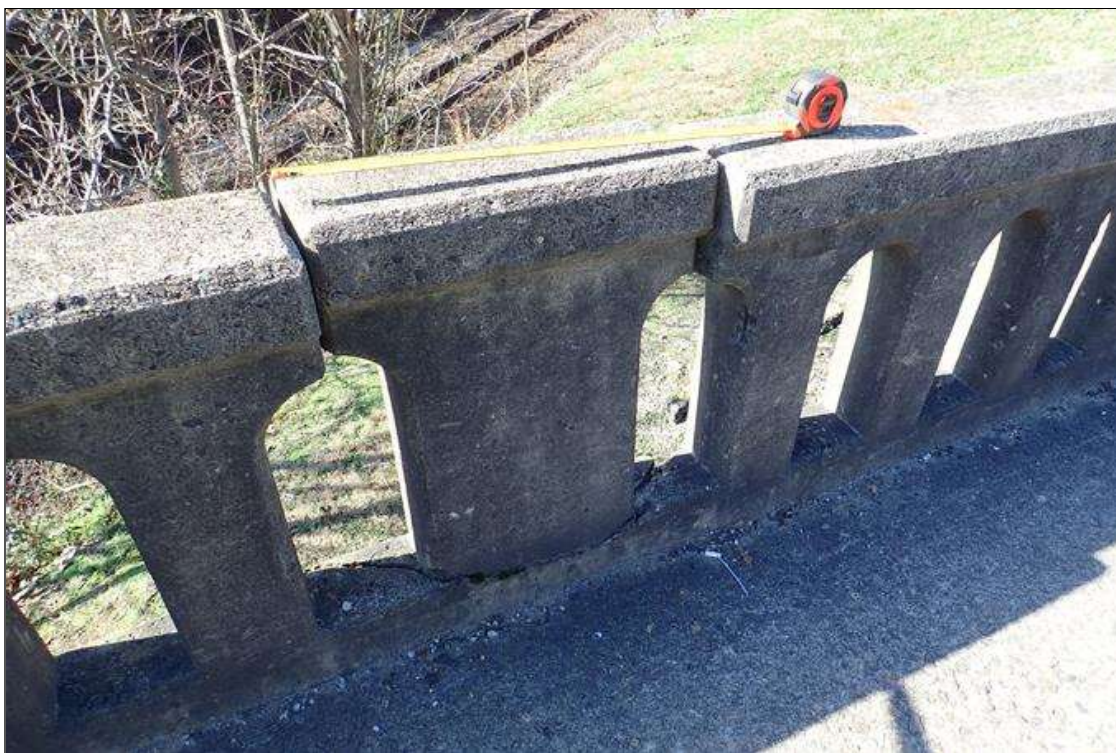
Span 1 Right Bridge Rail: (PAR) at midspan, impact damage (2'), broken at base

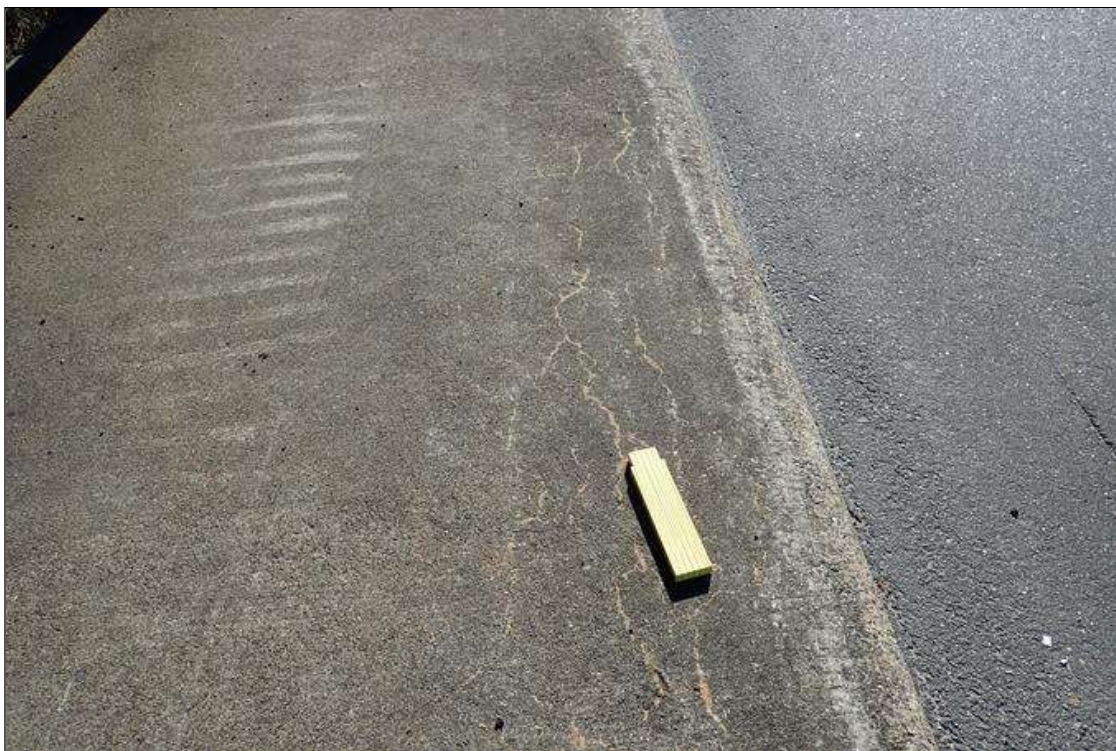
Span 1 Left Bridge Rail: along edge of sidewalk, map cracks (hairline x 1' x full length)

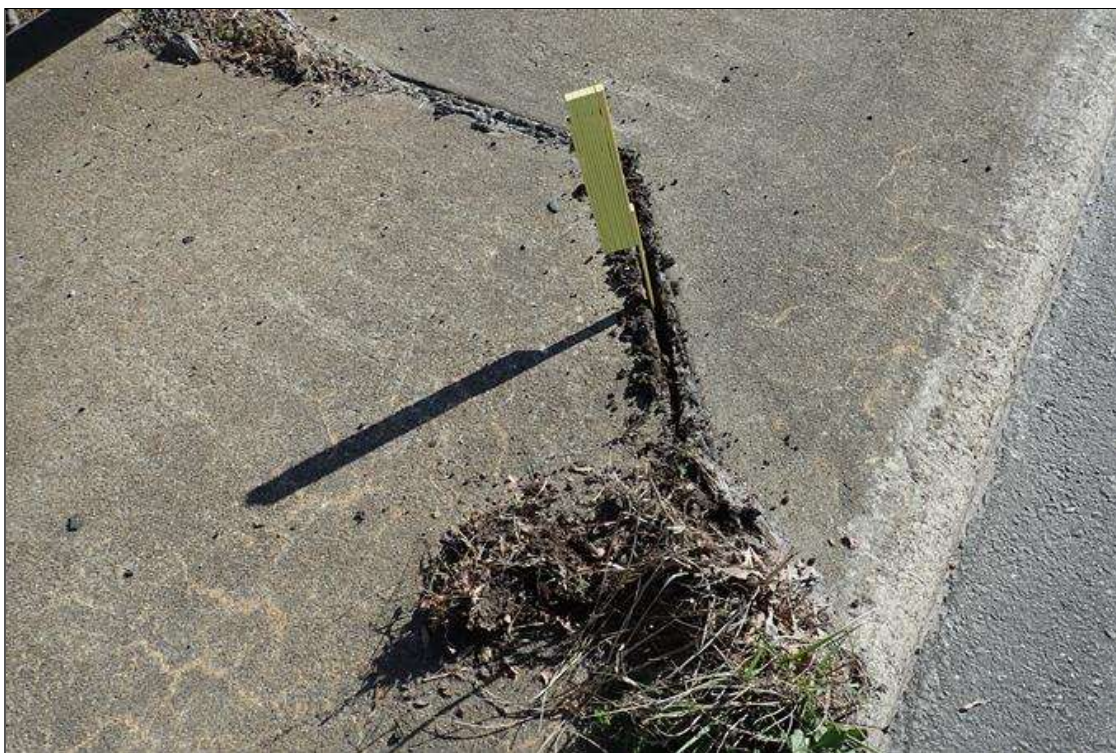
Bent 1 Joint : left sidewalk, joint material separated with debris and vegetation

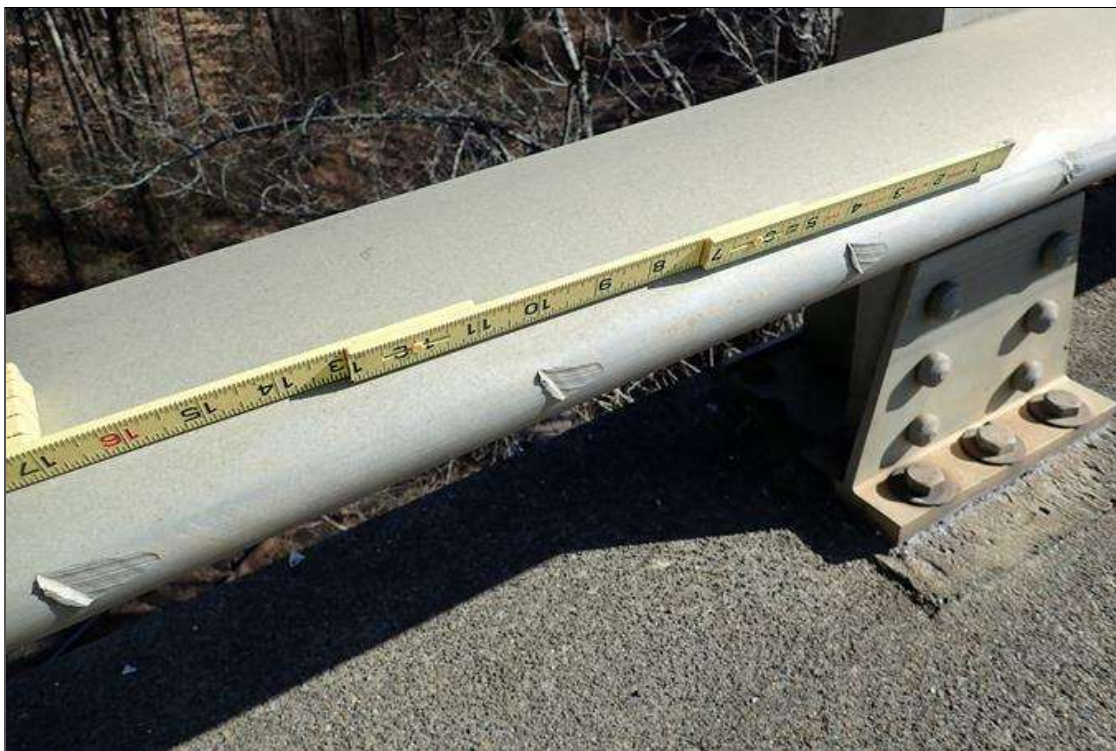
Span 4 Left Bridge Rail: at bent 4, bottom rail, impact damage with gouges (1/8" deep x 4')

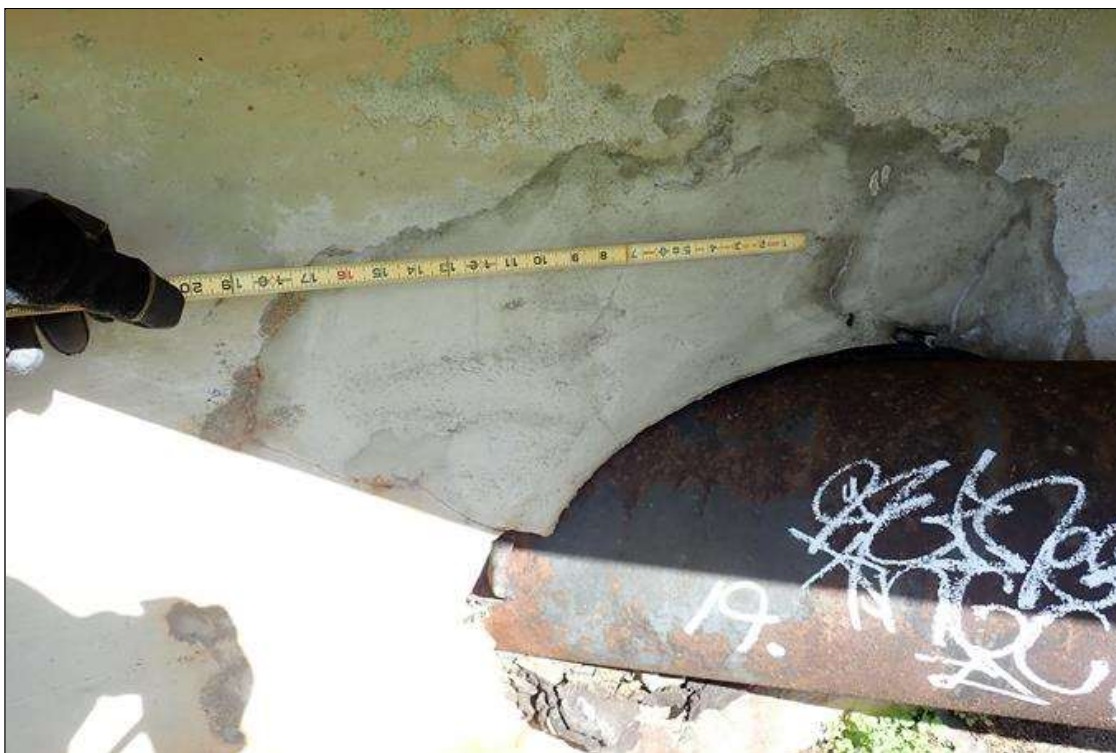
End Bent 1 Abutment/Backwall : right overhang at utility penetration, map cracks (hairline) with efflorescence

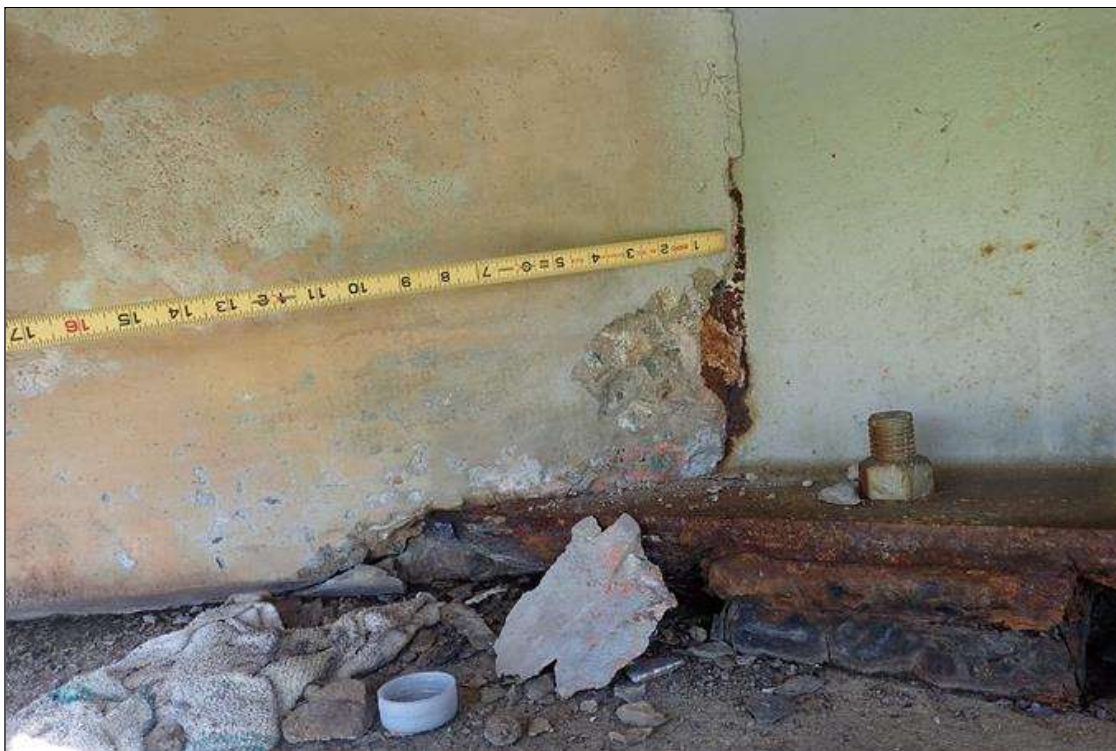
End Bent 1 Abutment/Backwall : right side of beam 11, bottom flange, spall (5" x 3" x 1/2")
