NC DEPARTMENT OF TRANSPORTATION
 DIVISION OF HIGHWAYS
 STRUCTURE MANAGEMENT UNIT

ATTENTION: **partial inspection, awaiting railroad entry permit; prompt action request, sketches revised, temporary repairs to caps**

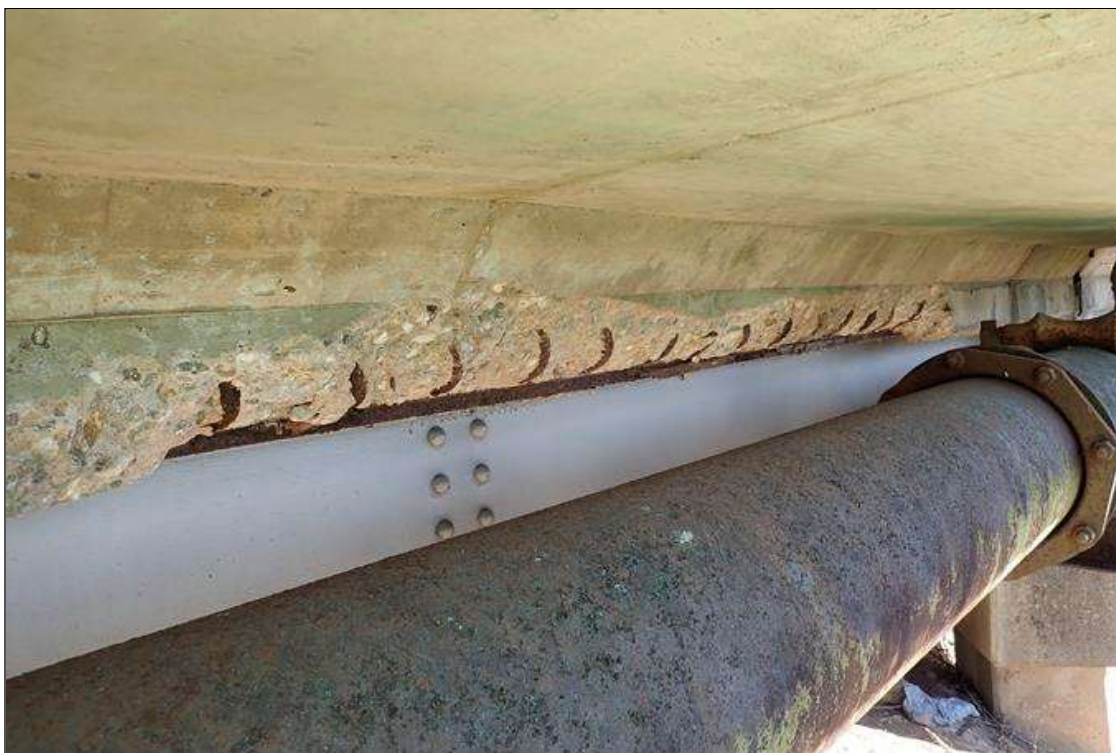
Span 1 Deck: (PAR) right side of beam 11 haunch, at bent 2, spall (14' x 6" x 5") with exposed rusted rebar

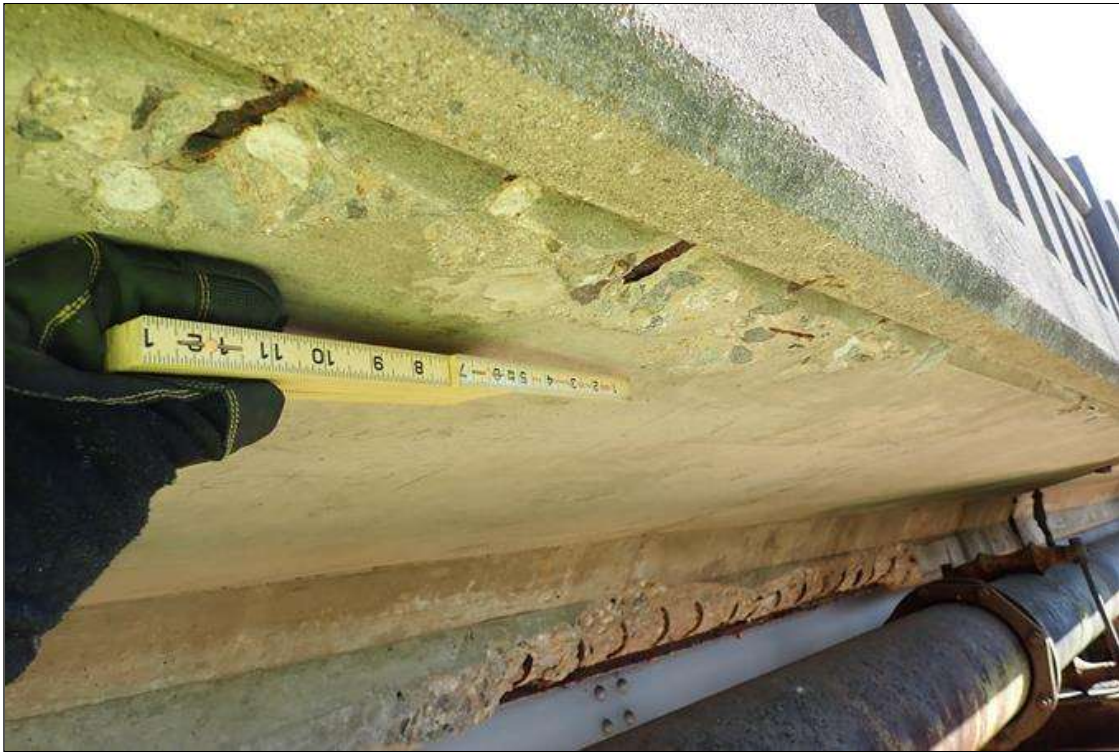
Span 1 Deck: along right drip edge, multiple spalls (up to 2' x 4" x 1/2") with exposed rusted rebar

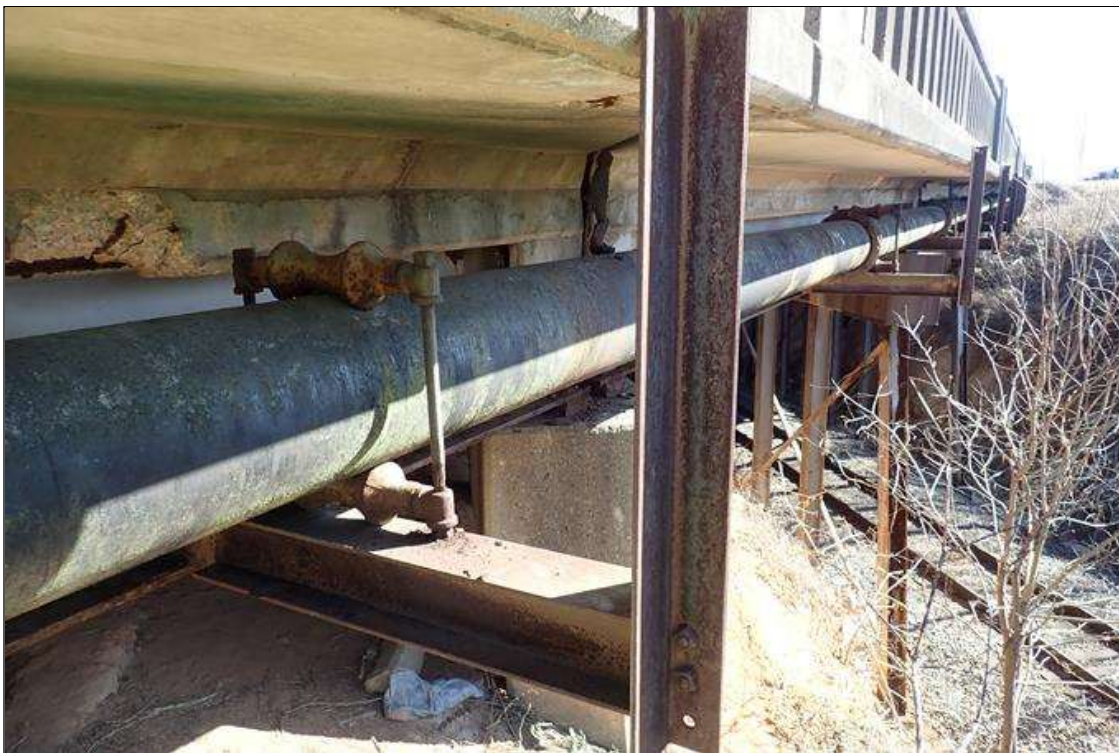
right overhang, throughout utility hangers, surface rust

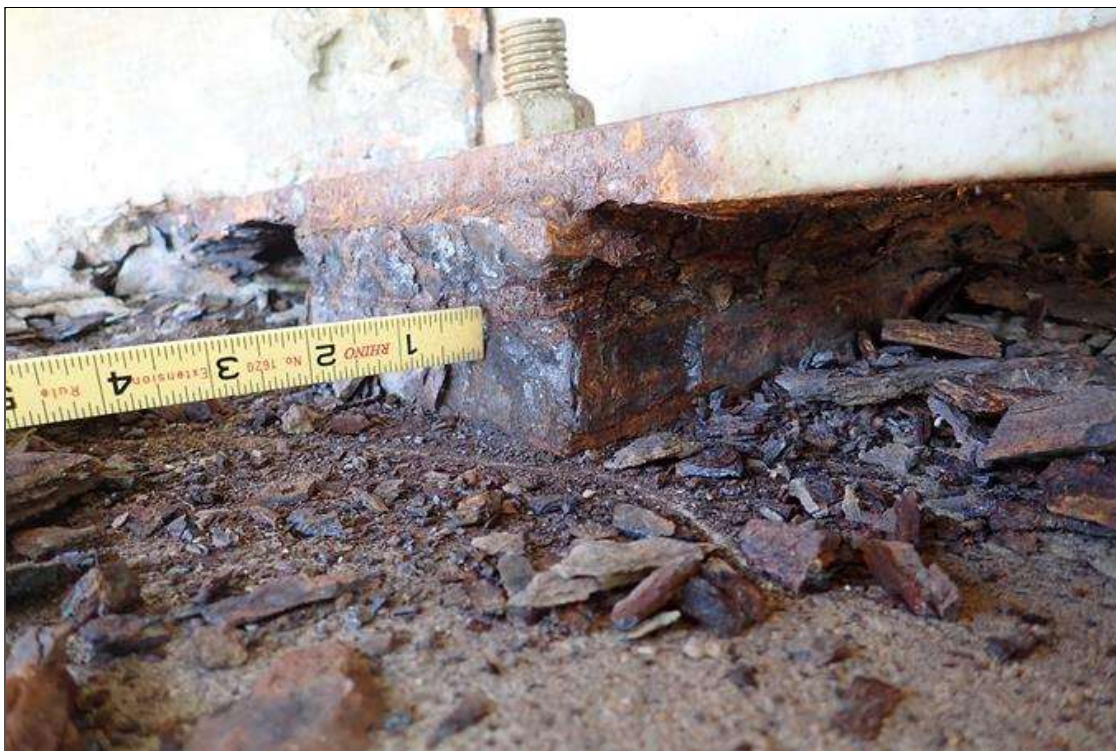
Span 1 Beam 11 Near Bearing 11: (PAR) corrosion with section loss (1/8" loss) at plate edges

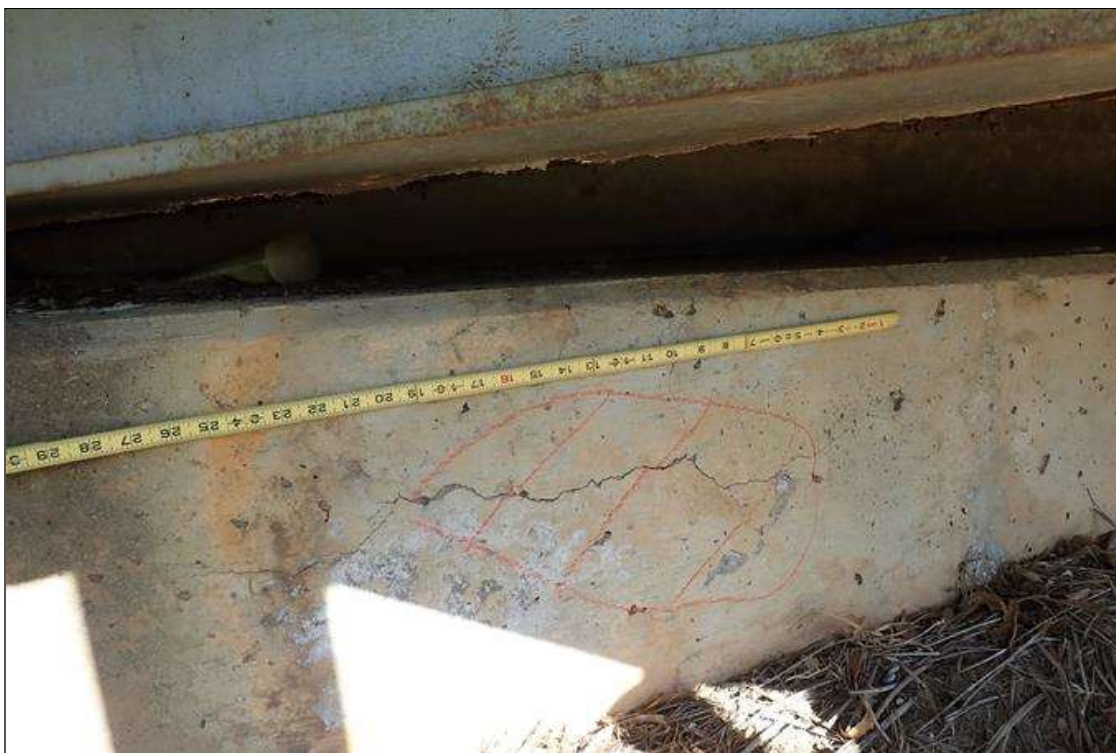
End Bent 1 Cap 1: face of cap, below beam 11, longitudinal crack (1/16" x 2') with delamination (16" x 10")

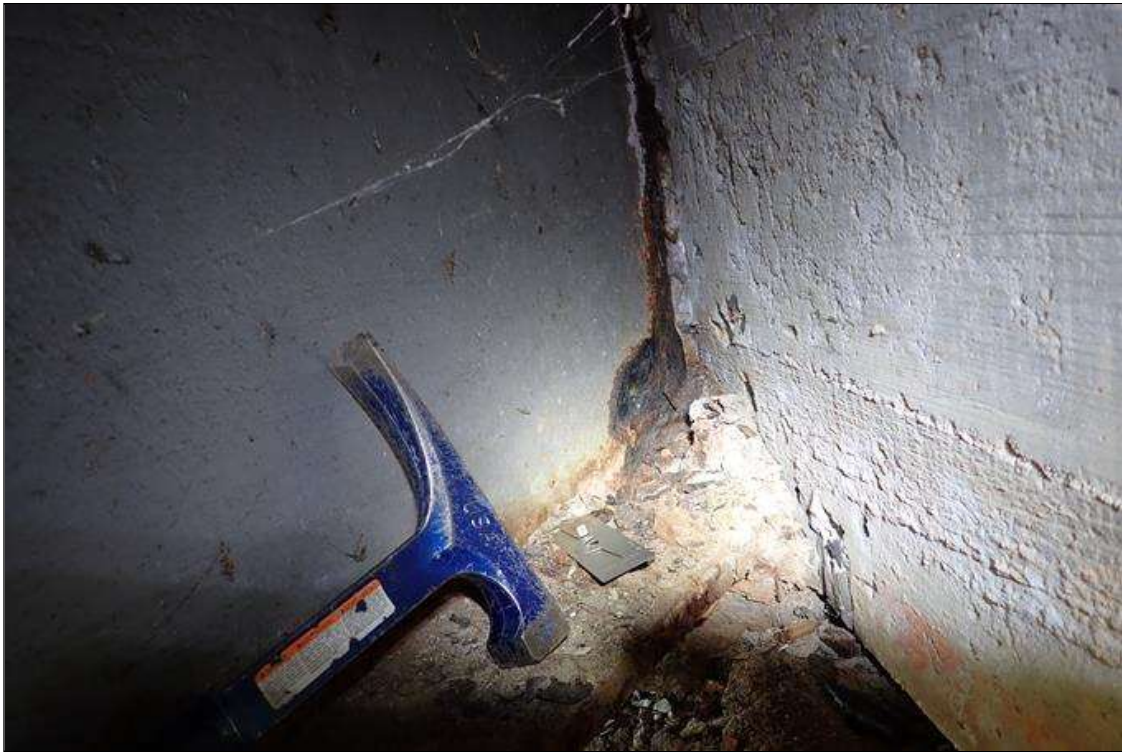
Span 1 Beam 11: (PAR) at end bent 1, bottom of web, left face, corrosion with section loss (1/4" remaining x 8" x 6")

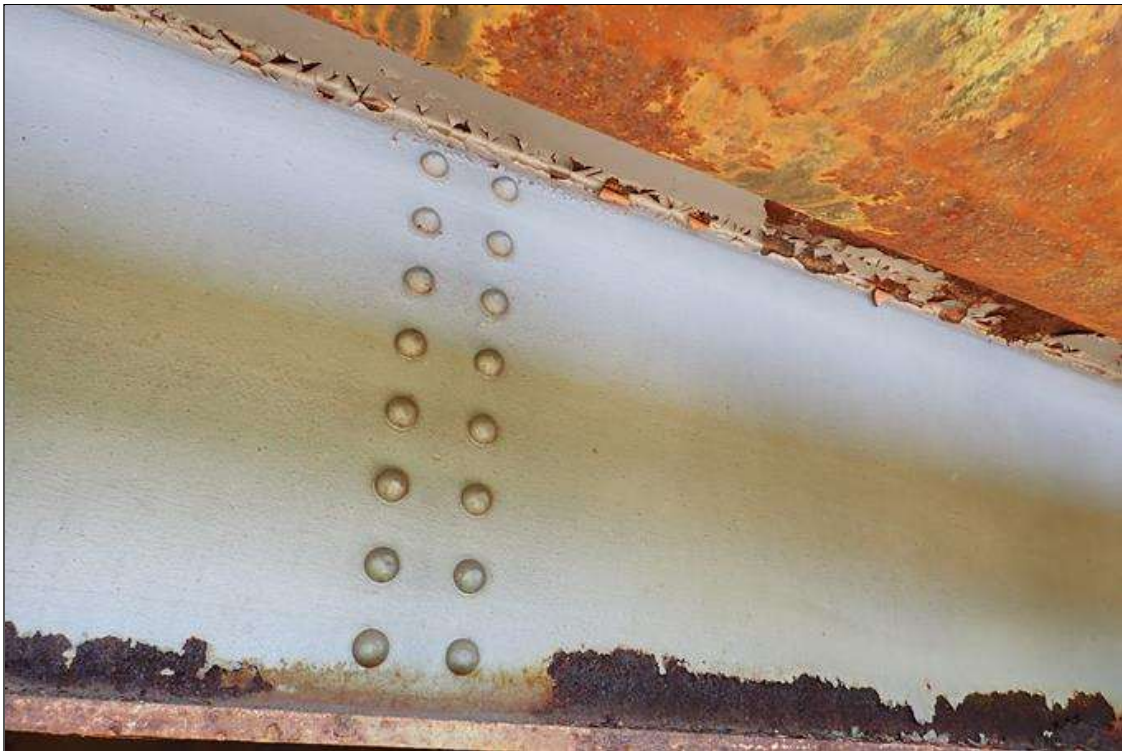
Span 1 Beam 11: both flanges, below deck haunch spall, rust scale with pitting (up to 1/16")

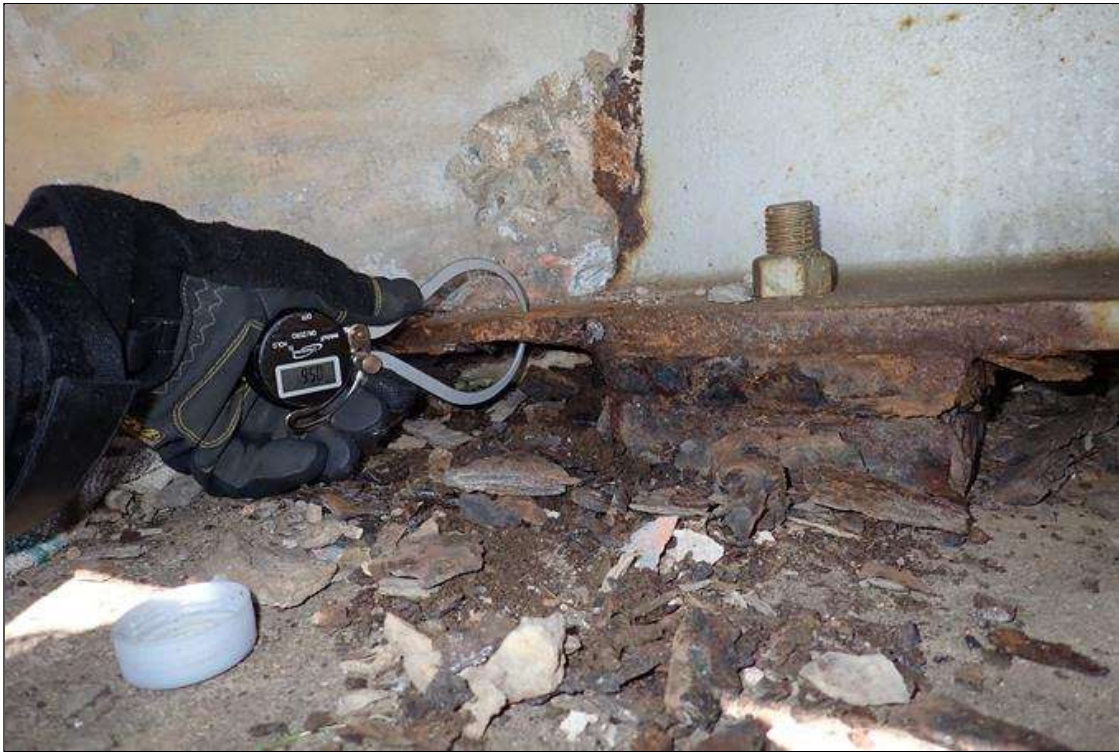
Span 1 Beam 11: (PAR) at end bent 1, behind bearing, corrosion with section loss (0.6" average remaining x 1')

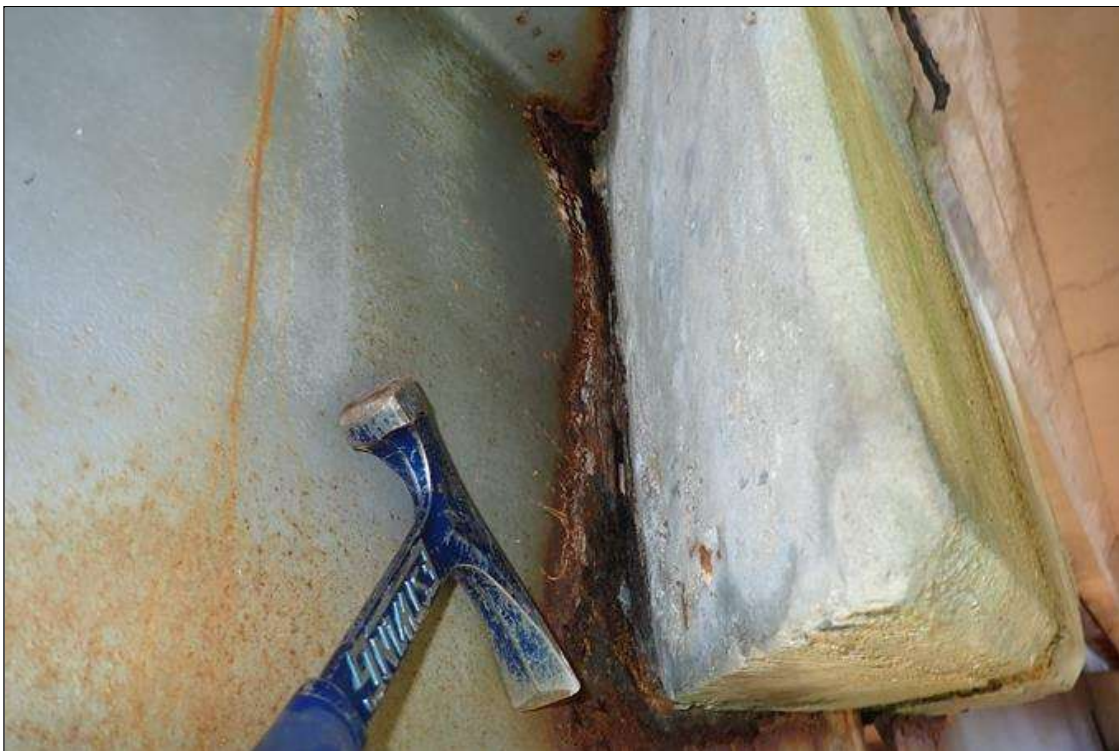
Span 1 Beam 11: (PAR) at bent 1, corrosion with section loss: bottom flange, (0.6" average remaining x 3'); web at end diaphragm, (1/8" remaining x 3" wide x 19")

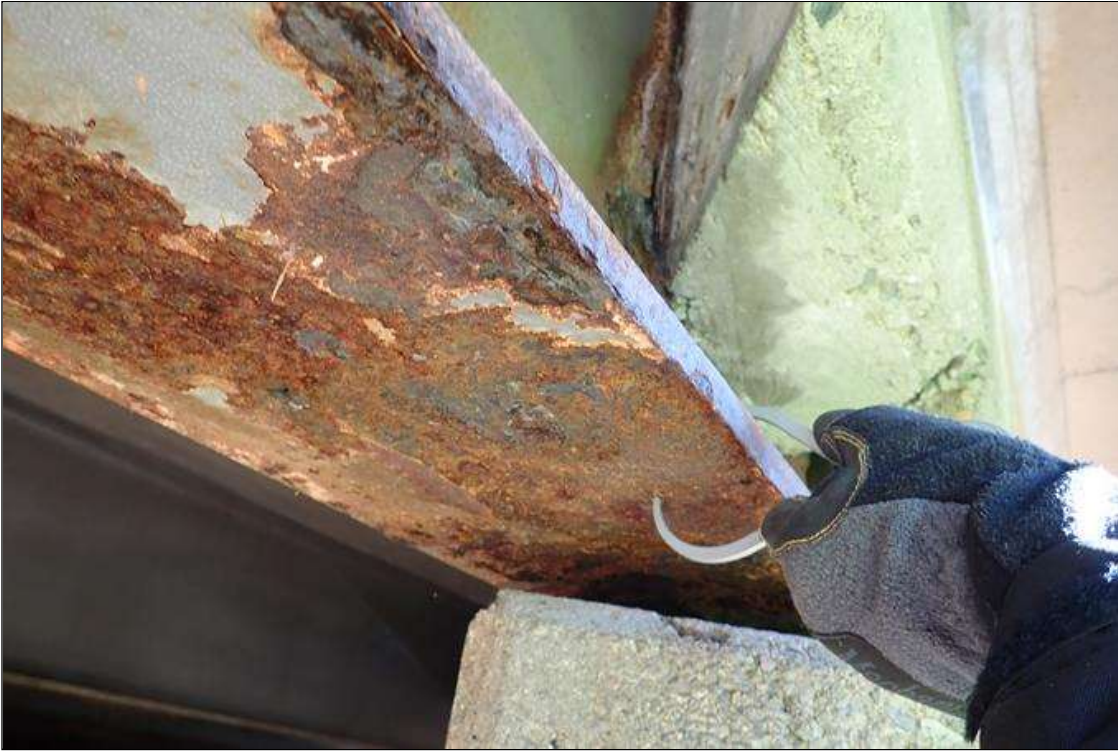
Span 1 Beam 11: (PAR) at bent 1, corrosion with section loss: bottom flange, (0.6" average remaining x 3'); web at end diaphragm, (1/8" remaining x 3" wide x 19")

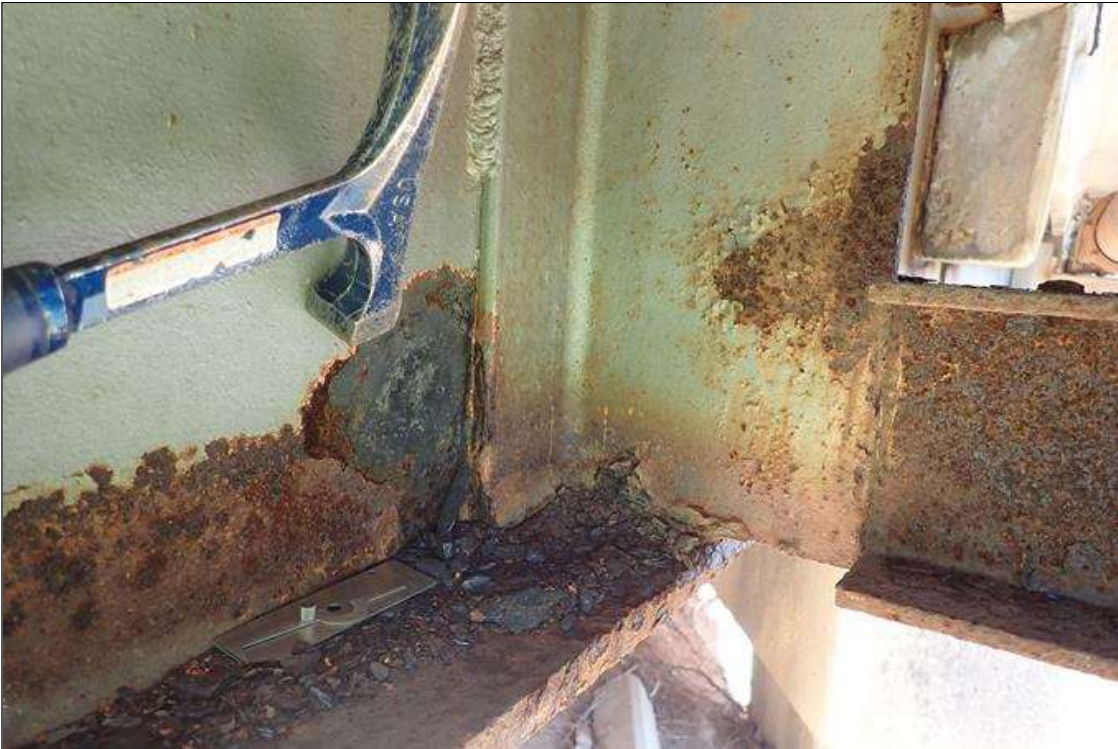
Span 1 Beam 11: (PAR) 8' from bent 1, at utility hanger, right face of web, corrosion with section loss (1/8" remaining x 6" x 6")

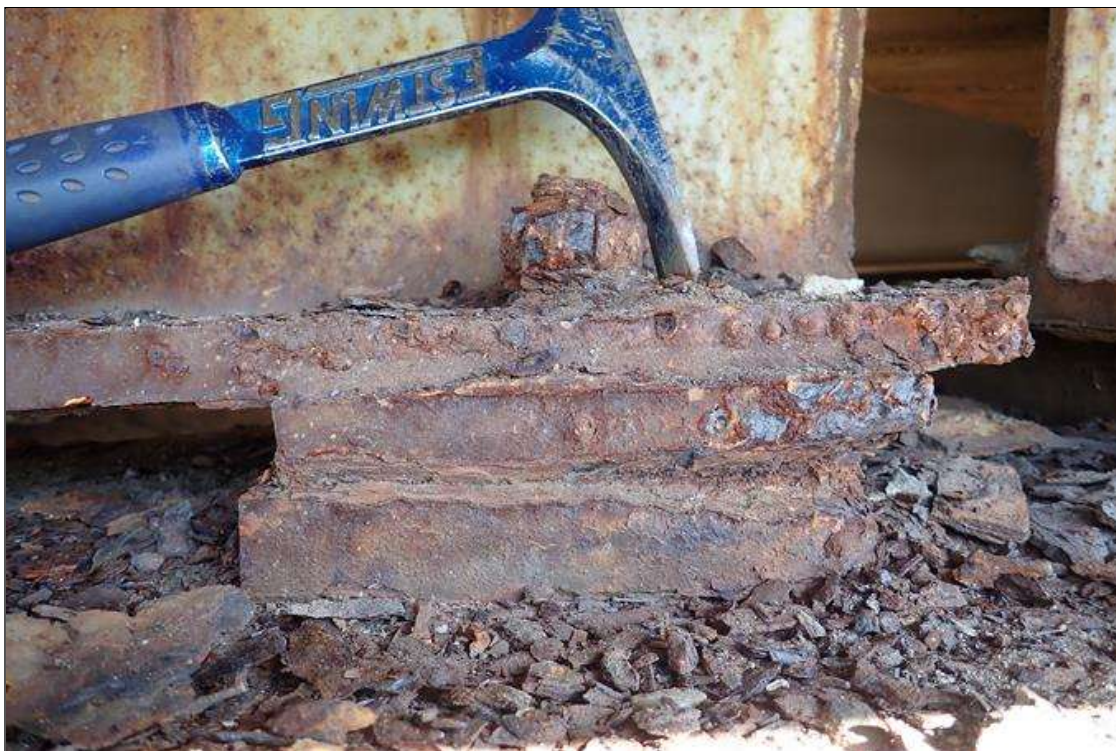
Span 1 Beam 11 Far Bearing 11: (PAR) bearing frozen with pack rust

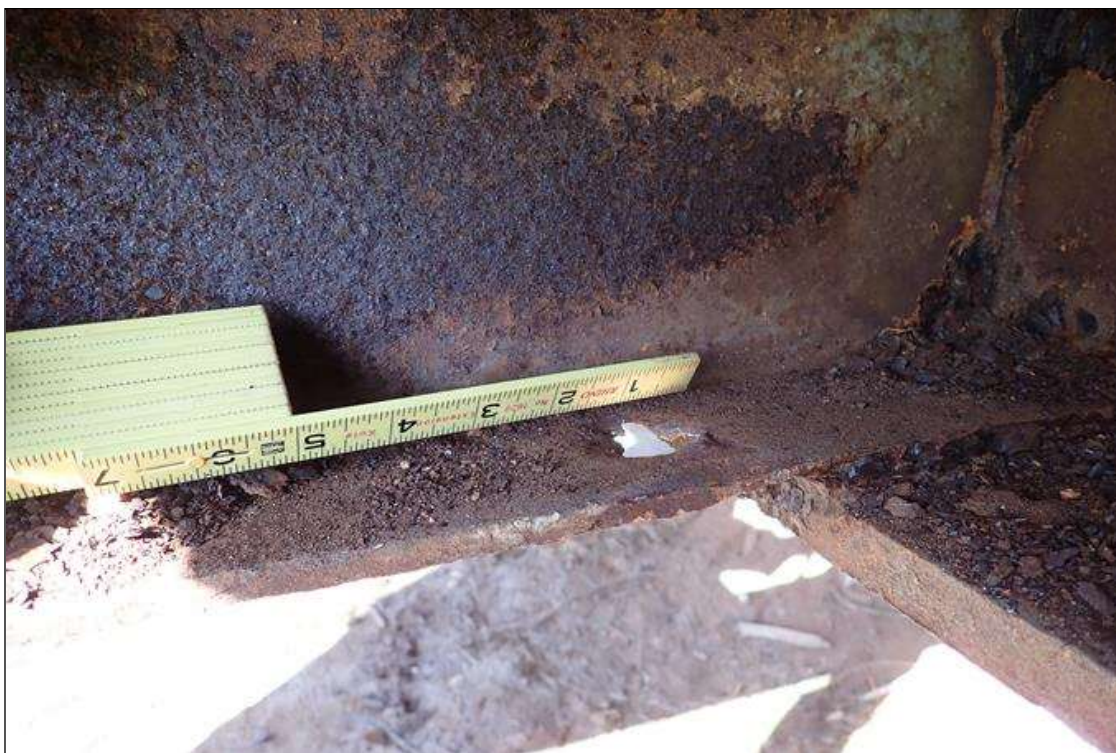
(PAR) span 1 utility, right overhang, 6' from bent 1, section loss on clamp rods (5/8" remaining); and bottom flange of bracket at beam, corrosion hole (1.5" diameter)

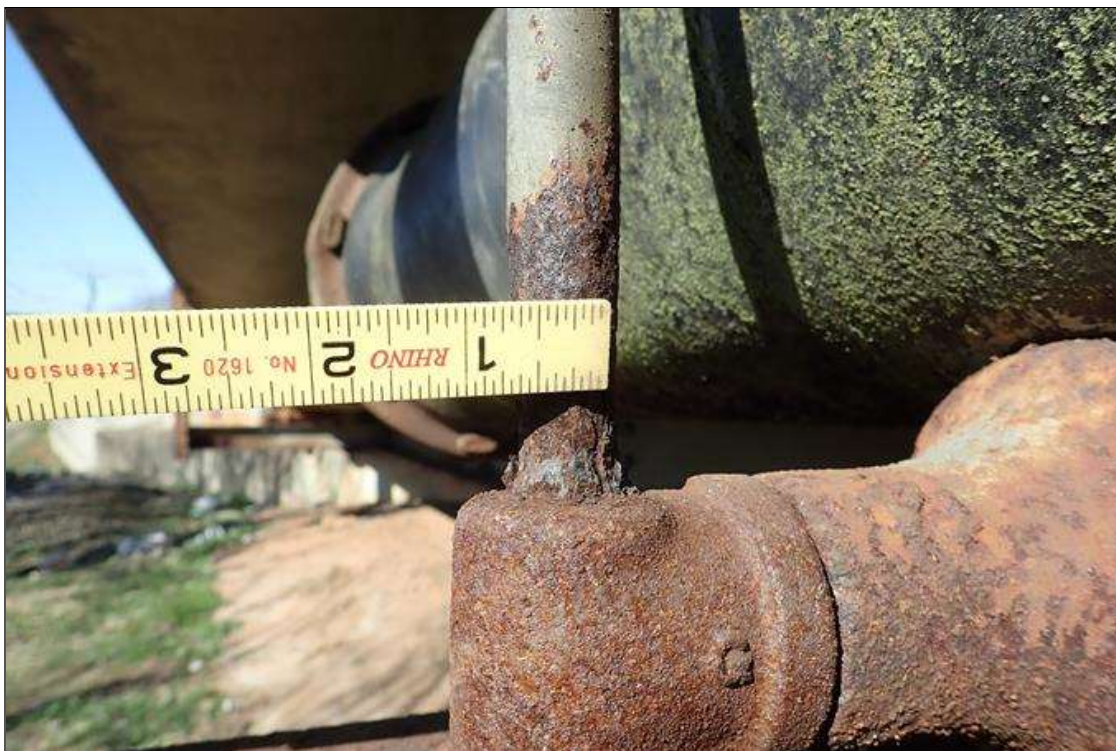
(PAR) span 1 utility, right overhang, 6' from bent 1, section loss on clamp rods (5/8" remaining); and bottom flange of bracket at beam, corrosion hole (1.5" diameter)

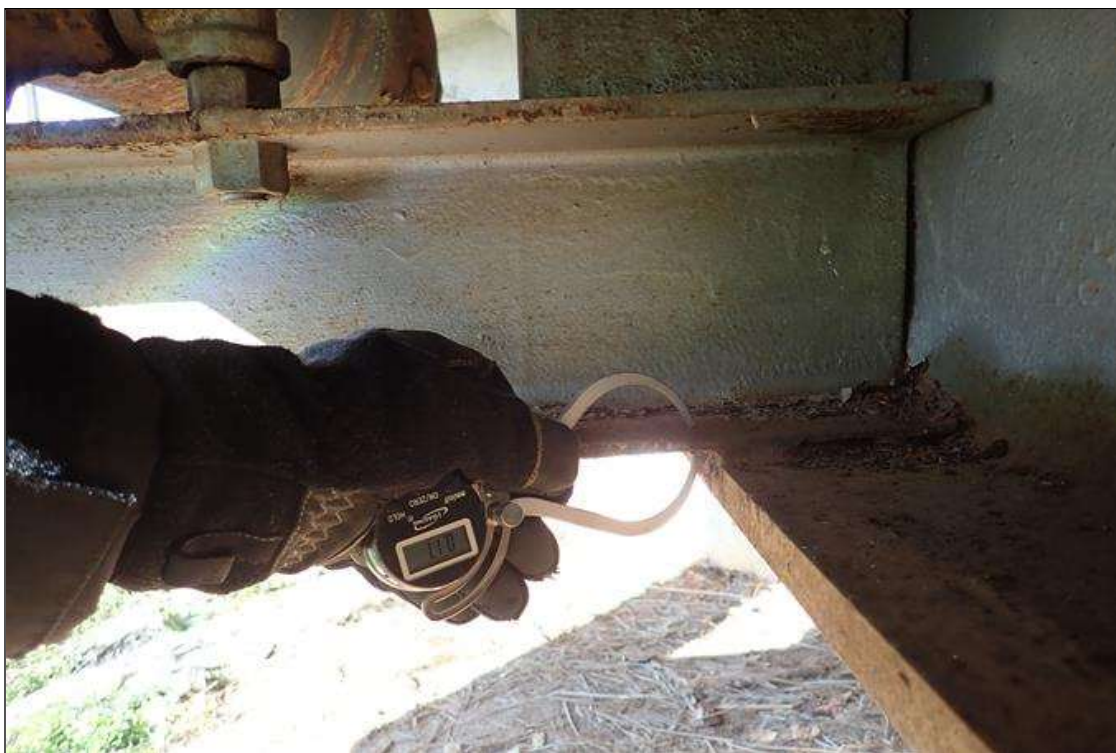
(PAR) right overhang, utility hanger, 7' from end bent 1, bottom flange of bracket at beam, corrosion with section loss (0.2" average remaining x 3")

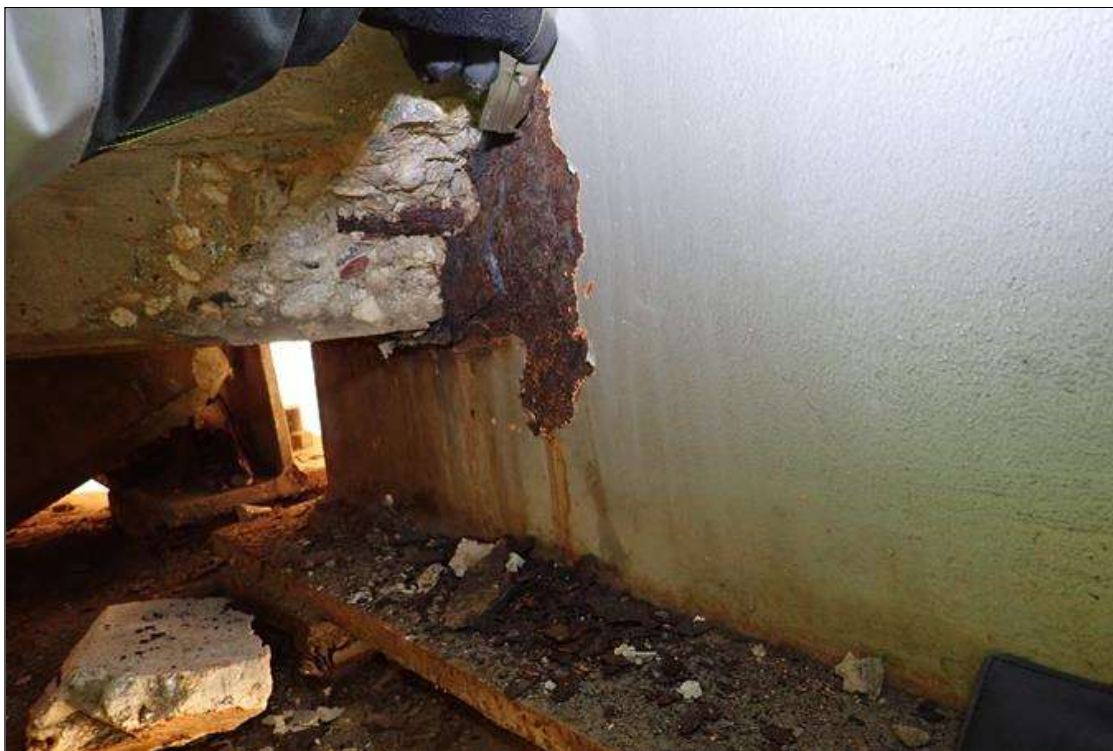
Span 1 Beam 10: (PAR) at bent 1, left face of web, corrosion with section loss (3/8" remaining x 7" x 8")

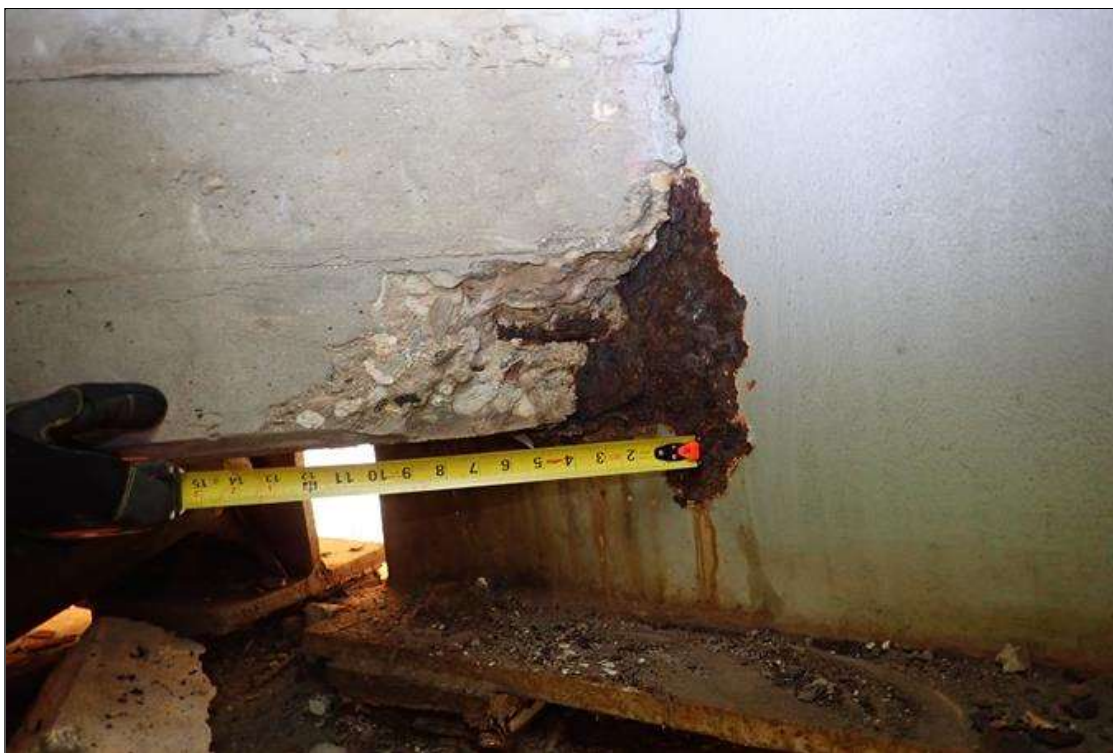
Span 1 Deck: bent 1 end diaphragm, bay 9. at beam 10, spall (12" x 6" x 6") with exposed rusted rebar

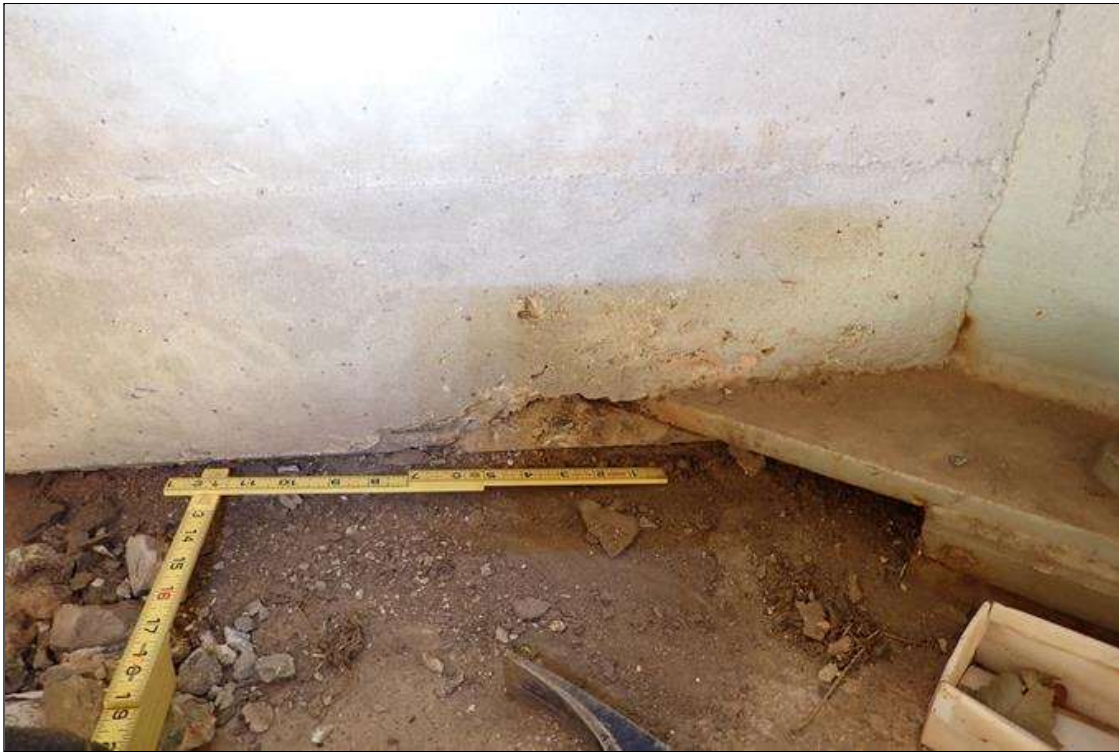
End Bent 1 Abutment/Backwall : bay 9 at beam 10 bottom flange, spall (8" x 2" x 1")

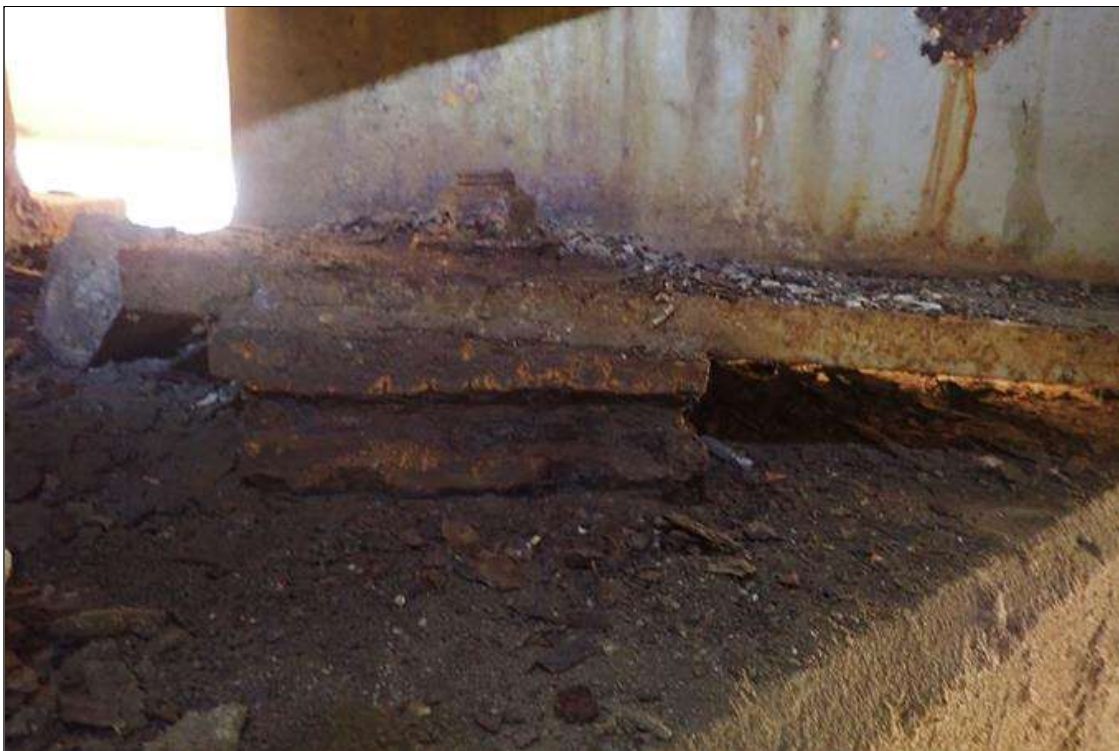
Span 1 Beam 10 Far Bearing 10: (PAR) bearing frozen with pack rust

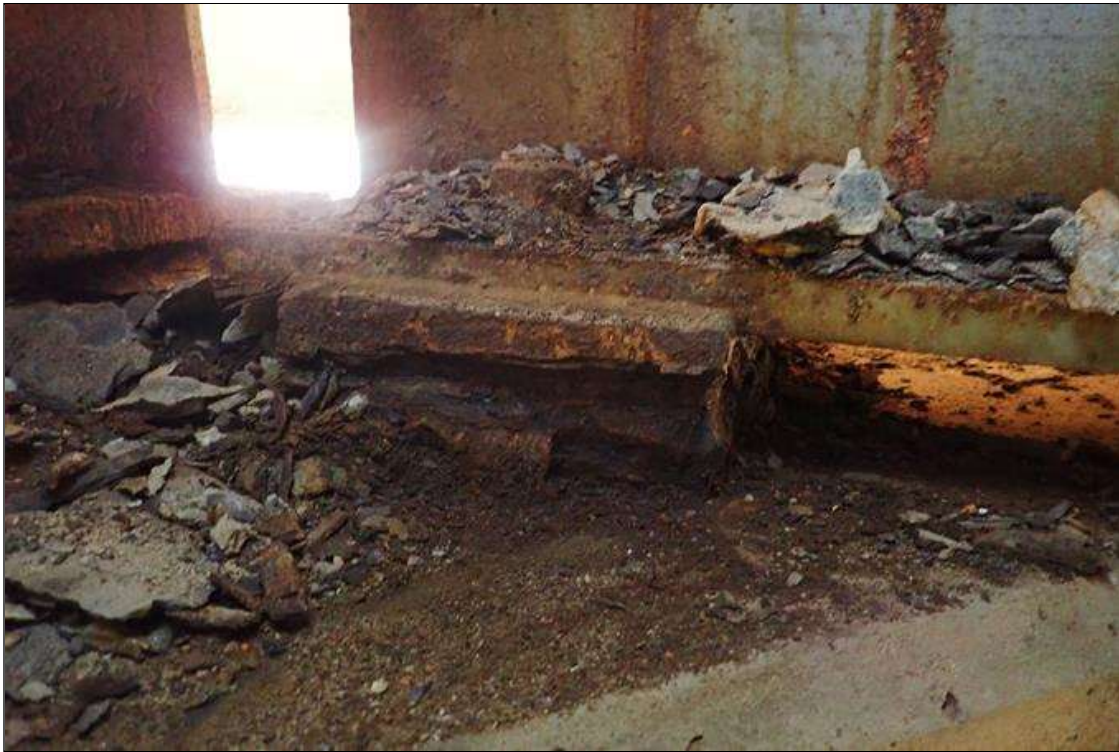
Span 1 Beam 9 Far Bearing 9: (PAR) bearing frozen with pack rust

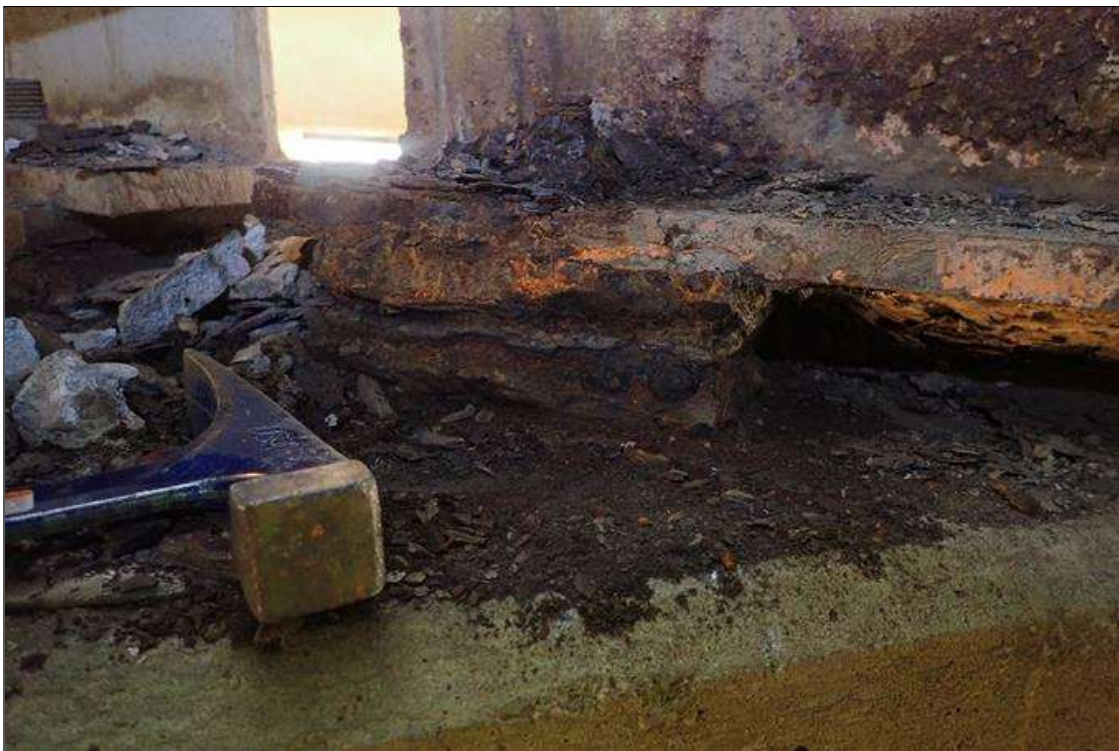
Span 1 Beam 8 Far Bearing 8: (PAR) bearing frozen with pack rust

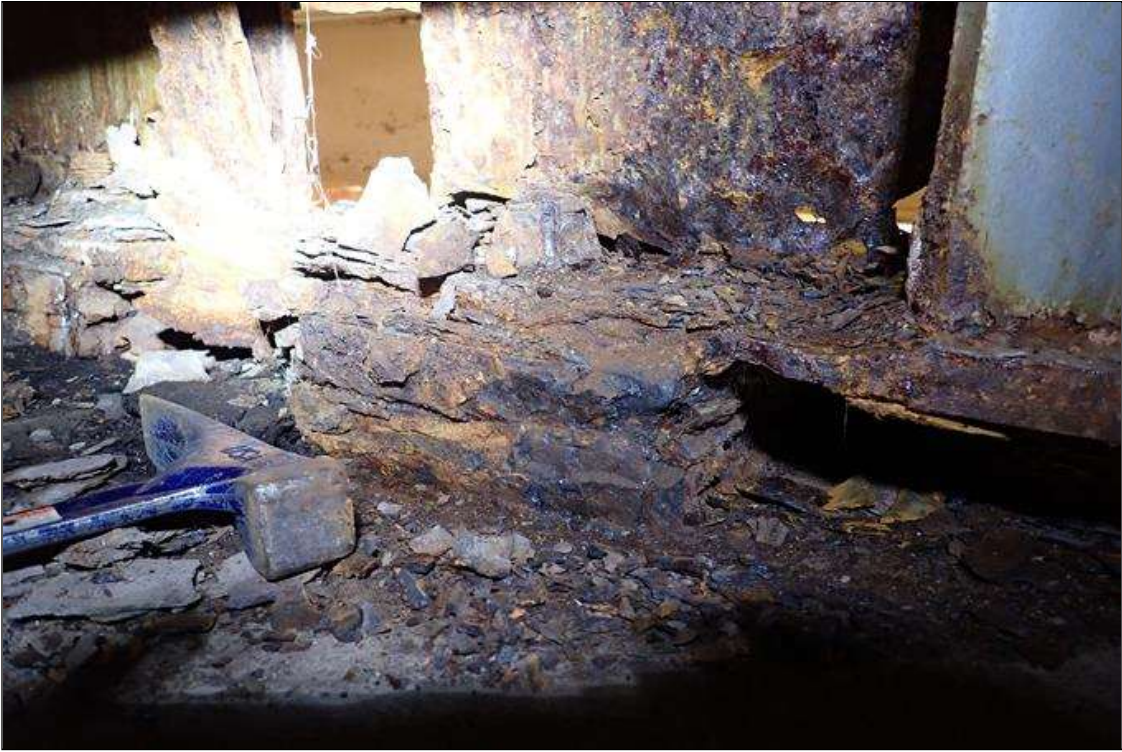
Span 1 Beam 7 Far Bearing 7: (PAR) bearing frozen with pack rust

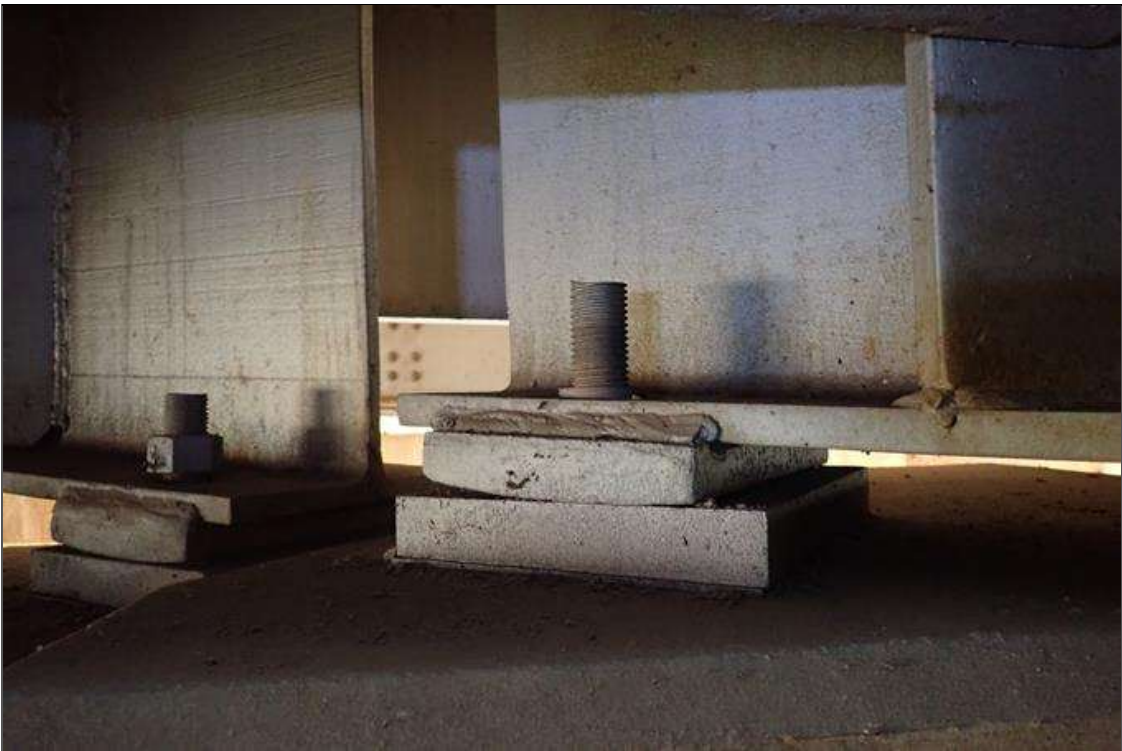
Span 1 Beam 5 Far Bearing 5: left anchor bolt nut missing

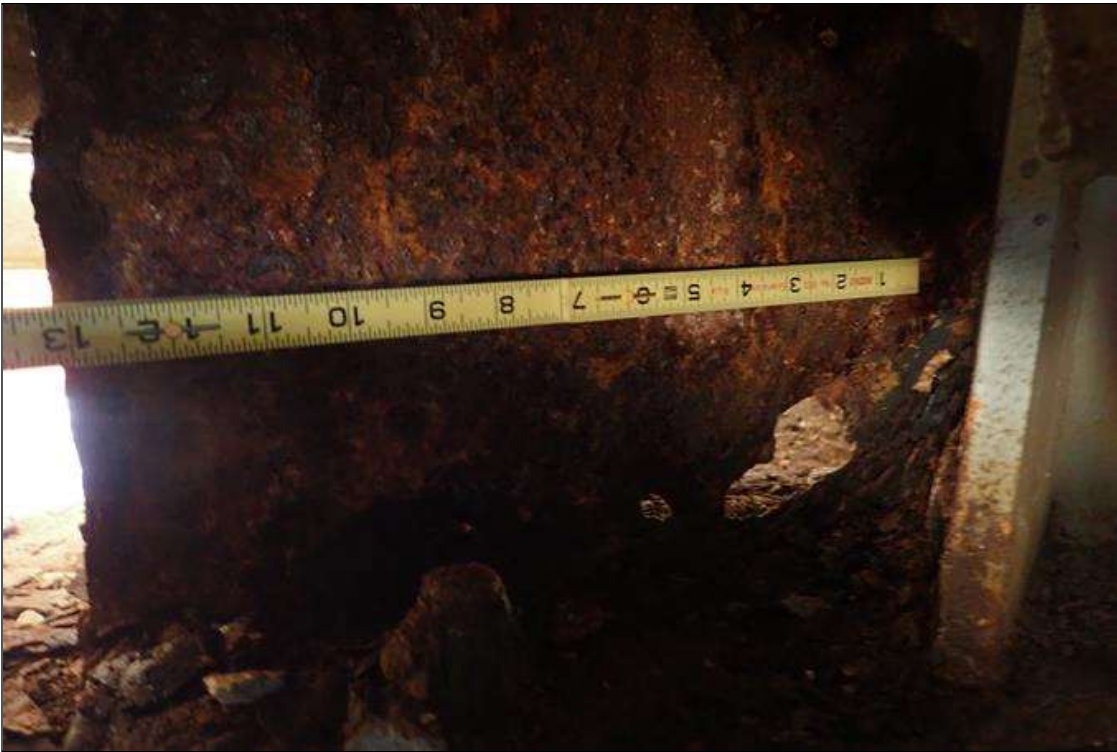
Span 1 Beam 7: (PAR) at bent 1, corrosion with section loss: web, corrosion hole at bearing (12" x 3"); bottom of web, (1/8" remaining x 4" x 11'), (5/16" remaining x 1" x next 6')

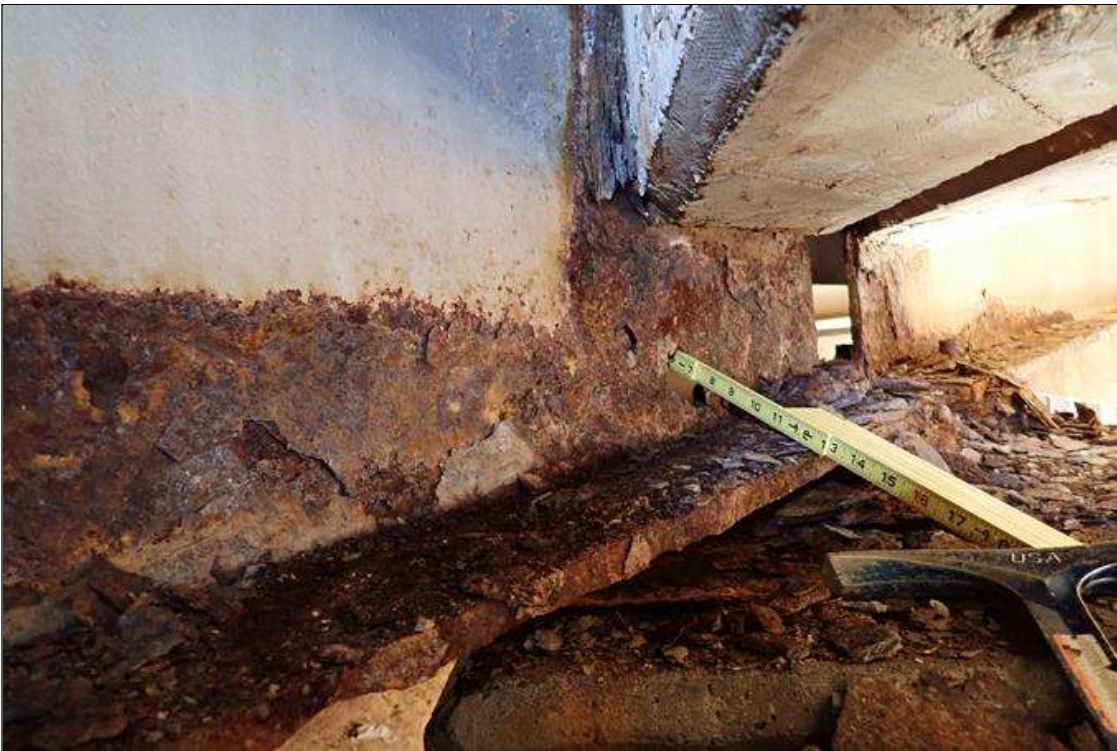
Span 1 Beam 7: (PAR) at bent 1, corrosion with section loss: web, corrosion hole at bearing (12" x 3"); bottom of web, (1/8" remaining x 4" x 11'), (5/16" remaining x 1" x next 6')

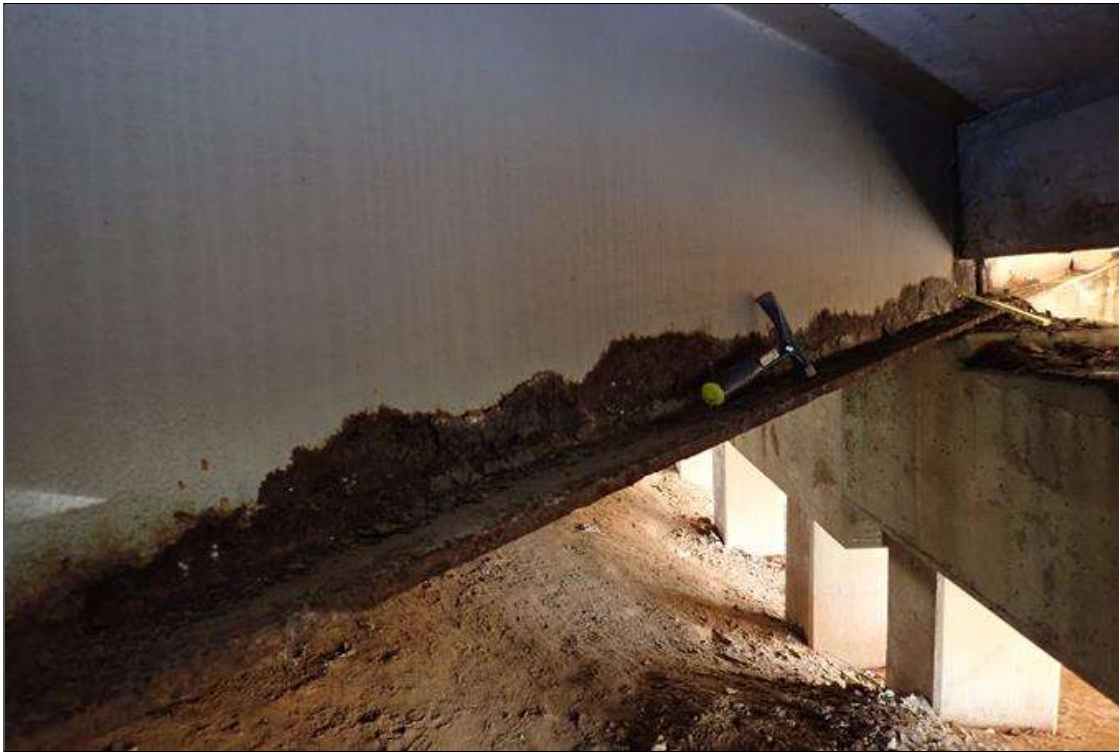
Span 1 Beam 7: (PAR) at bent 1, corrosion with section loss: web, corrosion hole at bearing (12" x 3"); bottom of web, (1/8" remaining x 4" x 11'), (5/16" remaining x 1" x next 6')
