NC DEPARTMENT OF TRANSPORTATION
 DIVISION OF HIGHWAYS
 STRUCTURE MANAGEMENT UNIT

ATTENTION: **partial inspection, awaiting railroad entry permit; prompt action request, sketches revised, temporary repairs to caps**

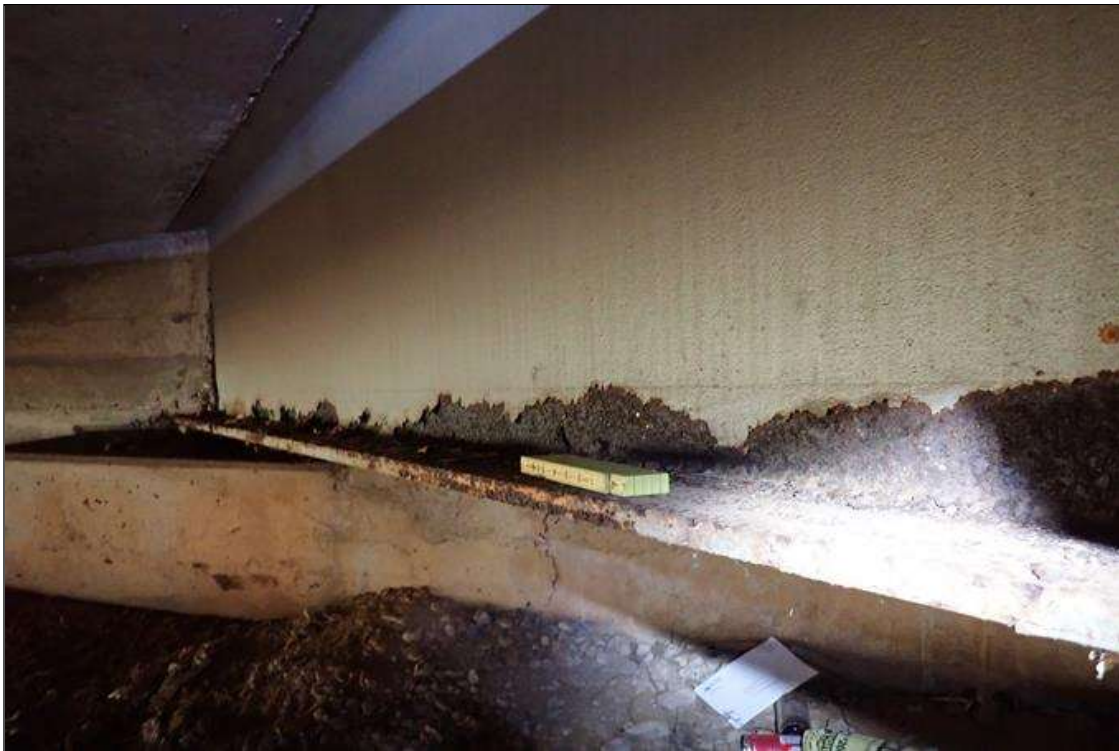
Span 1 Beam 7: at end bent 1, bottom of web, corrosion with section loss (7/16" remaining x 4" x 10')

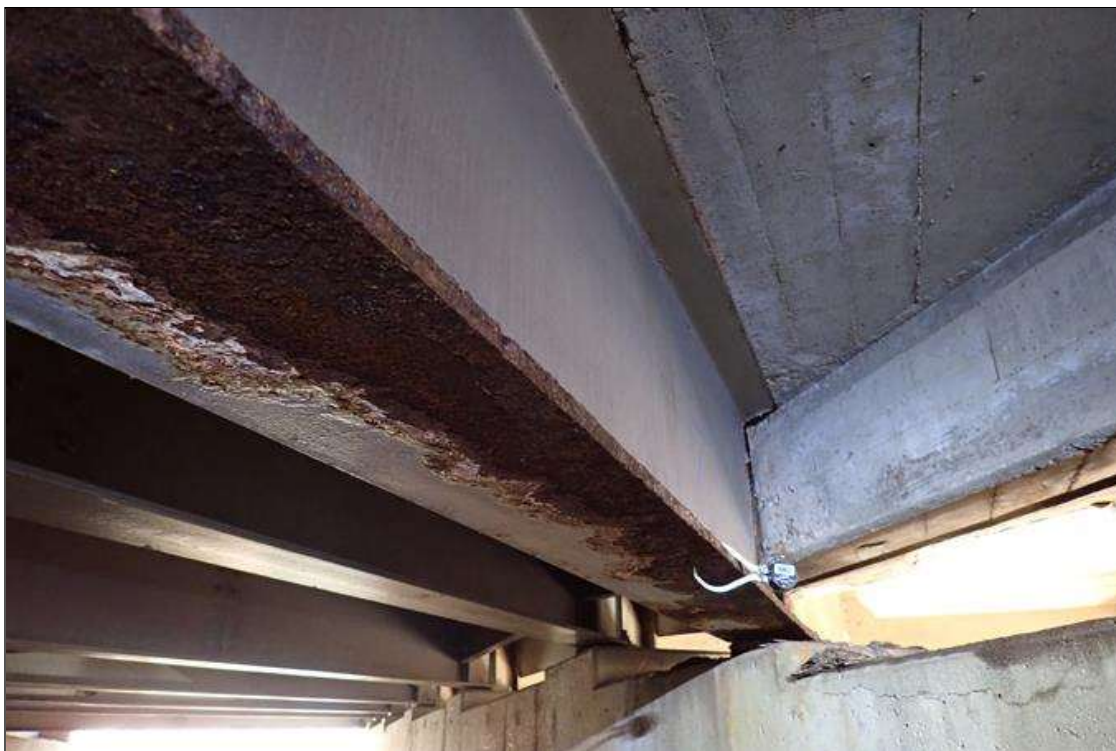
Span 1 Beam 7: (PAR) at bent 1, bottom flange, corrosion with section loss (0.6" average remaining x 11')

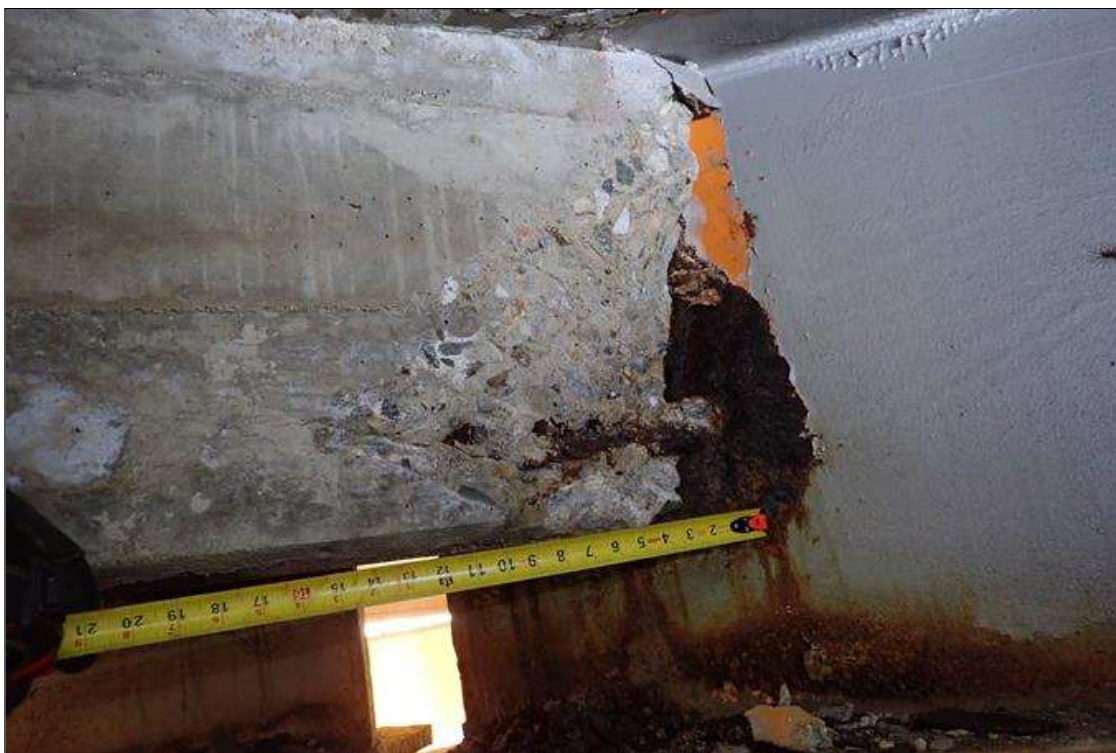
Span 1 Deck: bent 1 end diaphragm, bay 7 at beam 8, spall (16" x 18" x 2") with exposed rusted rebar

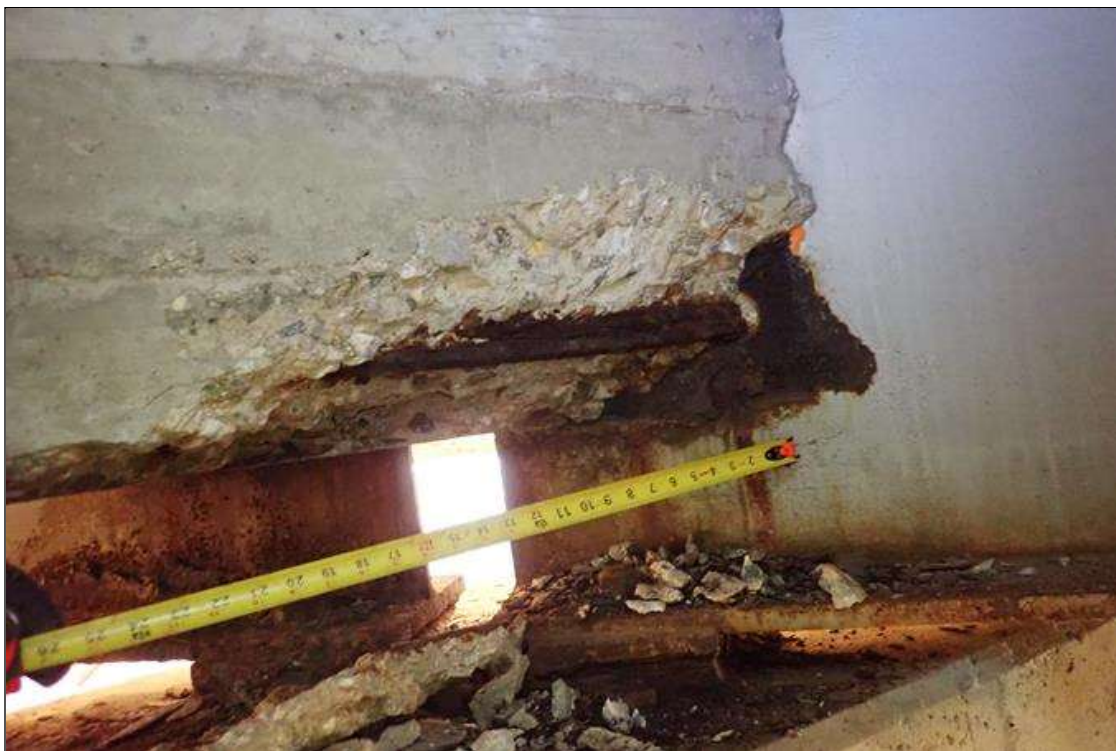
Span 1 Deck: bent 1 end diaphragm, bay 8 at beam 9, spall (30" x 8" x 4") with exposed rusted rebar, similar at beam 8

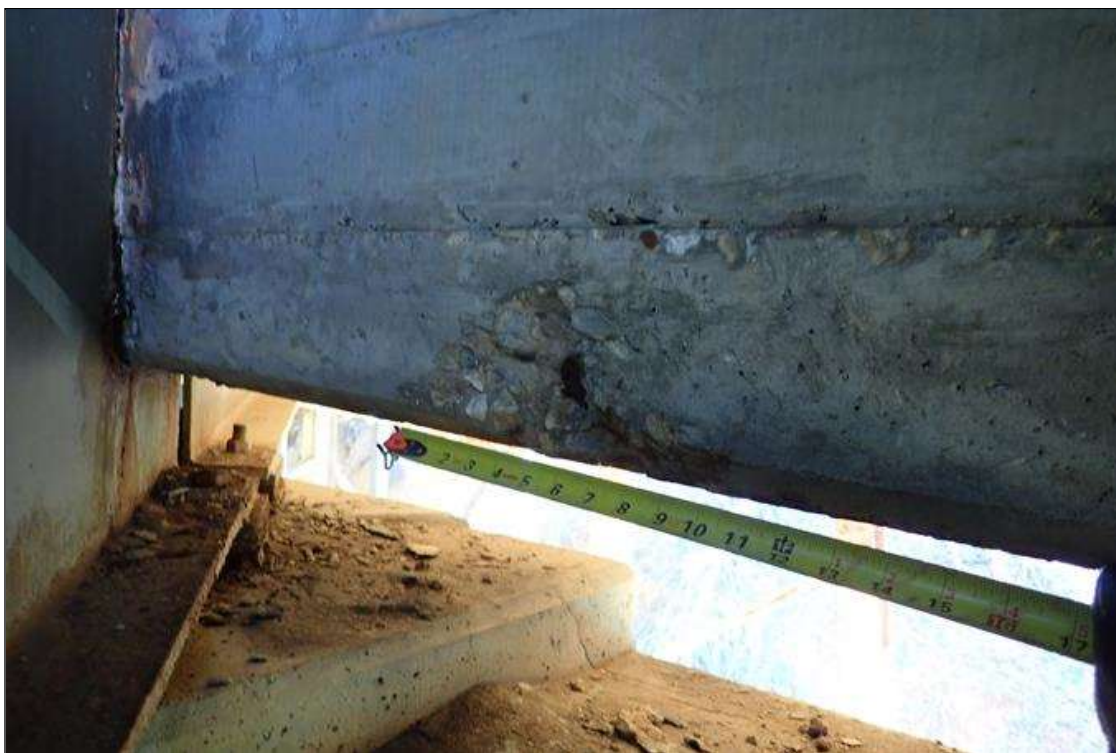
Span 1 Deck: bent 1 end diaphragm, bay 9 at beam 9, spall (12" x 4" x 1") with exposed rusted rebar

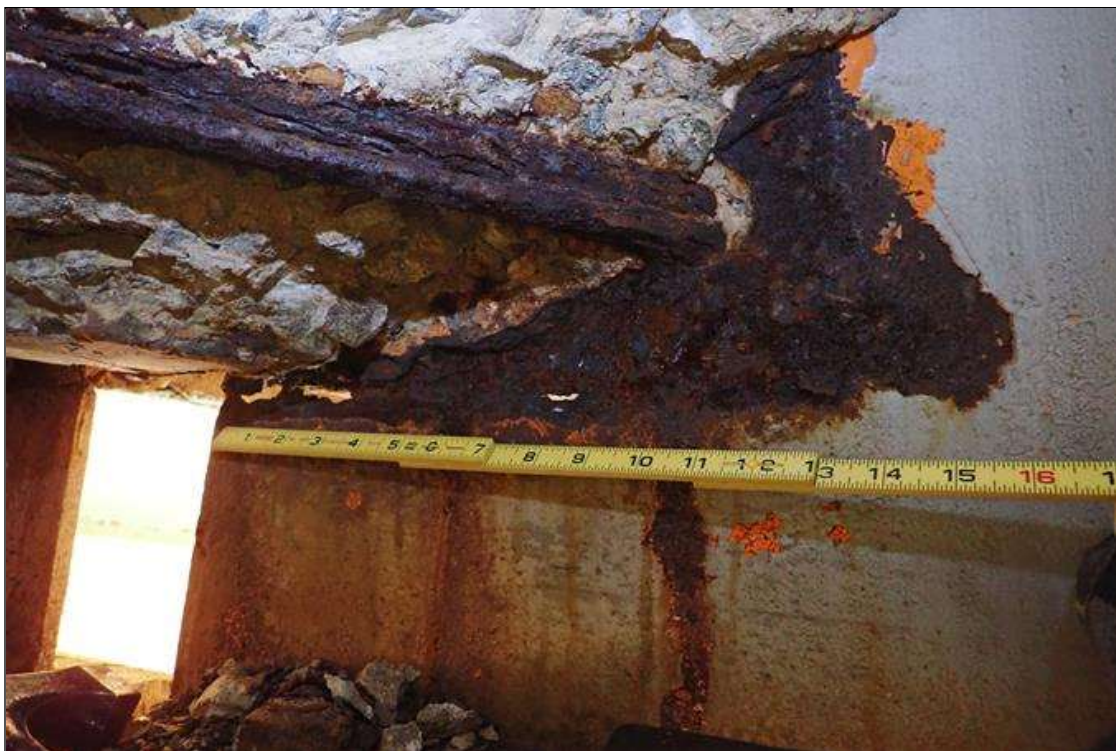
Span 1 Beam 9: (PAR) at bent 1 end diaphragm, corrosion with section loss: web, (1/8" remaining x 16" x 8") with corrosion hole (9" x 1/2")

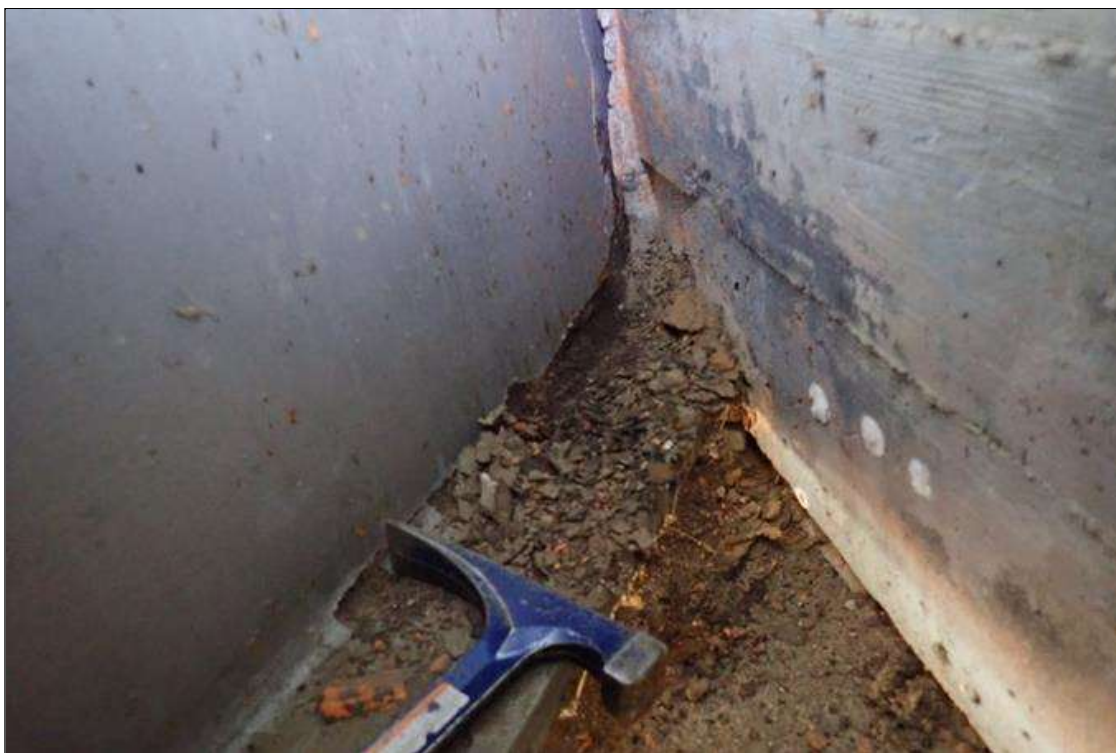
Span 1 Beam 9: at end bent 1, bottom of web, corrosion with section loss (7/16" remaining x 3" x 1')

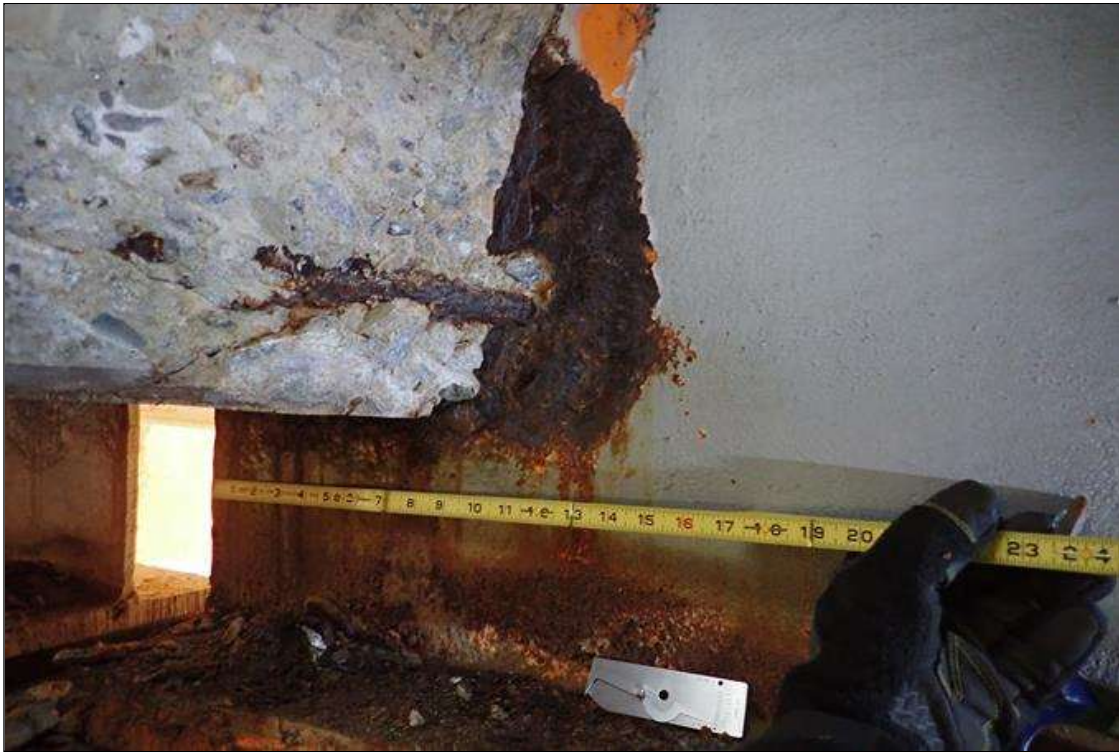
Span 1 Beam 8: (PAR) at bent 1 end diaphragm, web, corrosion with section loss (1/16" remaining x 16" x 10"); bottom flange, rust scale

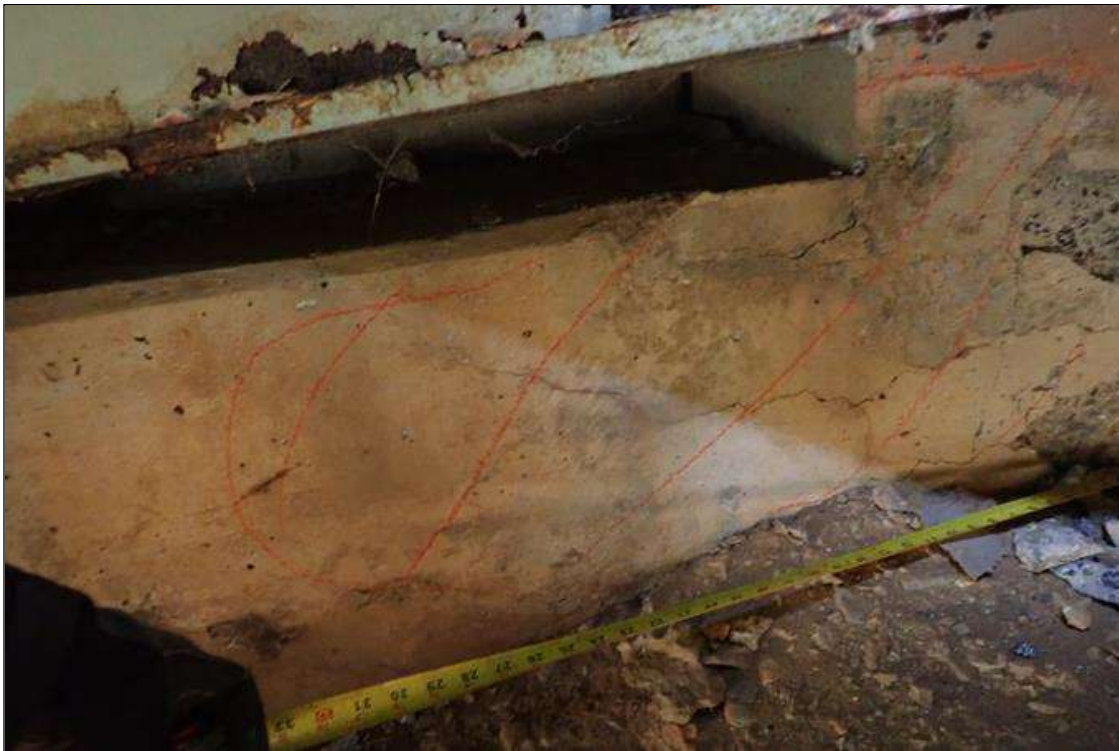
End Bent 1 Cap 1: face of cap, below beam 7, spall/delamination (3.5' x 1.5' x 1")

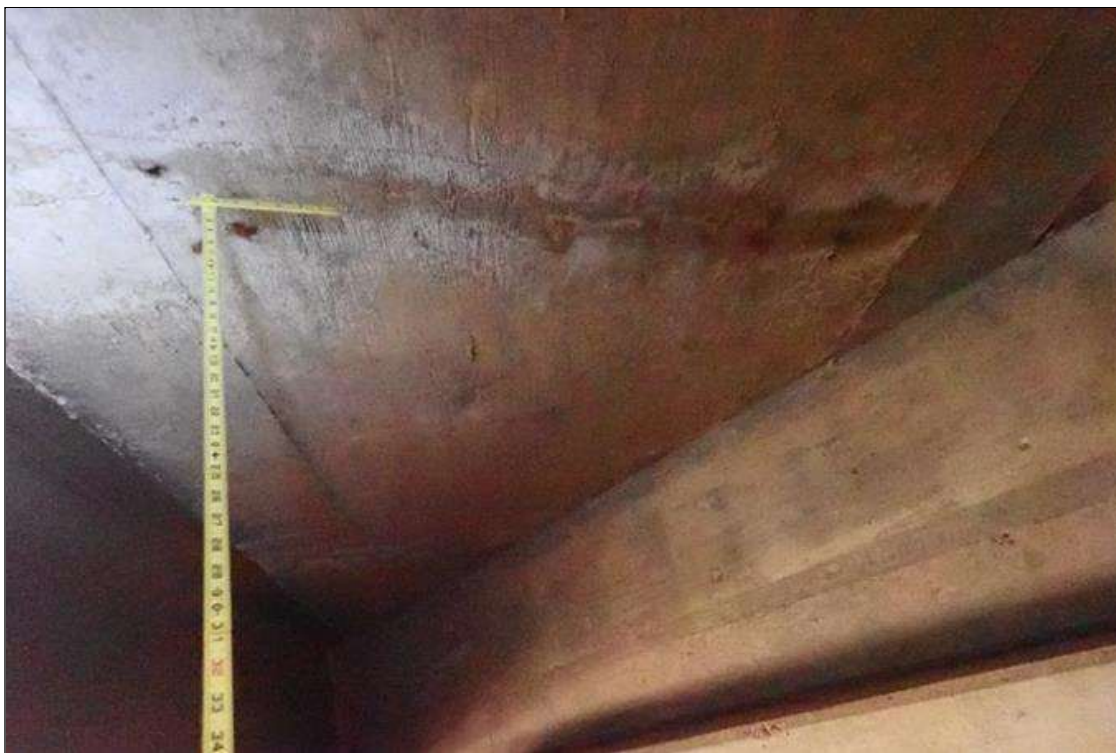
Span 1 Deck: underside of deck at end bent 1, bay 5, diagonal crack (hairline x 6') with efflorescence, similar bays 2 and 4

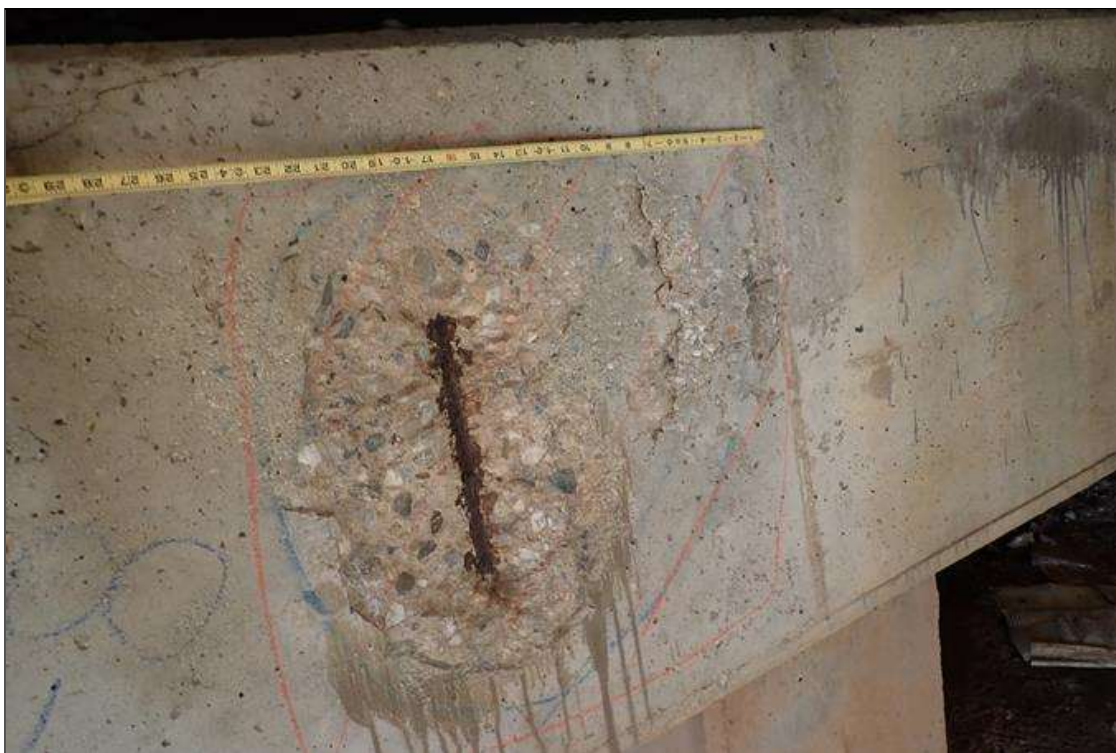
Bent 1 Cap 1: span 2 face, below beam 8, spall/delamination (2' x 2' x 1") with exposed rusted rebar

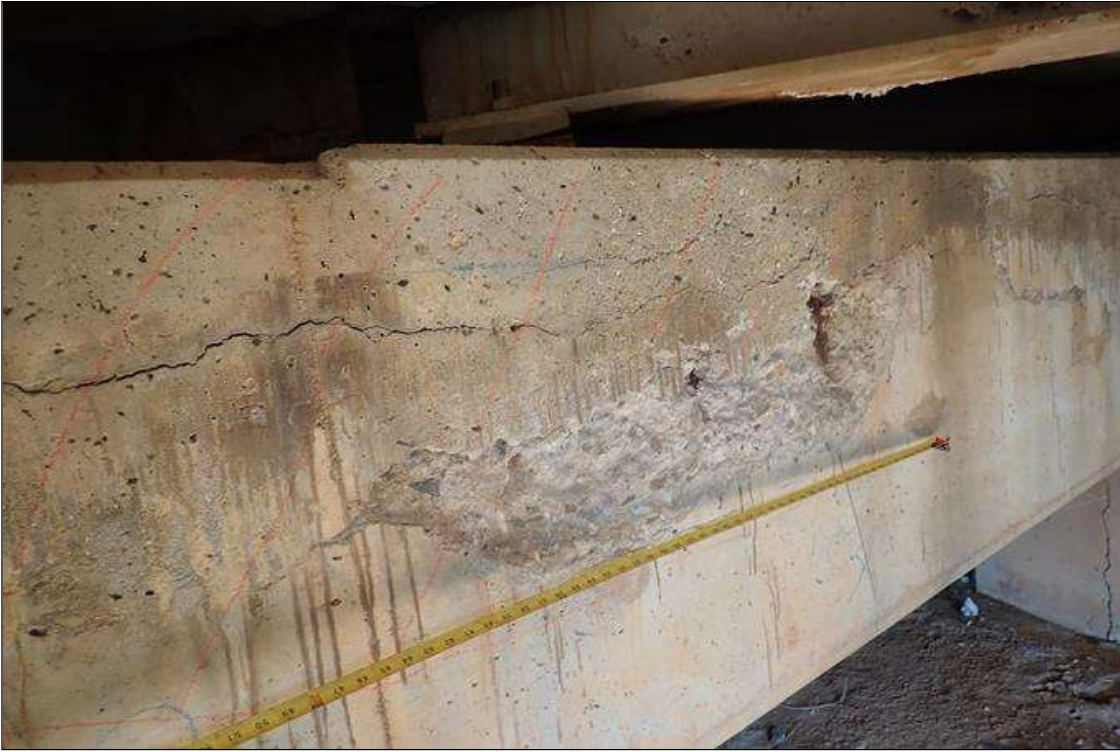
Bent 1 Cap 1: span 2 face, below beam 9, spall/delamination (5' x 2' x 1.5") with exposed rusted rebar

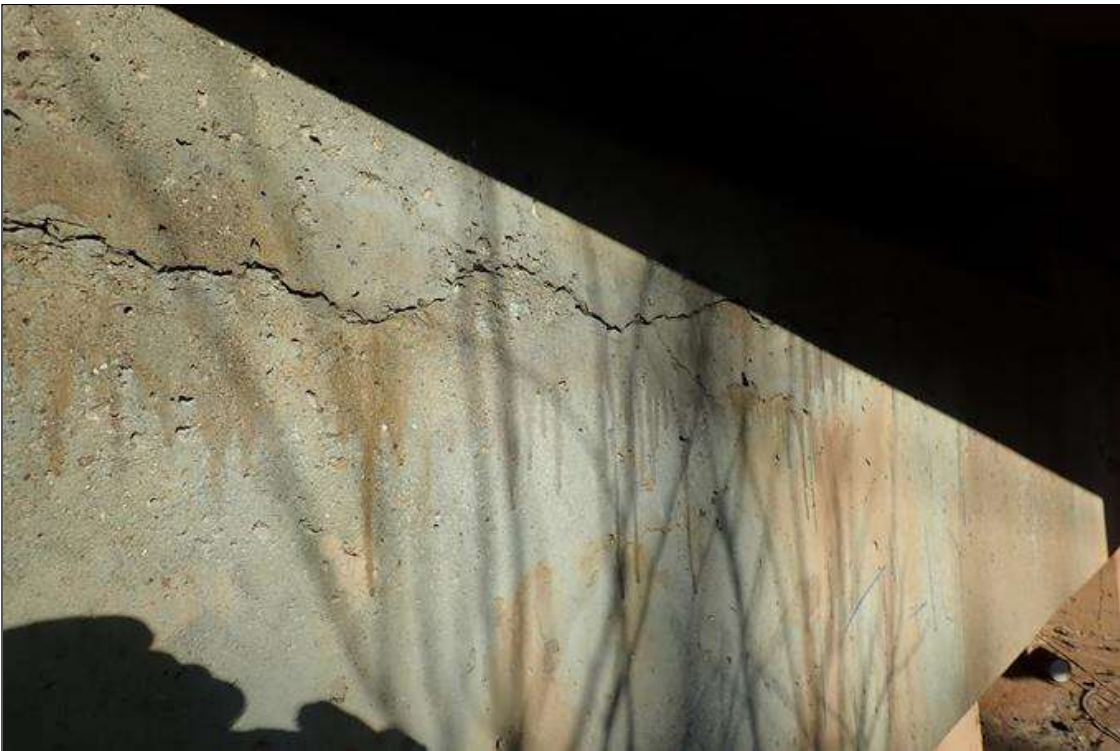
Bent 1 Cap 1: span 2 face, below beams 7 - 11, longitudinal crack (1/8" x 48') with areas of delaminations/spalls (up to 2' high x 1/2" deep), with some rust stains

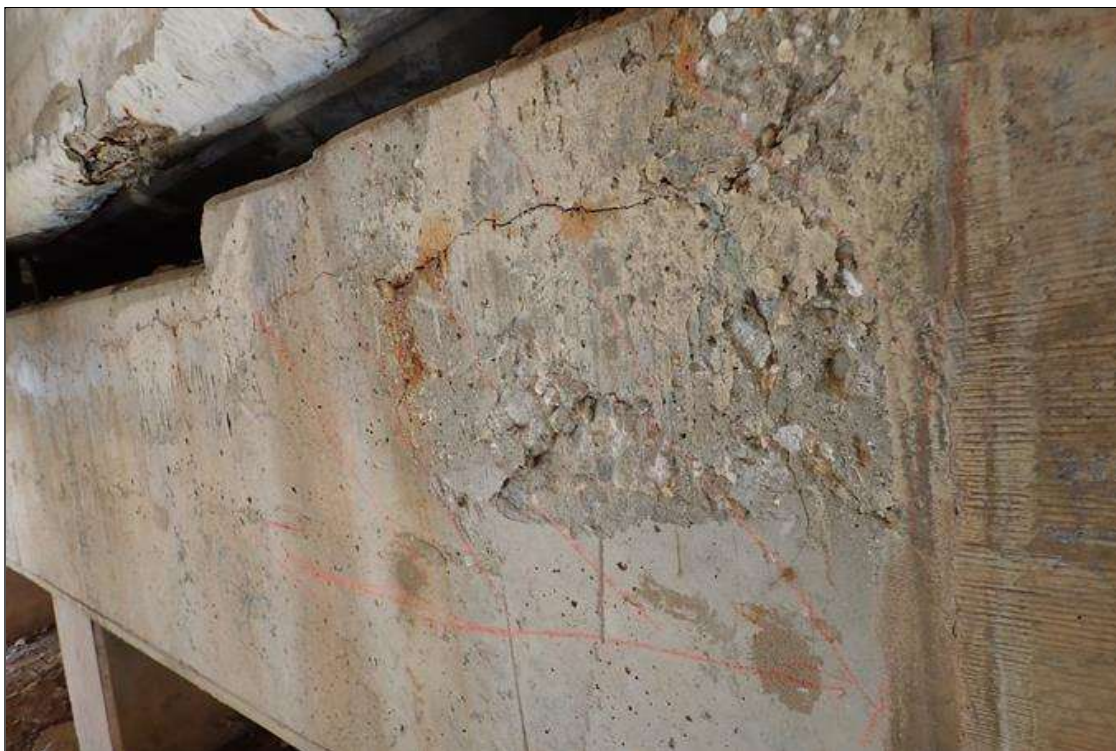
Bent 1 Cap 1: span 2 face, below beams 7 - 11, longitudinal crack (1/8" x 48') with areas of delaminations/spalls (up to 2' high x 1/2" deep), with some rust stains

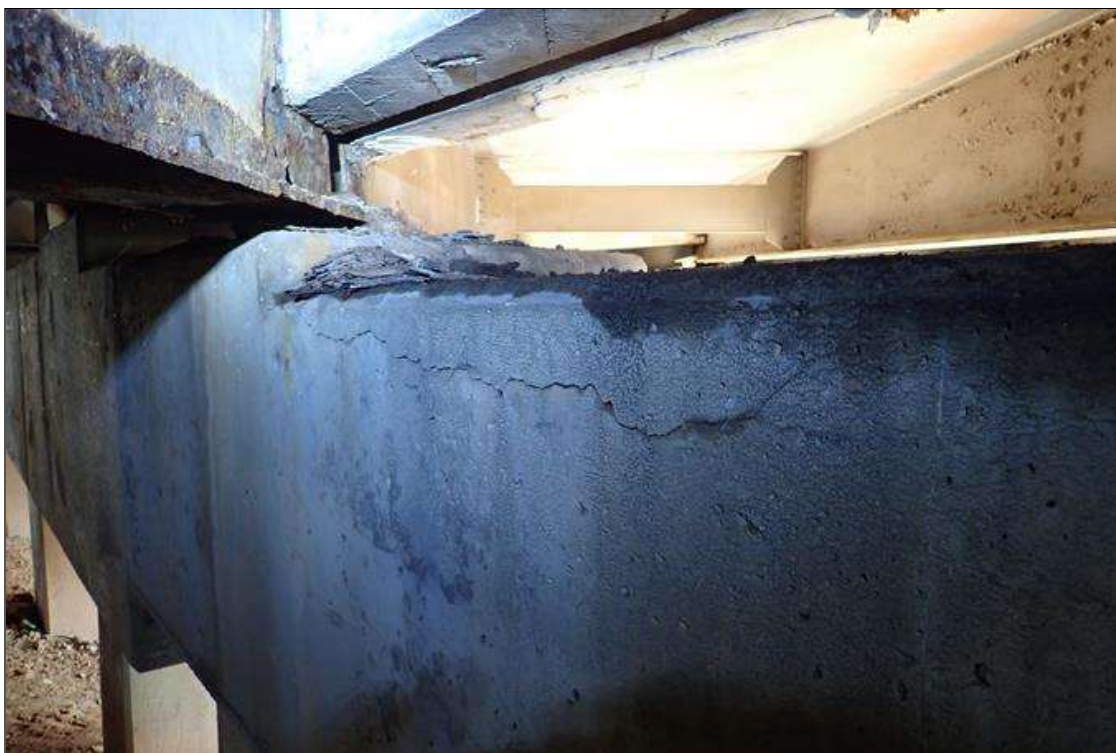
Bent 1 Cap 1: span 1 face, below beam 7, longitudinal crack (1/16" x 3')

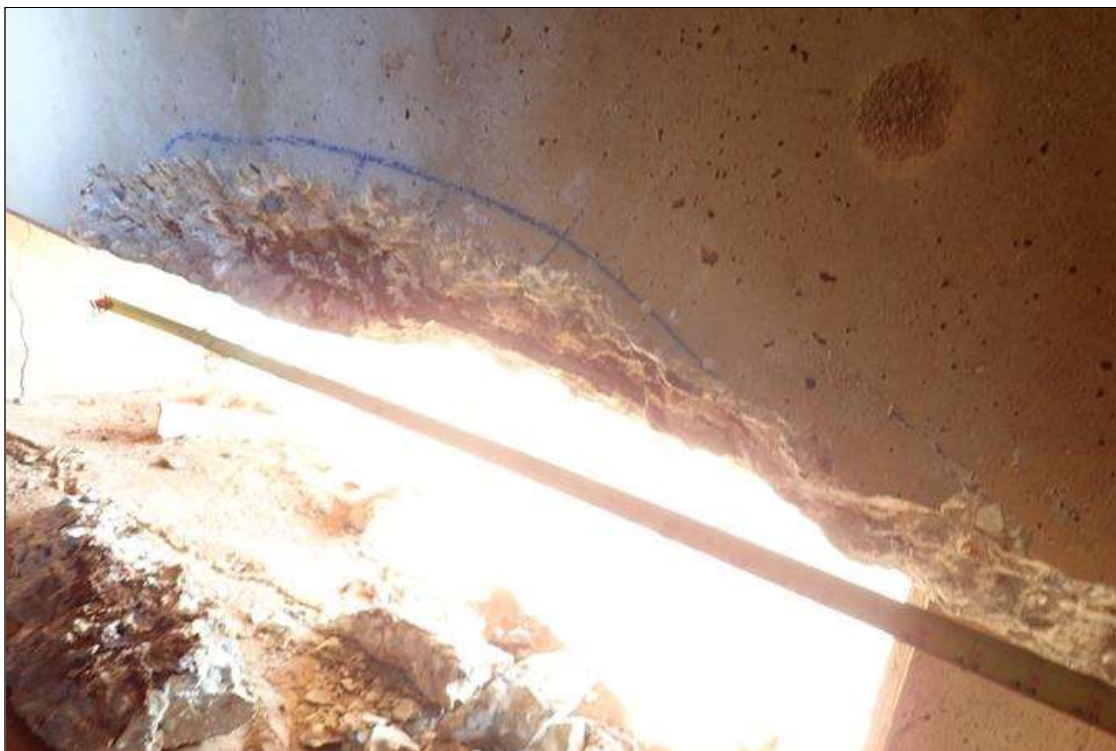
Bent 1 Cap 1: (PAR) span 1 face, below bay 9, bottom corner, spall (5' x 8" x 3") with exposed rusted rebar

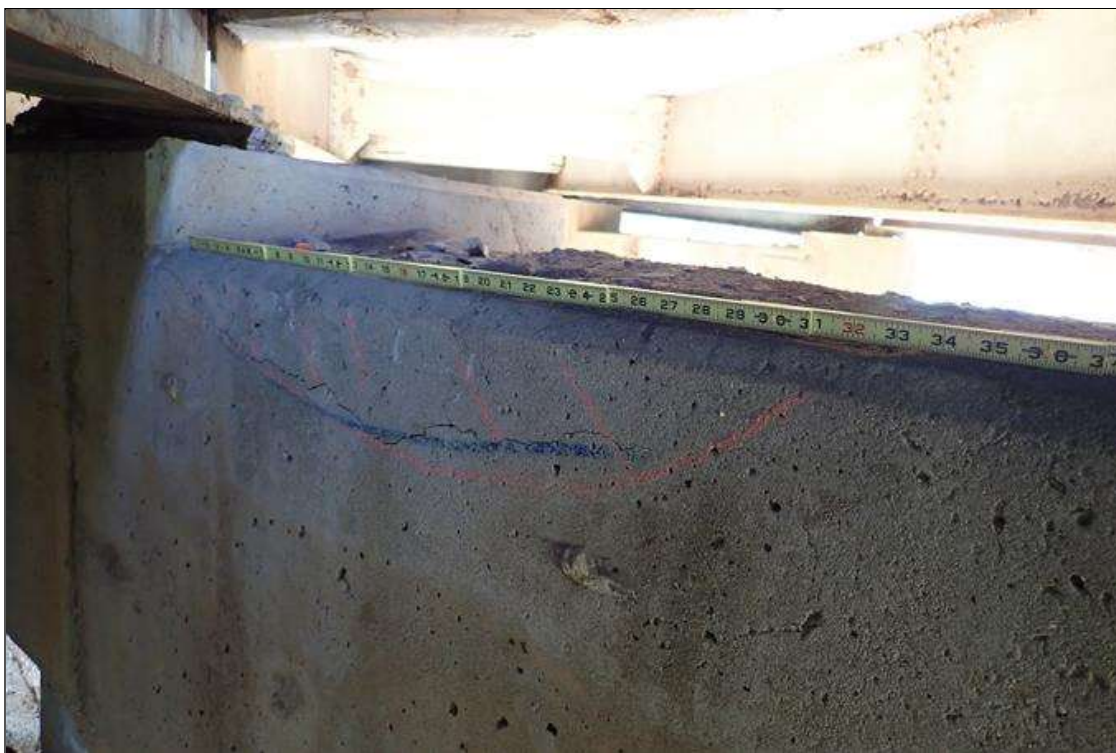
Bent 1 Cap 1: span 1 face, bay 9, top corner, delamination (2.5' x 6")

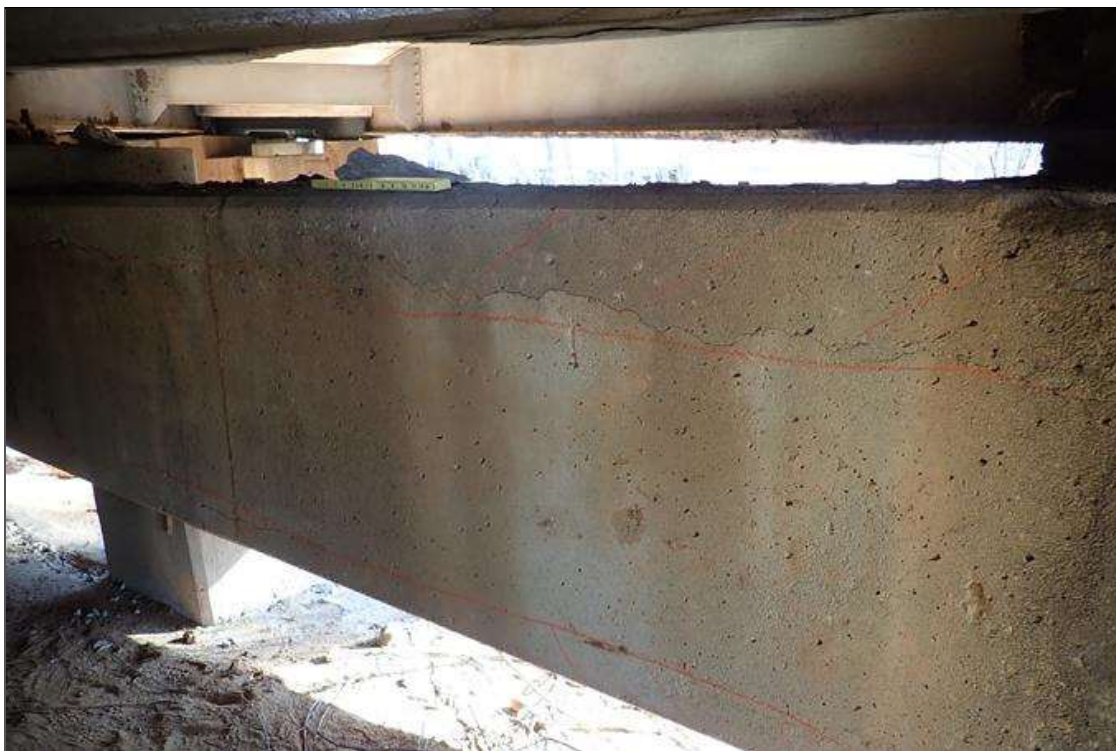
Bent 1 Cap 1: span 1 face, top corner, longitudinal crack (1/16" x 9') with delamination/spall (6" x 1"), similar bottom corner

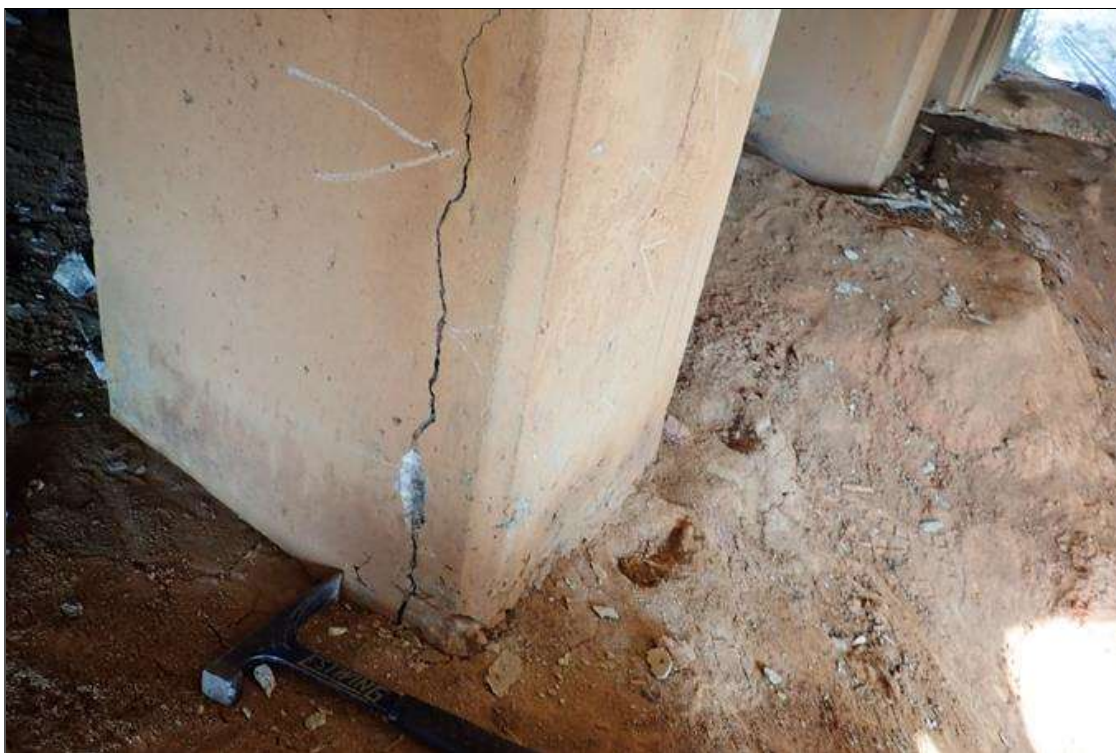
Bent 1 Pile 11: vertical cracks (up to 1/4" x 2')

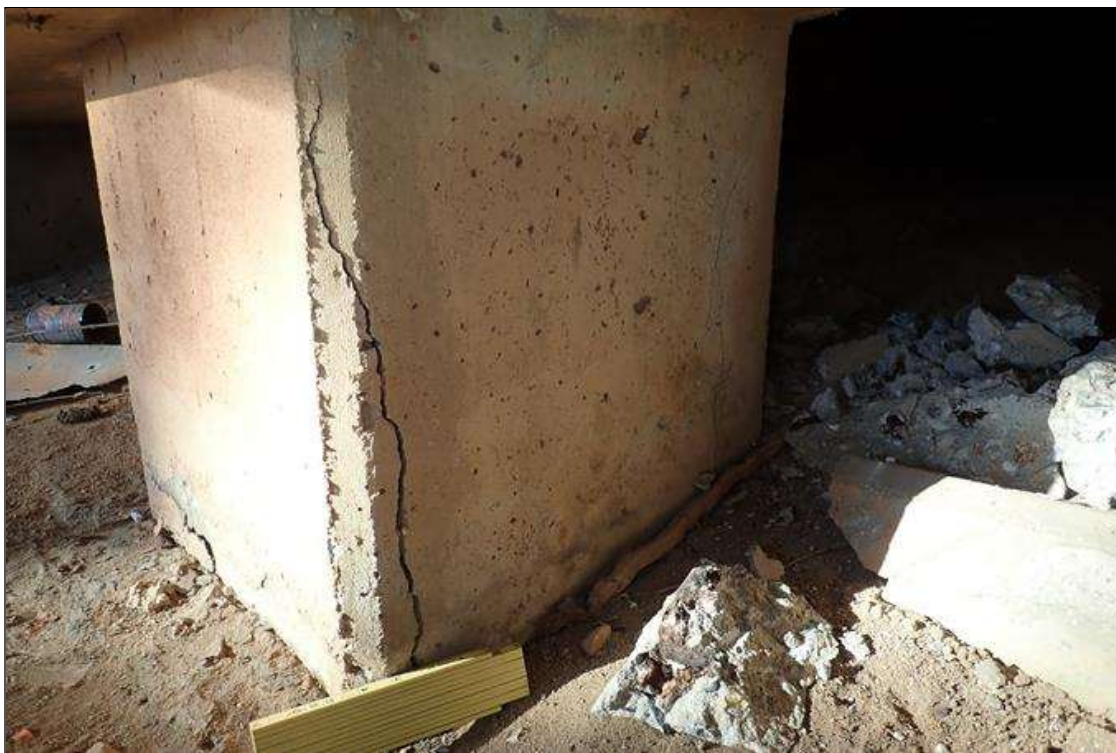
Bent 1 Pile 13: vertical cracks (up to 1/4" x 2')

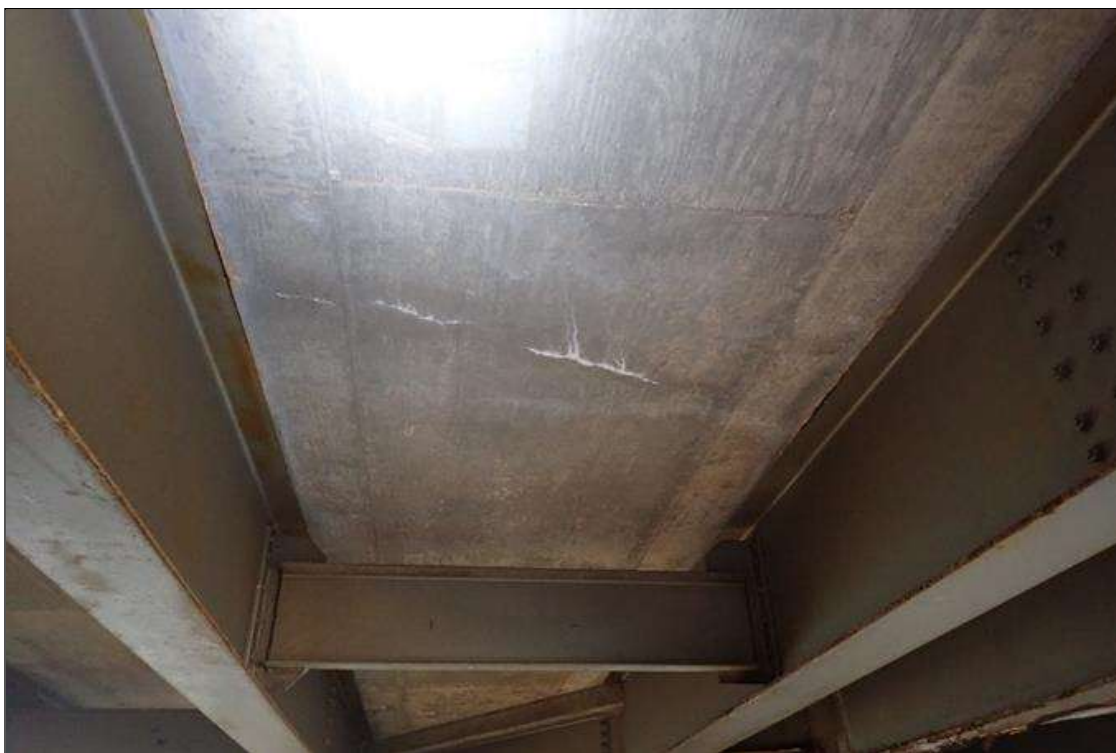
Span 2 Deck: underside, bay 5, at midspan, transverse crack (hairline x 7') with efflorescence

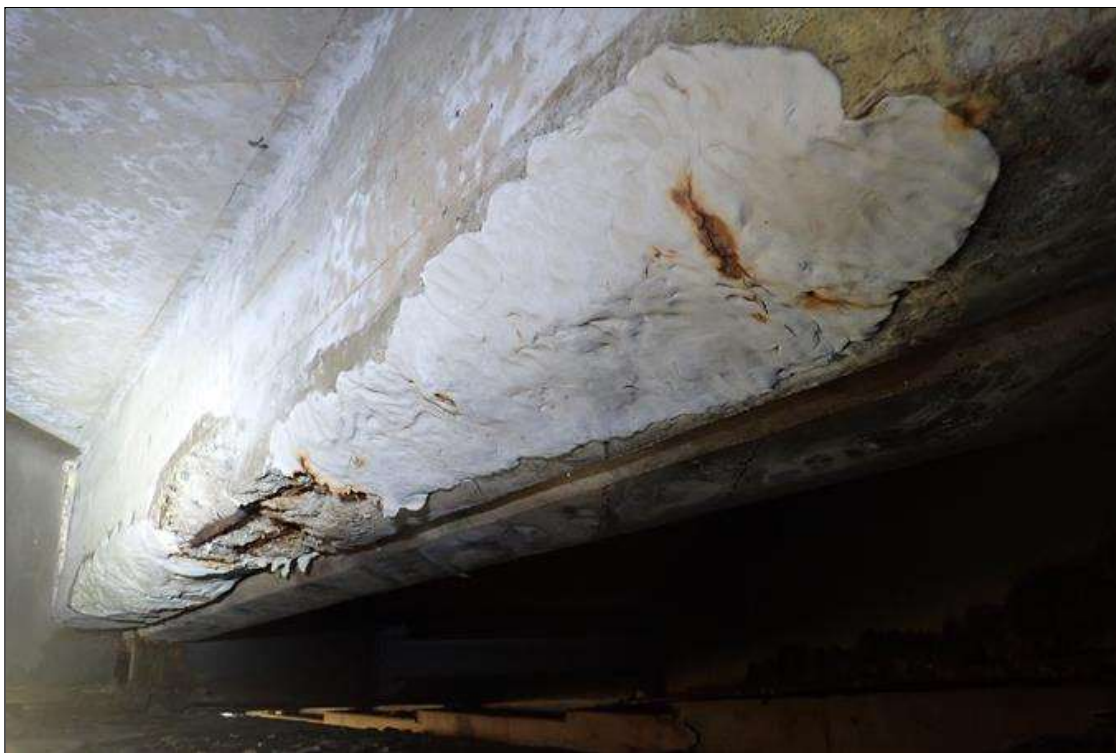
Span 2 Deck: (PAR) bent 1 end diaphragm, bay 7, failed previous repair (10' x 10" x 4") with section loss on rebar (3/8" remaining)

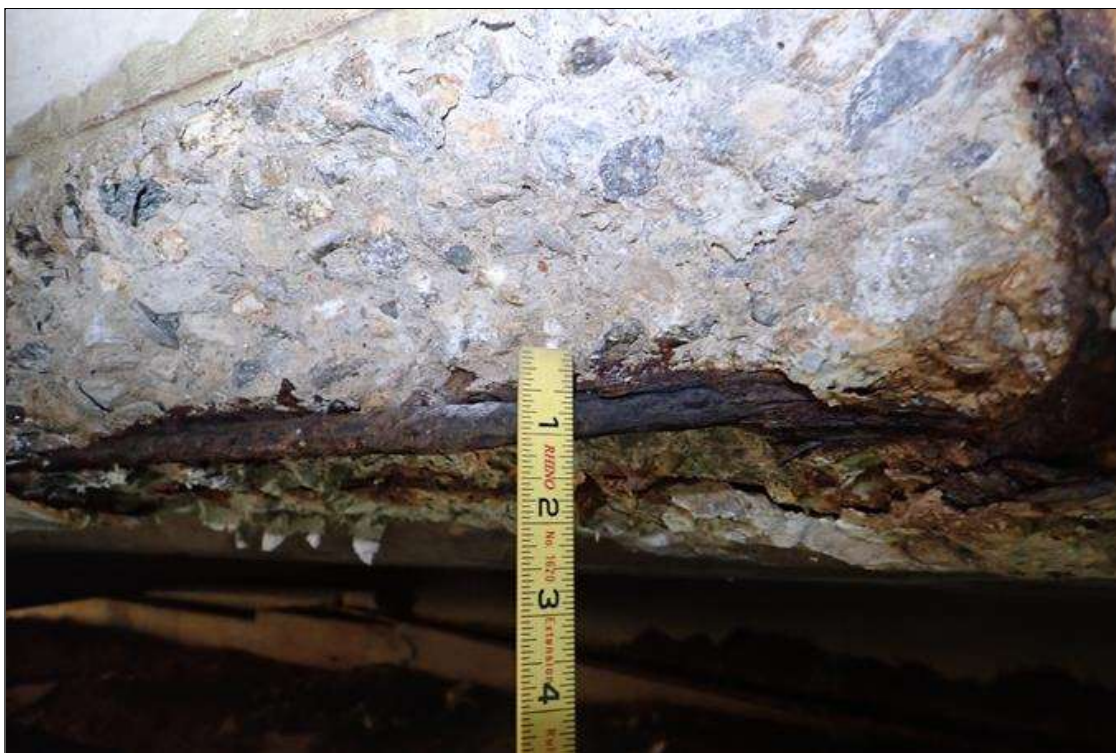
Span 2 Deck: (PAR) bent 1 end diaphragm, bay 7, failed previous repair (10' x 10" x 4") with section loss on rebar (3/8" remaining)

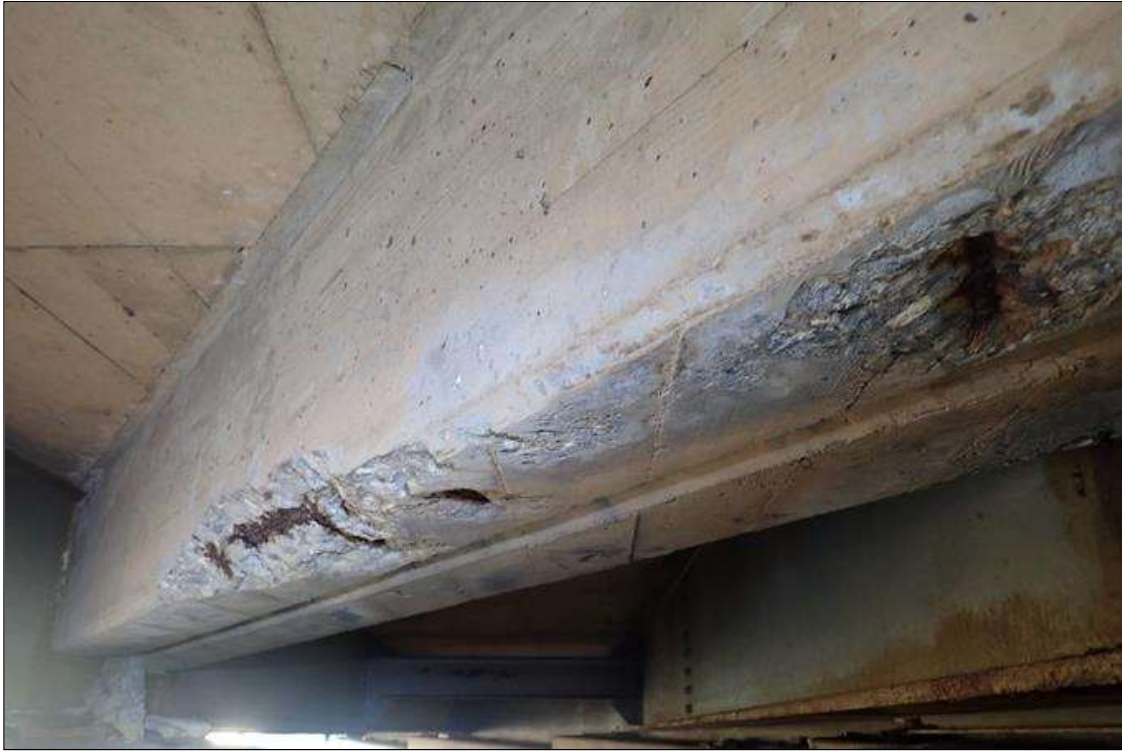
Span 2 Deck: bent 1 end diaphragm, bay 9, (2) spalls (up to 3.5' x 8" x 3") with exposed rusted rebar

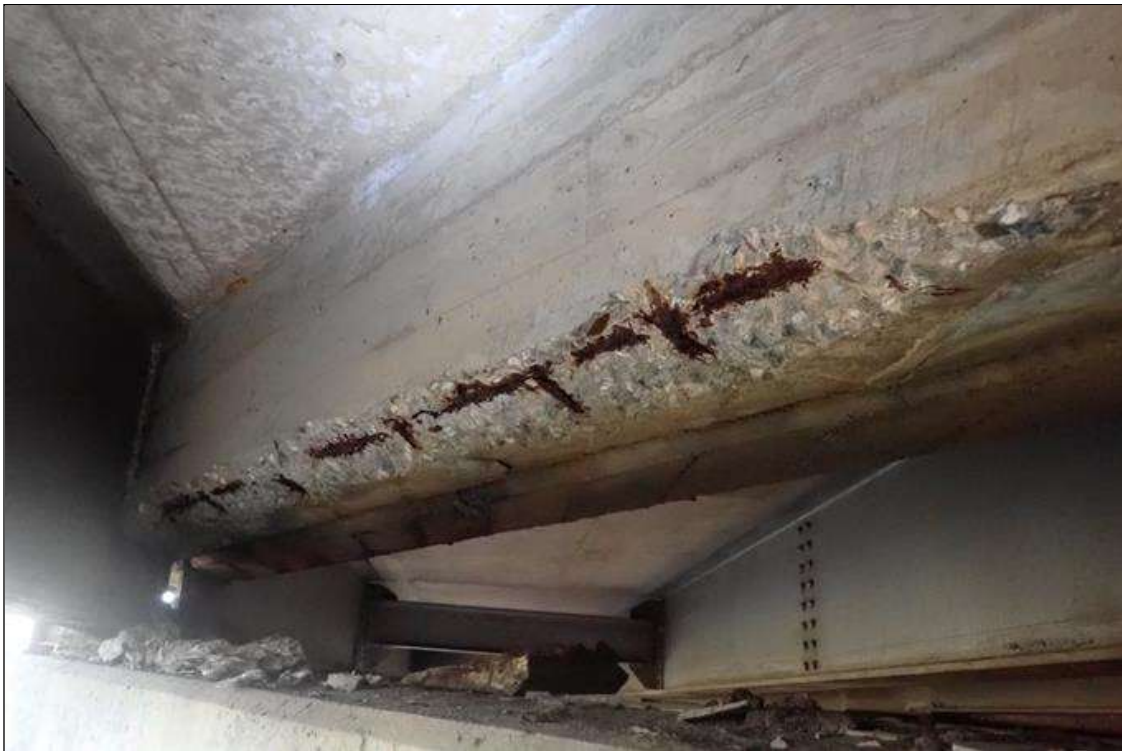
Span 2 Deck: bent 1 end diaphragm, bay 10, at beam 11, spall (6' x 7" x 2") with exposed rusted rebar

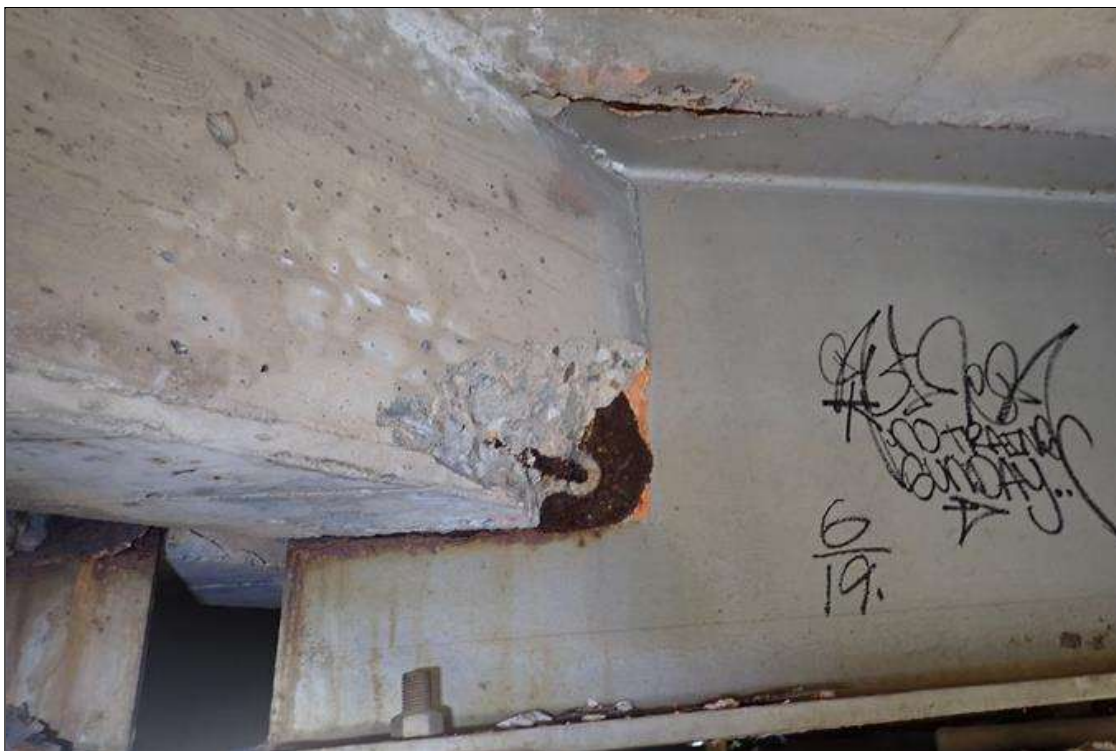
Span 2 Deck: bent 1 end diaphragm, bay 10, at beam 10, spall (1' x 8" x 2") with exposed rusted rebar
