NC DEPARTMENT OF TRANSPORTATION
 DIVISION OF HIGHWAYS
 STRUCTURE MANAGEMENT UNIT

ATTENTION: **partial inspection, awaiting railroad entry permit; prompt action request, sketches revised, temporary repairs to caps**

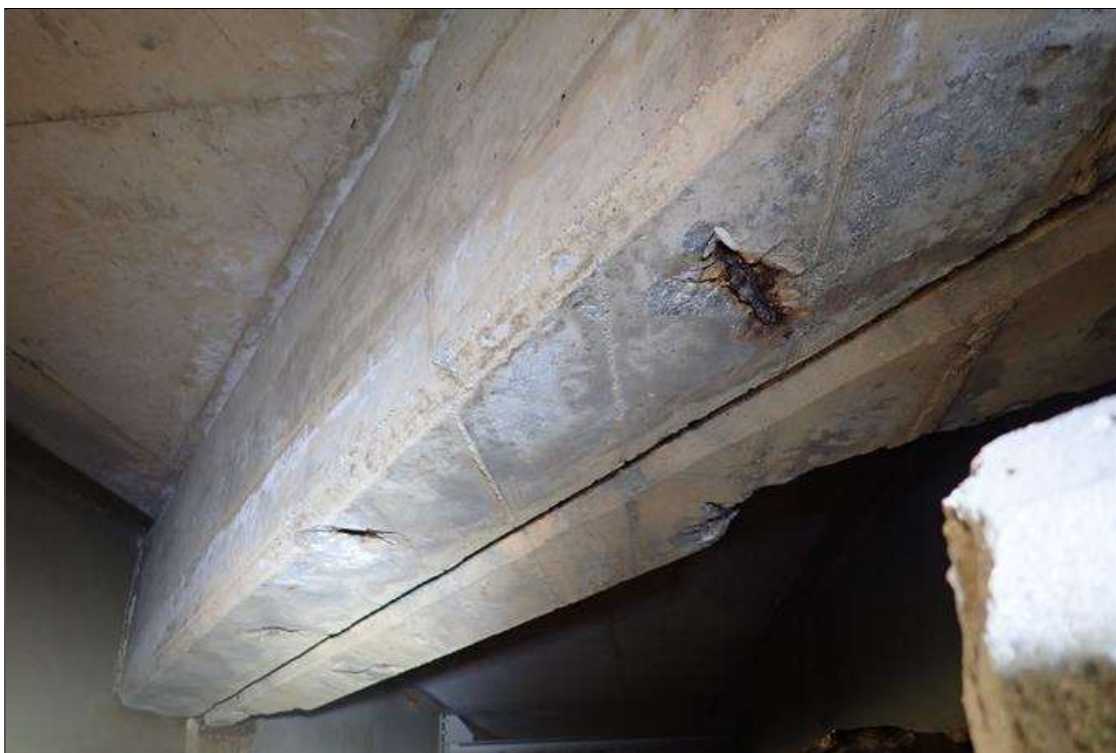
Span 2 Deck: bent 1 end diaphragm, bay 8, underside, (4) spalls (up to 7" diameter x 1") with exposed rusted rebar

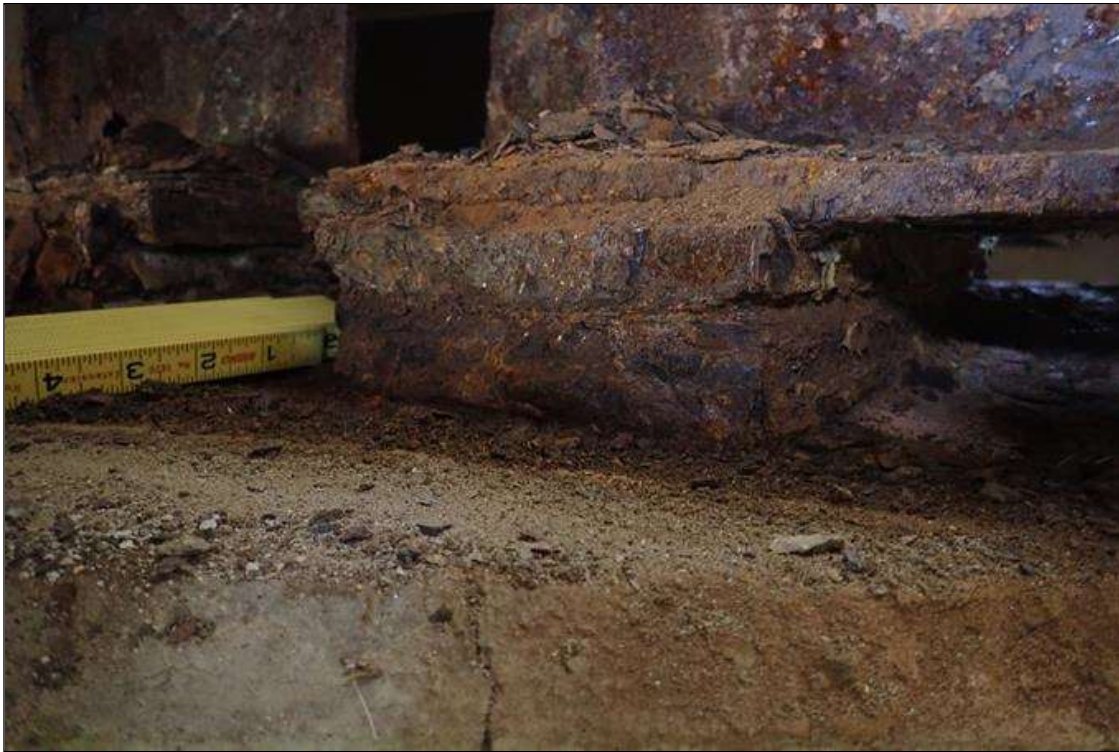
Span 2 Beam 7 Near Bearing: (PAR) pack rust with 1/8" section loss on edge of plate

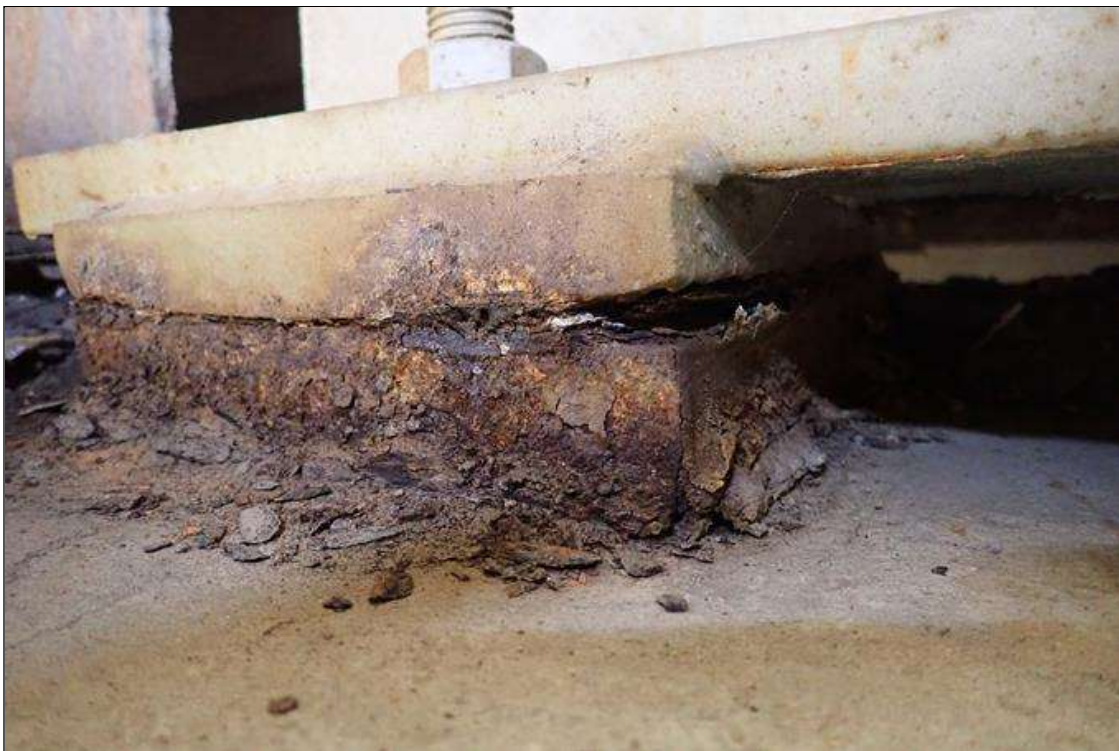
Span 2 Beam 8 Near Bearing 8: pack rust

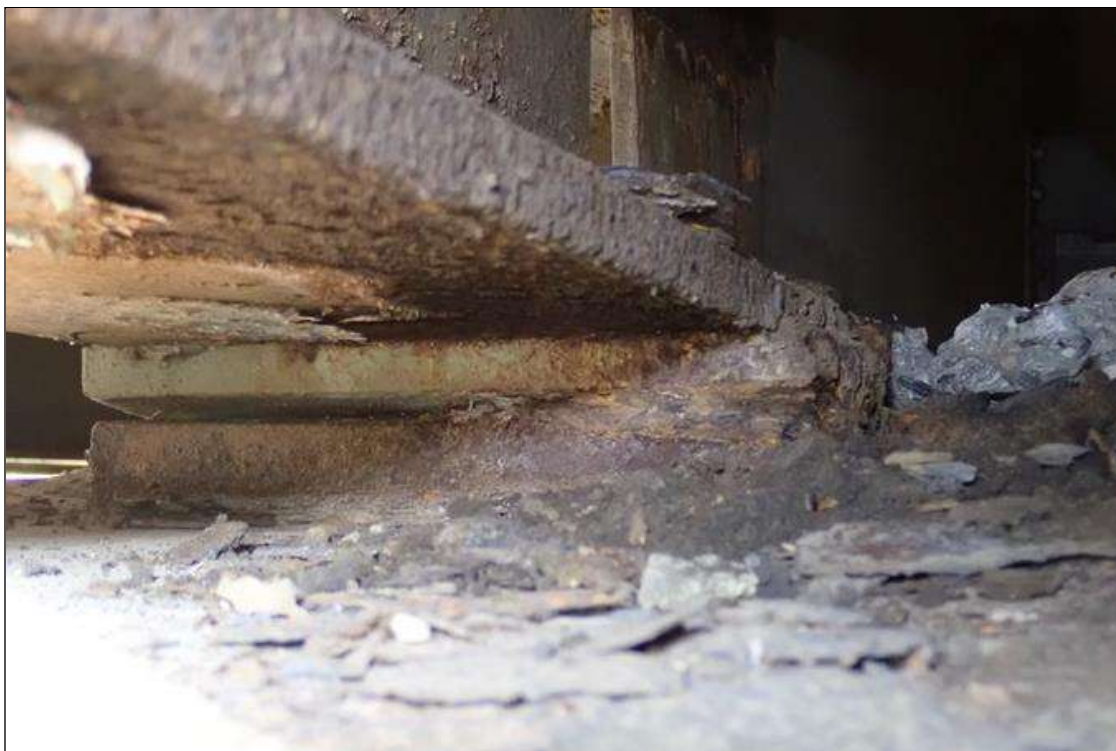
Span 2 Beam 9 Near Bearing 9: pack rust

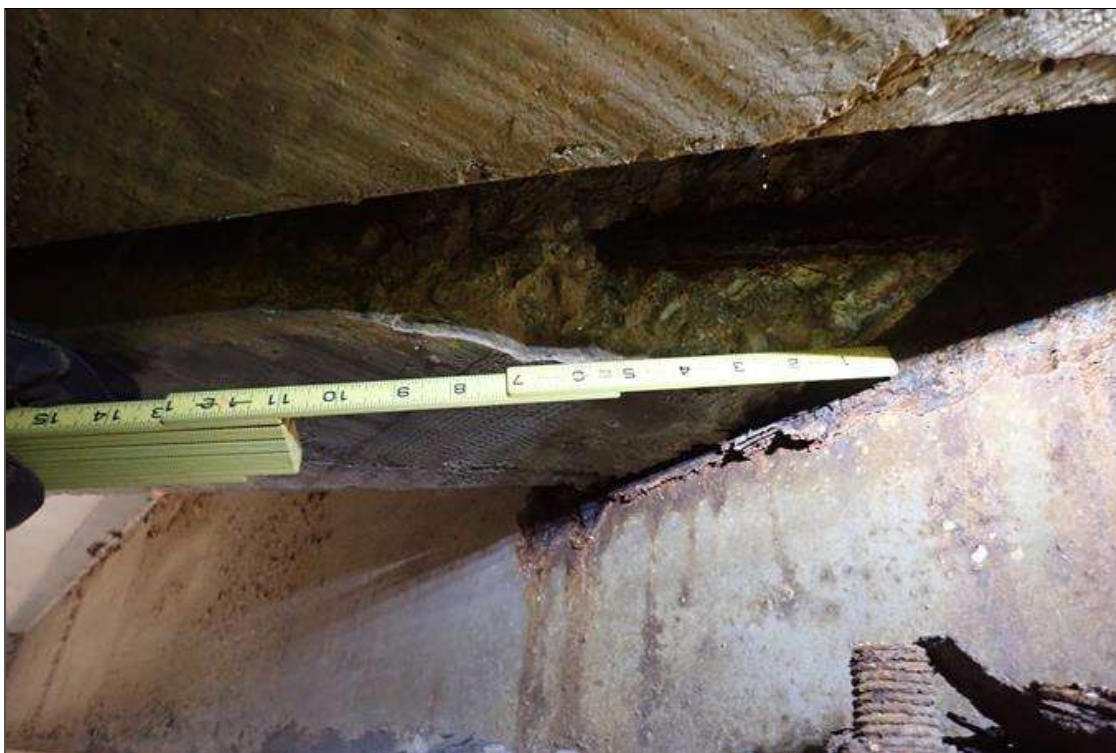
Span 2 Deck: bent 1 end diaphragm, bay 9, at beam 10, spall (18" x 4" x 2") with exposed rusted rebar

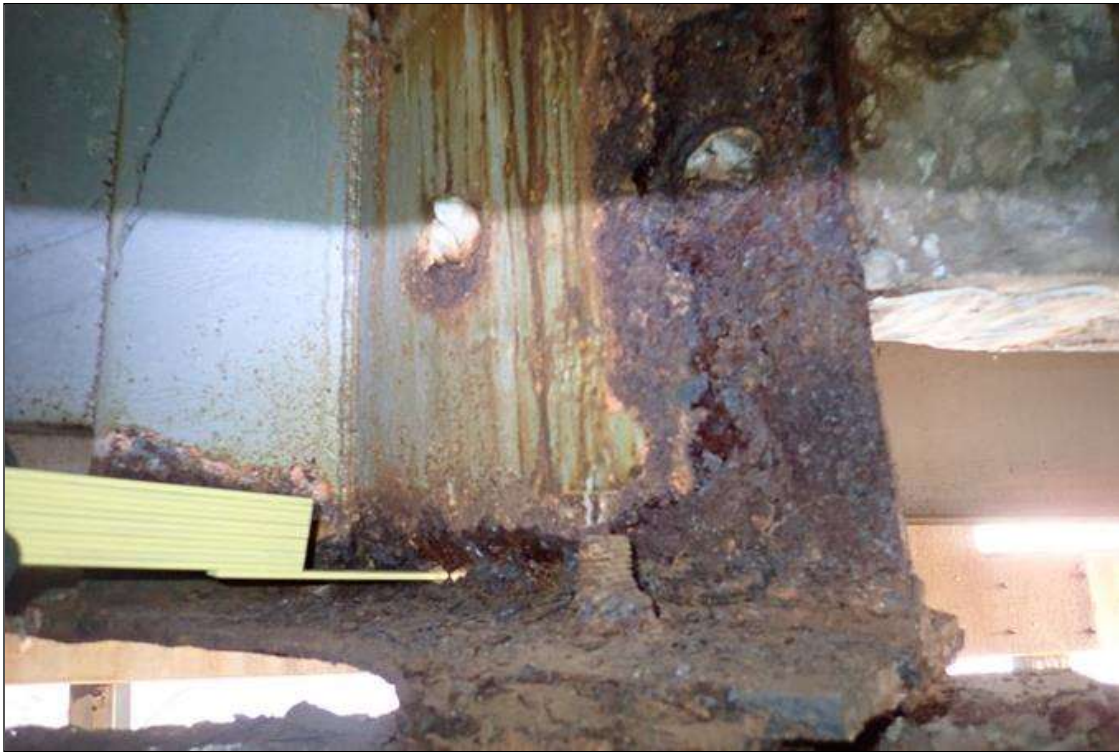
Span 2 Beam 7: (PAR) at bent 1, corrosion with section loss: bottom flange, (0.6" average remaining x 3'); web at bearing, (1/16" remaining x 1' x 16" high) with corrosion hole (2" x 1")

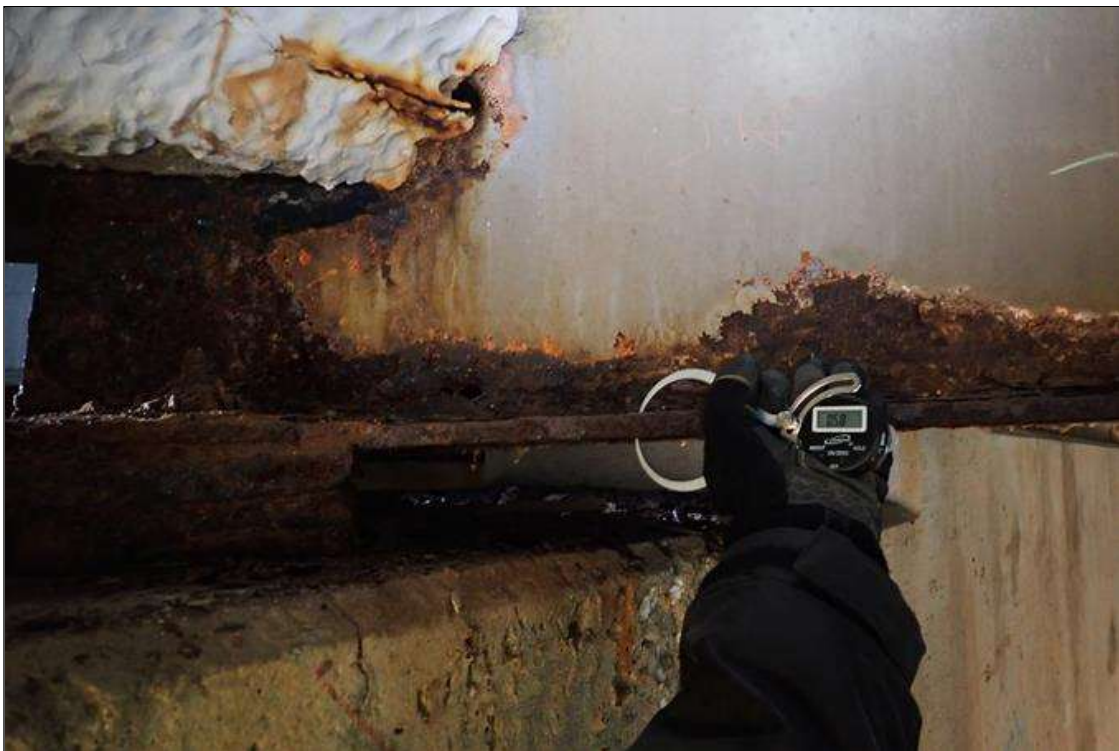
Span 2 Beam 7: (PAR) at bent 1, corrosion with section loss: bottom flange, (0.6" average remaining x 3'); web at bearing, (1/16" remaining x 1' x 16" high) with corrosion hole (2" x 1")

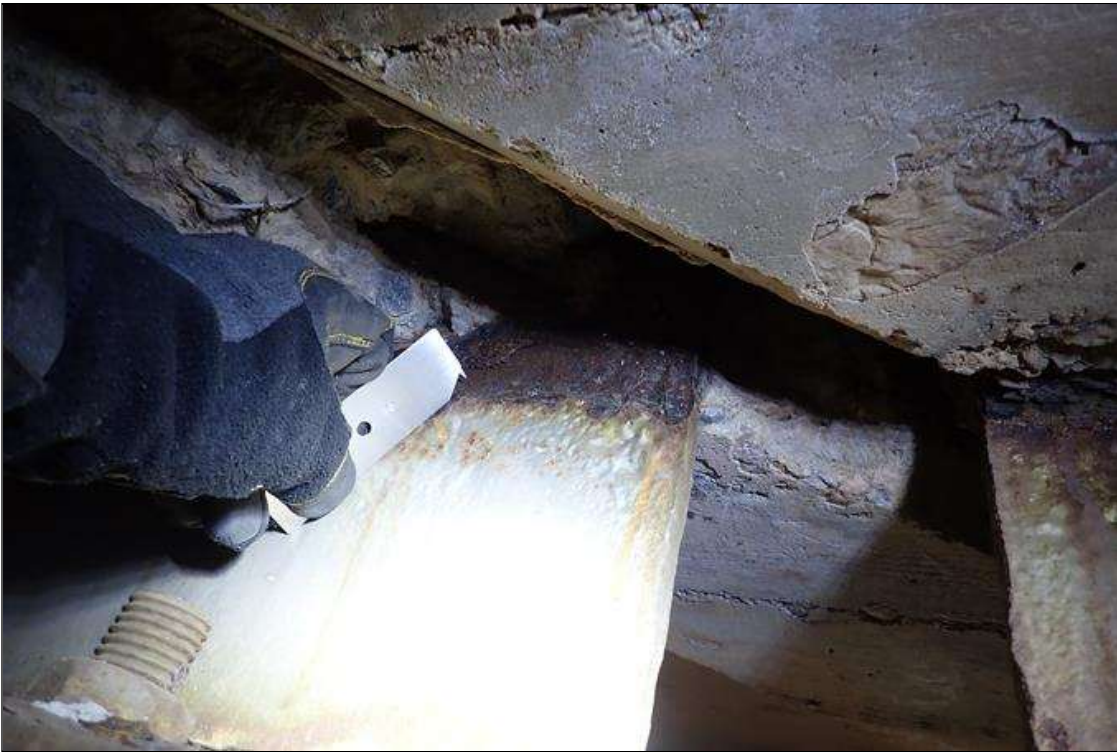
Span 2 Beam 8: (PAR) at bent 1, web at end diaphragm, corrosion with section loss (5/16" remaining x 10" x 7")

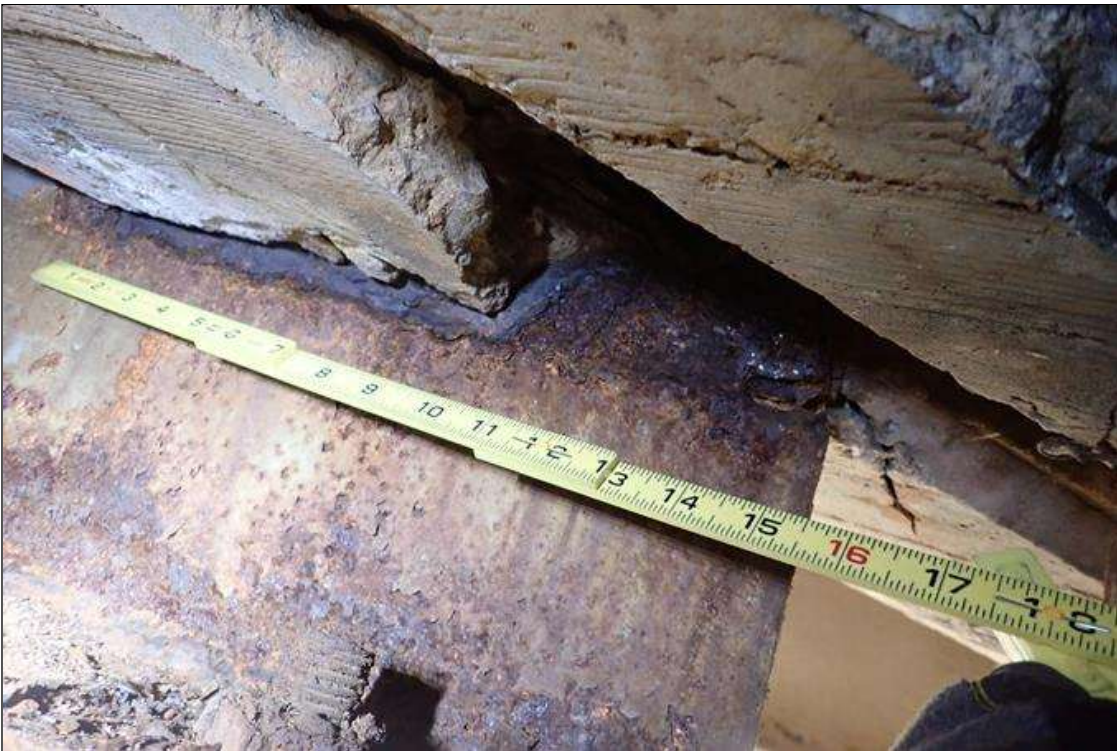
Span 2 Beam 9: (PAR) at bent 1, corrosion with section loss: bottom flange, (0.7" average remaining x 1.5'); web, at end diaphragm, (1/16" remaining x 16" x 4") with corrosion hole (1.5" x 1/2")

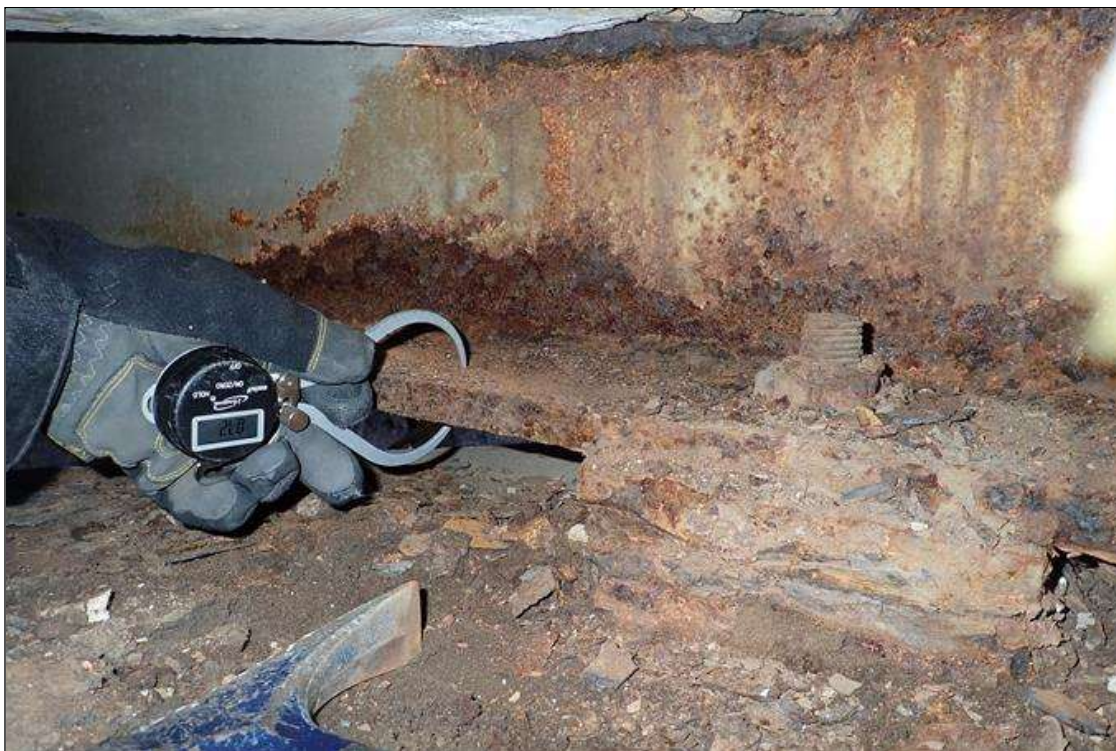
Span 2 Beam 9: (PAR) at bent 1, corrosion with section loss: bottom flange, (0.7" average remaining x 1.5'); web, at end diaphragm, (1/16" remaining x 16" x 4") with corrosion hole (1.5" x 1/2")

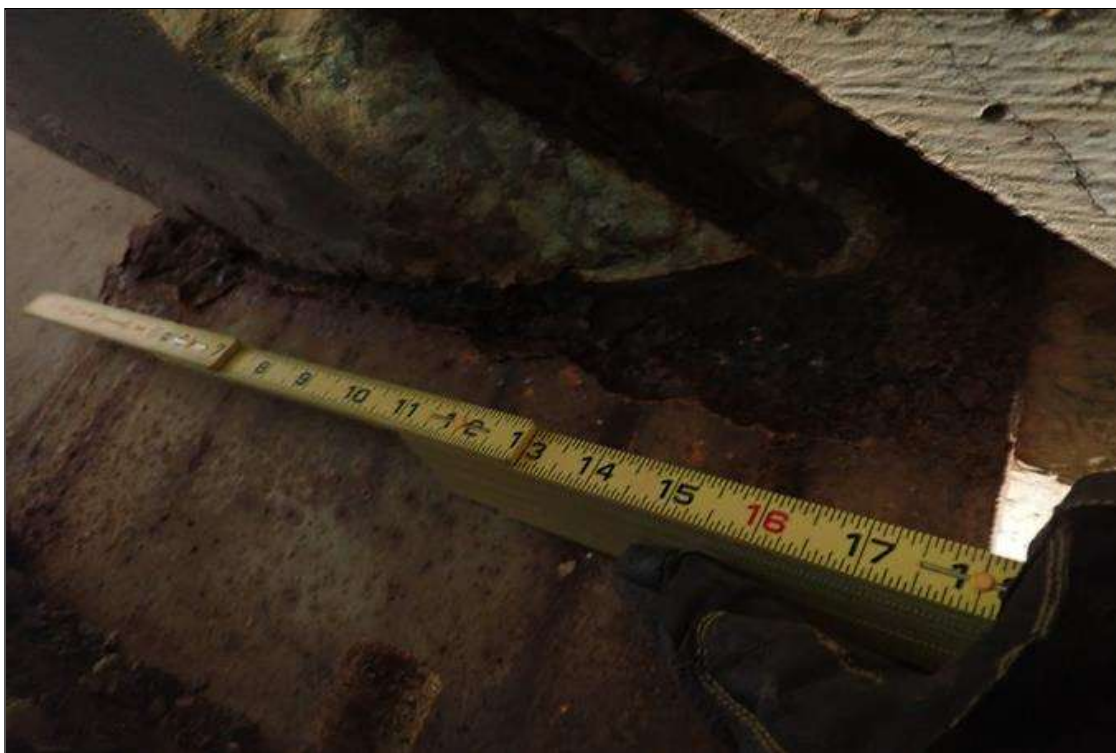
Span 2 Beam 10: (PAR) at bent 1, corrosion with section loss: web at end diaphragm, (1/16" remaining x 18" x 7")

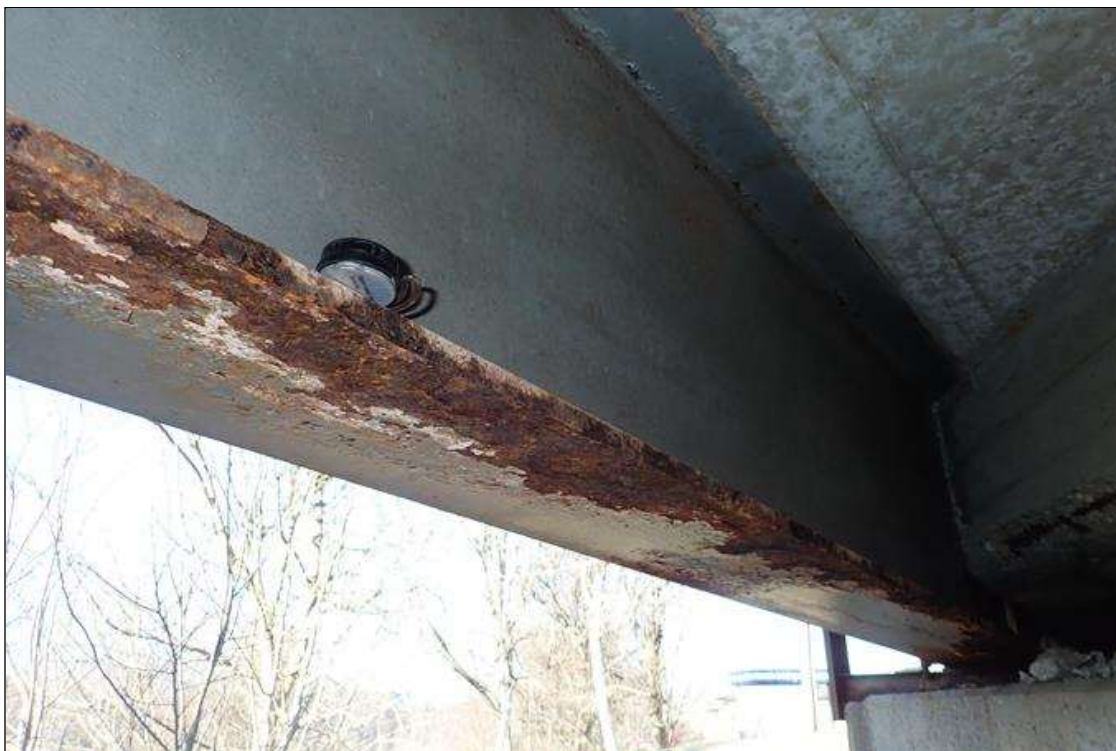
Span 2 Beam 11: at bent 1, bottom flange, corrosion with section loss (0.7" average remaining x 15')

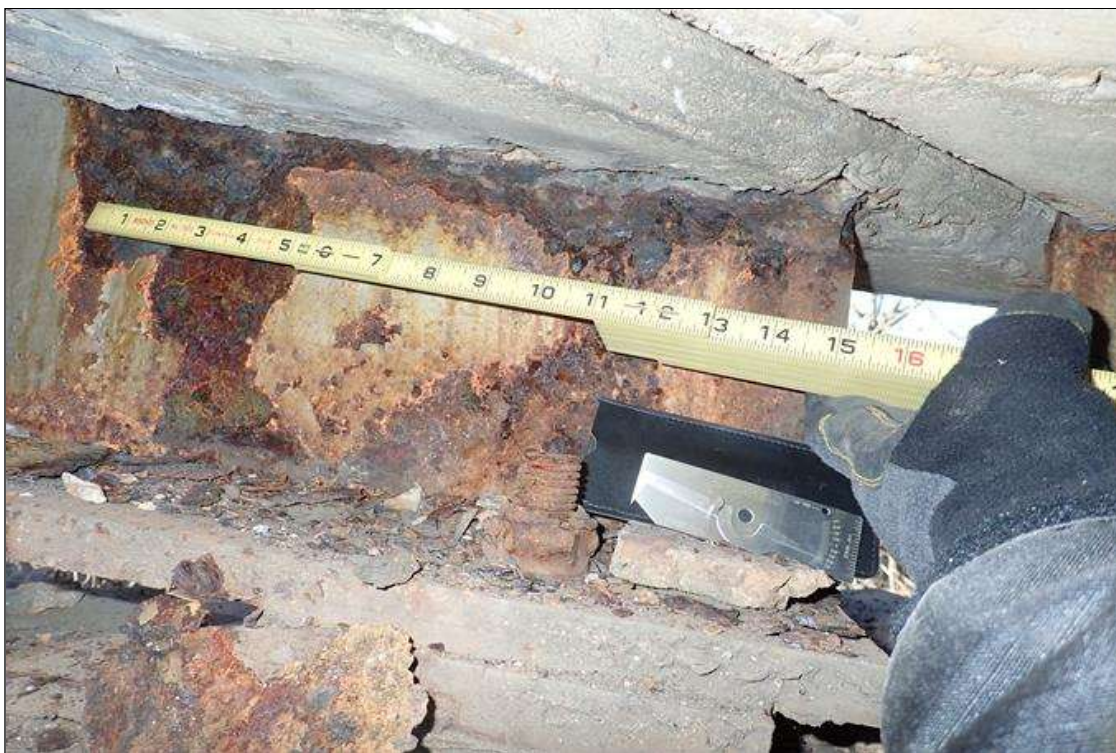
Span 2 Beam 11: (PAR) at bent 1, corrosion with section loss: web at end diaphragm, (0.25" remaining x 16" x 2")

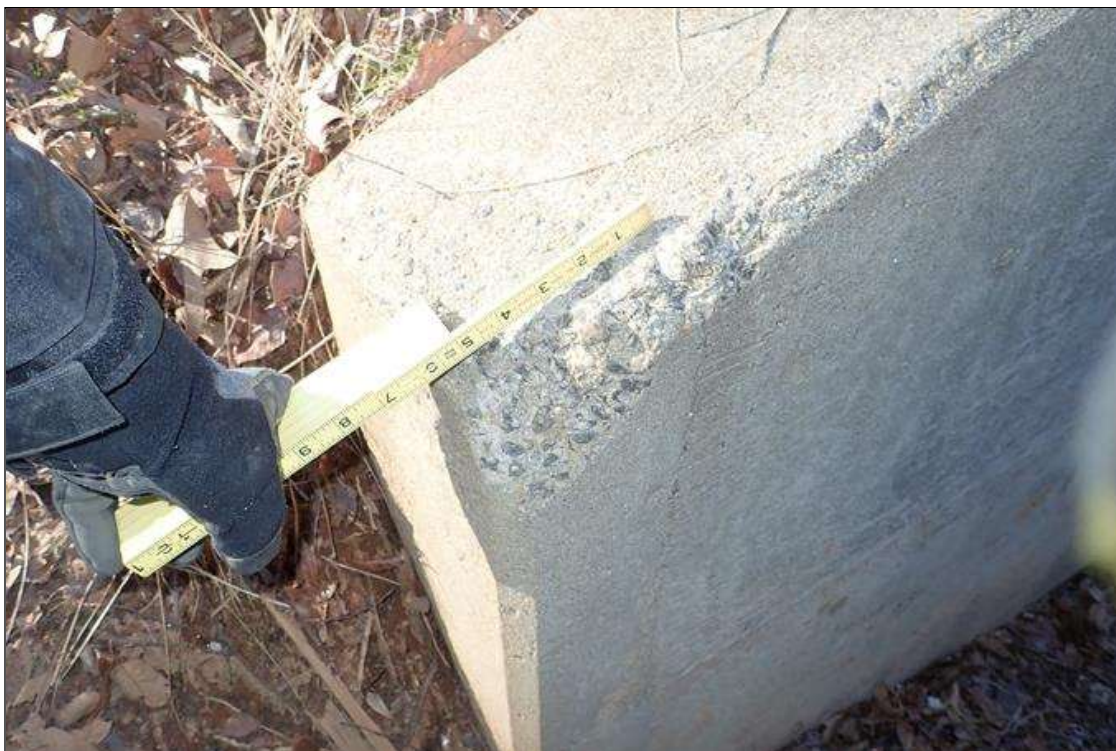
northeast wingwall, top corner at end, spall (6" x 3" x 1/2")

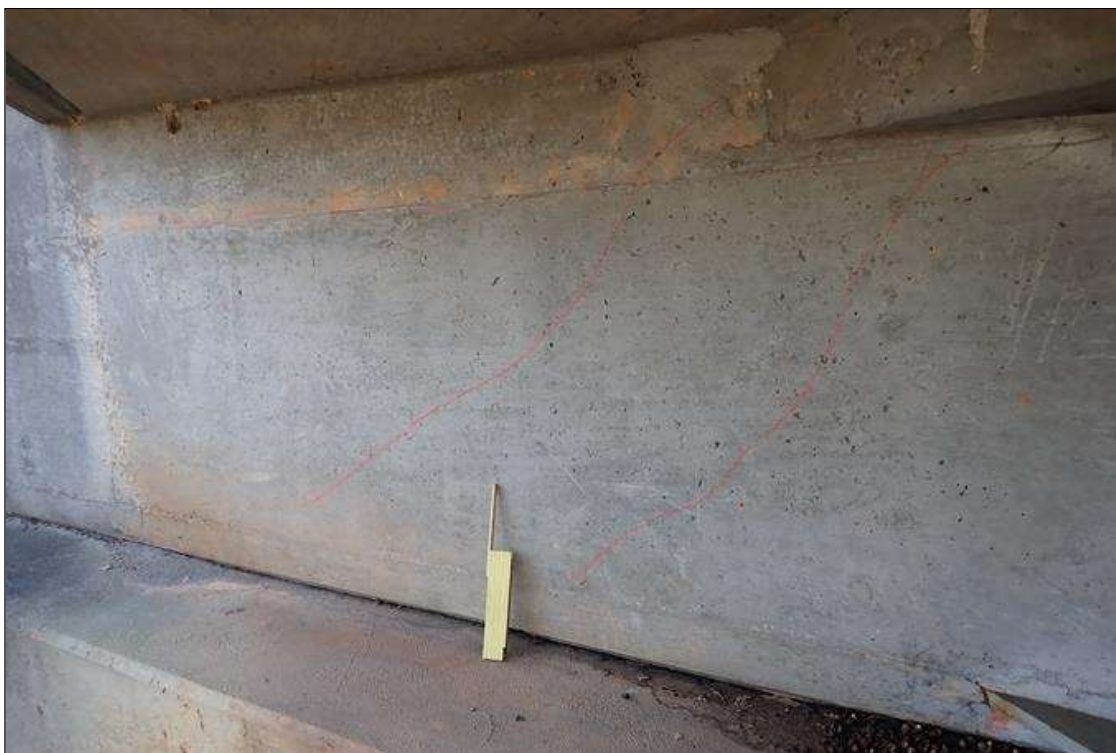
End Bent 2 Abutment/Backwall : left end, (3) diagonal cracks (1/32" x 5') with map cracks (hairline)

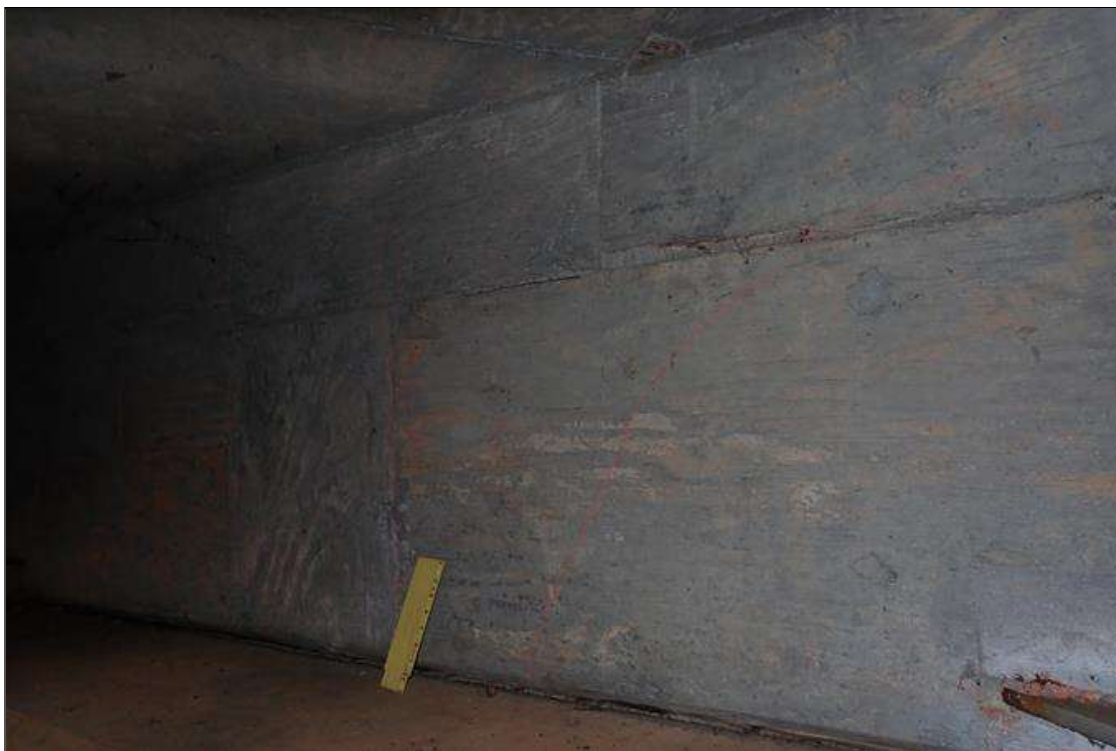
End Bent 2 Abutment/Backwall : bay 1, multiple vertical and diagonal cracks (1/32" x 3')

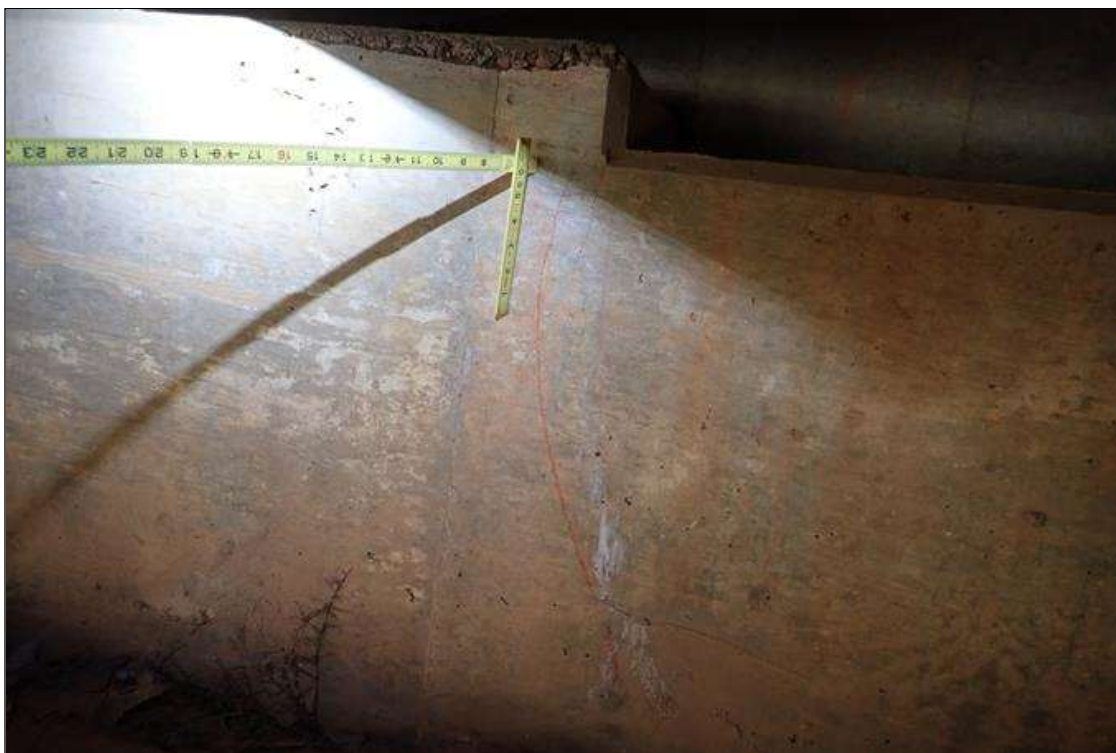
End Bent 2 Cap 1: at random, vertical cracks (hairline x up to 2') with efflorescence

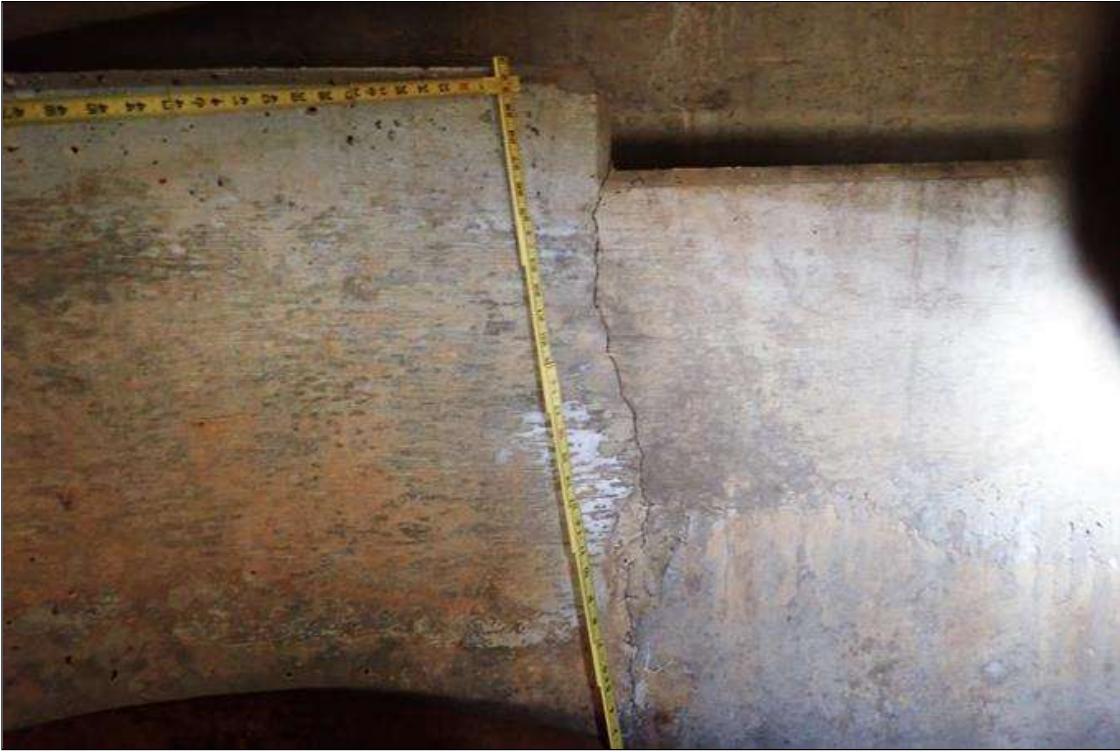
End Bent 2 Cap 1: at beam 5, vertical crack (1/16" x 2') at cold joint

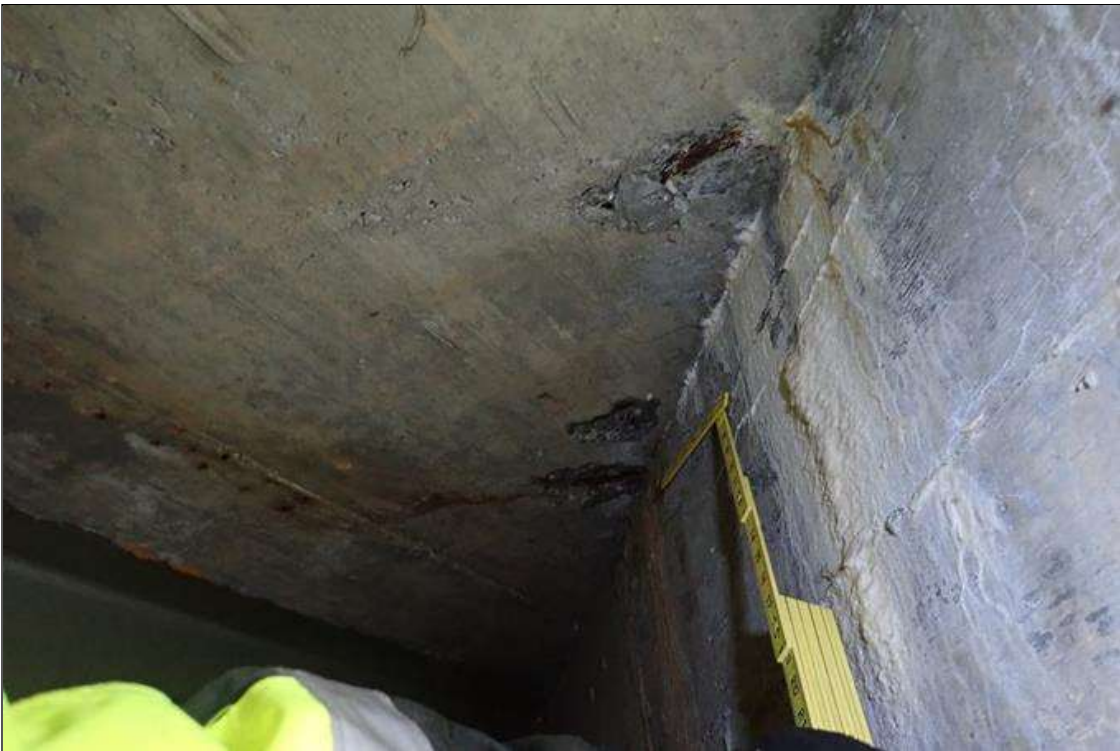
Span 5 Deck: underside, bay 6, at end bent 2, (3) spalls (7" diameter x 1") with exposed rusted rebar

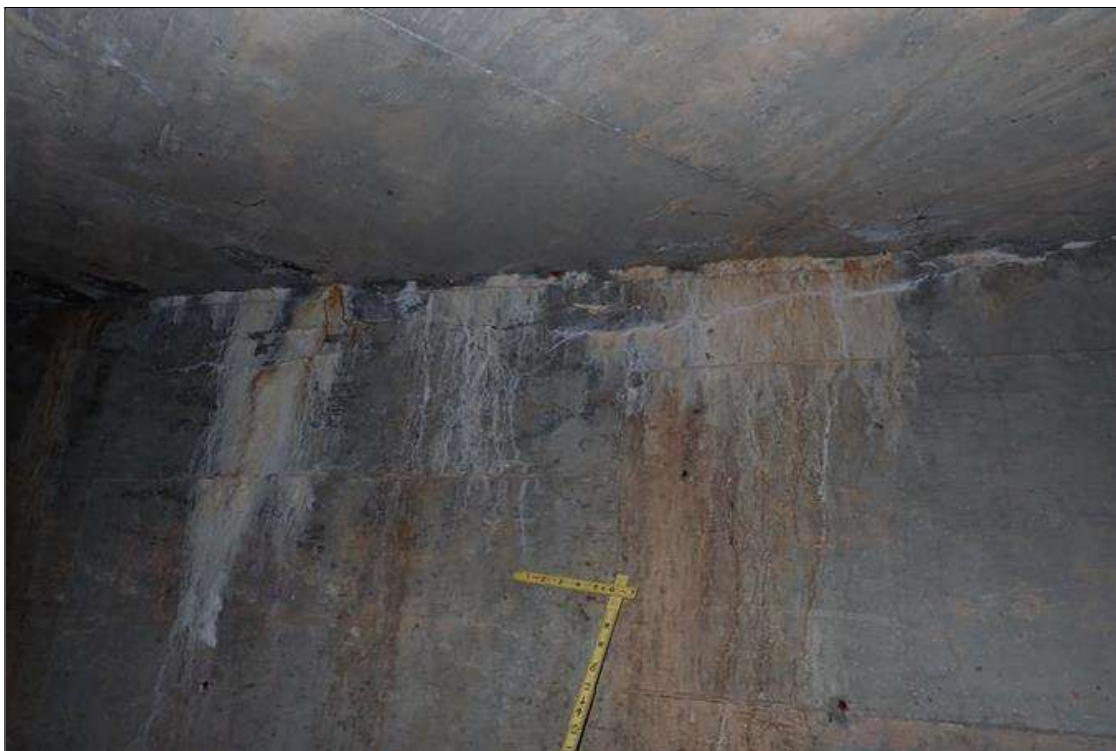
End Bent 2 Abutment/Backwall : bay 6, horizontal cracks (1/32" x 7') with efflorescence buildup

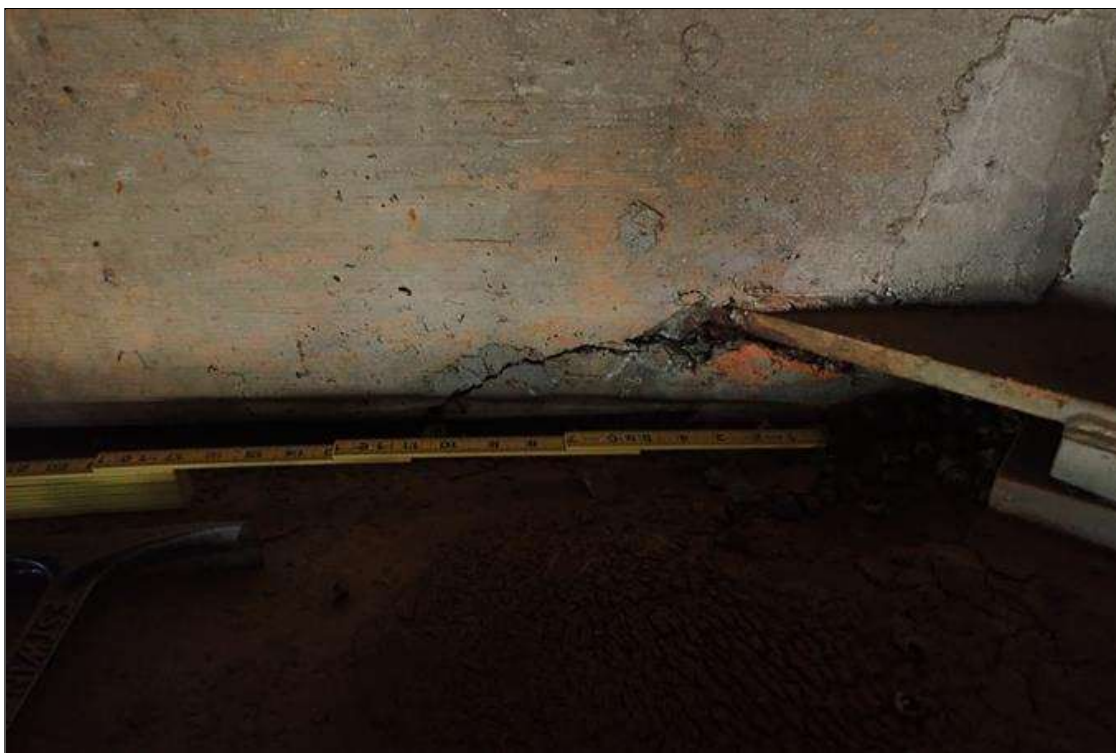
End Bent 2 Abutment/Backwall : bay 6, at beam 7, bottom flange, spall (12" x 3" x 1")

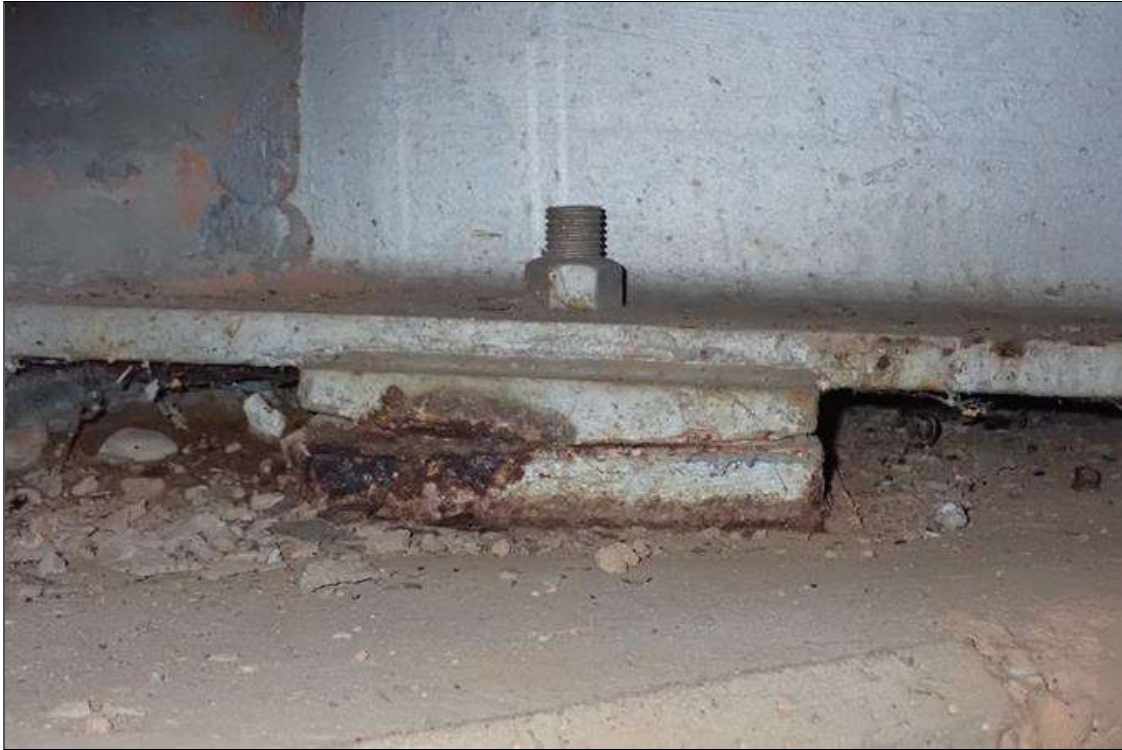
Span 5 Beam 8 Far Bearing 8: rust scale

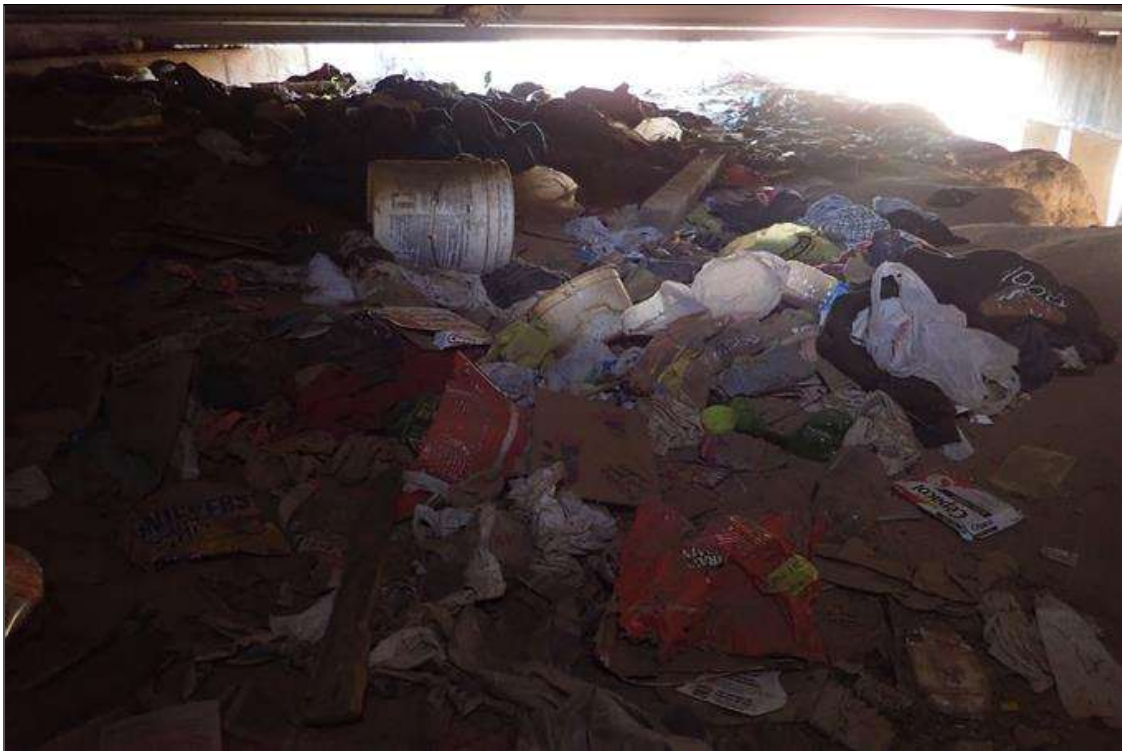
limited access to right half of span 5 due to vagrant debris

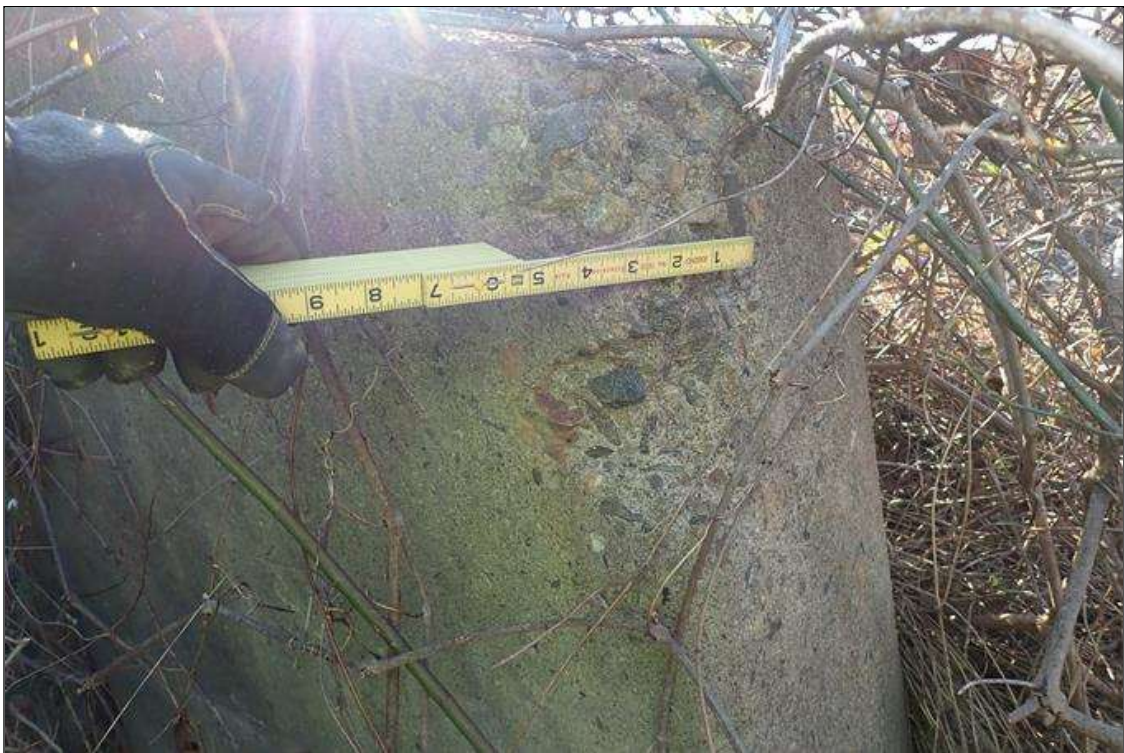
southeast wingwall, at end, spall (6" x 4" x 1")

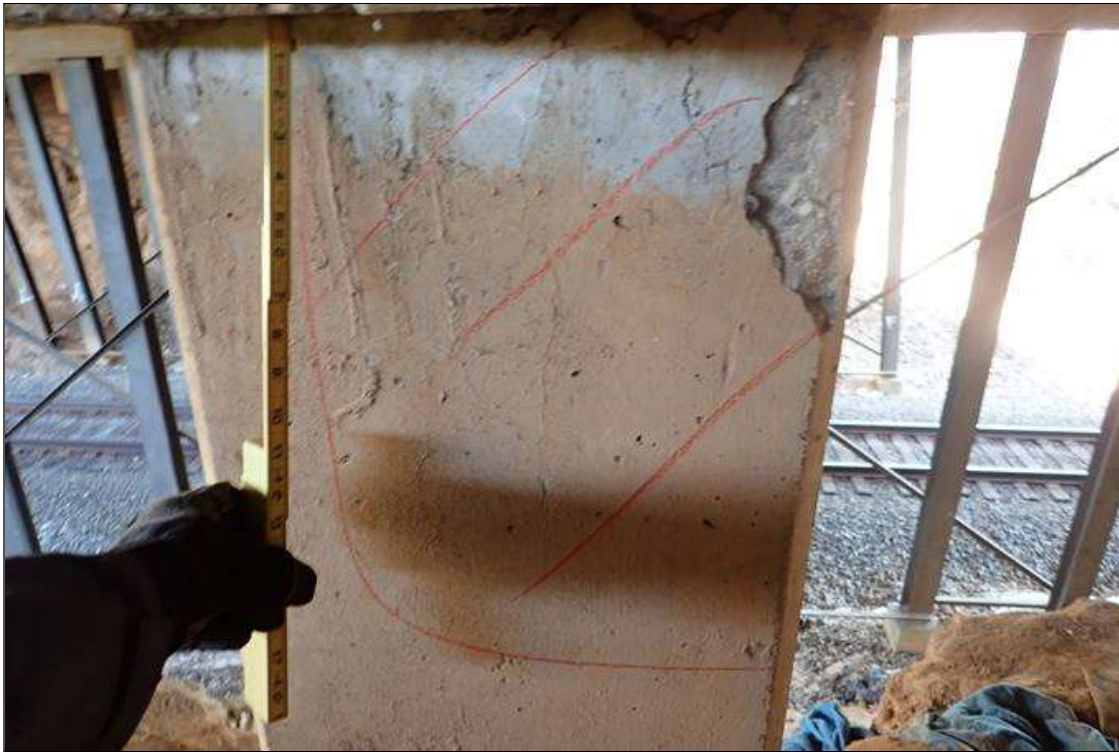
Bent 4 Pile 14: span 5 face, at top, delamination/spall (15" x 18" x 1/2")

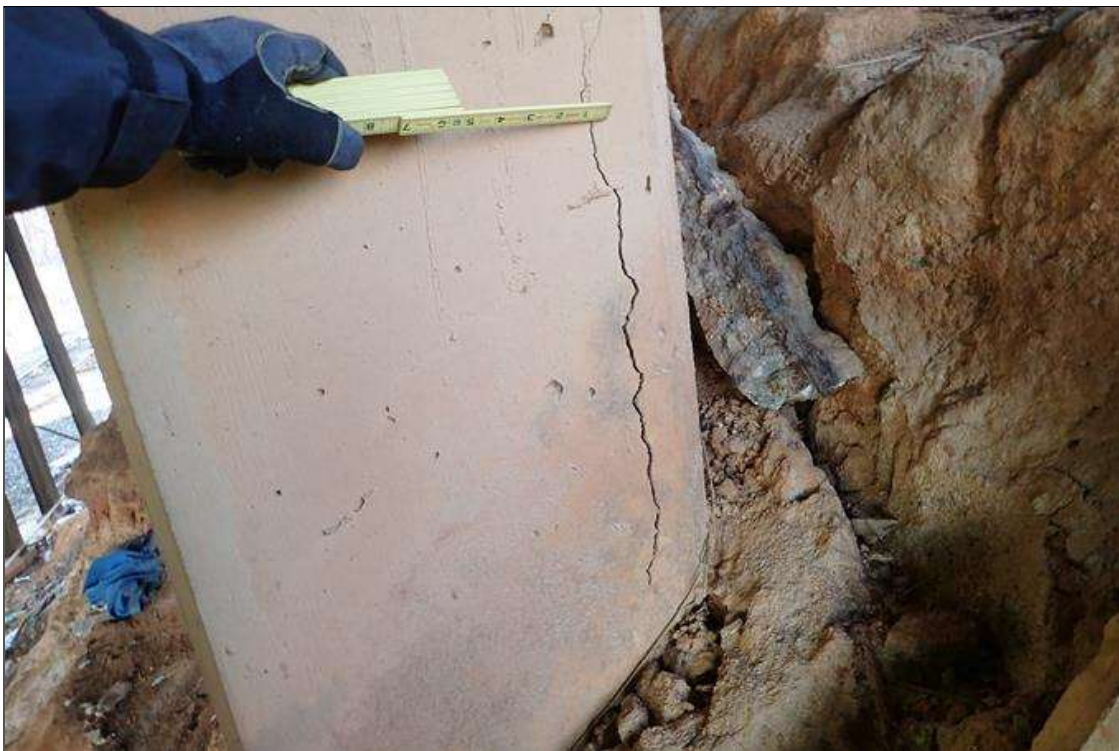
Bent 4 Pile 15: vertical crack (1/8" x 2')
