NC DEPARTMENT OF TRANSPORTATION
 DIVISION OF HIGHWAYS
 STRUCTURE MANAGEMENT UNIT

ATTENTION: **partial inspection, awaiting railroad entry permit; prompt action request, sketches revised, temporary repairs to caps**

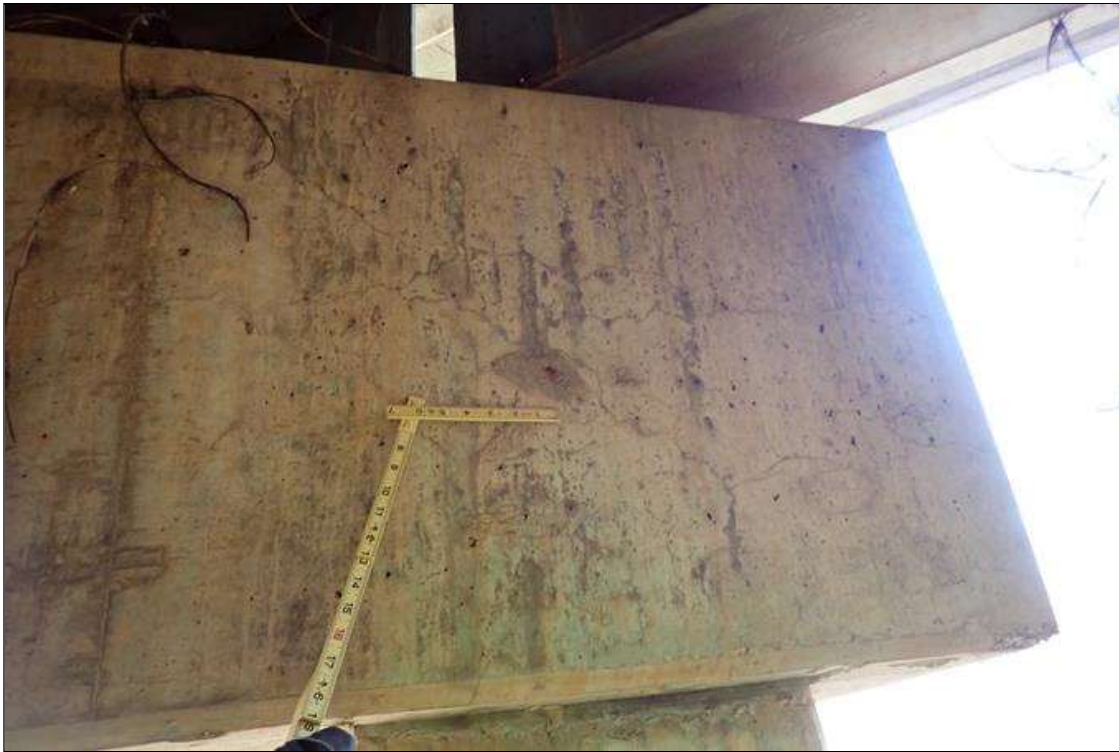
Bent 4 Cap 1: left end, map cracks (hairline x 2' x full height)

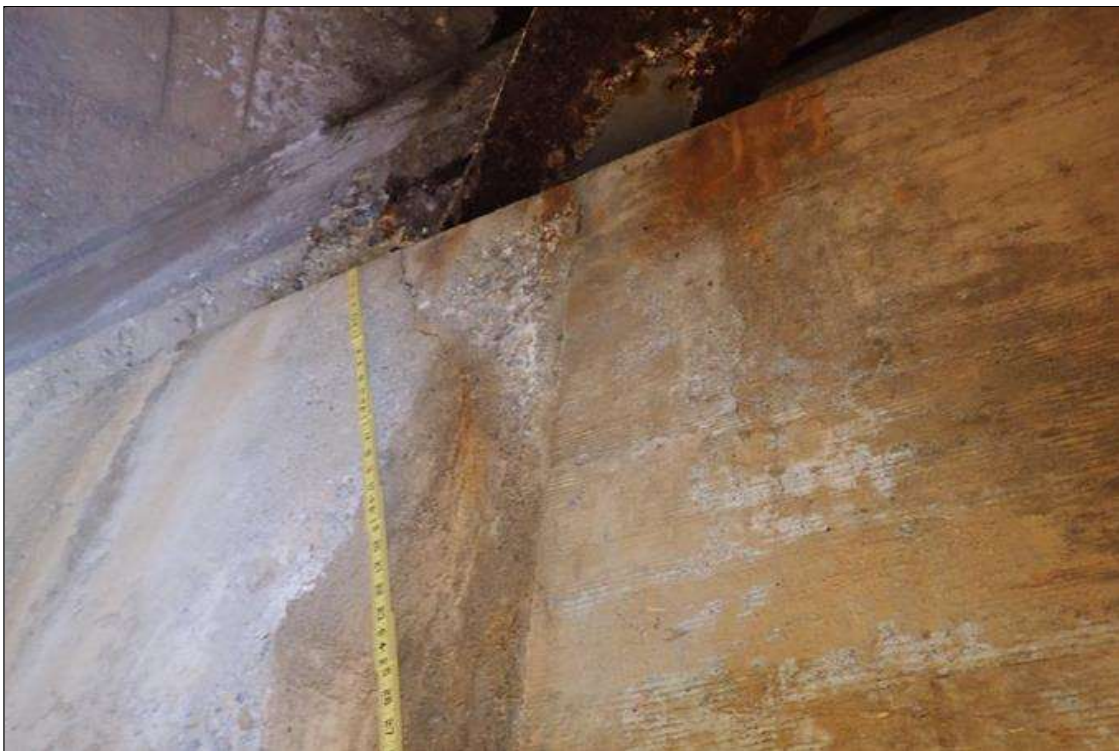
Bent 4 Cap 1: span 5 face at beam 7, vertical crack (1/16" x 2') with efflorescence

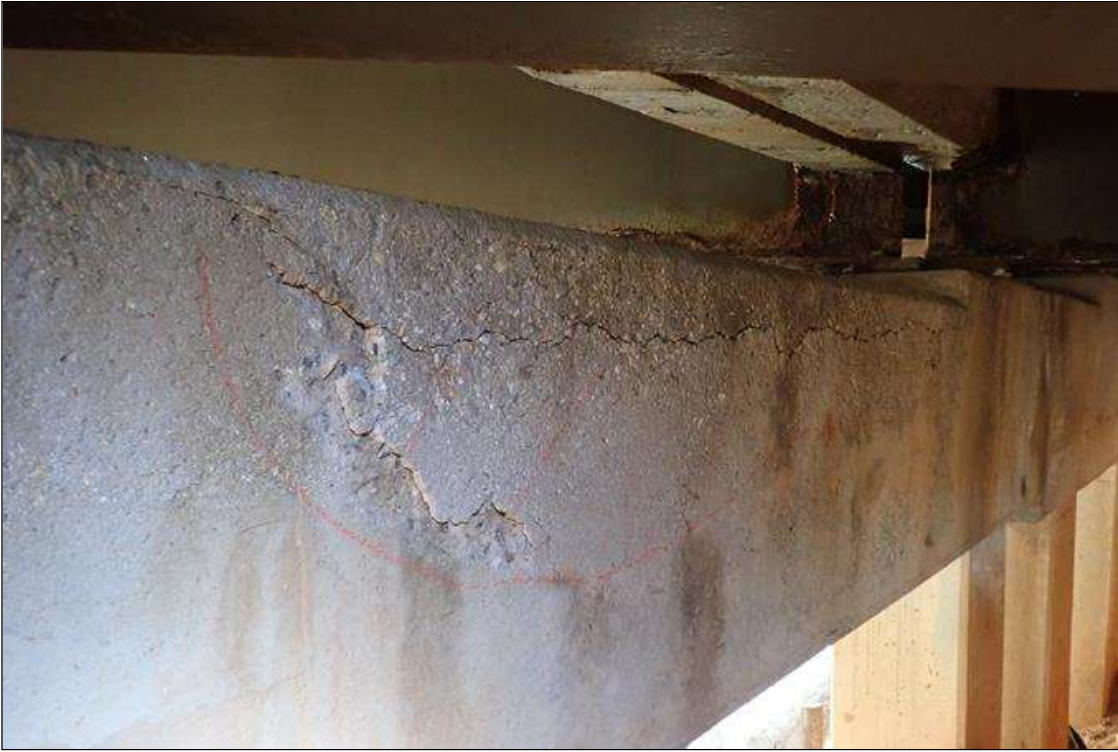
Bent 4 Cap 1: span 5 face, bay 7, delamination/spall (7' x 20" x 1") with longitudinal crack (1/8"); similar span 4 face

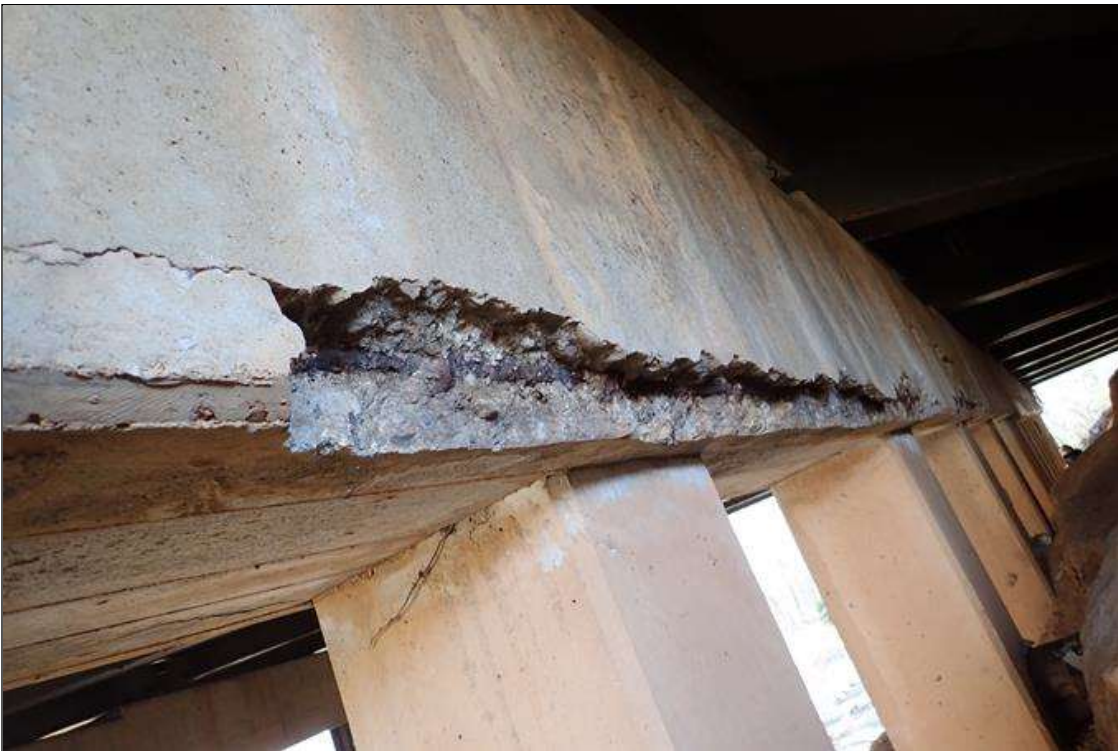
Bent 4 Cap 1: (PAR) span 5 face, from beam 8 to 11, longitudinal cracks (1/8" x 30') at top and bottom corners with delamination (up to full height x 30') and spalls (19' x up to 20" x 2") with exposed rusted rebar; cracks and delamination similar on span 4 face

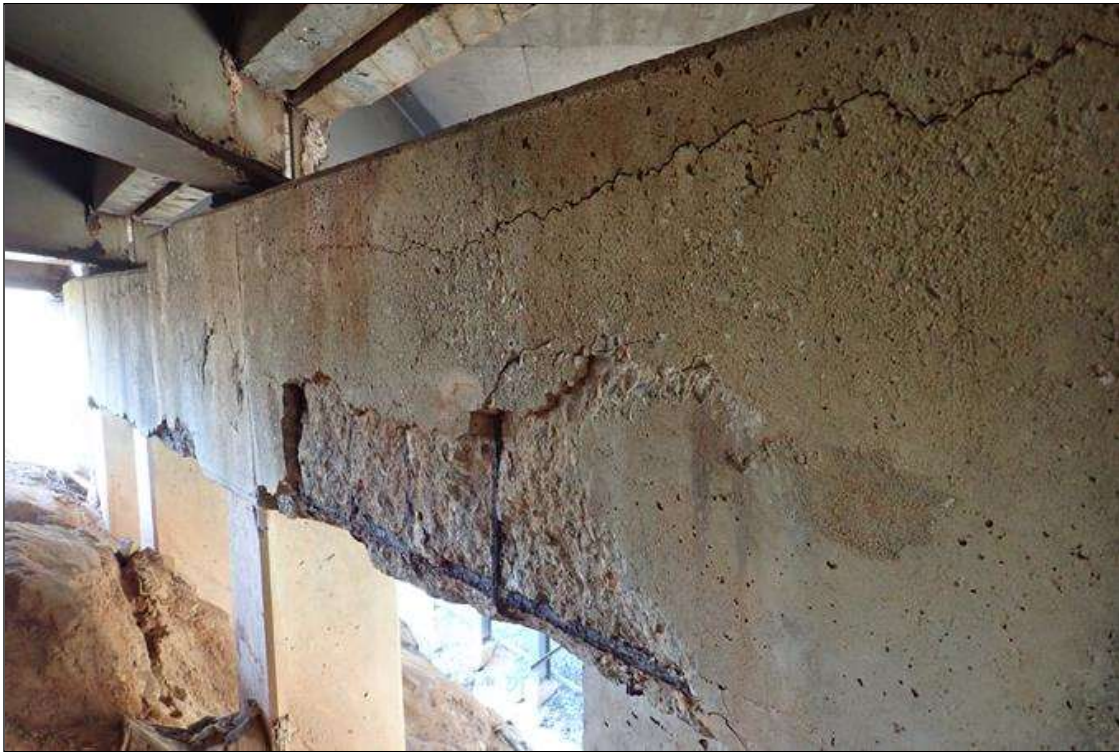
Bent 4 Cap 1: (PAR) span 5 face, from beam 8 to 11, longitudinal cracks (1/8" x 30') at top and bottom corners with delamination (up to full height x 30') and spalls (19' x up to 20" x 2") with exposed rusted rebar; cracks and delamination similar on span 4 face

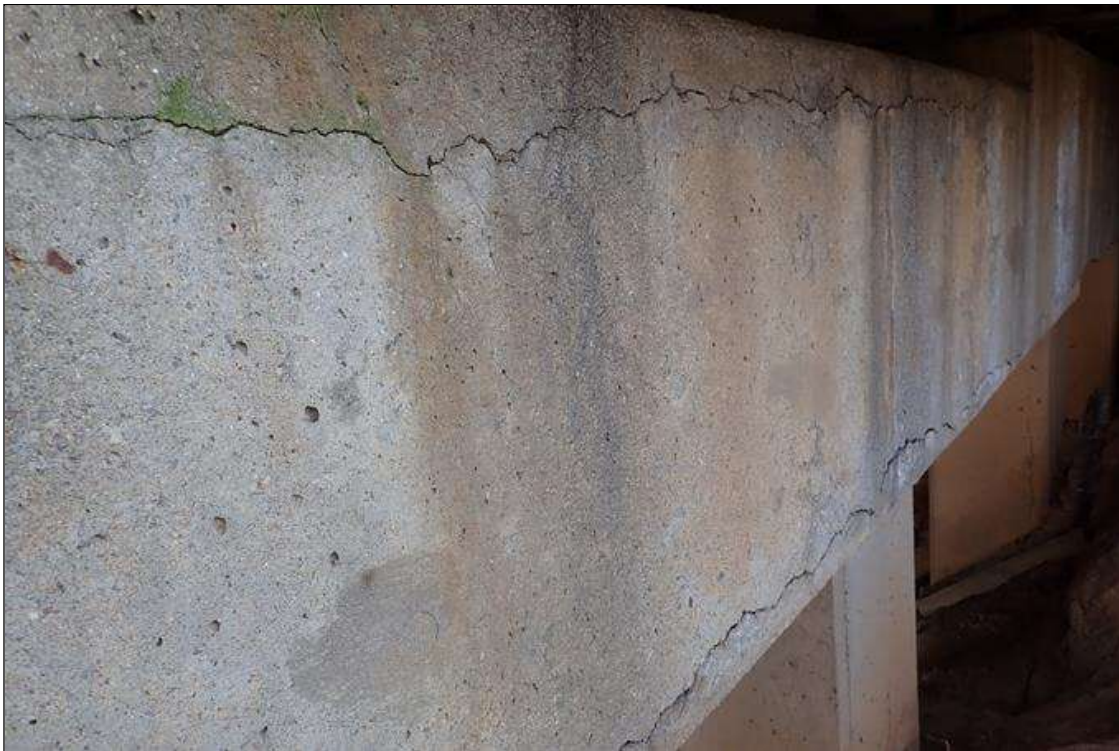
Bent 4 Cap 1: (PAR) span 5 face, from beam 8 to 11, longitudinal cracks (1/8" x 30') at top and bottom corners with delamination (up to full height x 30') and spalls (19' x up to 20" x 2") with exposed rusted rebar; cracks and delamination similar on span 4 face

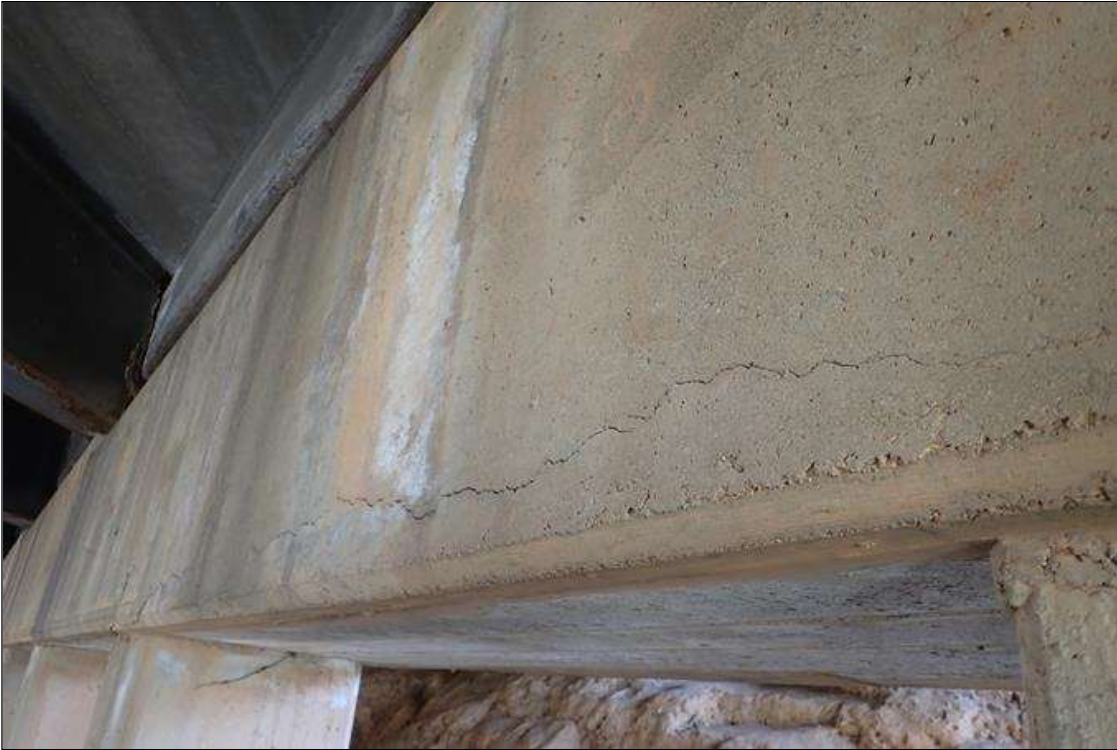
Bent 4 Cap 1: (PAR) span 5 face, from beam 8 to 11, longitudinal cracks (1/8" x 30') at top and bottom corners with delamination (up to full height x 30') and spalls (19' x up to 20" x 2") with exposed rusted rebar; cracks and delamination similar on span 4 face

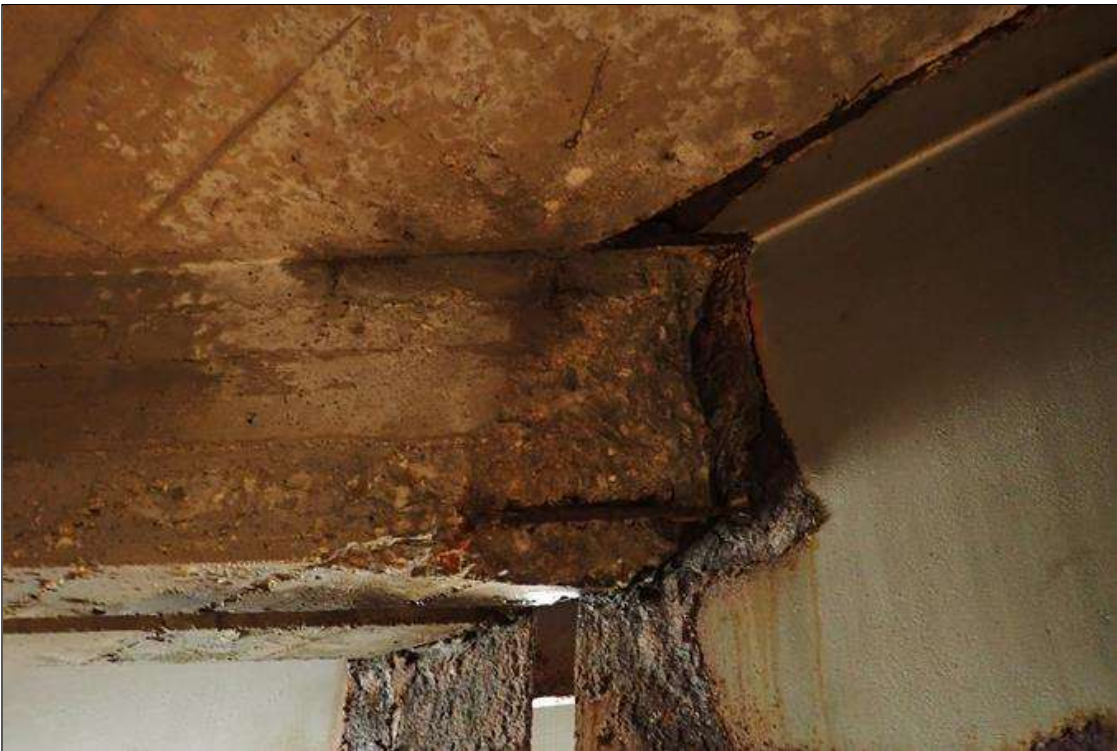
Span 5 Deck: bent 4 end diaphragm, bay 7 at beam 7, spall (2' x 18" x 2") with exposed rusted rebar

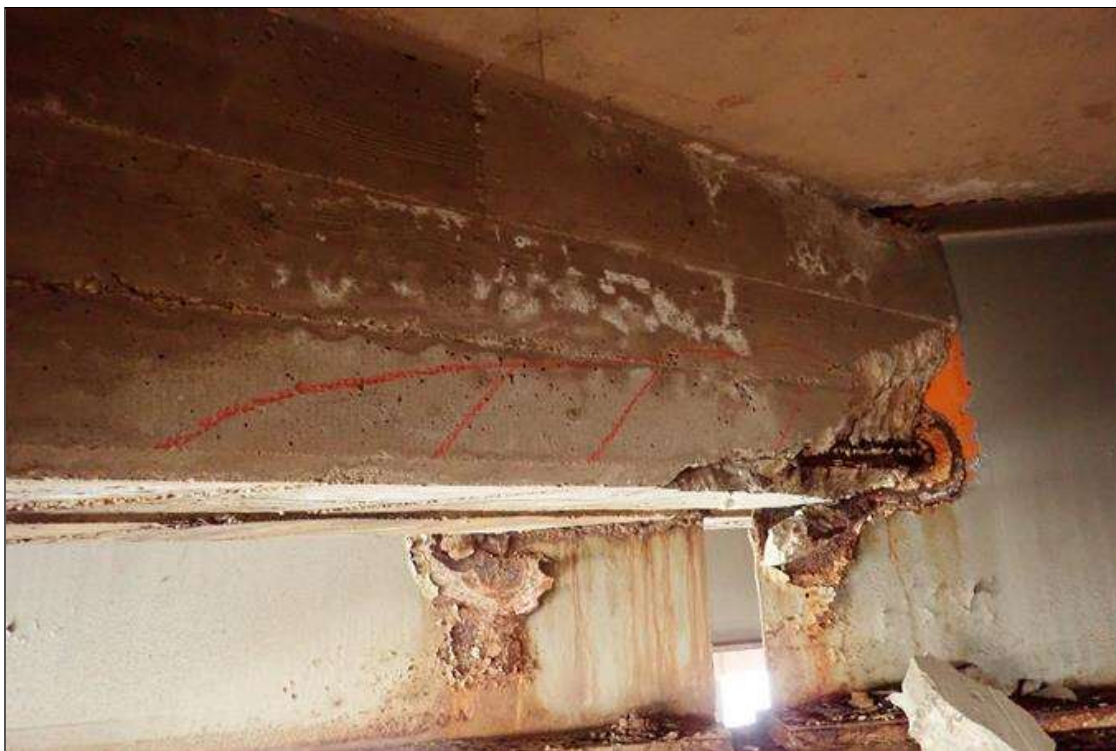
Span 5 Deck: bent 4 end diaphragm, bay 9, at beam 9, delamination/spall (4' x 1' x 3") with exposed rusted rebar

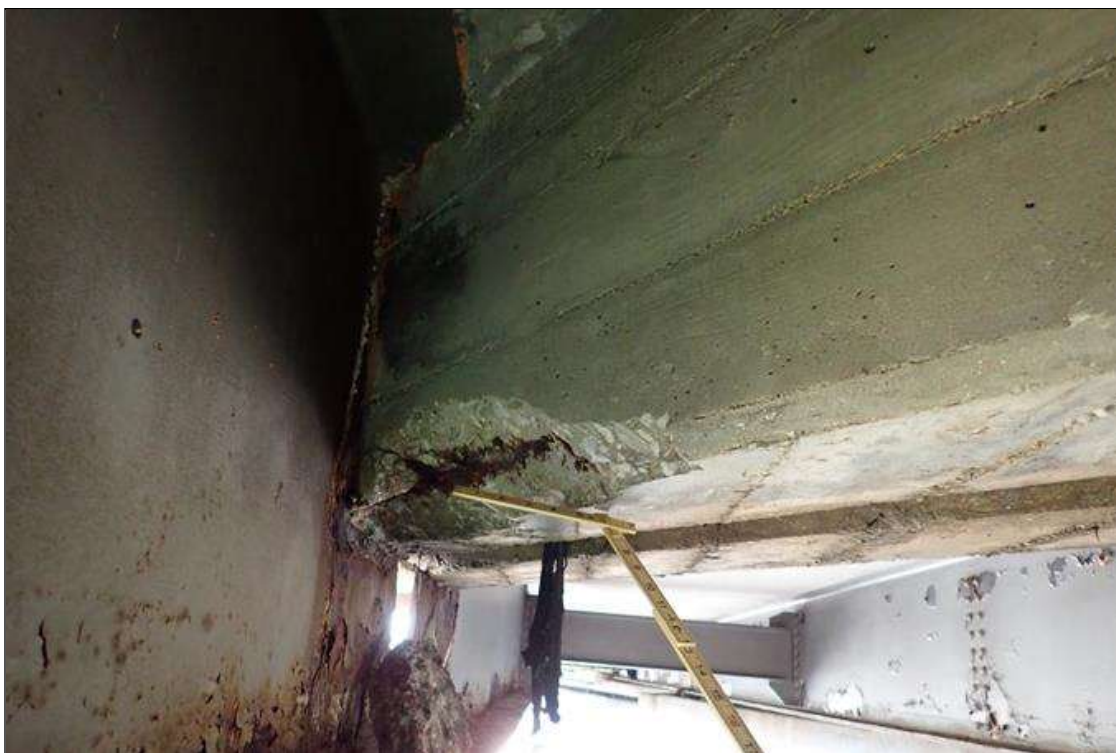
Span 5 Deck: bent 4 end diaphragm, bay 10, at beam 11, spall (18" x 3" x 4") with exposed rusted rebar

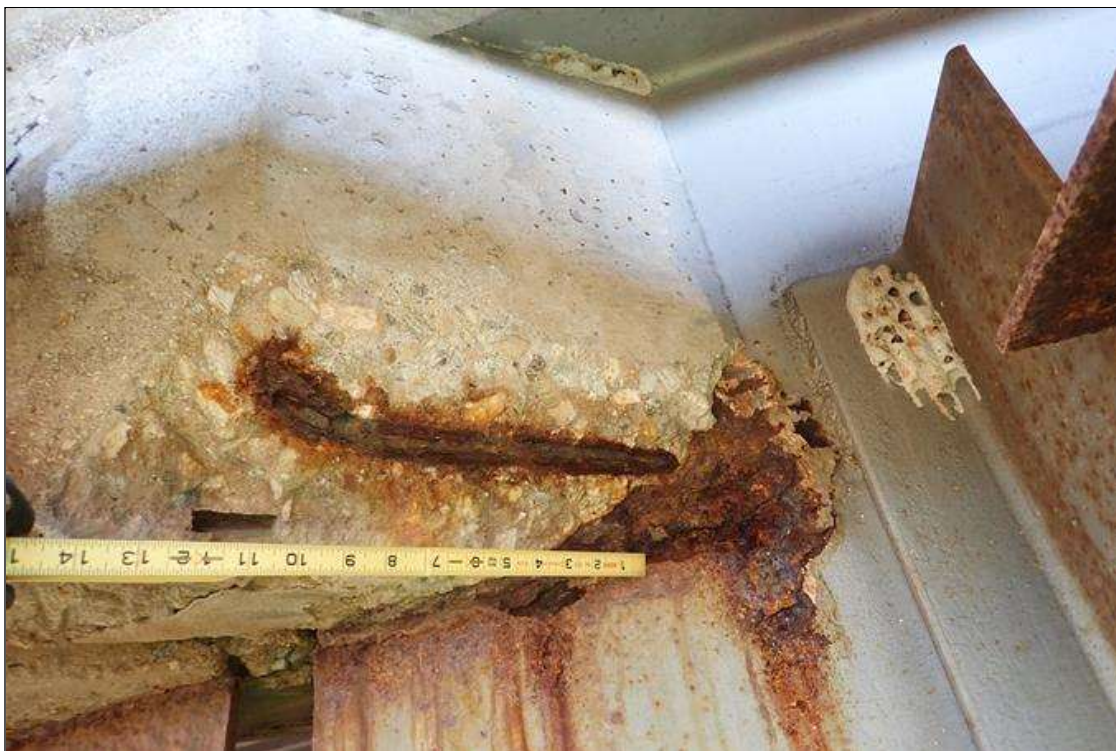
Span 5 Deck: bent 4 end diaphragm, right overhang, spall (12" x 6" x 2") with exposed rusted rebar

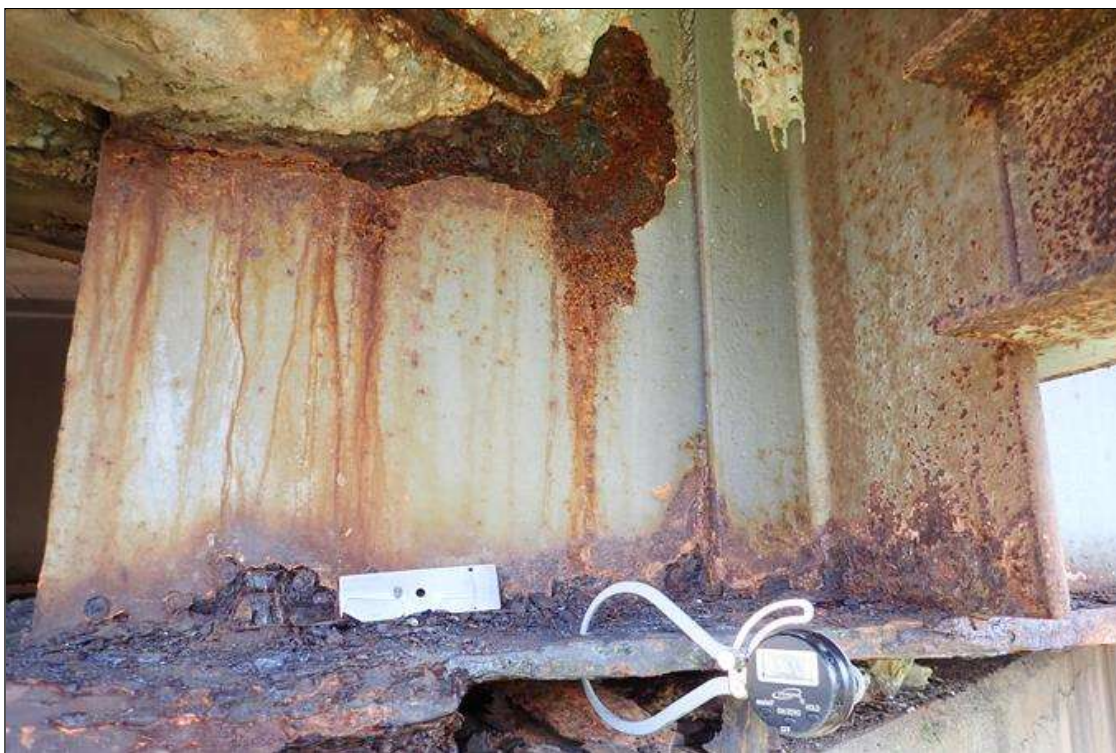
Span 5 Beam 11: (PAR) at bent 4, corrosion with section loss: bottom flange, (0.55" average remaining x 2'); web at end diaphragm, (1/16" remaining x 15" x 5")

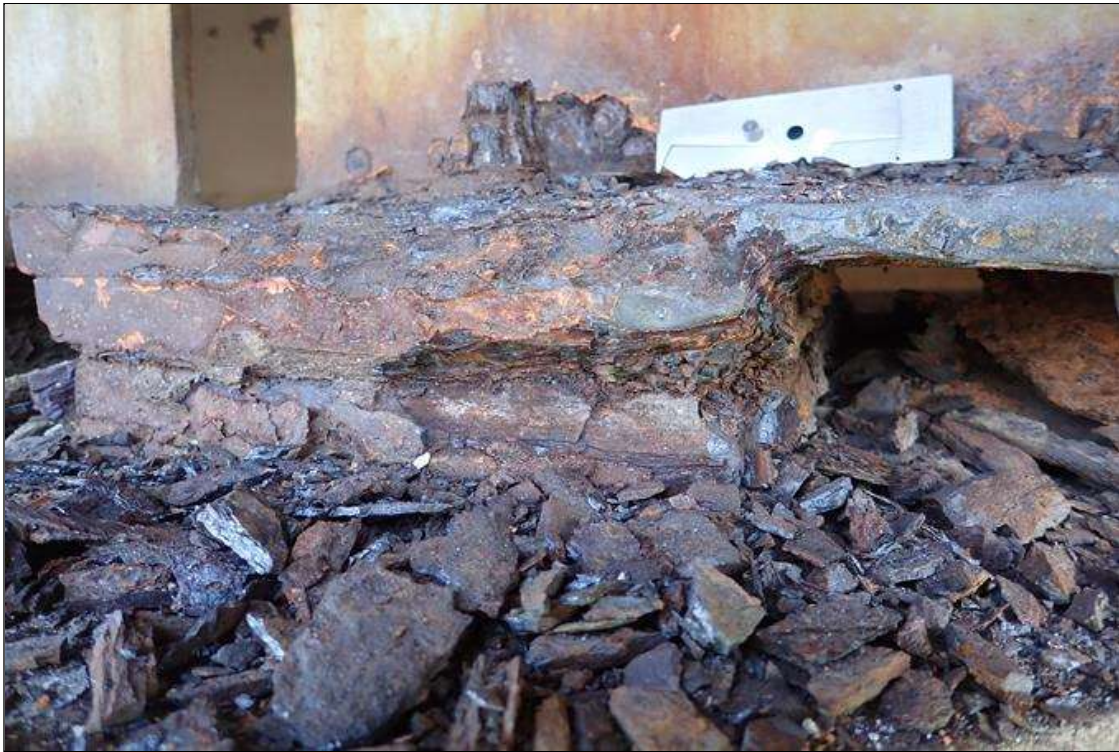
Span 5 Beam 11 Near Bearing 11: (PAR) bearing frozen with pack rust

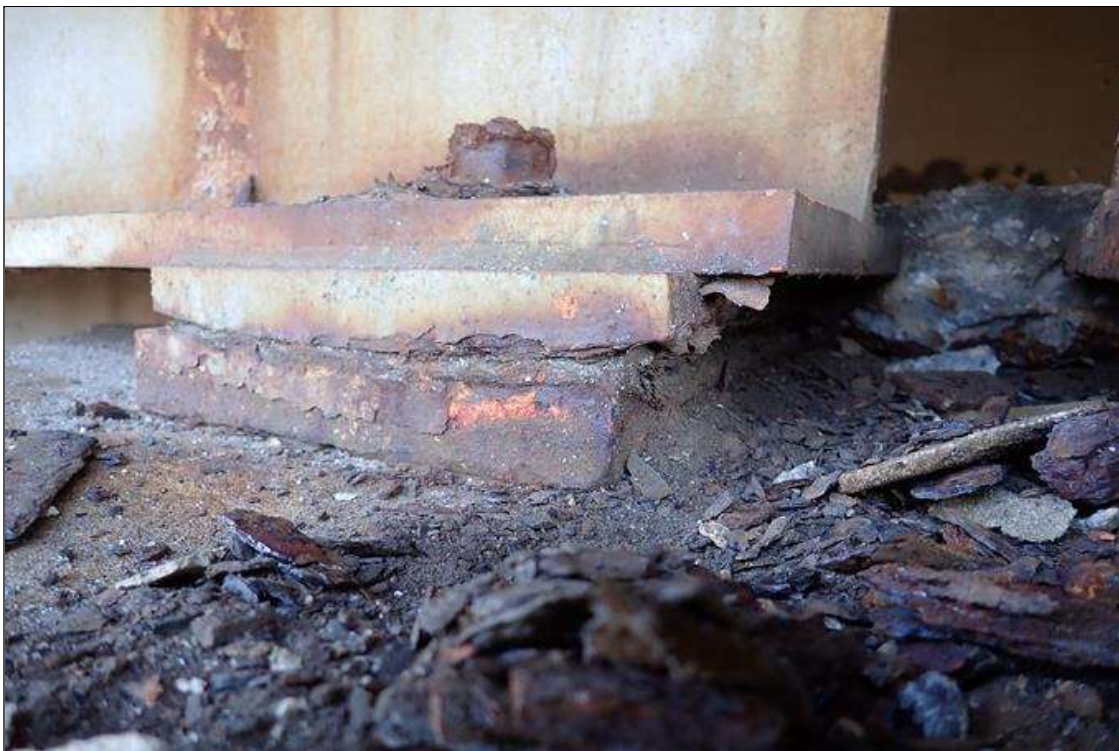
Span 4 Beam 11 Far Bearing 11: pack rust

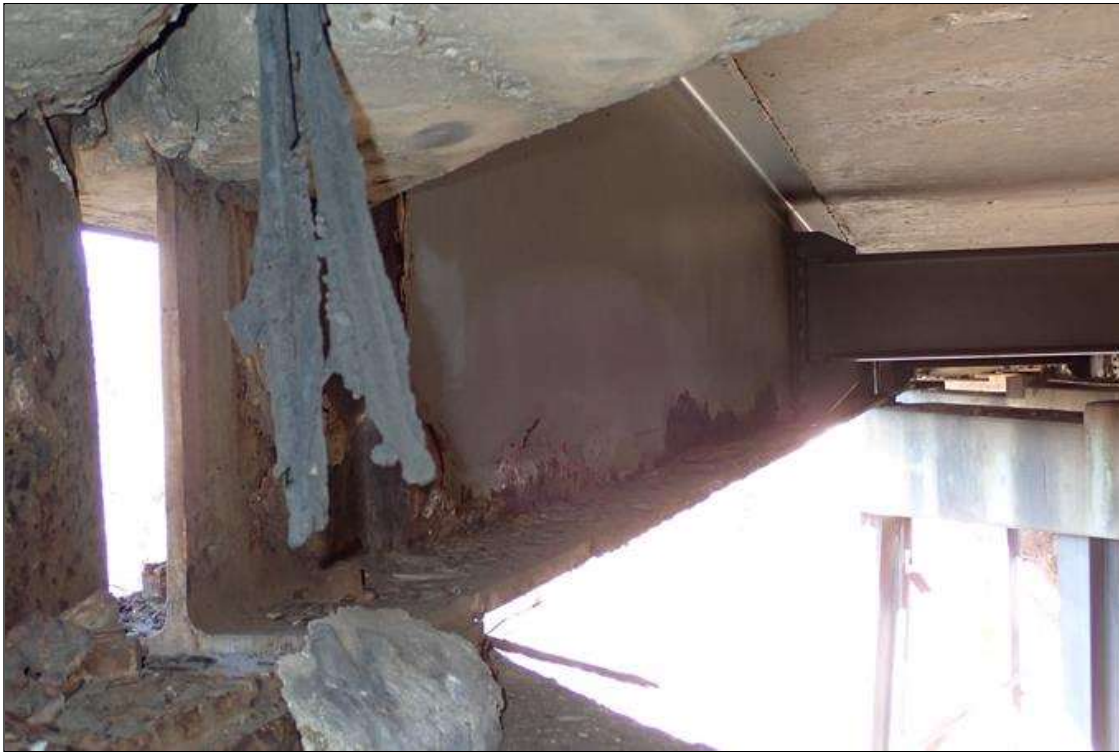
Span 4 Beam 11: 2020 no ladder access to verify section remaining, previously noted as: BEAM 11 SPAN 4 AT BENT 4: SECTION LOSS TO BOTTOM LEFT FLANGE WITH 11/16" REMAINING AND BOTTOM 4" OF WEB WITH 7/16" REMAINING FOR 15'

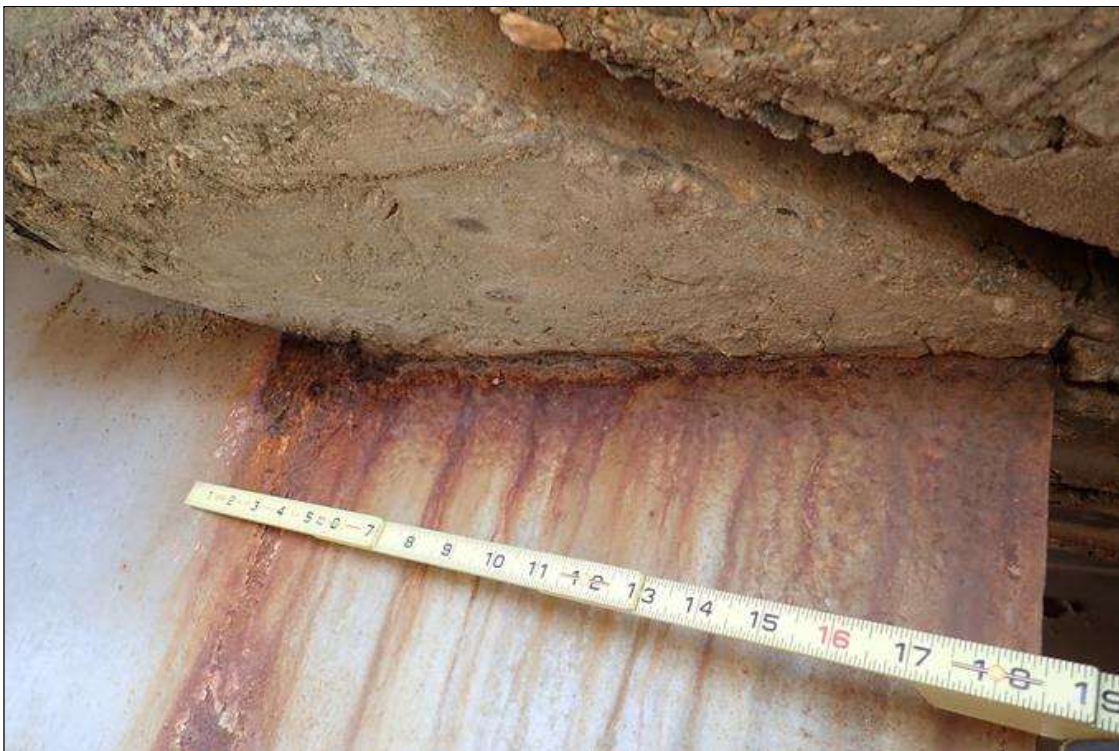
Span 4 Beam 11: (PAR) at bent 4, corrosion with section loss: web at end diaphragm, (1/4" remaining x 10" x 4")

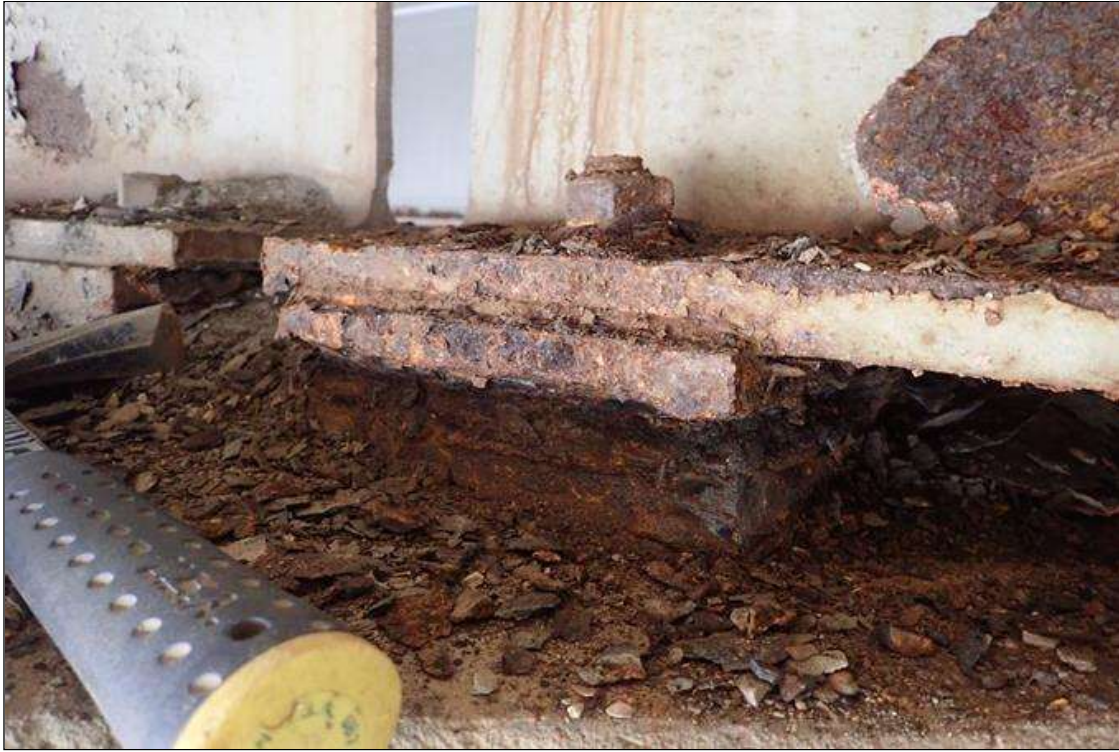
Span 5 Beam 10 Near Bearing 10: (PAR) bearing frozen with pack rust

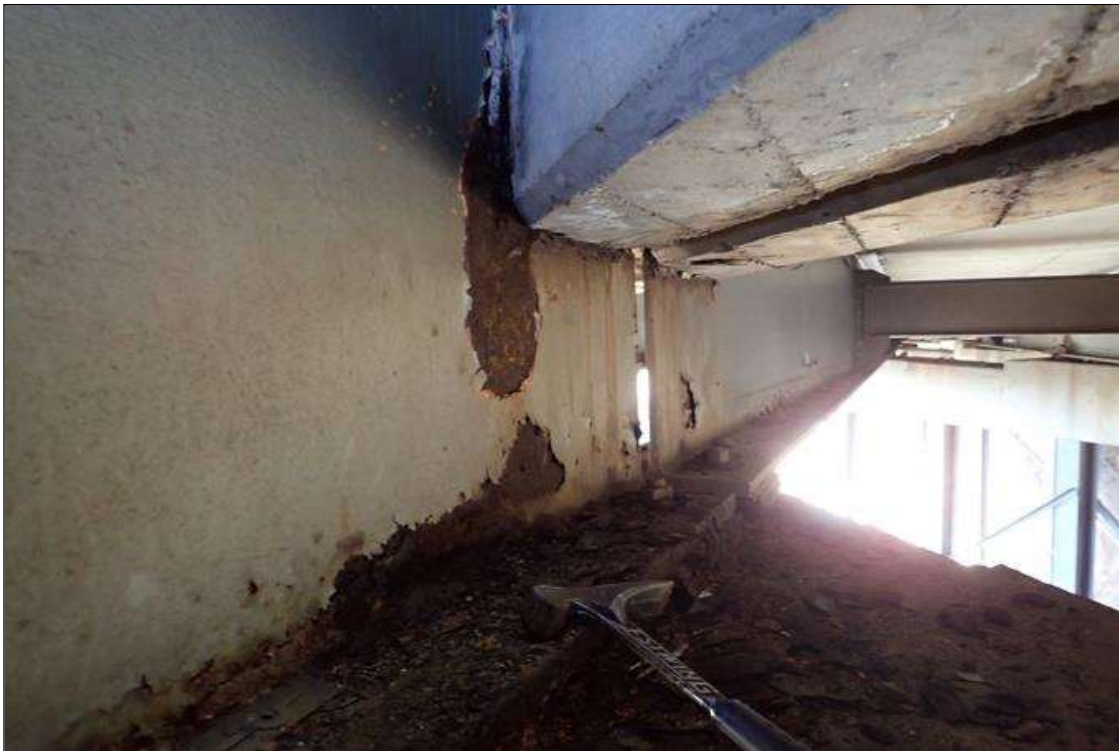
Span 5 Beam 10: at bent 4, corrosion with section loss: bottom of web and at end diaphragm, (1/16" loss x 2" x 1.5')

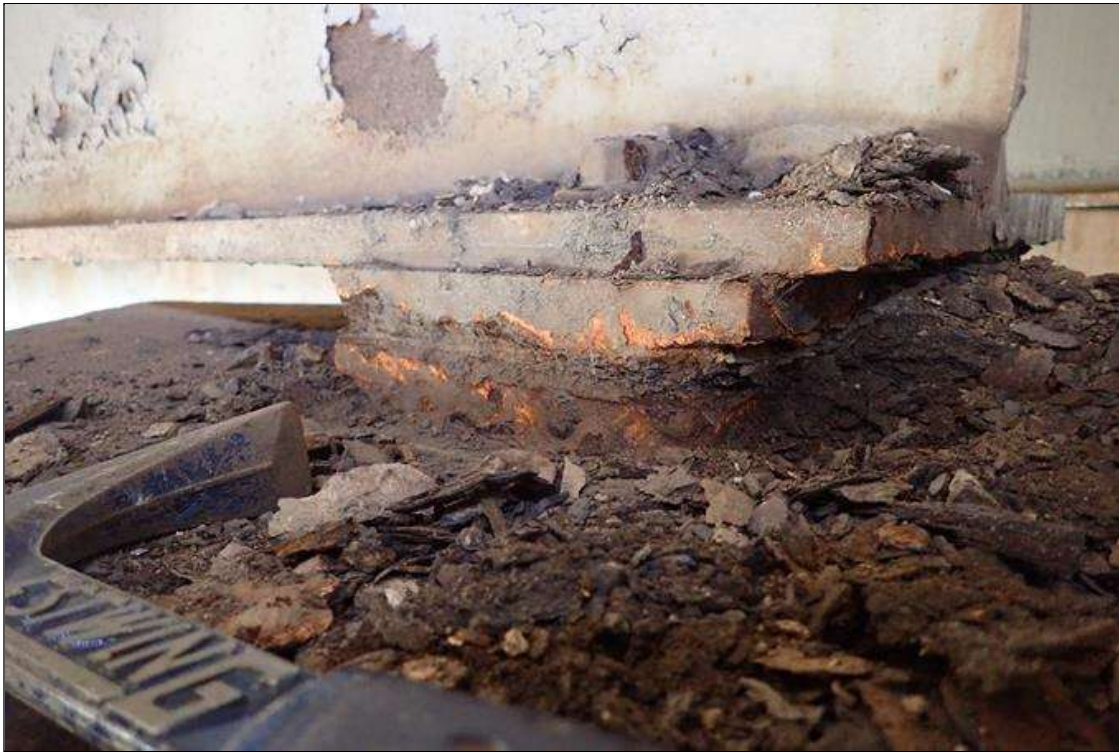
Span 4 Beam 10 Far Bearing 10: (PAR) bearing frozen with pack rust

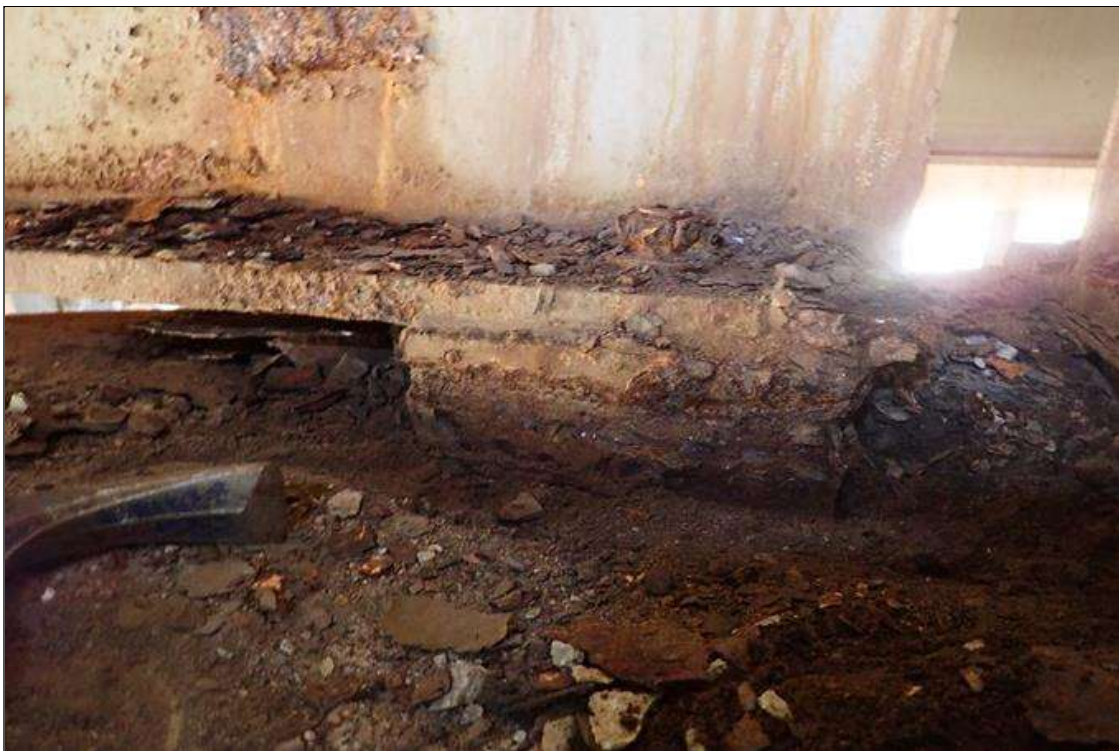
Span 4 Beam 9 Far Bearing 9: (PAR) bearing frozen with pack rust

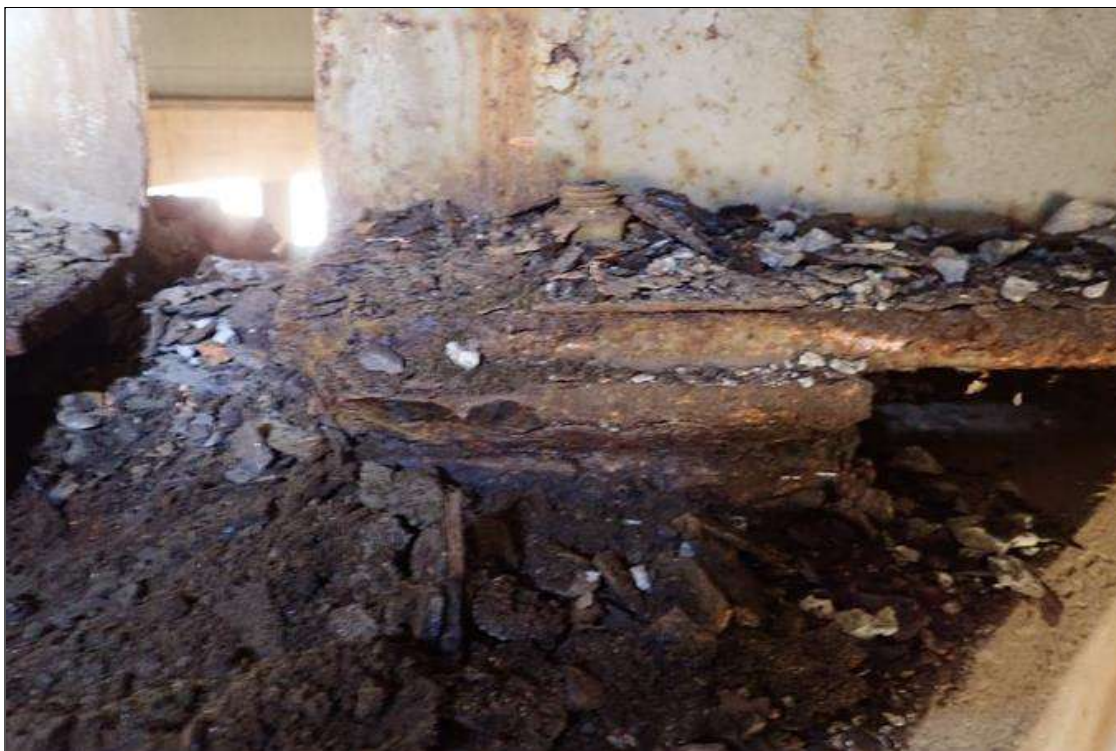
Span 5 Beam 9 Near Bearing 9: (PAR) bearing frozen with pack rust

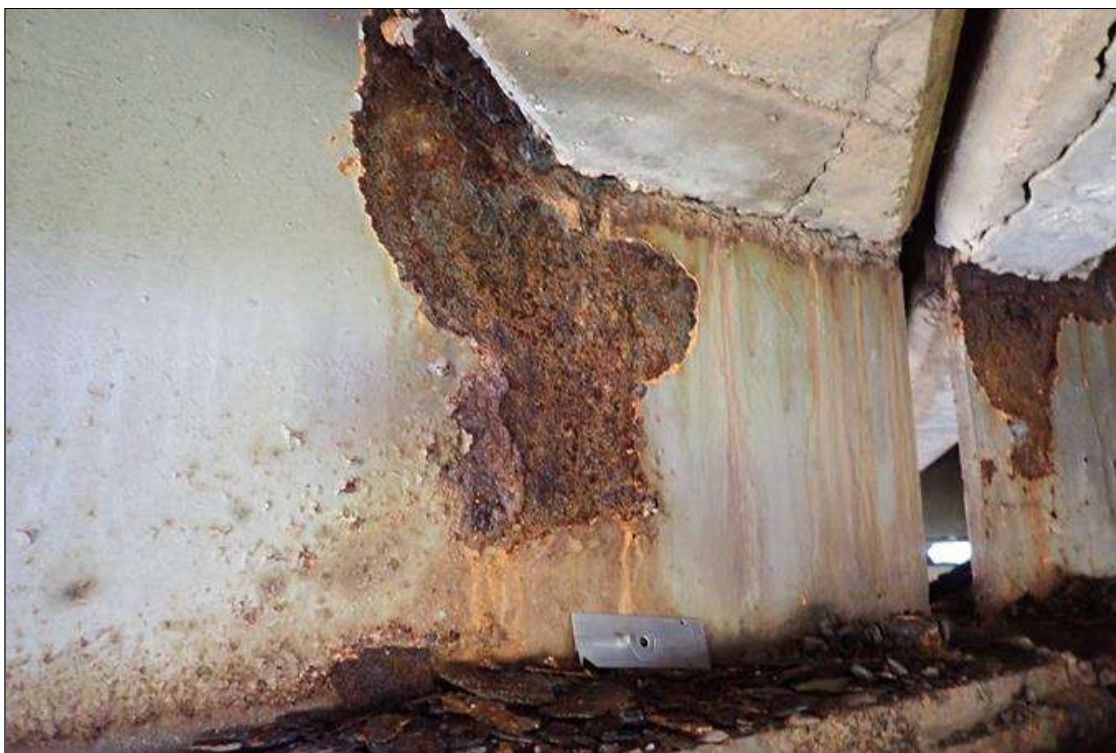
Span 4 Beam 9: (PAR) at bent 4, corrosion with section loss: web at end diaphragm, (1/4" remaining x 1.5' x up to 12")

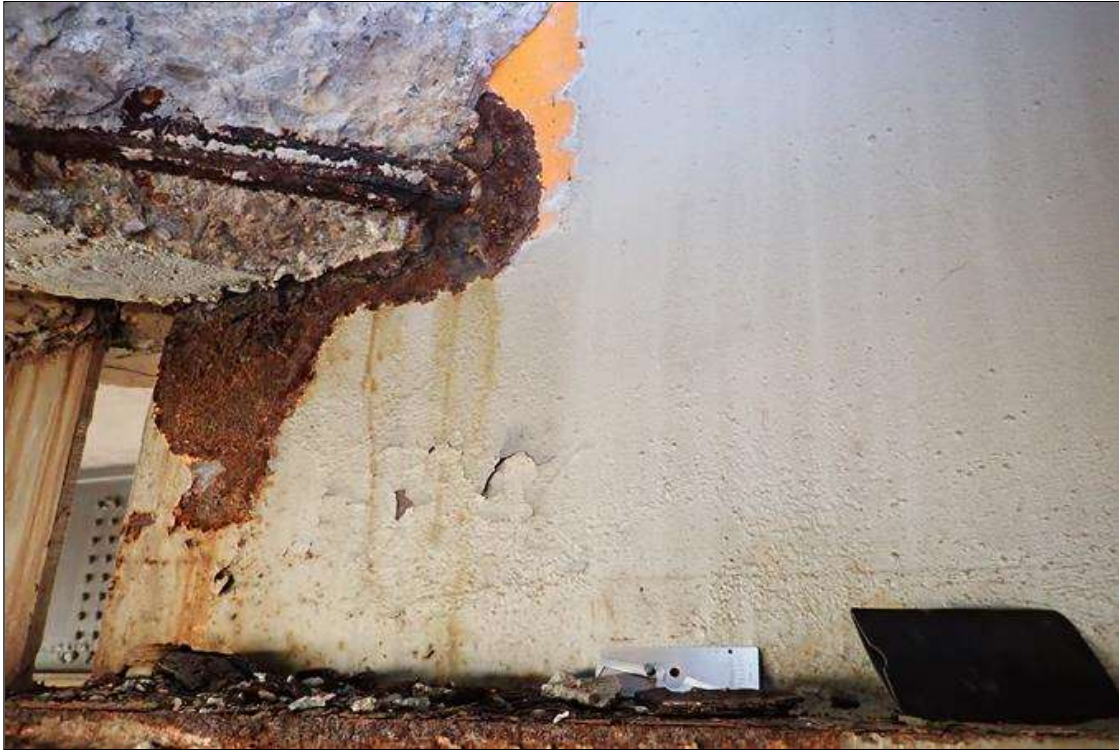
Span 5 Beam 9: (PAR) at bent 4, corrosion with section loss: web at end diaphragm, (1/4" remaining x 14" x 5"); bottom flange, pitting (up to 1/16" x 1.5')

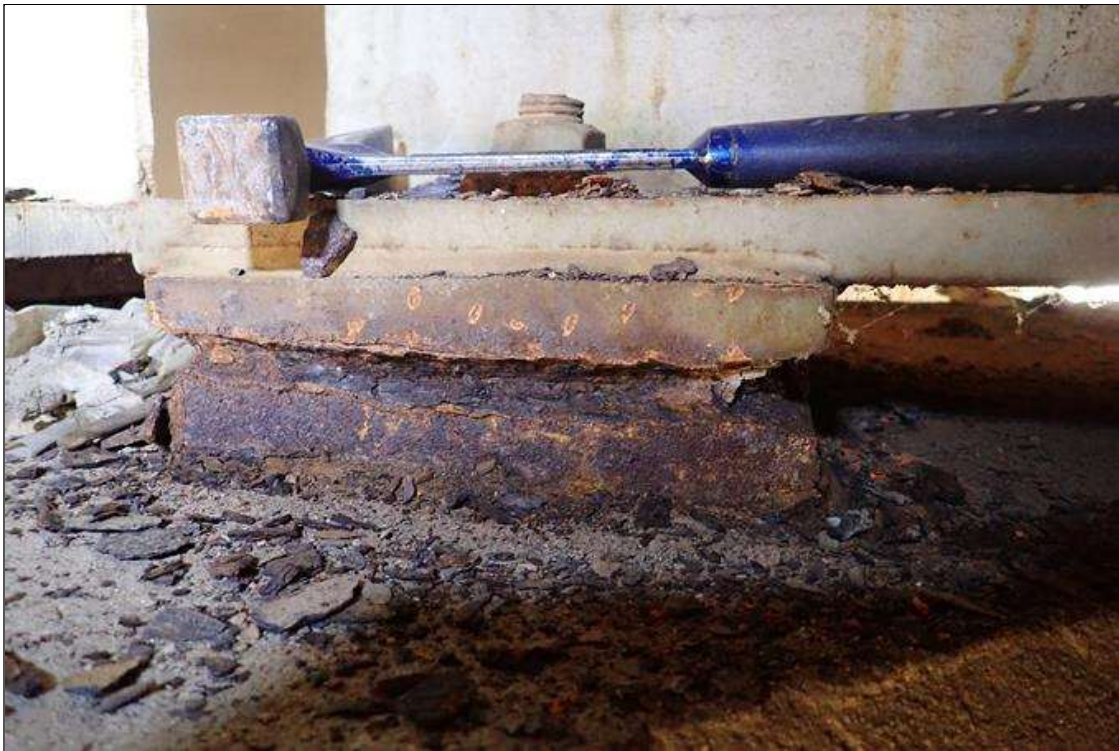
Span 5 Beam 8 Near Bearing 8: (PAR) bearing frozen with pack rust

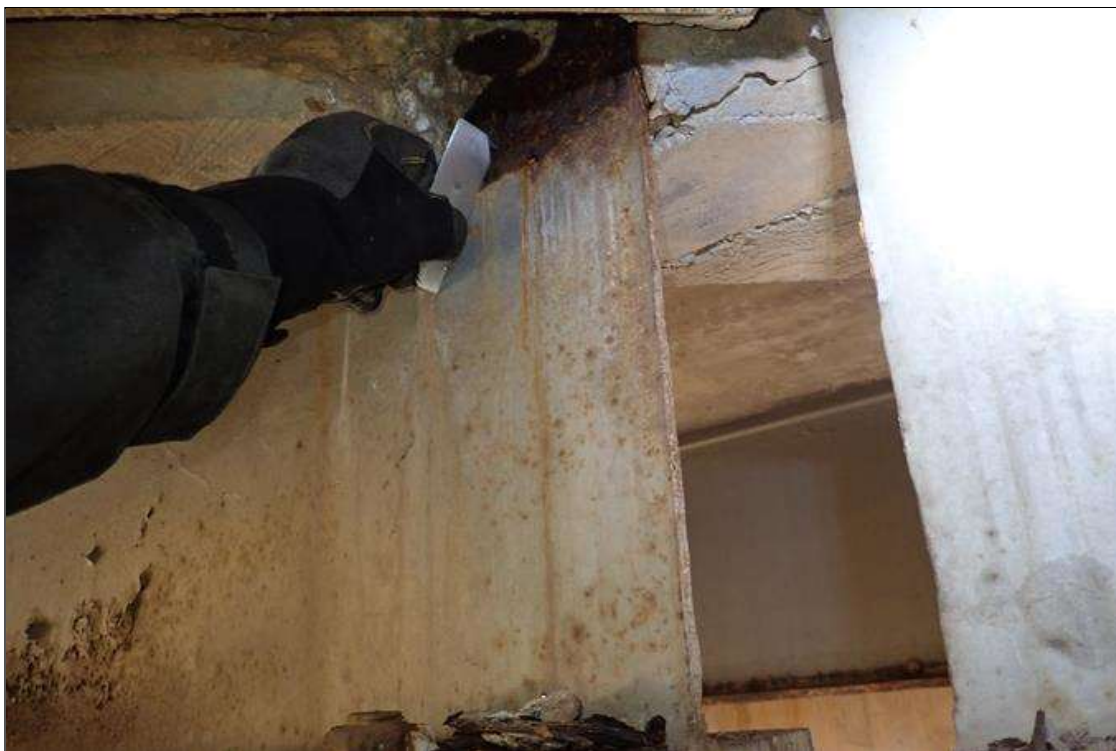
Span 4 Beam 8: (PAR) at bent 4, web at end diaphragm, (3/8" remaining x 6" x 4")

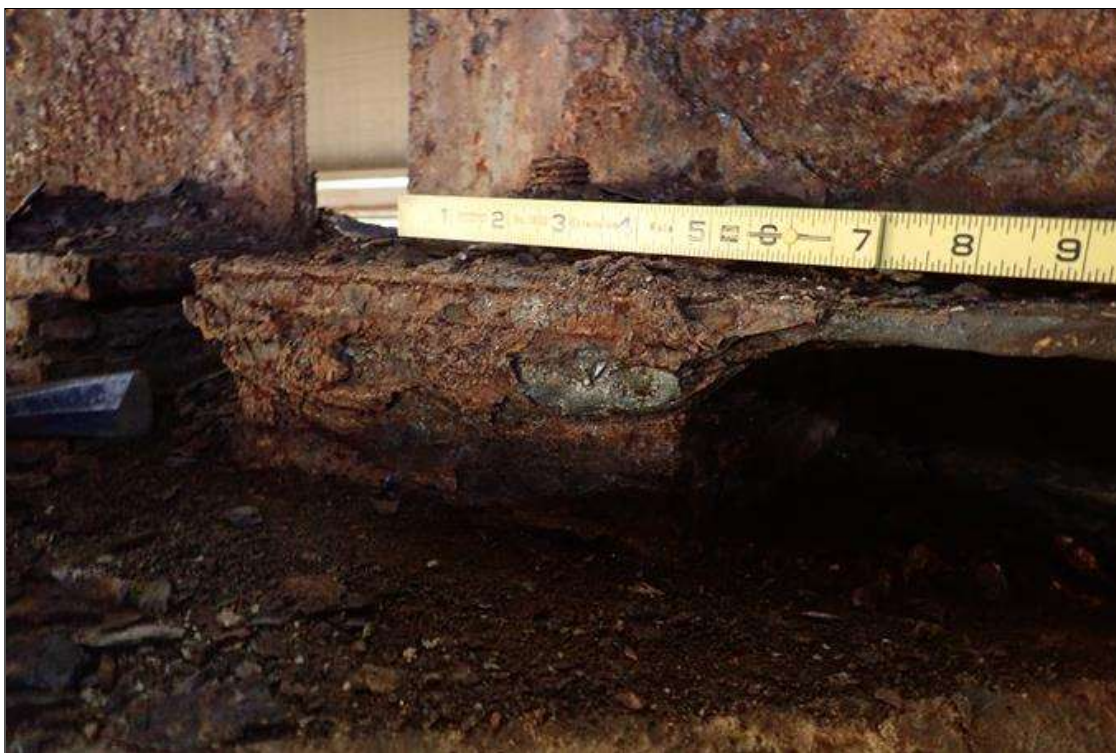
Span 5 Beam 7 Near Bearing 7: (PAR) bearing frozen with pack rust and 1/8" section loss at edge of plate
