NC DEPARTMENT OF TRANSPORTATION
 DIVISION OF HIGHWAYS
 STRUCTURE MANAGEMENT UNIT

ATTENTION: **partial inspection, awaiting railroad entry permit; prompt action request, sketches revised, temporary repairs to caps**

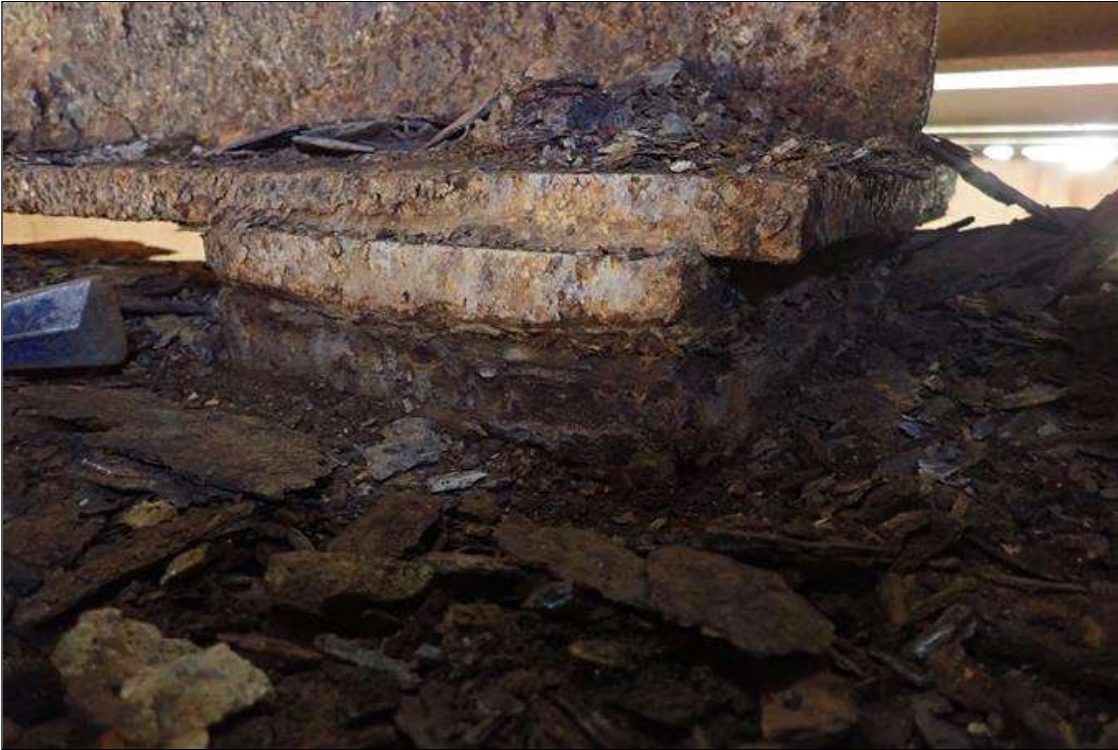
Span 4 Beam 7 Far Bearing 7: (PAR) bearing frozen with pack rust

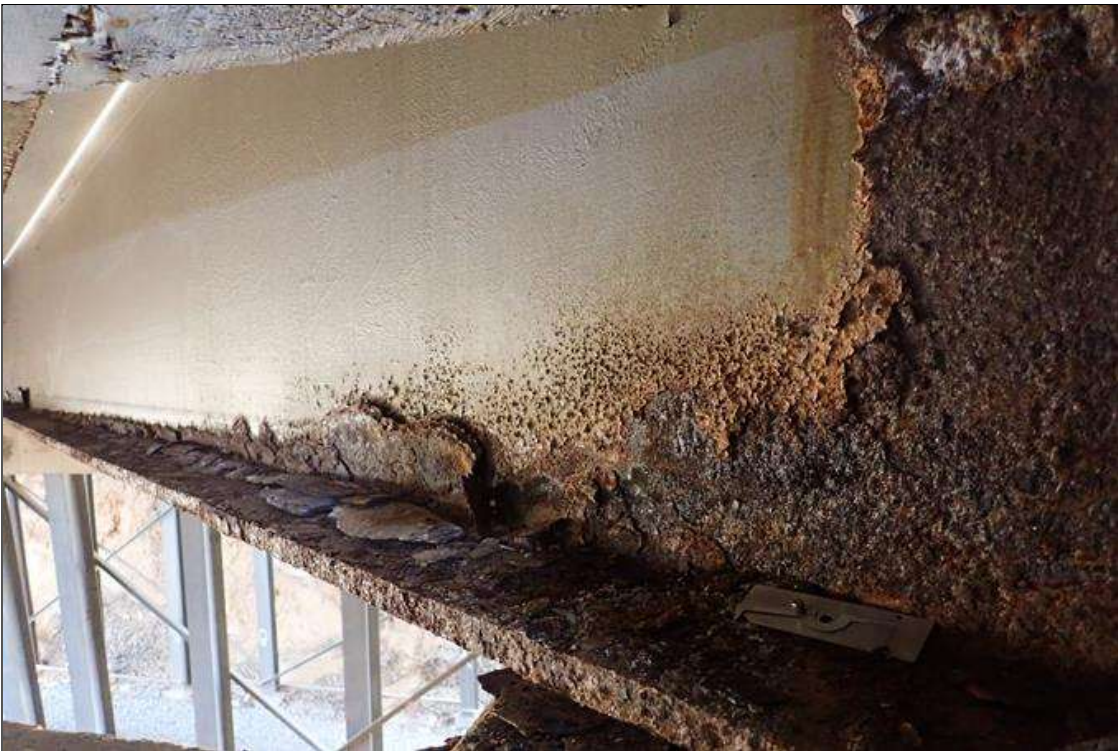
Span 4 Beam 7: (PAR) at bent 4, corrosion with section loss: web, at bearing, (3/8" remaining x 16" x 12"); bottom of web, (1/4" remaining x 2" x approximately 15'); bottom flange, (0.7" average remaining x 16")

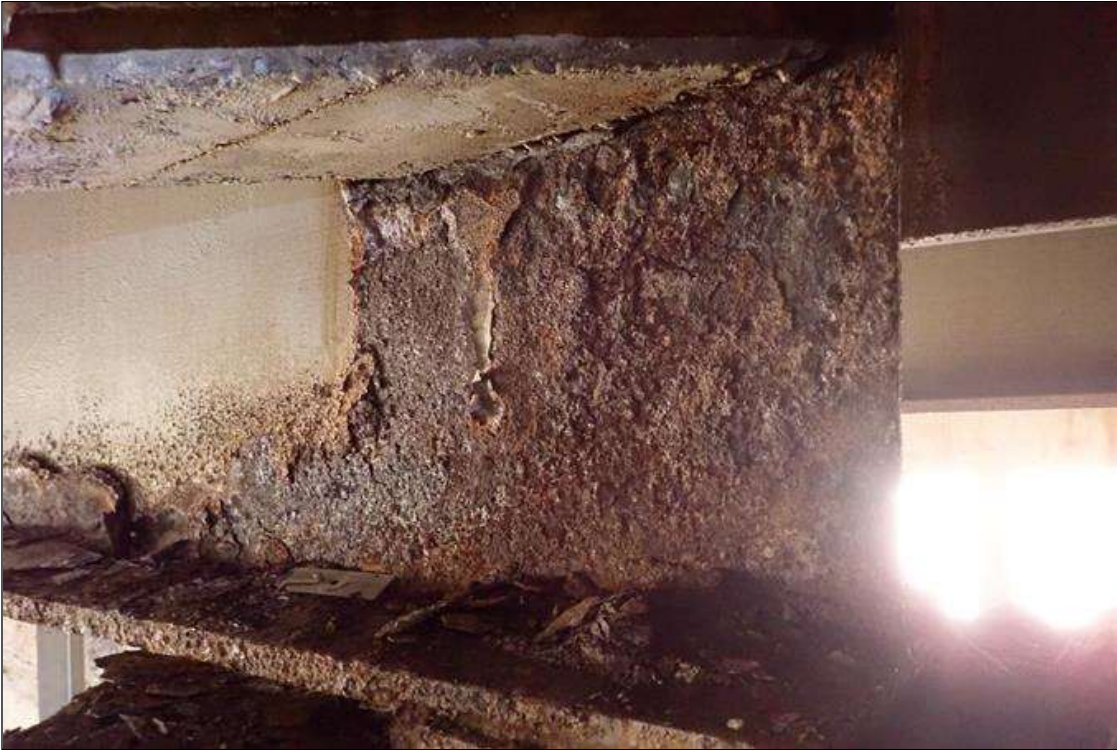
Span 4 Beam 7: (PAR) at bent 4, corrosion with section loss: web, at bearing, (3/8" remaining x 16" x 12"); bottom of web, (1/4" remaining x 2" x approximately 15'); bottom flange, (0.7" average remaining x 16")

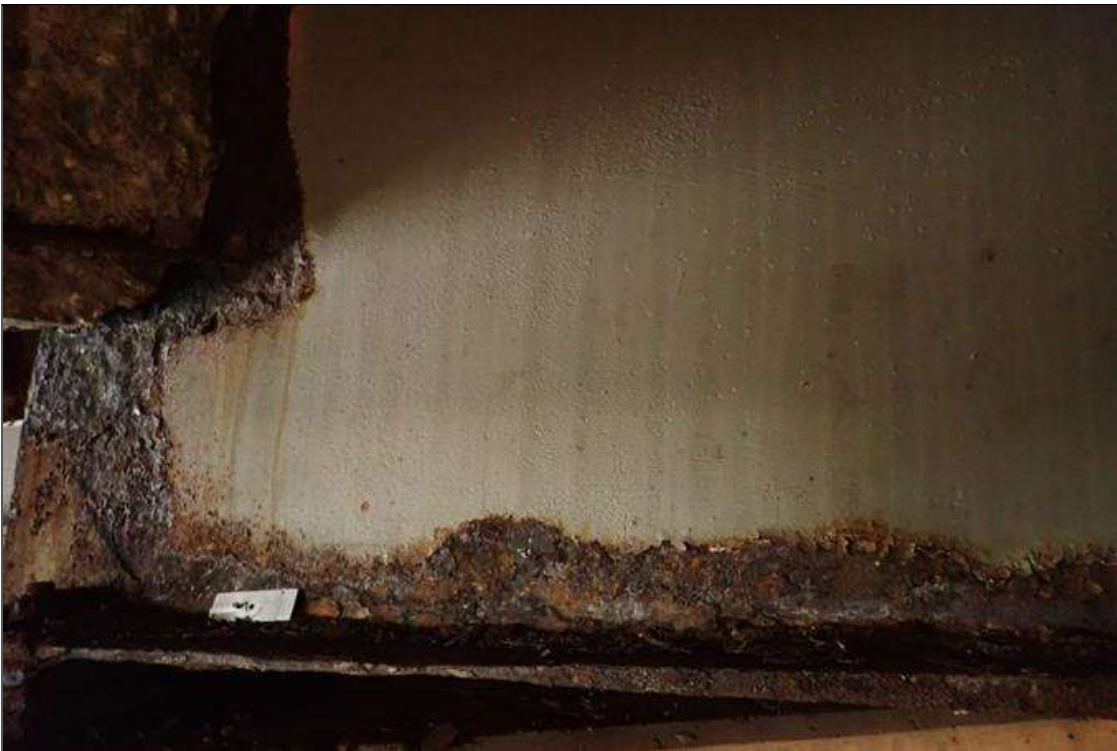
Span 5 Beam 7: (PAR) at bent 4, corrosion with section loss: bottom flange, (0.5" average remaining x 2.5'); web at end diaphragm, (1/4" remaining x 14" x 16"); bottom of web, (5/16" remaining x 3" x 4')

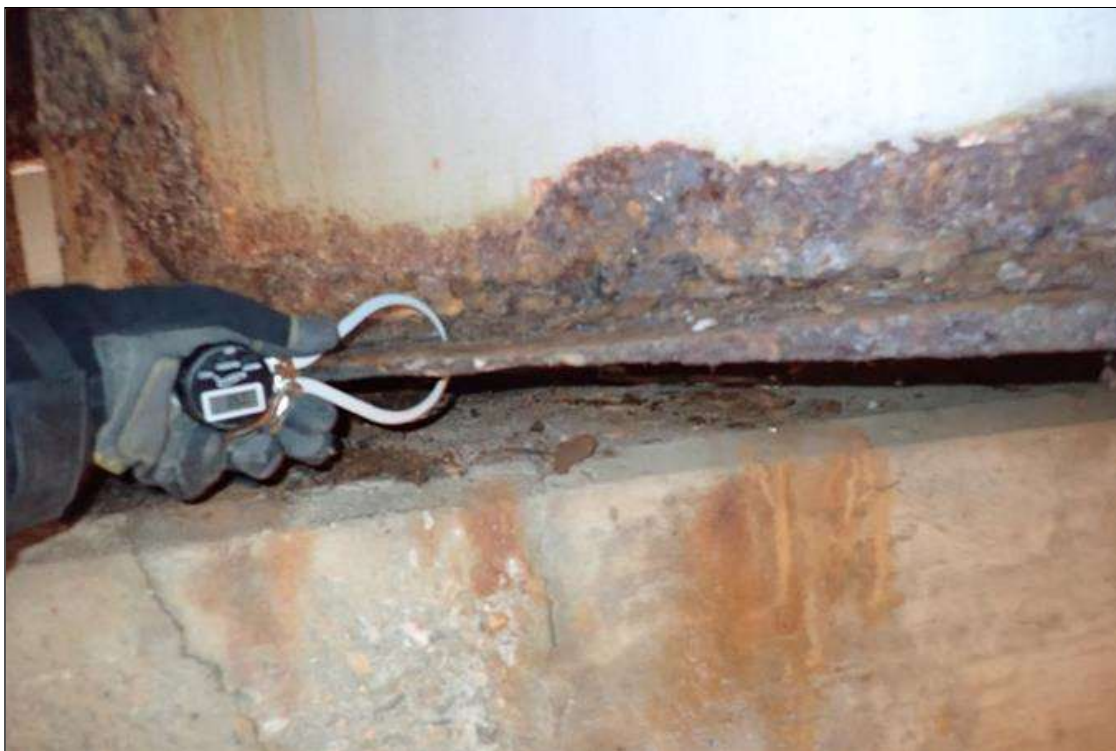
Span 5 Beam 7: (PAR) at bent 4, corrosion with section loss: bottom flange, (0.5" average remaining x 2.5'); web at end diaphragm, (1/4" remaining x 14" x 16"); bottom of web, (5/16" remaining x 3" x 4')

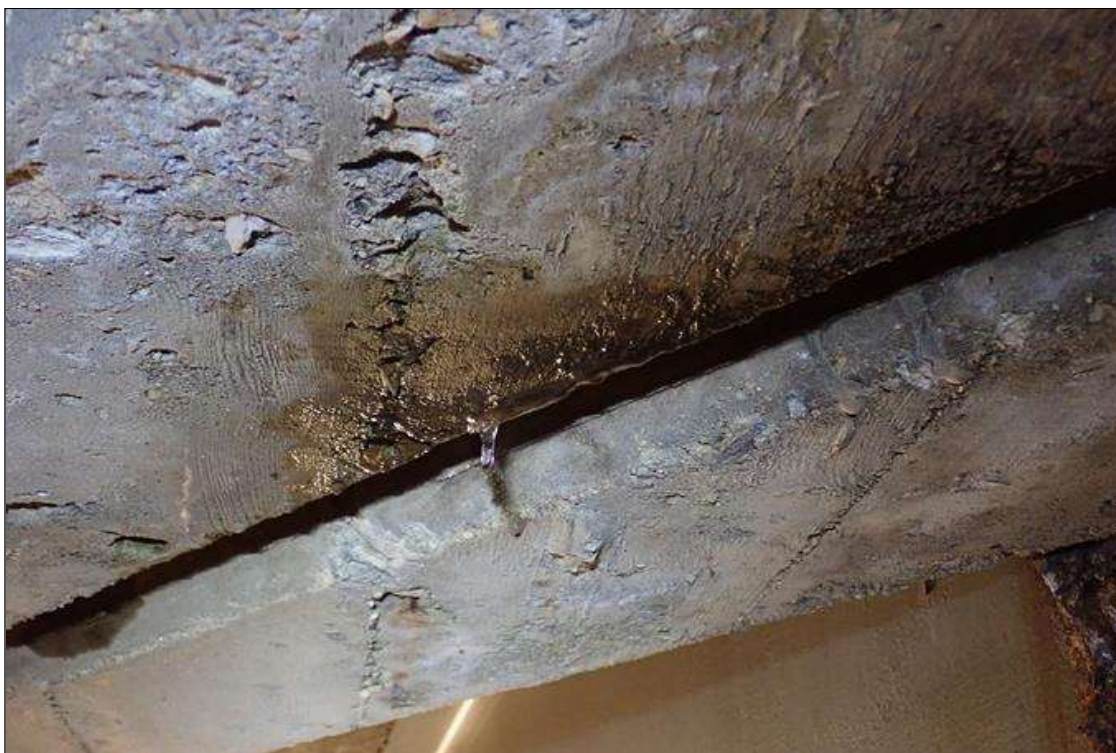
Bent 4 Joint : at random, active dripping

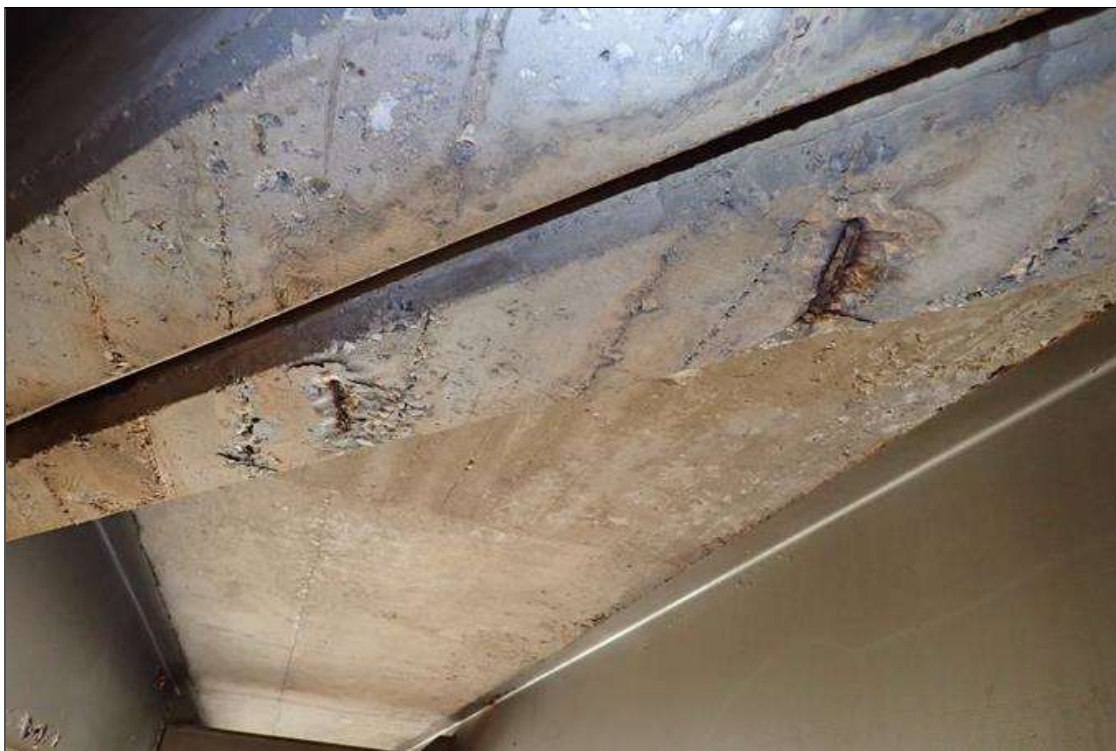
Span 4 Deck: bent 4 end diaphragm, bay 7, underside, multiple spalls (up to 8" x 6" x 1"); similar bays 8, 9 and 10

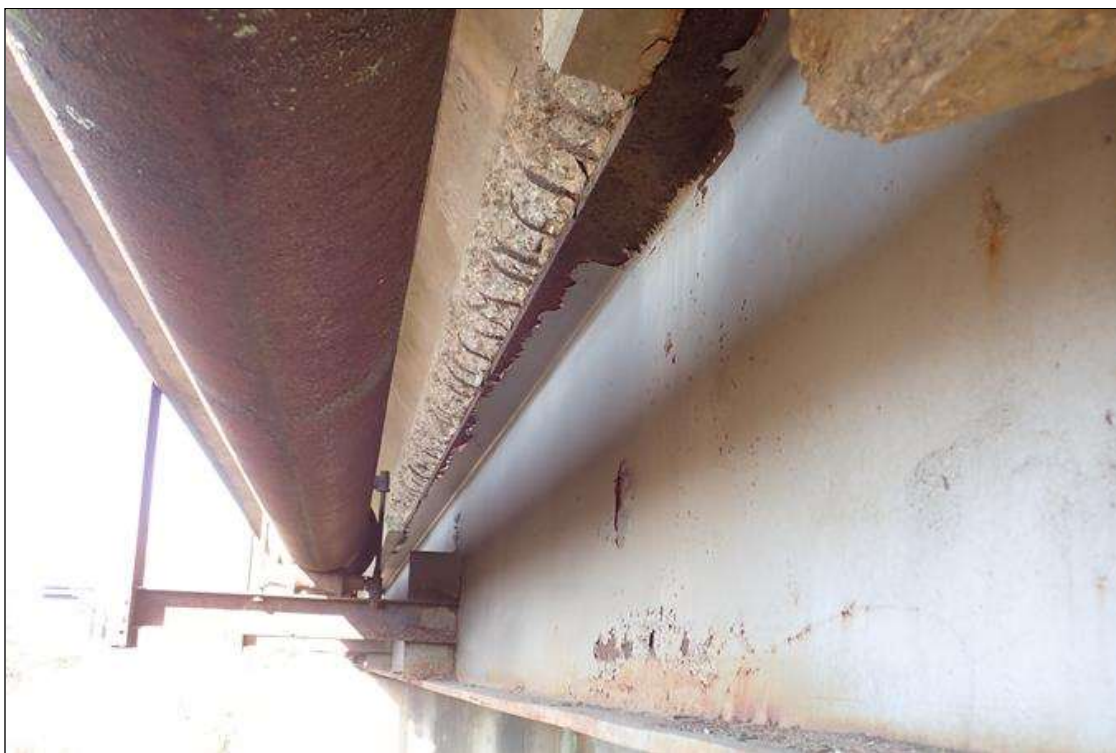
Span 4 Deck: (PAR) at bent 4, right side of beam 11 haunch, spall (25' x 5" x 5") with exposed rusted rebar

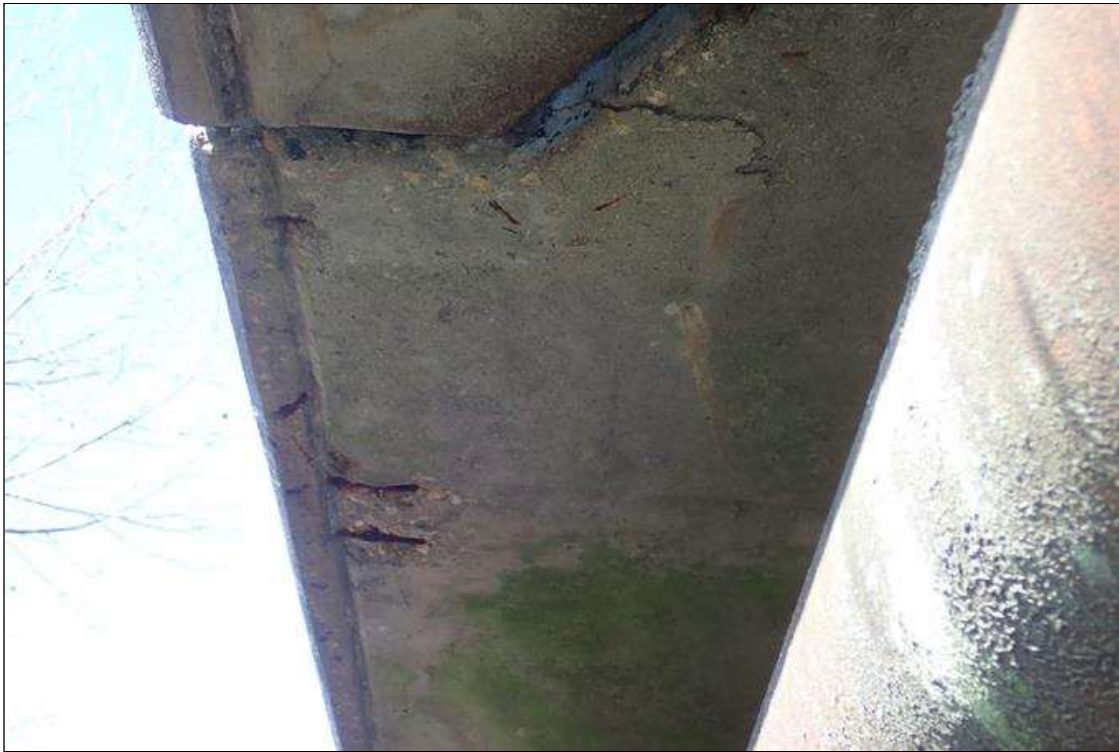
Span 4 Deck: underside of right overhang at bent 4, (2) spalls (8" diameter x 1") with exposed rusted rebar

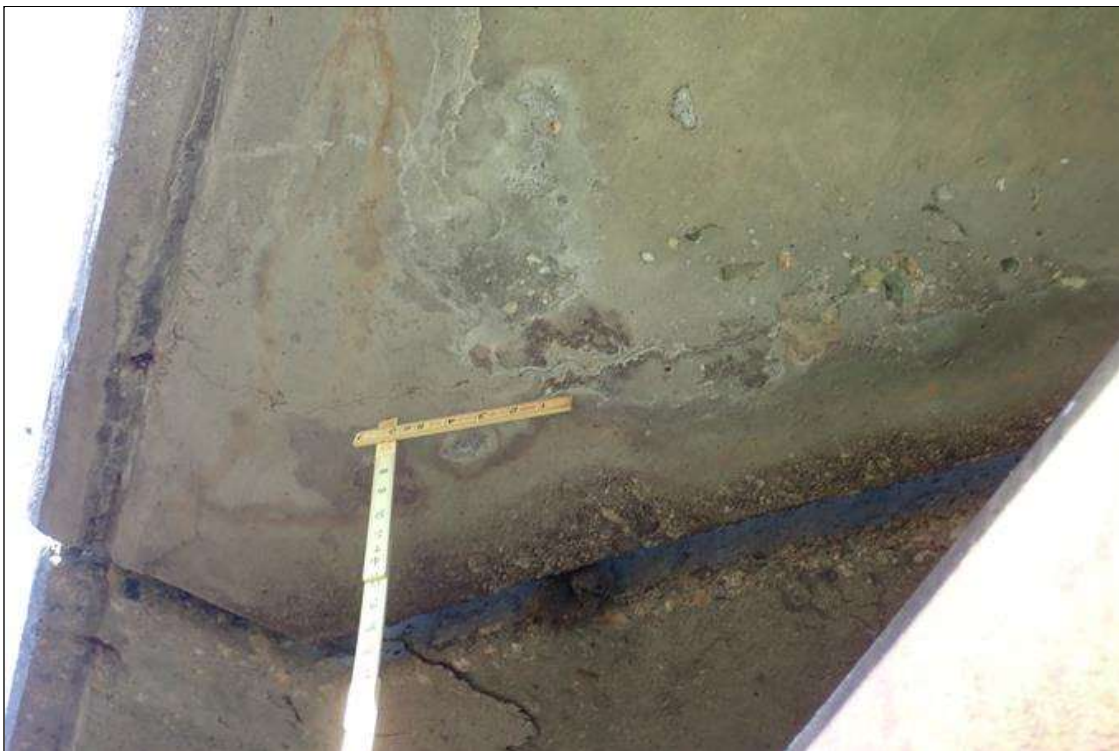
Span 5 Deck: underside of right overhang at bent 4, transverse crack (1/32" x 3')

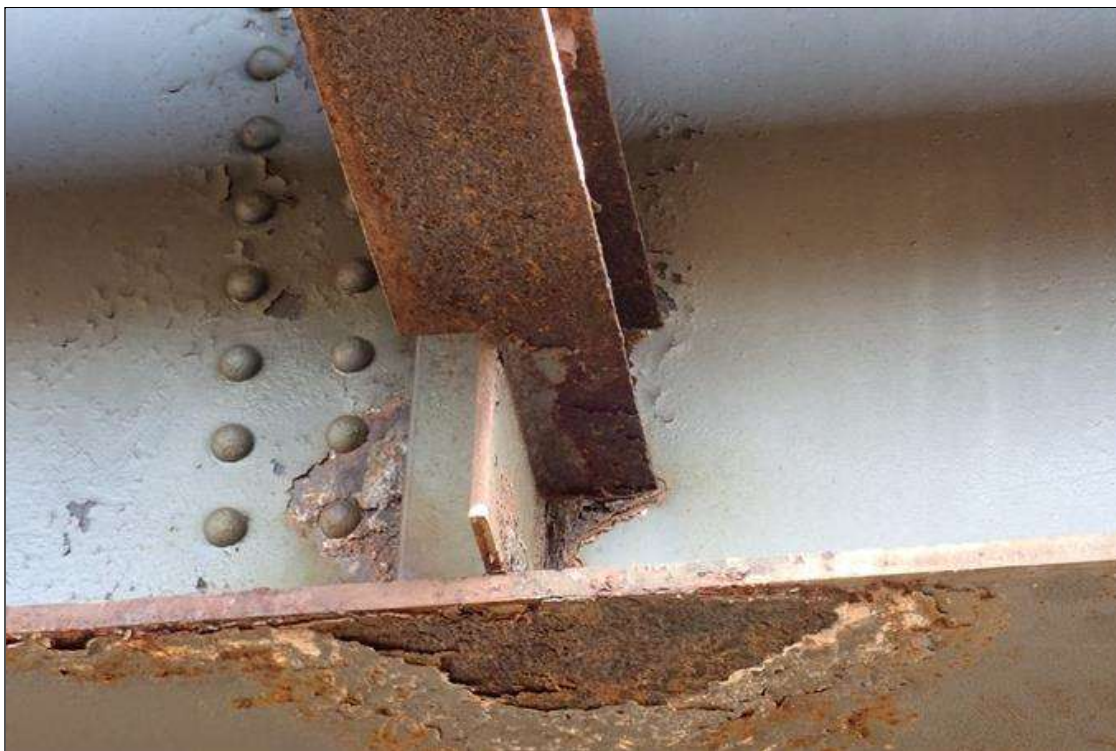
Span 4 Beam 11: midspan at utility connection, rust scale (no ladder access to verify remaining section)

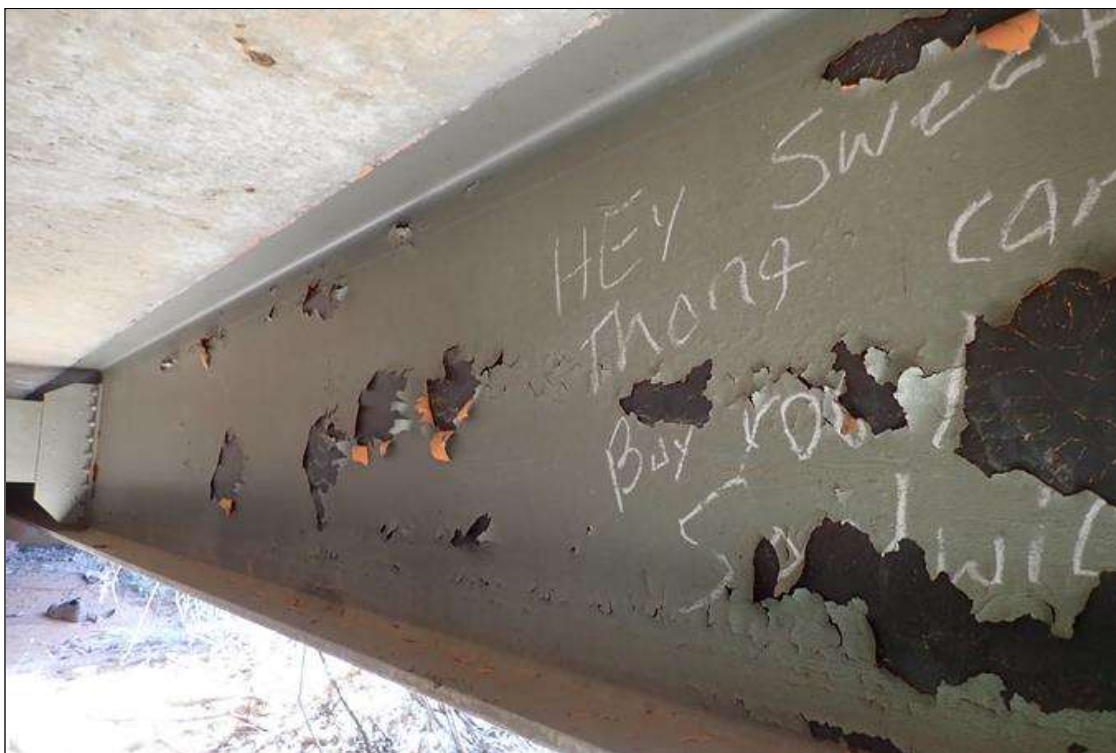
Span 5 Beam 11: paint peeling at random

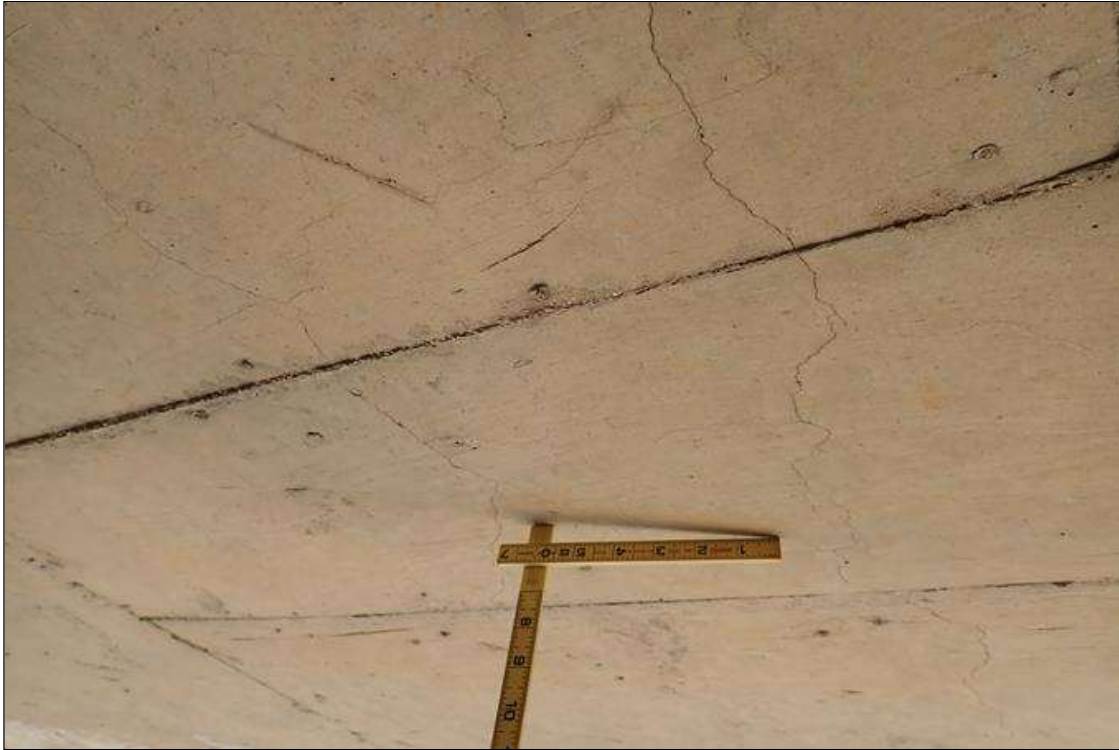
Span 2 Deck: underside at bent 4, bays 9 and 10, multiple transverse cracks (hairline up 1/32" x 7')

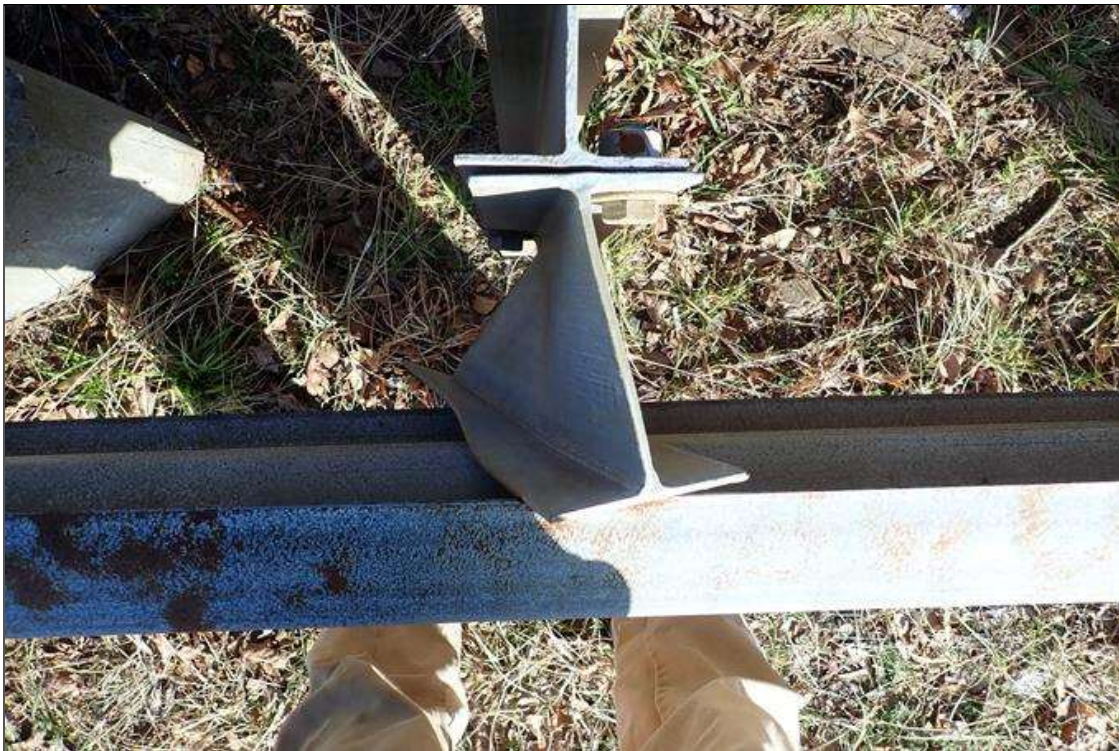
(PAR) northeast guardrail, near end bent 2, (2) spacer blocks twisted

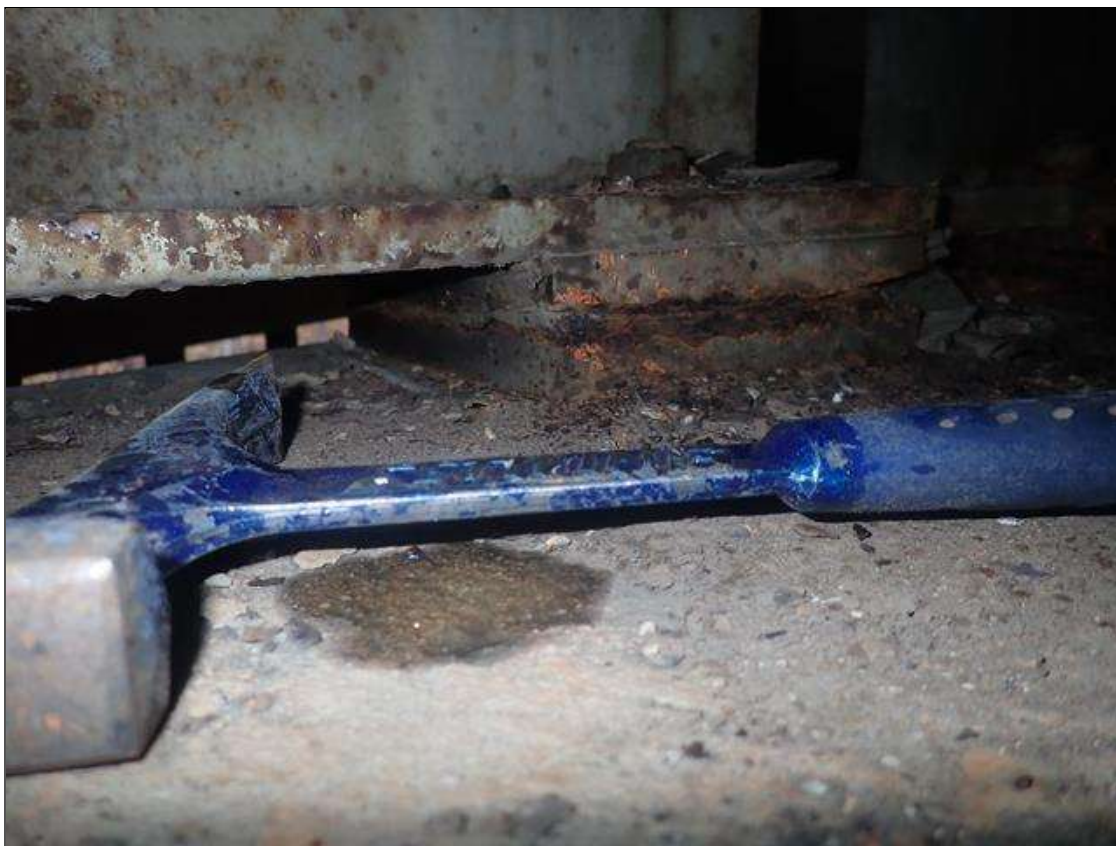
Span 4 Beam 8 Far Bearing 8: (PAR) bearing frozen with pack rust

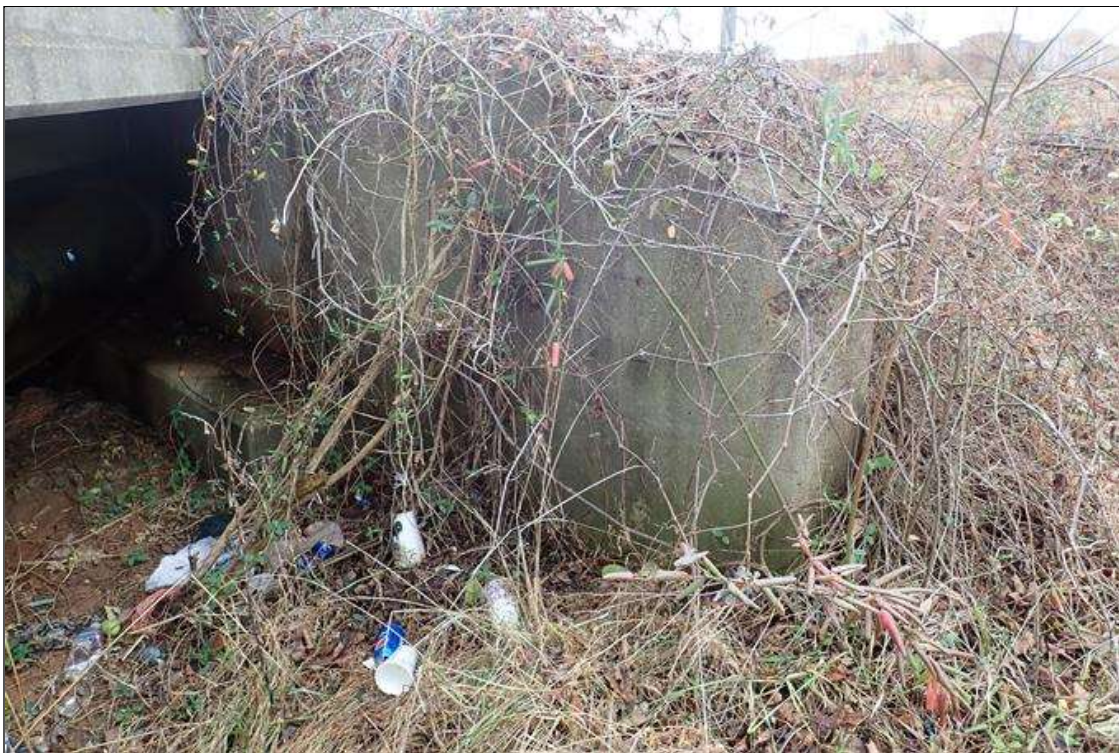
north profile looking south

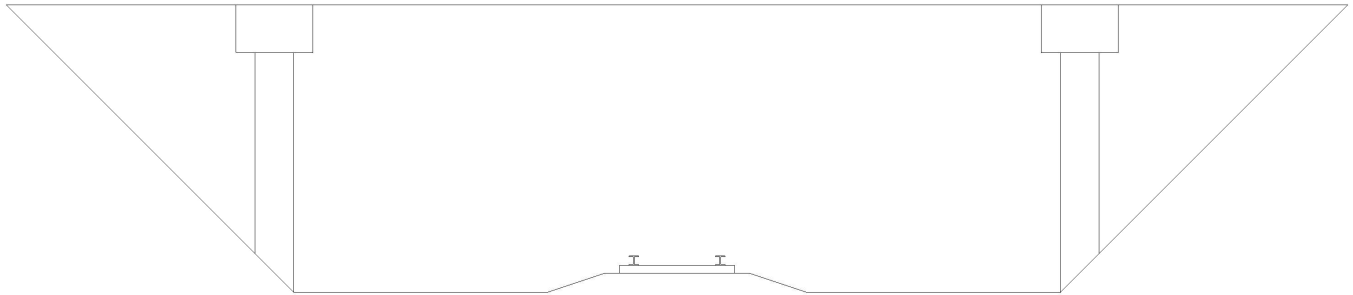
Measurements Under Span 3

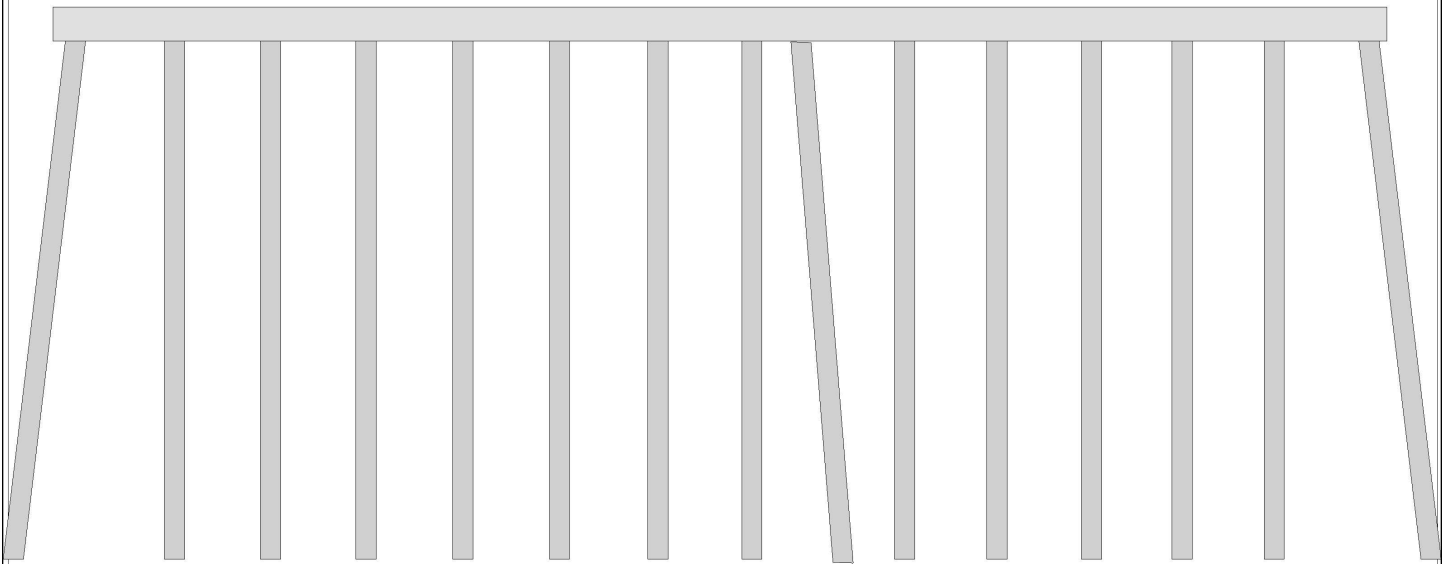
Cap Information			Material Cast-in-Place Concrete							
Length	Width	Height	Left Overhang	Right Overhang	Left Beam to End of Cap.	Right Beam to End of Cap.
