NC DEPARTMENT OF TRANSPORTATION
 DIVISION OF HIGHWAYS
 STRUCTURE MANAGEMENT UNIT

Structure Safety Report

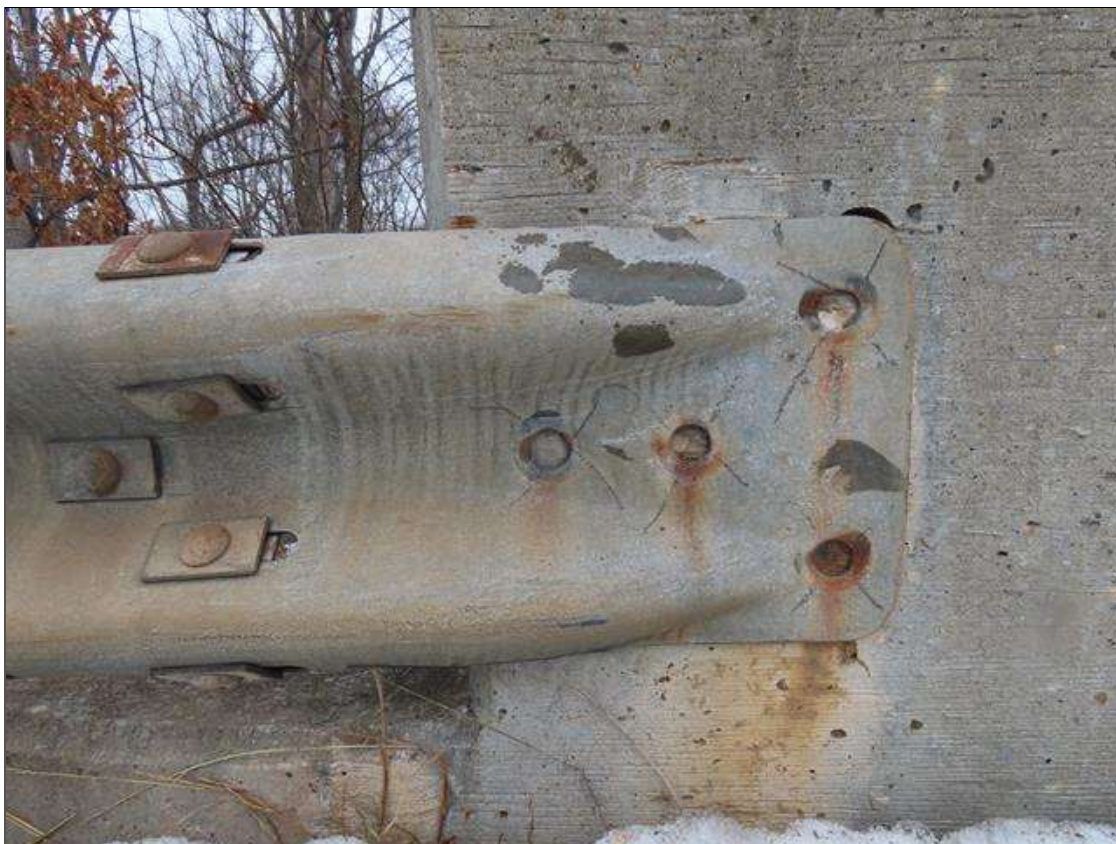
NEAR LEFT GUARDRAIL ATTACHMENT - NO ANCHOR BOLTS PRESENT (PAR PHOTO)

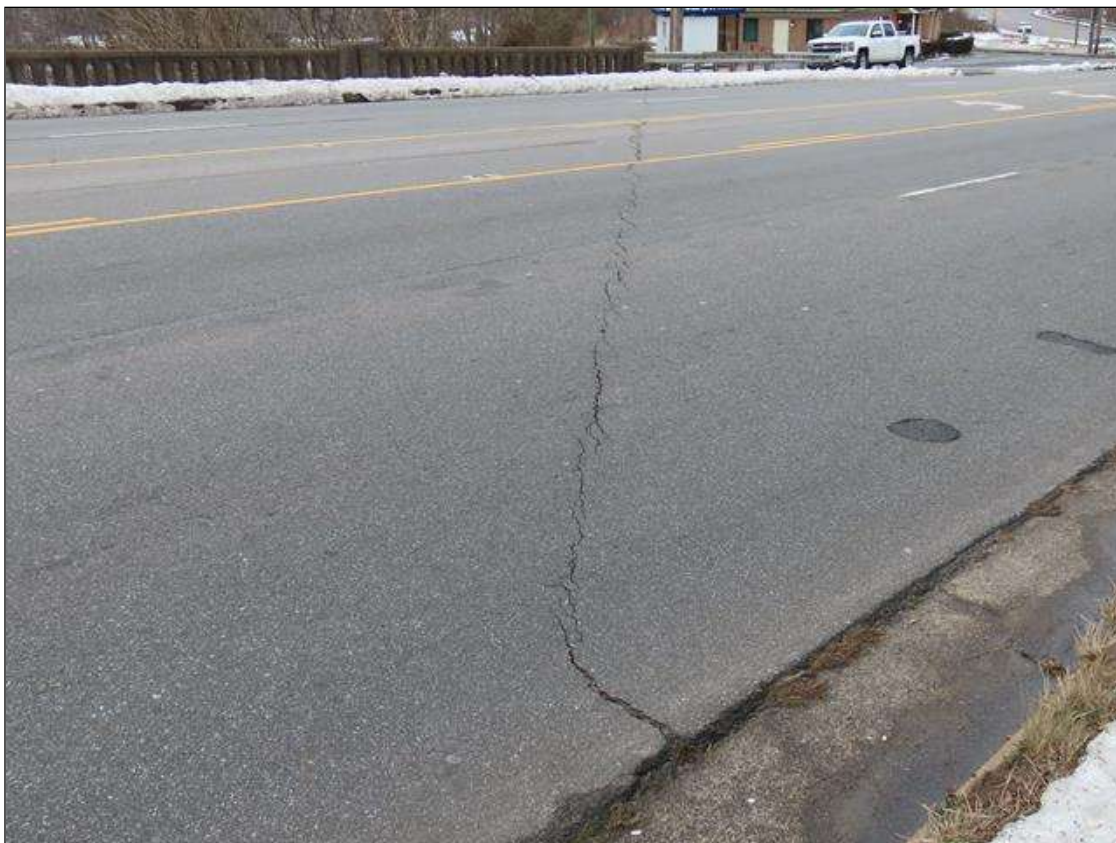
SPAN 1 AWS - FULL WIDTH TRANSVERSE CRACKING (UP TO 1/2IN) OVER END BENT 1 (SIMILAR OVER END BENT 2)

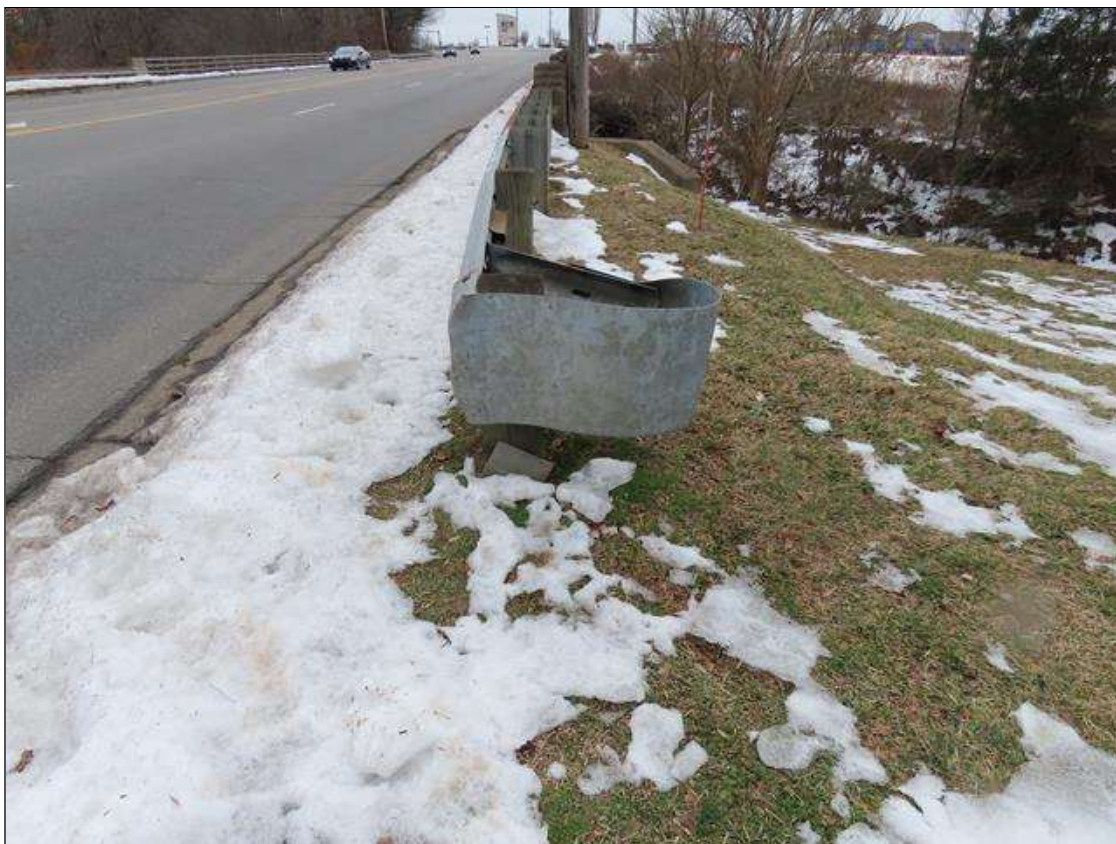
NEAR RIGHT GUARDRAIL END TREATMENT - MODERATE IMPACT DAMAGE

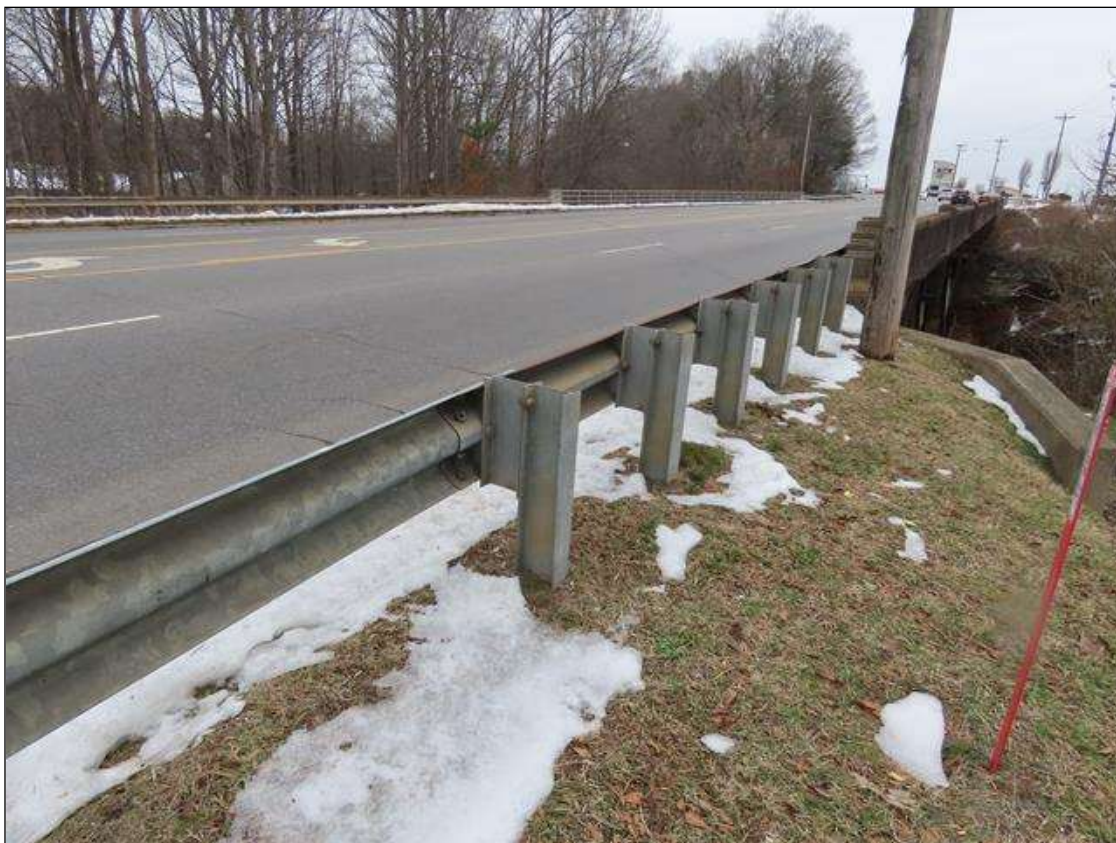
GUARDRAIL POST SPACING / TRANSITION AT NEAR RIGHT

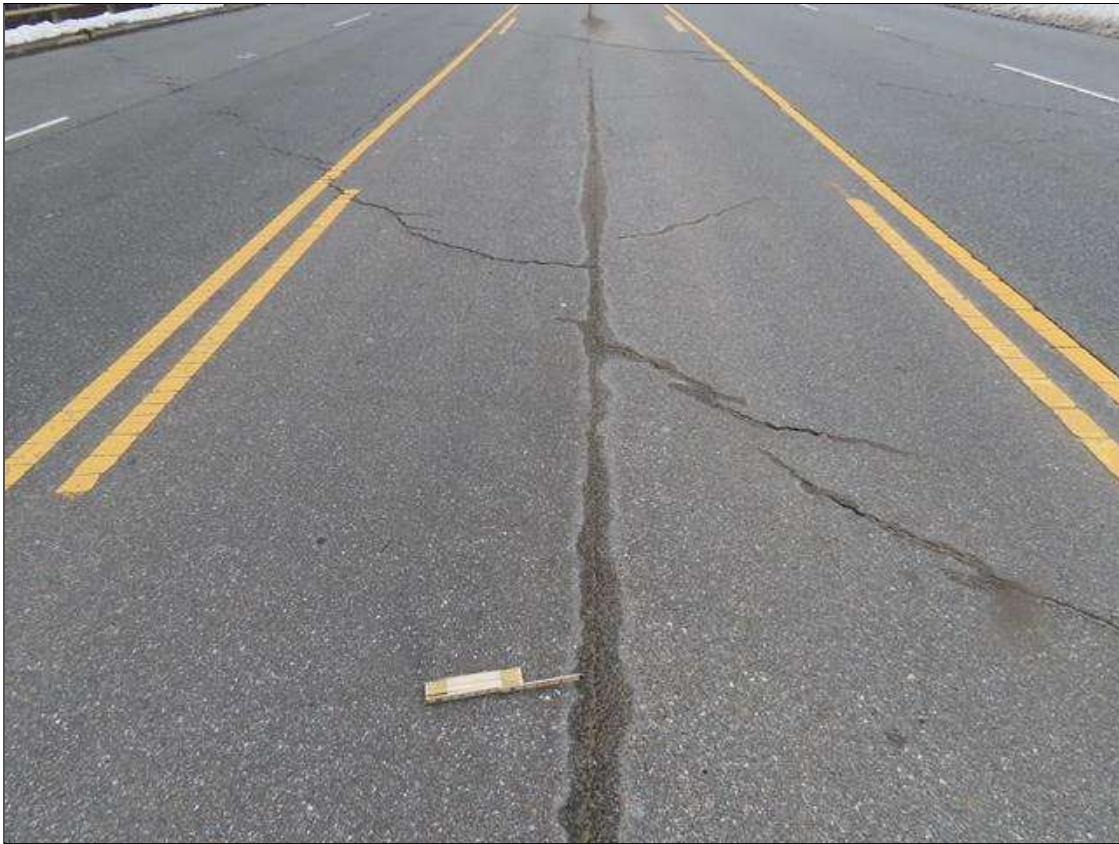
TYP. FULL LENGTH LONGITUDINAL CRACK (1/8IN) THROUGHOUT SPANS AT CENTER OF ROADWAY, SPAN 1

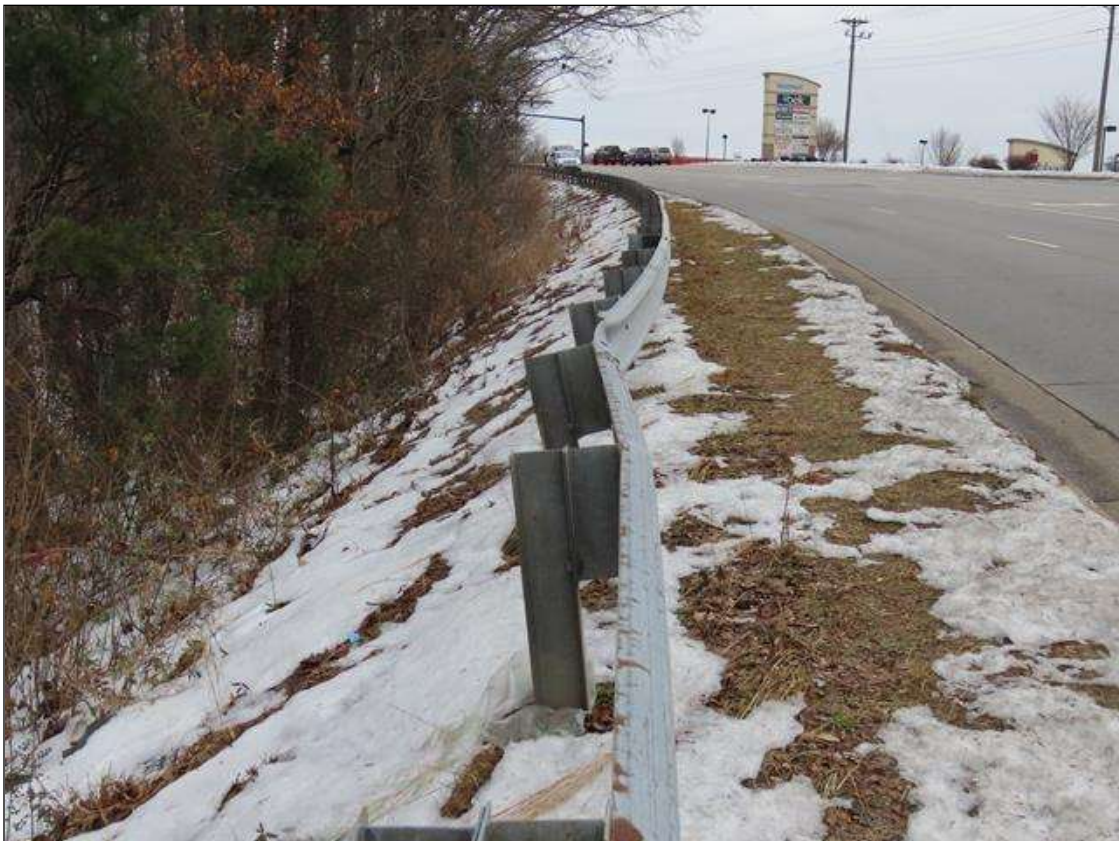
FAR LEFT GUARDRAIL - MODERATE IMPACT DAMAGE (20FT L. X 1FT DISTORTION) STARTING 60FT FROM BRIDGE

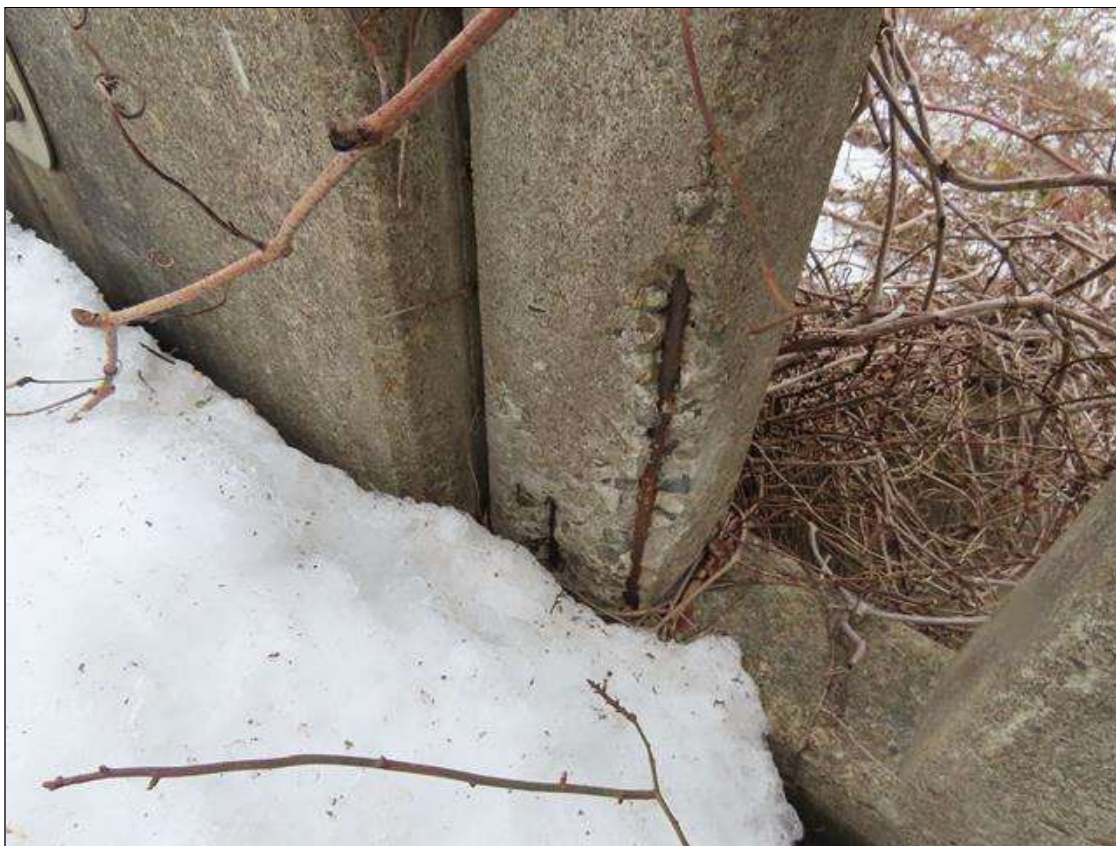
SPAN 5 RIGHT RAIL - SPALL (12IN X 5IN X 1IN) WITH EXPOSED REBAR TO NEAR SIDE OF FAR VERTICAL POST

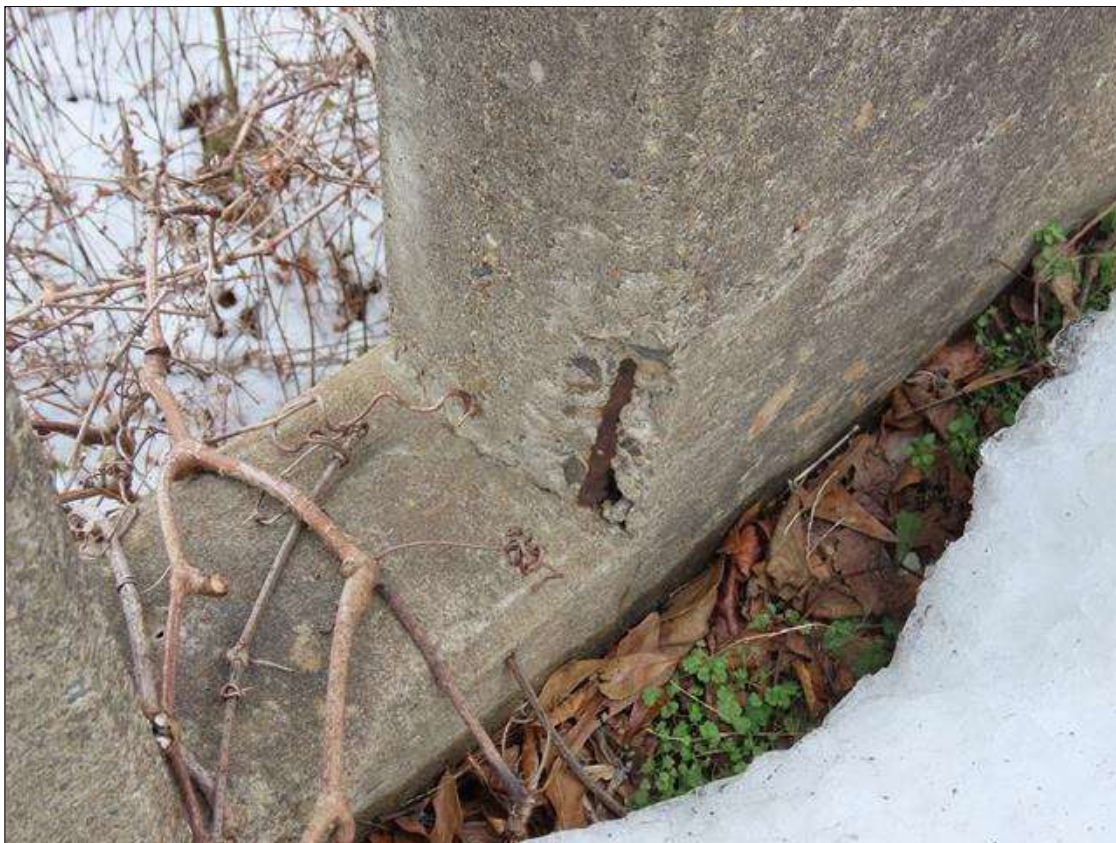
TYP. MINOR SPALLING (UP TO 6IN X 3IN X 1IN) WITH EXPOSED REBAR THROUGHOUT VERTICAL POSTS AT RIGHT RAIL, SPAN 5

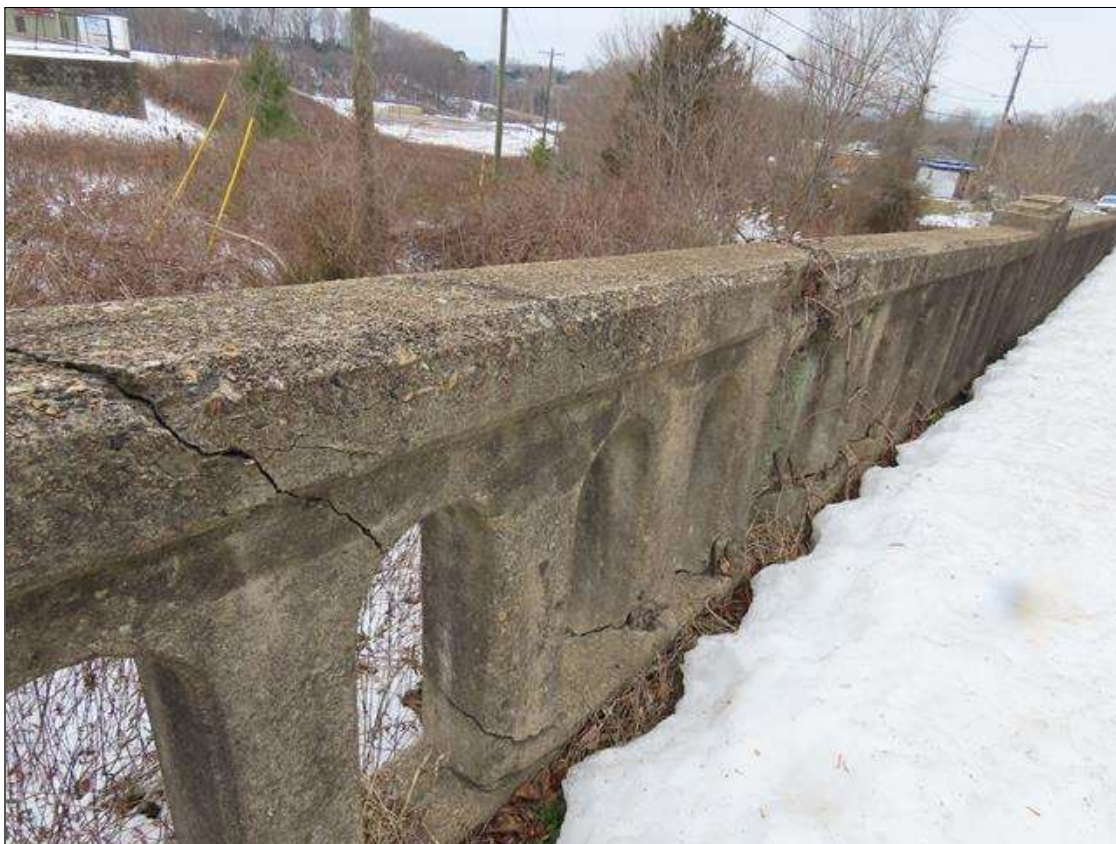
SPAN 5 RIGHT RAIL - HEAVY IMPACT DAMAGE (FULL HEIGHT X 10FT L.) WITH BROKEN/SPALLED CONCRETE & EXPOSED REBAR STARTING 5FT FROM NEAR END (PAR PHOTO 1/2)

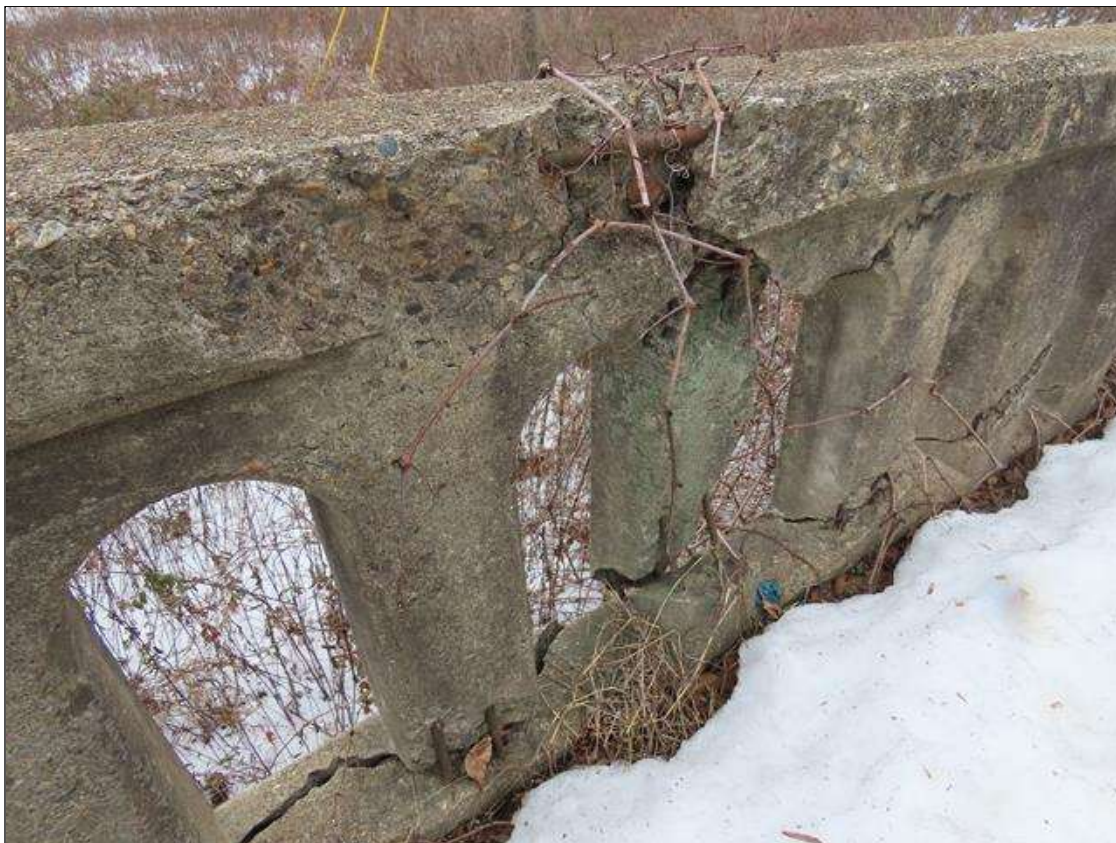
SPAN 5 RIGHT RAIL - HEAVY IMPACT DAMAGE (FULL HEIGHT X 10FT L.) WITH BROKEN/SPALLED CONCRETE & EXPOSED REBAR STARTING 5FT FROM NEAR END (PAR PHOTO 2/2)

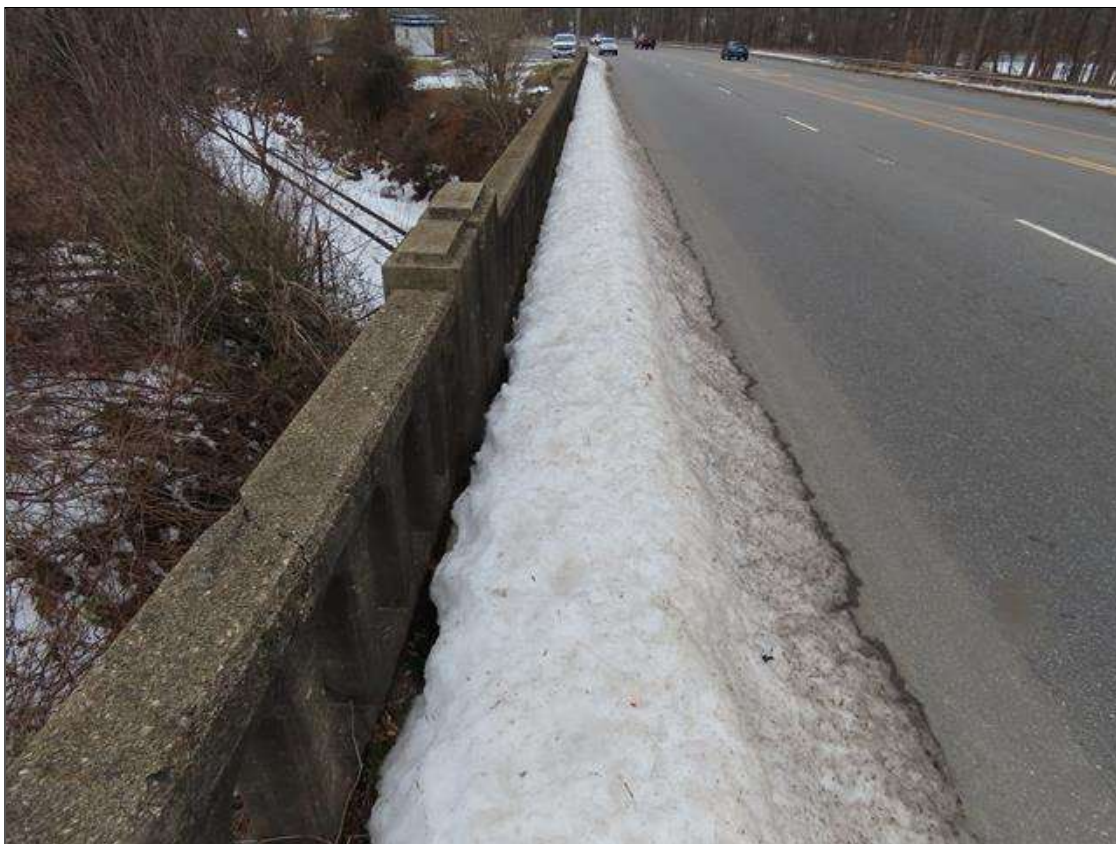
SPAN 5 DECK - SNOW/ICE PACKED THROUGHOUT RIGHT SIDE RAIL CURB

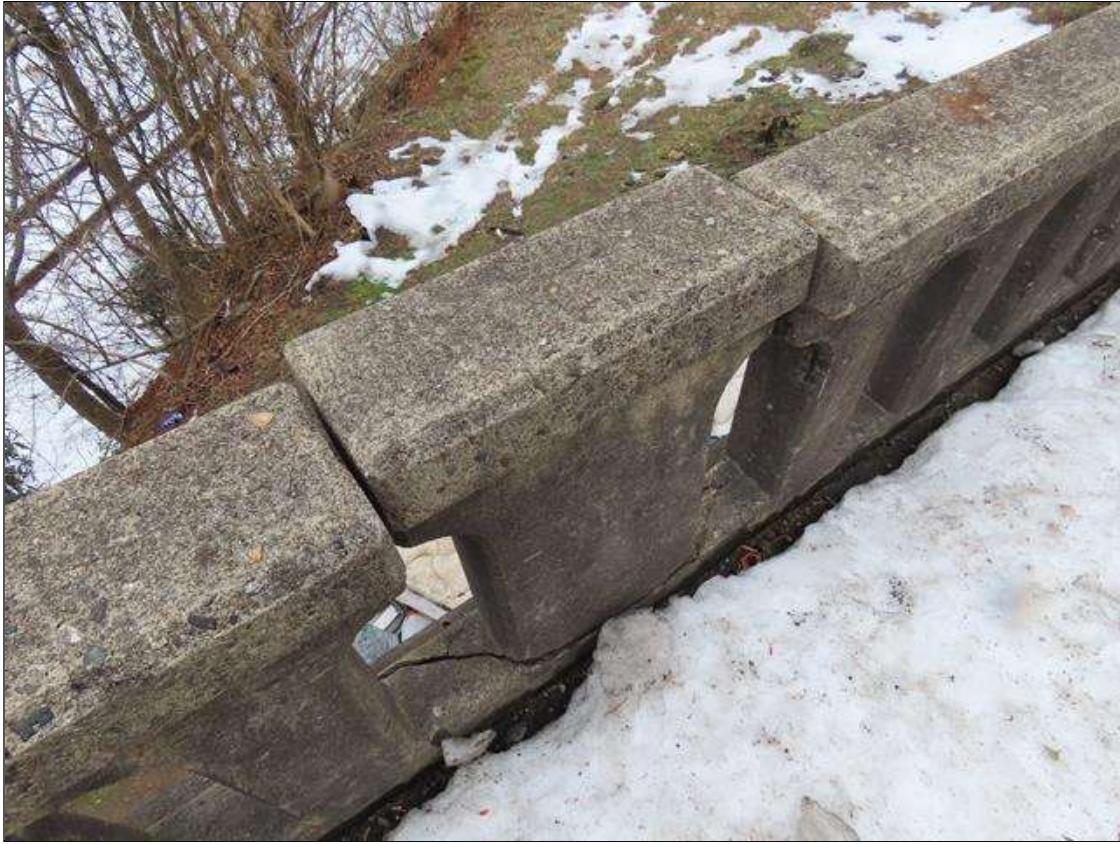
SPAN 1 RIGHT RAIL - HEAVY IMPACT DAMAGE (2FTL. X FULL HEIGHT) WITH BROKEN CONCRETE AND LEANING RAIL AT MIDSPAN (PAR PHOTO)

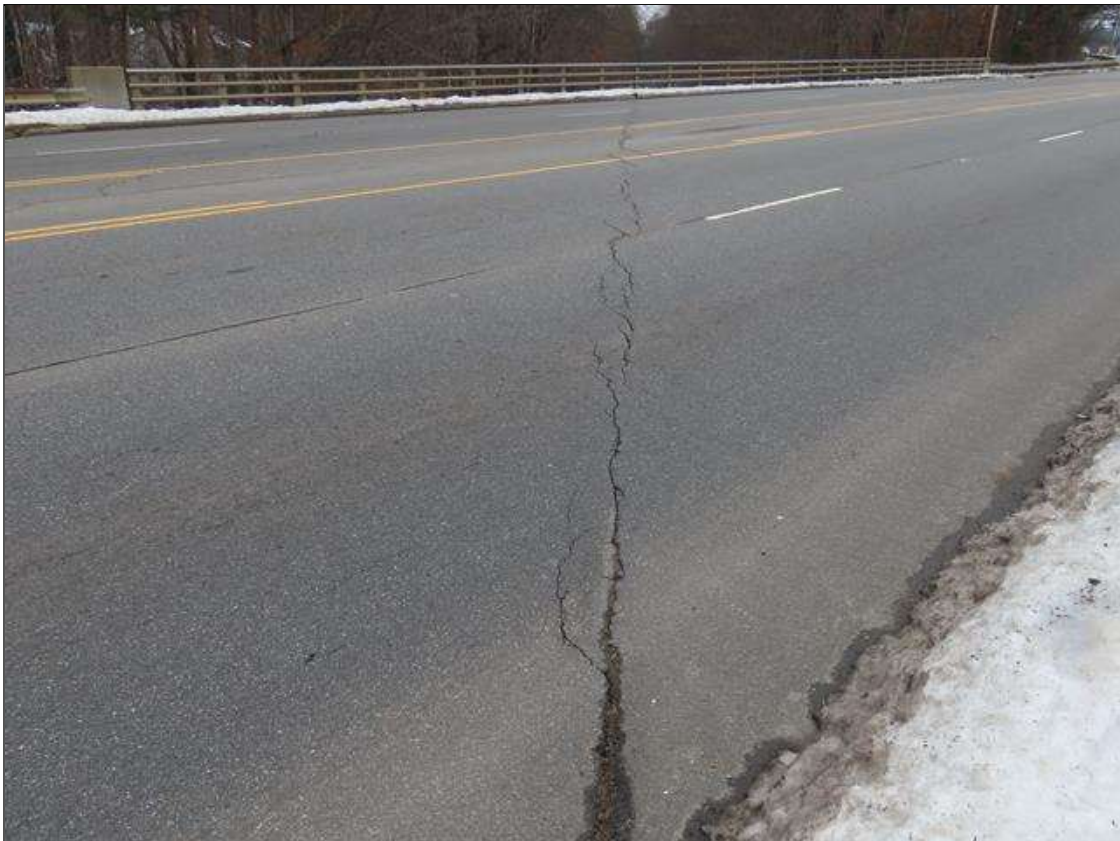
SPAN 2 AWS - FULL WIDTH TRANSVERSE CRACK (UP TO 1/4IN) OVER BENT 2 (SIMILAR OVER ALL INTERIOR BENTS)

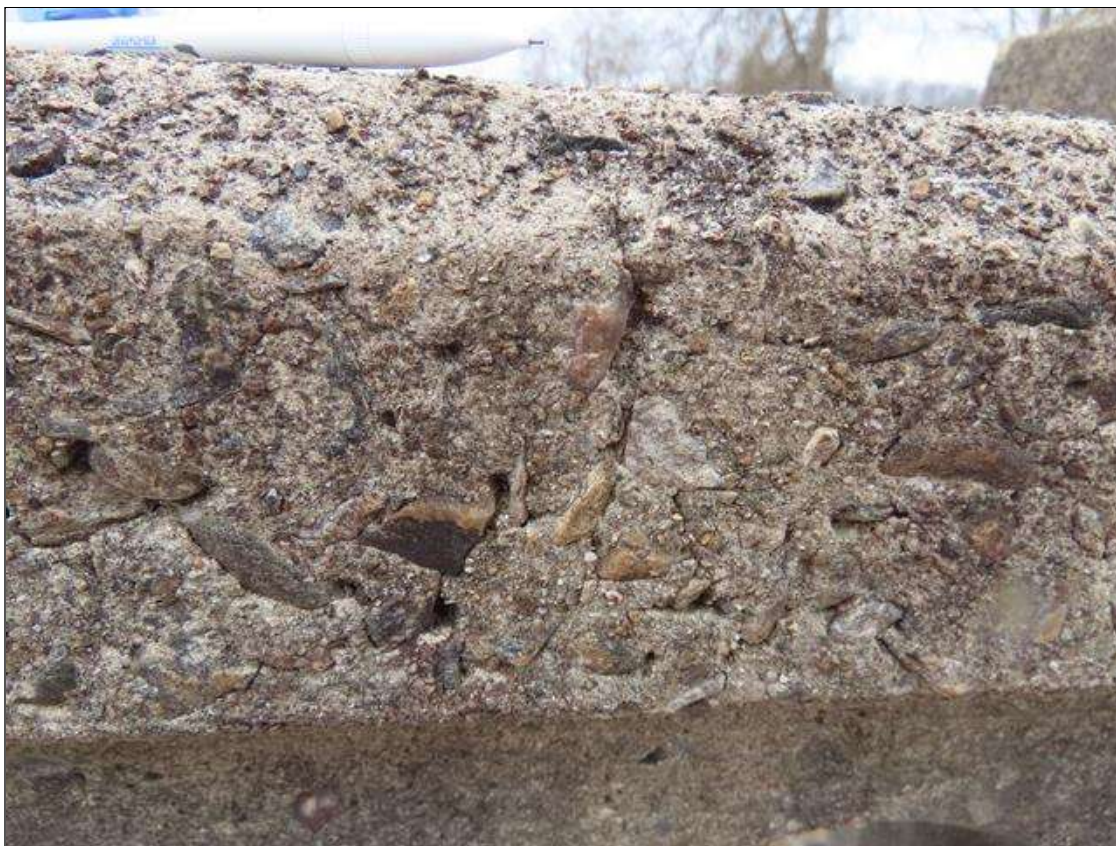
TYP. INTERMITTENT 1/32IN VERTICAL CRACKING THROUGHOUT RAILS, SPAN 1 RIGHT RAIL

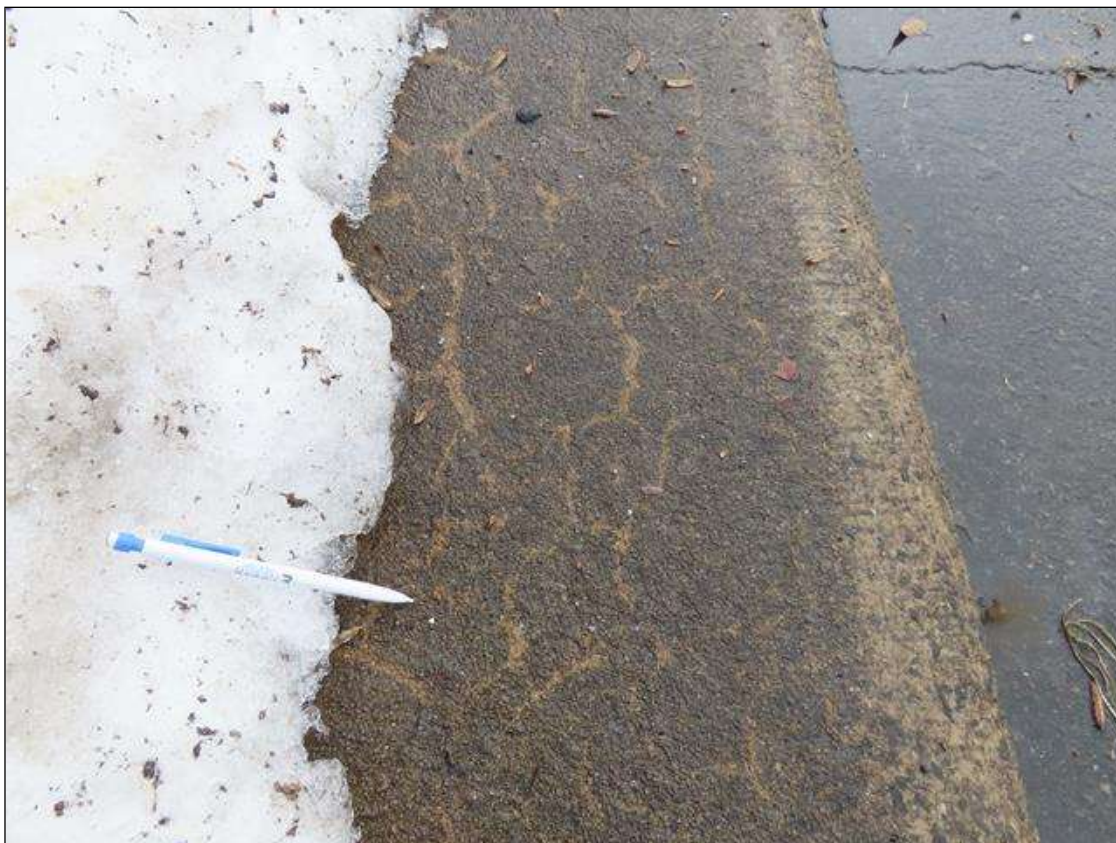
TYP. HAIRLINE MAP CRACKING THROUGHOUT LEFT SIDE SIDEWALK, SPAN 1

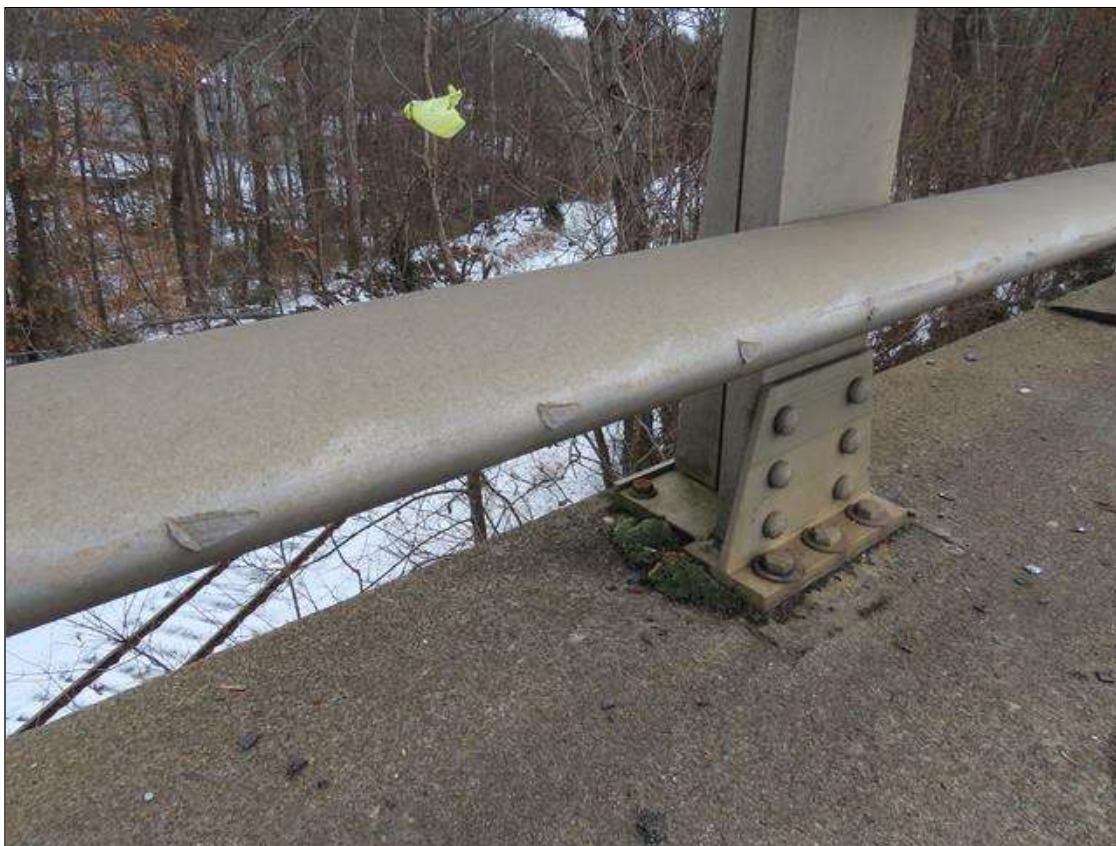
SPAN 4 LEFT RAIL - MINOR IMPACT DAMAGE (6FT L.) WITH MINOR GOUGING TO METAL RAILING AT FAR END

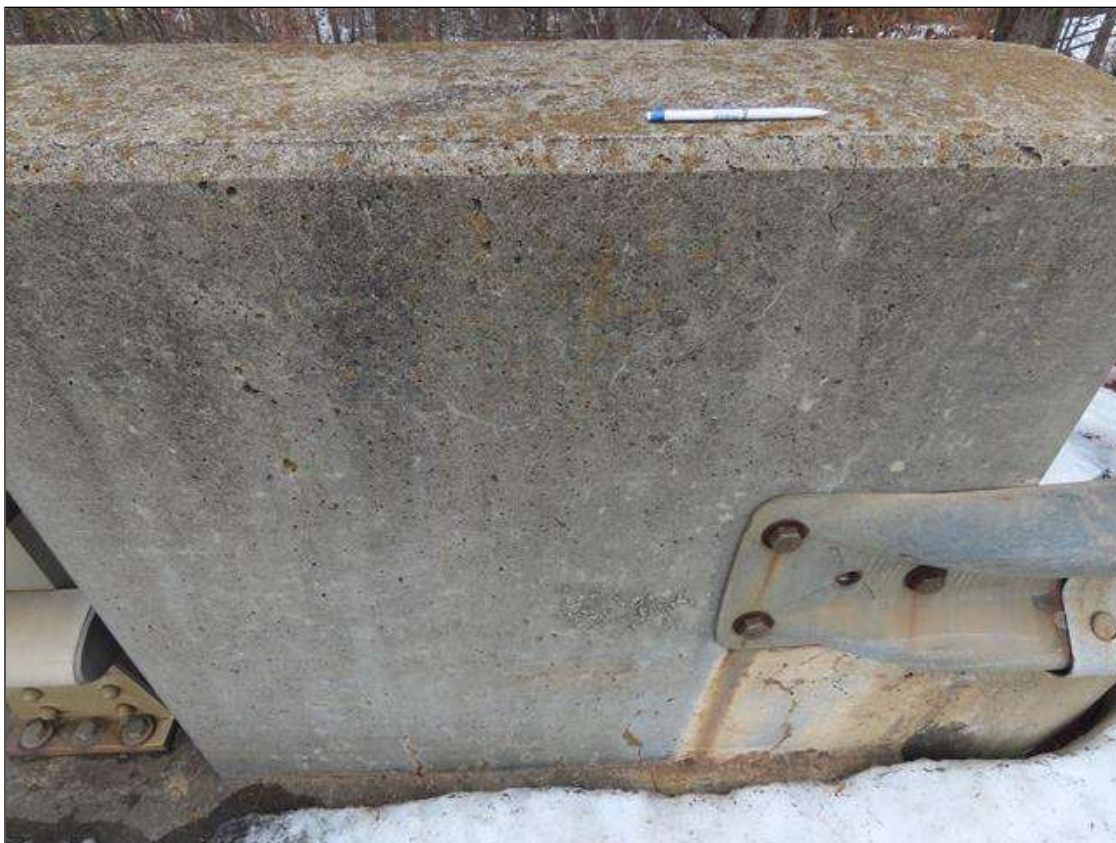
SPAN 5 LEFT RAIL - HAIRLINE MAP CRACKING (5 SQ. FT.) THROUGHOUT CONCRETE END POST

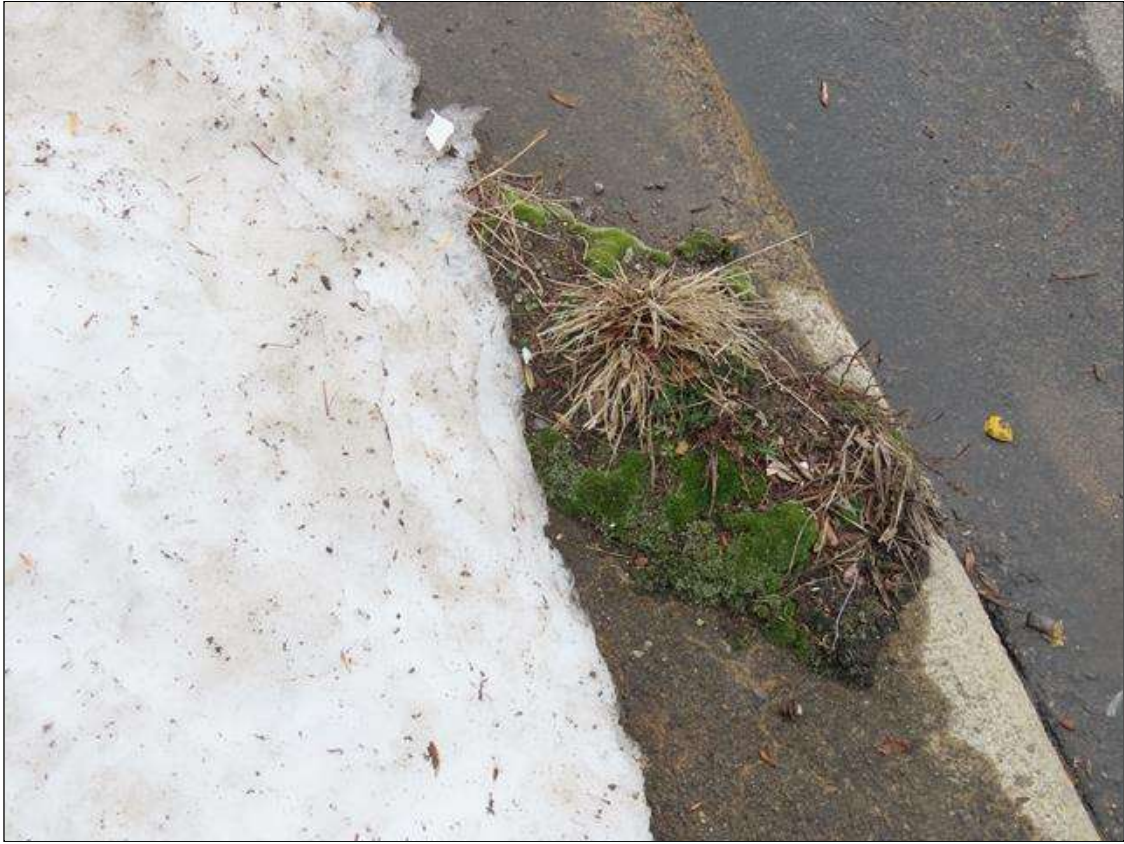
TYP. MODERATE VEGETATION GROWING AT JOINTS ON SIDEWALKS, JOINT OVER BENT 2

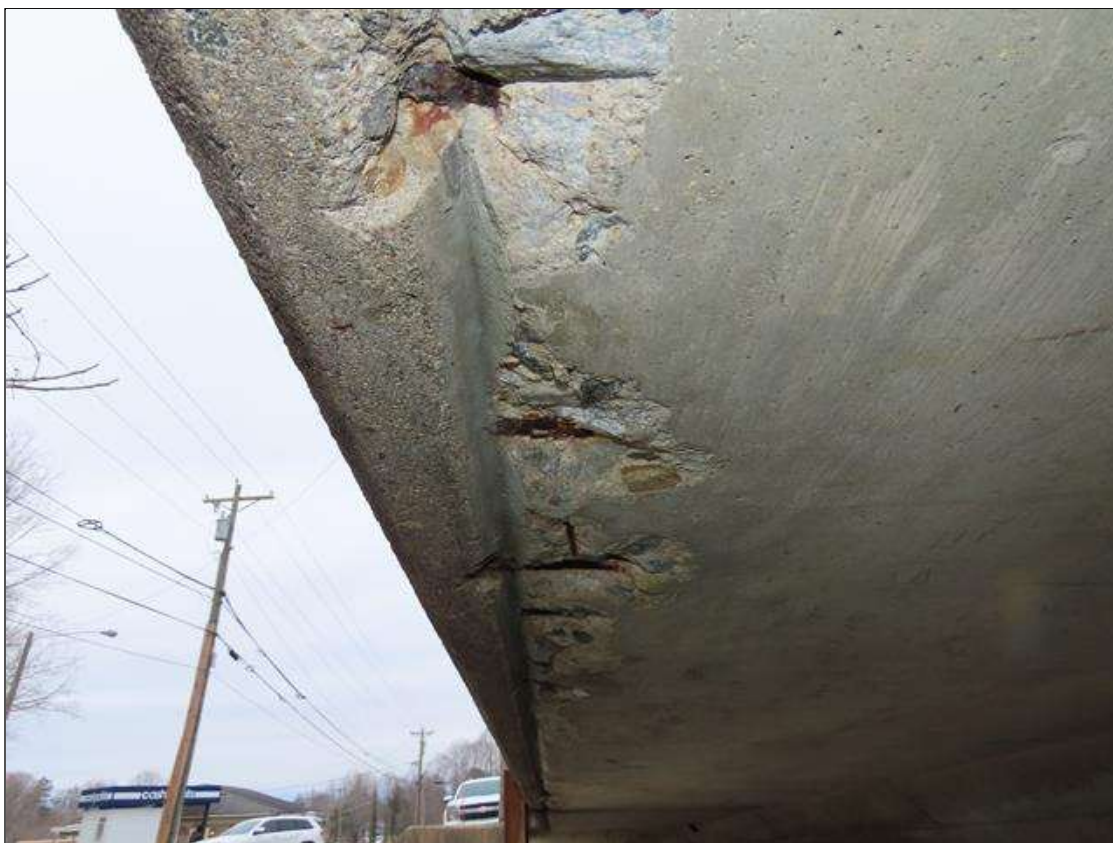
TYP. MINOR SPALLING (UP TO 6IN DIA. X 1IN D.) WITH EXPOSED REBAR THROUGHOUT RIGHT SIDE DRIP LINE, SPAN 1 RIGHT OVERHANG

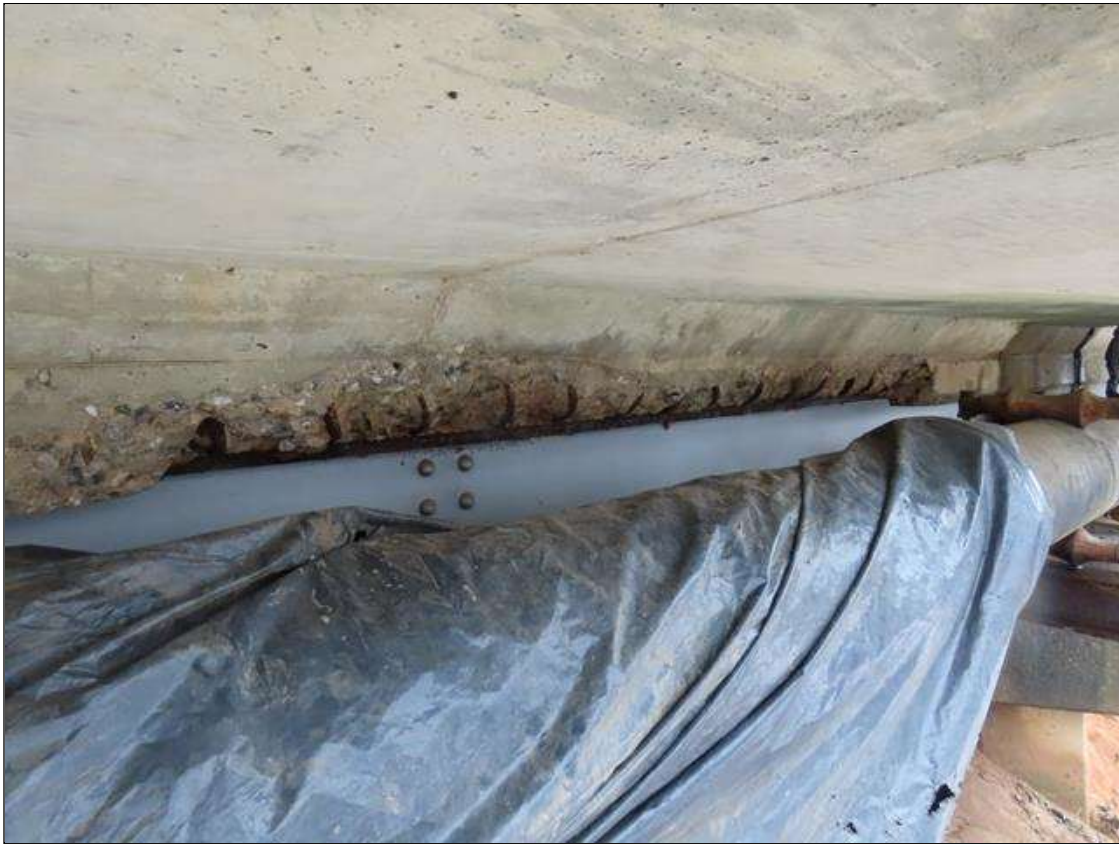
SPAN 1 DECK - SPALL & DELAMINATION (12FT L. X 1FT W. X 4IN D.) WITH EXPOSED REBAR RIGHT SIDE OF BEAM 11 HAUNCH AT FAR END (PAR PHOTO)

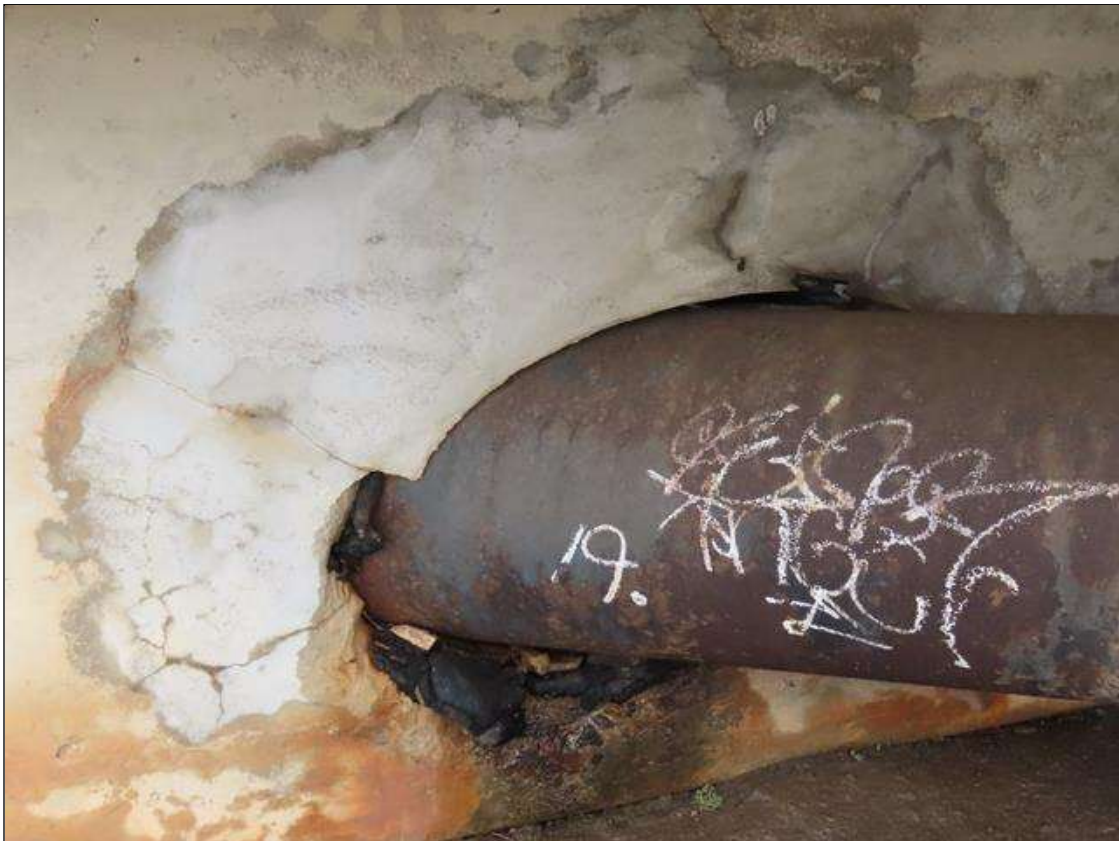
END BENT 1 ABUTMENT - HAIRLINE MAP CRACKING (4 SQ. FT.) THROUGHOUT RIGHT SIDE UTILITY OPENING PATCH

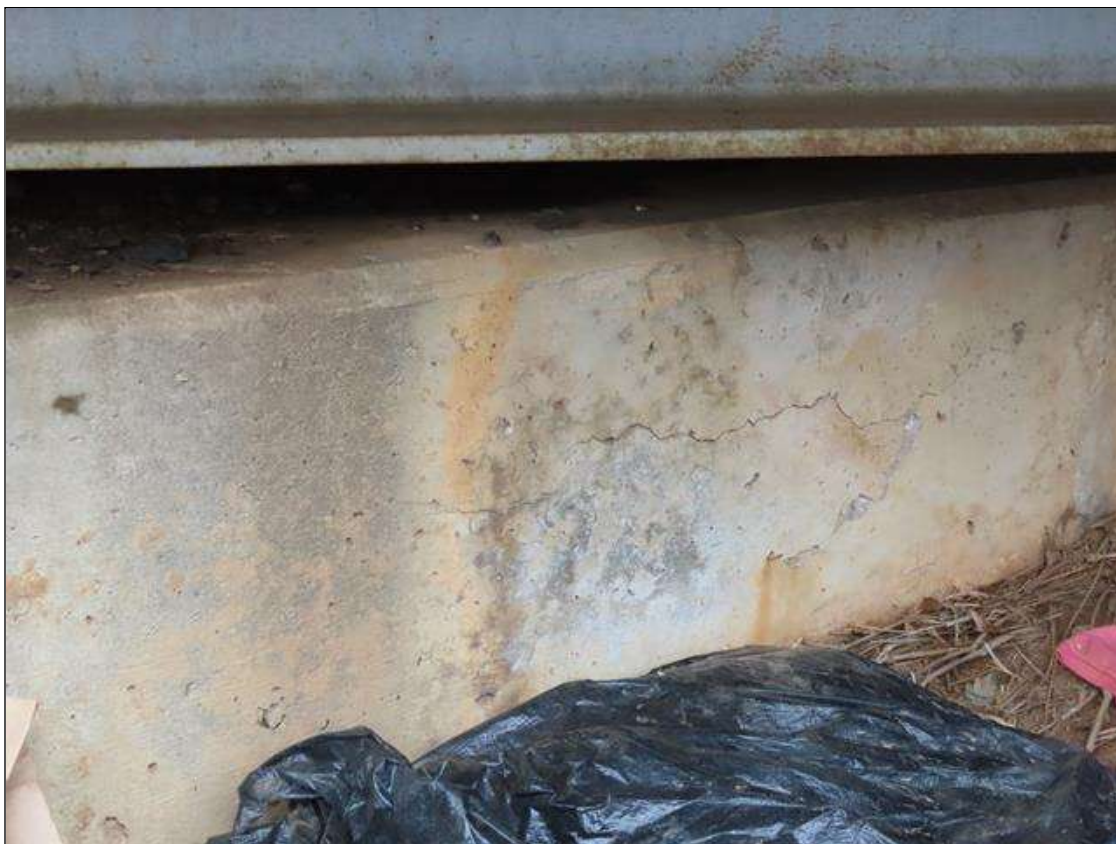
END BENT 1 CAP - DELAMINATION (24IN X 10IN) TO FACE BELOW BEAM 11

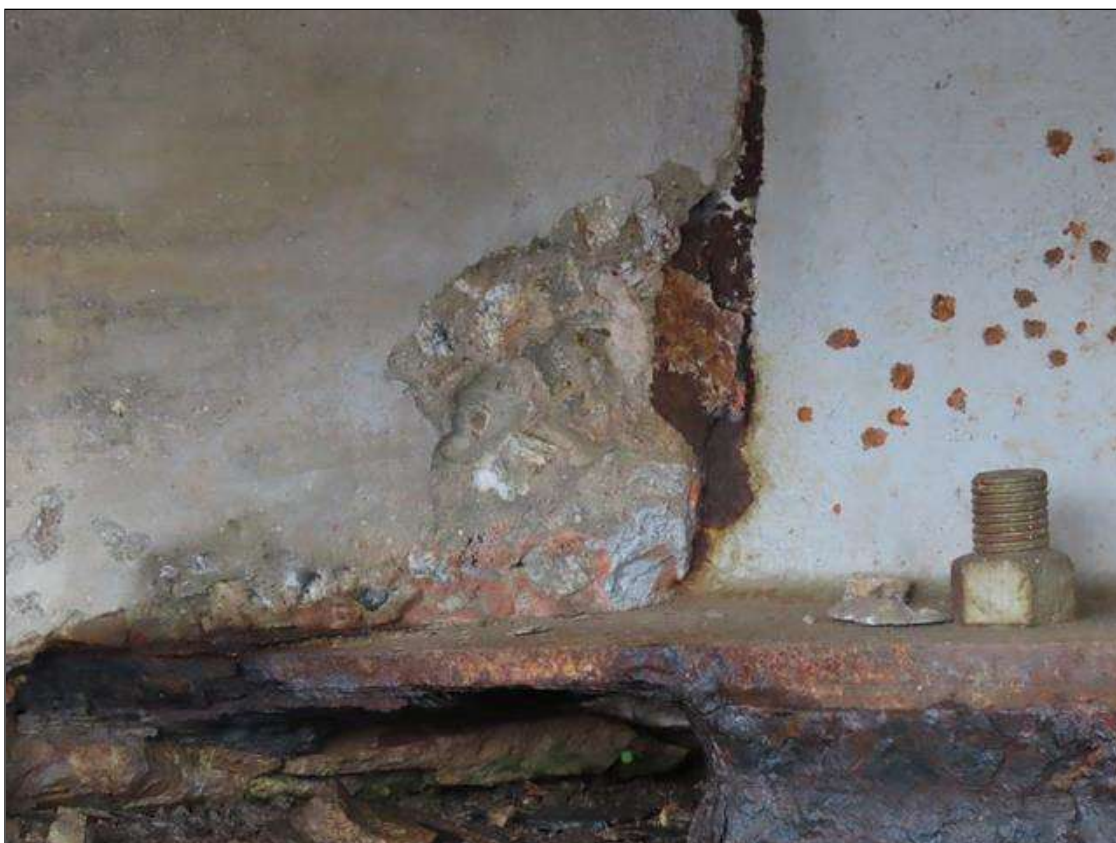
TYP. INTERMITTENT SPALLING (UP TO 8IN X 2IN X 1IN) WITH NO EXPOSED REBAR TO BACKWALL AT BOTTOM FLANGE ENDS, RIGHT OF BEAM 11

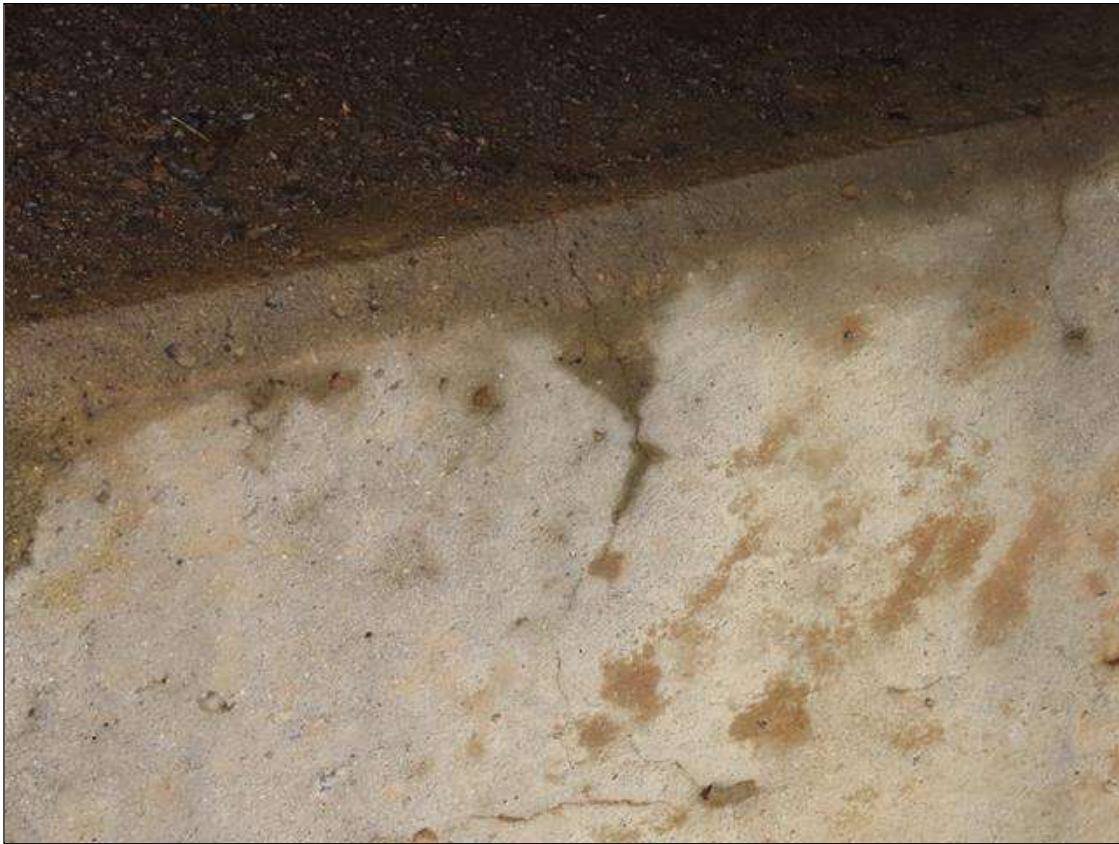
TYP. INTERMITTENT VERTICAL HAIRLINE CRACKING (UP TO FULL HEIGHT) THROUGHOUT END BENT 1 CAP, BELOW BAY 10
