NC DEPARTMENT OF TRANSPORTATION
 DIVISION OF HIGHWAYS
 STRUCTURE MANAGEMENT UNIT

Structure Safety Report

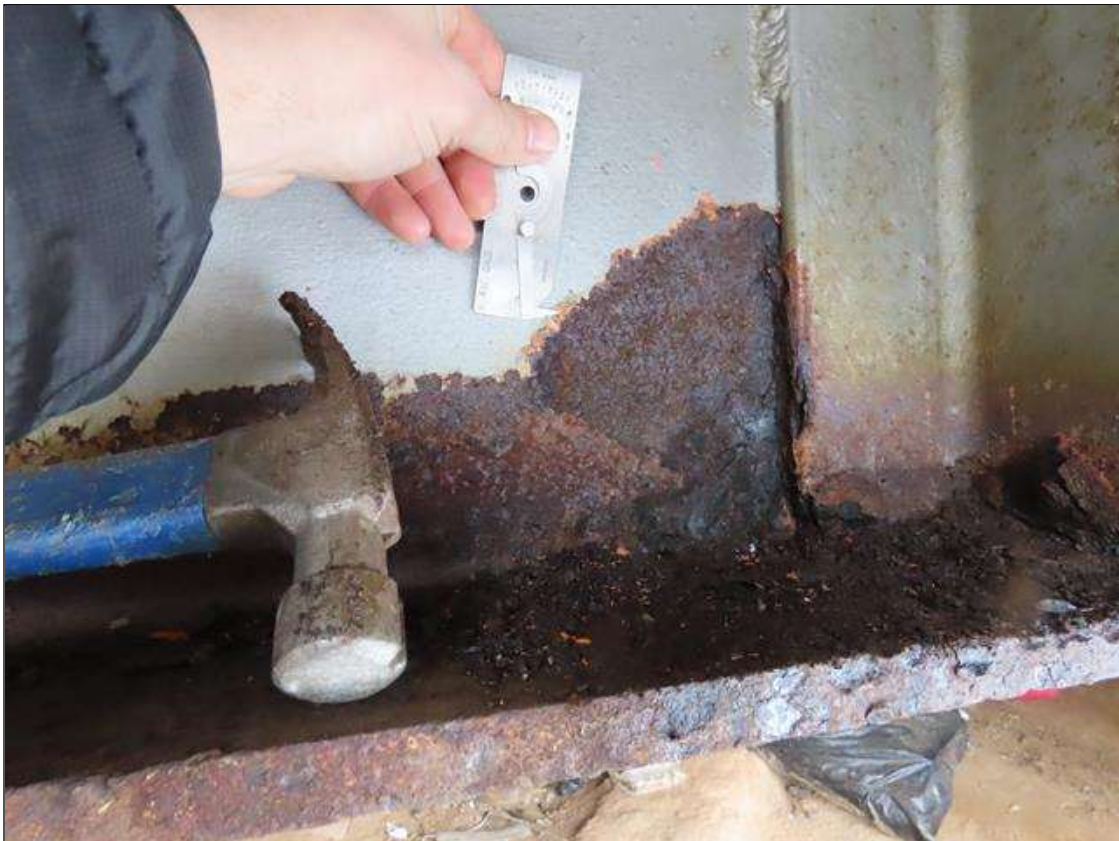
SPAN 1 BEAM 11 - WEB SECTION LOSS (3/16IN PITTING, 5/16IN REMAIN) TO RIGHT SIDE, 6IN X 6IN AT BOTH SIDES OF UTILITY BRACKET CONNECTION, 6FT FROM FAR END (PAR PHOTO)

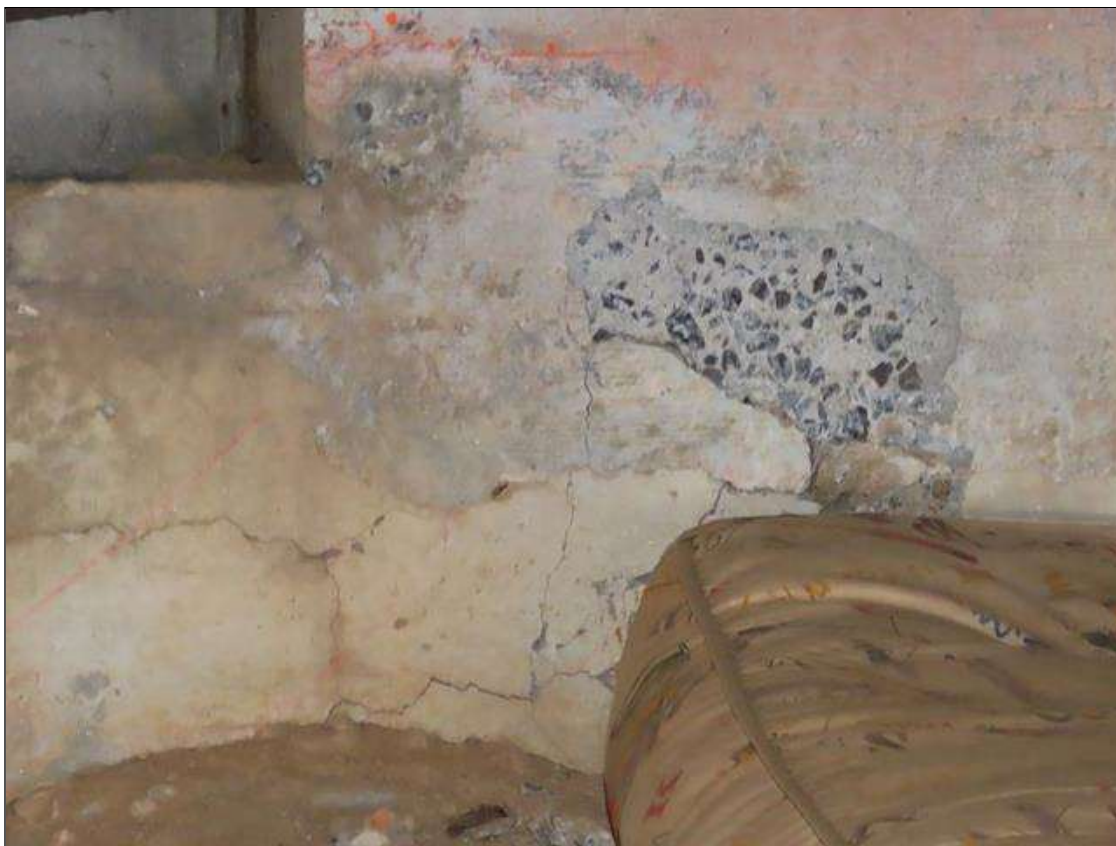
END BENT 1 CAP - SPALL & DELAMINATION (3.5FT X 1.5FT X 1IN) WITH NO EXPOSED REBAR TO FACE BELOW BAY 7

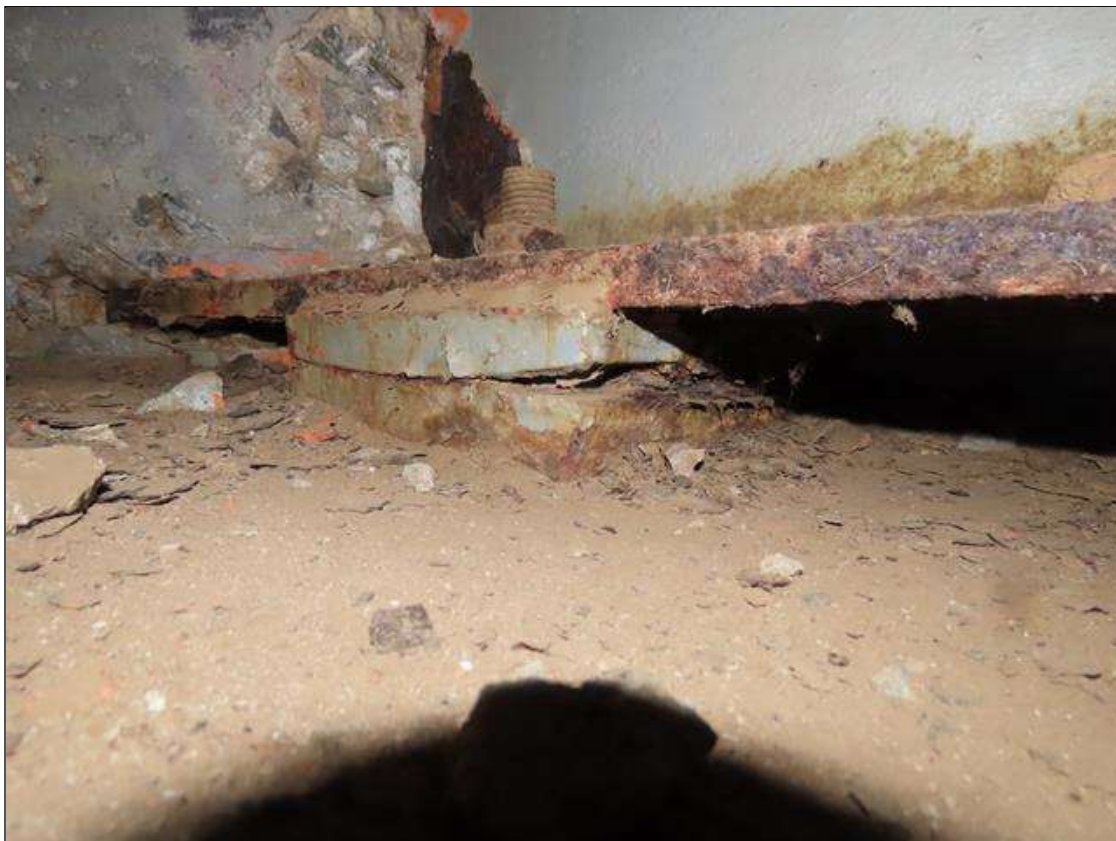
TYP. MINOR SURFACE CORROSION TO BEARINGS AT END BENT 1, BEAM 7 (BEAM 8-10 SIMILAR)

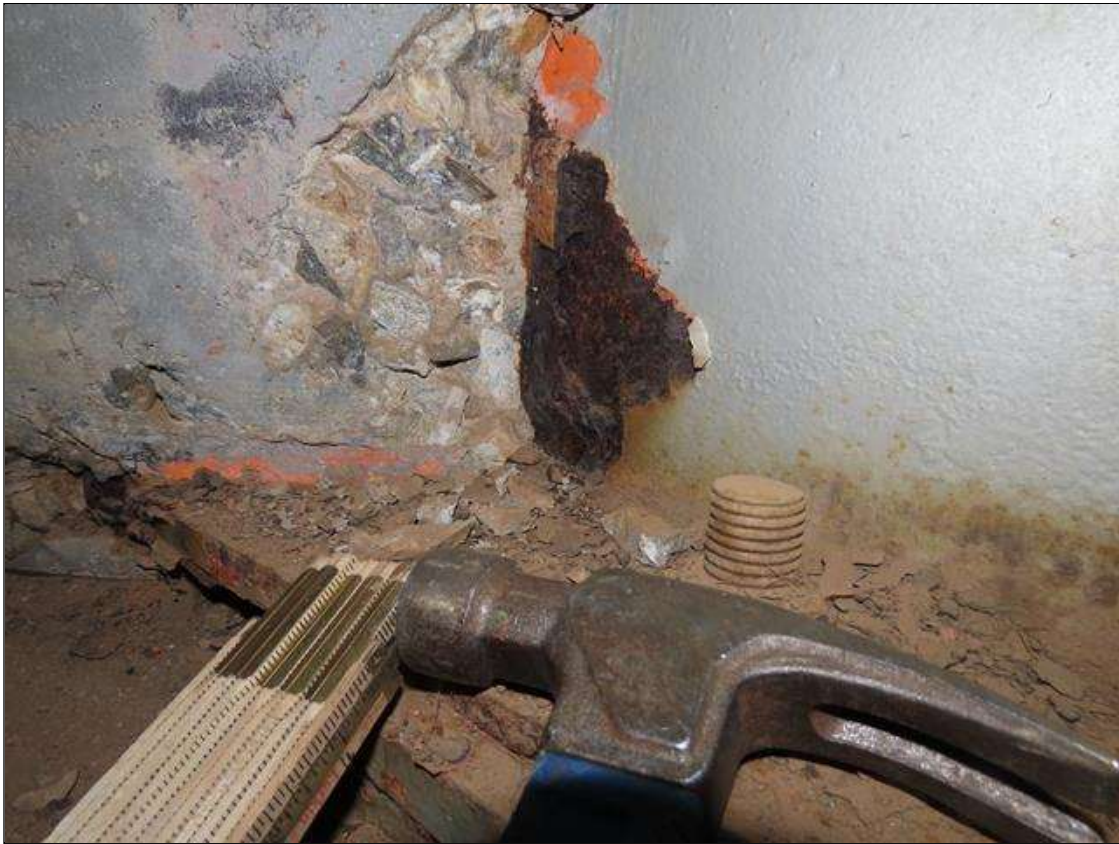
SPAN 1 BEAM 7 - WEB SECTION LOSS (1/16IN SL, 7/16IN REMAIN) TO RIGHT SIDE, 3IN X 3IN AT NEAR END BOTTOM

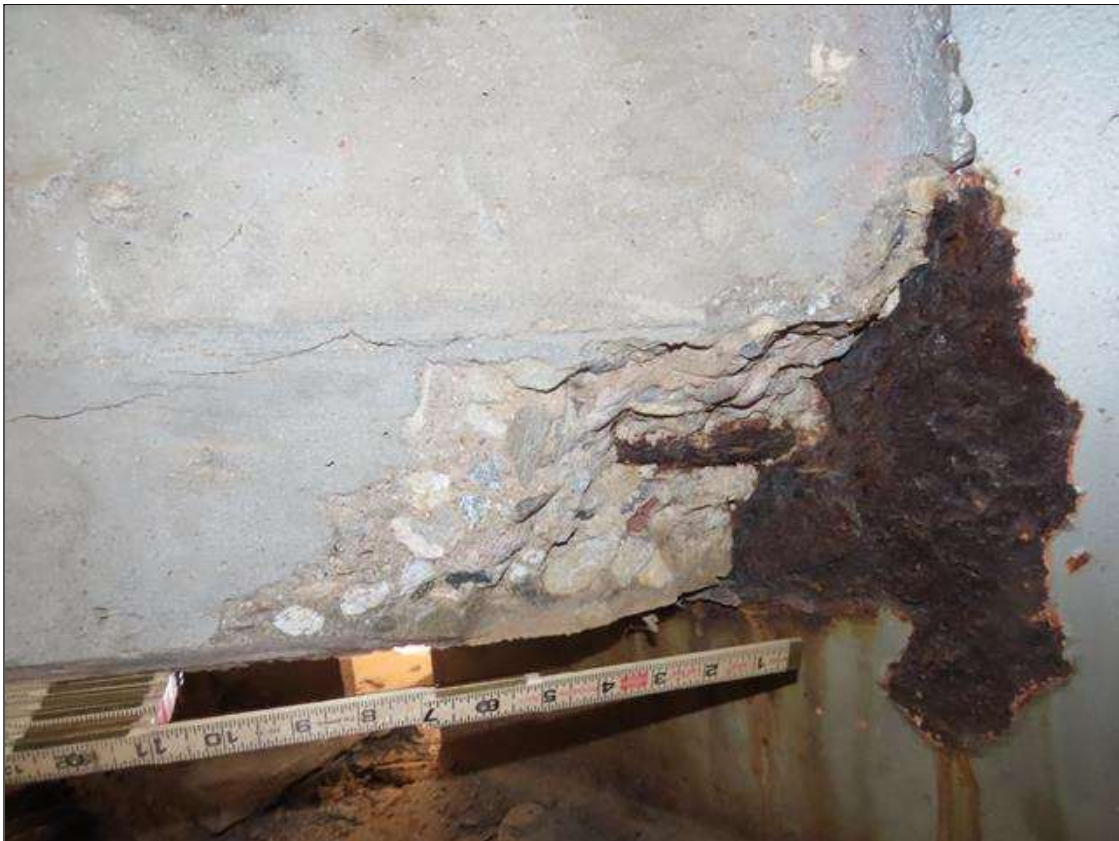
SPAN 1 BAY 9 FAR DIAPHRAGM - SPALL (12IN X 6IN 4IN) WITH EXPOSED REBAR ADJACENT TO BEAM 10 (PAR PHOTO)

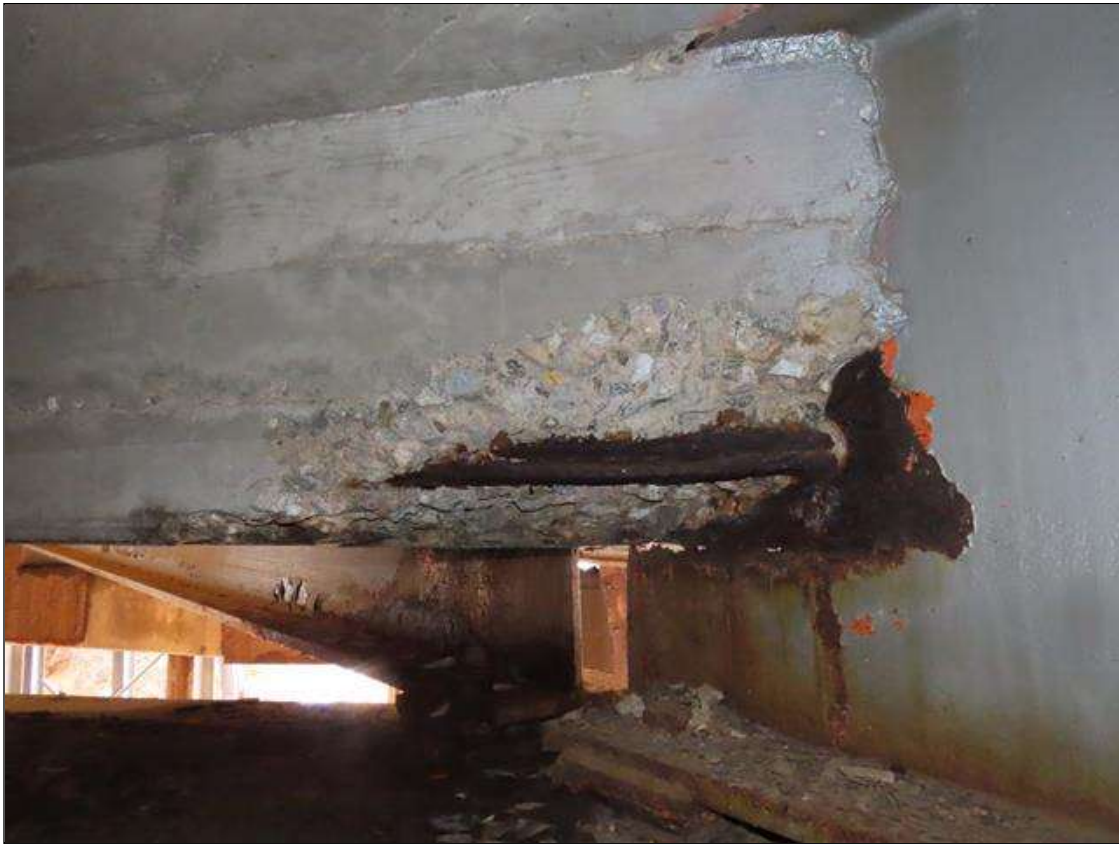
SPAN 1 BAY 8 FAR DIAPHRAGM - SPALL (30IN X 10IN X 4IN) WITH EXPOSED REBAR ADJACENT TO BEAM 9 (PAR PHOTO)

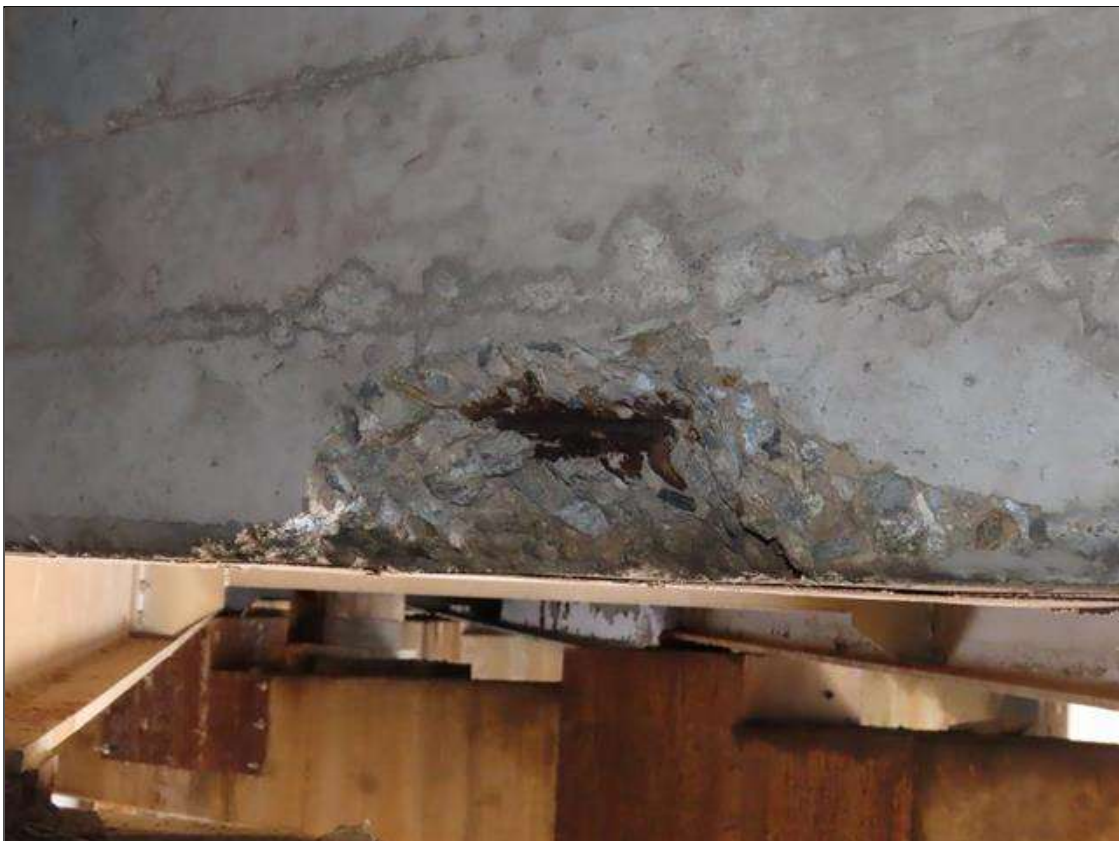
SPAN 1 BAY 8 FAR DIAPHRAGM - SPALL (24IN X 8IN X 4IN) WITH EXPOSED REBAR AT MIDDLE (PAR PHOTO)

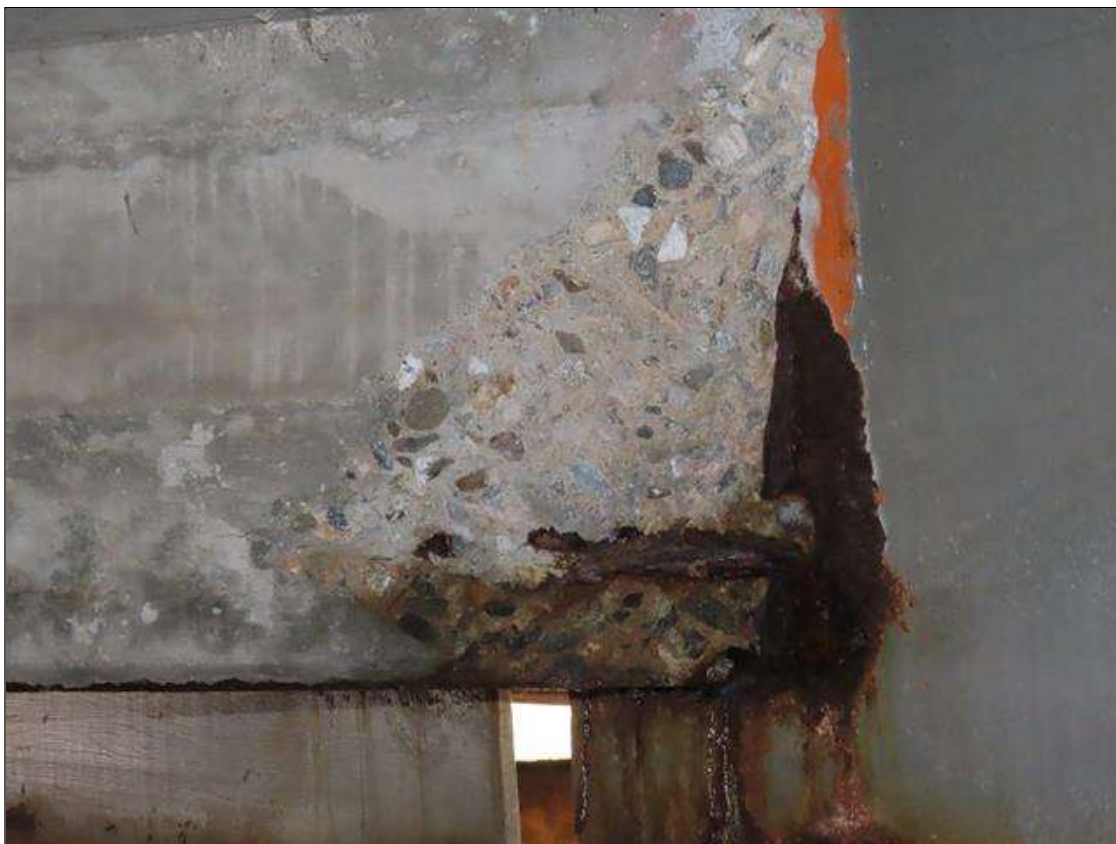
SPAN 1 BAY 7 FAR DIAPHRAGM - SPALL (18IN X 16IN X 3IN) WITH EXPOSED REBAR ADJACENT TO BEAM 8 (PAR PHOTO)

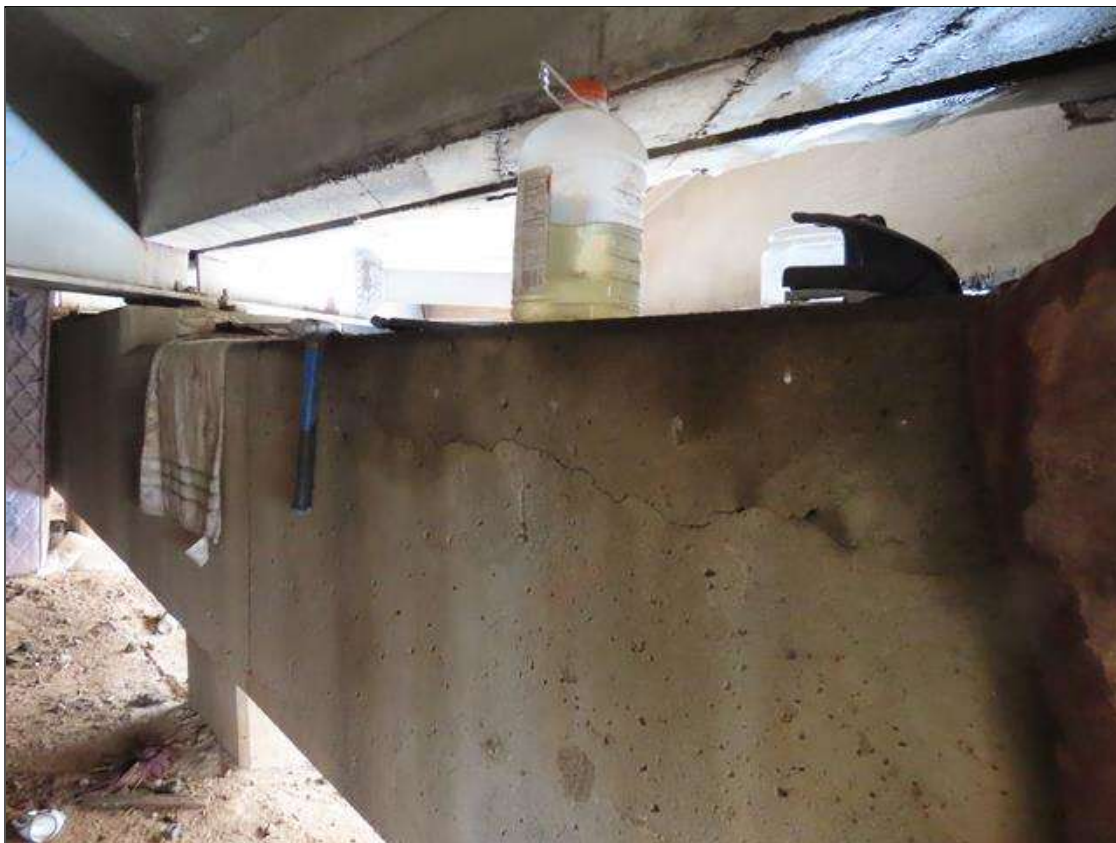
BENT 1 CAP - DELAMINATION (9FT L. X 10IN H.) TO NEAR FACE AT TOP CORNER BELOW BAY 10

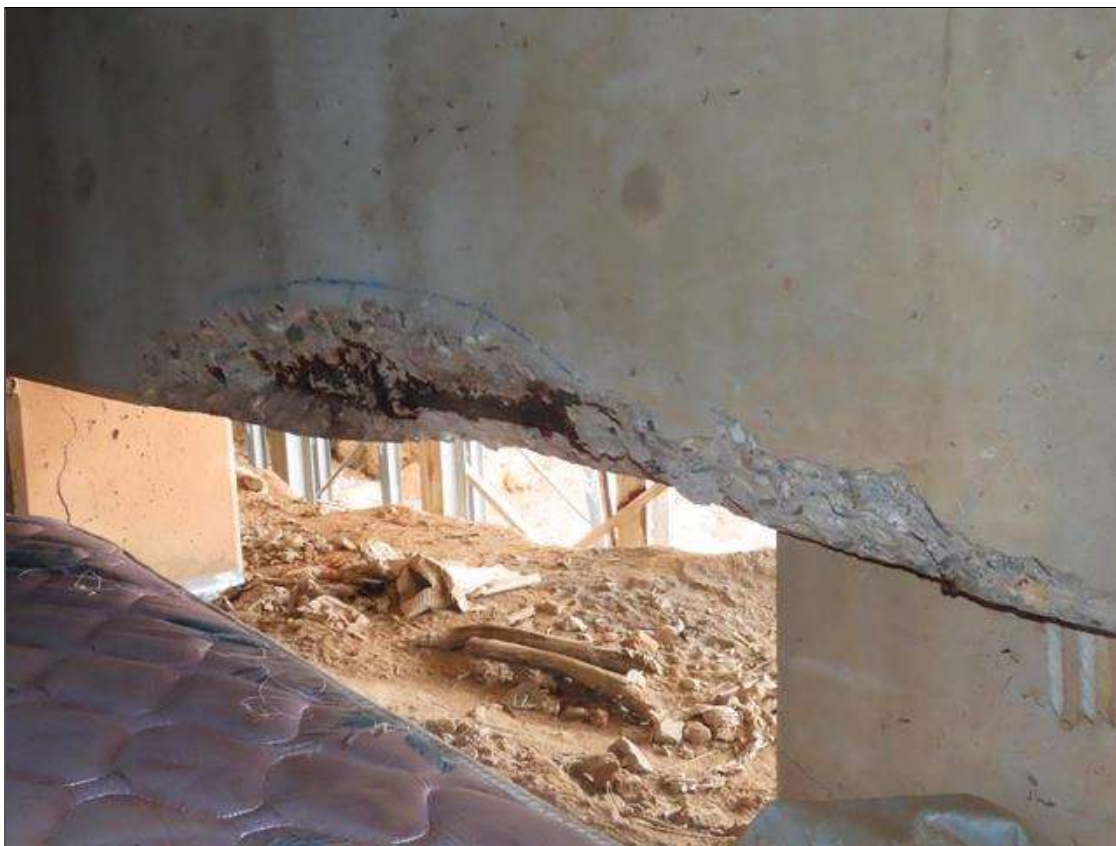
BENT 1 CAP - SPALL (48IN X 12IN X 5IN) WITH EXPOSED REBAR TO NEAR BOTTOM CORNER BELOW BAY 9 (PAR PHOTO)

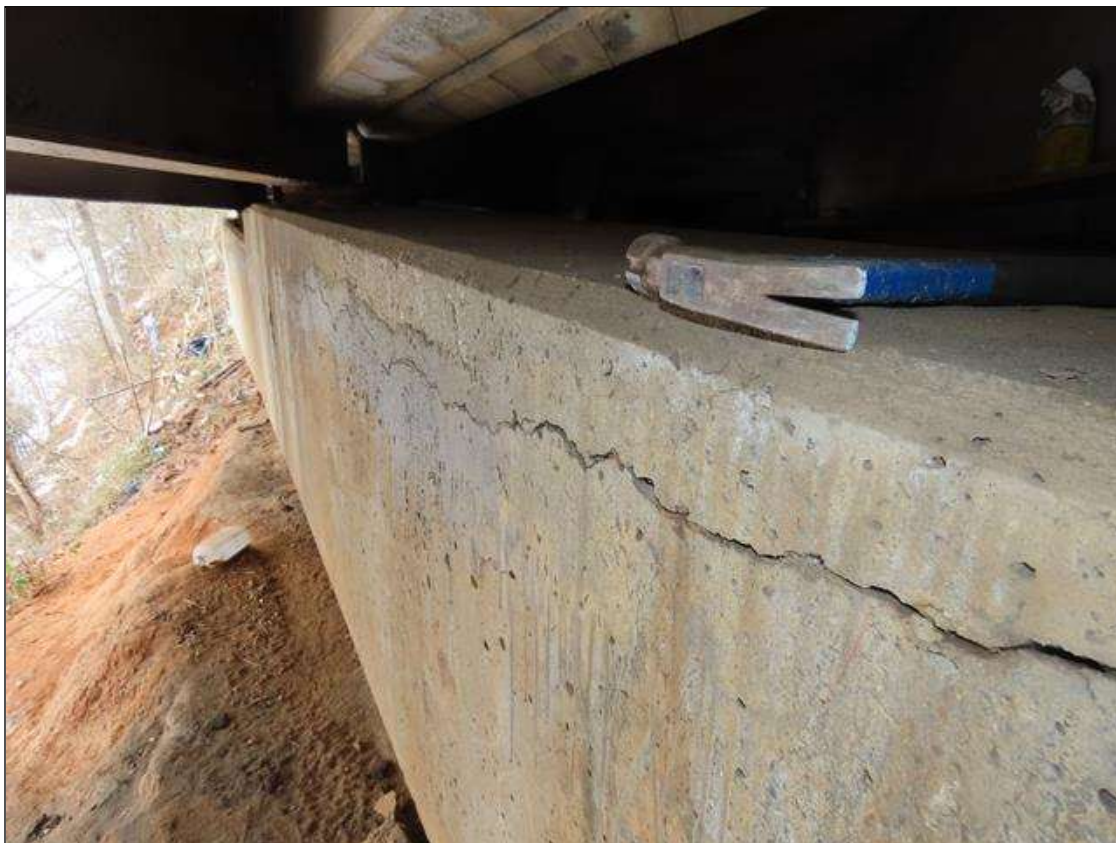
BENT 1 CAP - DELAMINATION (35FT L. X UP TO 24IN H.) TO FAR FACE AT TOP BELOW BAYS 7-11 (PAR PHOTO)

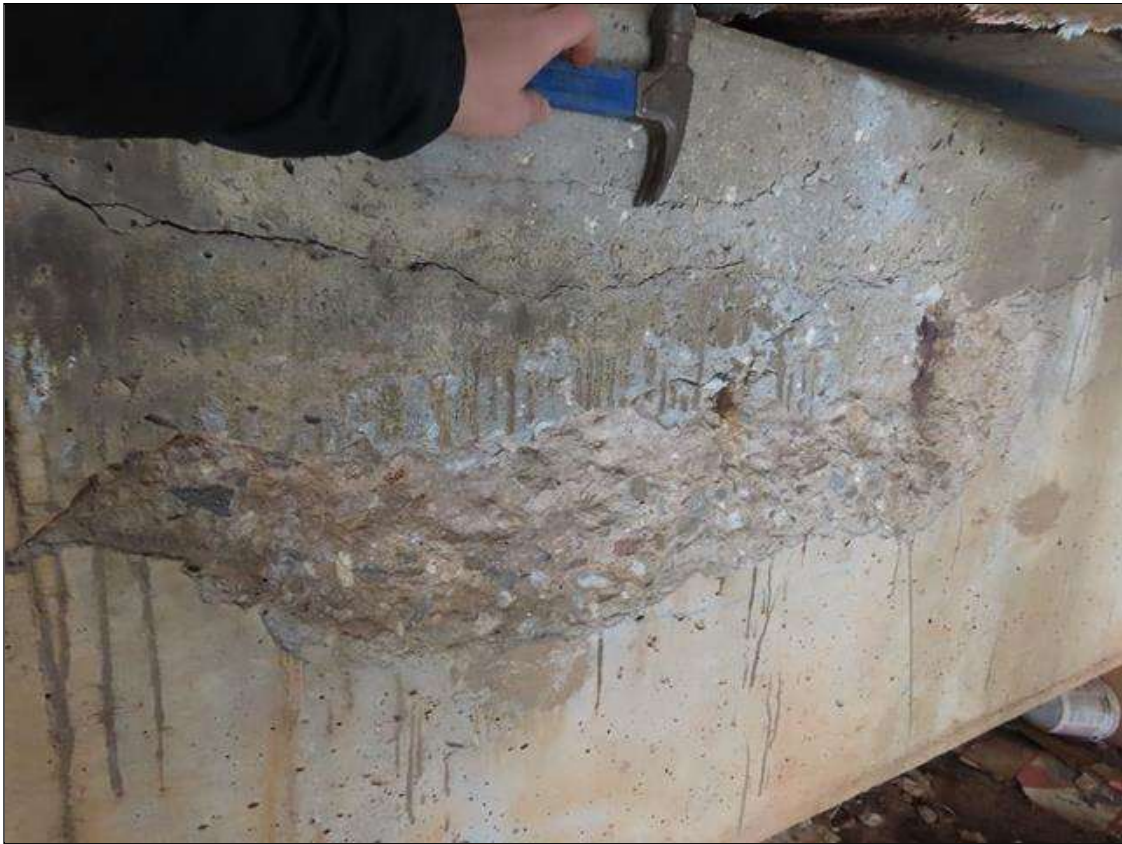
BENT 1 CAP - SPALL (36IN X 12IN X 2IN) WITH EXPOSED REBAR TO FAR FACE BELOW BEAM 9 (PAR PHOTO)

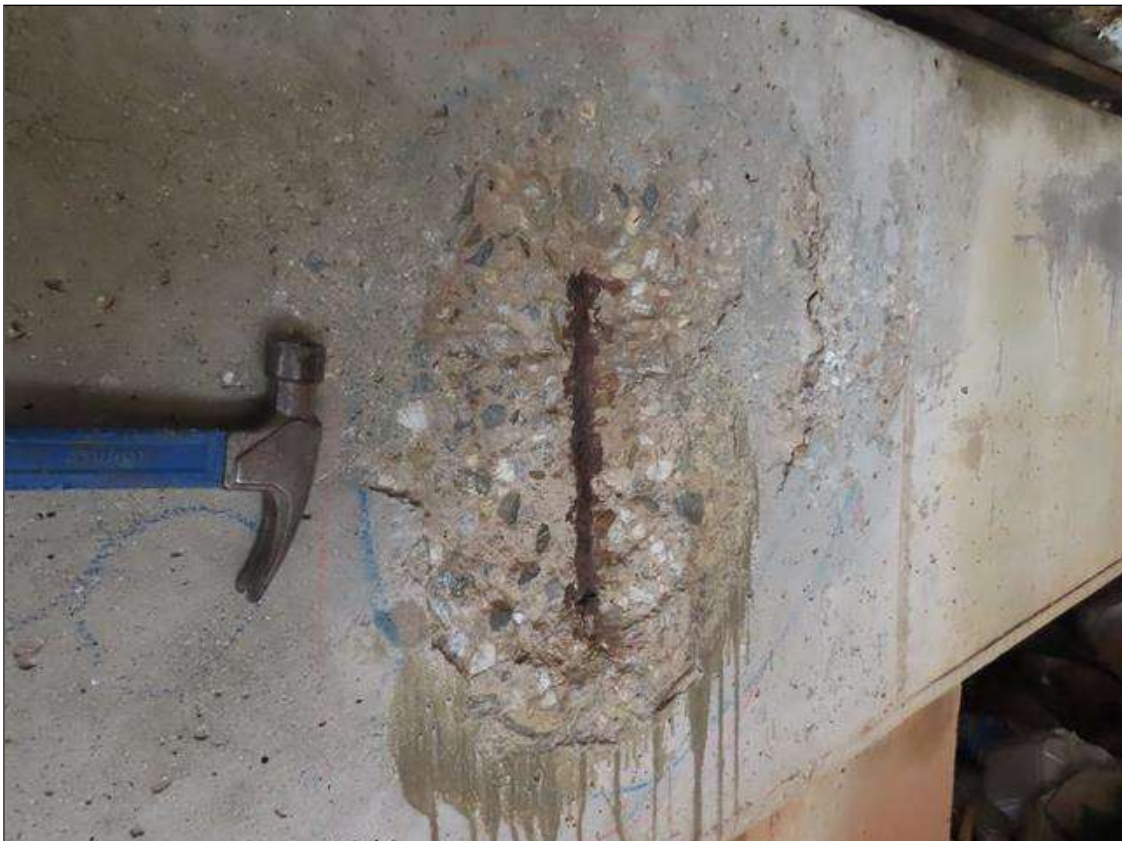
BENT 1 CAP - SPALL (24IN X 16IN X 1IN) WITH EXPOSED REBAR TO FAR FACE BELOW BEAM 8

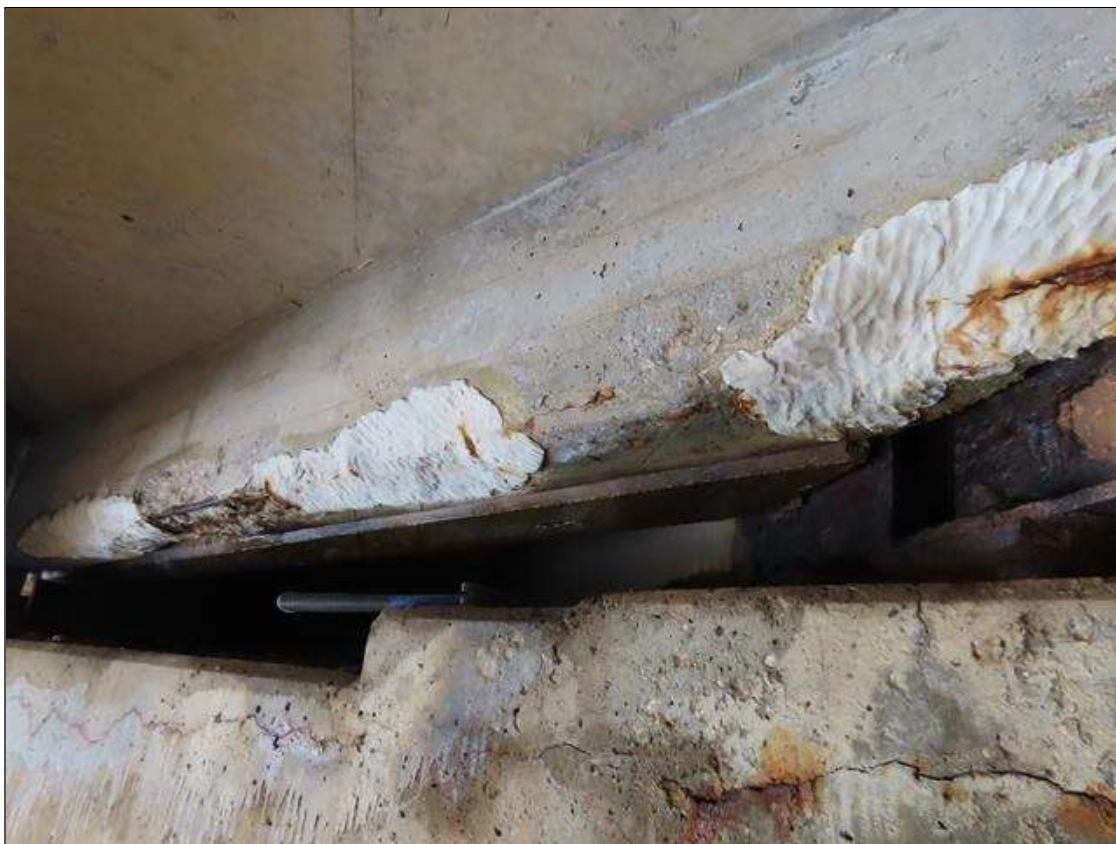
SPAN 2 BAY 7 NEAR DIAPHRAGM - FAILED REPAIR WITH SPALLING (UP TO 30IN X 12IN X 6IN) WITH EXPOSED REBAR THROUGHOUT (PAR PHOTO)

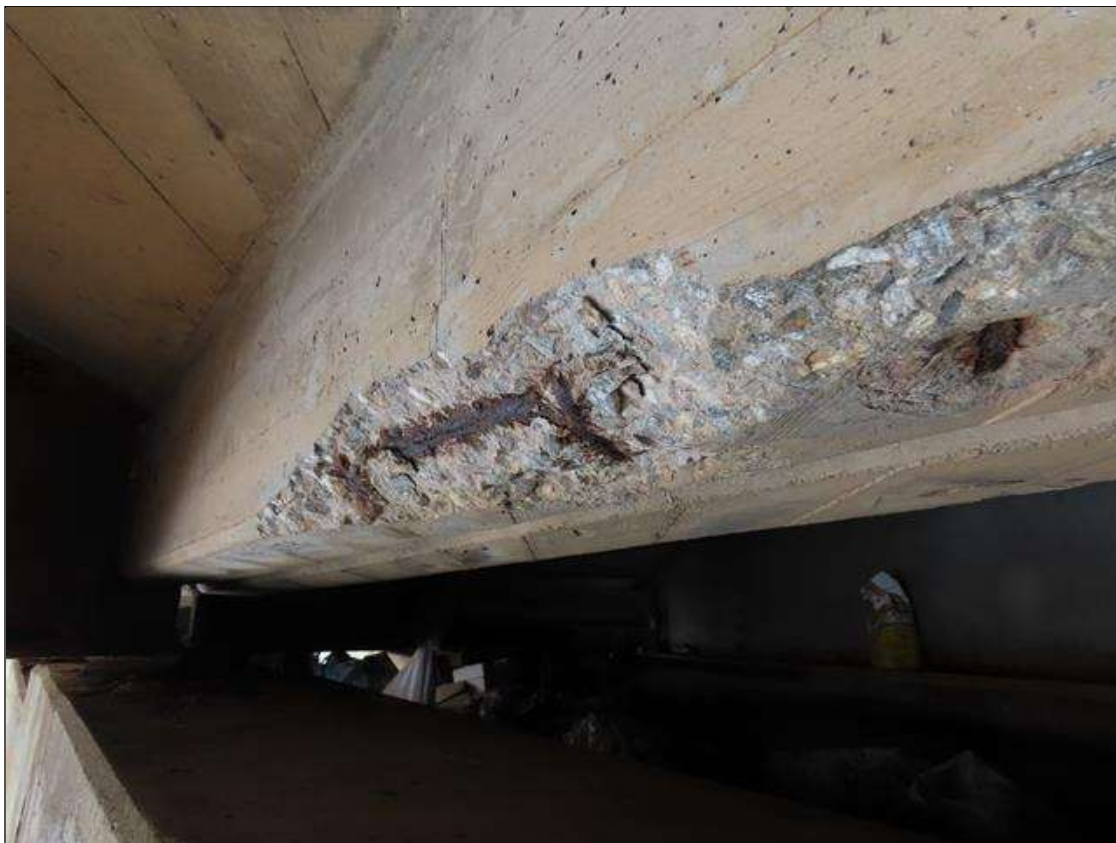
SPAN 2 BAY 9 NEAR DIAPHRAGM - SPALL (40IN X 12IN X 4IN) WITH EXPOSED REBAR THROUGHOUT (PAR PHOTO)

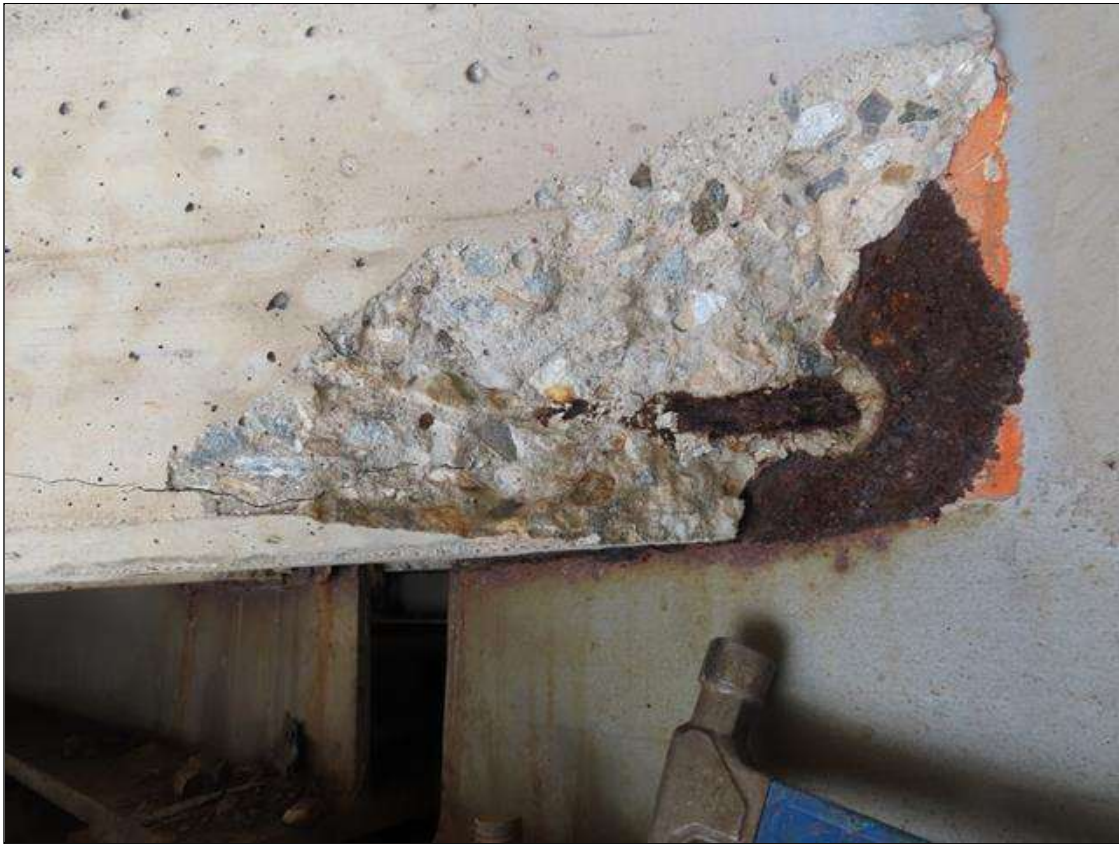
SPAN 2 BAY 10 NEAR DIAPHRAGM - SPALL (12IN X 8IN X 2IN) WITH EXPOSED REBAR ADJACENT TO BEAM 10 (PAR PHOTO)

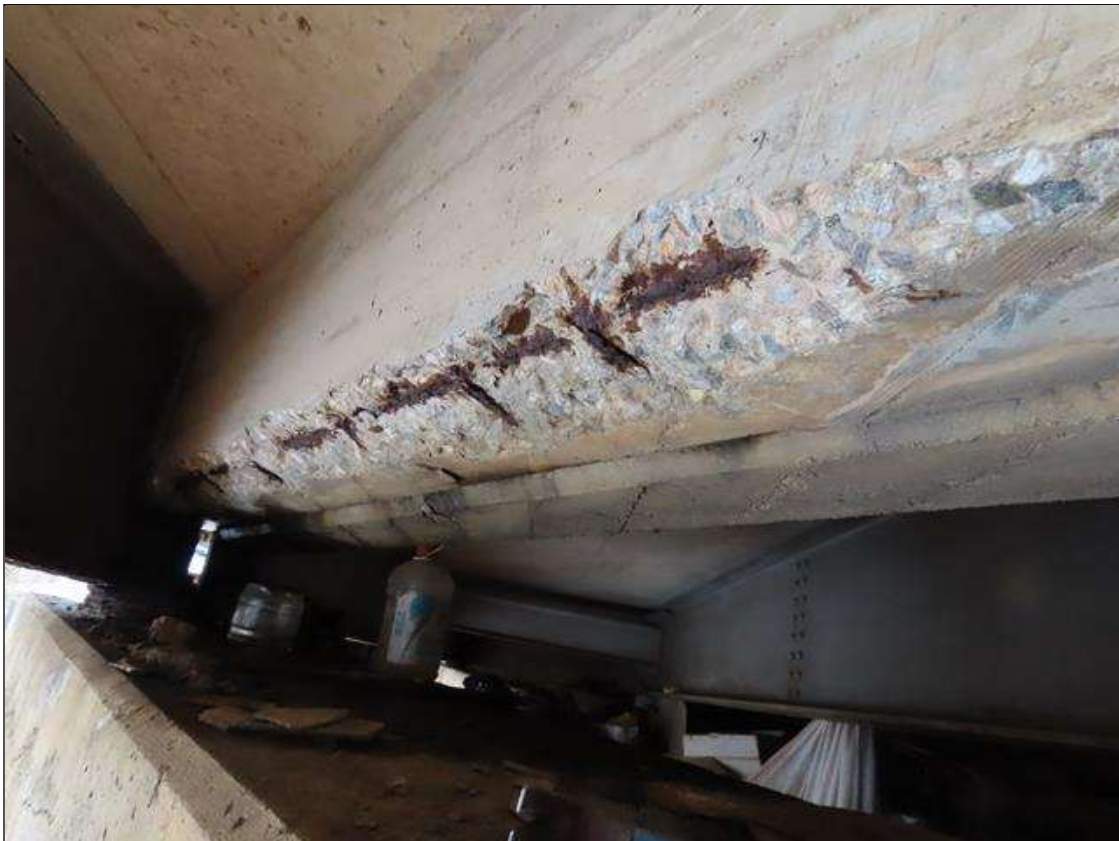
SPAN 2 BAY 10 NEAR DIAPHRAGM - SPALL (6FT X 7IN X 3IN) WITH EXPOSED REBAR THROUGHOUT (PAR PHOTO)

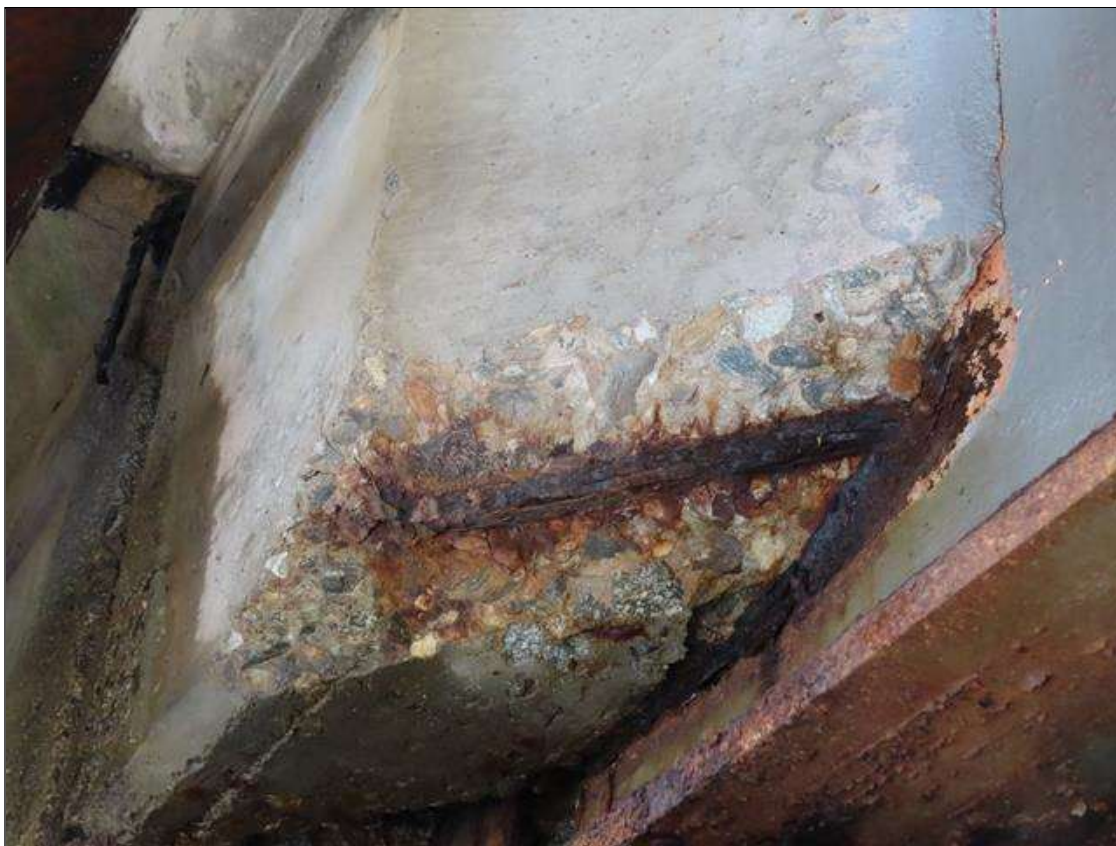
SPAN 2 RIGHT OVERHANG DIAPHRAGM AT NEAR END - SPALL (12IN X 8IN X 2IN) WITH EXPOSED REBAR TO FAR BOTTOM CORNER (PAR PHOTO)

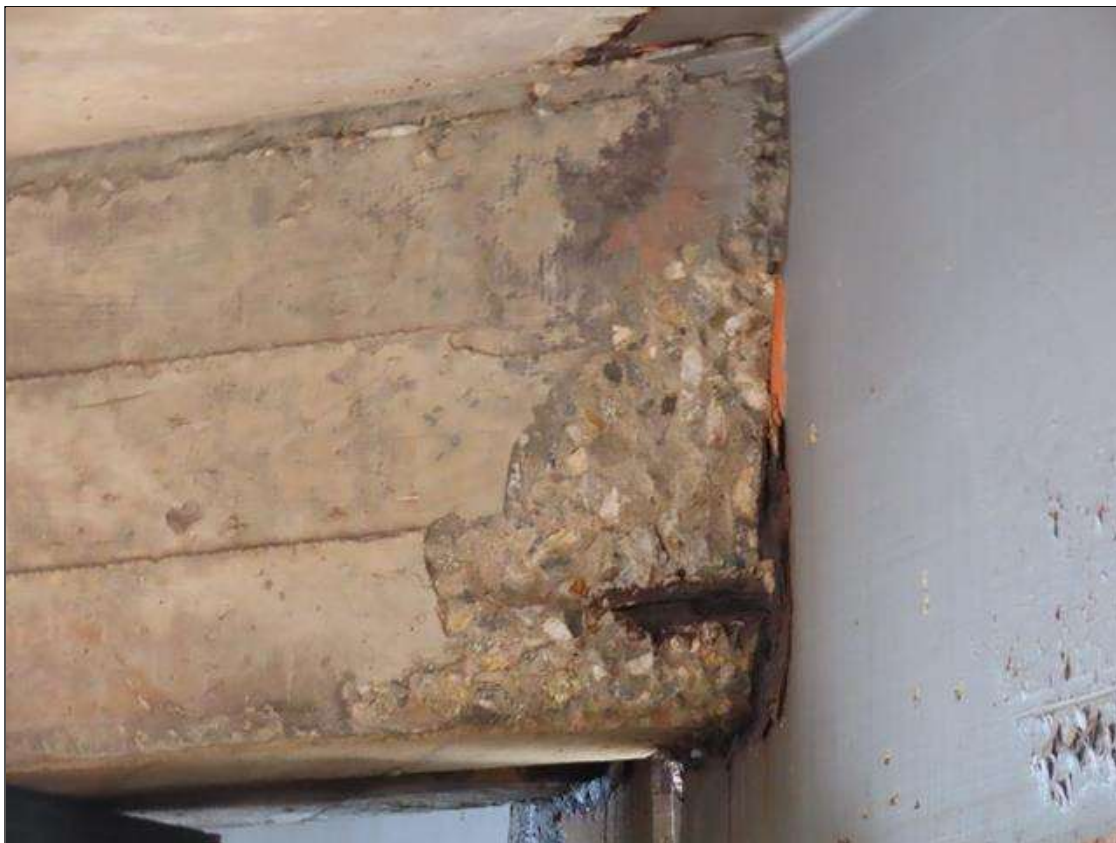
SPAN 2 BAY 7 FAR DIAPHRAGM - SPALL (12IN X 8IN X 2IN) WITH EXPOSED REBAR ADJACENT TO BEAM 8 (PAR PHOTO)

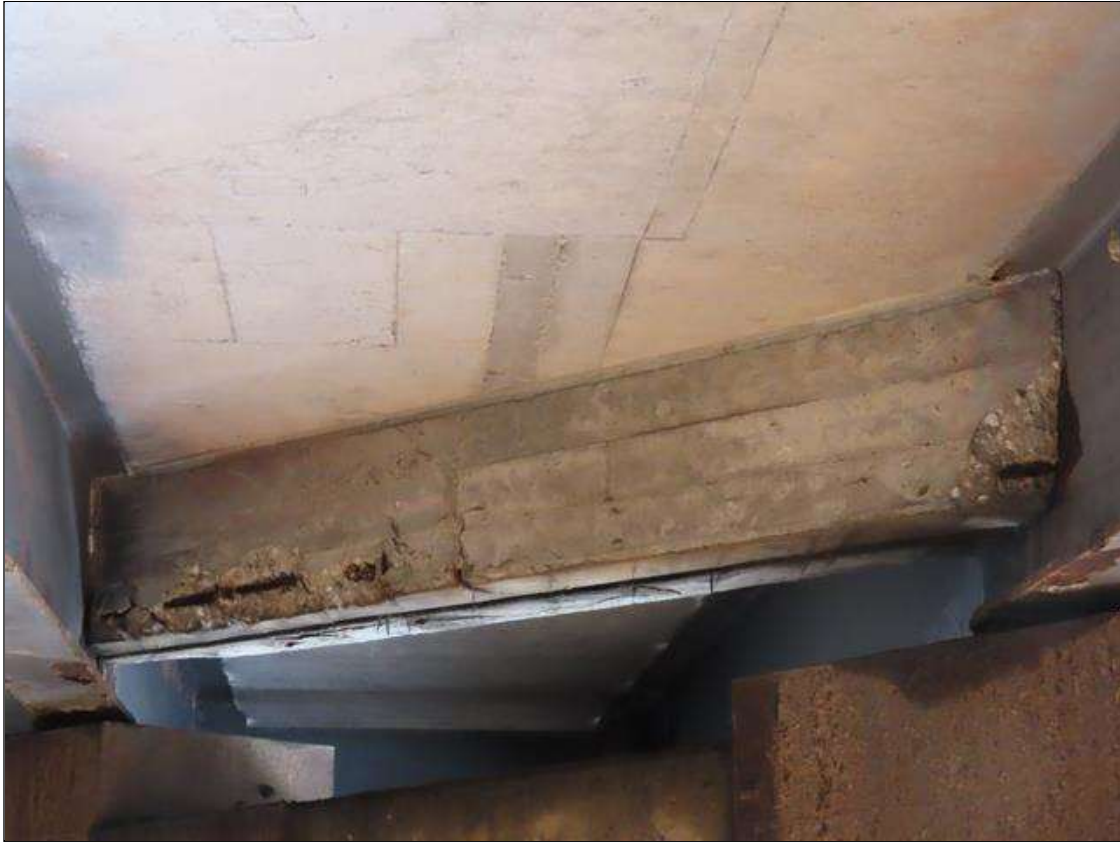
SPAN 2 BAY 9 FAR DIAPHRAGM - 2X SPALLS (UP TO 48IN X 12IN X 3IN) WITH EXPOSED REBAR THROUGHOUT (PAR PHOTO)

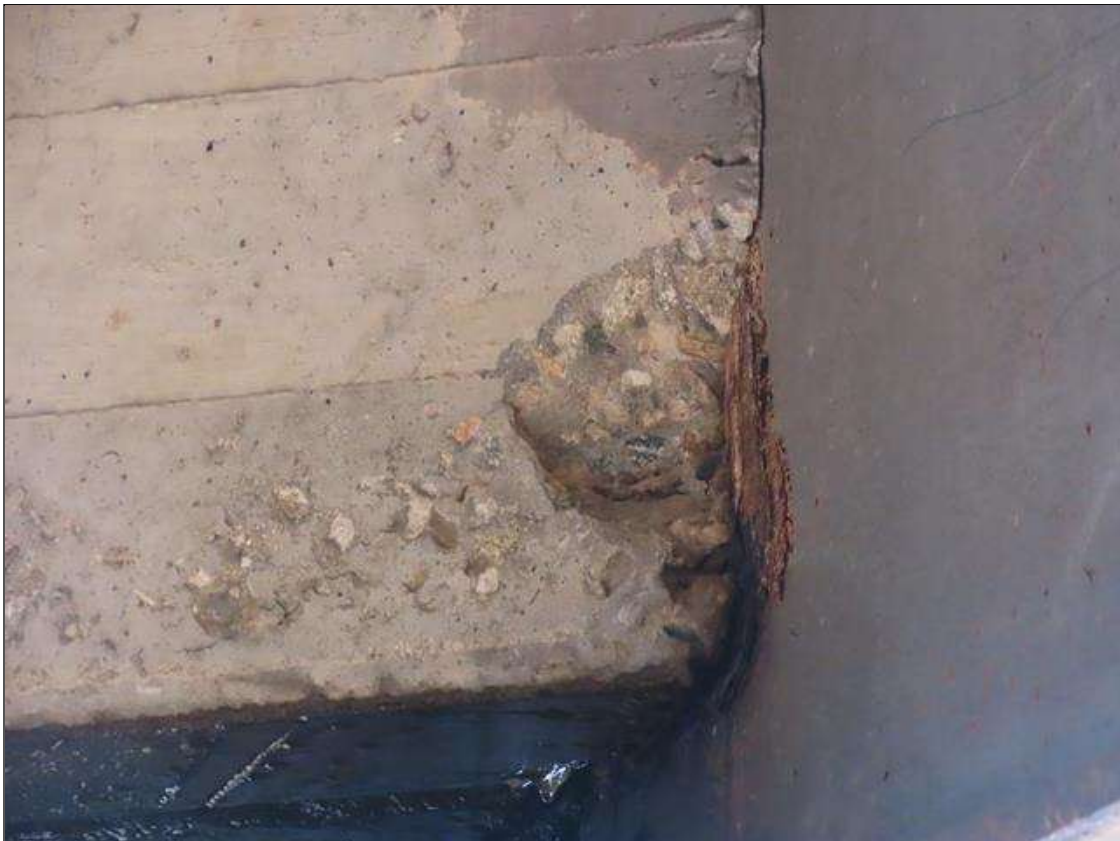
SPAN 2 BAY 10 FAR DIAPHRAGM - SPALL (6IN DIA. X 2IN D.) WITH NO EXPOSED REBAR ADJACENT TO BEAM

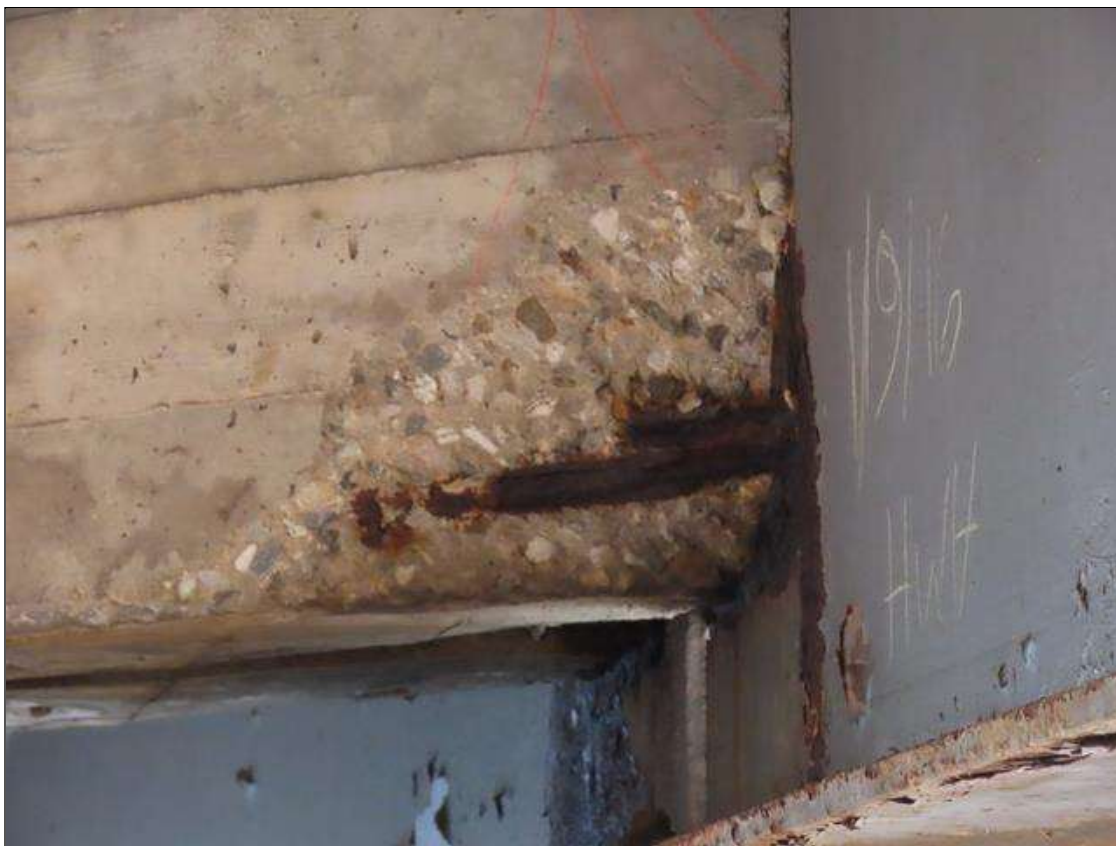
SPAN 2 BAY 8 FAR DIAPHRAGM - SPALL (18IN X 10IN X 3IN) WITH EXPOSED REBAR ADJACENT TO BEAM 9 (PAR PHOTO)

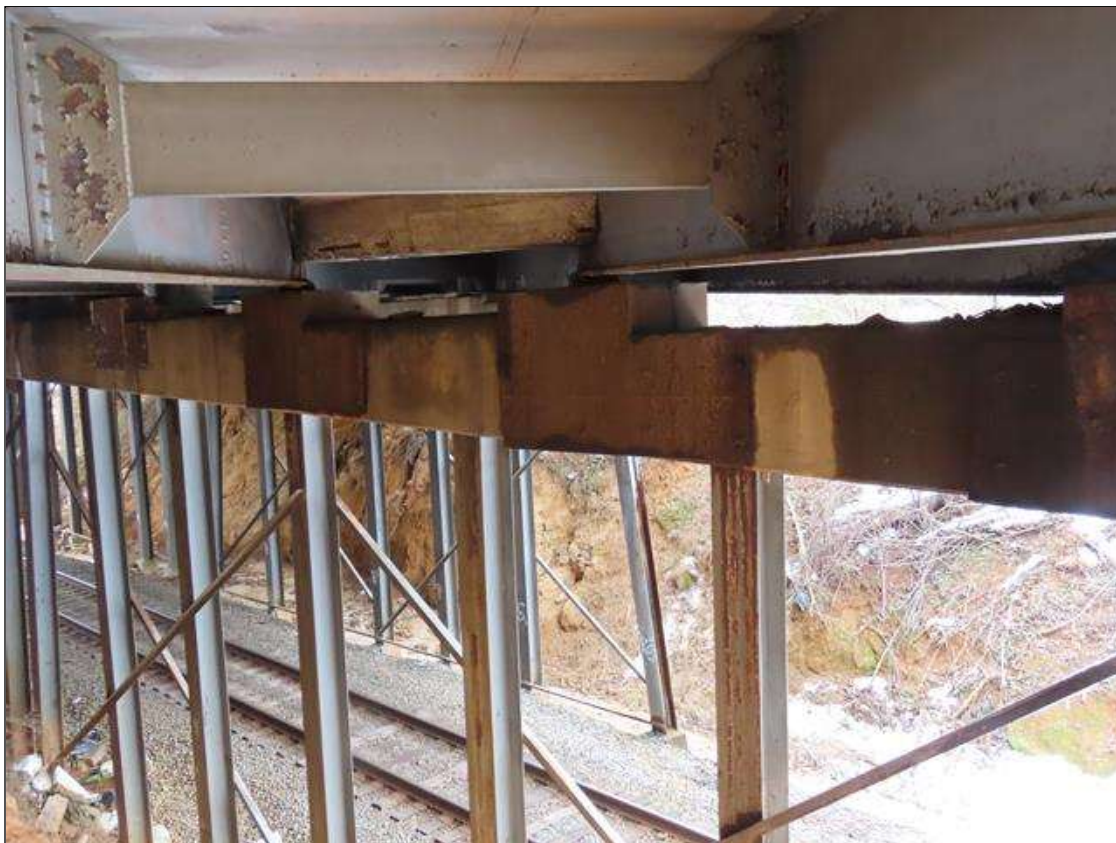
BENT 2 CAP - STEEL REPAIR PLATES (UP TO 6FT X FULL HEIGHT) (5X TOTAL) TO NEAR FACE BELOW BEAMS
7-11

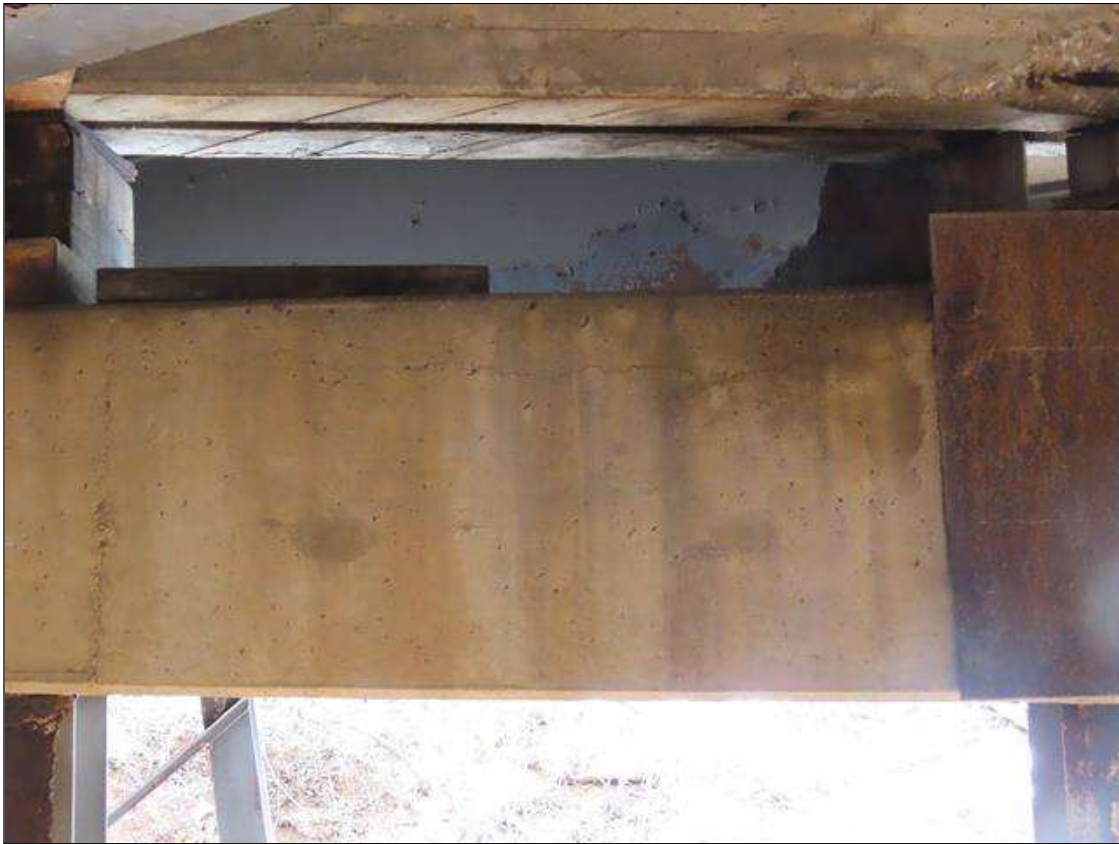
BENT 2 CAP - HORIZONTAL CRACK (1/32IN X 4.5FT L.) TO NEAR FACE AT TOP BELOW BAY 8
