NC DEPARTMENT OF TRANSPORTATION
 DIVISION OF HIGHWAYS
 STRUCTURE MANAGEMENT UNIT

Structure Safety Report

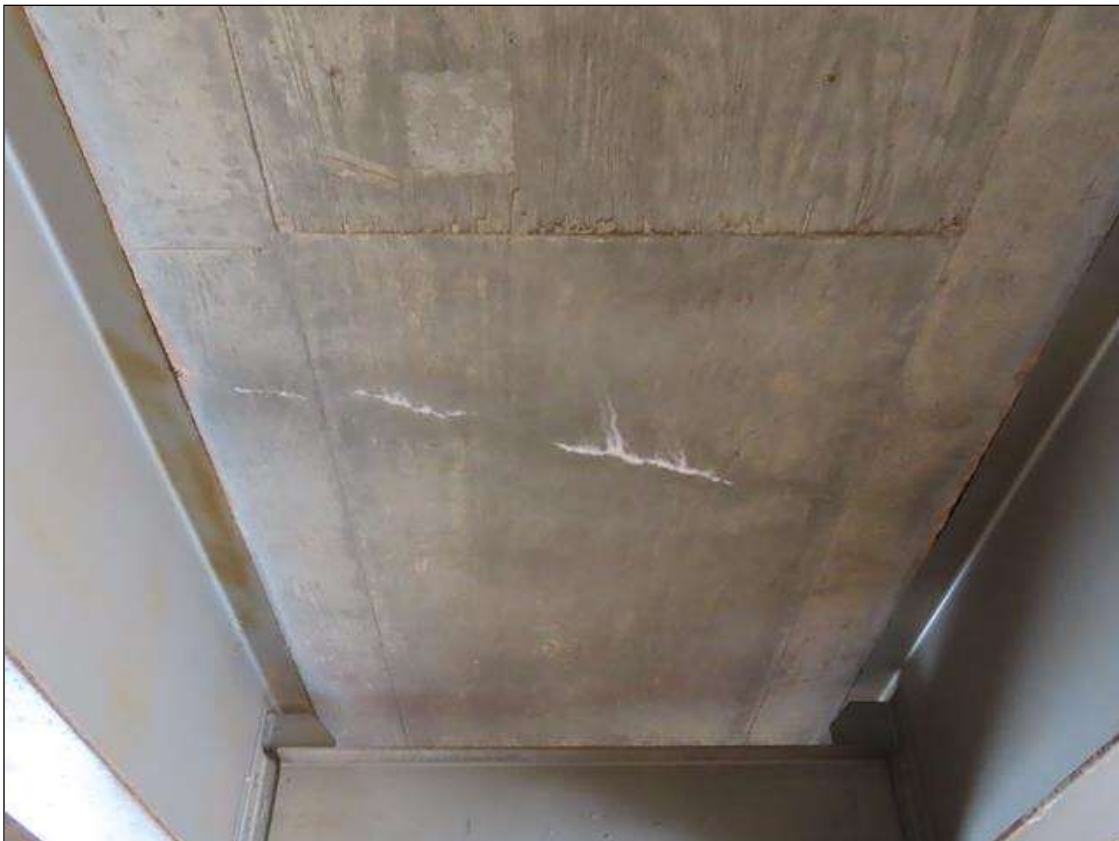
SPAN 2 DECK - TRANSVERSE HAIRLINE CRACK (8.5FT) WITH MINOR EFFLORESCENCE TO BOTTOM FACE BAY 5, 10FT FROM NEAR END

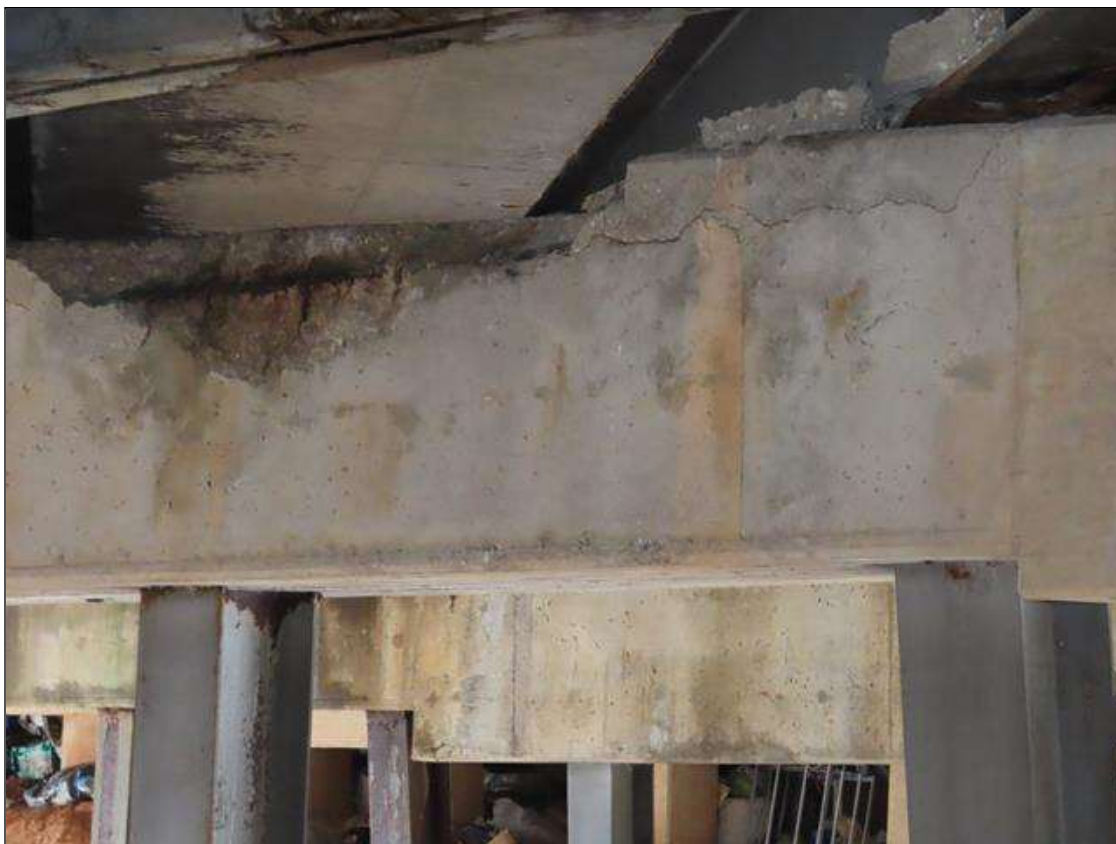
BENT 3 CAP - SPALL & DELAMINATION (9FT L. X 18IN H. X UP TO 6IN D.) WITH EXPOSED REBAR TO FAR FACE & TOP BELOW BAY 7 (PAR PHOTO)

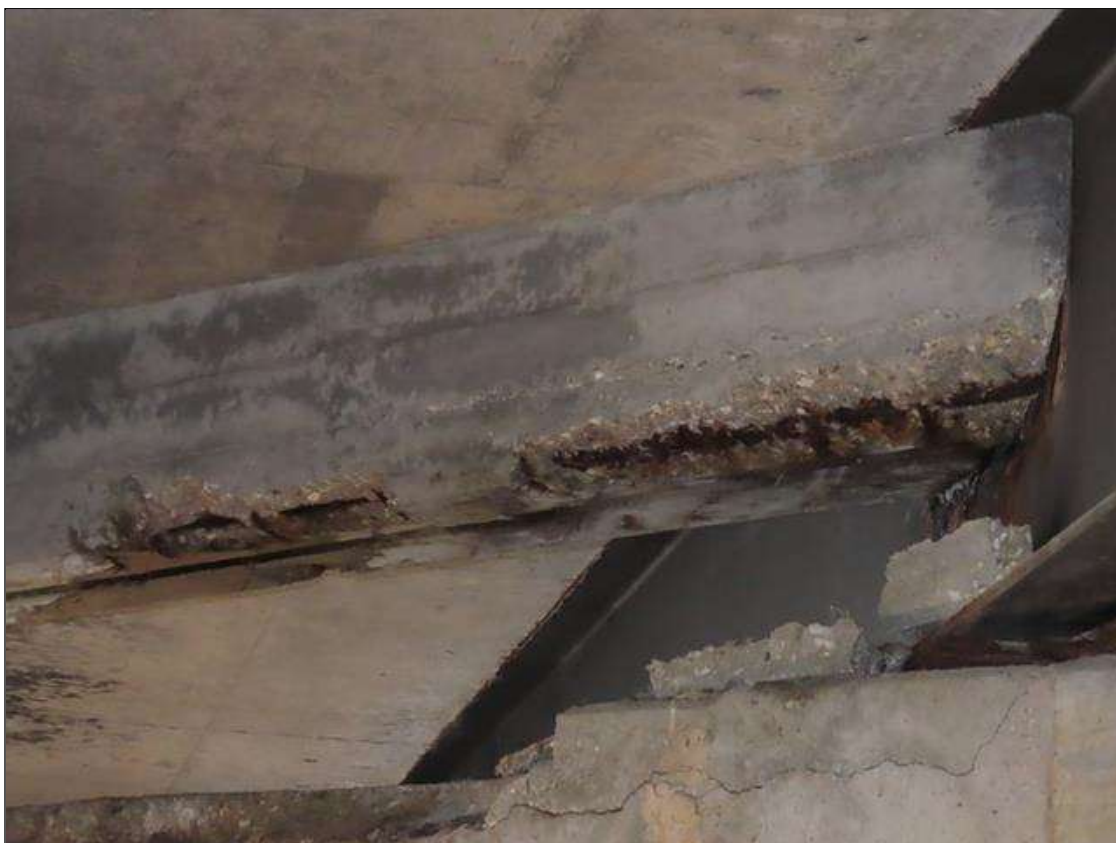
SPAN 4 BAY 7 NEAR DIAPHRAGM - 2X SPALLS (UP TO 40IN X 8IN X 4IN) WITH EXPOSED REBAR THROUGHOUT (PAR PHOTO)

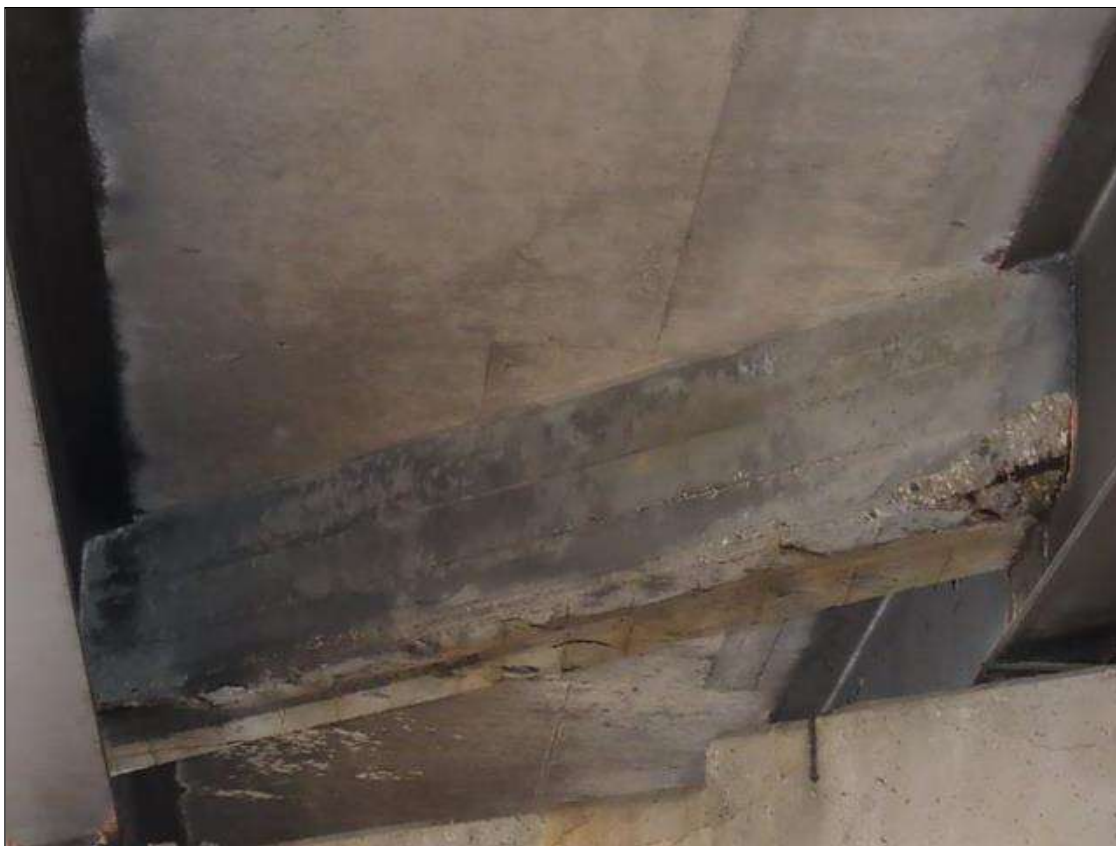
SPAN 4 BAY 8 NEAR DIAPHRAGM - SPALL & DELAMINATION (UP TO 48IN X 8IN X 2IN) WITH EXPOSED REBAR THROUGHOUT (PAR PHOTO)

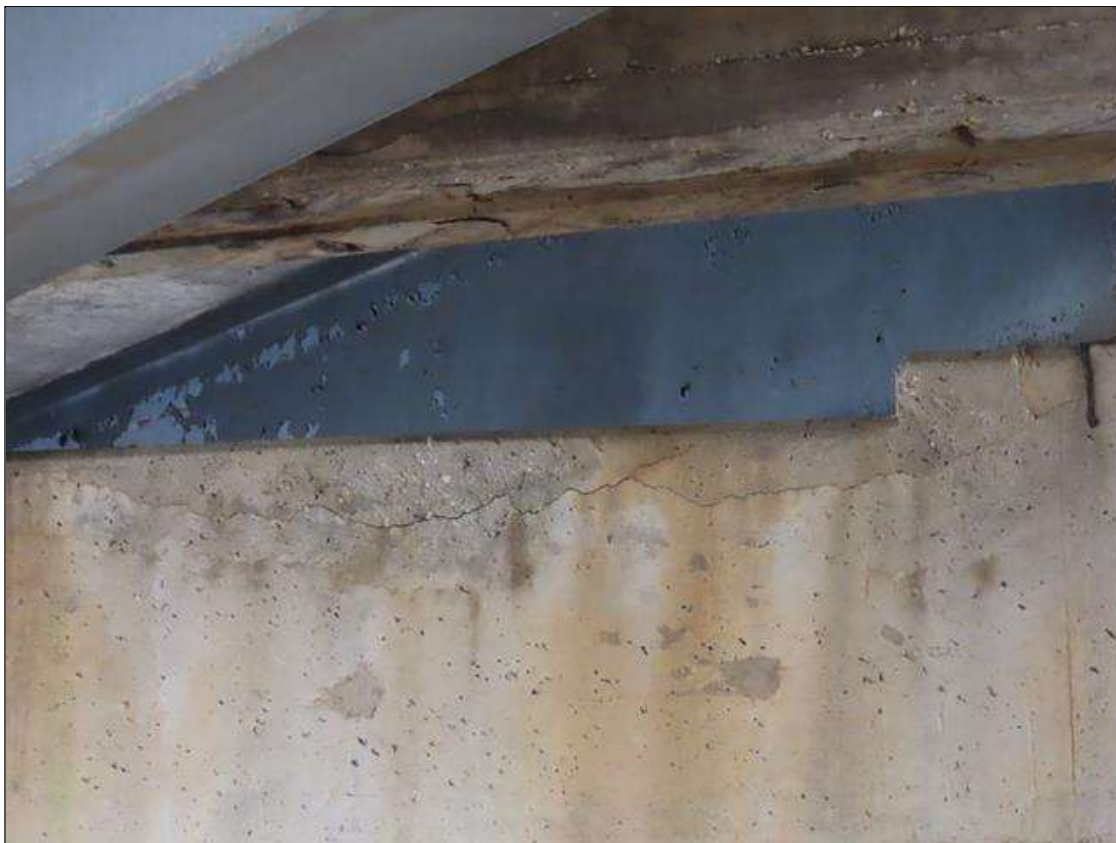
BENT 3 CAP - DELAMINATION (20FT L. X 8IN H.) TO FAR FACE BELOW BAYS 8 & 9

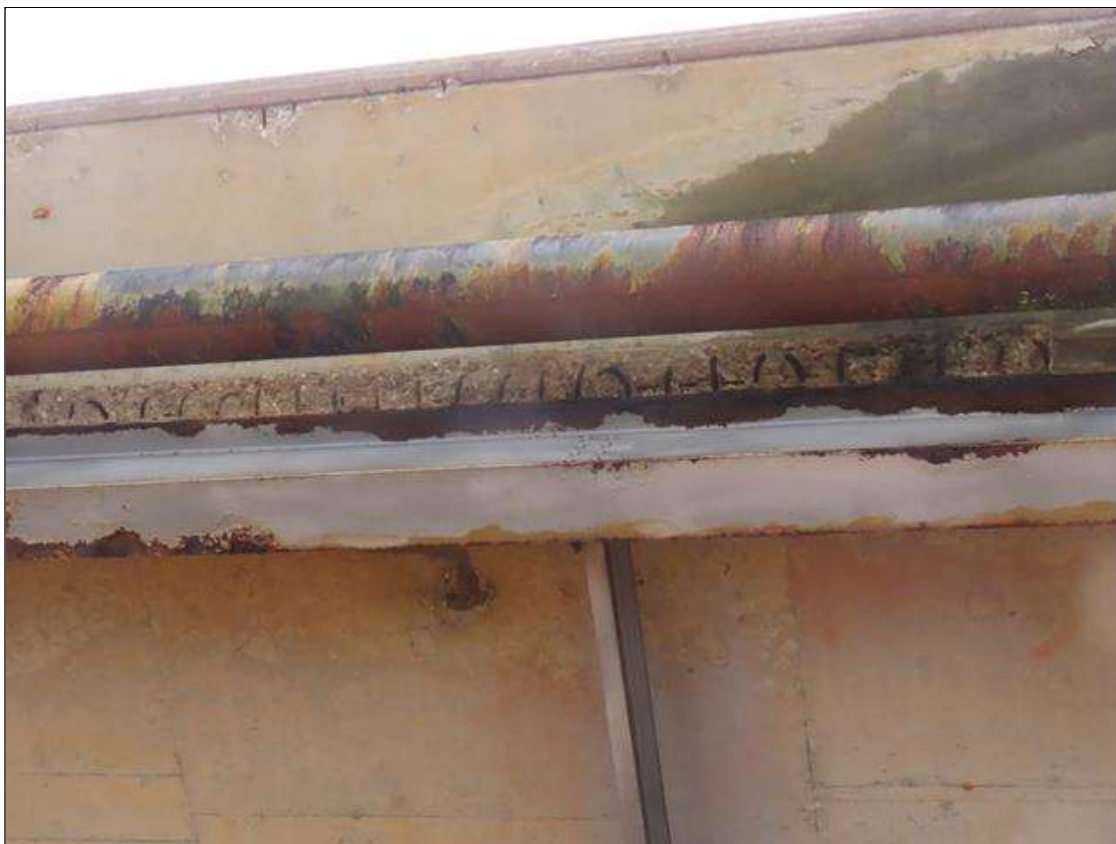
SPAN 2 DECK - SPALL (15FT X 8IN X 3IN) WITH EXPOSED REBAR TO RIGHT SIDE OF BEAM 11 HAUNCH AT MIDSPAN (PAR PHOTO)

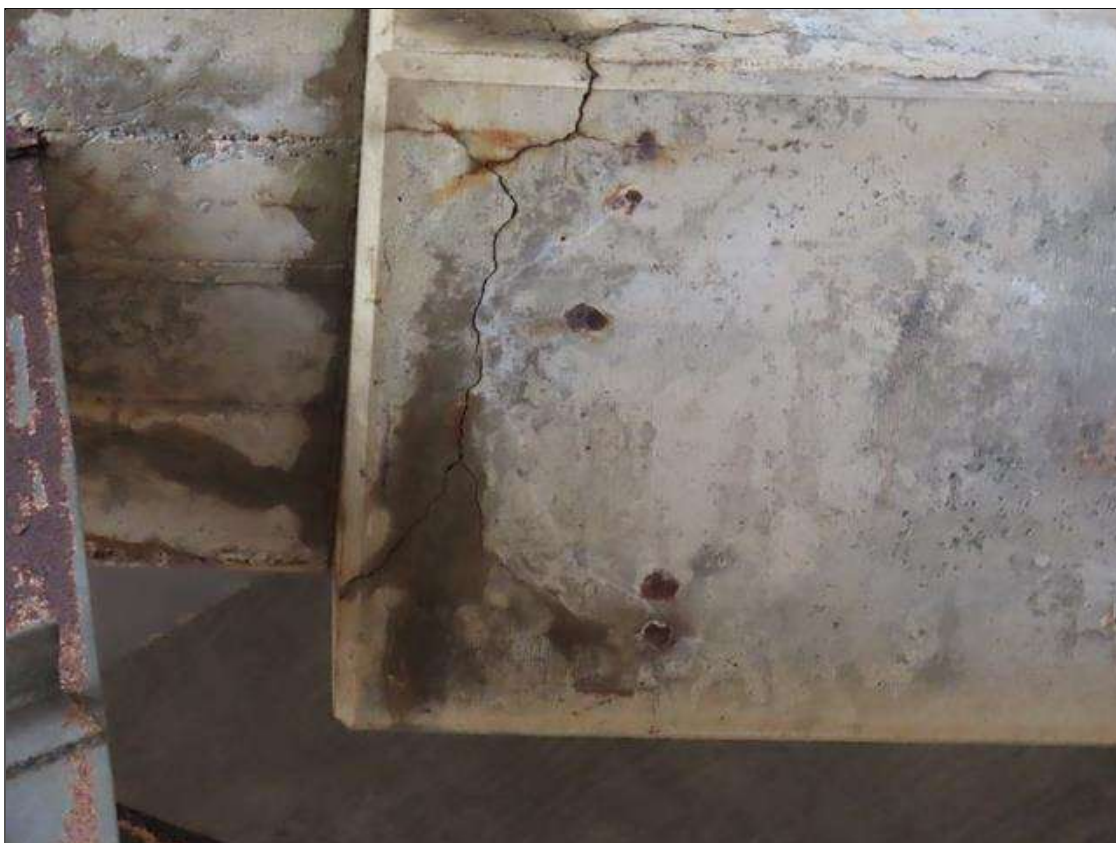
BENT 2 CAP - DELAMINATION (24IN X 8IN X 8IN) WITH MINOR RUST STAINING TO BOTTOM & FAR FACE OF CAP BETWEEN PILES 8 & 9 (PAR PHOTO)

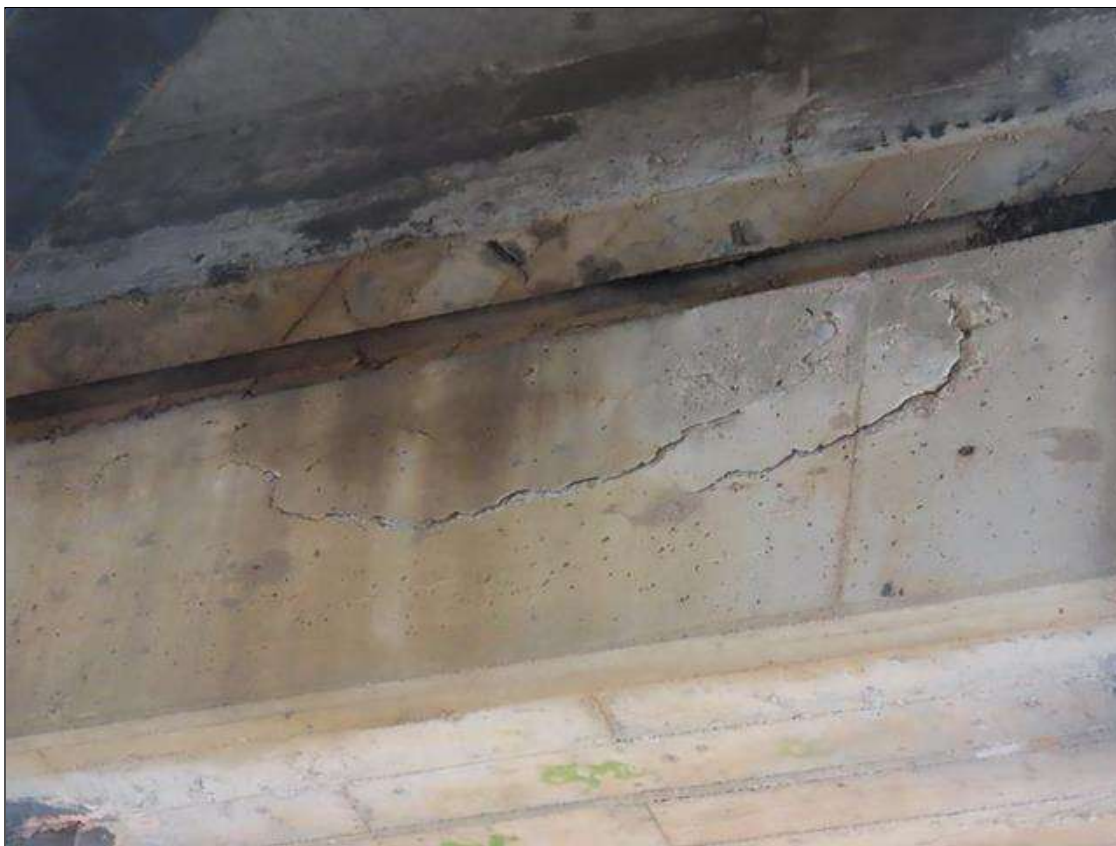
BENT 3 CAP - LOOSE DELAMINATION (4.5FT X 2FT) TO NEAR FACE BELOW BAY 8 (PAR PHOTO)

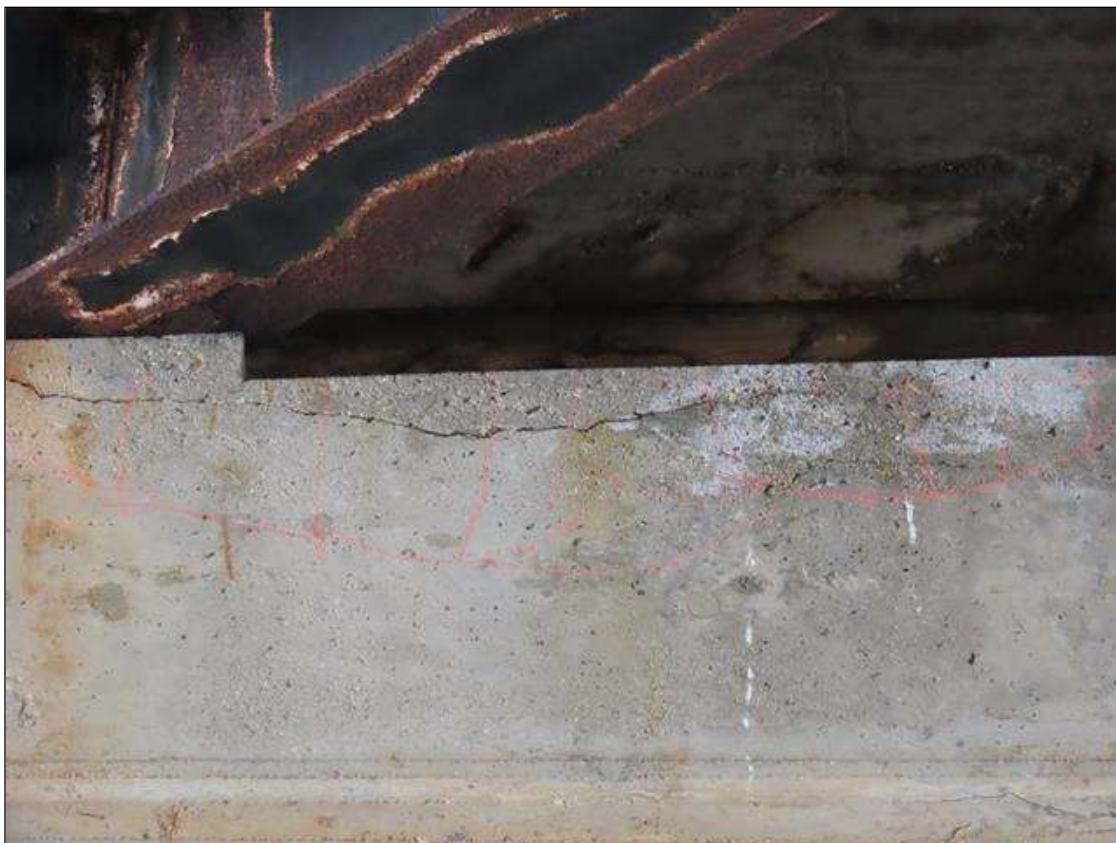
BENT 3 CAP - DELAMINATION (5FT X 1.5FT) TO NEAR FACE BELOW BEAM 7 & BAAY 7

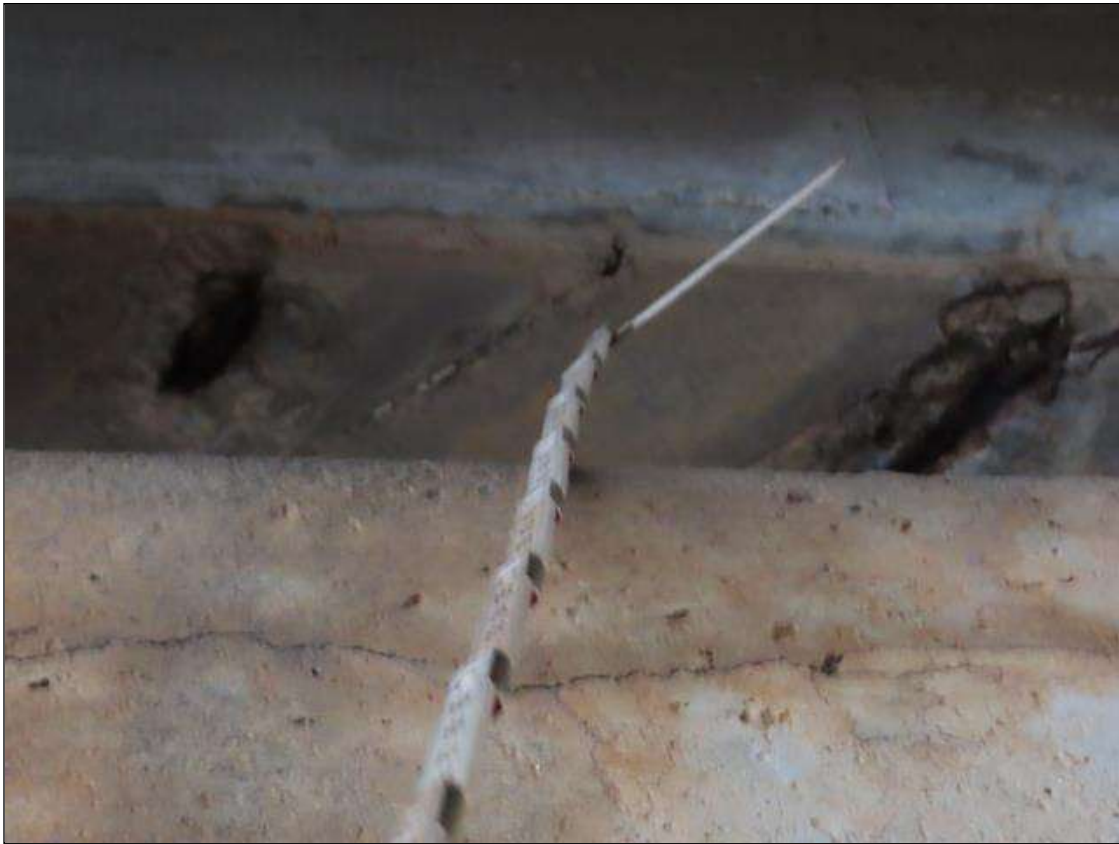
TYP. MINOR SPALLING (UP TO 8IN X 4IN X 1IN) WITH EXPOSED REBAR THROUGHOUT BOTTOM FACE OF DIAPHRAGMS, SPAN 4 BAY 7 FAR DIAPHRAGM

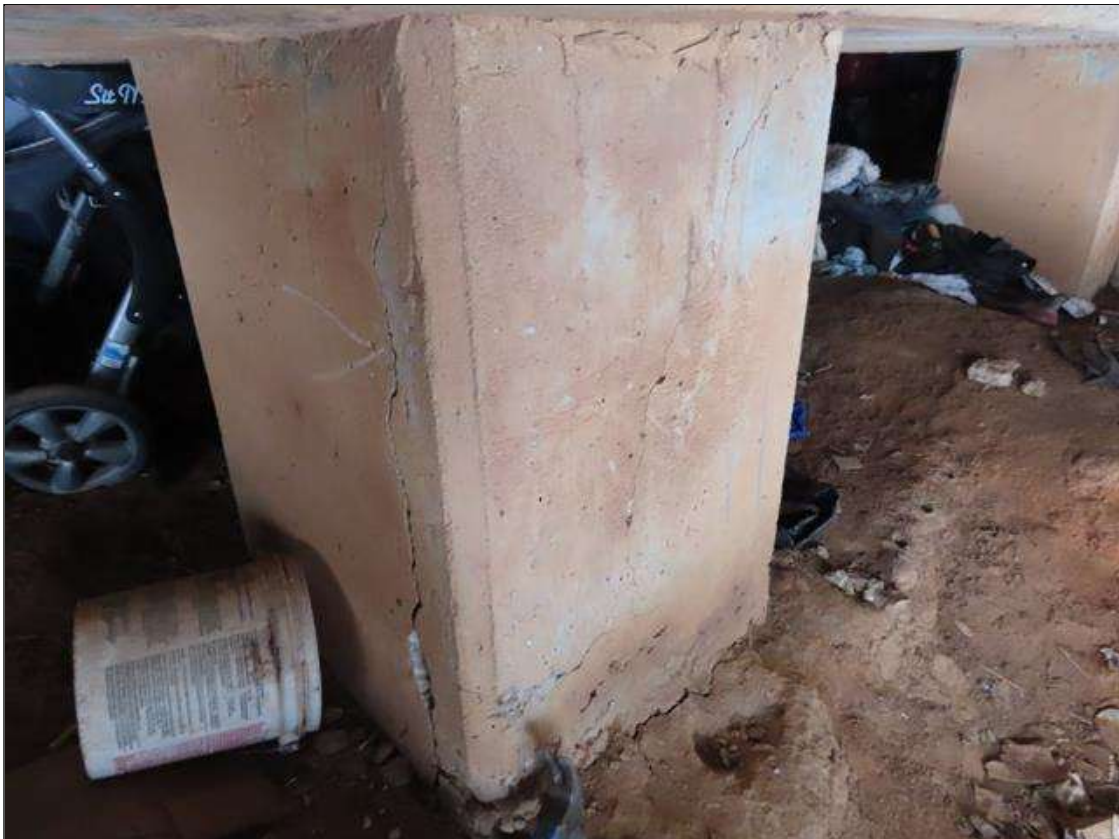
TYP. VERTICAL 1/4IN CRACKING & DELAMINATION (UP TO FULL WIDTH X 3FT H.) THROUGHOUT FAR FACE OF BENT 1 COLUMNS, COLUMN 11

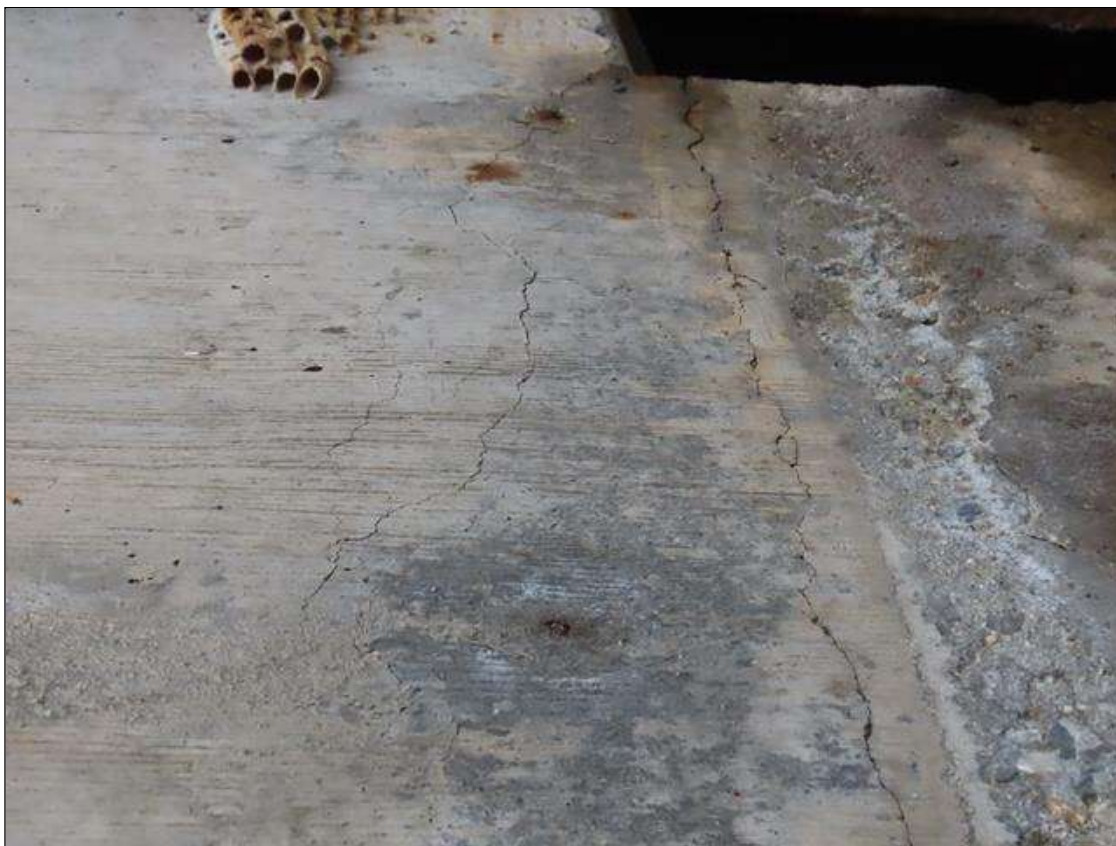
BENT 4 CAP - VERTICAL HAIRLINE TO 1/32IN CRACKING (FULL HEIGHT) TO NEAR FACE BELOW BAY 6

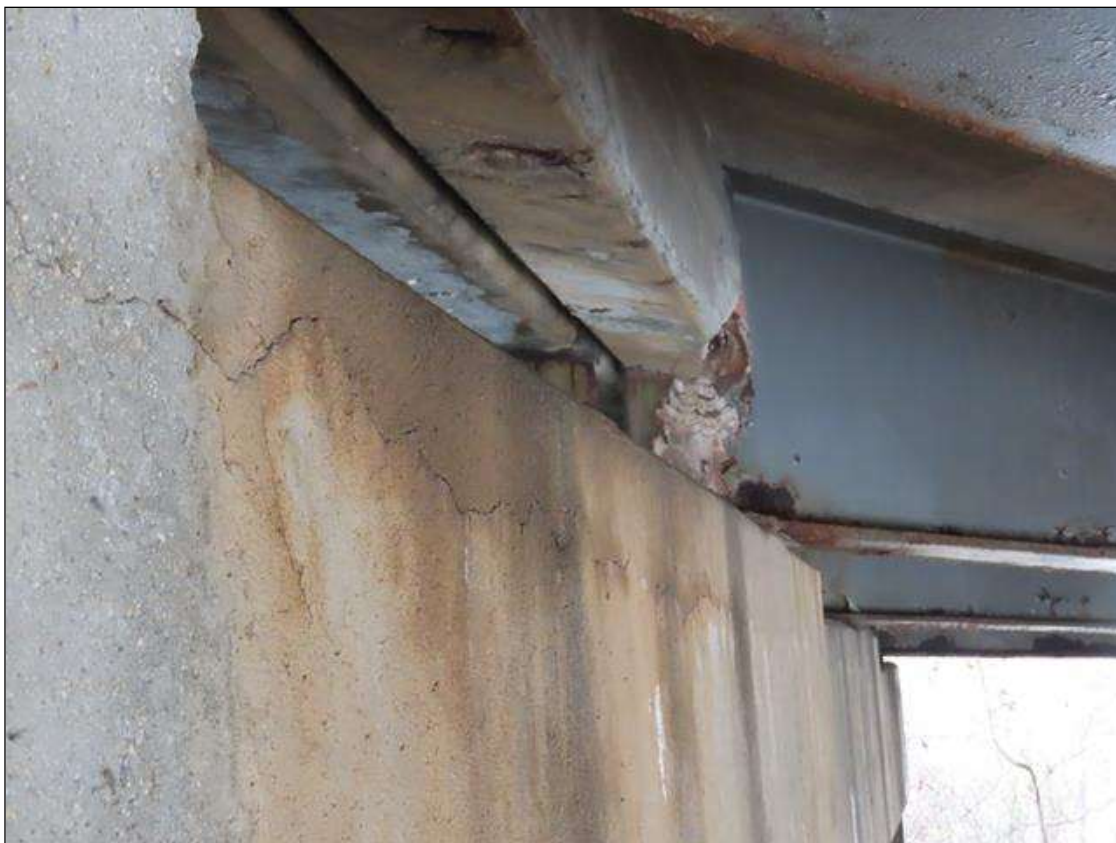
BENT 4 CAP - HORIZONTAL 1/8IN CRACKING & DELAM (UP TO 8IN H.) FOR 25FT BELOW BAYS 7-9

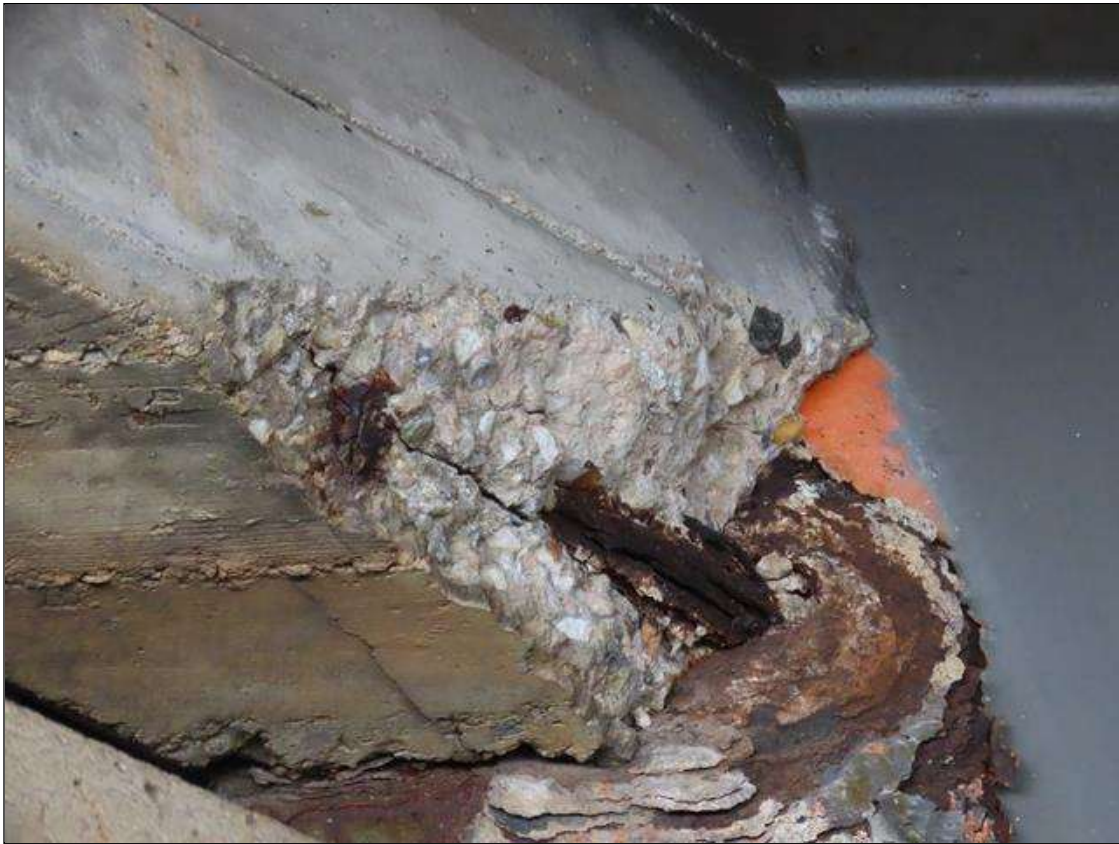
SPAN 4 BAY 8 FAR DIAPHRAGM - SPALL (16IN X 10IN X 4IN) WITH EXPOSED REBAR ADJACENT TO BEAM 9 (PAR PHOTO)

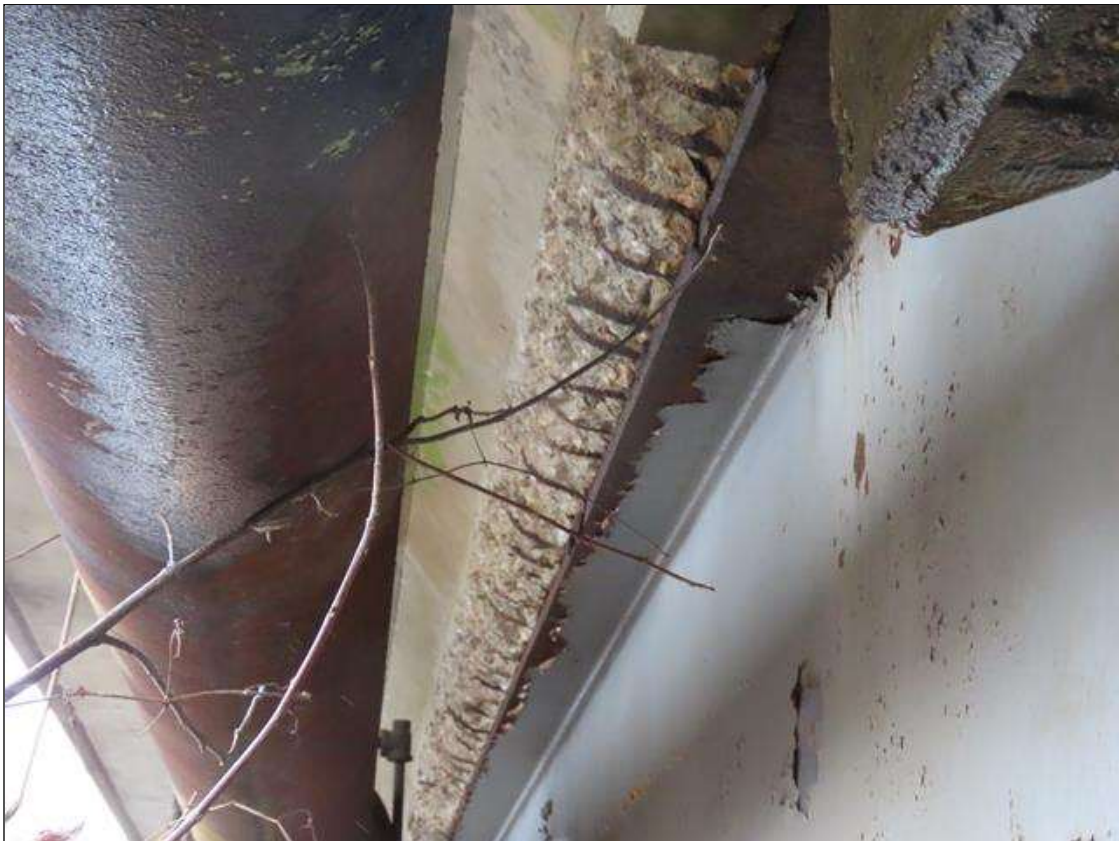
SPAN 4 DECK - SPALL (25FT X 6IN X 3IN) WITH EXPOSED REBAR TO RIGHT SIDE OF BEAM 11 HAUNCH AT FAR END (PAR PHOTO)

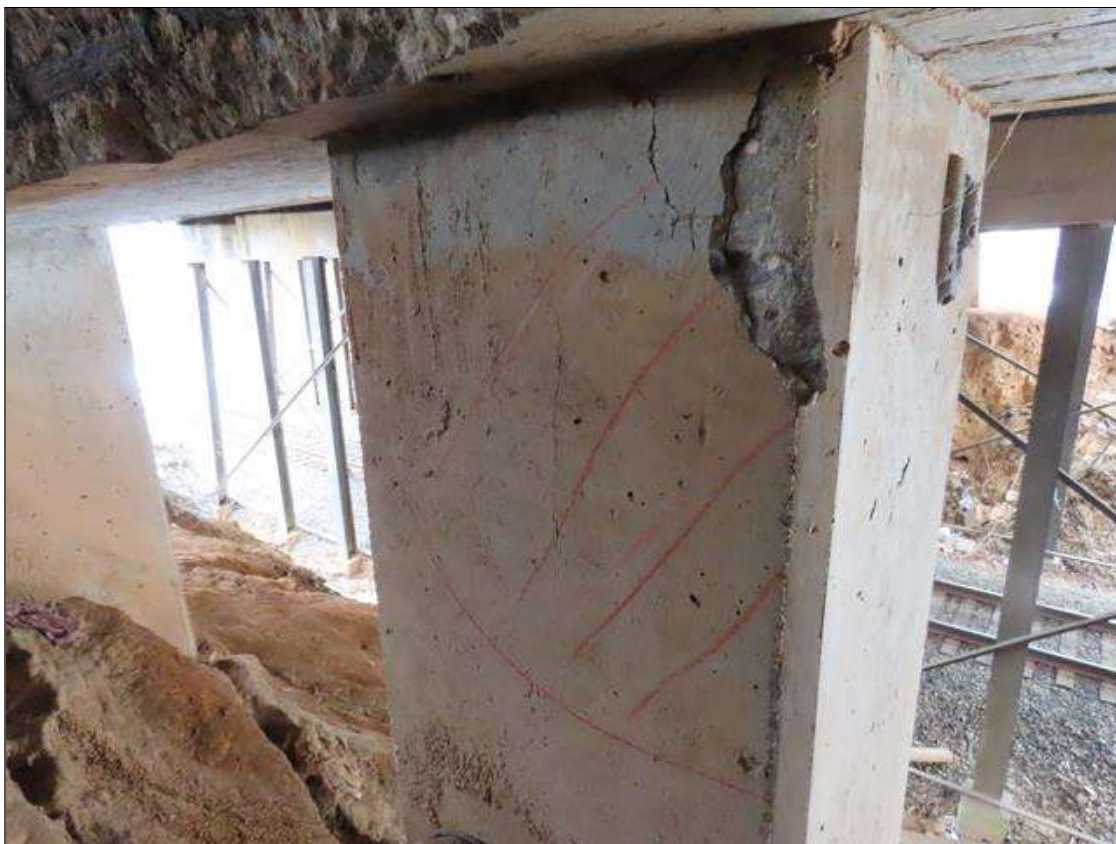
BENT 4 COLUMN 14 - SPALL & DELAMINATION (FULL WIDTH X 2FT X UP TO 1IN) TO FAR FACE AT TOP

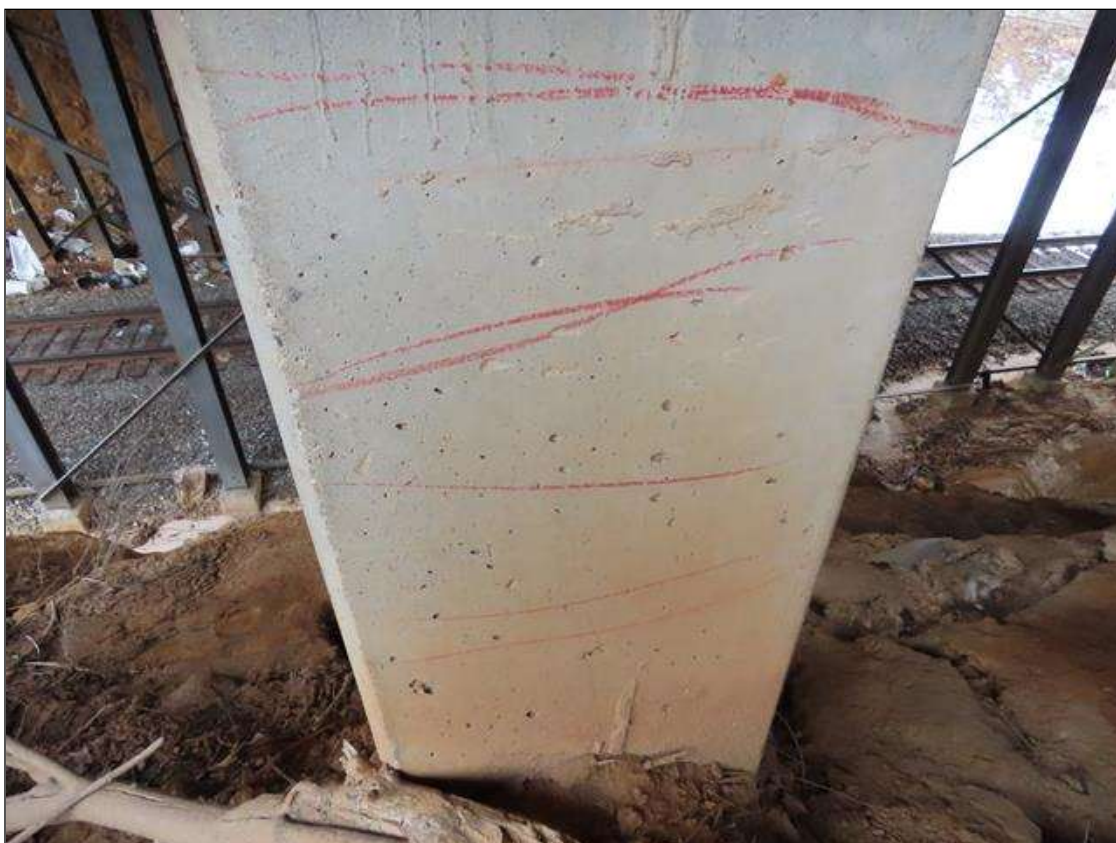
BENT 4 COLUMN 16 - DELAMINATION (3FT H. X FULL WIDTH) TO FAR FACE (COLUMN 15, 17 SIMILAR)

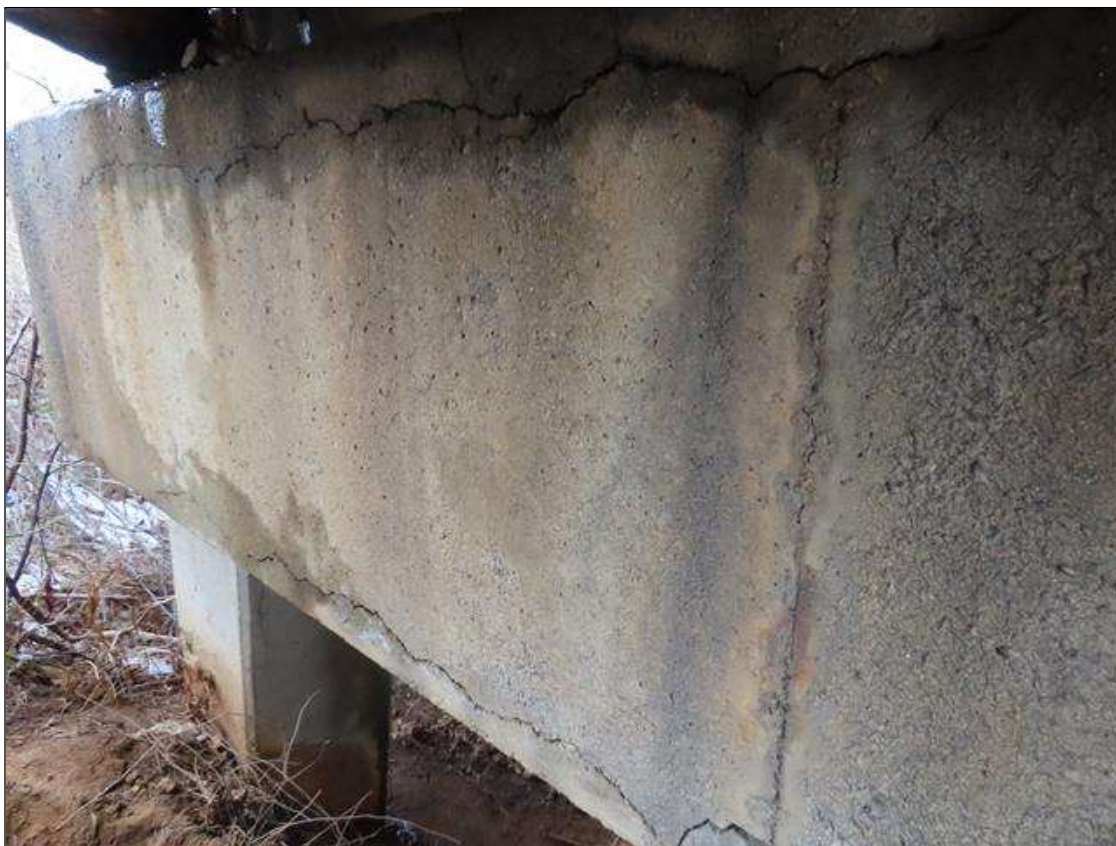
BENT 4 CAP - DELAMINATION (FULL HEIGHT) & 2X SPALLS (UP TO 48IN X 16IN X 3IN) WITH EXPOSED REBAR TO FAR FACE BELOW BAYS 8-10 (25FT TOTAL) (PAR PHOTO 1/3)

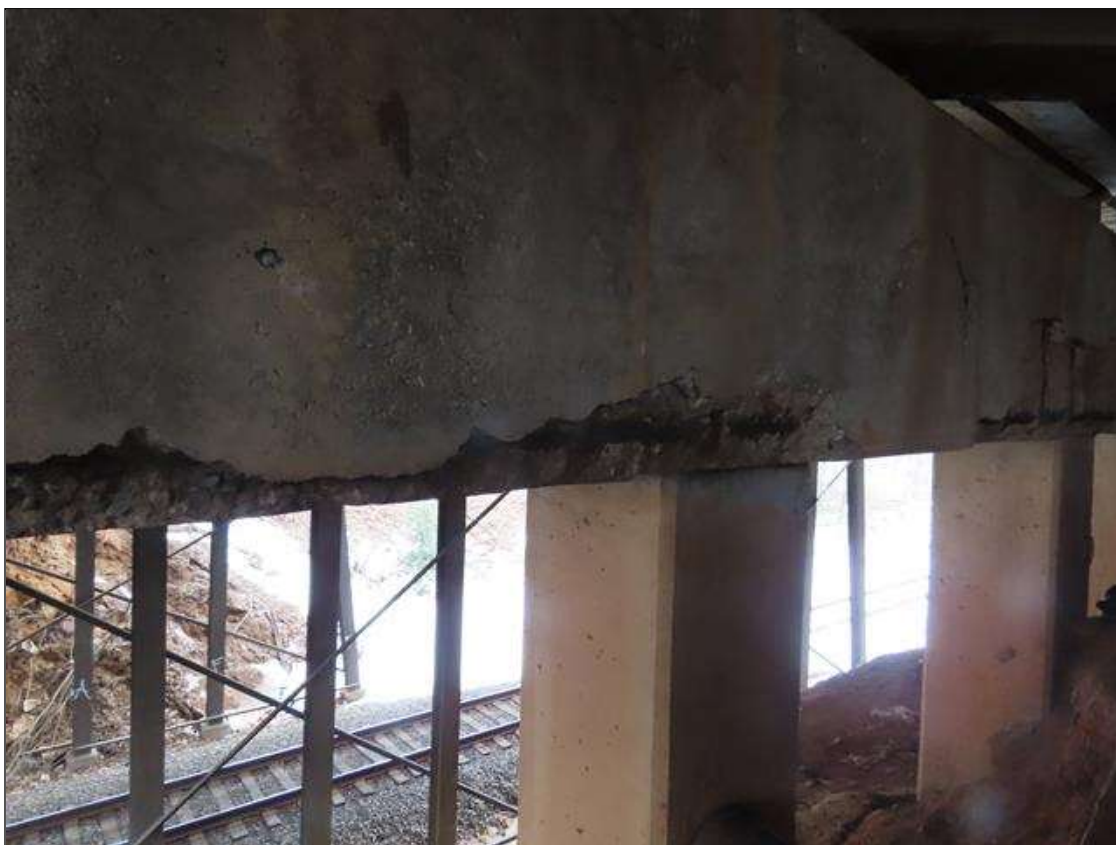
BENT 4 CAP - DELAMINATION (FULL HEIGHT) & 2X SPALLS (UP TO 48IN X 16IN X 3IN) WITH EXPOSED REBAR TO FAR FACE BELOW BAYS 8-10 (25FT TOTAL) (PAR PHOTO 2/3)

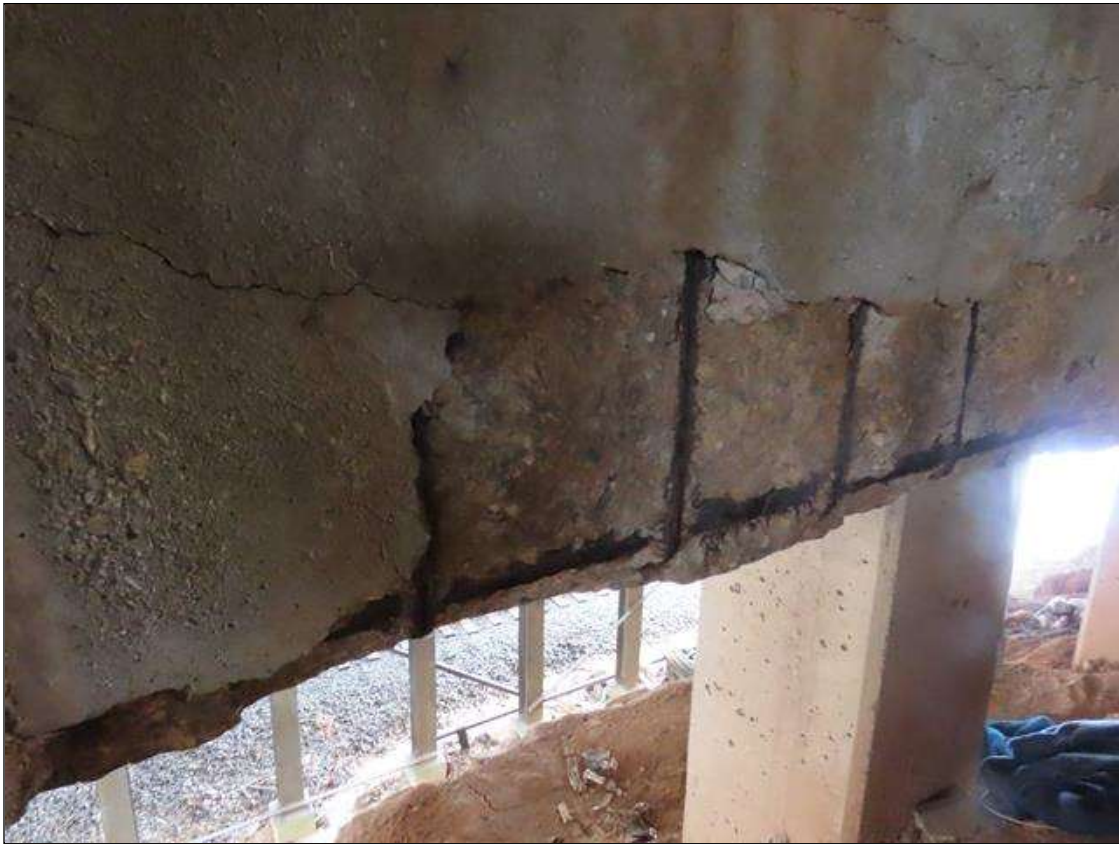
BENT 4 CAP - DELAMINATION (FULL HEIGHT) & 2X SPALLS (UP TO 48IN X 16IN X 3IN) WITH EXPOSED REBAR TO FAR FACE BELOW BAYS 8-10 (25FT TOTAL) (PAR PHOTO 3/3)

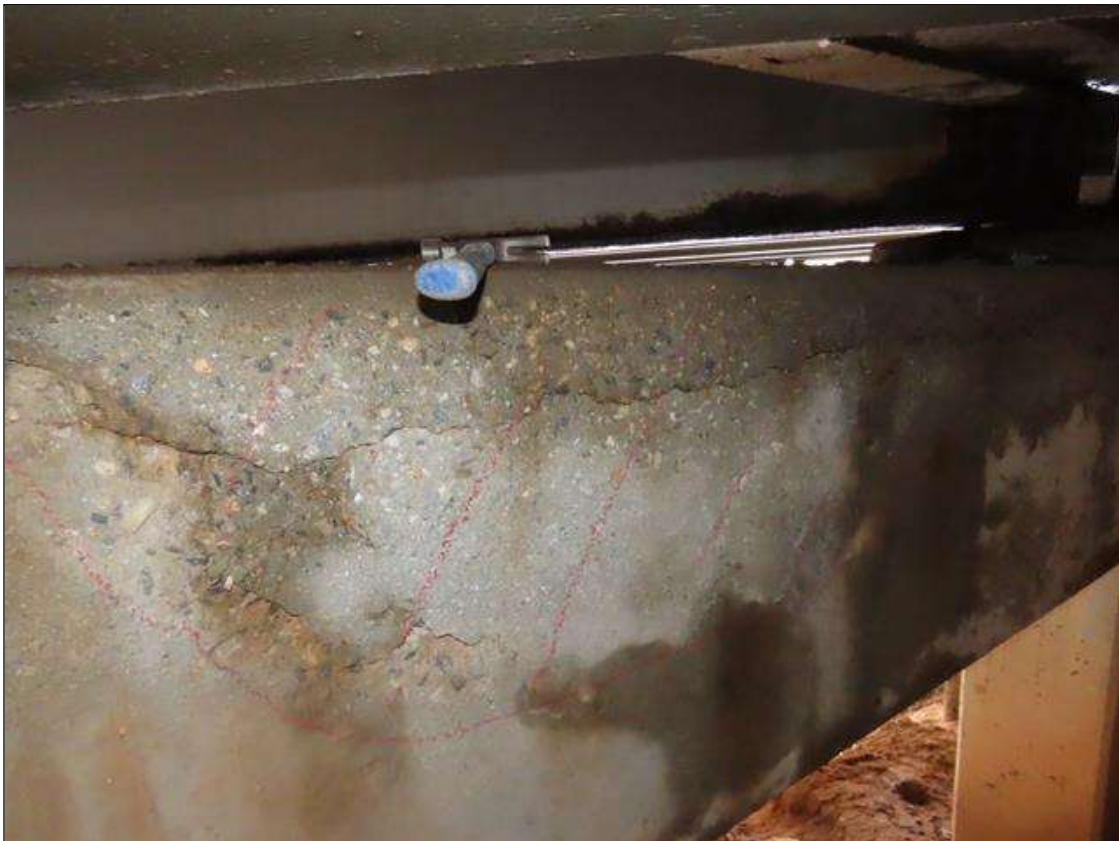
BENT 4 CAP - DELAMINATION (8 SQ. FT.) TO FAR FACE BELOW BAY 7

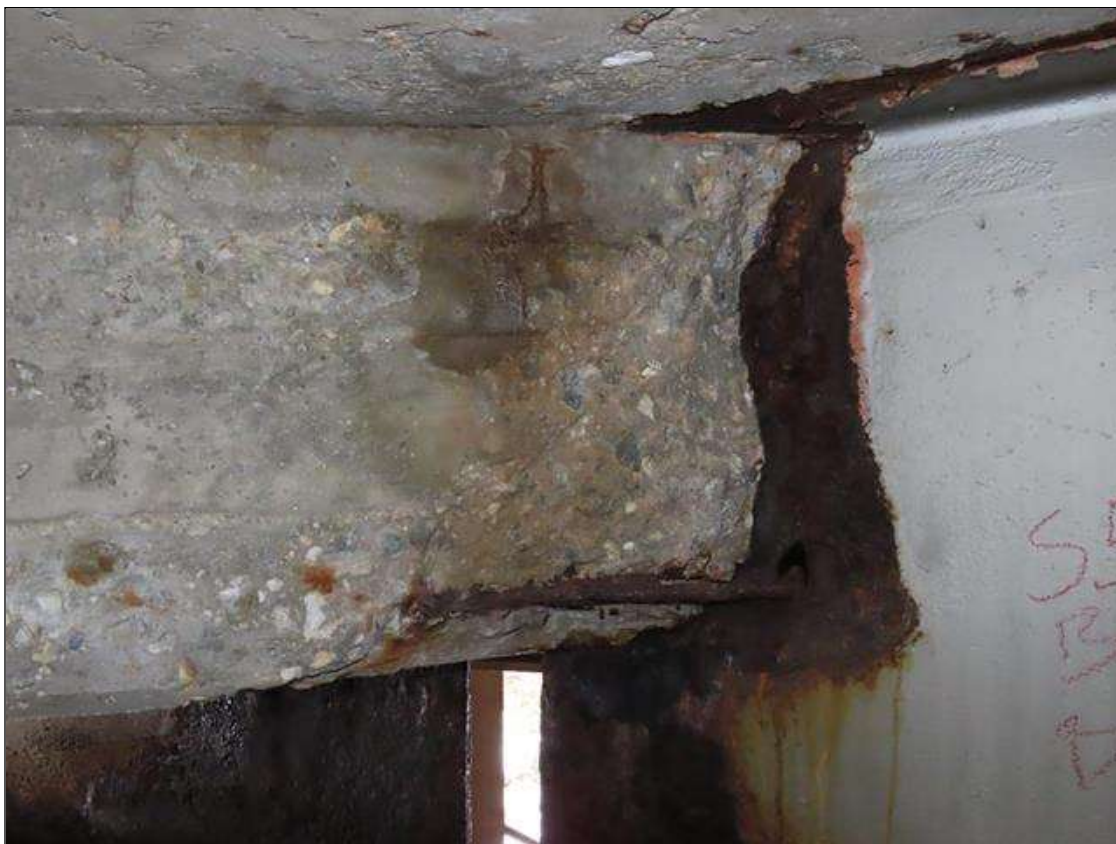
SPAN 5 BAY 7 NEAR DIAPHRAGM - SPALL (20IN X 20IN X 4IN) WITH EXPOSED REBAR ADJACENT TO BEAM 7 (PAR PHOTO)

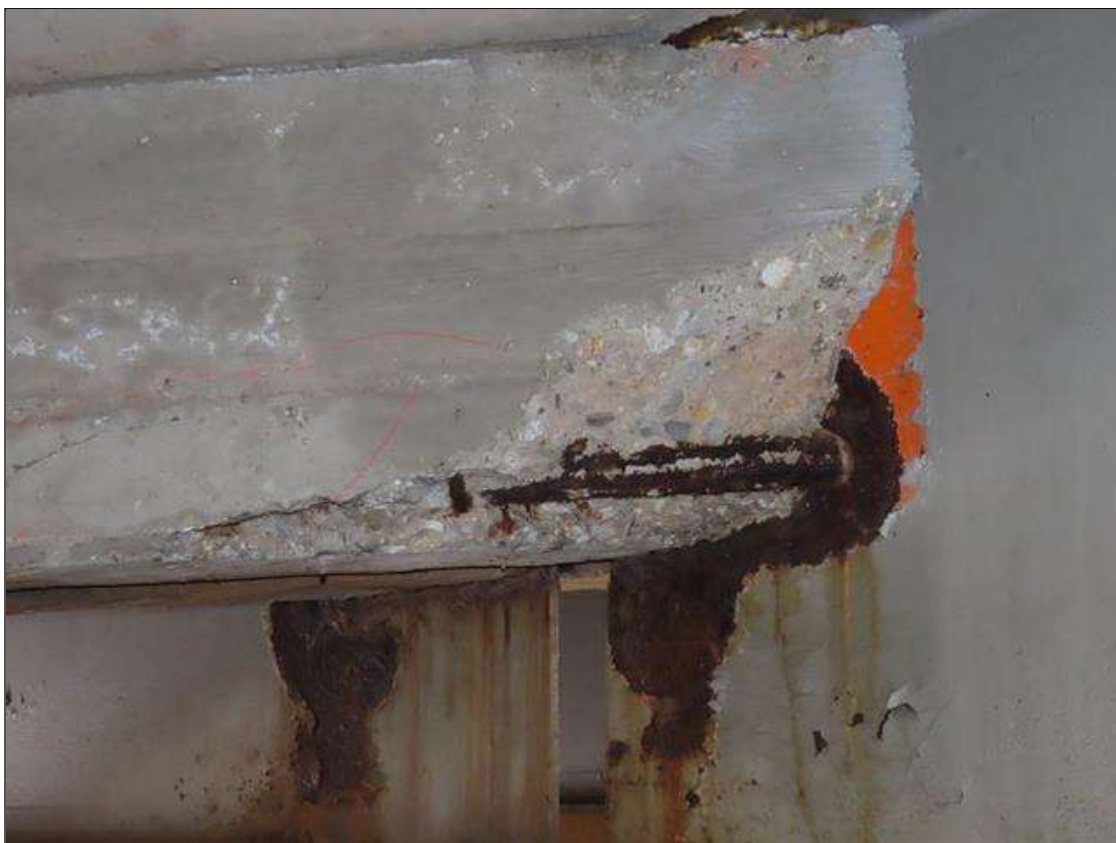
SPAN 5 BAY 9 NEAR DIAPHRAGM - SPALL (26IN X 12IN X 4IN) WITH EXPOSED REBAR ADJACENT TO BEAM 9 (PAR PHOTO)

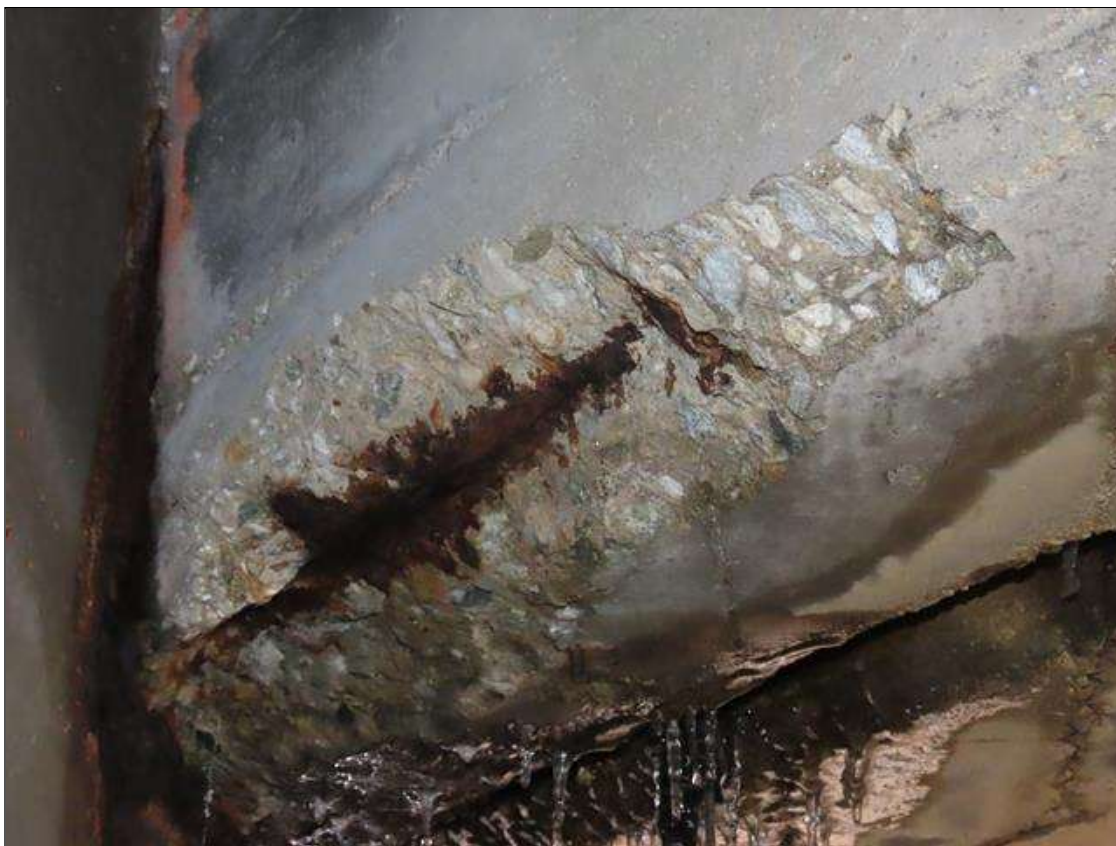
SPAN 5 BAY 10 NEAR DIAPHRAGM - SPALL (24IN X 8IN X 3IN) WITH EXPOSED REBAR ADJACENT TO BEAM 11 (PAR PHOTO)
