NC DEPARTMENT OF TRANSPORTATION
 DIVISION OF HIGHWAYS
 STRUCTURE MANAGEMENT UNIT

Structure Safety Report

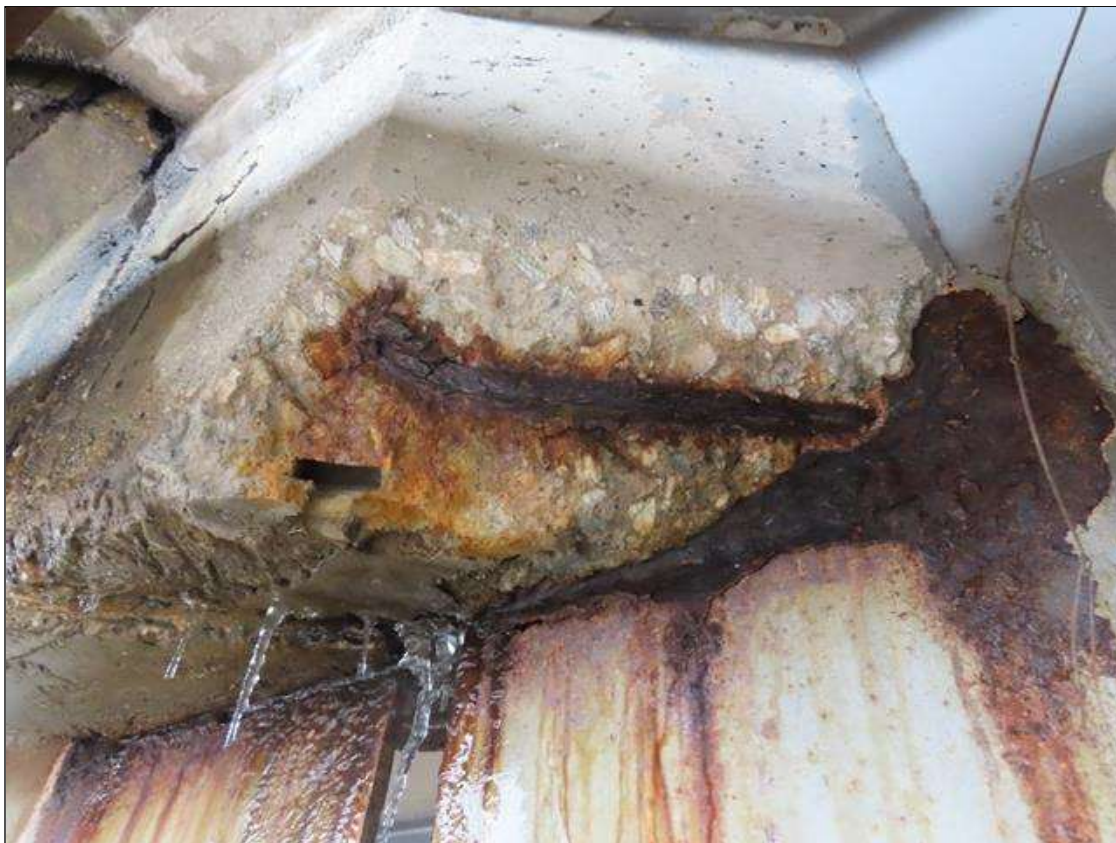
SPAN 5 RIGHT OVERHANG DIAPHRAGM AT NEAR END - SPALL (14IN X 8IN X 2IN) WITH EXPOSED REBAR (PAR PHOTO)

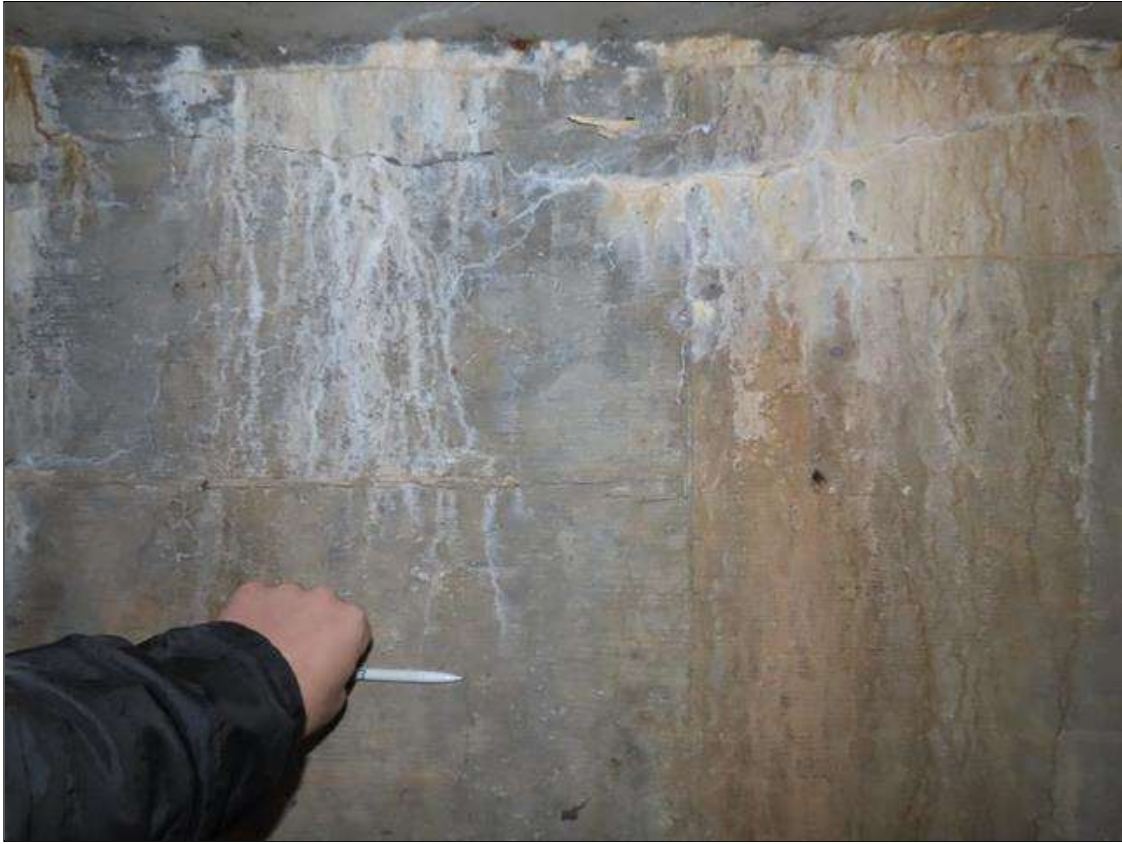
TYP. INTERMITTENT VERTICAL & TRANSVERSE HAIRLINE CRACKING THROUGHOUT END BENT 2 BACKWALL BAY 5

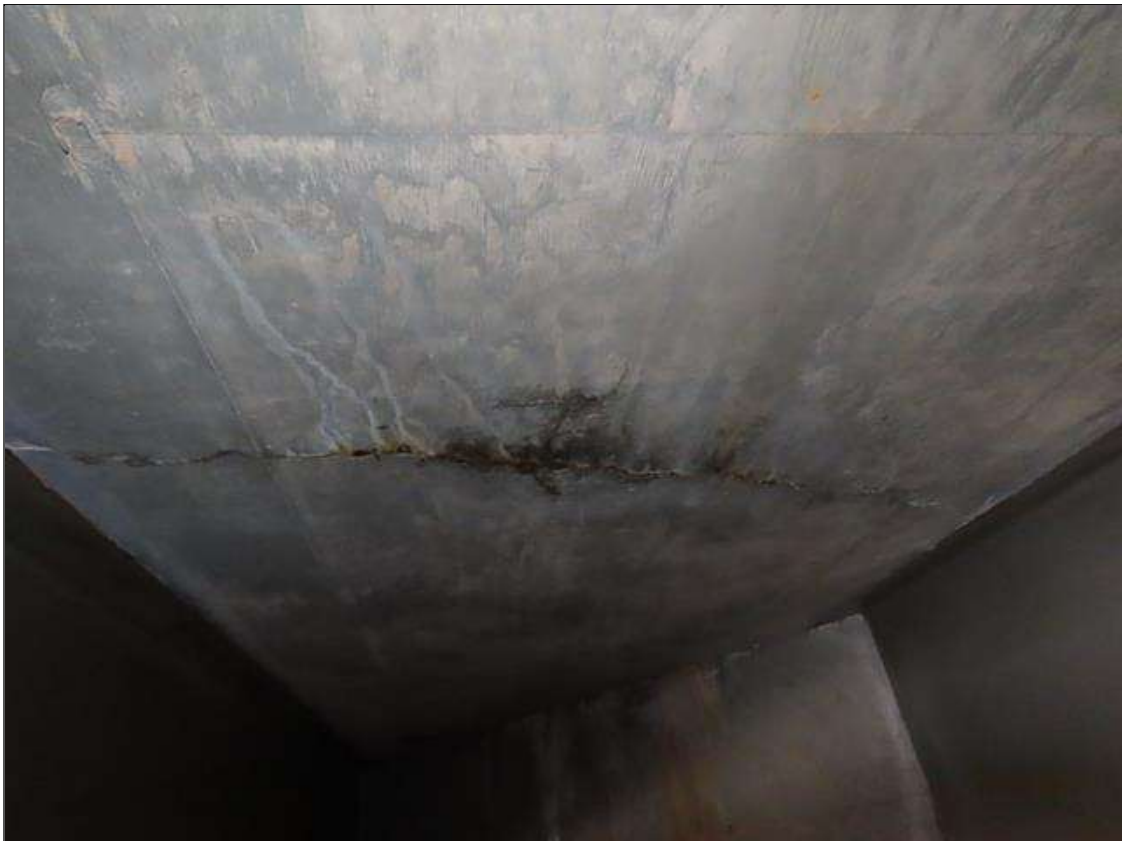
SPAN 5 DECK - TRANSVERSE HAIRLINE CRACK (8FT L.) WITH MODERATE EFFLORESCENCE IN BAY 5 AT MIDSPAN (SIMILAR BAY 6)

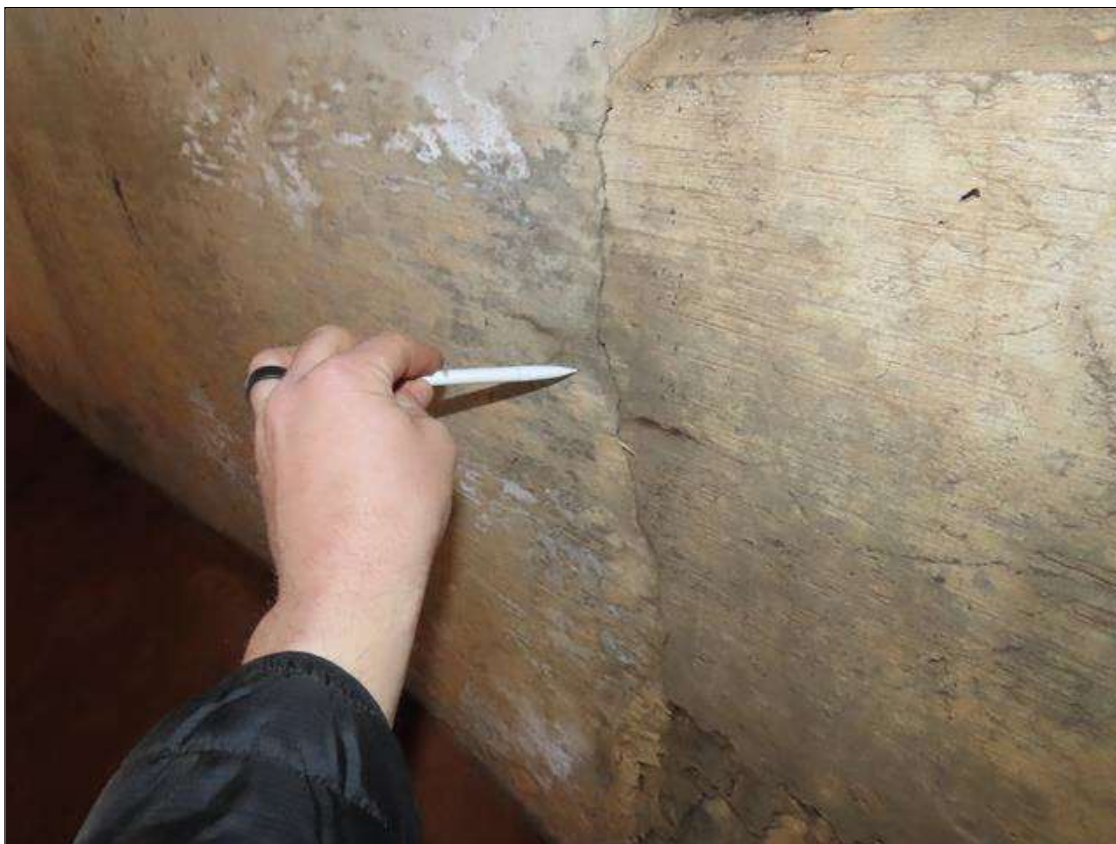
END BENT 2 CAP - VERTICAL CRACK (1/16IN X FULL HEIGHT) TO FACE BELOW BAY 5

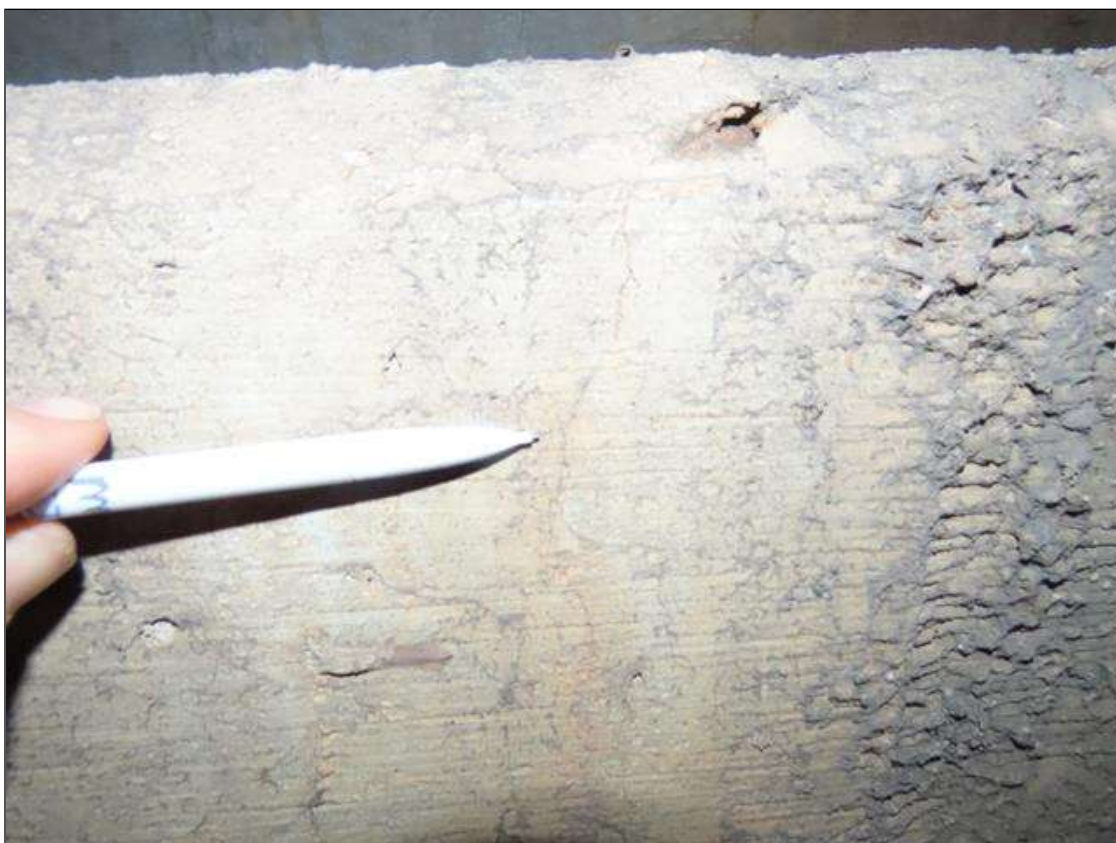
TYP. INTERMITTENT VERTICAL HAIRLINE CRACKING (UP TO FULL HEIGHT) THROUGHOUT END BENT 2 CAP, BAY 4

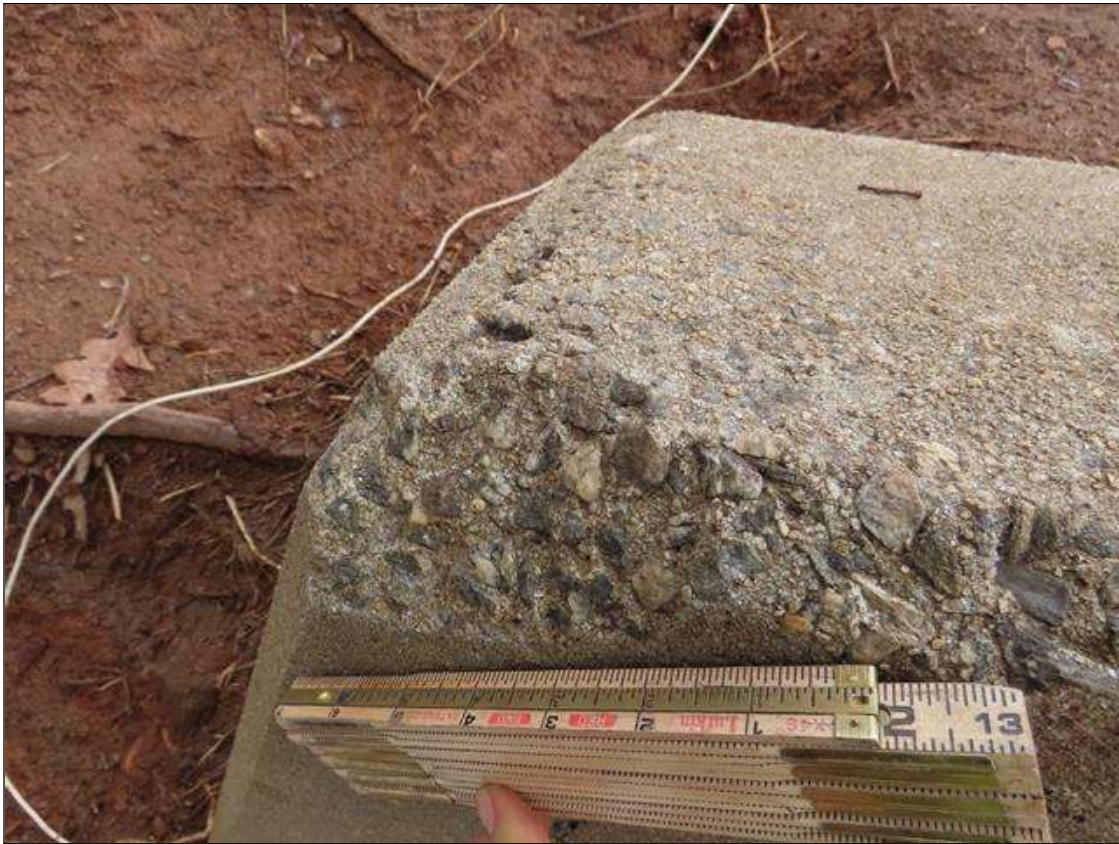
FAR LEFT WINGWALL - SPALL (6IN X 4IN X 1IN) WITH NO EXPOSED REBAR TO TOP CORNER AT LEFT SIDE
(FAR RIGHT WINGWALL SIMILAR, AT RIGHT SIDE TOP)

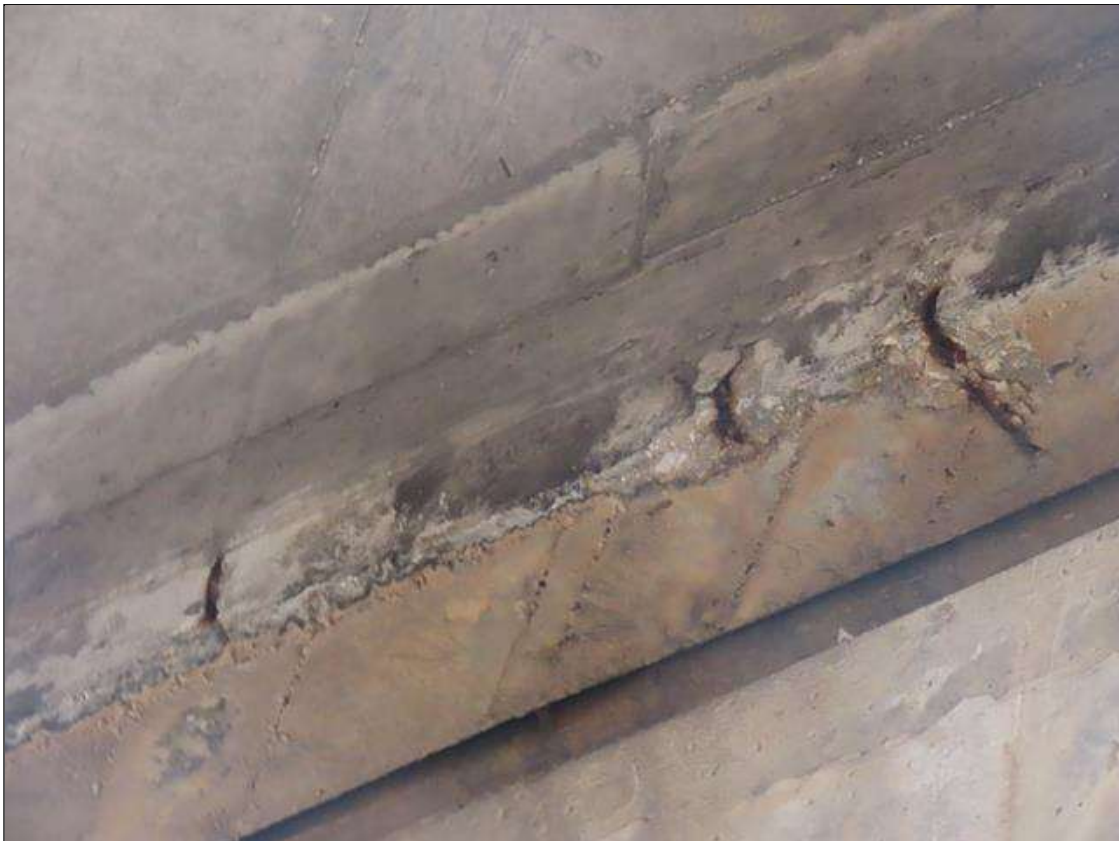
TYP. MULTIPLE MINOR SPALLS (UP TO 8IN X 3IN X 1/2IN) WITH EXPOSED REBAR THROUGHOUT SPAN 3
NEAR & FAR DIAPHRAGMS, SPAN 3 BAY 9 FAR DIAPHRAGM

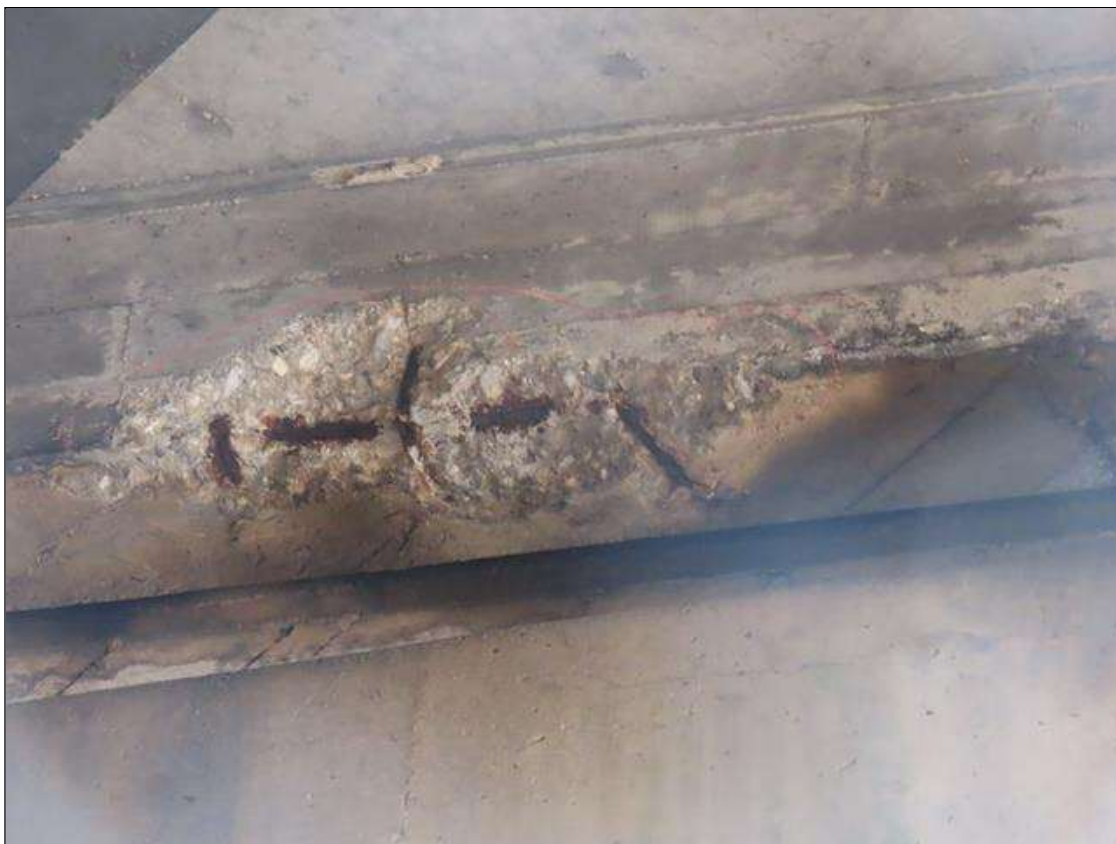
SPAN 3 BAY 10 FAR DIAPHRAGM - SPALL (36IN X 12IN X 4IN) WITH EXPOSED REBAR (PAR PHOTO)

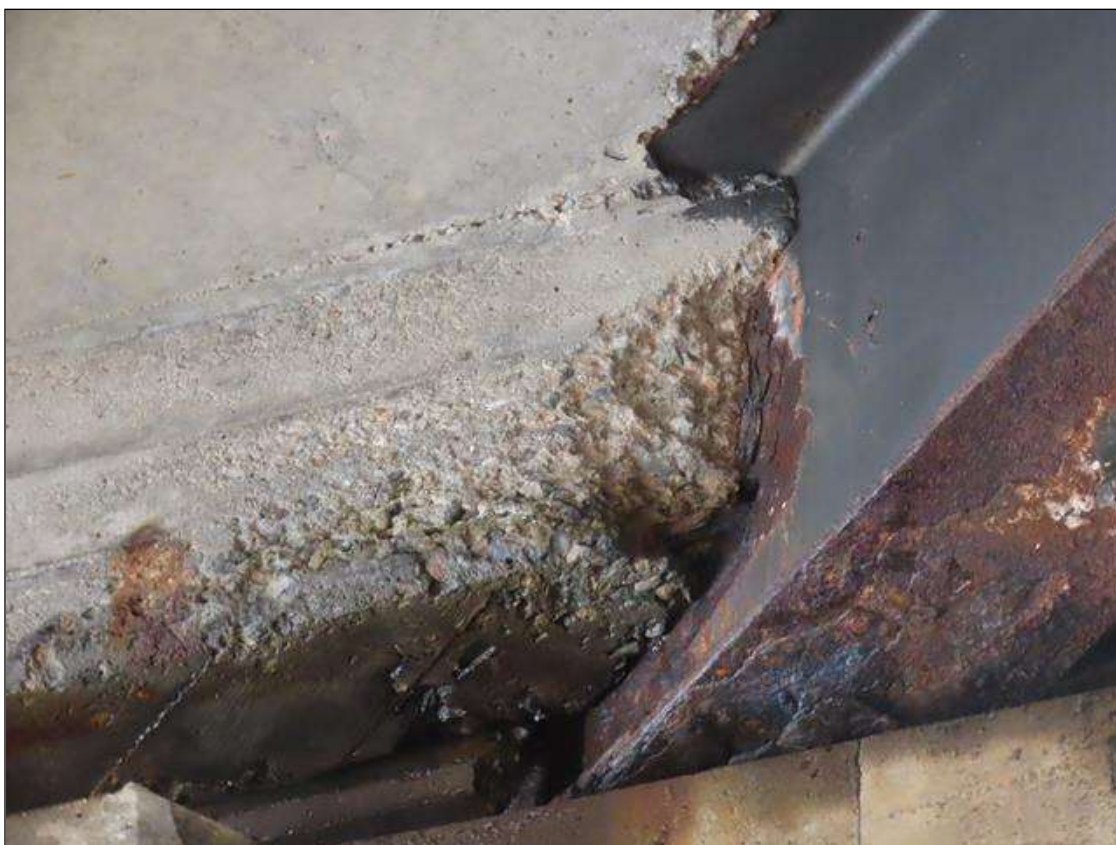
SPAN 3 BAY 7 NEAR DIAPHRAGM - SPALL (16IN X 16IN X 5IN) WITH EXPOSED REBAR ADJACENT TO BEAM 7 (PAR PHOTO)

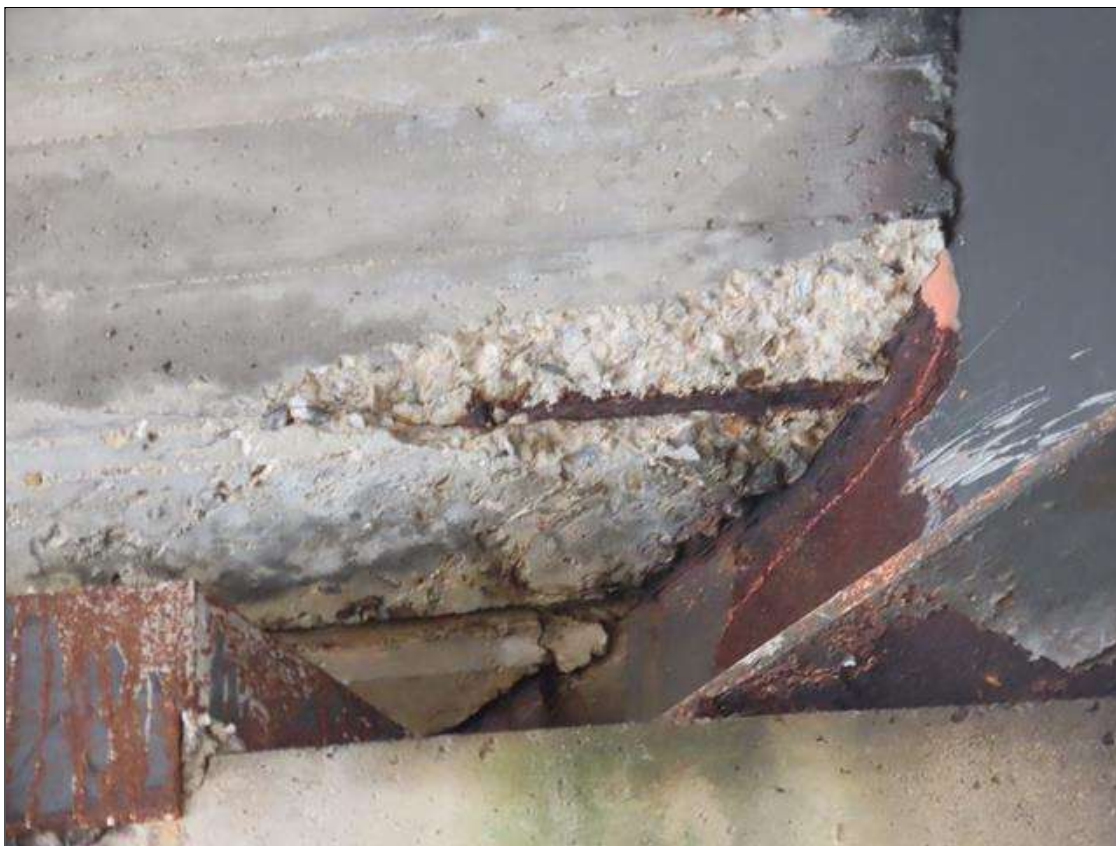
SPAN 3 BAY 8 NEAR DIAPHRAGM - SPALL (18IN X 8IN X 4IN) WITH EXPOSED REBAR ADJACENT TO BEAM 8 (PAR PHOTO)

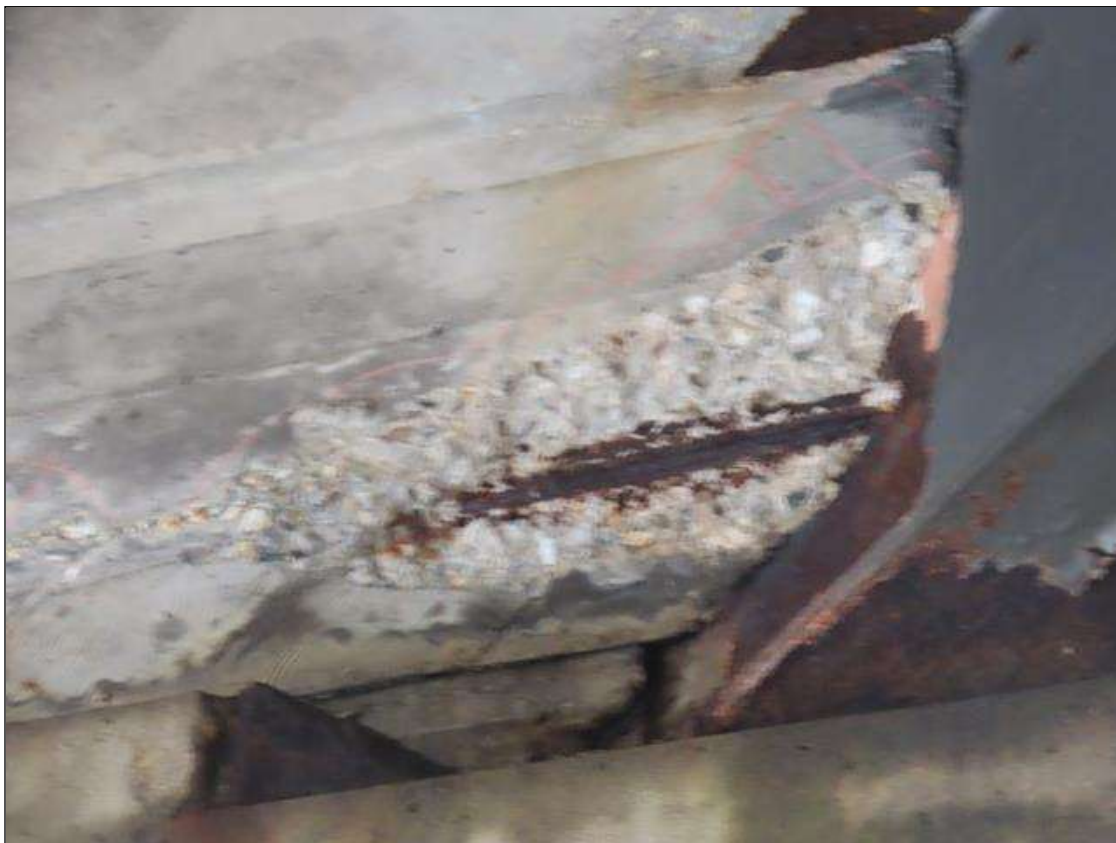
SPAN 3 BAY 9 NEAR DIAPHRAGM - SPALL (24IN X 24IN X 5IN) WITH EXPOSED REBAR ADJACENT TO BEAM 9 (PAR PHOTO)

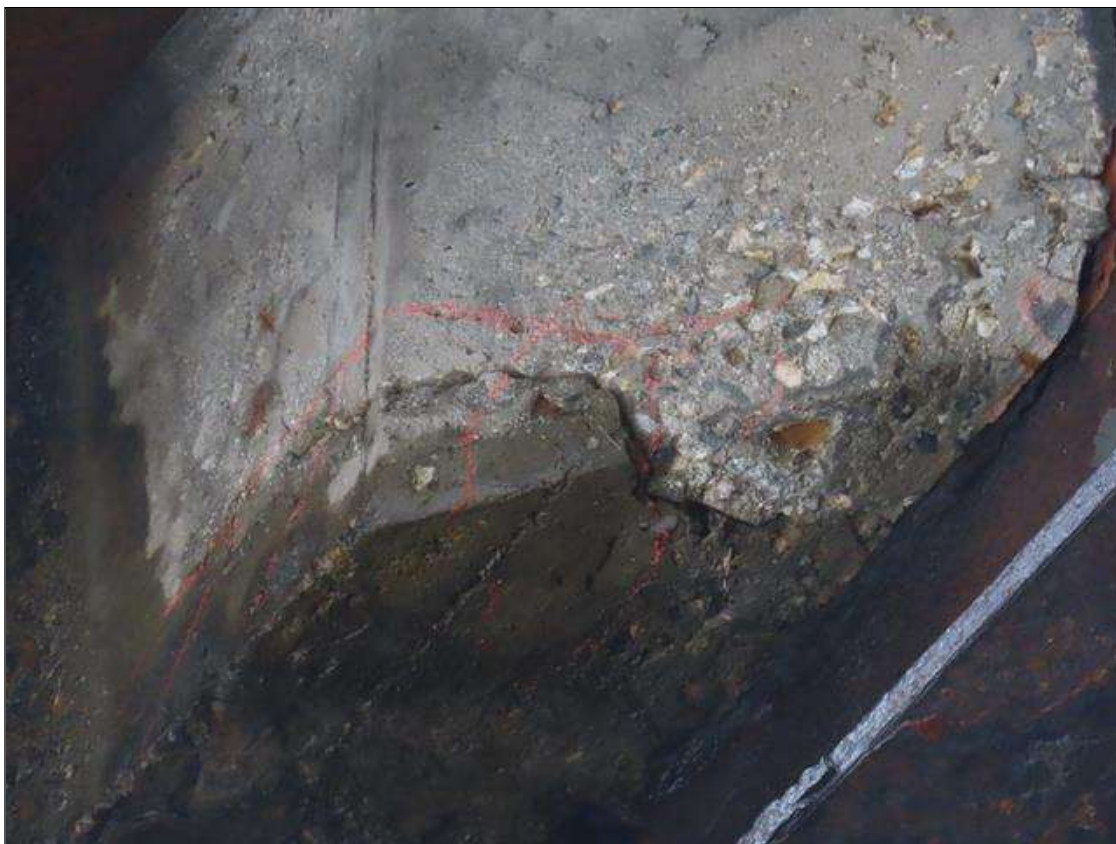
SPAN 3 RIGHT OVERHANG DIAPHRAGM AT NEAR END - DELAMINATION (1SQ. FT.) THROUGHOUT

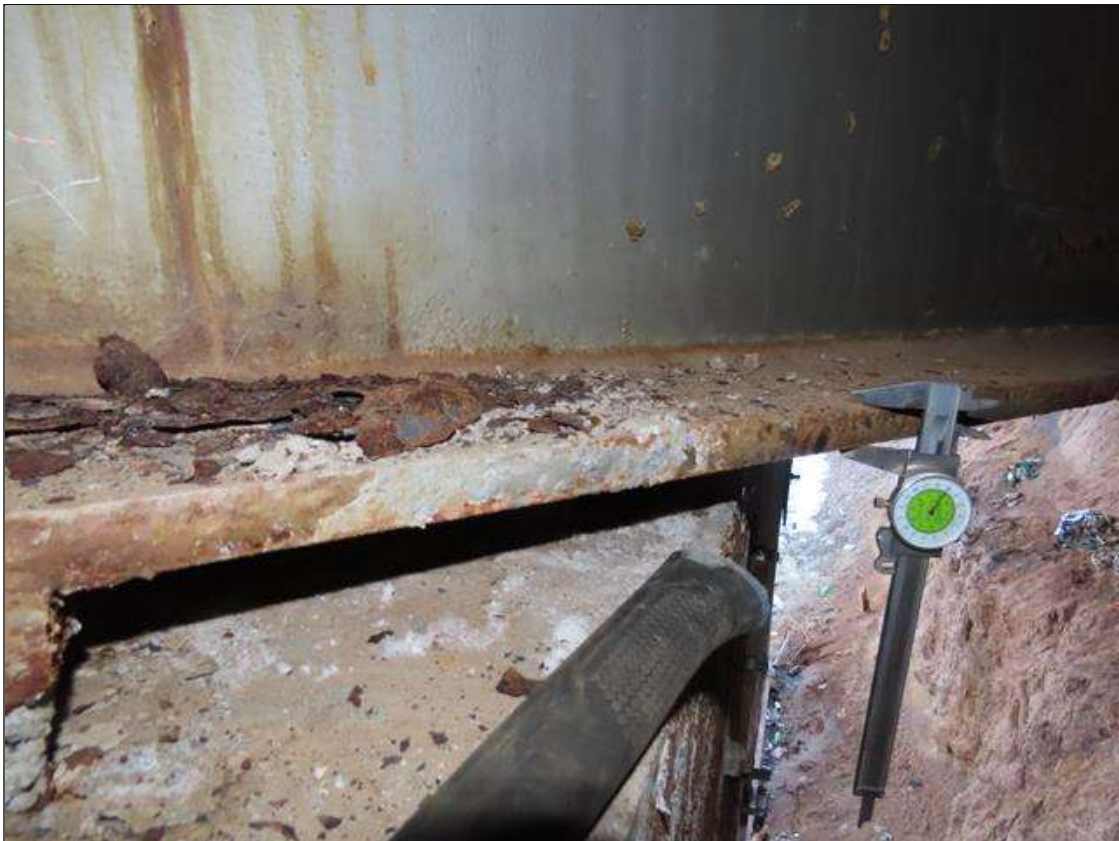
SPAN 2 BEAM 8 - BOTTOM FLANGE MODERATE SURFACE CORROSION FOR 2FT AT FAR END (SPAN 3 BEAM 8 SIMILAR FOR 1FT AT NEAR END)

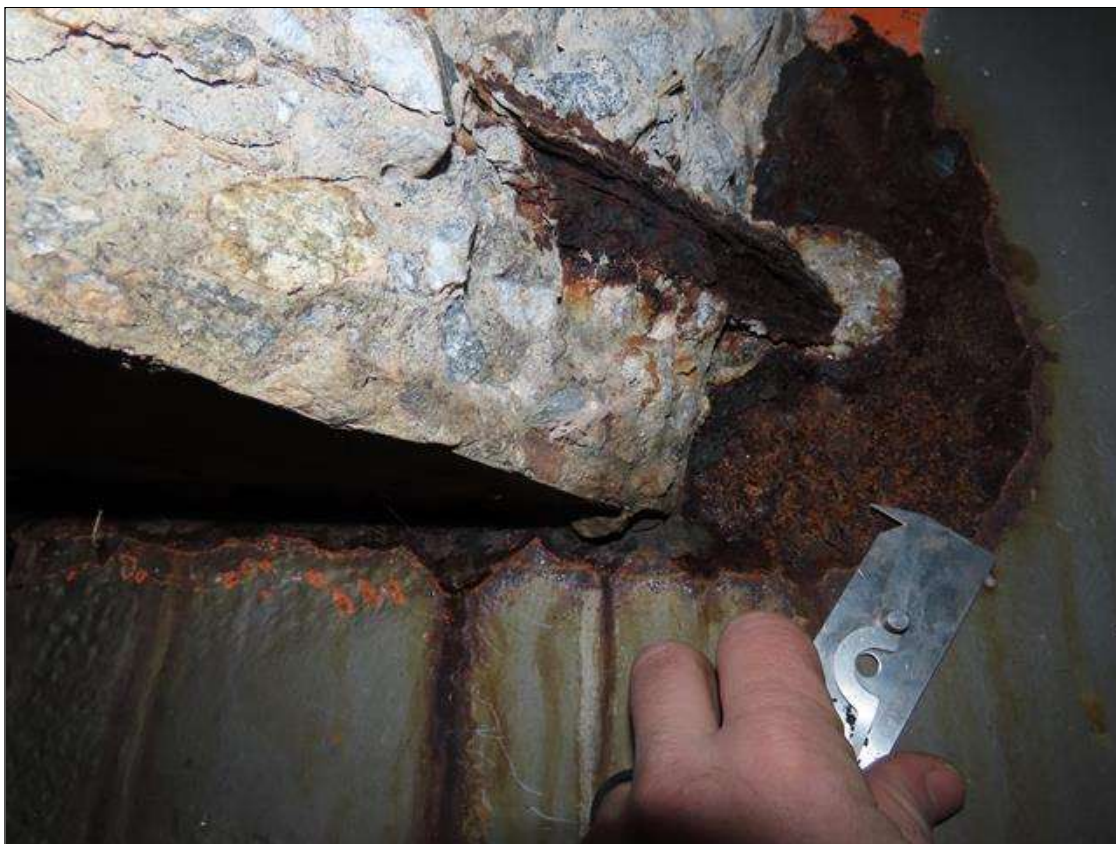
SPAN 2 BEAM 8 - WEB SECTION LOSS (UP TO 7/16IN SL, AVG. 1/8IN REMAIN) FOR 12IN L. X 6IN H. AT FAR END DIAPHRAGM (PAR PHOTO)

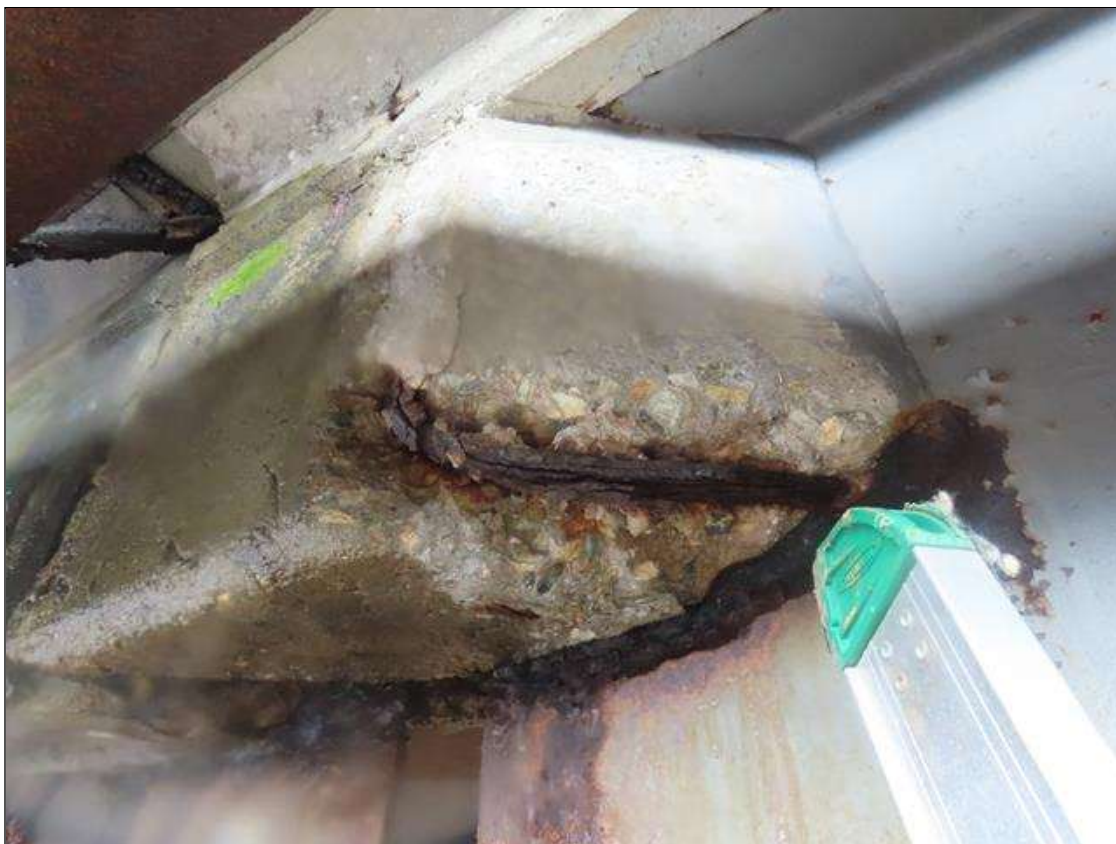
SPAN 4 RIGHT OVERHANG DIAPHRAGM AT NEAR END - SPALL (12IN X 6IN X 3IN) WITH EXPOSED REBAR (PAR PHOTO)

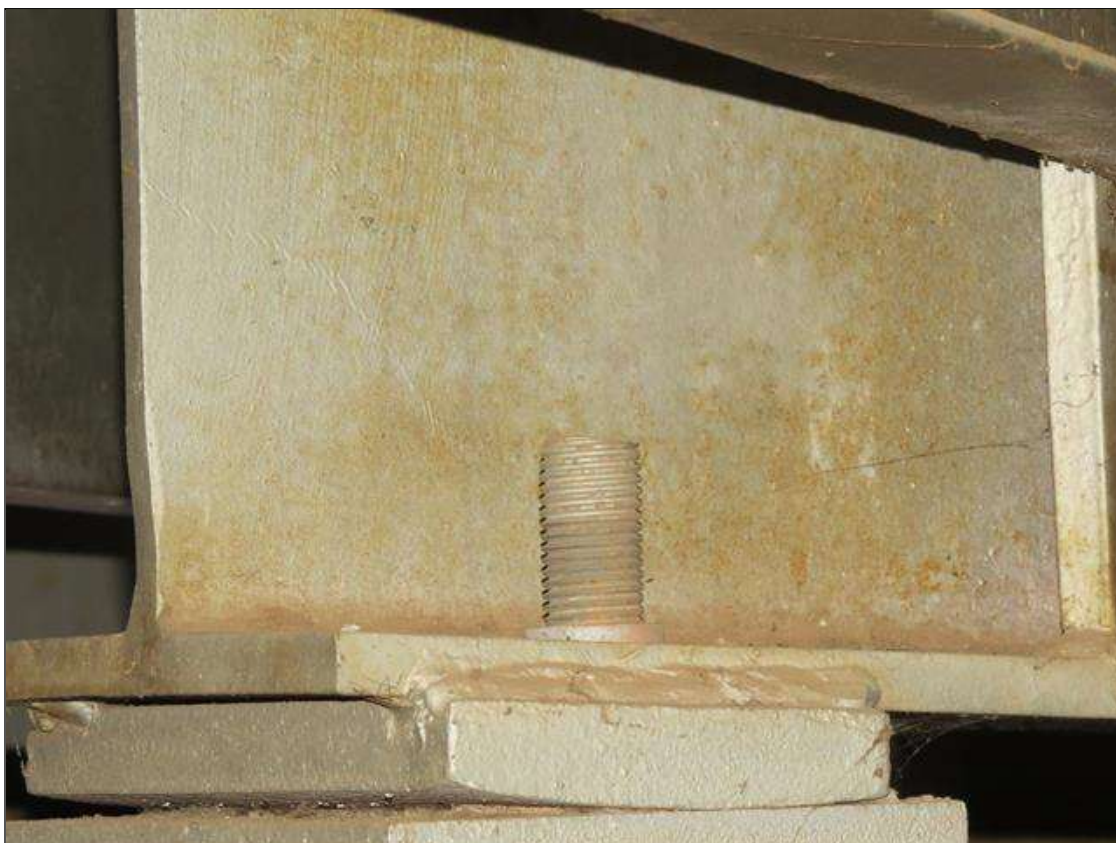
SPAN 1 BEAM 5 FAR BEARING - LEFT SIDE ANCHOR NUT MISSING (PAR PHOTO)

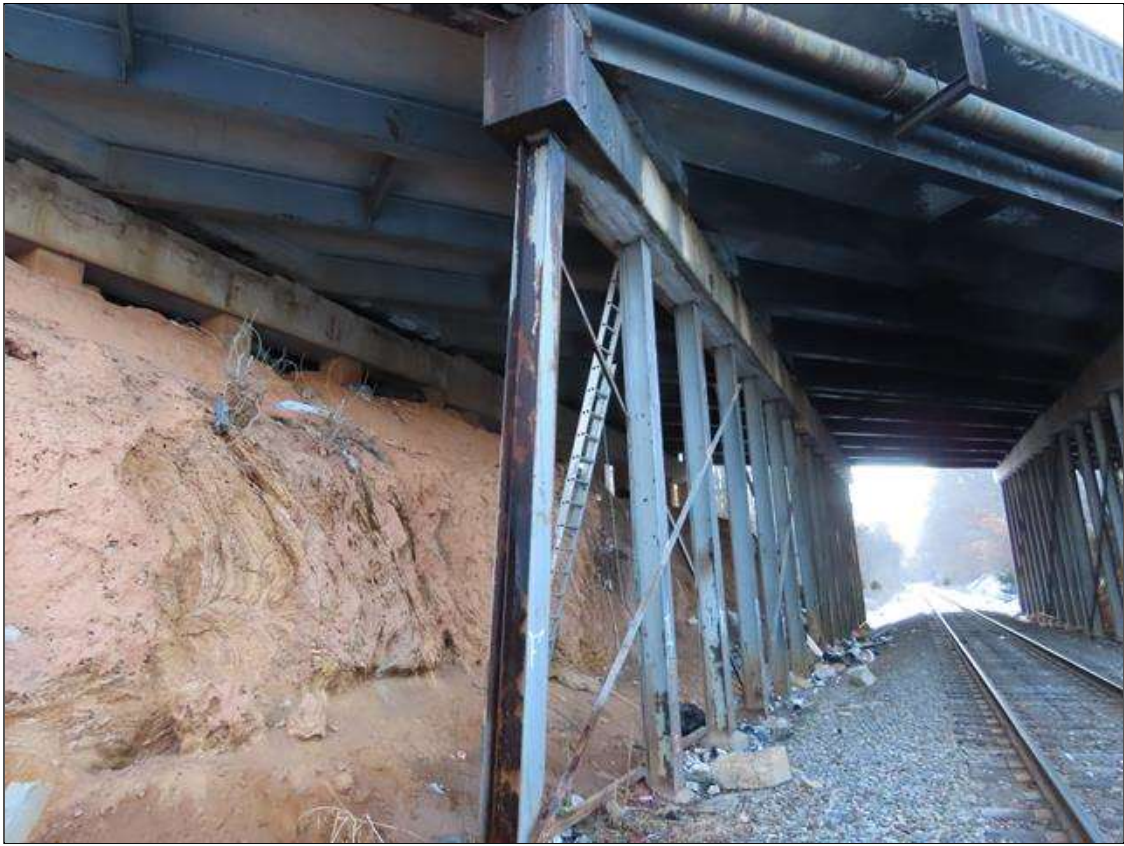
TYP. SUPERSTRUCTURE, SPAN 3 LOOKING AHEAD

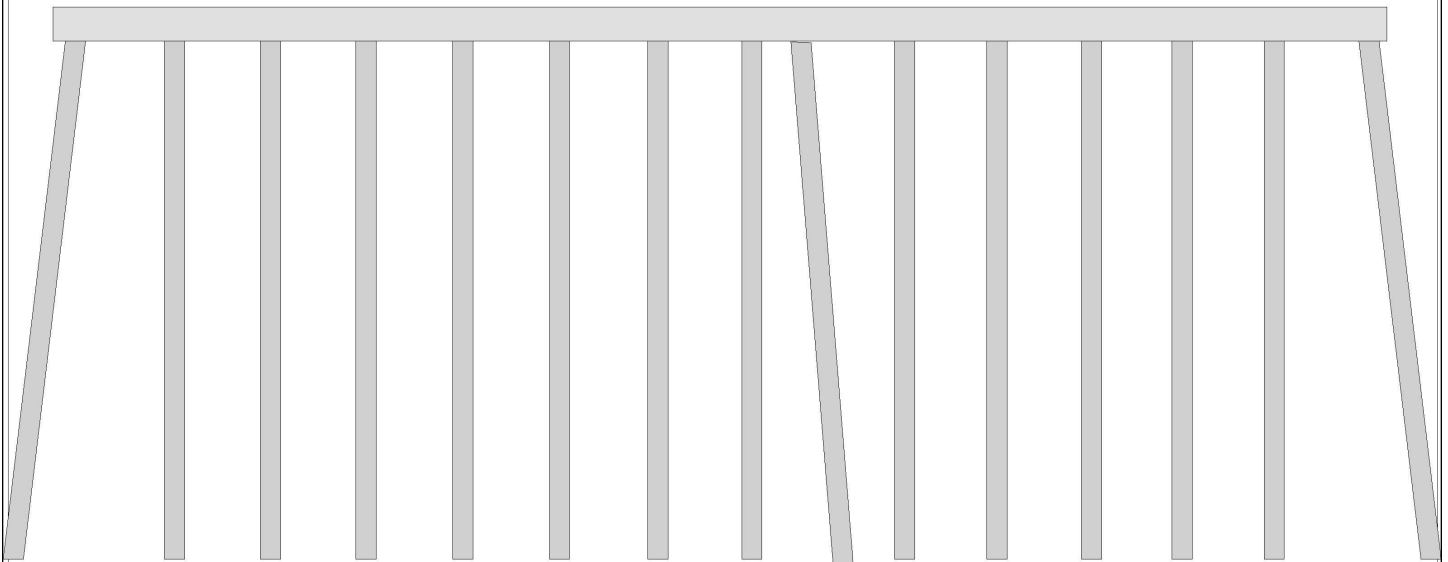
Cap Information			Material Cast-in-Place Concrete							
Length	Width	Height	Left Overhang	Right Overhang	Left Beam to End of Cap.	Right Beam to End of Cap.

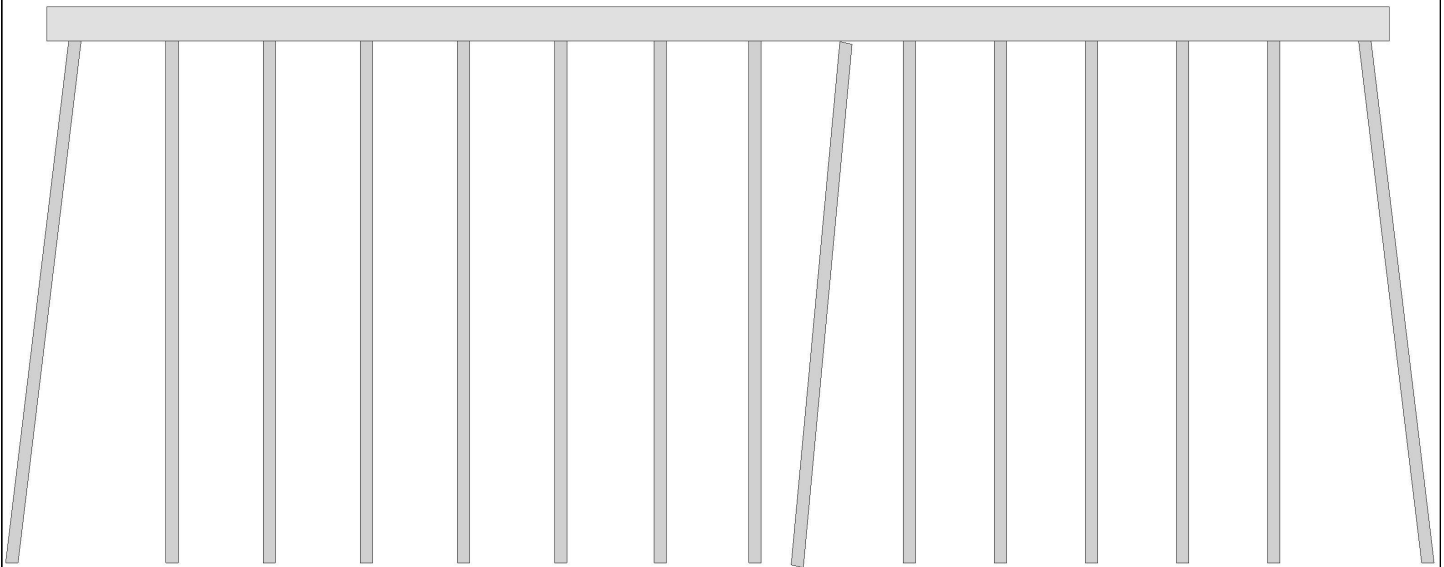
Cap Information			Material Cast-in-Place Concrete							
Length	Width	Height	Left Overhang	Right Overhang	Left Beam to End of Cap.	Right Beam to End of Cap.

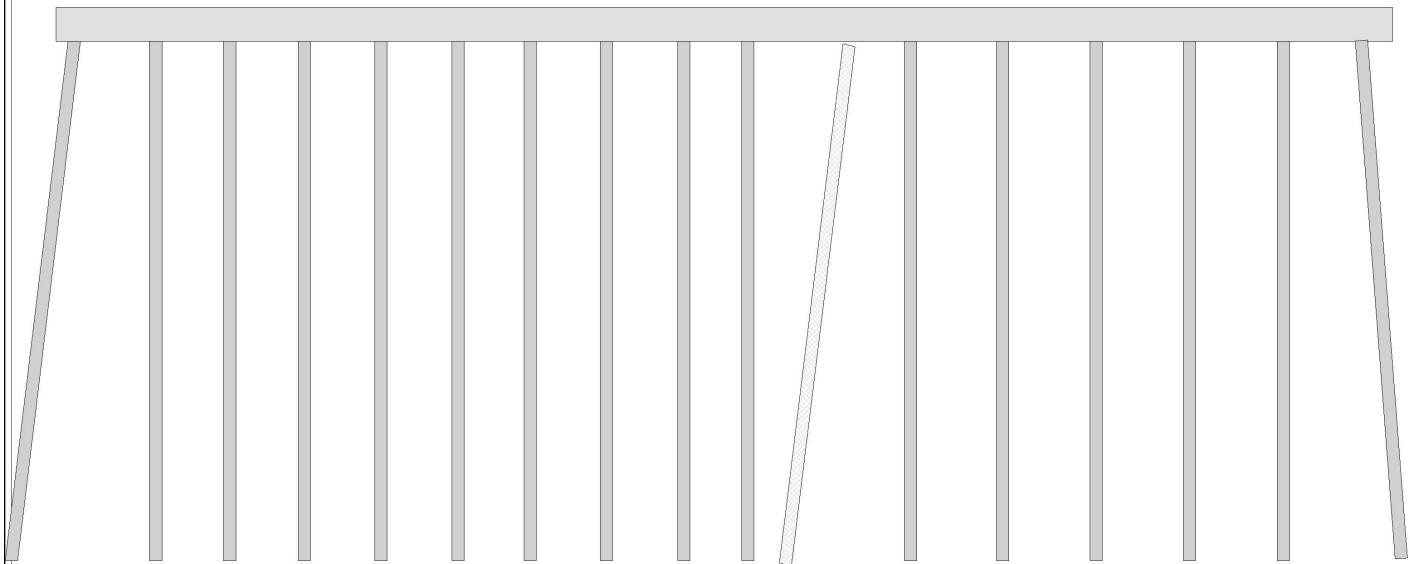
Cap Information		Material Cast-in-Place Concrete				
Length	Width	Height	Left Overhang	Right Overhang	Left Beam to End of Cap.	Right Beam to End of Cap.
110.550 ft.	2.500 ft.	2.830 ft.	1.510 ft.	1.470 ft.	2.150 ft.	1.500 ft.
