AS-BUILT REPAIR QUANTITY TABLE							
SPANS A, B AND C							
TOP OF DECK REPAIRS							
		ESTIM	ESTIMATE		ACTUAL		
SCARIFYING BRIDGE DECK		829.	829.3 SY				
HYDRO-DEMOLITION OF BRIDGE DECK		829.	3 SY				
CLASS II SURFACE PREPARATION			8 SY				
LATEX MODIFIED CONCRETE OVERLAY- VERY EARLY STRENGTH			40.5 CY				
PLACING & FINISHING LMC-VES OVERLAY			3 SY				
BRIDGE JOINT DEMOLITION		80.	6 SF				
GROOVING BRIDGE FLOORS		6830	O SF				
UNDERSIDE OF DECK REPAIRS							
	QUANTITIES						
SHOTCRETE REPAIRS	ESTI	ESTIMATE		ACTUAL			
	AREA SF	VOLUME CF	ARE SF		VOLUME CF		
UNDERSIDE OF DECK	0.0	0.0					
OVERHANG DIAPHRAGMS	0.0	0.0					
UNDERSIDE OF OVERHANG	0.0	0.0					
INTERIOR DIAPHRAGMS	0.0	0.0					
	ESTIMATE		ACTUAL				
UNDERSIDE EPOXY RESIN INJECTION	0.0 LF

PLAN OF SPANS

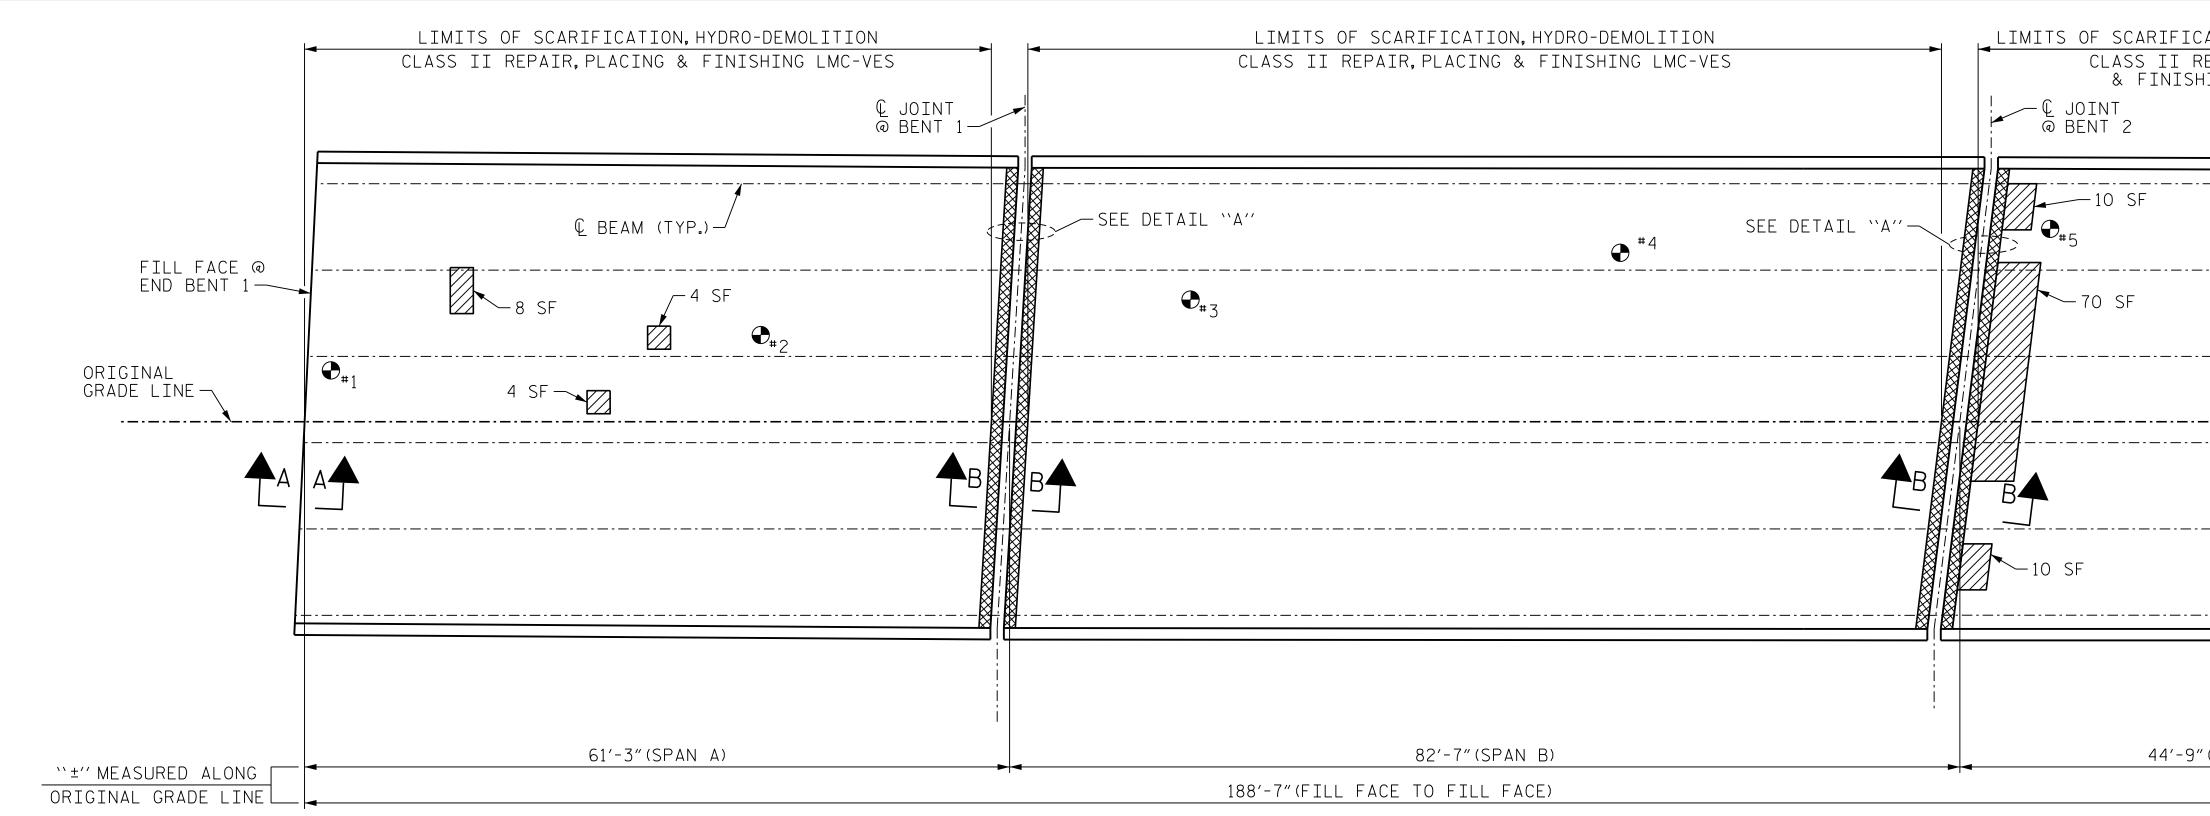
BRIDGE JOINT DEMOLITION

CLASS II SURFACE PREPARATION DECK SCARIFICATION, HYDRO-DEMOLITION AND LATEX MODIFIED CONCRETE OVERLAY-VES
