B-5981

BRIDGE NO. 300017

STATE OF NORTH CAROLINA DEPARTMENT OF TRANSPORTATION

DECK UNDERSIDE REPAIR SPAN E

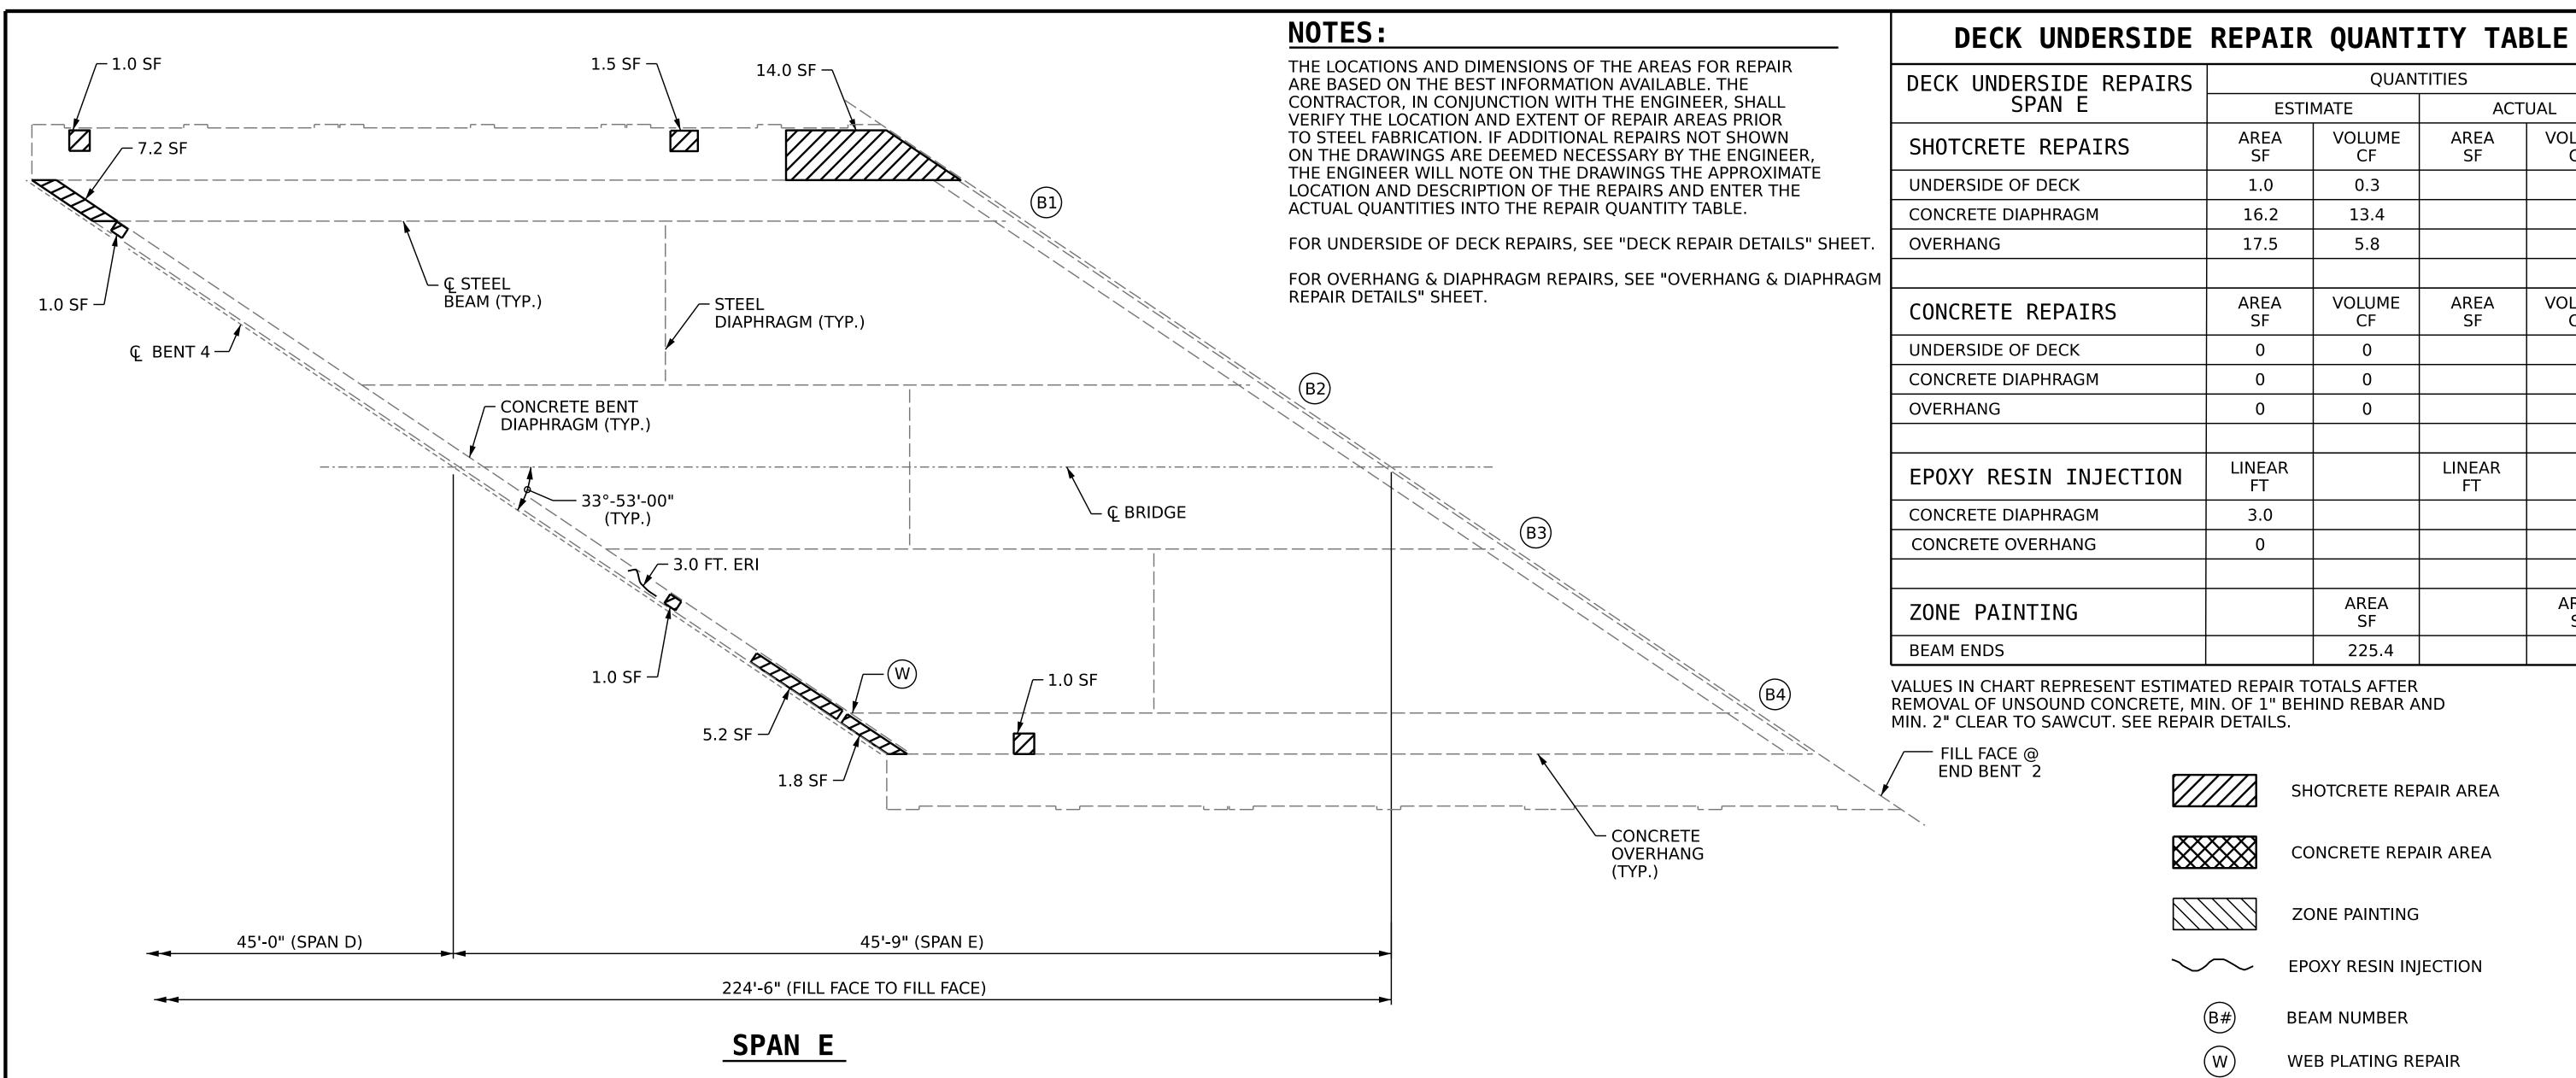
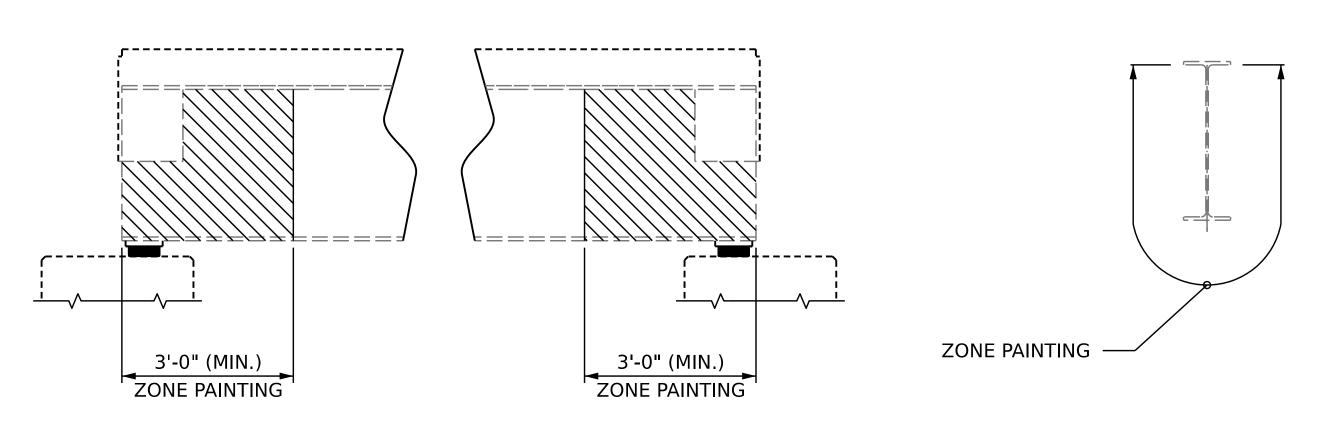
ANTICIPATED STEEL REPAIR LOCATIONS										
REPAIR TYPE	BEAM	LOCATION	DIM. "A"	DIM. "B''	DIM. "C''	DIM. "D''				
W	4	BENT 4	15"	15"

1.0 0.3 CONCRETE DIAPHRAGM 16.2 13.4 17.5 5.8 VOLUME AREA AREA VOLUME CONCRETE REPAIRS UNDERSIDE OF DECK CONCRETE DIAPHRAGM LINEAR LINEAR **EPOXY RESIN INJECTION** 3.0 CONCRETE DIAPHRAGM **CONCRETE OVERHANG** AREA AREA ZONE PAINTING 225.4 VALUES IN CHART REPRESENT ESTIMATED REPAIR TOTALS AFTER REMOVAL OF UNSOUND CONCRETE, MIN. OF 1" BEHIND REBAR AND MIN. 2" CLEAR TO SAWCUT. SEE REPAIR DETAILS.

(SEE SHEETS S2-26, S2-27 AND S2-28 FOR BEAM REPAIR DETAILS AND DIMENSIONS.)
