PROJECT NO. **B-5981**
DUPLIN COUNTY
 BRIDGE NO. **300017**
 SHEET 5 OF 6

STATE OF NORTH CAROLINA
 DEPARTMENT OF TRANSPORTATION
 RALEIGH
**SUBSTRUCTURE REPAIR
 BENT 4**

REVISIONS						SHEET NO. S2-20
NO.	BY:	DATE:	NO.	BY:	DATE:	
1			3			TOTAL SHEETS 31
2			4

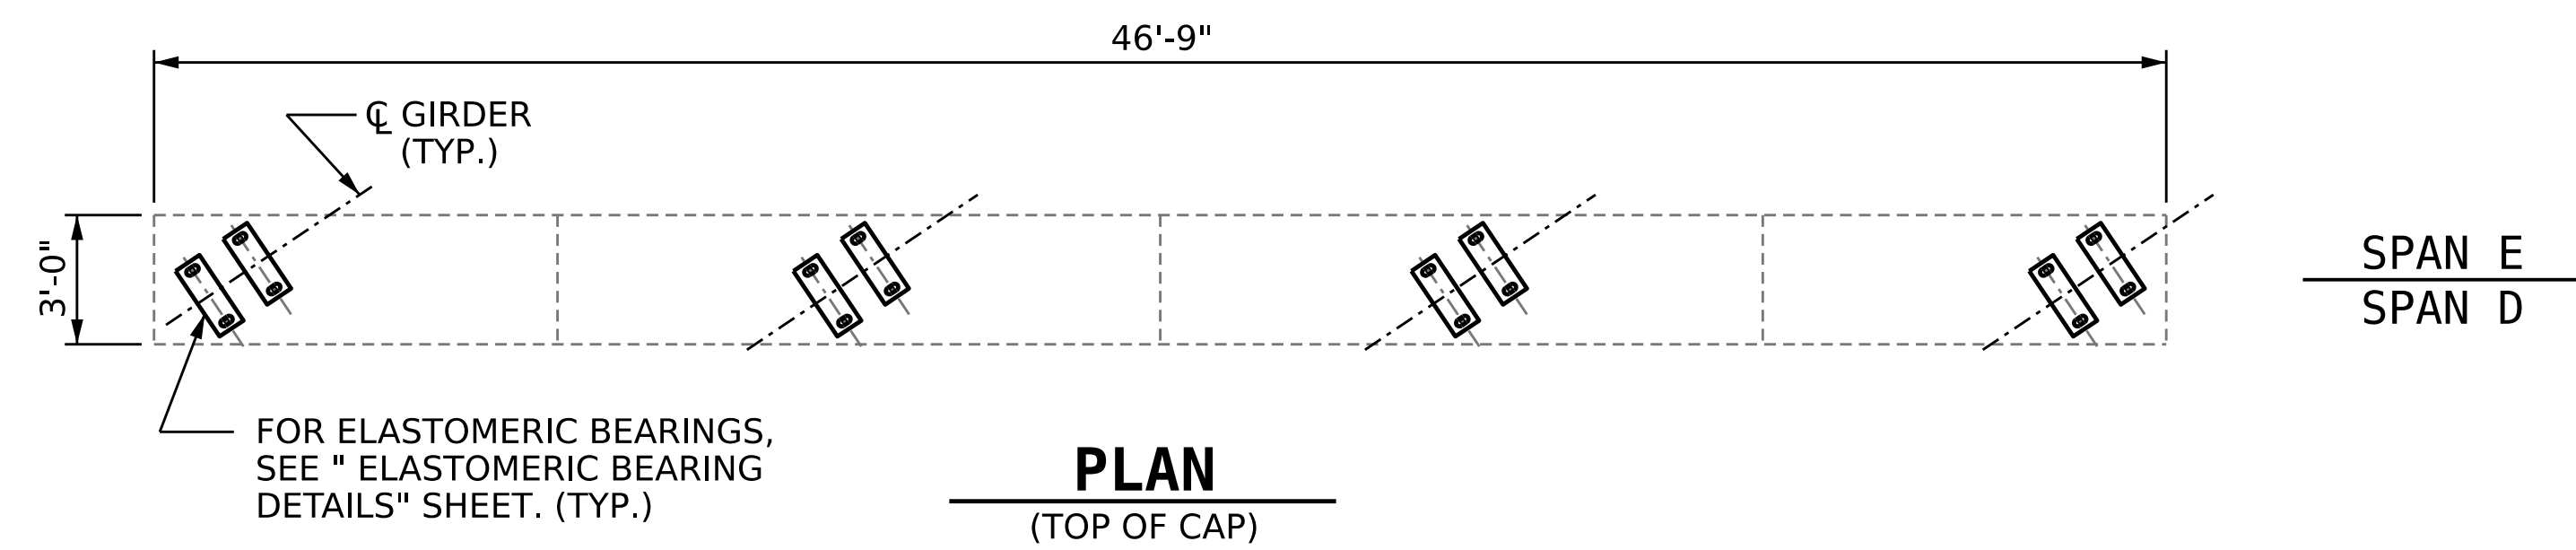
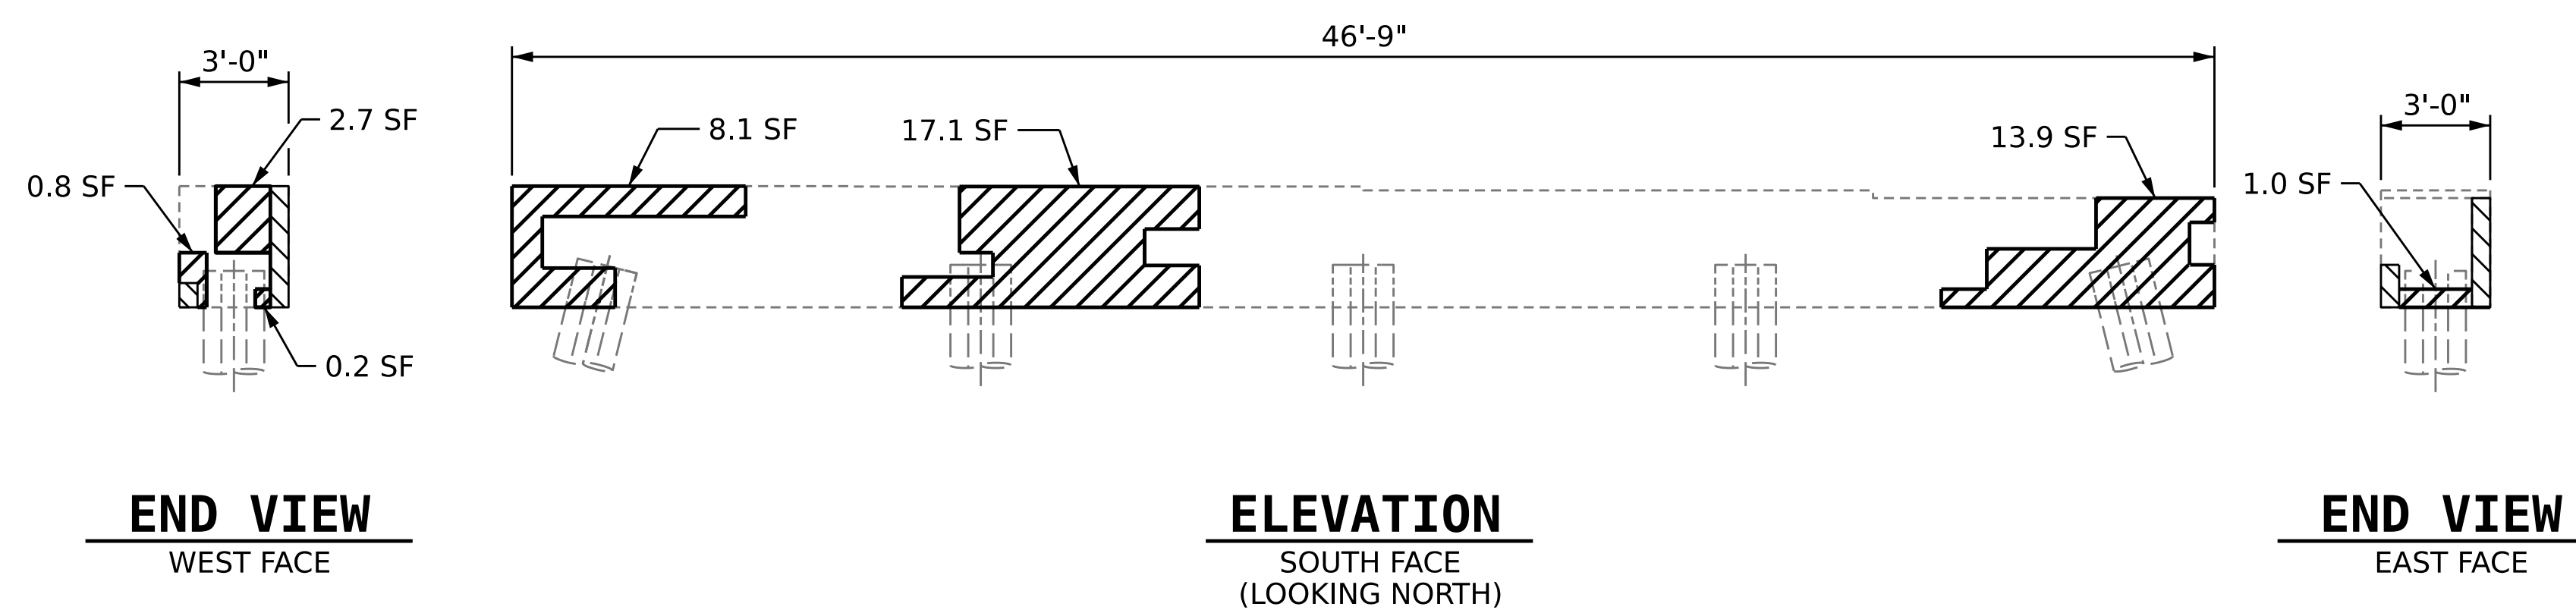
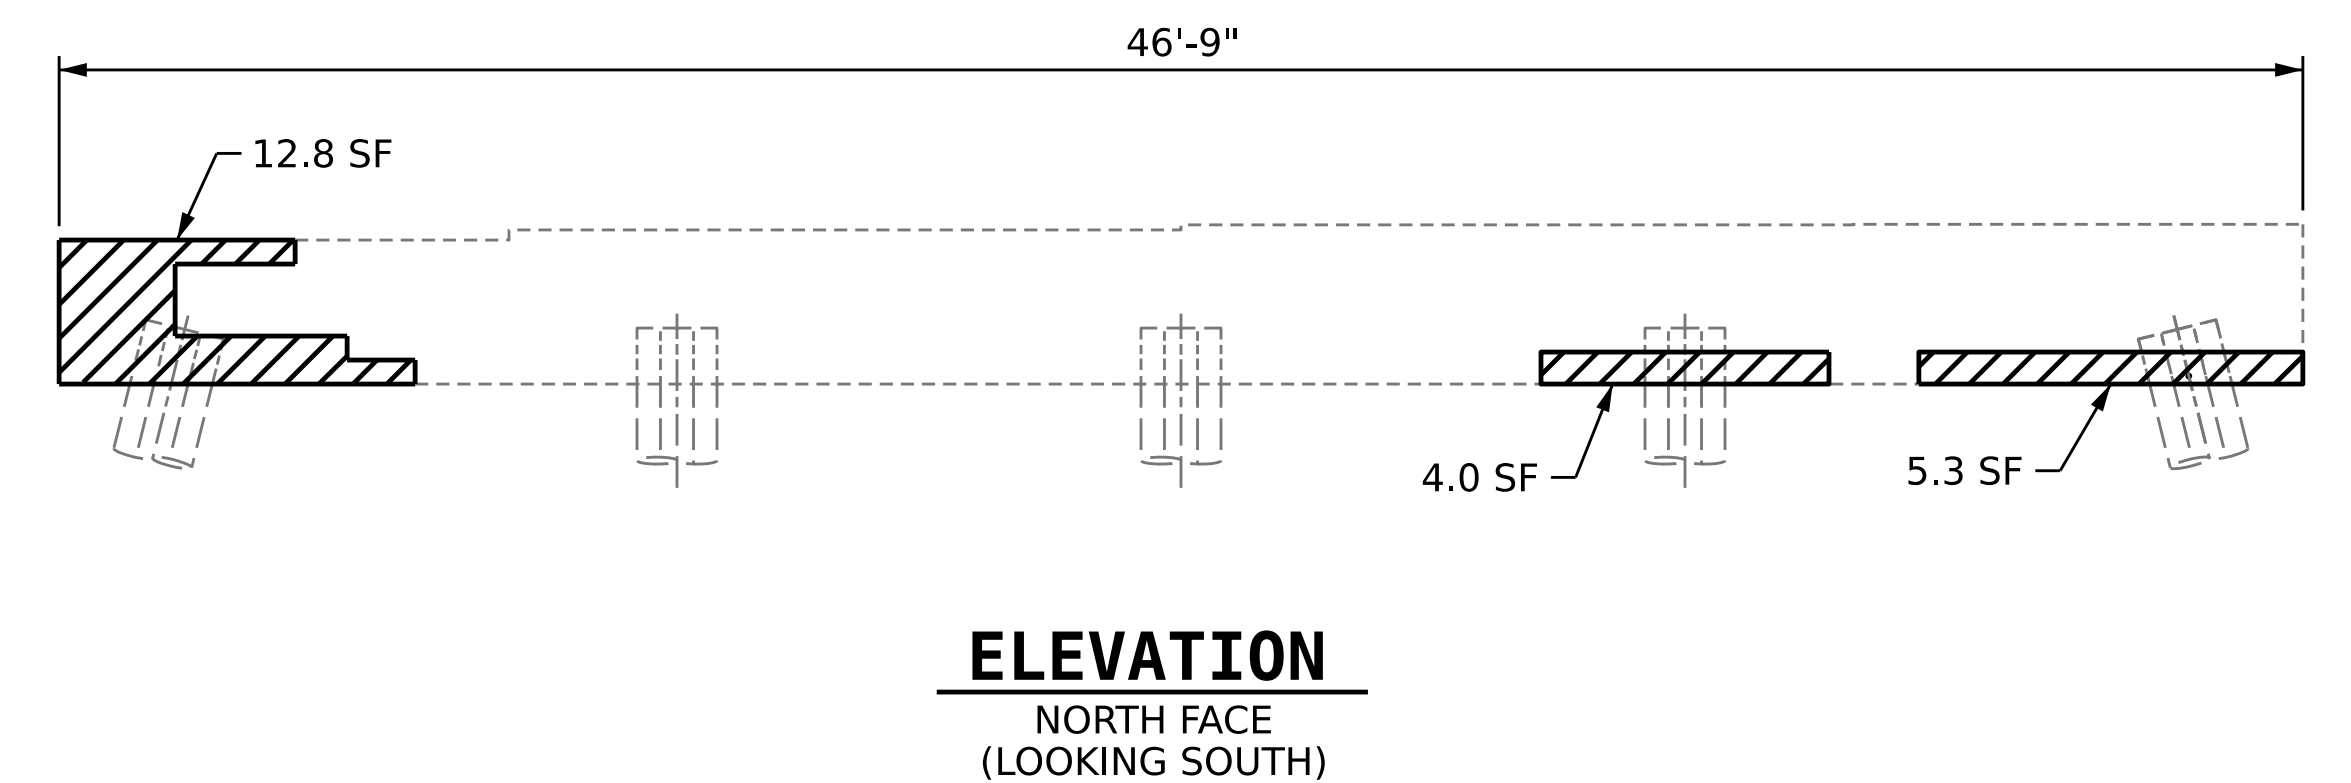
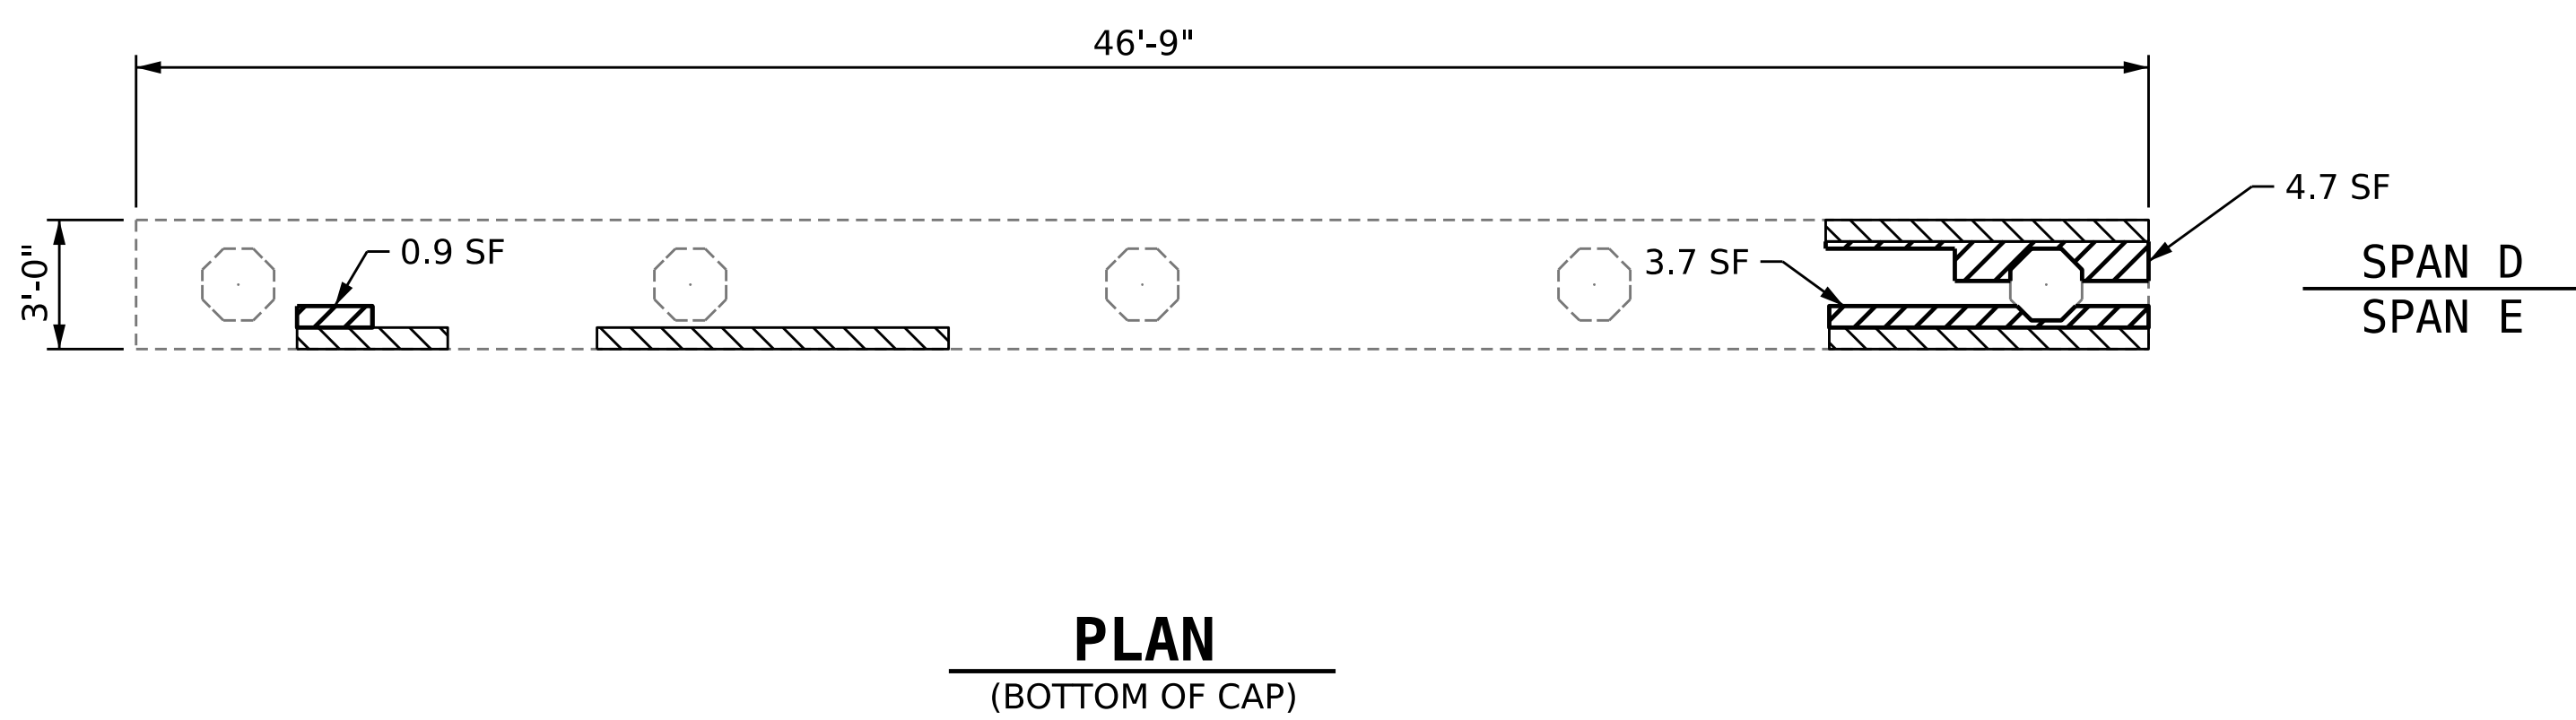
SUBSTRUCTURE REPAIR QUANTITY TABLE				
REPAIRS - BENT 4	QUANTITIES			
	ESTIMATE		ACTUAL	
SHOTCRETE REPAIRS	AREA SF	VOLUME CF	AREA SF	VOLUME CF
CAP	75.2	37.6		
COLUMN	0	0		
CONCRETE REPAIRS	AREA SF	VOLUME CF	AREA SF	VOLUME CF
CAP	0	0		
COLUMN	0	0		
EPOXY RESIN INJECTION		LINEAR FT		LINEAR FT
CAP		0		
COLUMN		0		
EPOXY COATING		AREA SF		AREA SF
CAP		130.5

VALUES IN CHART REPRESENT ESTIMATED REPAIR TOTALS AFTER REMOVAL OF UNSOUND CONCRETE, MIN. OF 1" BEHIND REBAR AND MIN. 2" CLEAR TO SAWCUT. SEE REPAIR DETAILS.

CLEAN AND REMOVE DEBRIS FROM THE TOP OF THE CAP AND APPLY EPOXY PROTECTIVE COATING. EPOXY COATING SHALL BE APPLIED TO THE TOP SURFACE OF THE CAP AFTER ELASTOMERIC BEARINGS AND ANCHOR BOLTS ARE INSTALLED. THE CONTRACTOR SHALL NOT COAT THE AREA OF THE CAP BENEATH THE BEARINGS.

FOR REPAIR DETAILS, SEE "TYPICAL CAP AND COLUMN REPAIR DETAILS" SHEET.
