NC DEPARTMENT OF TRANSPORTATION  
 DIVISION OF HIGHWAYS  
 STRUCTURE MANAGEMENT UNIT

ATTENTION: **PRIORITY ACTION REQUEST ISSUED**

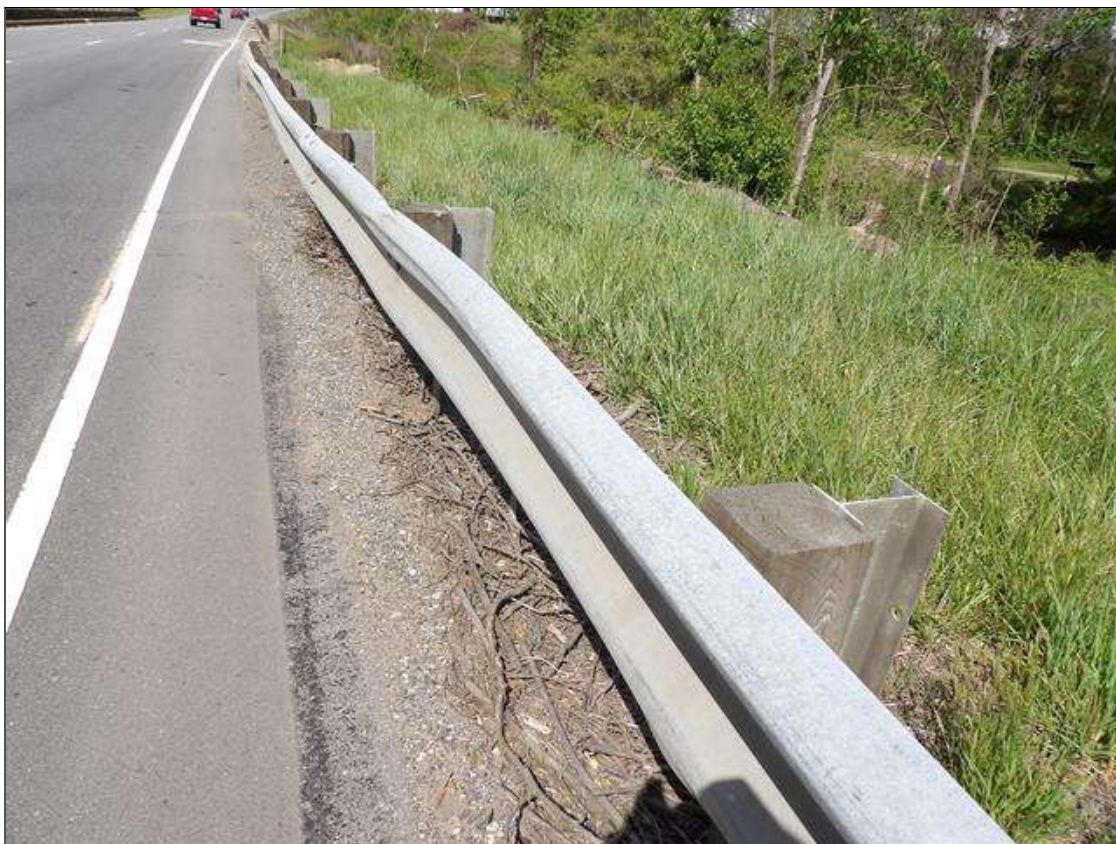
SOUTHEAST GUARDRAIL IMPACT DAMAGE 10 FOOT LONG 50 FEET FROM BRIDGE

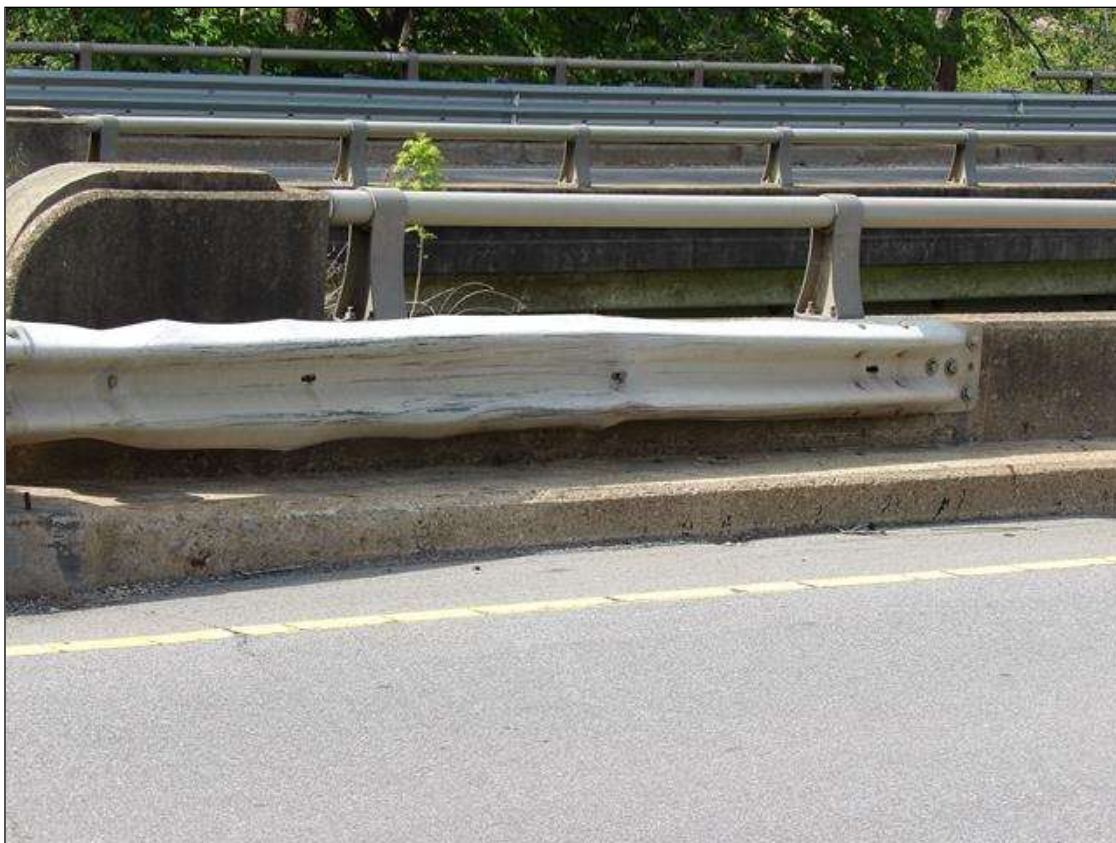
SOUTHWEST GUARDRAIL IMPACT DAMAGE 10 FOOT LONG AT BRIDGE

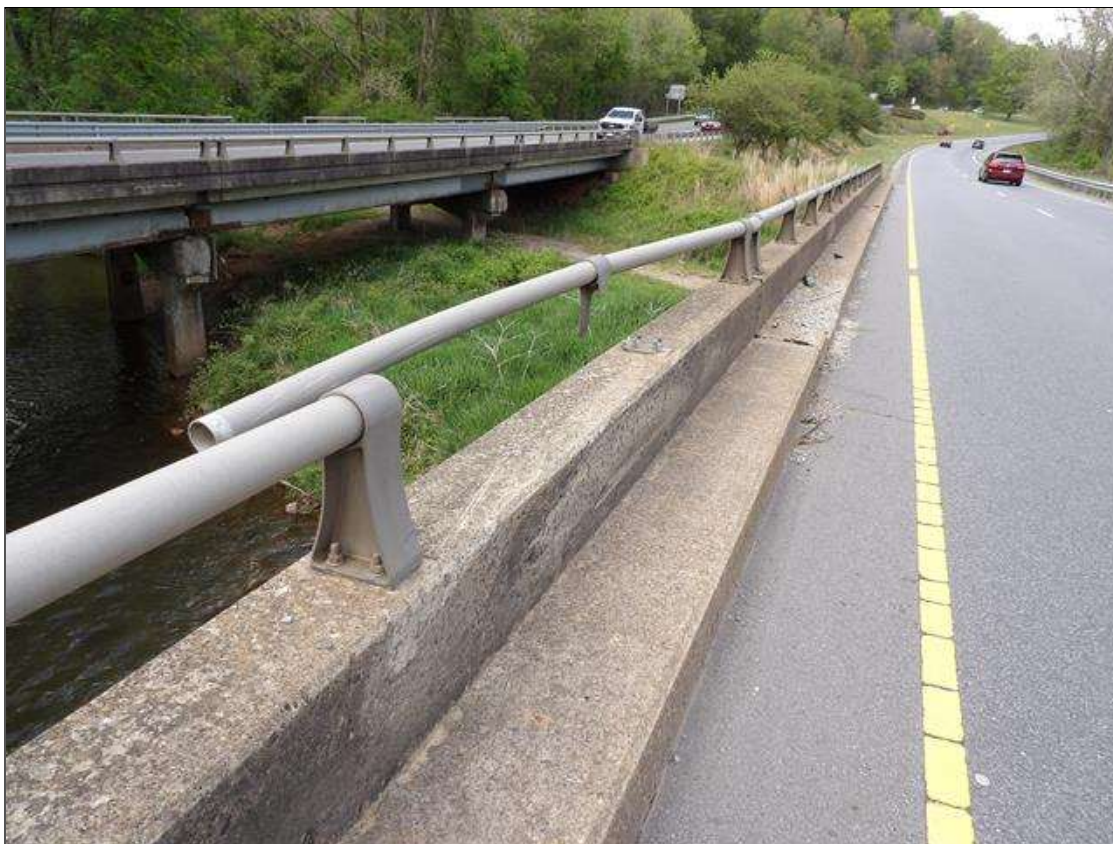
Span 2 Left Bridge Rail: PAR--IMPACT DAMAGE TO RAIL AND POST AT PIER 2, RAIL IS BROKEN/SEPARATED AND RAIL POSTS IS DISCONNECTED FROM BRIDGE

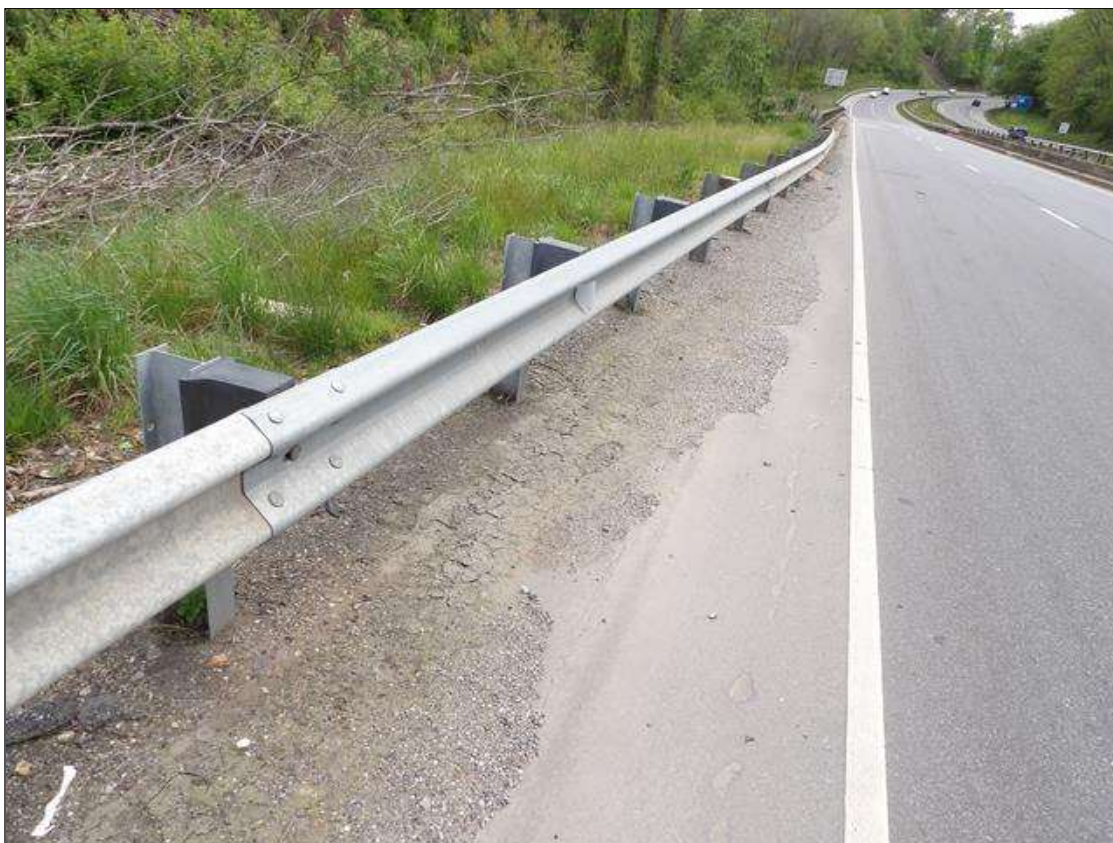
NORTHEAST GUARDRAIL HAS BEEN REPLACED 50 FOOT LONG 50 FOOT FROM BRIDGE

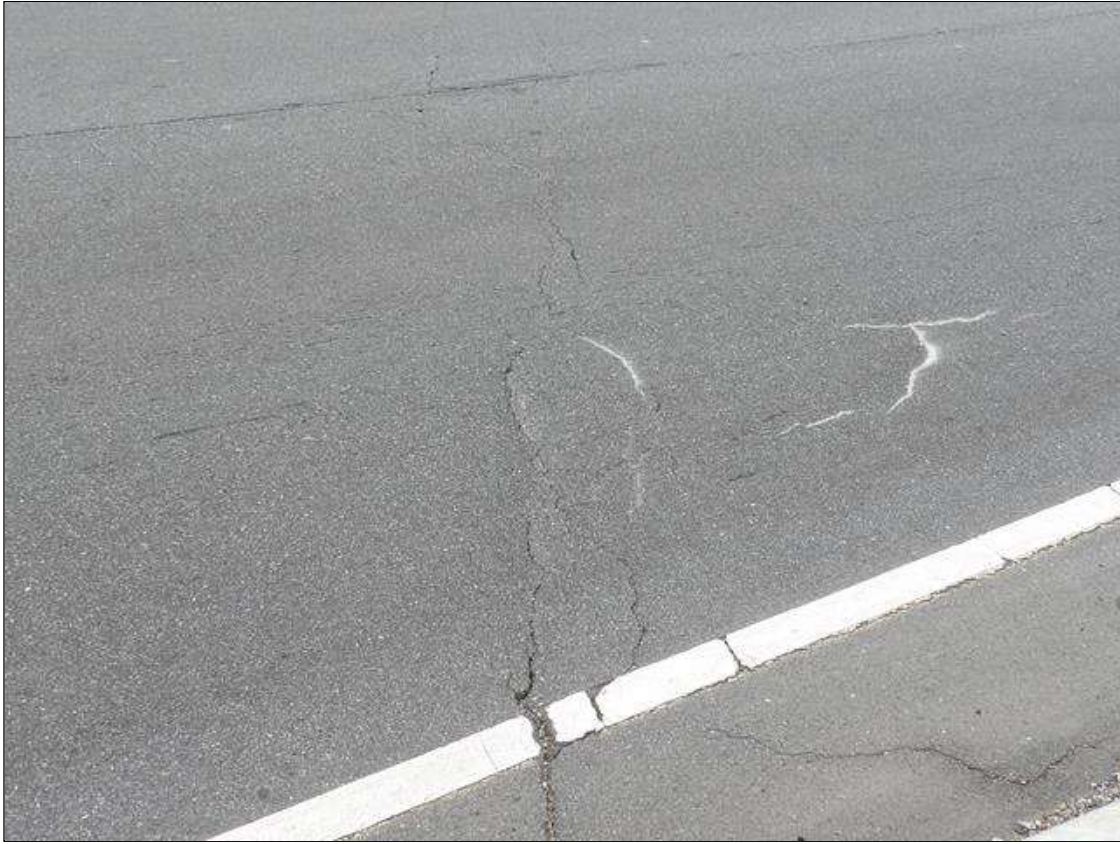
TYPICAL--UP TO 1/8 INCHES TRANSVERSE CRACKS OVER SUBSTRUCTURES END BENT 1 SHOWN

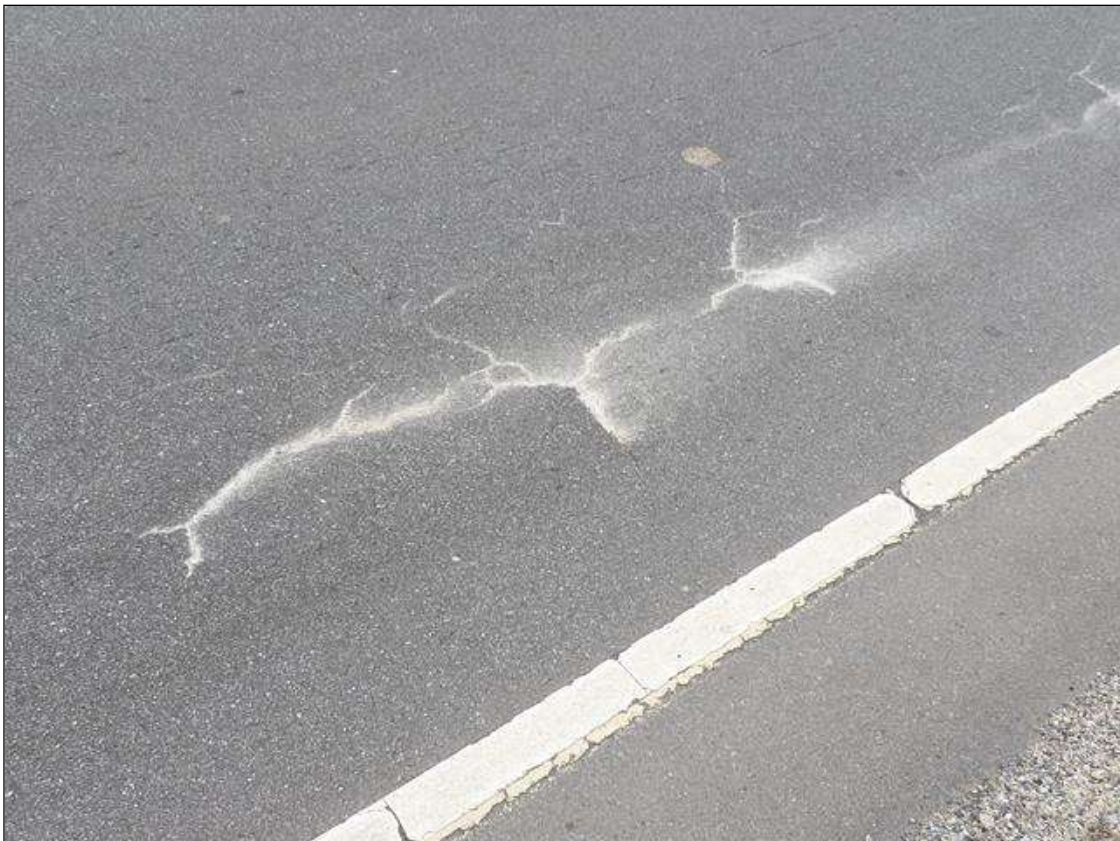
Span 1 Wearing Surface: UP TO 1/32 INCHES TRANSVERSE, LONGITUDINAL AND ALLIGATOR CRACKS IN VARIOUS LOCATIONS

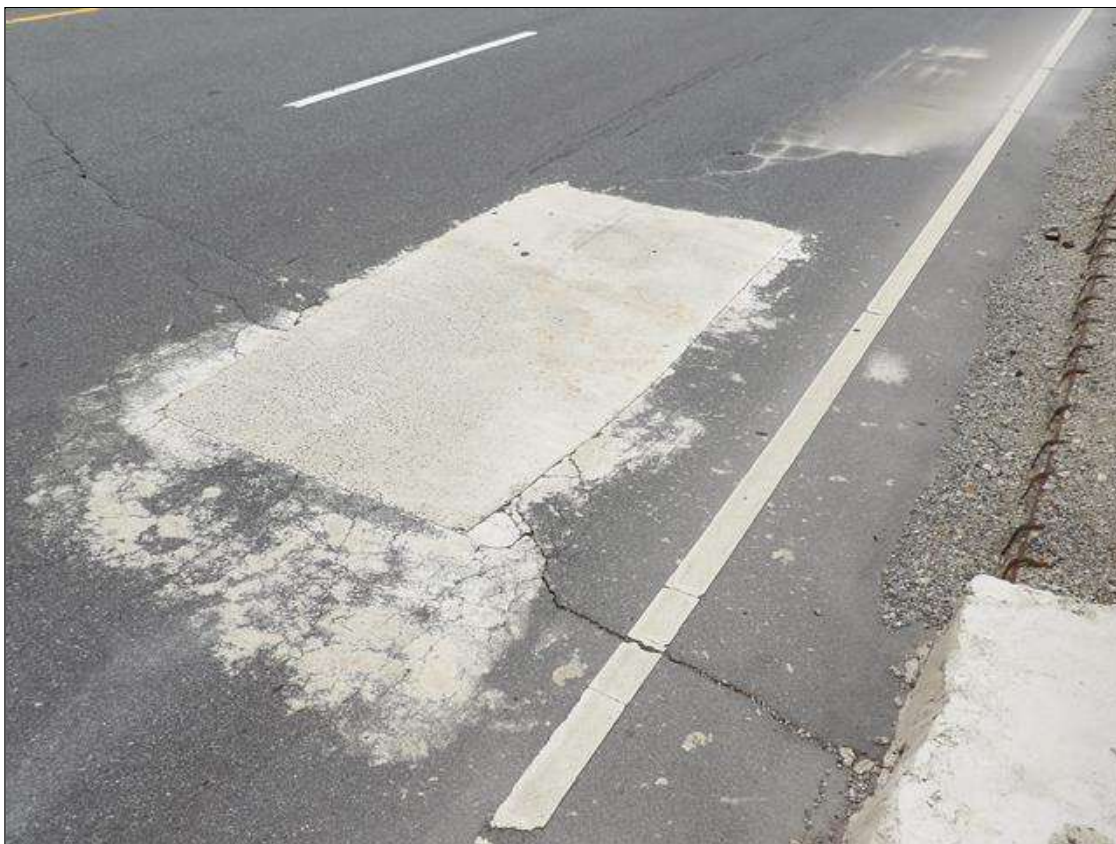
Span 2 Wearing Surface: SOUND PATCH 5 FOOT X 3 FOOT IN RIGHT TRAVEL LANE OVER PIER 1

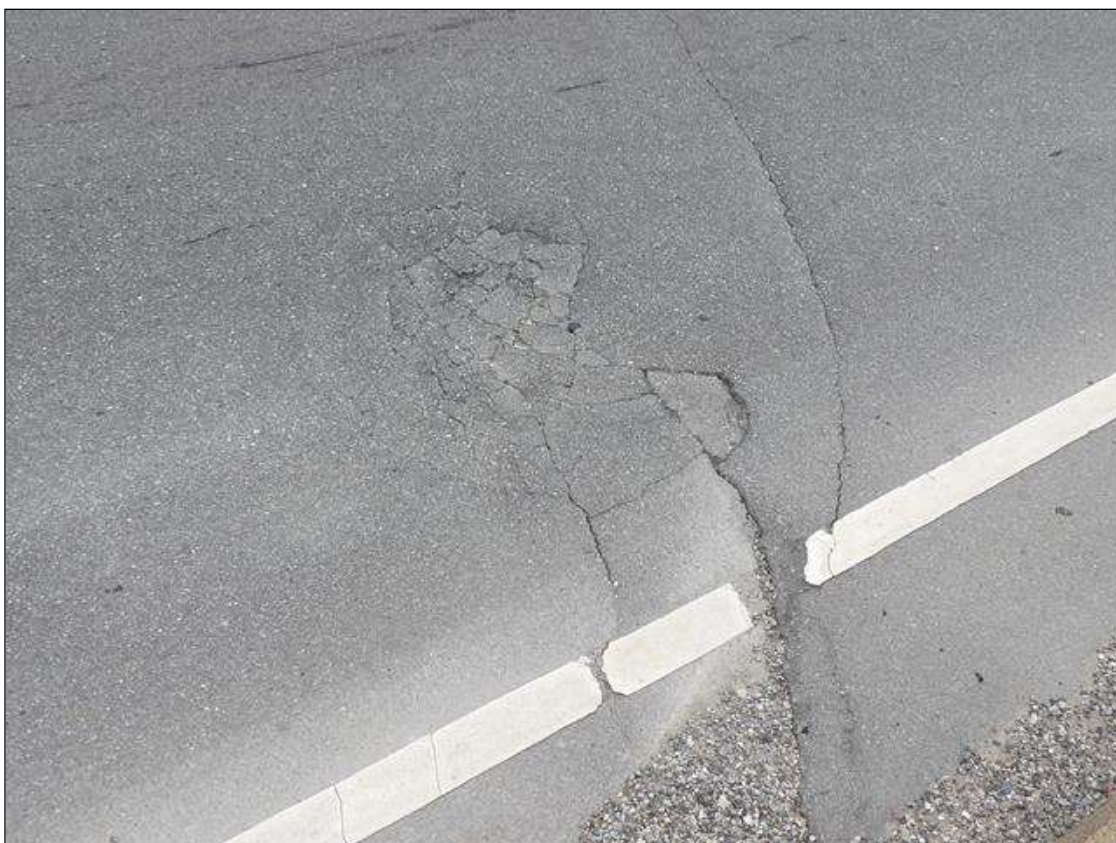
Span 2 Wearing Surface: 4 FOOT X 2 FOOT AREA OF DETERIORATED ASPHALT IN RIGHT LANE AT PIER 2

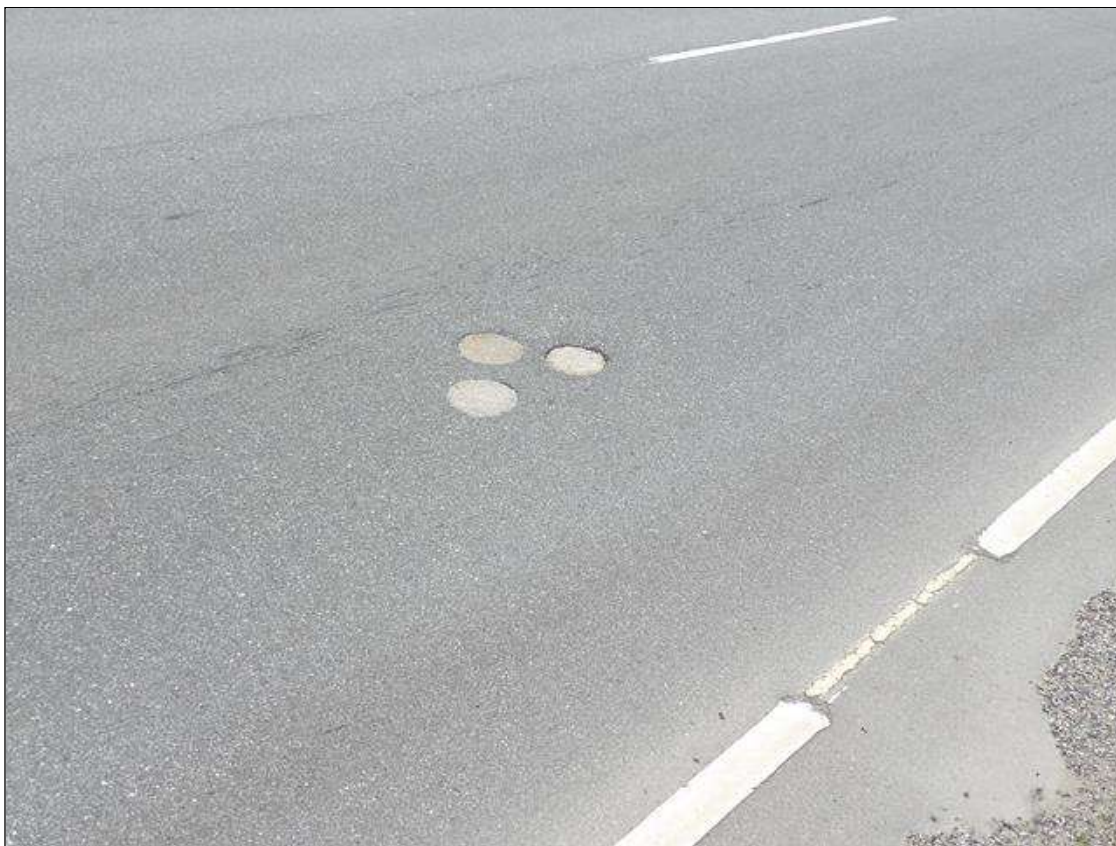
Span 3 Wearing Surface: (3) 8 INCHES DIAMETER FILLED CORED HOLES IN OUTSIDE LANE NEAR MIDSPAN

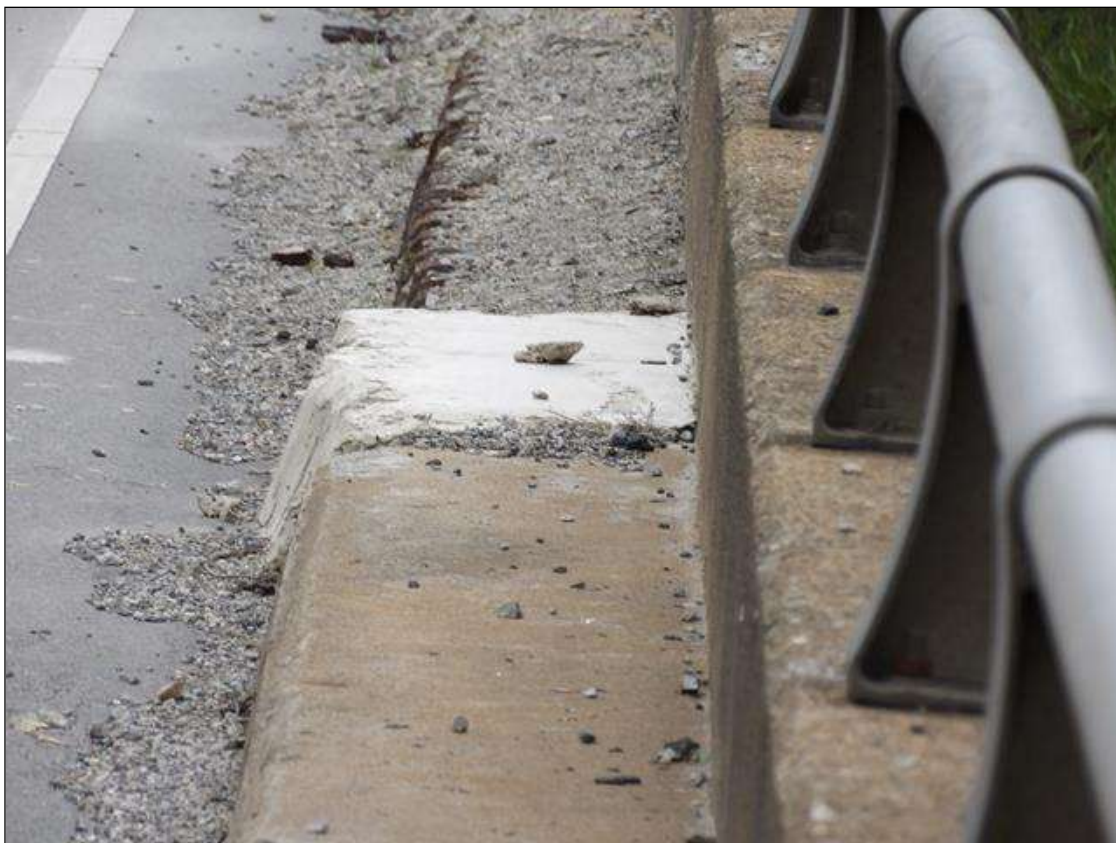
SPAN 2 RIGHT RAIL 3 FOOT X 1 FOOT 5 INCH SOUND PATCH IN CURB AT PIER 1

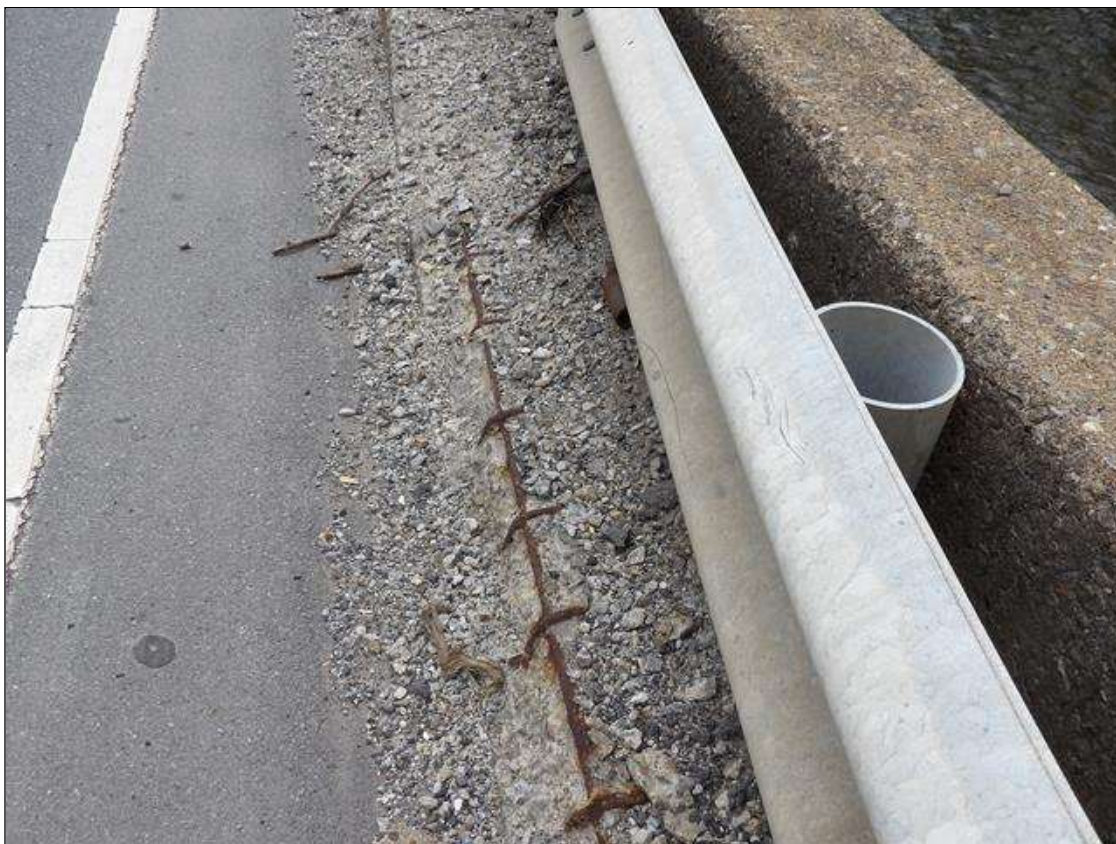
Span 1 Right Bridge Rail: RIGHT CURB HAS DETERIORATED CONCRETE ON TOP AND VERTICAL FACES 18 IN WIDE UP TO 2.5 IN DEEP WITH REBAR EXPOSED WITH ONSET OF SECTION LOSS AT BEGINNING 30 FEET OF SPAN

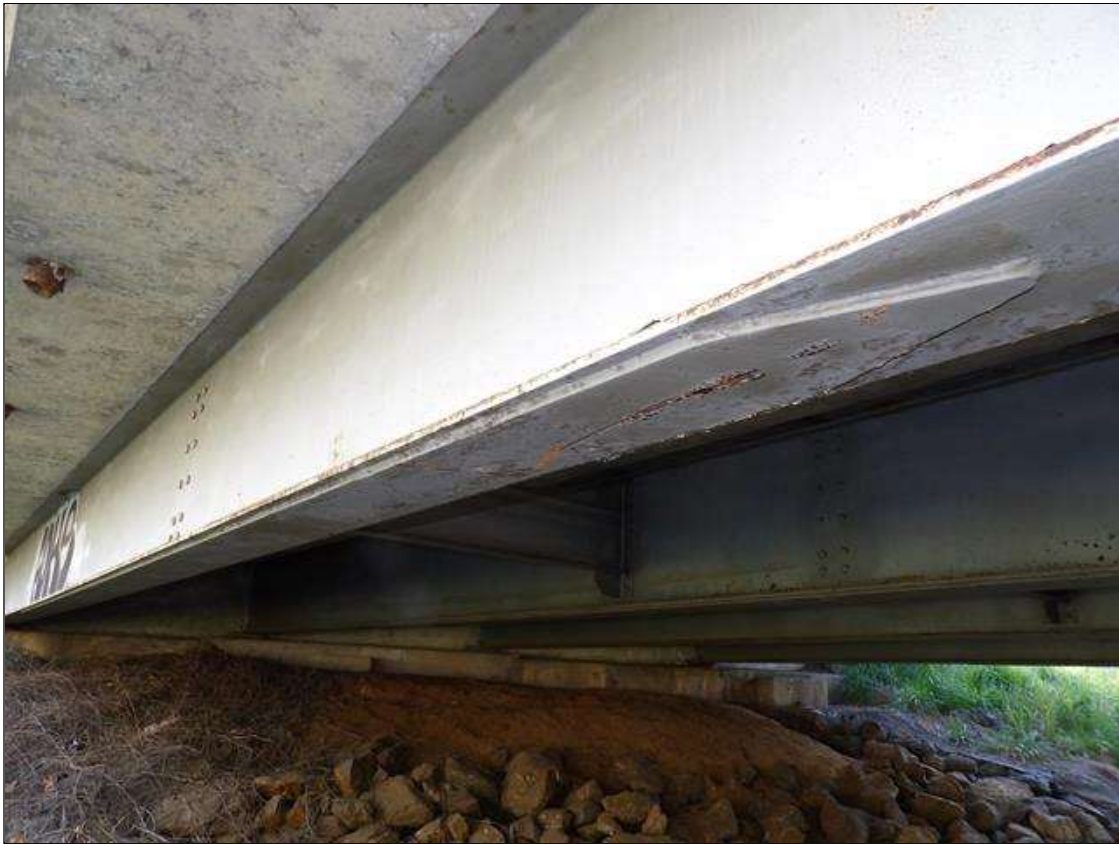
Span 1 Beam 4: SPOT FRECKLED SURFACE RUST ON WEB AND FLANGES.

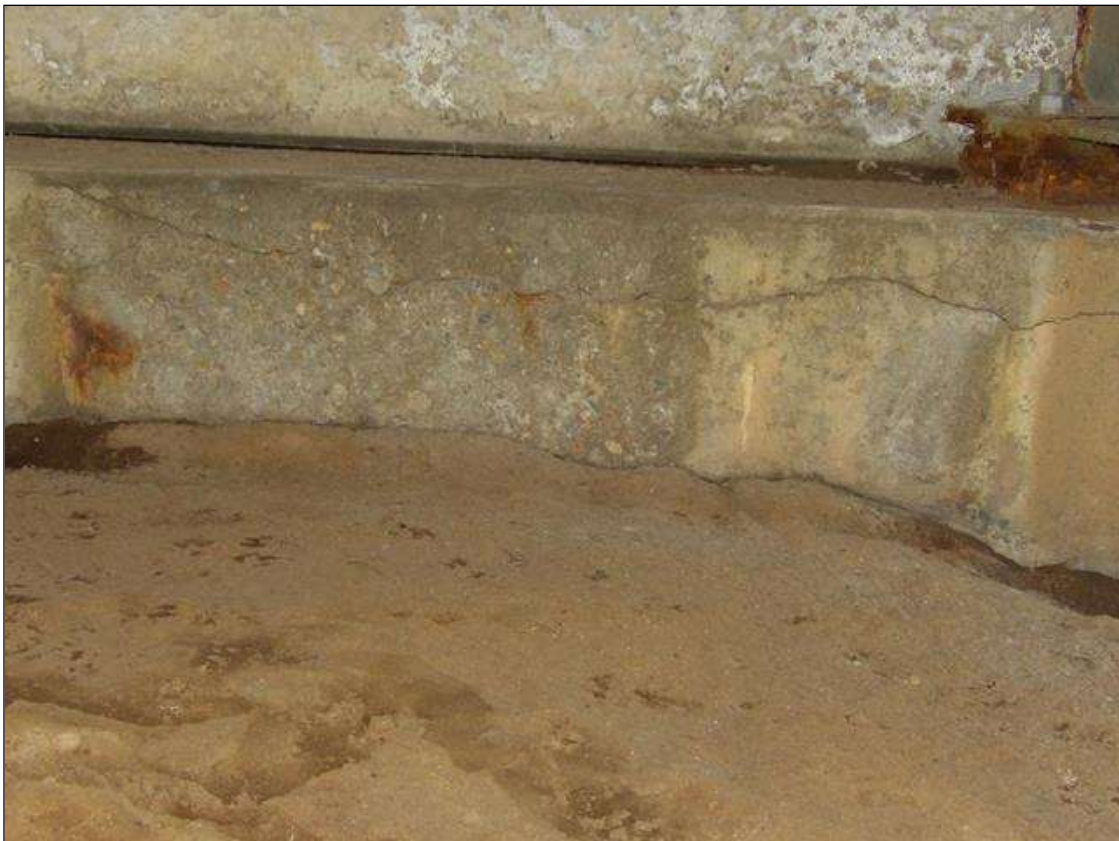
End Bent 2 Cap 1: BELOW BAY 3, 11 FEET LONG X UP TO 1/8 INCH WIDE HORIZONTAL CRACK

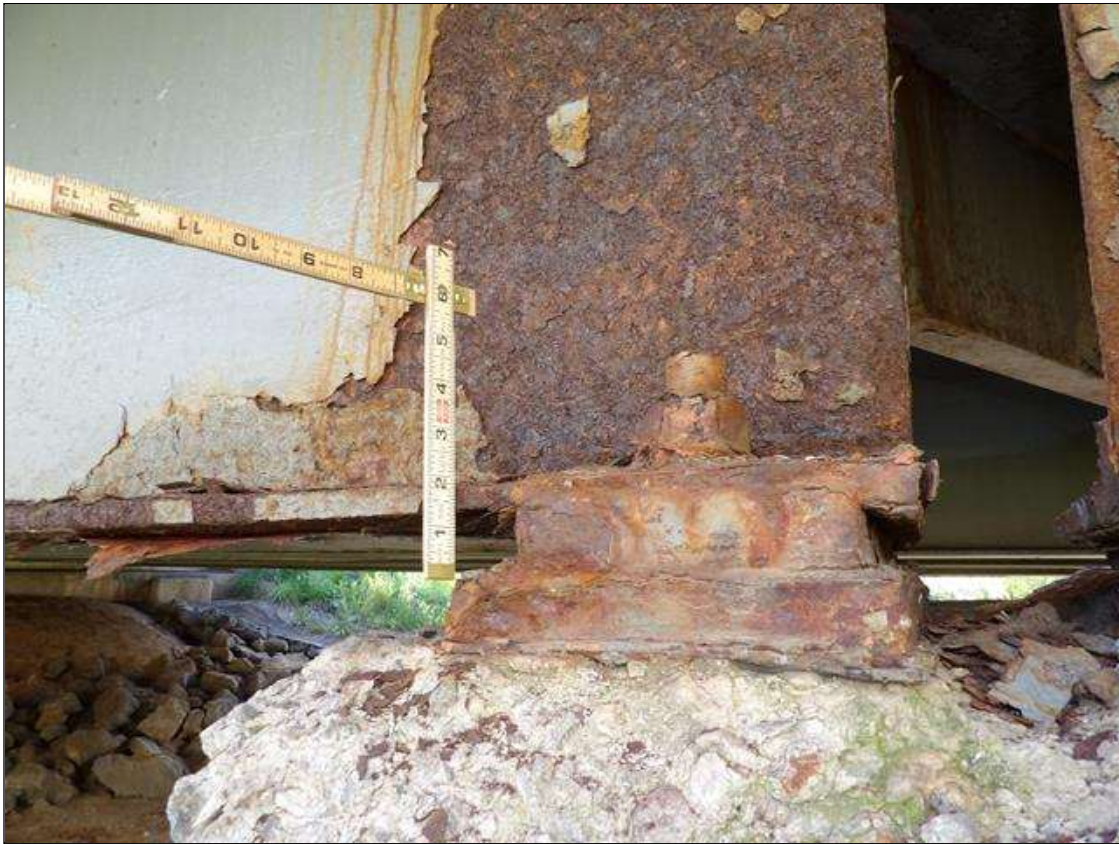
Span 4 Beam 1: CORROSION ALONG BOTH FACES OF WEB AND BOTTOM FLANGE UP TO 29 INCHES LONG X 31 1/2 INCHES HIGH DOWN TO 1/2 INCHES RESIDUAL WEB, AND 36 INCHES LONG X 11 1/2 INCHES WIDE DOWN TO 1/2 INCHES RESIDUAL FLANGE AT BENT 3

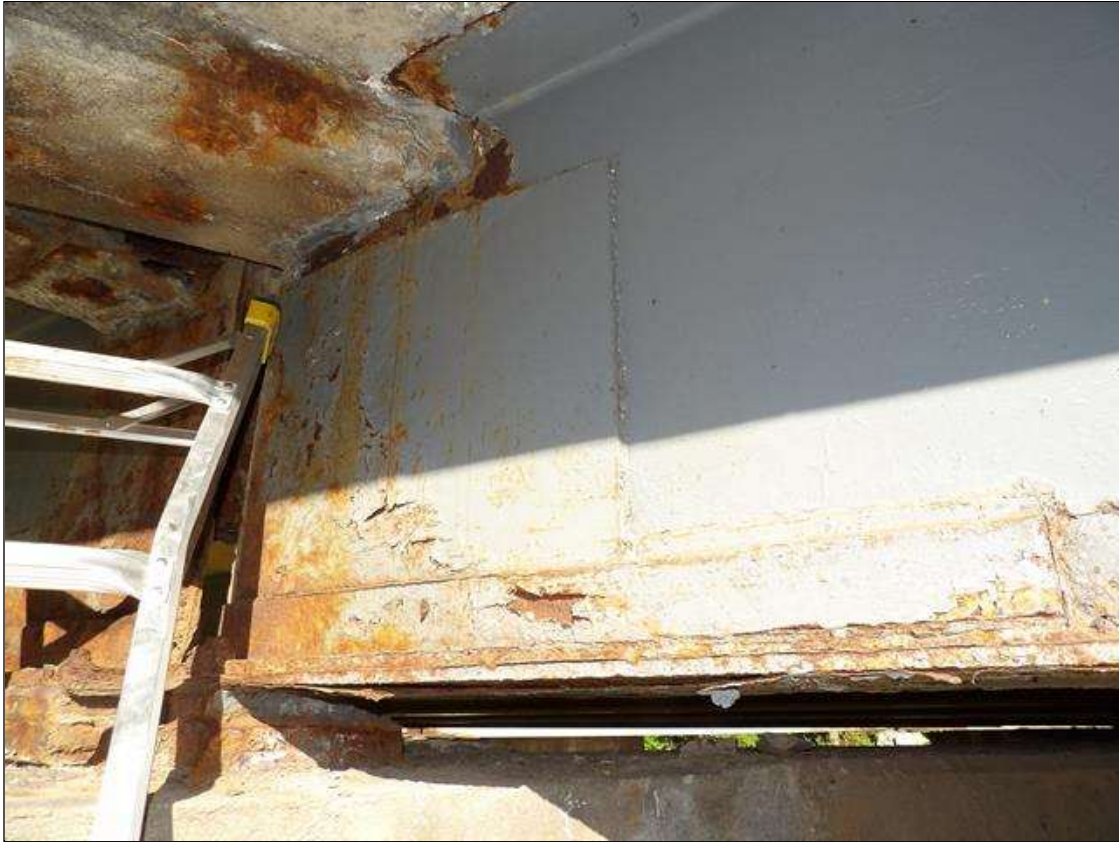
TYPICAL BEAM 4-- WELDED PLATE REPAIR AT BENT 3 BOTTOM FLANGE HAS A 3 FOOT 3 INCH X 4 INCH X 4 INCH X 1/2 INCH ANGLE ON RIGHT AND 2 FOOT X 4 INCH X 4 INCH X 1/2 INCH ON LEFT AND WEB HAS A 24 INCH X 24 INCH X 1/2 INCH ON RIGHT SIDE, SPAN 1 FAR, SPAN 2 FAR, SPAN 3 AND SPAN 4 NEAR

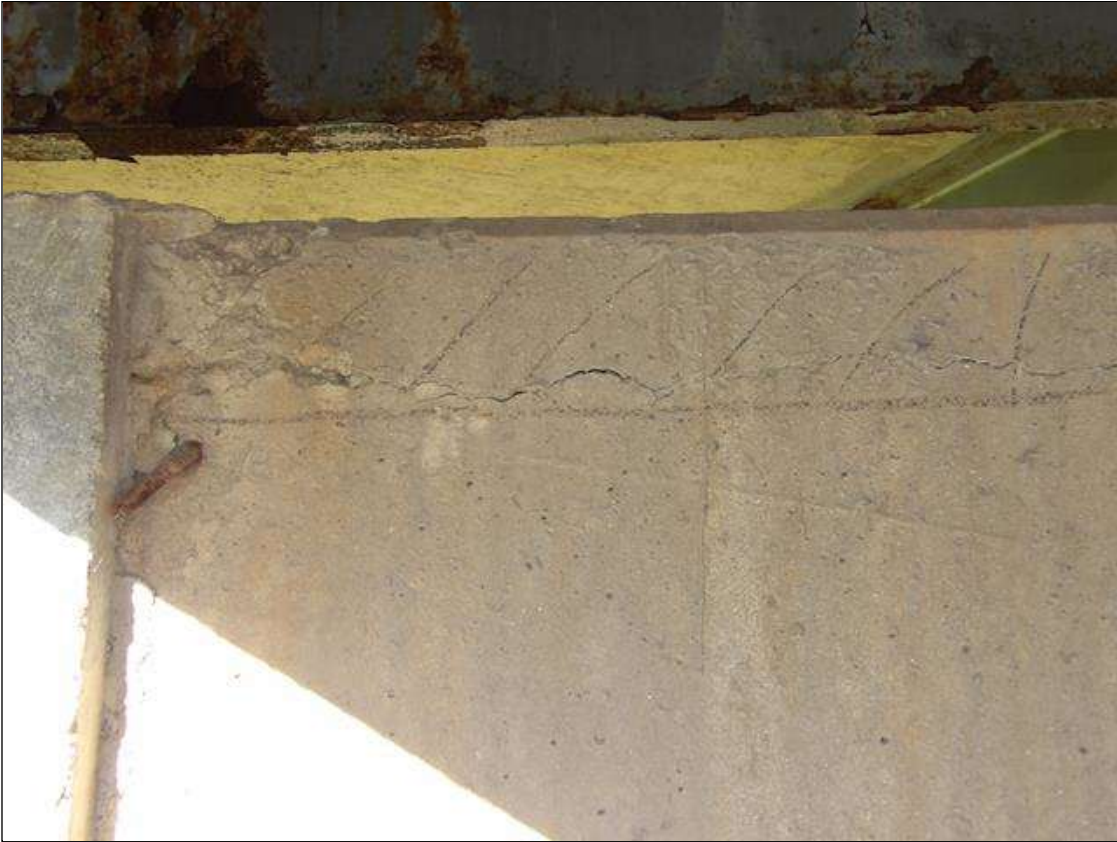
Bent 3 Cap 1: 32 INCHES X 9 INCHES X 7 INCHES AREA OF DELAMINATION WITH UP TO 1/16 INCHES HORIZONTAL CRACKS IN TOP AND SPAN 4 FACE OF CAP TO LEFT OF BEAM 4

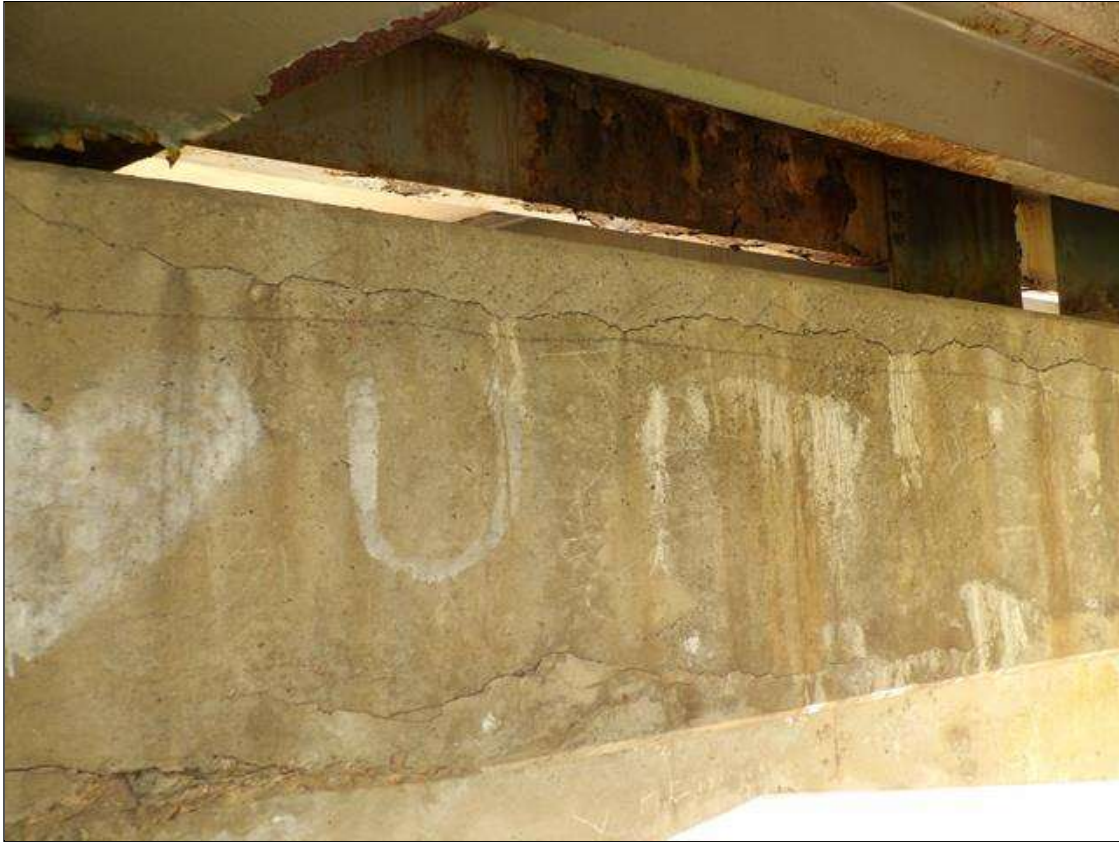
Bent 3 Cap 1: 10 FEET X 8 INCHES X 10 INCHES AREA OF DELAMINATION WITH UP TO 1/8 INCHES HORIZONTAL CRACKS WITH AND WITHOUT EFFLORESCENCE IN TOP AND SPAN 3 FACE OF CAP BENEATH BAY 2

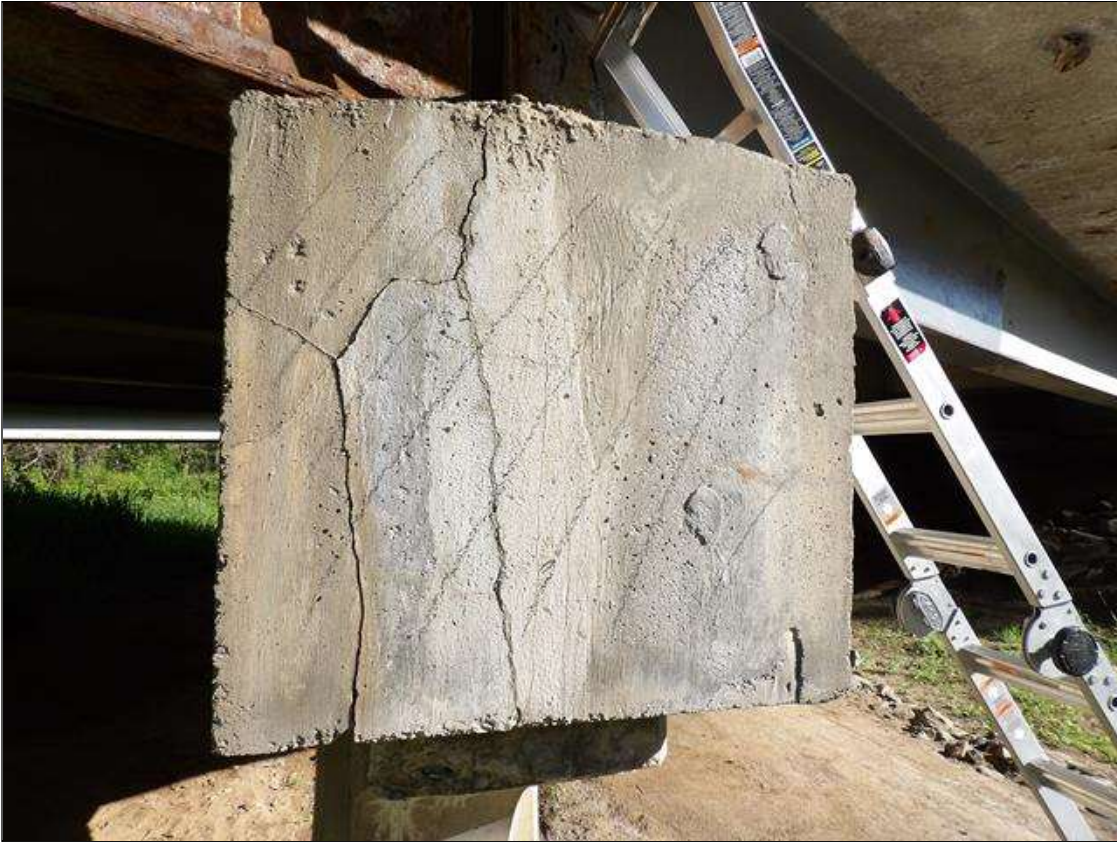
Bent 3 Cap 1: AT RIGHT END, UNSOUND PATCH FULL HEIGHT AND FULL WIDTH WITH CRACKS UP TO 1/8 IN WIDE

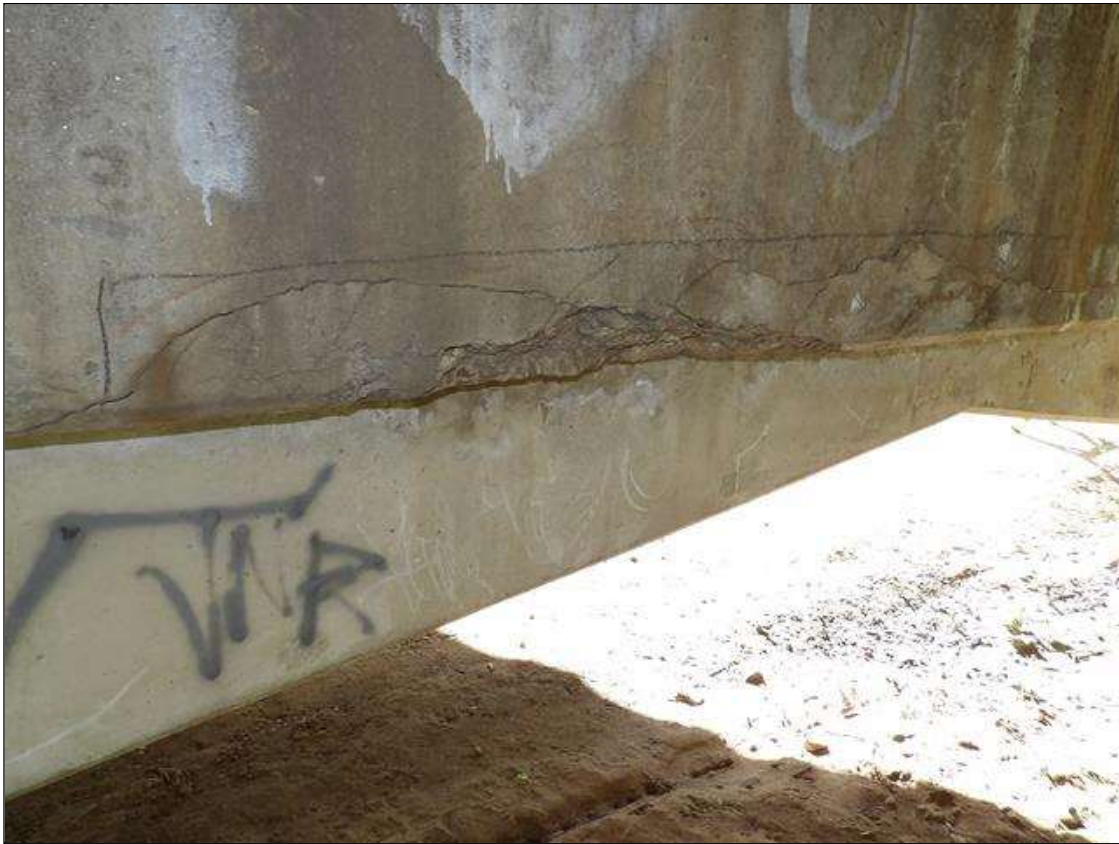
Bent 3 Cap 1: 90 INCHES X 6 INCHES X 8 INCHES AREA OF DELAMINATION WITH UP TO 1/16 INCHES LONGITUDINAL AND HORIZONTAL CRACKS AND 32 INCHES X 4 INCHES X 4 INCHES SPALL IN BOTTOM AND SPAN 3 FACE OF CAP, BEGINNING APPROXIMATELY 3 FEET TO RIGHT OF COLUMN 1

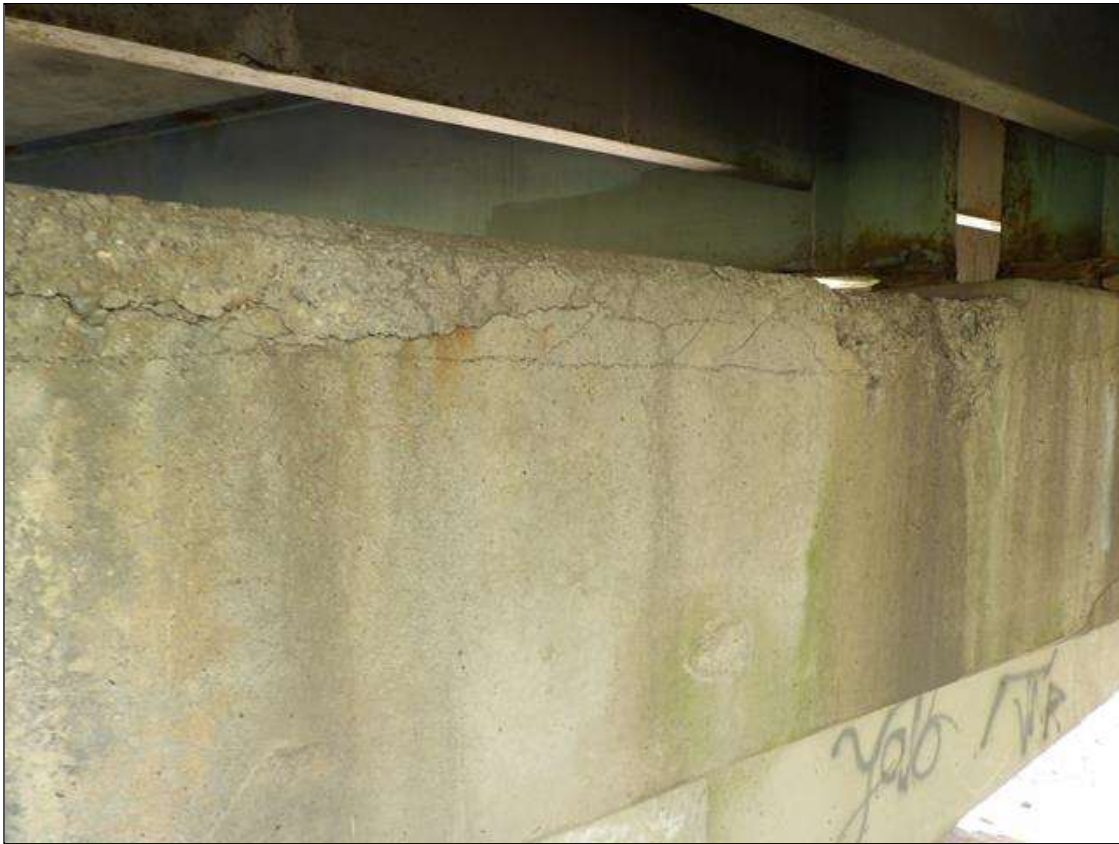
Bent 3 Cap 1: 9 FEET X 30 INCHES X 30 INCHES AREA OF DELAMINATION WITH 3/8 INCHES LONGITUDINAL AND HORIZONTAL CRACKS WITH AND WITHOUT EFFLORESCENCE, AND (2) SPALLS UP TO 28 INCHES X 12 INCHES X 10 INCHES IN TOP AND BOTH FACES OF CAP FROM LEFT END TO BAY 2 SOUTH FACE SHOWN

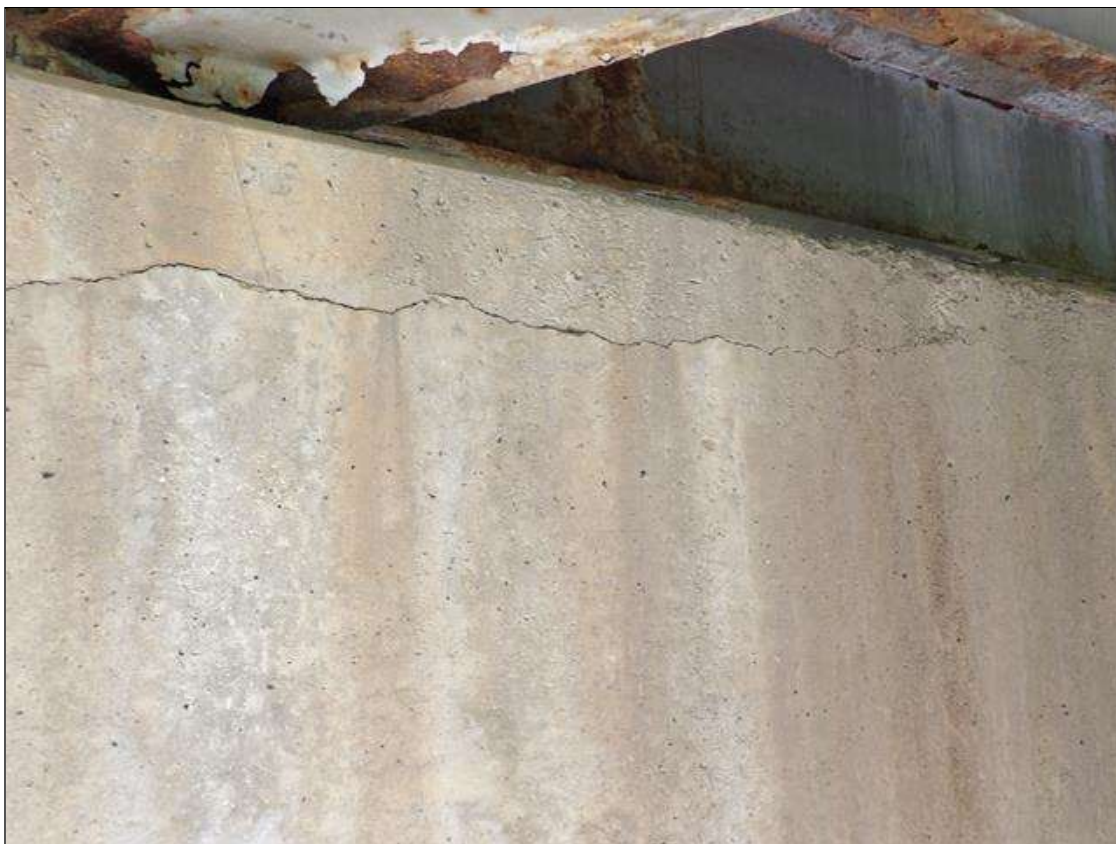
Bent 3 Cap 1: UP TO 1/16 INCHES HORIZONTAL CRACKS WITH AREAS OF DELAMINATION UP TO 50 INCHES X 7 INCHES X 6 INCHES IN TOP, BOTTOM AND SPAN 4 FACE OF CAP BENEATH BAY 2 AND BEAM 3

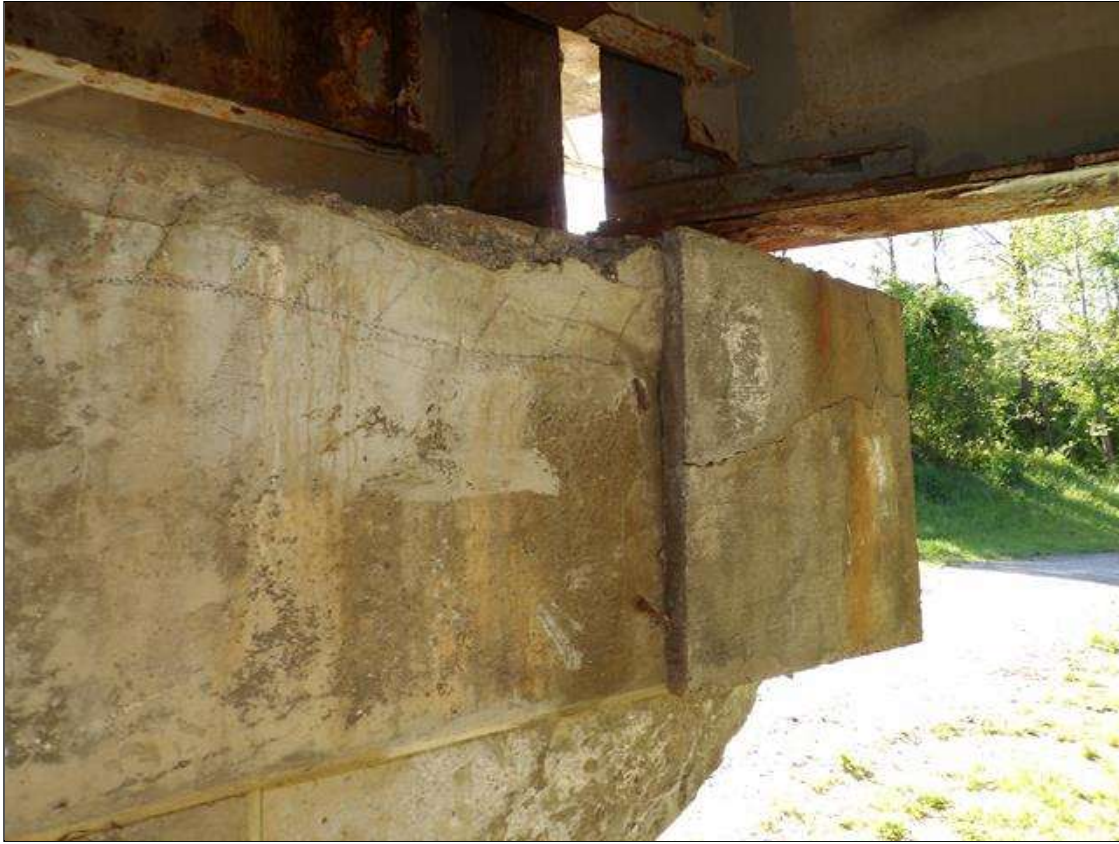
Bent 3 Cap 1: 70 INCHES X 8 INCHES X 9 INCHES AREA OF DELAMINATION WITH UP TO 1/16 INCHES LONGITUDINAL AND HORIZONTAL CRACKS WITH AND WITHOUT EFFLORESCENCE, AND 32 INCHES X 9 INCHES X 9 INCHES UNSOUND PATCH WITH 15 INCHES X 5 INCHES X 1 INCHES DEEP SPALL IN TOP AND SPAN 3 FACE OF CAP BENEATH BAY 3 AND BEAM 4

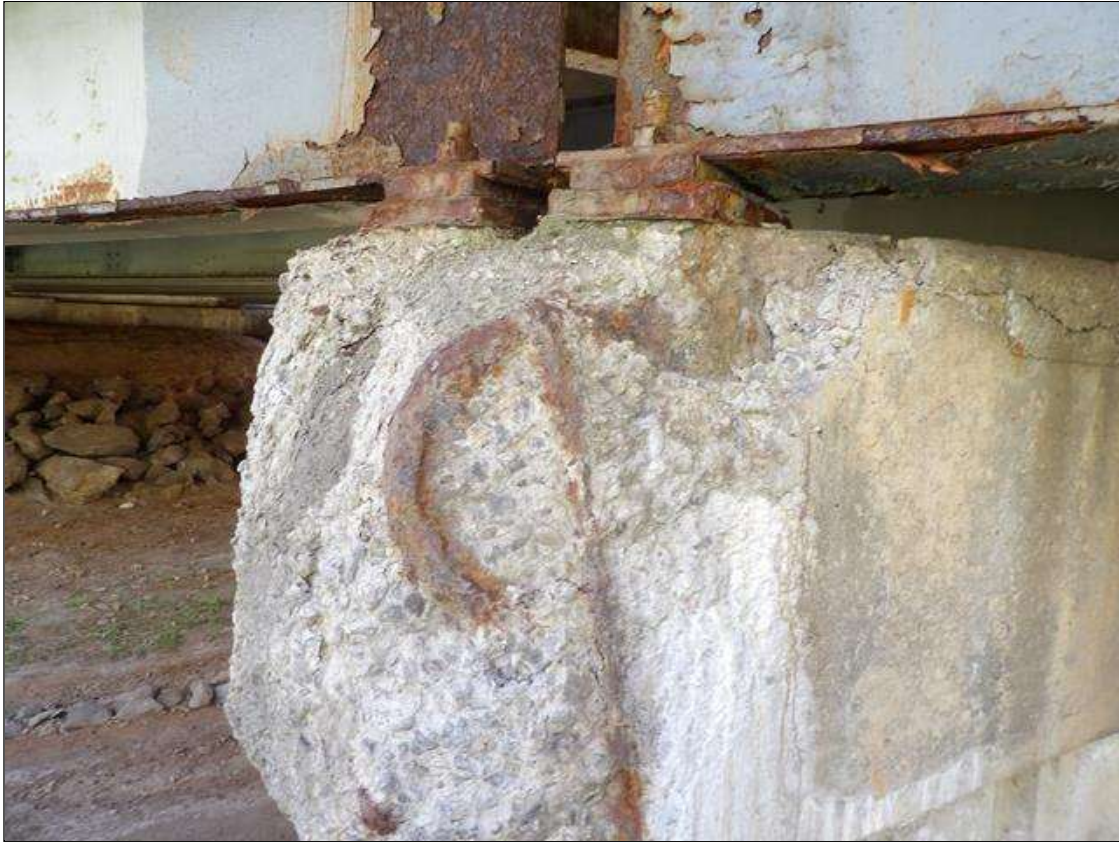
Bent 3 Cap 1: PAR: 26 INCHES X 20 INCHES X 30 INCHES SPALL WITH EXPOSED REBAR IN LEFT END OF CAP WITH MINOR LOSS OF BEARING LESS THAN 5 PERCENT UNDER BOTH BEARINGS
