NC DEPARTMENT OF TRANSPORTATION  
 DIVISION OF HIGHWAYS  
 STRUCTURE MANAGEMENT UNIT

ATTENTION: **PRIORITY ACTION REQUEST ISSUED**

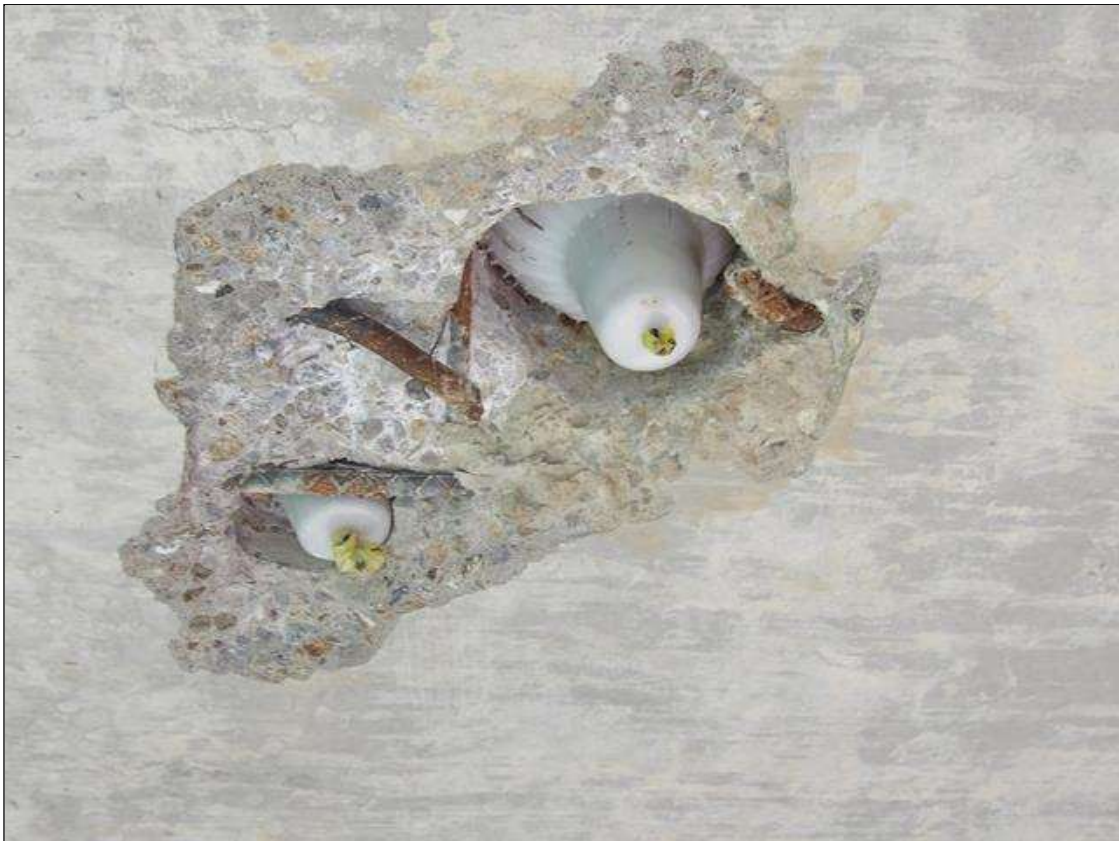
Span 3 Deck: PAR--23 INCHES X 19 INCHES X 6 INCHES DEEP SPALL WITH EXPOSED BROKE REBAR DUE TO CORE IN BOTTOM OF DECK AT CORE HOLE LOCATIONS IN BAY 3 NEAR MIDSPAN

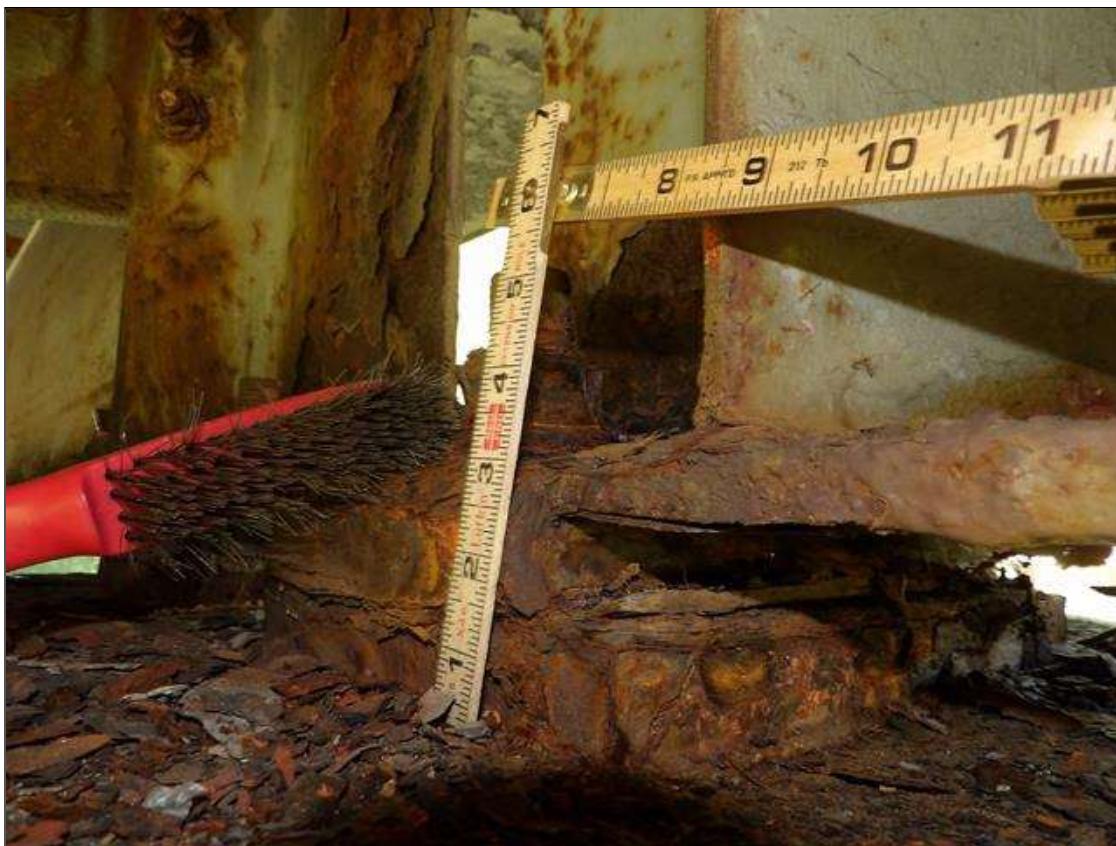
Span 3 Beam 1: CORROSION ALONG BOTH FACES OF WEB AND BOTTOM FLANGE UP TO 5 FEET LONG X 6 INCHES HIGH DOWN TO 1/2 INCHES RESIDUAL WEB, AND 5 FEET LONG X 11 1/2 INCHES WIDE DOWN TO 1/2 INCHES RESIDUAL FLANGE AT BENT 2

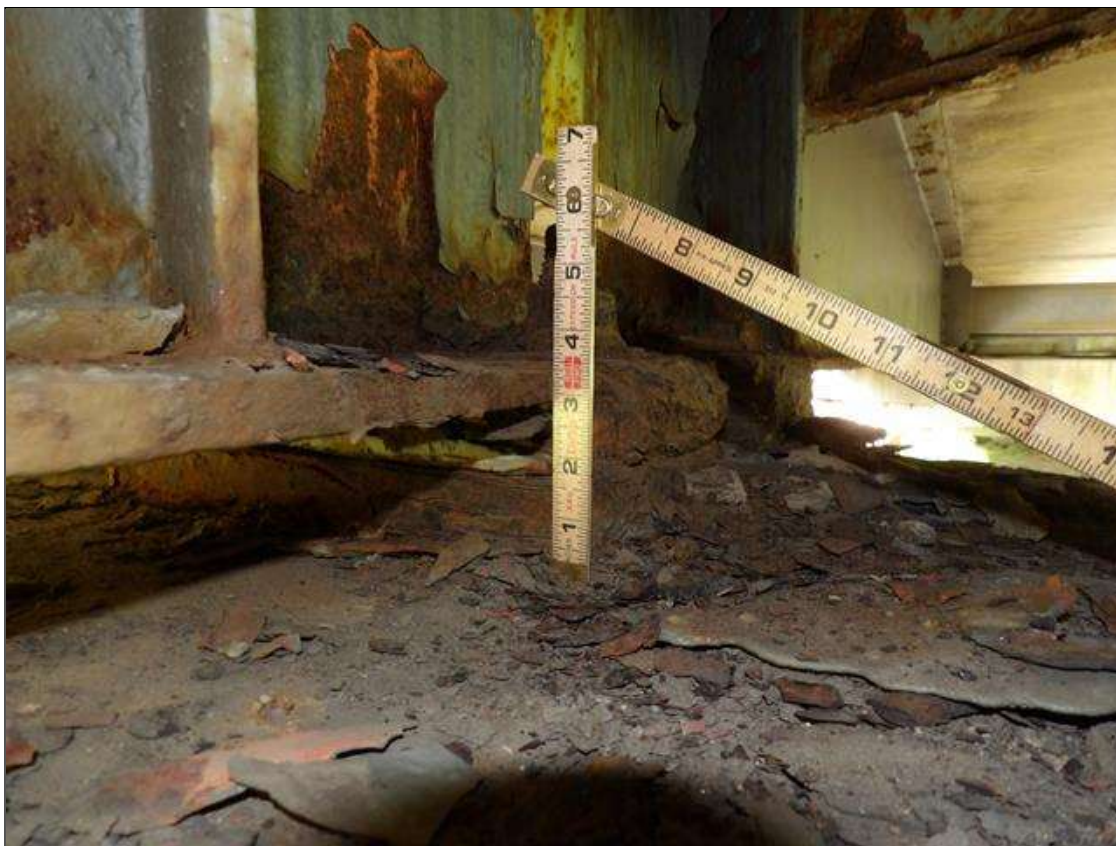
Span 3 Beam 3: PAR: CORROSION ALONG BOTH FACES OF WEB AND BOTTOM FLANGE UP TO 11 INCHES LONG X 4 INCHES HIGH DOWN TO 1/2 INCHES RESIDUAL WEB, AND 12 INCHES LONG X 5 1/2 INCHES WIDE DOWN TO 3/8 INCHES RESIDUAL FLANGE AT BENT 2

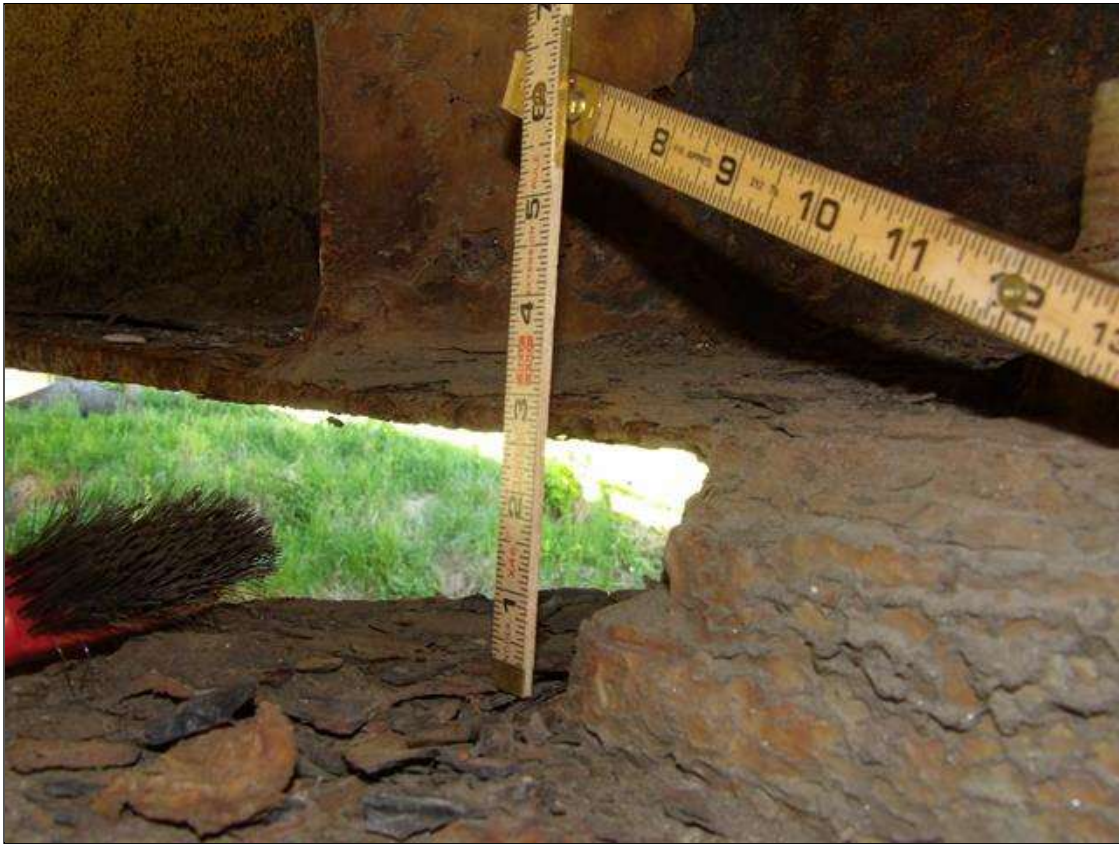
Span 2 Beam 3: PAR: CORROSION ALONG BOTH FACES OF WEB AND BOTTOM FLANGE UP TO 68 INCHES LONG X 7 INCHES HIGH DOWN TO 1/2 INCHES RESIDUAL WEB, AND 60 INCHES LONG X 11 1/2 INCHES WIDE DOWN TO 3/16 INCHES RESIDUAL FLANGE AT BENT 2

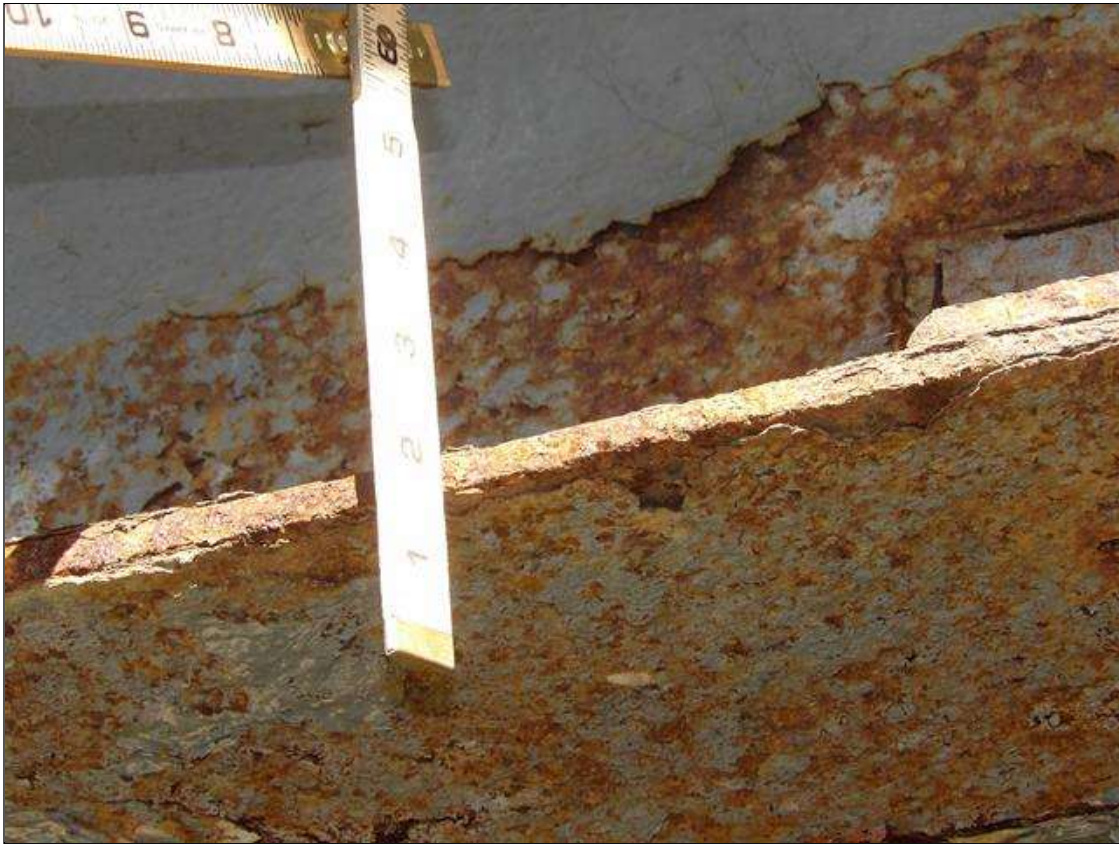
Span 3 Beam 4: PAR: CORROSION ALONG RIGHT FACE OF WEB AND BOTTOM FLANGE UP TO 60 INCHES LONG X 6 INCHES HIGH DOWN TO 1/2 INCHES RESIDUAL WEB, AND 48 INCHES LONG X 5 1/2 INCHES WIDE DOWN TO 3/8 INCHES RESIDUAL FLANGE, EXTENDING FROM PLATE REPAIR 1 FEET FROM BENT 3

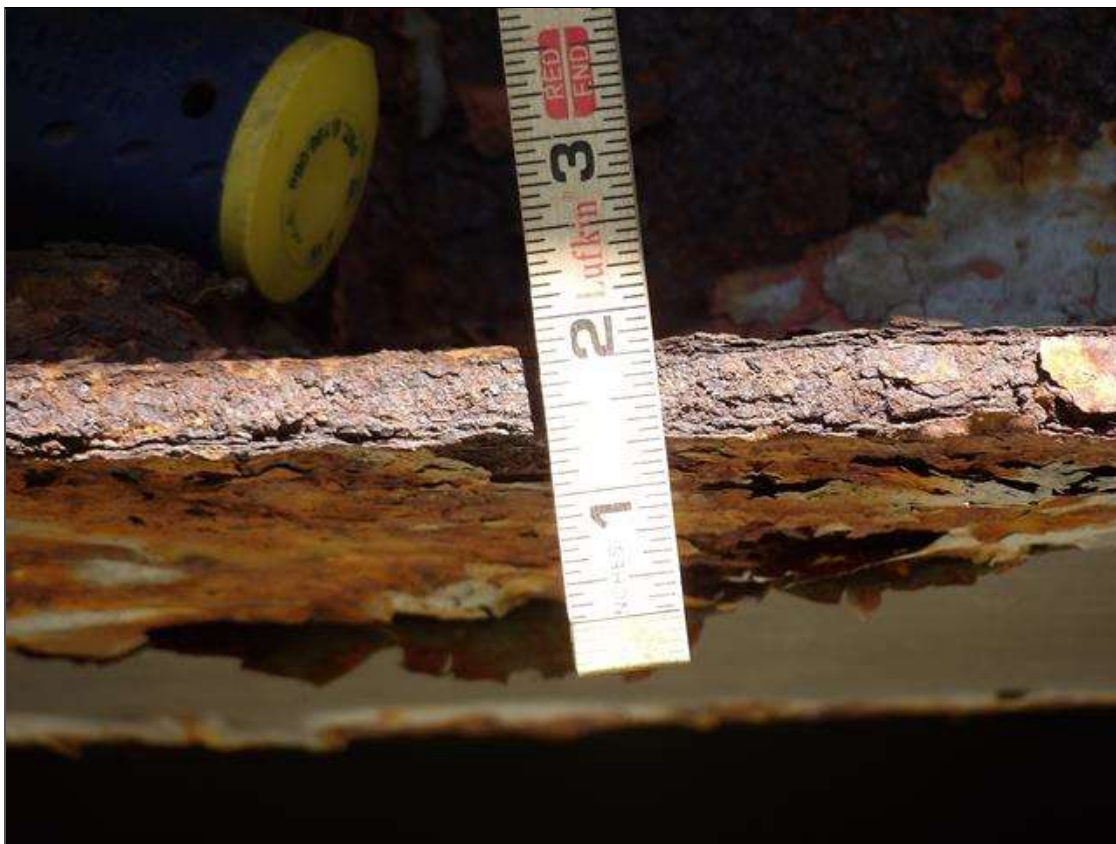
Span 3 Beam 4: PAR--CORROSION ALONG RIGHT FACE OF WEB AND BOTTOM FLANGE UP TO 24 INCHES LONG X 4 INCHES HIGH DOWN TO 1/2 INCHES RESIDUAL WEB, AND 24 INCHES LONG X 5 1/2 INCHES WIDE DOWN TO 3/8 INCHES RESIDUAL FLANGE, EXTENDING FROM PLATE REPAIR 4 FEET FROM BENT 2

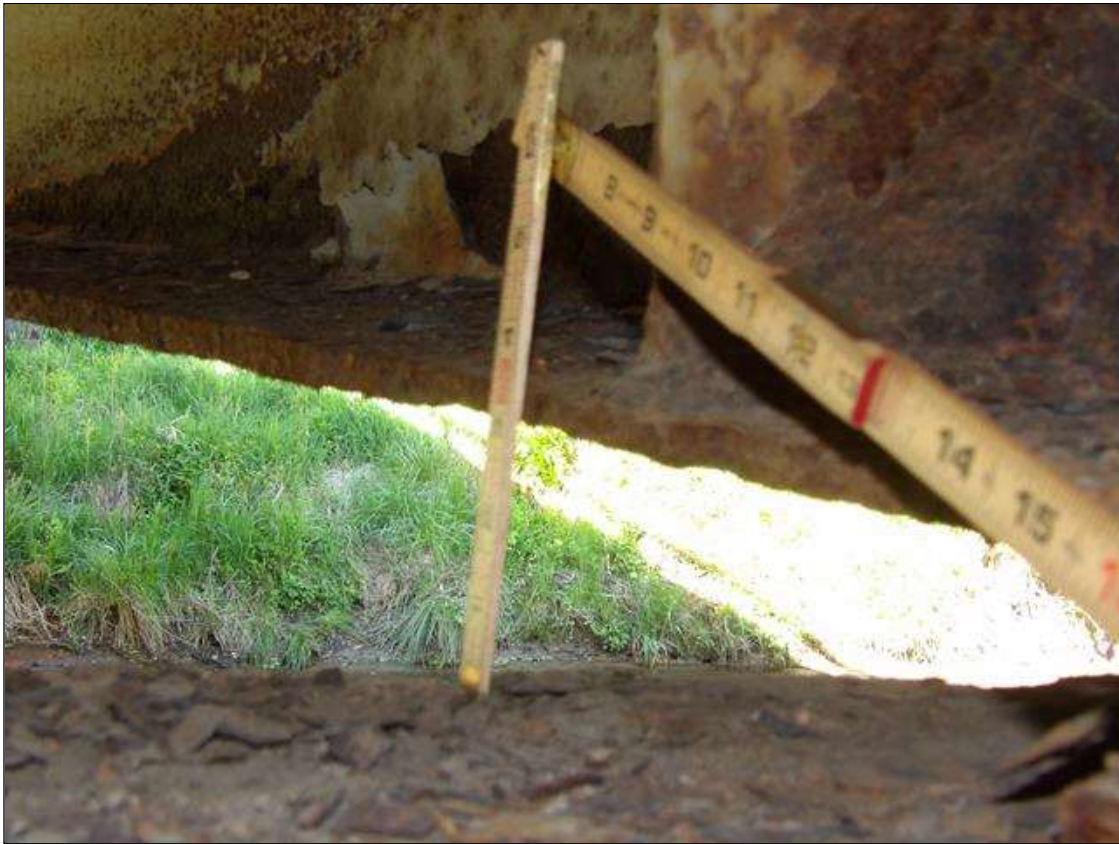
Span 2 Beam 2: PAR: CORROSION ALONG BOTH FACES OF WEB AND BOTTOM FLANGE UP TO 48 INCHES LONG X 10 INCHES HIGH DOWN TO 1/2 INCHES RESIDUAL WEB, AND 48 INCHES LONG X 11 1/2 INCHES WIDE DOWN TO 3/8 INCHES RESIDUAL FLANGE AT BENT 2

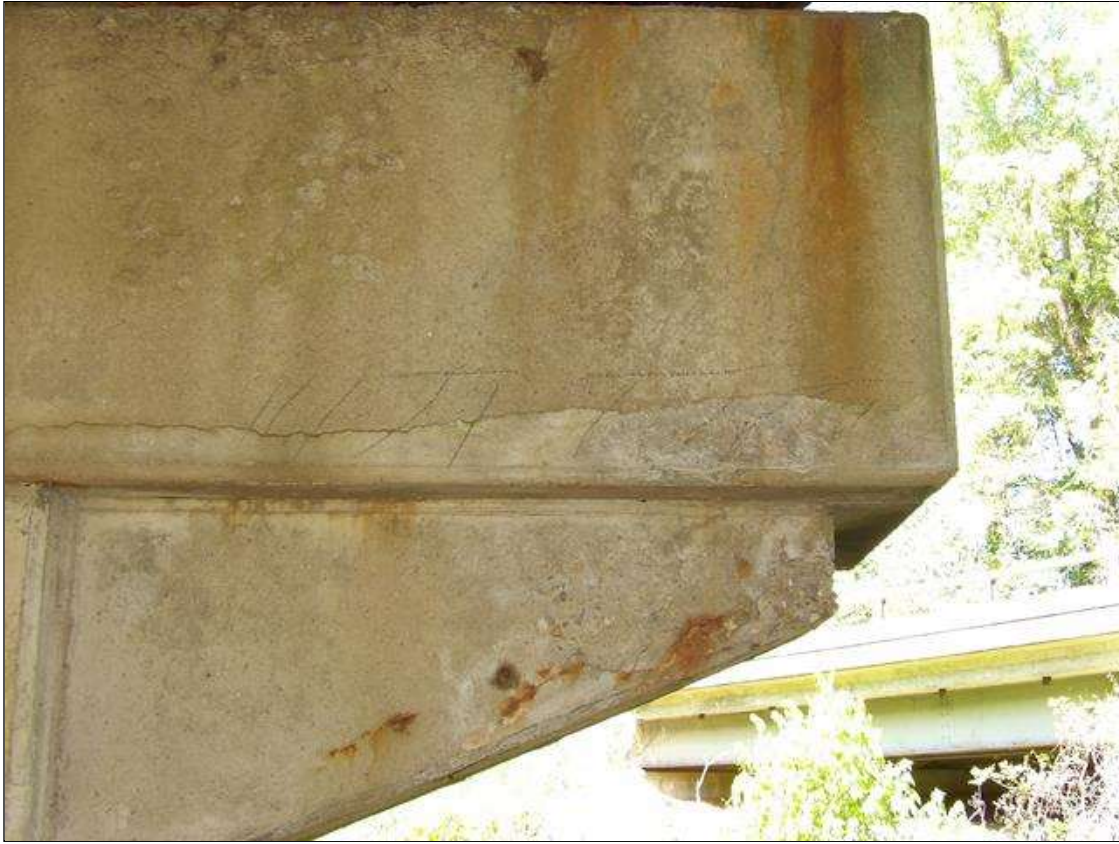
Bent 2 Cap 1: 55 INCHES X 4 INCHES X 10 INCHES AREA OF DELAMINATION WITH UP TO 1/16 INCHES LONGITUDINAL AND HORIZONTAL CRACKS IN BOTTOM AND SPAN 3 FACE OF CAP AT LEFT END

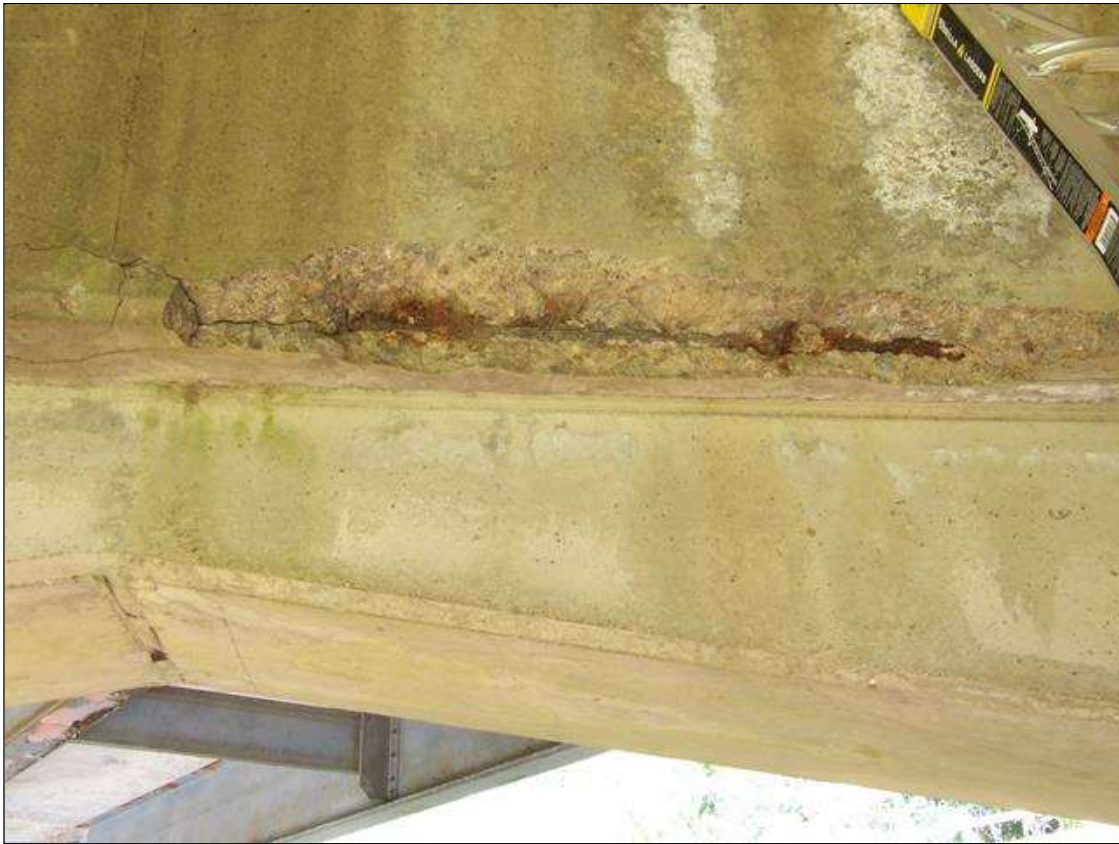
Bent 2 Cap 1: 51 INCHES X 6 INCHES X 10 INCHES AREA OF DELAMINATION WITH UP TO 0.035 INCHES LONGITUDINAL AND HORIZONTAL CRACKS AND 40 INCHES X 6 INCHES X 2 INCHES DEEP SPALL WITH EXPOSED REBAR NO LOSS IN BOTTOM AND SPAN 3 FACE OF CAP TO RIGHT OF COLUMN 1

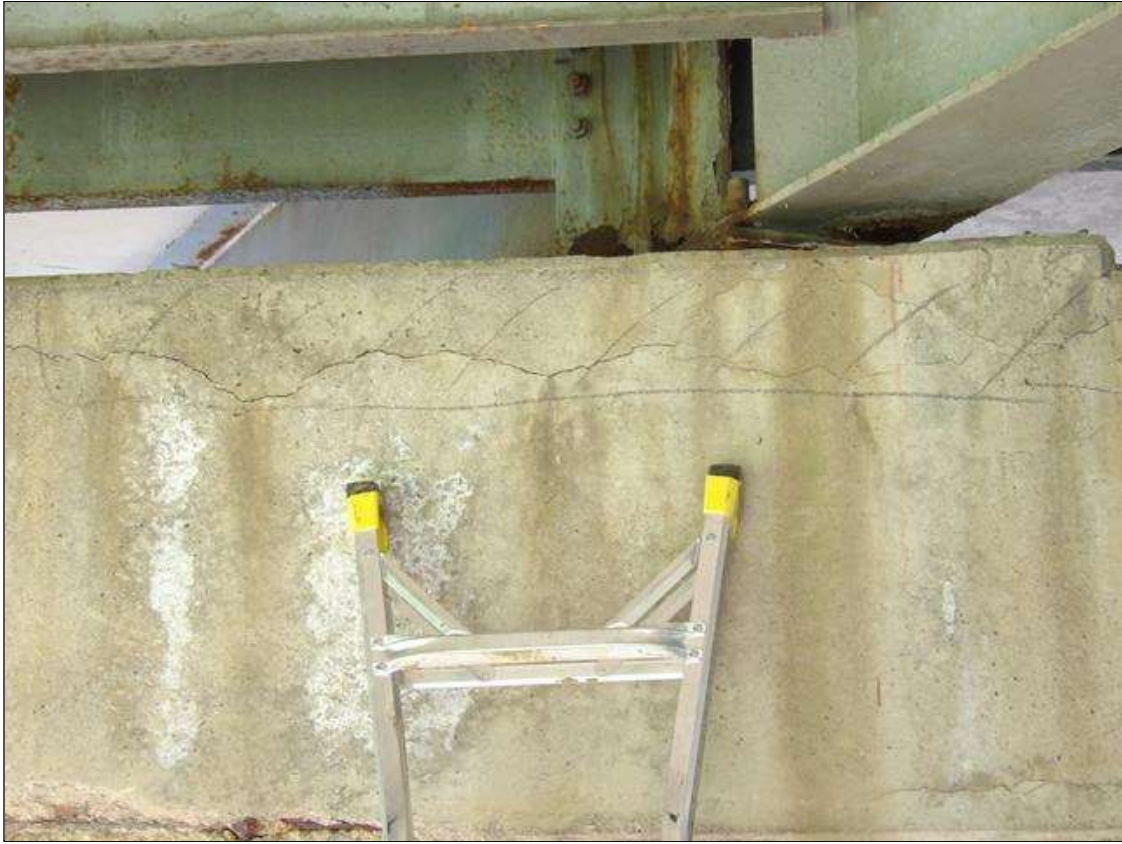
Bent 2 Cap 1: 72 INCHES X 7 INCHES X 11 INCHES AREA OF DELAMINATION WITH UP TO 1/16 INCHES HORIZONTAL CRACKS IN TOP AND SPAN 3 FACE OF CAP BENEATH BEAM 2 AND BAY 2

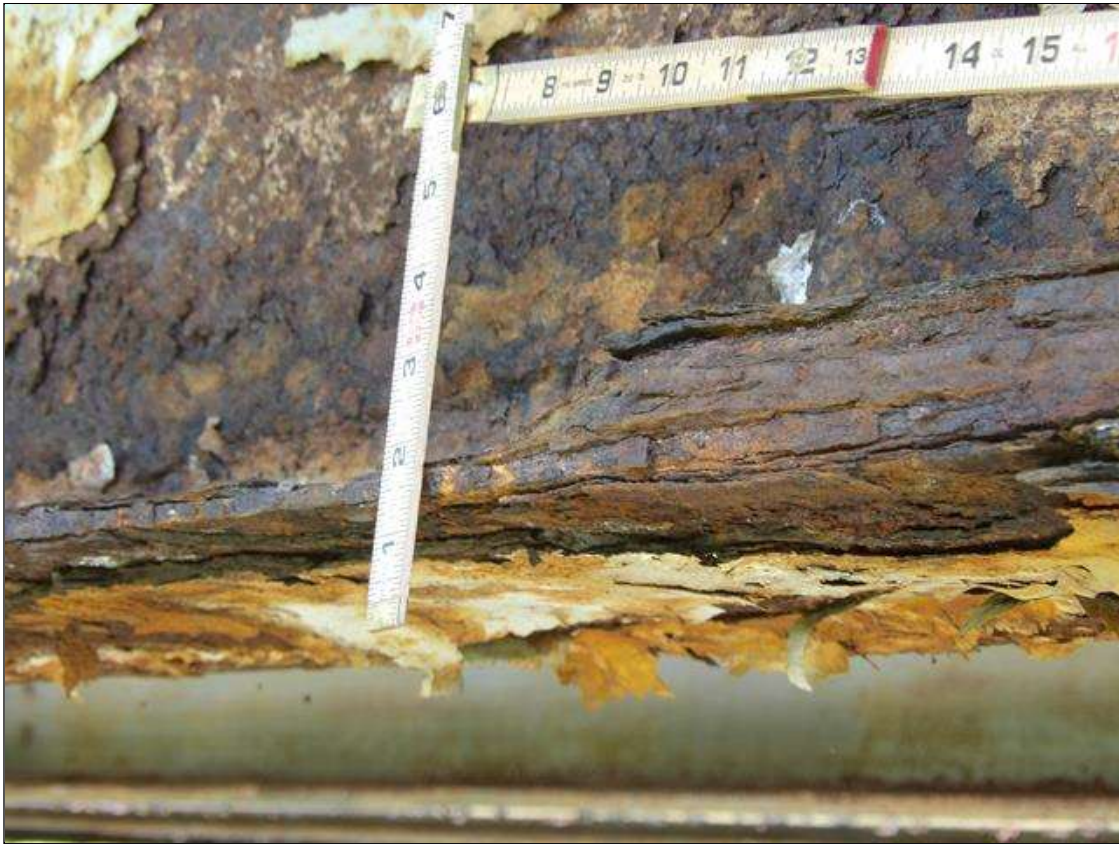
Span 2 Beam 4: PAR: CORROSION ALONG BOTH FACES OF WEB AND BOTTOM FLANGE UP TO 80 INCHES LONG X 10 INCHES HIGH DOWN TO 1/2 INCHES RESIDUAL WEB, AND 82 INCHES LONG X 11 1/2 INCHES WIDE DOWN TO 3/8 INCHES RESIDUAL FLANGE, EXTENDING FROM PLATE REPAIR 4 FEET FROM BENT 2

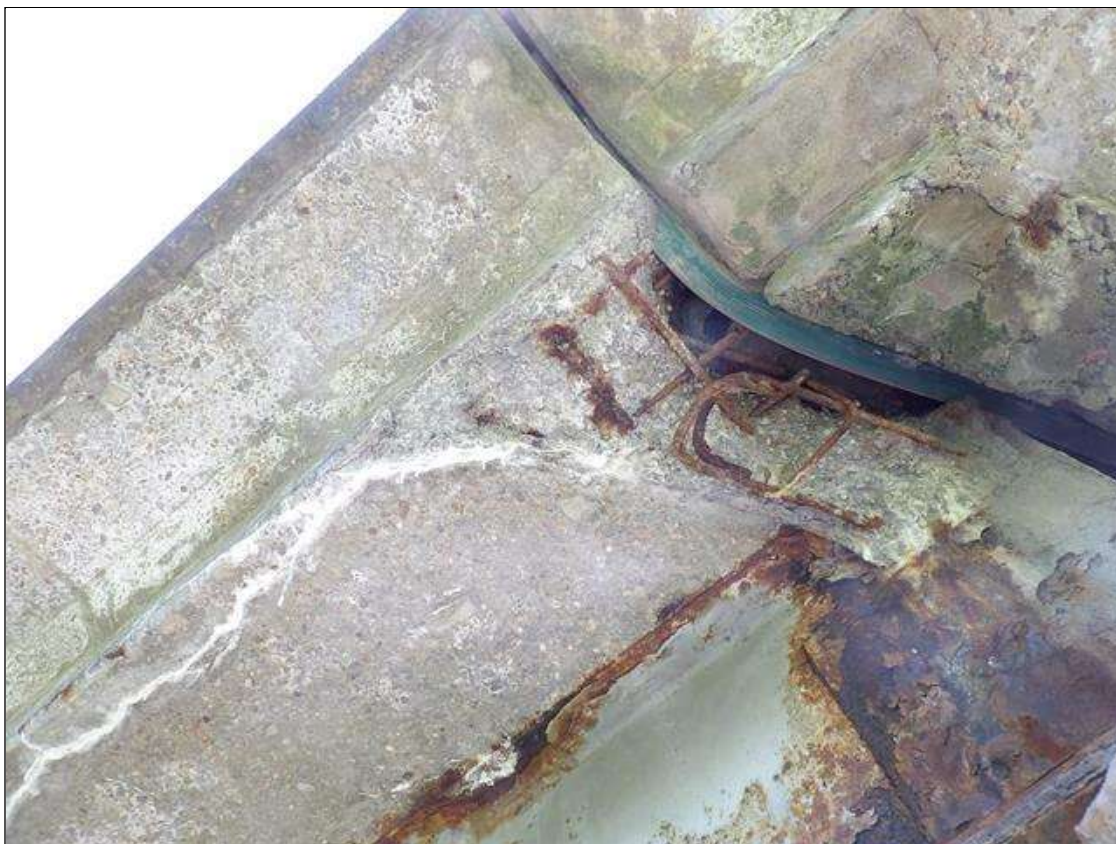
Span 2 Deck: 30 INCHES X 18 INCHES X 4 INCHES DEEP SPALL WITH EXPOSED REBAR NO LOSS IN BOTTOM OF RIGHT OVERHANG ABOVE BENT 2

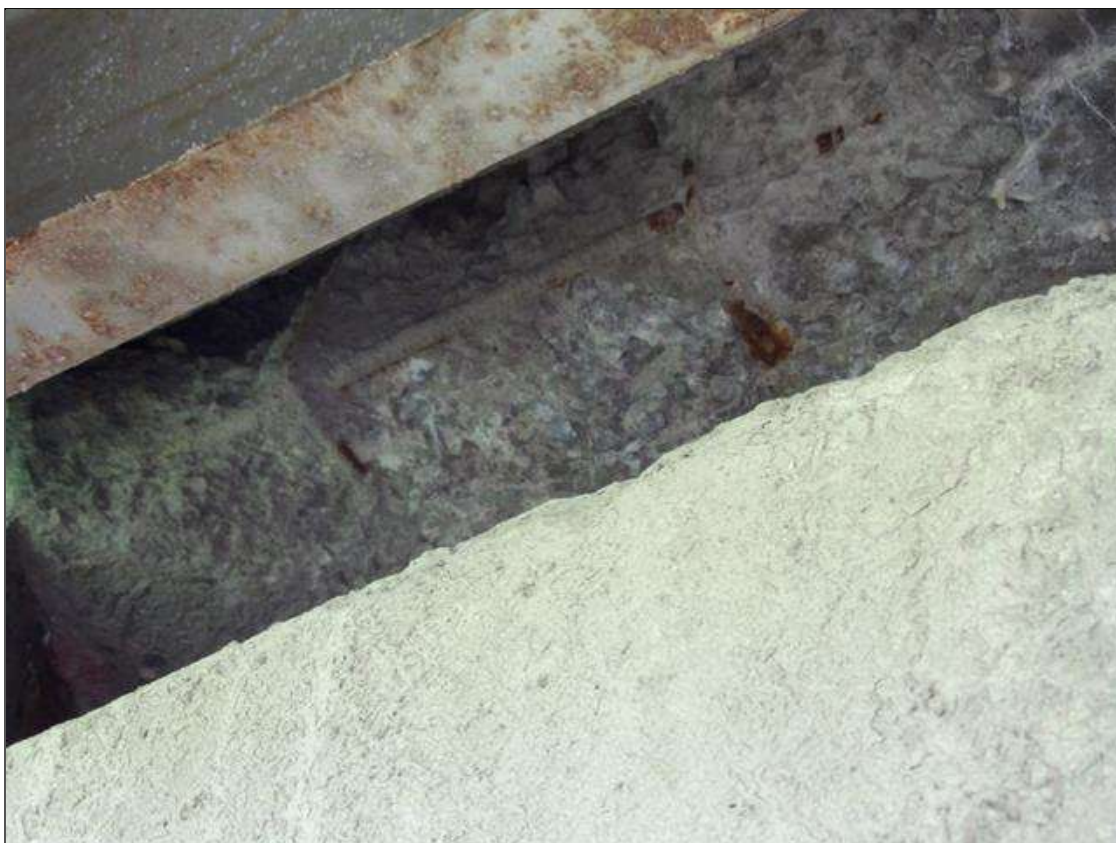
TYPICAL DIAPHRAGM SPALL WITH EXPOSED REBAR NO LOSS, BAY 3 SPAN 3 AT PIER 2 SHOWN

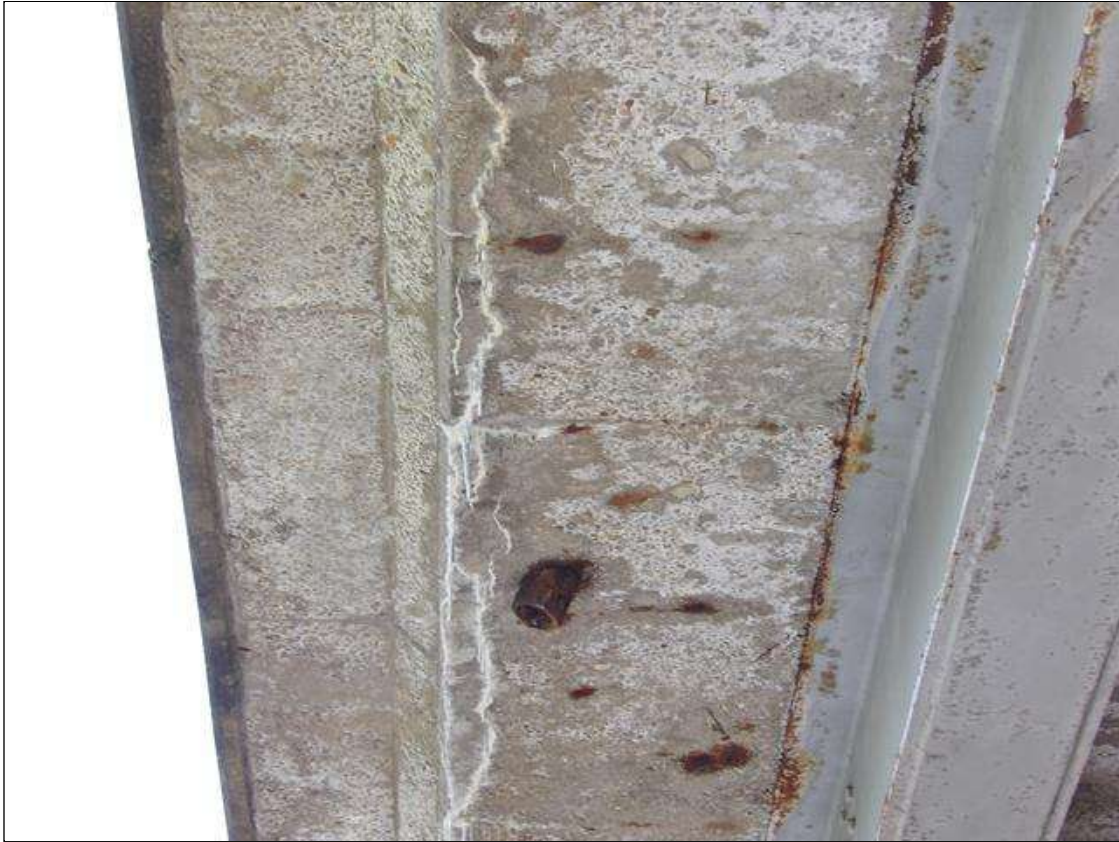
Span 2 Deck: UP TO 1/32 INCHES TRANSVERSE AND LONGITUDINAL CRACKS WITH EFFLORESCENCE AND RUST STAINING THROUGHOUT BOTTOM OF RIGHT OVERHANG IN VARIOUS LOCATIONS

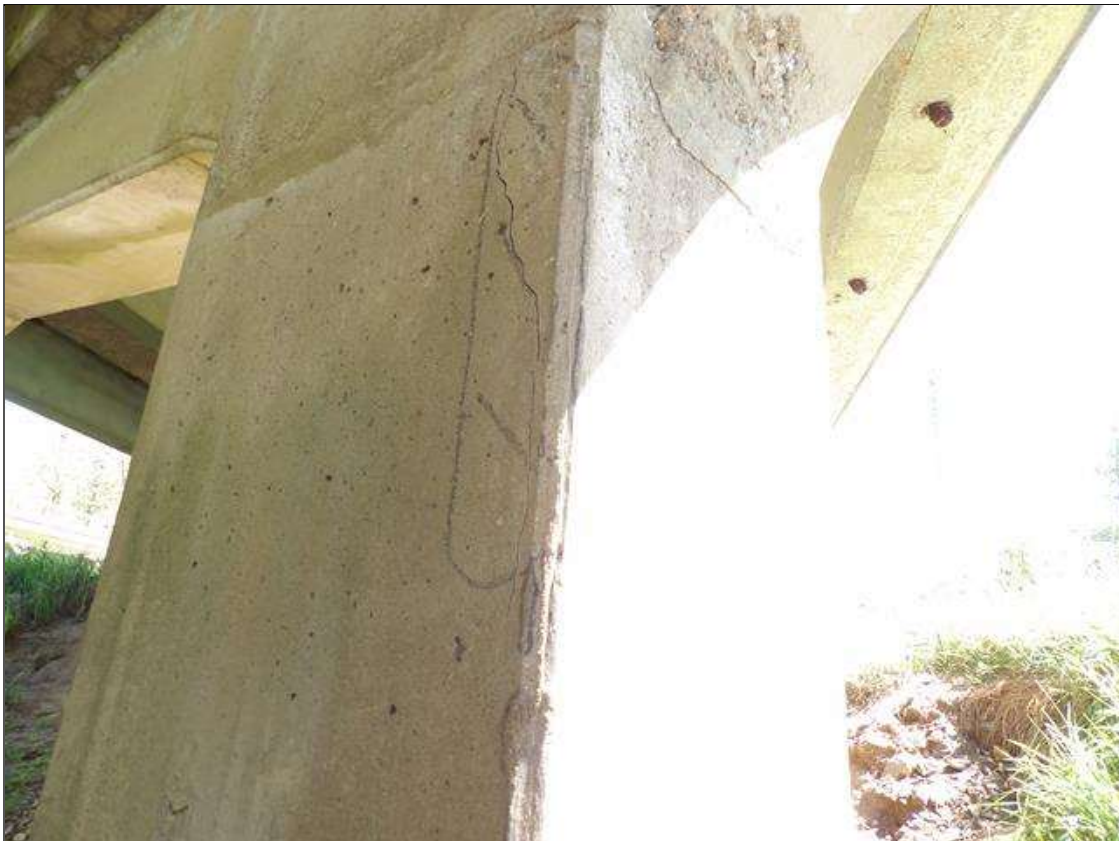
Bent 2 Pile 2: 32 INCHES HIGH UP TO 1/16 INCHES VERTICAL CRACK IN SOUTHEAST CORNER OF COLUMN, APPROXIMATELY 3 FEET FROM BOTTOM OF CAP

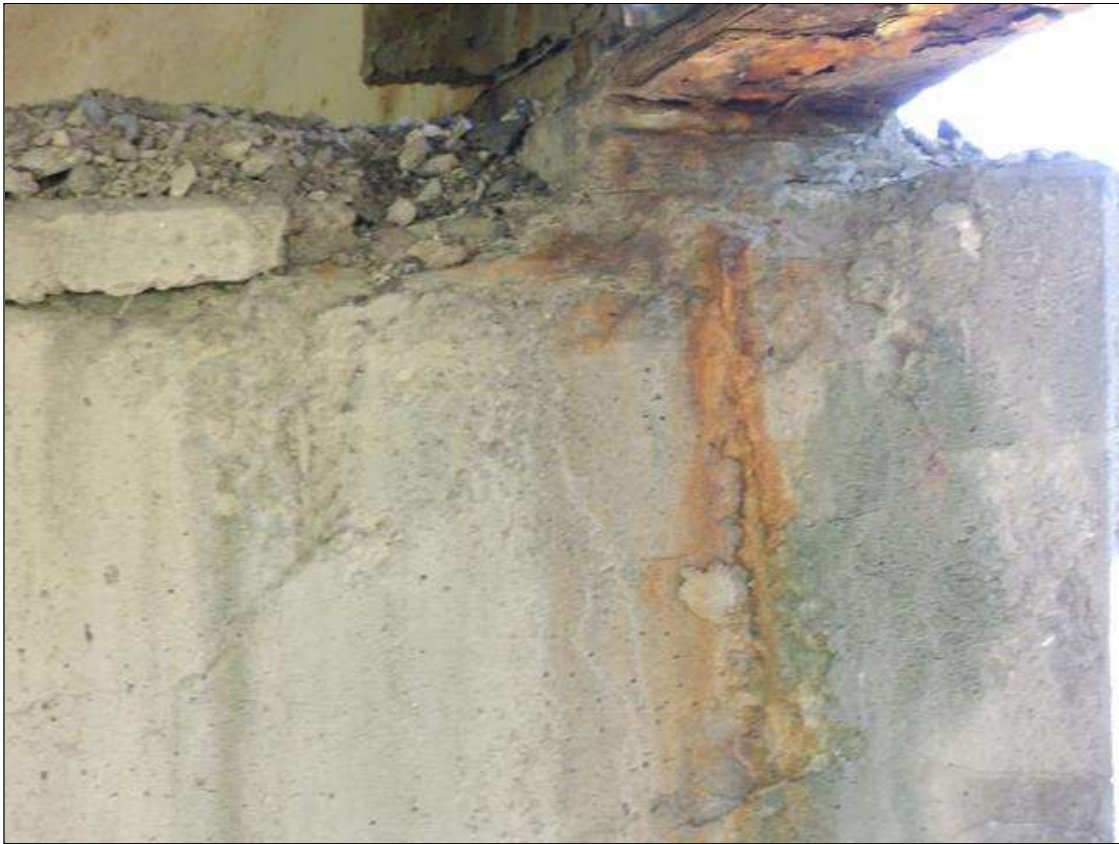
Bent 2 Cap 1: PAR: 48 INCHES X 22 INCHES X 3 INCHES DEEP SPALL WITH EXPOSED REBAR IN SPAN 2 FACE OF CAP BENEATH BEAM 4 WITH 5 PERCENT BEARING LOSS

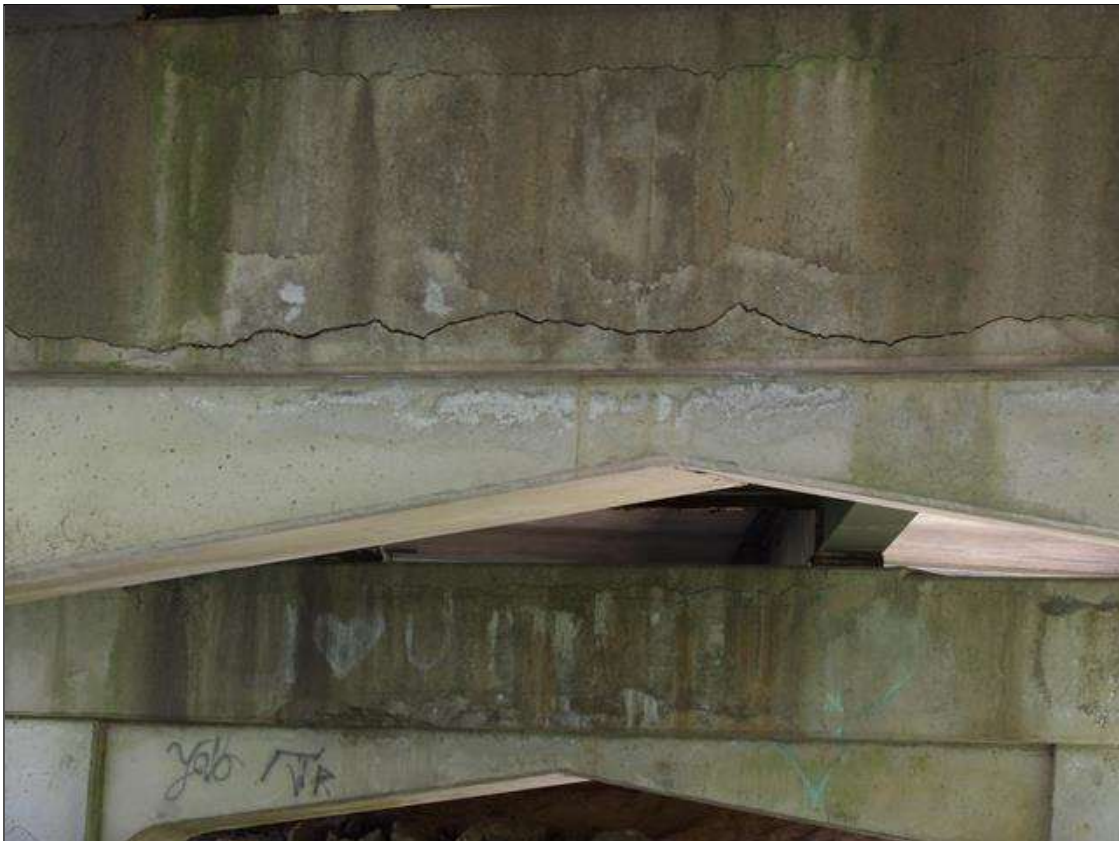
Bent 2 Cap 1: 31 FEET OF UP TO 3/8 INCHES LONGITUDINAL AND HORIZONTAL CRACKS WITH AND WITHOUT EFFLORESCENCE AND AREAS OF DELAMINATION THROUGHOUT TOP, BOTTOM AND SPAN 2 FACE OF CAP

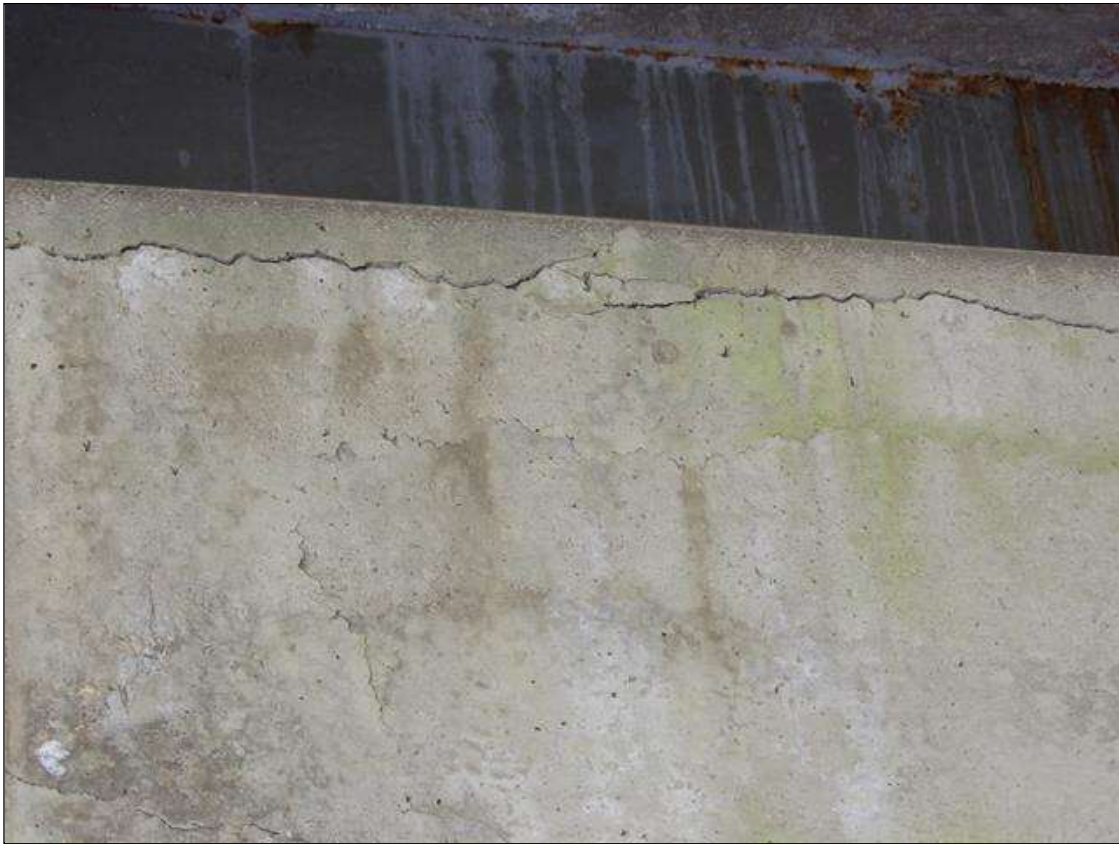
Bent 1 Cap 1: 31 FEET OF UP TO 1/4 INCHES LONGITUDINAL AND HORIZONTAL CRACKS WITH AND WITHOUT EFFLORESCENCE THROUGHOUT TOP, BOTTOM AND SPAN 2 FACE OF CAP

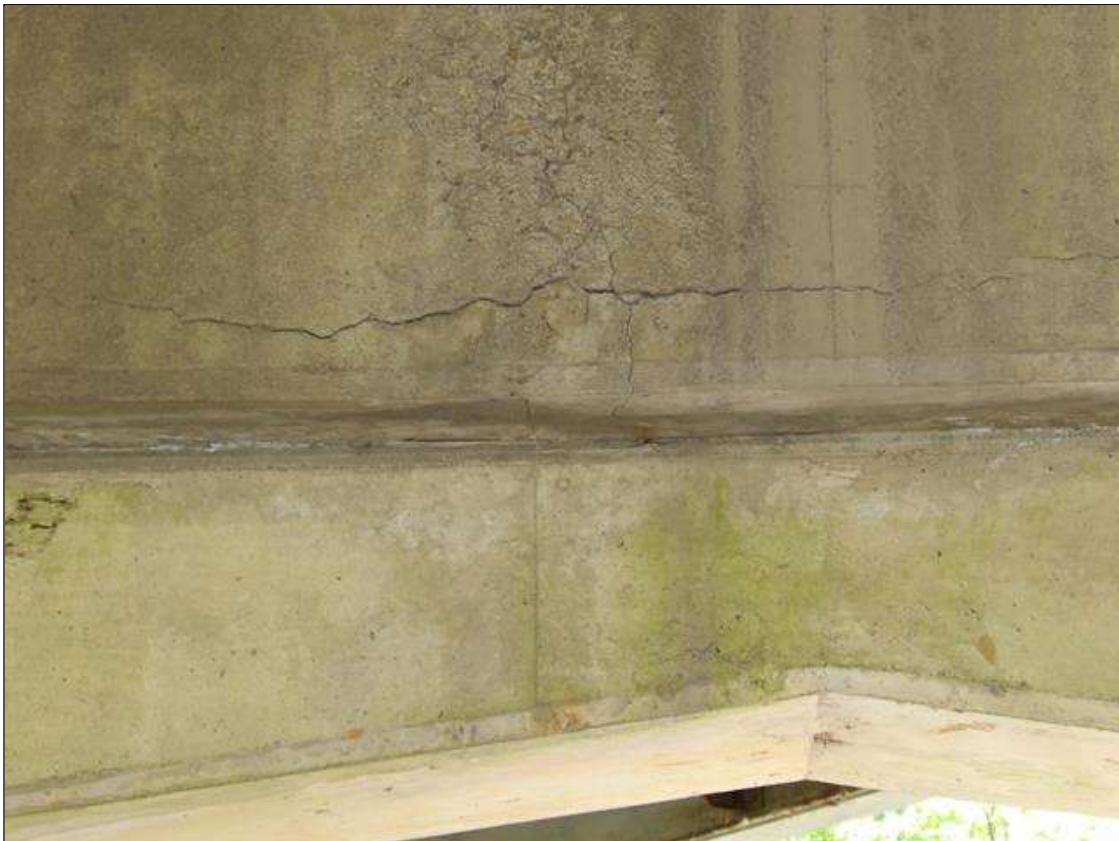
Bent 1 Cap 1: 41 INCHES X 6 INCHES X 14 INCHES AREA OF DELAMINATION WITH UP TO 1/16 INCHES HORIZONTAL AND VERTICAL CRACKS IN BOTTOM AND SPAN 1 FACE OF CAP AT MID LENGTH

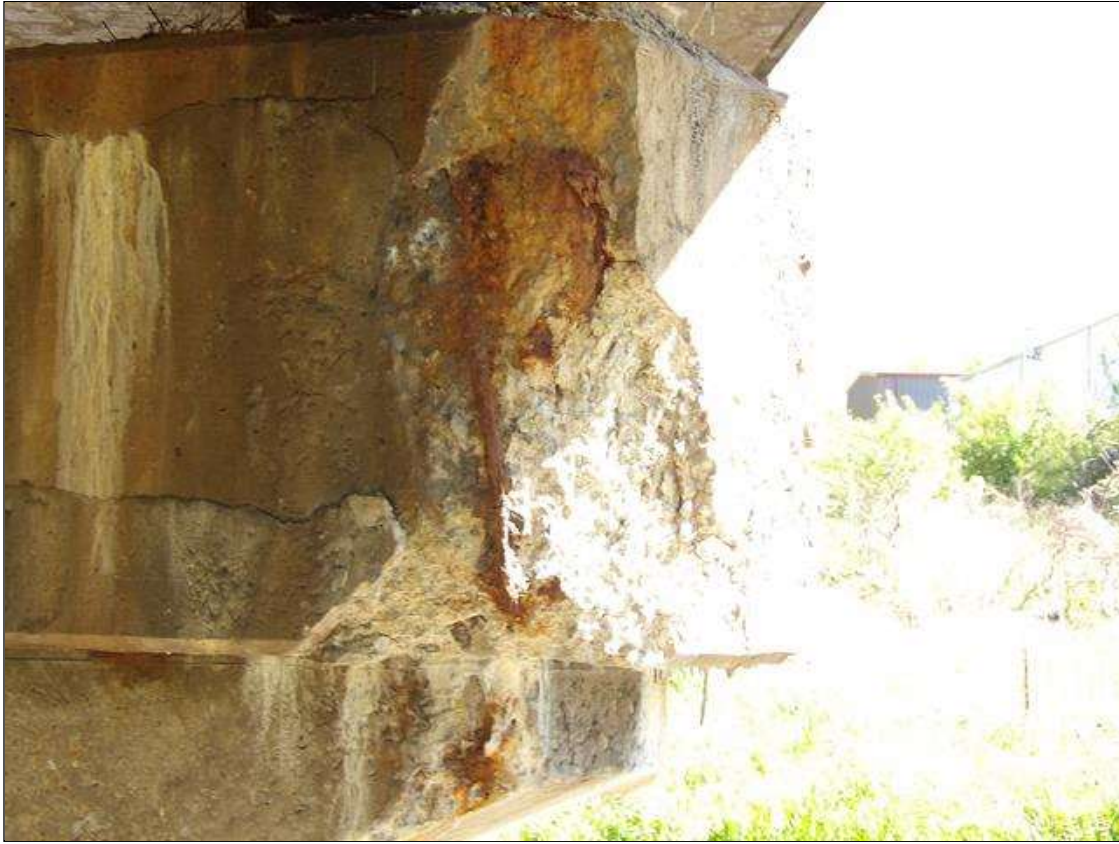
Bent 1 Cap 1: PAR: 30 INCHES X 12 INCHES X 6 INCHES DEEP SPALL WITH EXPOSED REBAR WITH SECTION LOSS IN SPAN 1 FACE OF CAP AT RIGHT END

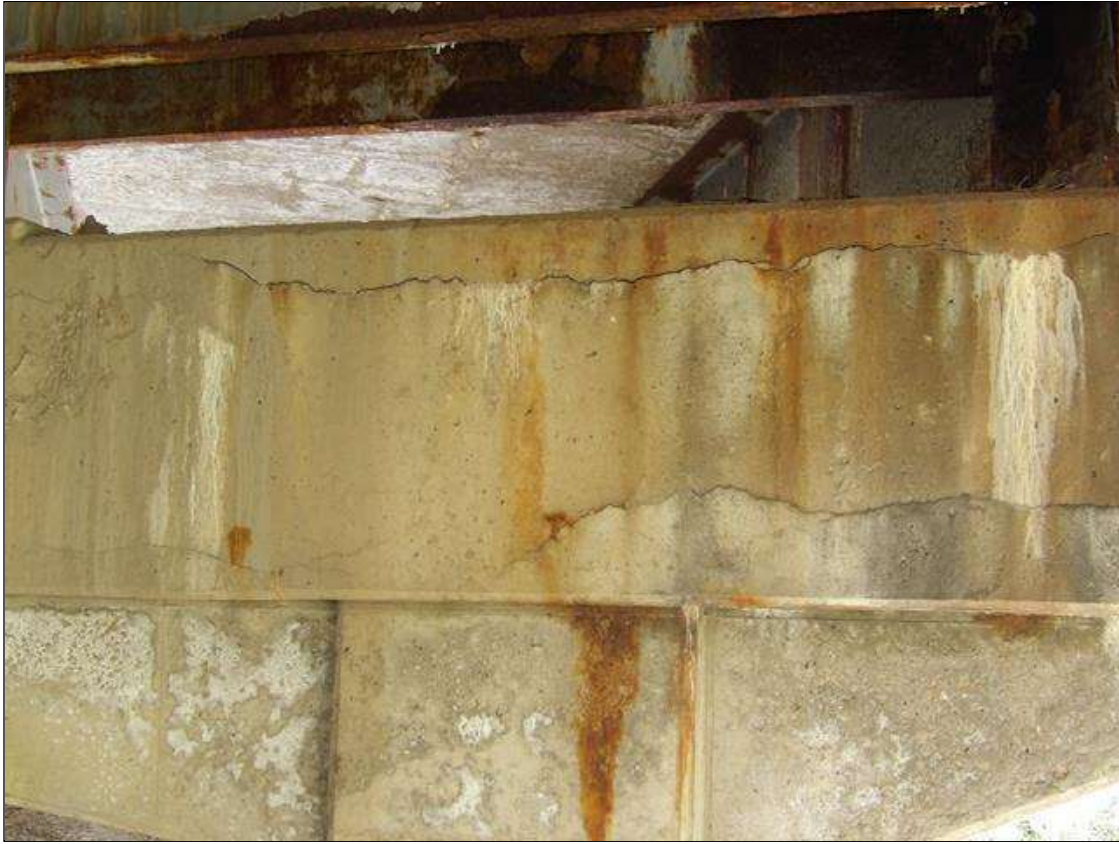
Bent 1 Cap 1: UP TO 3/8 INCHES LONGITUDINAL AND HORIZONTAL CRACKS WITH AND WITHOUT EFFLORESCENCE AND AREAS OF DELAMINATION THROUGHOUT TOP, BOTTOM AND SPAN 1 FACE OF CAP FROM BEAM 3 TO RIGHT END

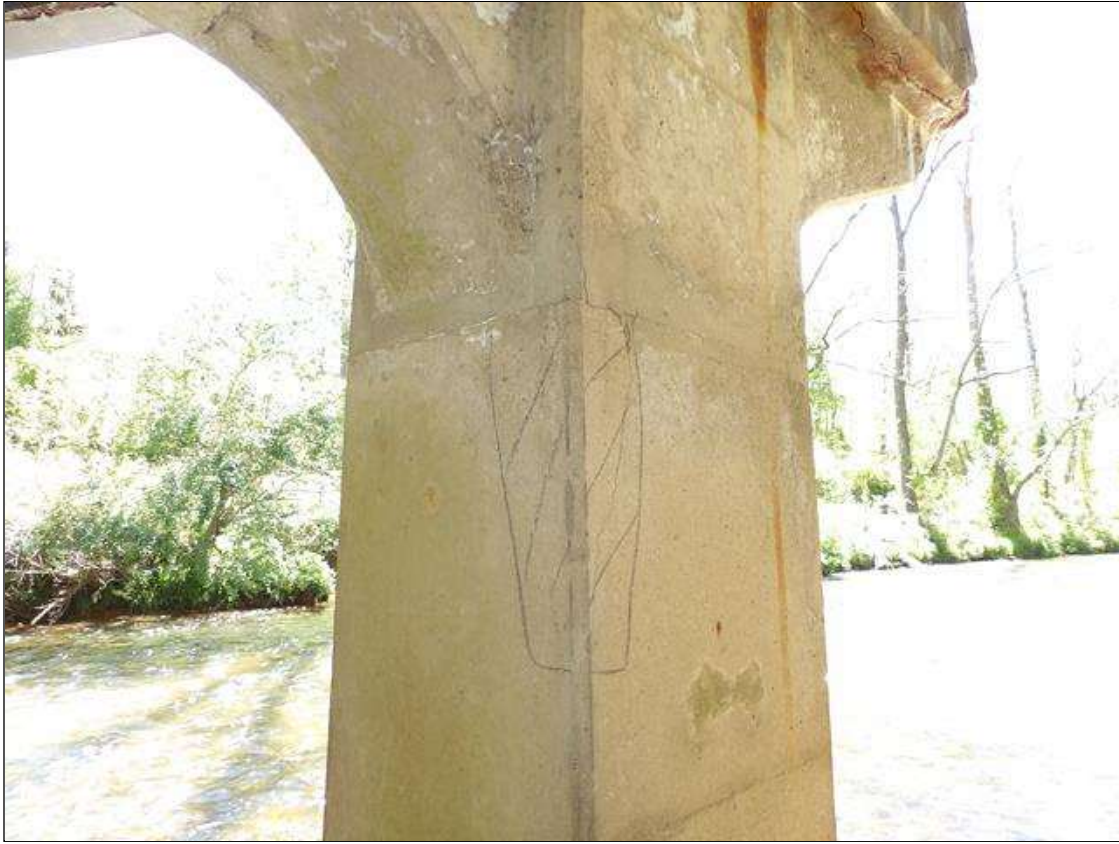
Bent 1 Pile 2: 33 INCHES X 6 INCHES X 9 INCHES AREA OF DELAMINATION WITH UP TO 1/16 INCHES VERTICAL CRACKS IN SOUTHWEST CORNER OF COLUMN, APPROXIMATELY 3 FEET FROM BOTTOM OF CAP

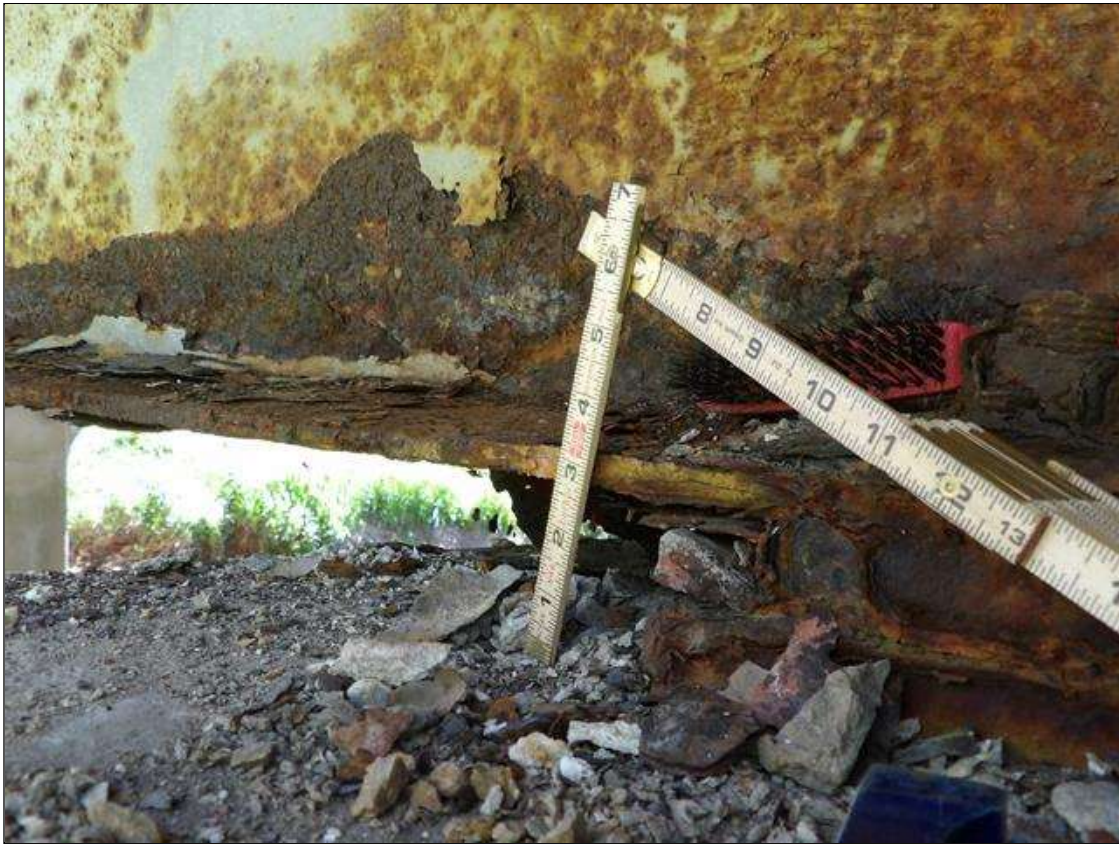
Span 2 Beam 1: PAR: CORROSION ALONG BOTH FACES OF WEB AND BOTTOM FLANGE UP TO 36 INCHES LONG X 6 INCHES HIGH DOWN TO 1/2 INCHES RESIDUAL WEB, AND 36 INCHES LONG X 11 1/2 INCHES WIDE DOWN TO 7/16 INCHES RESIDUAL FLANGE AT BENT 1
