NC DEPARTMENT OF TRANSPORTATION  
 DIVISION OF HIGHWAYS  
 STRUCTURE MANAGEMENT UNIT

ATTENTION: **PRIORITY ACTION REQUEST ISSUED**

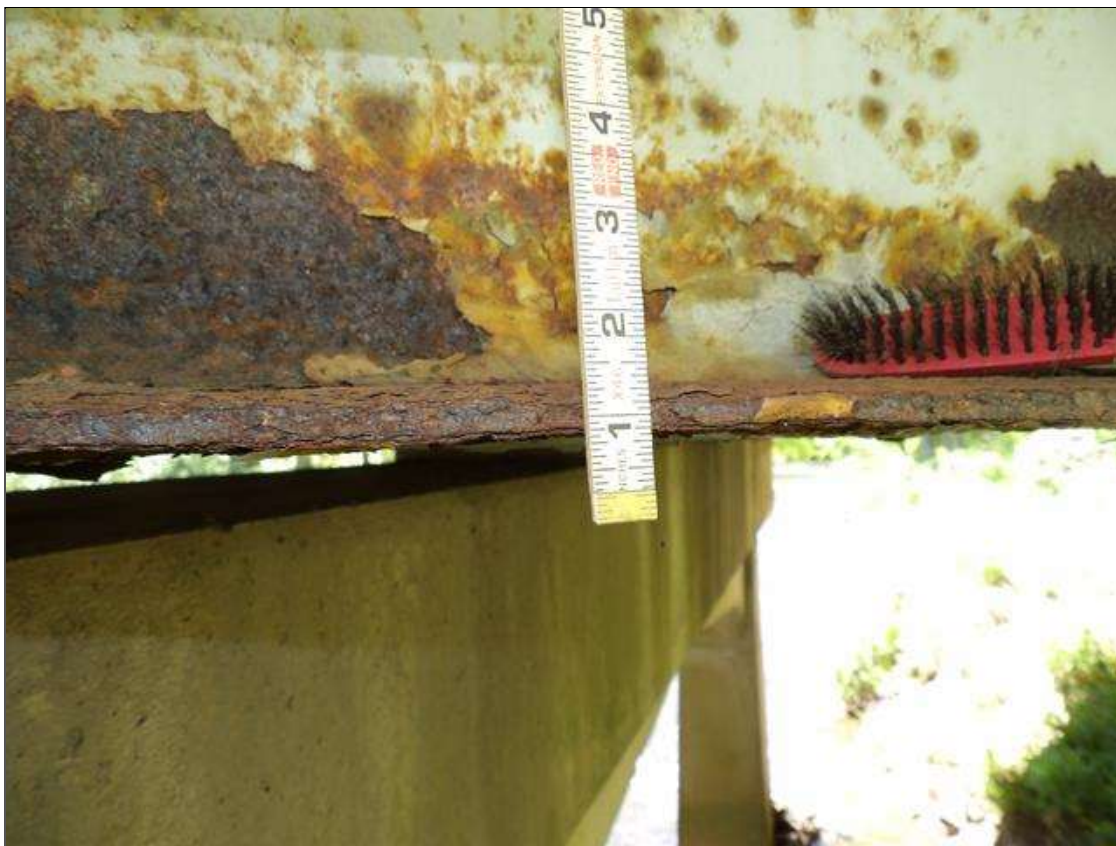
Span 1 Beam 1: PAR: CORROSION ALONG BOTH FACES OF WEB AND BOTTOM FLANGE UP TO 29 INCHES LONG X 10 INCHES HIGH DOWN TO 1/2 INCHES RESIDUAL WEB, AND 30 INCHES LONG X 11 1/2 INCHES WIDE DOWN TO 3/8 INCHES RESIDUAL FLANGE AT BENT 1

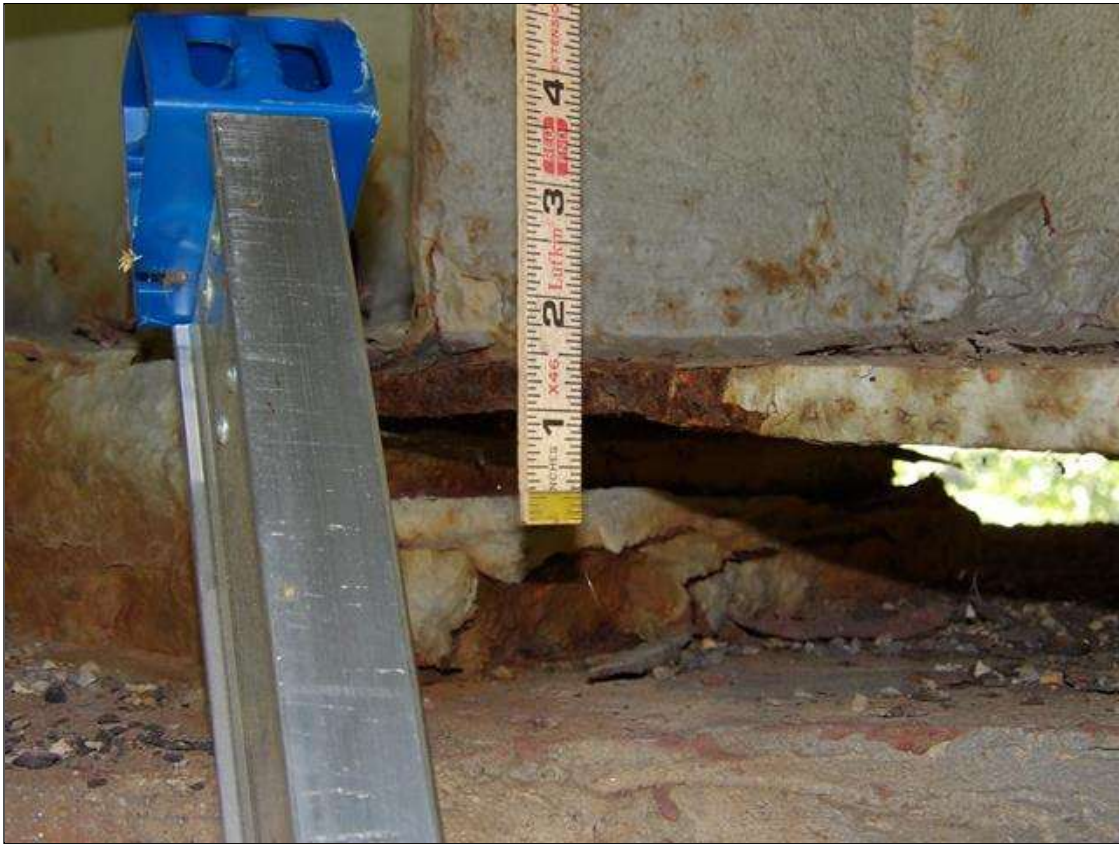
Span 1 Beam 2: PAR: CORROSION ALONG BOTTOM FLANGE 8 INCHES LONG X 11 1/2 INCHES WIDE DOWN TO 3/8 INCHES RESIDUAL THICKNESS AT BENT 1

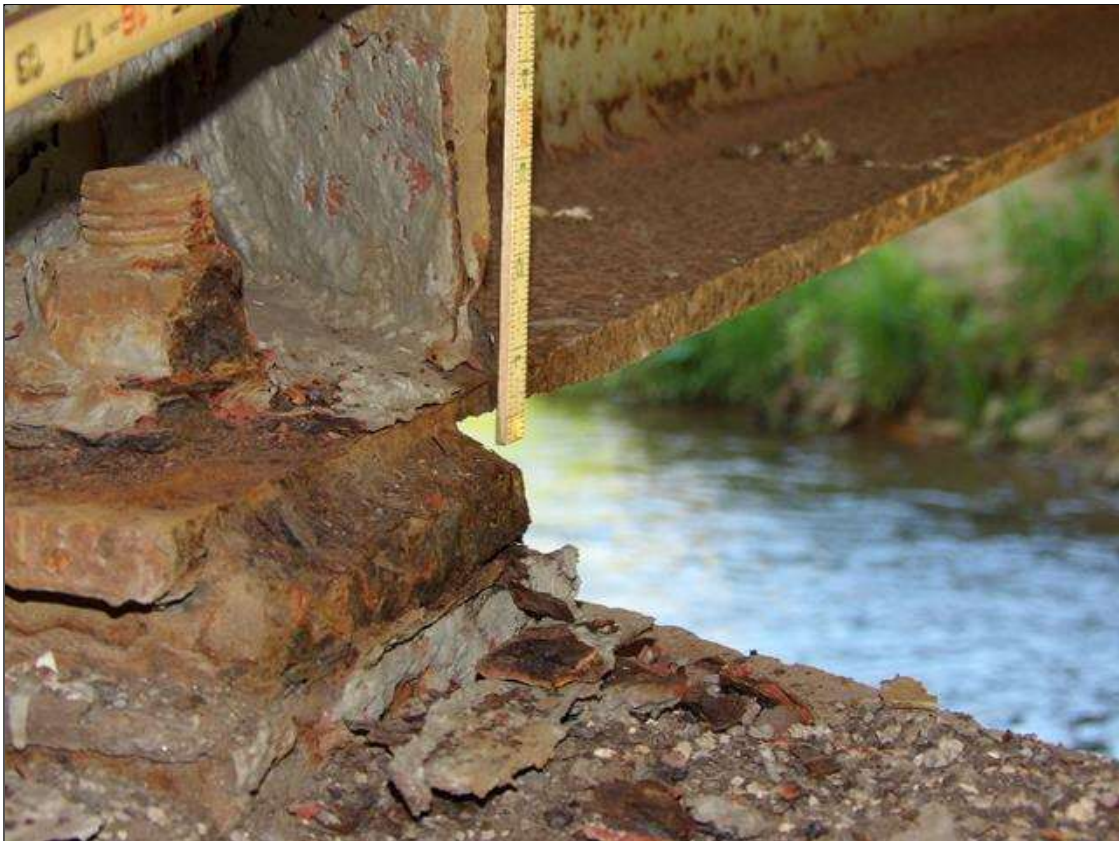
Span 2 Beam 2: PAR: CORROSION ALONG BOTTOM FLANGE 10 INCHES LONG X 11 1/2 INCHES WIDE DOWN TO 5/16 INCHES RESIDUAL THICKNESS ON RIGHT SIDE AT BENT 1

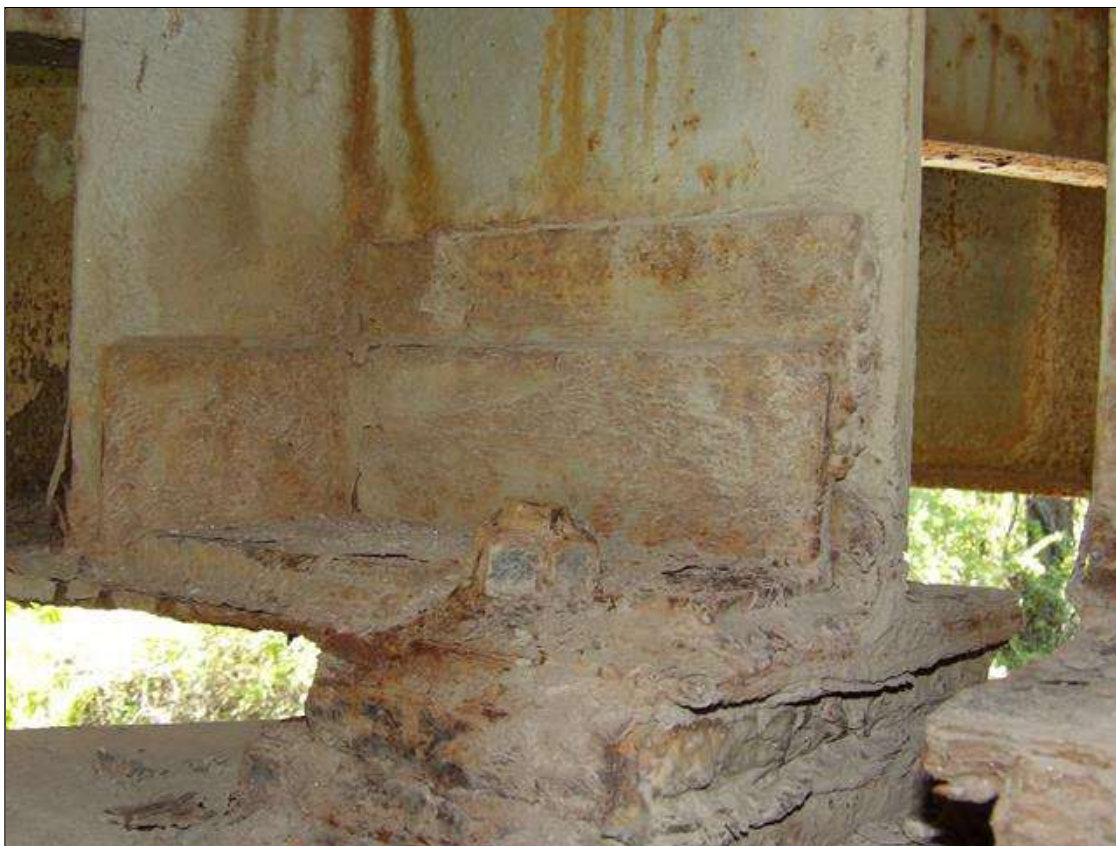
SPAN 2 BEAM 3--WELDED REPAIR PLATE LEFT SIDE AT PIER 1 BOTTOM FLANGE ANGLE 12 INCH LONG X 4 INCH X 4 INCH X 1/2 INCH, WEB 12 INCH LONG X 6 INCH HIGH X 1/4 INCH , STIFFNER 4 INCH X 4 INCH X 1/2 AT BOTTOM

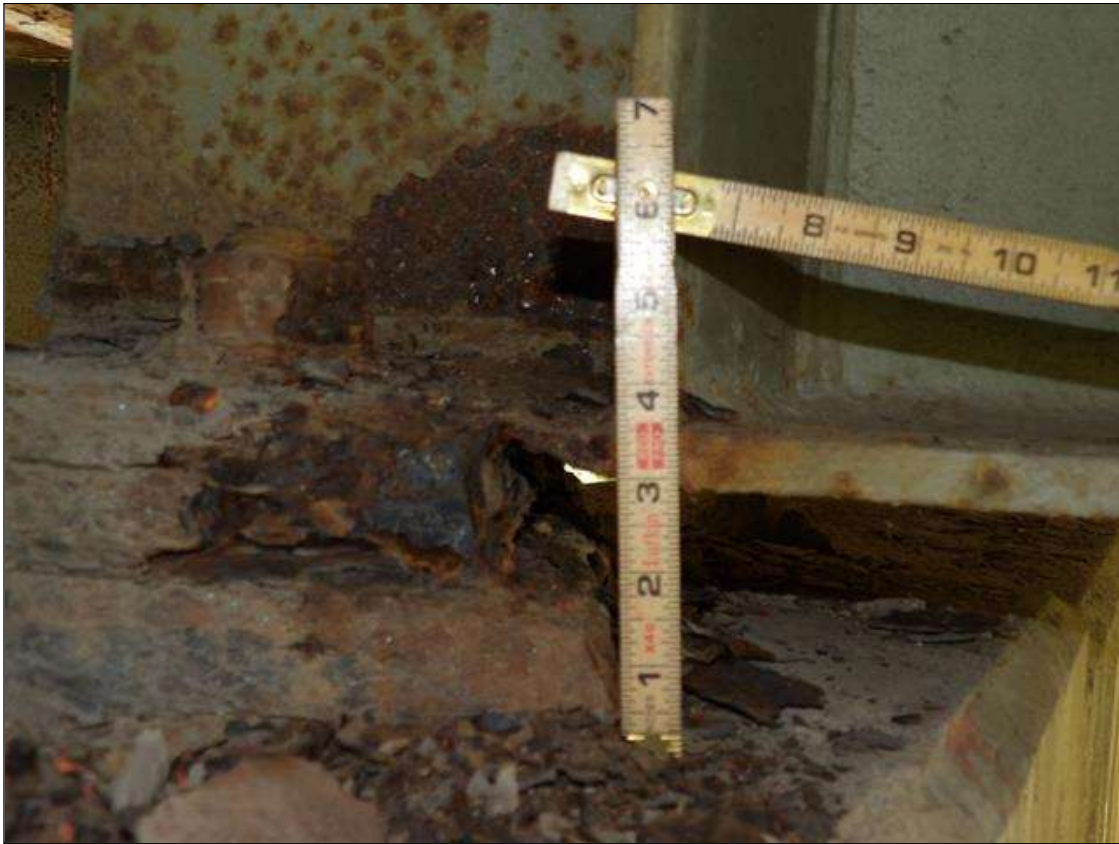
Span 1 Beam 3: PAR: CORROSION ALONG BOTH FACES OF WEB AND BOTTOM FLANGE UP TO 10 INCHES LONG X 6 INCHES HIGH DOWN TO 1/2 INCHES RESIDUAL WEB, WEB HAS A 1 INCH X 1/16 INCH PERFORATION OVER BEARING AND 9 INCHES LONG X 11 1/2 INCHES WIDE DOWN TO 1/4 INCHES RESIDUAL FLANGE WITH 1/4 INCH VERTICAL DEFORMATION IN BOTTOM FLANGE AT BEARING PLATE AT BENT 1

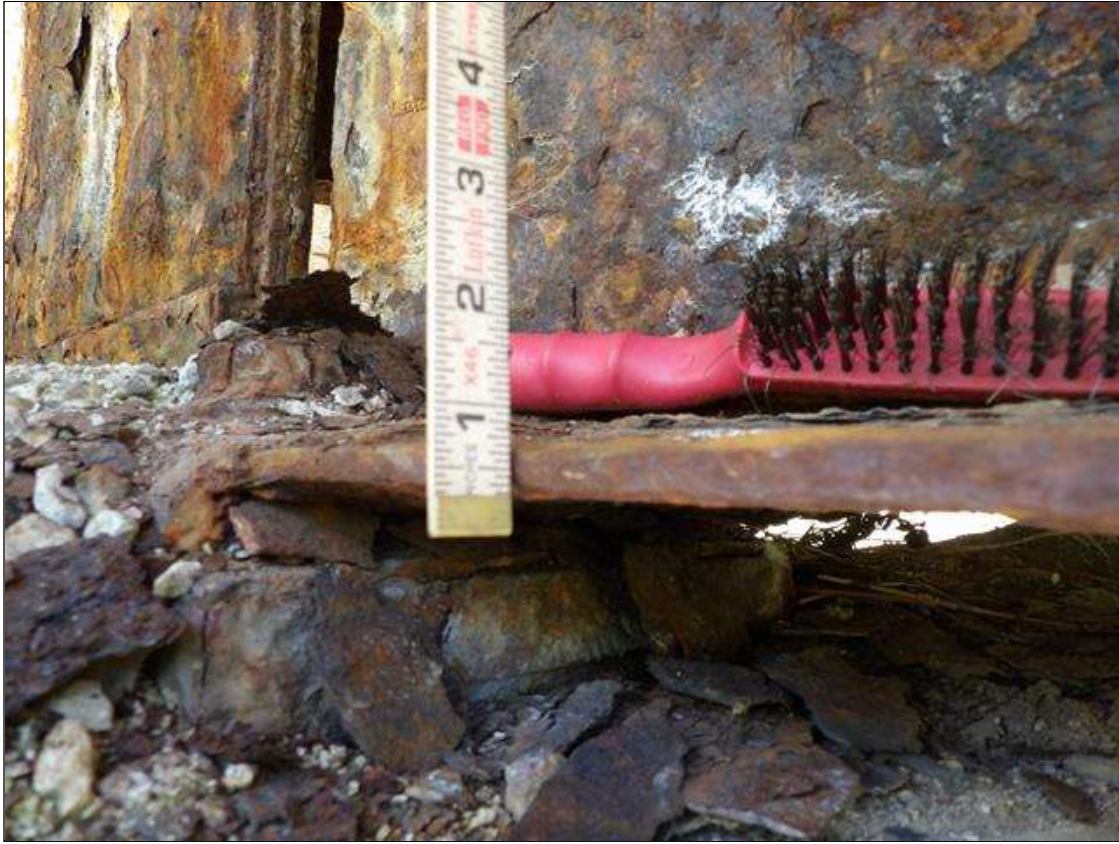
Span 2 Beam 4: PAR: CORROSION ALONG BOTH FACES OF WEB AND BOTTOM FLANGE UP TO 6 FEET LONG X 31 1/2 INCHES HIGH DOWN TO 1/2 INCHES RESIDUAL WEB, AND 6 FEET LONG X 11 1/2 INCHES WIDE DOWN TO 5/16 INCHES RESIDUAL FLANGE AT BENT 1

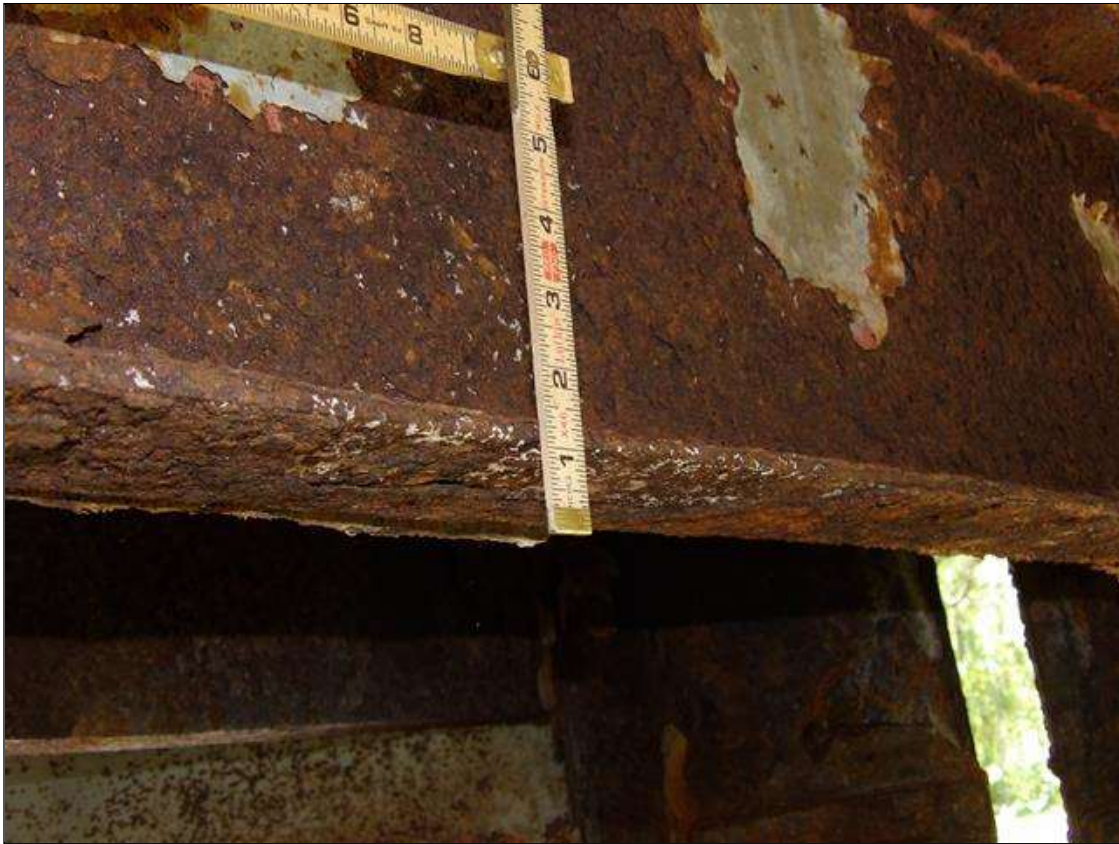
Span 1 Beam 4: PAR: CORROSION THROUGHOUT BENT 1 DIAPHRAGM UP TO 6 FEET LONG X 14 INCHES HIGH DOWN TO 1/4 INCHES RESIDUAL WEB, AND 6 FEET LONG X 3 1/2 INCHES WIDE DOWN TO 1/4 INCHES RESIDUAL FLANGES IN BAY 3

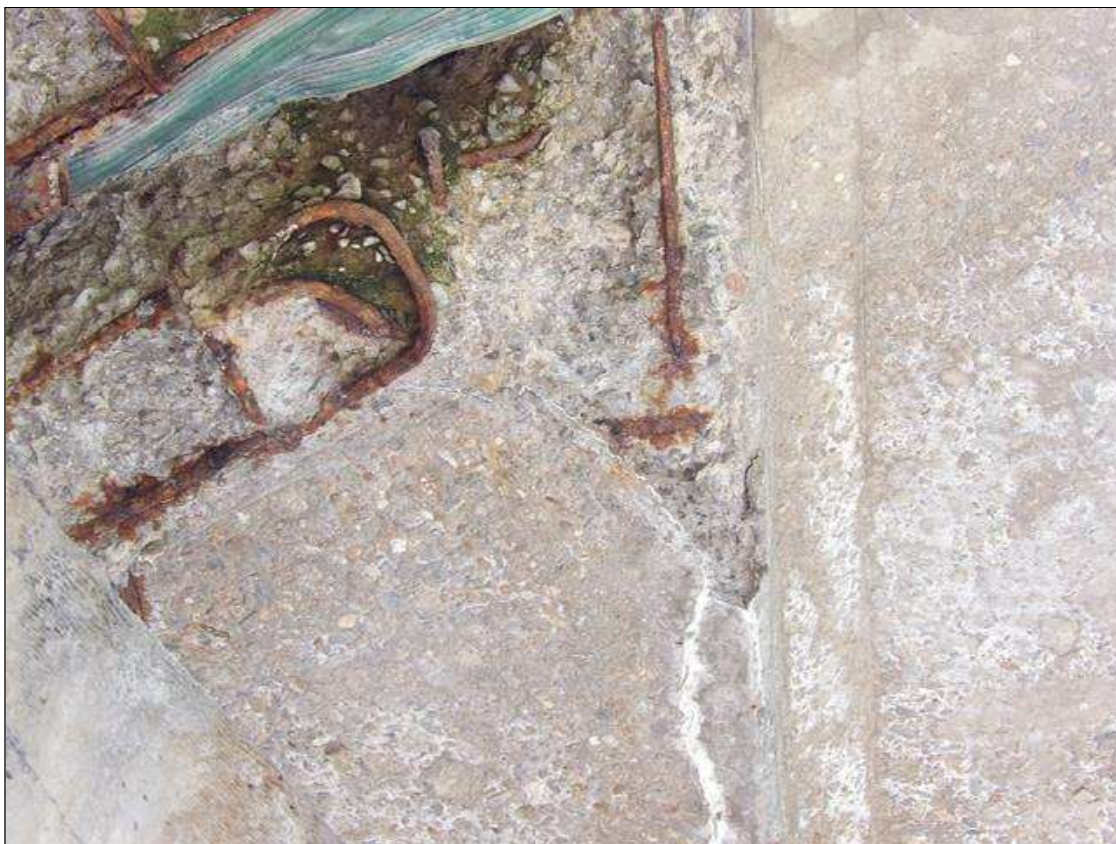
Span 2 Deck: PAR: 26 INCHES X 14 INCHES X 4 INCHES DEEP SPALL WITH EXPOSED REBAR WITH MINOR LOSS IN BOTTOM OF RIGHT OVERHANG ABOVE BENT 1

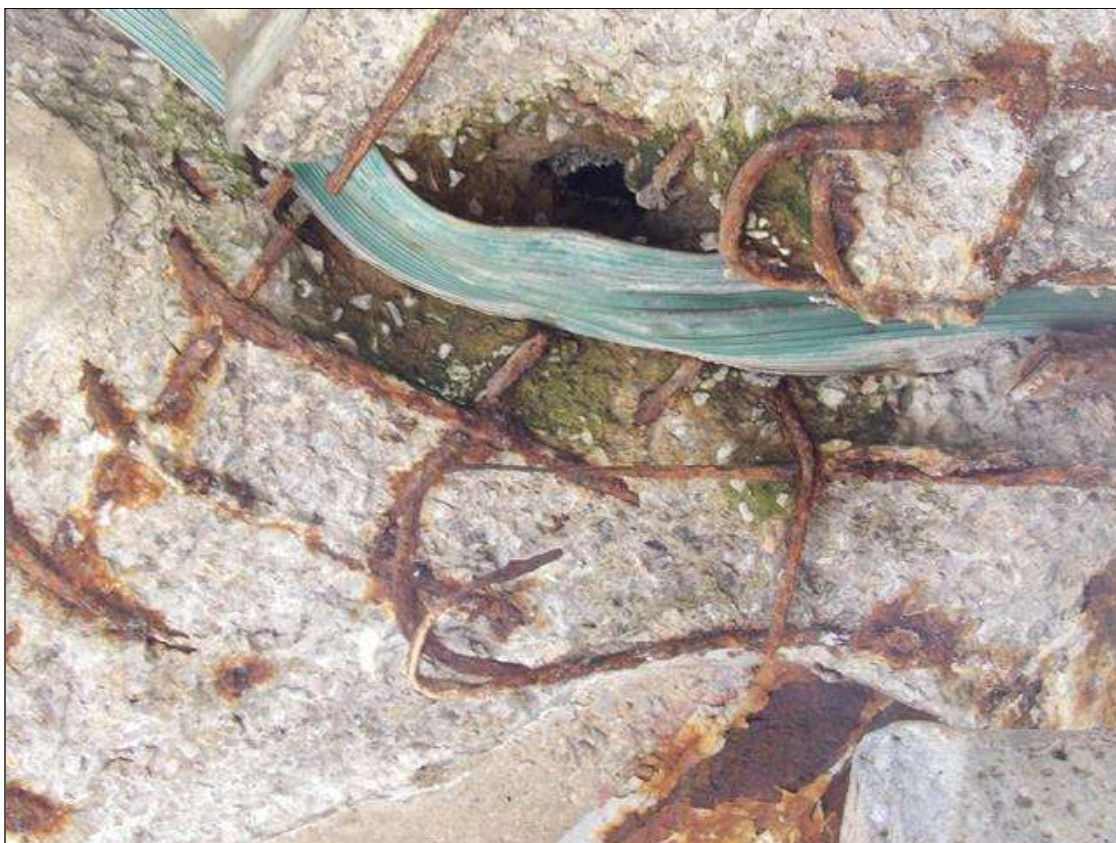
PAR--SPAN 1 BENT 1 RIGHT OVERHANG DIAPHRAGM, SPALL 1 FEET LONG X 2 FEET WIDE X FULL DEPTH WITH EXPOSED REBAR WITH 70 PERCENT SECTION LOSS

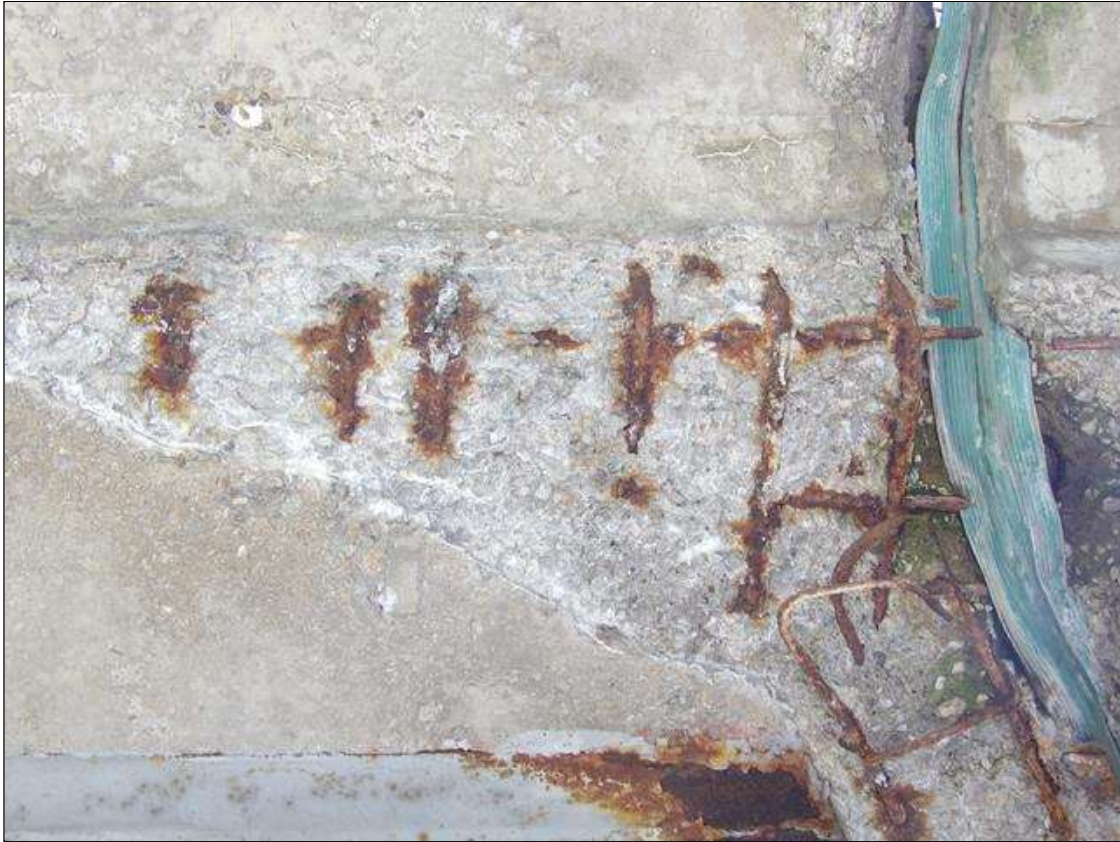
Span 1 Deck: PAR: 53 INCHES X 21 INCHES X 4 INCHES DEEP SPALL WITH EXPOSED REBAR MINOR LOSS IN BOTTOM OF RIGHT OVERHANG ABOVE BENT 1

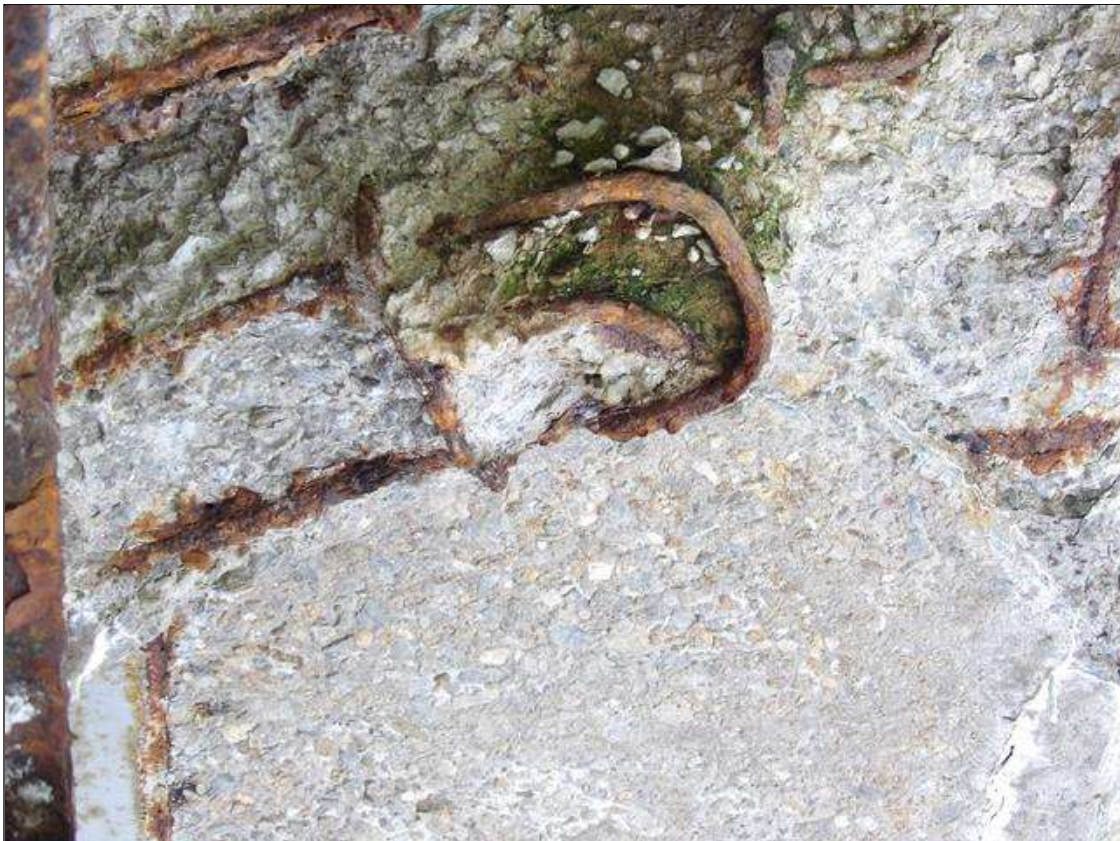
PAR-- SPAN 2 BENT 1 RIGHT OVERHANG DIAPHRAGM, SPALL 1 FEET LONG X 2 FEET WIDE X FULL DEPTH WITH EXPOSED REBAR WITH 60 PERCENT SECTION LOSS

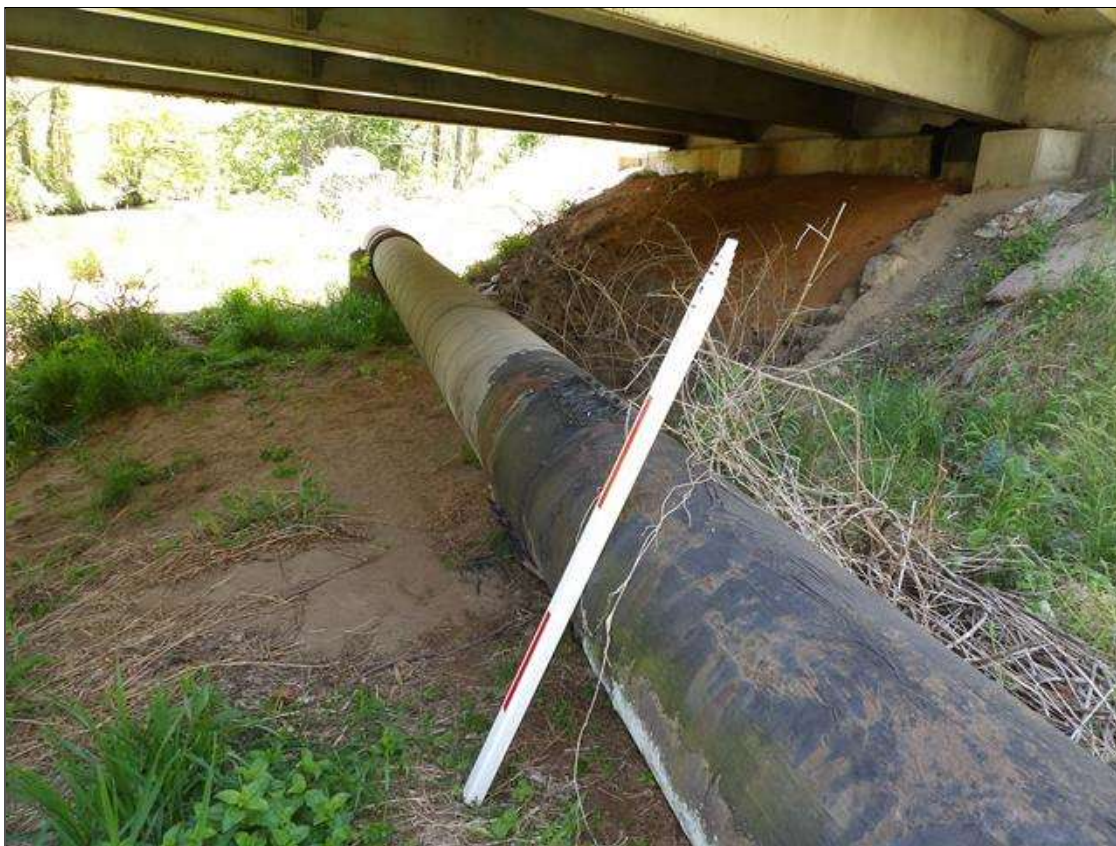
UTILITY UNDER SPAN 1 NOT ATTACHED TO BRIDGE

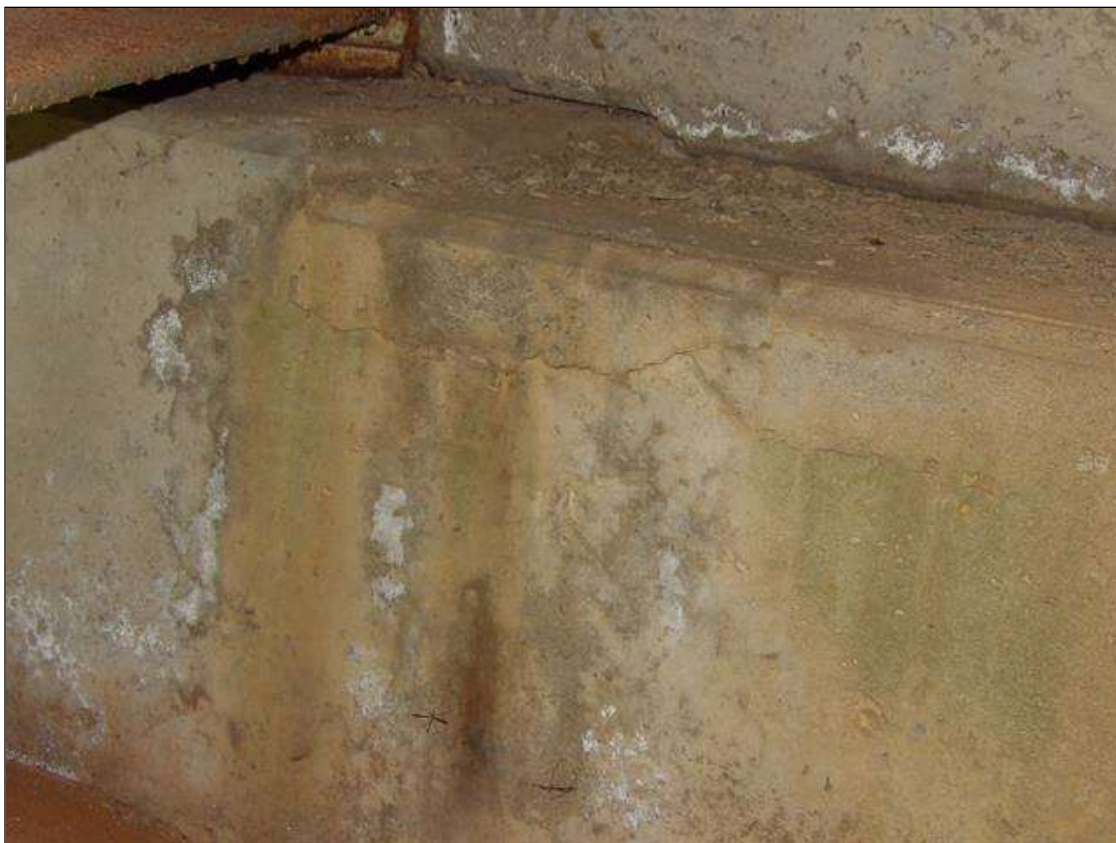
End Bent 1 Cap 1: UP TO 1/16 INCHES HORIZONTAL CRACK IN FACE OF CAP TO LEFT OF BEAM 2

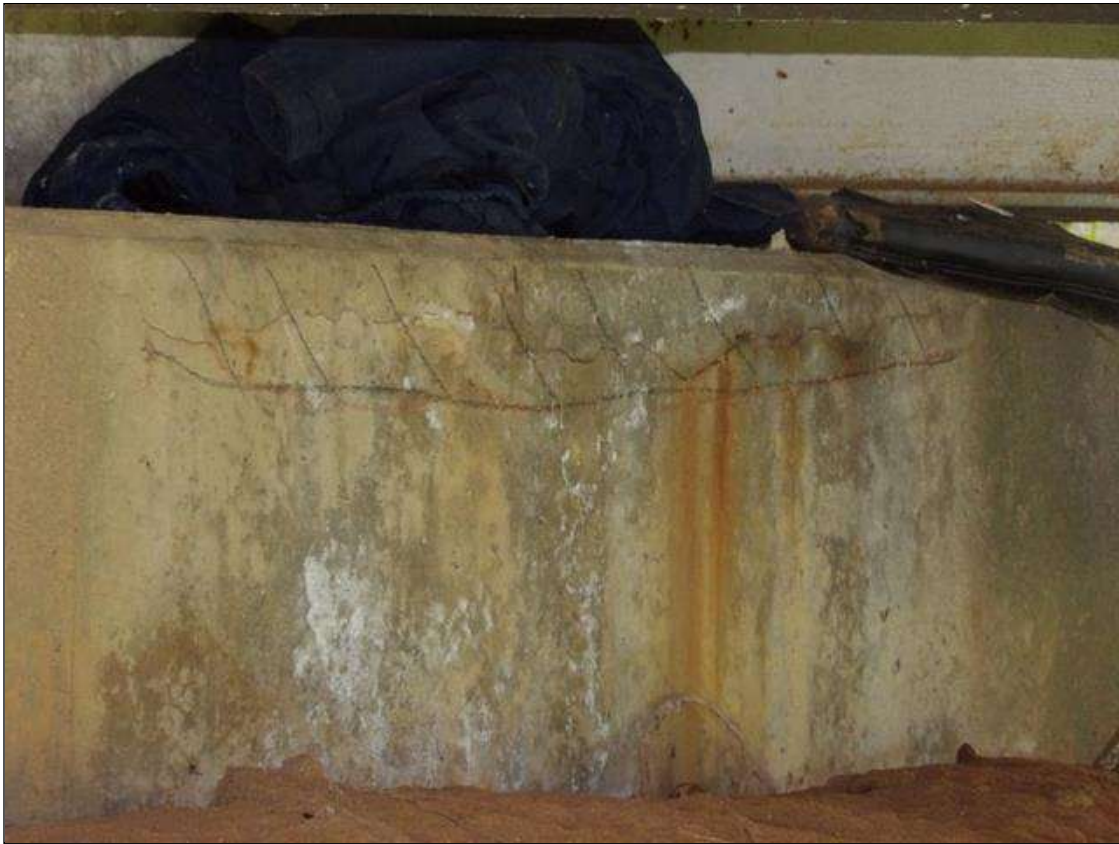
End Bent 1 Cap 1: 55 INCHES X 11 INCHES X 7 INCHES AREA OF DELAMINATION WITH UP TO 1/4 INCHES LONGITUDINAL AND HORIZONTAL CRACKS WITH RUST STAINING IN TOP AND FACE OF CAP BENEATH BAY 1

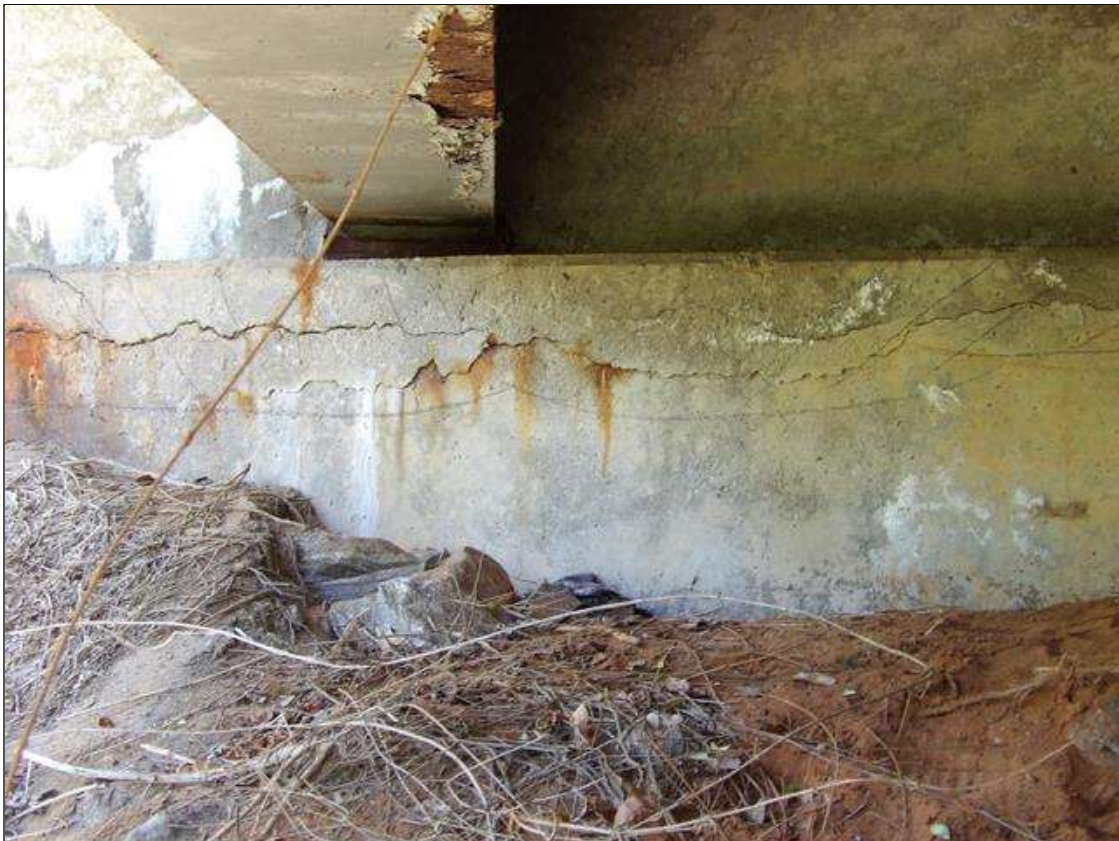
End Bent 1 Cap 1: 10 FEET X 9 INCHES X 13 INCHES AREA OF DELAMINATION WITH UP TO 1/4 INCHES LONGITUDINAL AND HORIZONTAL CRACKS IN TOP AND FACE OF CAP BENEATH BEAM 4 AND BAY 3

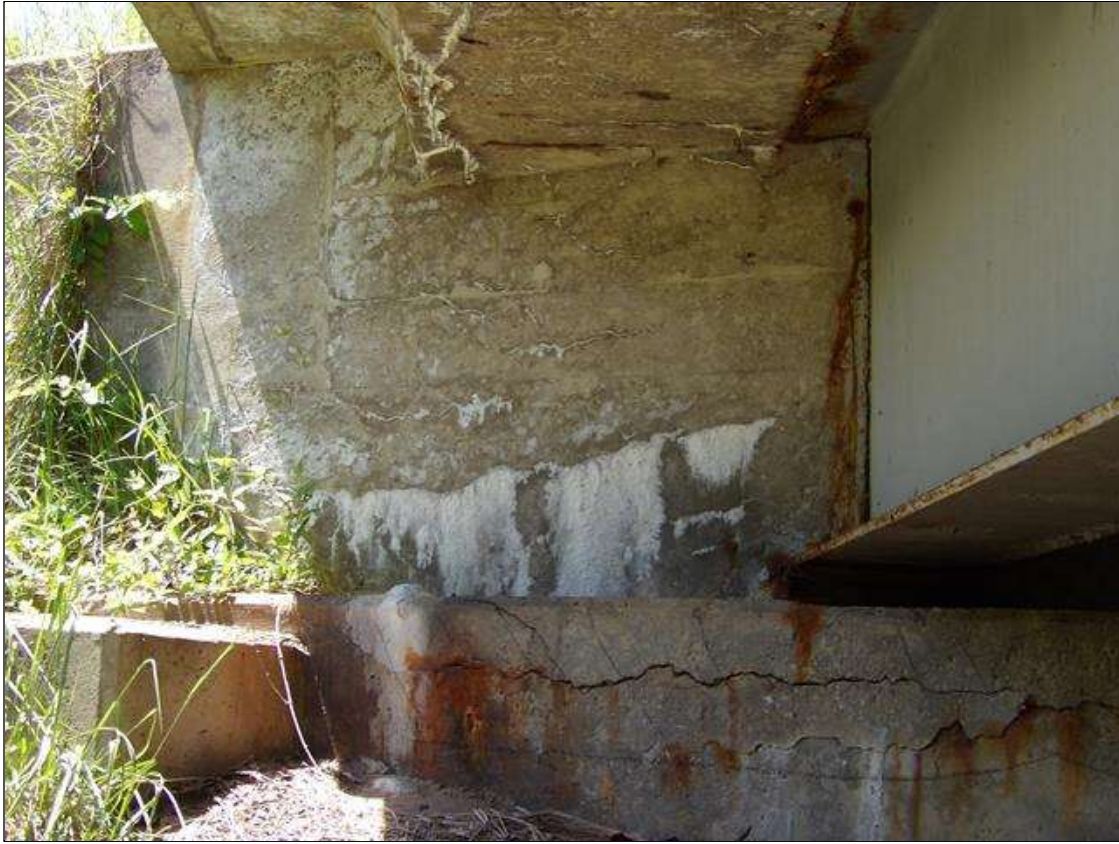
End Bent 1 Abutment: 57 INCHES X 42 INCHES AREA OF HAIRLINE HORIZONTAL AND MAP CRACKS WITH EFFLORESCENCE IN FACE OF CURTAIN WALL AT RIGHT END

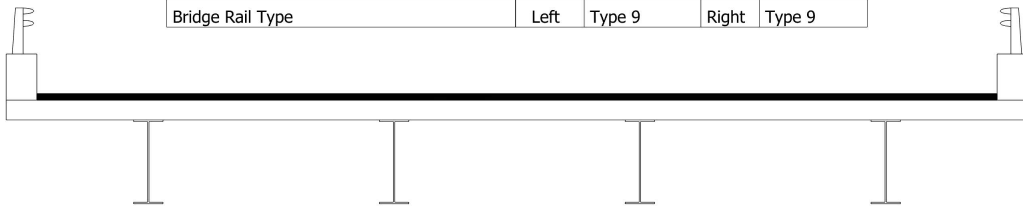
Measurements for Span #	1		
Deck Thickness	7.75in	Left Overhang	4.625ft
Top of Rail to Bottom of Beam (Avg)	6.375ft	Right Overhang	4.625ft
