NC DEPARTMENT OF TRANSPORTATION
 DIVISION OF HIGHWAYS
 STRUCTURE MANAGEMENT UNIT

ATTENTION: **PRIORITY ACTION REQUEST ISSUED; CHANGE TO APPROACH ROADWAY DATA**

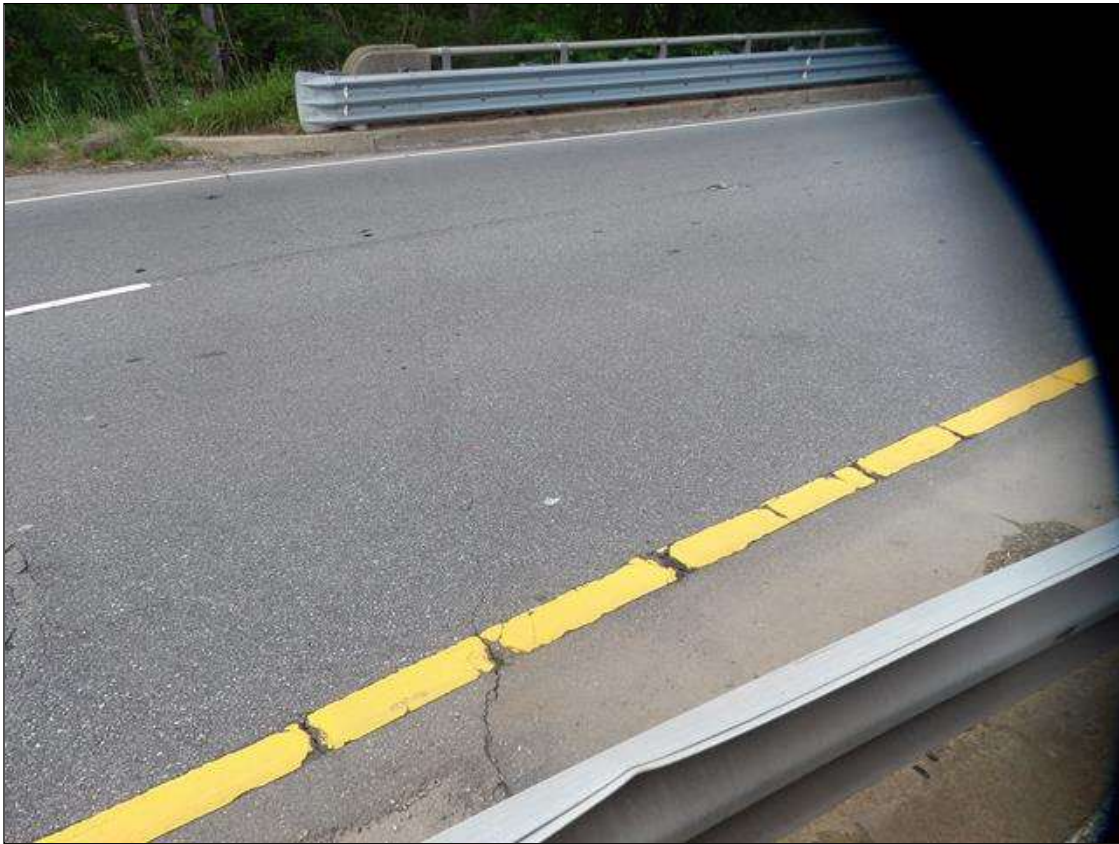
Span 1 Wearing Surface: UP TO 1/32 INCHES DIAGONAL CRACKS ALONG END BENT 1 FILL FACE IN INSIDE LANE

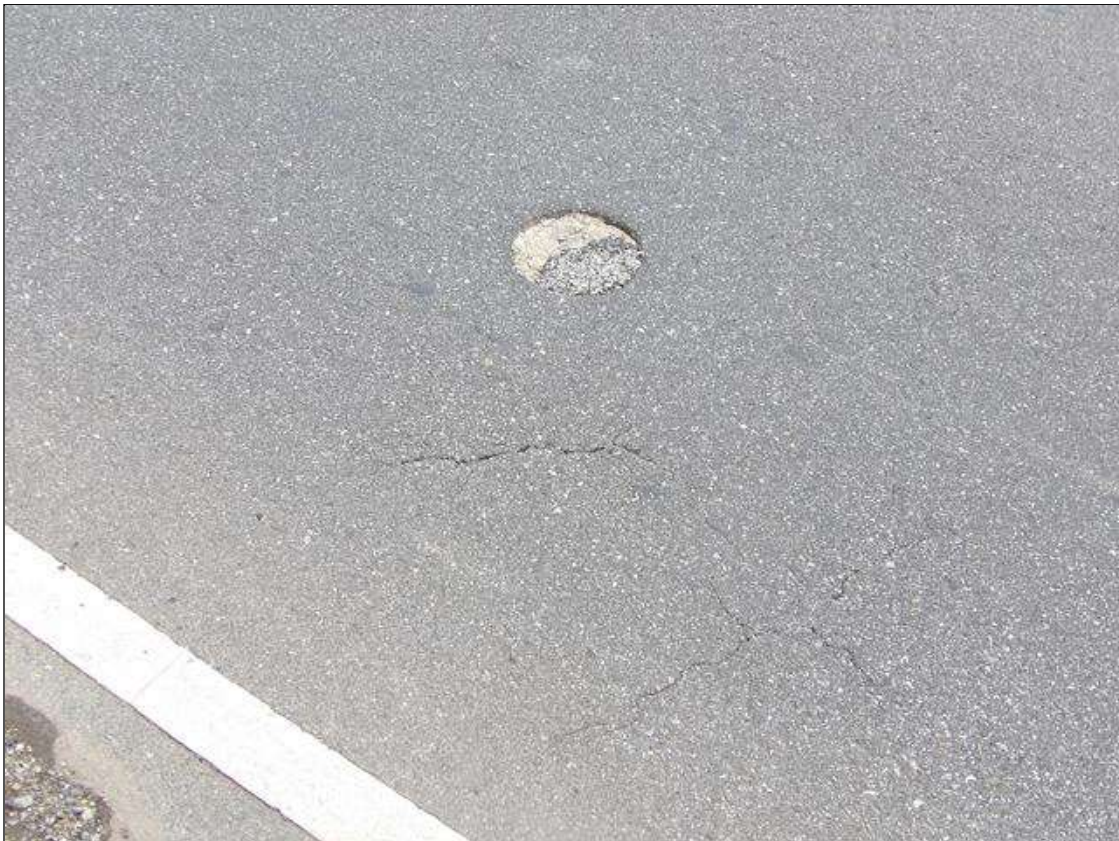
Span 1 Wearing Surface: 8 INCHES DIAMETER PATCHED CORED HOLE IN OUTSIDE LANE, APPROXIMATELY 15 FEET FROM BENT 1

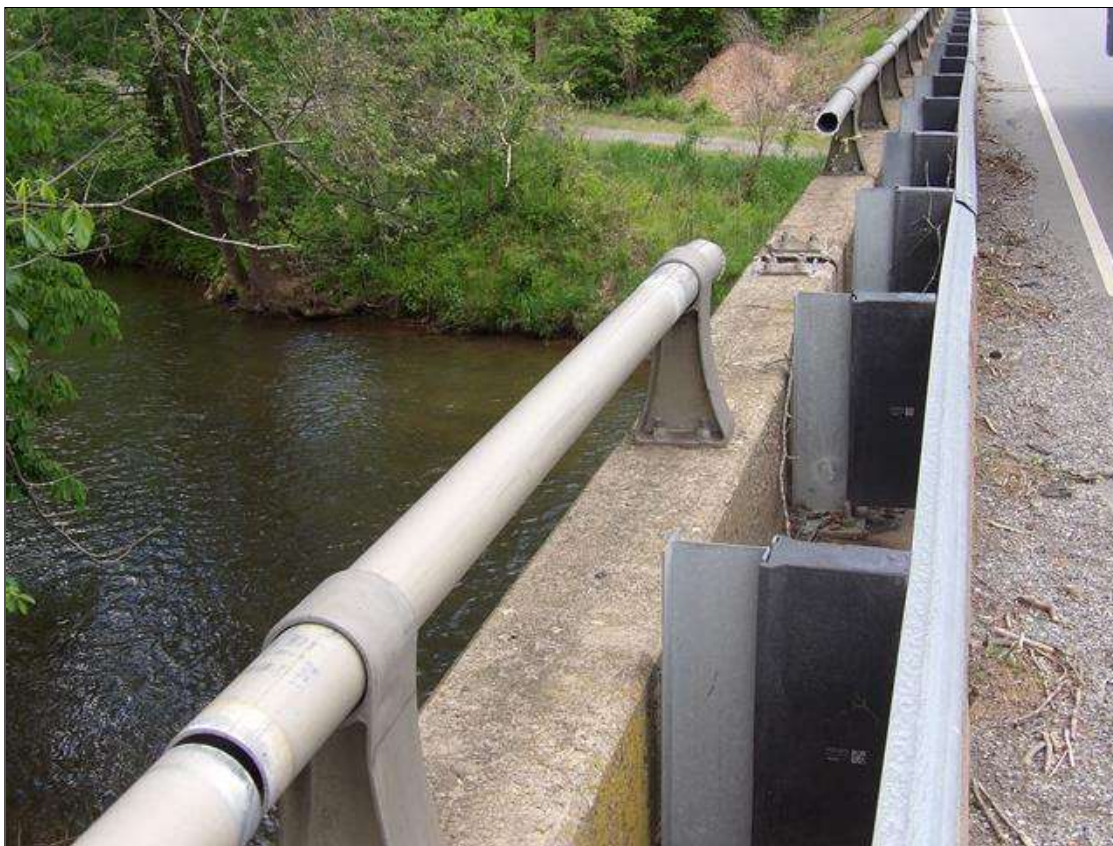
Span 1 Left Bridge Rail: 10 FEET SECTION OF IMPACT DAMAGE WITH MISSING RAIL AND RAIL POST EXTENDING FROM BENT 1; CONDITION MITIGATED WITH ADDITION OF THRIE BEAM METAL RAIL

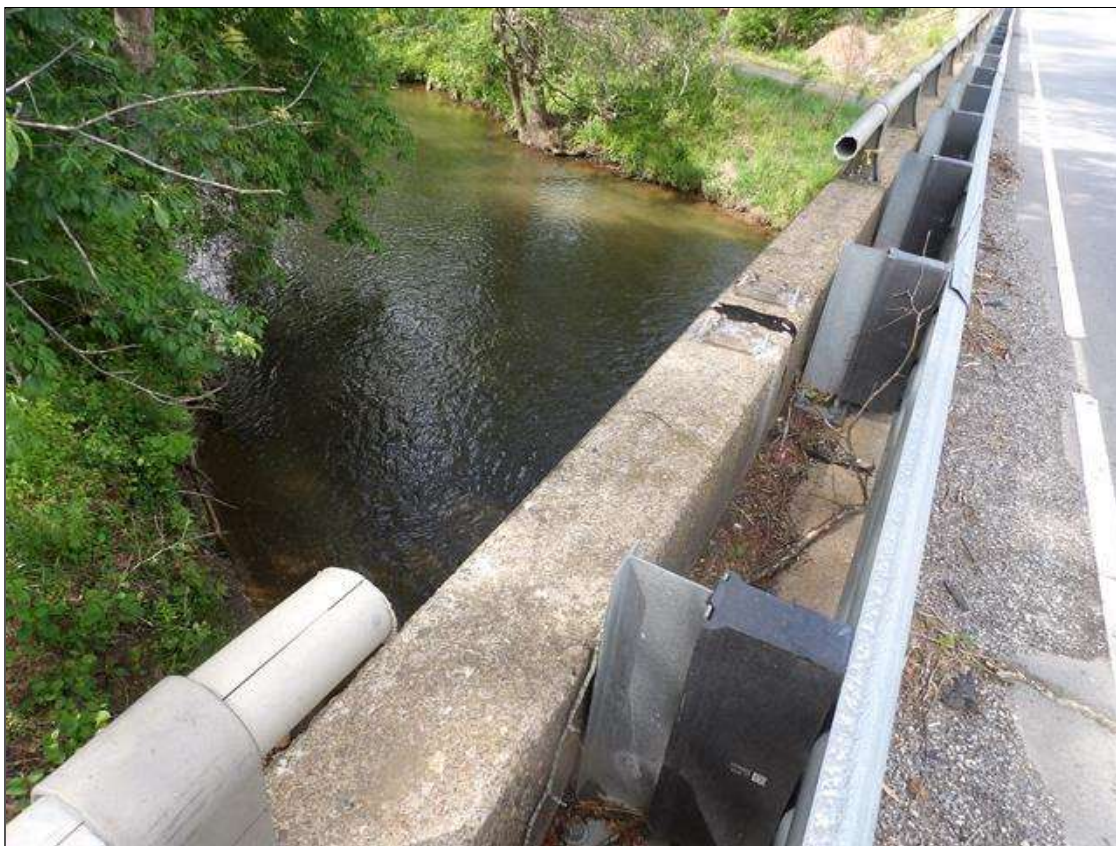
Span 2 Left Bridge Rail: 15 FEET SECTION OF IMPACT DAMAGE WITH SEPARATED, CRACKED AND MISSING RAIL AND RAIL POSTS EXTENDING FROM BENT 1; CONDITION MITIGATED WITH ADDITION OF THREE BEAM METAL RAIL

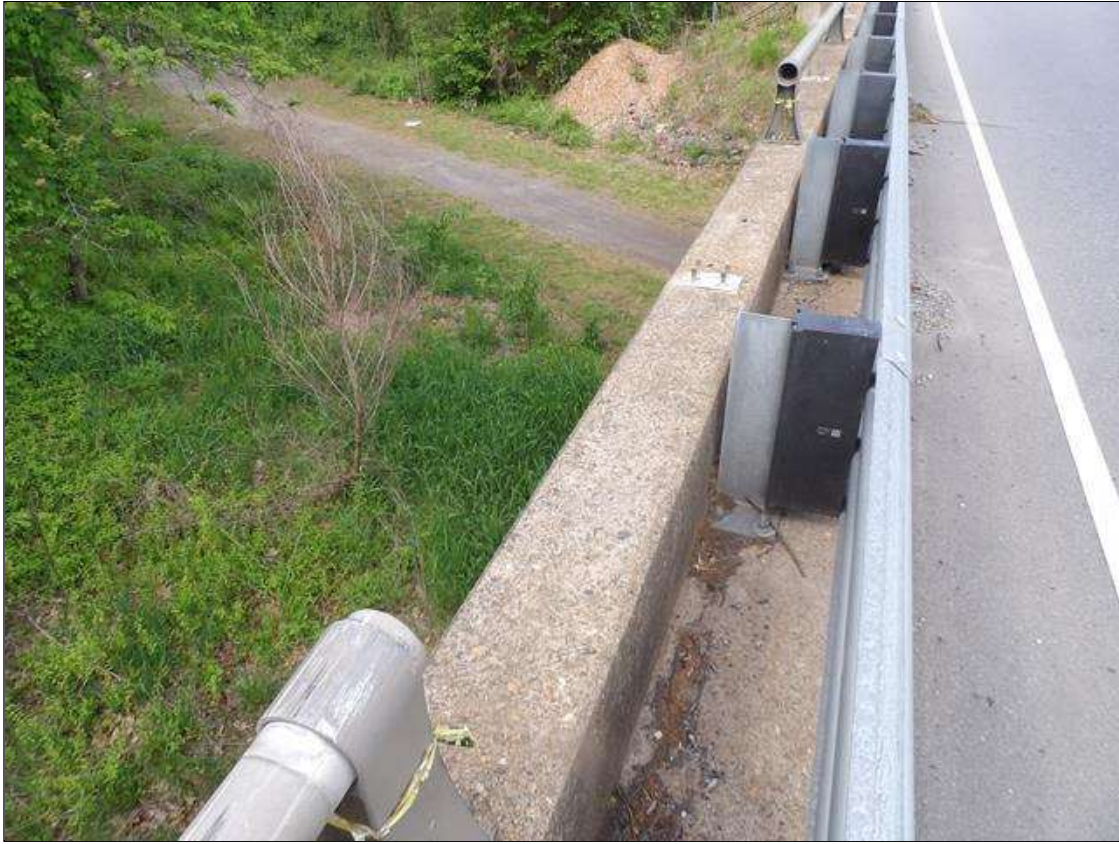
Span 3 Left Bridge Rail: 30 FEET SECTION OF IMPACT DAMAGE WITH SEPARATED, CRACKED AND MISSING RAIL AND RAIL POSTS EXTENDING FROM BENT 3; CONDITION MITIGATED WITH ADDITION OF THREE BEAM METAL RAIL

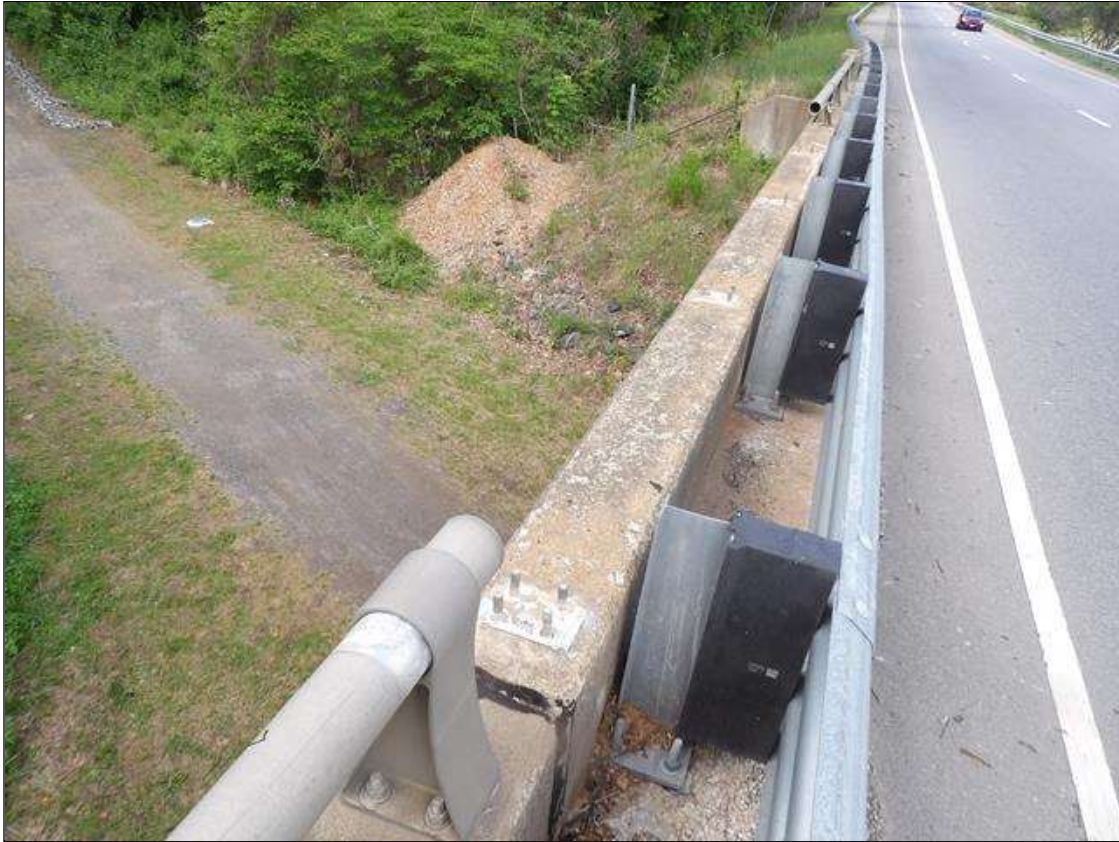
Span 4 Left Bridge Rail: 25 FEET SECTION OF IMPACT DAMAGE WITH MISSING RAIL AND RAIL POSTS EXTENDING FROM BENT 3; CONDITION MITIGATED WITH ADDITION OF THRIE BEAM METAL RAIL

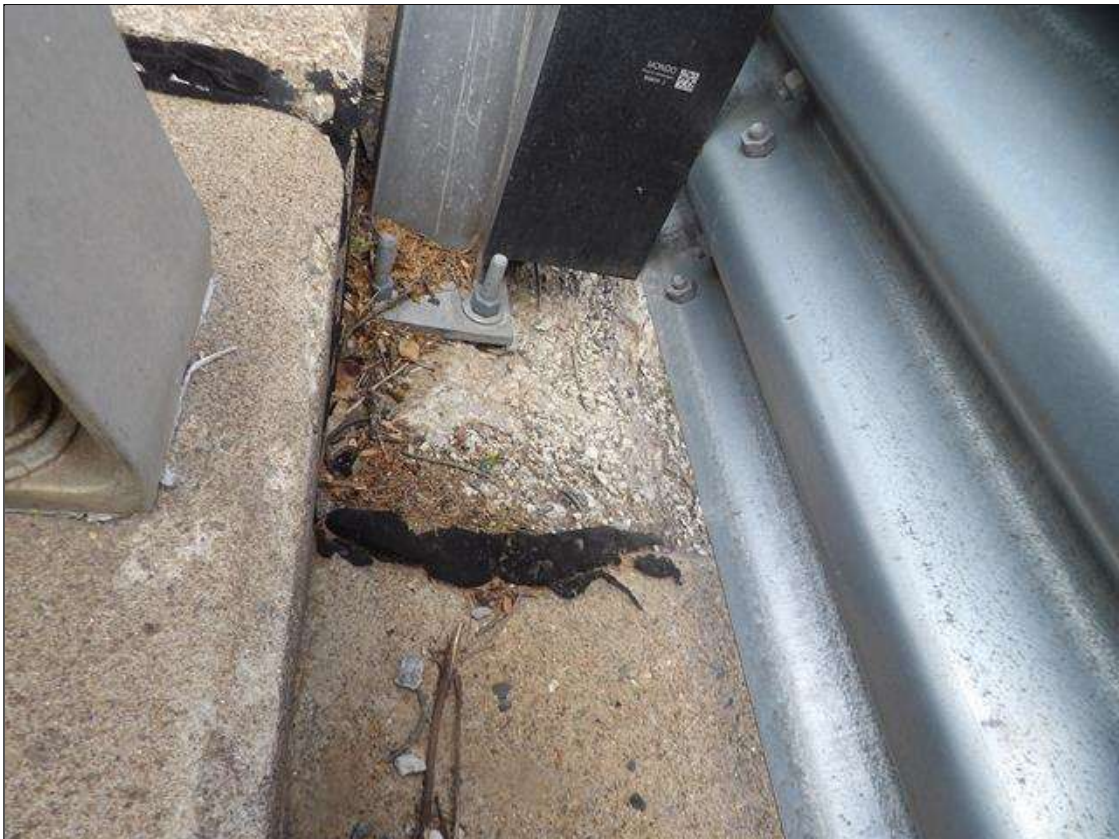
Span 4 Left Bridge Rail: SPALL WITH EXPOSED REBAR 8 INCHES WIDE X 18 INCHES LONG X 3 INCHES DEEP AT BENT 3

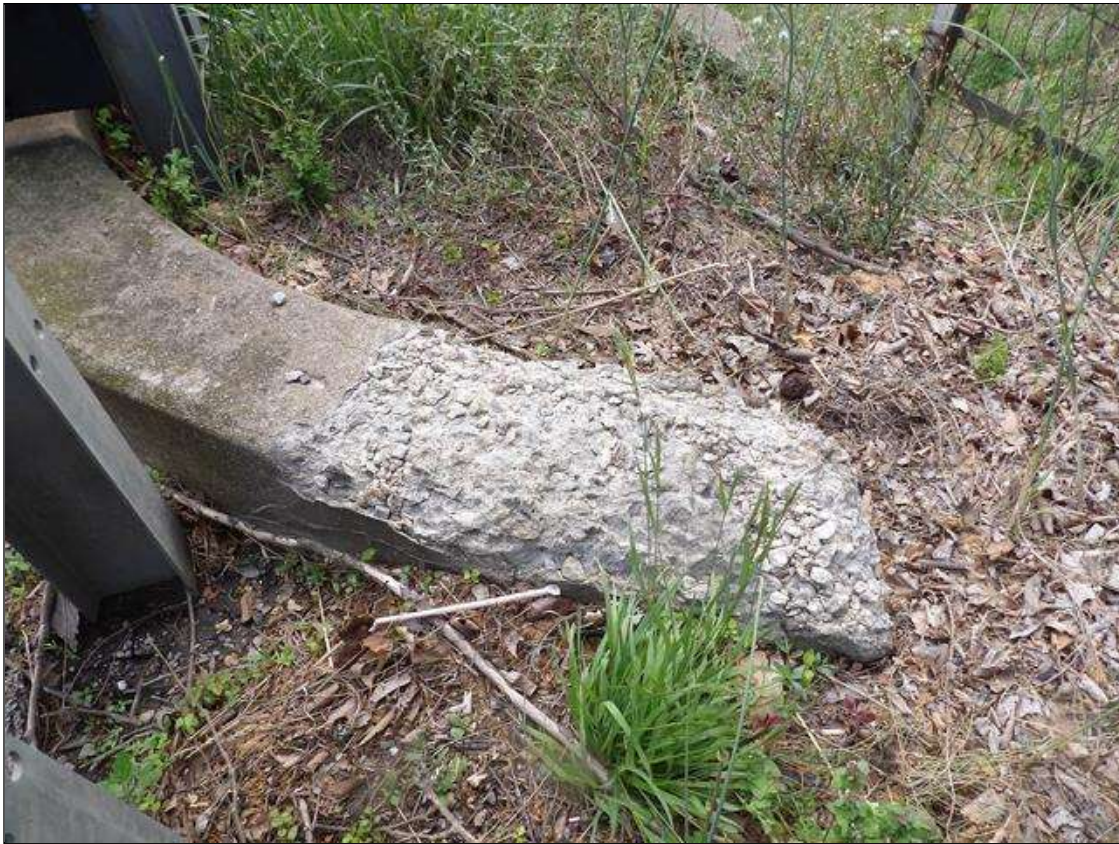
Span 4 Left Bridge Rail: END BENT 2 WHEEL GUARD EXTENSION, SPALL 3 FEET LONG X UP TO 12 INCHES WIDE X 2 INCHRS DEEP, RIGHT SIDE SIMILAR

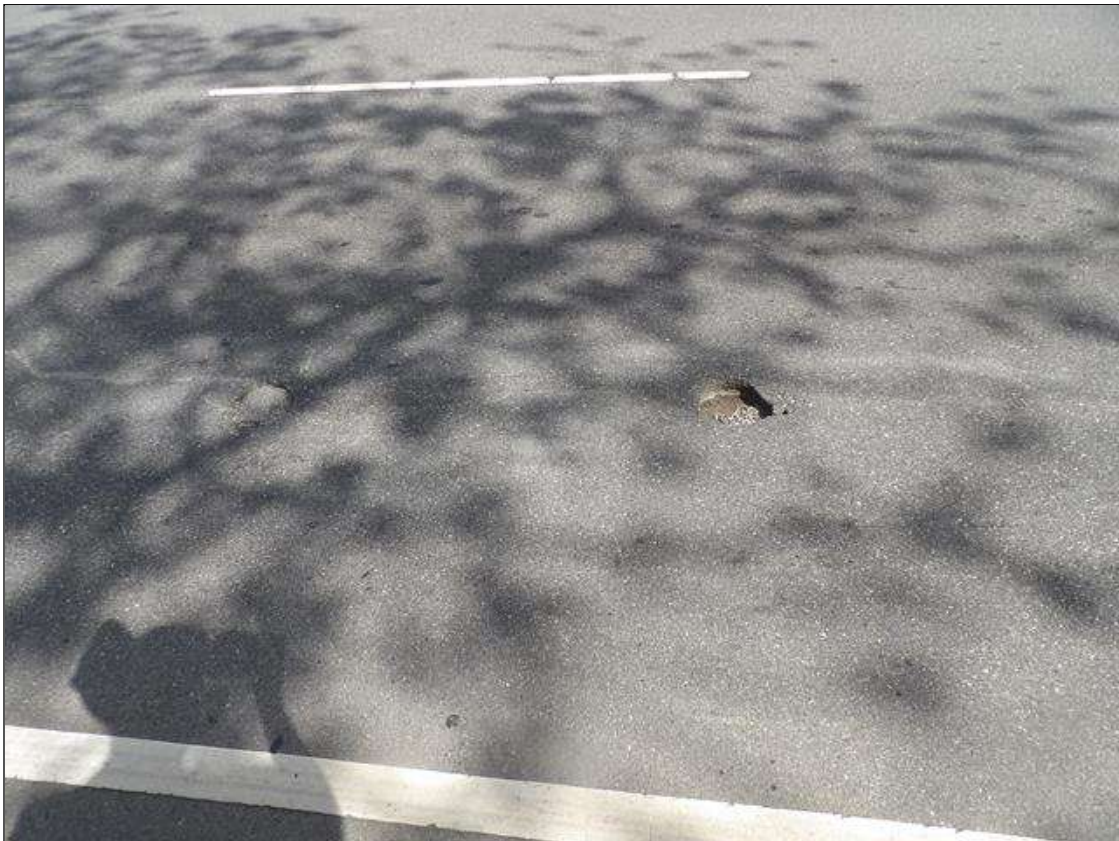
NORTH APPROACH ROADWAY WITH TWO 8 INCH DIAMETER CORES WITH ASPHALT MISSING UP TO 6 INCHES DEEP, SOUTH APPROACH SIMILAR

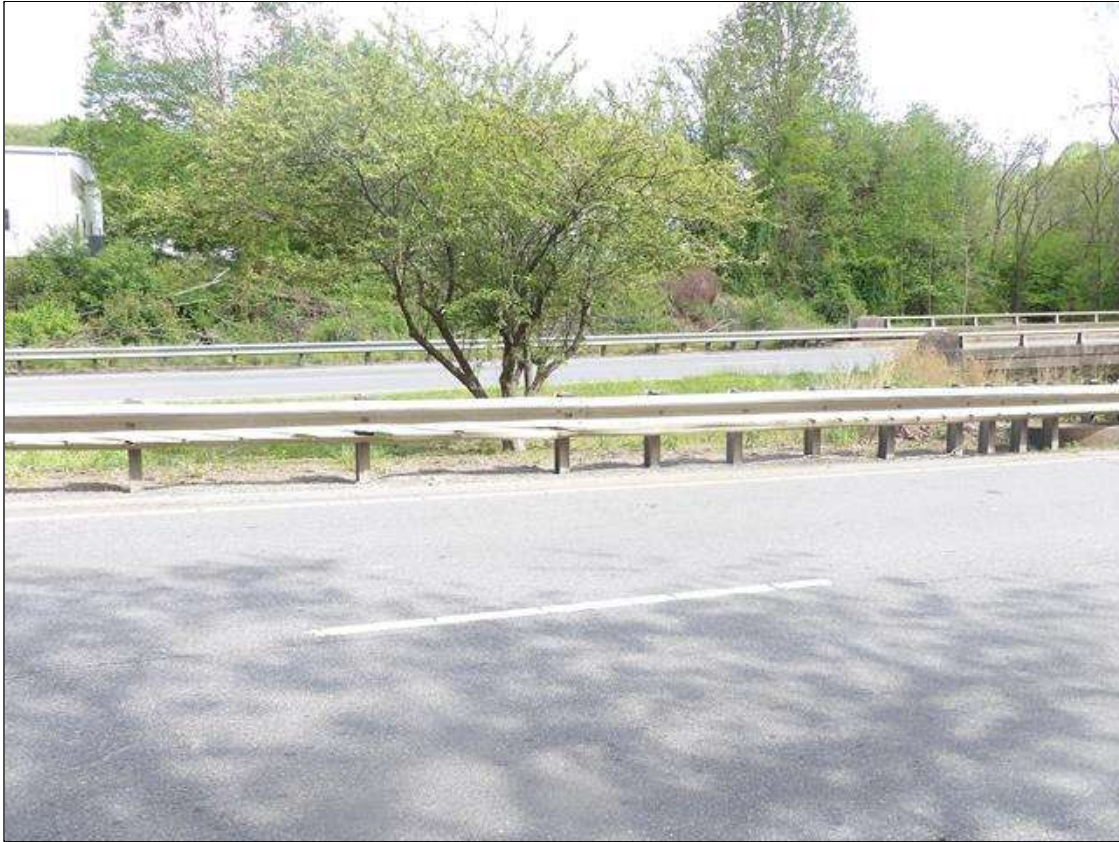
NORTHEAST GUARDRAIL IMPACT DAMAGE 50 FOOT LONG WITH TEARS IN GUARDRAIL STARTING AT ABUTMENT 2

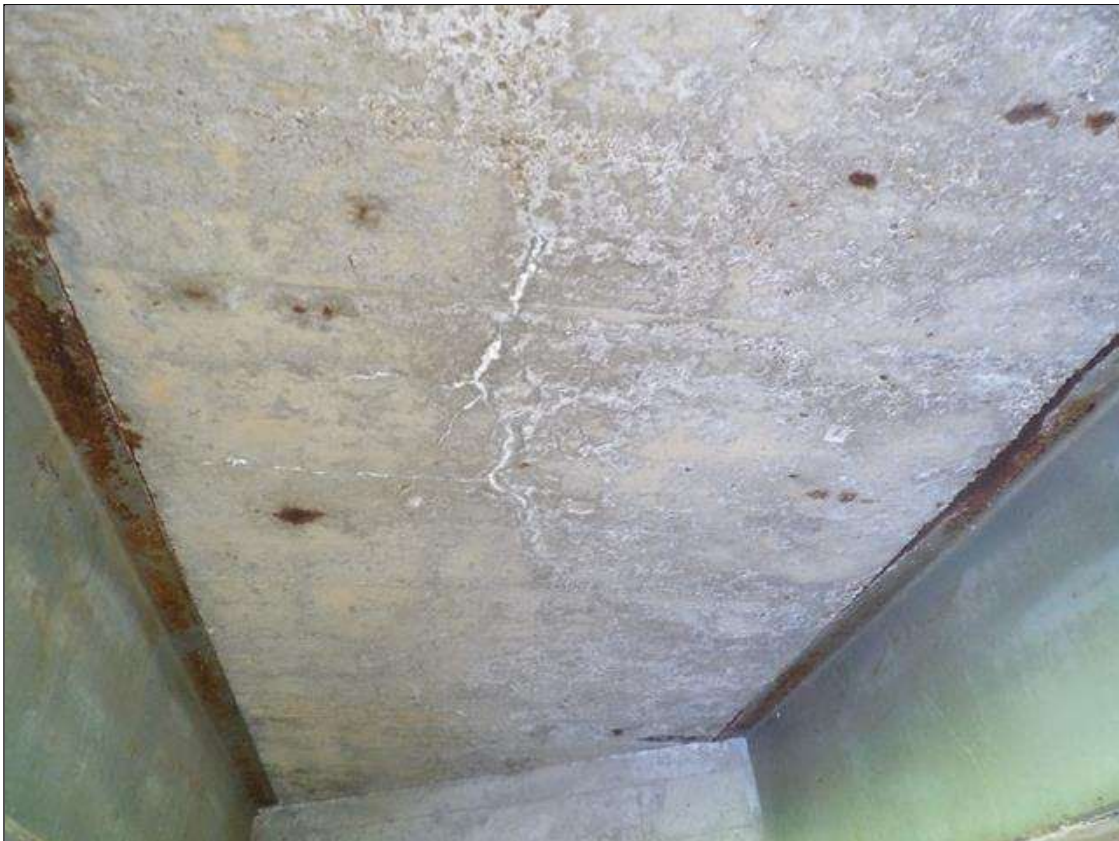
Span 1 Deck: UP TO 1/32 INCHES TRANSVERSE AND LONGITUDINAL AND HAIRLINE MAP CRACKS WITH AND WITHOUT EFFLORESCENCE IN BOTTOM OF DECK IN VARIOUS LOCATIONS

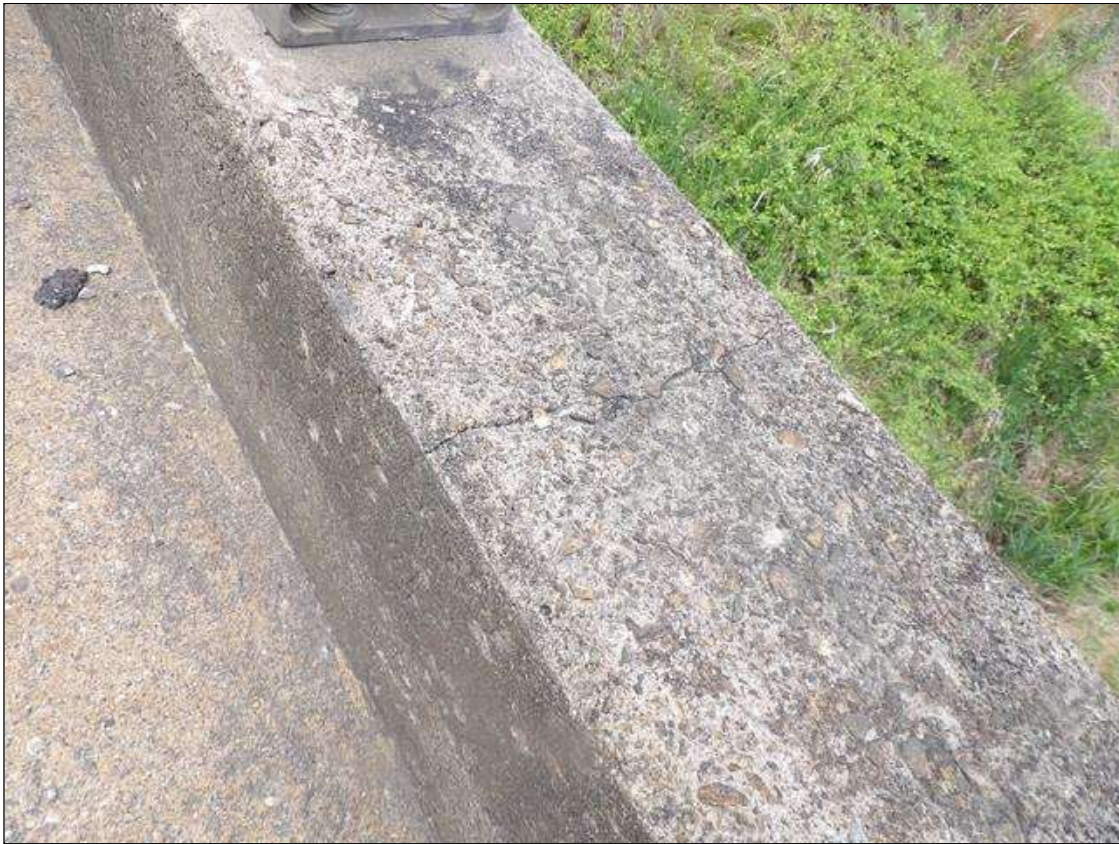
TYPICAL UP UP TO 1/32 INCHES TRANSVERSE AND VERTICAL CRACKS SCATTERED THROUGHOUT

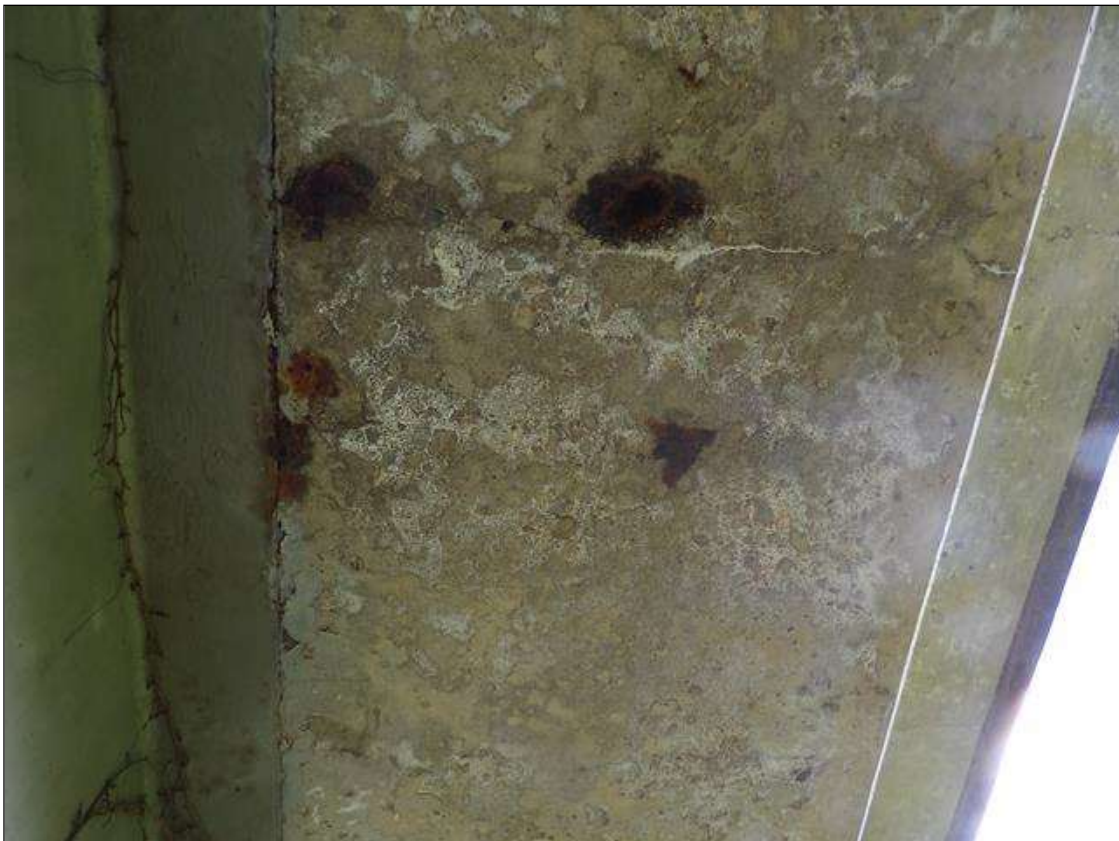
Span 1 Deck: ALONG BOTH OVERHANG DECK SOFFITS, HAIRLINE MAP CRACKING WITH ABRASION UP TO 1/16 INCH DEEP WITH EXPOSED BUT SECURE AGGREGATE AND EFFLORESCENCE AND RUST STAINING

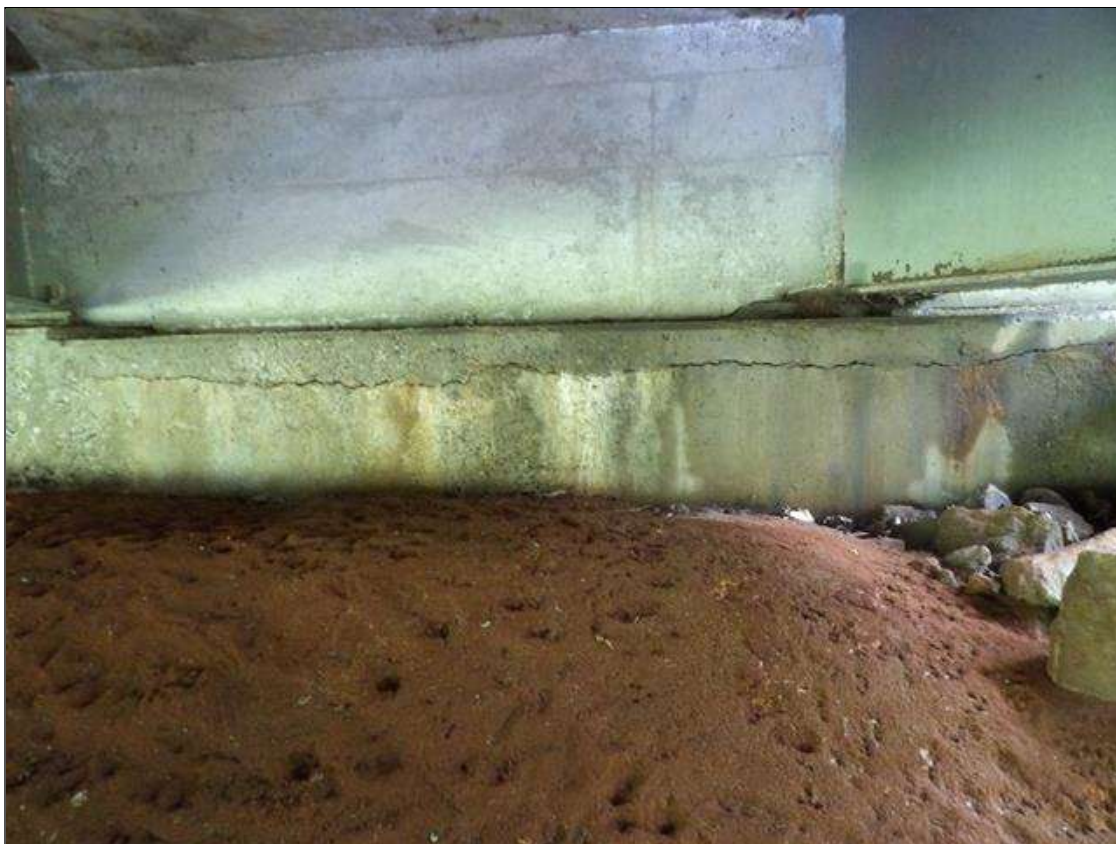
End Bent 1 Cap 1: 11 FEET X 18 INCHES X 8 INCHES AREA OF DELAMINATION WITH UP TO 3/8 INCHES HORIZONTAL CRACKS WITH AND WITHOUT EFFLORESCENCE IN TOP AND FACE OF CAP BENEATH BAY 1

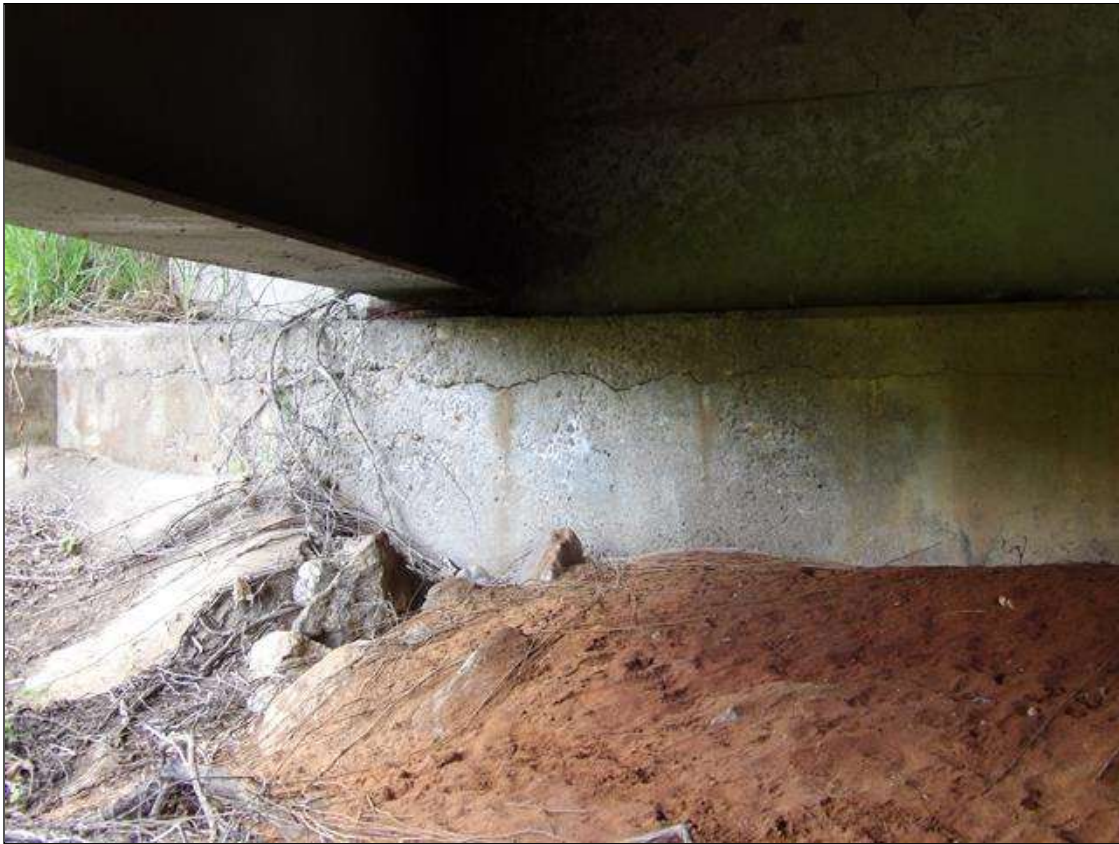
End Bent 1 Cap 1: UP TO 3/8 INCHES HORIZONTAL CRACK WITH AND WITHOUT EFFLORESCENCE AND 86 INCHES X 14 INCHES X 8 INCHES AREA OF DELAMINATION IN TOP AND FACE OF CAP BENEATH BAY 3 AND BEAM 4

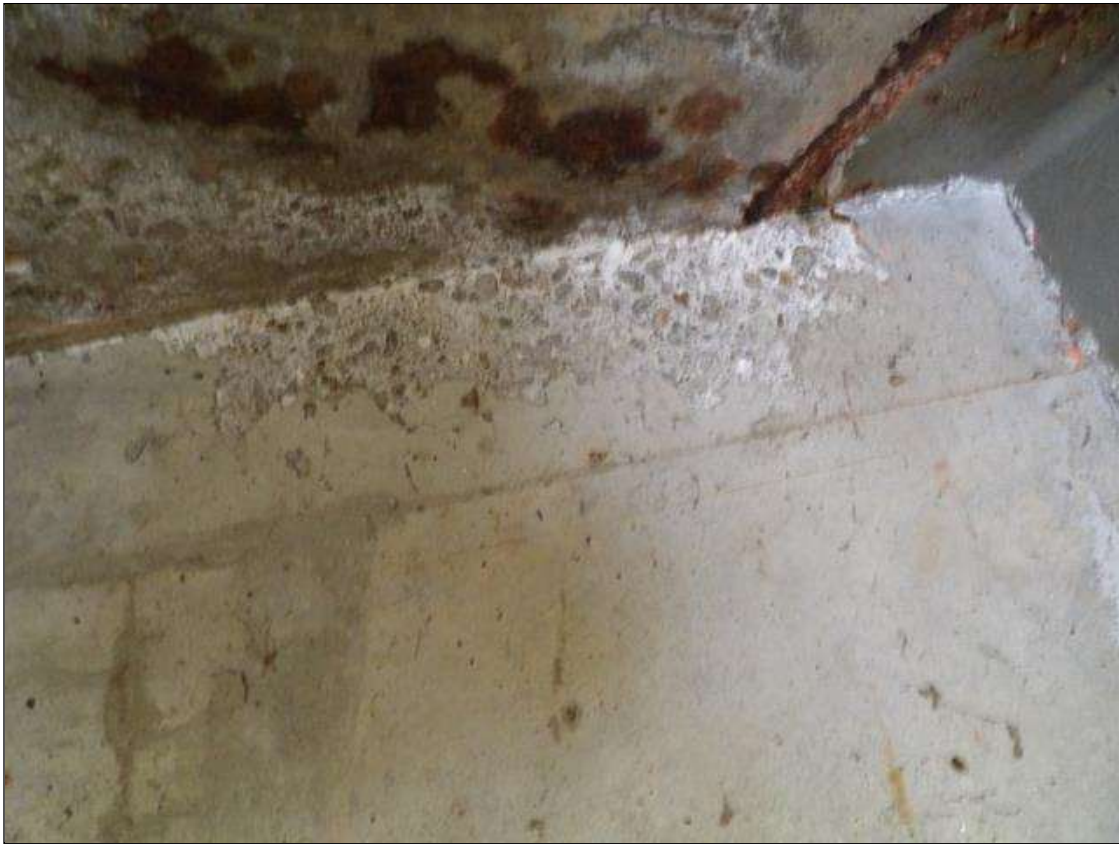
End Bent 1 Abutment: BELOW BAY 1 ADJACENT TO BEAM 1, 1 FOOT LONG X 4 INCHES HIGH X UP TO 1/4 INCHES DEEP SPALL

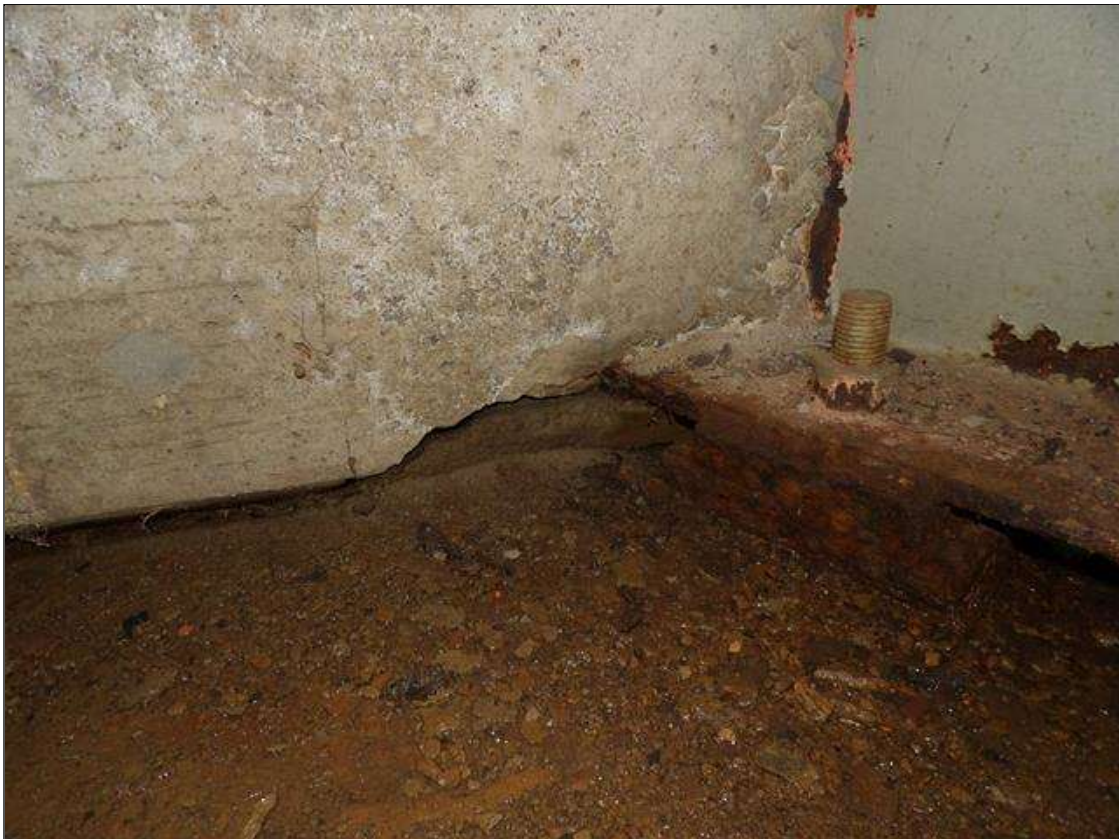
End Bent 1 Abutment: UP TO 6 INCH X 2 INCH X 1/4 INCH DEEP SPALL IN FACE OF CURTAIN WALL RIGHT EDGE OF BOTTOM FLANGE OF BEAMS 1 AND 3

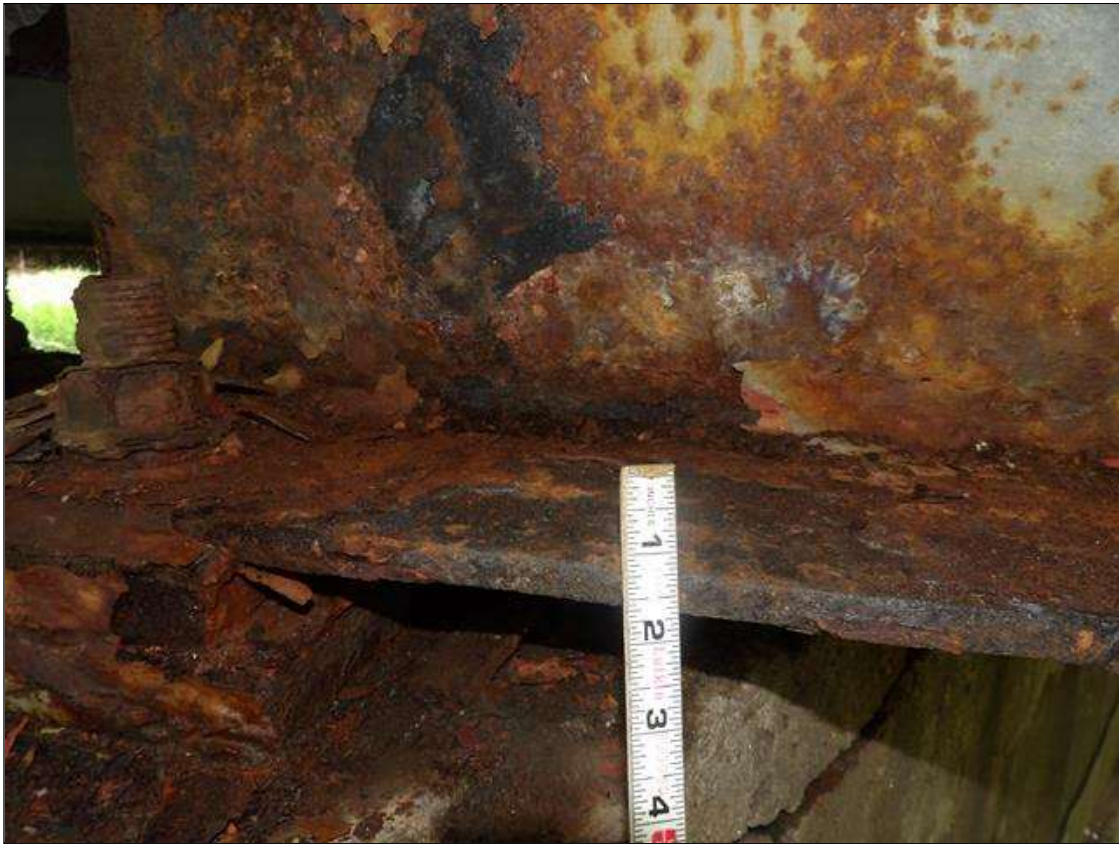
Span 1 Beam 1: PAR: CORROSION ALONG BOTTOM FLANGE AND WEB. FLANGE REDUCED TO 3/16 INCHES WITH 1/2 INCH AVERAGE REMAINING FOR 36 INCHES LONG X 11 5/8 INCHES WIDE BEGINNING AT FAR END. WEB ALSO REDUCED TO 3/8 INCHES WITH 7/16 INCH AVERAGE REMAINING THE FULL HEIGHT X 11 INCHES LONG BEGINNING AT THE FAR END.

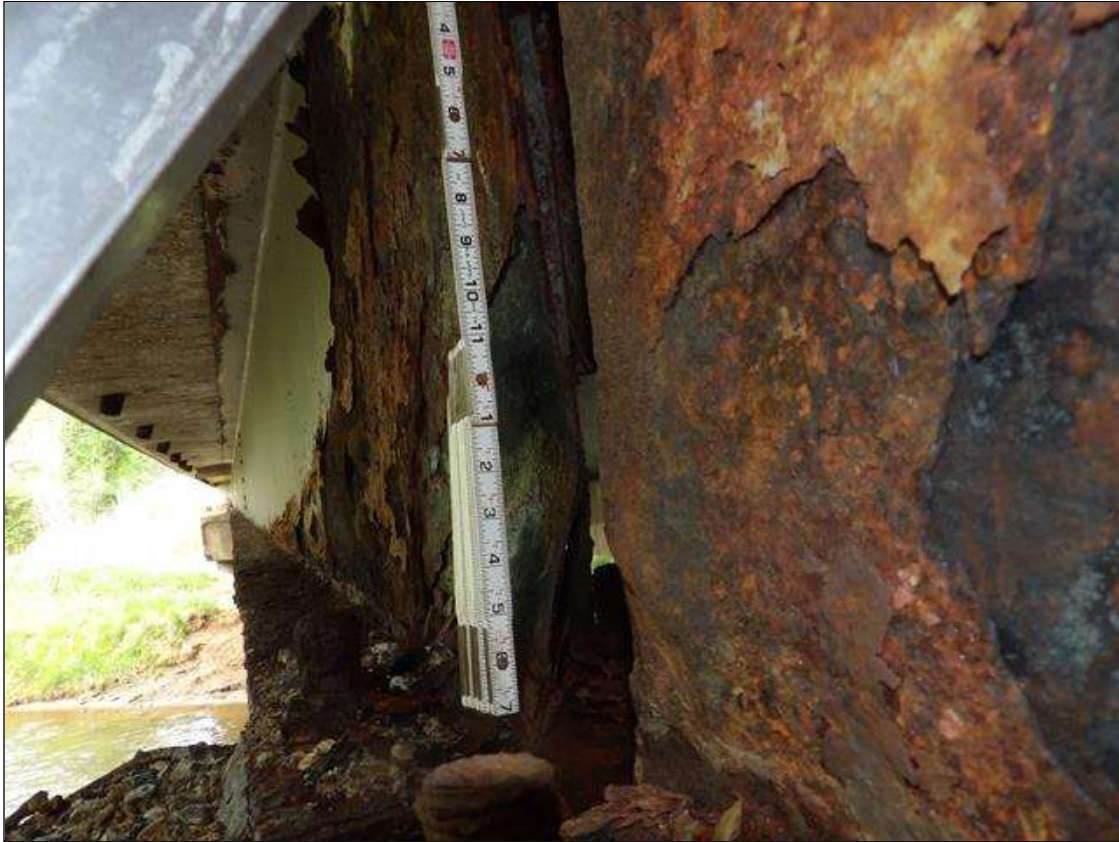
Span 2 Beam 1: PAR: CORROSION ALONG BOTH FACES OF WEB AND BOTTOM FLANGE. WEB: UP TO 8 FEET LONG X FULL HEIGHT DOWN TO 1/8 INCHES RESIDUAL WEB WITH 4 INCHES WIDE X 7 INCHES HIGH X 1/2 INCHES DEEP BUCKLING AT THE BASE OF THE WEB. 8 FEET LONG X FULL WIDTH DOWN TO 1/16 INCHES RESIDUAL FLANGE AT BENT 1.

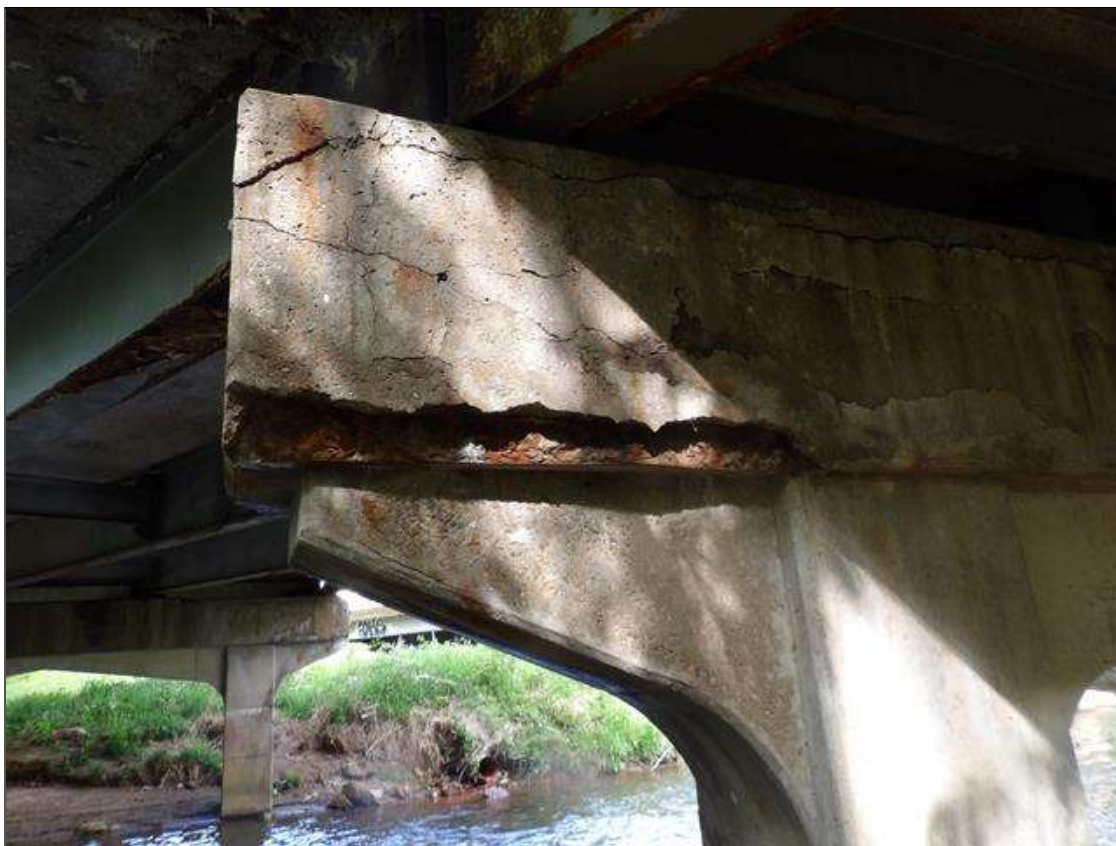
Bent 1 Cap 1: PAR: 50 INCHES X 4 INCHES X 5 INCHES SPALL WITH EXPOSED REBAR WITH MINOR SECTION LOSS IN BOTTOM AND SPAN 1 FACE OF CAP AT LEFT END

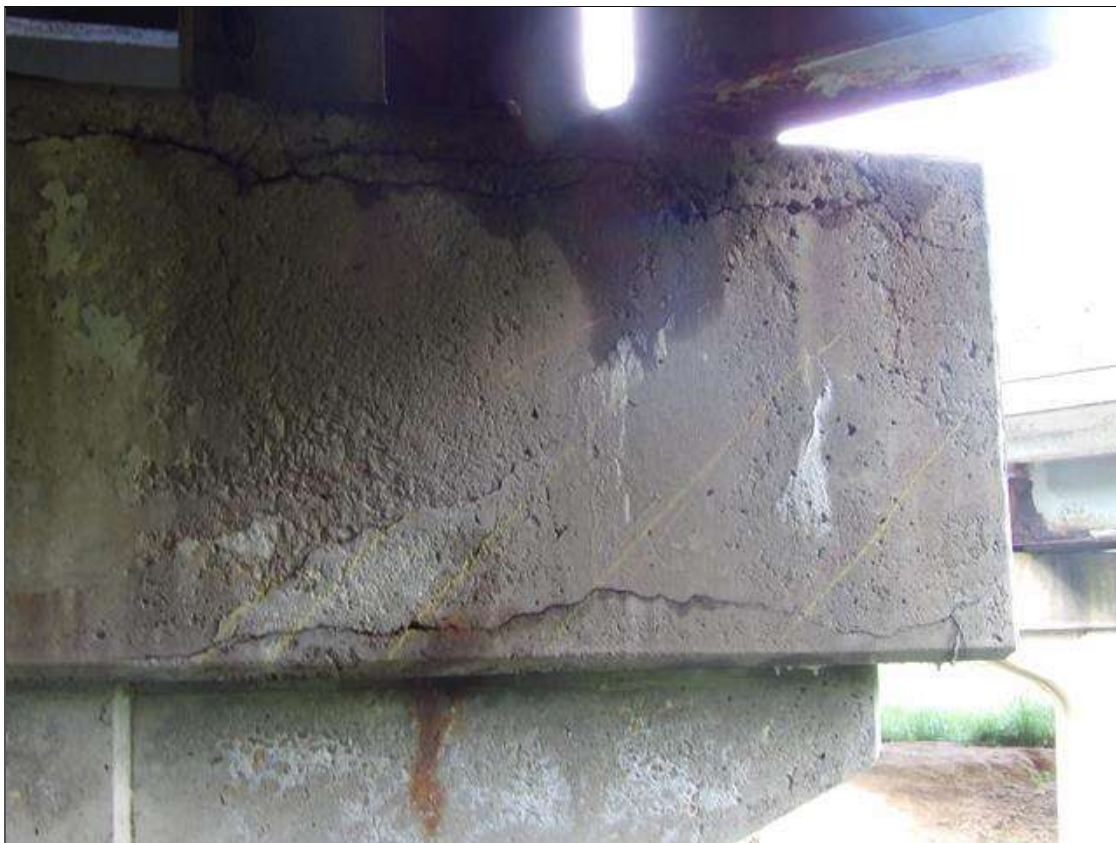
Bent 1 Cap 1: DELAMINATED AREA 30 INCHES WIDE X 14 INCHES HIGH ON SOUTH FACE NEAR RIGHT END.

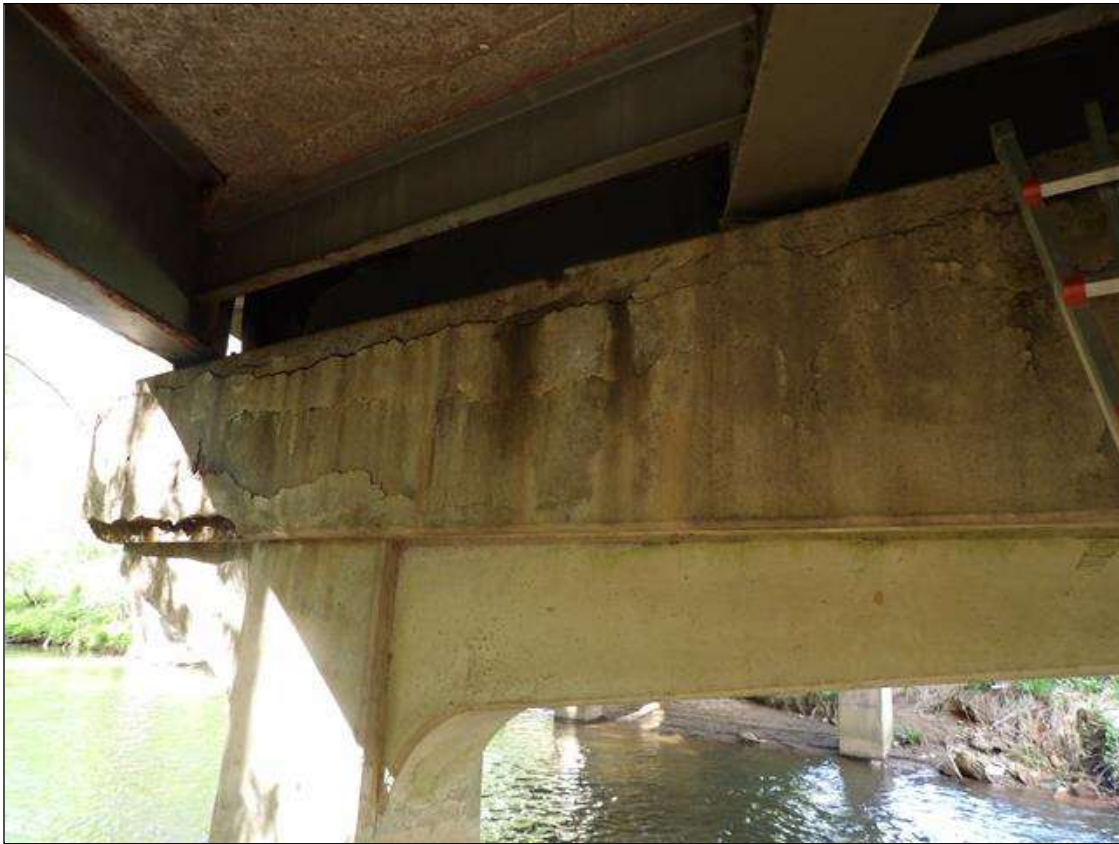
Bent 1 Cap 1: 31 FEET OF UP TO 3/8 INCHES LONGITUDINAL AND HORIZONTAL CRACKS WITH AND WITHOUT EFFLORESCENCE AND AREAS OF DELAMINATION IN TOP, BOTTOM AND SPAN 1 FACE OF CAP, SIMILAR ON SPAN 2 FACE AND PIER 2

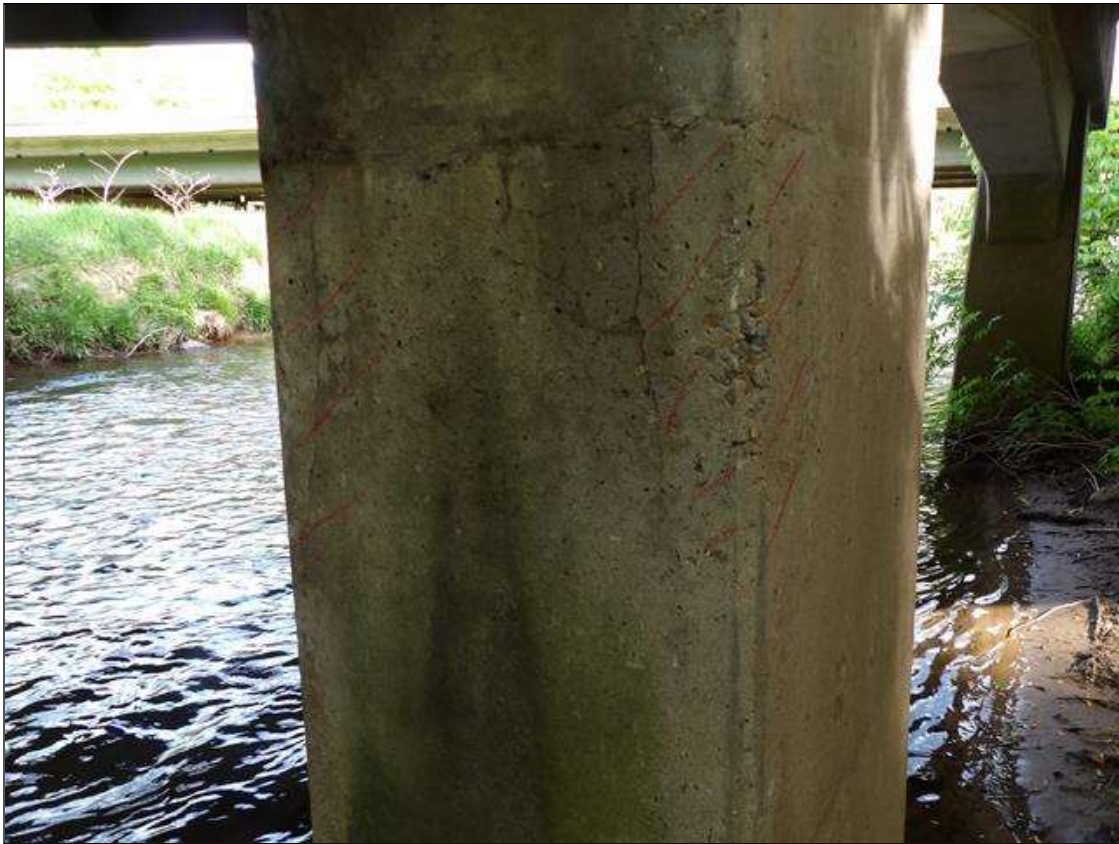
Bent 1 Pile 1: (2) AREAS OF DELAMINATION UP TO 24 INCHES X 5 INCHES X 5 INCHES WITH 1/32 INCHES VERTICAL CRACKS IN SOUTHWEST AND NORTHWEST CORNERS OF COLUMN, APPROXIMATELY 3 FEET FROM BOTTOM OF CAP
