NC DEPARTMENT OF TRANSPORTATION
 DIVISION OF HIGHWAYS
 STRUCTURE MANAGEMENT UNIT

ATTENTION: **PRIORITY ACTION REQUEST ISSUED; CHANGE TO APPROACH ROADWAY DATA**

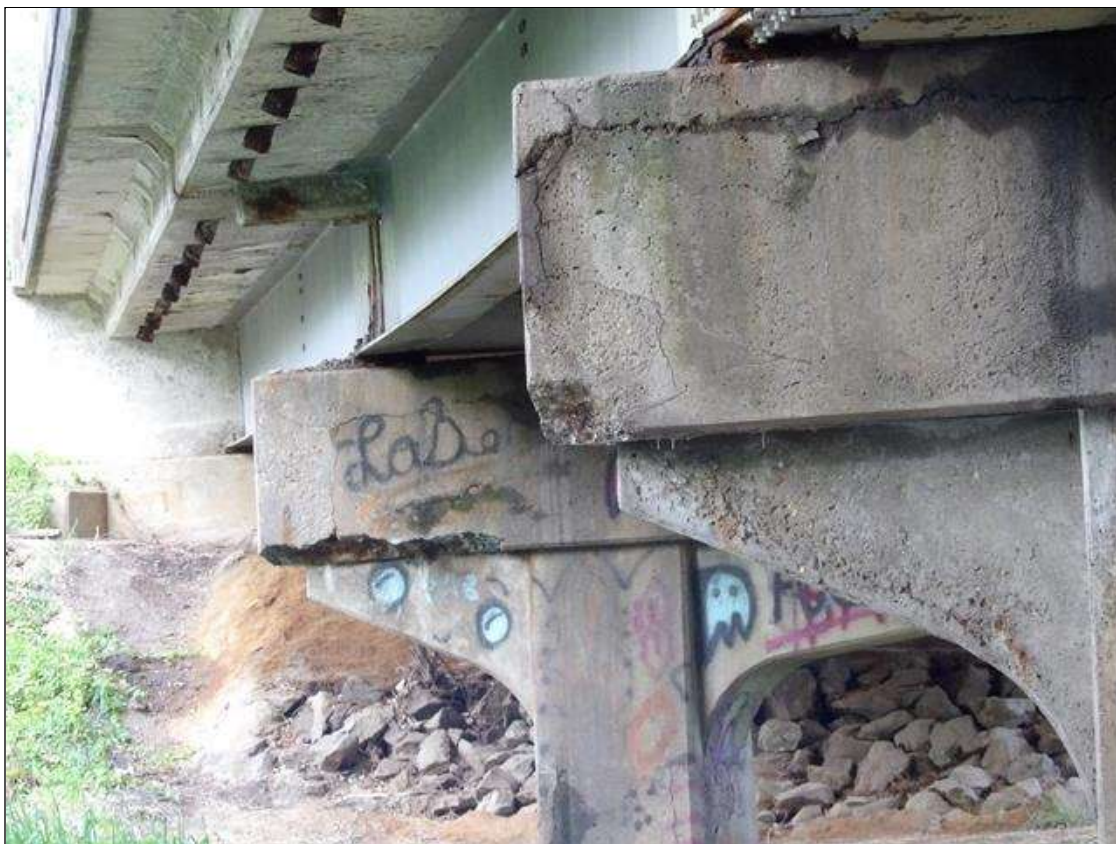
Bent 2 Cap 1: LEFT END OF CAP, DELAMINATED AREA FULL HEIGHT AND FULL WIDTH WITH CRACKING UP 1/4 INCH WITH 8 INCH DIAMETER X 2 INCH DEEP SPALL AT SOUTHWEST CORNER

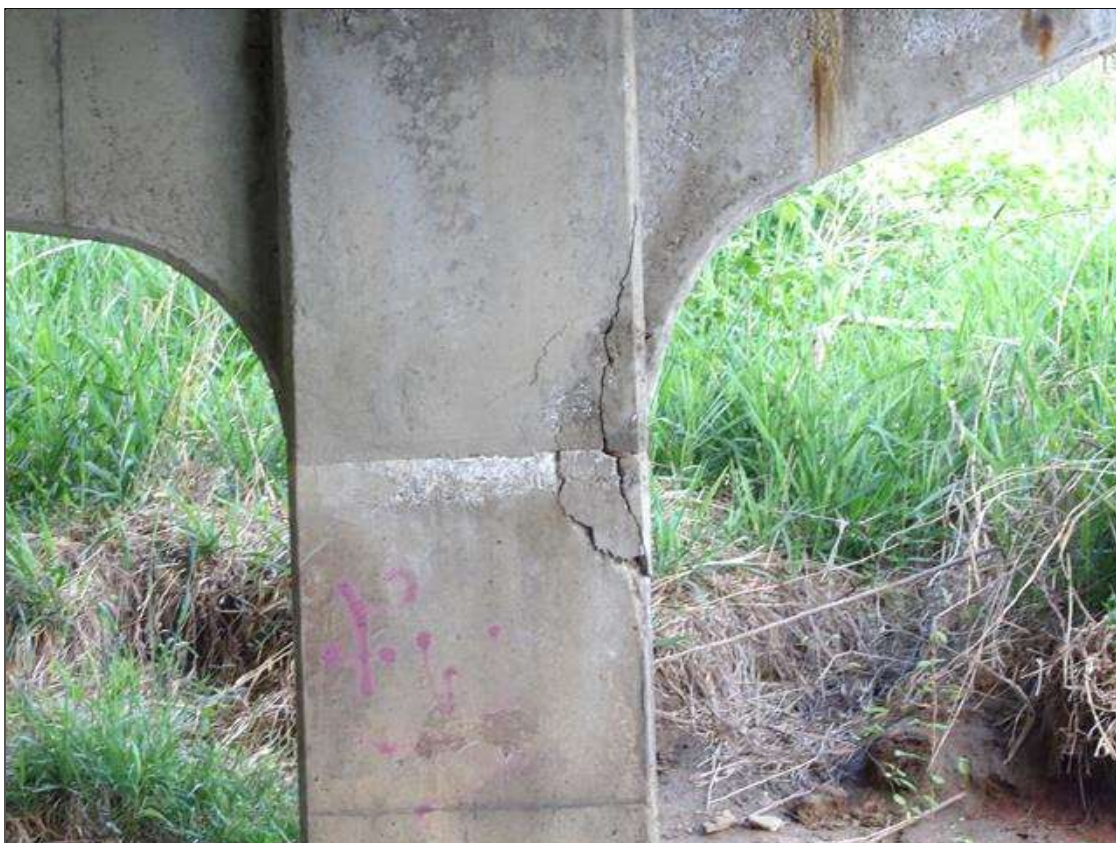
Bent 2 Pile 2: 40 INCHES X 9 INCHES X 6 INCHES AREA OF DELAMINATION WITH UP TO 3/8 INCHES VERTICAL CRACKS IN SOUTHEAST CORNER OF COLUMN, APPROXIMATELY 3 FEET FROM BOTTOM OF CAP

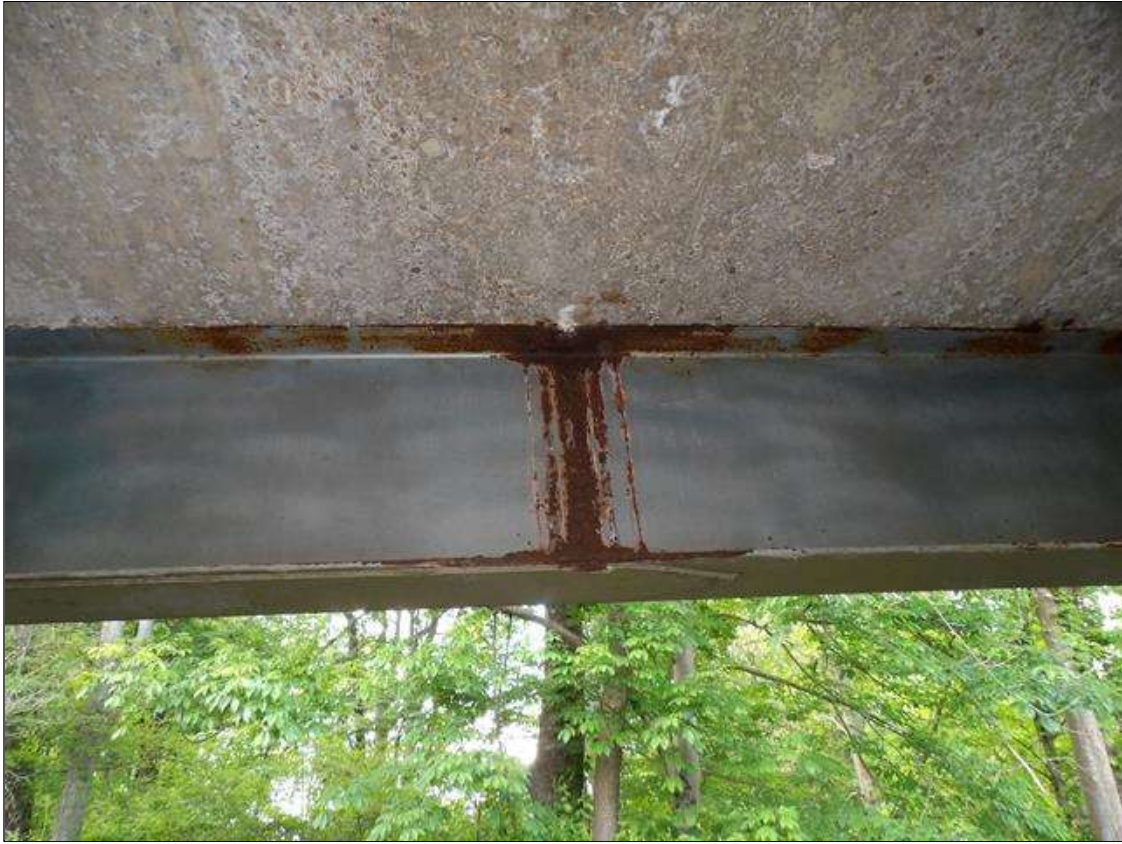
TYPICAL AREAS OF SURFACE CORROSION AND CORROSION WITH NO MEASURABLE SECTION LOSS THROUGHOUT BEAM, BEAM 1 SPAN 1 SHOWN

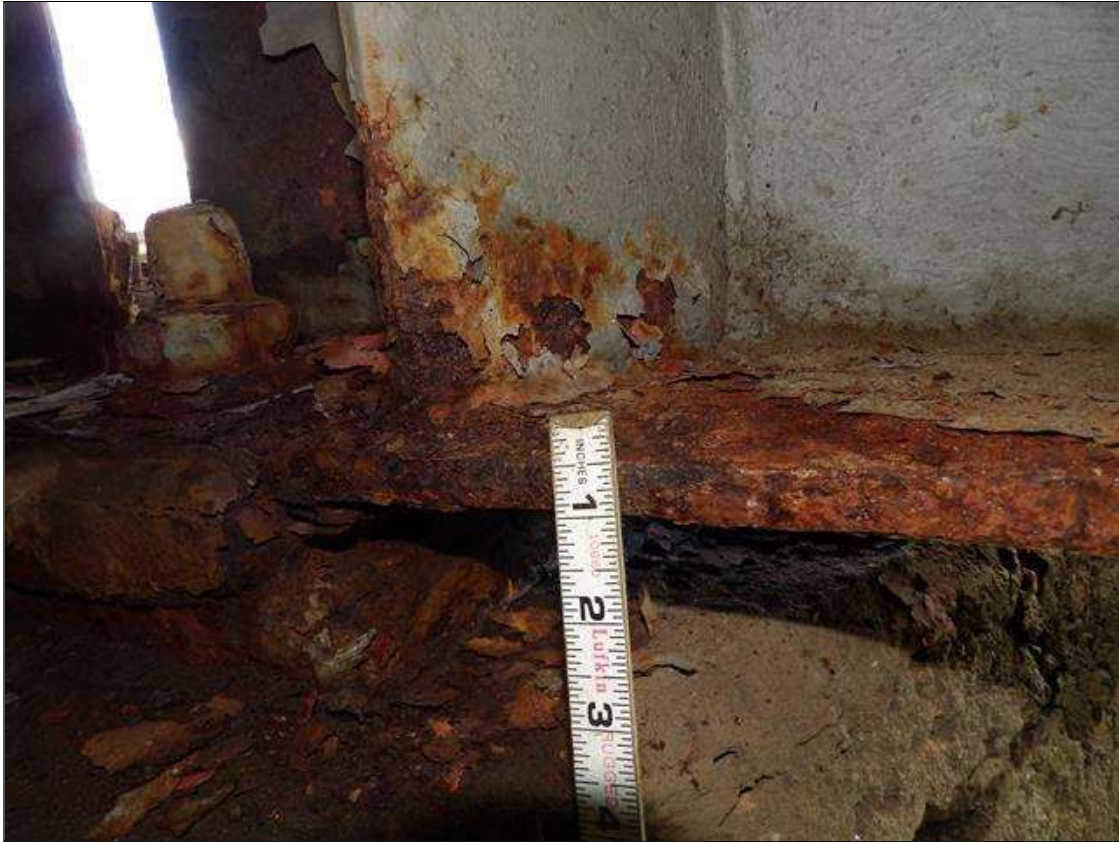
Span 1 Beam 4: PAR: CORROSION ALONG BOTH FACES OF WEB AND BOTTOM FLANGE UP TO 60 INCHES LONG X 31 1/2 INCHES HIGH DOWN TO 7/16 INCHES RESIDUAL WEB, AND 60 INCHES LONG X 11 5/8 INCHES WIDE DOWN TO 5/16 INCHES RESIDUAL FLANGE AT BENT 1

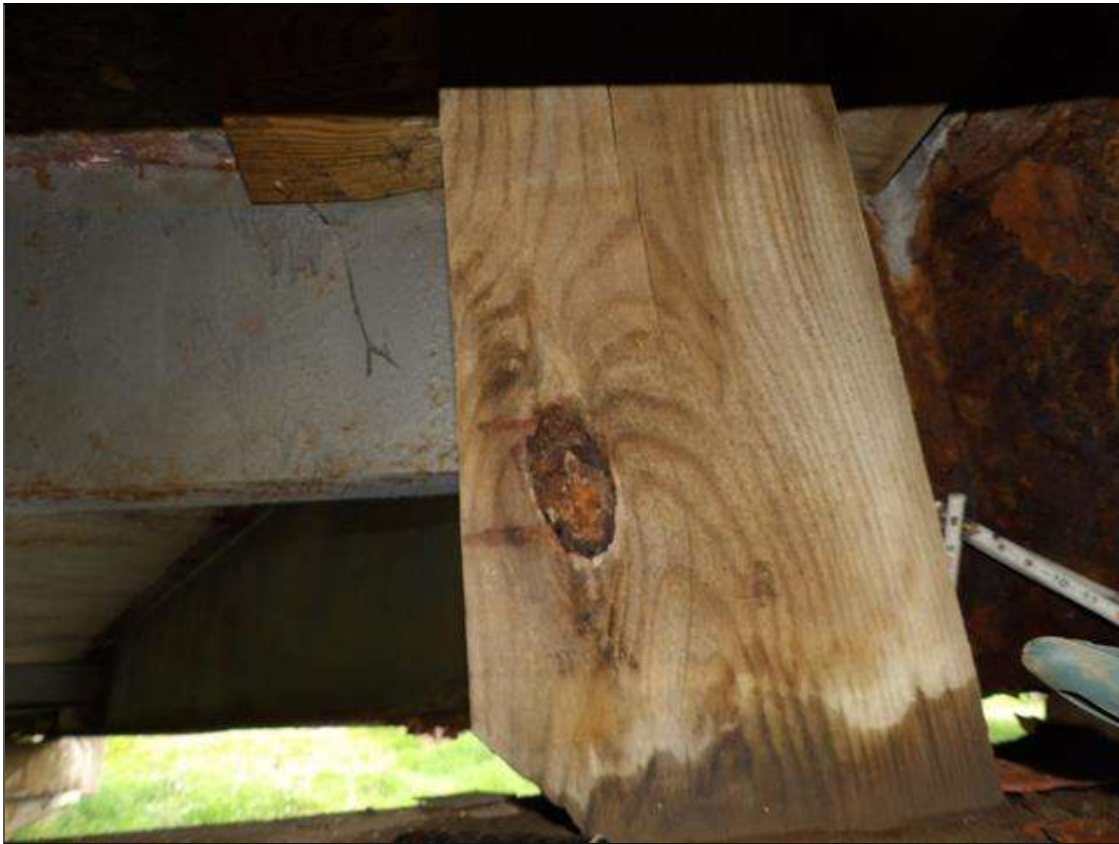
Span 2 Beam 4: PAR: CORROSION ALONG BOTH FACES OF WEB, BOTTOM FLANGE AND LEFT STIFFENER UP TO 60 INCHES LONG X 31 1/2 INCHES HIGH DOWN TO 1/2 INCHES RESIDUAL WEB, 66 INCHES LONG X 11 5/8 INCHES WIDE DOWN TO KNIFE'S EDGE RESIDUAL FLANGE WITH 2 INCHES X 3 INCHES LOSS OF SECTION, AND 10 INCHES HIGH X 5 INCHES WIDE DOWN TO KNIFE'S EDGE RESIDUAL STIFFENER WITH 1 INCHES DIAMETER HOLE AT BENT 1; TIMBER BLOCK ADDED ADJACENT TO BEAM

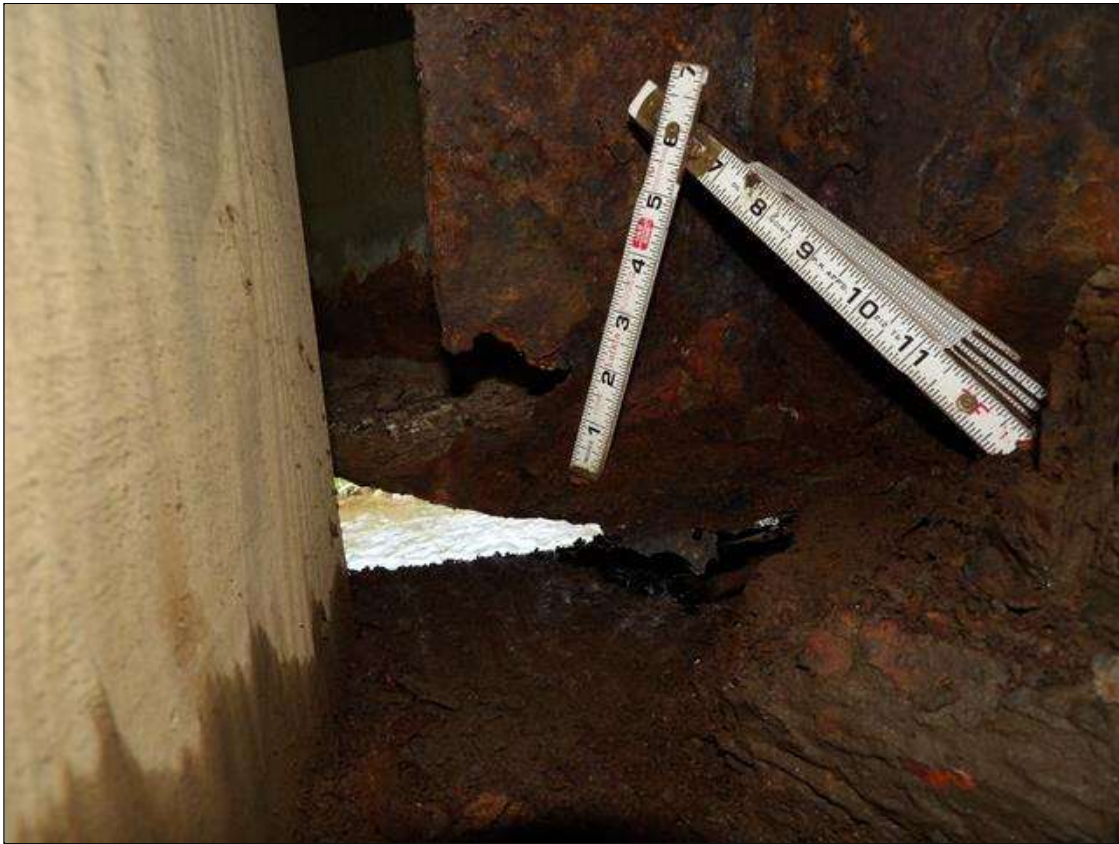
Span 2 Beam 4: PAR: CORROSION ALONG BOTH FACES OF WEB, BOTTOM FLANGE AND LEFT STIFFENER UP TO 60 INCHES LONG X 31 1/2 INCHES HIGH DOWN TO 1/2 INCHES RESIDUAL WEB, 66 INCHES LONG X 11 5/8 INCHES WIDE DOWN TO KNIFE'S EDGE RESIDUAL FLANGE WITH 2 INCHES X 3 INCHES LOSS OF SECTION, AND 10 INCHES HIGH X 5 INCHES WIDE DOWN TO KNIFE'S EDGE RESIDUAL STIFFENER WITH 1 INCHES DIAMETER HOLE AT BENT 1; TIMBER BLOCK ADDED ADJACENT TO BEAM

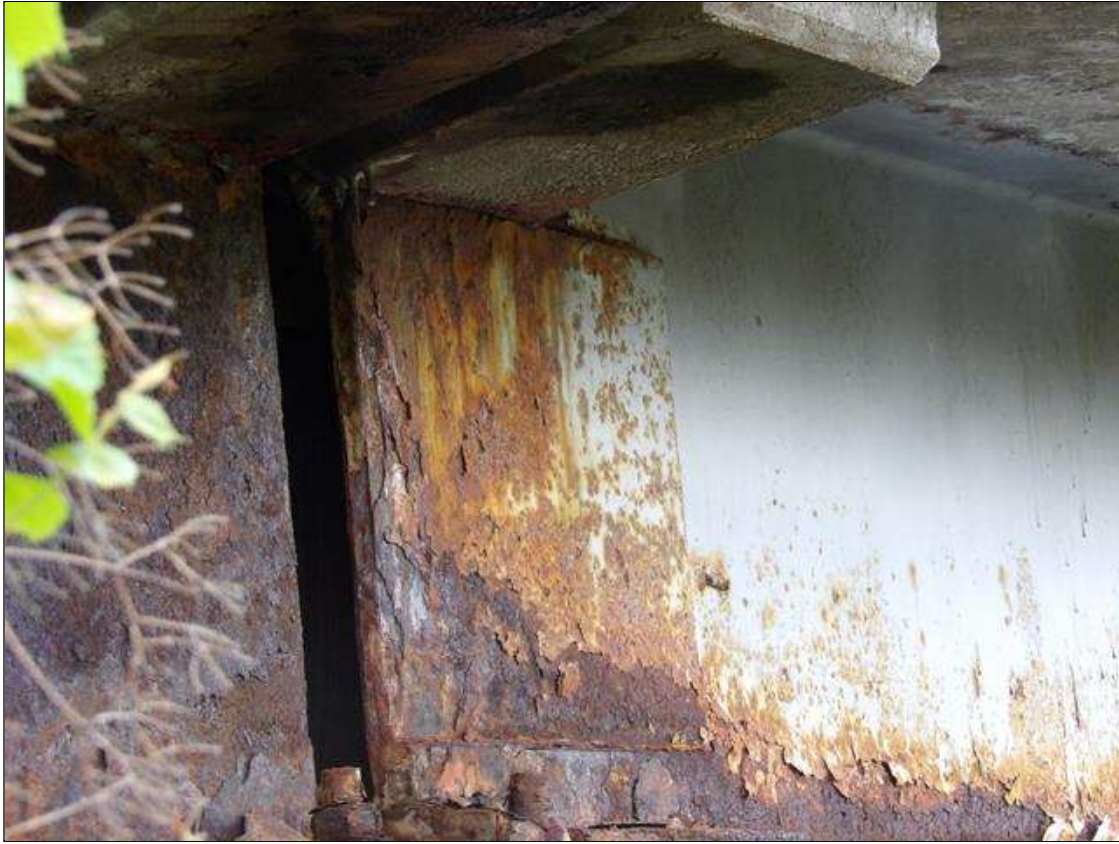
BEAM 4 SPAN 2 WITH WELDED PLATE REPAIRS ON RIGHT FACE OF WEB AND BOTTOM FLANGE 24 INCHES LONG X 24 INCHES HIGH X 1/2 INCH THICK IN WEB, AND 24 INCHES LONG X 4 INCHES X 1/2 INCH WIDE IN FLANGE AT BENT 1

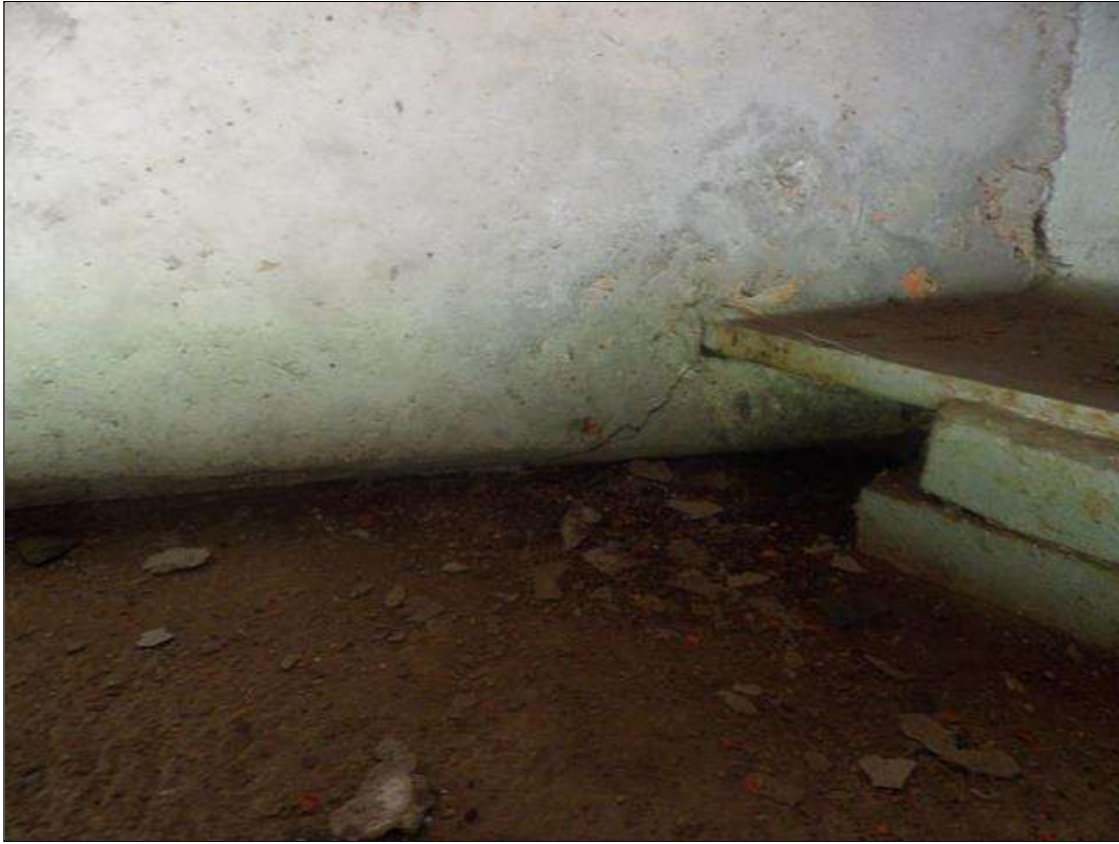
End Bent 2 Abutment: UP TO 1/16 INCHES DIAGONAL CRACKS IN FACE OF CURTAIN WALL EXTENDING FROM LEFT EDGE OF BOTTOM FLANGE OF BEAMS 1, 3 AND 4

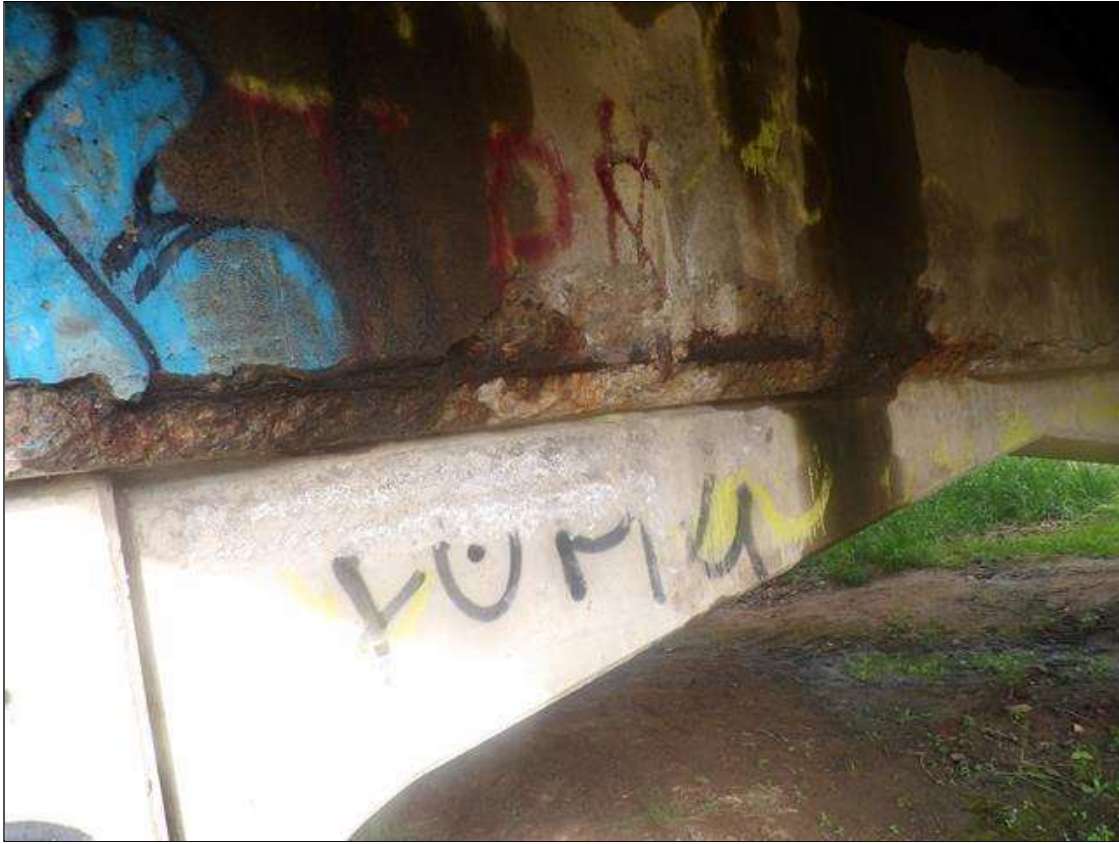
Bent 3 Cap 1: PAR: 96 INCHES X 6 INCHES X 9 INCHES SPALL WITH EXPOSED REBAR WITH MINOR SECTION LOSS AND 125 INCHES X 6 INCHES X 12 INCHES AREA OF DELAMINATION WITH UP TO 1/4 INCHES LONGITUDINAL AND HORIZONTAL CRACKS IN BOTTOM AND SPAN 4 FACE OF CAP BETWEEN COLUMNS

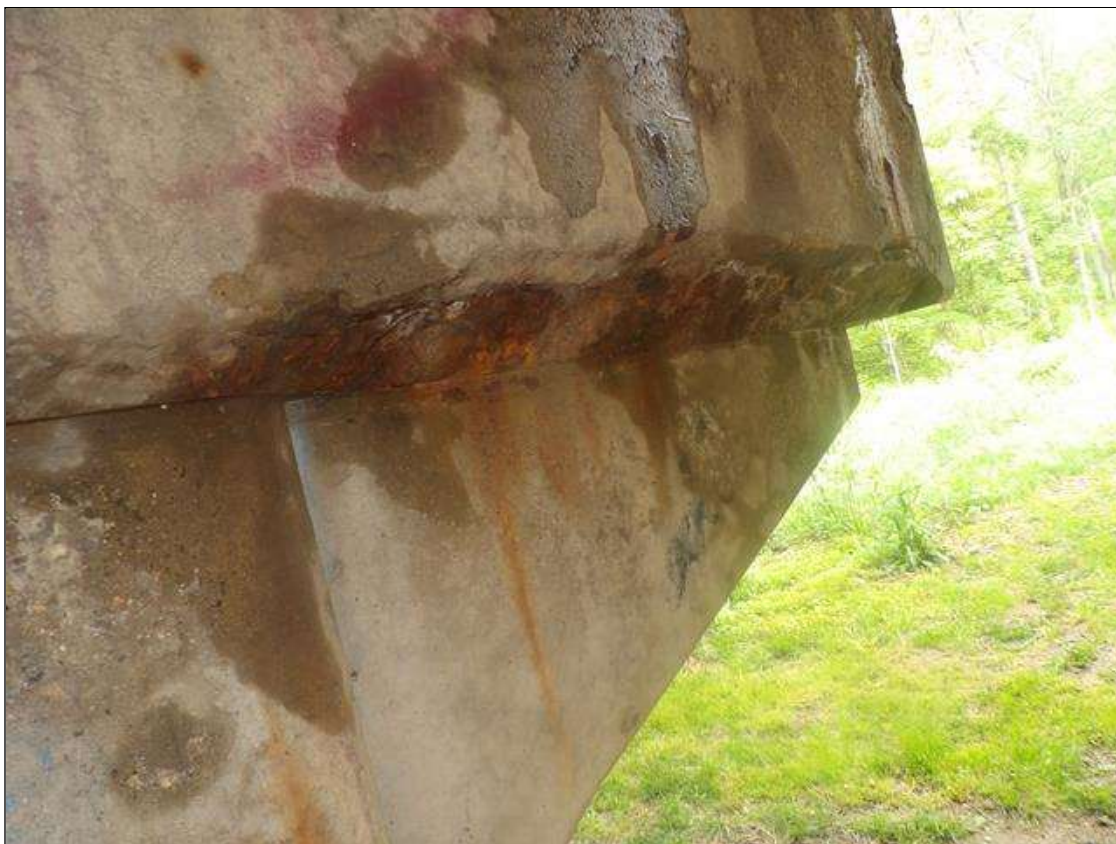
Bent 3 Cap 1: 60 INCHES X 6 INCHES X 4 INCHES SPALL WITH EXPOSED REBAR NO LOSS IN BOTTOM AND SPAN 4 FACE OF CAP AT LEFT END

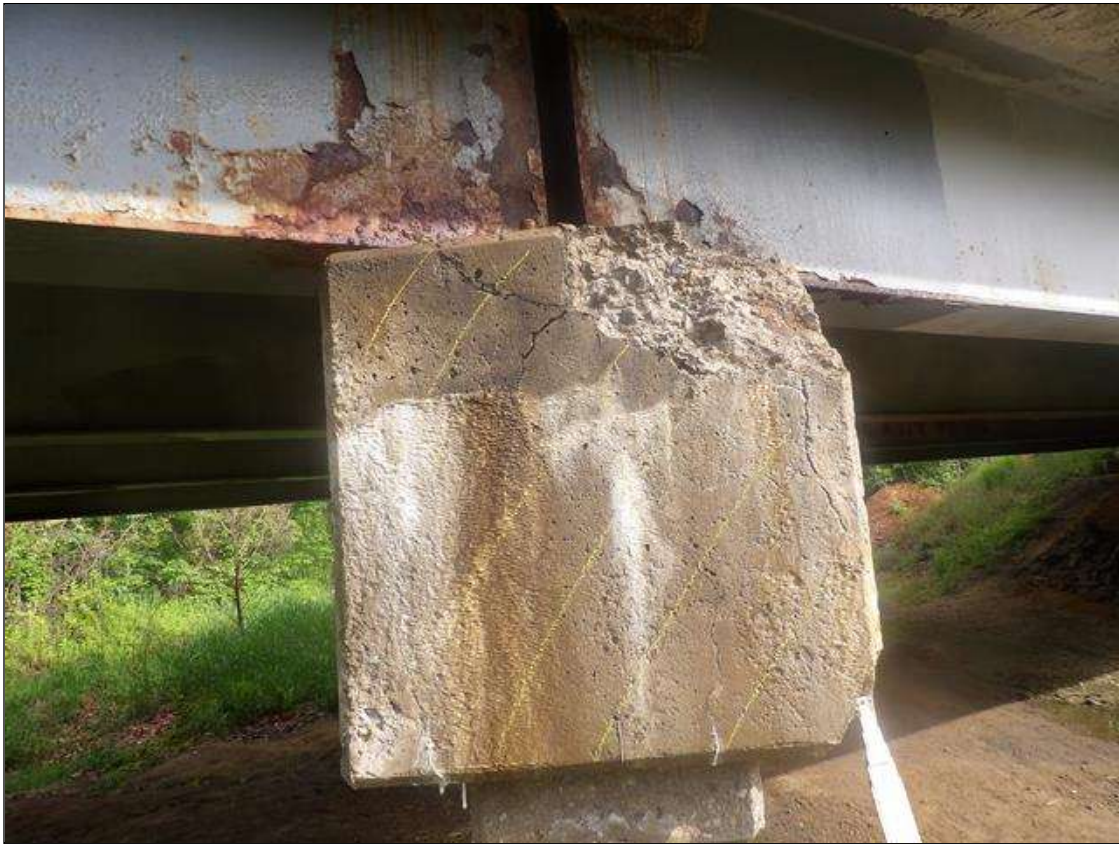
Bent 3 Cap 1: 32 INCHES X 30 INCHES X 30 INCHES AREA OF DELAMINATION WITH UP TO 1/4 INCHES HORIZONTAL AND MAP CRACKS AND 10 INCHES X 9 INCHES X 6 INCHES DEEP SPALL WITH EXPOSED REBAR NO LOSS THROUGHOUT RIGHT END OF CAP

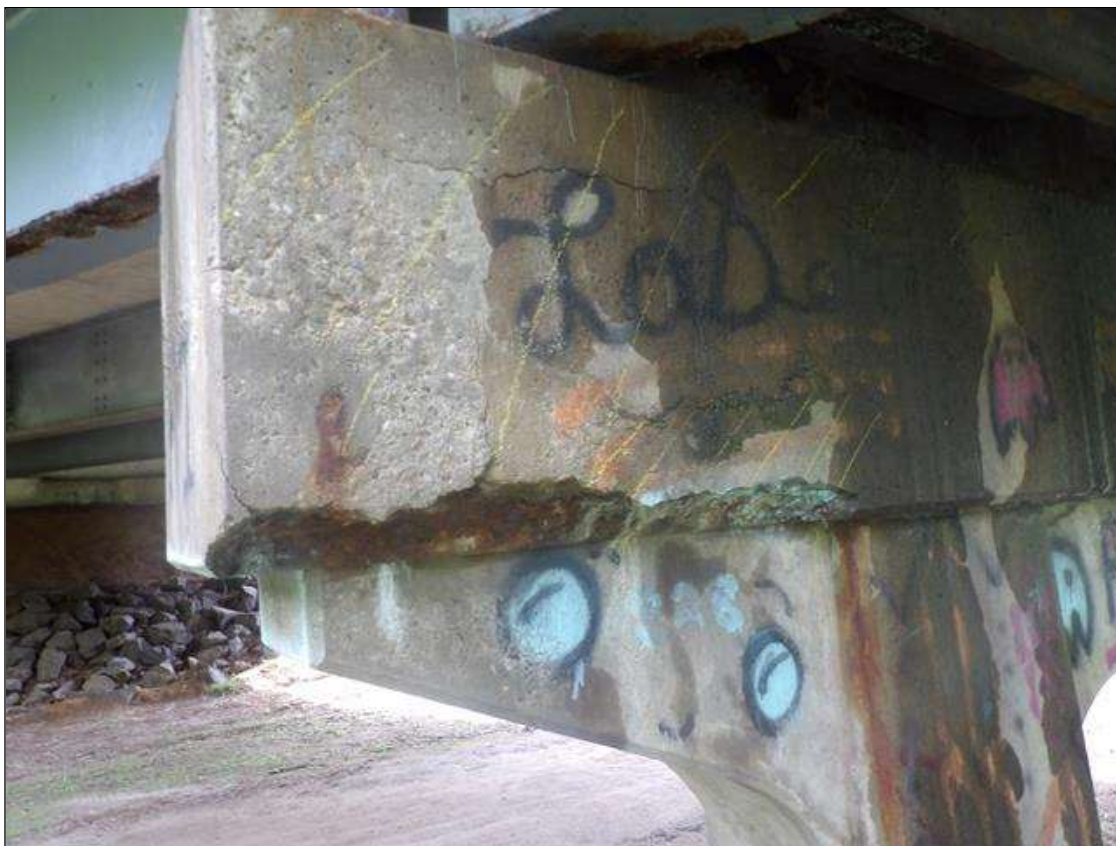
Bent 3 Cap 1: PAR: 78 INCHES X 30 INCHES X 9 INCHES AREA OF DELAMINATION WITH UP TO 1/16 INCHES VERTICAL AND HORIZONTAL CRACKS AND 48 INCHES X 6 INCHES X 6 INCHES SPALL WITH EXPOSED REBAR WITH MINOR SECTION LOSS IN TOP, BOTTOM, LEFT END AND SPAN 3 FACE OF CAP

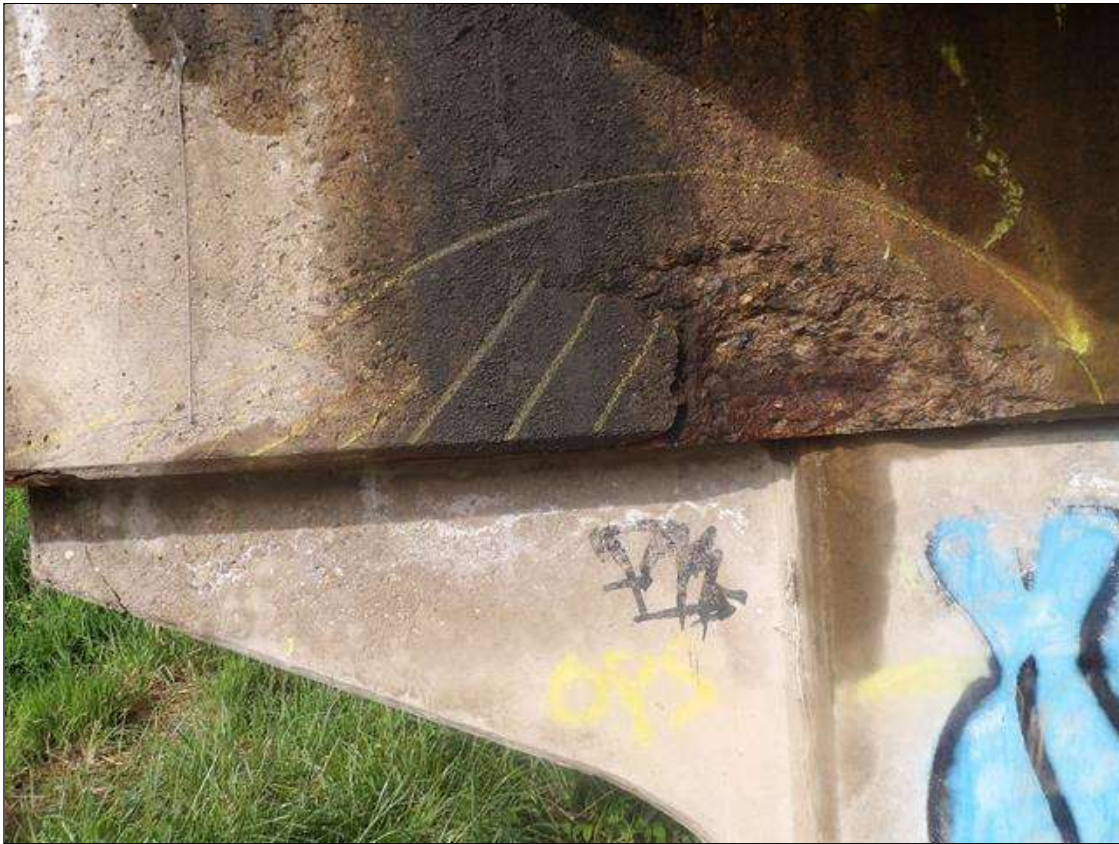
Bent 3 Cap 1: PAR: 26 INCHES X 2 INCHES X 11 INCHES SPALL WITH EXPOSED REBAR WITH MINOR SECTION LOSS AND 45 INCHES X 9 INCHES X 6 INCHES AREA OF DELAMINATION WITH UP TO 1/4 INCHES LONGITUDINAL AND HORIZONTAL CRACKS IN BOTTOM AND SPAN 4 FACE OF CAP AT RIGHT END

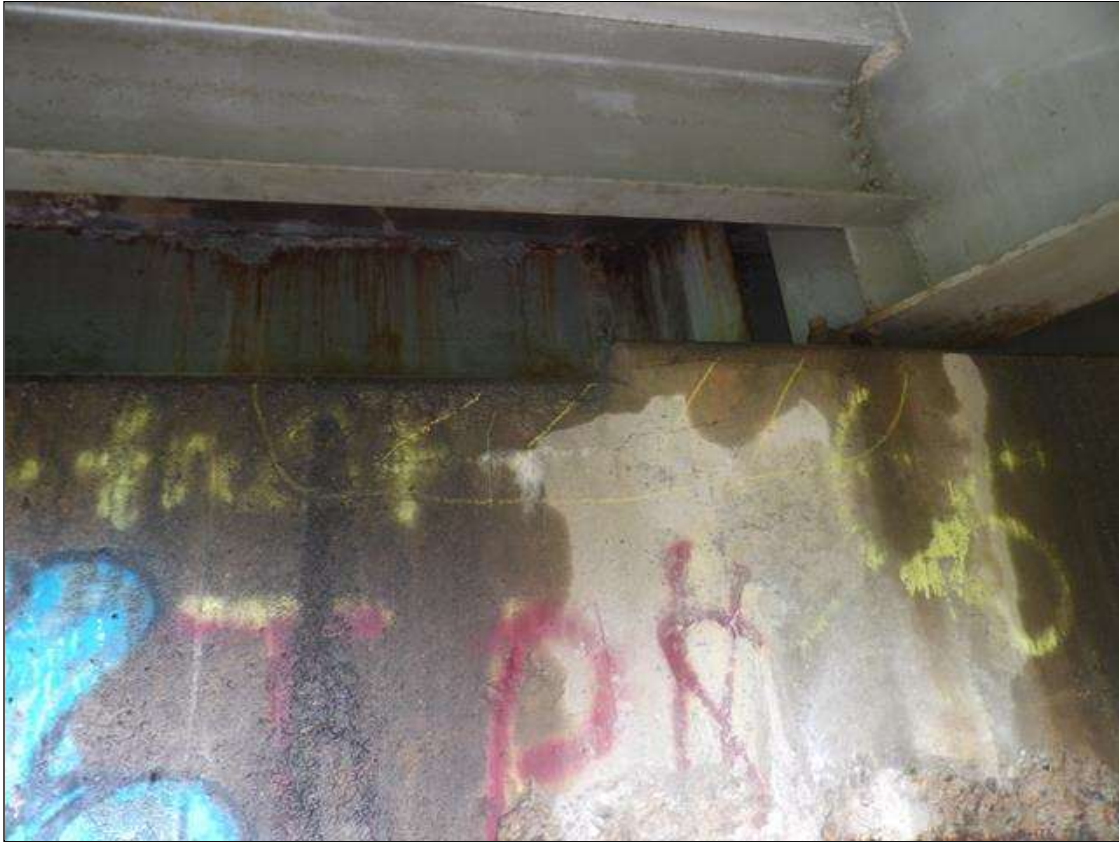
Bent 3 Cap 1: 36 INCHES X 6 INCHES X 12 INCHES AREA OF DELAMINATION WITH UP TO 1/32 INCHES LONGITUDINAL AND HORIZONTAL CRACKS IN TOP AND SPAN 4 FACE OF CAP BENEATH BAY 3

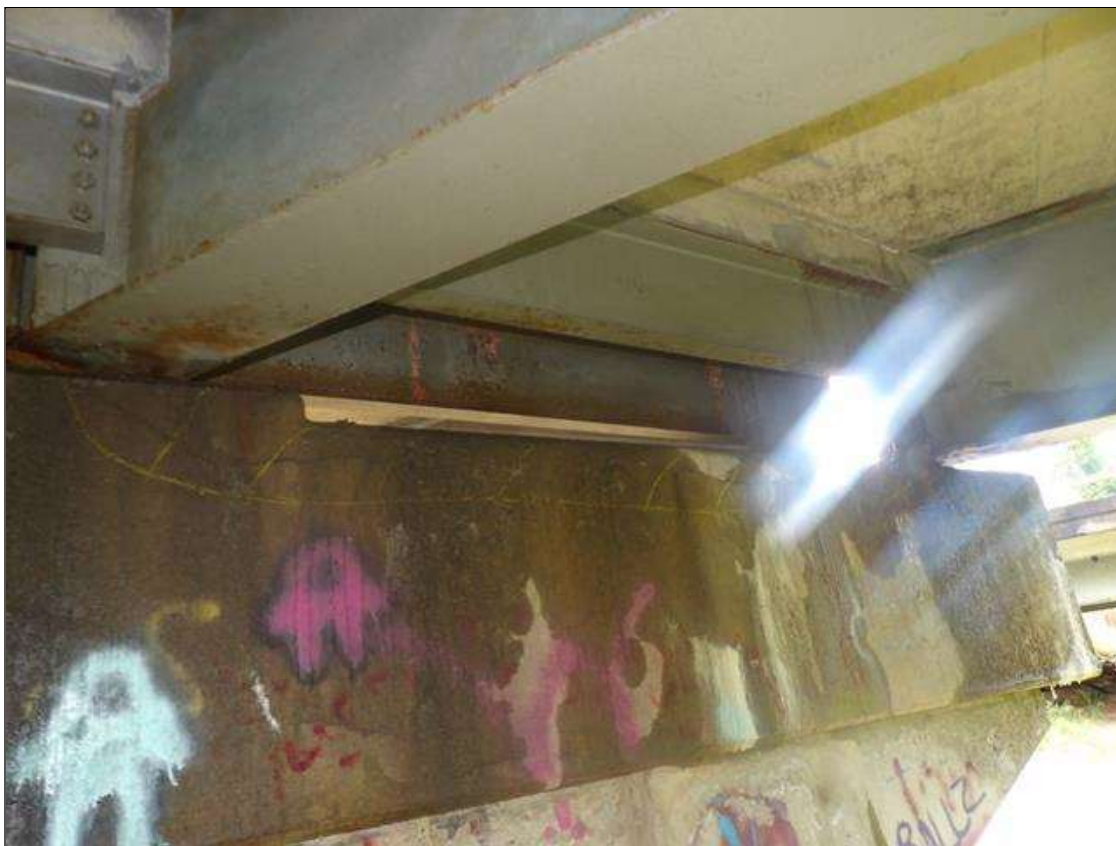
Bent 3 Cap 1: 7 FEET X 6 INCHES X 22 INCHES AREA OF DELAMINATION WITH UP TO 1/16 INCHES LONGITUDINAL AND HORIZONTAL CRACKS WITH AND WITHOUT EFFLORESCENCE IN TOP AND SPAN 3 FACE OF CAP BENEATH BAY 3

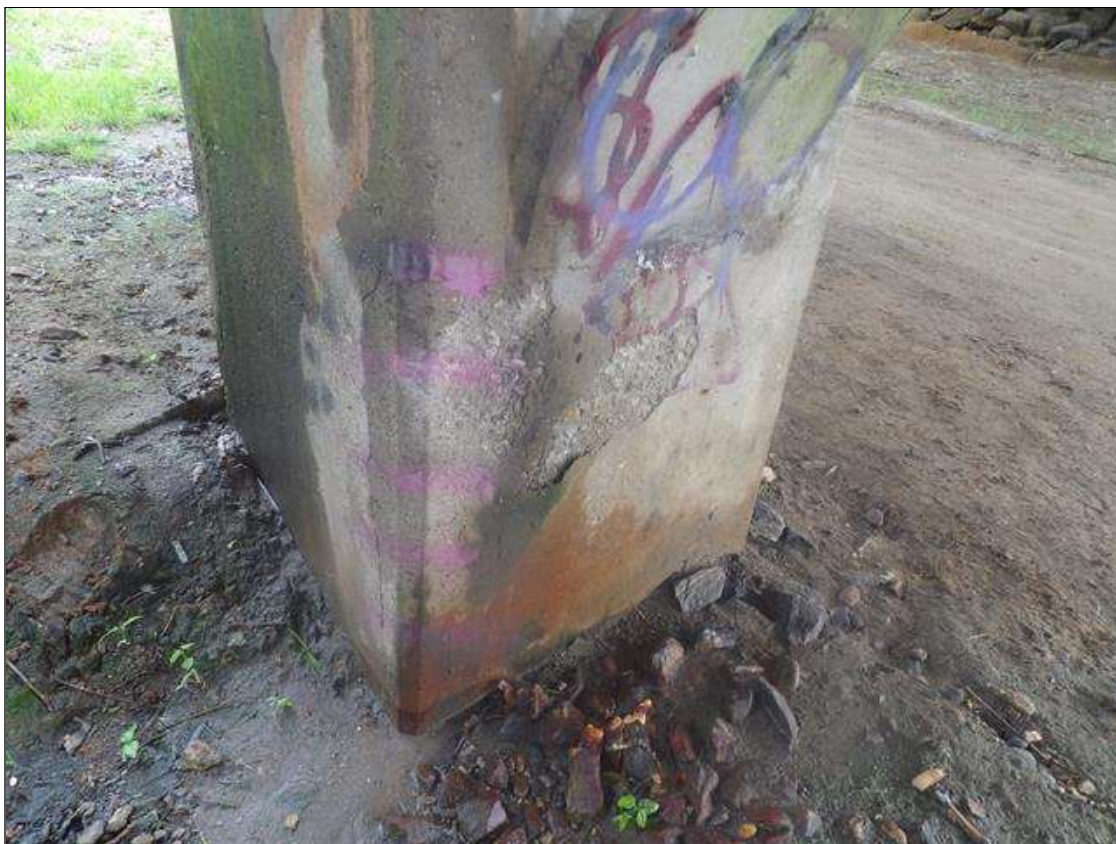
Bent 3 Pile 1: WEST FACE STARTING AT BOTTOM OF PILE, SPALL 2 FEET HIGH X 1 FEET WIDE X UP TO 1/8 INCH DEEP

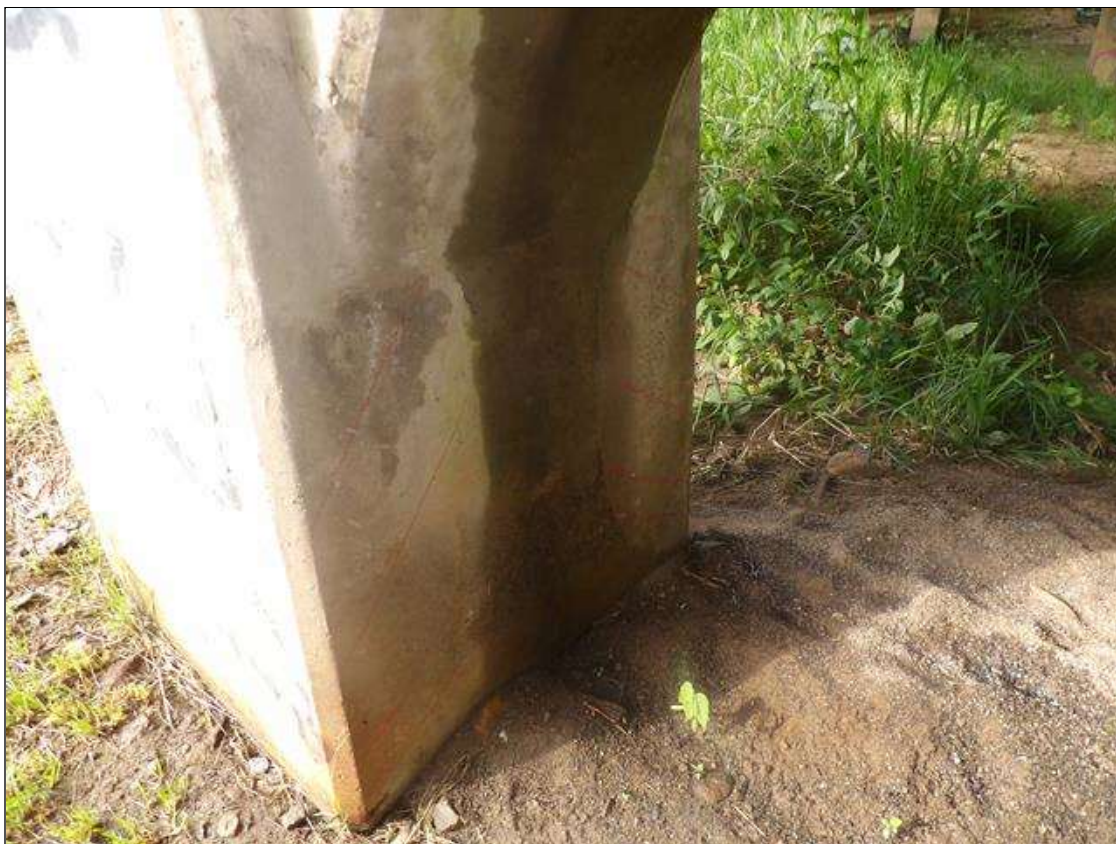
Bent 3 Pile 2: (2) AREAS OF DELAMINATION UP TO 33 INCHES X 9 INCHES X 9 INCHES WITH UP TO 1/16 INCHES VERTICAL CRACKS IN SOUTHWEST AND NORTHWEST CORNERS, APPROXIMATELY 3 FEET FROM BOTTOM OF CAP

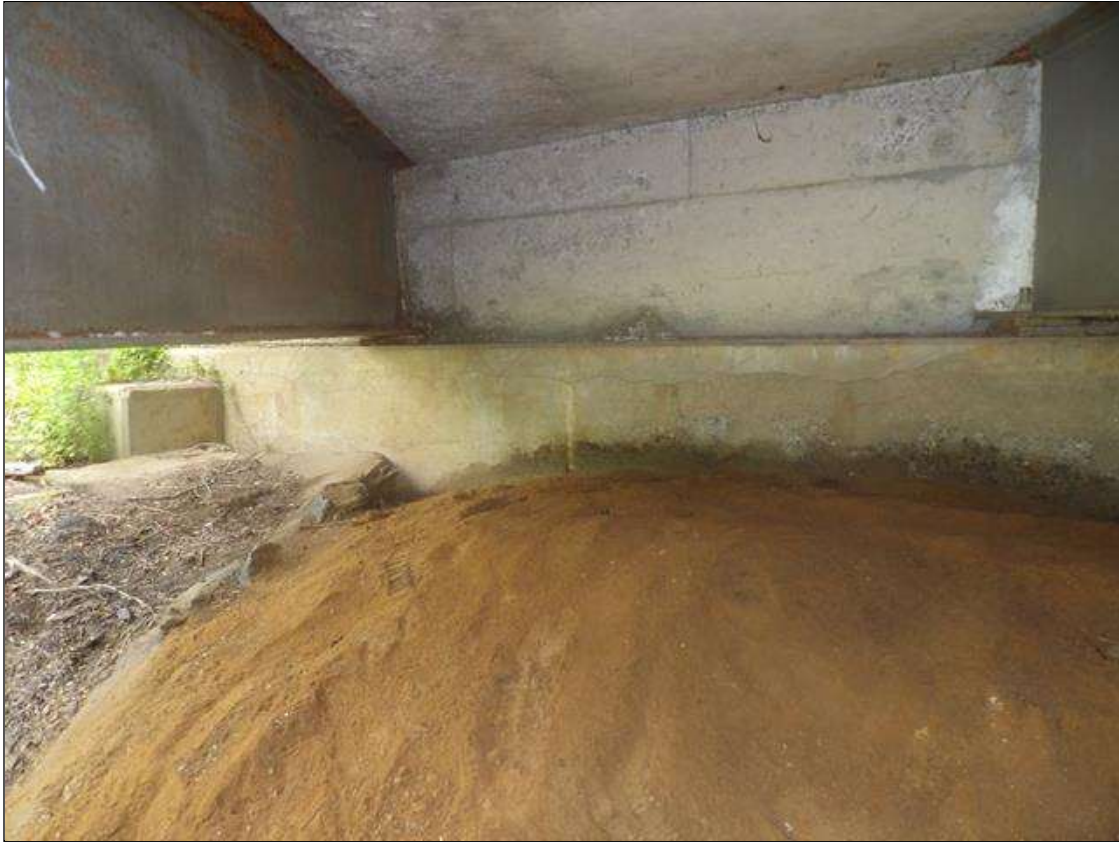
End Bent 2 Cap 1: 13 FEET X 15 INCHES X 8 INCHES AREA OF DELAMINATION WITH UP TO 1/16 INCHES LONGITUDINAL AND HORIZONTAL CRACKS WITH AND WITHOUT EFFLORESCENCE IN TOP AND FACE OF CAP FROM LEFT OF BEAM 1 TO BEAM 2

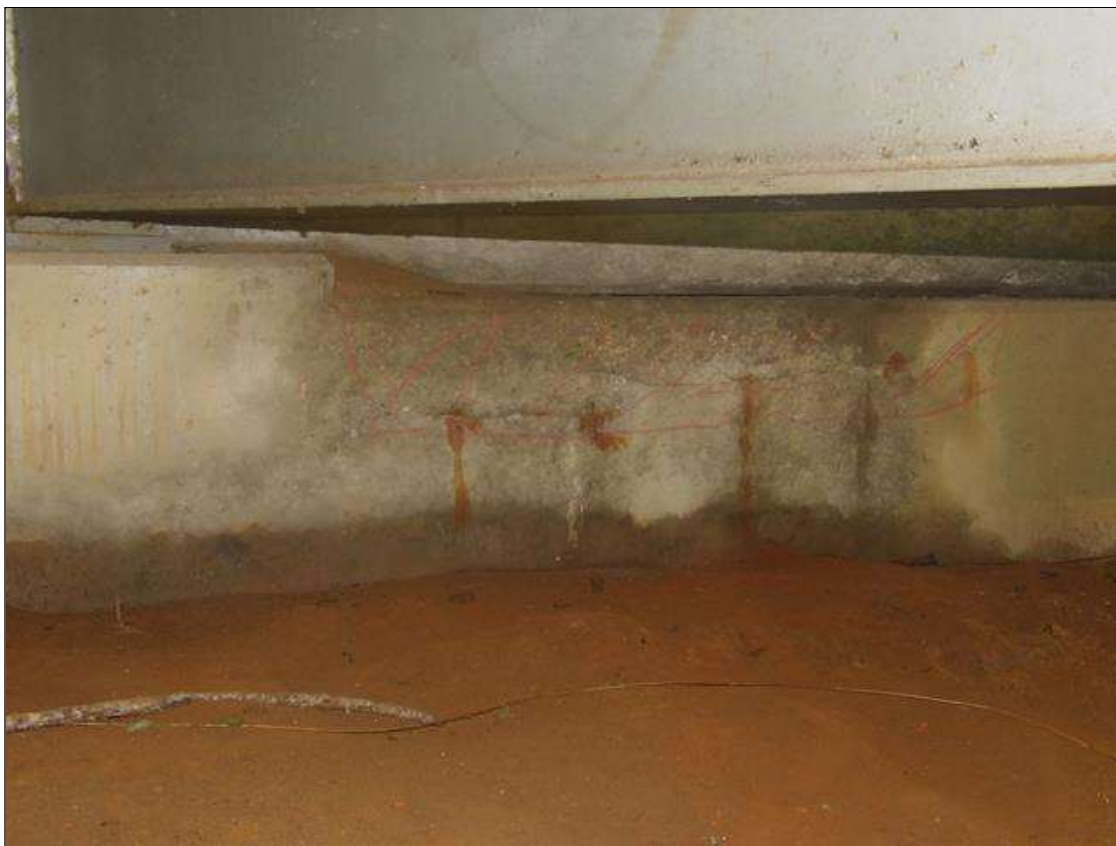
End Bent 2 Cap 1: 46 INCHES X 8 INCHES X 9 INCHES AREA OF DELAMINATION WITH UP TO 1/16 INCHES LONGITUDINAL AND HORIZONTAL CRACKS WITH AND WITHOUT EFFLORESCENCE IN TOP AND FACE OF CAP BENEATH BAY 3

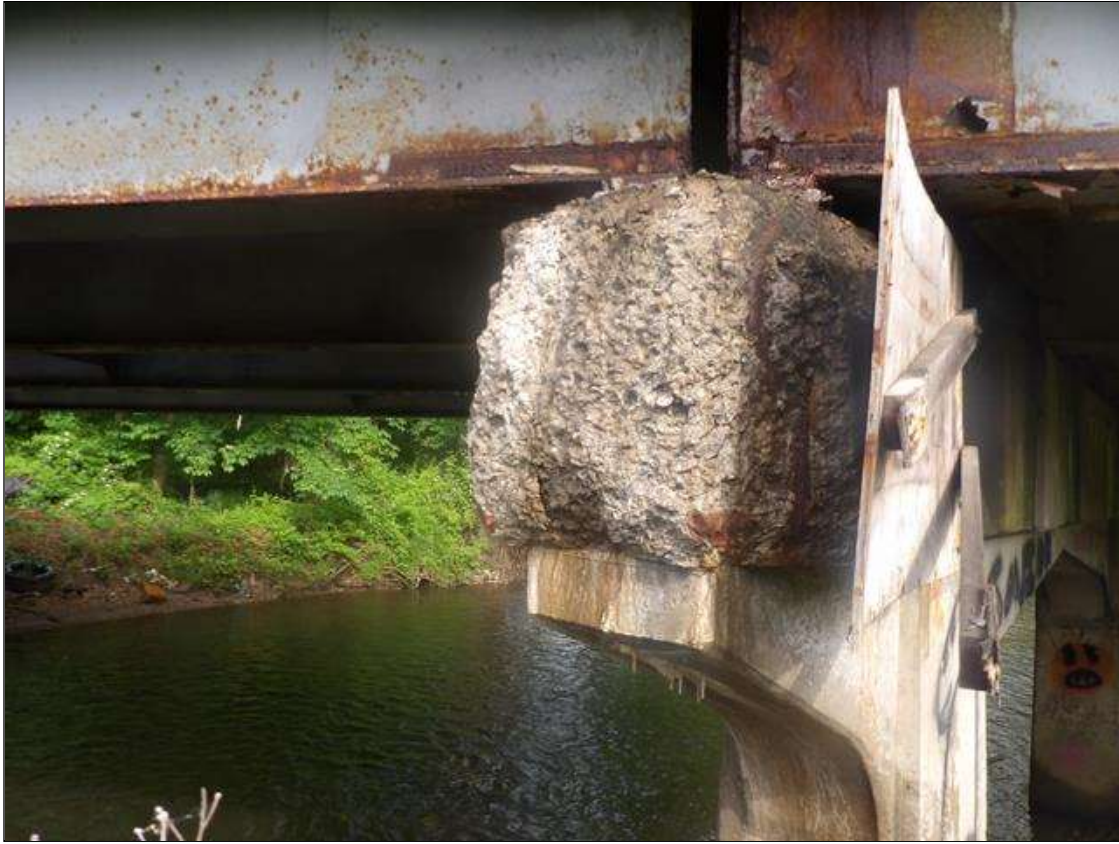
Bent 2 Cap 1: PAR: 30 INCHES X 30 INCHES X 12 INCHES DEEP SPALL WITH EXPOSED REBAR WITH MINOR SECTION LOSS AND FAILED REPAIR WITH 4 FEET SECTION OF FORMWORK IN RIGHT END OF CAP

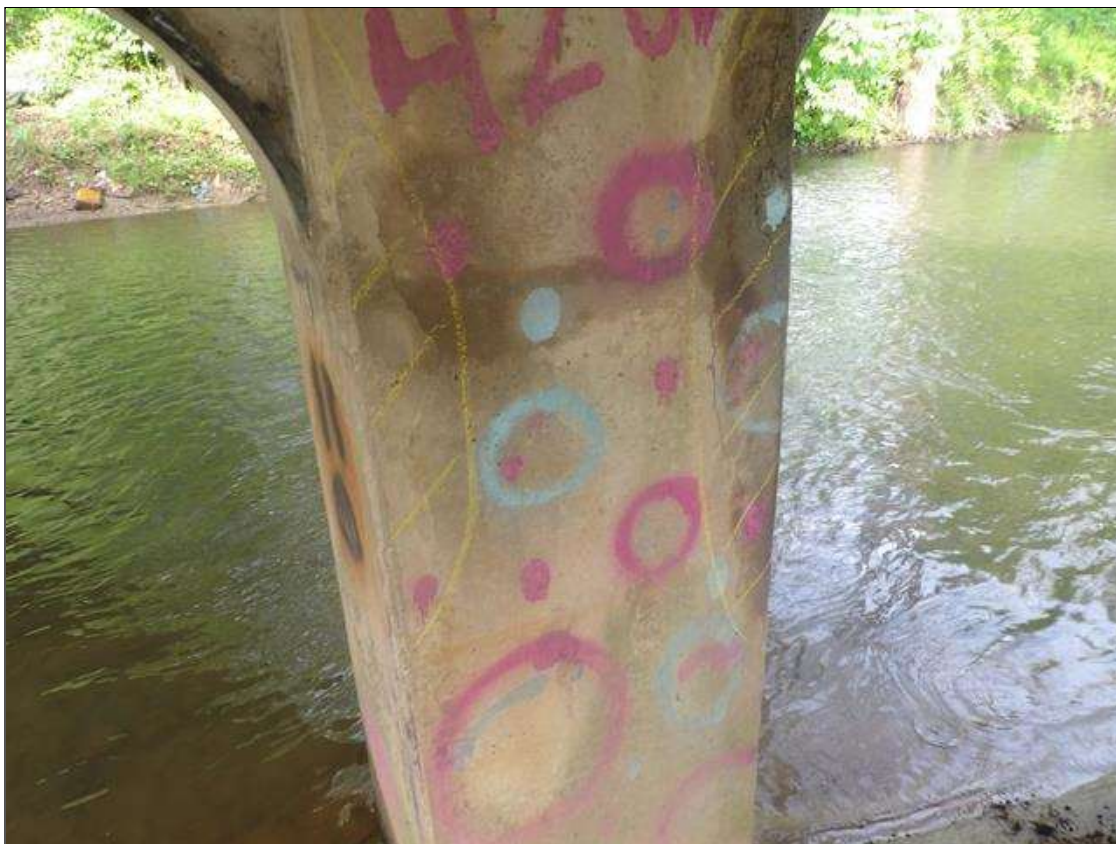
Bent 2 Pile 1: (2) AREAS OF DELAMINATION UP TO 36 INCHES X 7 INCHES X 5 INCHES WITH 1/16 INCHES VERTICAL CRACKS IN NORTHWEST AND NORTHEAST CORNERS OF COLUMN, APPROXIMATELY 3 FEET FROM BOTTOM OF CAP

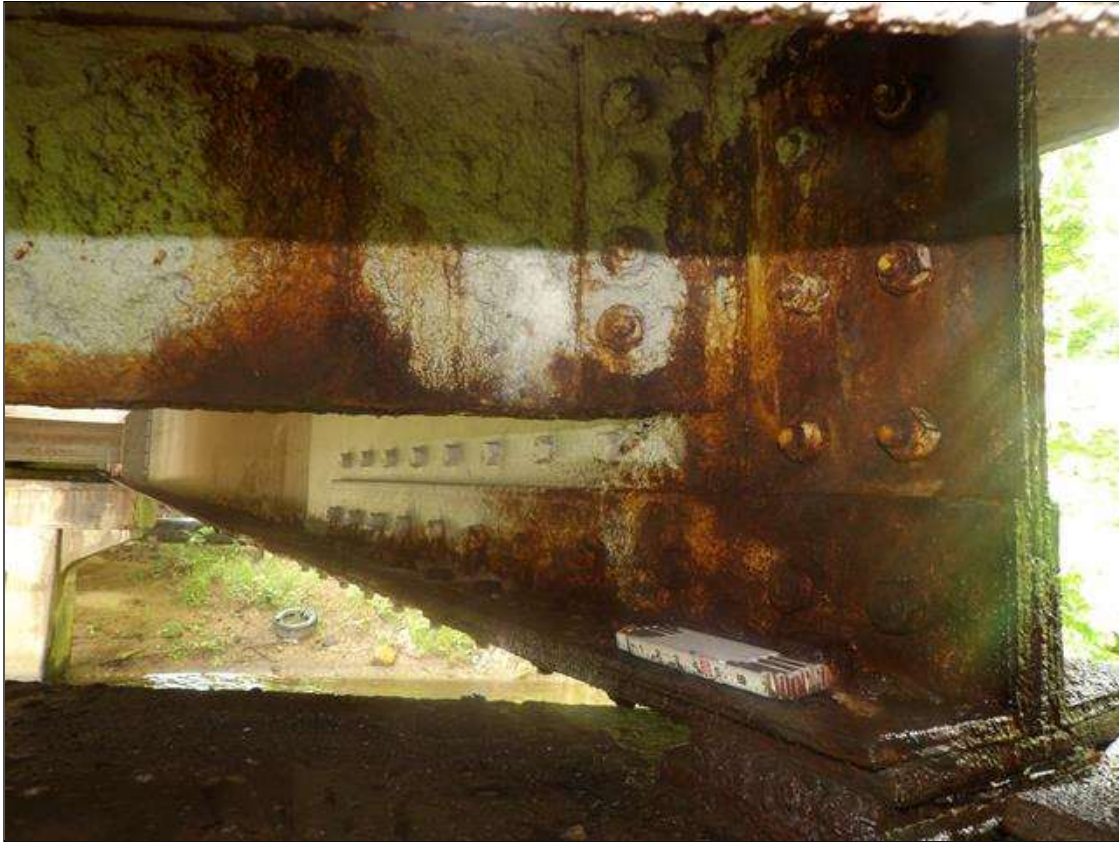
SPAN 2 BEAM 1 AT BENT 2 END, REPAIR PLATE 6 INCH X 6 INCH X 1/2 INCH ANGLE THAT IS 5 FEET LONG BOLTED TO WEB AND FLANGE WITH 3/4 INCH DIAMETER BOLTS SPACED AT 6 INCH ON CENTER. WEB HAS 10 INCH LONG X 1 FEET 9 INCH HIGH X 3/8 INCH THICK PLATE ALSO BOLTED WITH 3/4 INCH DIAMETER BOLTS.

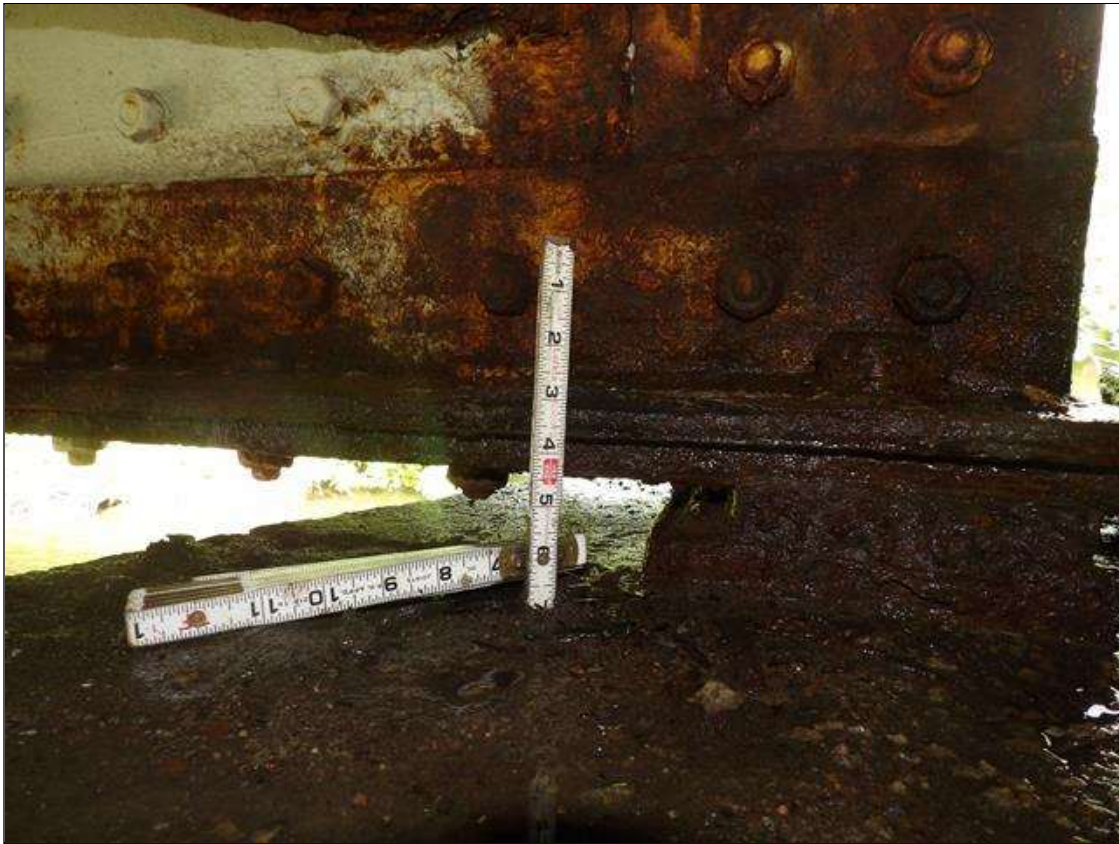
Span 2 Beam 1: AT BENT 2 END, REPAIR HAS BEEN INSTALLED CONSISTING OF 6 INCH X 6 INCH X 1/2 INCH ANGLE THAT IS 5 FEET LONG BOLTED TO WEB AND FLANGE WITH 3/4 INCH DIAMETER BOLTS SPACED AT 6 INCH ON CENTER. WEB HAS 10 INCH LONG X 1 FEET 9 INCH HIGH X 3/8 INCH THICK PLATE ALSO BOLTED WITH 3/4 INCH DIAMETER BOLTS. ANGLE HAS 1/16 INCH SECTION LOSS ON OUTER EDGES WITH 7/16 INCH AVERAGE REMAINING AND PLATE HAVE SURFACE CORROSION.
