NC DEPARTMENT OF TRANSPORTATION
 DIVISION OF HIGHWAYS
 STRUCTURE MANAGEMENT UNIT

ATTENTION: **PRIORITY ACTION REQUEST ISSUED; CHANGE TO APPROACH ROADWAY DATA**

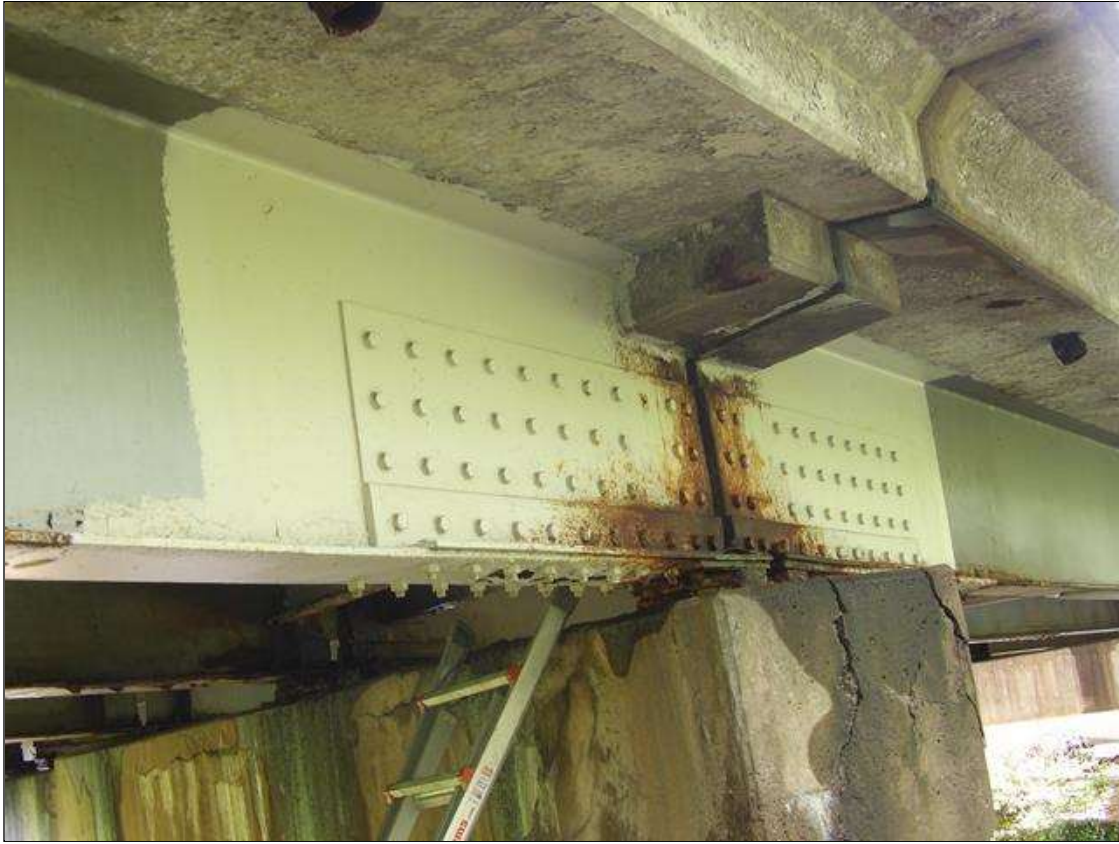
SPAN 3 BEAM 1 AT BENT 2 END, REPAIR PLATES 6 IN X 6 IN X 1/2 IN ANGLE THAT IS 5 FT LONG BOLTED TO WEB AND FLANGE WITH 3/4 IN DIAMETER BOLTS SPACED AT 6 IN ON CENTER. WEB HAS 10 IN LONG X 1 FT 9 IN HIGH X 3/8 IN THICK PLATE ALSO BOLTED WITH 3/4 IN DIAMETER BOLTS. ANGLE AND PLATE HAVE SURFACE RUST.

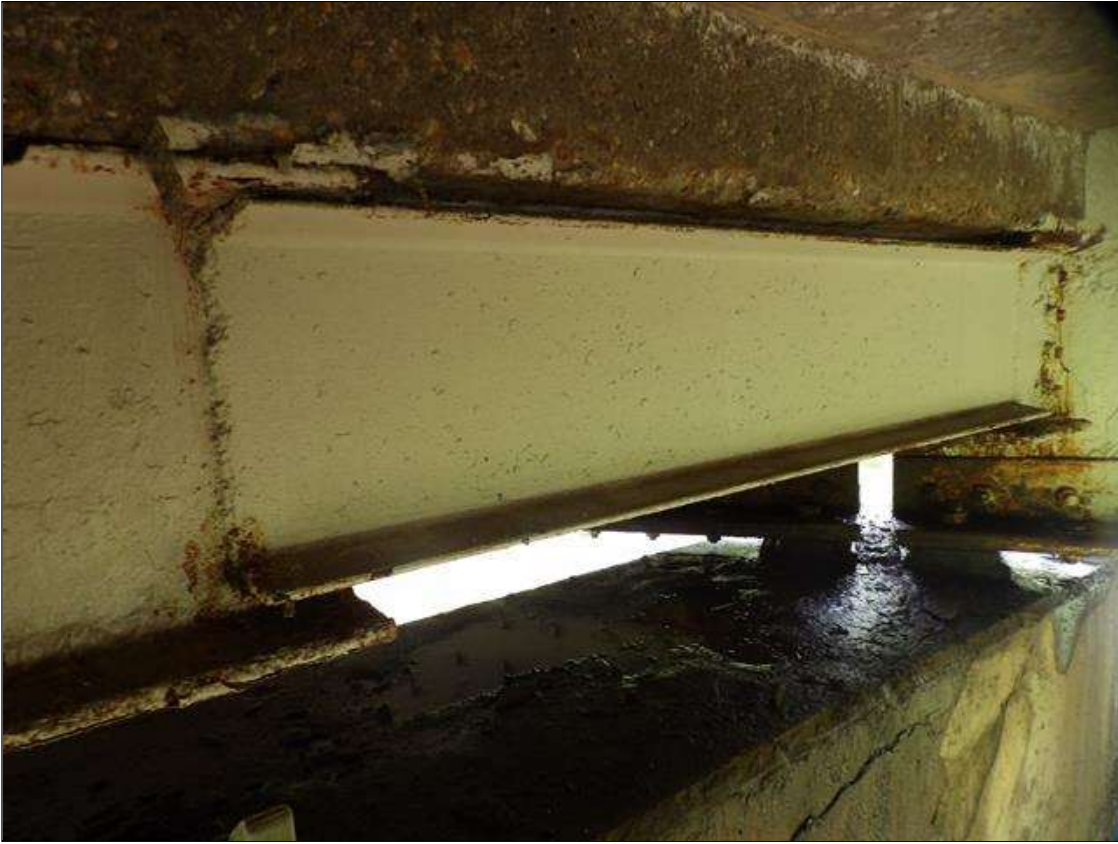
SPAN 3 BENT 2 DIAPHRAGM IN BAY 1, 5 FEET LONG SECTION HAS BEEN REPLACED WITH 12 INCHES X 3 INCHES STEEL CHANNEL WELDED AT EACH END

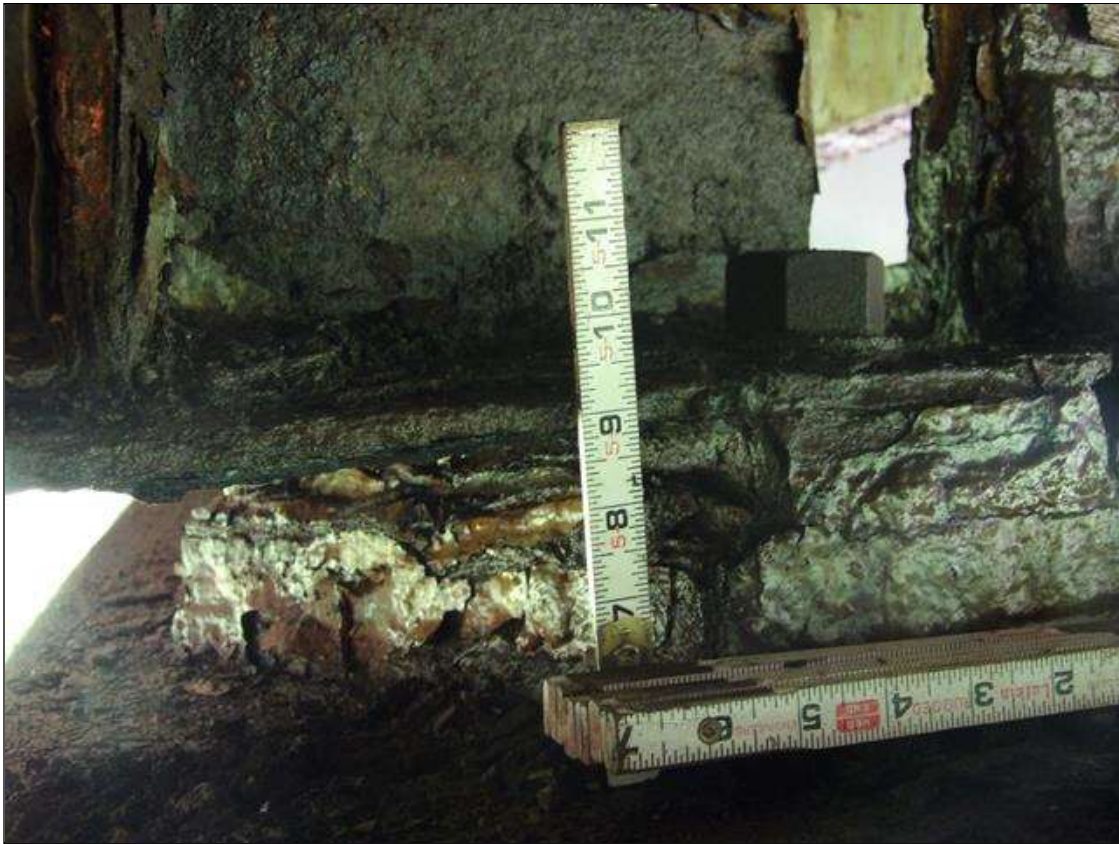
Span 3 Beam 2: PAR: CORROSION ALONG BOTH FACES OF WEB AND BOTTOM FLANGE UP TO 10 INCHES LONG X 4 INCHES HIGH DOWN TO 1/4 INCHES RESIDUAL WEB, AND 12 INCHES LONG X 5 1/2 INCHES WIDE DOWN TO 3/8 INCHES RESIDUAL FLANGE AT BENT 2

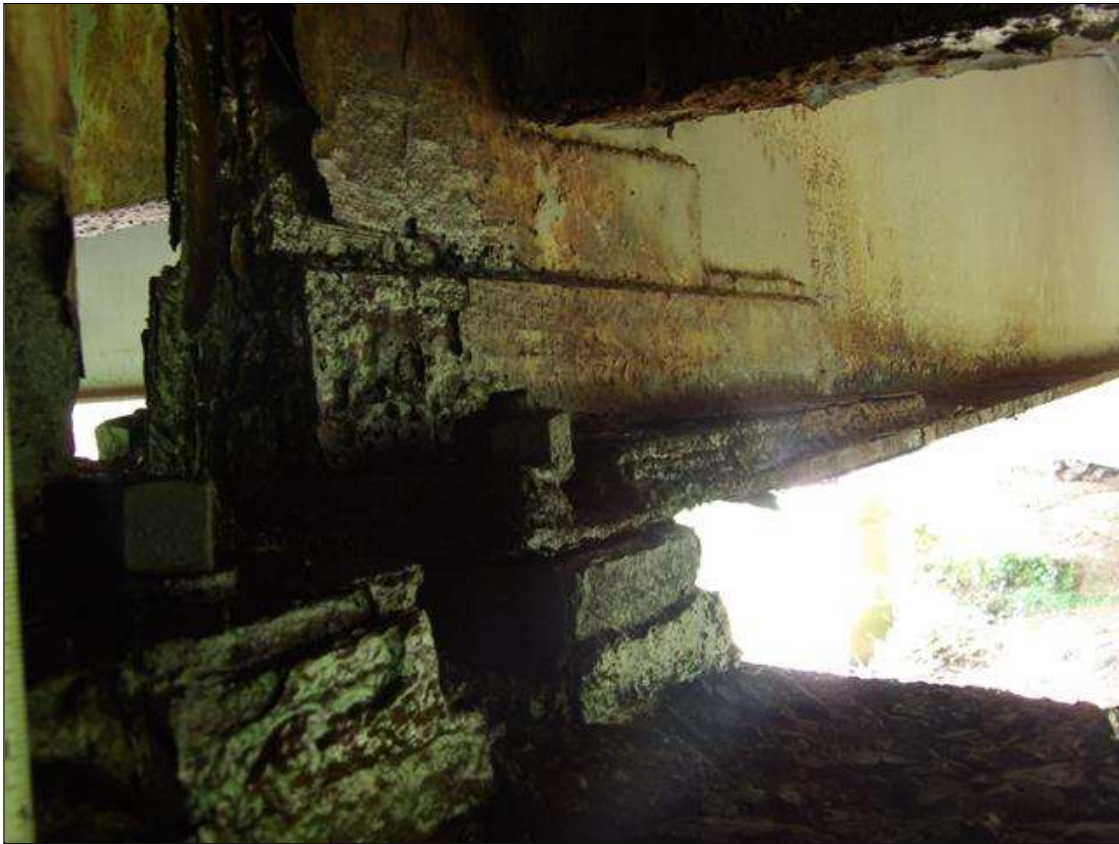
SPAN 2 BEAM 2 AT BENT 2, WELDED PLATE REPAIRS ON BOTH FACES OF WEB AND BOTTOM FLANGE UP TO 36 INCHES LONG X 20 INCHES HIGH 1/2 INCH THICK IN WEB, AND 36 INCHES LONG X 4 INCHES WIDE X 4 INCH HIGH X 1/2 INCH THICK ANGLE

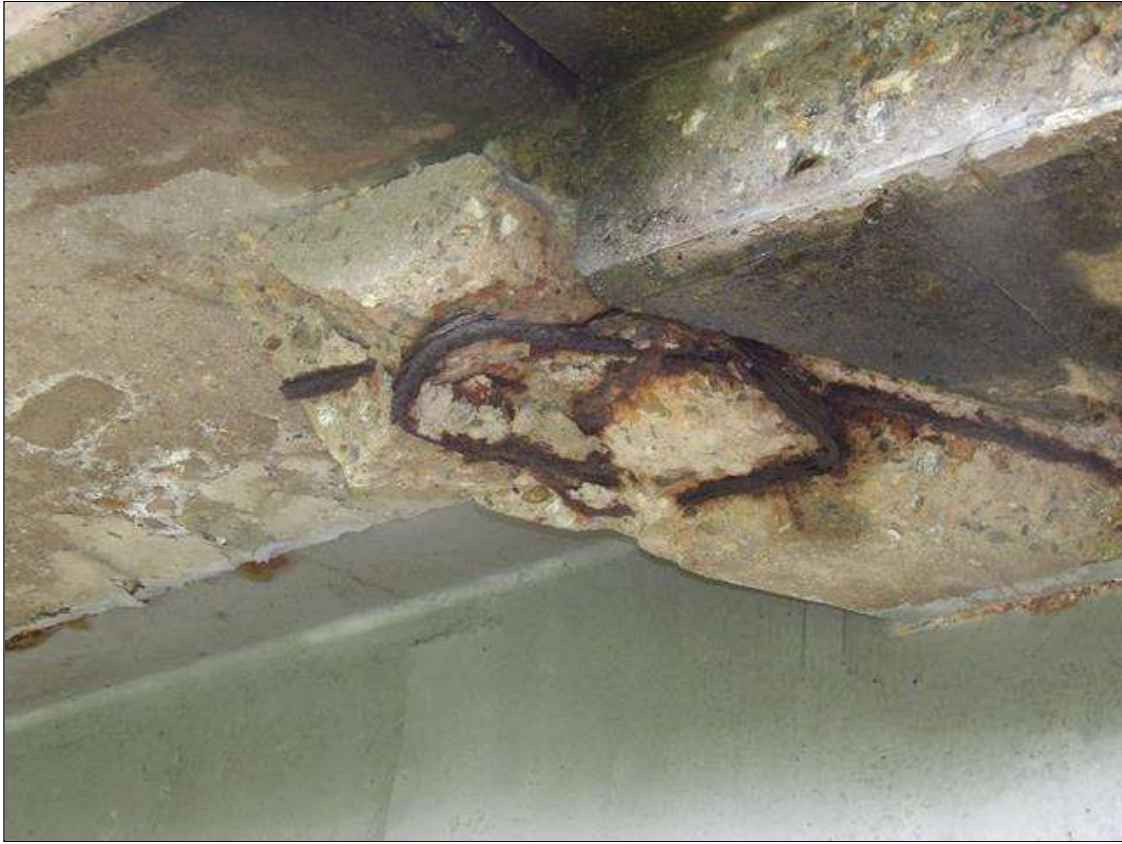
TYPICAL OVERHANG DIAPHRAGM SPALL 1 FEET LONG X 2 FEET WIDE X UP TO 4 INCH DEEP WITH EXPOSED REBAR WITH NO MEASURABLE SECTION LOSS, AT BENT 2 SHOWN

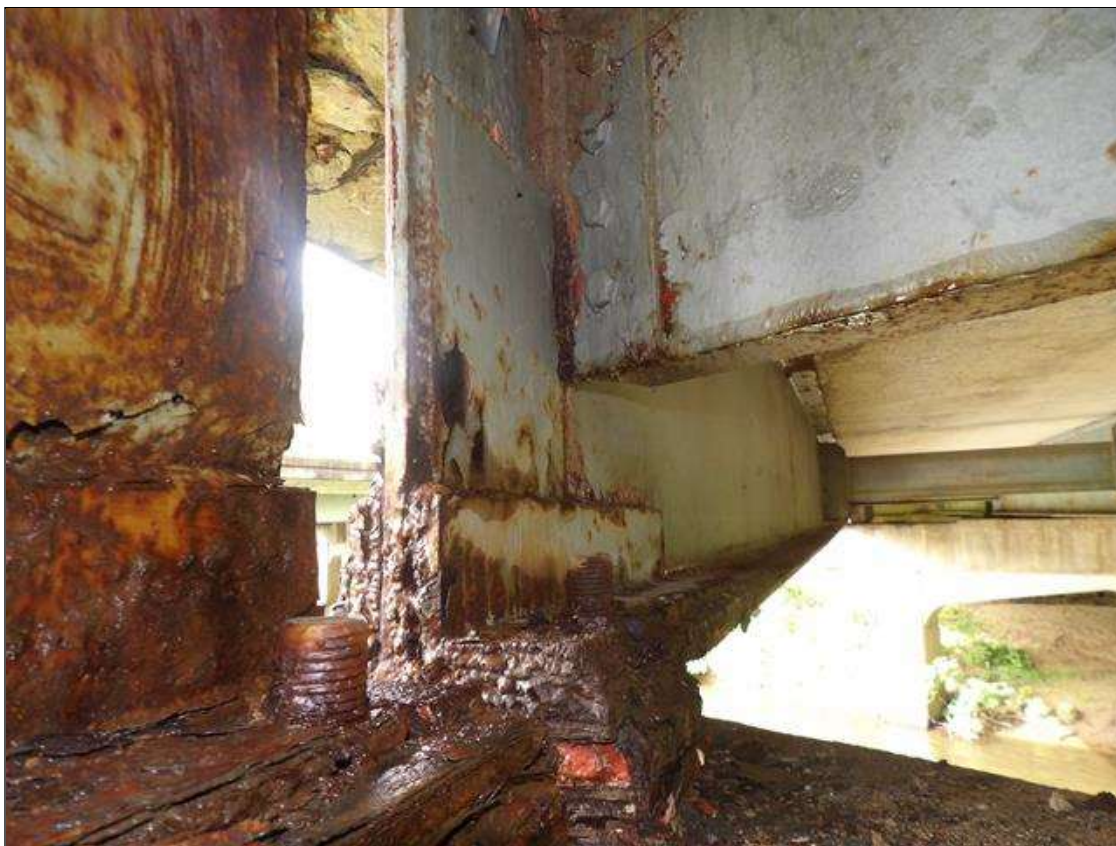
SPAN 2 BEAM 4 AT BENT 2 WELDED PLATE REPAIRS ON BOTH FACES OF WEB AND BOTTOM FLANGE UP TO 30 INCHES LONG X 14 INCHES HIGH X 1/2 INCH THICK IN WEB, AND 30 INCHES LONG X 4 INCHES WIDE X 1/2 INCH THICK IN FLANGE AT BENT 2

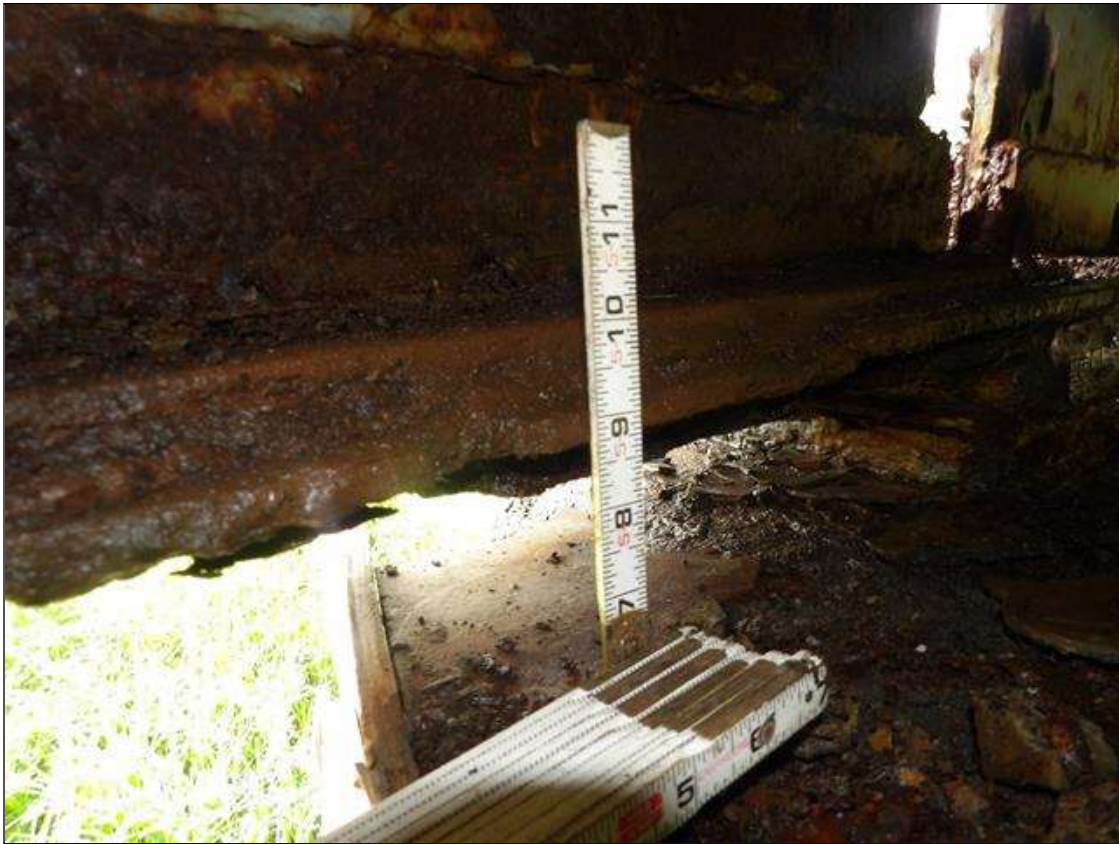
Span 3 Beam 4: PAR--6 FOOT LONG CORROSION IN BOTTOM FLANGE REPAIR PLATE WITH 1/4 INCH AVERAGE REMAINING WITH 1 1/2 INCH X 1/2 INCH HOLE IN LEFT SIDE AT 18 INCHES FROM BEARING, BOTTOM FLANGE BELOW REPAIR PLATE WITH 3/8 INCH AVERAGE REMAINING WITH 24 INCH X UP TO 1 1/2 INCH WIDE HOLE IN LEFT SIDE STARTING AT BEARING. MEASUREMENTS OF WELDED PLATE REPAIRS ON BOTH FACES OF WEB AND BOTTOM FLANGE UP TO 60 INCHES LONG X 21 1/2 INCHES HIGH X 1/2 INCH THICK IN WEB, AND 60 INCHES LONG X 4 INCHES WIDE X 1/2 INCH THICK IN FLANGE AT BENT 2

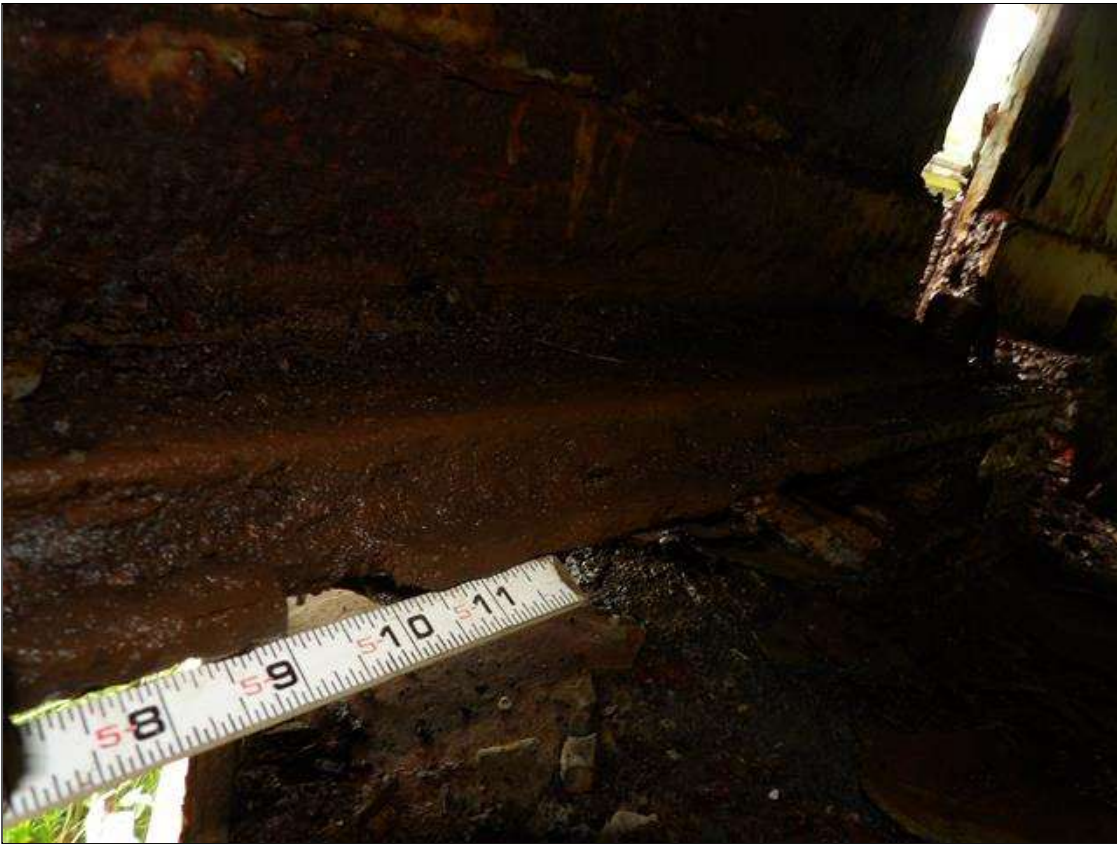
Span 3 Beam 4: PAR--6 FOOT LONG CORROSION IN BOTTOM FLANGE REPAIR PLATE WITH 1/4 INCH AVERAGE REMAINING WITH 1 1/2 INCH X 1/2 INCH HOLE IN LEFT SIDE AT 18 INCHES FROM BEARING, BOTTOM FLANGE BELOW REPAIR PLATE WITH 3/8 INCH AVERAGE REMAINING WITH 24 INCH X UP TO 1 1/2 INCH WIDE HOLE IN LEFT SIDE STARTING AT BEARING. MEASUREMENTS OF WELDED PLATE REPAIRS ON BOTH FACES OF WEB AND BOTTOM FLANGE UP TO 60 INCHES LONG X 21 1/2 INCHES HIGH X 1/2 INCH THICK IN WEB, AND 60 INCHES LONG X 4 INCHES WIDE X 1/2 INCH THICK IN FLANGE AT BENT 2

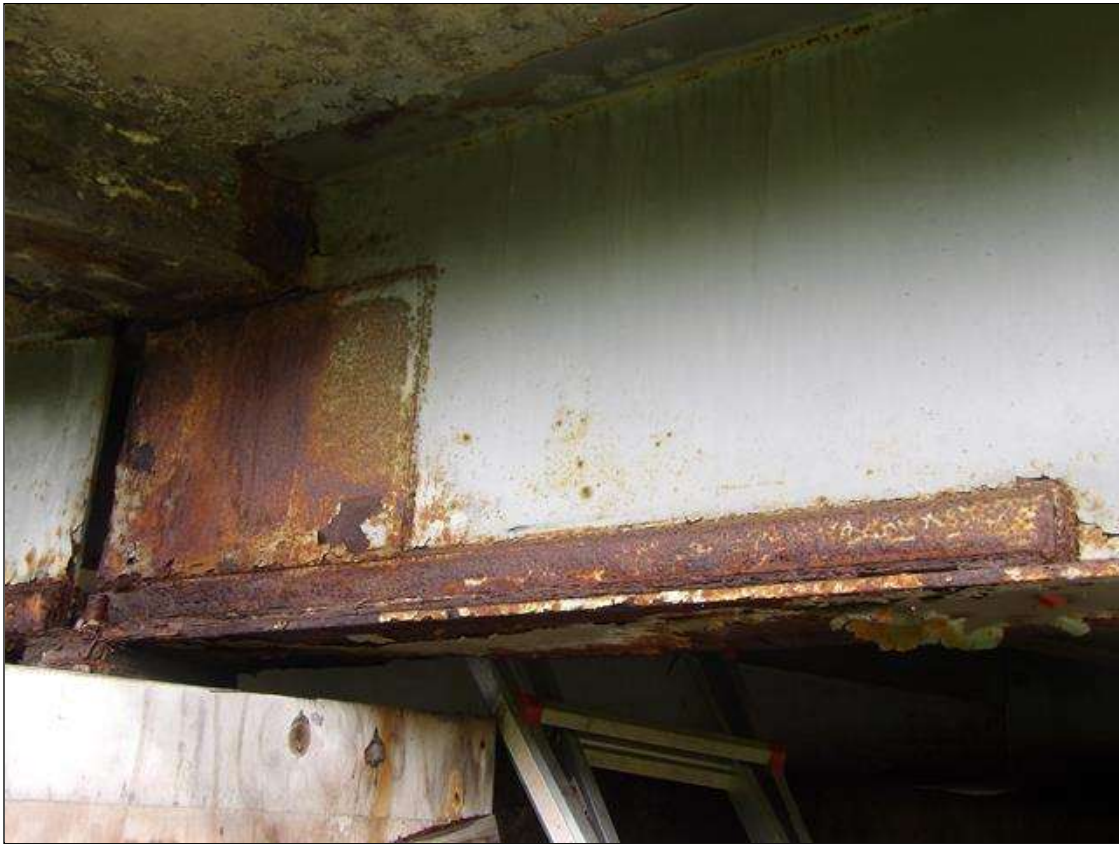
SPAN 3 BEAM 4 AT BENT 2 WELDED PLATE REPAIRS ON BOTH FACES OF WEB AND BOTTOM FLANGE UP TO 60 INCHES LONG X 21 1/2 INCHES HIGH X 1/2 INCH THICK IN WEB, AND 60 INCHES LONG X 4 INCHES WIDE X 1/2 INCH THICK IN FLANGE AT BENT 2

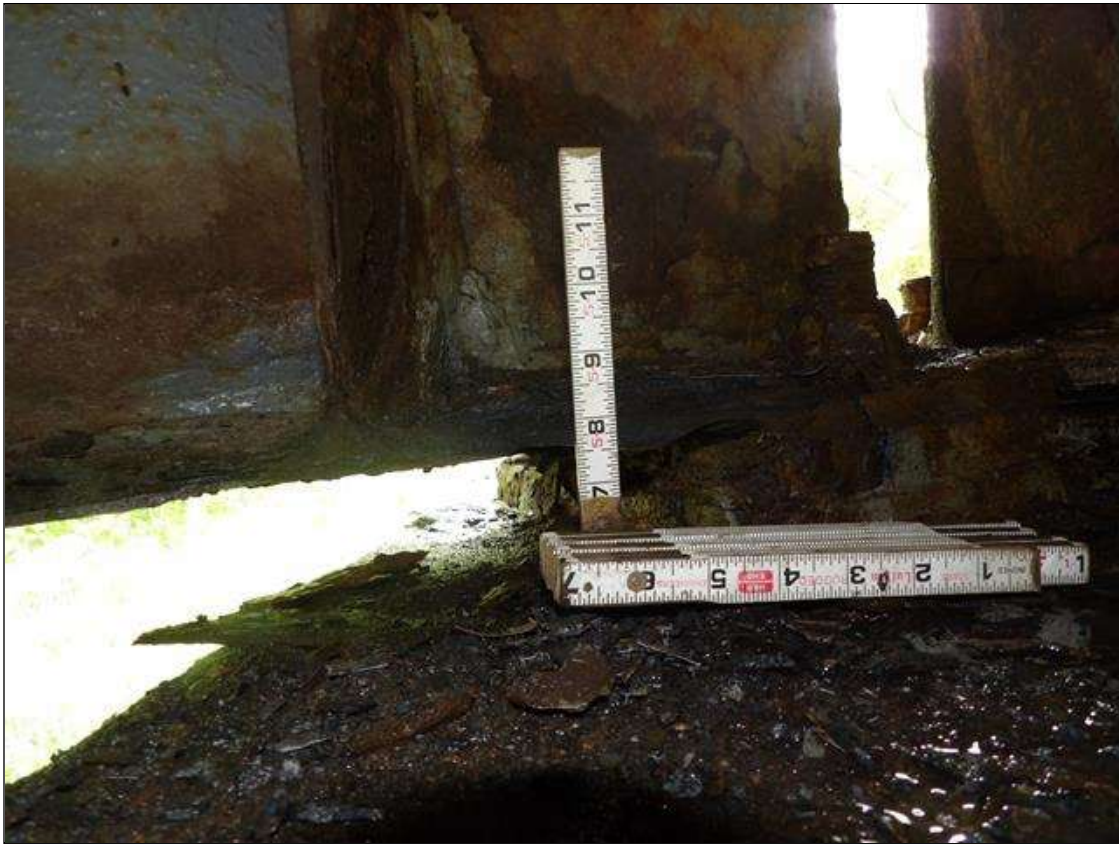
Span 3 Beam 1: PAR: CORROSION ALONG BOTH FACES OF WEB AND BOTTOM FLANGE UP TO 43 INCHES LONG X 10 INCHES HIGH DOWN TO 1/2 INCHES RESIDUAL WEB, AND 36 INCHES LONG X UP TO 11 INCHES WIDE WITH SECTION LOSS DOWN TO KNIFES EDGE WITH 1/4 INCH AVERAGE REMAINING FULL WIDTH OF FLANGE WITH 8 INCH X 2 INCH AREA AT BEARING THAT IS PAPER THIN WITH PERFORATIONS ON RIGHT SIDE AT BENT 3

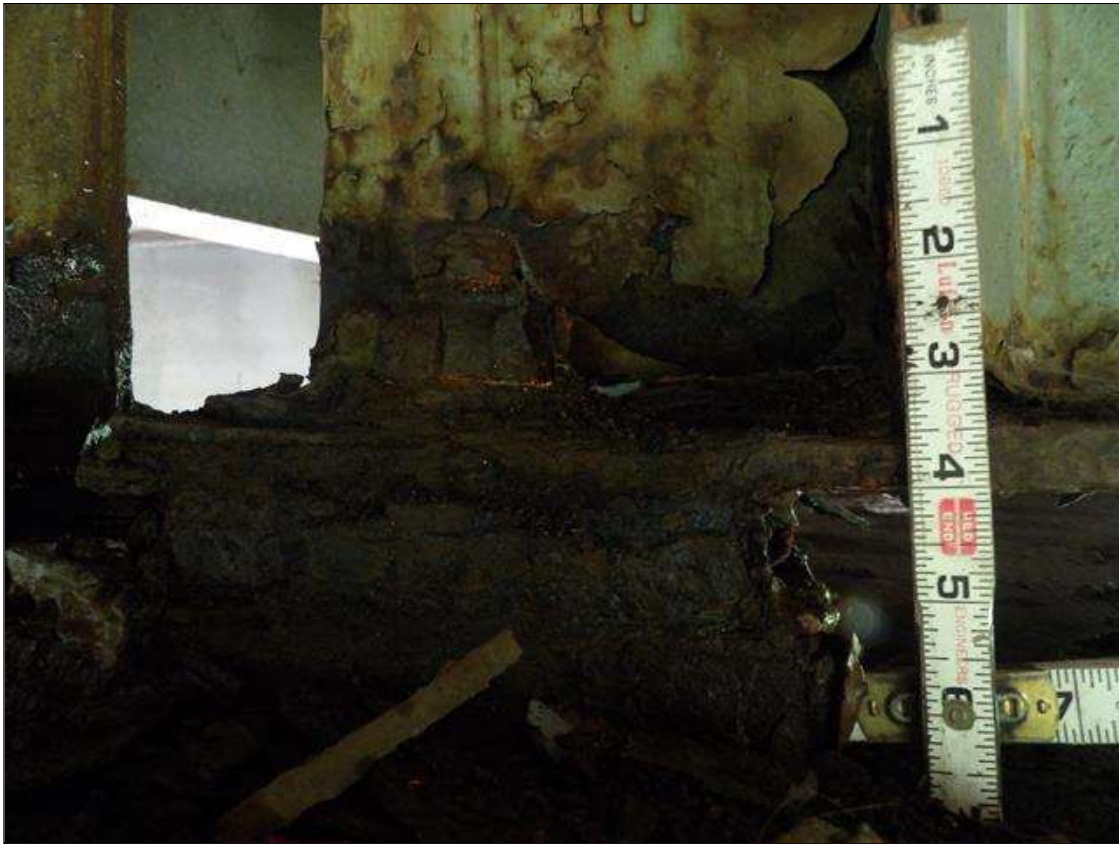
Span 3 Beam 2: CORROSION WITH 1/16 INCH SECTION LOSS ALONG LEFT EDGE OF BOTTOM FLANGE 9 INCHES LONG X 5 1/2 INCHES WIDE (9/16 INCH REMAINING) AT BENT 3

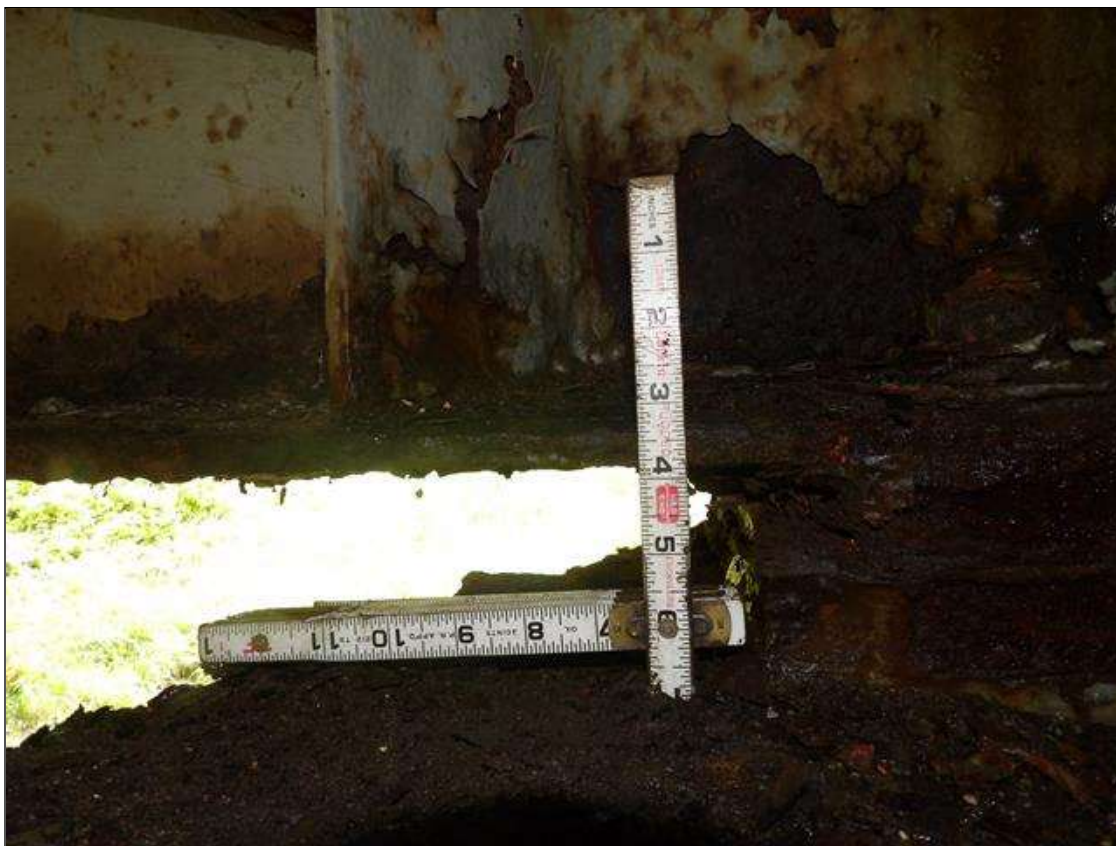
Span 4 Beam 2: CORROSION WITH 1/16 INCH SECTION LOSS ALONG LEFT EDGE OF BOTTOM FLANGE 20 INCHES LONG X 11 5/8 INCHES WIDE (9/16 INCH REMAINING) AND CORROSION WITH NO MEASURABLE LOSS OF SECTION ALONG BOTH FACES OF WEB UP TO 27 INCHES LONG X 5 INCHES HIGH IN WEB AT BENT

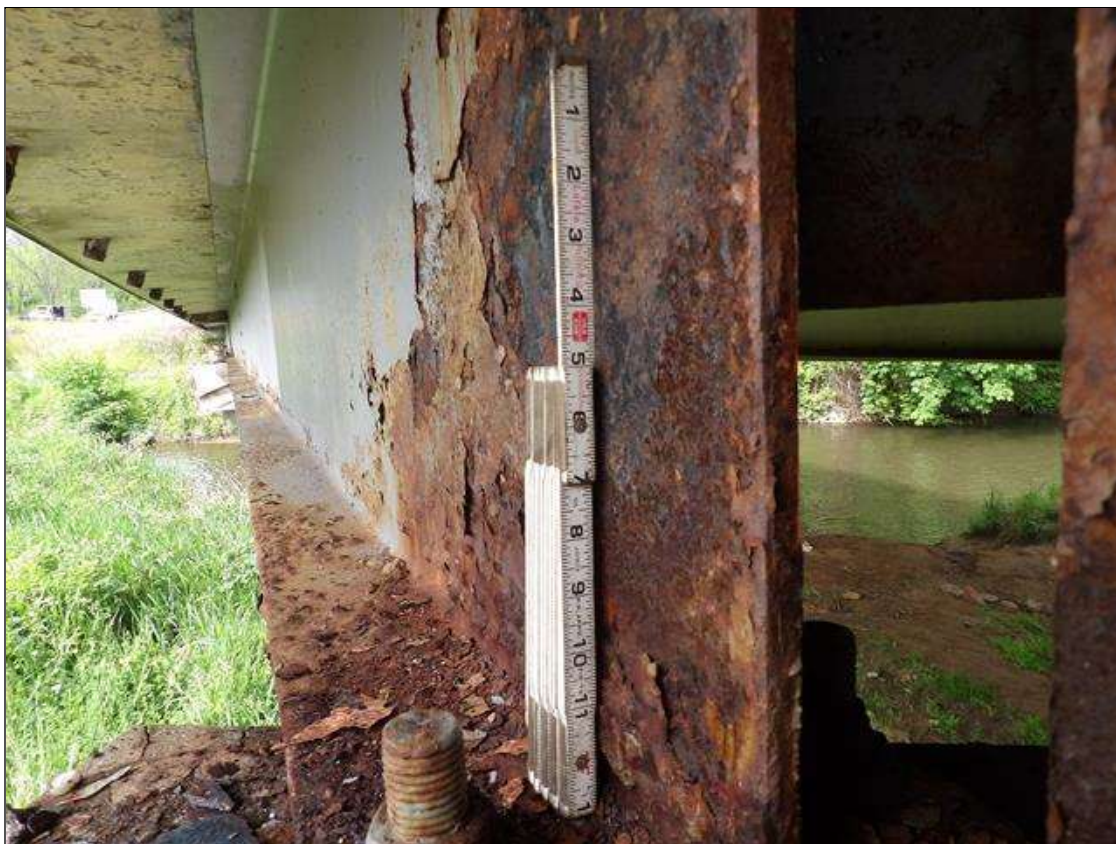
Span 3 Beam 4: 2 FOOT LONG CORROSION IN BOTTOM FLANG AND WEB WITH 1/16 INCH SECTION LOSS IN BOTTOM FLANGE FULL WIDTH WITH 9/16 INCH AVERAGE REMAINING AND UP TO 22 INCHES HIGH IN WEB WITH 1/16 INCH SECTION LOSS WITH 9/16 INCH AVERAGE REMAINING AT BENT 3

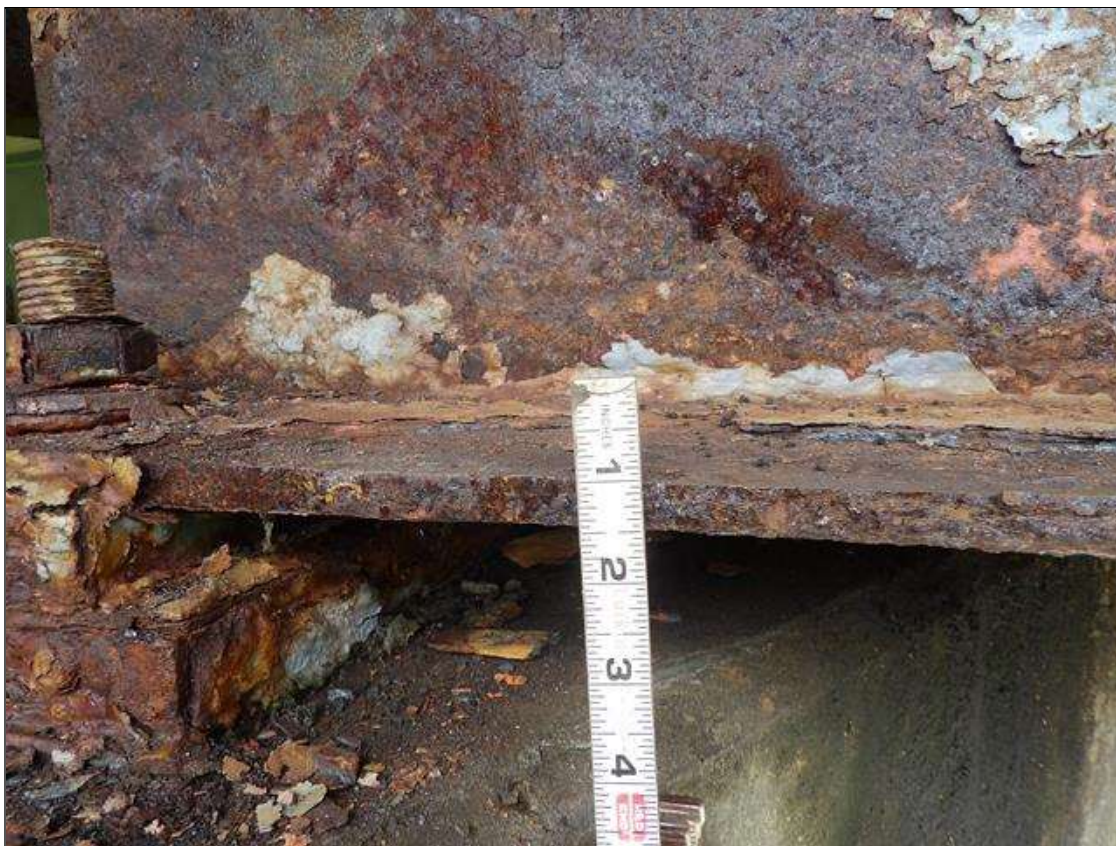
Span 4 Beam 4: CORROSION ALONG BOTH FACES OF WEB AND BOTTOM FLANGE UP TO 36 INCHES LONG X 13 INCHES HIGH WITH NO MEASURABLE LOSS OF SECTION IN WEB, AND 36 INCHES LONG X 5 1/2 INCHES WIDE DOWN TO 7/16 INCHES RESIDUAL WITH 1/2 INCH AVERAGE REMAINING IN FLANGE AT BENT 3

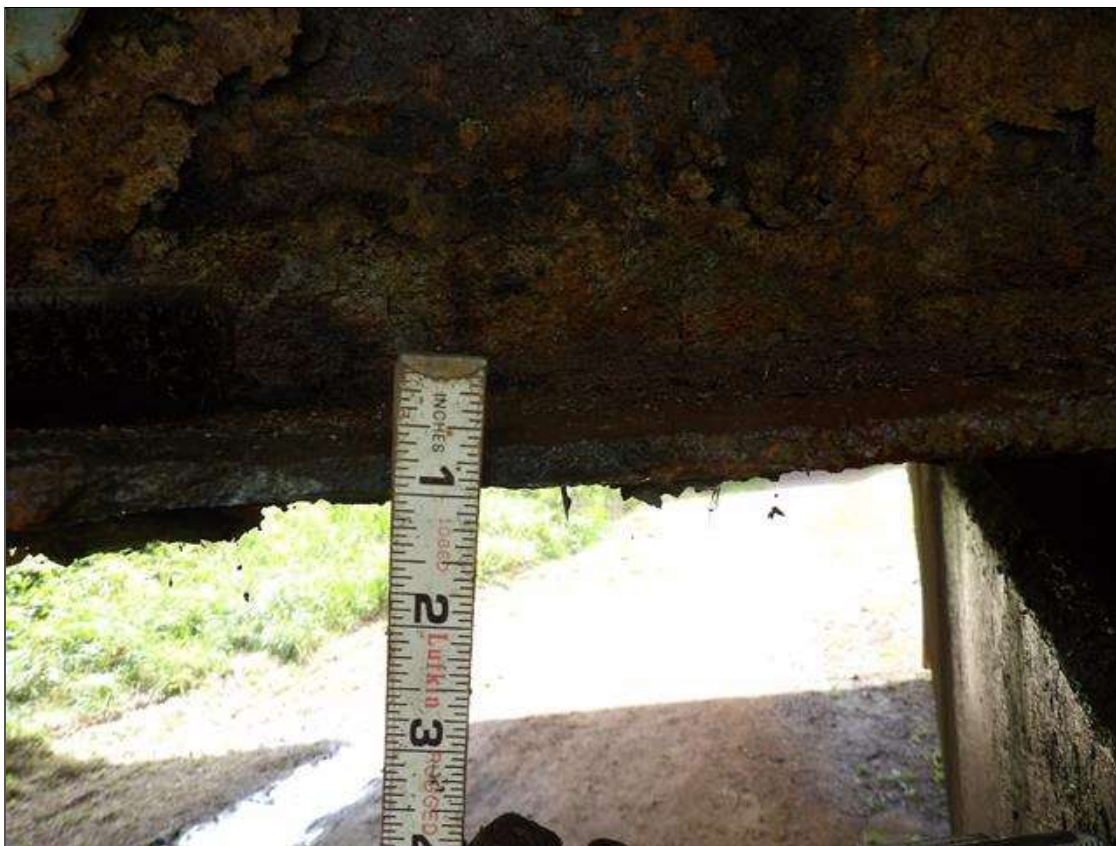
Span 4 Beam 1: PAR: CORROSION ALONG BOTH FACES OF WEB AND BOTTOM FLANGE UP TO 72 INCHES LONG X 31 1/2 INCHES HIGH DOWN TO 7/16 INCHES RESIDUAL WEB, AND 82 INCHES LONG X 11 5/8 INCHES WIDE DOWN TO 3/8 INCHES RESIDUAL FLANGE AT BENT 3

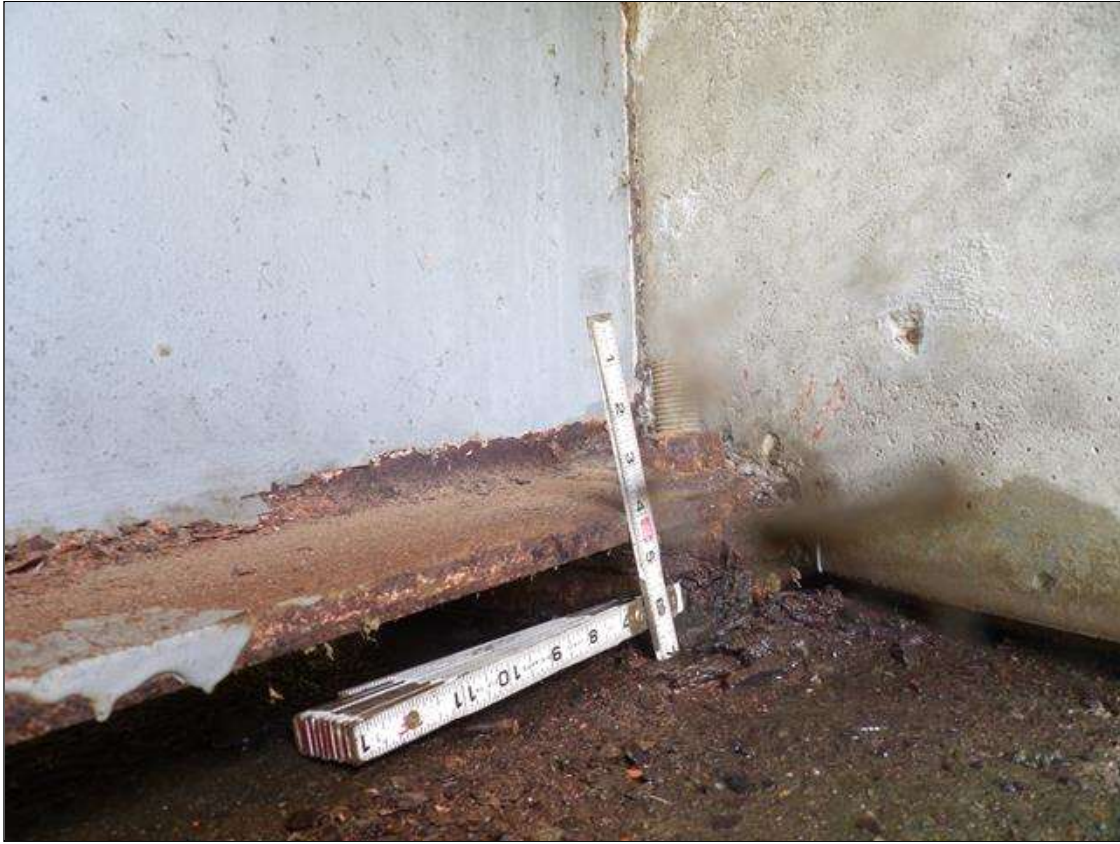
Span 4 Beam 4: CORROSION WITH 1/16 INCH LOSS OF SECTION ALONG RIGHT EDGE OF BOTTOM FLANGE WITH 9/16 INCH REMAINING 6 INCHES LONG X 2 INCHES WIDE AT END BENT 2

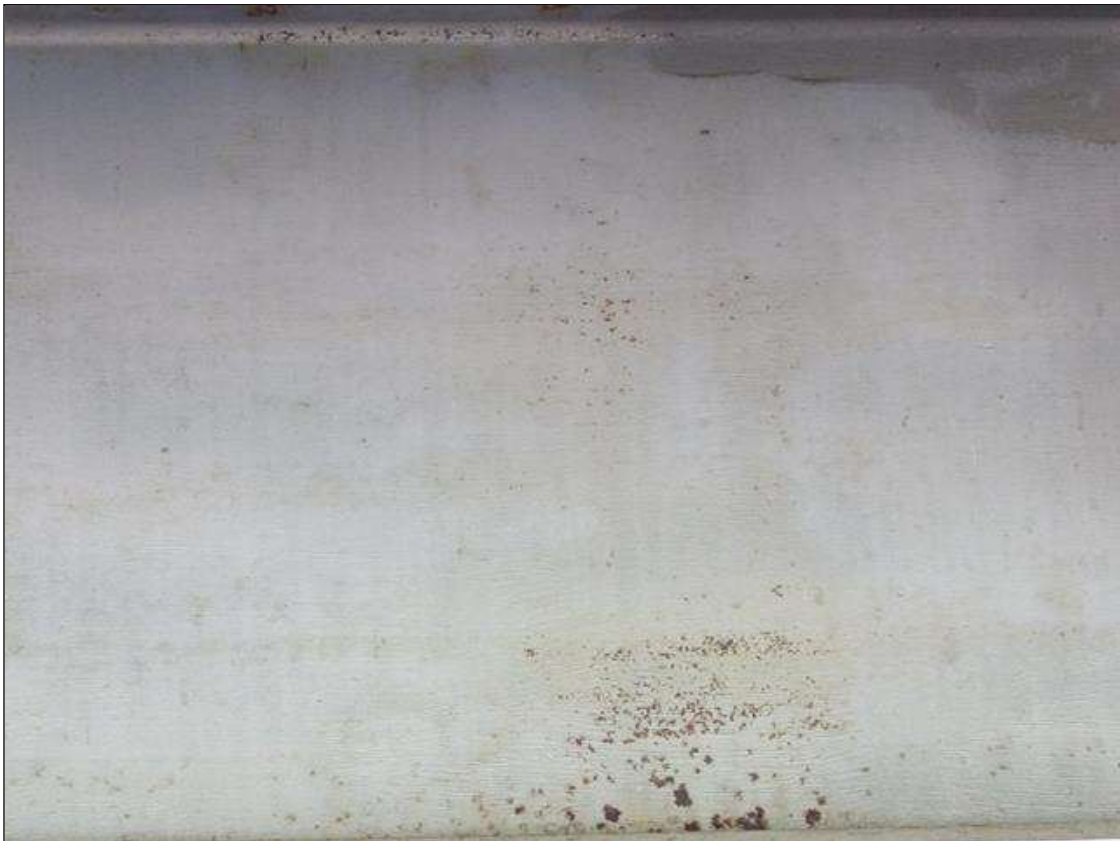
TYPICAL AREAS OF SURFACE CORROSION THROUGHOUT BEAM, SPAN 4 BEAM 3 SHOWN

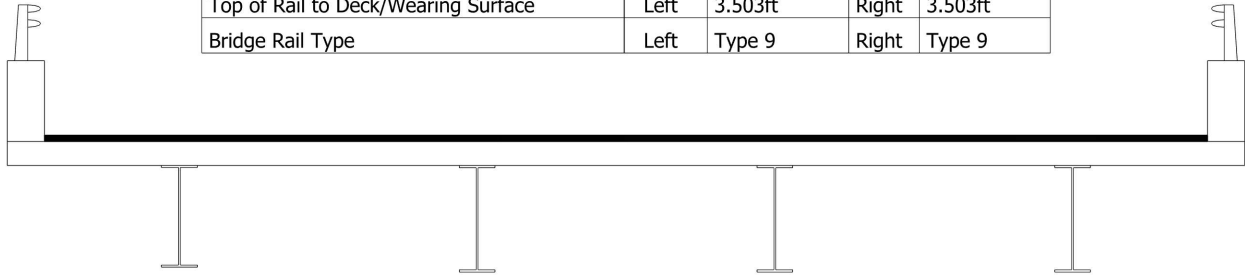
Measurements for Span #	1		
Deck Thickness	7.75in	Left Overhang	4.625ft
Top of Rail to Bottom of Beam (Avg)	7.113ft	Right Overhang	4.625ft
