NC DEPARTMENT OF TRANSPORTATION
 DIVISION OF HIGHWAYS
 STRUCTURE MANAGEMENT UNIT

ATTENTION: **PAR SUBMITTED**
NEW REPAIRS ON RAILS
TEMPORARY REPAIRS ON BEAMS

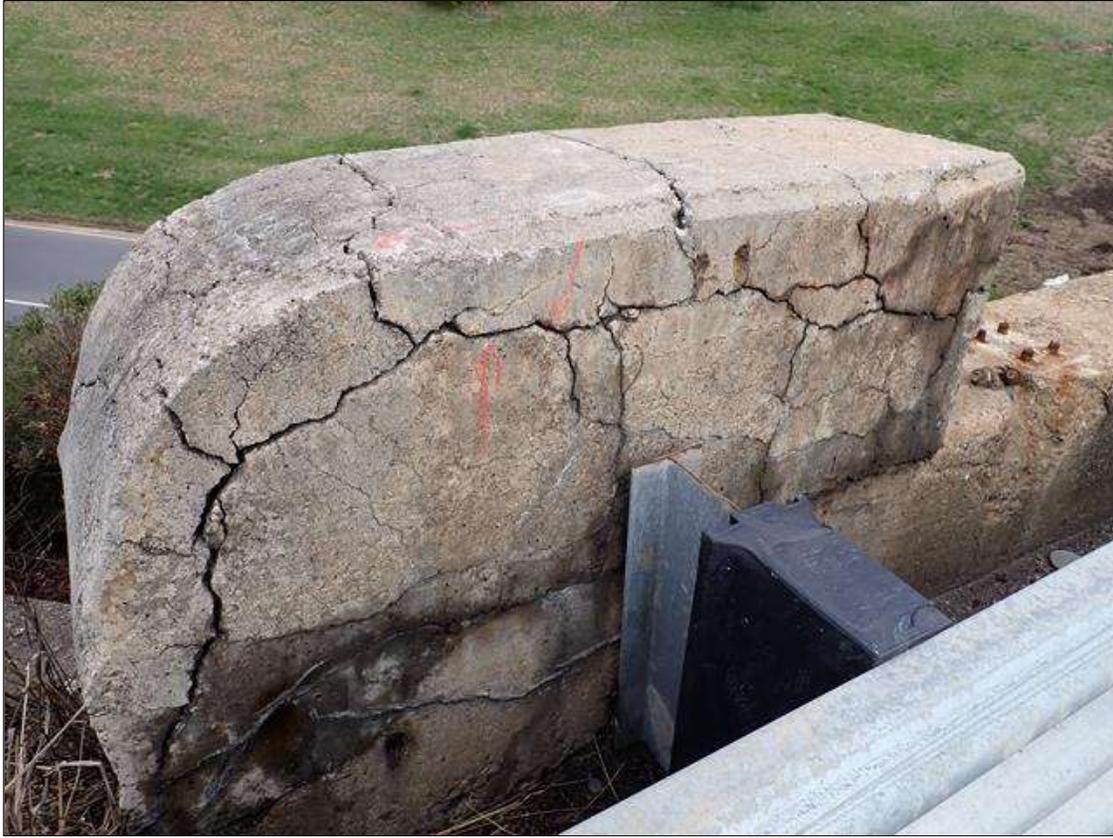
Span 1 Left Bridge Rail: AT END BENT 1, 20 SF MAP CRACKING UP TO 1/2IN WIDE

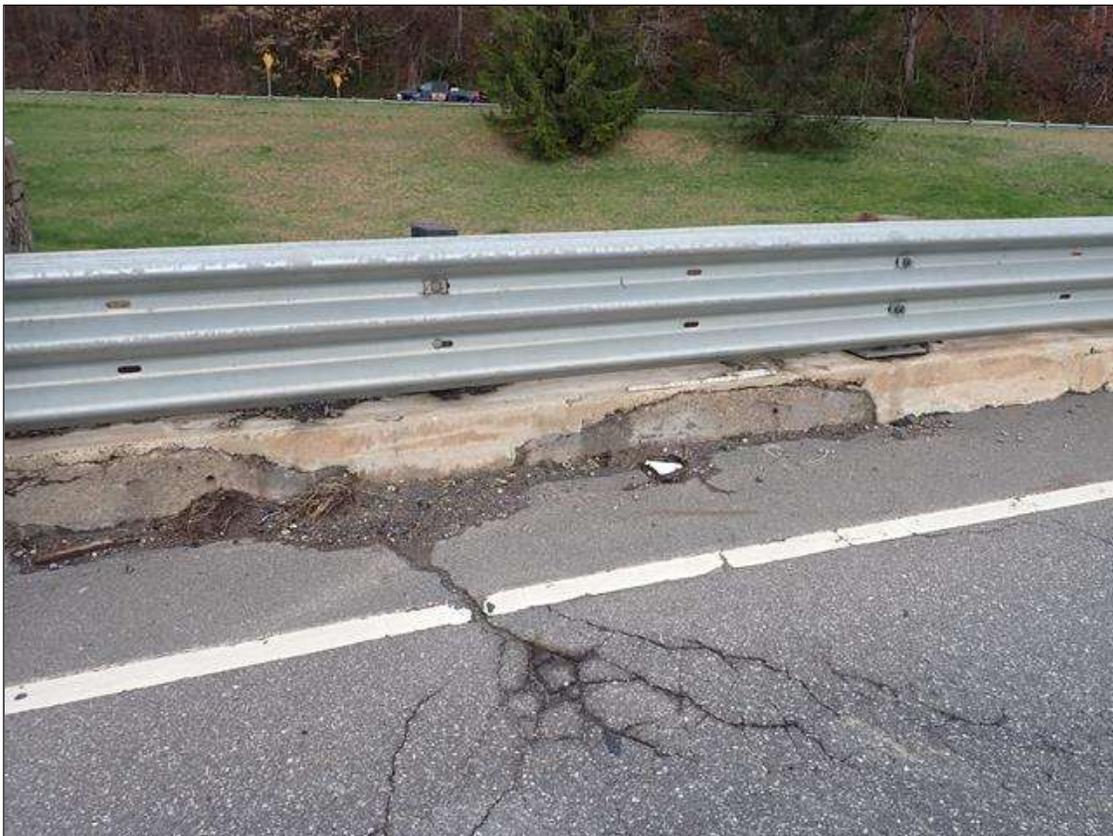
Span 1 Left Bridge Rail: TOP AND EAST FACES OF CURB BEGINNING AT END BENT 1, 42FT X UP TO 16IN X 8IN AREA OF DETETIORATION WITH EXPOSED REINFORCING (NO MEASURABLE LOSS)

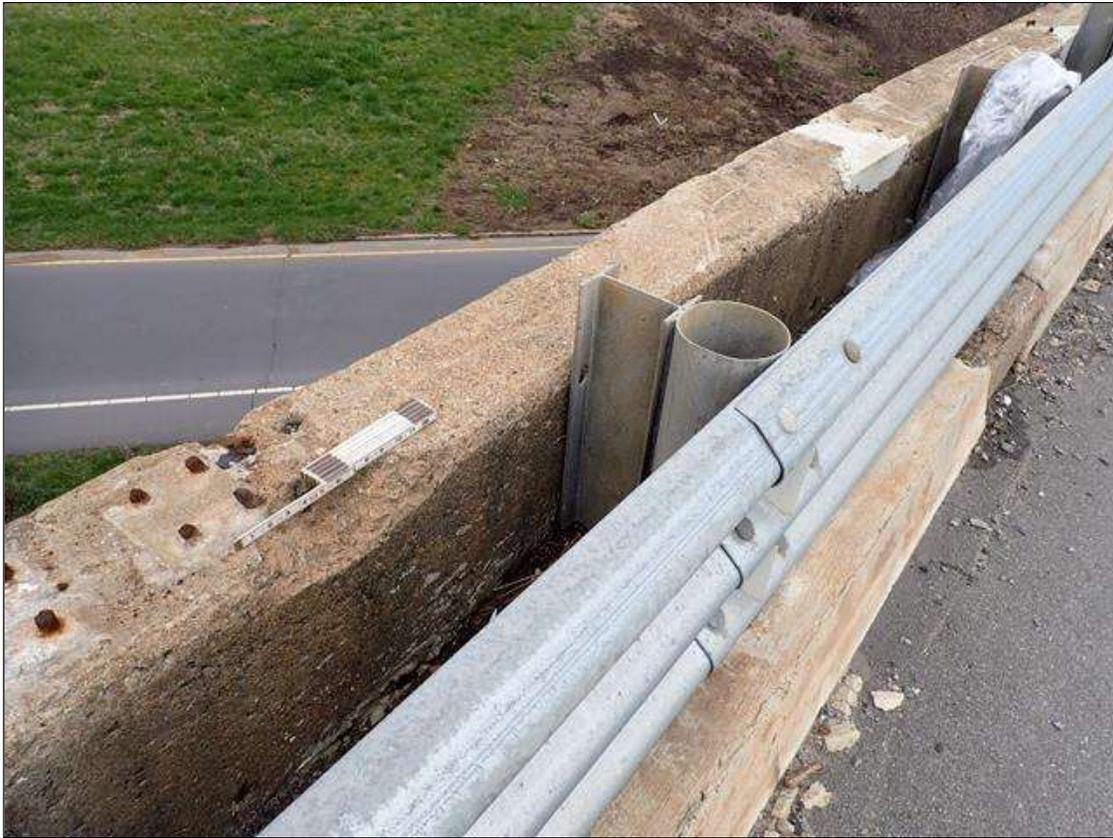
Span 1 Left Bridge Rail: (5) UP TO 2FT X 1FT X 4IN SPALLS AT RANDOM THROUGHOUT TOP OF RAIL, SOME WITH SOUND PATCHED AREAS

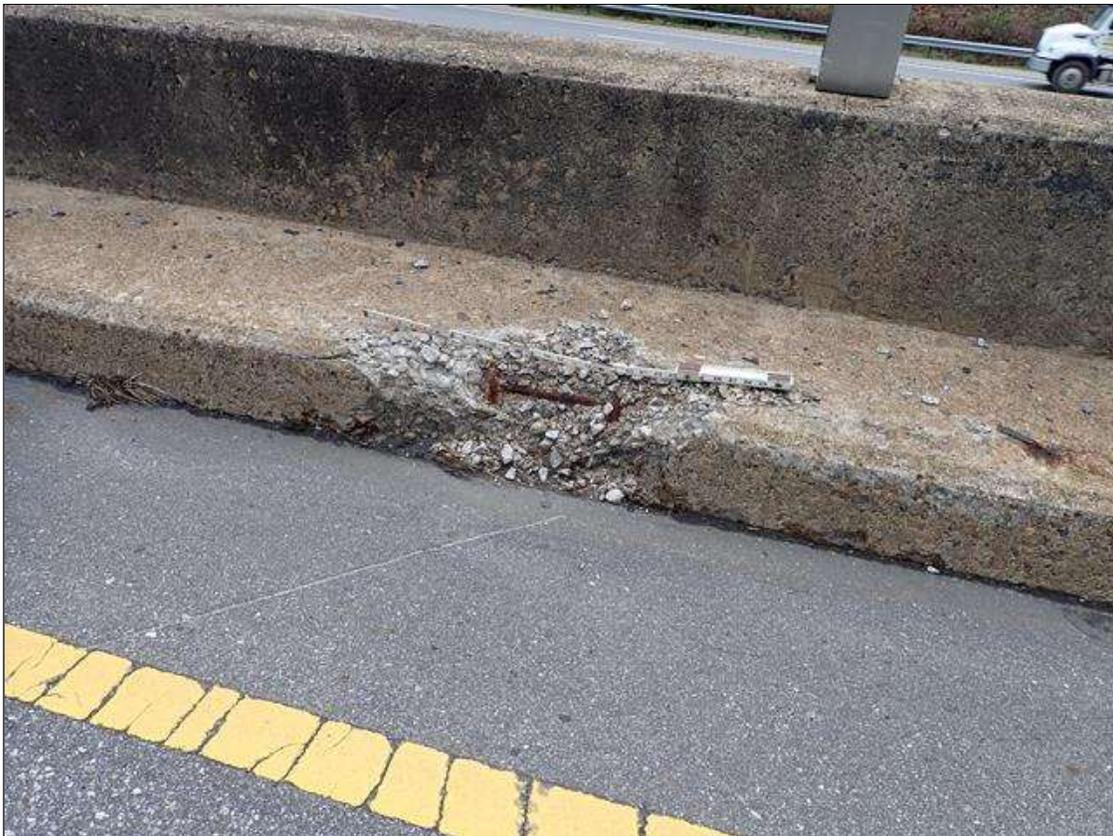
Span 1 Right Bridge Rail: TOP AND WEST FACE OF CURB 5FT FROM BENT 1, 20IN X 8IN X UP TO 8IN SPALL WITH EXPOSED RUSTED REBAR (NO MEASURABLE LOSS)

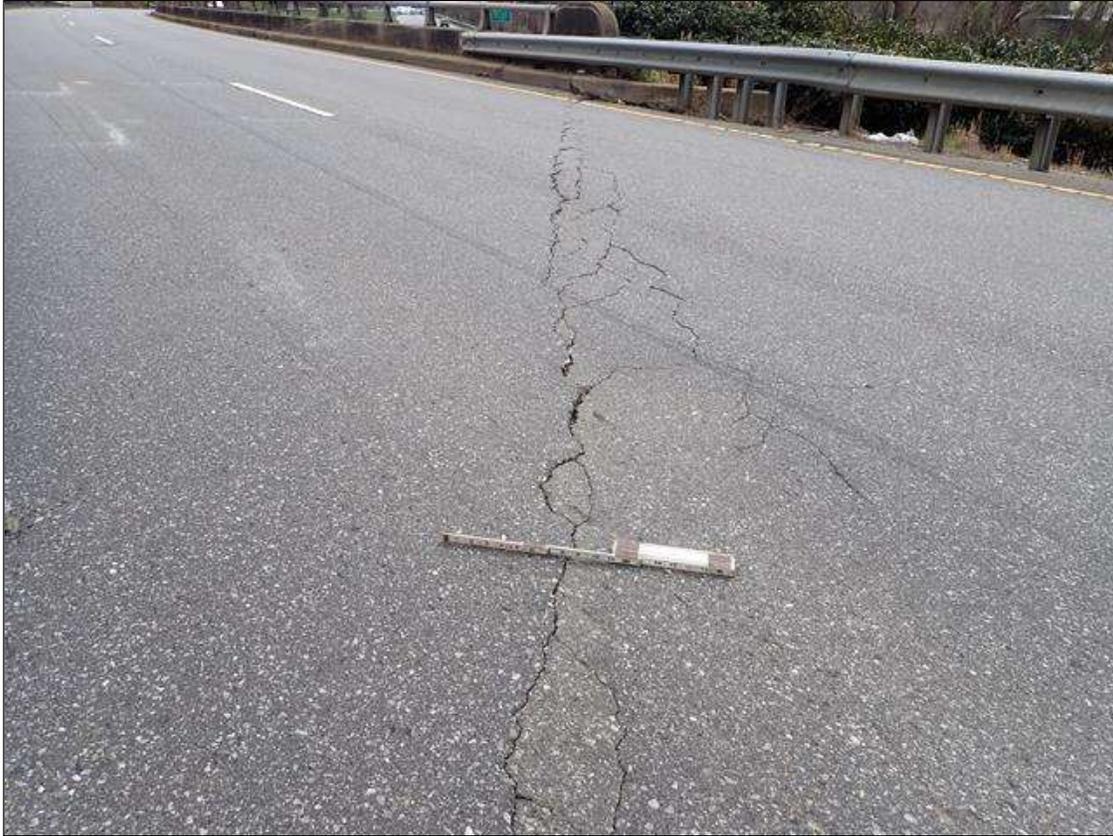
Span 1 Wearing Surface: AT END BENT 1, FULL WIDTH TRANSVERSE CRACK UP TO 1/8IN WIDE

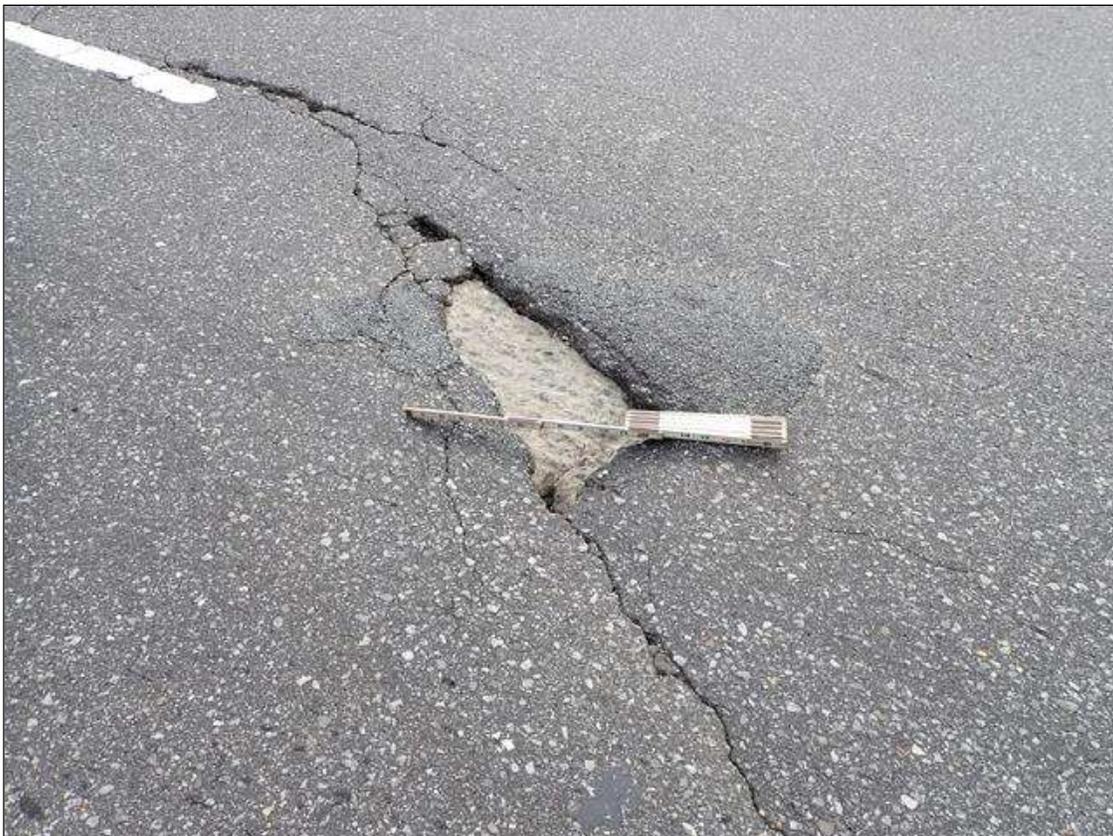
Span 1 Wearing Surface: 50FT FROM END BENT 1, WEST LANE, 8FT OF TRANSVERSE CRACKING UP TO 1/8IN WIDE WITH A POTHOLE (20IN X 4IN X 1/2IN DEEP)

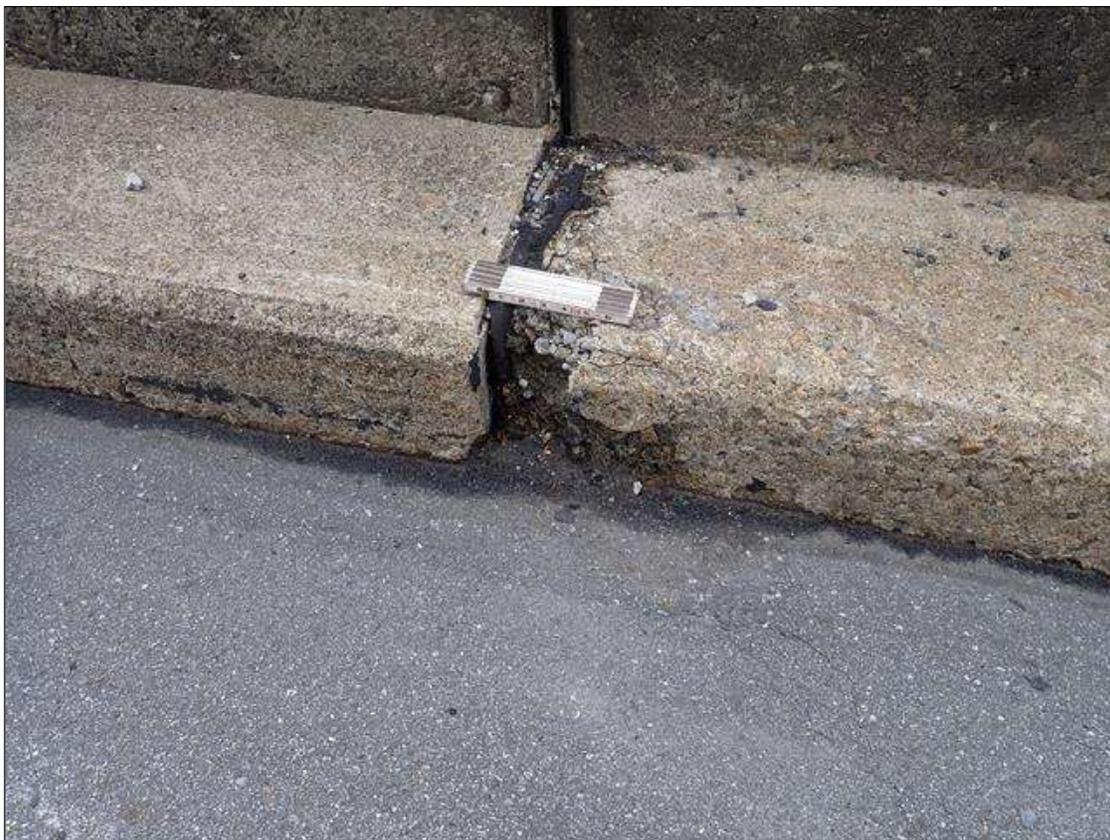
Span 1 Right Bridge Rail: CURB AT BENT 1, WEST FACE, SPALL (8IN X 4IN X UP TO 3IN)

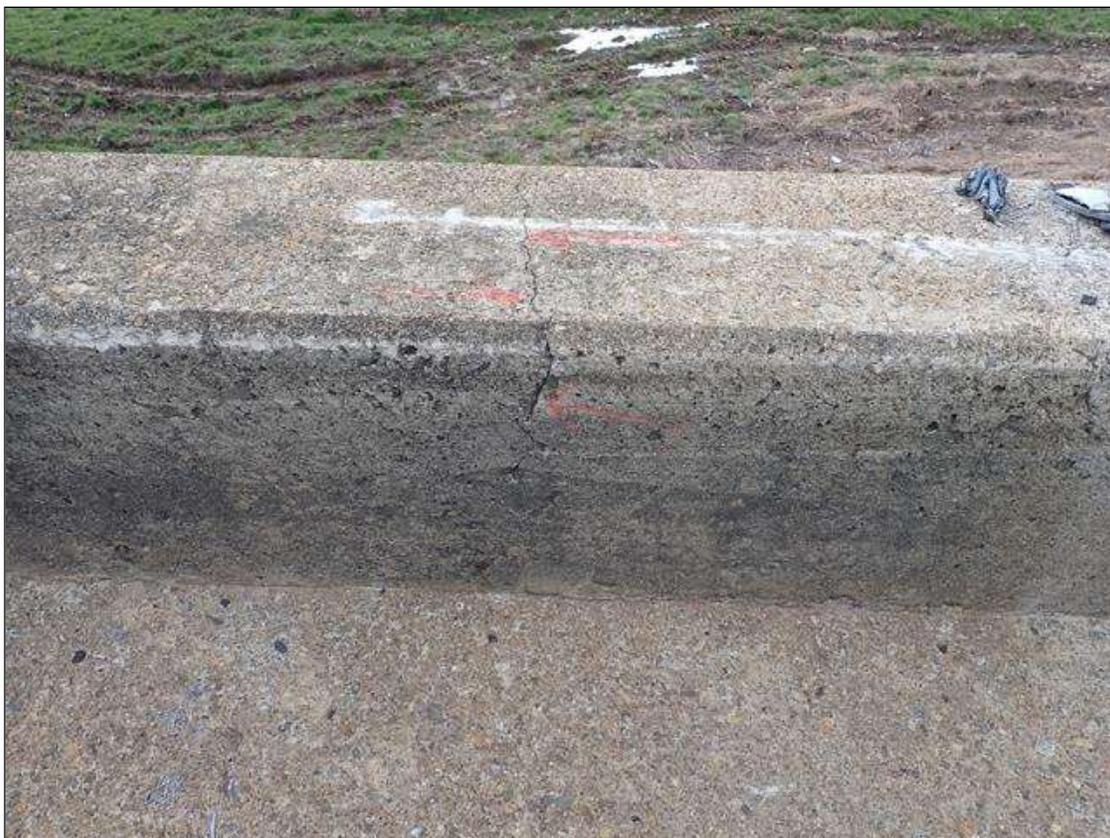
Span 1 Right Bridge Rail: (8) UP TO 1/16IN WRAP AROUND CRACKS AT RANDOM THROUGHOUT

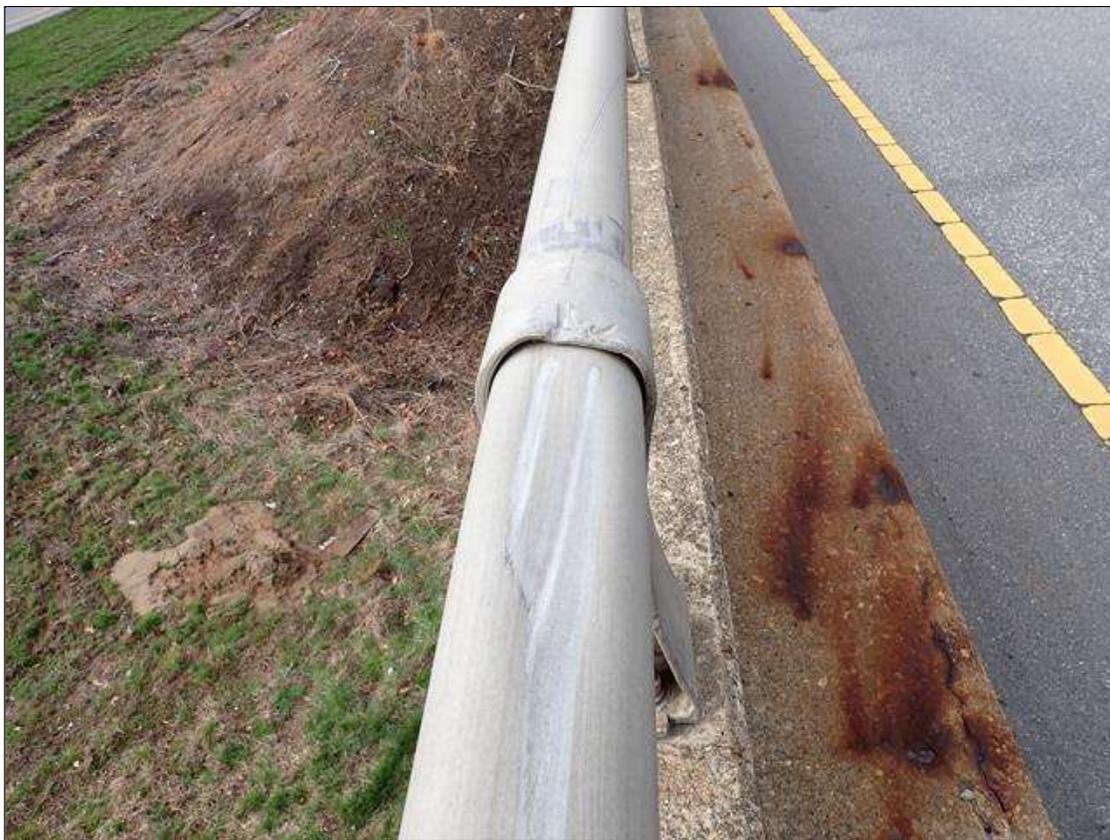
Span 2 Right Bridge Rail: METAL RAIL NEAR MID SPAN, 20FT OF DAMAGE AND SCRAPING

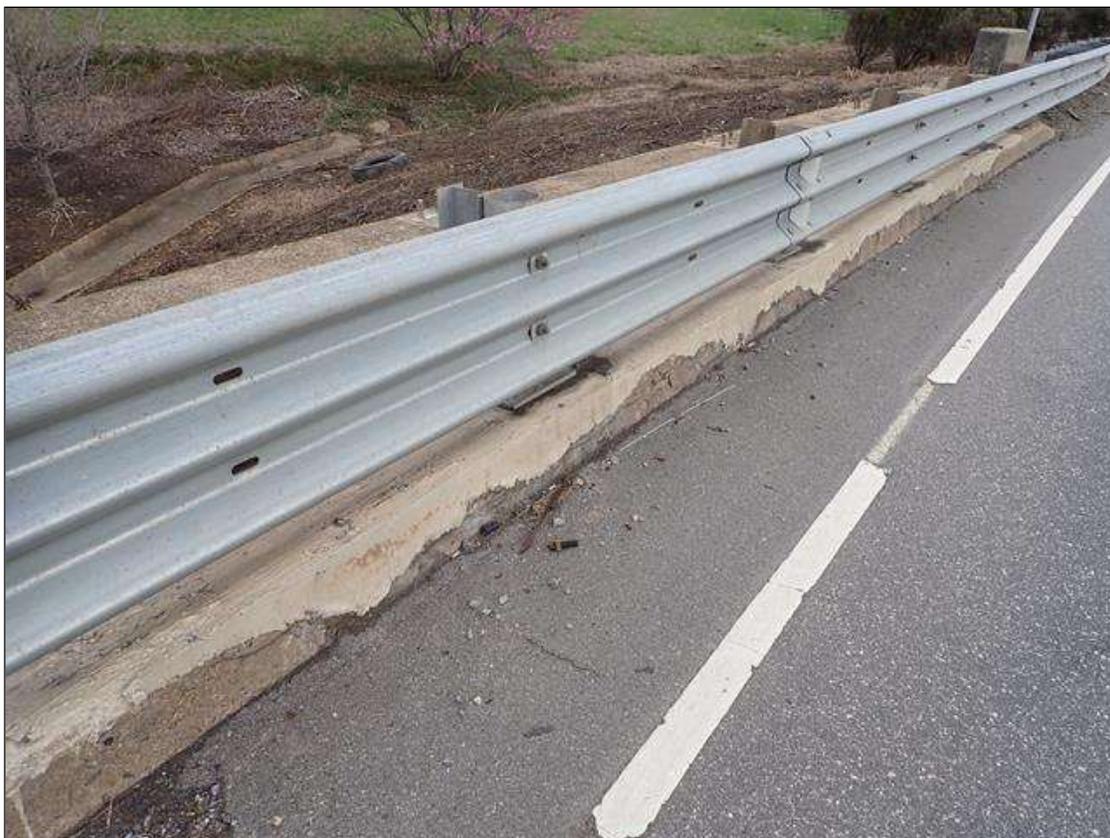
Span 4 Left Bridge Rail: (repaired as of 2023-03-13) TOP AND EAST FACES OF CURB BEGINNING 8FT FROM END BENT 2, 26FT X 14IN X UP TO 8IN AREA OF DETERIORATION

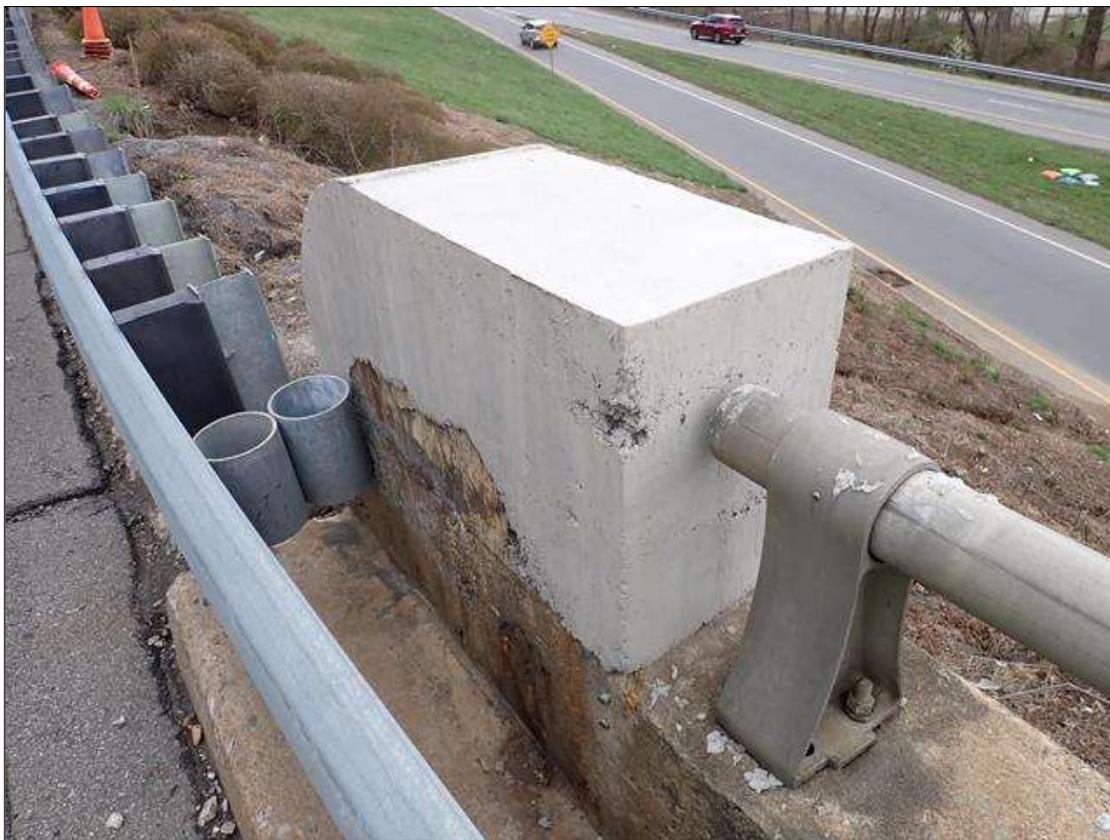
Span 4 Right Bridge Rail: (repaired as of 2023-03-13) NORTHEAST CORNER OF RAIL AT END BENT 2, 4SF MAP
CRACKING UP TO 1/4IN

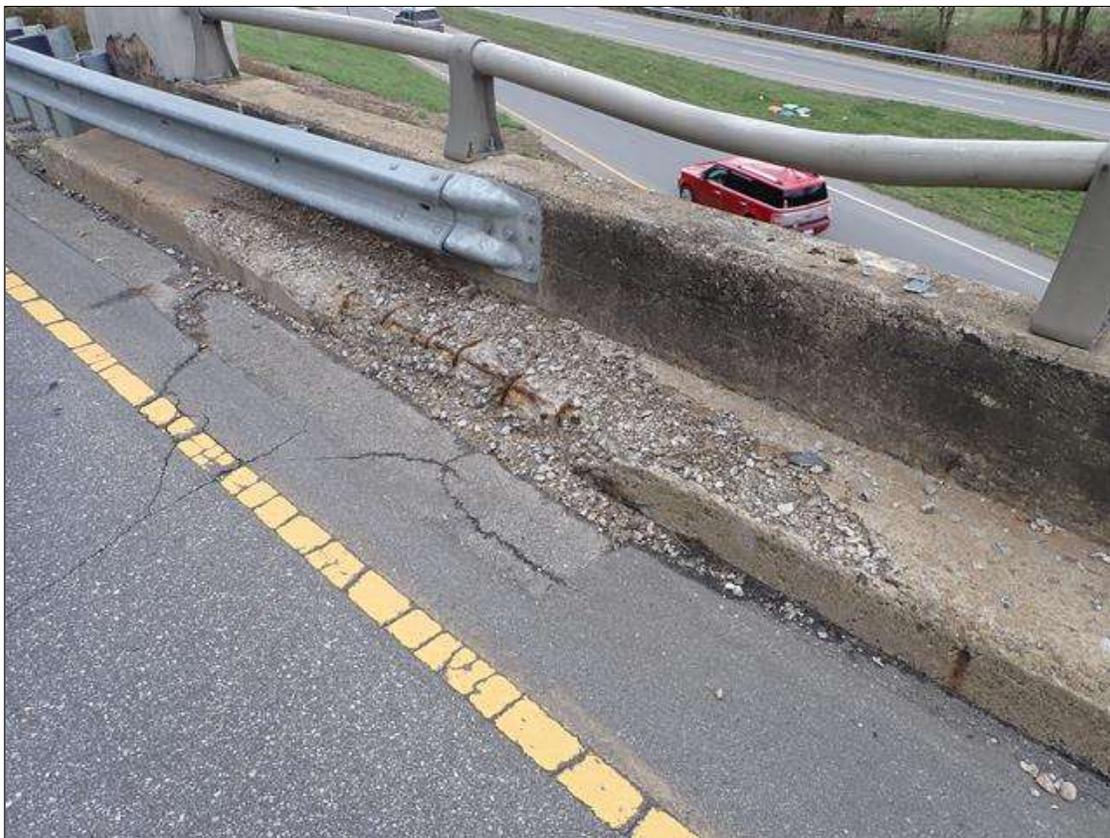
Span 4 Right Bridge Rail: BEGINNING 5FT FROM END BENT 2, 10FT X 8IN X UP TO 1FT AREA OF
DETERIORATION WITH EXPOSED REBAR (NO MEASURABLE LOSS)

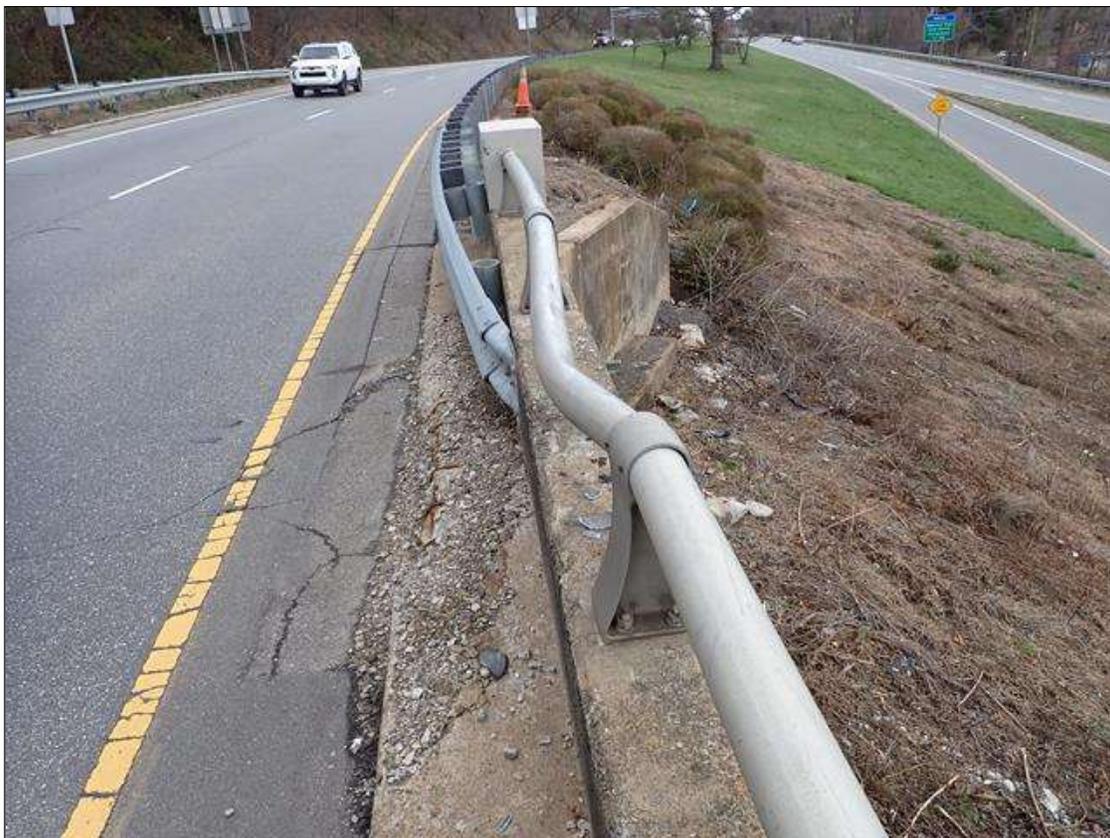
Span 4 Right Bridge Rail: 5ft from end bent 2, damage to metal pipe rail with distortion up to 3in

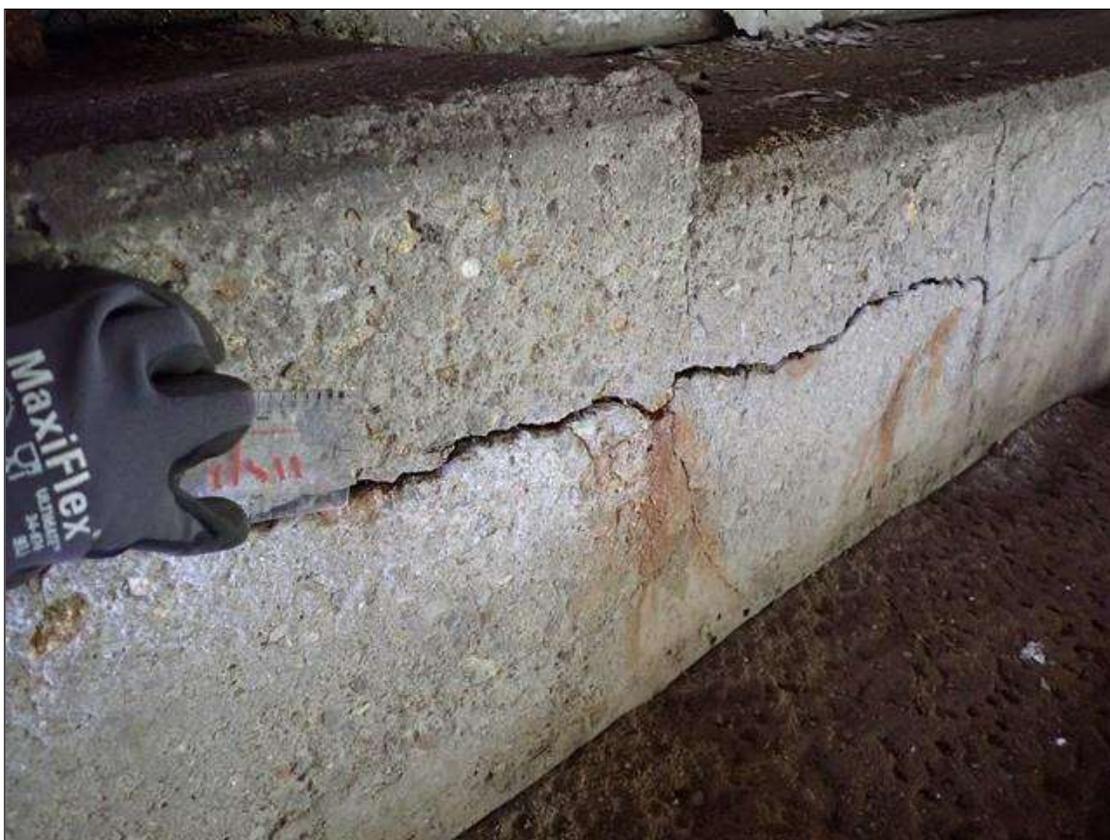
End Bent 1 Cap 1: NORTH FACE OF CAP, HORIZONTAL CRACKING (FULL LENGTH OF CAP X UP TO 1/2IN WIDE)

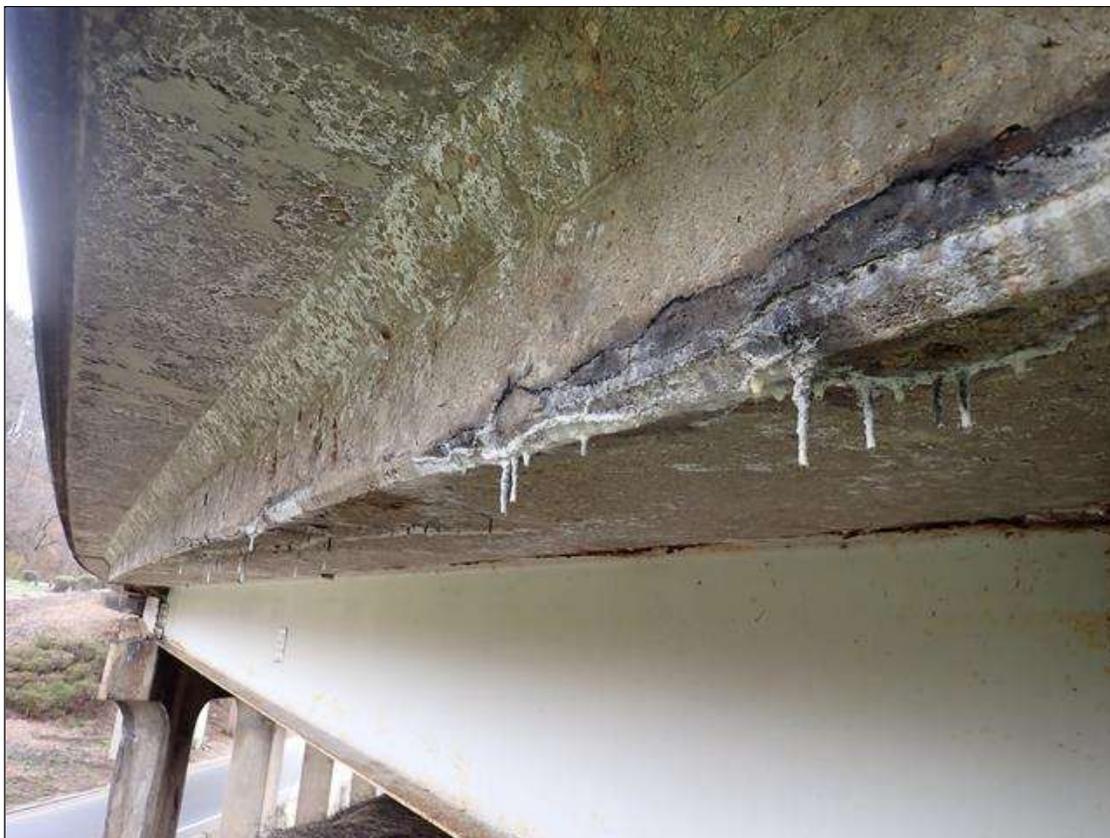
Span 1 Deck: LEFT OVERHANG BEGINNING AT END BENT 1, 20SF MAP CRACKING UP TO 1/16IN WITH HEAVY EFFLORESCENCE BUILDUP WITH STALACTITES

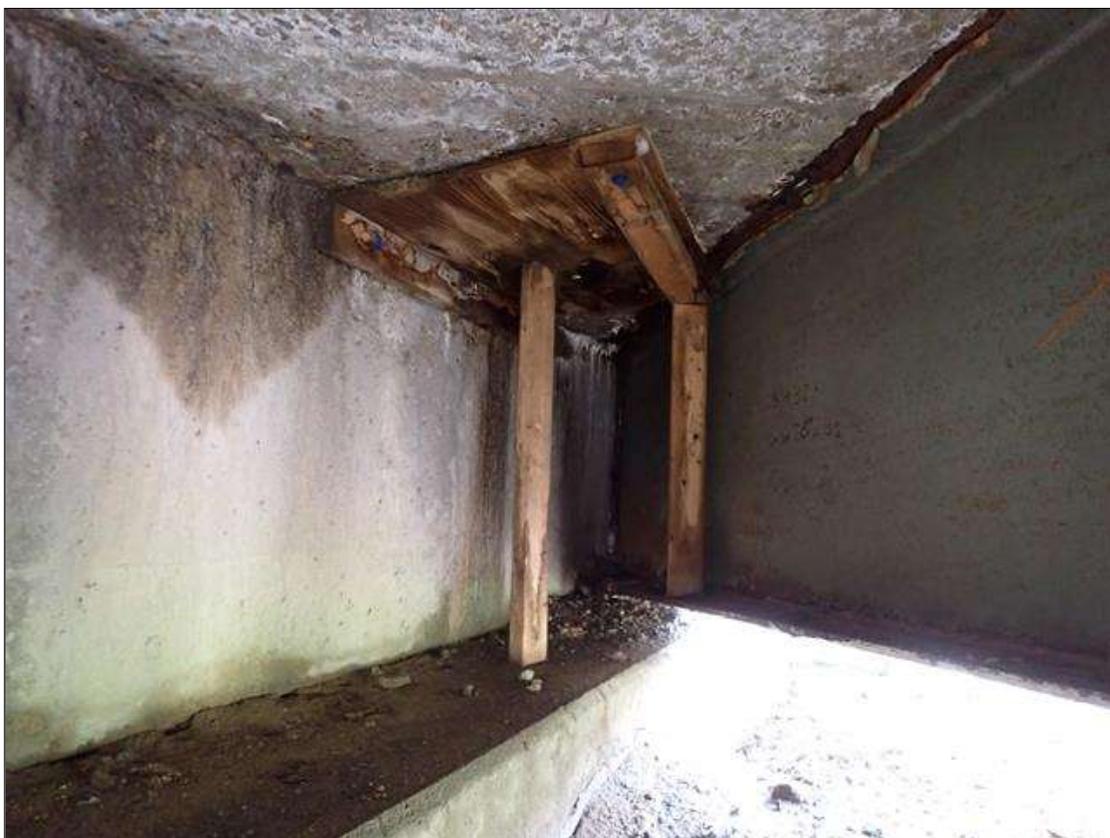
Span 1 Deck: BAY 1 AT ABUTMENT 1, 18IN LONG X 3FT WIDE SOUND PATCH. WOODEN FORMWORK IN PLACE

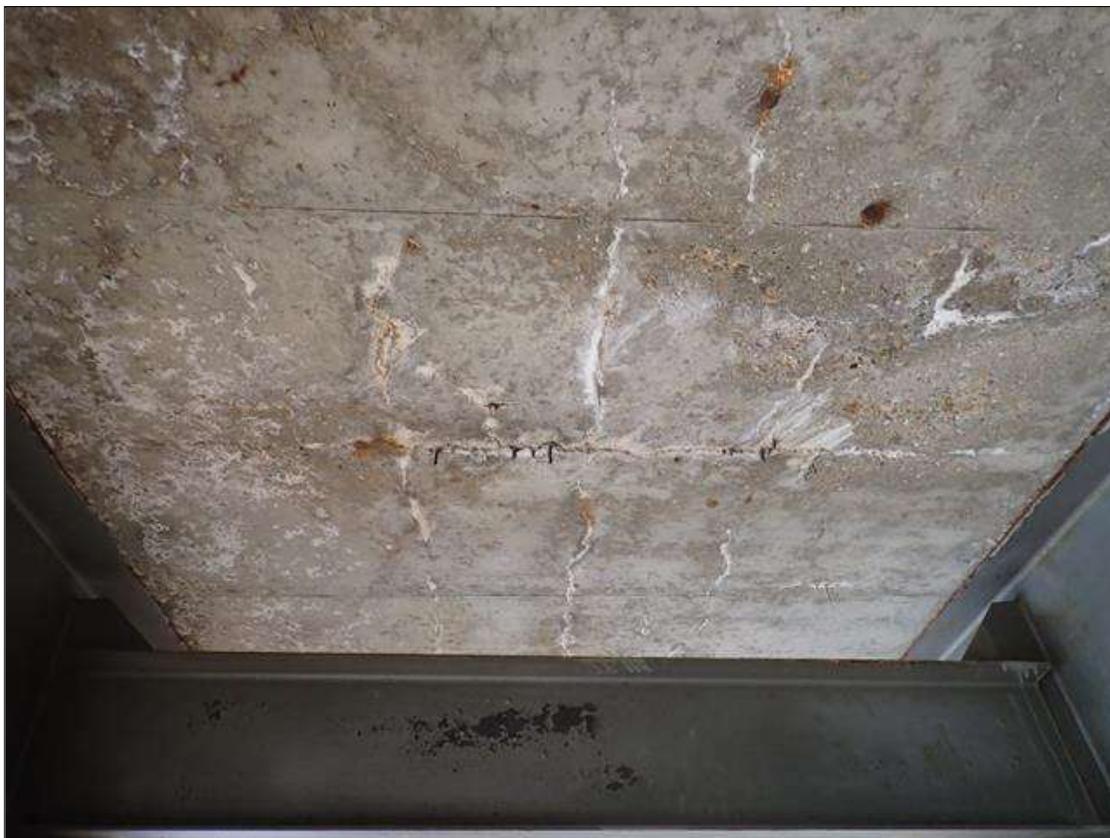
Span 1 Deck: UNDERSIDE, 100SF MAP CRACKING UP TO 1/64IN WITH EFFLORESCENCE BUILDUP AT RANDOM THROUGHOUT

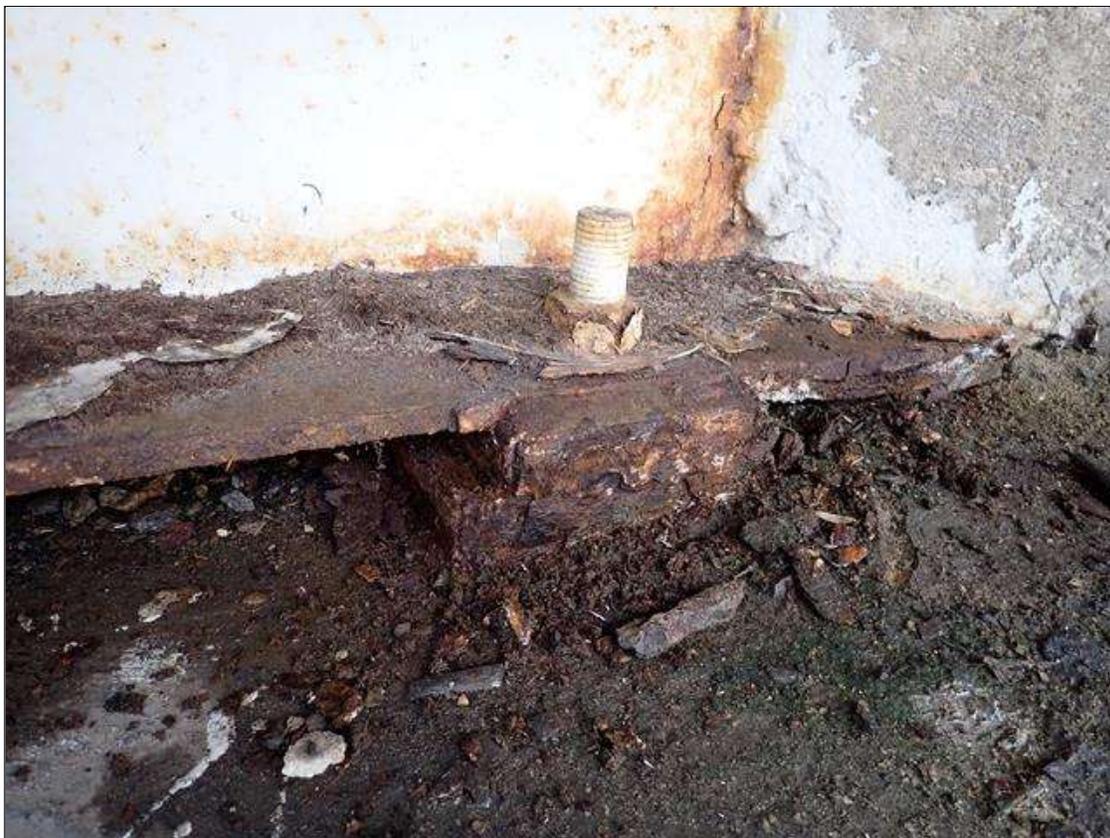
Span 1 Beam 1 - Near Bearing: corrosion with rust scale

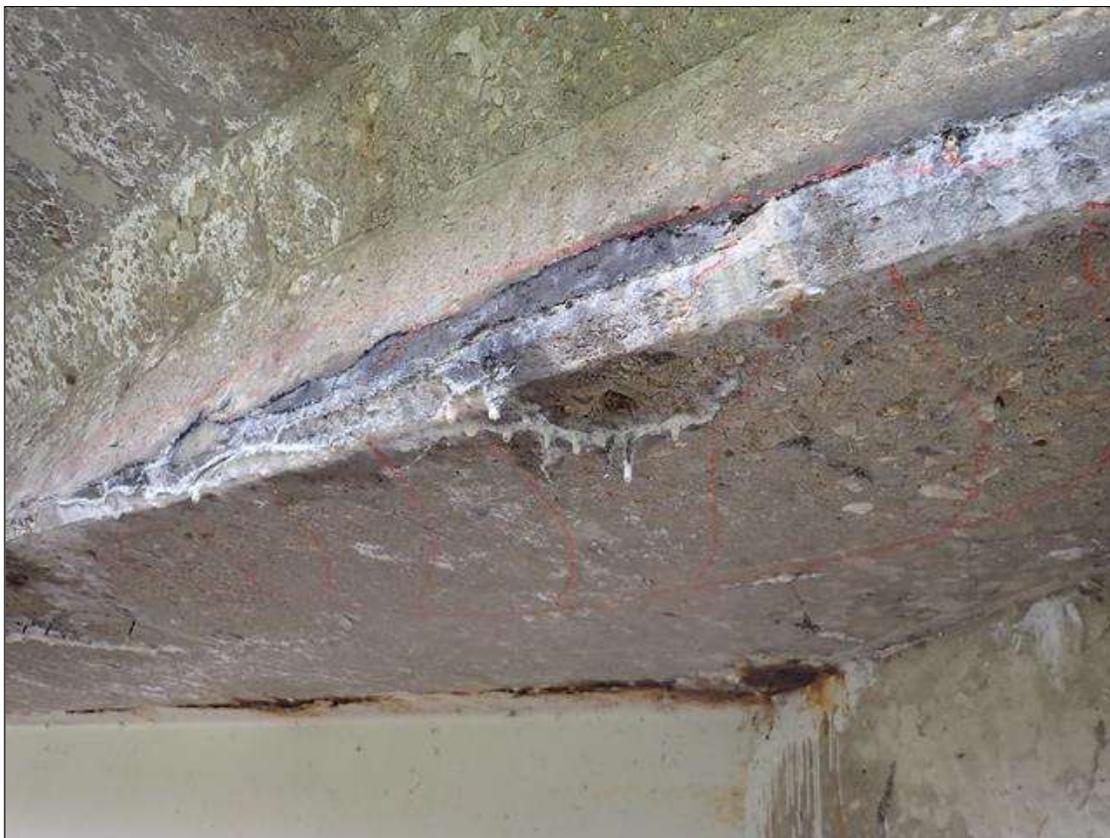
Span 1 Deck: left overhang 5ft from end bent 1, delamination (44in x up to 20in)

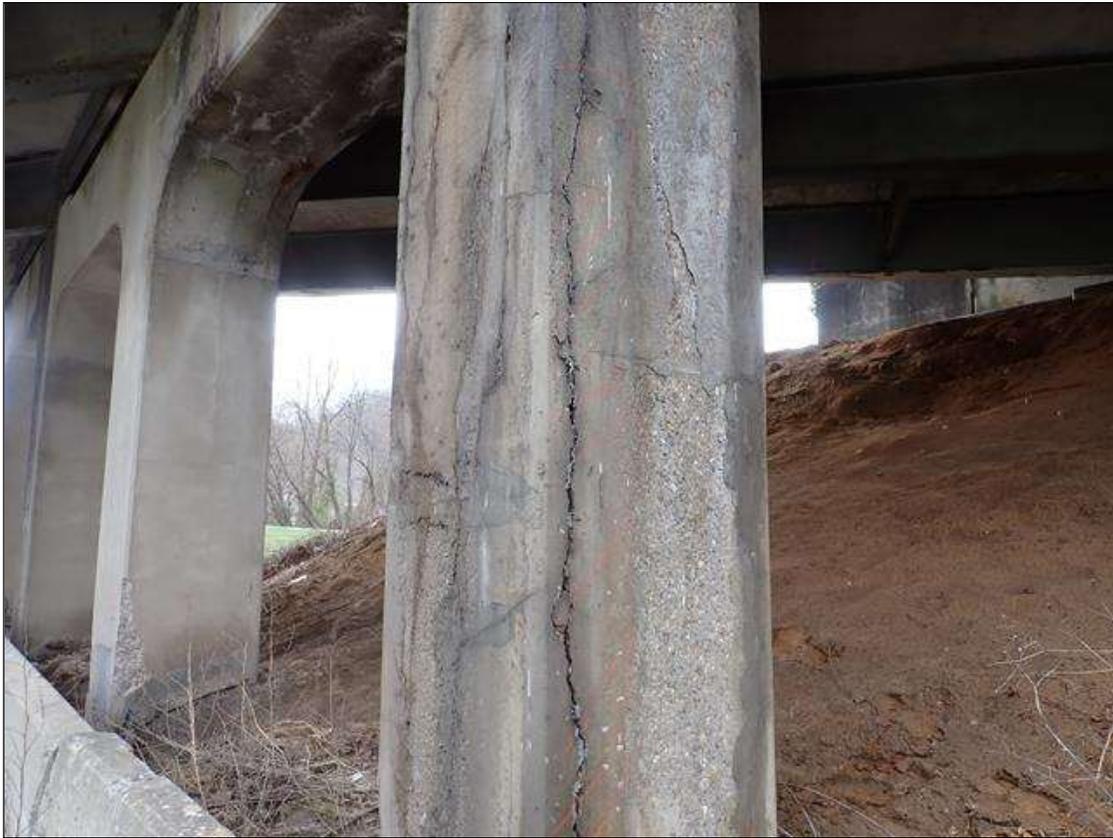
Bent 1 Pile 1: (8) UP TO 10FT X 1/4IN VERTICAL CRACKS WITH ADJACENT DELAMINATIONS 16IN X UP TO 10FT AT RANDOM THROUGHOUT.

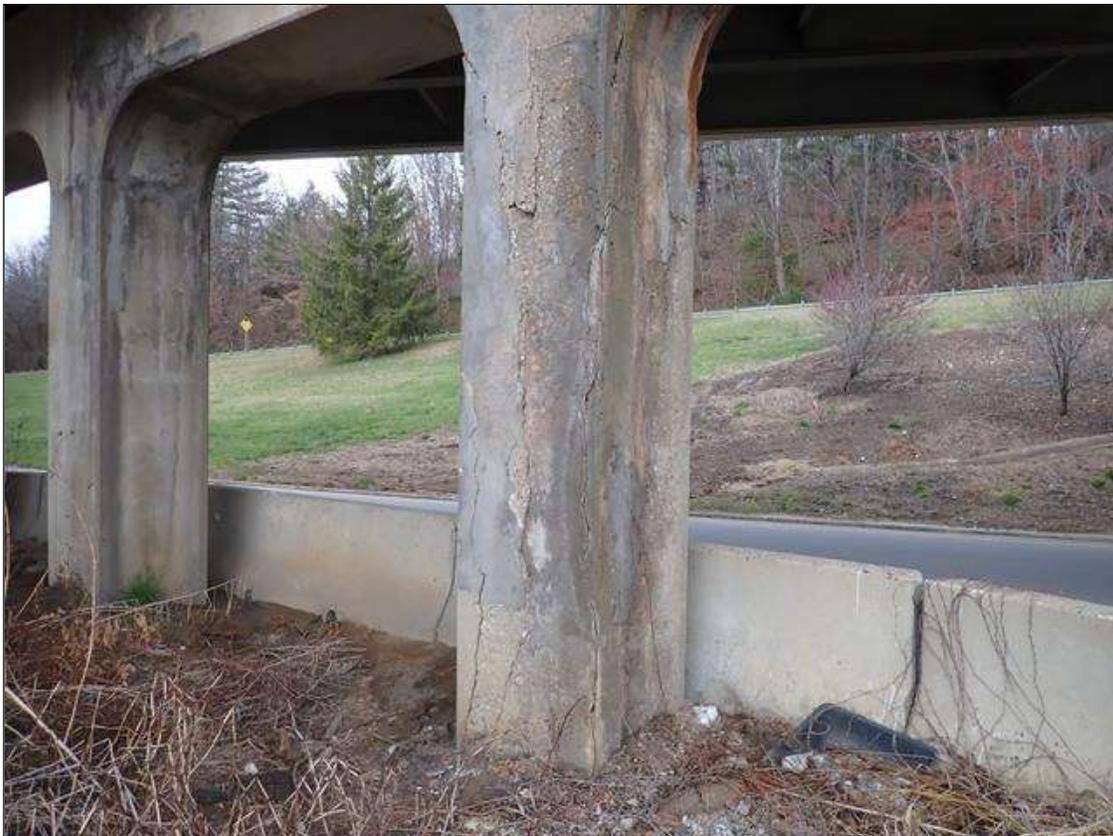
Bent 1 Pile 4: SOUTH AND EAST FACE, FULL HEIGHT AREA OF DELAMINATION UP TO FULL WIDTH. SPALL ON SOUTH FACE AT MIDHEIGHT, 1FT TALL X 6IN WIDE X 2IN DEEP

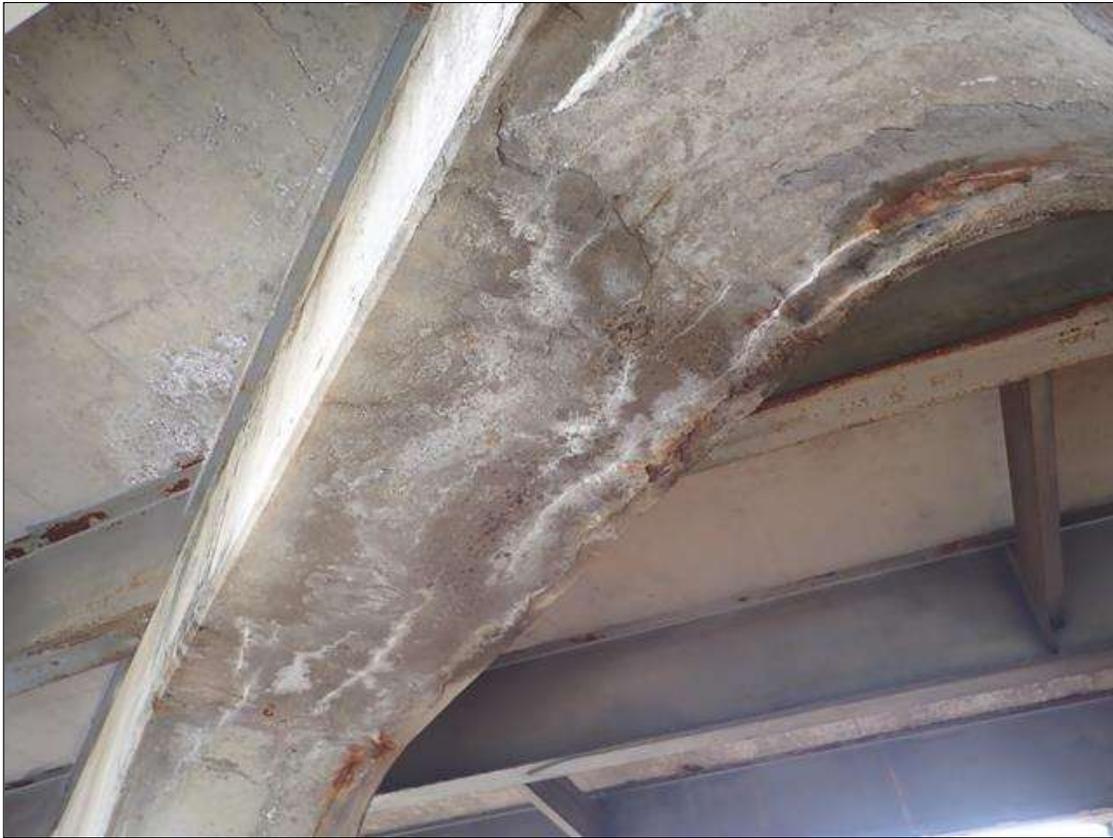
Bent 1 Cap 1: BOTTOM OF CAP BETWEEN PILES 1 AND 2, 10FT X UP TO 33IN AREA OF MAP CRACKING UP TO 1/16IN WIDE WITH HEAVY EFFLORESCENCE AND RUST STAINING

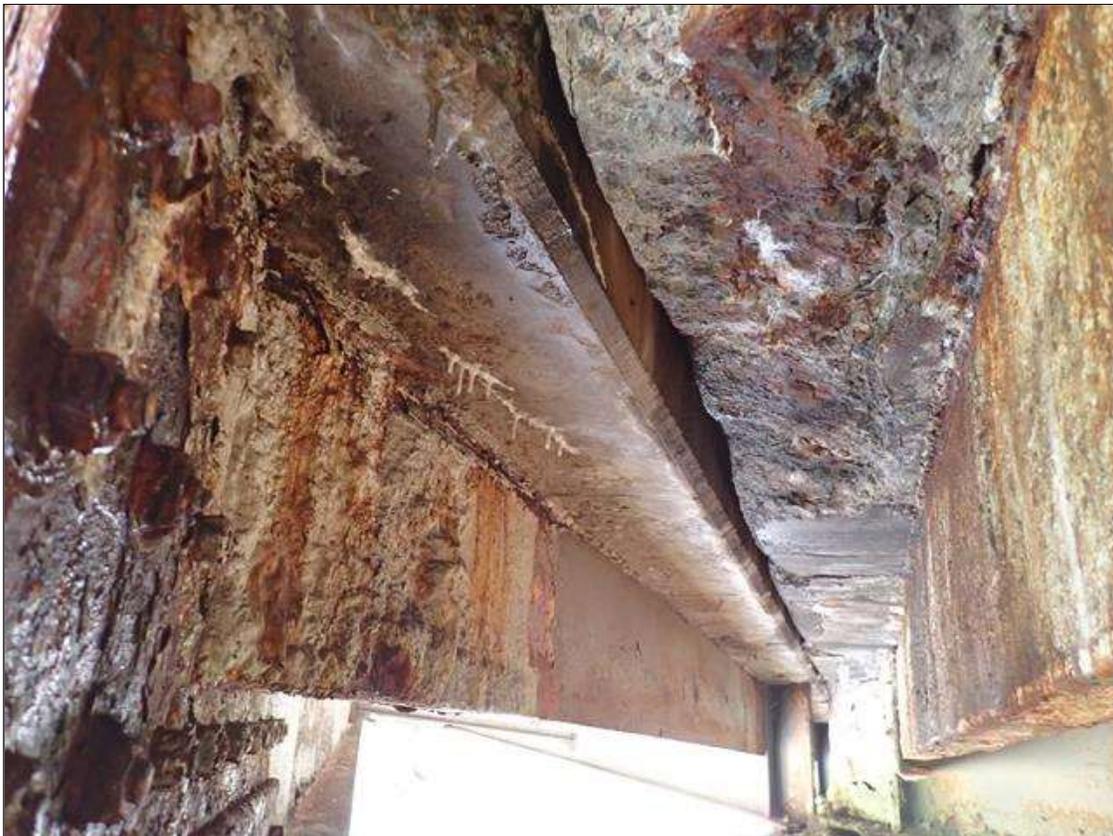
Span 1 Deck: (PAR) WEST OVERHANG EXTERIOR AND BAY 1 DIAPHRAGM AT BENT 1, 10FT WIDE X 1FT LONG X UP TO 3IN DEEP SPALLS WITH EXPOSED REBAR (NO MEASURABLE LOSS) (PHOTO 1 OF 2)

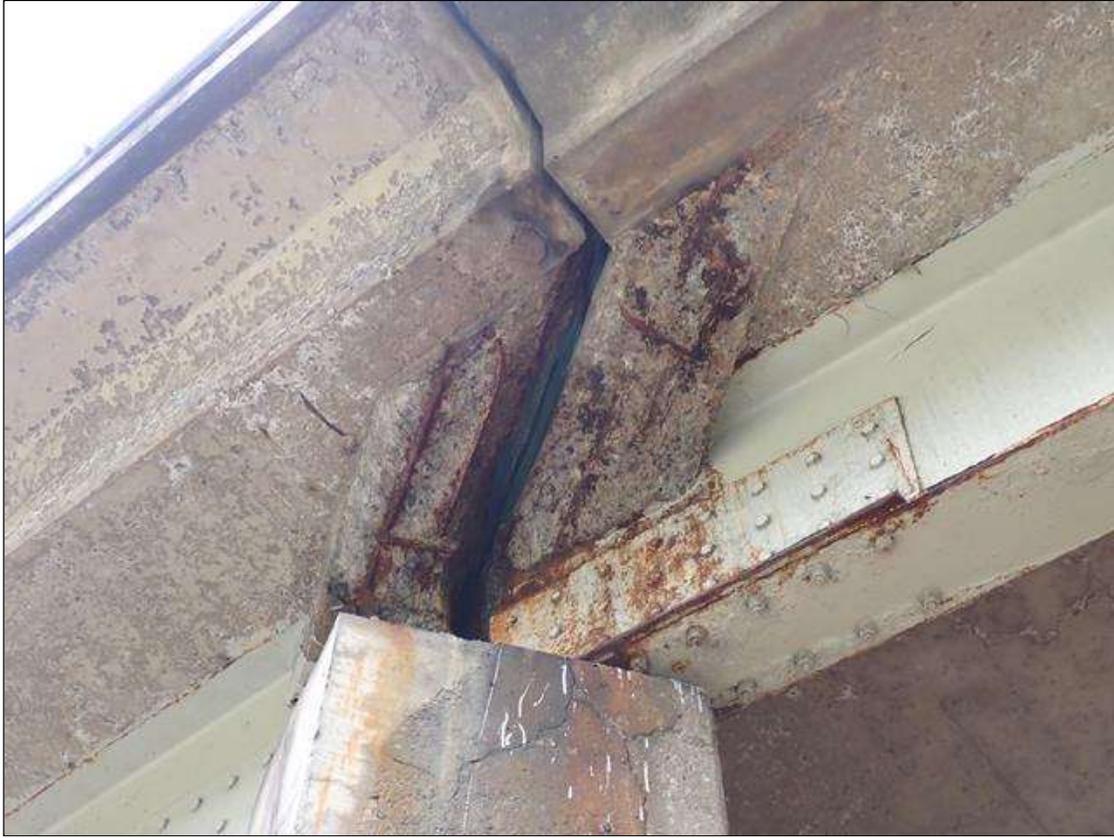
Span 1 Deck: (PAR) WEST OVERHANG EXTERIOR AND BAY 1 DIAPHRAGM AT BENT 1, 10FT WIDE X 1FT LONG X UP TO 3IN DEEP SPALLS WITH EXPOSED REBAR (NO MEASURABLE LOSS) (PHOTO 2 OF 2)
